Assessment of Dam Safety Coal Combustion Surface Impoundments Draft Report

Duke Energy
Buck Steam Station
Spencer, North Carolina

July 13, 2009

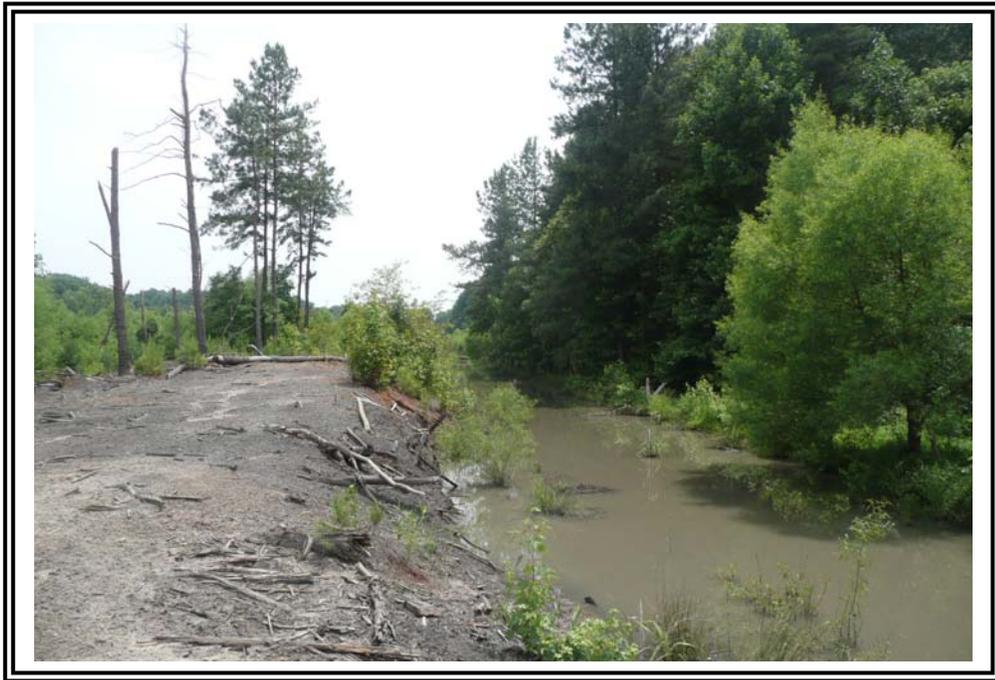
85

Ash Dike to control flows and prevent standing water in area of yard sump discharge.

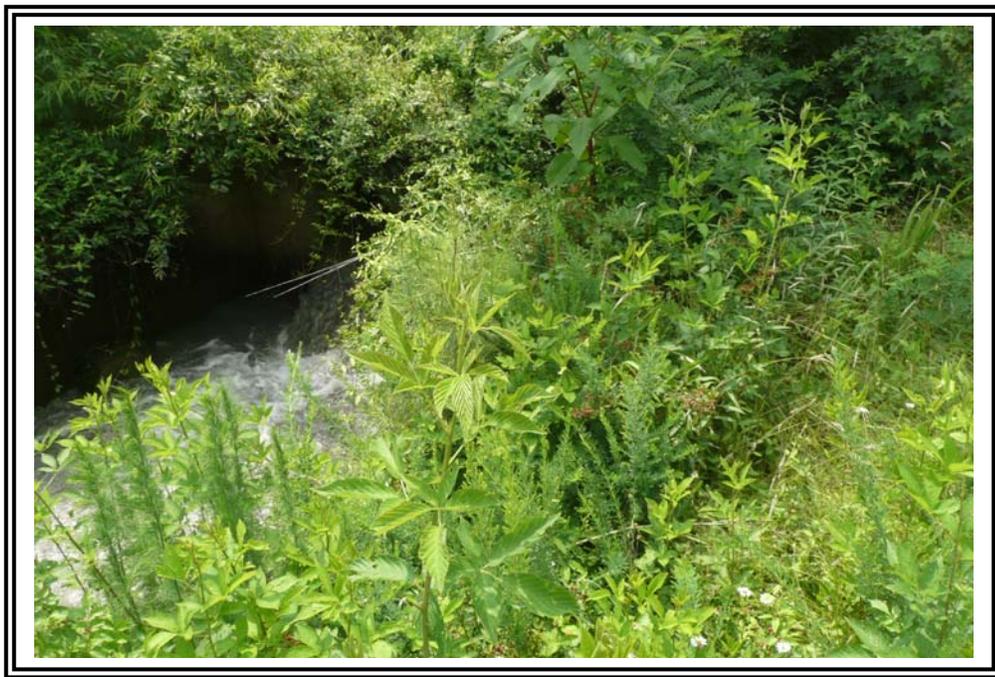
86

Yard sump discharged point on north end of Basin 2.

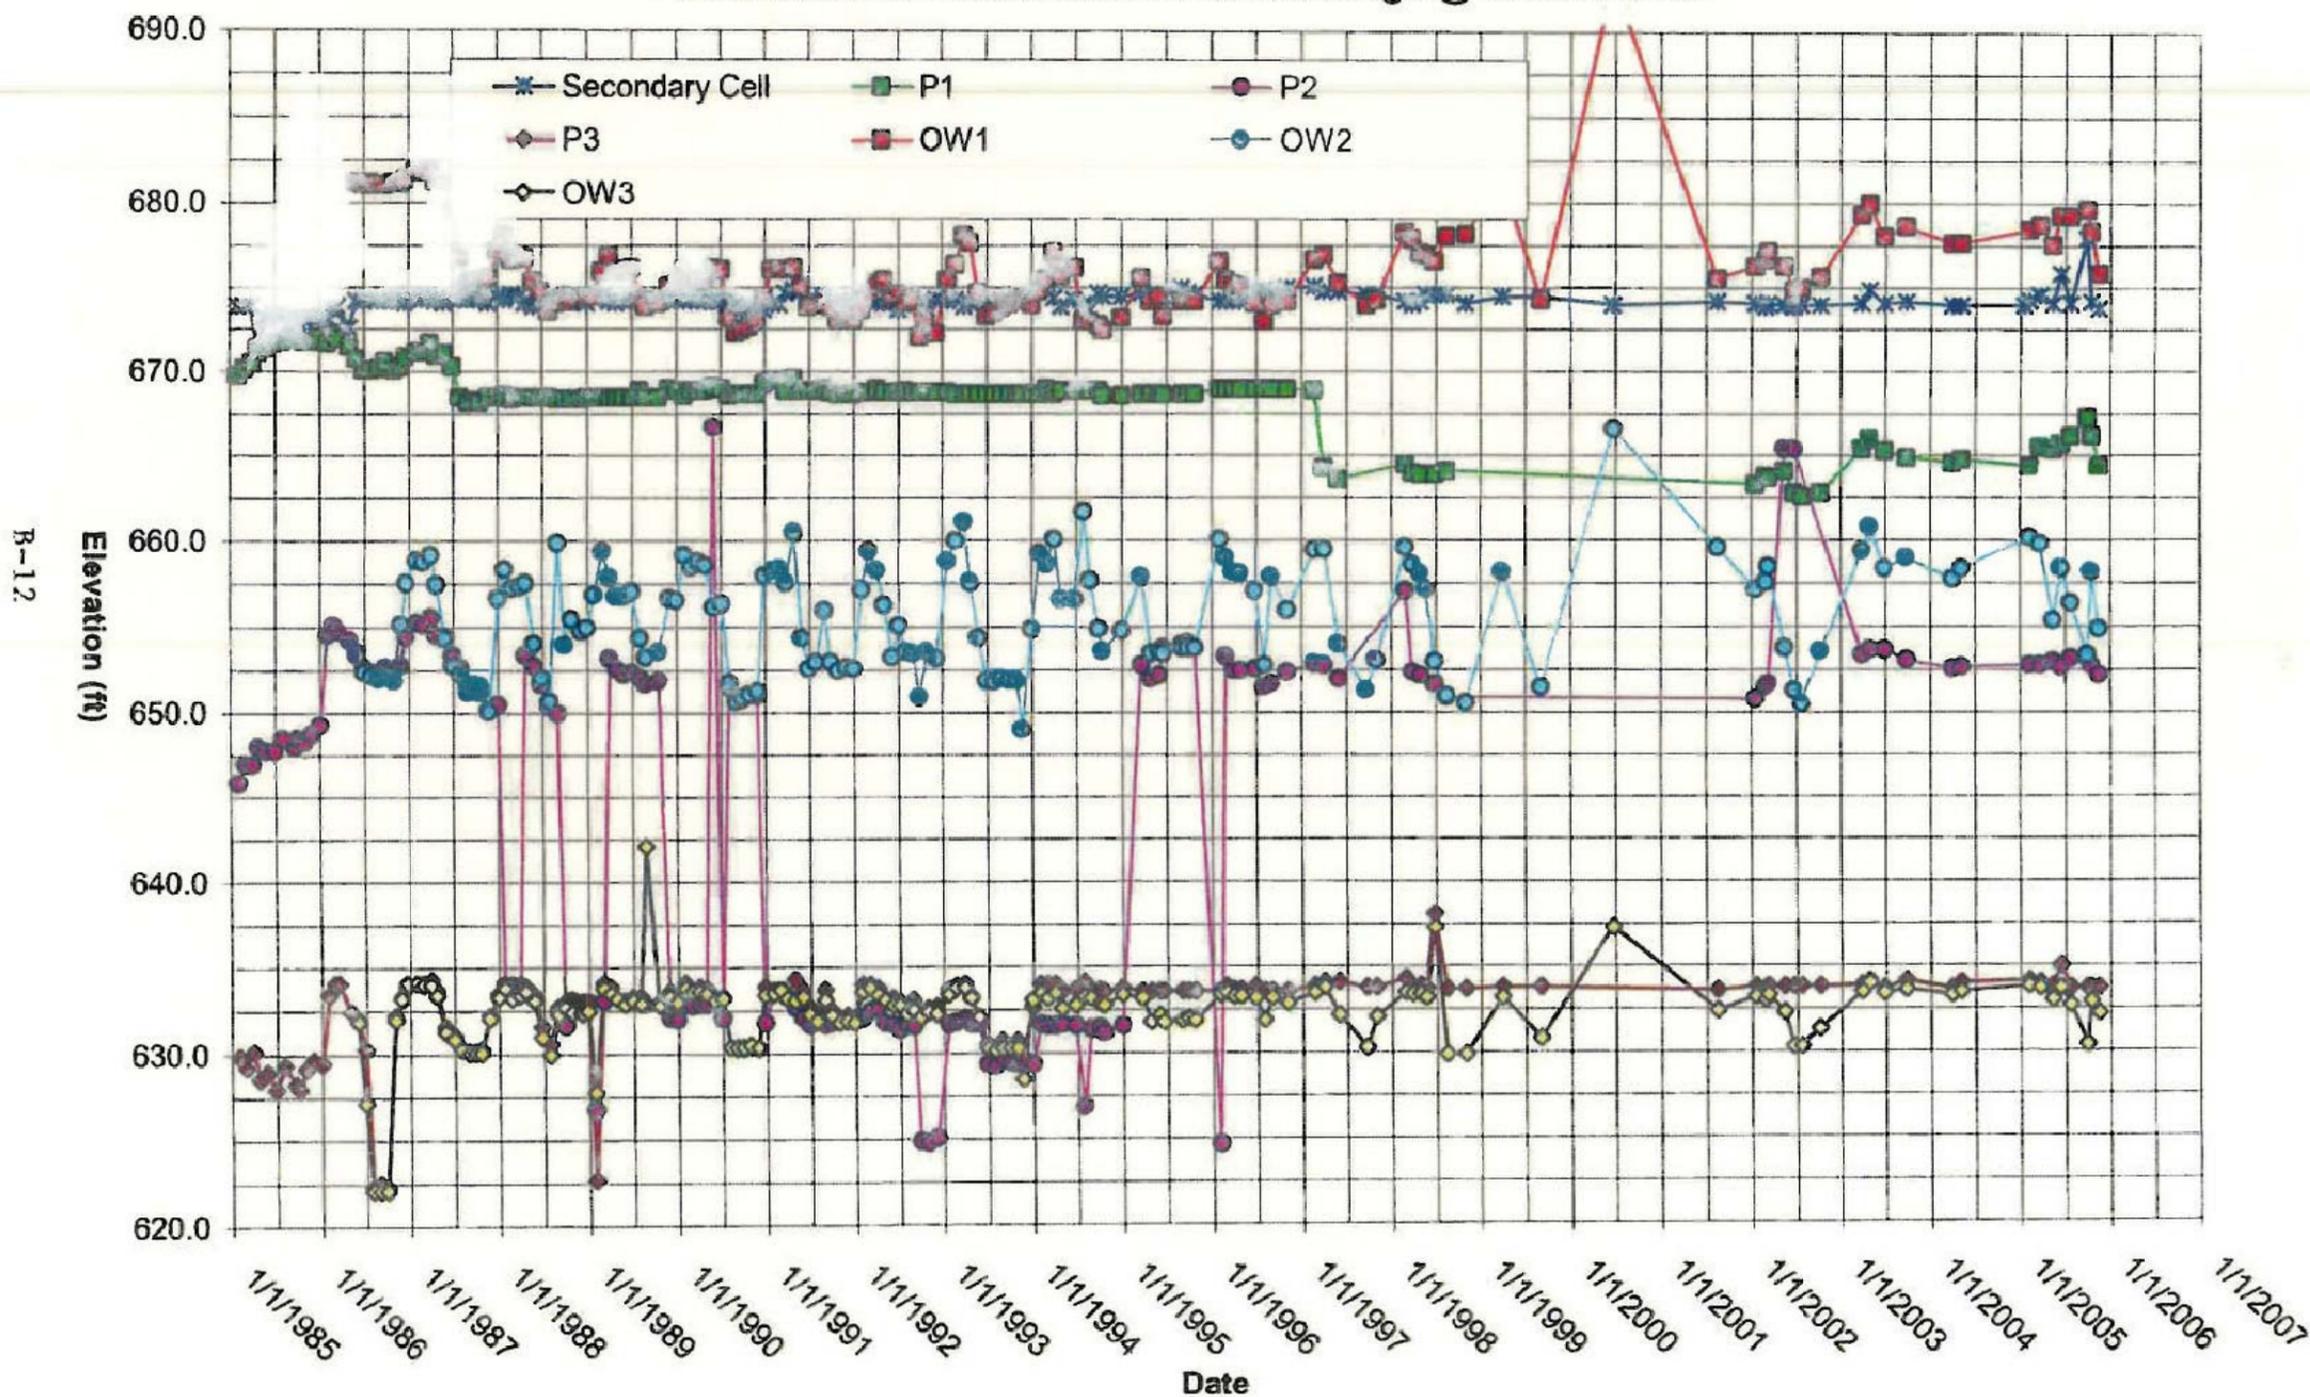
PROJECT NO.
20085.5000
DATE: JULY 2009
FIGURE 8A-1

In February 1996 Stations 5+40 (Primary Cell/Basin 2) and 7+50 (Secondary Cell/Basin 3) of the main dike were analyzed to study the effect of higher pheratic conditions measured since 1986. Station 5+40 exhibited the lowest safety factor with a 1.4 which is below the recommended minimum factor of safety of 1.5. Outputs from these analyses are shown on Figures 16A and 16B.

The steady state analyses in 1996 for the main dike with their minimum safety factors of 1.4 are below the recommended criteria of 1.5, but were reportedly viewed as somewhat conservative because they assume hydrostatic uplift conditions below the pheratic surface, whereas there is evidence from the instrumentation that uplift conditions at depth are somewhat below hydrostatic. Additional piezometers were installed after the fourth independent inspection report to verify uplift conditions at depth in the main dike.

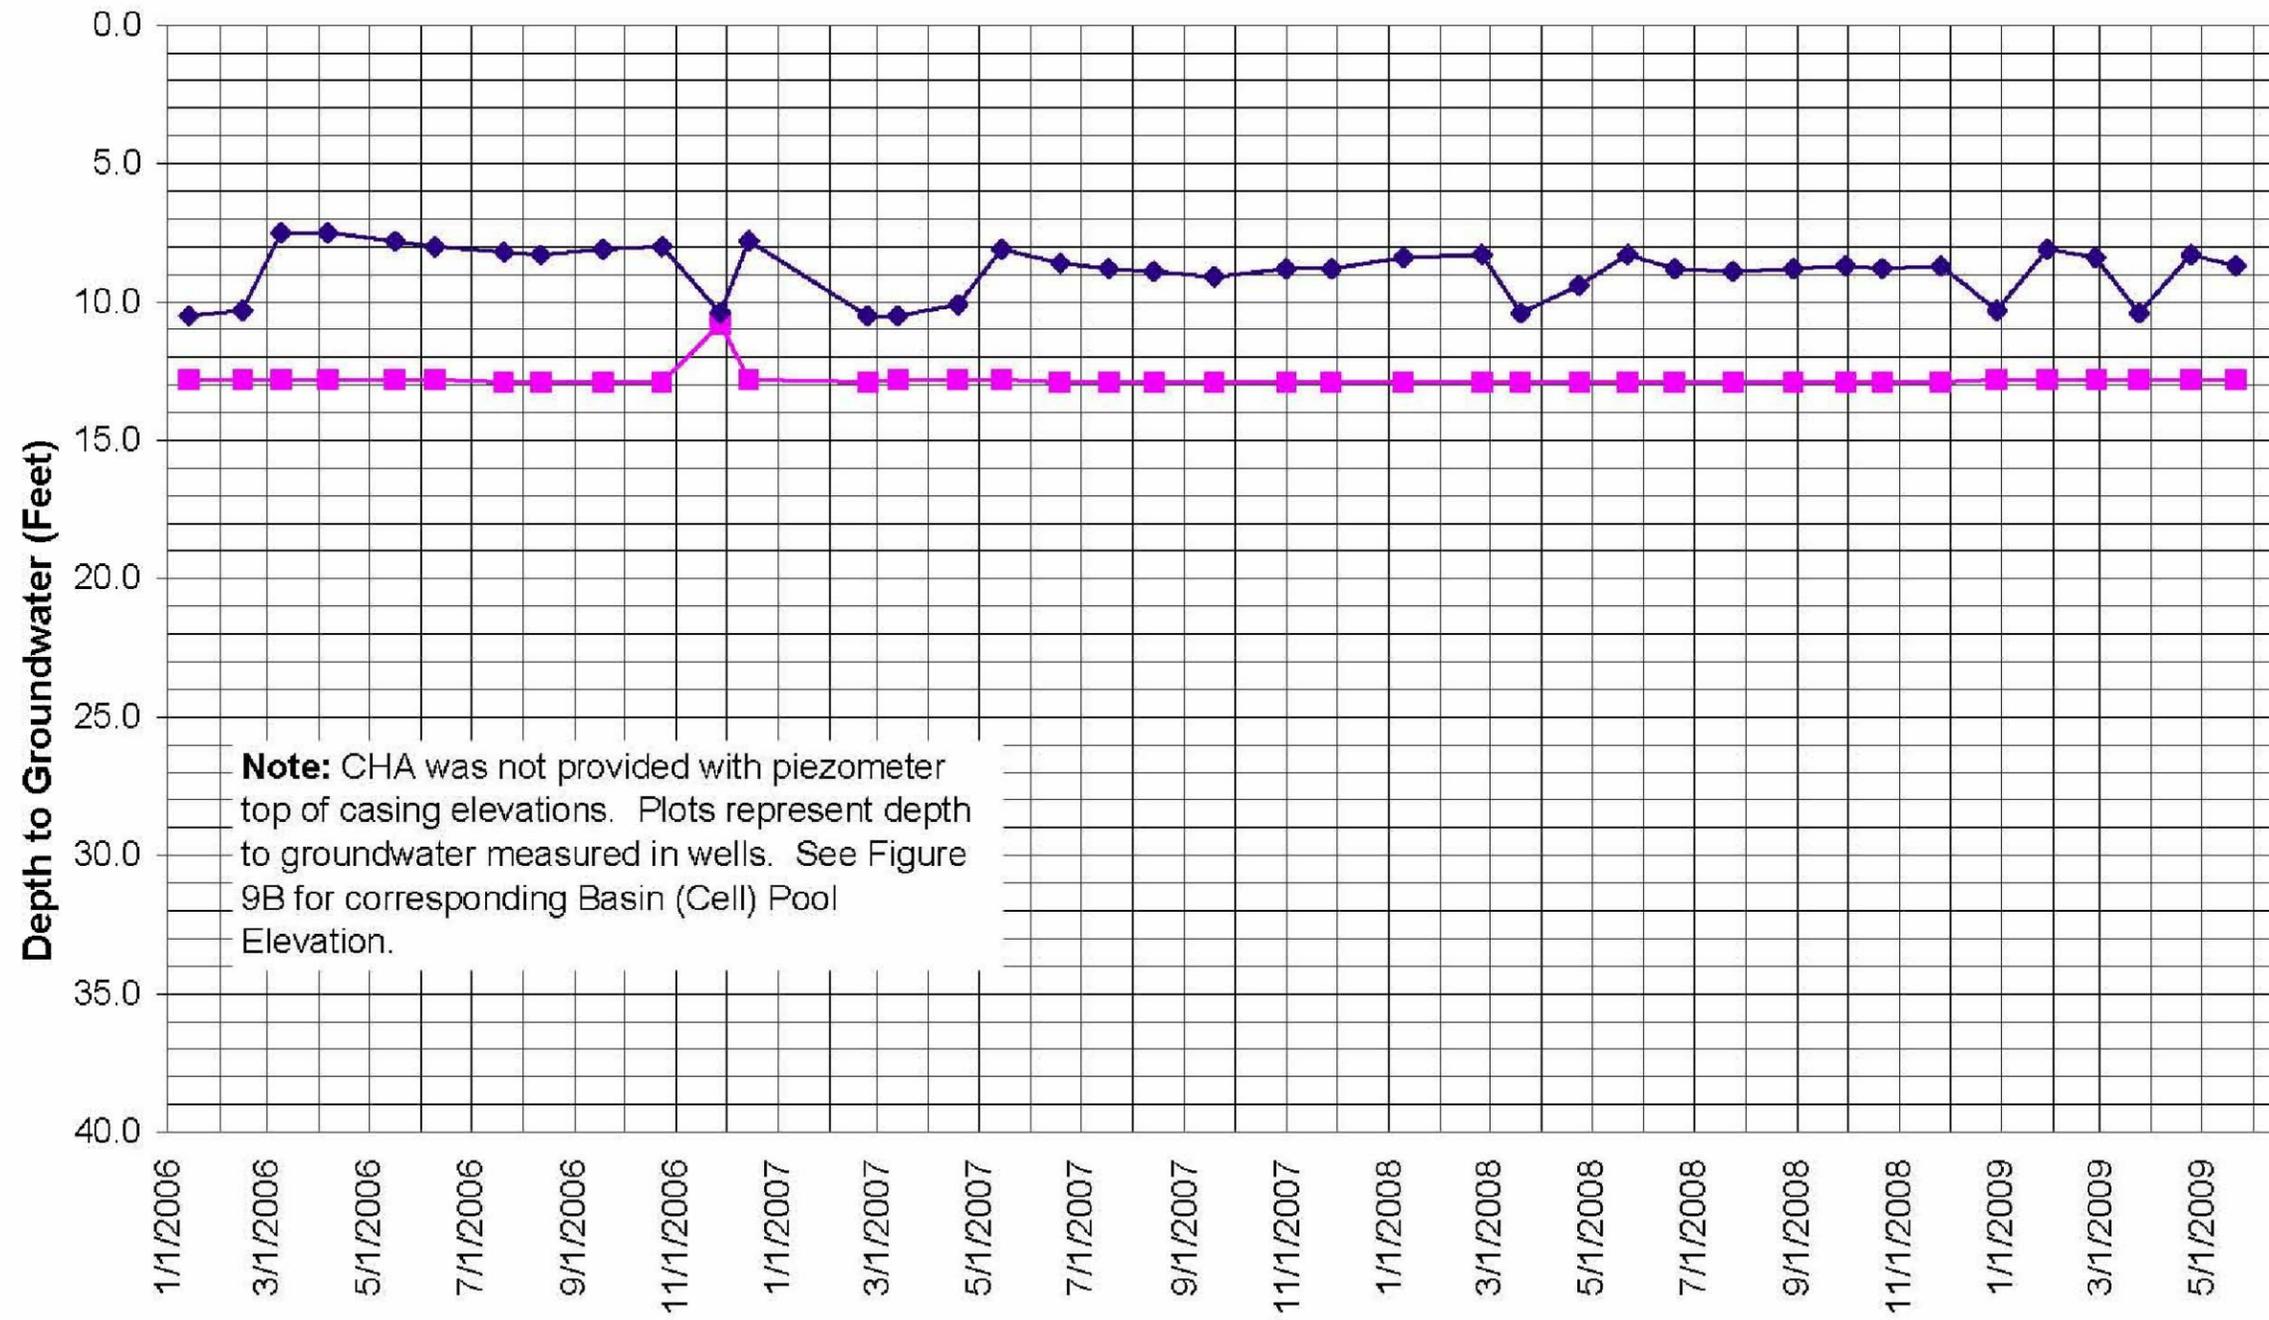
PROJECT NO.
20085.5000
DATE: JULY 2009
FIGURE 8B-2

Note: CHA was not provided with piezometer top of casing elevations. Plots represent depth to groundwater measured in wells. See Figure 9B for corresponding Basin (Cell) Pool Elevation.

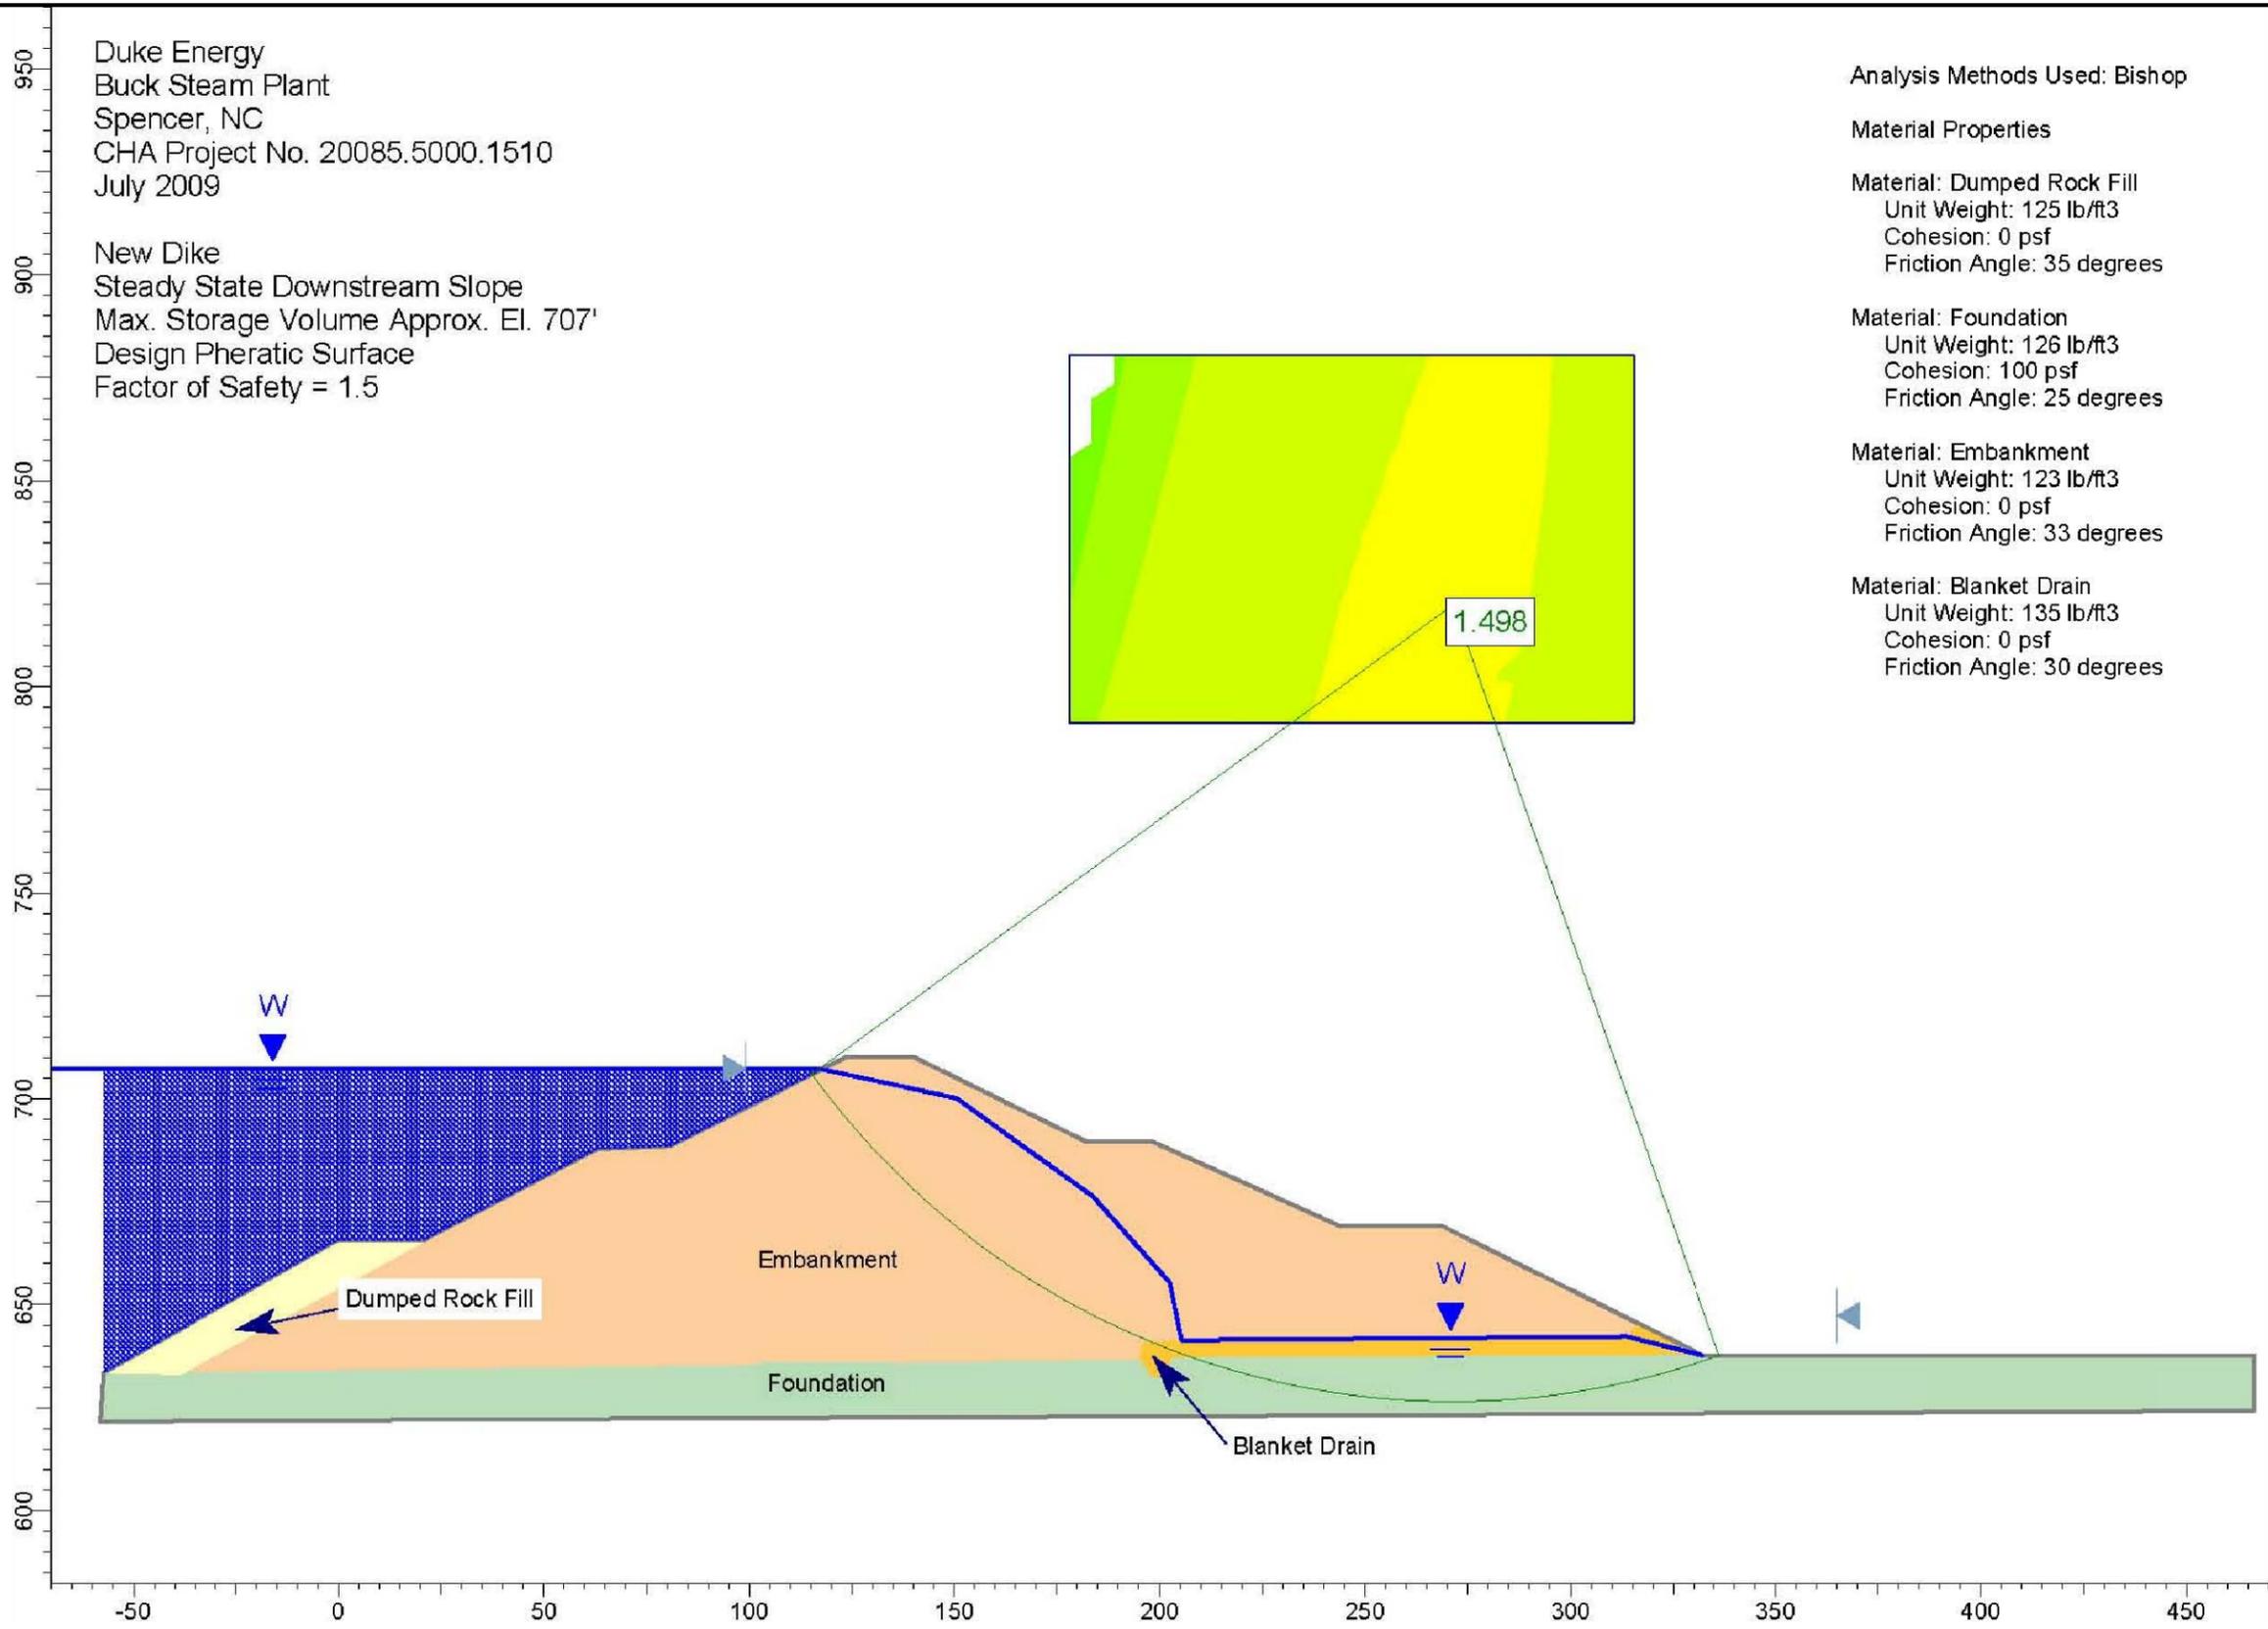
CROSS SECTION OF NEW DIKE
STABILITY ANALYSIS
BUCK STEAM STATION
DUKE ENERGY
SPENCER, NORTH CAROLINA

The factor of safety for CHA's recreated analyses was calculated to be 1.5, approximately the same as previous analyses. Our Slide™ output for this analysis is shown on Figure 13. We also created a model with a pheratic surface which reflects current (May 2009) piezometers readings provided by Duke Energy for piezometers P13, P14, P15 and P16. The factor of safety was calculated to be 1.8 as shown on Figure 14.

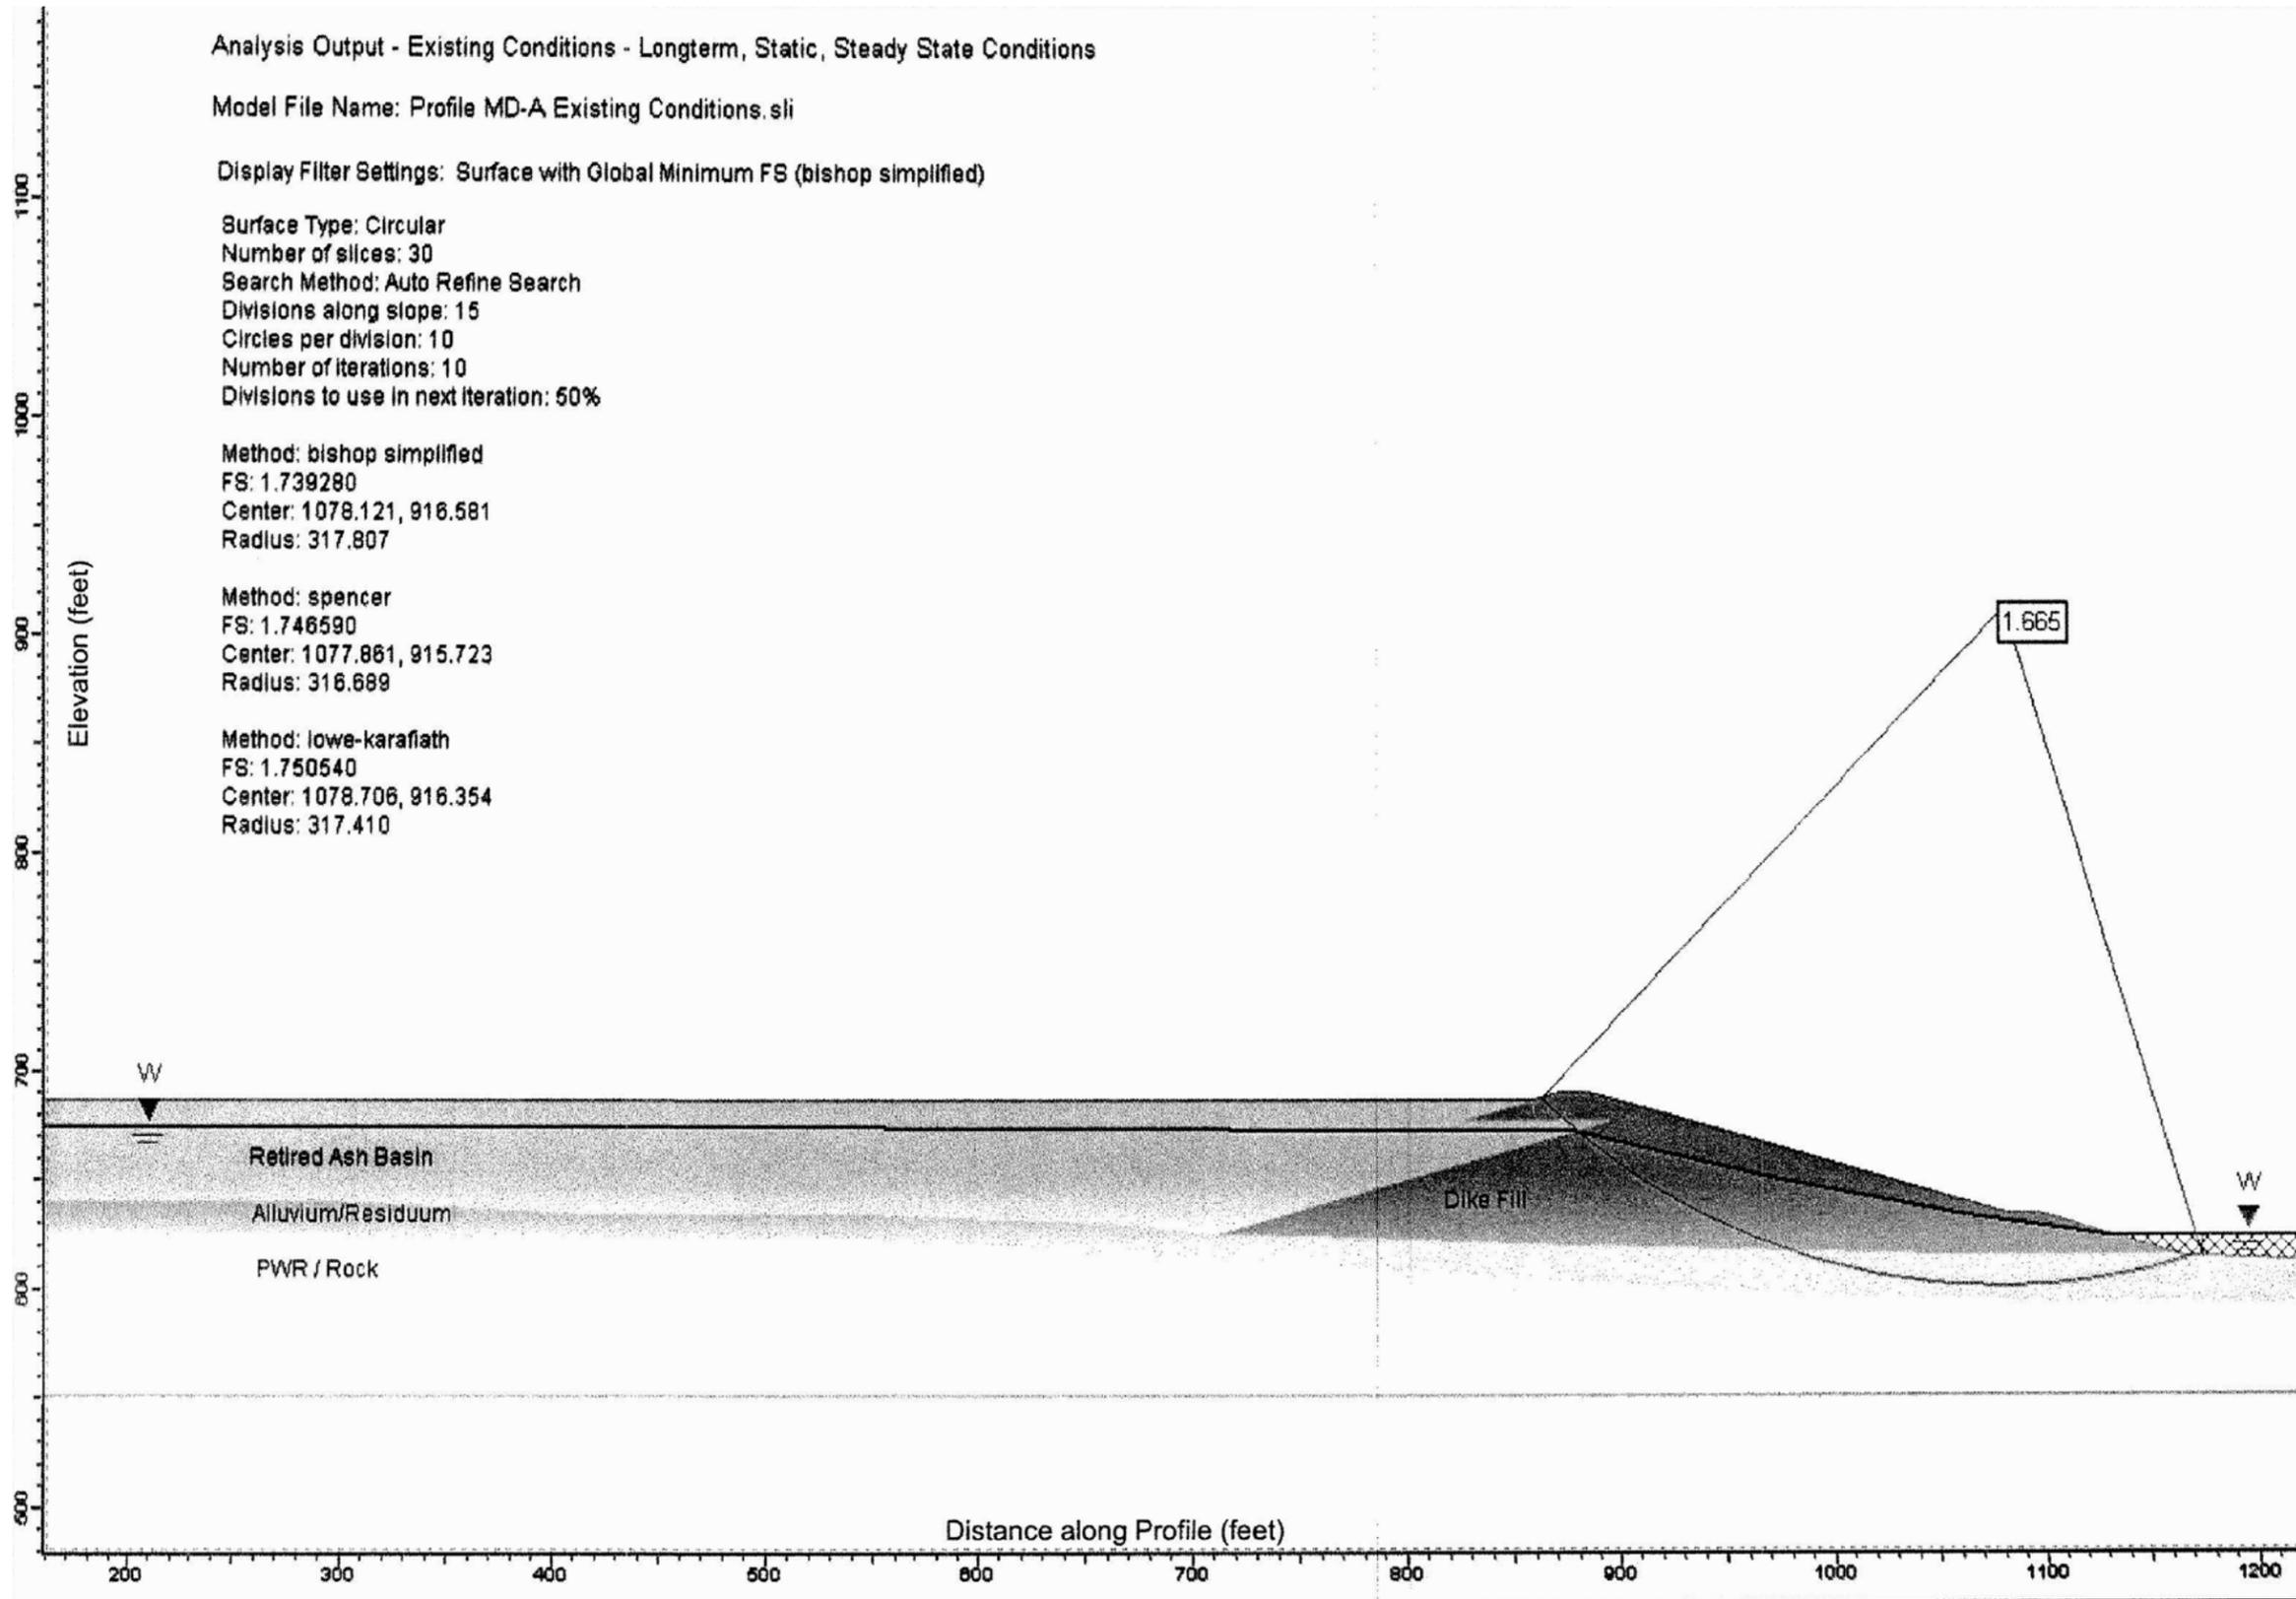
PROJECT NO.
20085.5000
DATE: JULY 2009
FIGURE 19

The preliminary engineering study included slope stability analyses for long-term, steady-state condition for the existing main dike (using Cross Section MD-A, primary cell). Figure 19 shows the section that was analyzed and the analyses results. The piezometric surface in the main dike was generally defined by the most recent available monitoring well readings recorded in June 2008. This analysis for the long-term, steady-steady state, static condition for the existing main dike resulted in a computed critical factor of safety of 1.7 which is above the recommended factor of safety of 1.5.

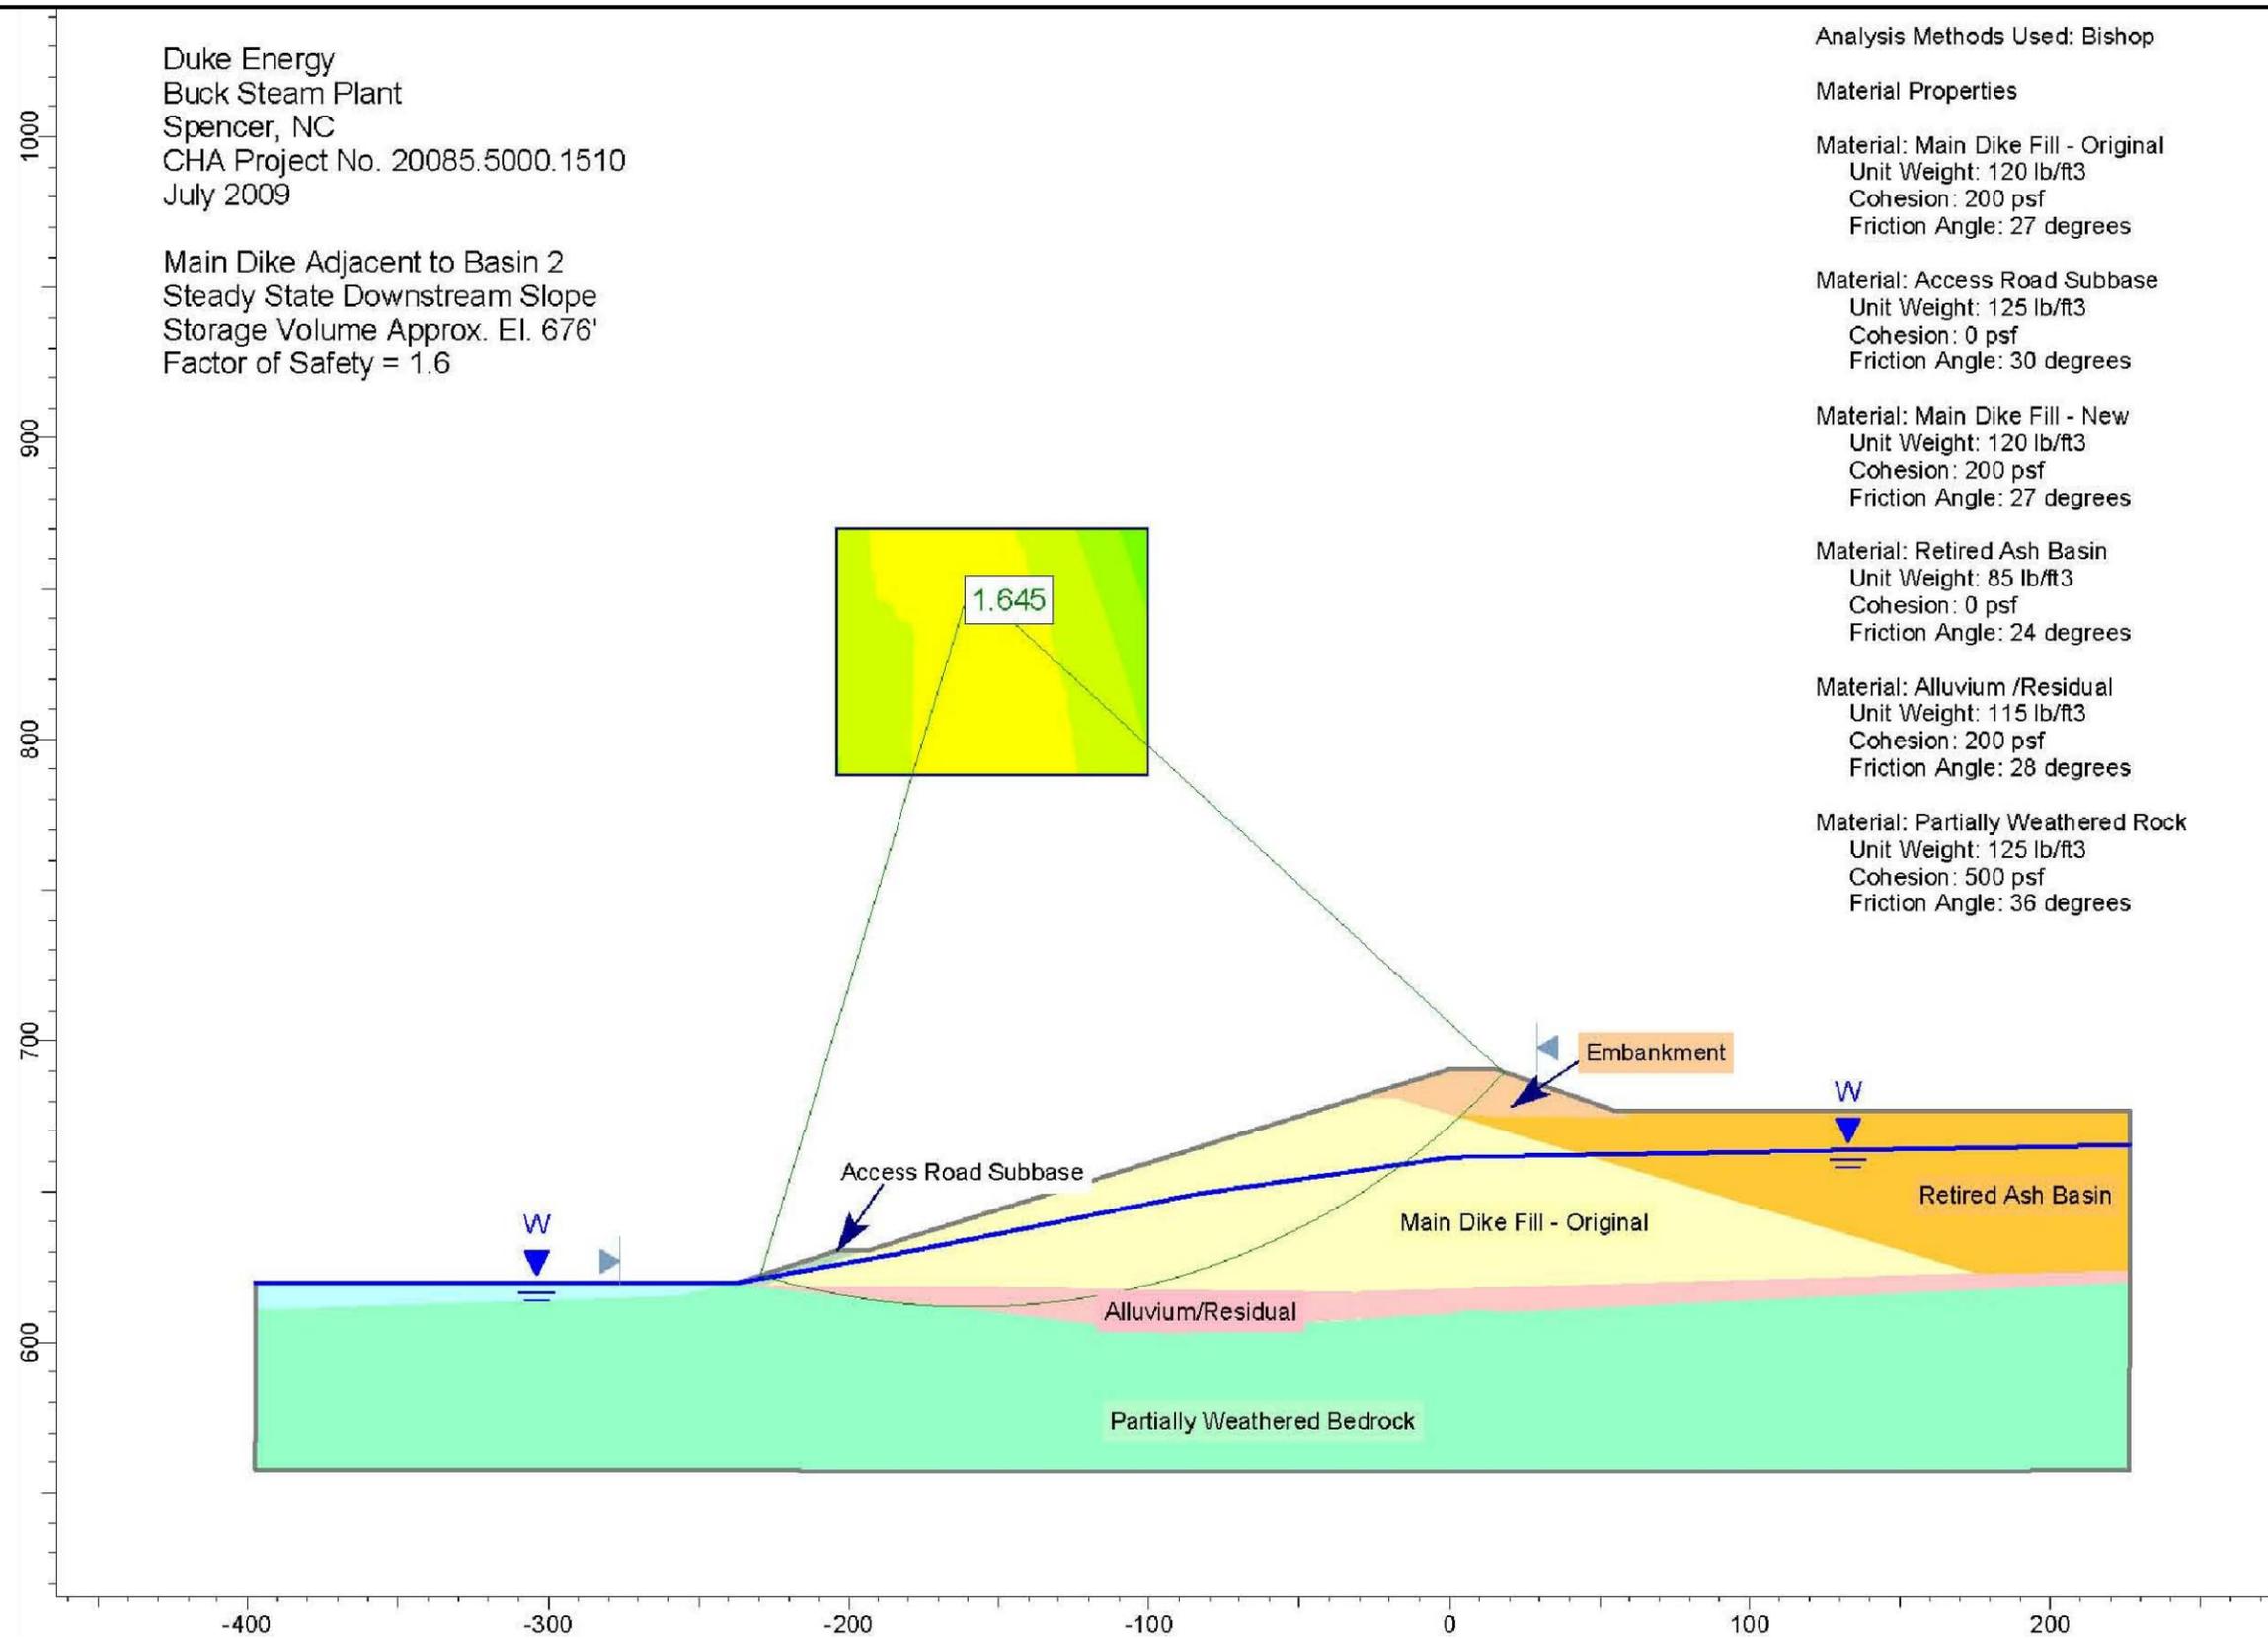
PROJECT NO.
20085.5000
DATE: JULY 2009
FIGURE 21

The factor of safety for CHA’s recreated analyses was calculated to be 1.6 which is comparable to the 1.7 that was reported on S&ME’s 2009 report. Our Slide™ output for this analysis is shown on Figure 21.
