Assessment of Dam Safety Coal Combustion Surface Impoundments Draft Report

Duke Energy
Buck Steam Station
Spencer, North Carolina

July 13, 2009

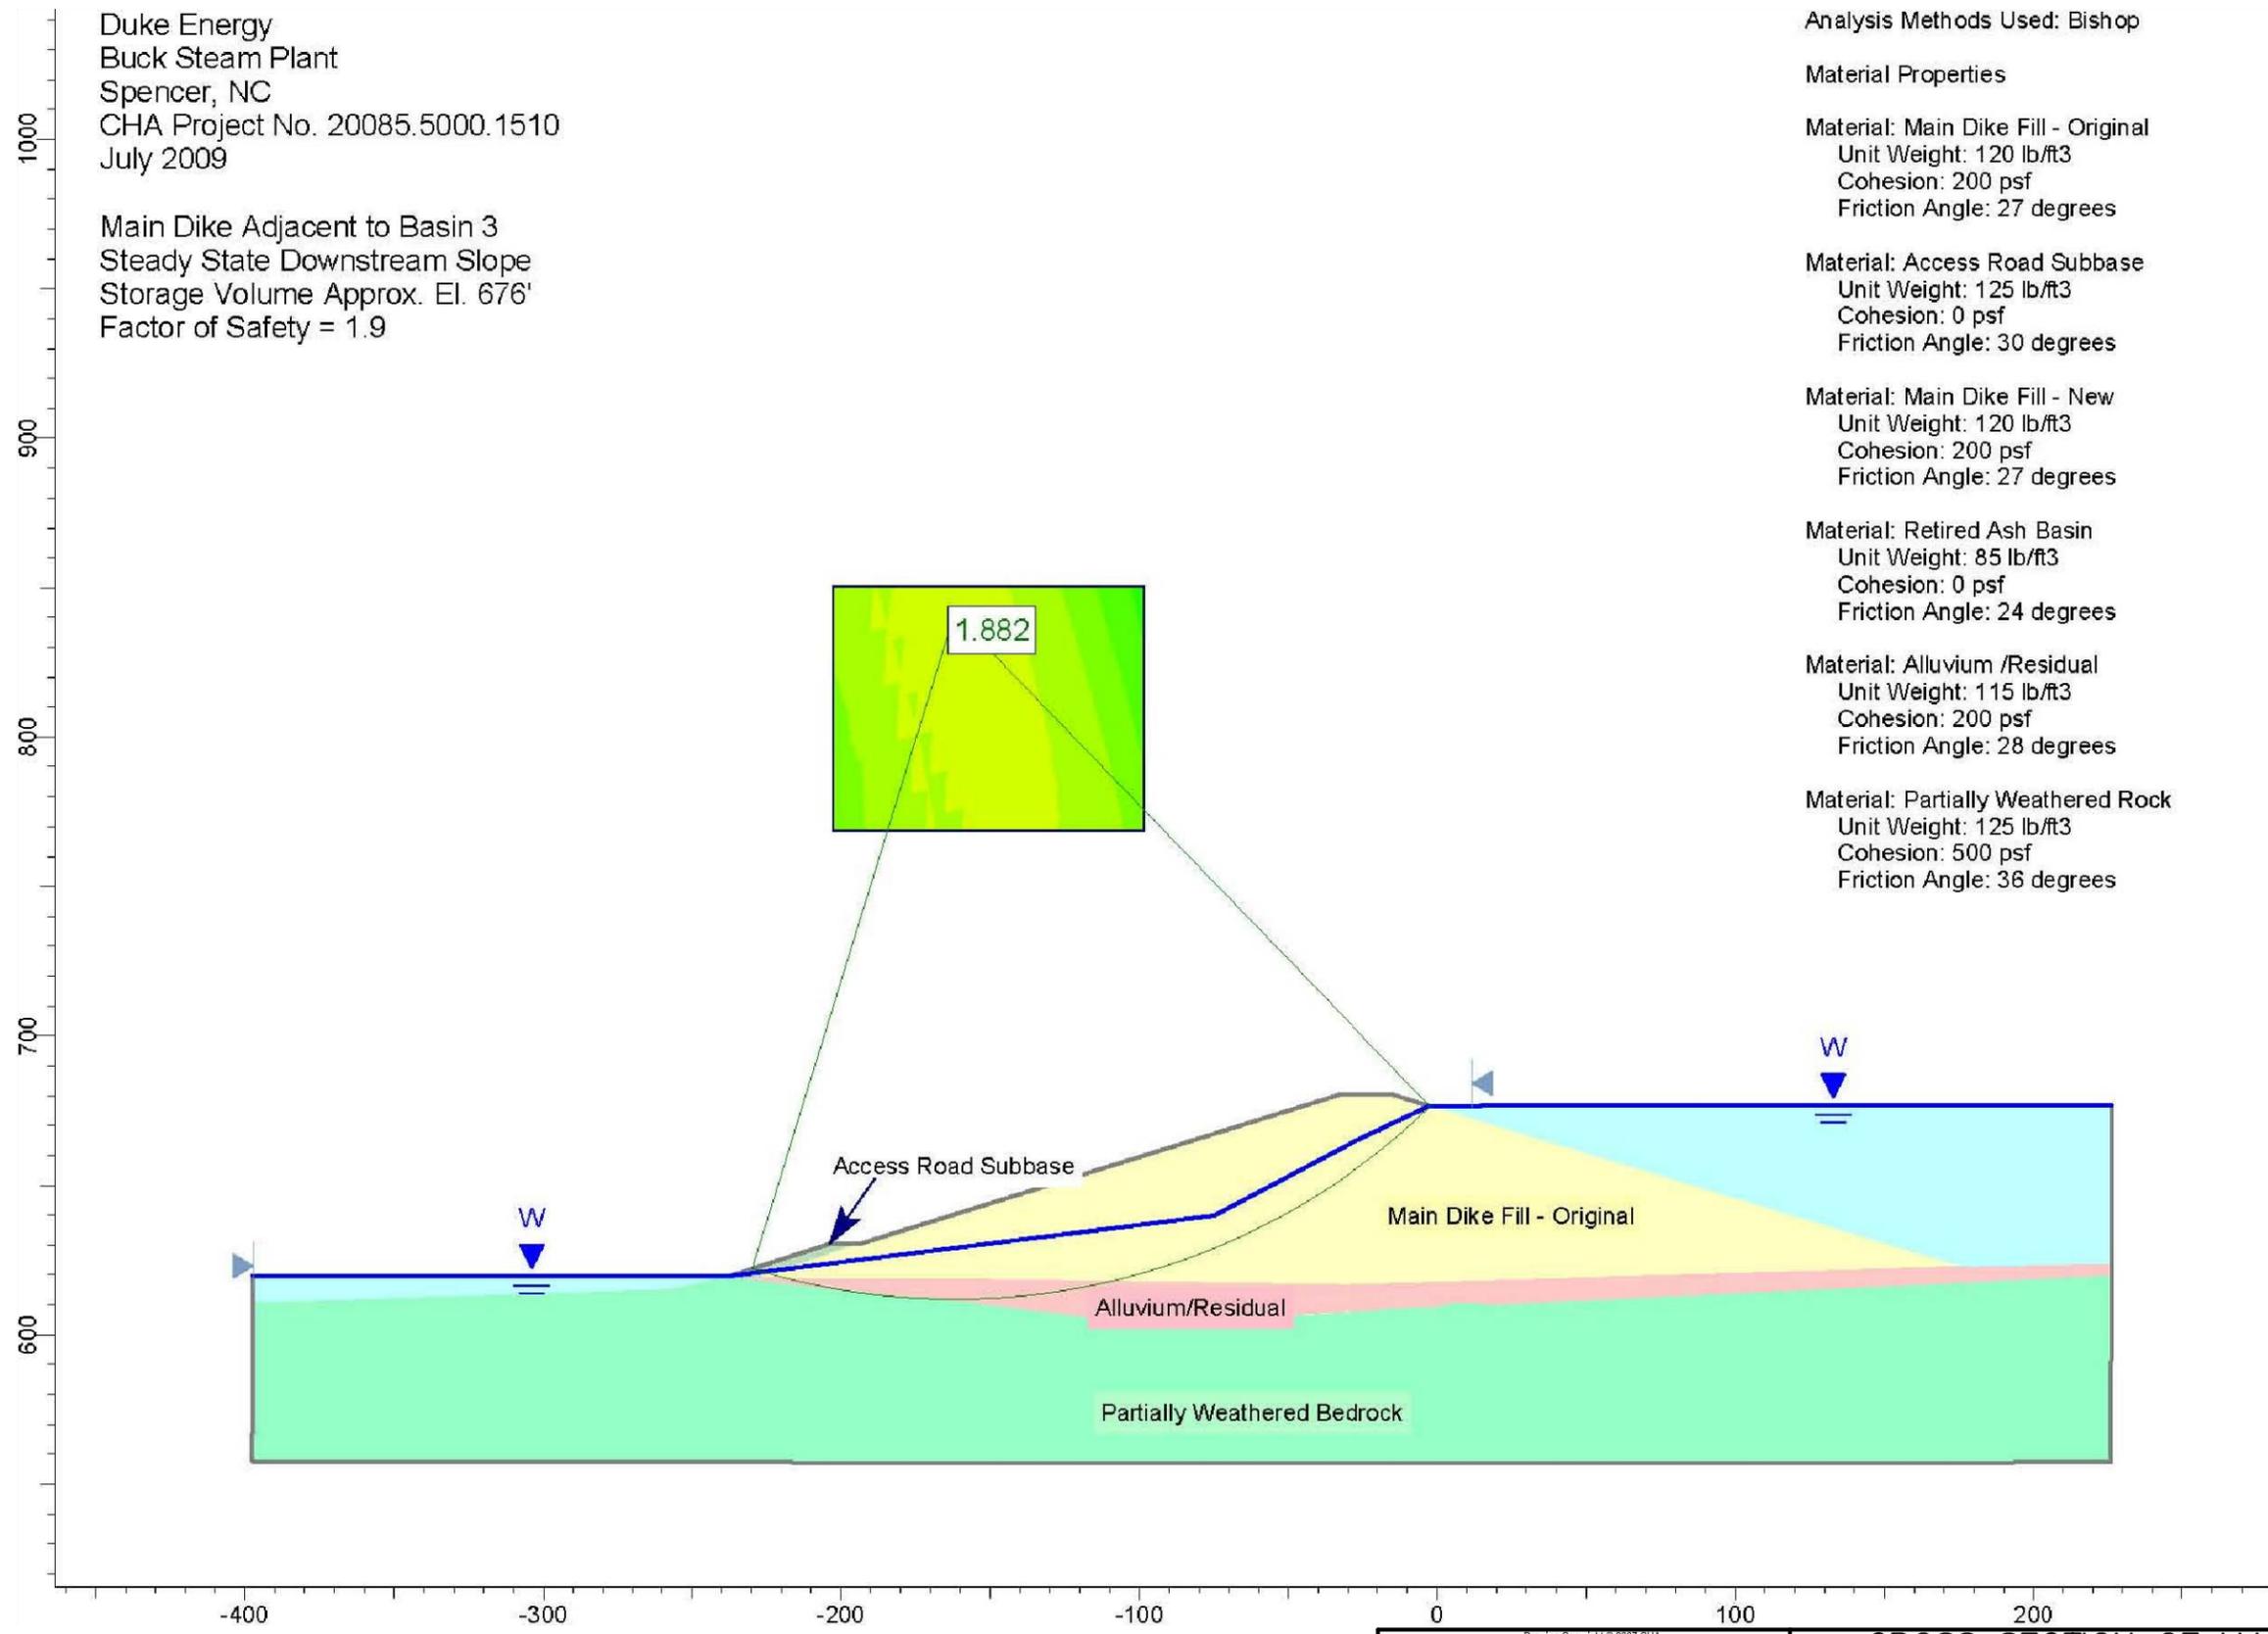
PROJECT NO.
20085.5000
DATE: JULY 2009
FIGURE 23

The factor of safety for CHA’s recreated analyses was calculated to be 1.9. Our Slide™ output resulted in a similar factor of safety as shown on Figure 23.

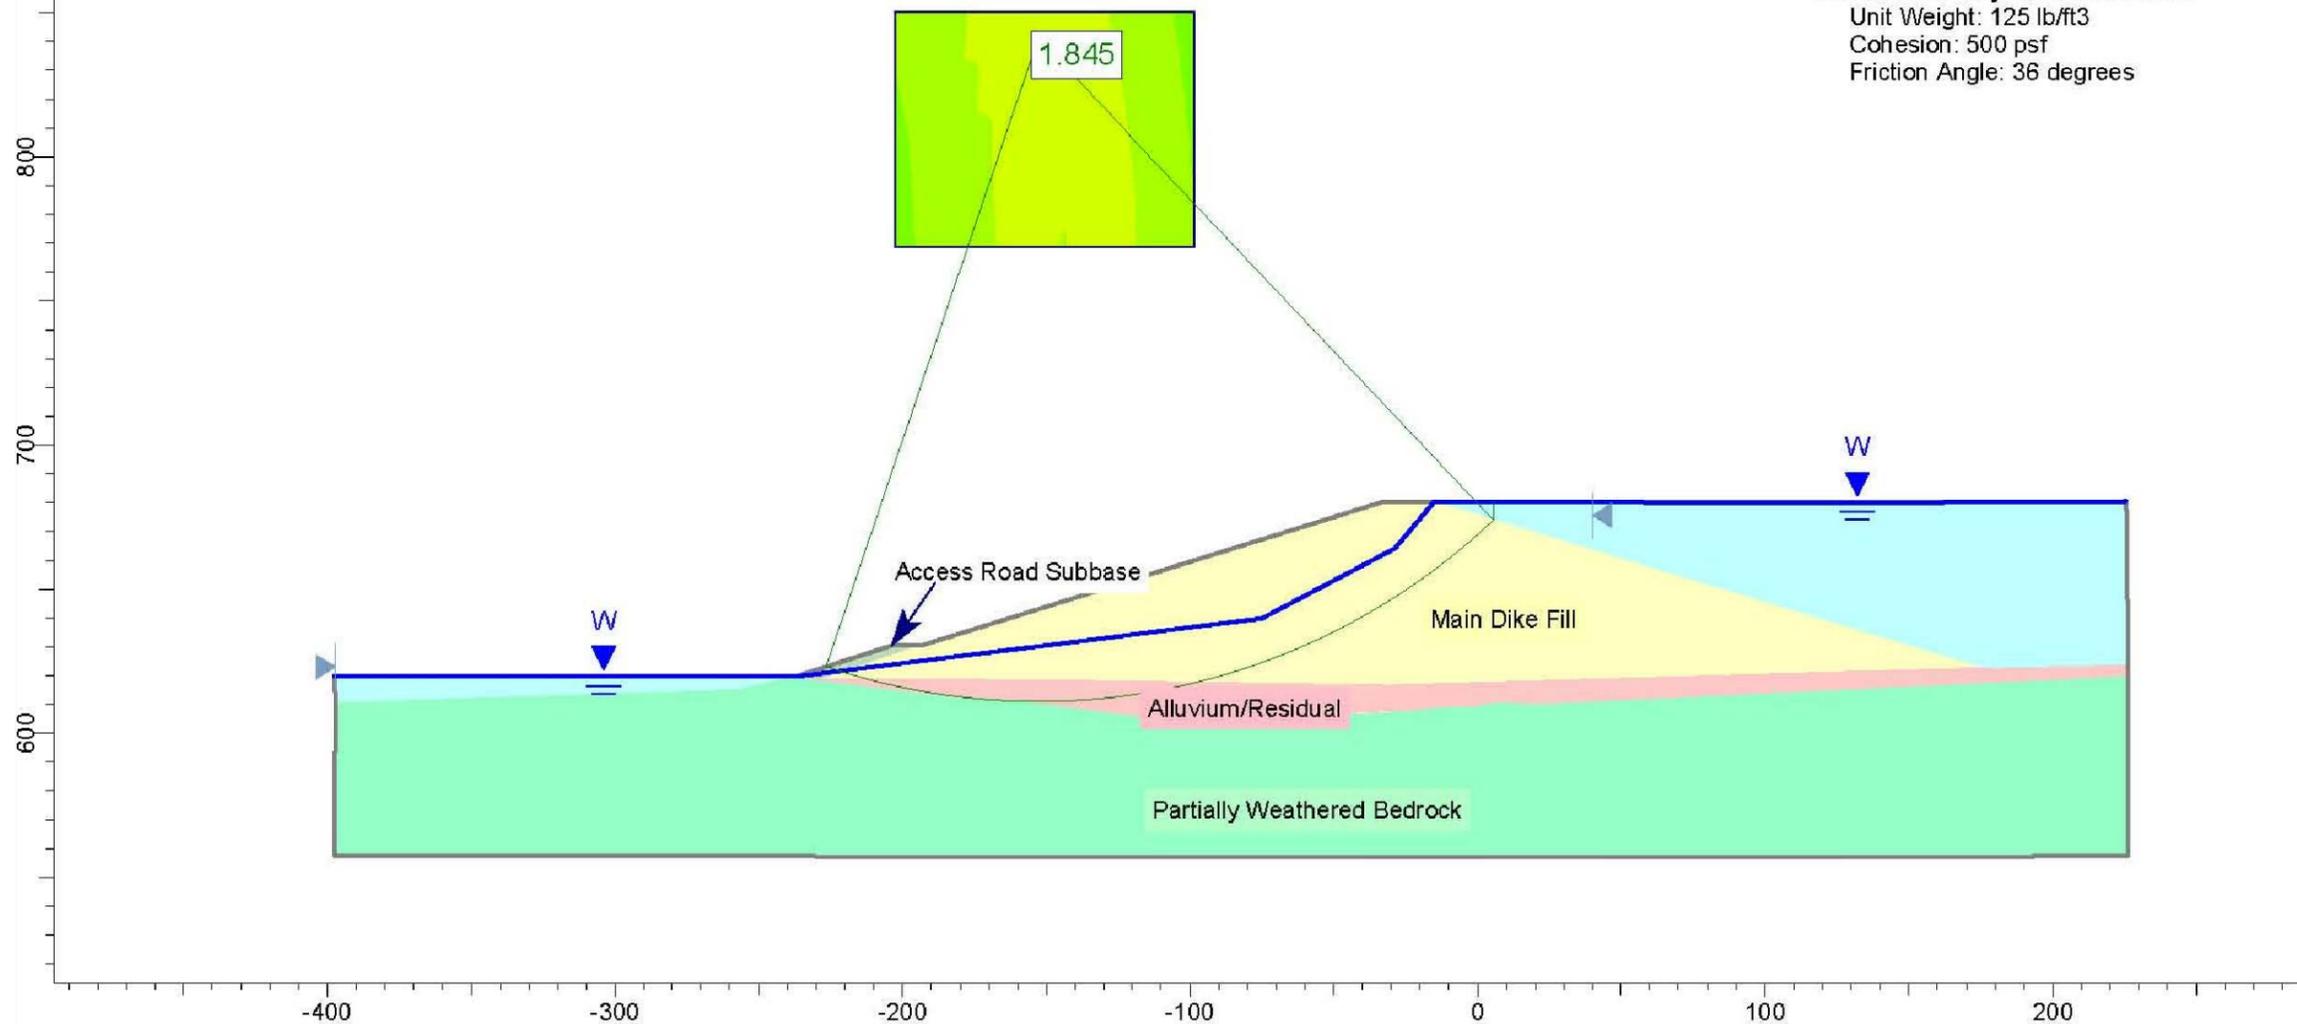
PROJECT NO.
20085.5000
DATE: JULY 2009
FIGURE 24

We also modeled the rapid drawdown and flood loading conditions as Basin 3. The factors of were calculated to be 1.2 and 1.8, respectively. The rapid drawdown factor of safety is slightly below the NCDENR’s required 1.25 and the flood condition factor of safety was above the required 1.4. Our Slide™ outputs are shown as Figures 24 and 25.

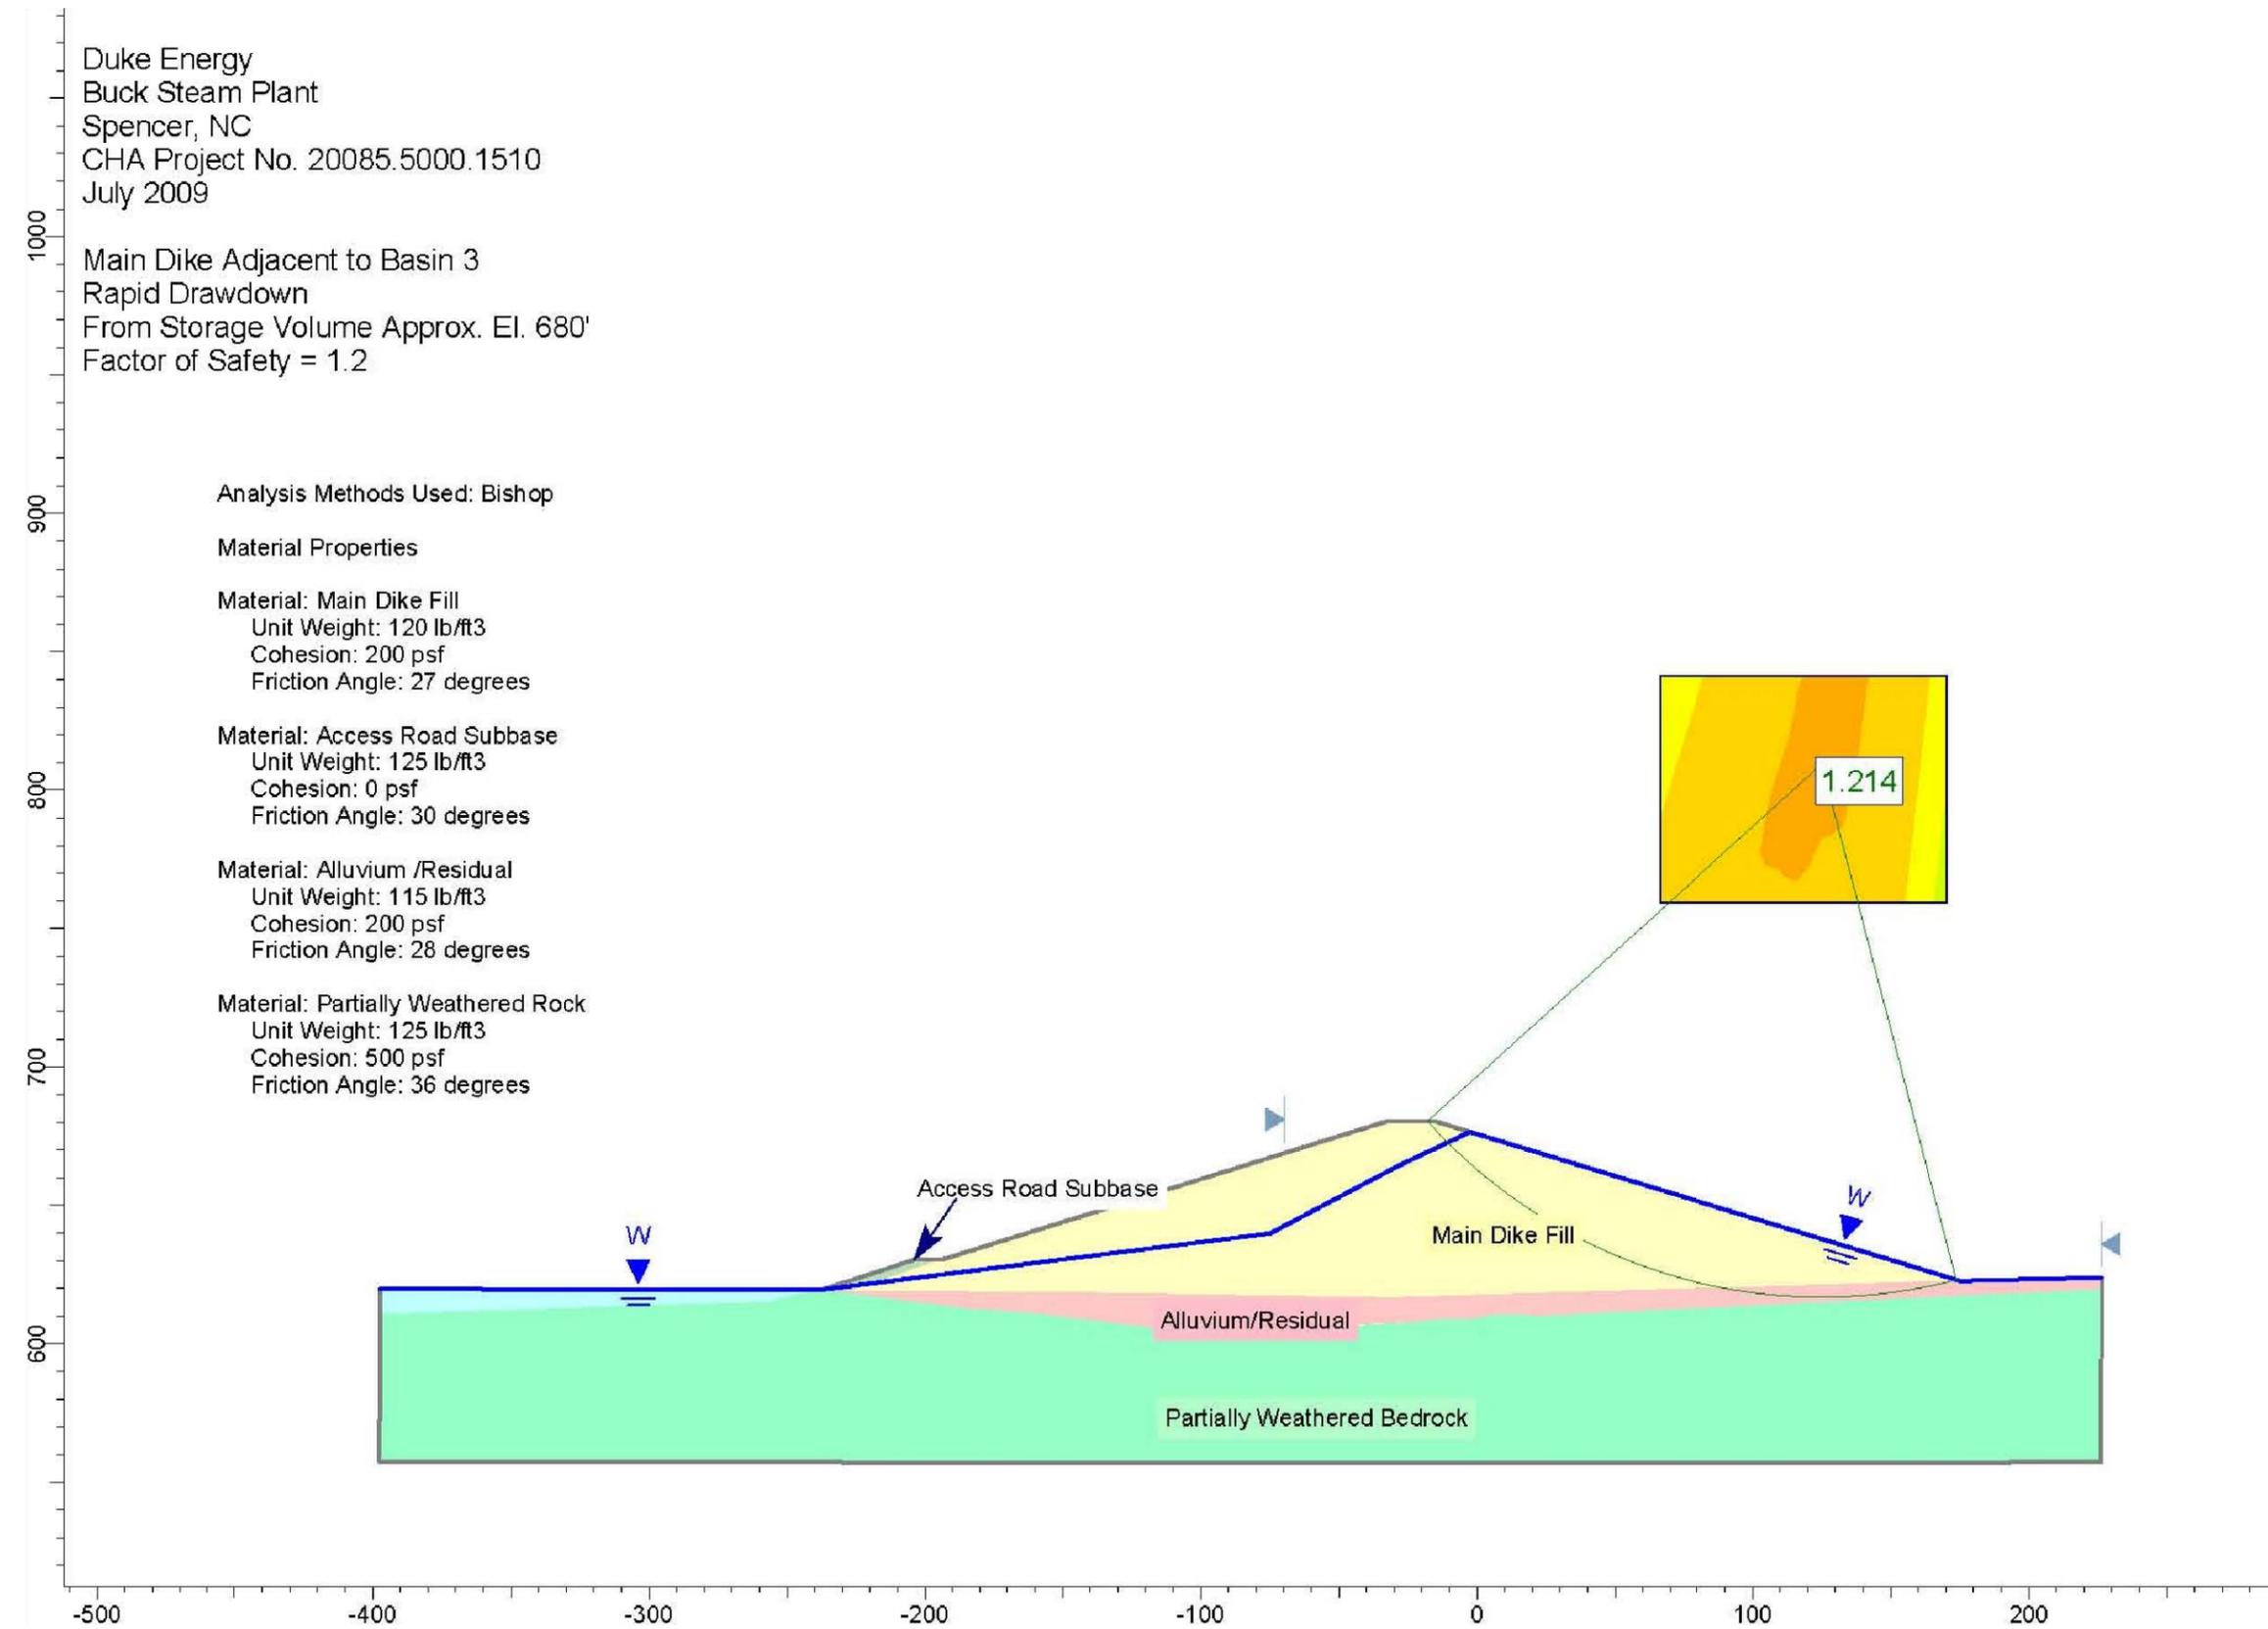
PROJECT NO.
20085.5000
DATE: JULY 2009
FIGURE 25

Main Dike Adjacent to Basin 3
Flood Condition
Storage Volume Approx. El. 680'
Factor of Safety = 1.8

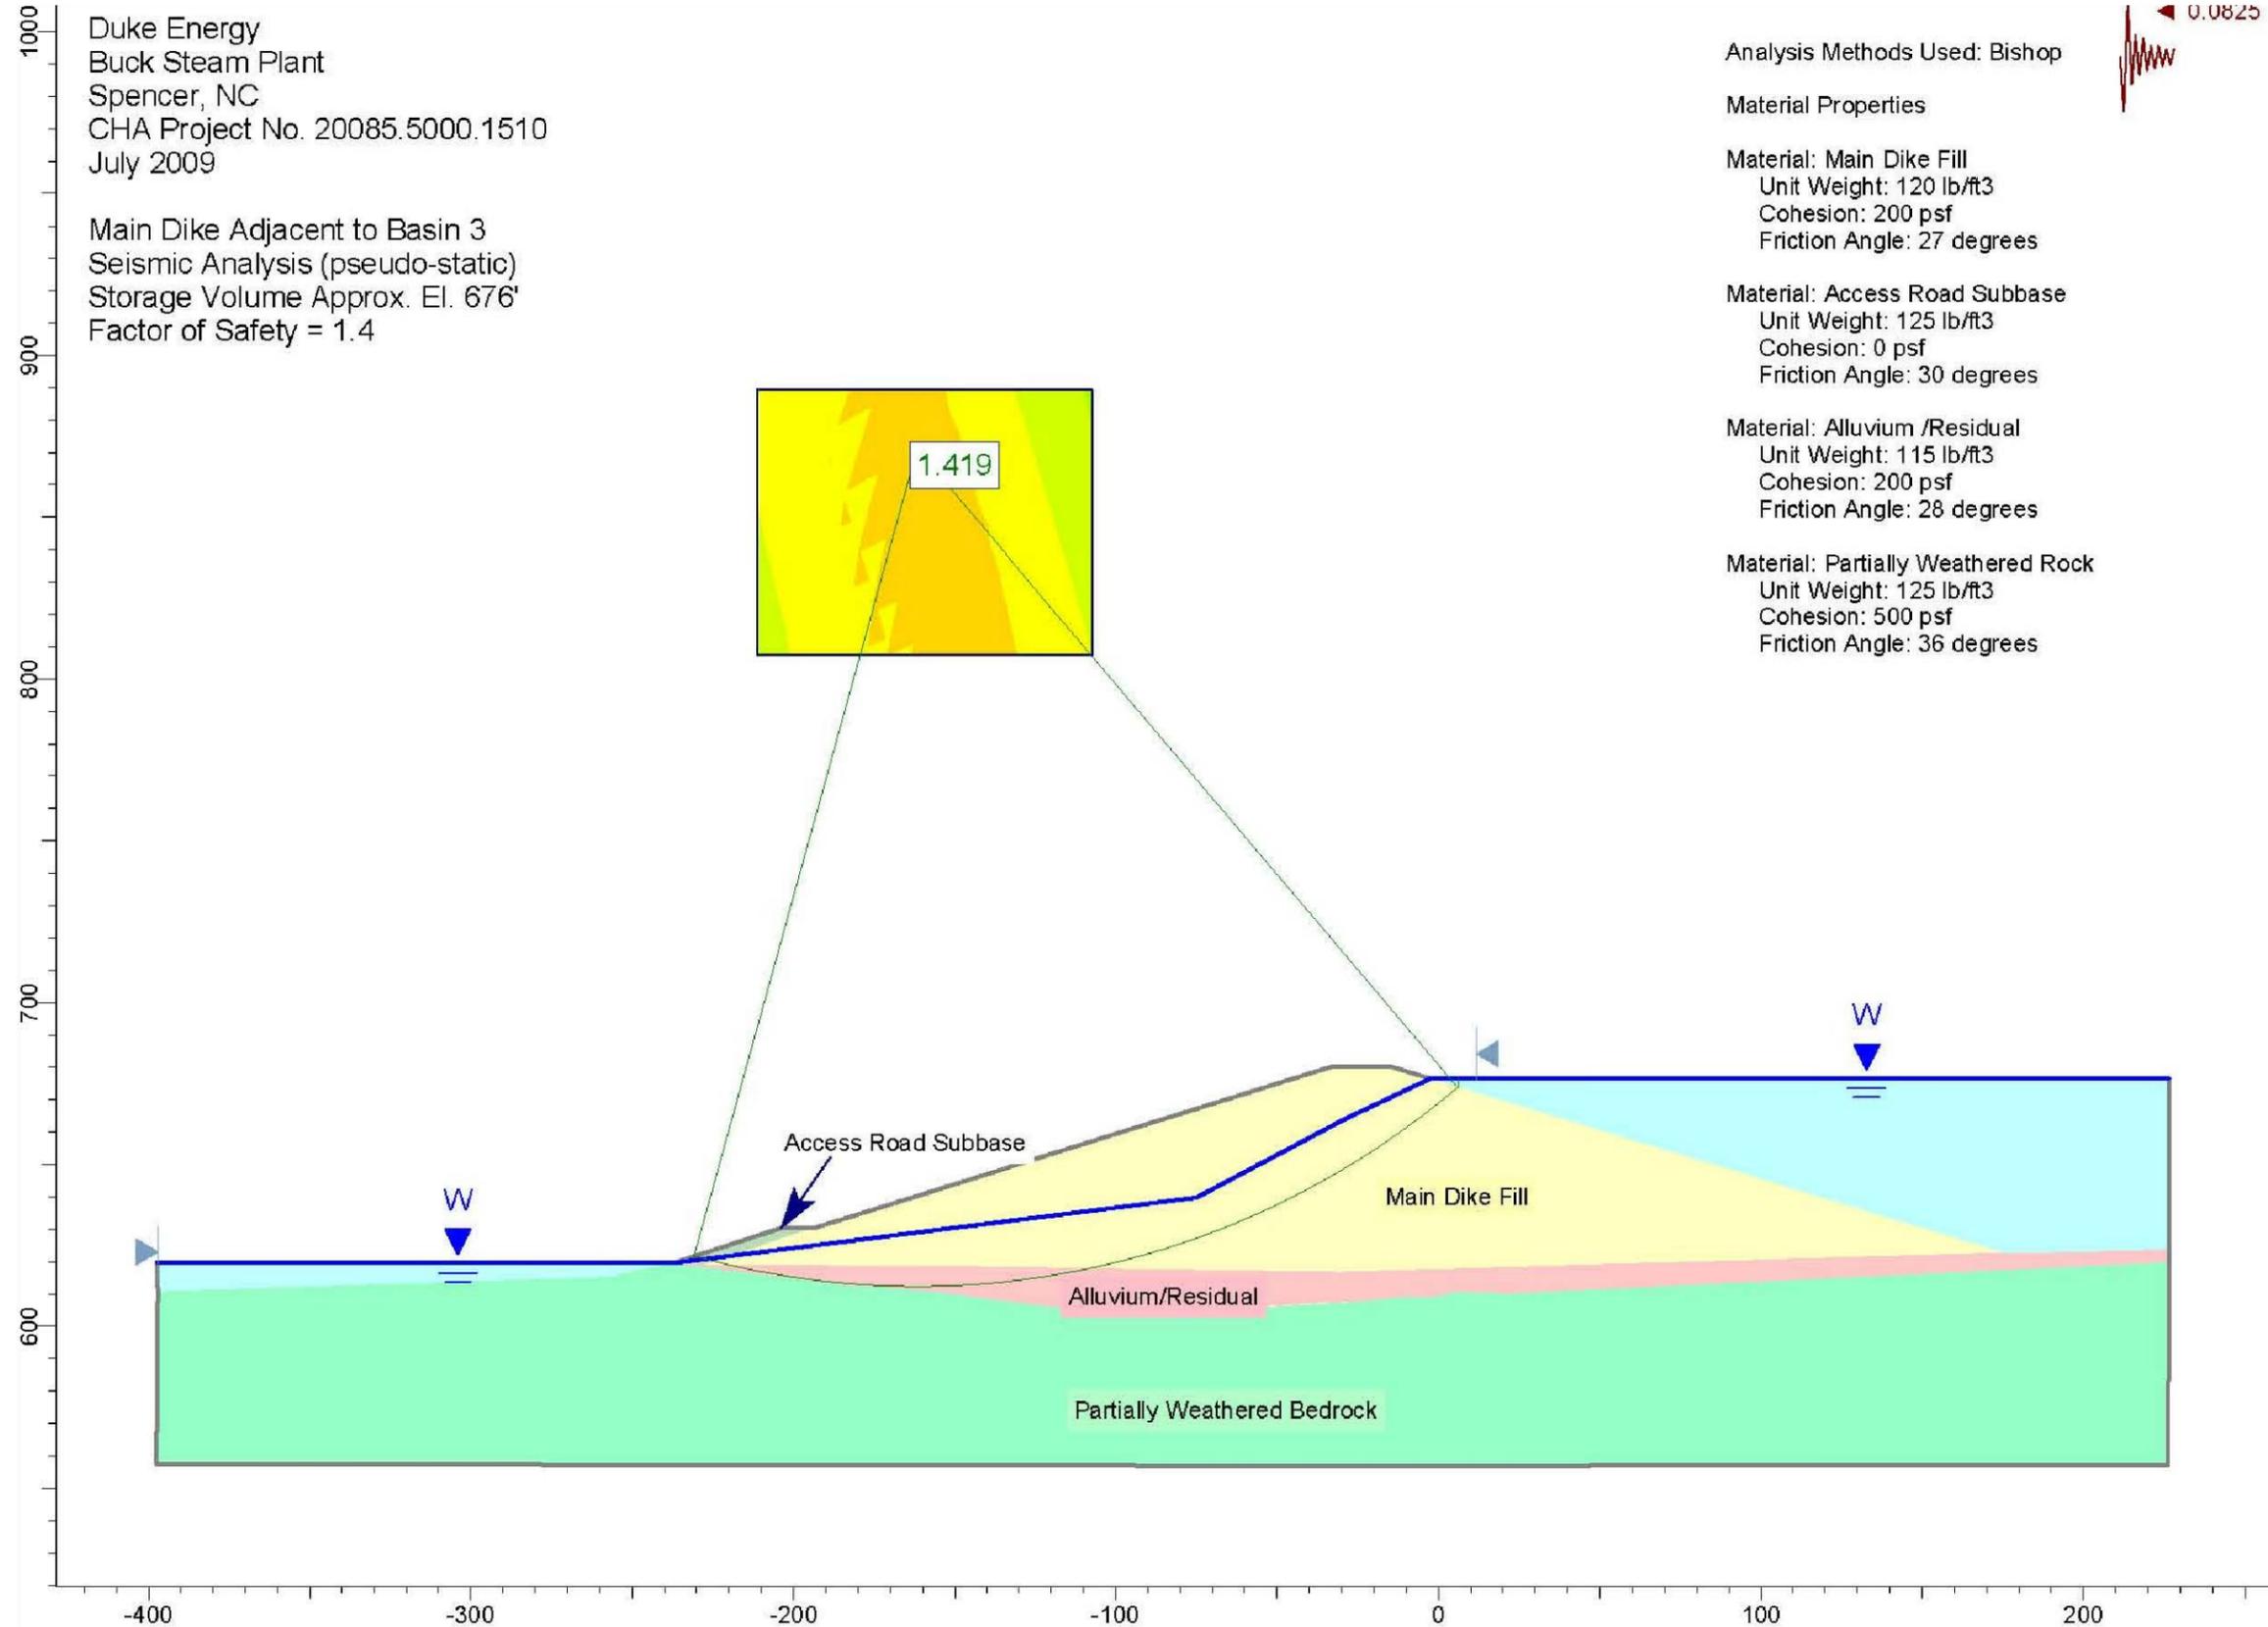
PROJECT NO.
20085.5000
DATE: JULY 2009
FIGURE 26

The seismic loading condition for the main dike adjacent to Basin 3 was also analyzed. The output from our analyses is labeled as Figure 26. The seismic analyses were performed using a pseudo static analysis with a horizontal seismic coefficient of 0.0825g. This coefficient was provided in the S&ME Engineering Preliminary Engineering Study for the Proposed Buck
