# Assessment of Dam Safety

## Coal Combustion Surface Impoundments (Task 3)

Duke Energy  
Buck Steam Station  
Spencer, North Carolina

September 14, 2009

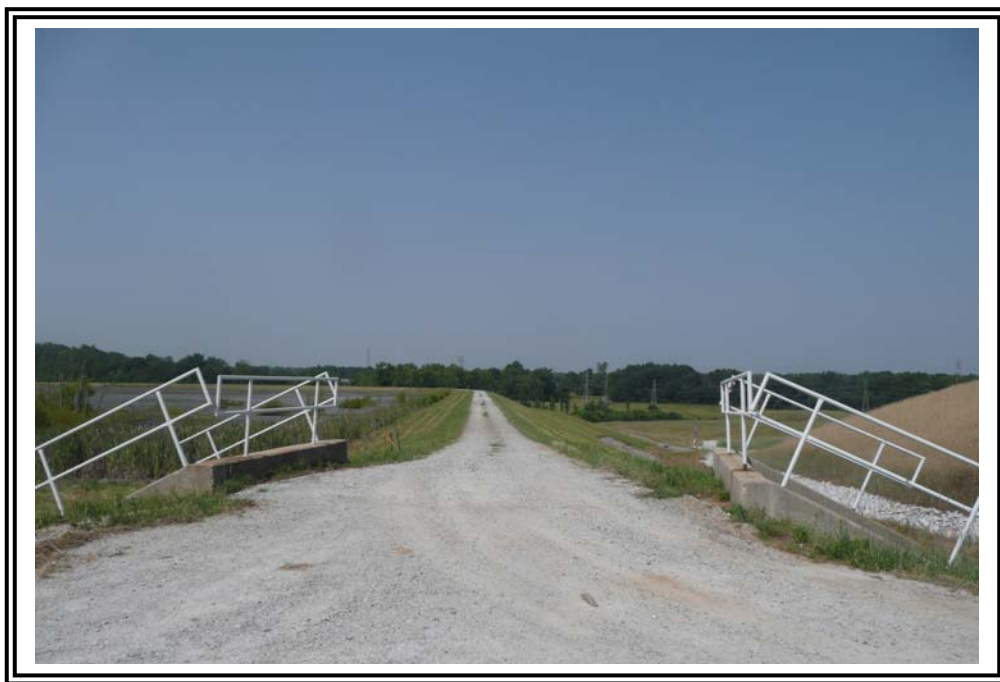
In general, the alignment of the new dike crest does not show signs of change in its horizontal alignment. No evidence of prior releases, failures or patchwork on was observed at the time of the site visit. Photos 2 and 23 show the north and west portions of the new dike crest alignment, respectively.

New Dike crest looking southwest (from North Abutment).

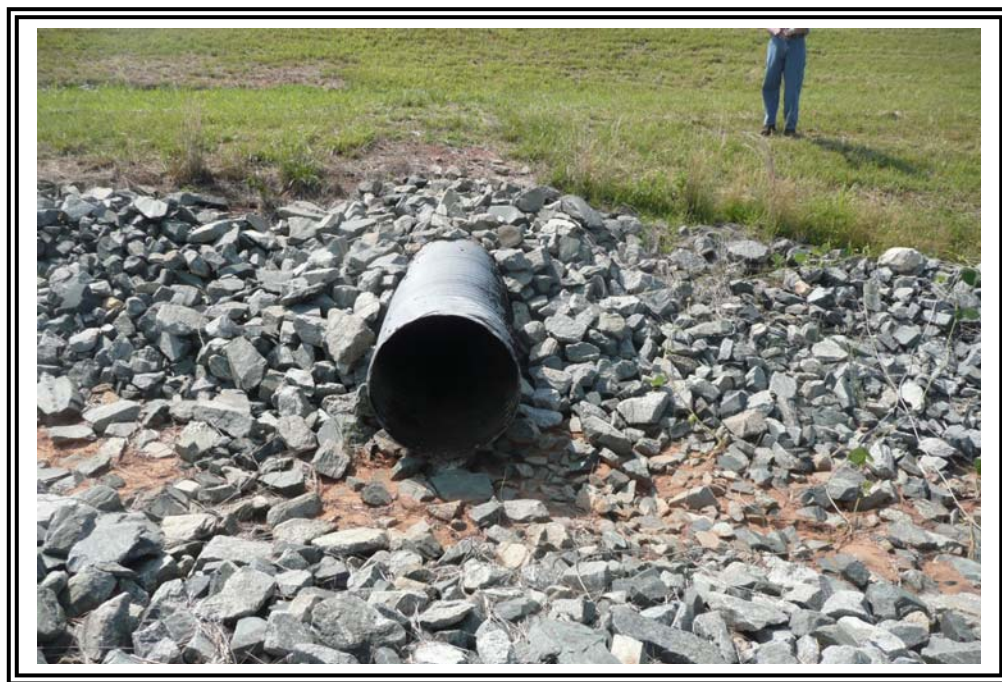
8

Upper bench drainage swale culvert discharging into toe swale.

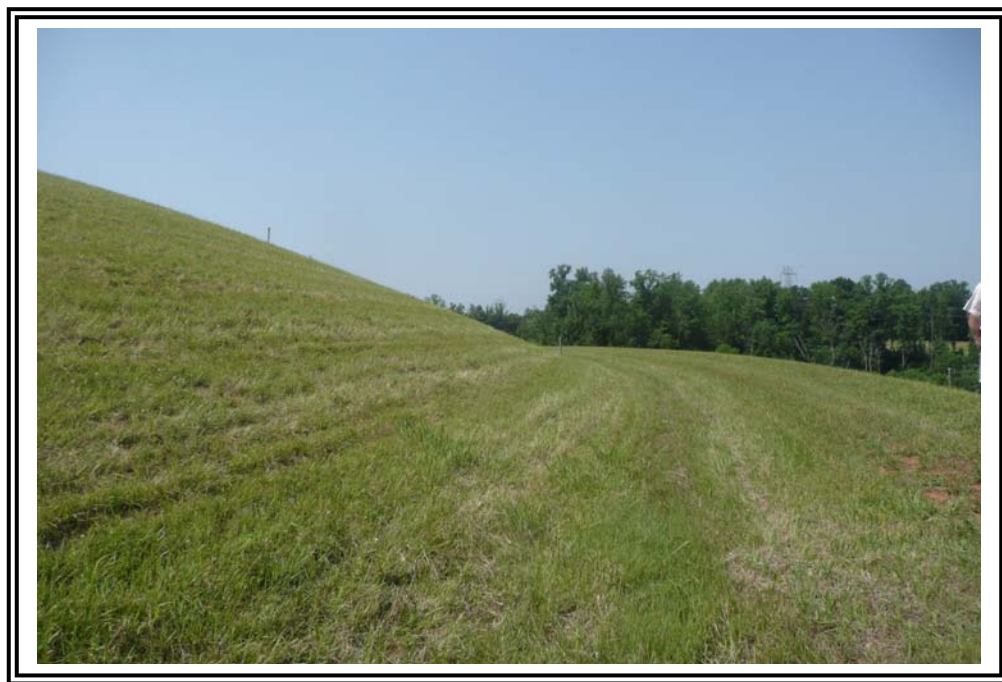
The downstream slope was reasonably uniformly graded, and covered with appropriate grass vegetation. There are occasional areas where the grass is sparse, such as those areas shown in Photos 10 and 13.

Downstream Slope at Upper Bench of New Dike looking southwest. Note occasional sparse grass cover.

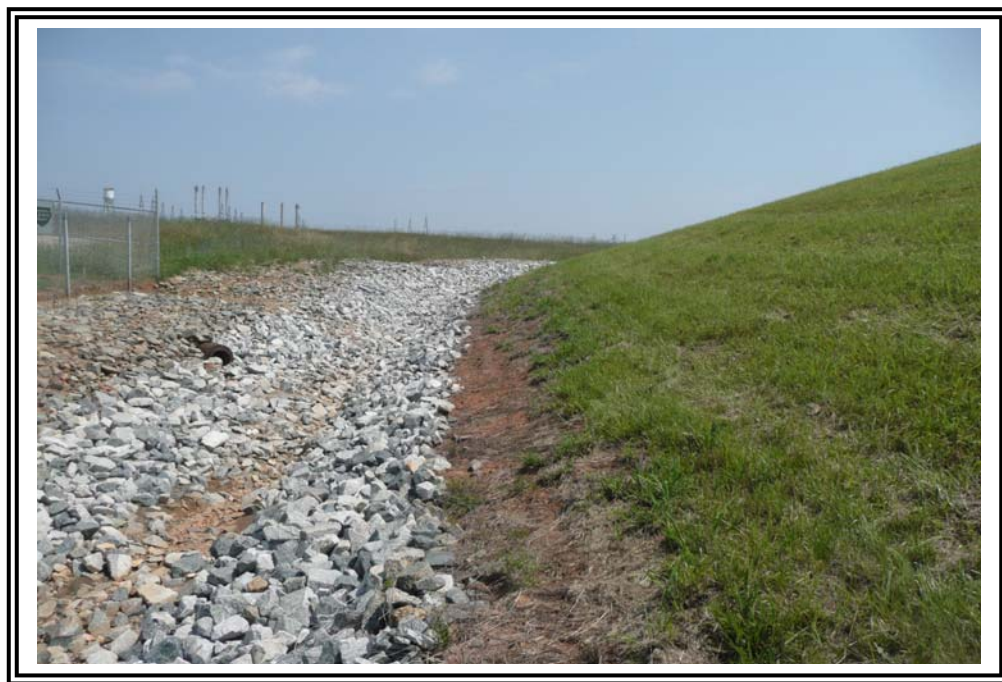
16

Toe swale of New Dike looking north. Note drainage pipe entering drainage swale from across access road to new combined cycle plant site. Sparse vegetation along rip rap edge likely from herbicide use to control weeds in the rip rap.

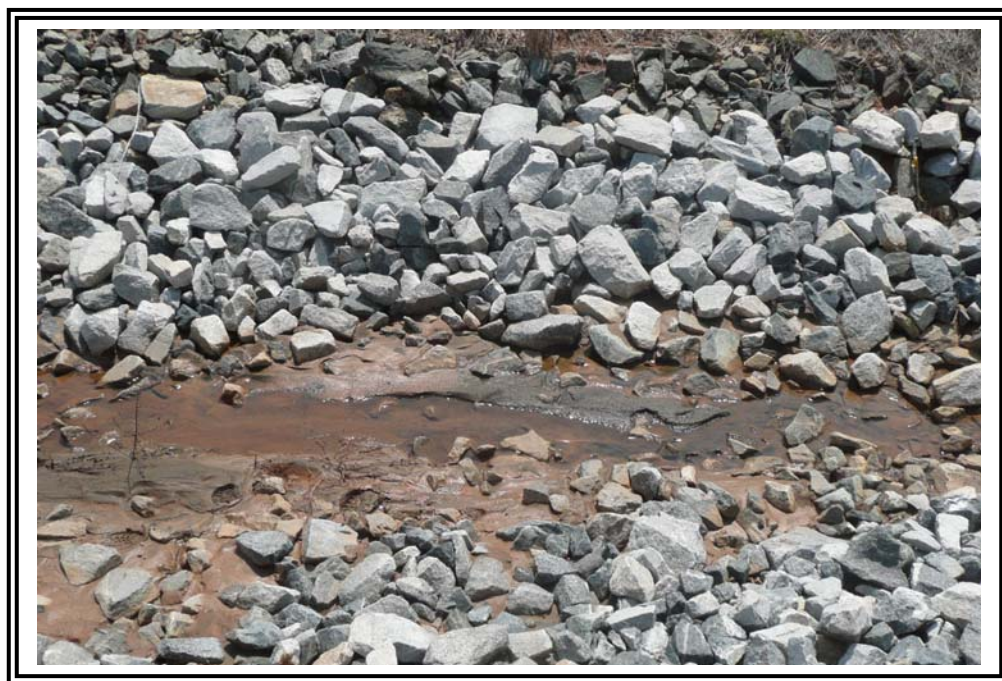
18

Closeup of toe drain seepage at New Dike. Water was flowing clear. Reportedly Duke Energy is in the process of discussing installation of a seepage monitoring system with an outside consultant.

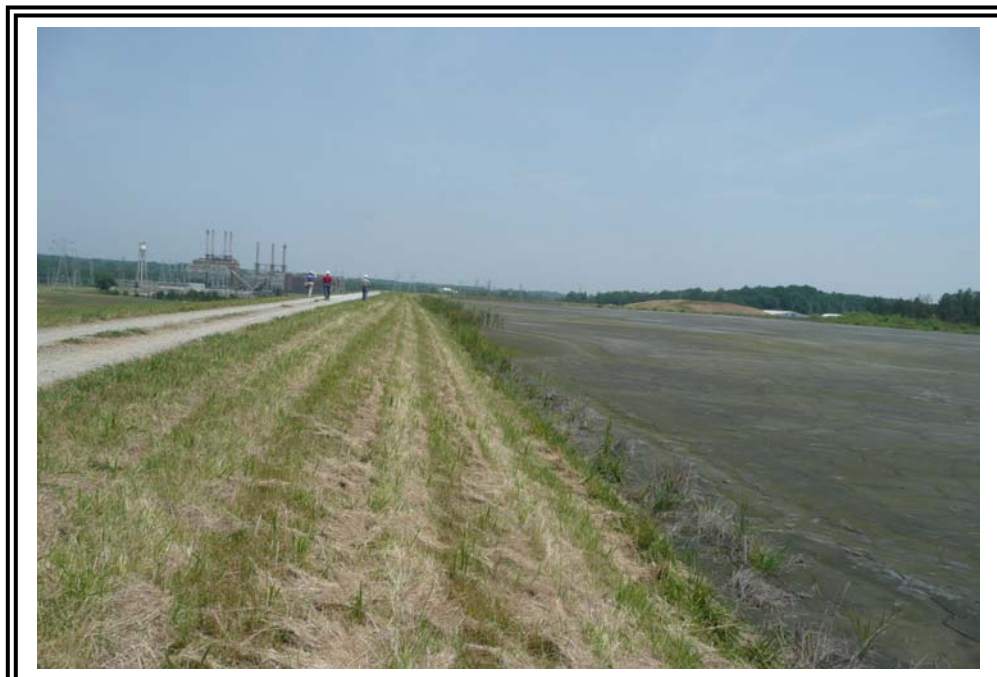
23

Upstream slope and crest alignment of west portion of New Dike, looking north.

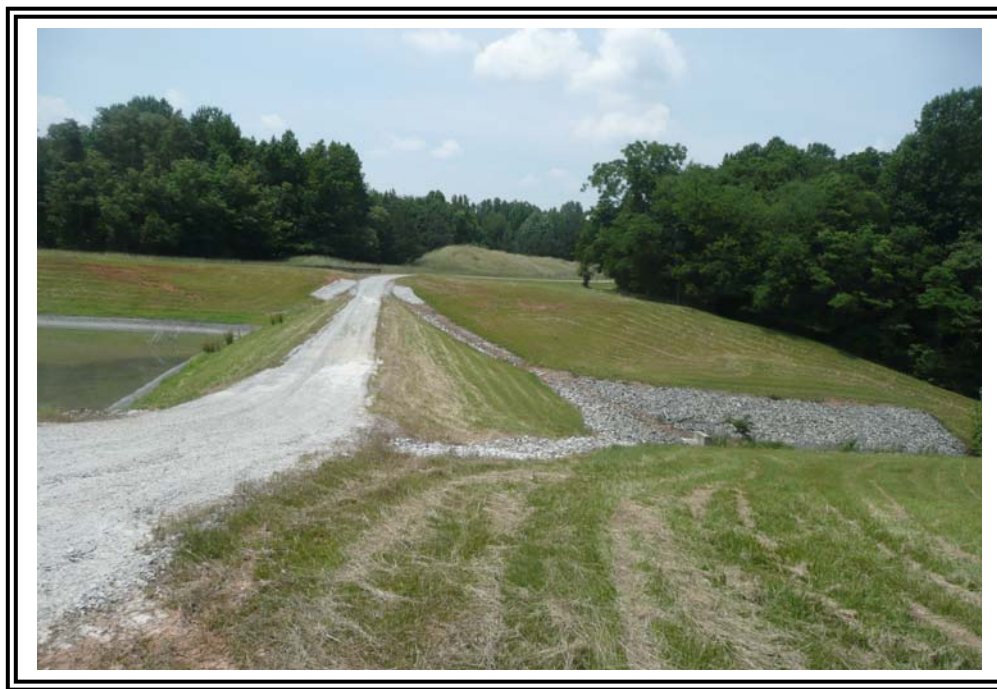
The Basin 1 to Basin 2 Outlet Dam is about 260 feet long. The crest is at El. 710 per design drawings; the same as the new dike. Photos 24 and 25 show this structure. No evidence of prior releases, failures or patchwork on was observed at the time of the site visit. Failure of this structure would not release impounded fluid or materials outside of the basin system although this is discussed further in Section 3.4.

Outlet dam from Basin 1 to Basin 2 looking north. This dam is in a cut channel created to drain Basin 1 into Basin2 through a high point in the natural topography.

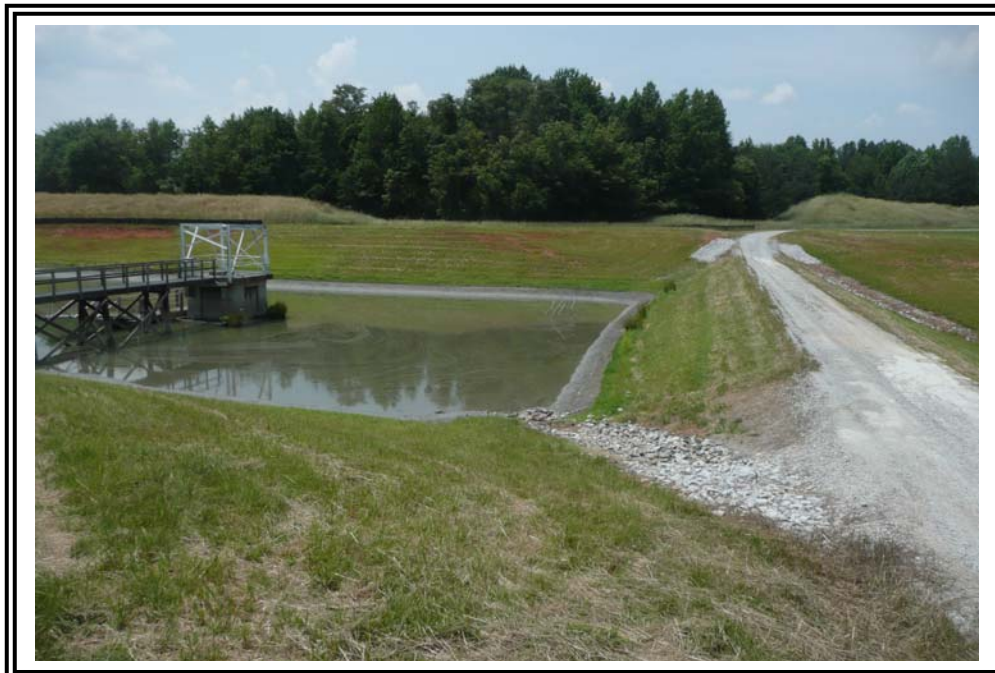
25

The outlet control structure controls the water level in Basin 1 via stop logs in an overflow weir. The water then discharges through a 36-inch diameter concrete pipe into Basin 2. As can be seen in Photo 25, the stop log system experiences significant leakage resulting in the lowering of water in Basin 1 below the normal decant elevation when ash is not being actively sluiced into Basin 1. During our visit, the Buck Steam Station was not generating power so no ash was being sluiced into Basin 1.

Basin 1 Outlet Tower.

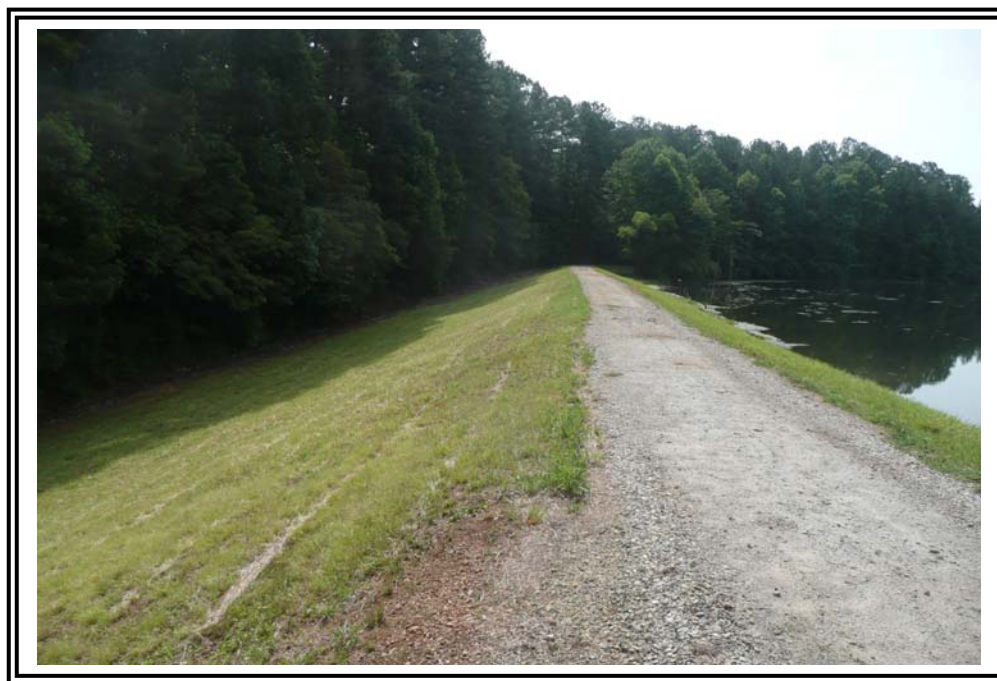
In general, the alignment of the crest of the main dike does not show signs of change in horizontal alignment. No evidence of prior releases, failures or patchwork on was observed at the time of the site visit. Photos 31 through 33 show the general condition of the main dike crest.

East portion of Main Dike crest adjacent to Basin 3, looking east.

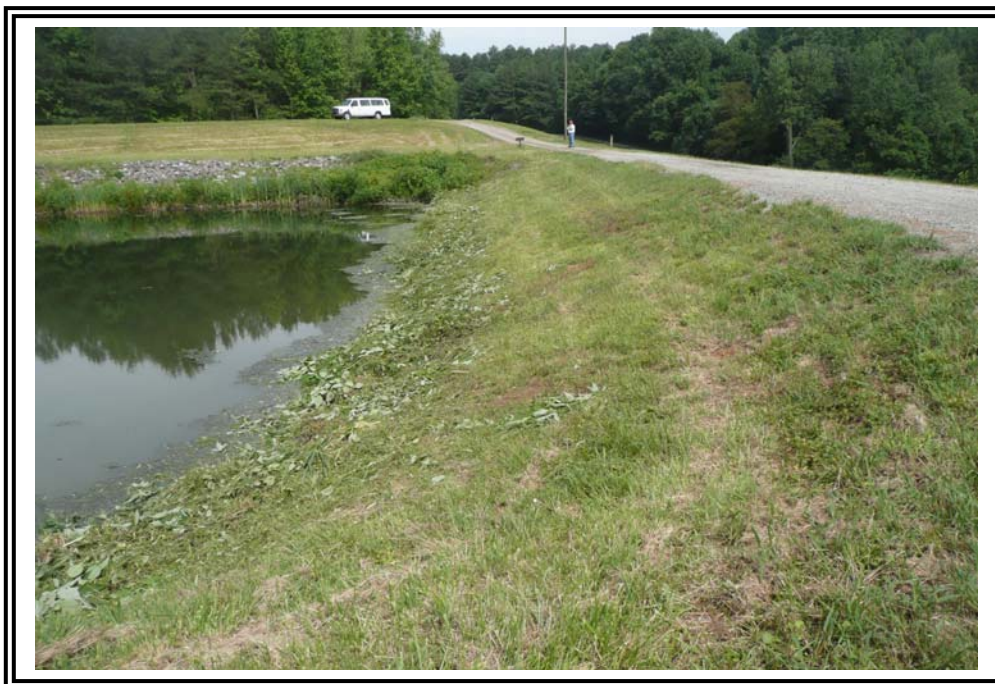
32

Middle portion of Main Dike crest and upstream slope adjacent to Basin 3, looking west. Van is parked on the diverter dike.

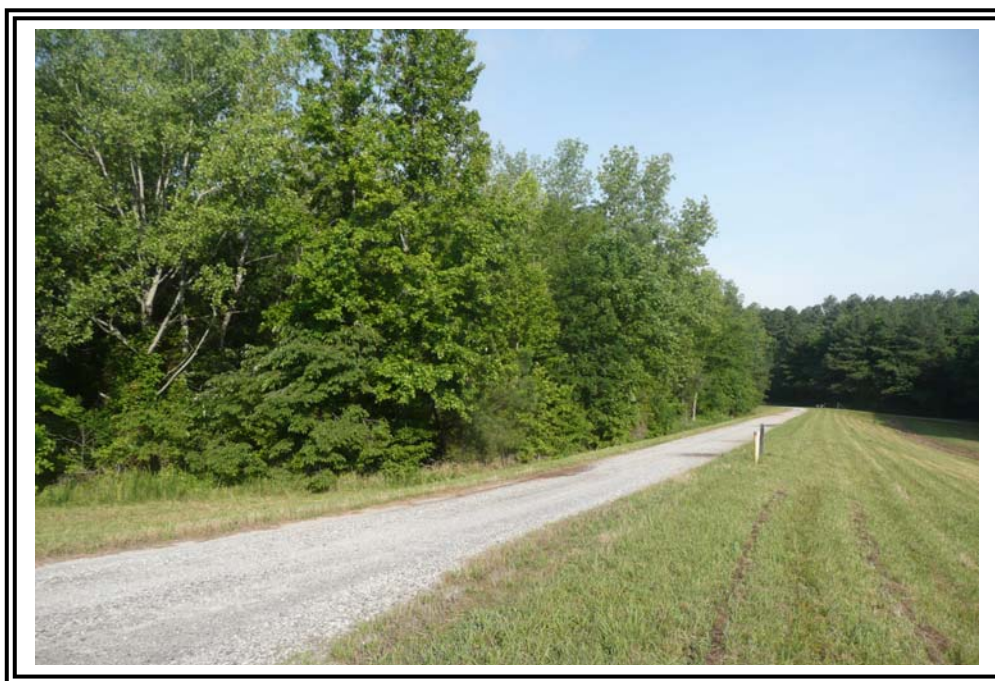
33

West portion of Main Dike crest adjacent to Basin 2, looking west.

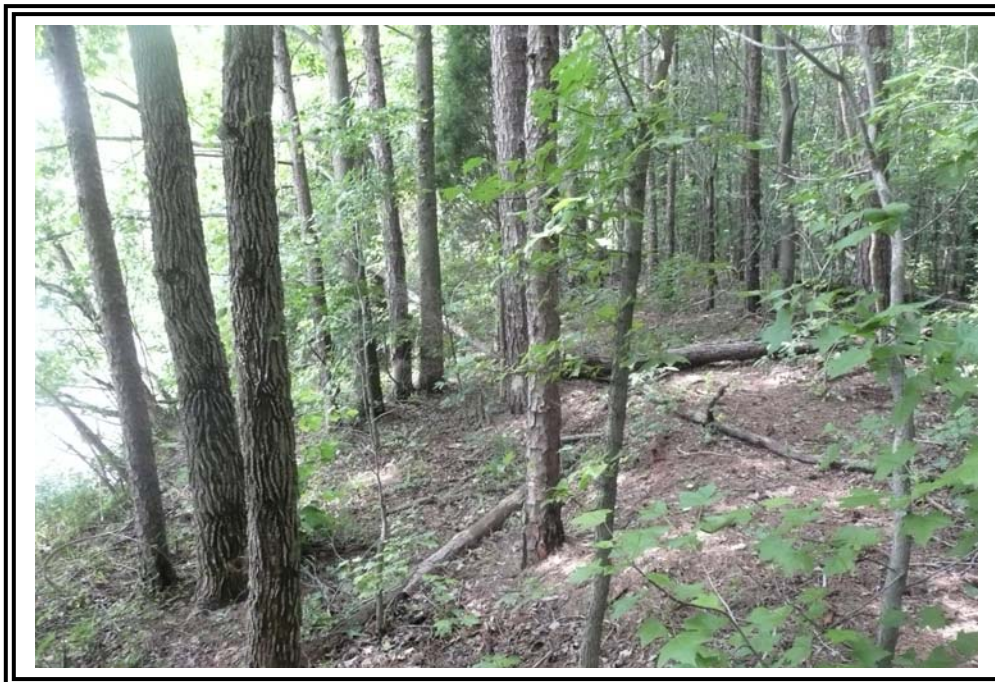
Although difficult to distinguish in the photograph, Photo 34 is typical of the conditions of the second portion of the main dike.

Main Dike extended all the way to the emergency spillway. Overgrown portion not impounding water during normal pool operations.

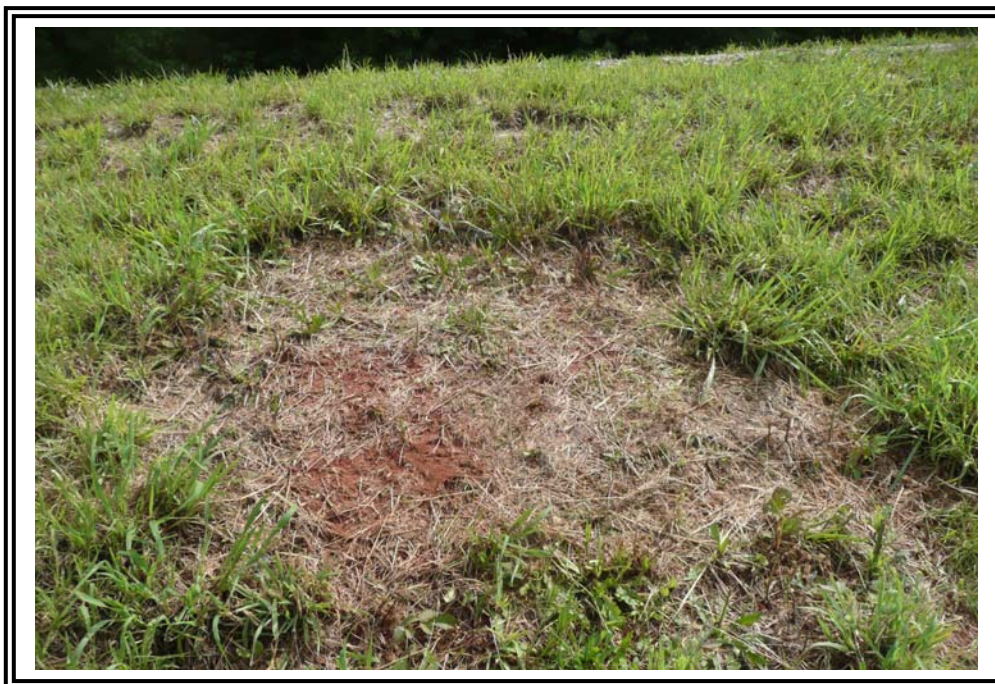
36

Close up of poor vegetation cover area.

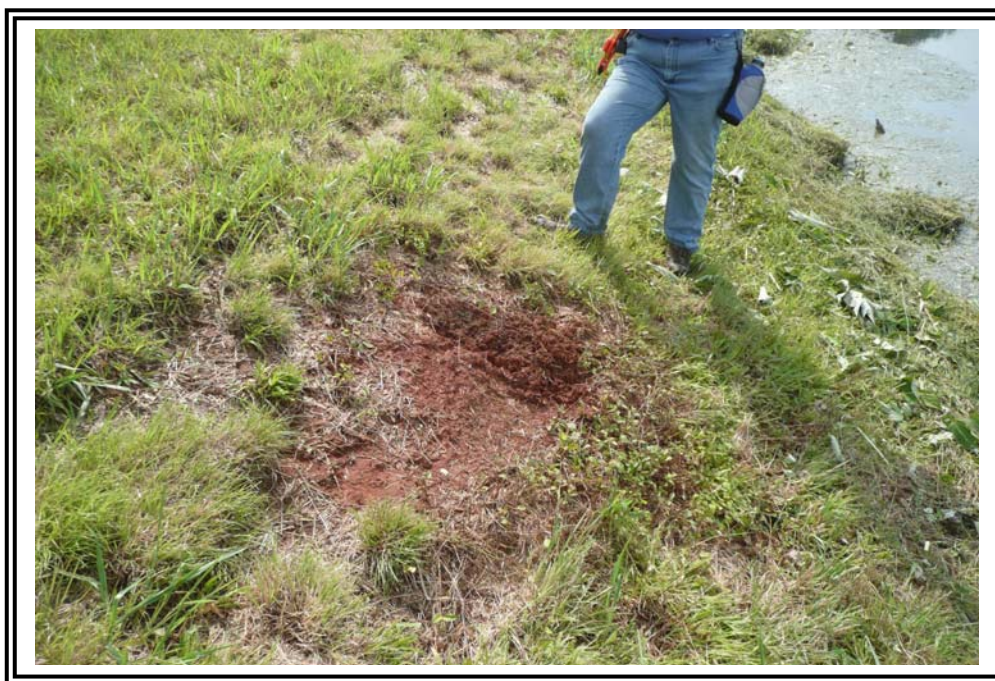
37

Close up of animal disturbance (possibly turtle nest).

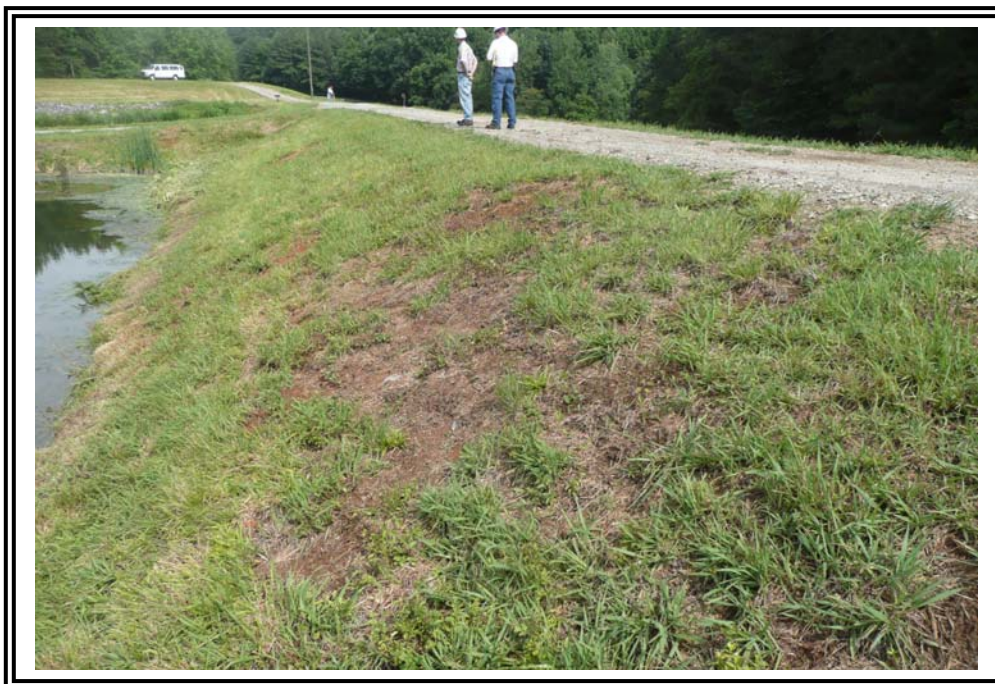
38

Close up of poor vegetation cover area.

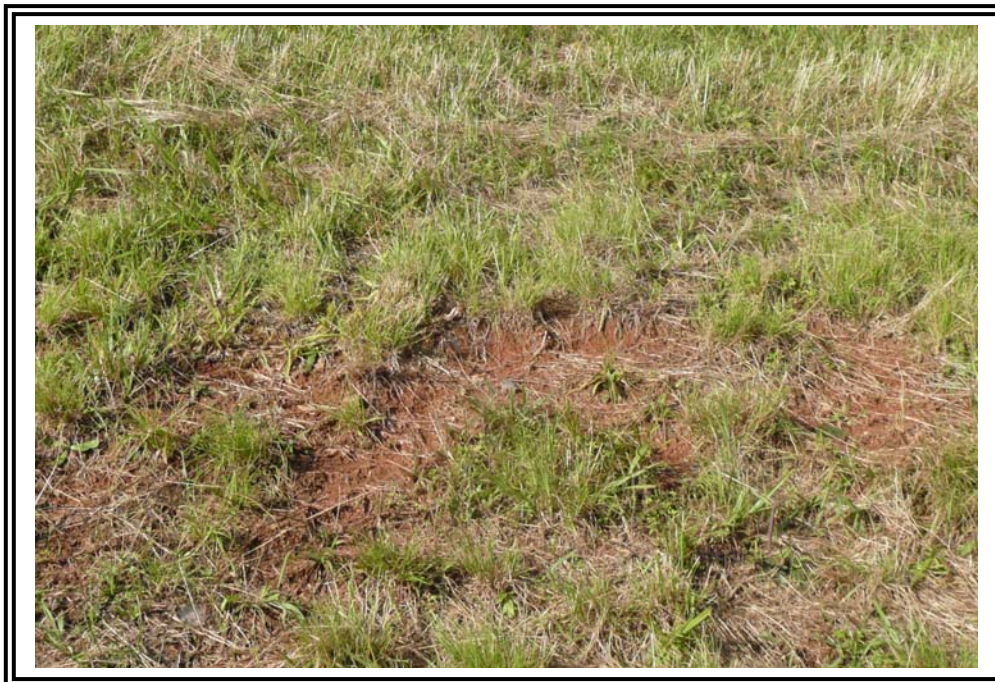
42

Close up of poor vegetation cover on downstream slope of Main Dike.

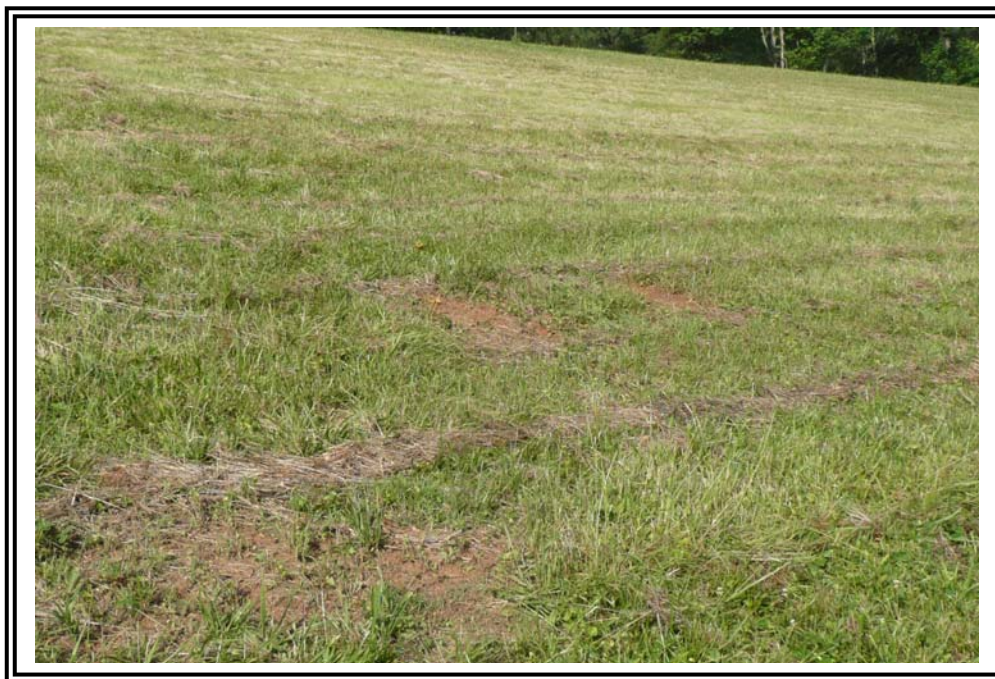
45

Close-up of sparse vegetation cover.

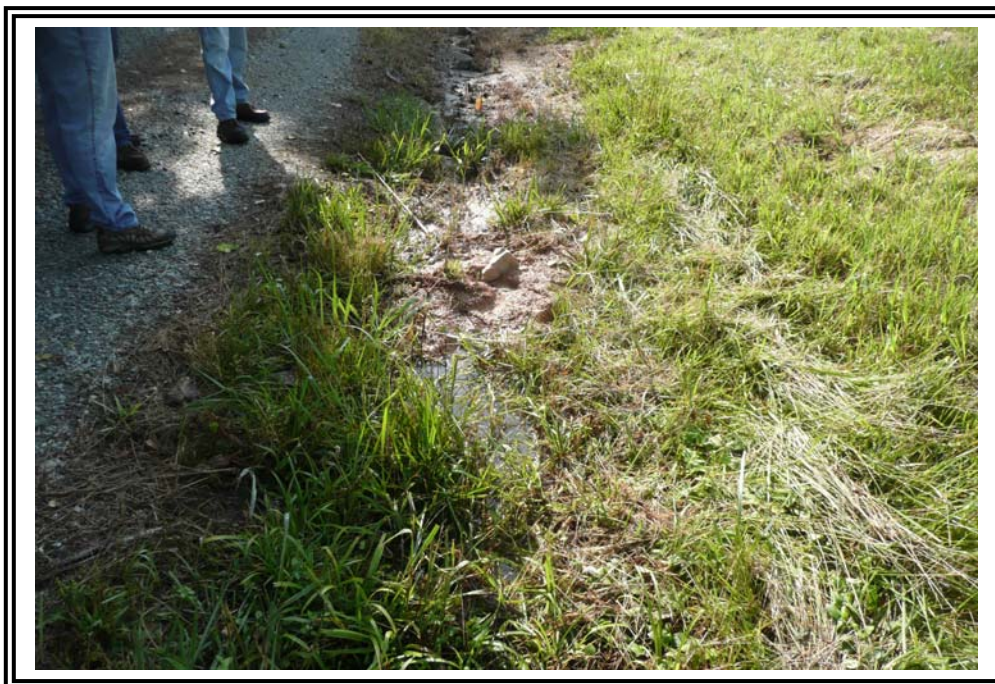
46

Clogged groin drainage swale on west end of Main Dike. Sediment appeared to include bentonite chips, possible runoff from poorly cleaned up drilling at “new” monitoring wells.

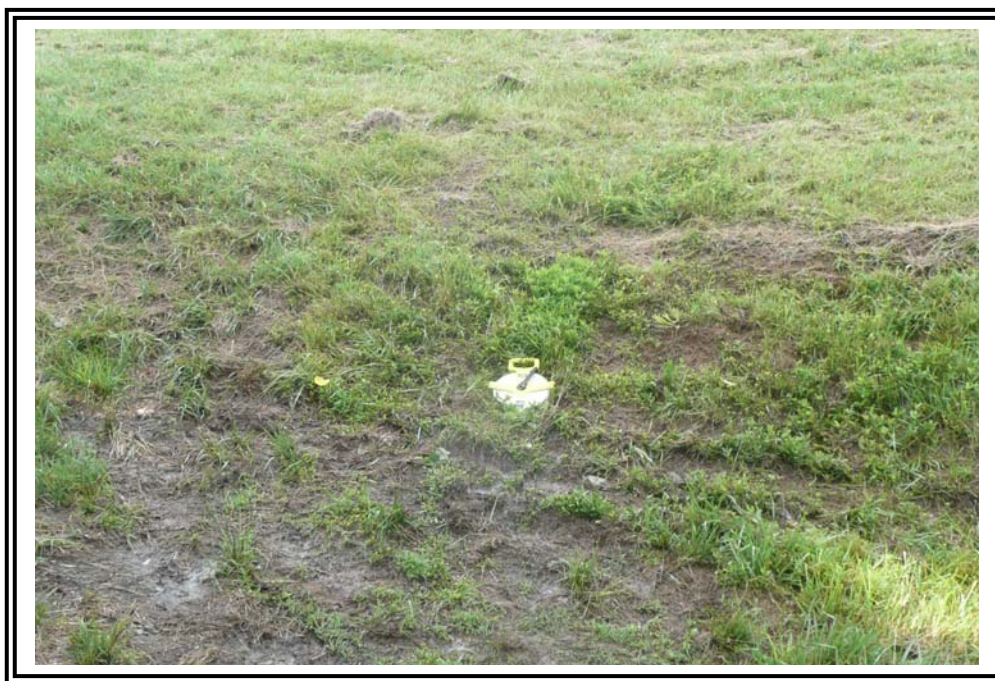
47

Sparse vegetation at toe of Main Dike near the outlet structure.

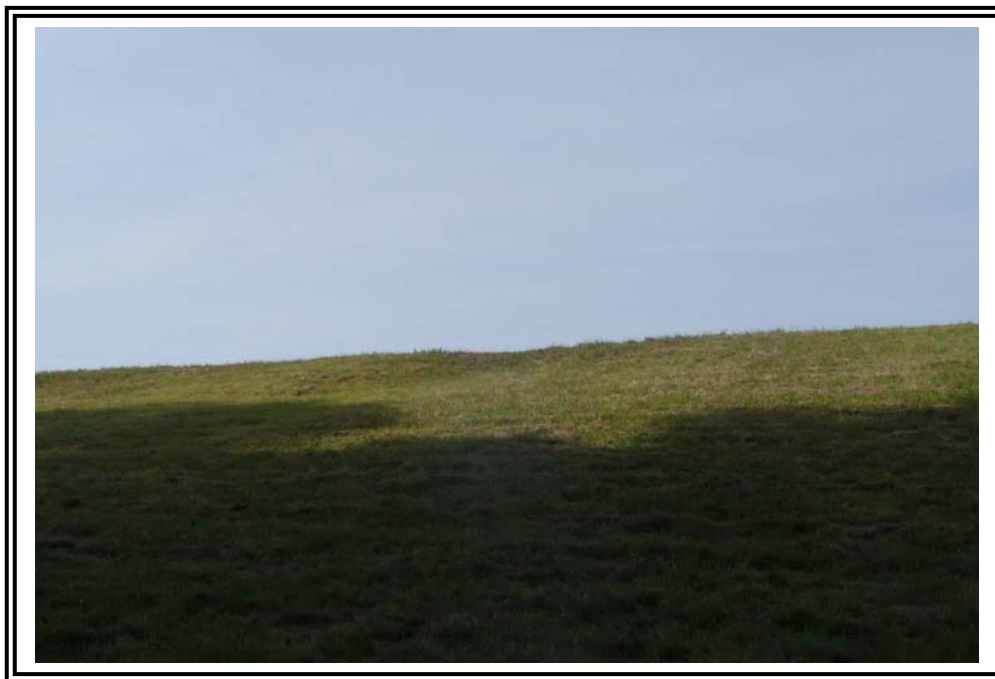
49

Low spot at crest, as seen from toe of Main Dike, location is adjacent to Basin 3.

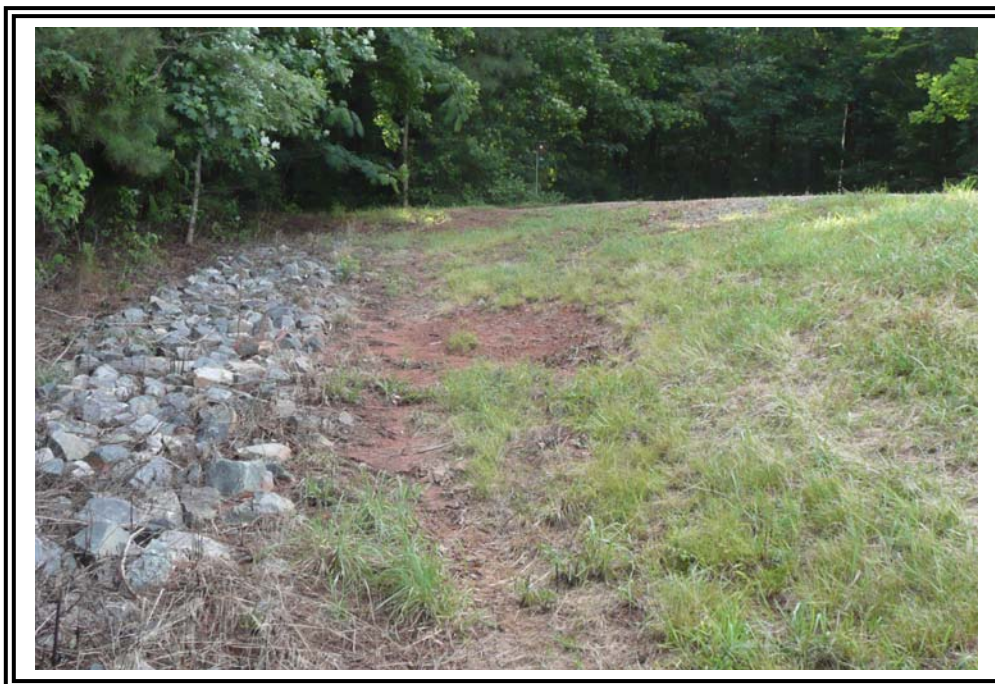
50

Sparse vegetation on downstream slope at east end of maintained Main Dike, looking east.

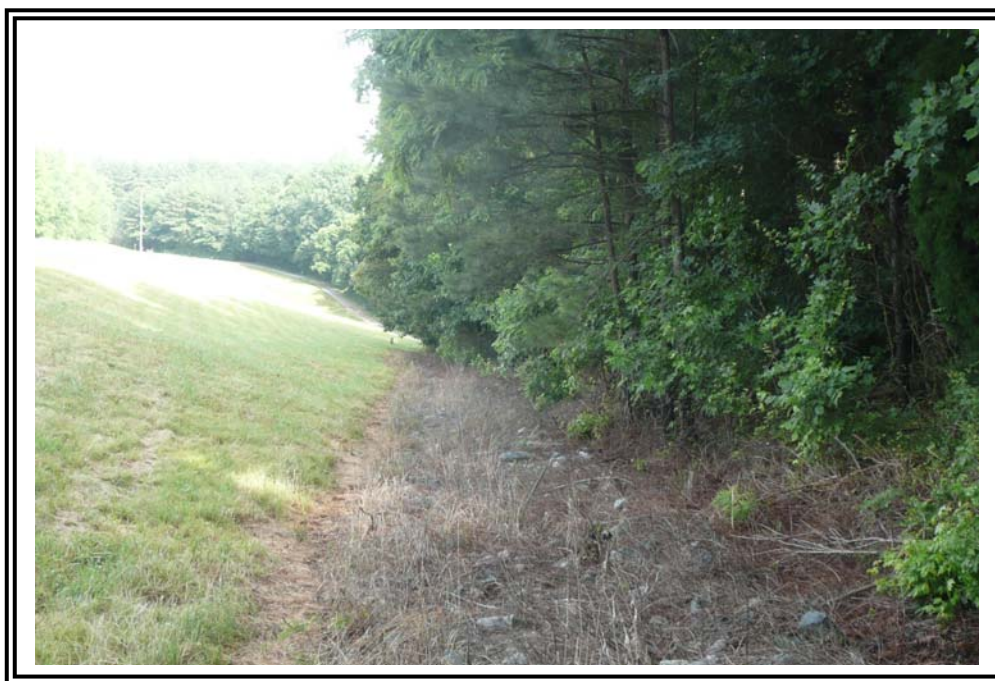
51

Herbicide treated vegetation in groin swale at the east end of Main Dike.

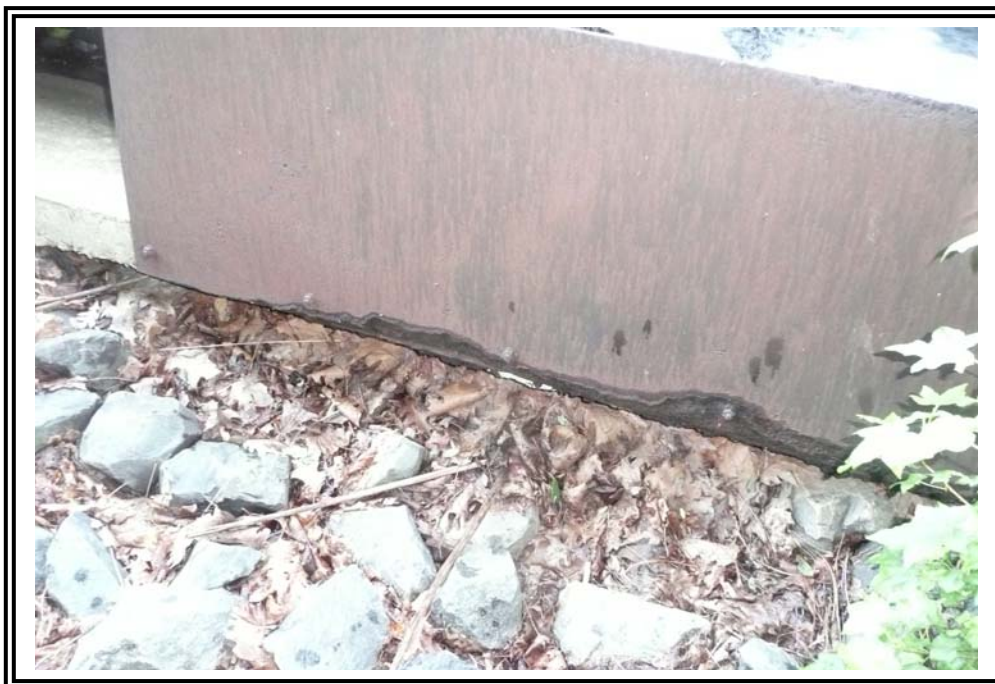
58

Slight undermining of concrete discharge channel at outlet structure.  
Baffles in place to control splash out of channel during high flows.

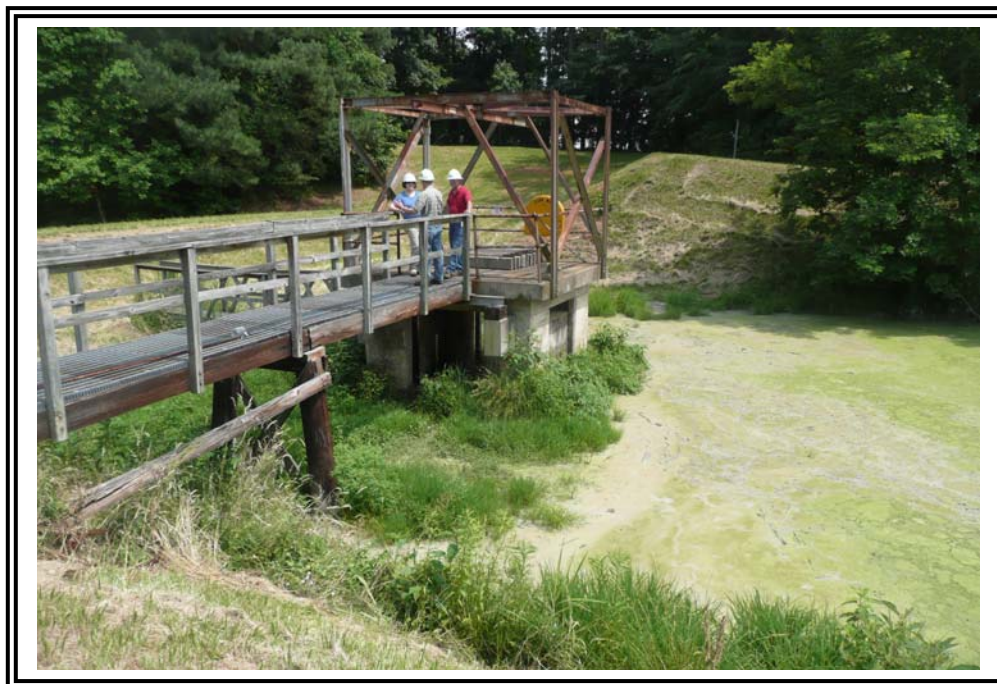
62

Basin 2 outlet control structure. Vegetation at base of tower and access bridge is on deposited ash.

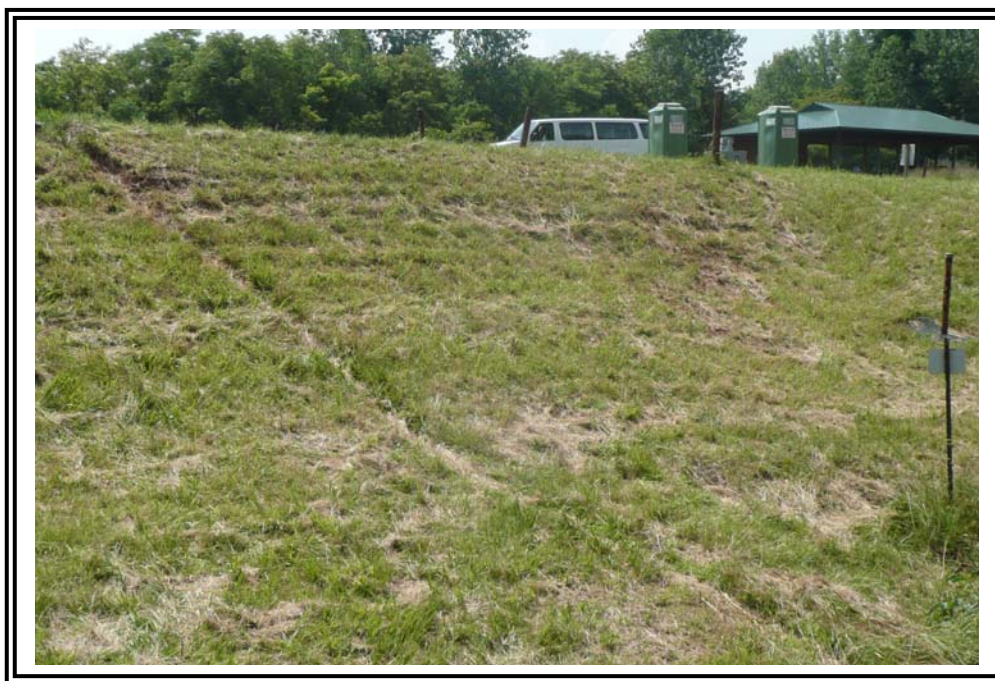
65

Animal trail on downstream slope of Basin 2 to Basin 3 outlet dam.

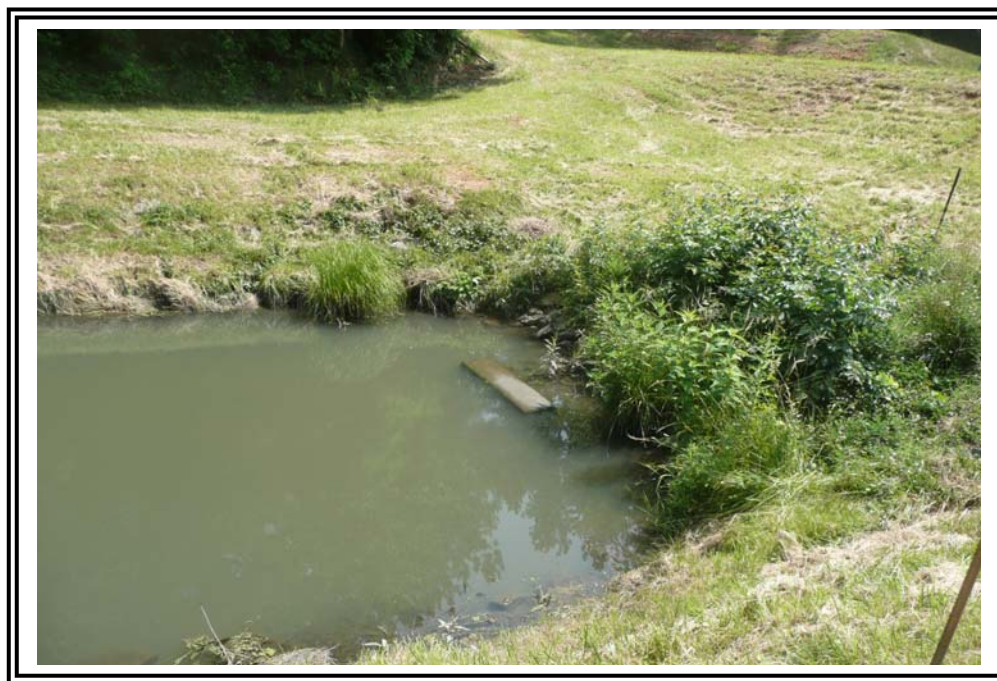
67

Basin 2 outlet pipe submerged on downstream end.  
Note: Headwall visible at water surface.

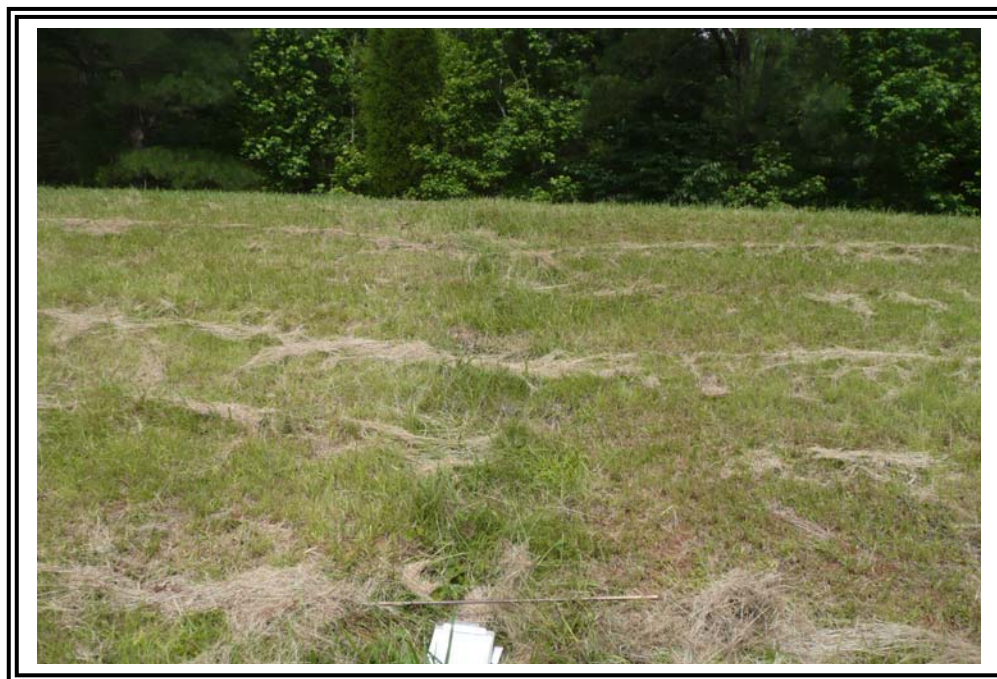
72

Erosion swale on downstream slope of Diverter Dike.

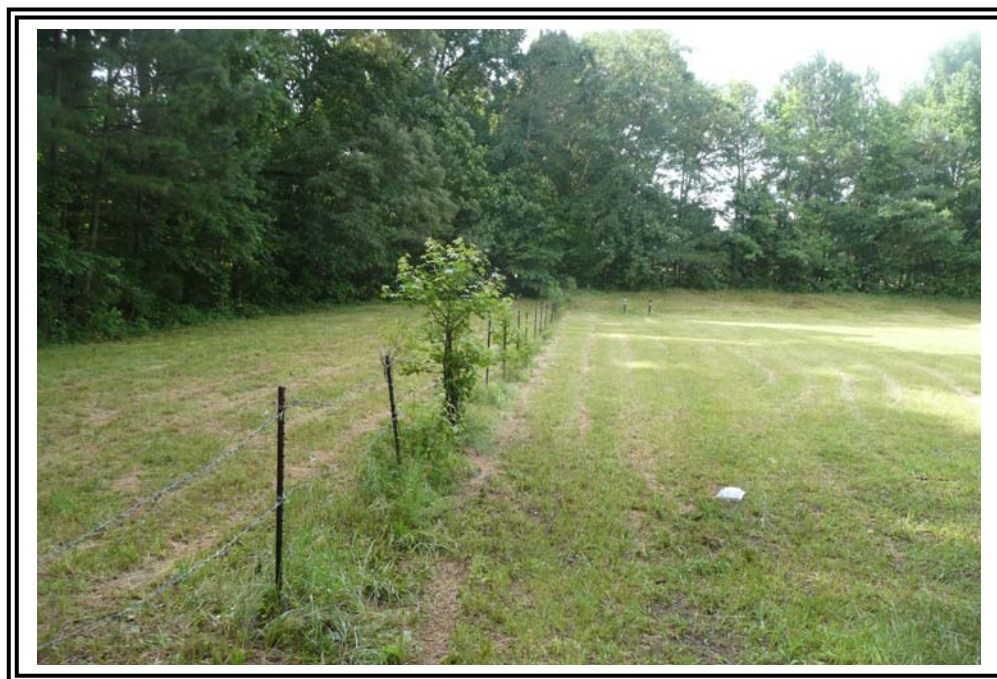
81

Fence across Emergency Spillway.  
Note: Emergency Spillway flows into wooded area to left in photo.

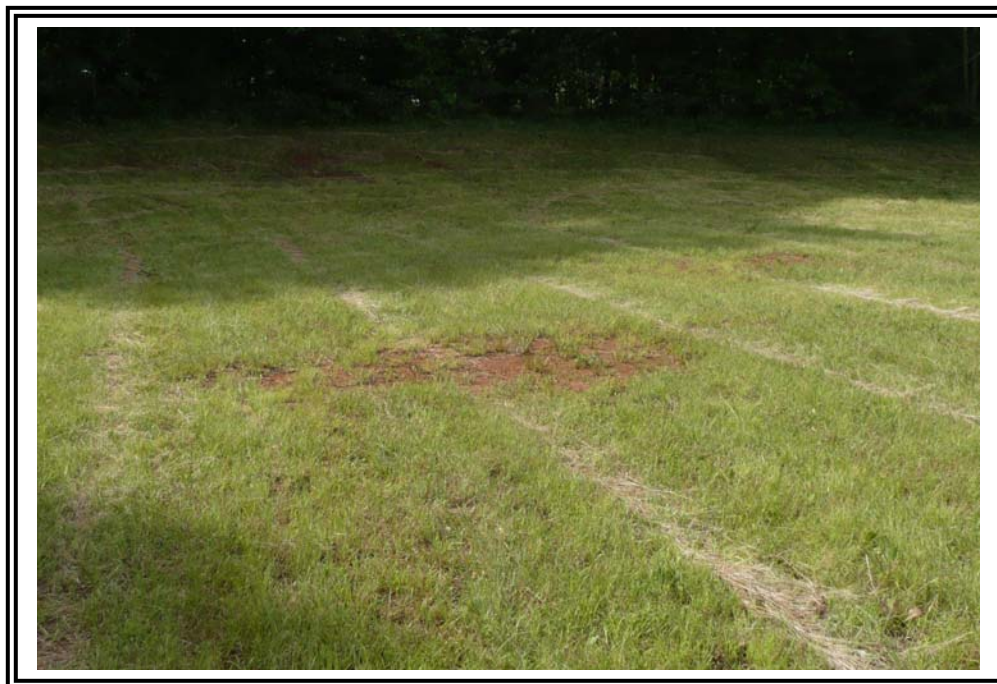
82

Sparse vegetation within Emergency Spillway.

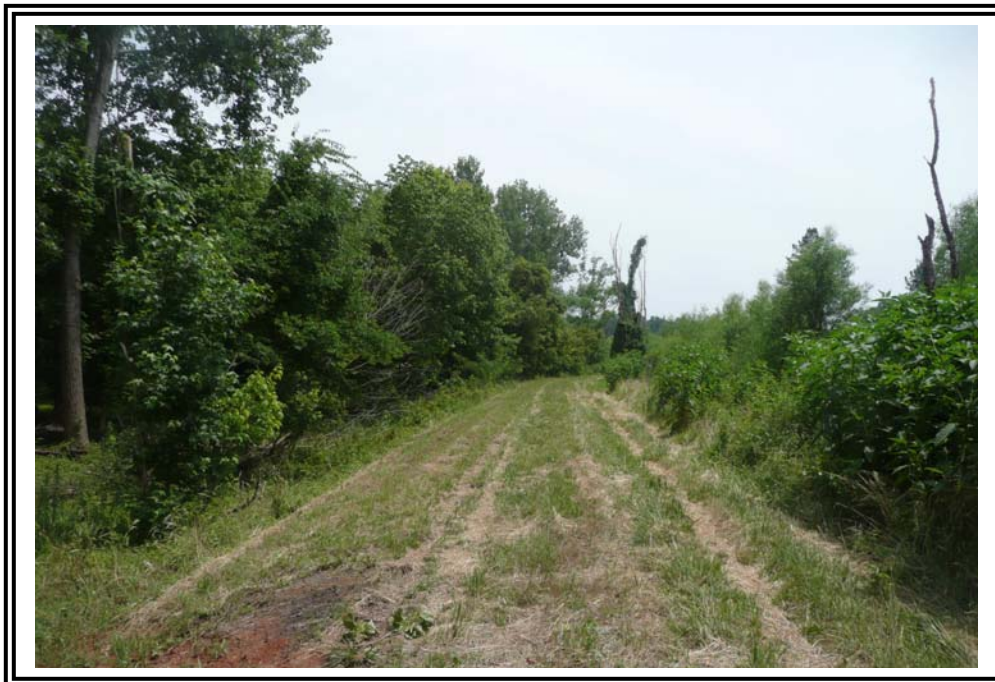
83

Dike through Basin 2 for access on inactive portion of Basin. Yard sumps discharged into channel in Basin 2 to right in photo, looking south.

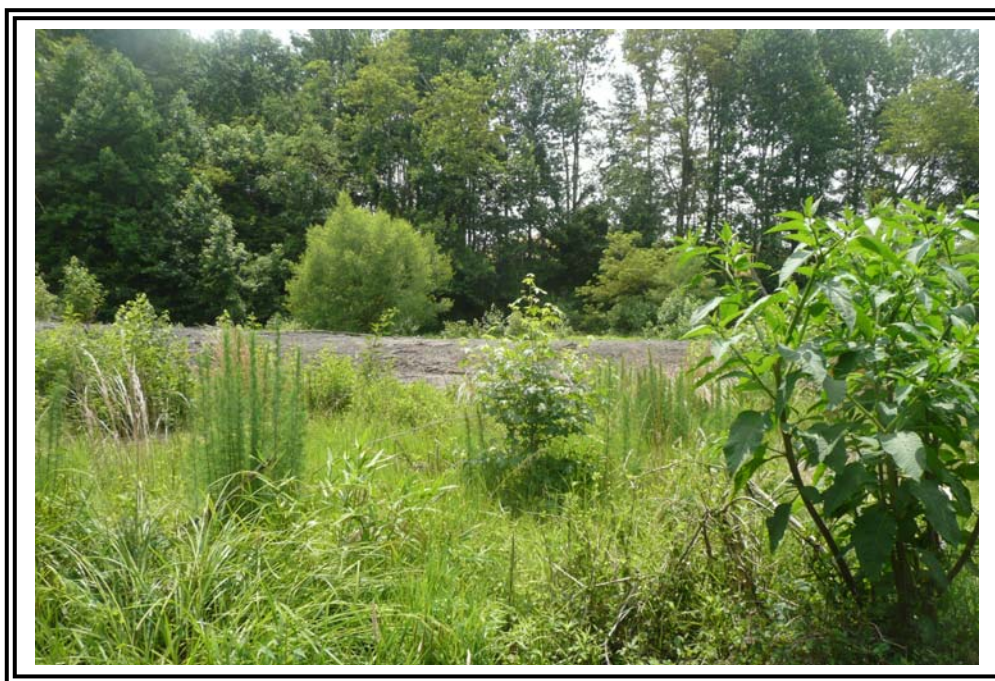
84

Ash Dike to control flows and prevent standing water in area of yard sump discharge.

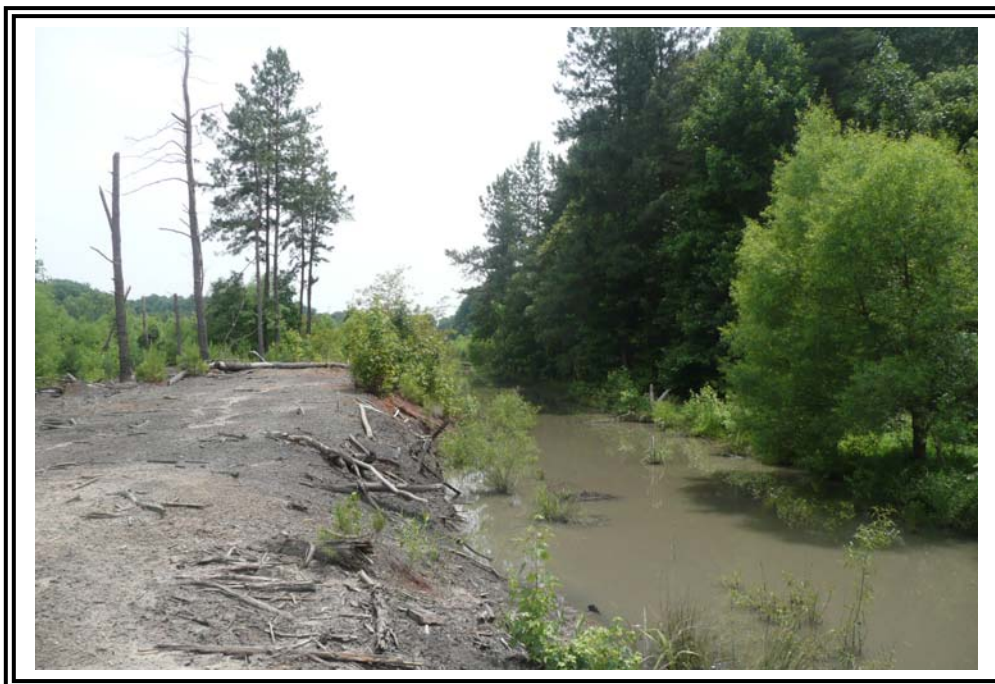
85

Ash Dike to control flows and prevent standing water in area of yard sump discharge.
