# Assessment of Dam Safety

## Coal Combustion Surface Impoundments (Task 3)

Duke Energy  
Buck Steam Station  
Spencer, North Carolina

September 14, 2009

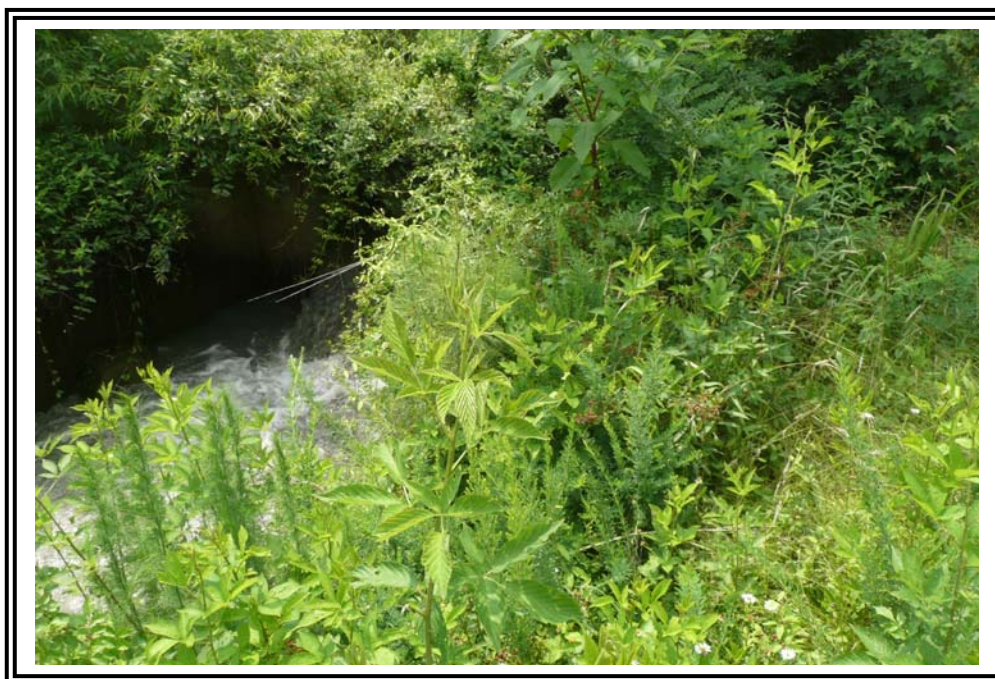
86

Yard sump discharged point on north end of Basin 2.
