**DRAFT REPORT
ROUND 10 DAM ASSESSMENT – MAY 24, AND 25, 2011
DYNEGY MIDWEST GENERATION, INC. – BALDWIN ENERGY COMPLEX
PRIMARY FLY ASH POND, SECONDARY FLY ASH POND, SECONDARY POND,
INTERMEDIATE POND, FINAL POND
BALDWIN, ILLINOIS**

RE: DRAFT Assessment of Dam Safety of Coal Combustion Surface Impoundments at the
Baldwin Energy Complex

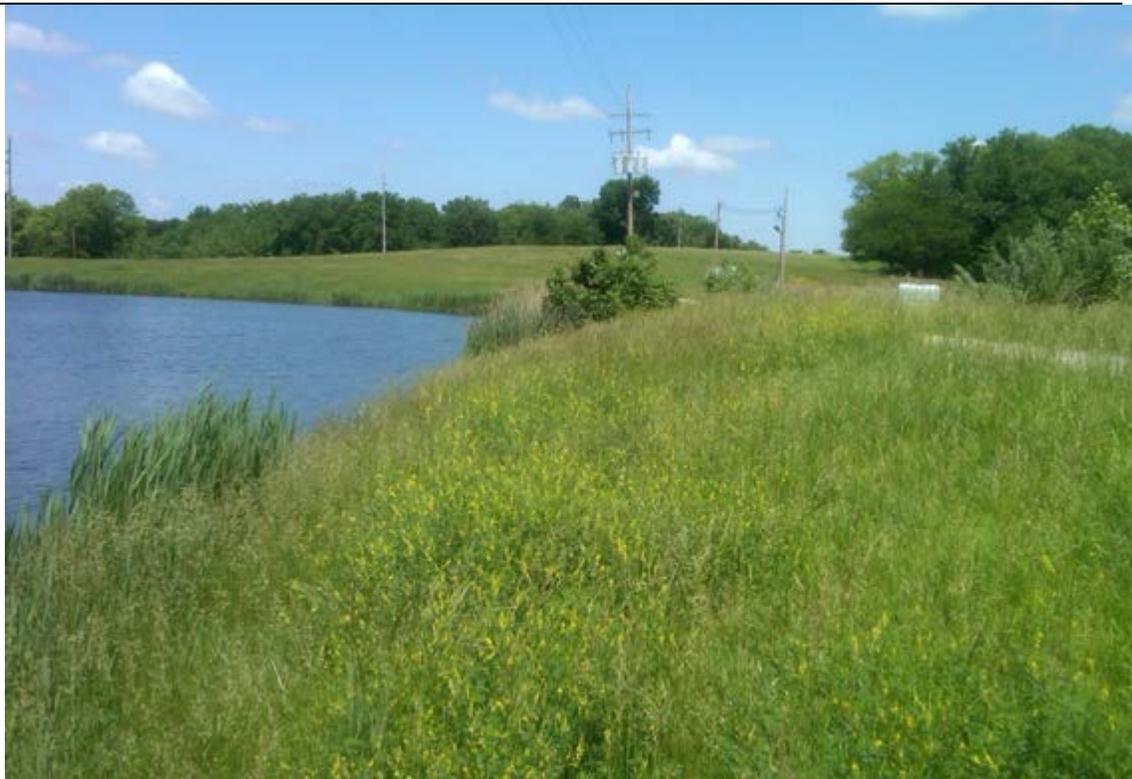
Downstream slope of the
Ash Pond Dike.

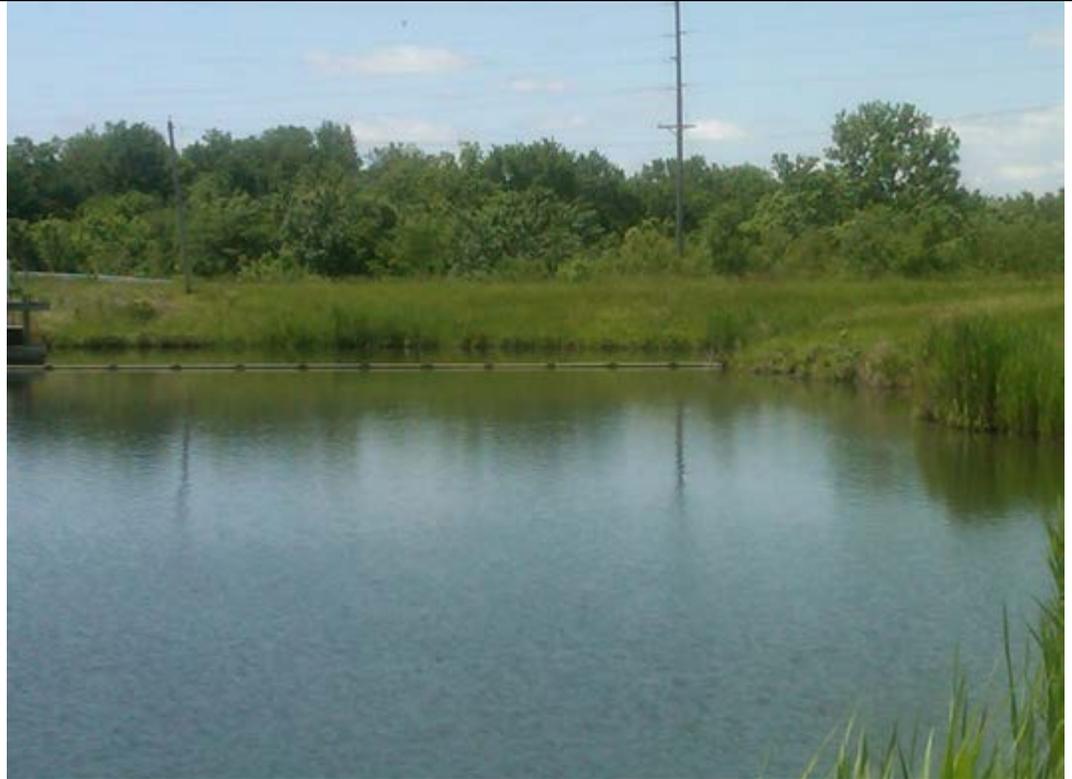
Upstream slope of the Final
Pond.

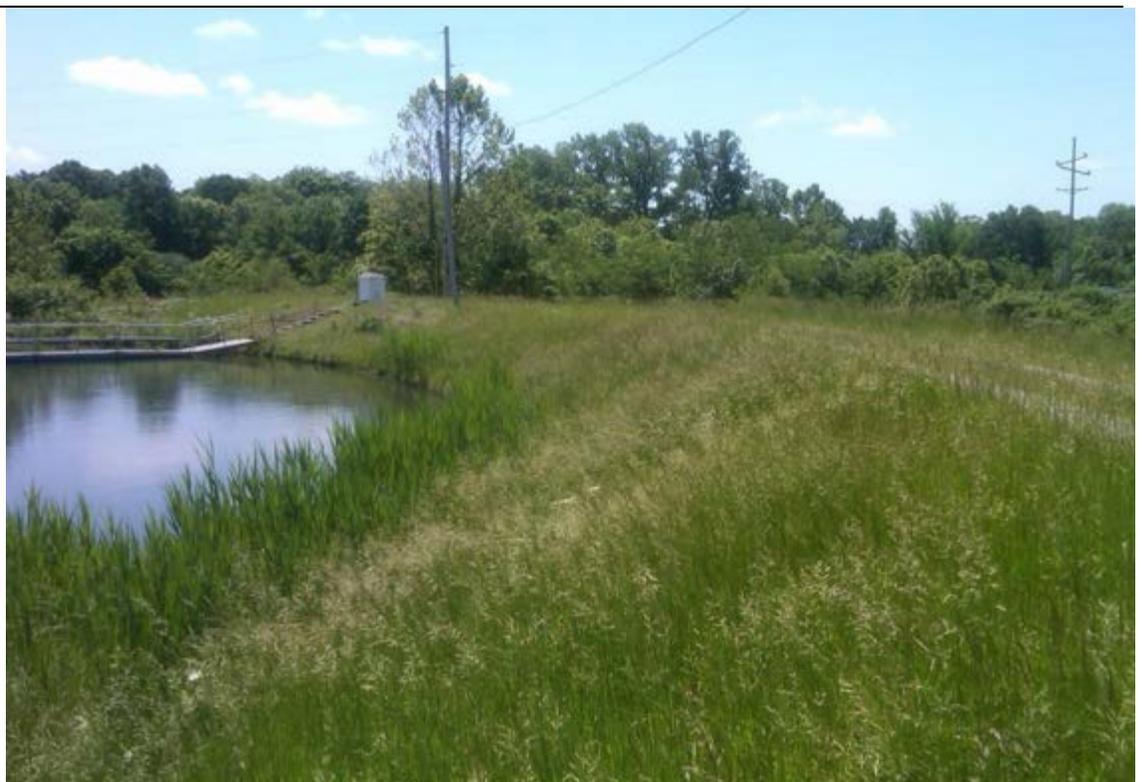
Photo No.
8

Upstream slope of the Final
Pond.

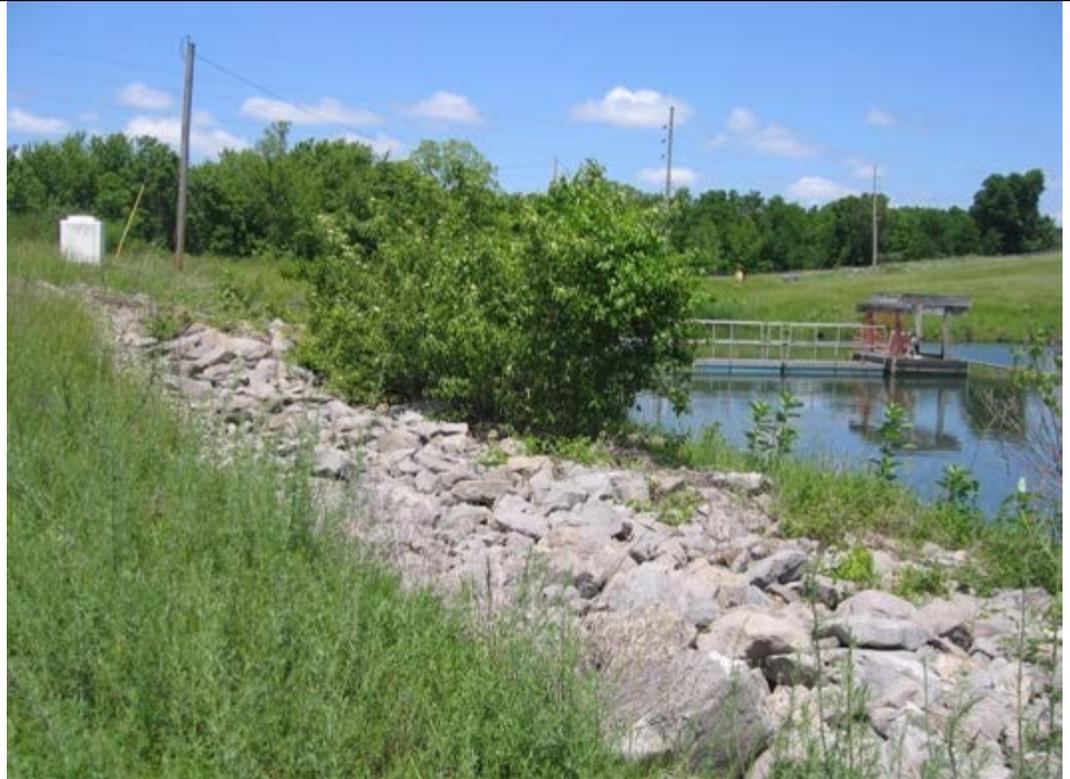
Upstream slope and decant
structure of the Final Pond.

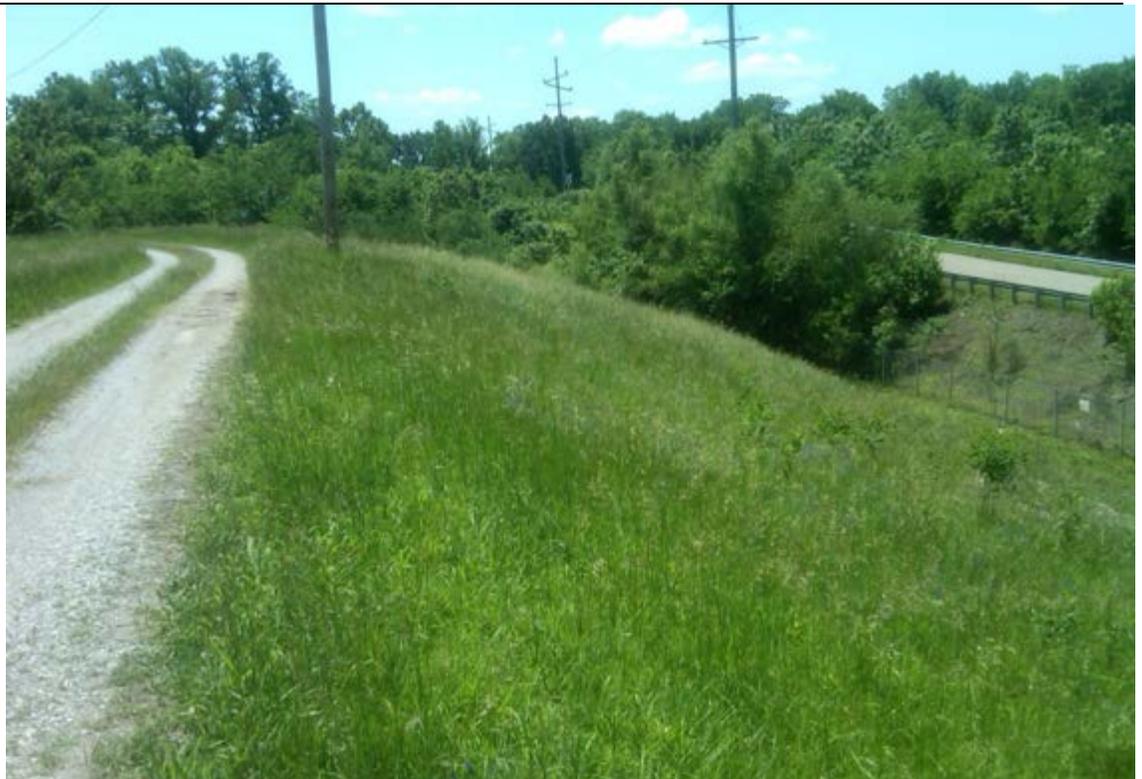
Photo No.
10

Crest and downstream slope
of the Final Pond.

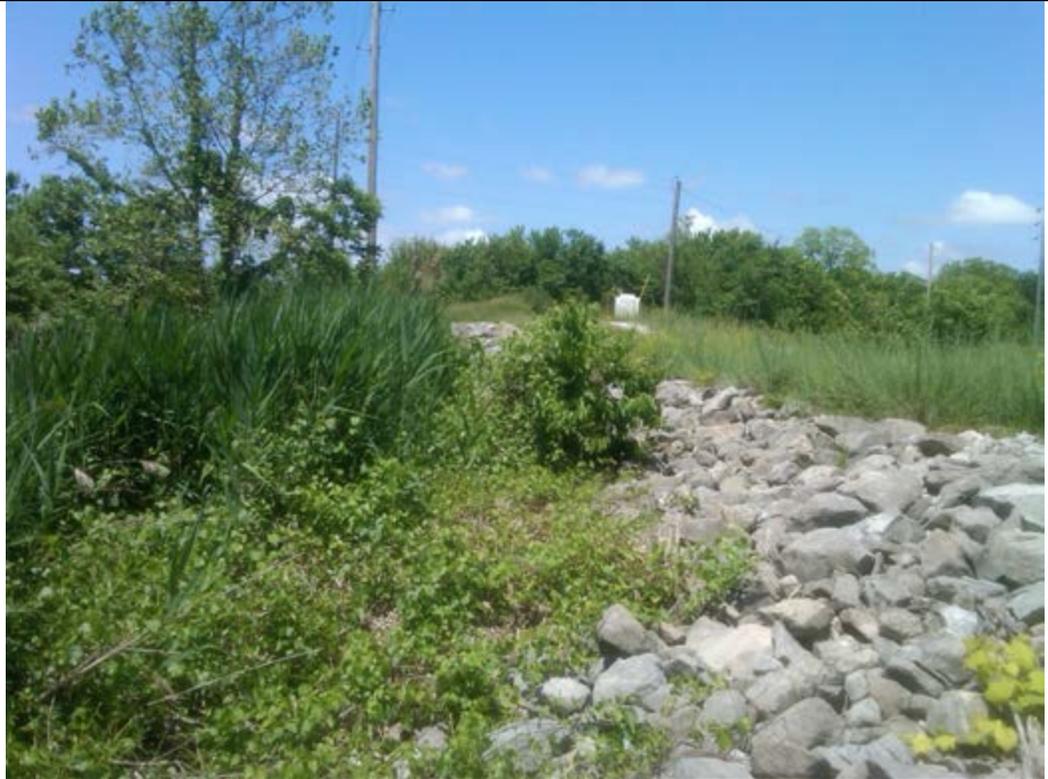
Description:
Riprap on downstream slope
of the Final Pond.

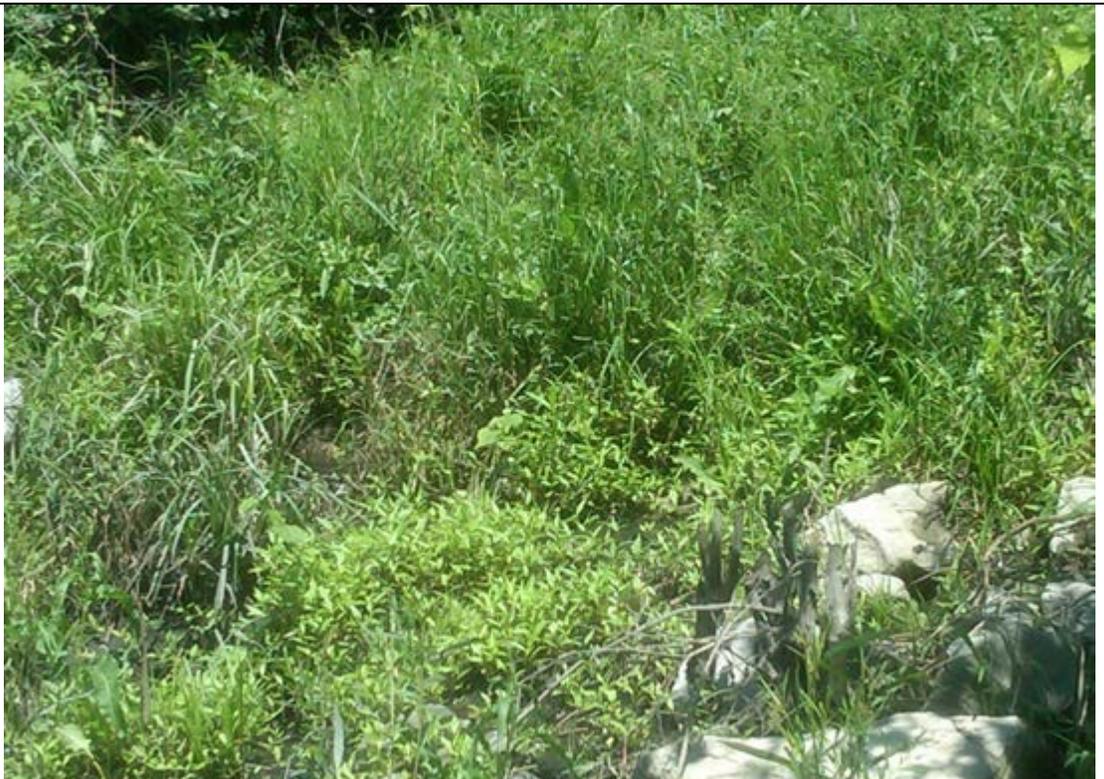
Photo No.
14

Description:
Seepage on downstream
slope of the Final Pond.

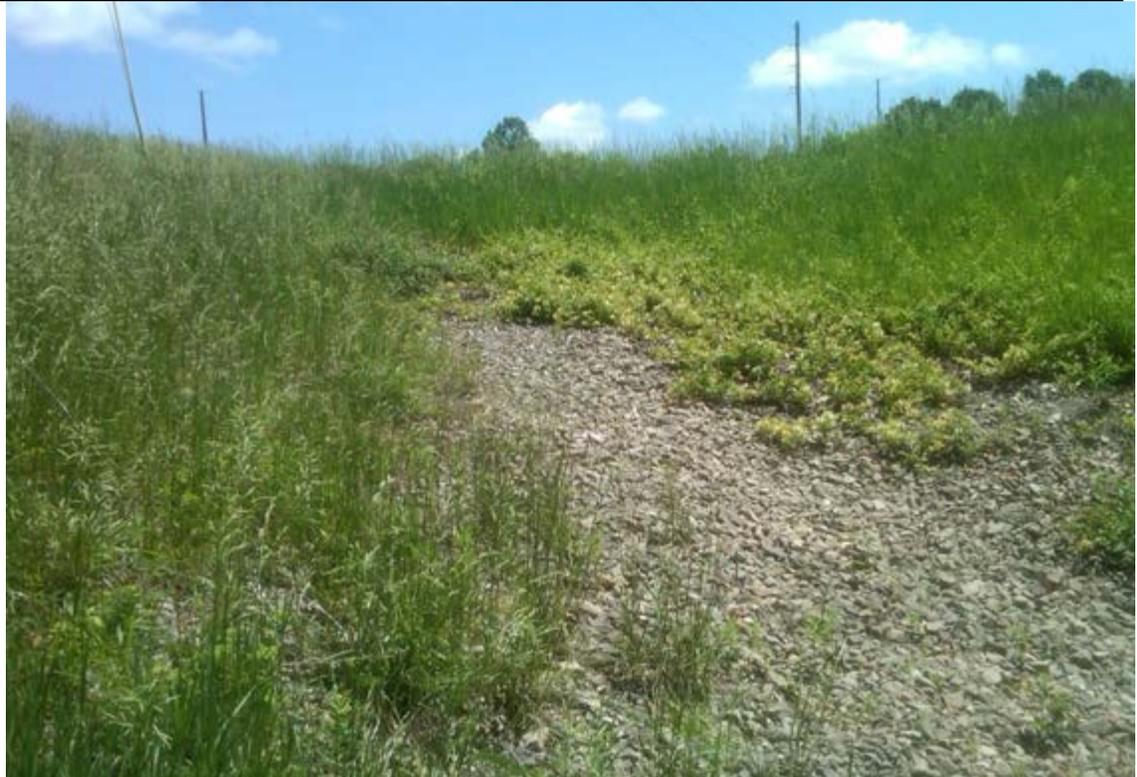
Description:
Gravel lined drainage ditch on downstream slope of the Final Pond.

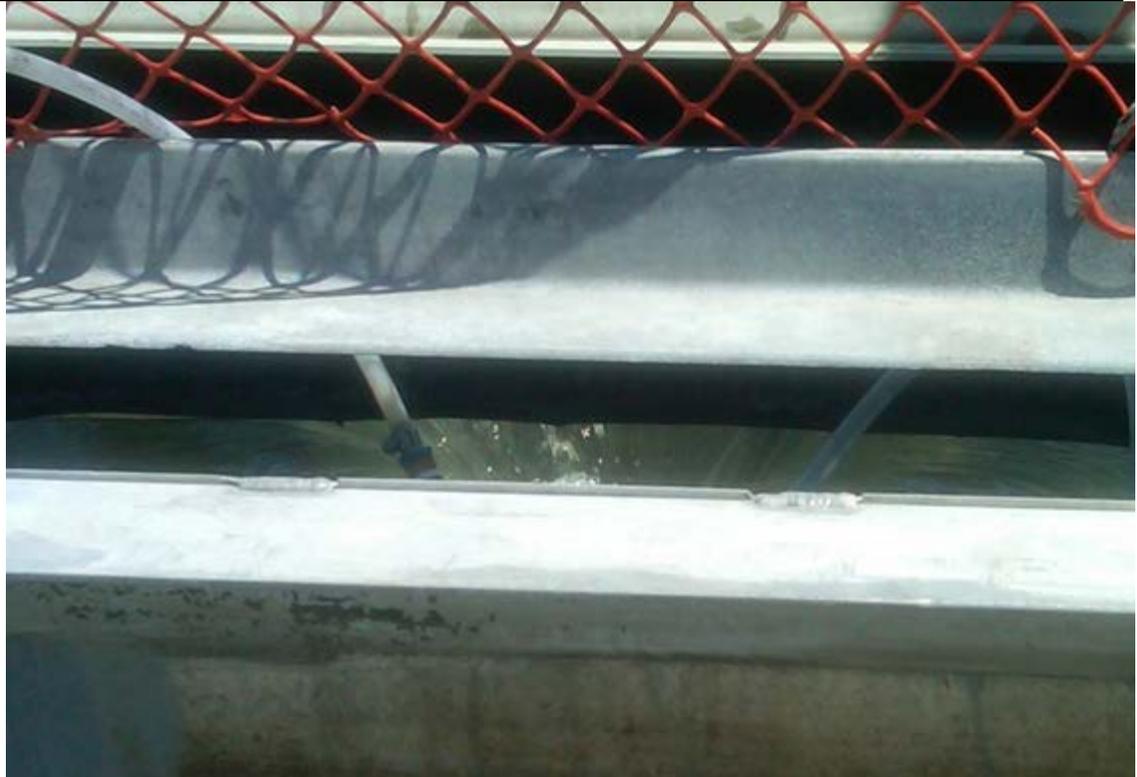
Description:
Decant structure of the Final Pond showing the decant pipe appears to be nearly at capacity.

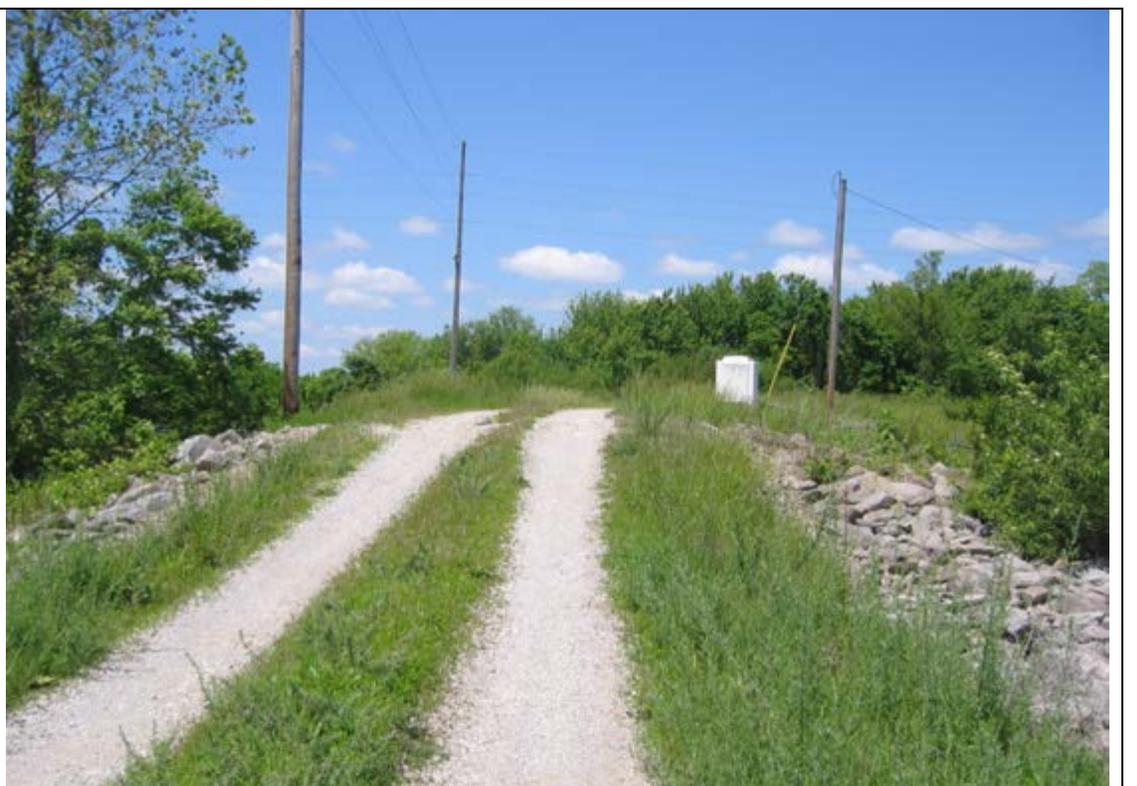
| Photo No. 18 | Date: 5/24/11 |

Description:
Crest of the Settling Pond Dike.

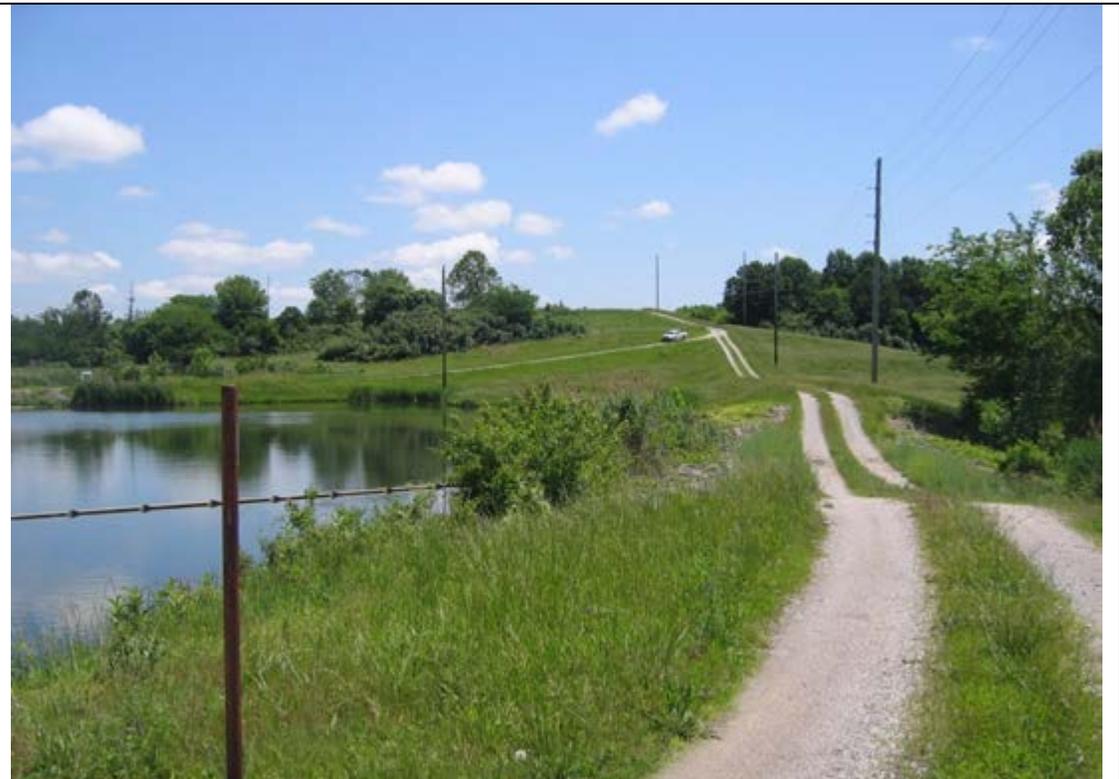
Photo No.
20

Description:
Crest of the Settling Pond
Dike near the overflow
section.

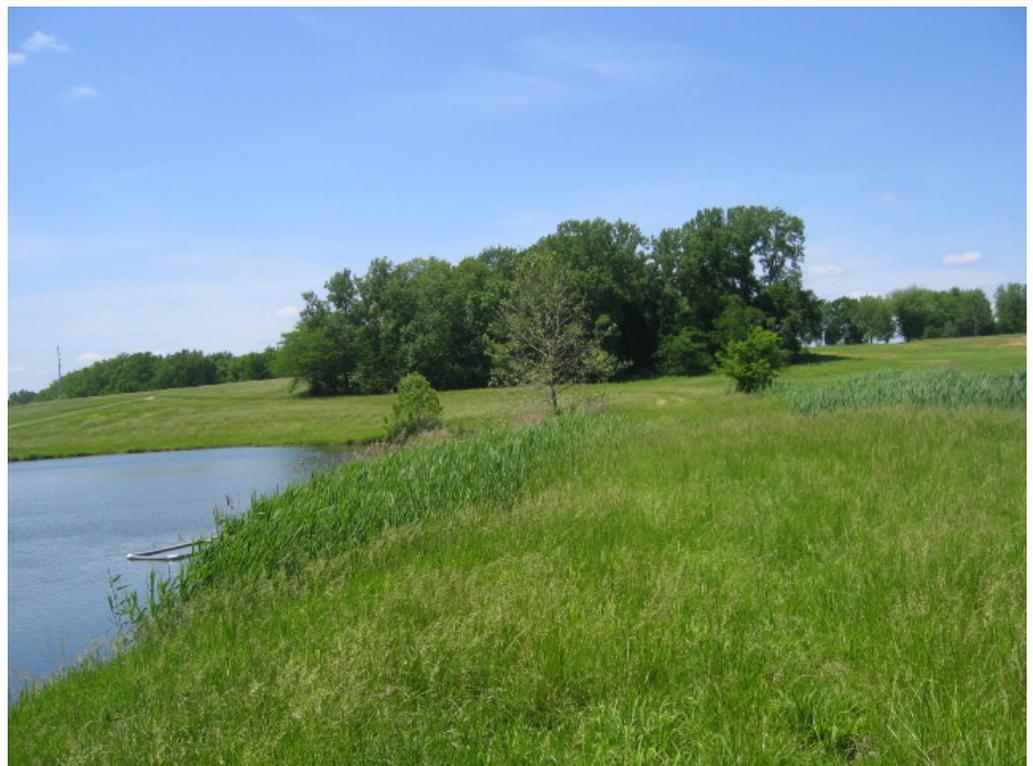
Photo No.
24

Crest, upstream and
downstream slope of the
Secondary Dike

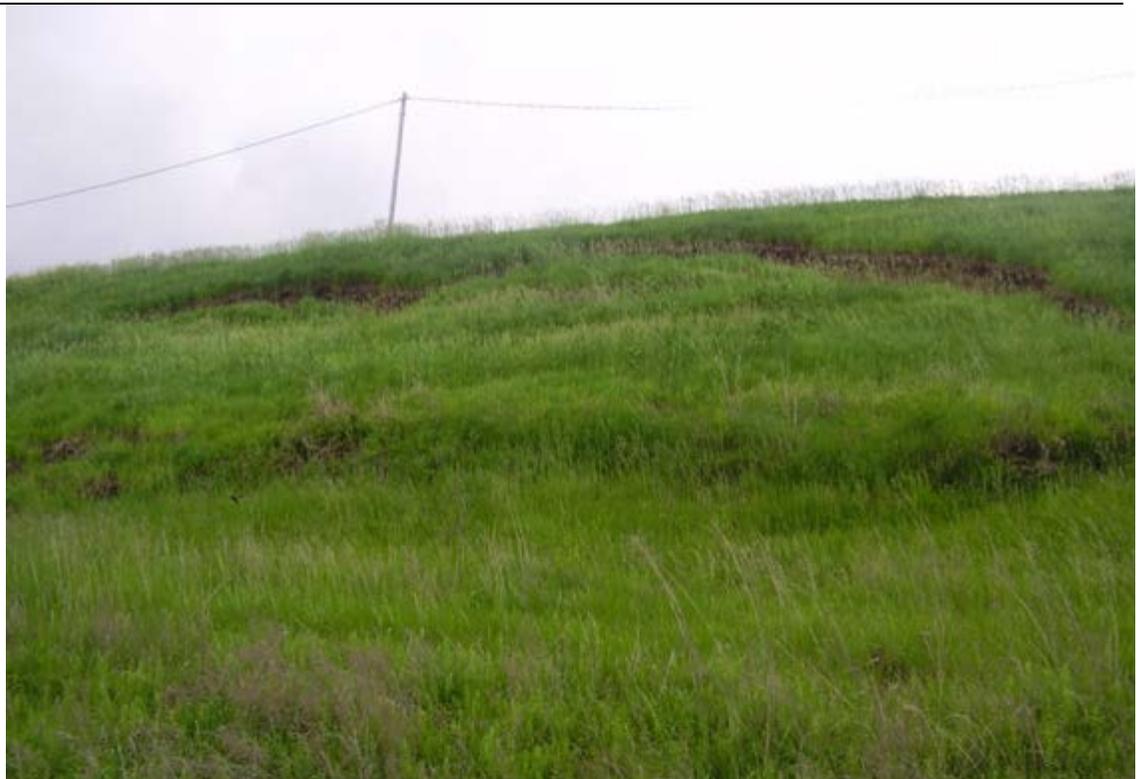
A scarp was observed near the crest of the downstream slope of the northwestern embankment at the approximate location shown on **Figure 8**. The scarp was approximately 100 feet wide along the slope and extended approximately 30 feet to 40 feet down the slope. The vertical face at the head of the scarp was approximately 2 feet high. The scarp had reportedly developed 2 weeks prior to our inspection and repair of the scarp has been completed since our visit according to BEC personnel. Moist surface conditions that may have been an indicator of seepage were observed along the toe of the southern embankment. However, we were not able to confirm the nature or extent of moist conditions due to the thick vegetation.

Description:
Scarp on downstream slope
of the Northern Dike.

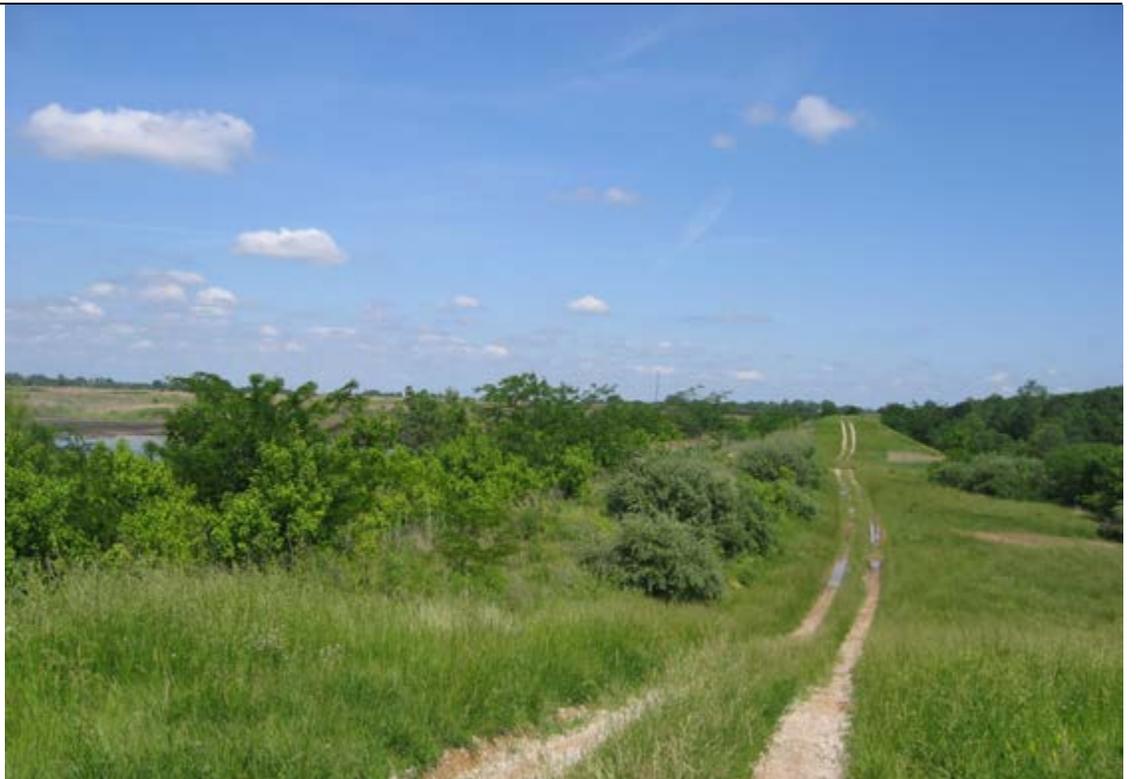
Photo No.
48

Crest and upstream slope of
the Secondary Fly Ash Pond
in the area of the 1995
Failure.

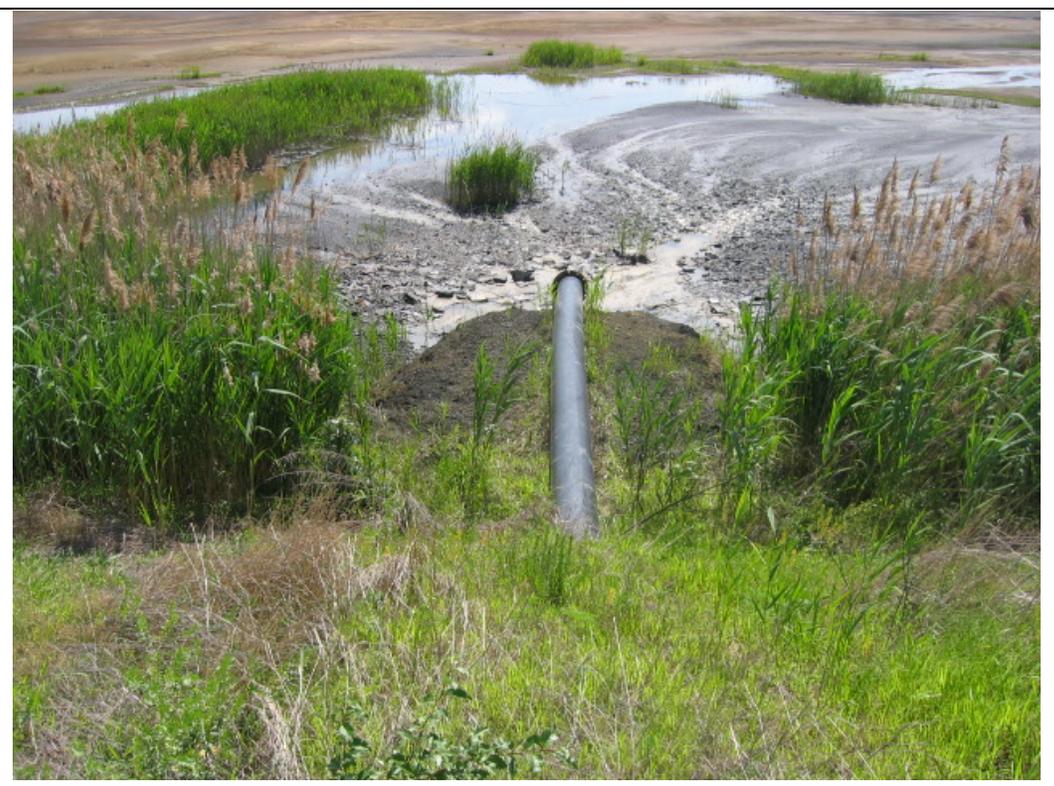
| Photo No. 52 | Date: 5/24/11 |

Description:
One of several discharge pipes from the Primary Fly Ash Pond into the Secondary Fly Ash Pond.

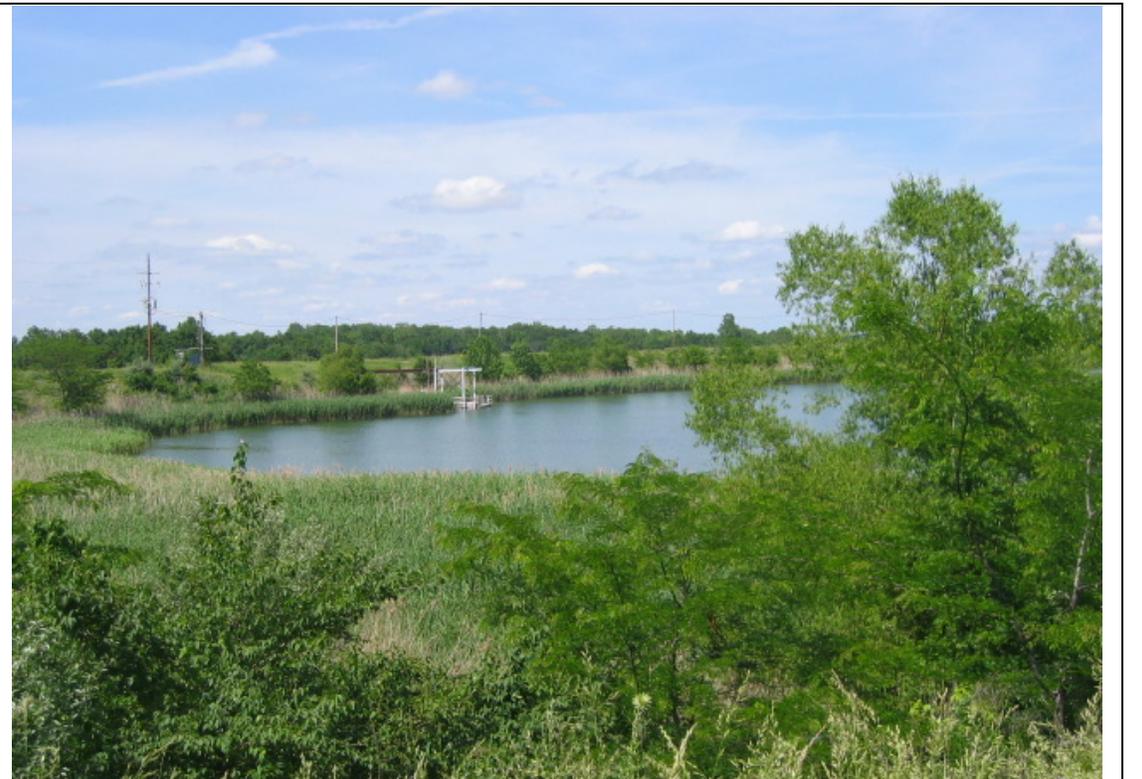
Photo No.
54

Description:
Upstream slope and decant
structure in the Secondary
Fly Ash Pond

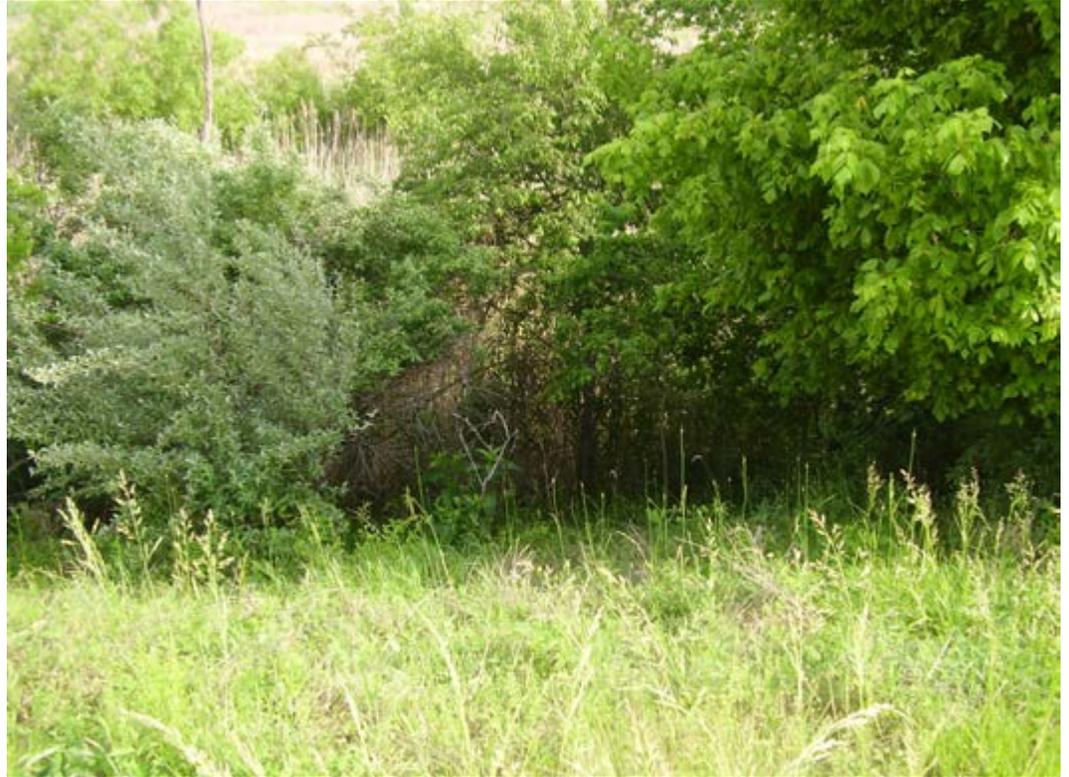
Photo No.
58

Crest and upstream slope of the southern embankment of the Primary Fly Ash Pond.

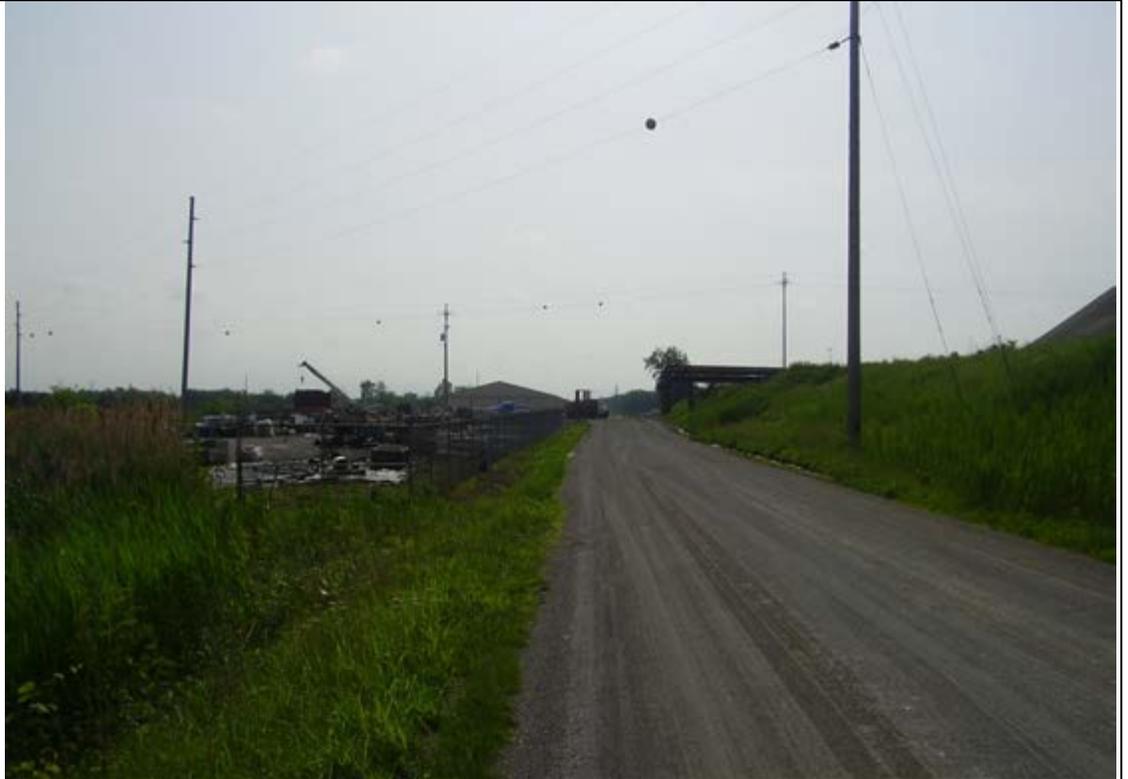
Photo No.
60

Toe and downstream slope
of the northern embankment
of the Primary Fly Ash Pond.

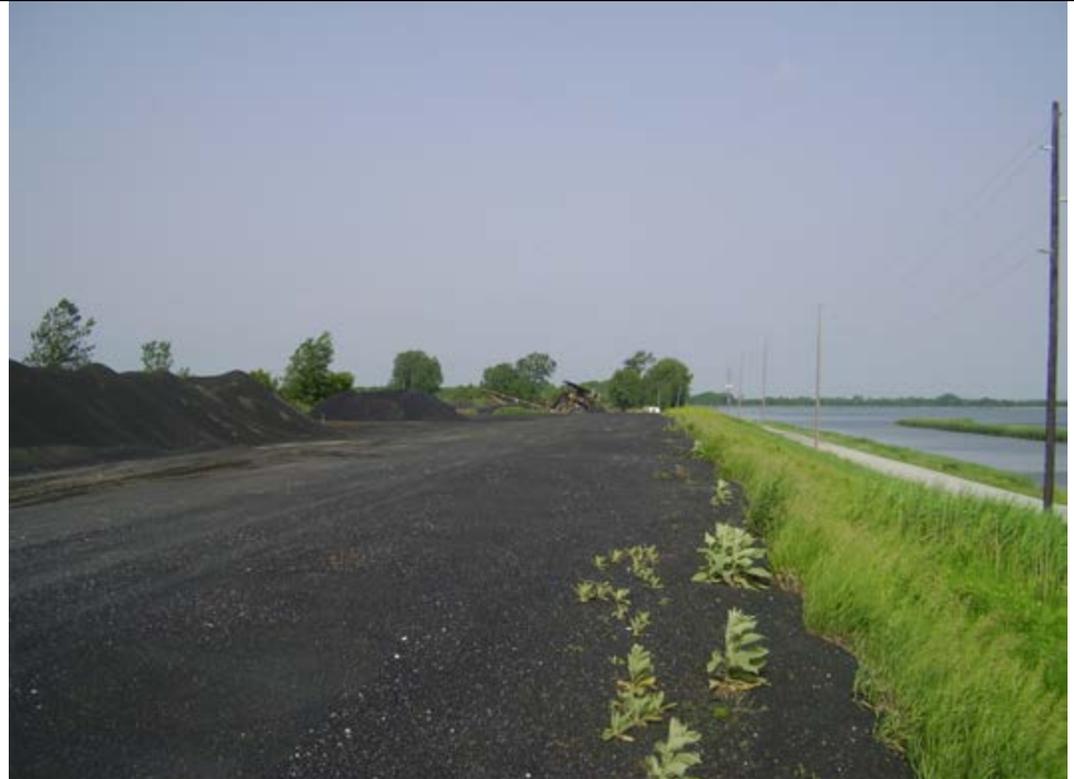
Photo No.
62

Toe and downstream slope
of the northern embankment
of the Primary Fly Ash Pond.

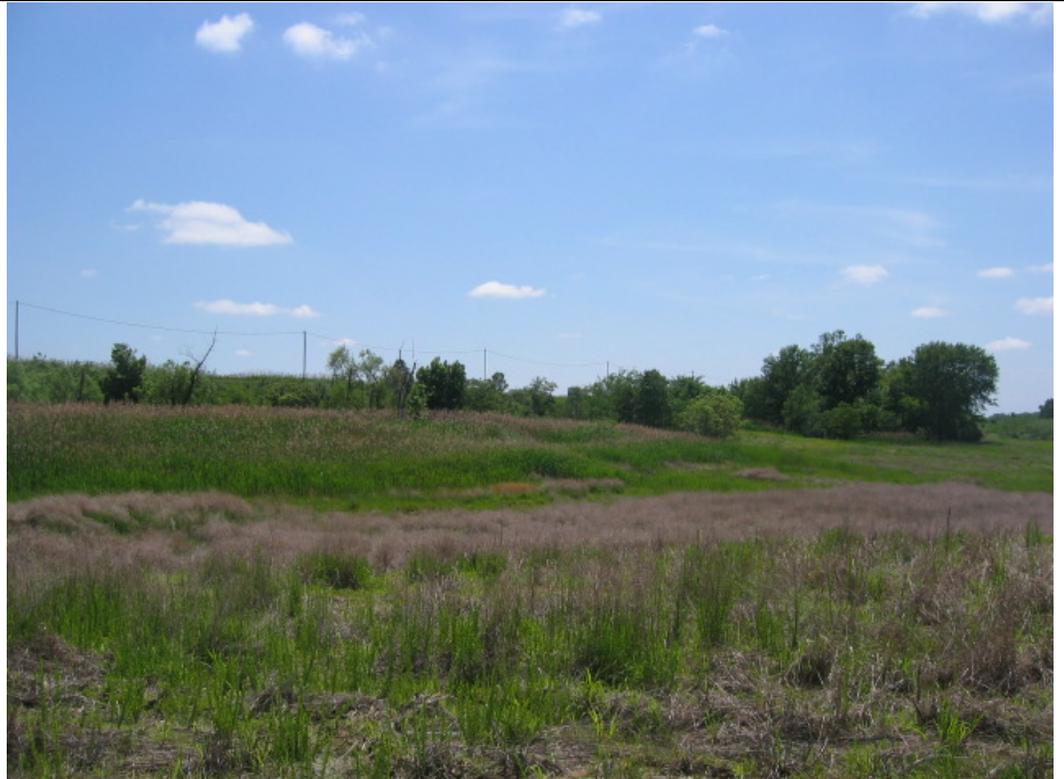
| Photo No. 68 | Date: 5/25/11 |

Description:
Crest and upstream area of the western embankment of the Primary Fly Ash Pond.

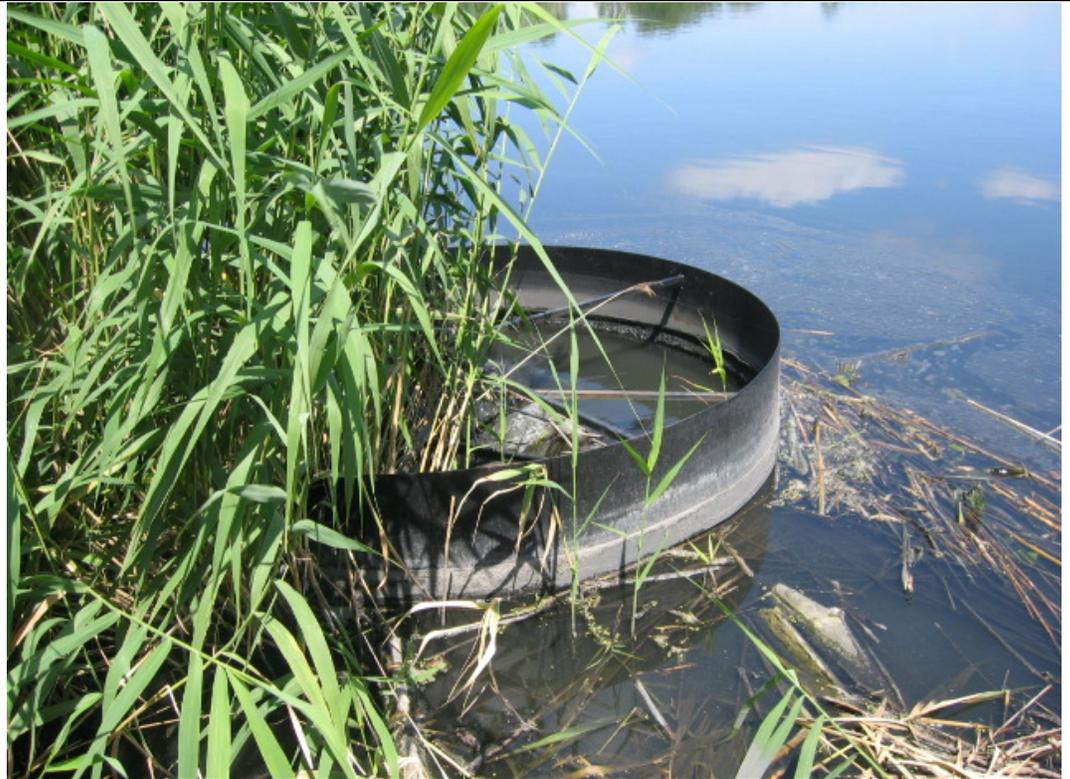
Photo No.
70

Interior berm in Primary Fly
Ash Pond separating the
northern and southern
portions.

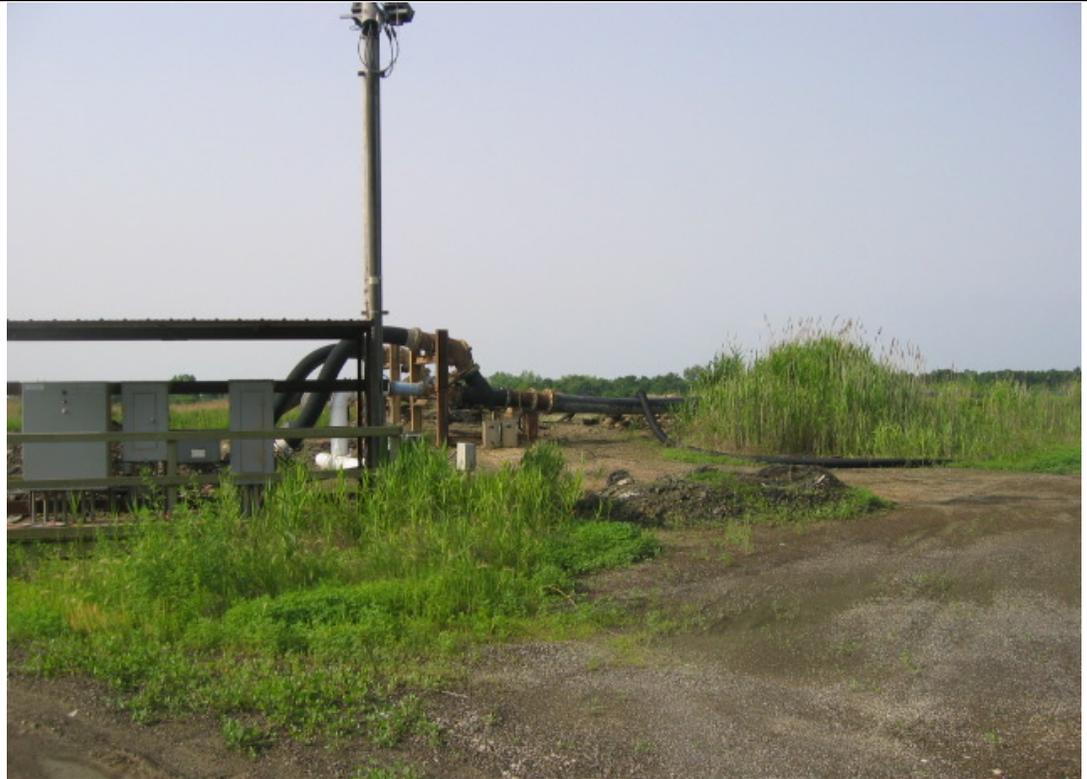
Photo No.
72

Description:
Transport pipes for fly ash
process water.

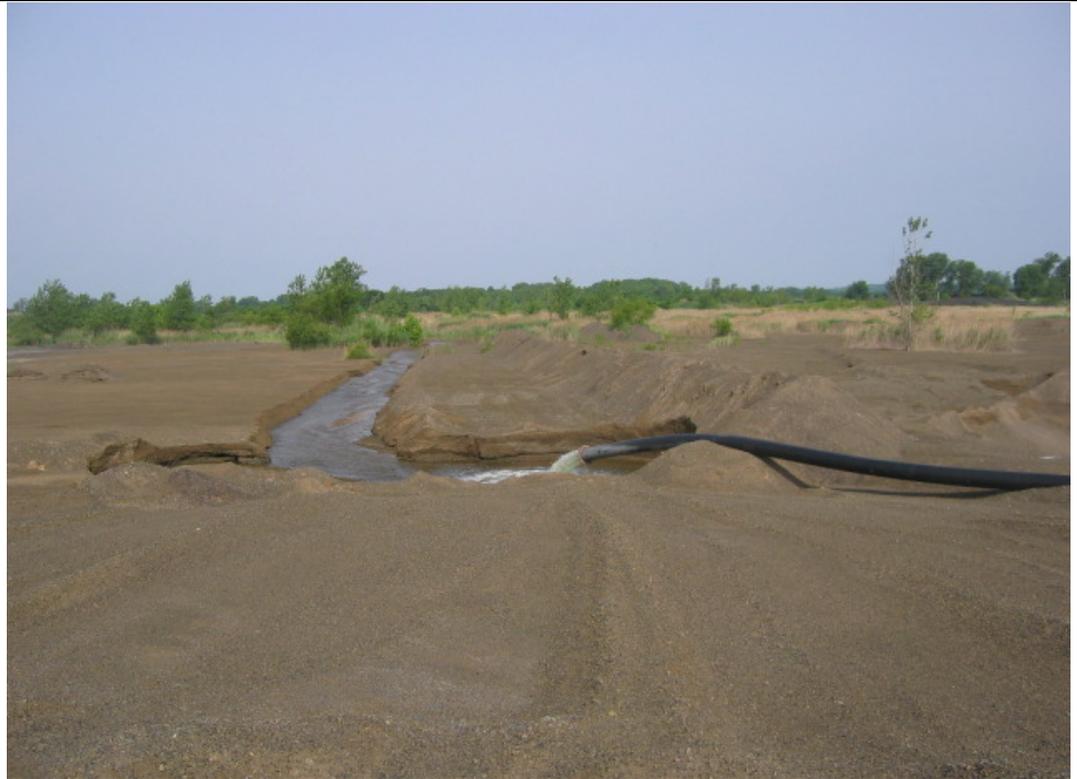
Photo No.
74

Several discharge lines into the bottom ash processing area of the Primary Fly Ash Pond.

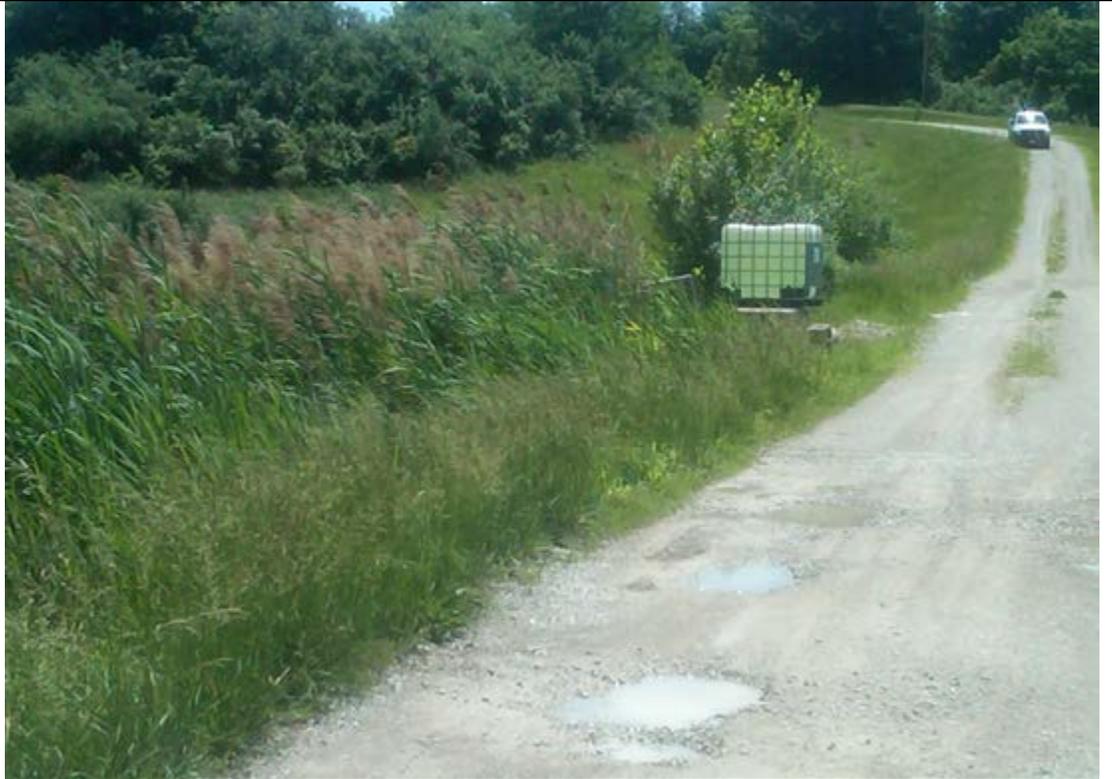
Photo No.
76

Description:
Crest and upstream slope of the Ash Pond Dike.

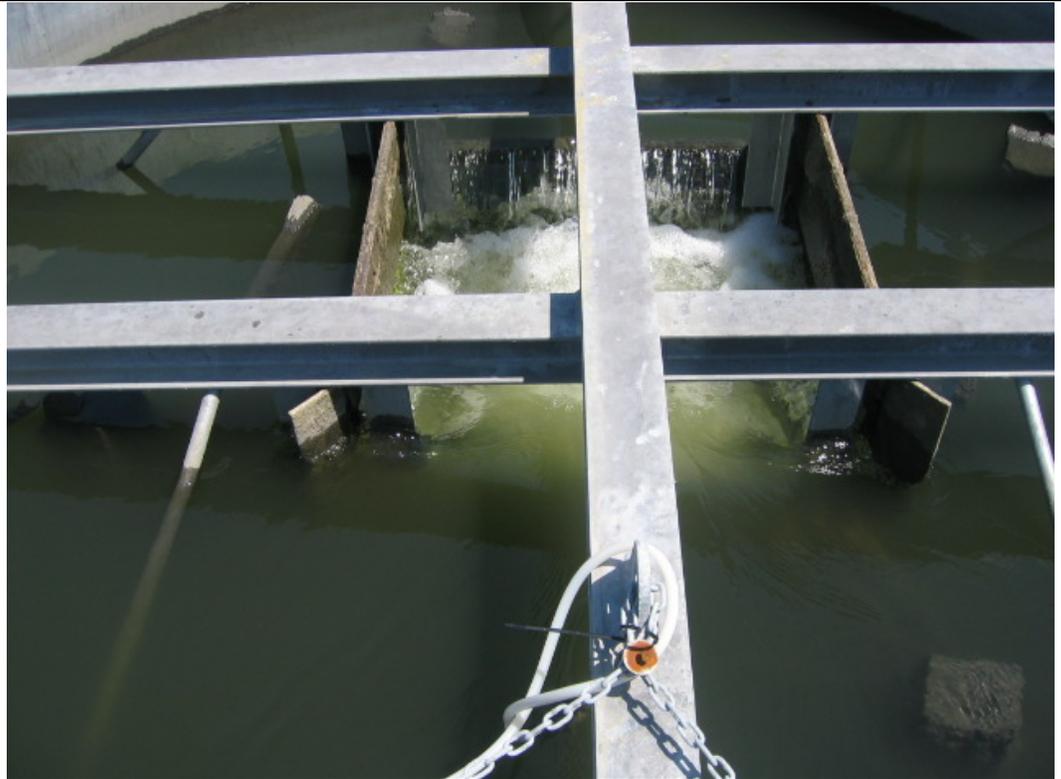
Description:
Decant structure of the
Intermediate Pond.
