**FINAL REPORT  
ROUND 10 DAM ASSESSMENT  
DYNEGY MIDWEST GENERATION, LLC – BALDWIN ENERGY COMPLEX  
PRIMARY FLY ASH POND, SECONDARY FLY ASH POND, SECONDARY POND,  
INTERMEDIATE POND, FINAL POND  
BALDWIN, ILLINOIS**

December 21, 2012  
GZA File No. 170142.30

RE: FINAL Assessment of Dam Safety of Coal Combustion Surface Impoundments at the Baldwin Energy Complex

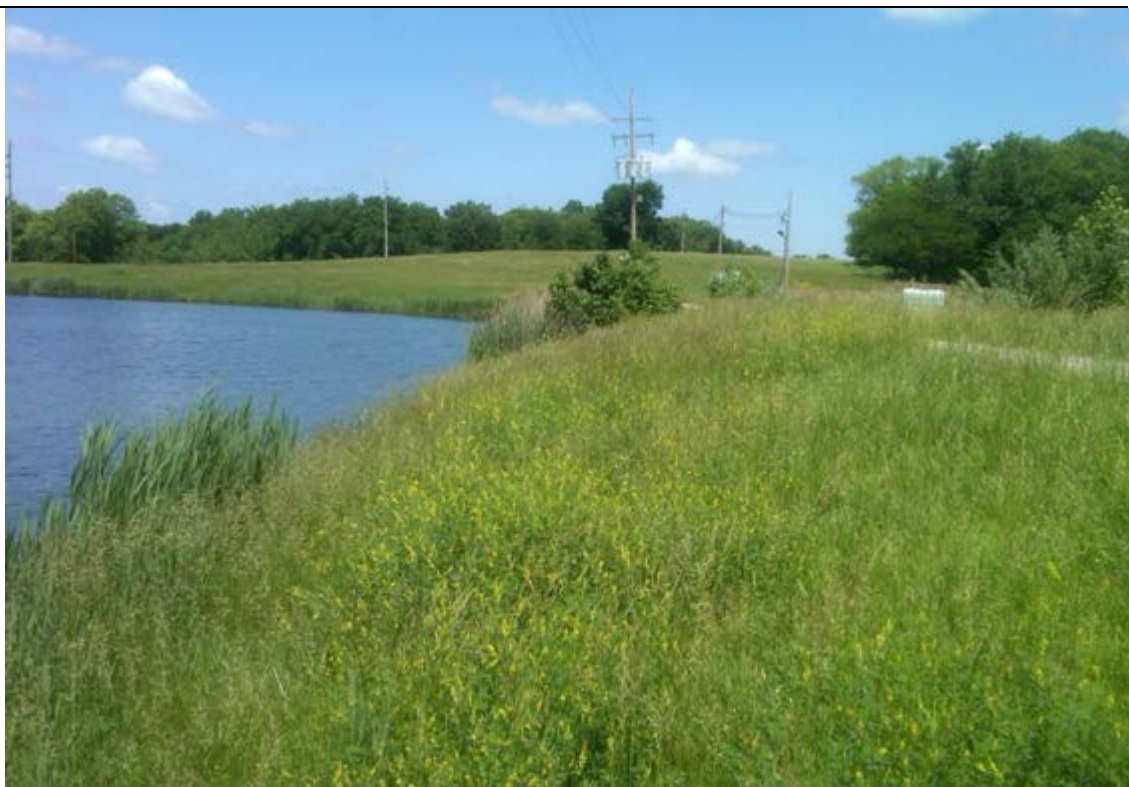
| <b>Description:</b><br>Seepage from the downstream slope of the Ash Pond Dike. | | | |

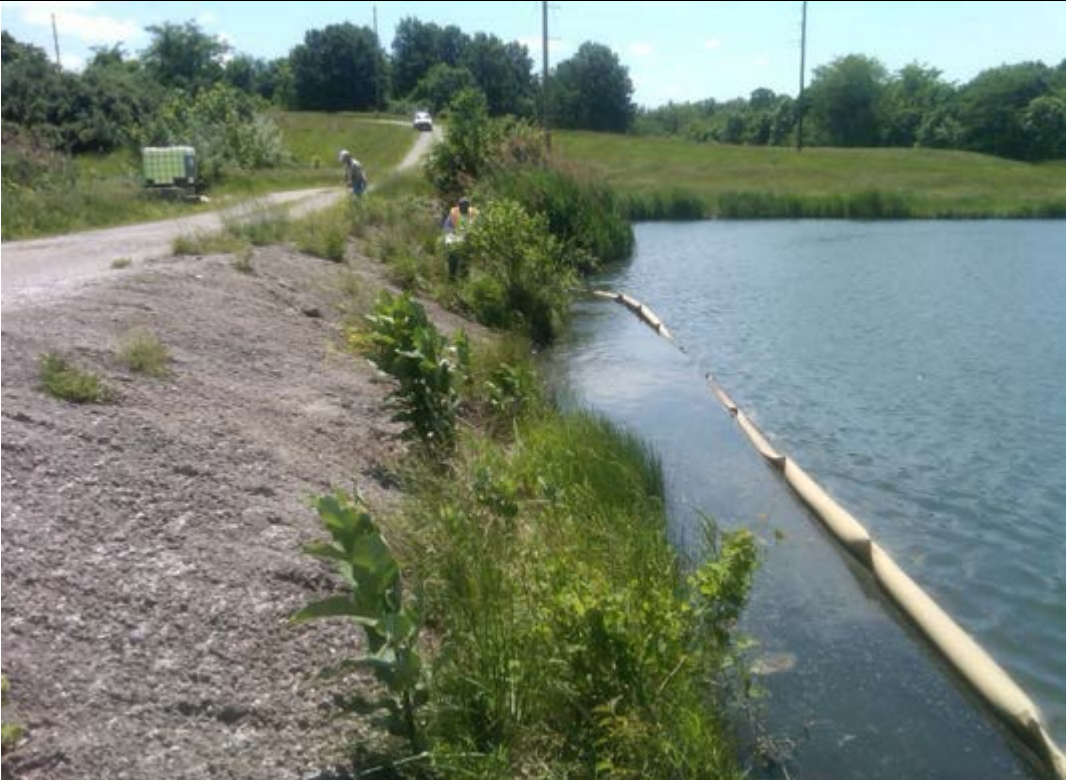
| <b>Photo No.</b><br><b>4</b> | <b>Date:</b><br>5/24/11 | |

| <b>Description:</b><br>Surface grouting/concrete along the downstream slope of Ash Pond Dike. Seepage present beneath the surface grouting in several locations. | | |

1. Repair the discharge pipe and the embankment erosion near the discharge pipe from PFAP's northern decant. Protect the embankment with riprap or other erosion control features.
2. Remove the concrete located on the downstream slope of the Ash Pond Dike. Repair any erosion observed beneath the concrete and replace with fill engineered to provide a stable embankment that is not susceptible to erosion or piping.
3. Pending the results of the hydraulic/hydrologic analysis, modify the design or operation of the impoundments to provide adequate capacity.
4. Pending the results of the complete seepage and stability analysis for each impoundment, modify the design or operation of the impoundments to provide conditions that result in embankments that meet the generally accepted factors of safety.

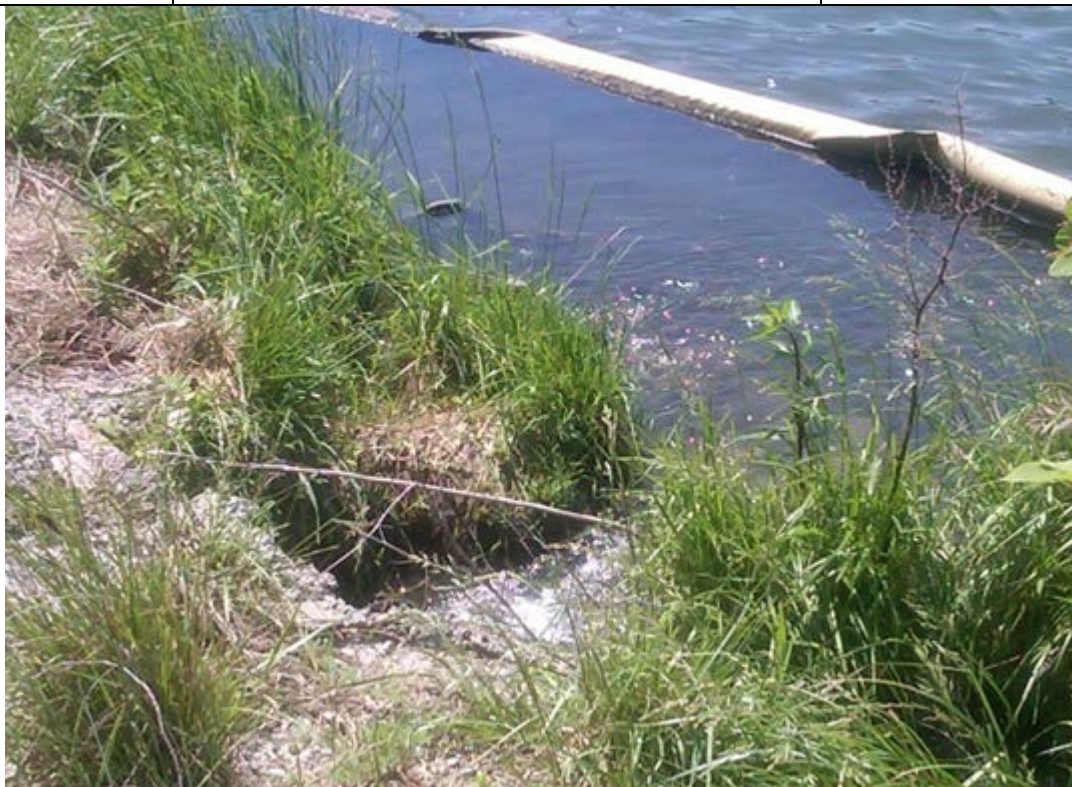
**Description:**  
Seepage beneath the surface  
grouting on Ash Pond Dike.

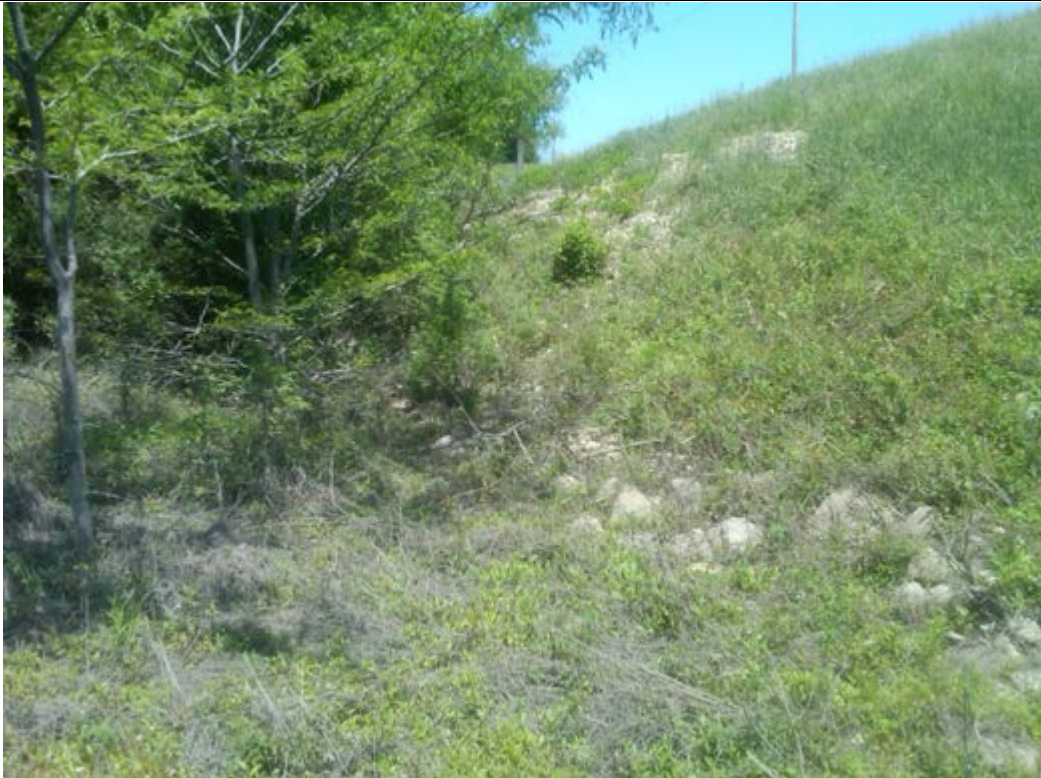
| <b>Photo No.</b><br><b>12</b> | <b>Date:</b><br>5/24/11 | |

| <b>Description:</b><br>Downstream slope of the Final Pond. | | |

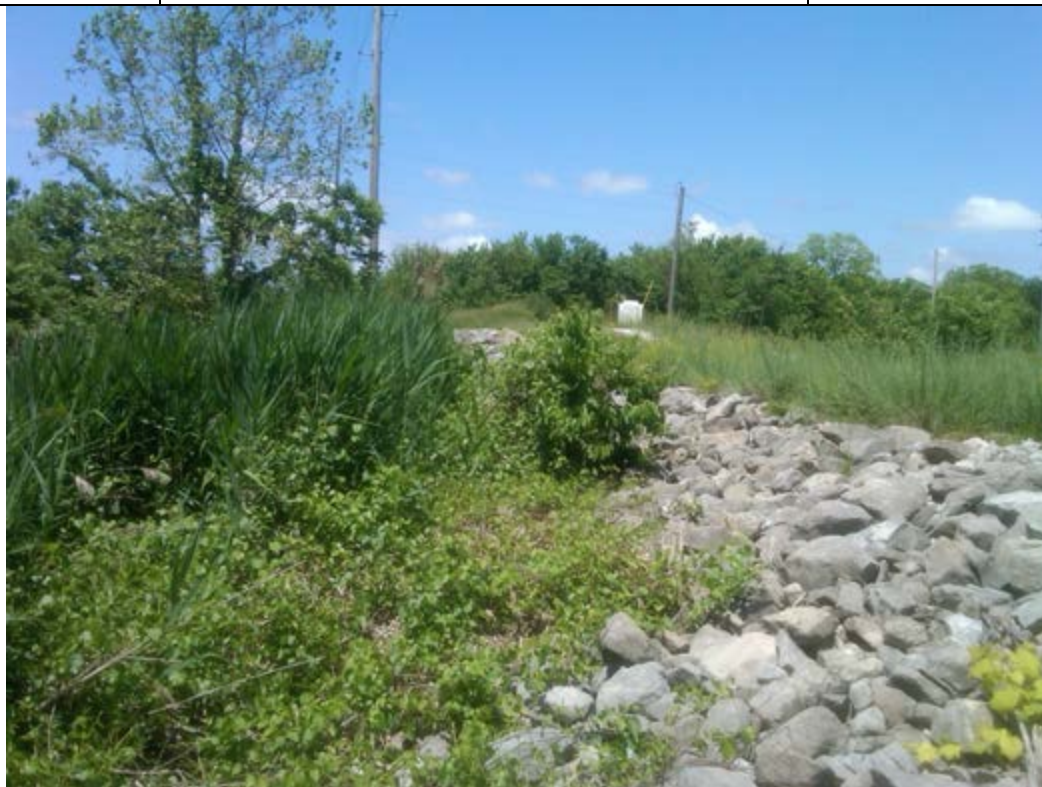
**Description:**  
Riprap on downstream slope  
of the Final Pond.

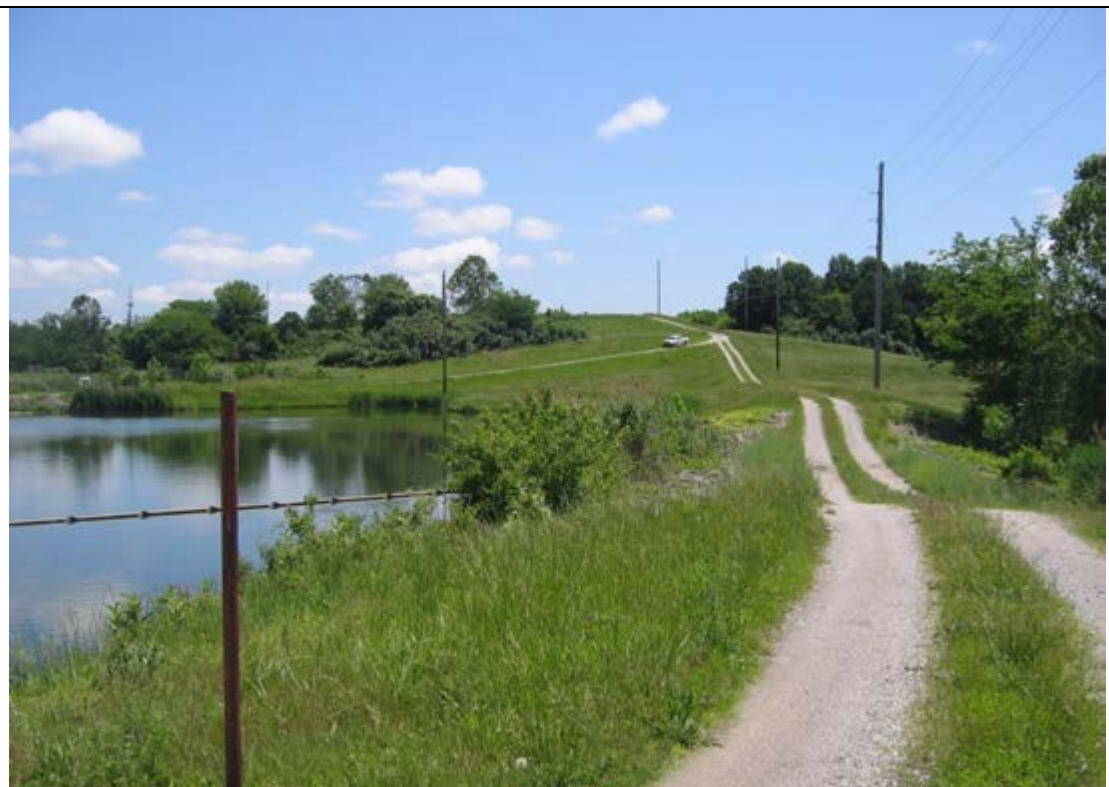
**Description:**  
Crest of the Settling Pond  
Dike near the overflow  
section.

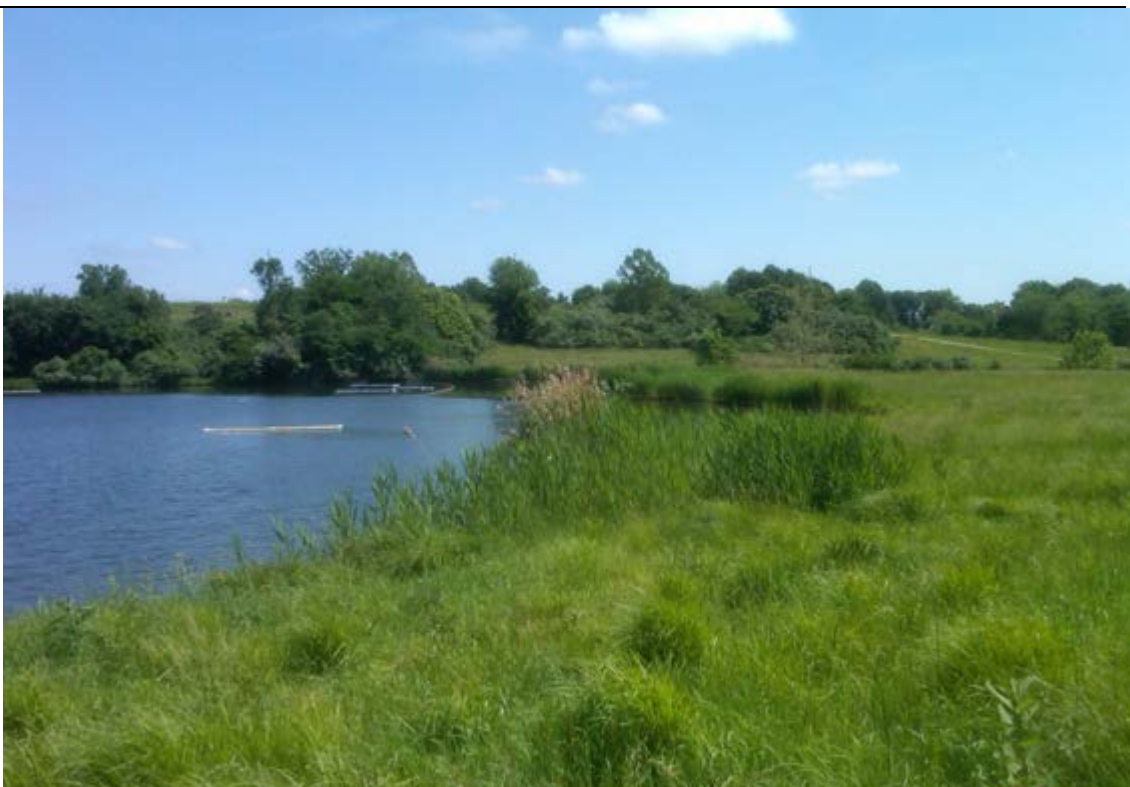
**Photo No.**  
**26**

**Description:**  
Upstream slope of the  
Secondary Dike.

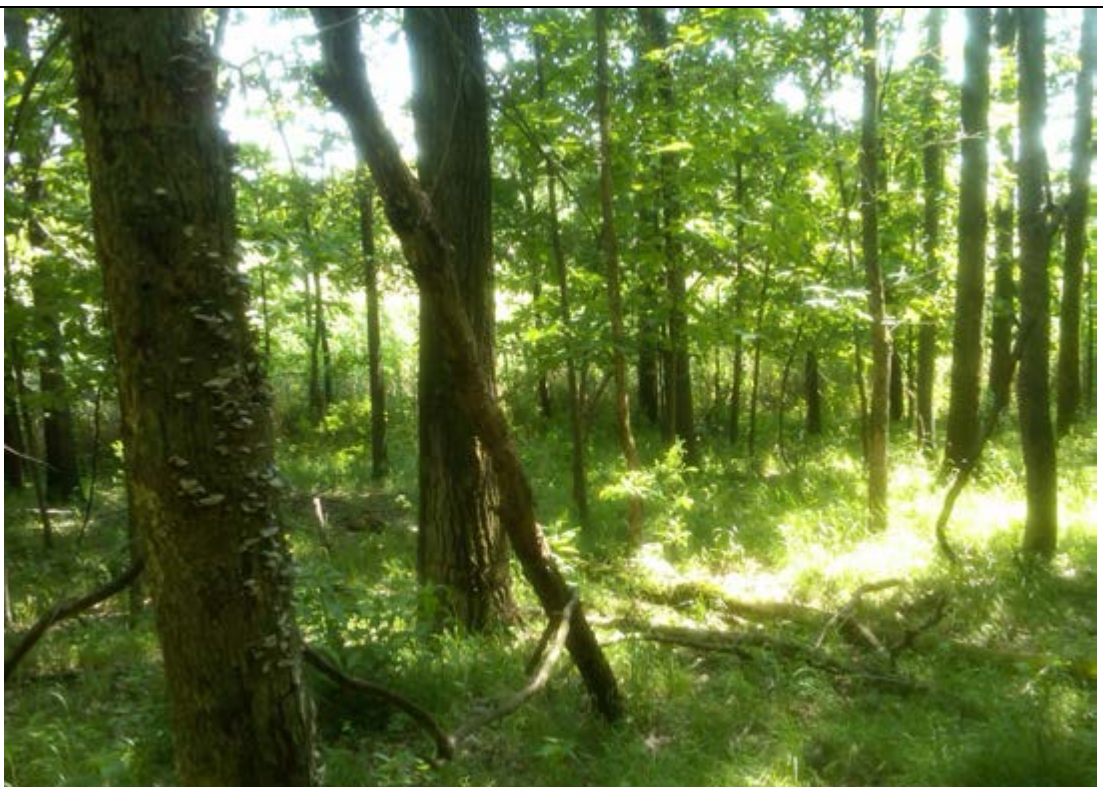
**Photo No.**  
**28**

**Description:**  
Upstream slope of the  
Secondary Pond

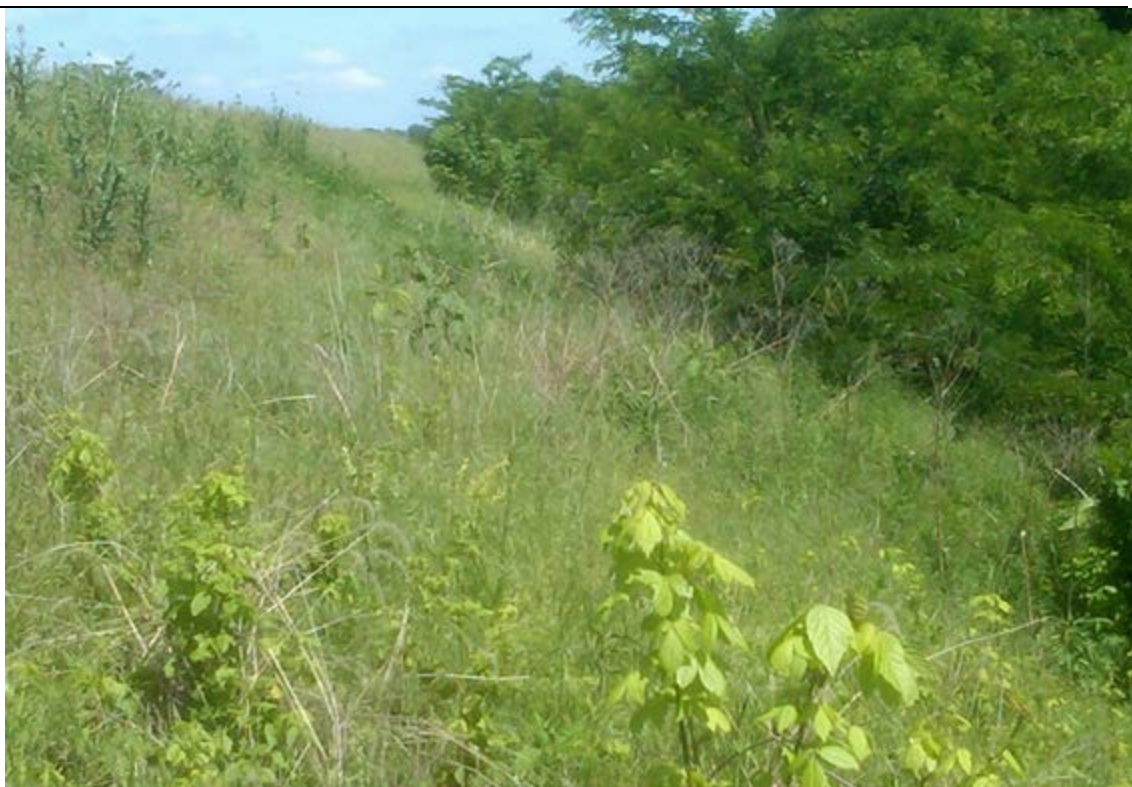
**Photo No.**  
**32**

**Description:**  
Downstream slope of the  
southern embankment of the  
Secondary Fly Ash Pond.

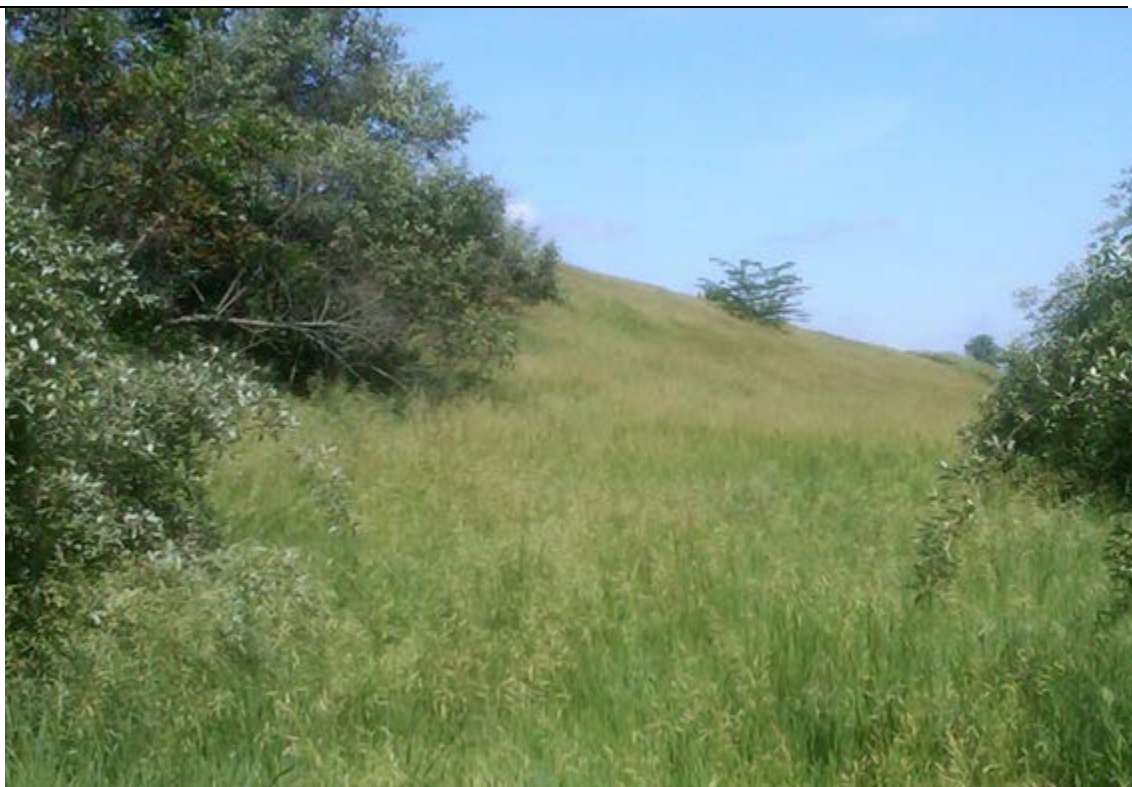
**Photo No.**  
**34**

**Description:**  
Downstream slope and toe of  
the southern embankment of  
the Secondary Fly Ash Pond.

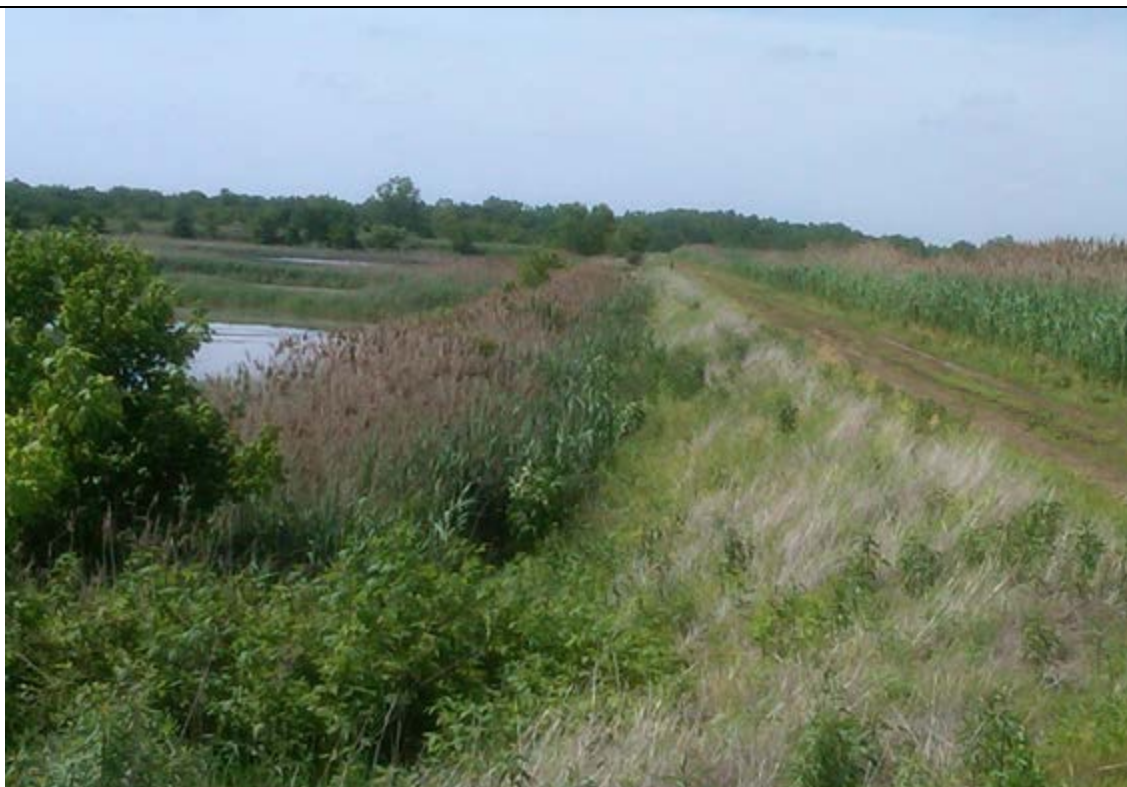
**Photo No.**  
**36**

Downstream slope and crest  
of Intermediate  
Embankment.

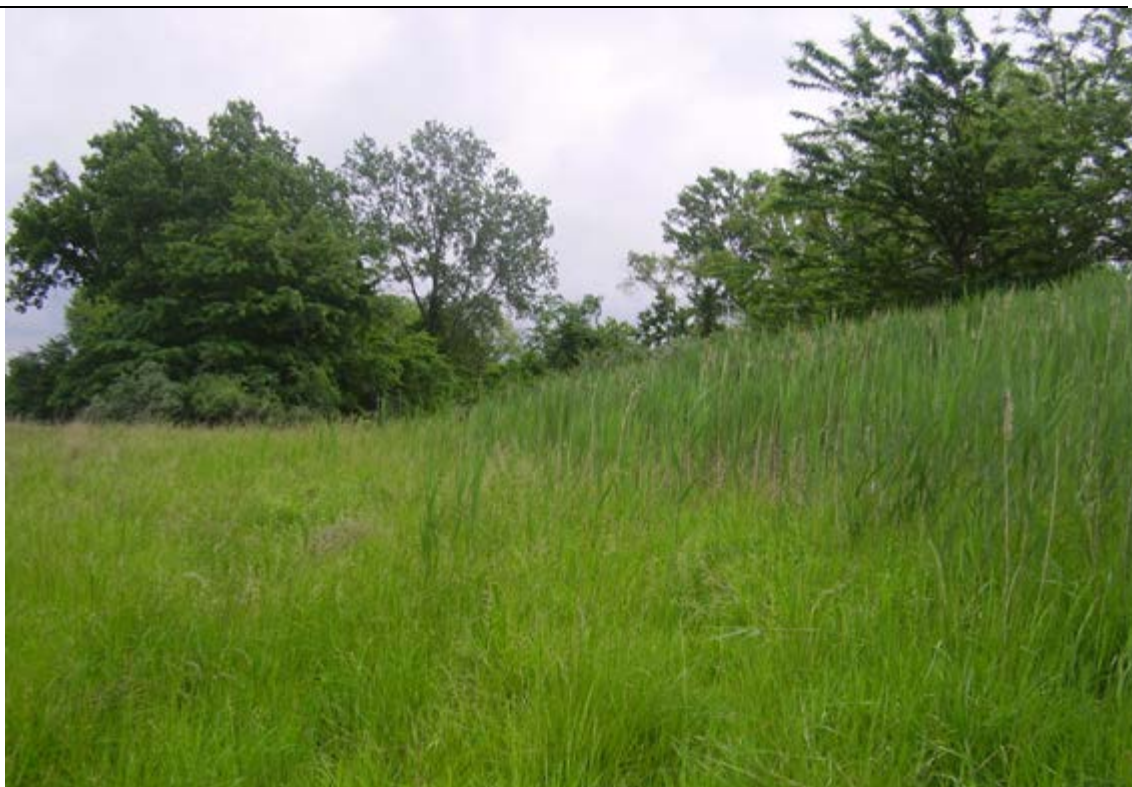
**Photo No.**  
**46**

Downstream slope and toe of  
the northern embankment of  
the Secondary Fly Ash Pond.

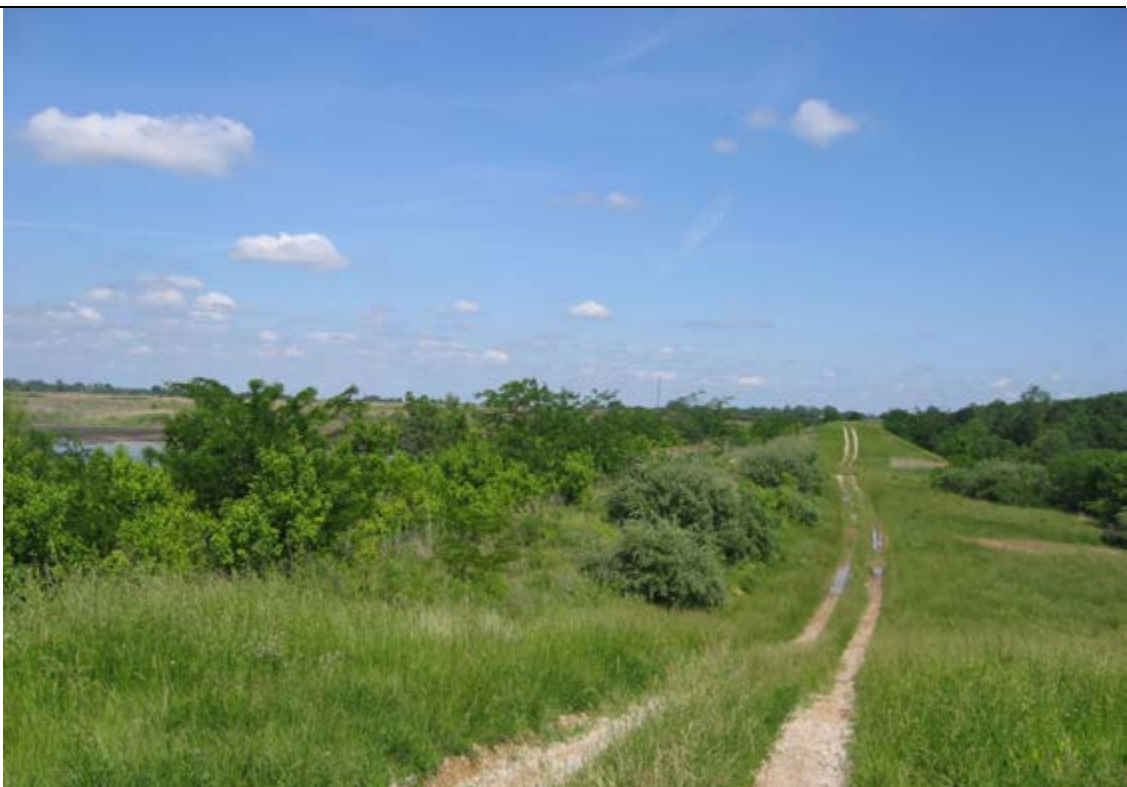
**Photo No.**  
**48**

**Description:**  
Crest and upstream slope of  
the Secondary Fly Ash Pond  
in the area of the 1995  
Failure.

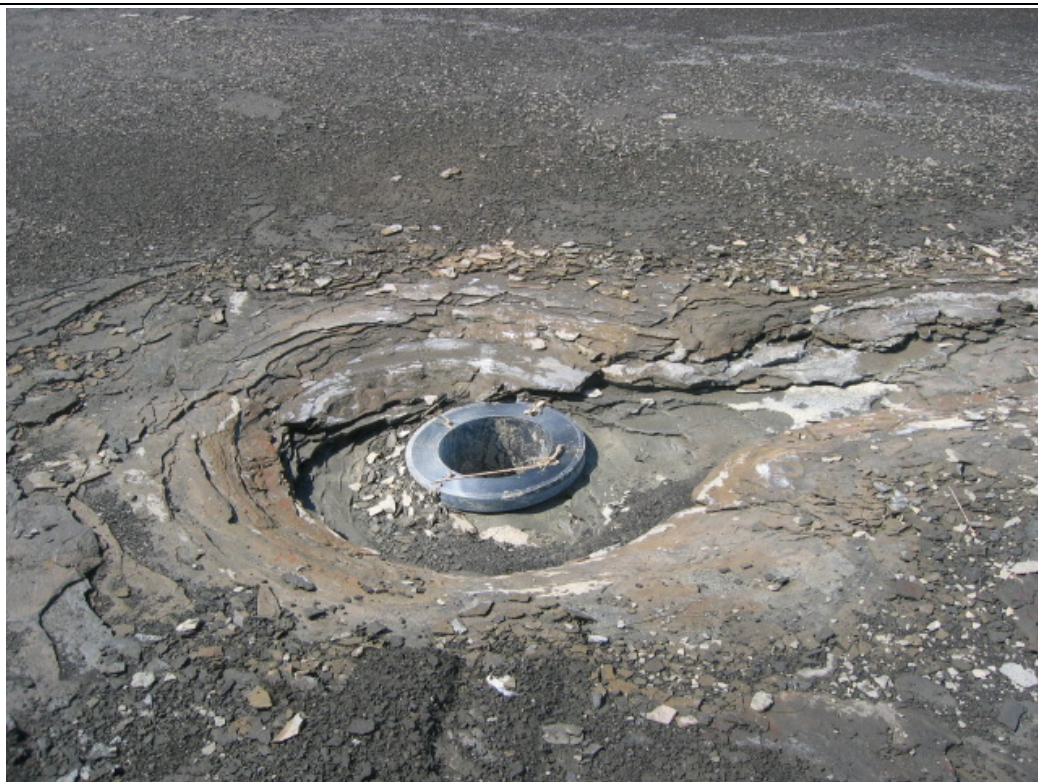
**Photo No.**  
**50**

One of several decant pipes  
used to transport water from  
the southern portion of the  
Primary Fly Ash Pond to the  
Secondary Fly Ash Pond.

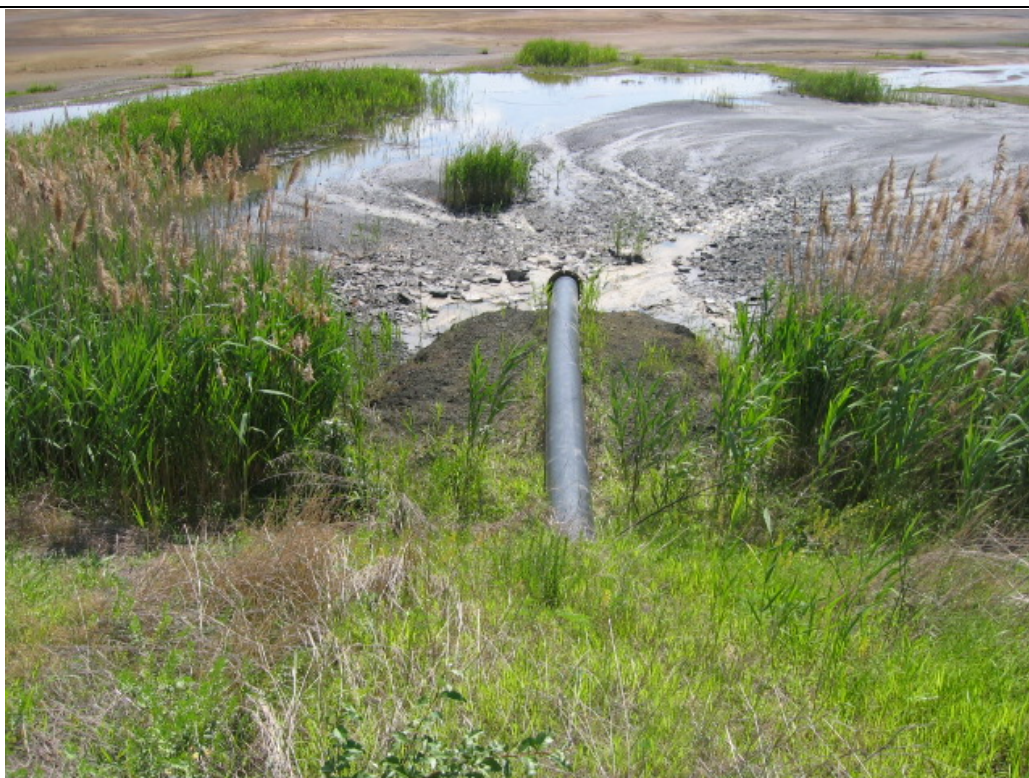
**Photo No.**  
**52**

One of several discharge  
pipes from the Primary Fly  
Ash Pond into the Secondary  
Fly Ash Pond.

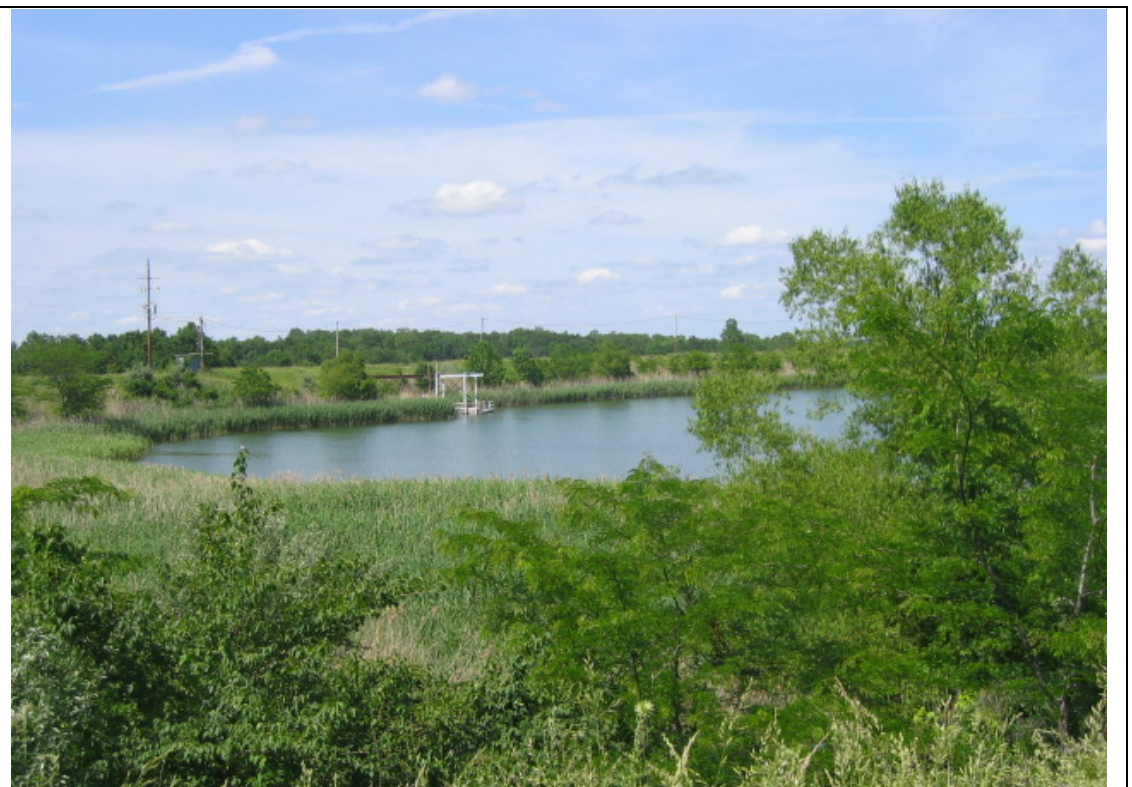
**Photo No.**  
**54**

**Description:**  
Upstream slope and decant  
structure in the Secondary  
Fly Ash Pond

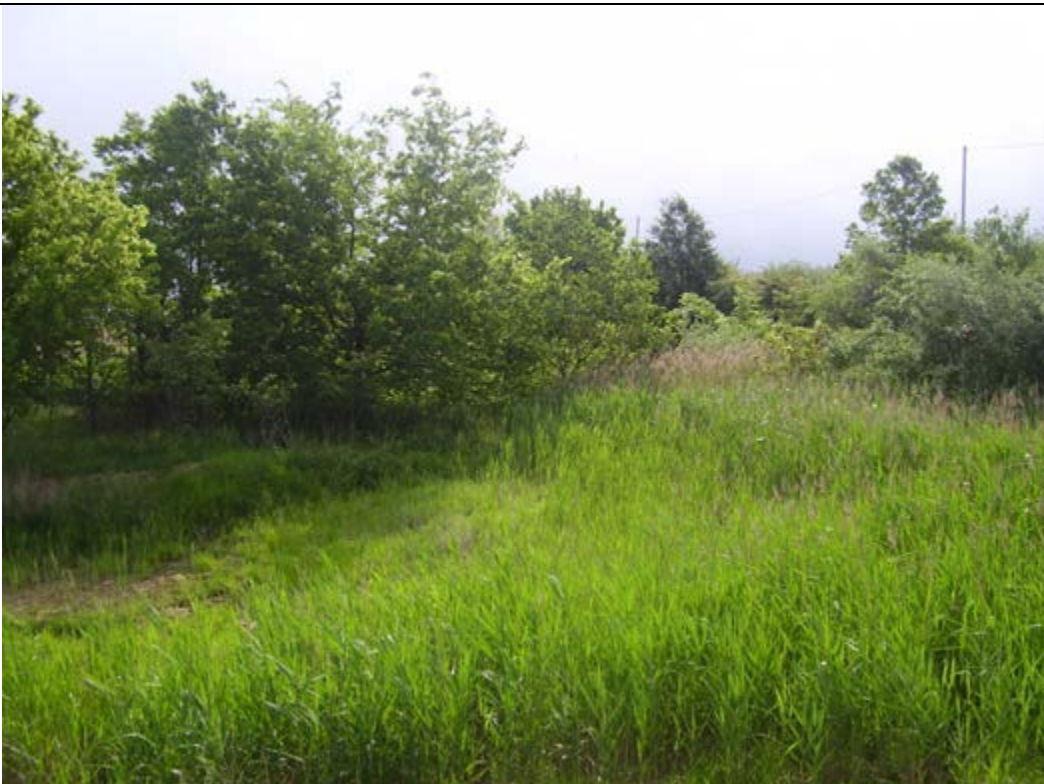
**Photo No.**  
**56**

**Description:**  
Downstream slope of the  
eastern embankment of the  
Primary Fly Ash Pond.

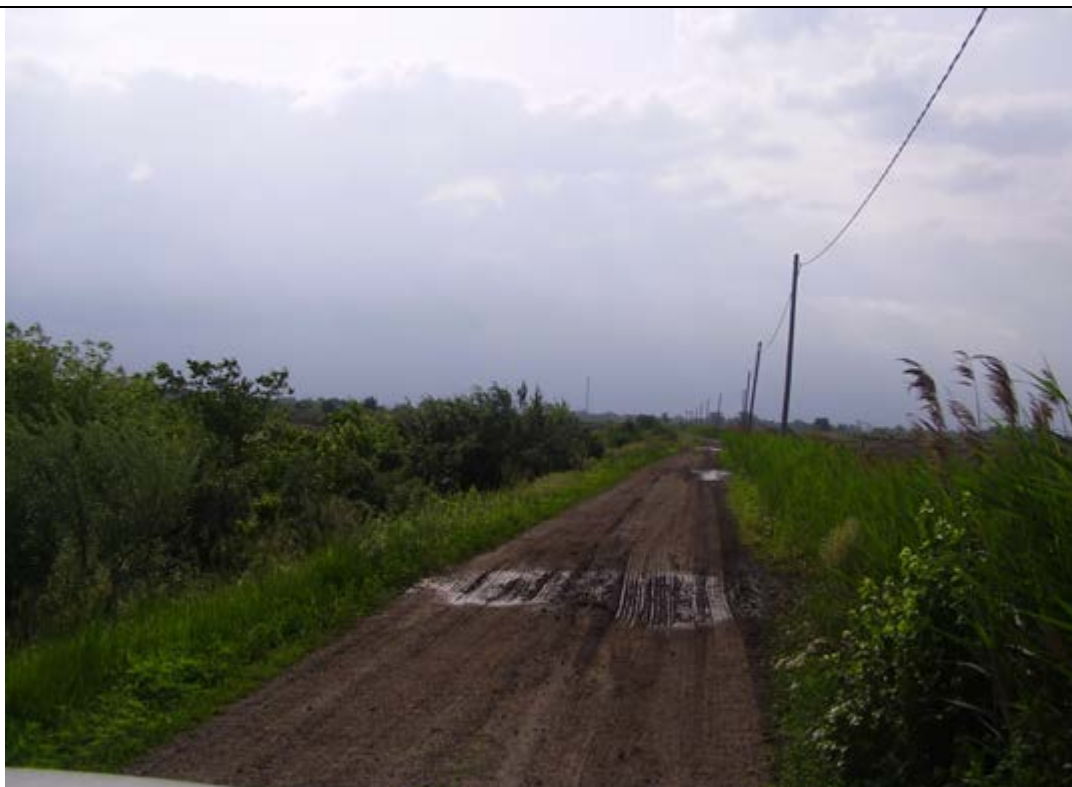
**Photo No.**  
**58**

**Description:**  
Crest and upstream slope of  
the southern embankment of  
the Primary Fly Ash Pond.

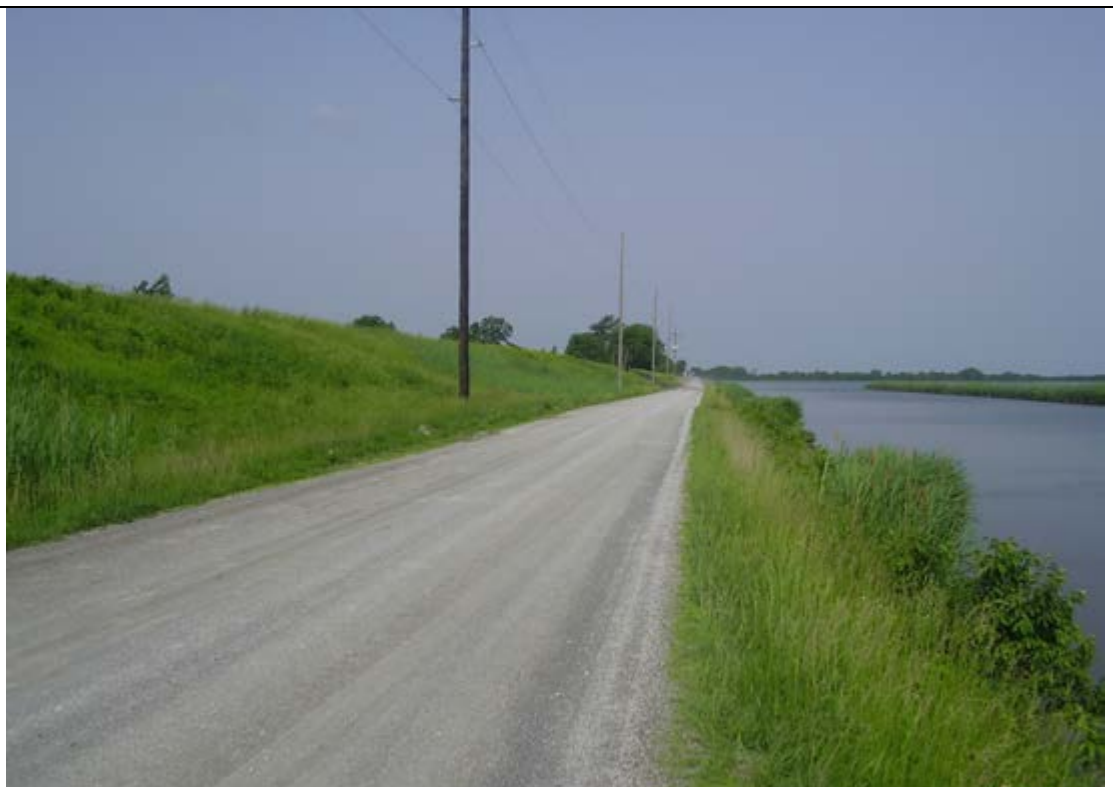
**Photo No.**  
**60**

Toe and downstream slope  
of the northern embankment  
of the Primary Fly Ash Pond.

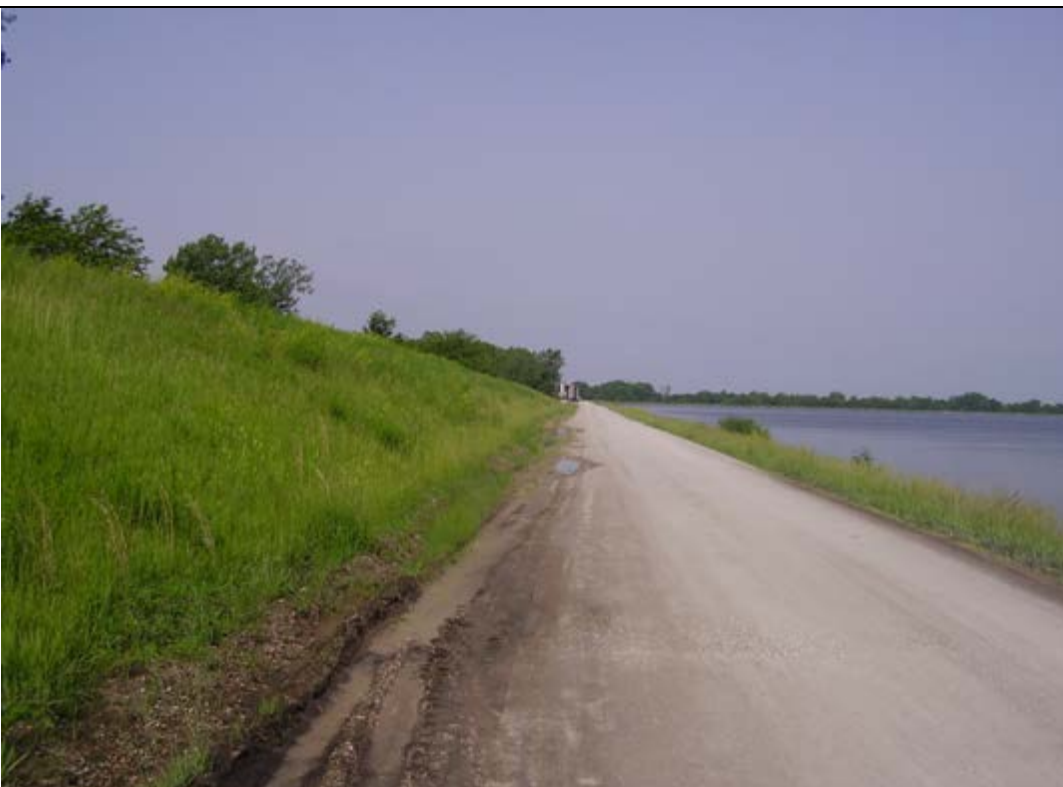
**Photo No.**  
**62**

**Description:**  
Toe and downstream slope  
of the northern embankment  
of the Primary Fly Ash Pond.

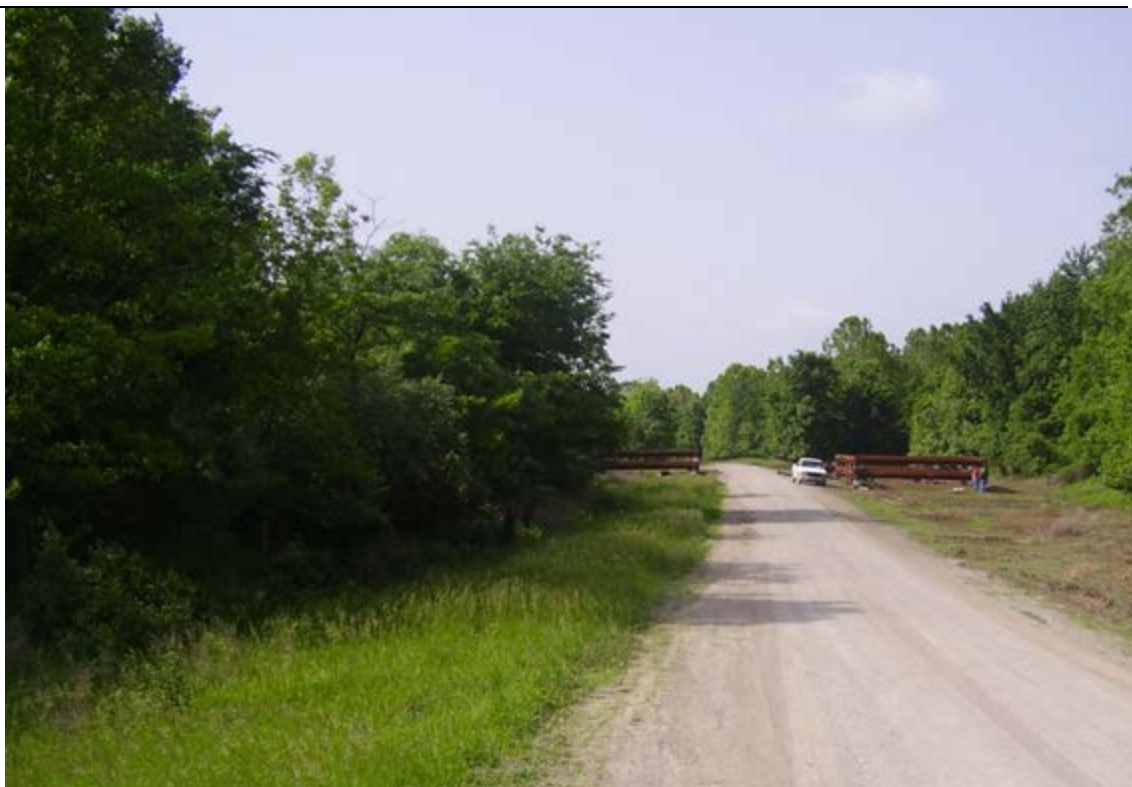
**Photo No.**  
**64**

**Description:**  
Crest and upstream slope of  
the northern embankment of  
the Primary Fly Ash Pond.

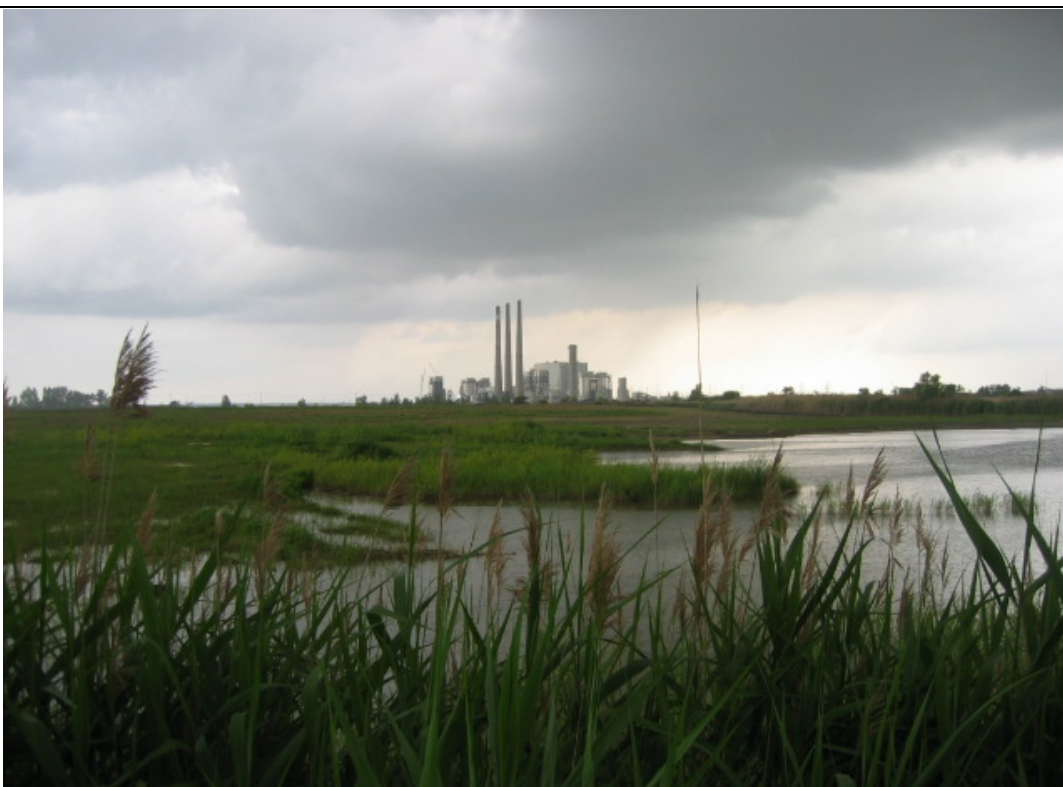
**Photo No.**  
**66**

**Description:**  
Upstream slope of the  
Primary Fly Ash Pond.

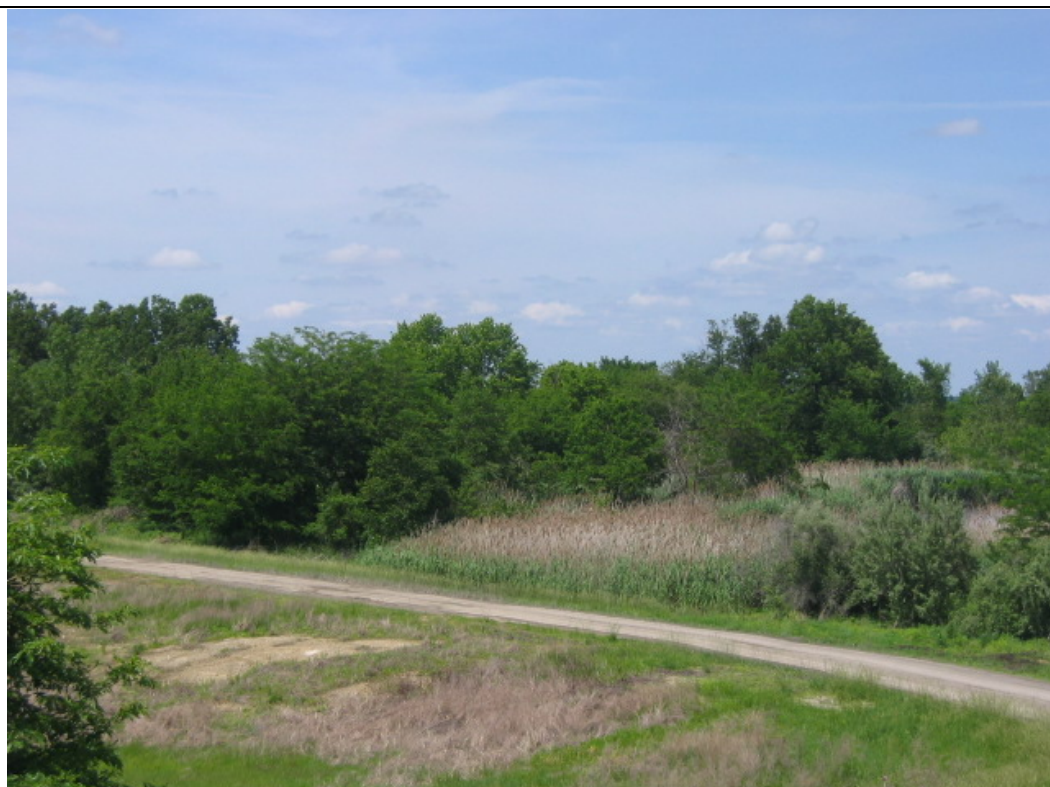
**Photo No.**  
**68**

**Description:**  
Crest and upstream area of  
the western embankment of  
the Primary Fly Ash Pond.

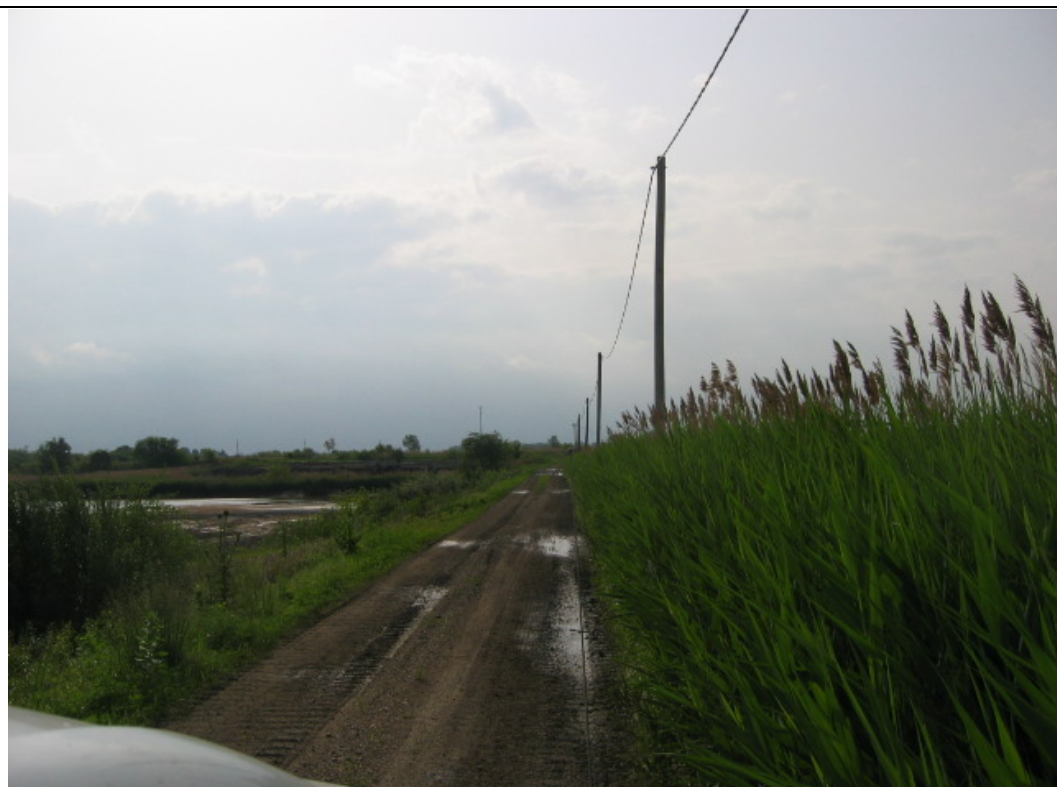
**Photo No.**  
**70**

Interior berm in Primary Fly  
Ash Pond separating the  
northern and southern  
portions.

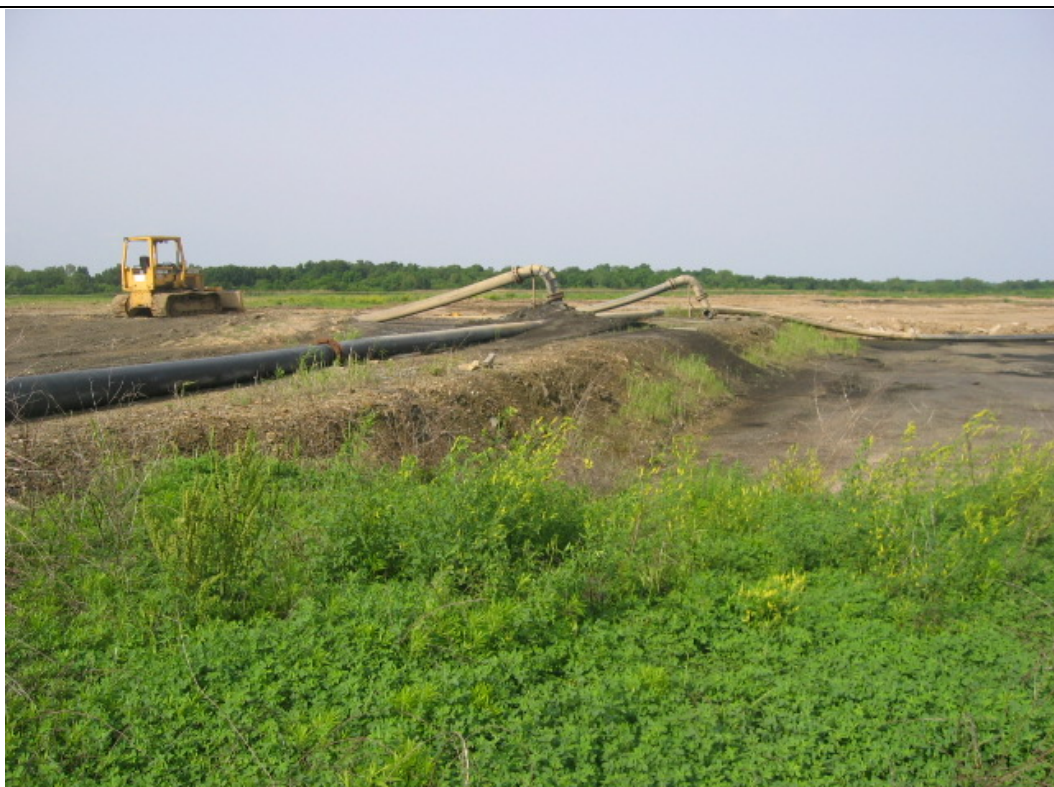
**Photo No.**  
**72**

Transport pipes for fly ash  
process water.

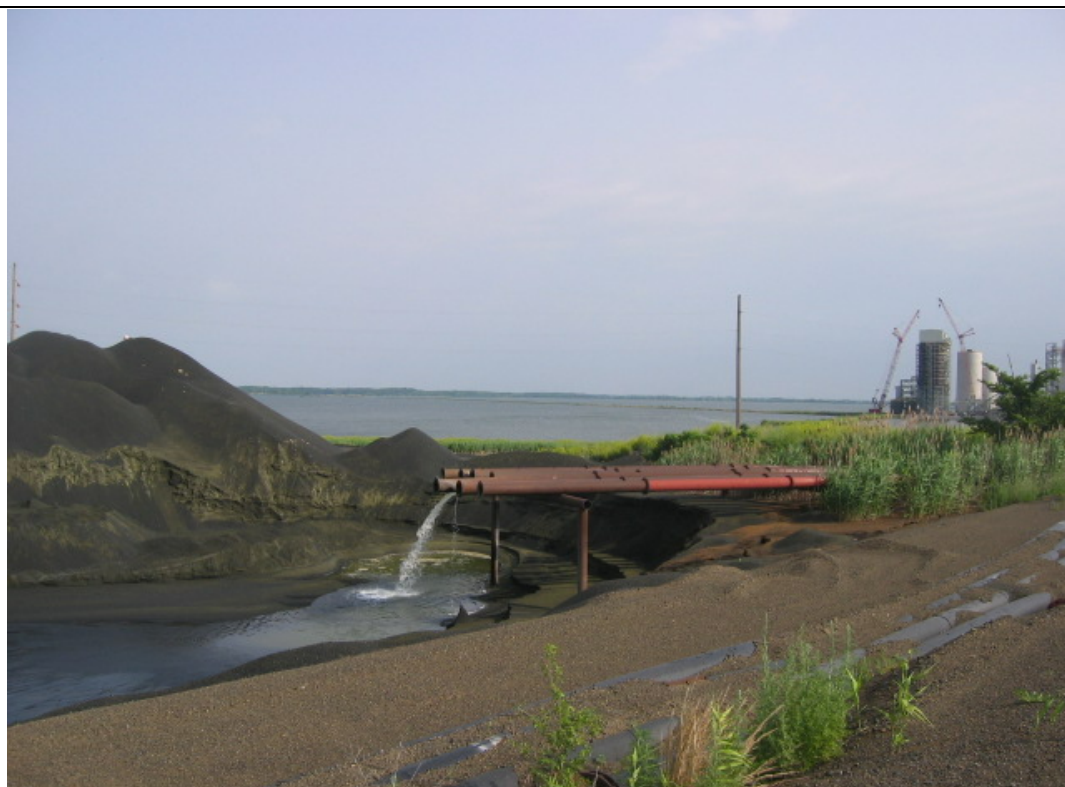
**Photo No.**  
**74**

Several discharge lines into  
the bottom ash processing  
area of the Primary Fly Ash  
Pond.
