**FINAL REPORT  
ROUND 10 DAM ASSESSMENT  
DYNEGY MIDWEST GENERATION, LLC – BALDWIN ENERGY COMPLEX  
PRIMARY FLY ASH POND, SECONDARY FLY ASH POND, SECONDARY POND,  
INTERMEDIATE POND, FINAL POND  
BALDWIN, ILLINOIS**

December 21, 2012  
GZA File No. 170142.30

RE: FINAL Assessment of Dam Safety of Coal Combustion Surface Impoundments at the Baldwin Energy Complex

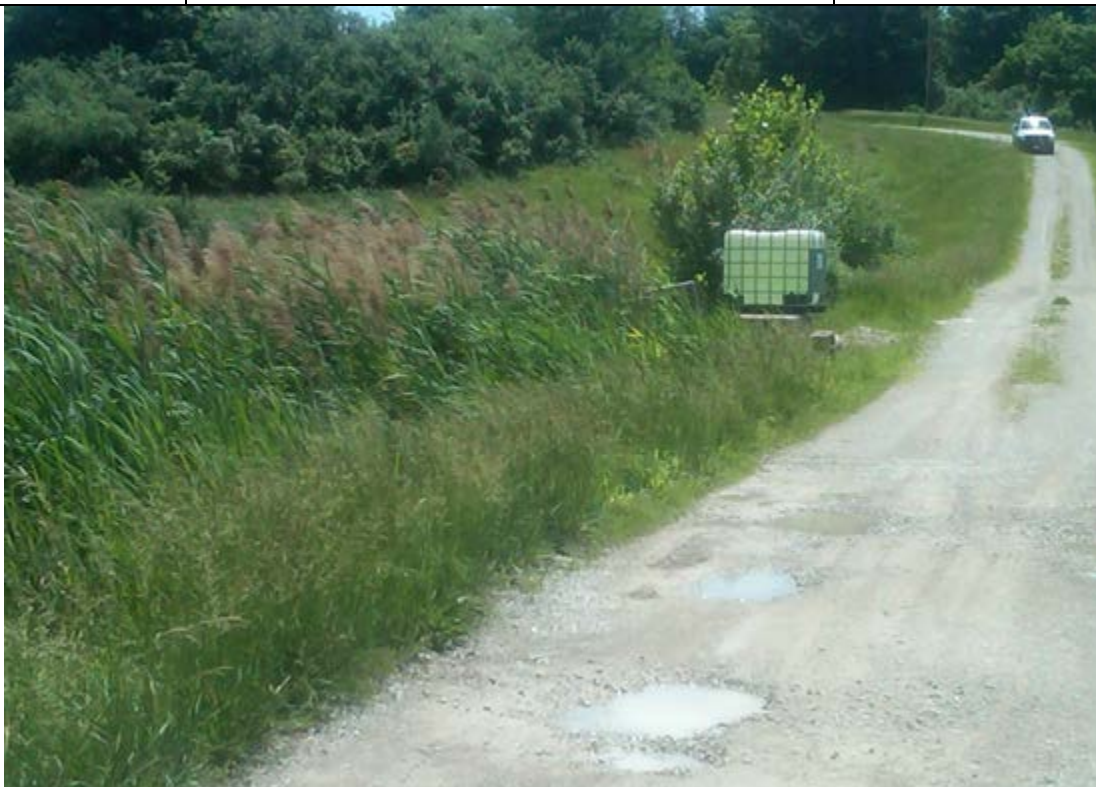
**Description:**  
Crest and upstream slope of  
the Ash Pond Dike.

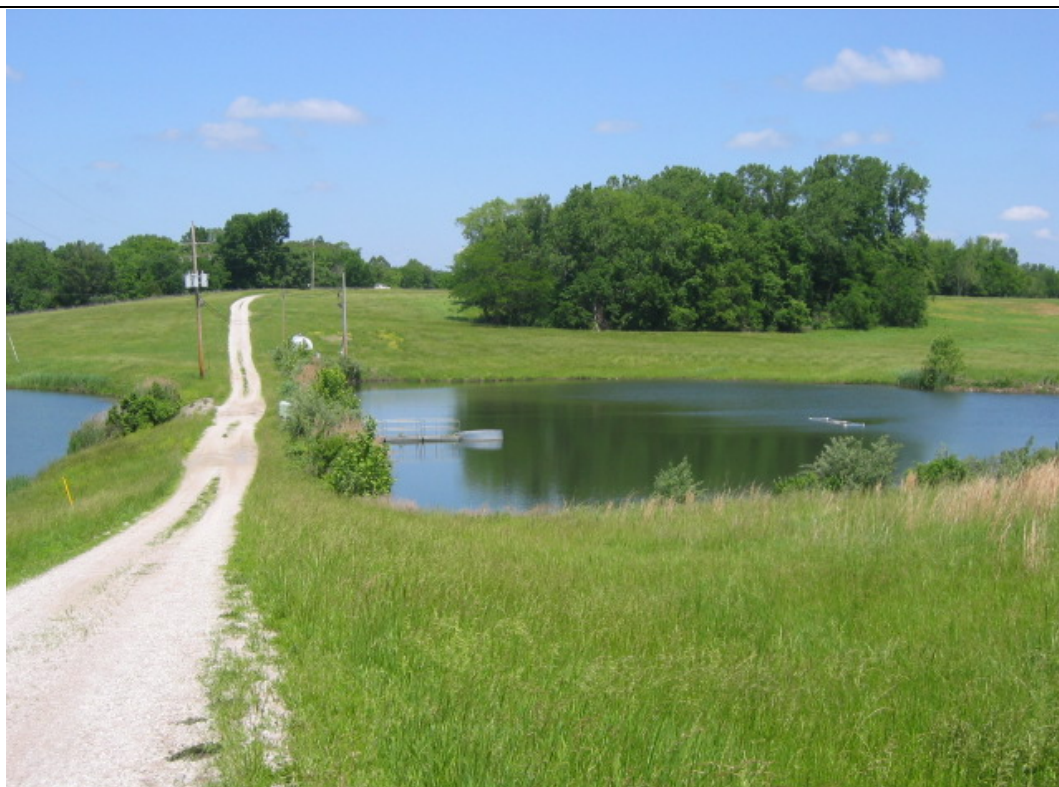
**Photo No.**  
**76**

**Description:**  
Crest and upstream slope of  
the Ash Pond Dike.

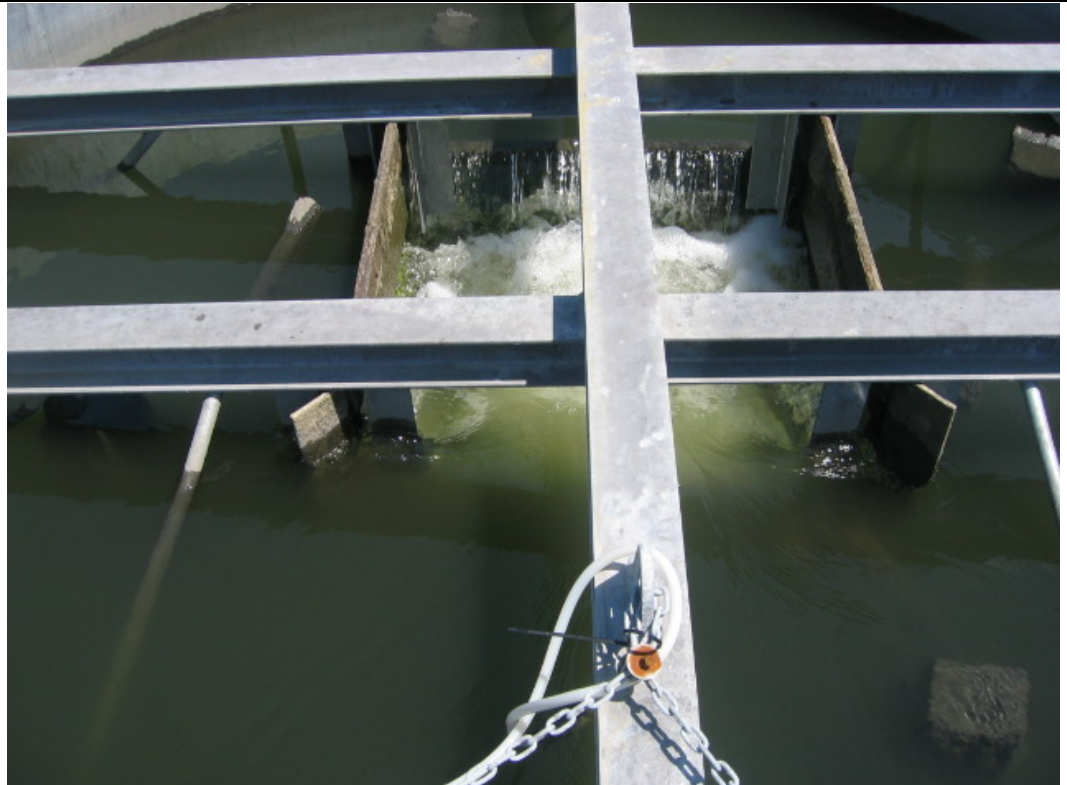
**Description:**  
Decant structure of the  
Intermediate Pond.
