**DRAFT REPORT
ROUND 10 DAM ASSESSMENT - MAY 23, 2011
DYNEGY MIDWEST GENERATION, INC. – HENNEPIN POWER STATION
ACTIVE EAST ASH POND SYSTEM, EAST ASH POND SYSTEM, WEST ASH POND
SYSTEM
HENNEPIN, ILLINOIS**

March 15, 2012
GZA File No. 170142.30

RE: DRAFT Assessment of Dam Safety of Coal Combustion Surface Impoundments at the
Hennepin Power Station

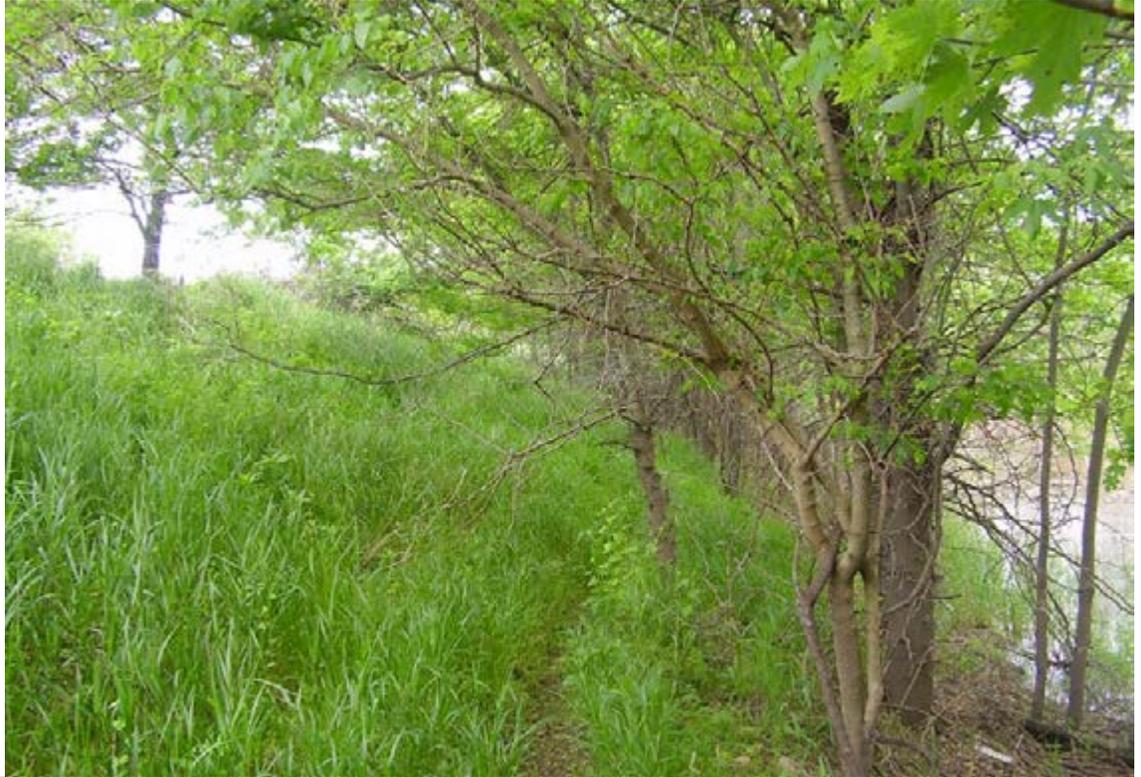
Photo No.
6

Description:
Downstream slope of the
WAPS.

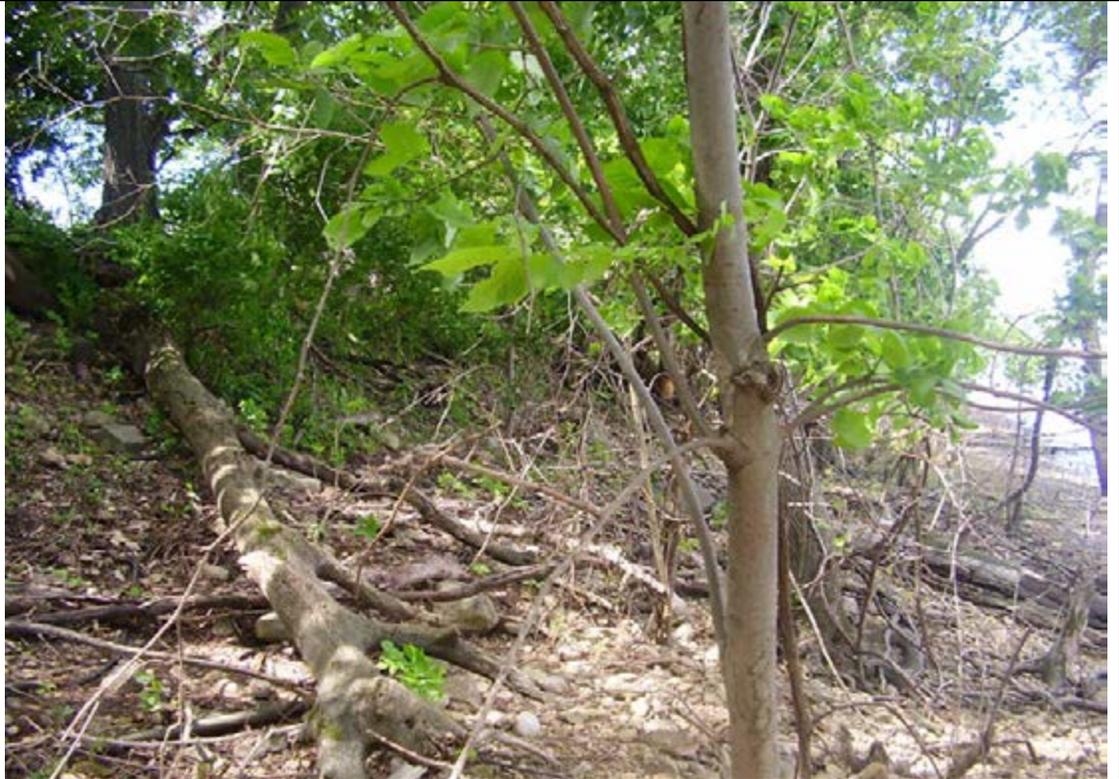
Photo No. 10	Date: 5/23/11
Direction Photo Taken: Southwest

Description:
Downstream slope of the WAPS.

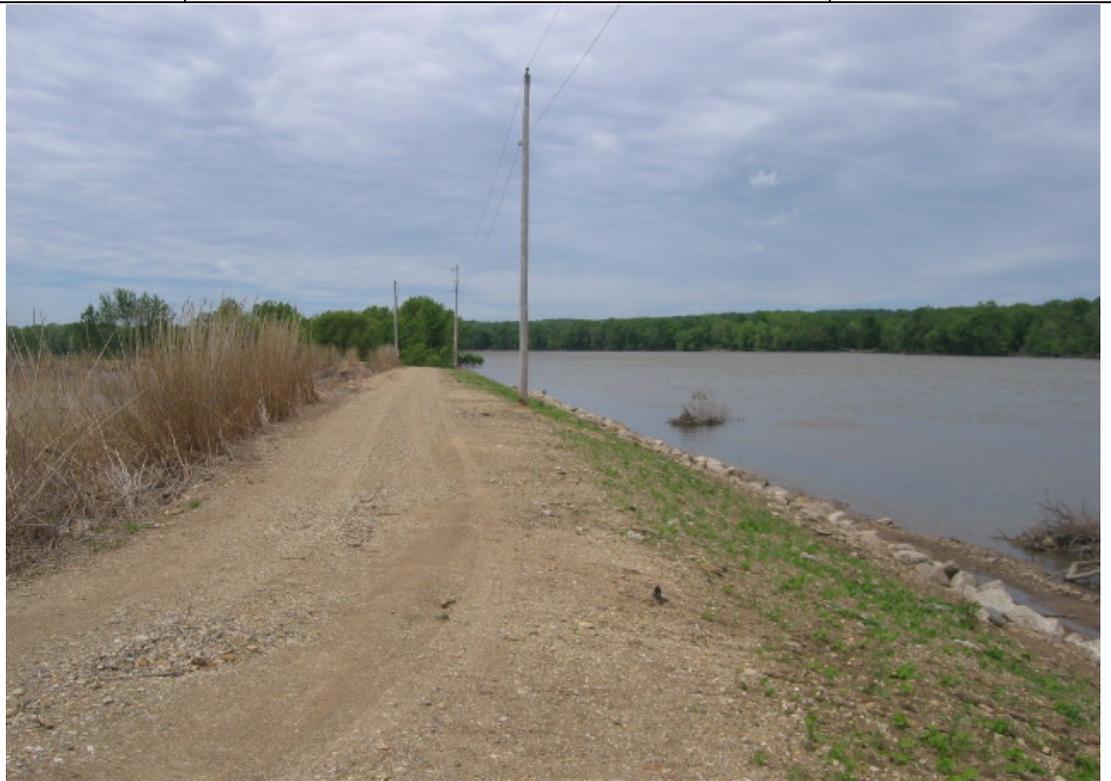
Photo No.
18

Description:
Crest of the WAPS.

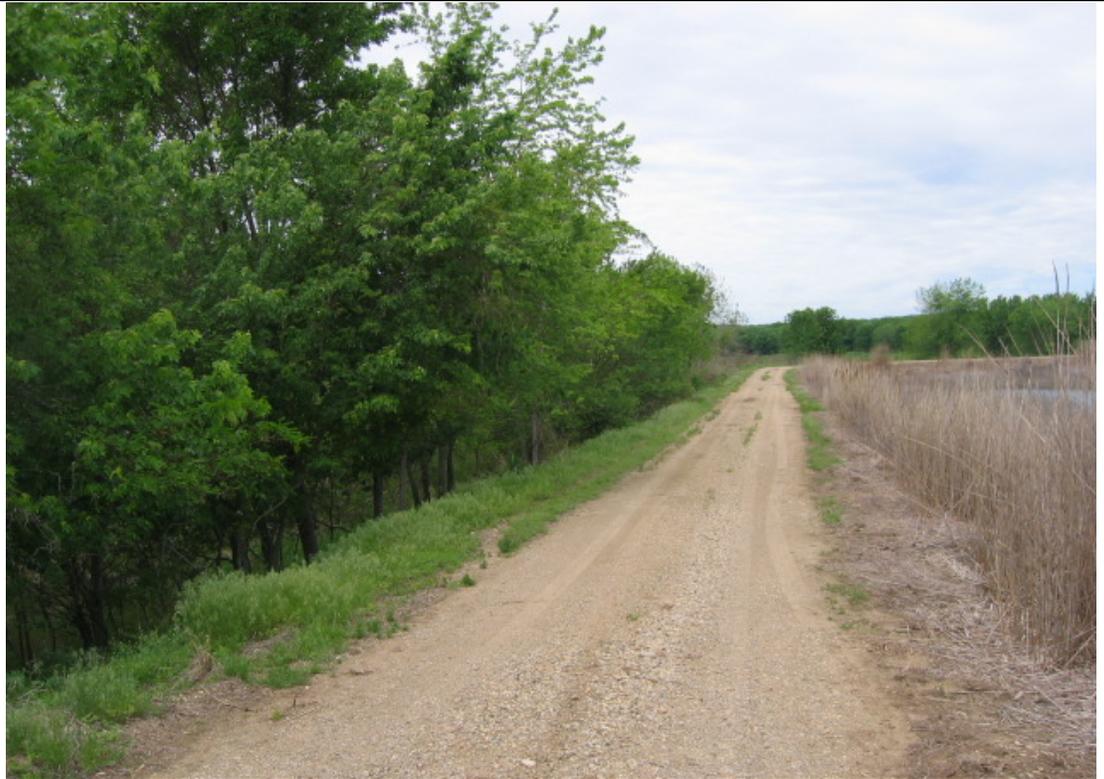
Photo No.
20

Description:
Crest and upstream slope of
the WAPS.

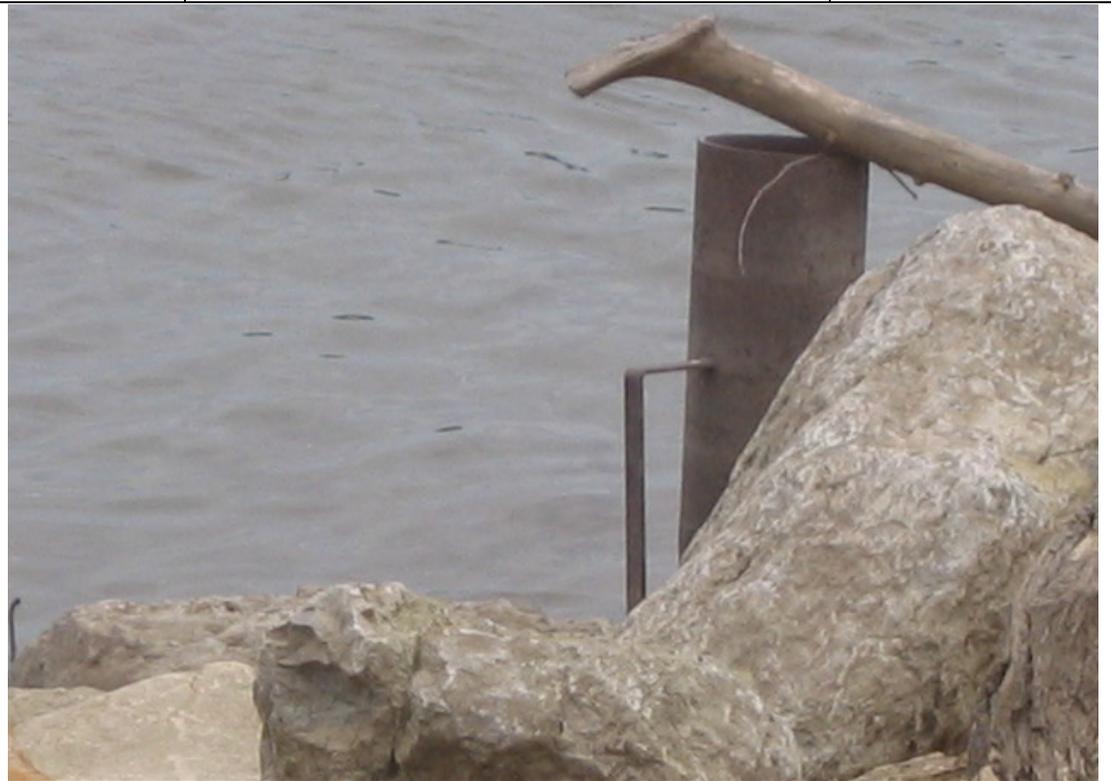
Photo No.
24

Discharge pipe from the
WAPS into the Illinois
River.

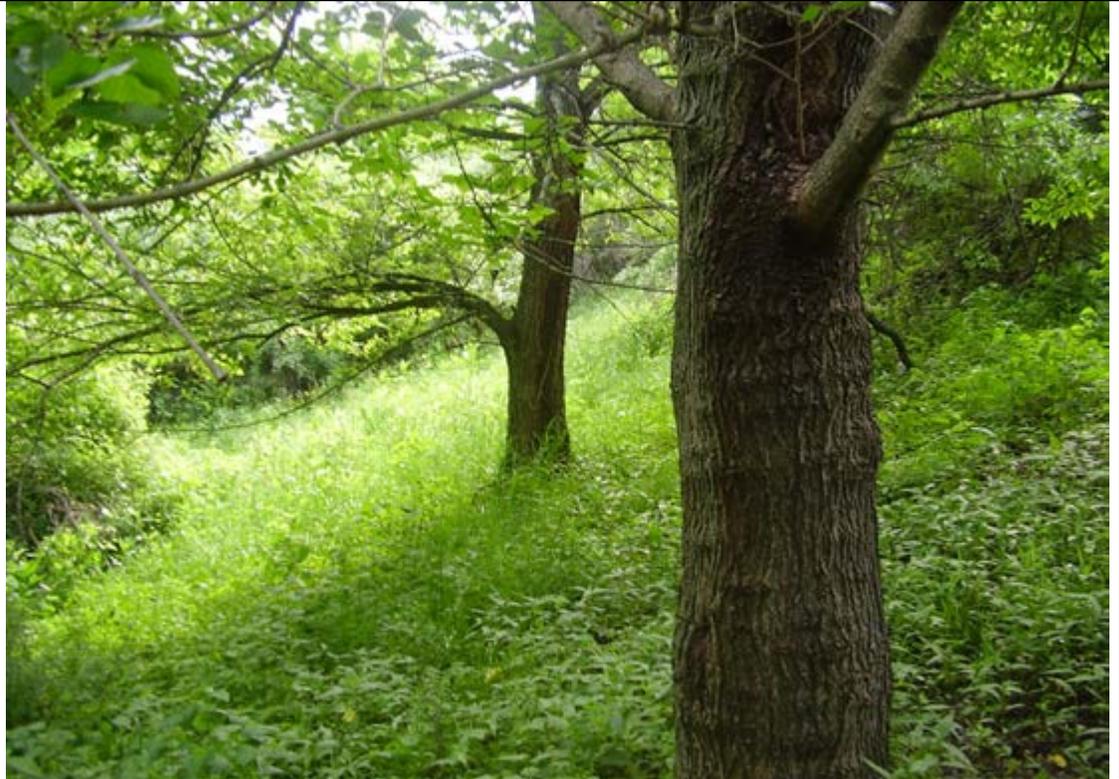
Photo No.
26

Description:
Downstream slope of the
EAPS.

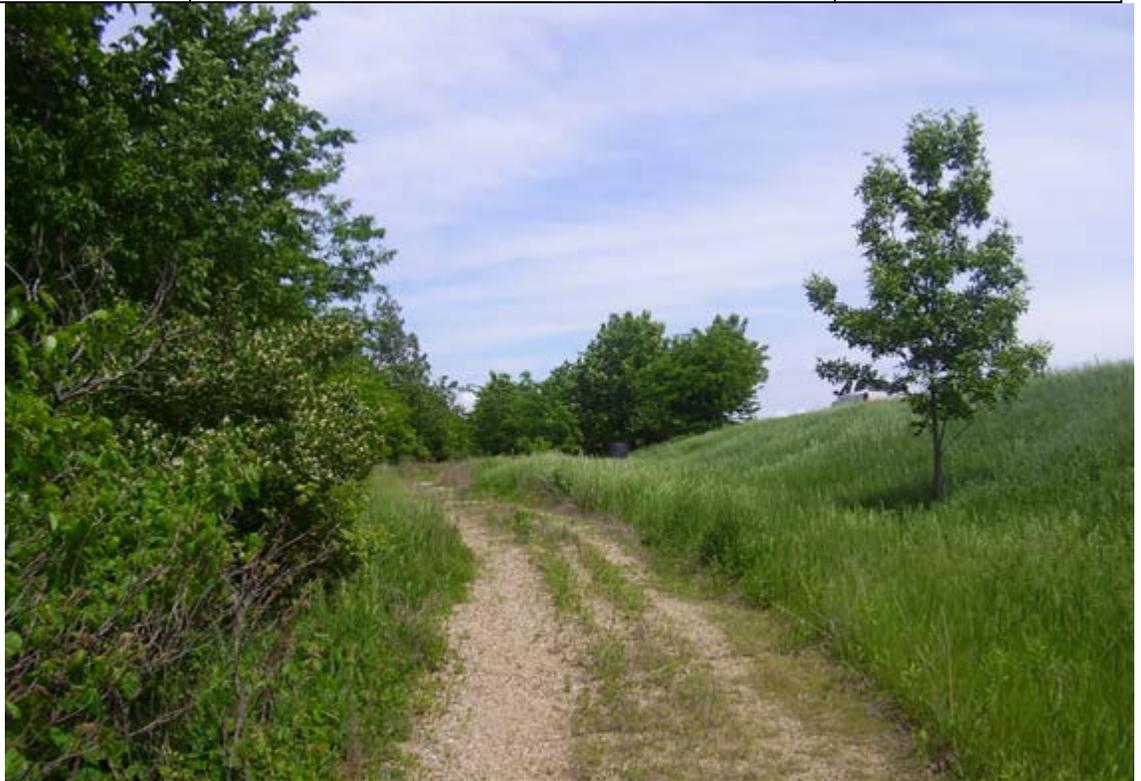
Photo No.
28

Description:
Crest of the 1978
embankment and
downstream slope of the
1995 embankment along the
EAPS.

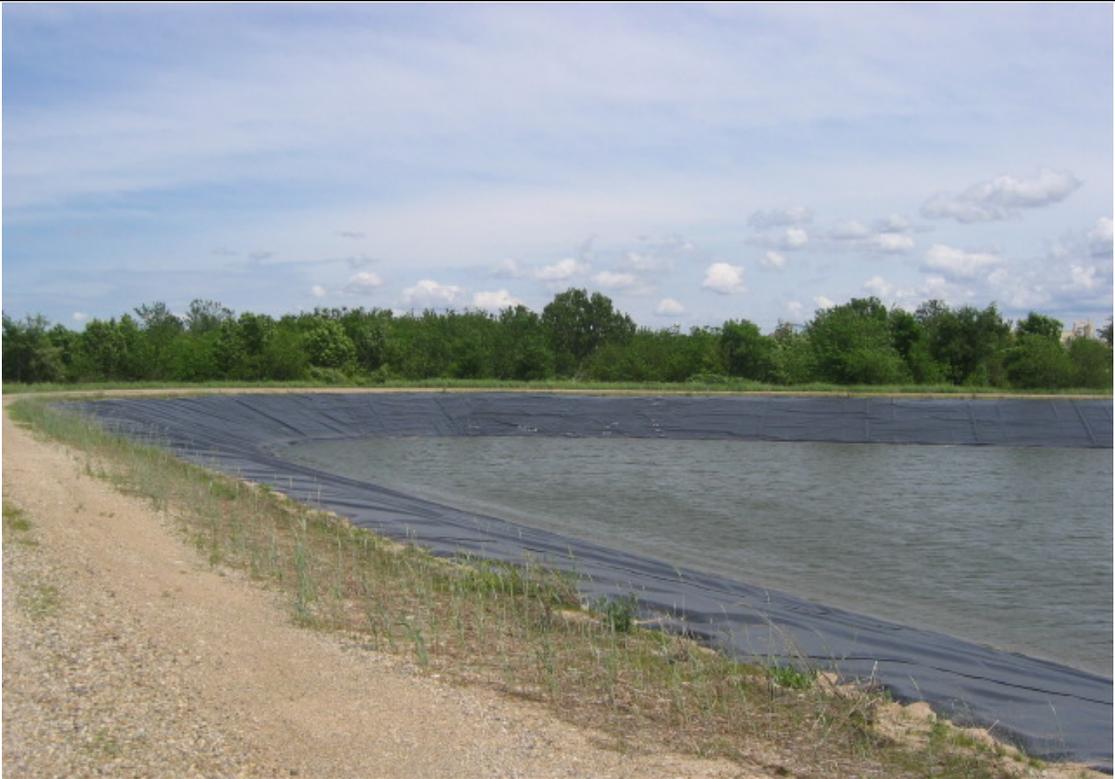
Description:
Crest and upstream slope of Pond 2E.

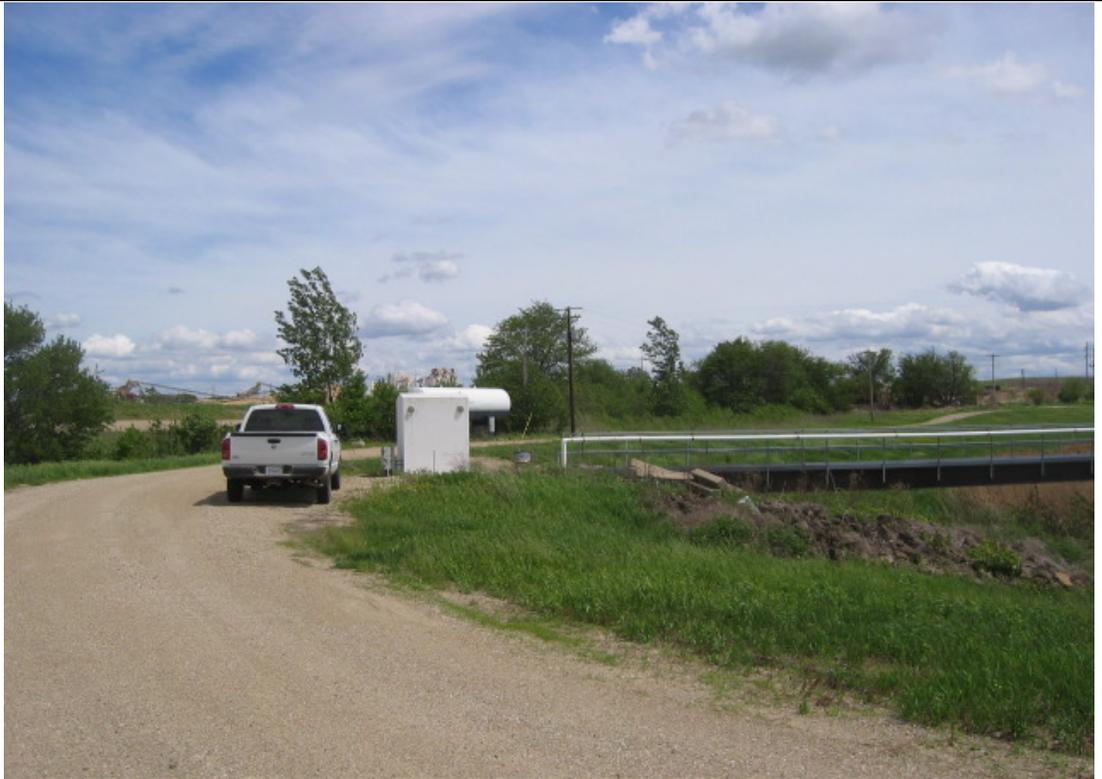
Description:
Crest and upstream slope of
the Secondary Cell.

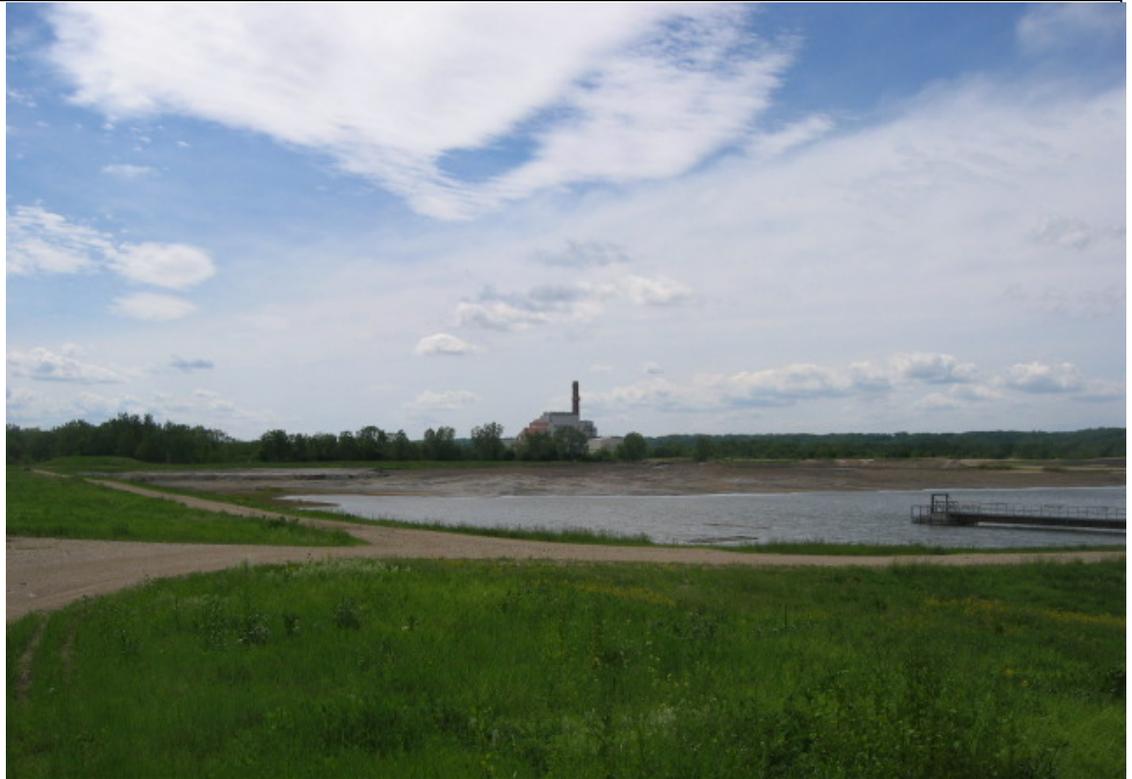
Description:
Crest and upstream slope of
the Secondary Cell.

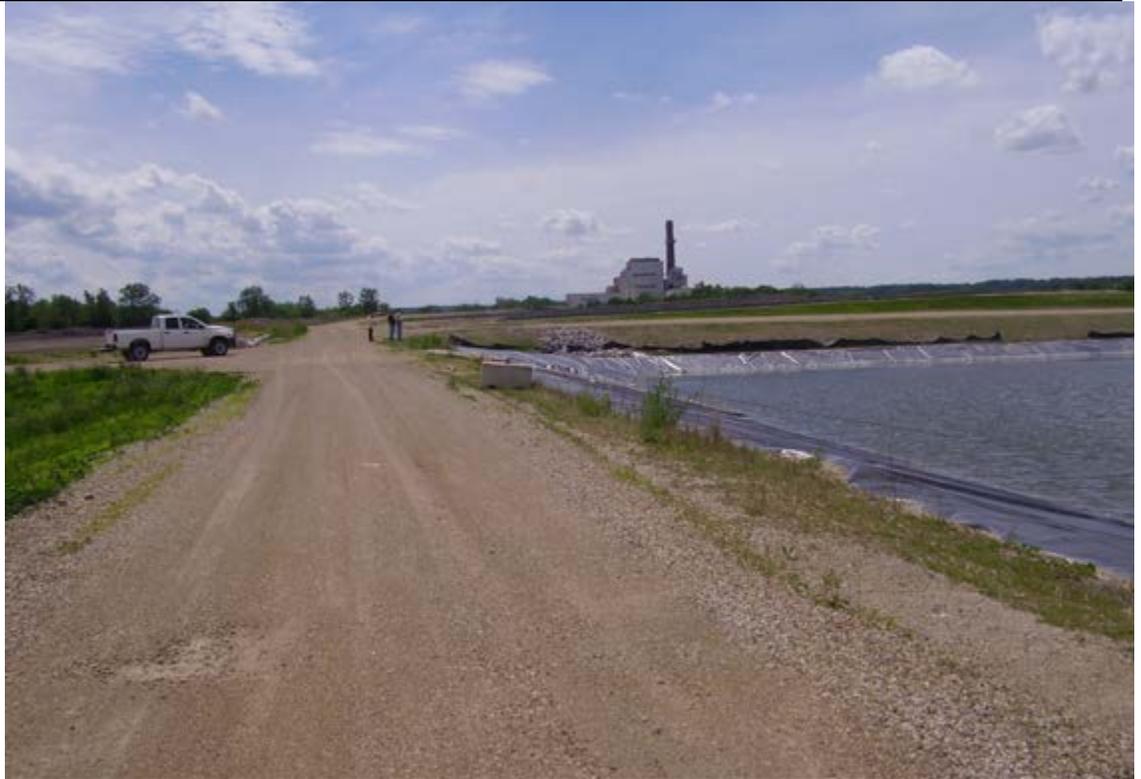
Crest of the embankment
between Pond 2E and the
Secondary Cell.

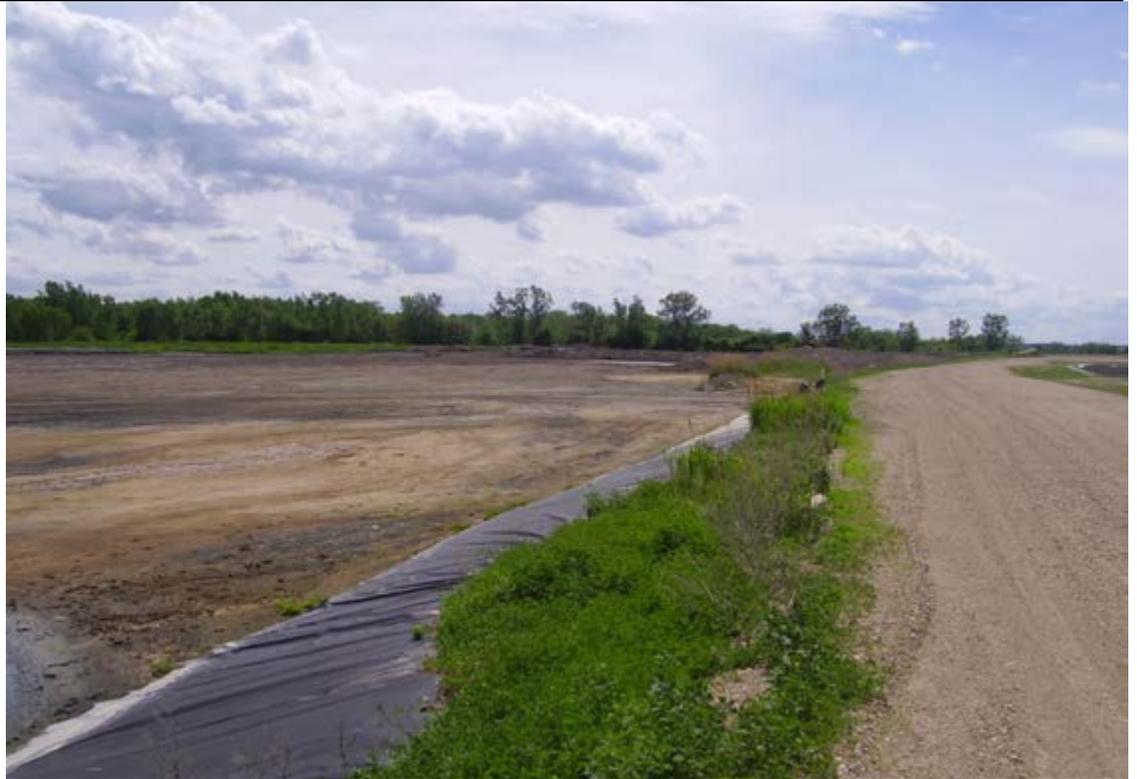
Description:
Crest and upstream slope of
the Primary Cell.

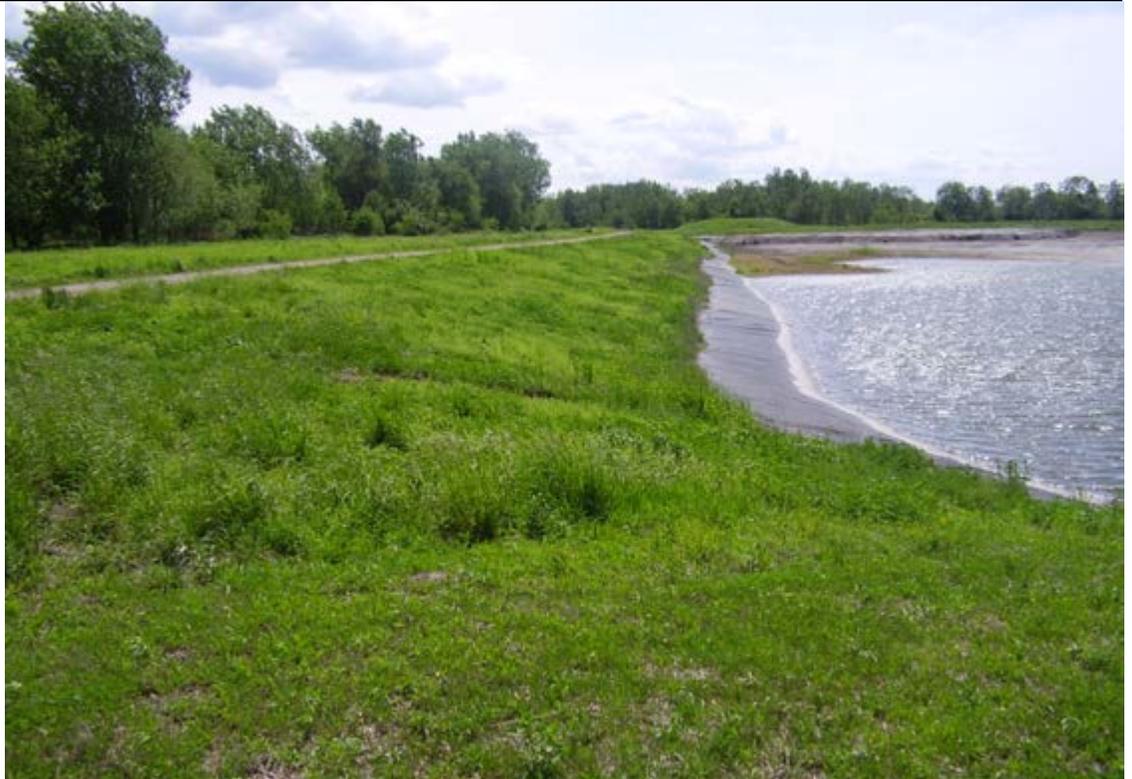
Description:
Upstream slope of the
Primary Cell.

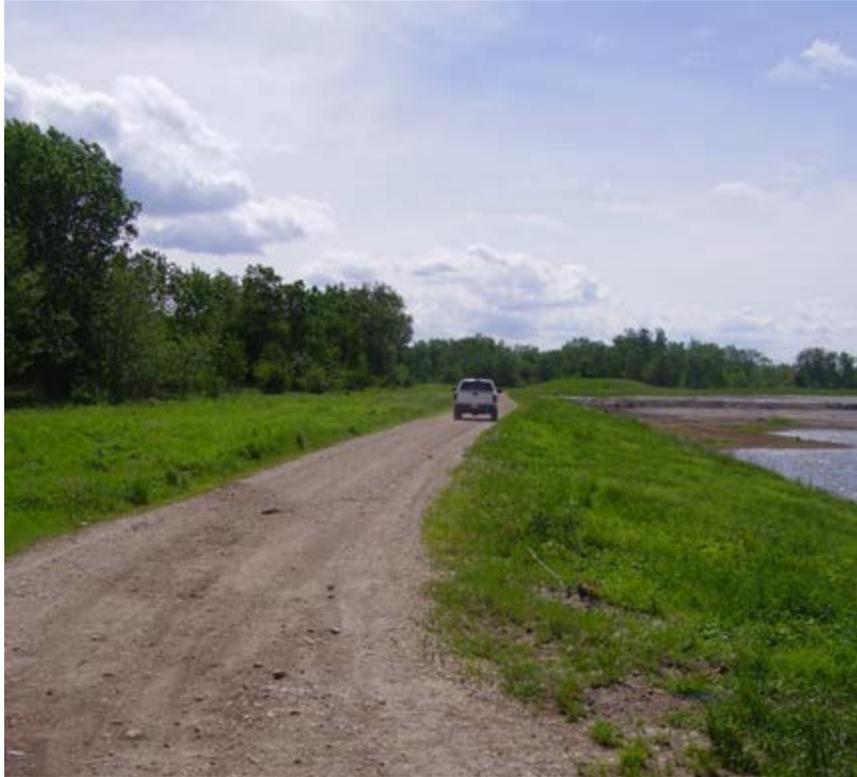
Description:
Crest and upstream slope of
the Primary Cell.

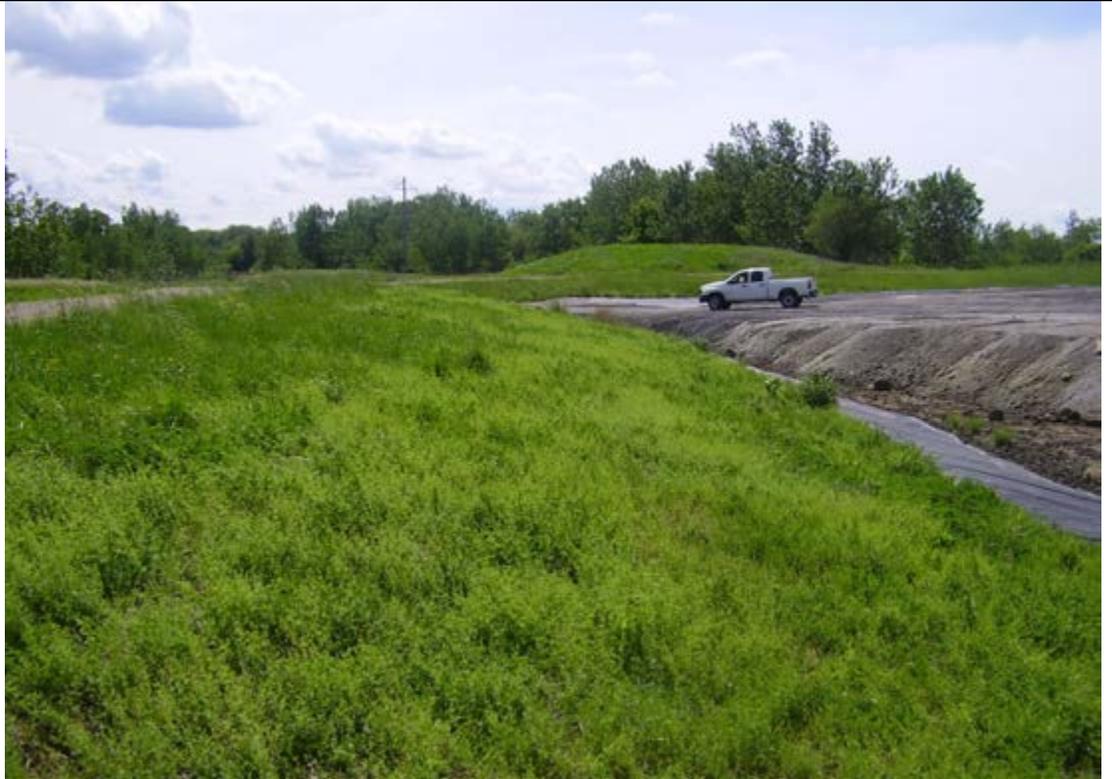
Description:
Upstream slope of the
Primary Cell.

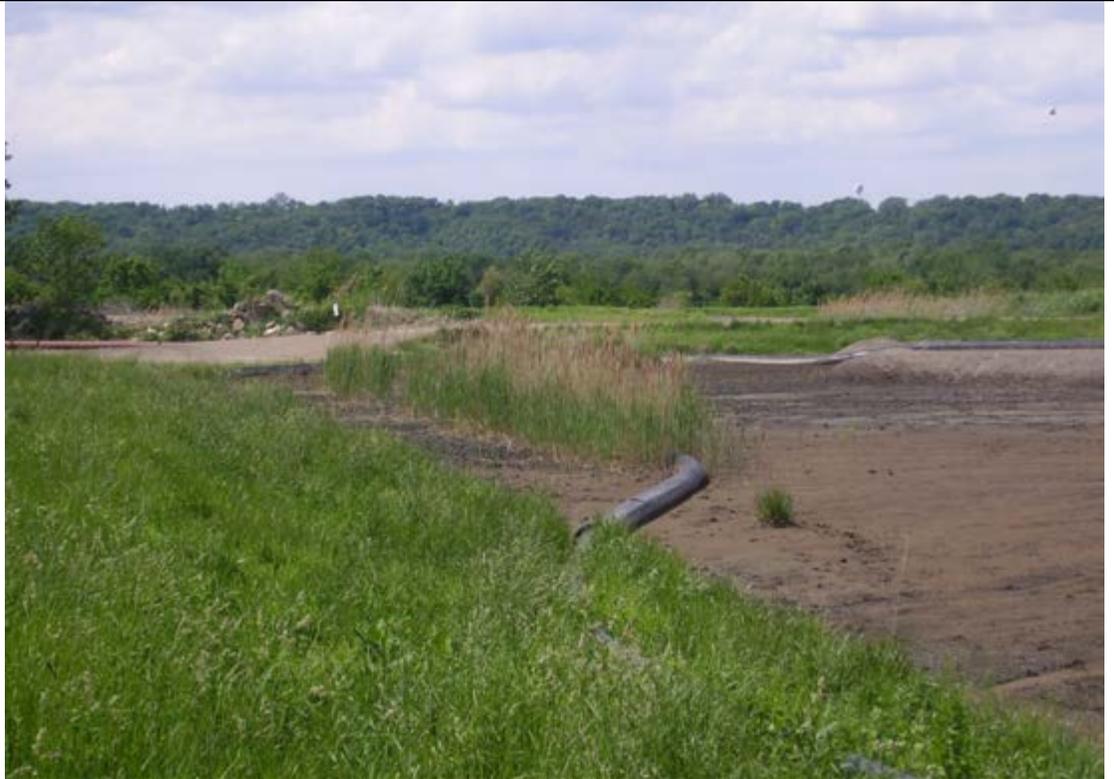
Description:
Crest and upstream slope of
the Primary Cell.

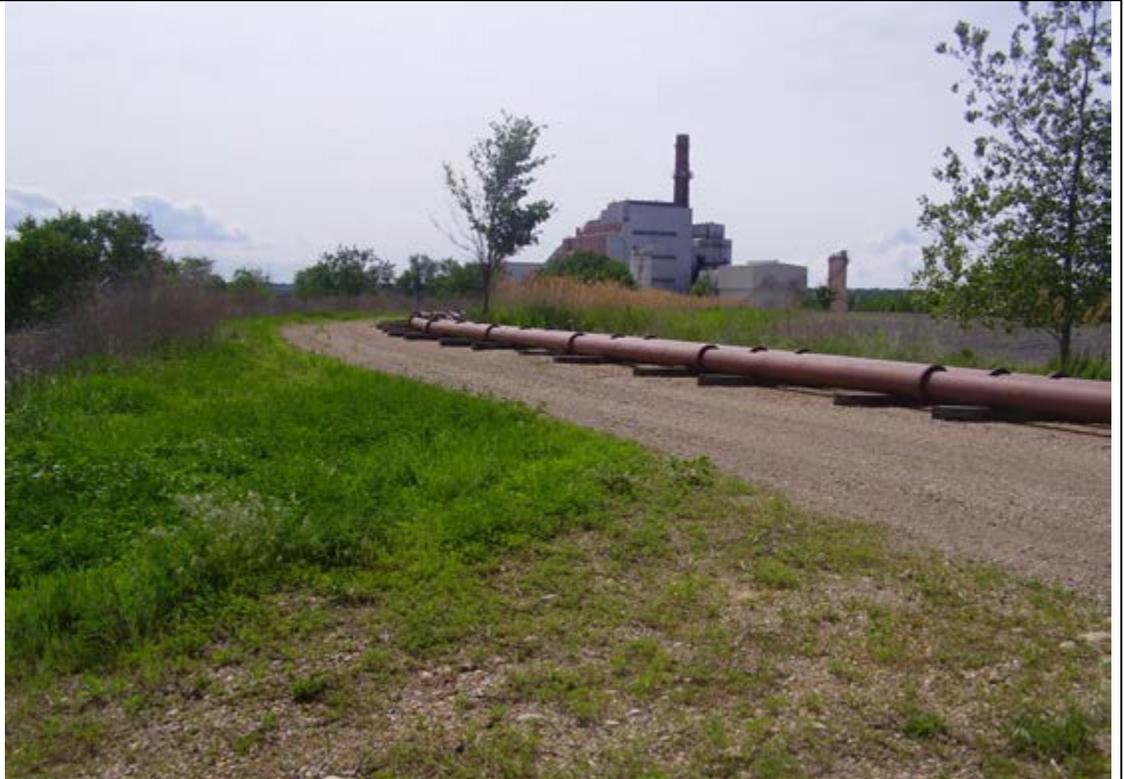
Crest and downstream slope
of the EAPS.

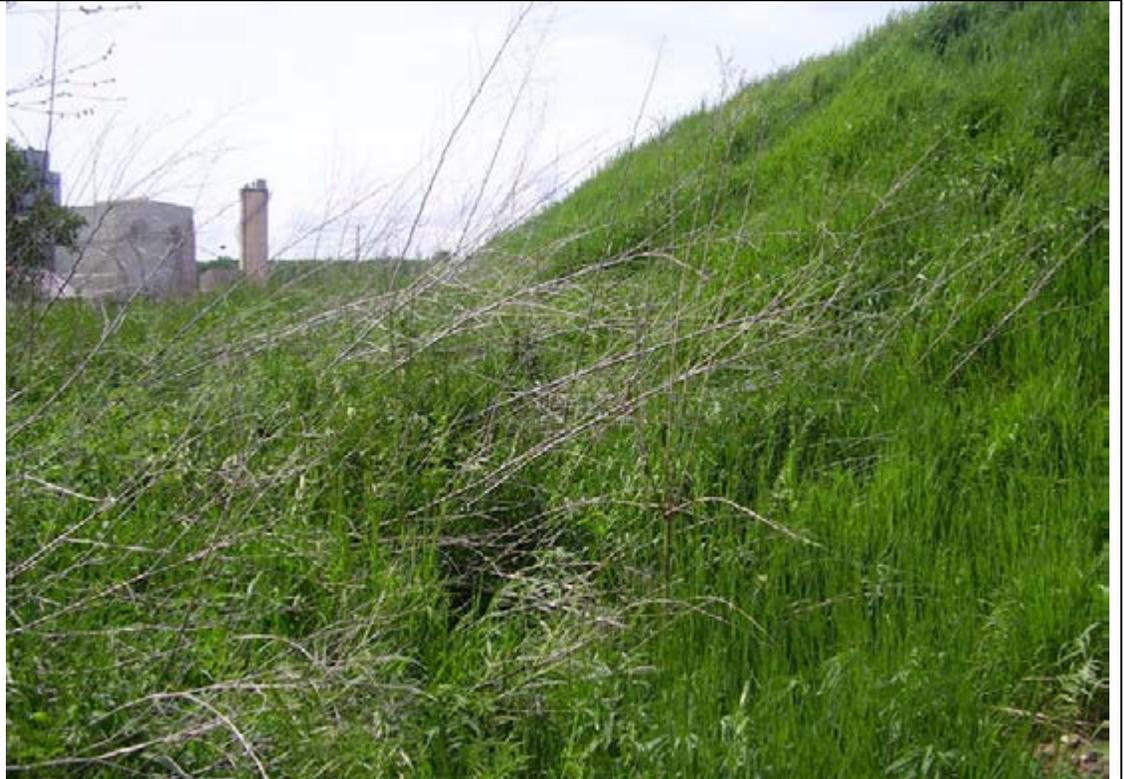
Description:
Downstream slope of the
EAPS.

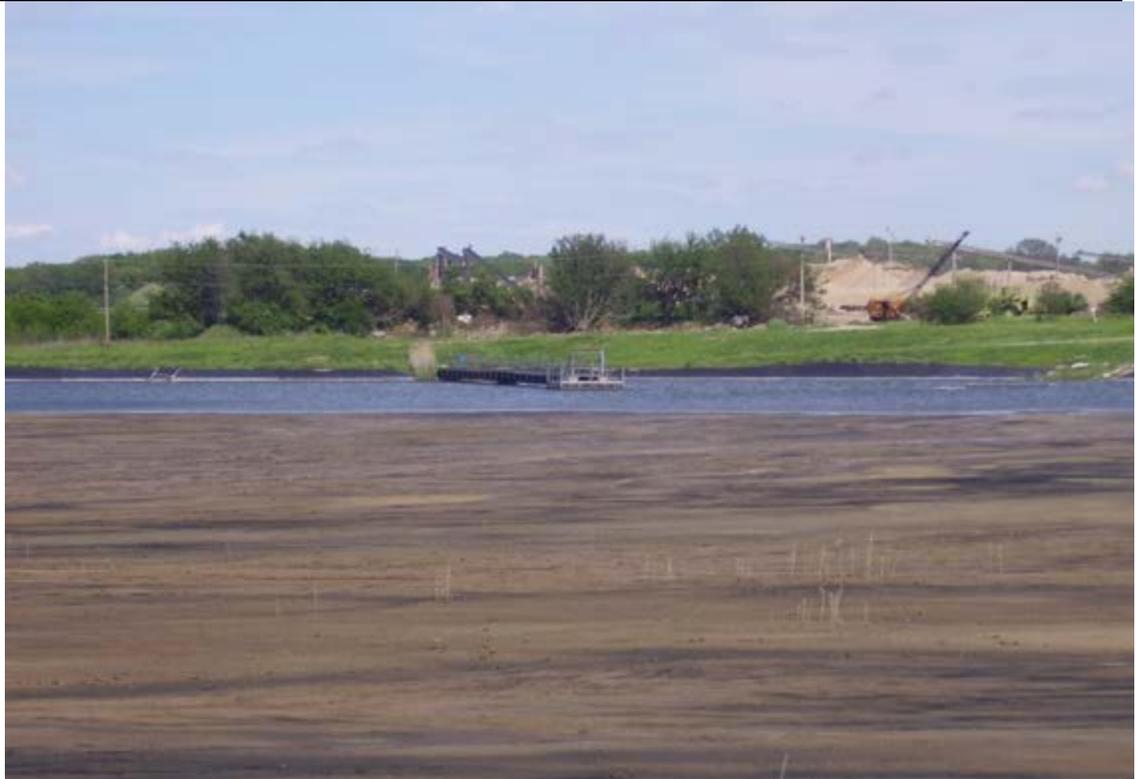
Description:
Old decant structure in the
Primary Cell.

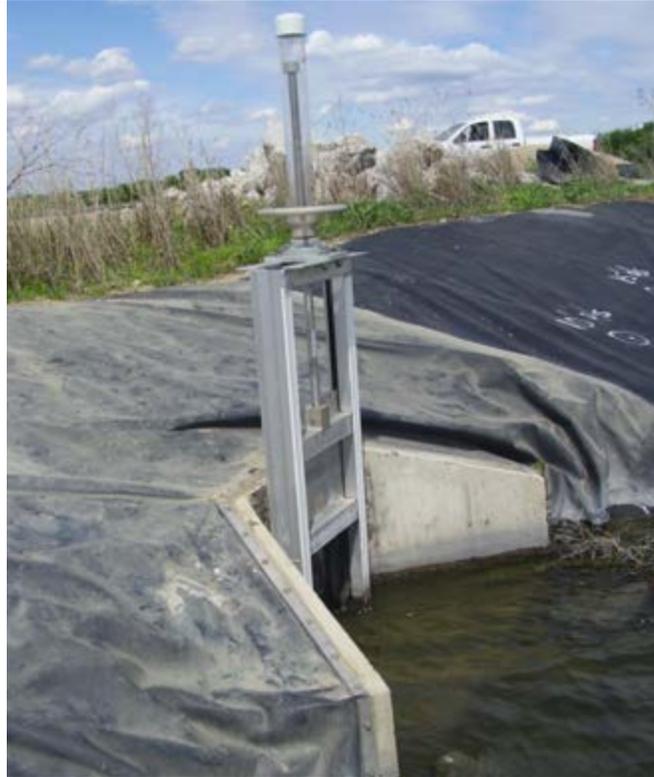
Description:
Decant structure in the
Primary Cell.

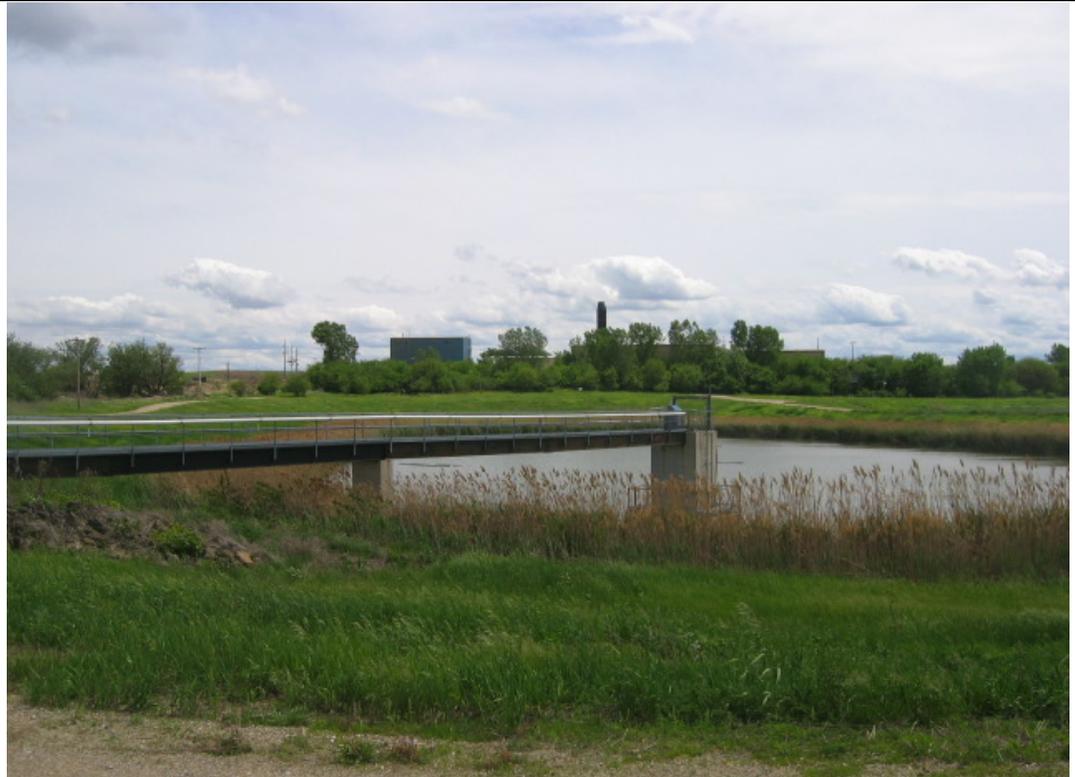
Description:
Decant structure in the
Secondary Cell.

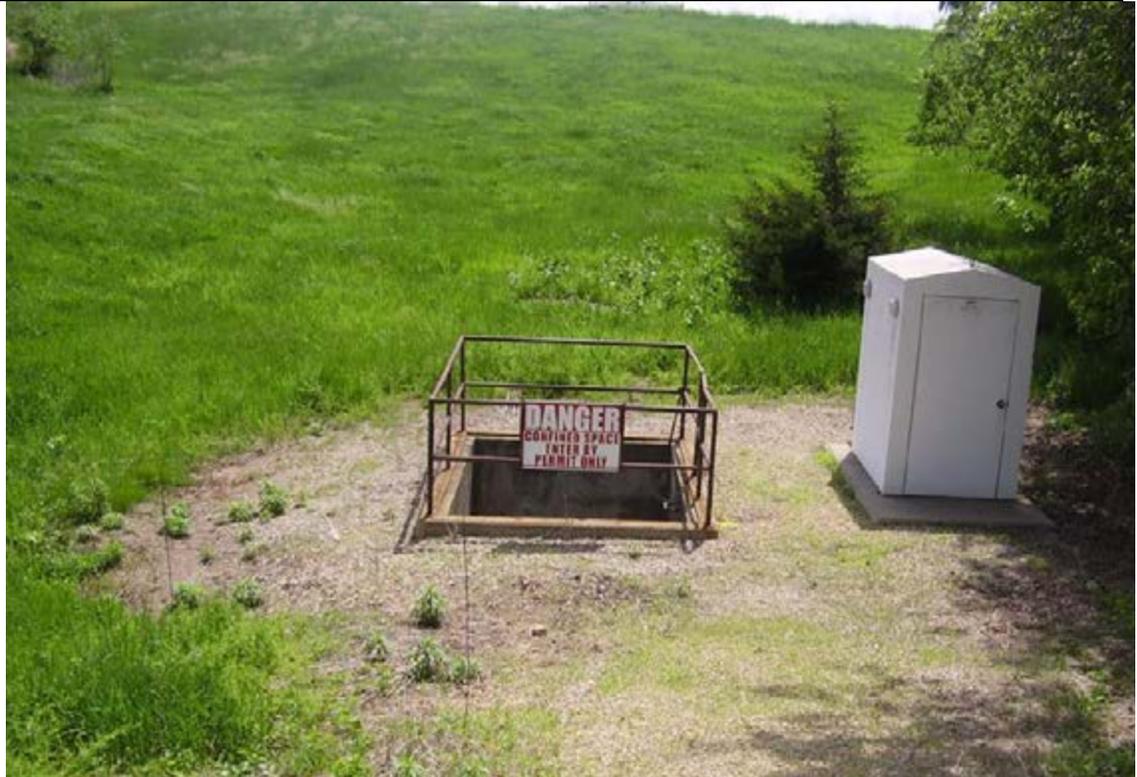
Description:
Surface features of the flume structure in the discharge line from the Secondary Cell to the Illinois River.

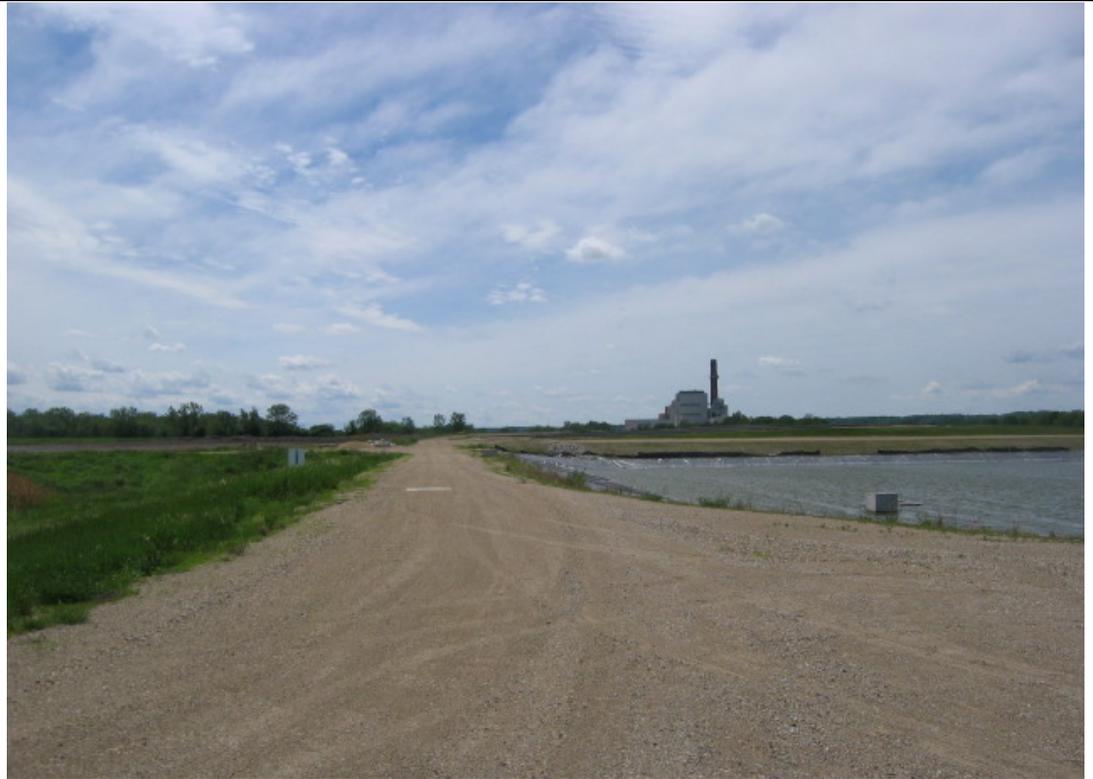
Crest of the interior
embankment in the AEAPS
with the Pond 2E decant
structure shown.

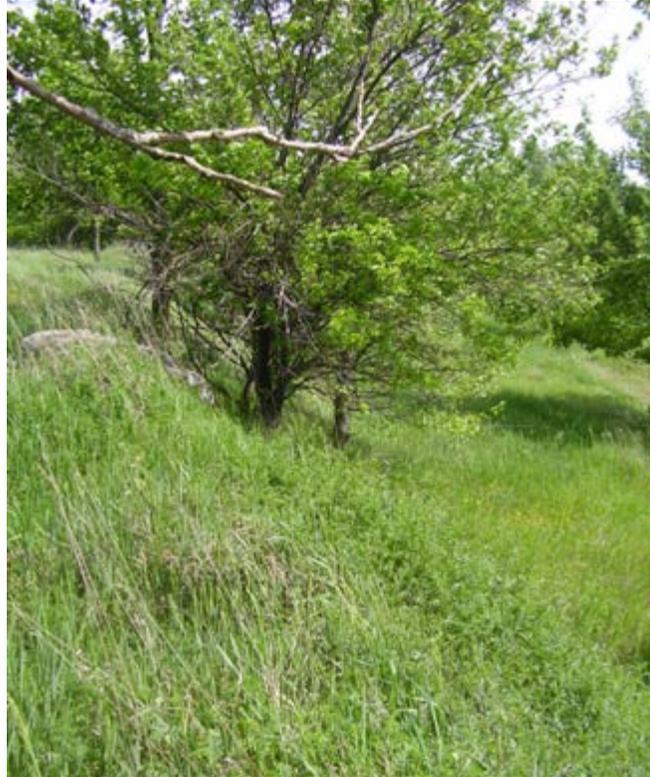
Description:
Downstream slope of EAPS
near Pond 4.

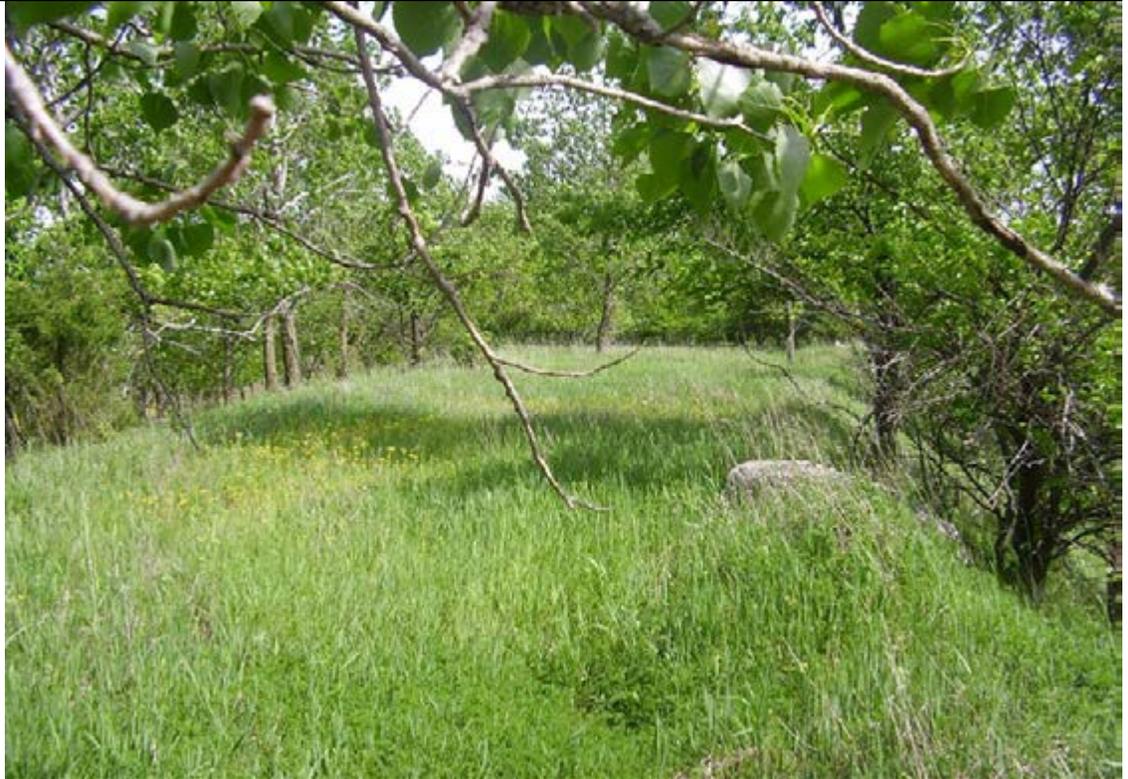
Description:
Crest of the EAPS near Pond
4.

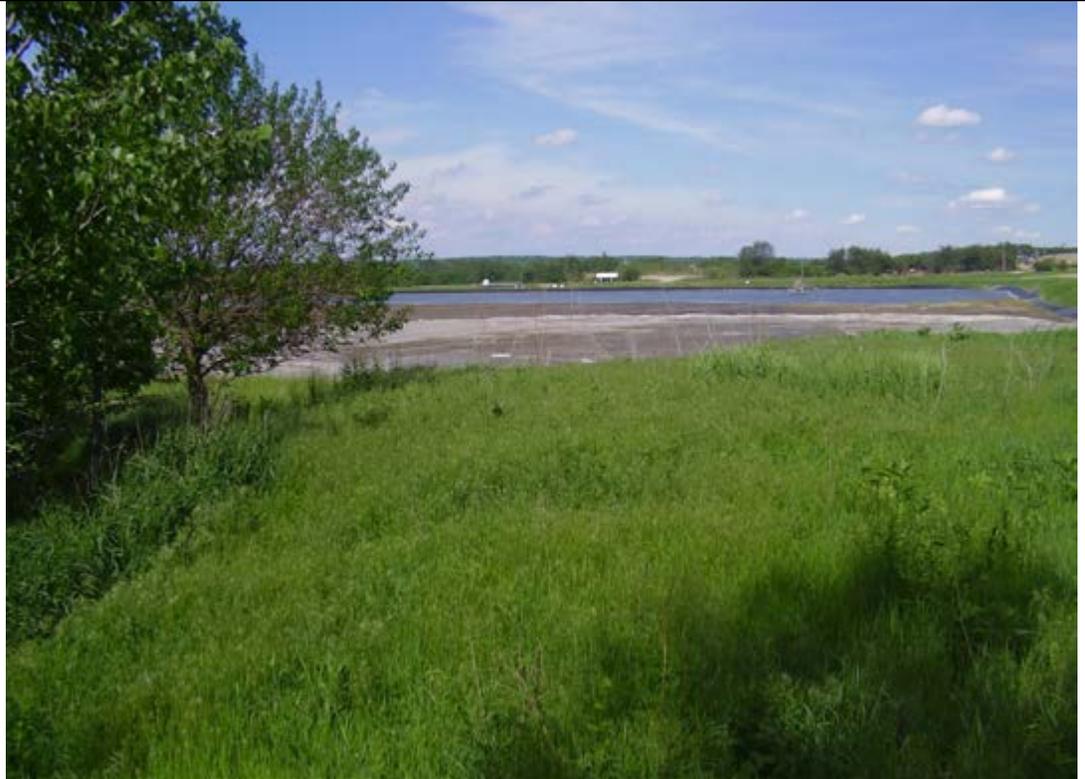
Description:
Crest of the EAPS looking
over the Primary Cell.

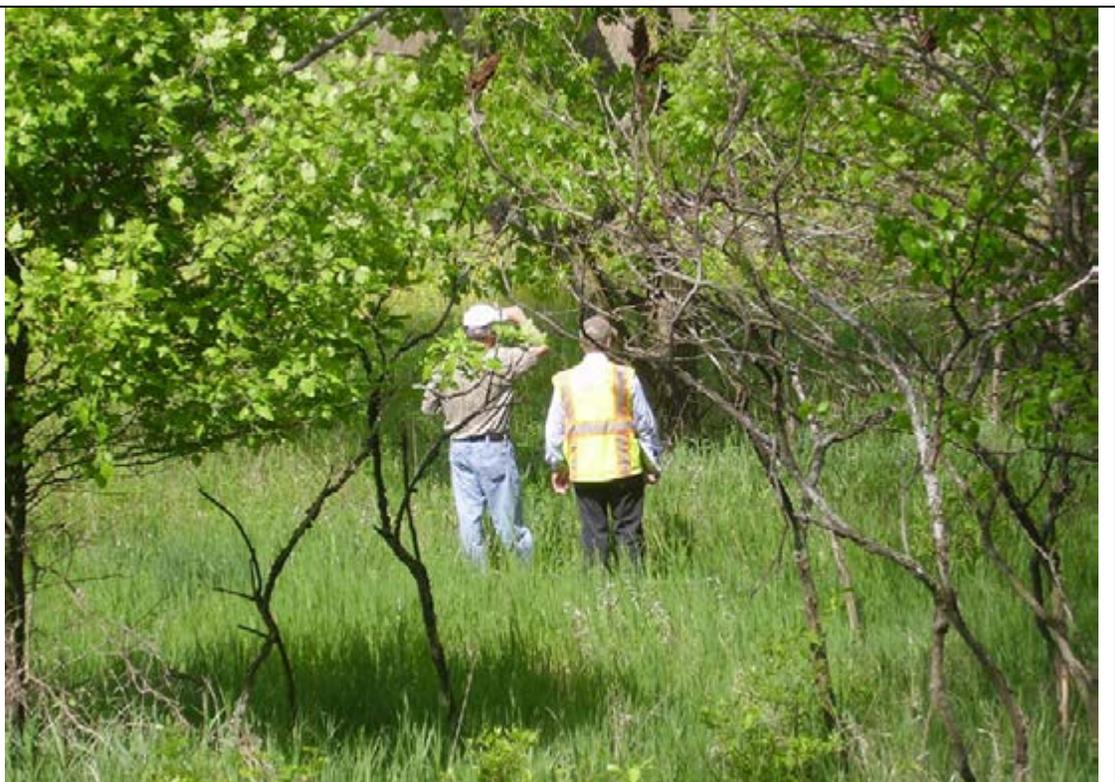
Photo No.
74

Description:
Crest of the EAPS near Pond
4.
