**FINAL REPORT
ROUND 10 DAM ASSESSMENT
DYNEGY MIDWEST GENERATION, LLC – HENNEPIN POWER STATION
ACTIVE EAST ASH POND SYSTEM, EAST ASH POND SYSTEM, WEST ASH POND
SYSTEM
HENNEPIN, ILLINOIS**

December 6, 2012
GZA File No. 170142.30

RE: FINAL Assessment of Dam Safety of Coal Combustion Surface Impoundments at the
Hennepin Power Station

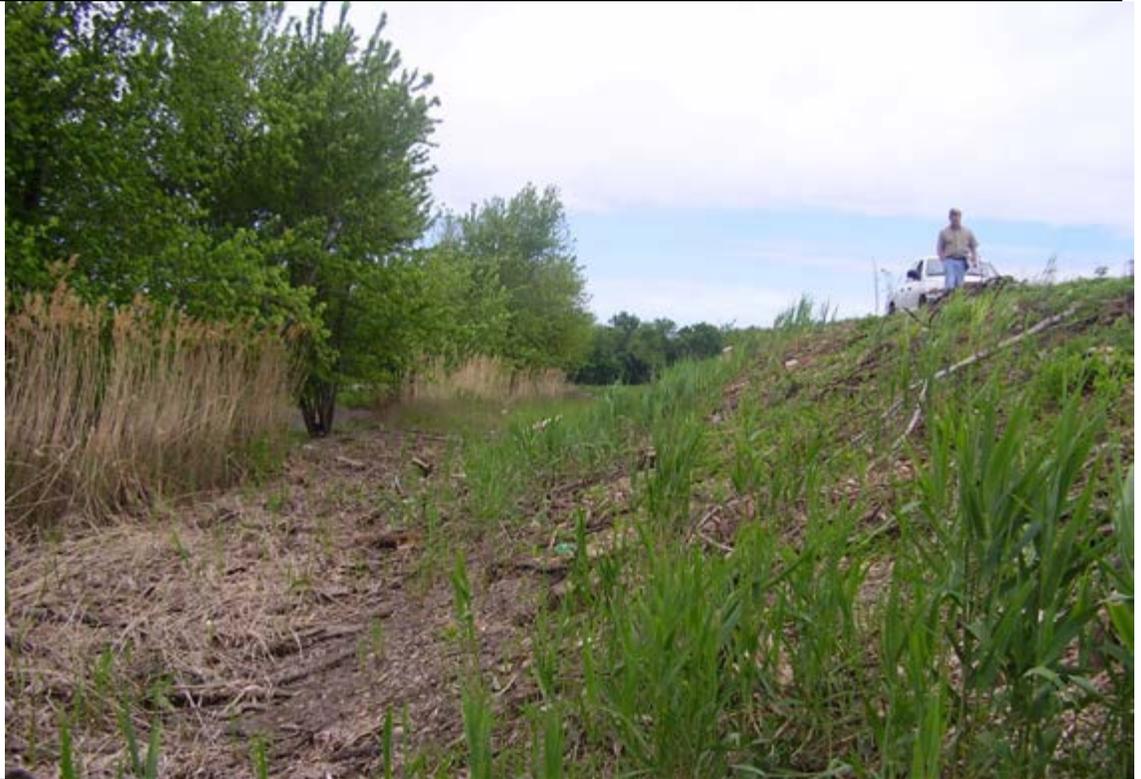
Photo No.
4

Description:
Downstream slope of the
WAPS.

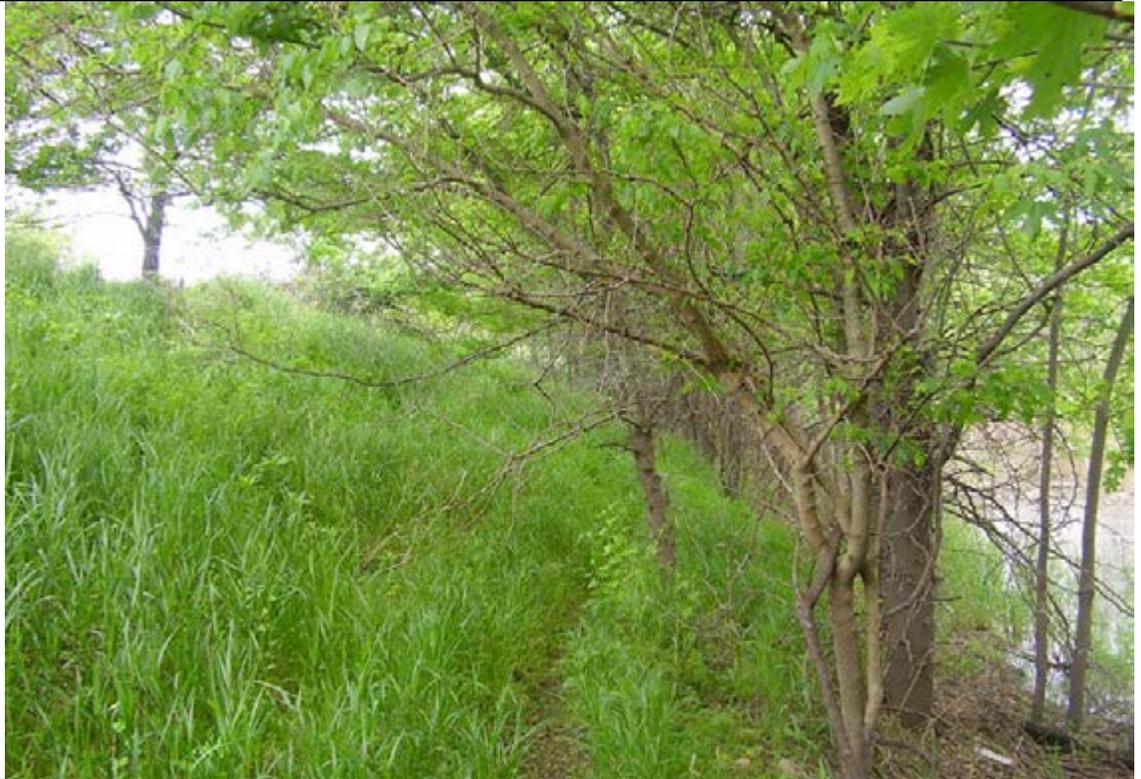
Photo No.
6

Description:
Downstream slope of the
WAPS.

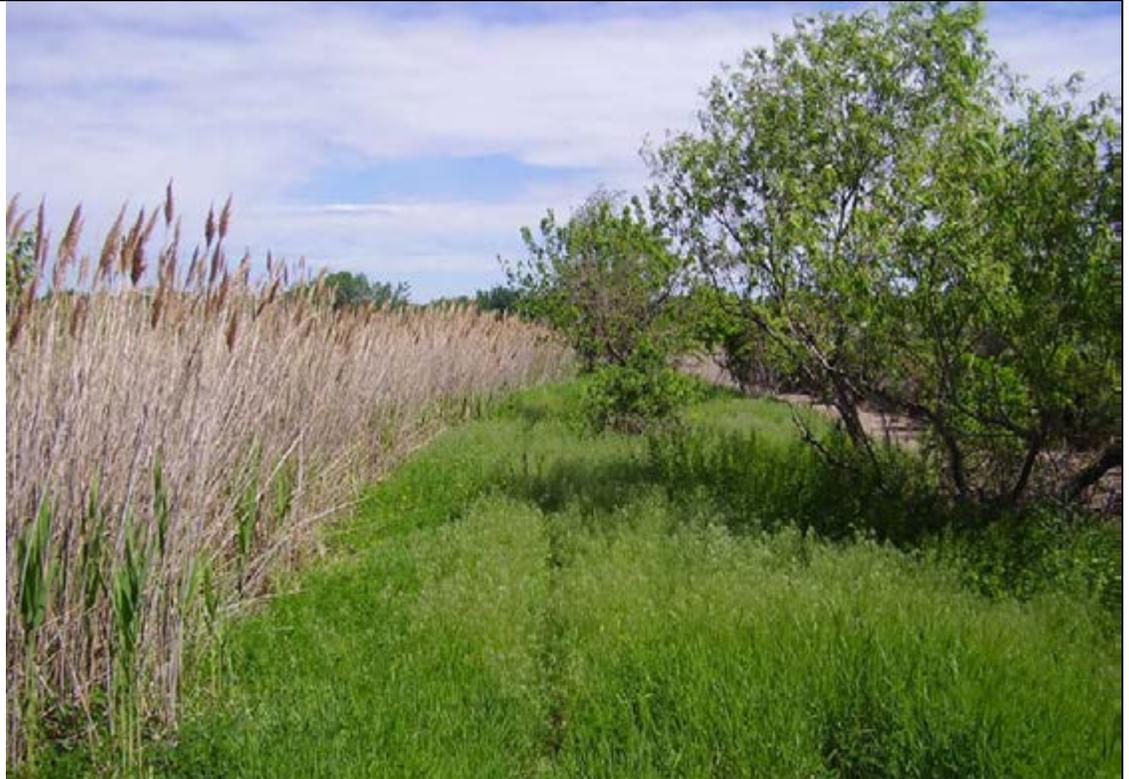
Photo No.
8

Description:
Crest and downstream slope
of the WAPS.

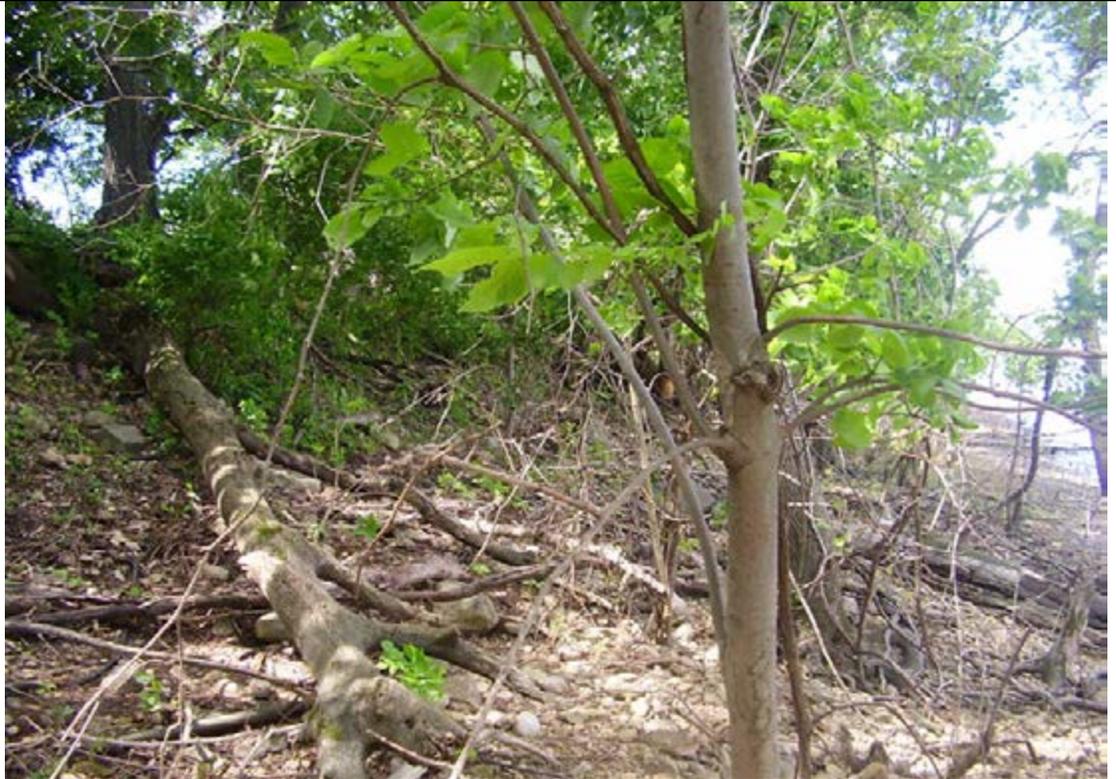
Photo No.
10

Description:
Downstream slope of the
WAPS.

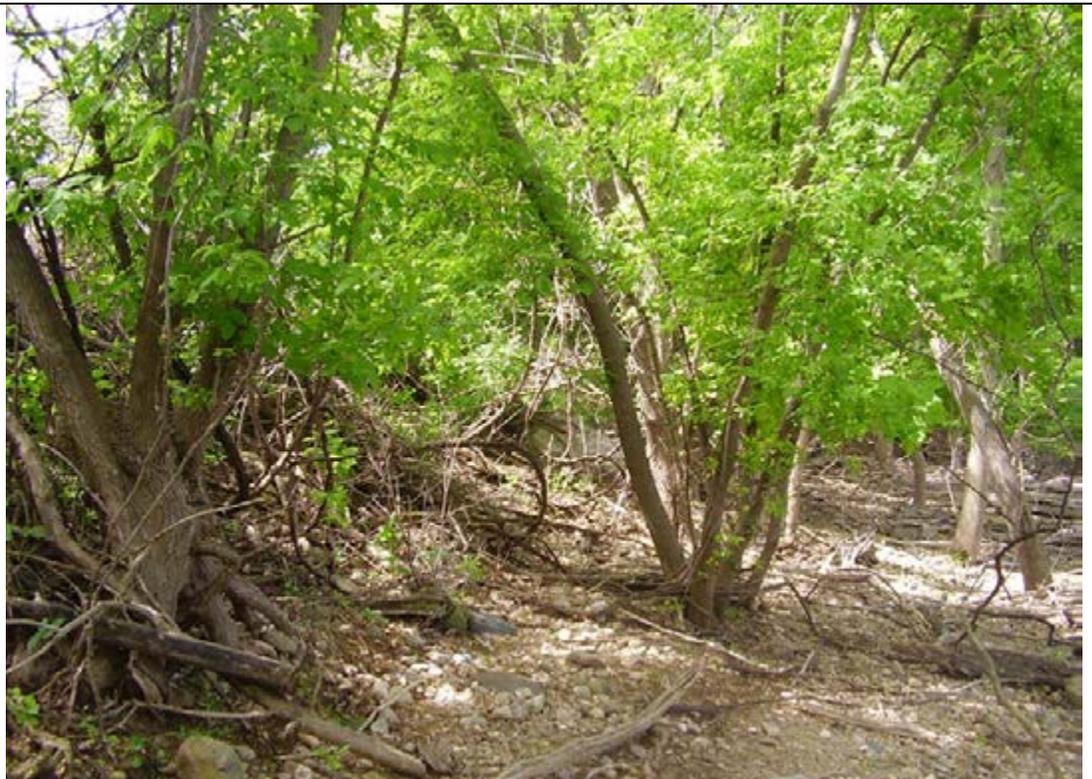
Description:
Downstream slope of the
WAPS.

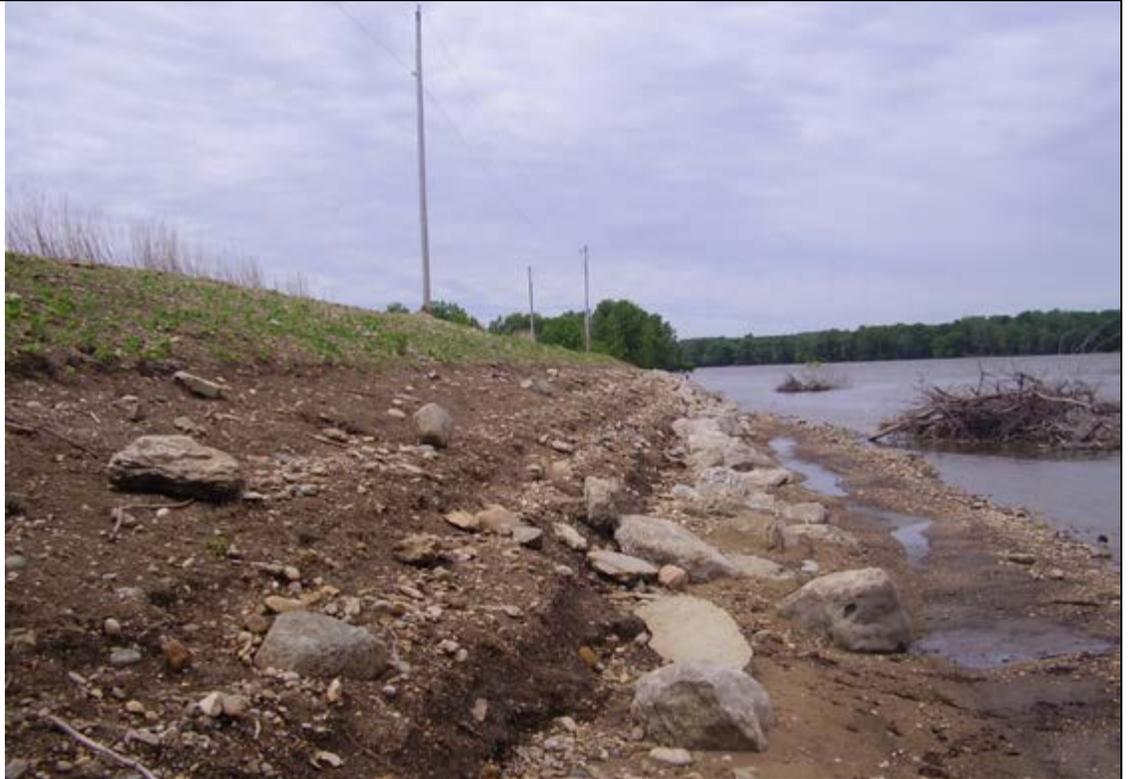
Photo No.
14

Description:
Toe access road along the
eastern portion of the
WAPS.

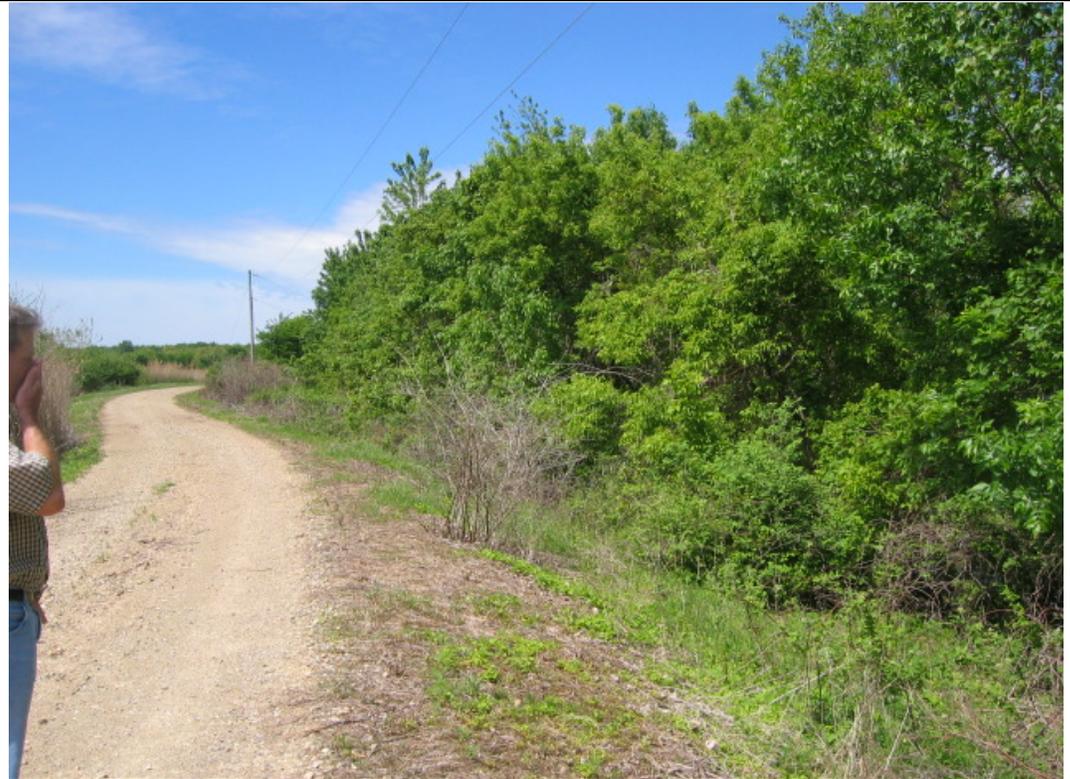
Photo No.
16

Description:
Crest of the WAPS.

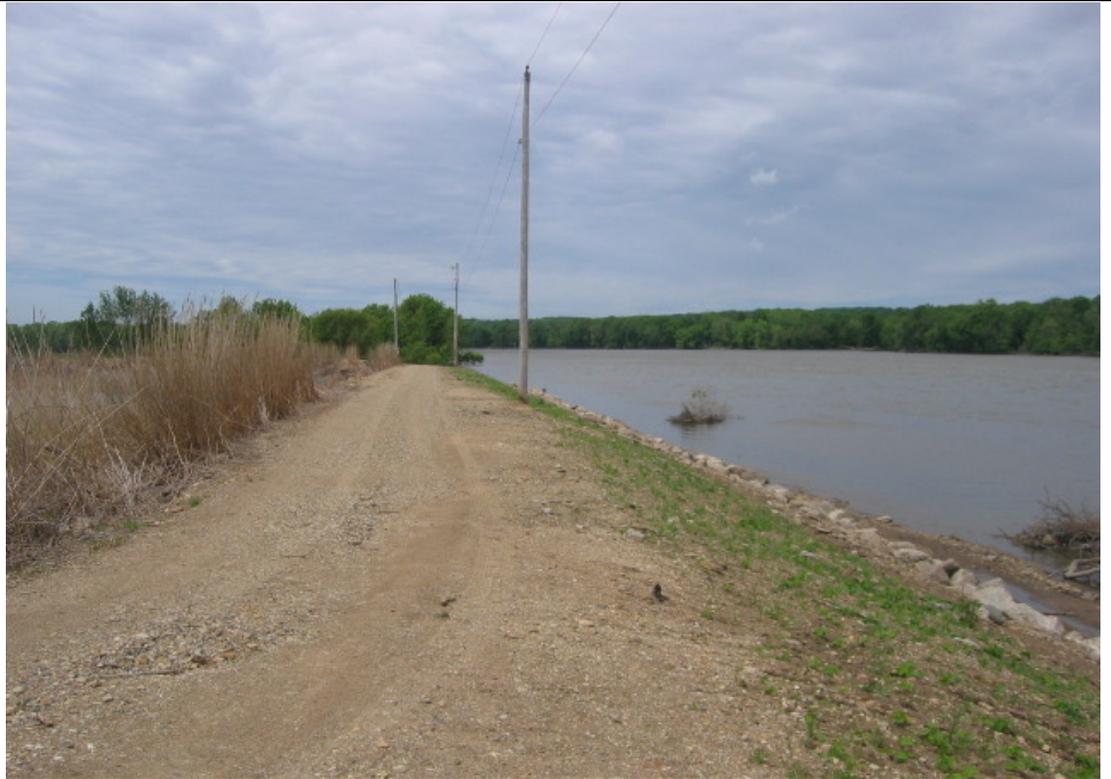
Photo No.
18

Description:
Crest and upstream slope of
the WAPS.

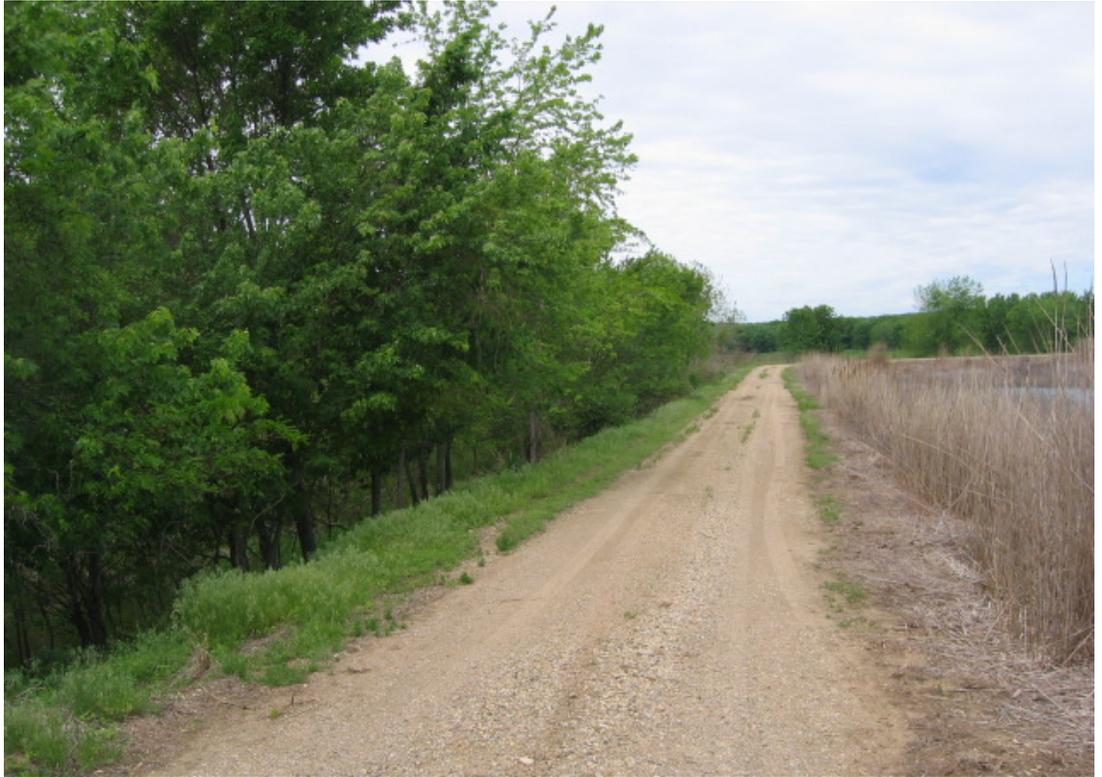
Photo No.
20

Description:
Crest and upstream slope of
the WAPS.

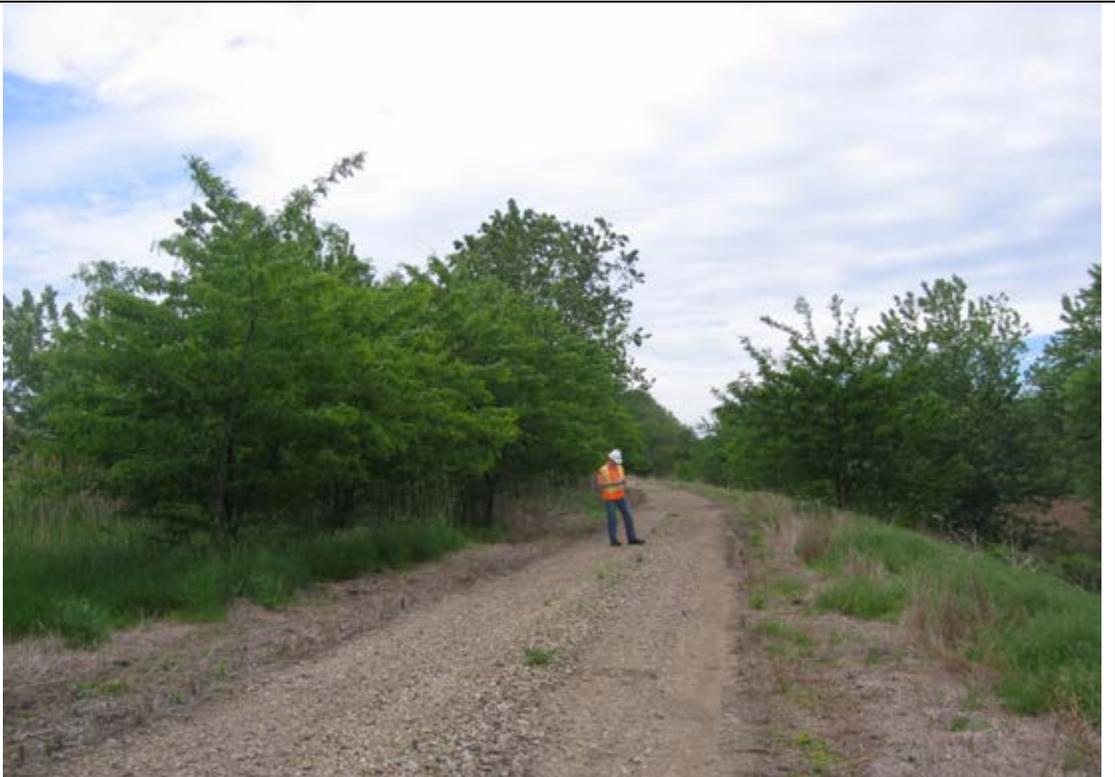
The decant structure for the WAPS Impoundment consists of a 12-inch diameter steel pipe with a trash rack as shown in Photo 21. The pipe discharges into the Illinois River and the discharge pipe is shown in Photo 22. The decant and discharge portions of the pipe appeared to be in good condition at the time of our assessment.

Description:
Decant structure in the
WAPS.

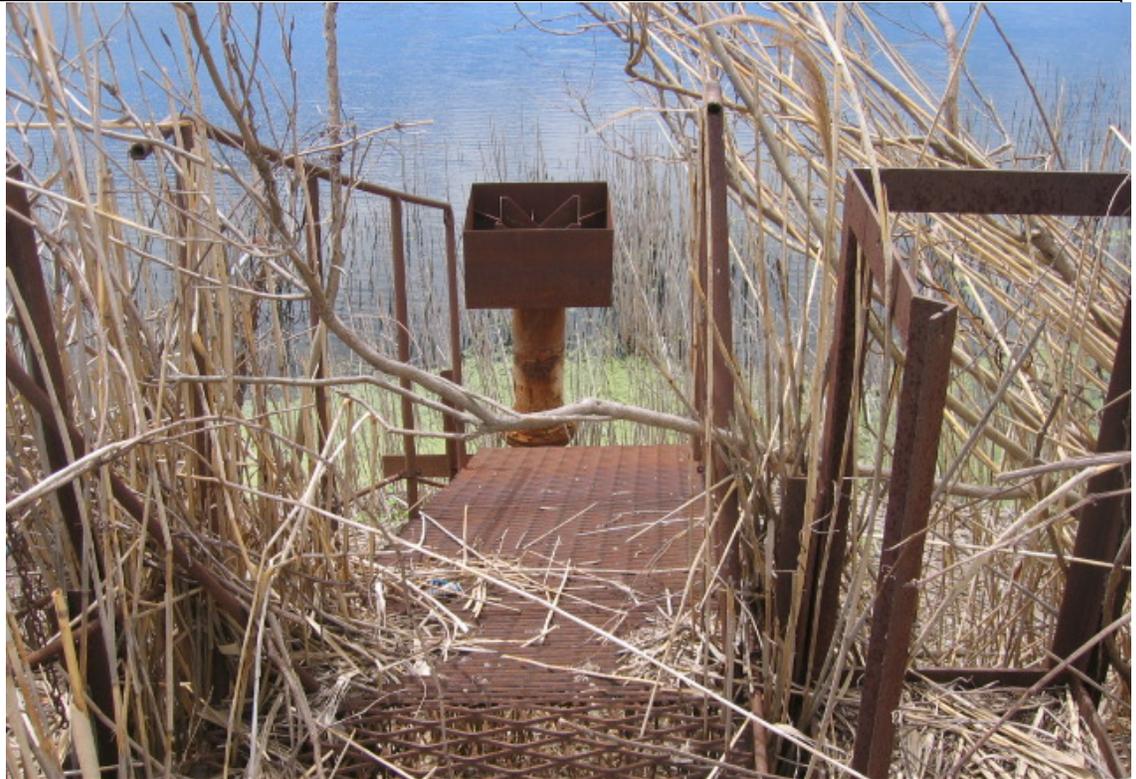
Photo No.
22

Discharge pipe from the
WAPS into the Illinois
River.

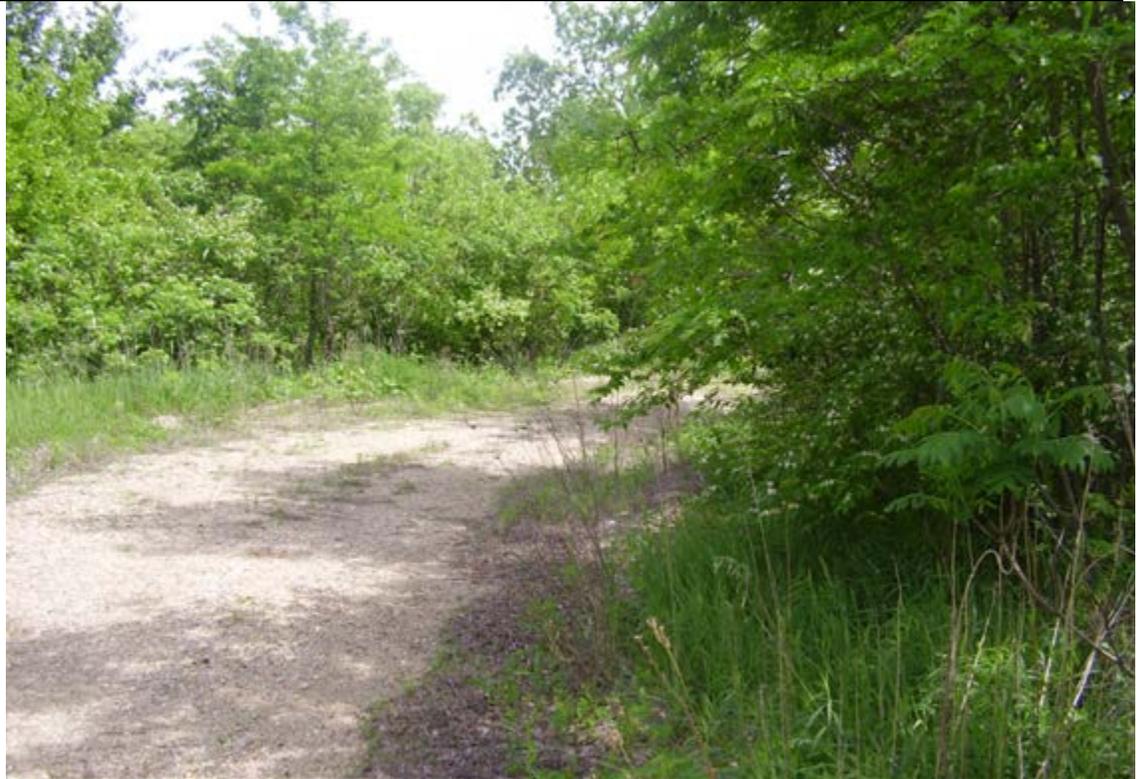
Photo No.
30

Crest of the 1978
embankment and
downstream slope of the
1995 embankment near Pond
2E.

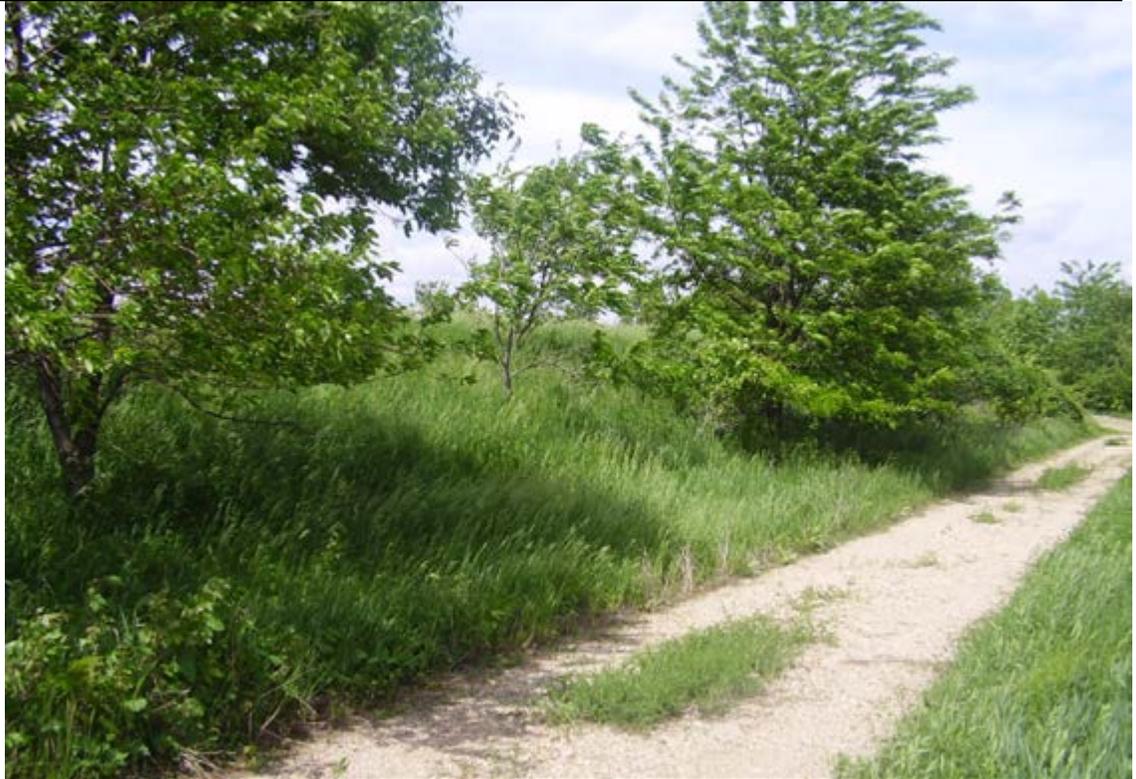
Photo No.
32

Description:
Downstream slope of Pond
2E along crest of the 1978
embankment.

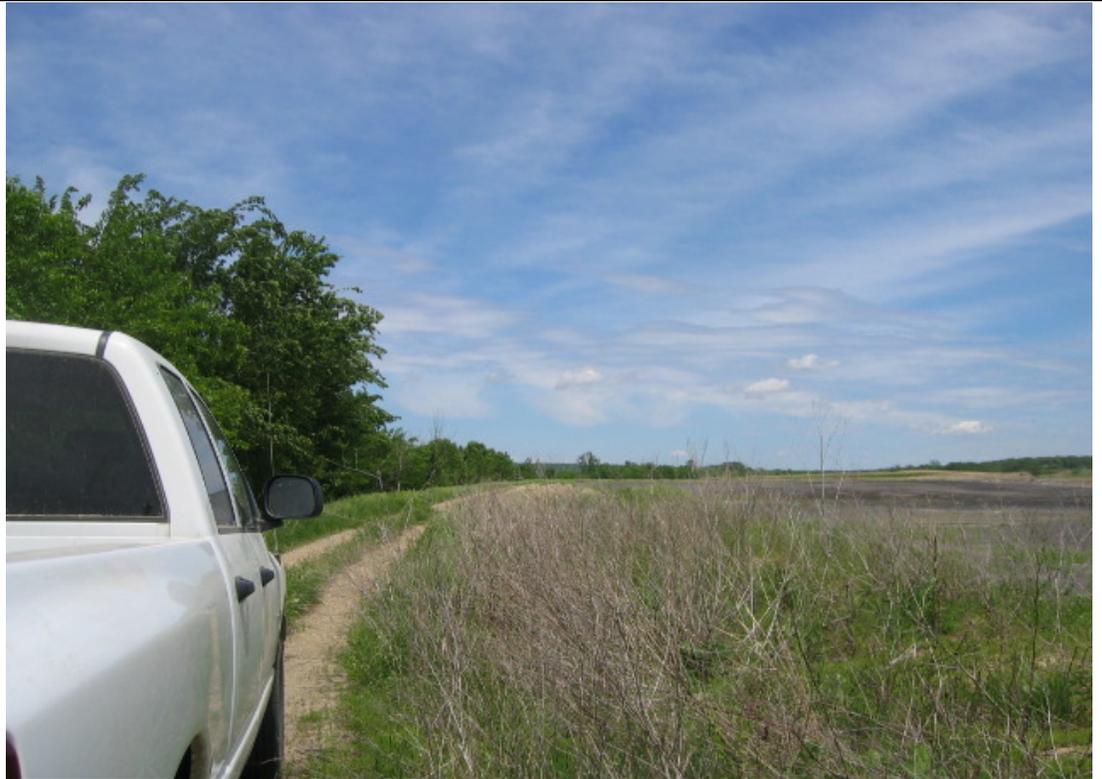
Photo No.
34

Description:
Crest and upstream slope of
the EAPS.

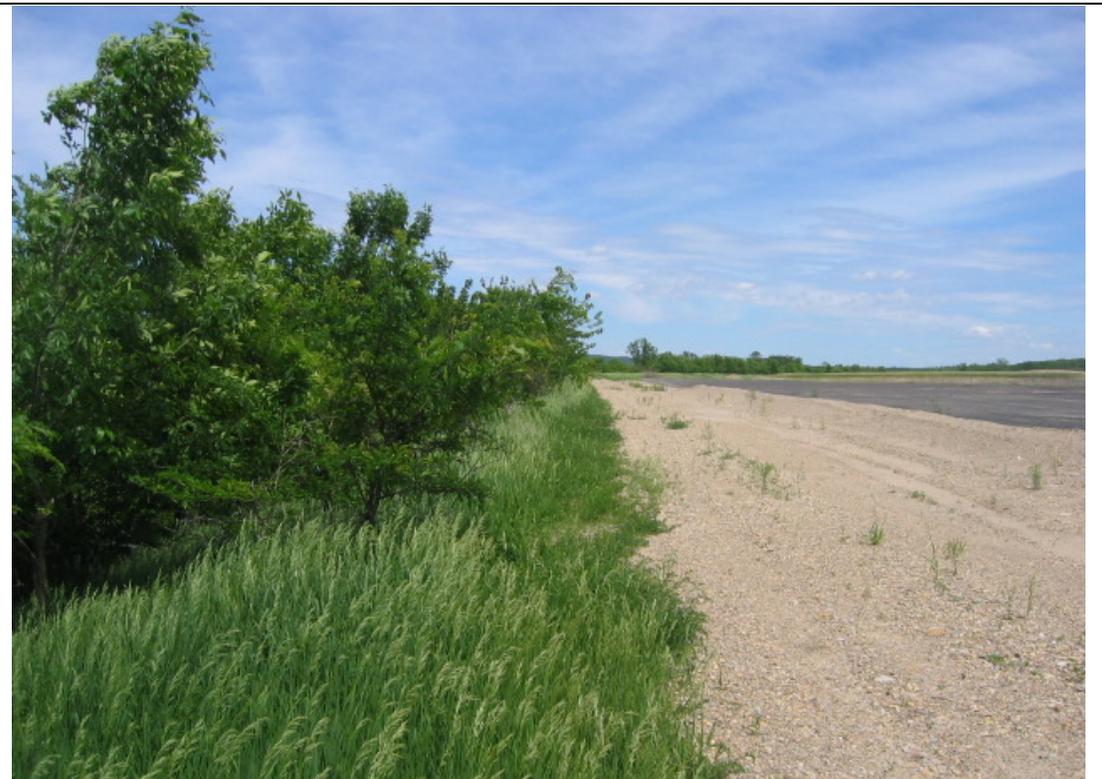
Description:
Crest and upstream slope of
the EAPS.

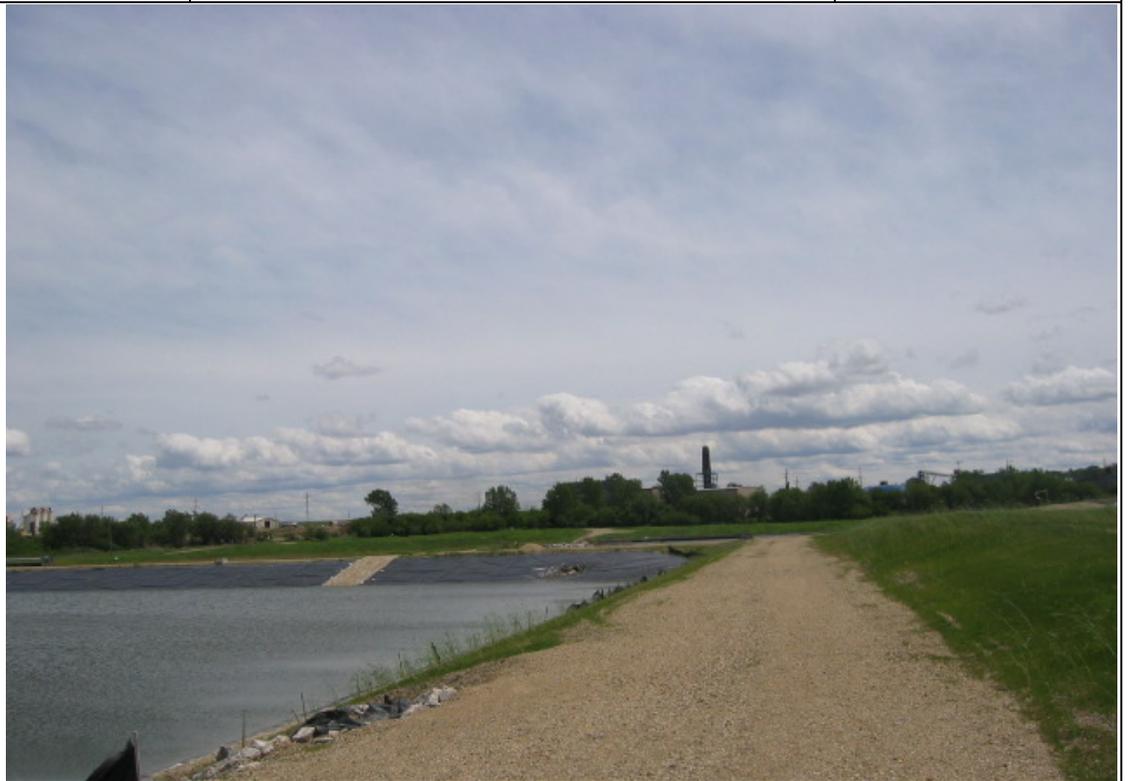
Crest of embankment
between the EAPS and Pond
2E.

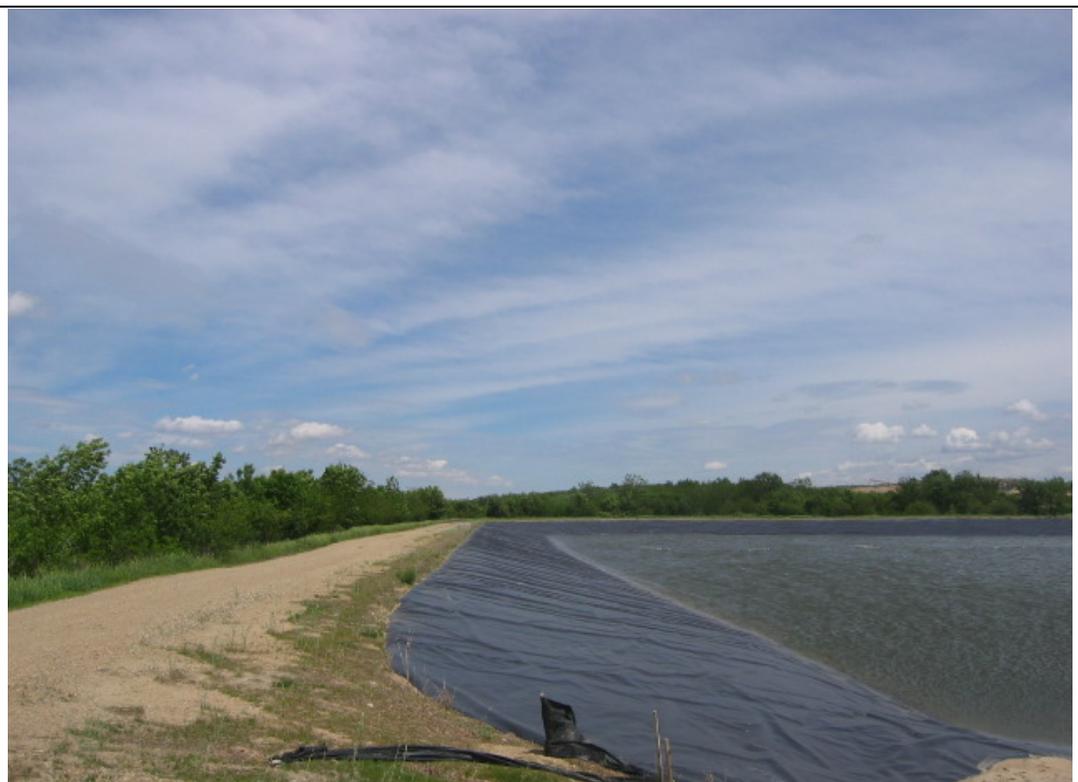
Photo No.
36

Crest and upstream slope of
Pond 2E.

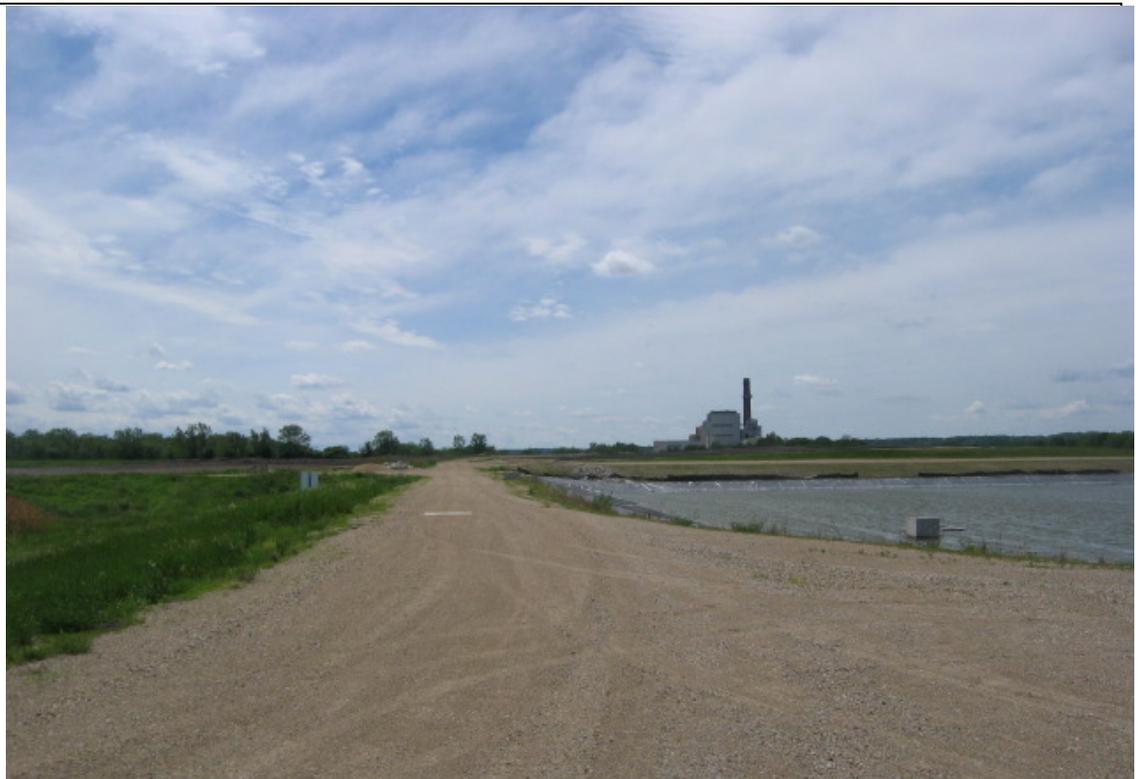
Photo No.
38

Description:
Crest of the embankment
between Pond 2E and
Secondary Cell.

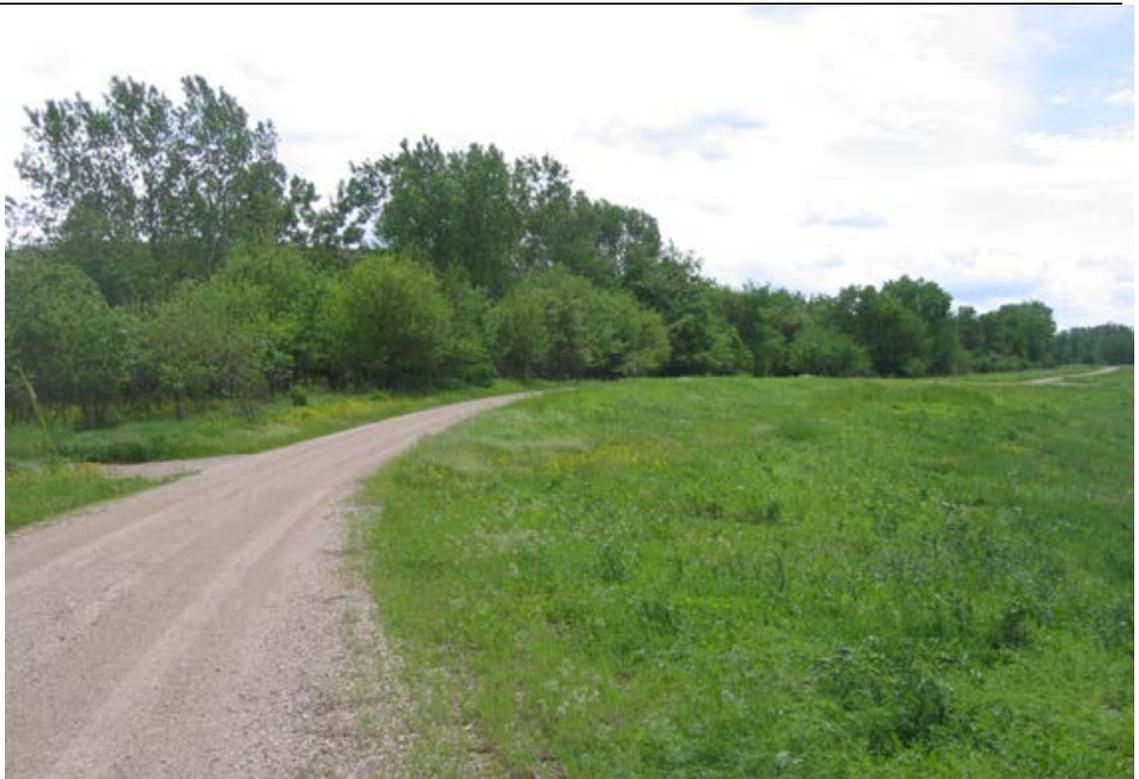
Photo No.
40

Description:
Crest and upstream slope of
the Secondary Cell.

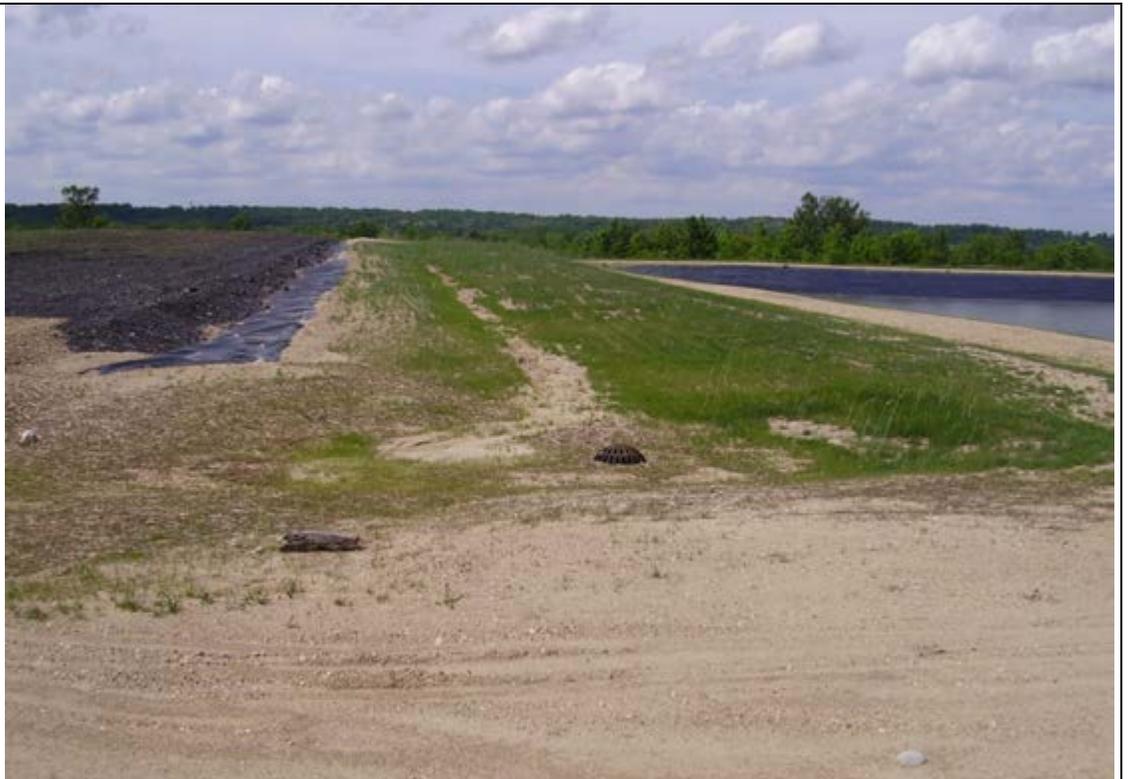
Photo No.
44

The EAPS no longer functions as an active ash impoundment and no CCW sluice piping is present. Storm water drains have been installed along portions of the perimeter of the permitted landfill as shown in Photo 44. The drains appeared to be in good condition at the time of our assessment.

Upstream slope of the EAPS.

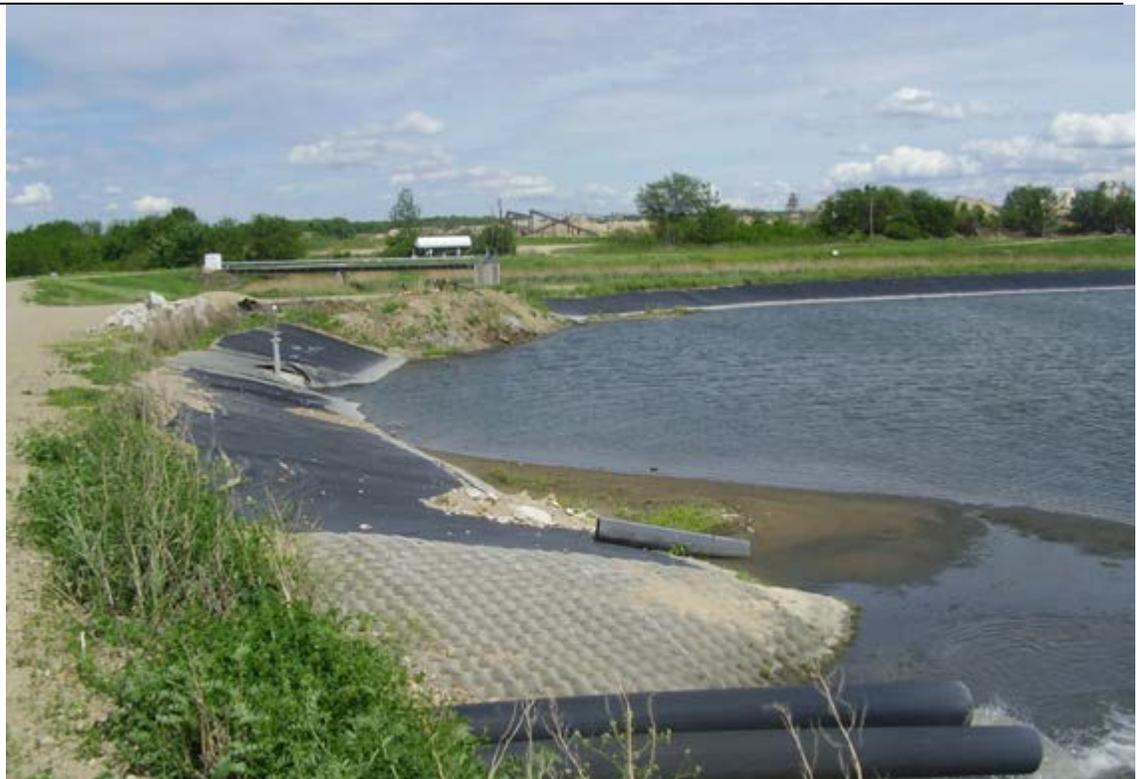
Photo No.
46

Description:
Upstream slope of the
Primary Cell.

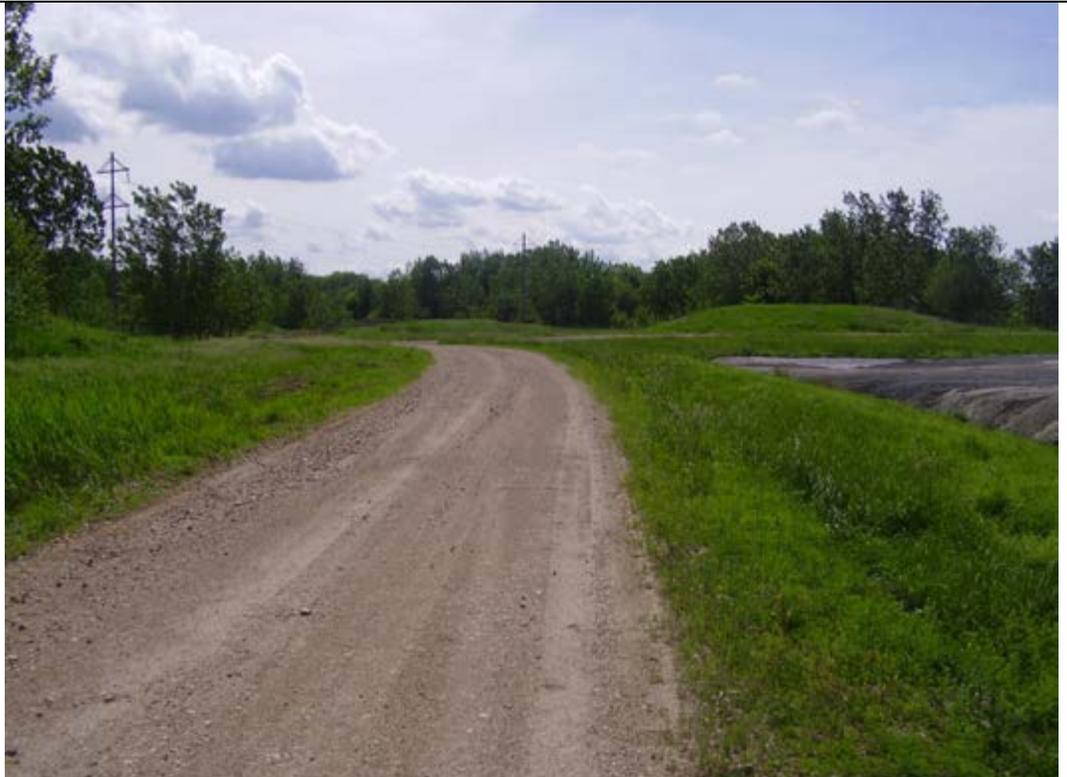
Photo No.
50

Description:
Crest and upstream slope of
the Primary Cell.

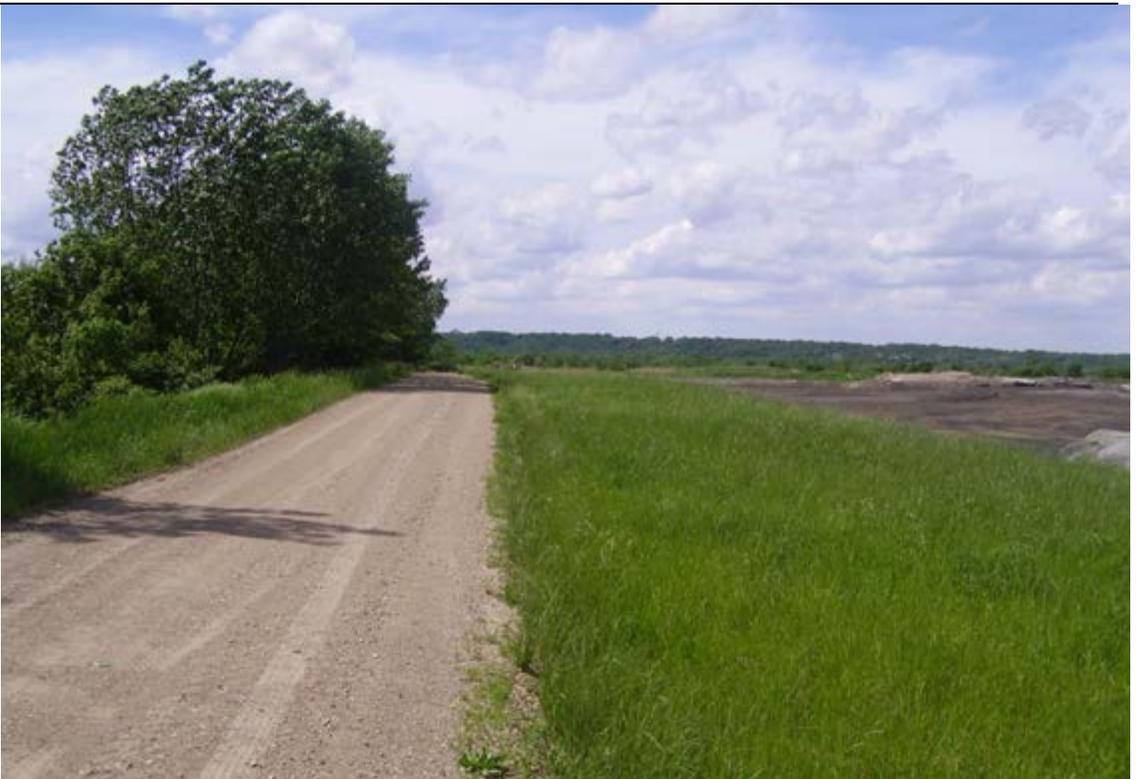
Photo No.
52

Description:
Crest and upstream slope of
the Primary Cell.

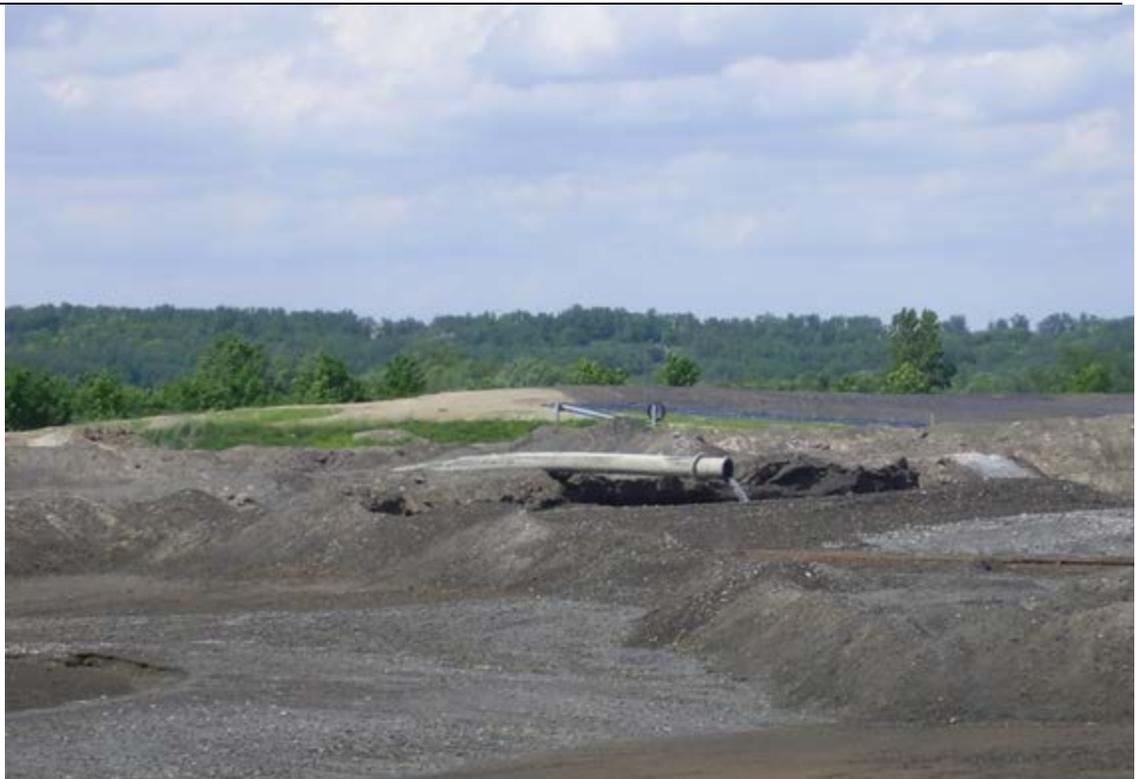
Photo No.
58

Description:
Discharge pipe into the
northwest portion of the
Primary Cell.

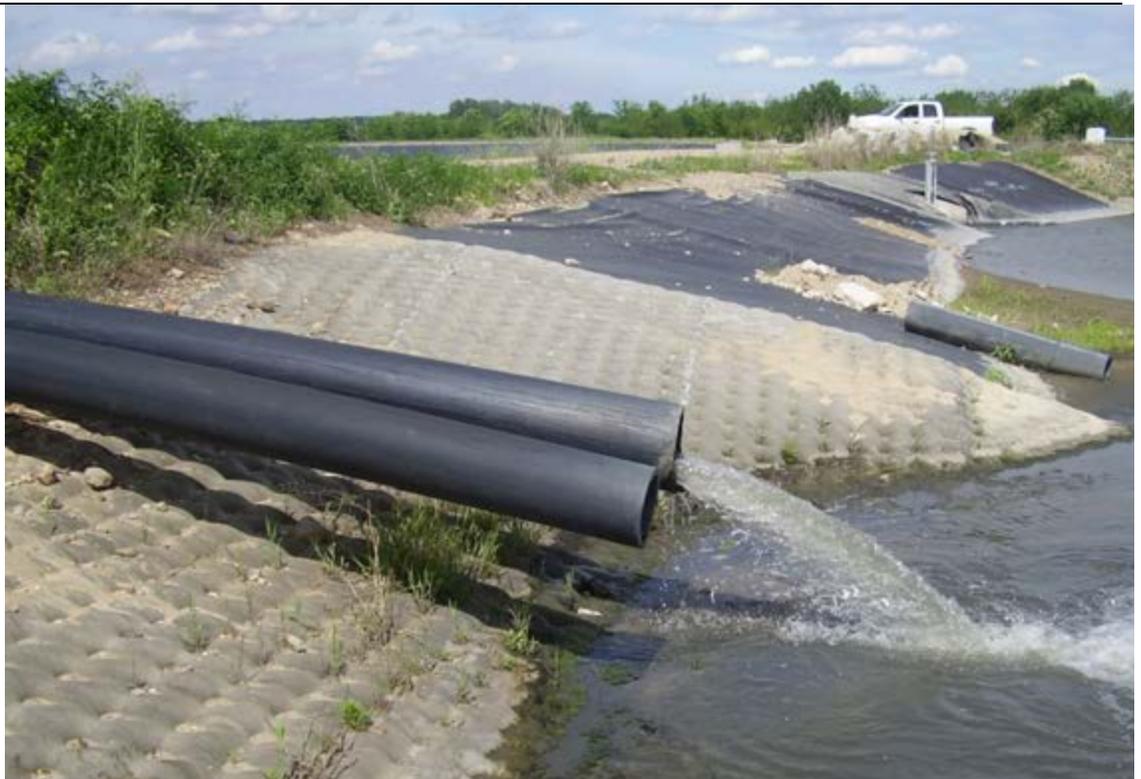
Photo No.
60

Description:
Discharge pipe into the
Primary Cell near the
northeast corner.
