**FINAL REPORT
ROUND 10 DAM ASSESSMENT
DYNEGY MIDWEST GENERATION, LLC – HENNEPIN POWER STATION
ACTIVE EAST ASH POND SYSTEM, EAST ASH POND SYSTEM, WEST ASH POND
SYSTEM
HENNEPIN, ILLINOIS**

December 6, 2012
GZA File No. 170142.30

RE: FINAL Assessment of Dam Safety of Coal Combustion Surface Impoundments at the
Hennepin Power Station

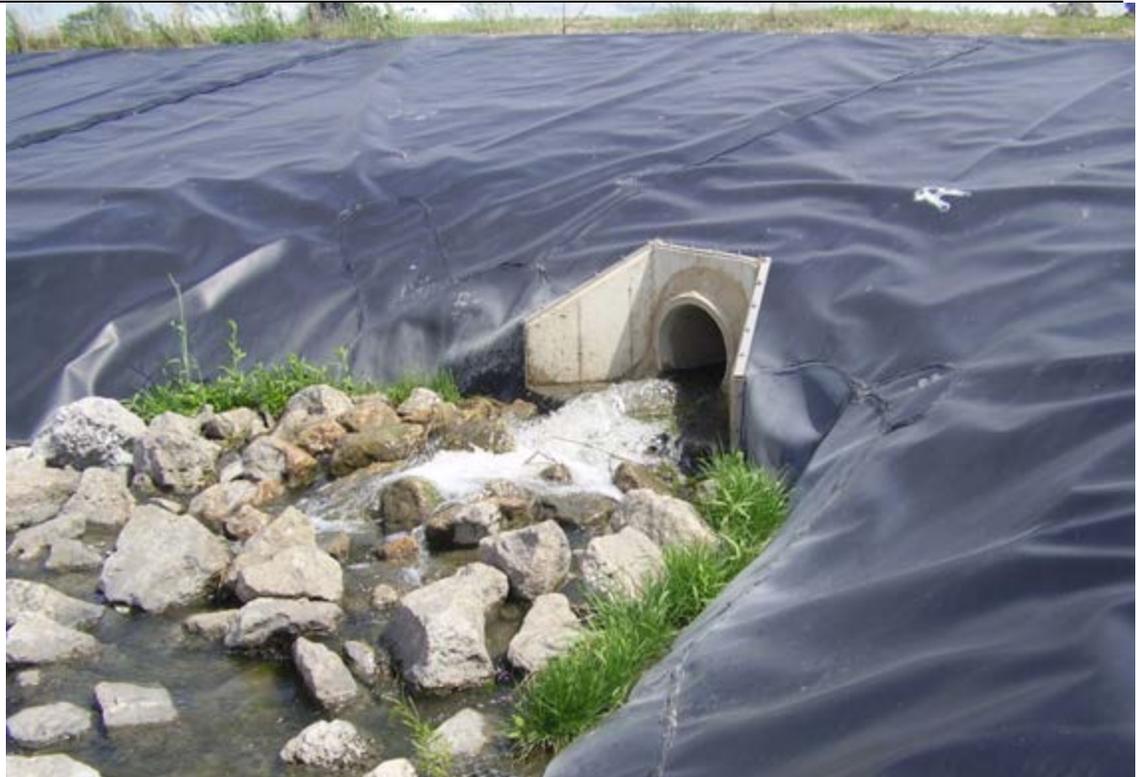
Photo No.
62

Description:
Discharge pipe from the
Primary Cell to Pond 2E.

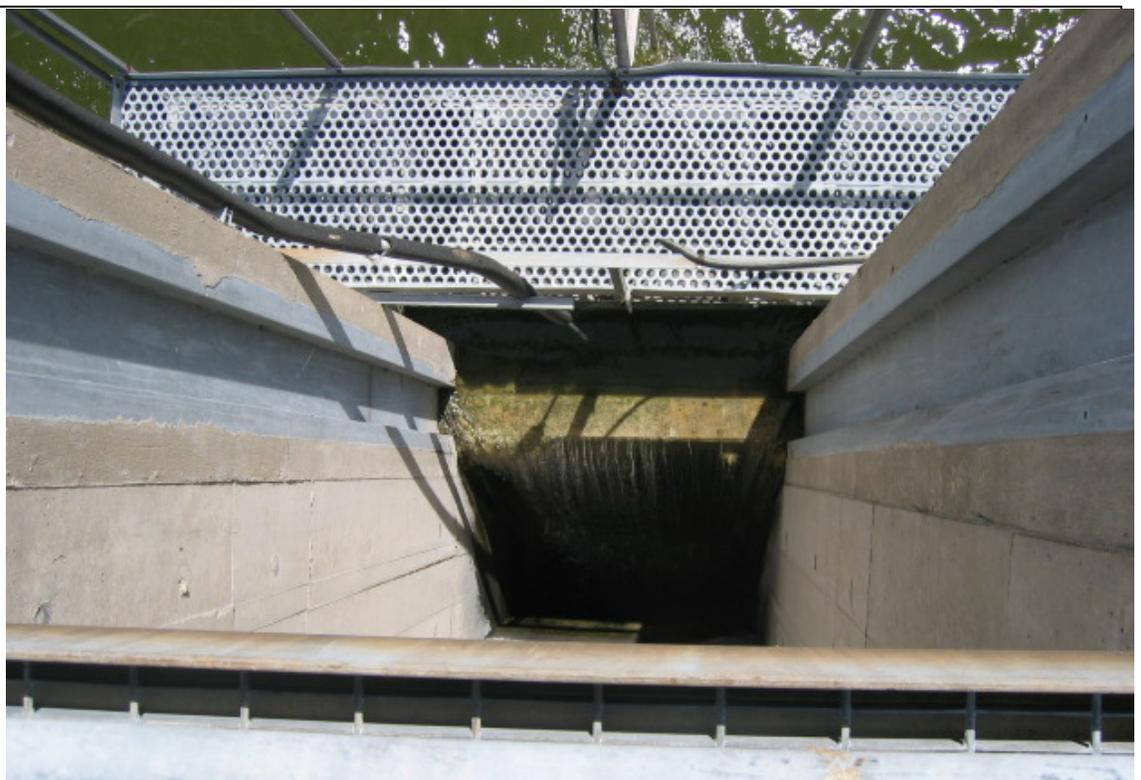
Photo No.
64

Description:
Decant structure in the
Secondary Cell.

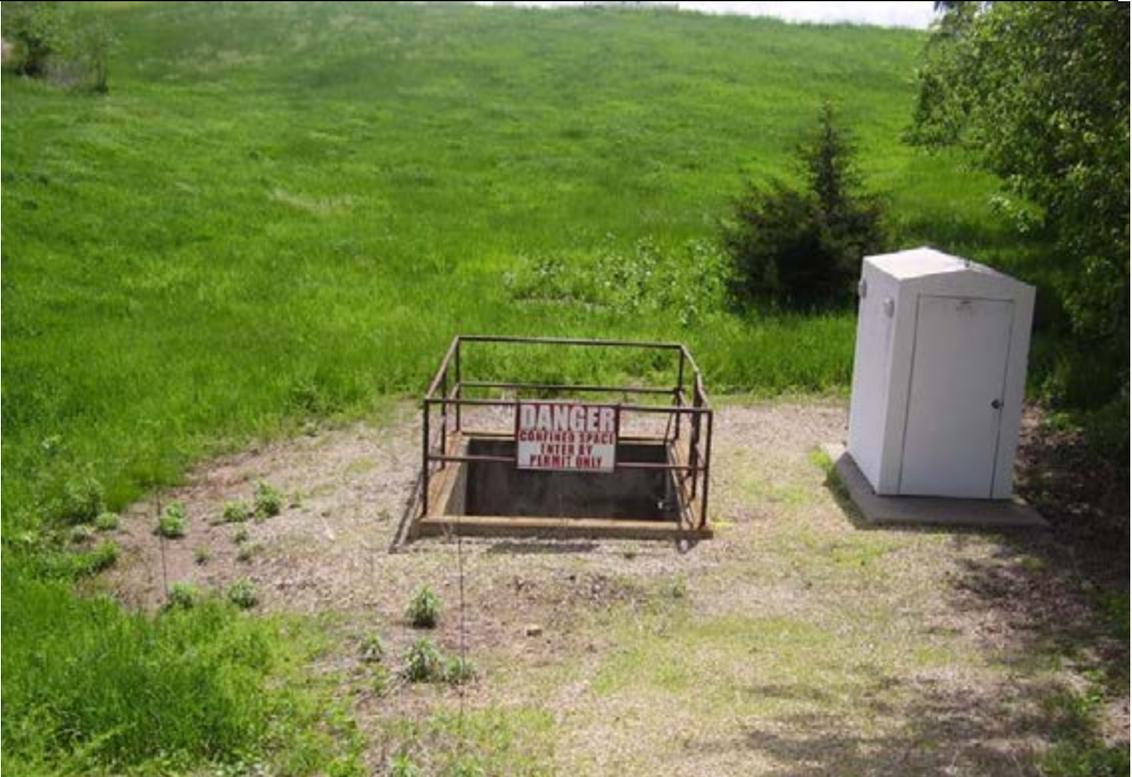
Photo No. 65	Date: 5/23/11
Direction Photo Taken: Southwest

Description:
Surface features of the flume structure in the discharge line from the Secondary Cell to the Illinois River.

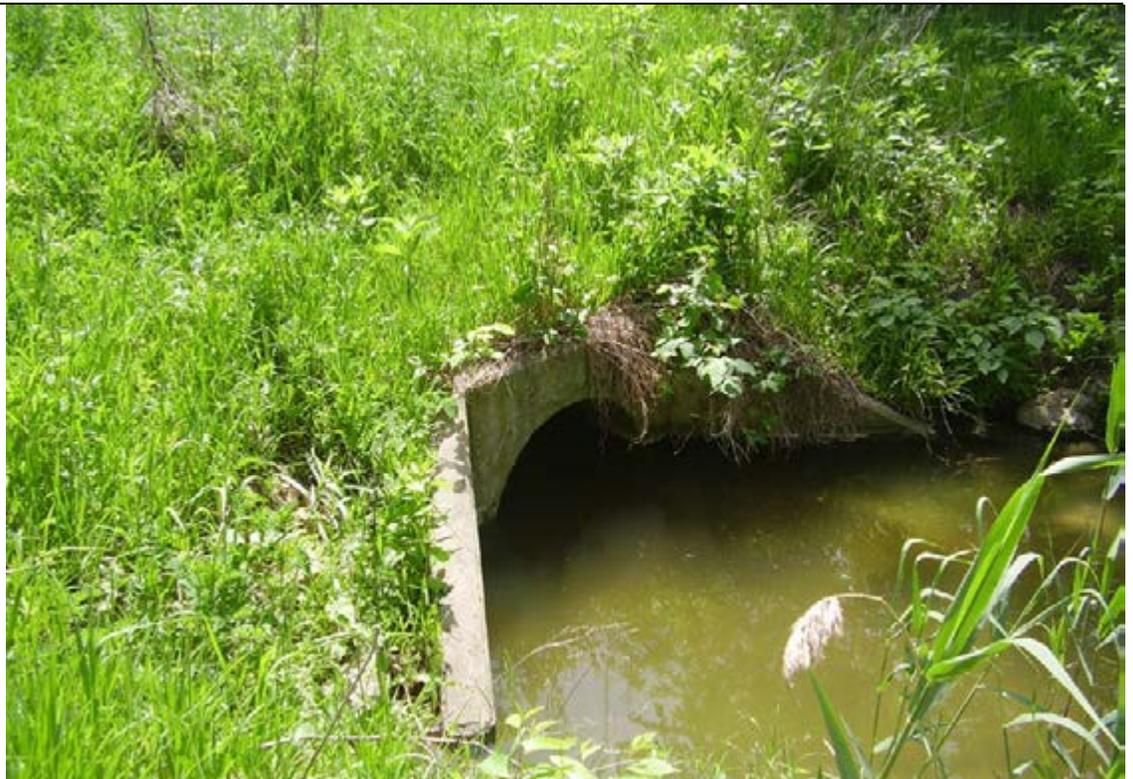
Photo No.
68

Outfall at the Illinois River.

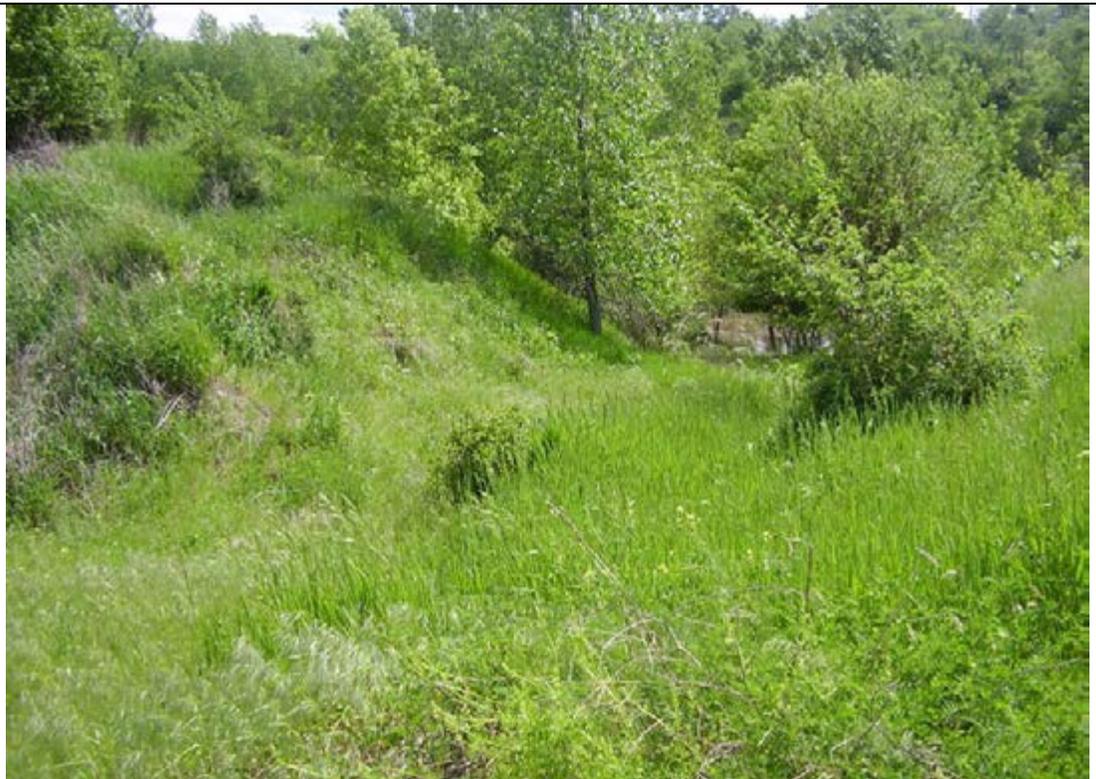
Photo No.
70

Description:
Downstream slope of the
EAPS near Pond 4.

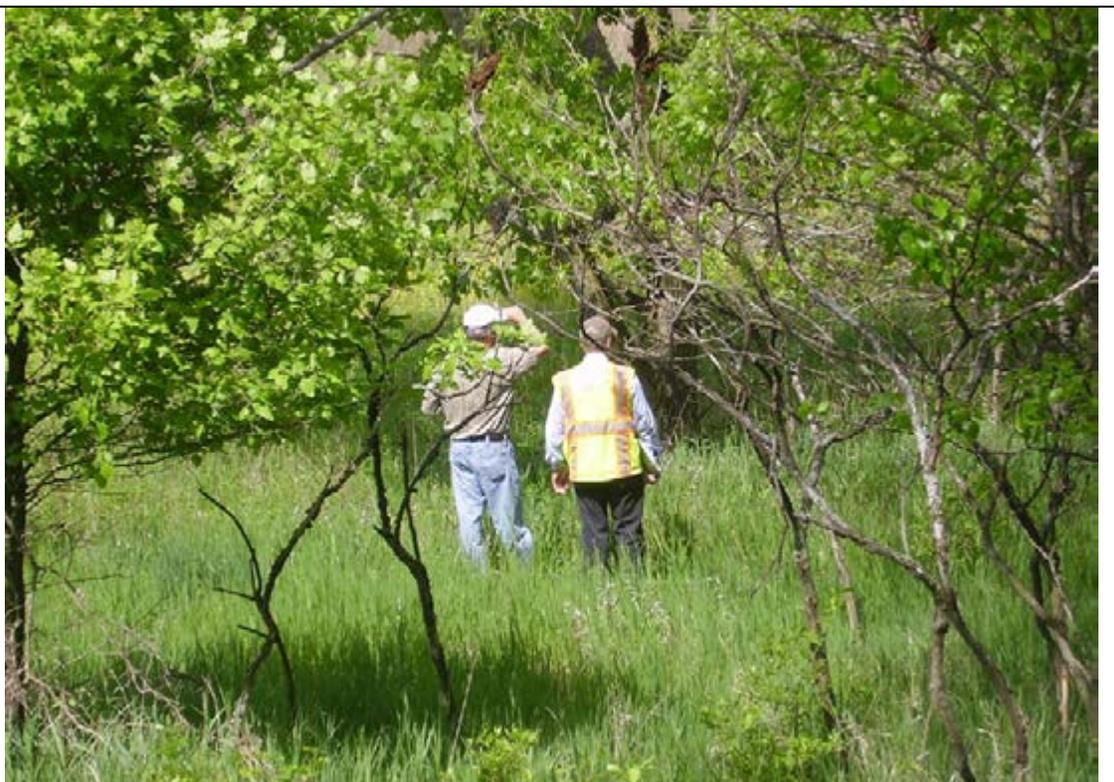
Photo No.
74

Description:
Crest of the EAPS near Pond
4.
