Report of Geotechnical Investigation
Dam Safety Assessment of Coal Combustion
Surface Impoundments
East Kentucky Power Cooperative
William C. Dale Power Station, Winchester, KY

AMEC Project No. 3-2106-0177.0001

September 2010

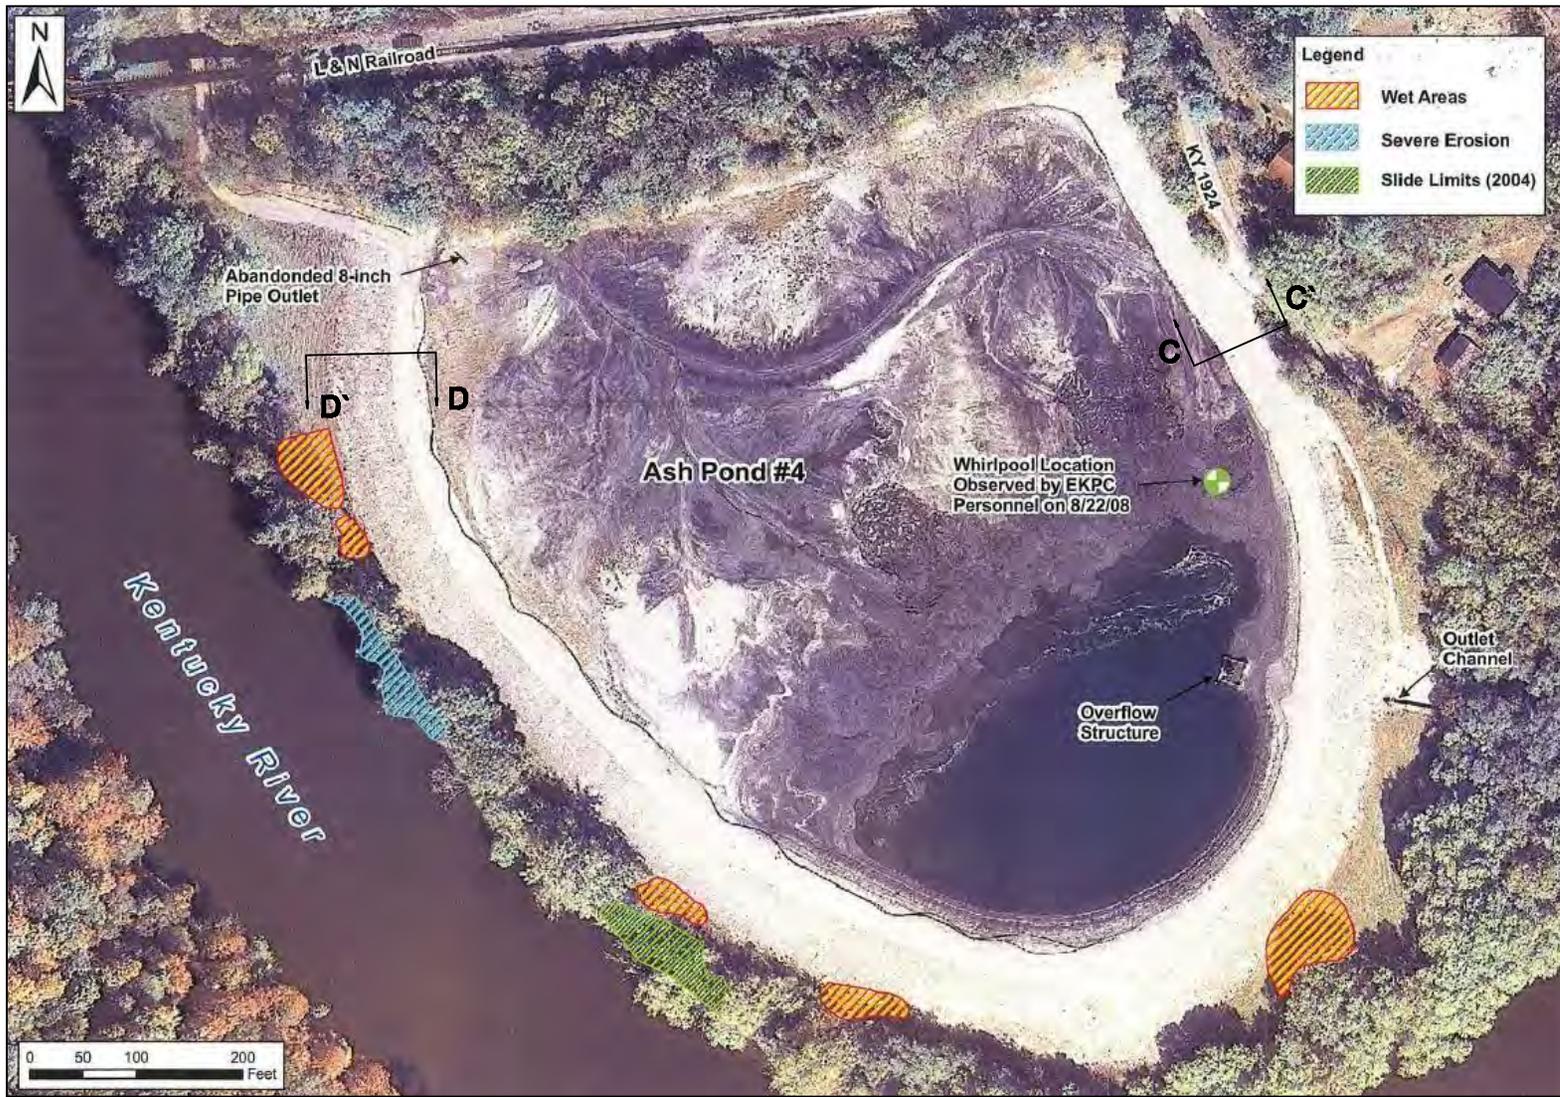
REV. NO.: A
 DATE: 8/31/10
 PROJECT NO.: 3-2106-0177-0001
 FIGURE No. 10

Figure 10 provides a plan view of Ash Pond 4 that illustrates the location of the critical observations described above, as well as the location of two embankment cross sections that were surveyed during Stantec’s site visit. The two cross sections, labeled C-C” and D-D”, are illustrated on Figure 11. These figures were originally provided by Stantec in their 2009 Inspection Report (DS CBI 000069-000120).

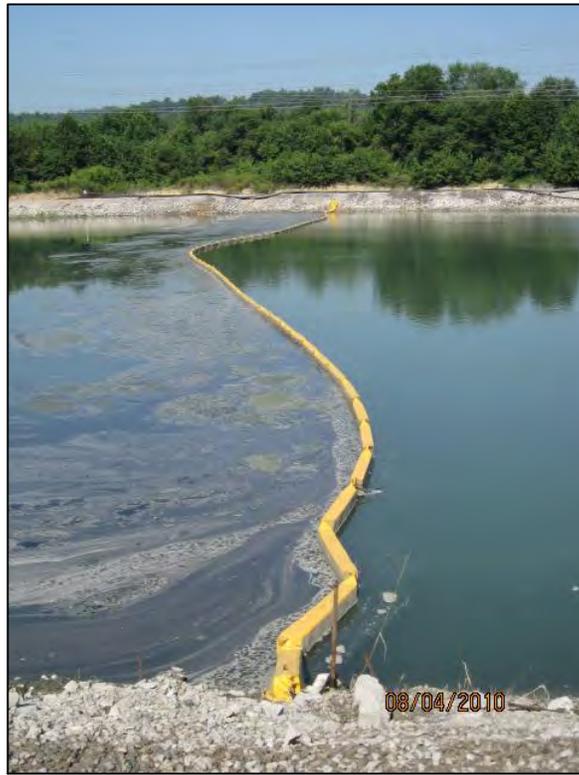
2-7

LOOKING WEST FROM EAST DIKE AT BOOMS ACTING AS SKIMMER

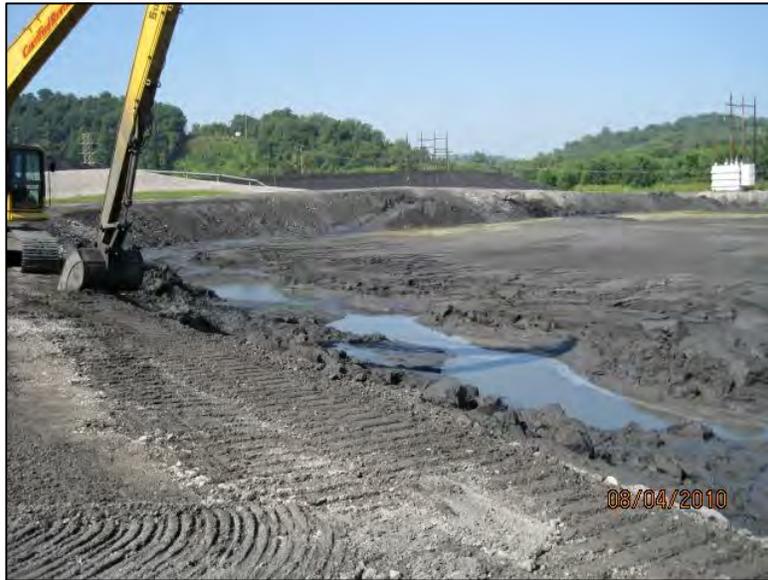
2-8

FROM EASTERN BANK LOOKING SOUTHWEST AT SOUTHERN CREST AND UPSTREAM SLOPE, COAL PILE IN BACKGROUND

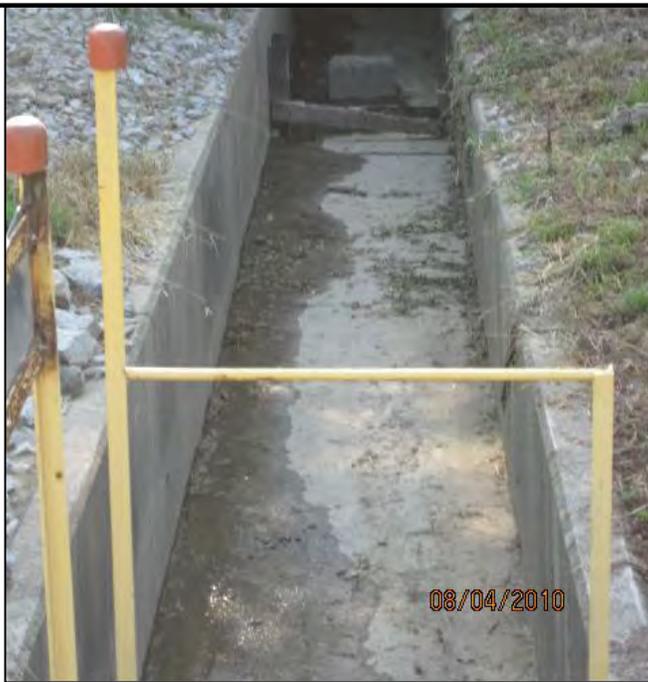
4-5

CONCRETE DISCHARGE CHANNEL AWAY FROM SOUTHEAST SLOPE

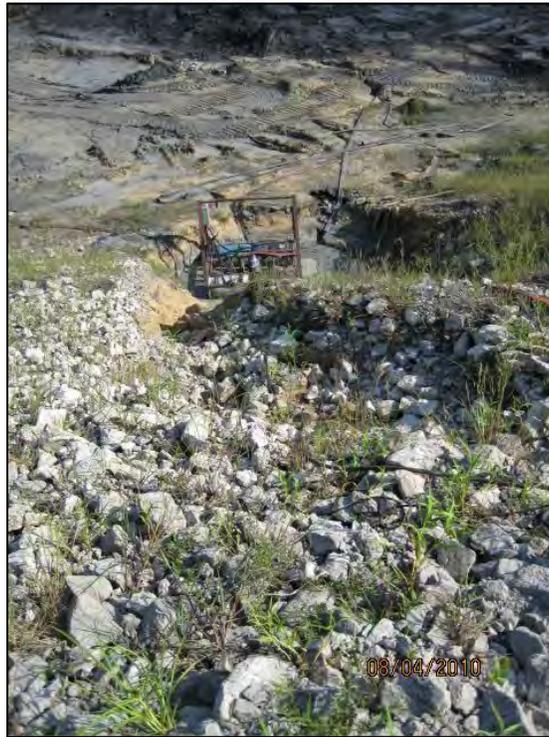
4-13

**PUMP UTILIZED DURING LOWERING OF PHREATIC SURFACE,
EXCAVATED SUMP AND EROSION GULLEYS ON UPSTREAM SLOPE**

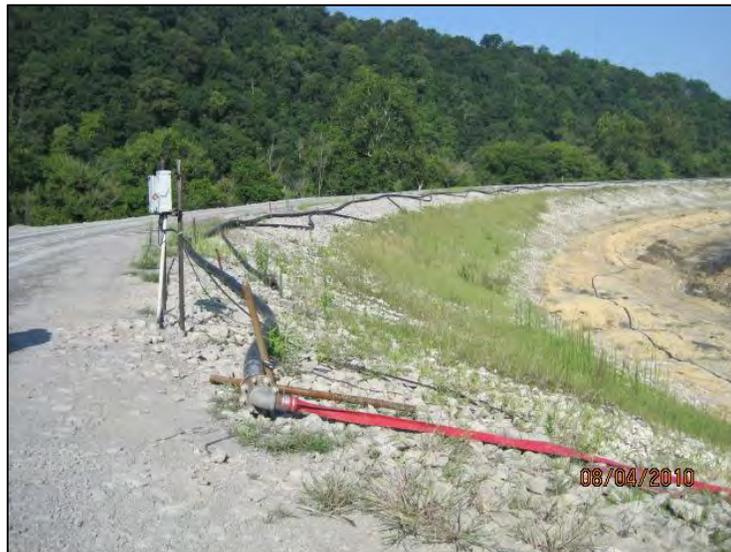
4-14

**LOOKING WEST FROM SOUTH DIKE AT CREST, UPSTREAM SLOPES AND HDPE PIPES USED
TO TRANSPORT CCW TO POND #2**
