Report of
Dam Safety Assessment of Coal Combustion Surface
Impoundments

East Kentucky Power Cooperative
William C. Dale Power Station, Winchester, KY

AMEC Project No. 3-2106-0177.0001

April 2011

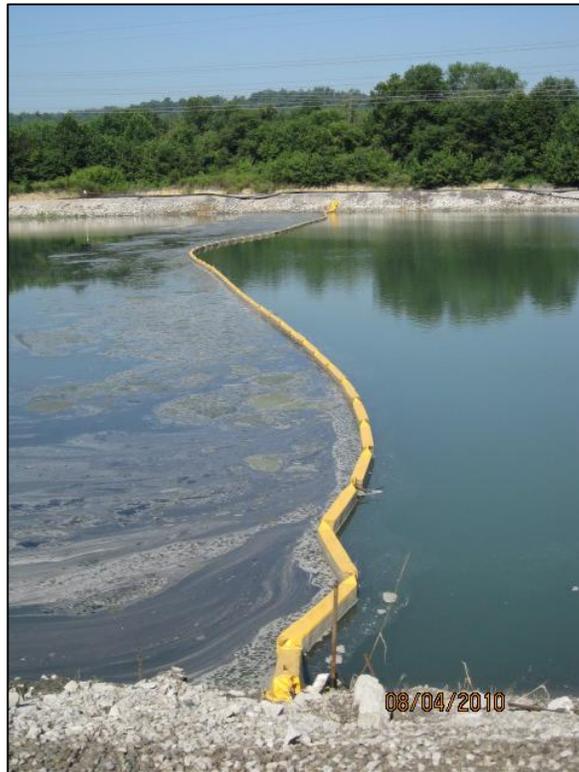
2-7

LOOKING WEST FROM EAST DIKE AT BOOMS ACTING AS SKIMMER

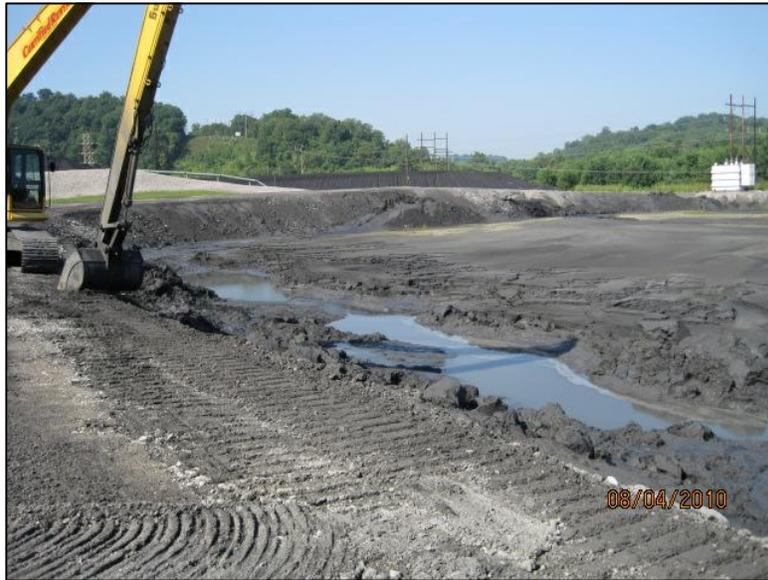
2-8

FROM EASTERN BANK LOOKING SOUTHWEST AT SOUTHERN CREST AND UPSTREAM SLOPE, COAL PILE IN BACKGROUND

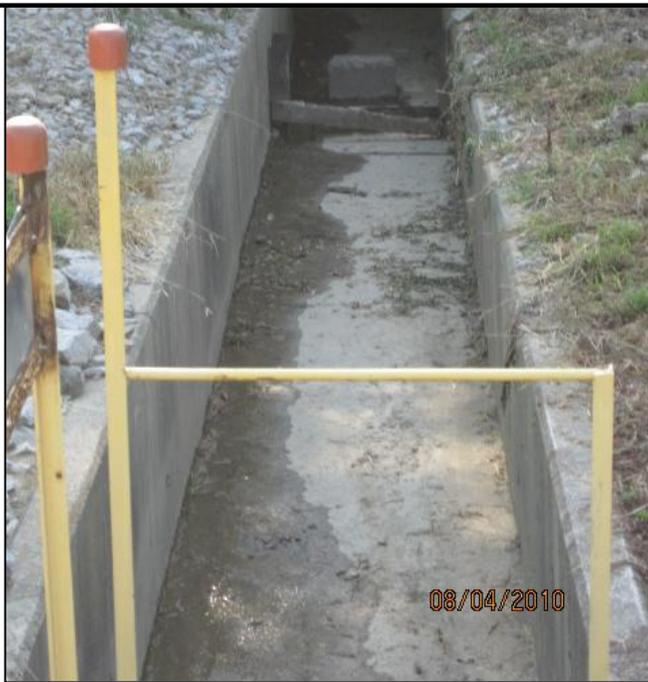
4-5

CONCRETE DISCHARGE CHANNEL AWAY FROM SOUTHEAST SLOPE

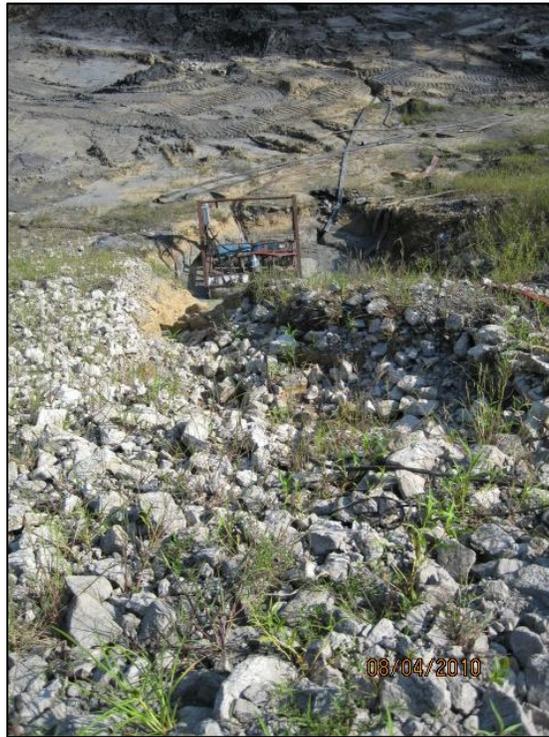
4-13

**PUMP UTILIZED DURING LOWERING OF PHREATIC SURFACE,
EXCAVATED SUMP AND EROSION GULLEYS ON UPSTREAM SLOPE**

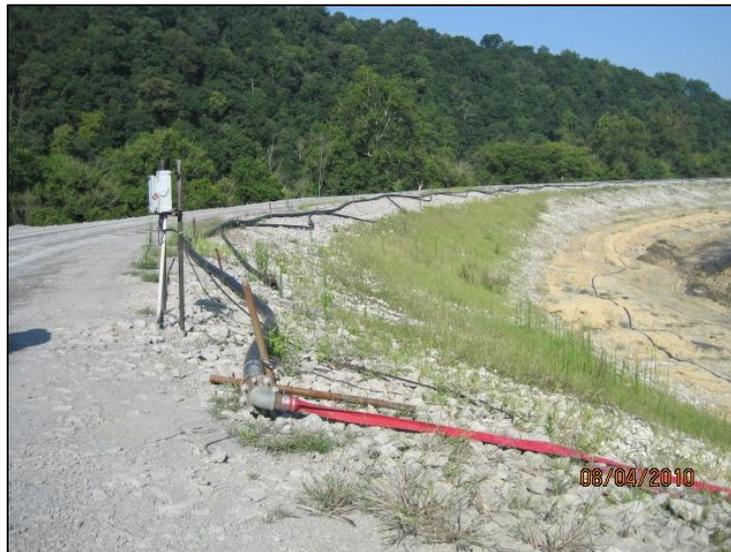
4-14

**LOOKING WEST FROM SOUTH DIKE AT CREST, UPSTREAM SLOPES AND HDPE PIPES USED
TO TRANSPORT CCW TO POND #2**
