**Coal Combustion Residue Impoundment
Round 9 - Dam Assessment Report**

H.L. Spurlock Power Station
Spurlock Ash Pond
East Kentucky Power Cooperative
Maysville, Kentucky

Dewberry & Davis, LLC
Fairfax, Virginia

Under Contract Number: EP-09W001727
March 2011

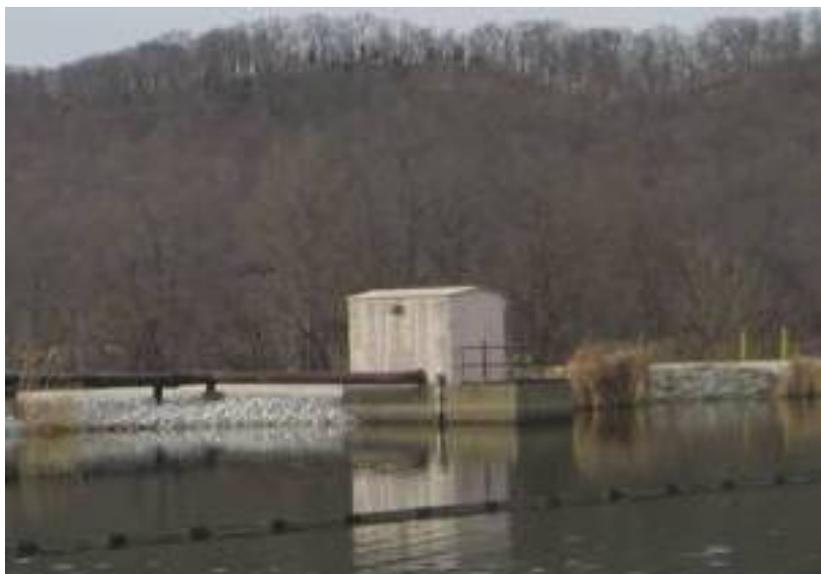
Note also that there is no emergency spillway, the water level within the pond is maintained using an ash water transfer pump station capable of discharging at a rate of 4800 gpm (See Appendix C, Photo 01). An engineering study was conducted in July 2010, referenced in Appendix A, Doc. 06, to evaluate risks of the 100-year rain event and freeboard requirement. Based on the study results it was recommended that the water surface elevation not exceed an elevation of 526.7. This would provide the recommended one (1) foot freeboard and storage for a 6-hour, 100-year rain event, and-compensate for the lack of an emergency spillway-protect against pump failure, and/or other contingencies that would further increase the potential for overtopping the dikes.

Photo 01: Ash Water Transfer Pump Station
H.L. Spurlock Power Station Ash Pond; February 15, 2011

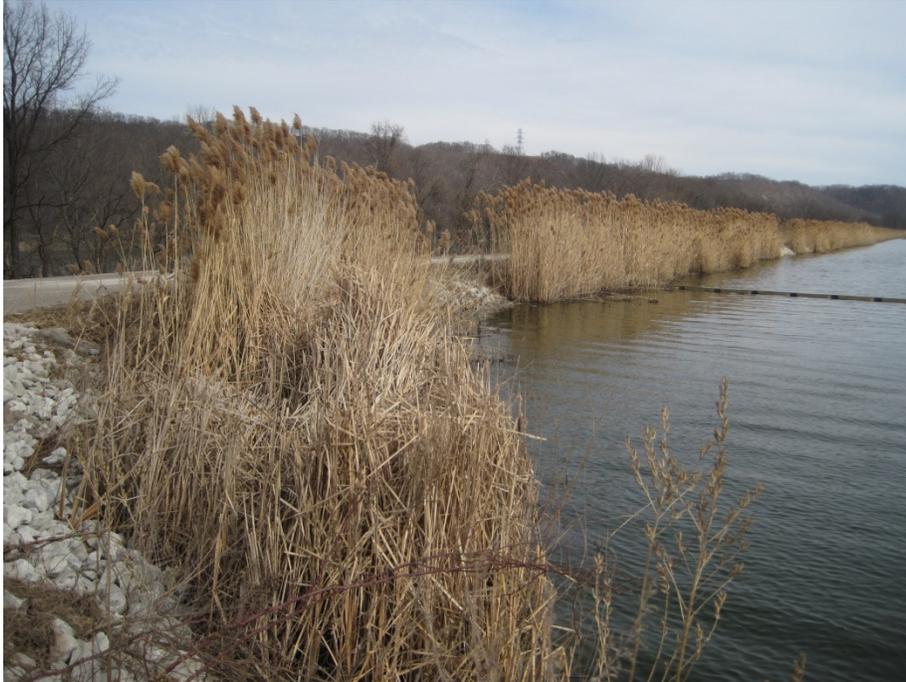
The visible parts of the embankment dikes and outlet structure (pump station) were observed to have no signs of overstress, significant settlement, shear failure, or other signs of instability. However, visual observations of the floodside embankments were restricted by the presence of thick vegetation, specifically phragmites, in some areas (See Appendix C, Photos 02 and 03).

As mentioned in Section 1.1.5, current grades of the interior slopes could not be verified because large segments of the interior embankment were covered by excessive vegetation, specifically tall phragmites (See Appendix C, Photos 02 and 03). The portion of embankment visually available indicated that the slopes were protected against erosion due to wind, water, and wave action by a layer of 18" thick riprap, and experiencing no erosion (See Appendix C, Photos 26 and 27).

Photo 03: Phragmites Along Inside perimeter of Ash Pond (2 of 2)
H.L. Spurlock Power Station Ash Pond; February 15, 2011

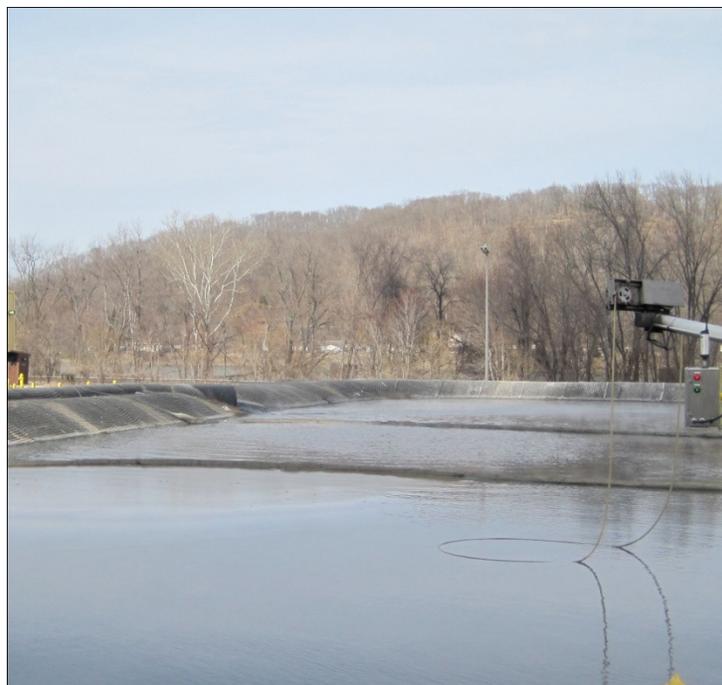
The water atop the settled bottom ash within the Pond (See Appendix C, Photo 20) is pumped to the Primary Lagoon and Secondary Lagoon (See Appendix C, Photos 06 and 07, respectively), where additional settling occurs. From the Secondary Lagoon the water is either pumped back to the bottom ash sluicing system or discharged through a KPDES permitted outfall, into a ditch that empties into the Ohio River, which runs parallel to the Impoundment's Northern embankment (See Photo 21).

Photo 07: Secondary Lagoon

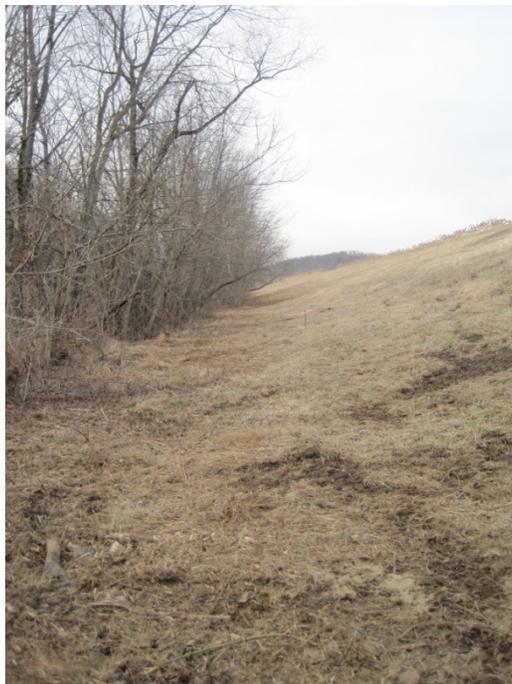
Photo 08: Area Observed Just West of Toe of SE Corner of Outside Embankment

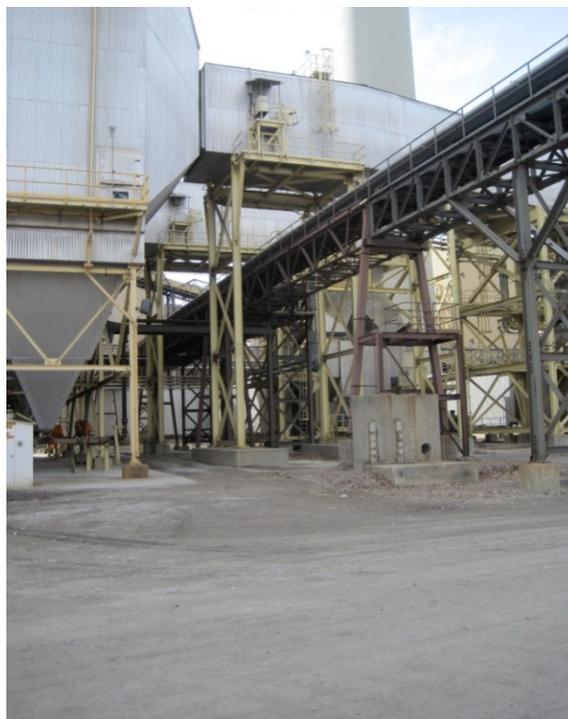
The bottom ash, approximately 20% of the ash component, collects in hoppers at the base of the furnace and is sluiced to the ash pond via 3 transport pipes, as seen in Appendix C, Photos 09 through 13. Additional photos of the bottom ash within the Pond can be found in Appendix C, Photos 17, 18, and 19.

Photo 09: Structural Bridging System Containing Pipes Carrying CCR (Bottom Ash) from Plant to Pond (1 of 2)

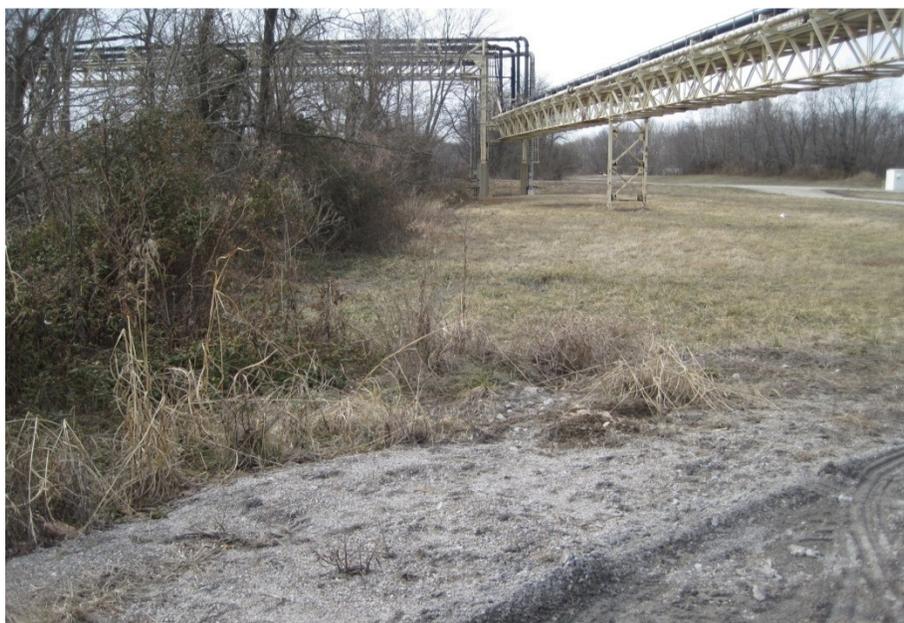
Photo 10: Structural Bridging System Containing Pipes Carrying CCR (Bottom Ash) from Plant to Pond (2 of 2)

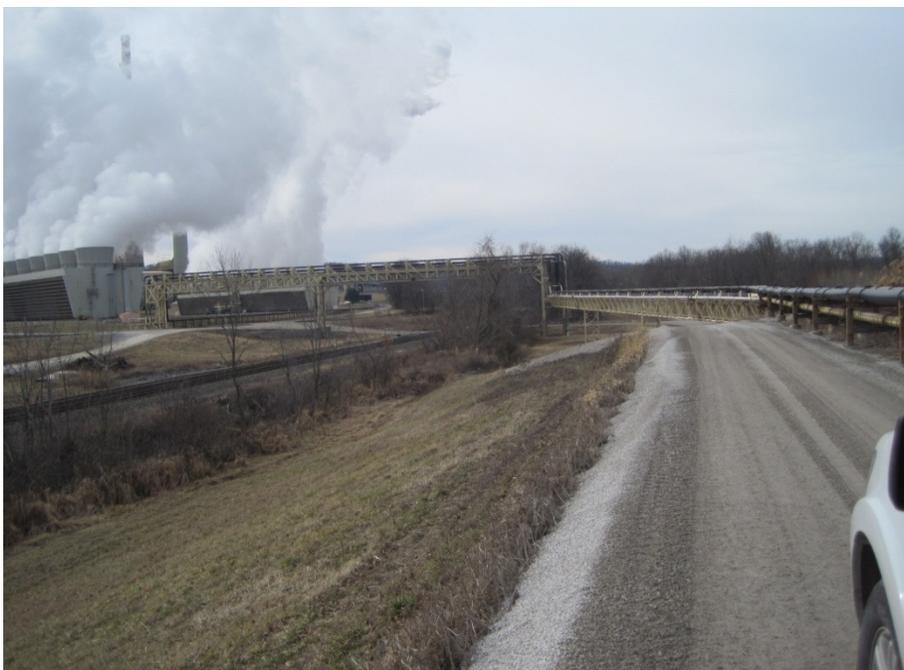
Photo 11: Looking SW Toward Plant from South Crest; Pipes Carrying CCR (Bottom Ash) on the Right

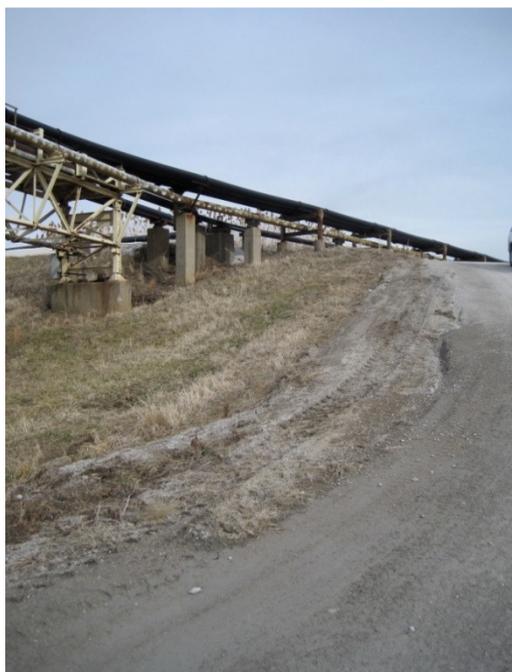
Photo 12: Looking NE from Toe of SW Corner of Outside Embankment; Portal Entry of Pipes Carrying CCR (Bottom Ash)

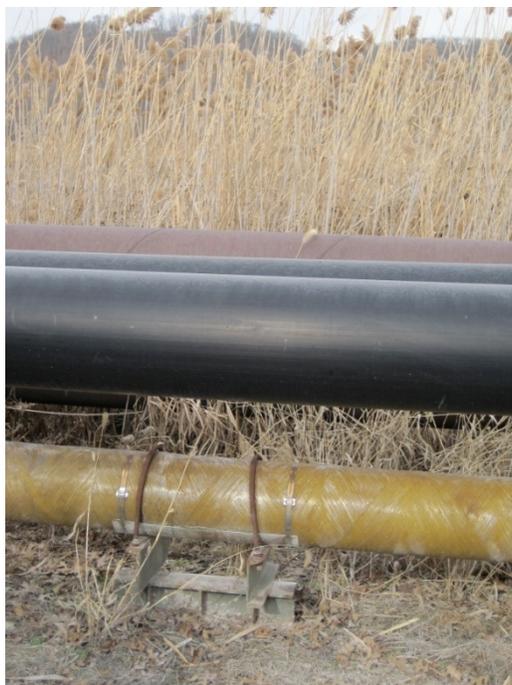
Photo 13: HDPE (Black) Pipes Transporting CCR (Bottom Ash) from the Plant to the Pond; Fiberglass Pipe (Lower) and Metal Pipe (top) are Abandoned
H.L. Spurlock Power Station Ash Pond; February 15, 2011

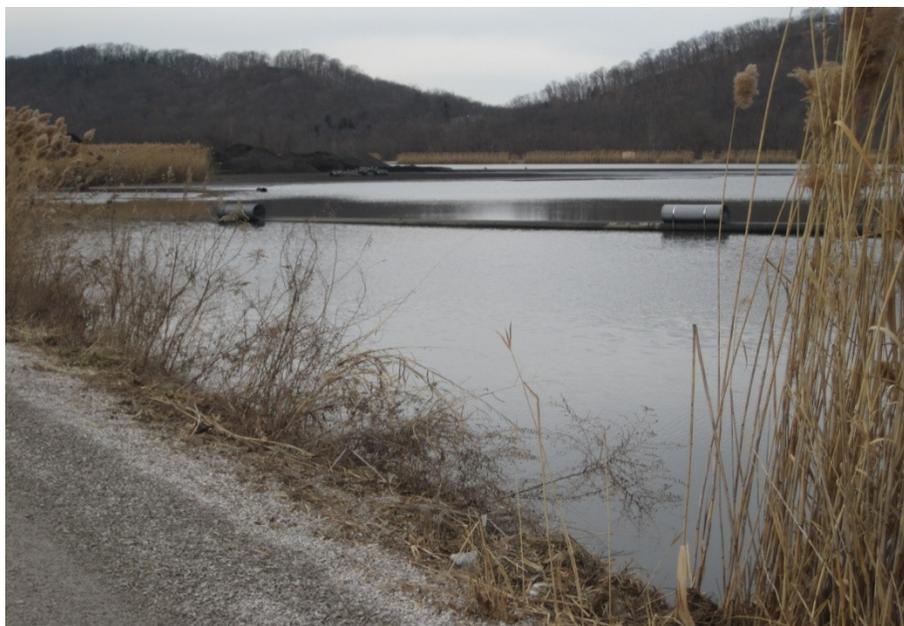
The 3 transport pipes as mentioned in Section 2.2.2 can be adjusted within the pond, resting them atop a series of pipe floaters (See Appendix C, Photos 14 and 15). Being able to relocate the pipes' inlet prevent the piles from growing too large. One of the 3 pipes' inlet to the Pond can be seen in Appendix C, Photo 16, depositing CCR, specifically bottom ash, into the Ash Pond.

Photo 14: Pipe Floaters Within Ash Pond (1 of 2)
H.L. Spurlock Power Station Ash Pond; February 15, 2011

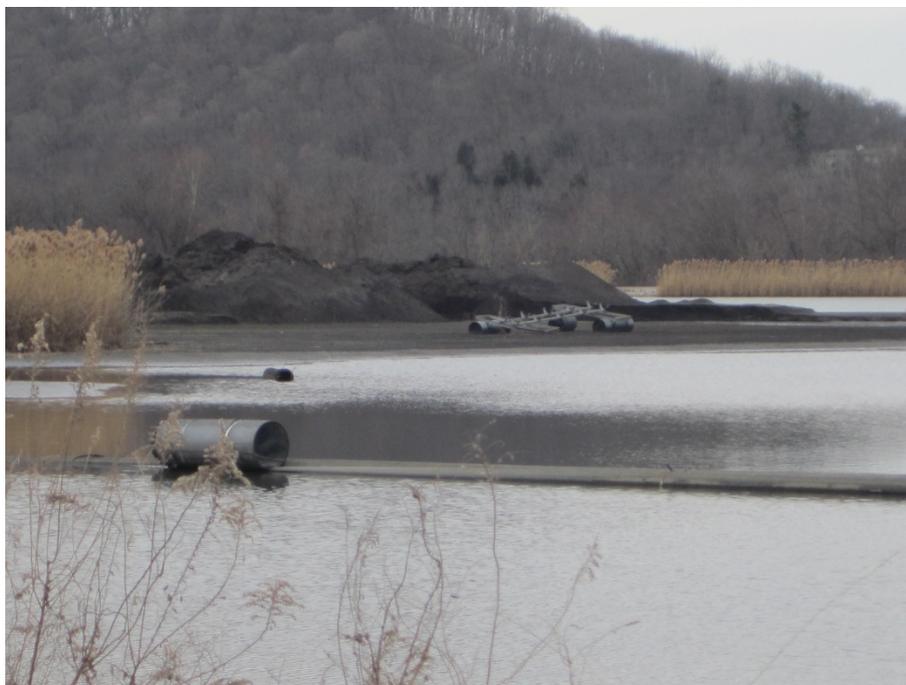
Photo 15: Pipe Floaters within Ash Pond (2 of 2)
H.L. Spurlock Power Station Ash Pond; February 15, 2011

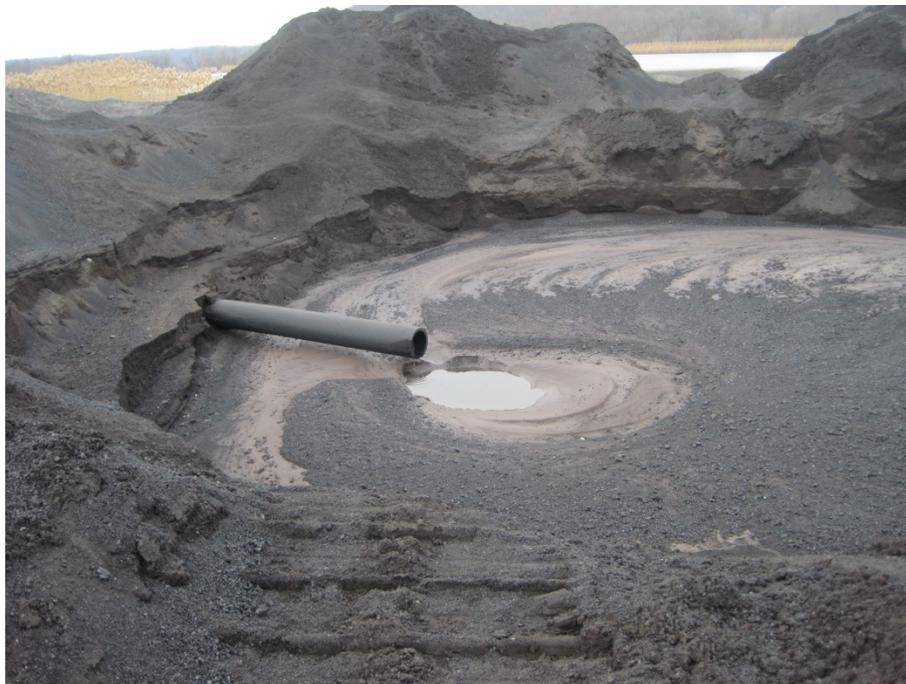
Photo 16: Inlet Pipe Releasing CCR (Bottom Ash) from Plant
H.L. Spurlock Power Station Ash Pond; February 15, 2011

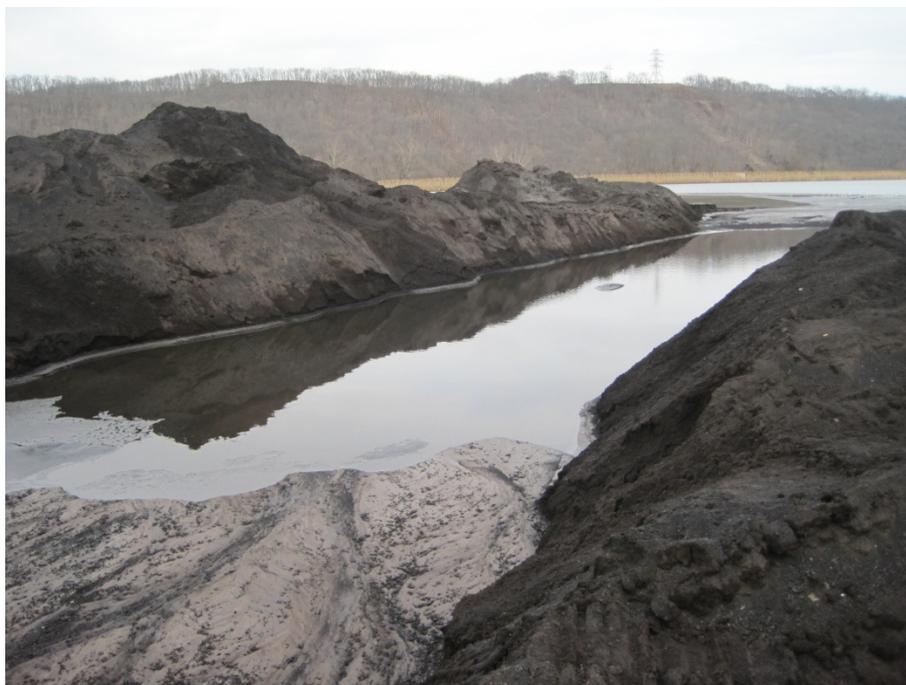
Photo 17: Bottom Ash Stockpiles and Surface Water within Ash Pond
H.L. Spurlock Power Station Ash Pond; February 15, 2011

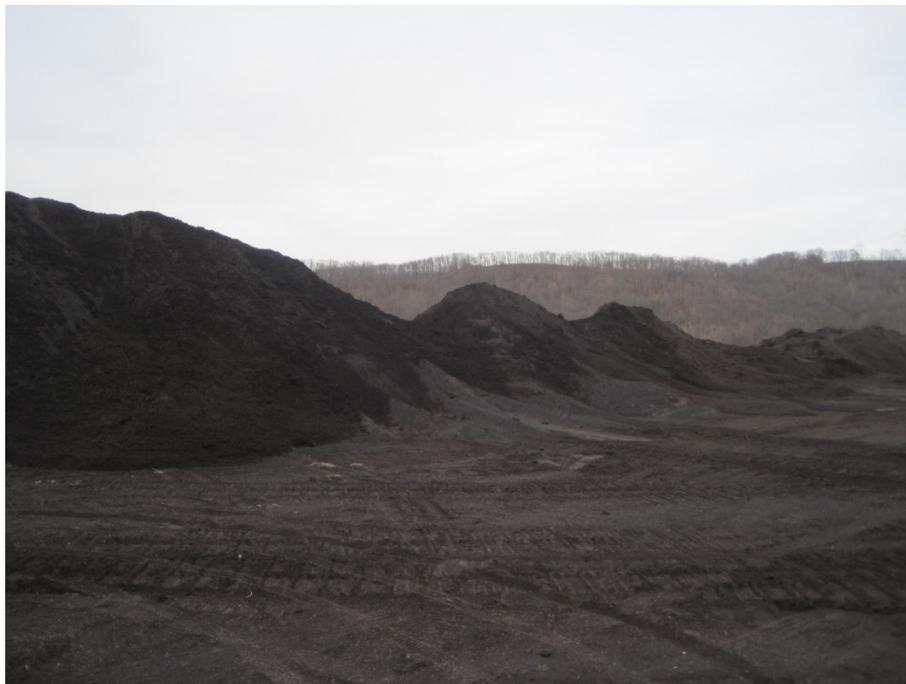
Photo 18: Bottom Ash Stockpiles within Ash Pond
H.L. Spurlock Power Station Ash Pond; February 15, 2011

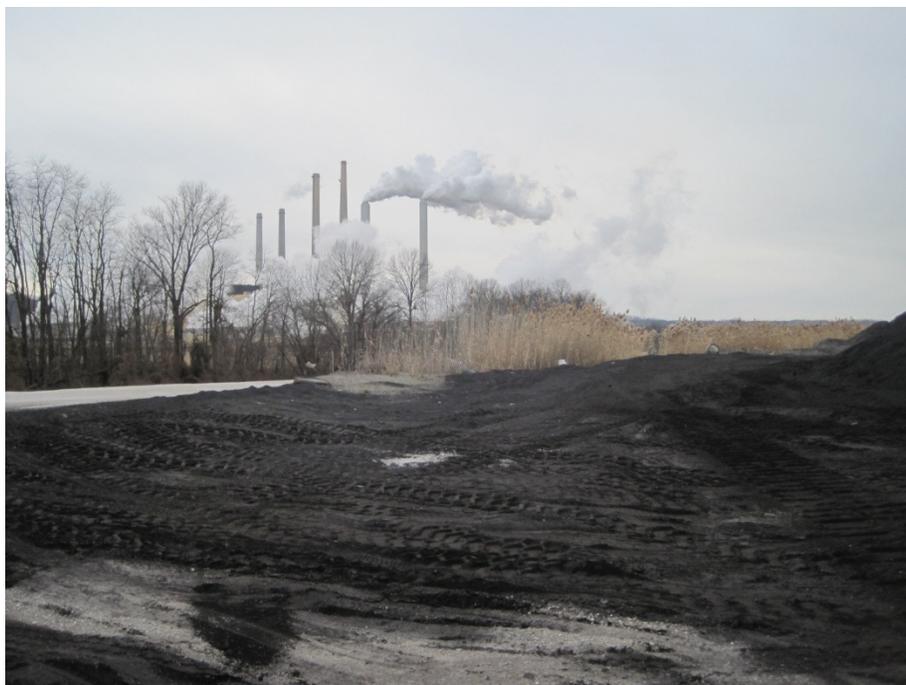
Photo 19: Looking SW Toward Plant from Staging Area of Stockpiled Bottom Ash
H.L. Spurlock Power Station Ash Pond; February 15, 2011

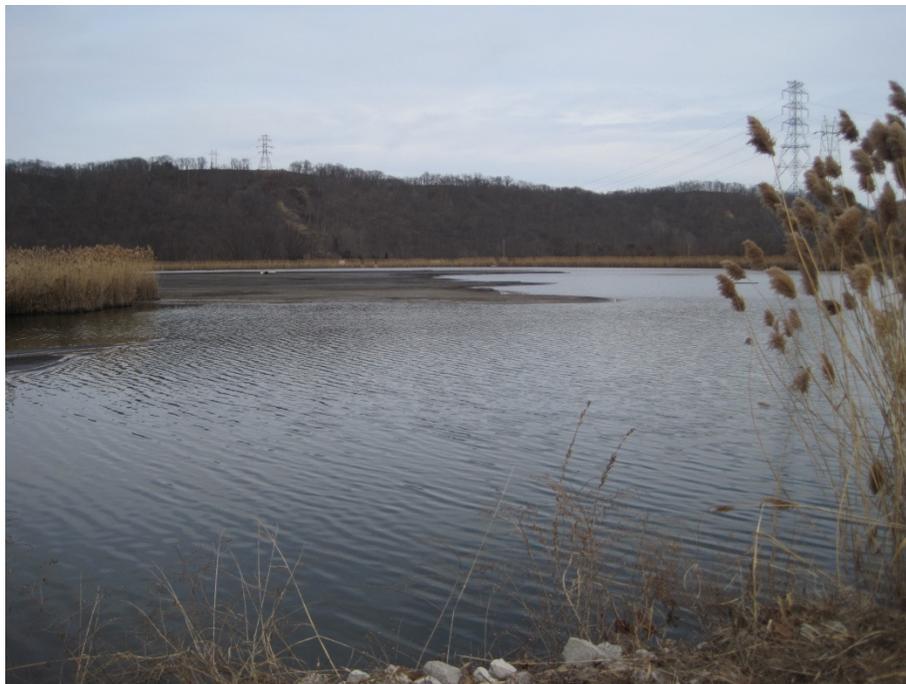
Photo 20: Water Within the Spurlock Ash Pond
H.L. Spurlock Power Station Ash Pond; February 15, 2011

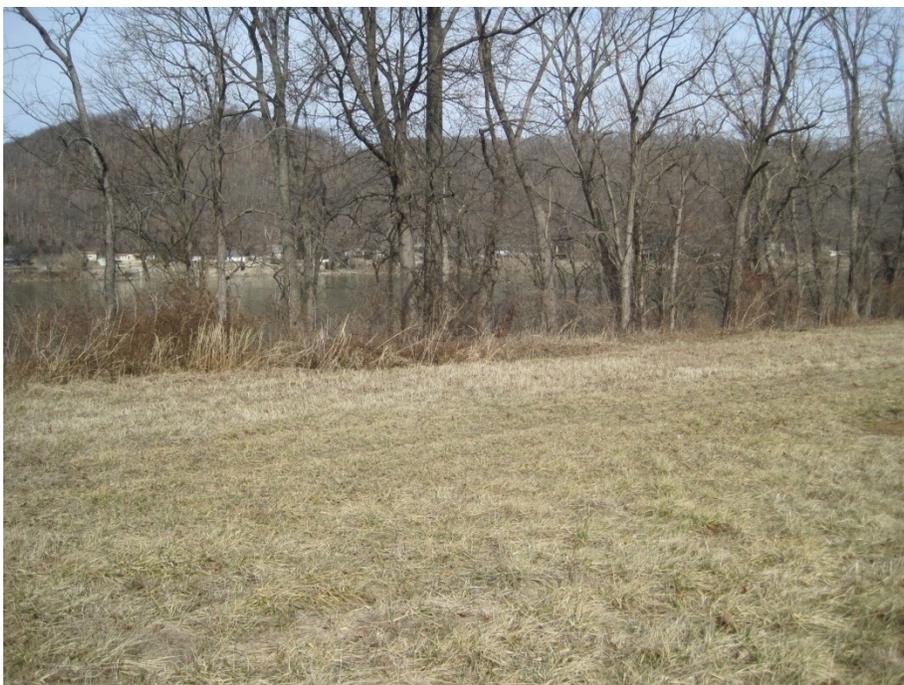
Photo 21: Ohio River, Running Parallel to the Northern Embankment of the Ash Pond
H.L. Spurlock Power Station Ash Pond; February 15, 2011

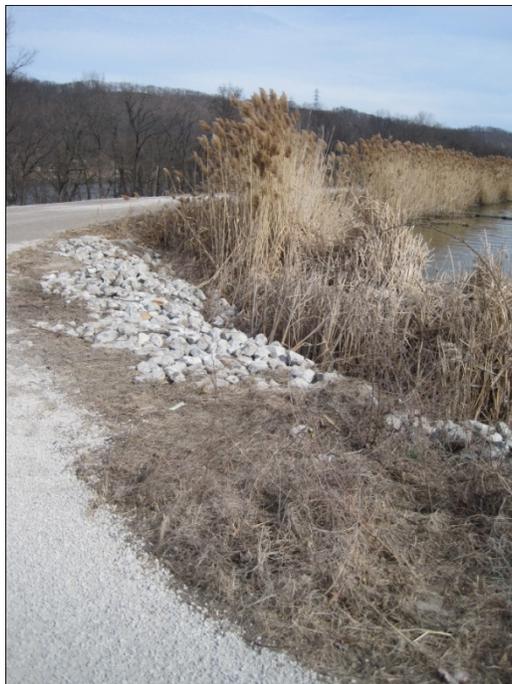
The crest of the Ash Pond had no signs of depressions, tension cracks, or other indications of settlement or shear failure, and appeared to be in satisfactory condition at the time of this assessment. Typical conditions of the Ash Pond's North, South, East, and West crests can be seen within Appendix C, as Photos 22, 23, 24, and 25, respectively.

Photo 22: Looking NE from Western Crest at Northern Crest Typical Conditions (See Top Left Corner of Photo)
H.L. Spurlock Power Station Ash Pond; February 15, 2011

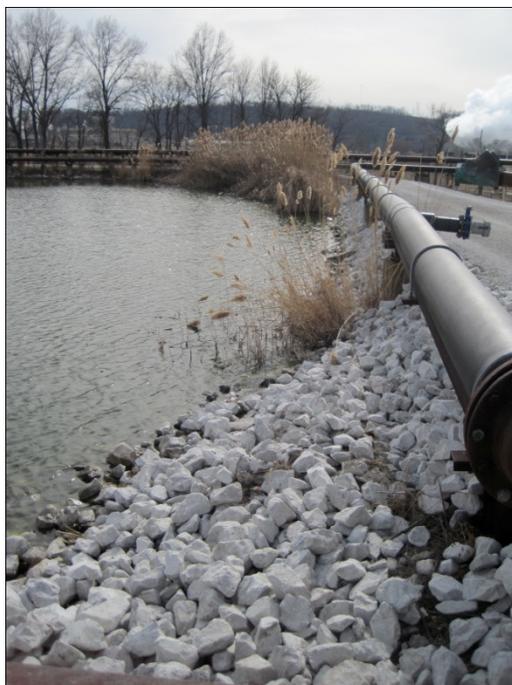
Photo 27: Layer of 18" Thick Riprap Combined with Phragmites Surrounding Inside Perimeter of Ash Pond

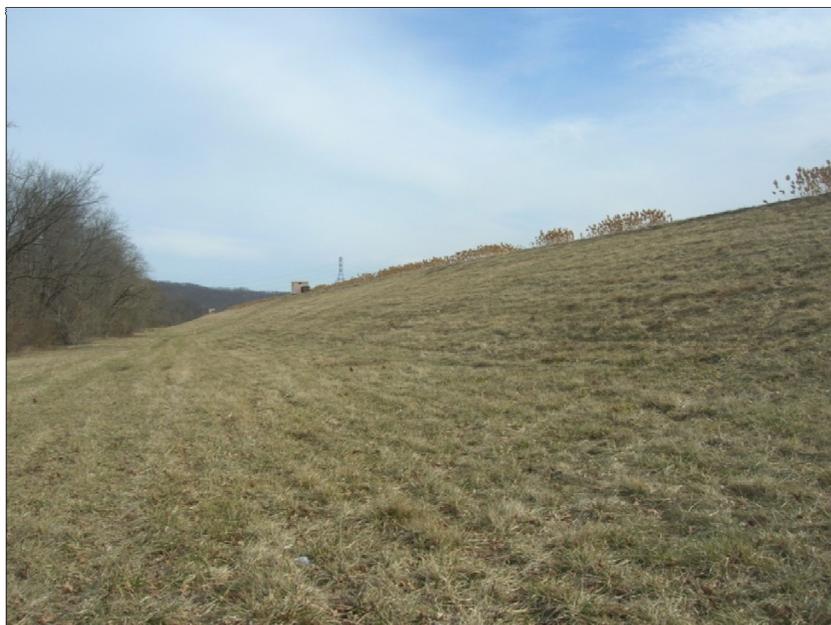
embankments were generally in good condition with adequate grass cover and well maintained (See Appendix C, Photos 28,29,30,31 for the general condition of the North, South, East, and West exterior embankments, respectively). There were no observed scarps, sloughs, bulging, cracks, depressions, or other indications of slope instability or signs of erosion found during this assessment.

Photo 28: Northern Exterior Embankment

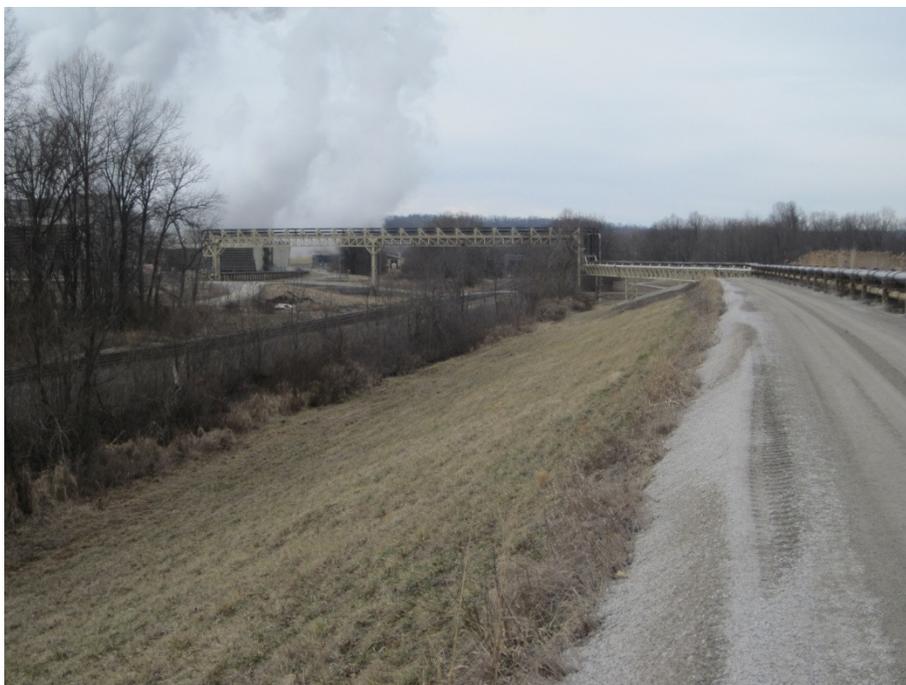
Photo 29: Southern Exterior Embankment
H.L. Spurlock Power Station Ash Pond; February 15, 2011

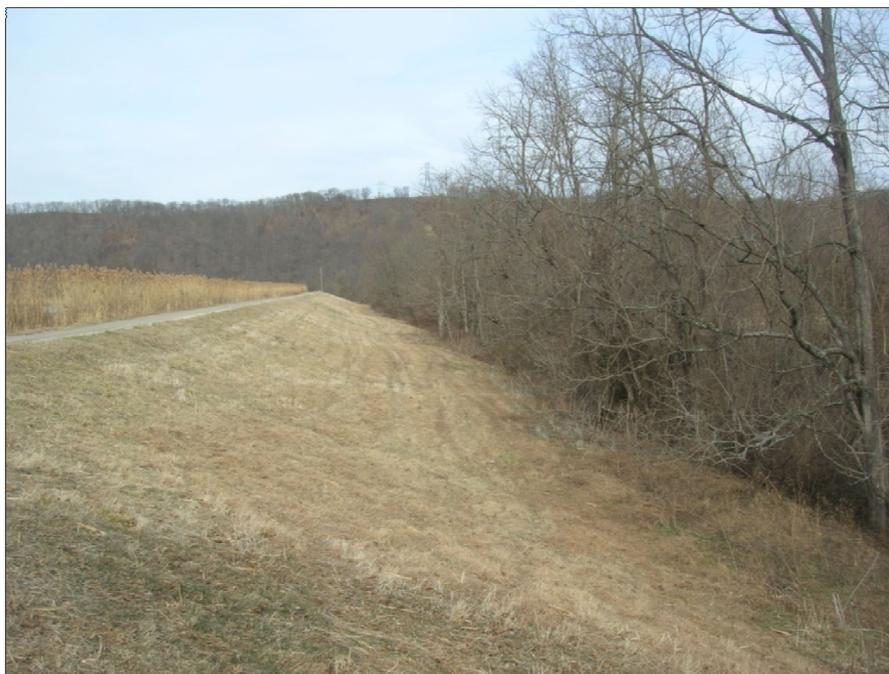
Photo 30: Eastern Exterior Embankment
H.L. Spurlock Power Station Ash Pond; February 15, 2011

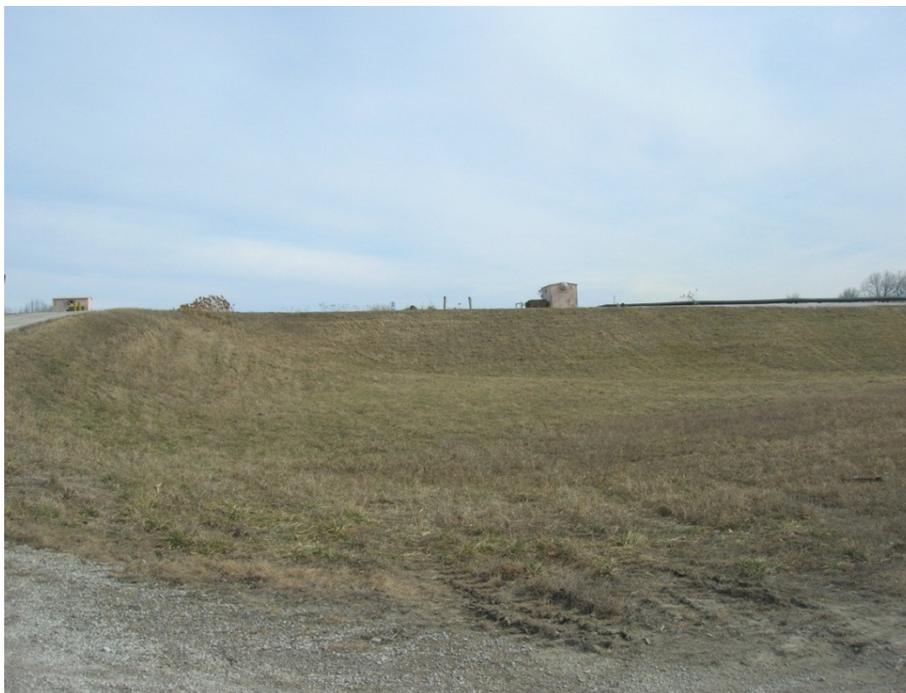
Photo 31: Western Exterior Embankment
H.L. Spurlock Power Station Ash Pond; February 15, 2011
