# Assessment of Dam Safety Coal Combustion Surface Impoundments (Task 3) Draft Report

**Kentucky Utilities**

**Ghent Generating Station**

December 8, 2009

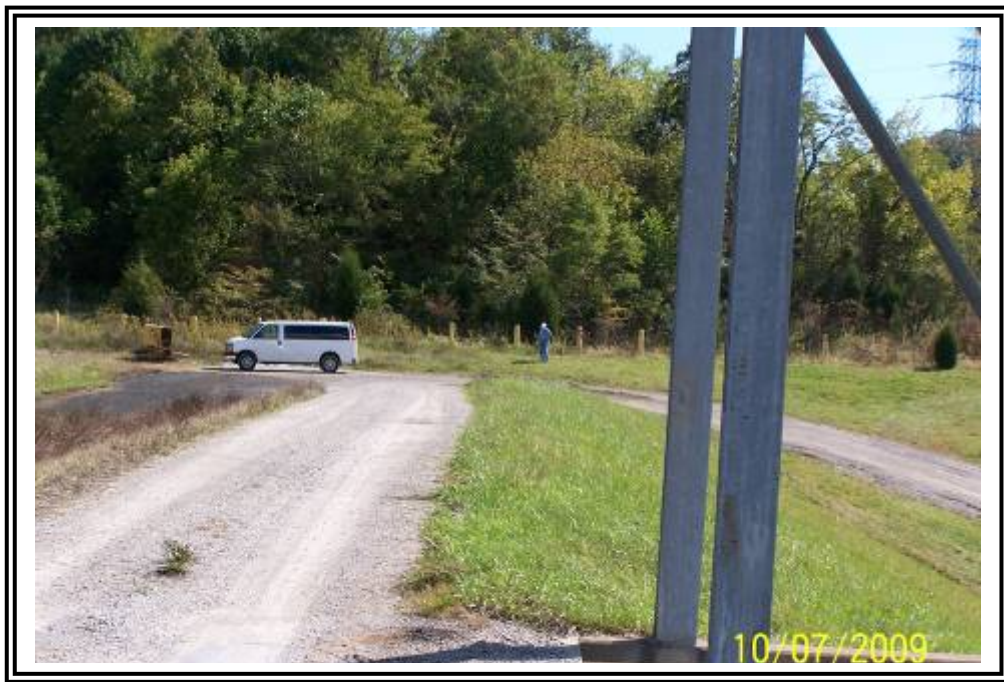
2

West abutment of ATB #1 looking south.

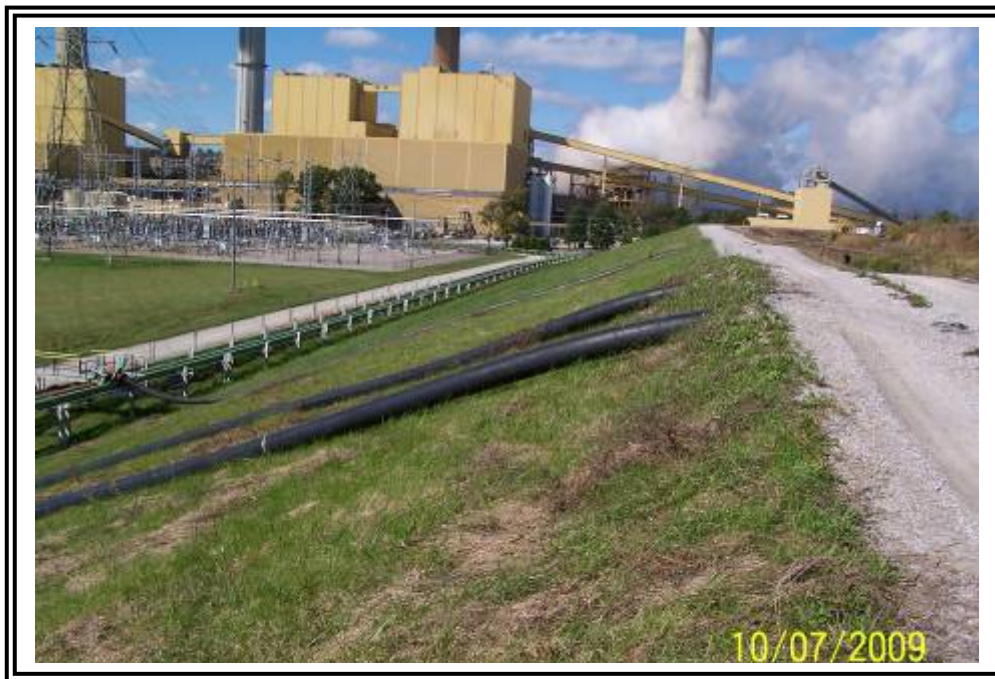
4

In general, the ATB #1 dike does not show signs of changes in horizontal alignment from the proposed alignment. The up and downstream slopes were reasonably uniformly graded and vegetation had been recently mowed at the time of our site visit. Photos 4, 5, 13, 14, 16, and 20 show the general condition of the downstream embankment, which is covered with appropriate grass vegetation. As noted in Photo 13, some areas at the crest are over steepened, which Kentucky Utilities staff indicated may have occurred during regrading of the crest when work was performed to ensure the top elevation was at the design elevation. No signs of movement were observed in these areas. Photo 14 also shows typical tire rutting from mowers. This is common on earthen embankments, and requires observation to ensure that erosion and sloughing does not occur. Kentucky Utilities indicated that they have reduced their maintenance program to mowing twice a year from three times a year to reduce the impact of mower rutting on the embankments. A few areas of different vegetation were noted along the north slope, which can be an indication of softer soil or seepage. These observed areas, while softer at the surface were firm below a depth of about 6 to 8 inches.

Downstream slope ATB #1 west dike looking north.

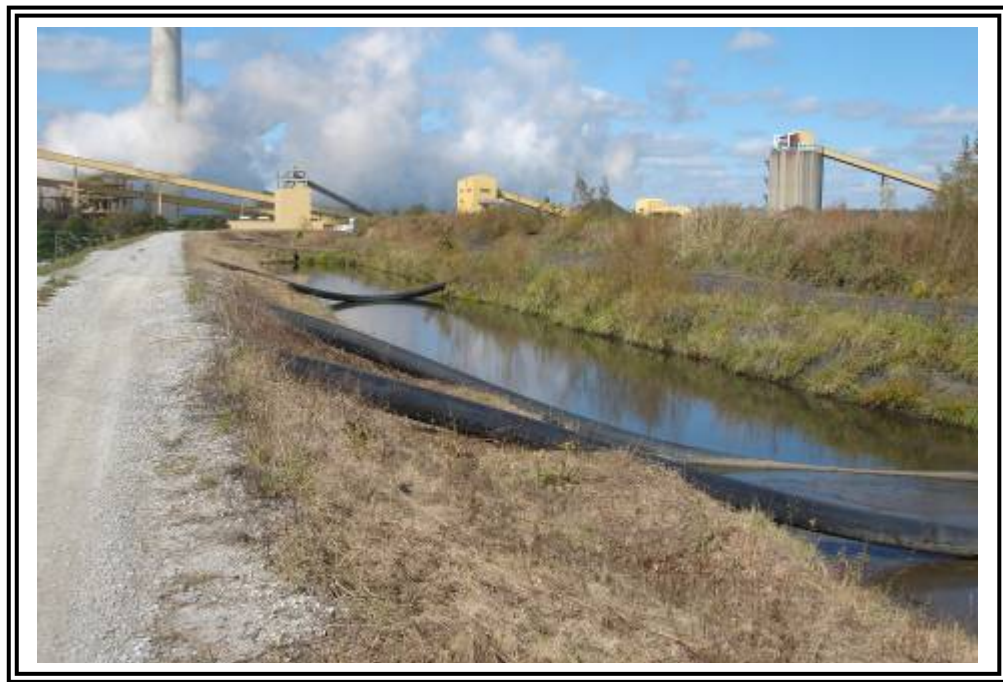
6

The general condition of the ATB #1 upstream slope is shown in Photos 3, 6, 9, 10, 12 and 21. The upstream slope is weed covered, but had been trimmed to near the water line. ATB #1 is not a primary disposal site now and primarily receives outflow from ATB #2 and a comparatively small flow of waste water from the plant. This has resulted in ash deposits that are above the water line. Along the west and majority of the north dikes, the ash is within 3 to 5 feet of the top of the dike. As shown in Photo 12, small trees have begun to grow on the exposed ash within the basin. As can be seen in Photo 21, erosion on the upstream slope of the east dike has been filled with rip rap.

Upstream slope ATB #1 west dike looking north.

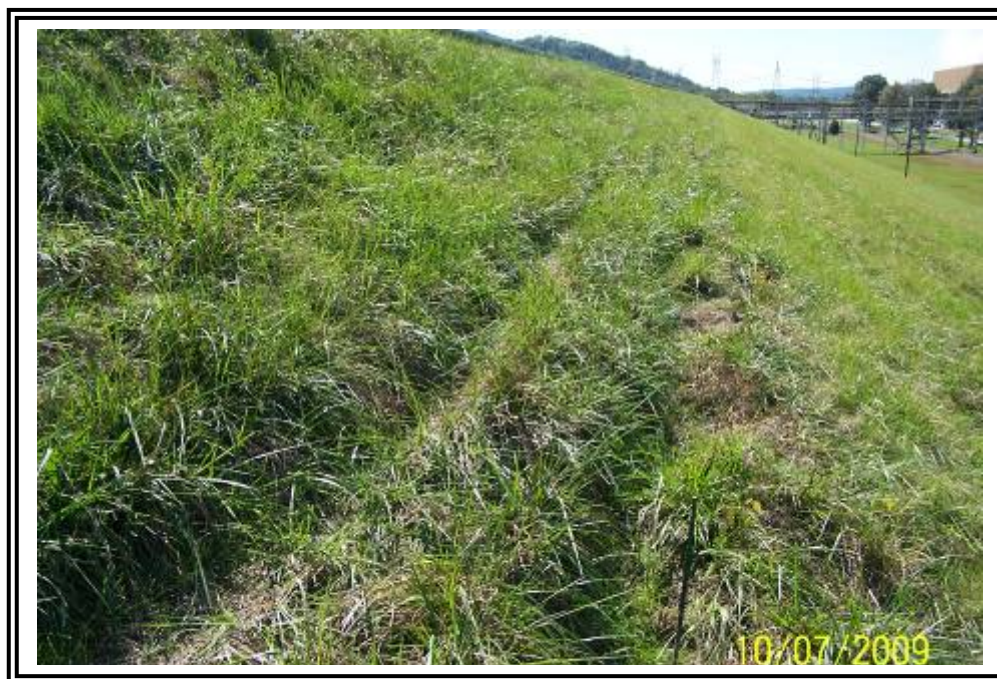
14

Tire ruts from mower on over steepened area.

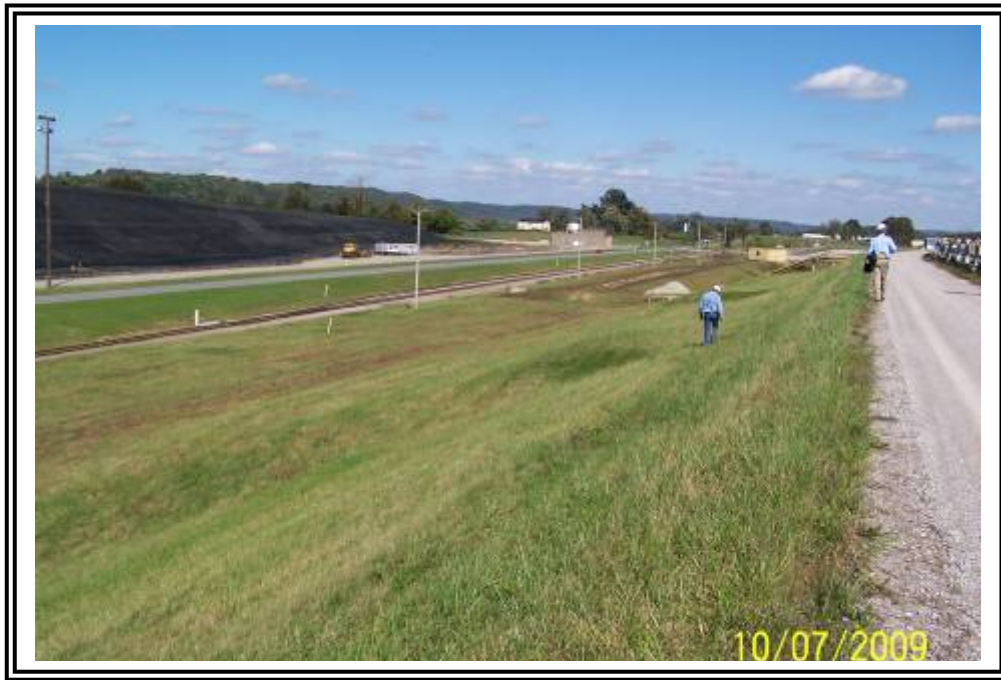
At the northeast corner of the embankment there is a bench about half way down the slope as shown in Photo 16 and 22. A depression was observed in the bench near the northeast corner as shown in Photo 17. Occasional shallow erosion rills were also noted.

Start of bench around northwest corner of ATB #1 dike.

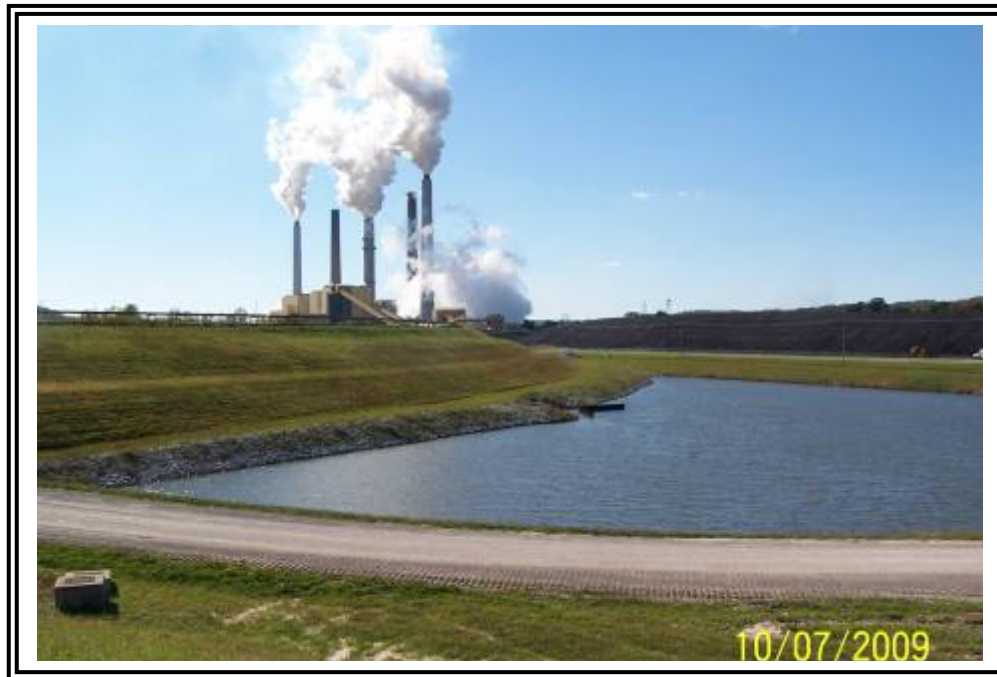
22

Downstream slope of ATB #1 northeast corner looking northwest.

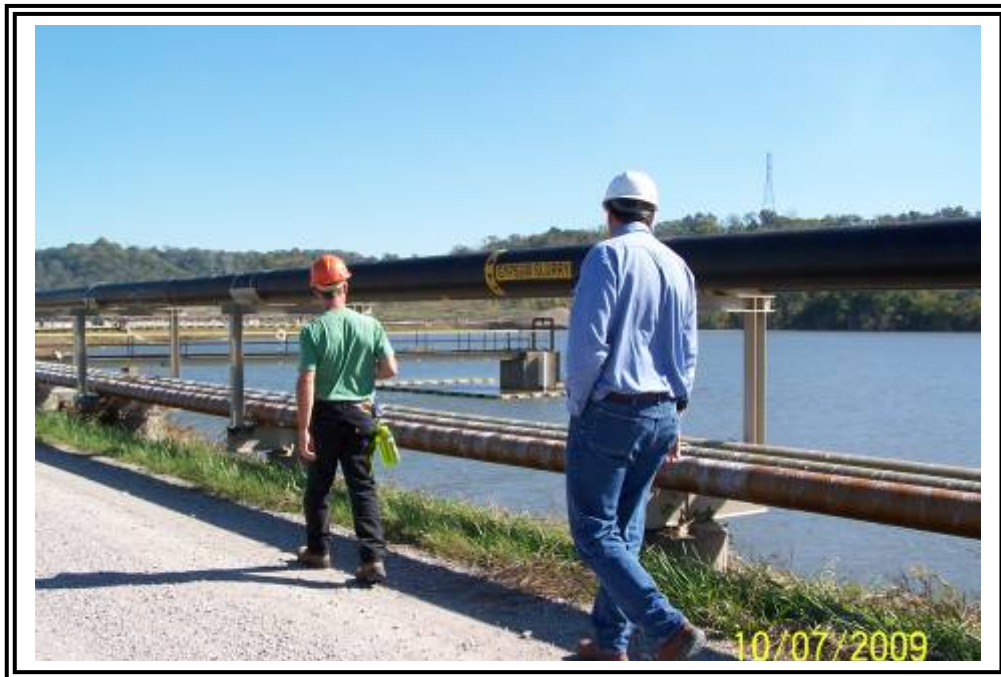
24

Outlet structure in ATB #1.

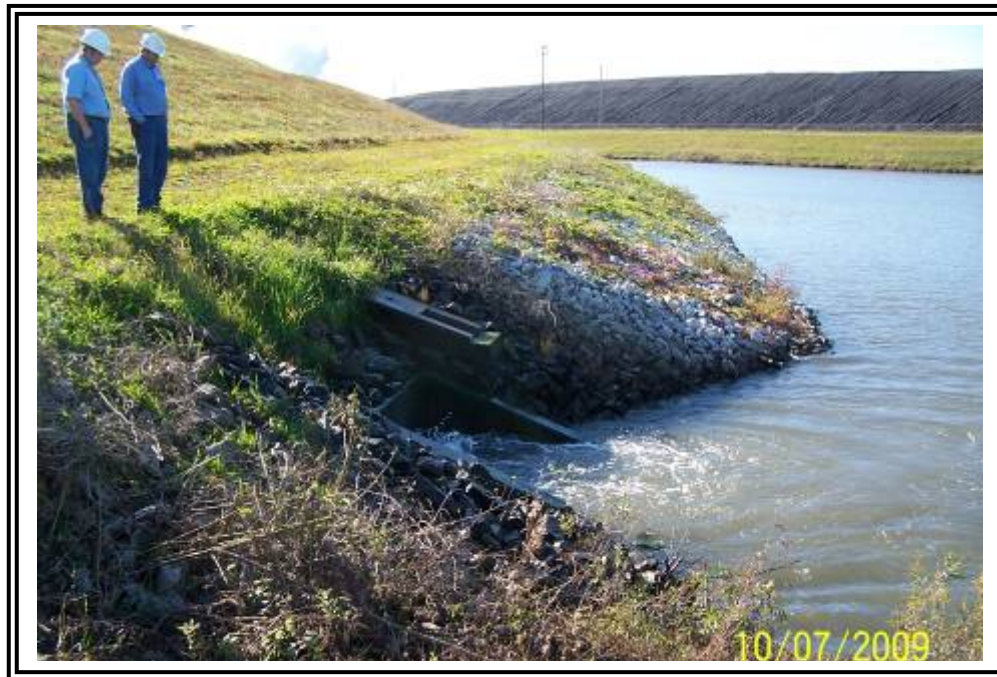
26

Outlet pipe discharge into secondary Ash treatment basin.

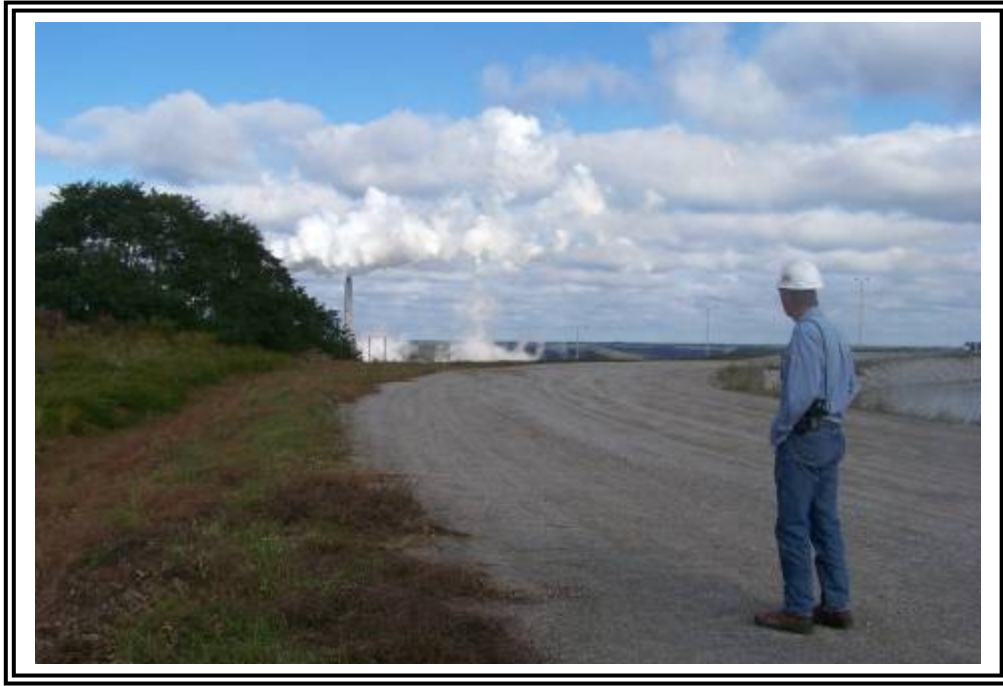
The crest of the ATB #2 dam is uniform and did not show signs of significant settlement or deflection. Photos 35 through 40 show the general condition of the crest.

Crest of ATB #2 at west end looking northeast.

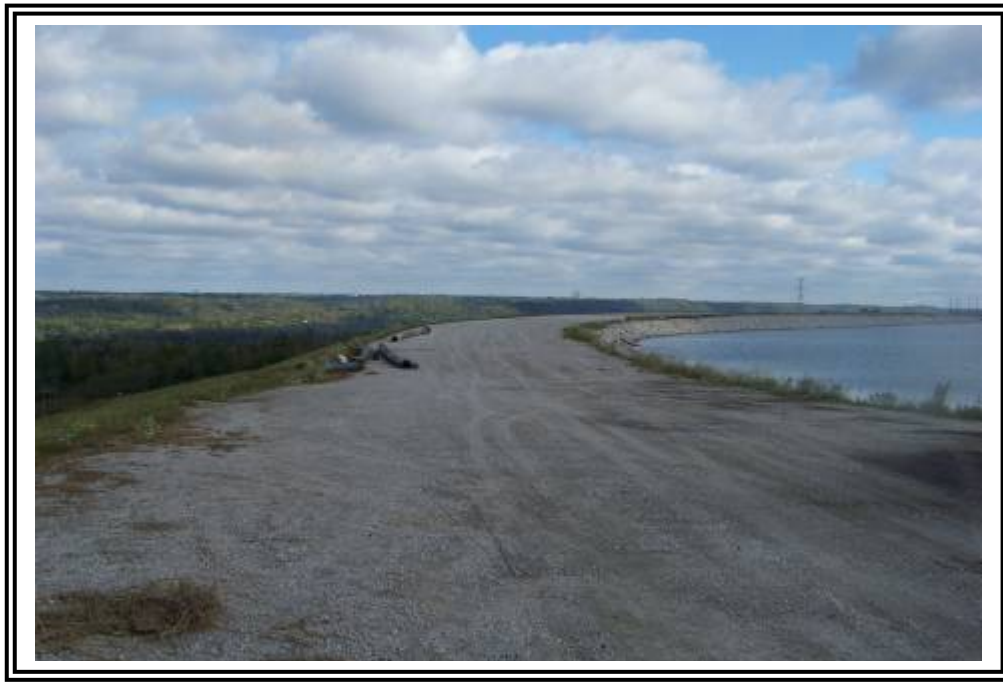
36

Crest of ATB #2 from access to decant structure looking east.

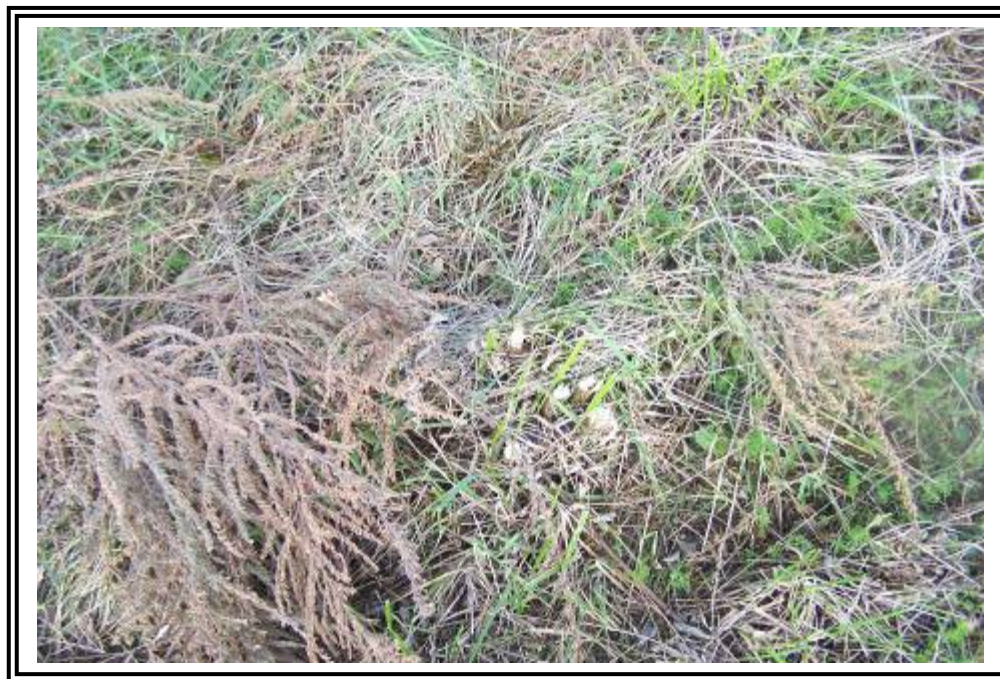
42

Maintenance includes removal of woody brush.

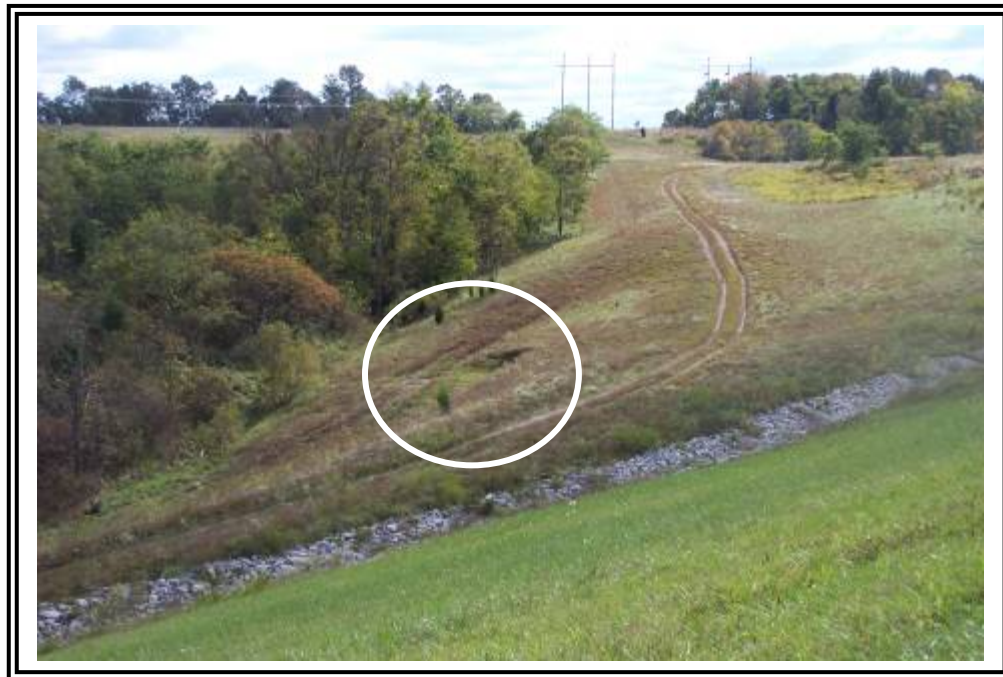
54

Slump in natural slope near the east abutment of ATB #2.

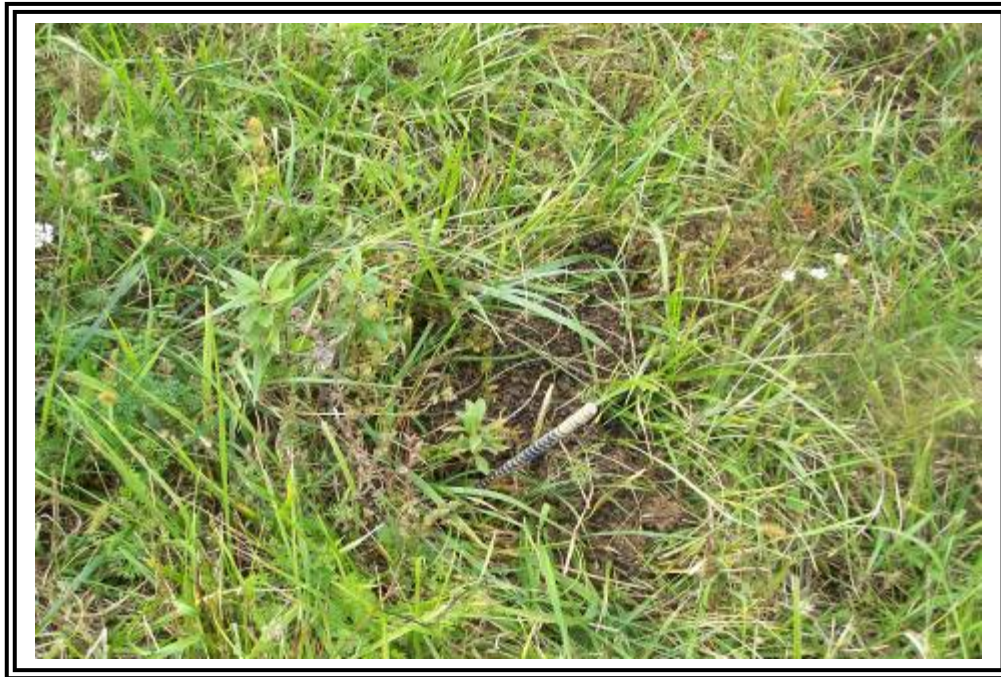
58

Small rodent hole on bench in secondary drainage fill section about 18 inches deep..

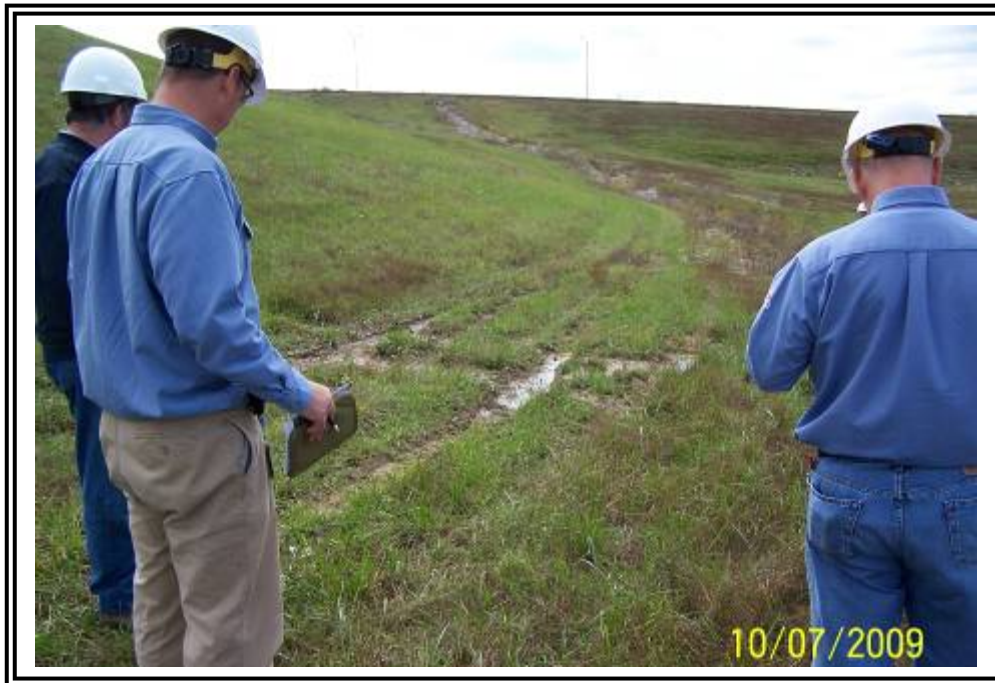
72

Standing water on west end of upper bench.

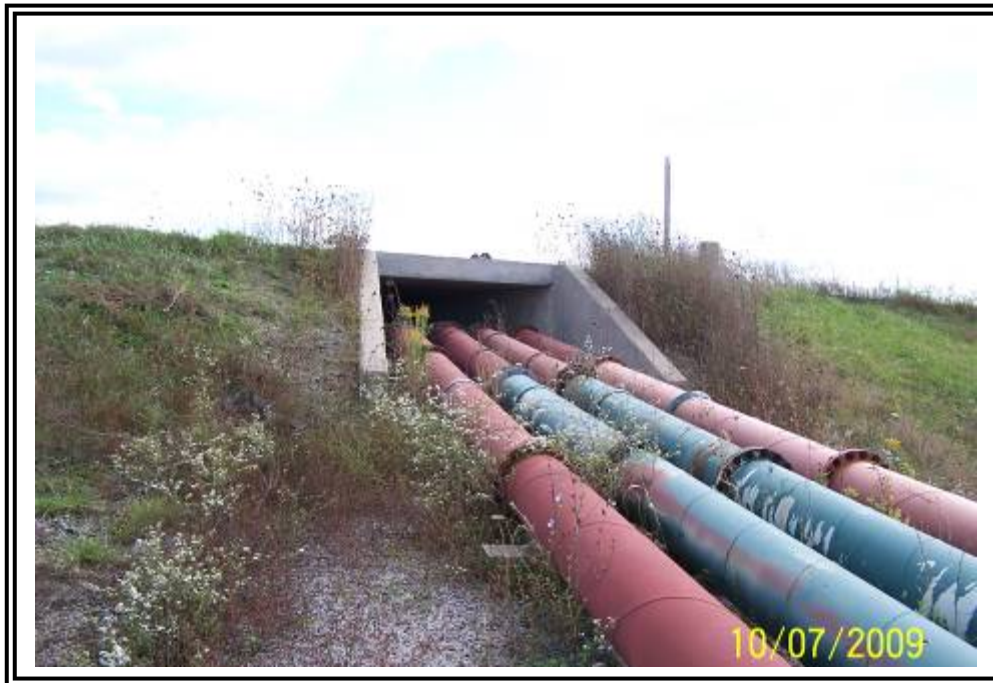
74

Utilidor of sluice lines at dam crest. Crest slightly higher at this location.

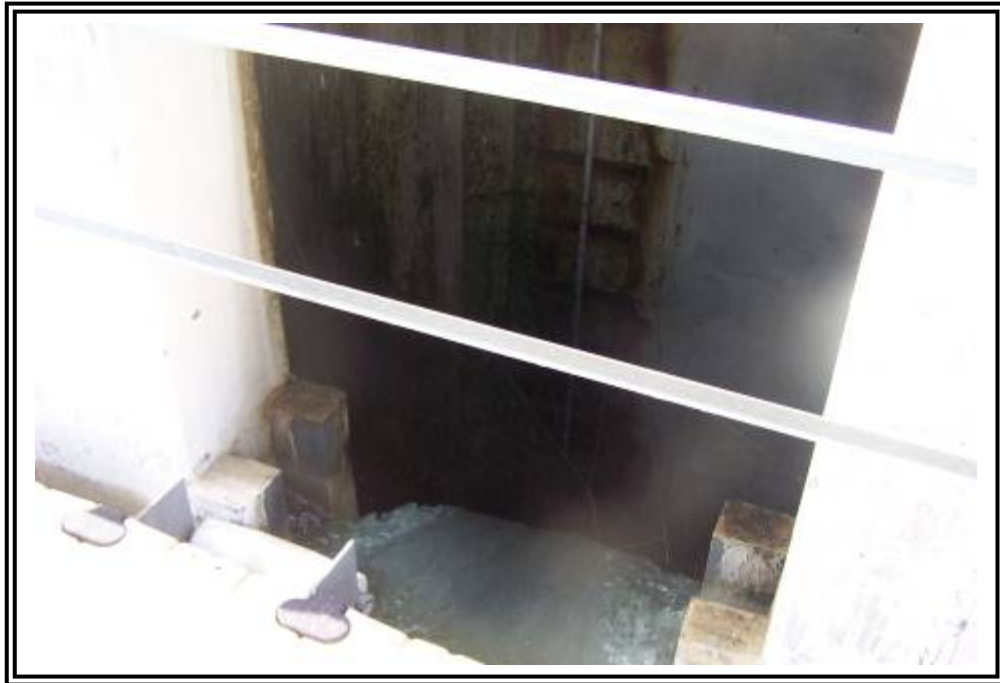
76

Decant over stop logs in outlet structure.

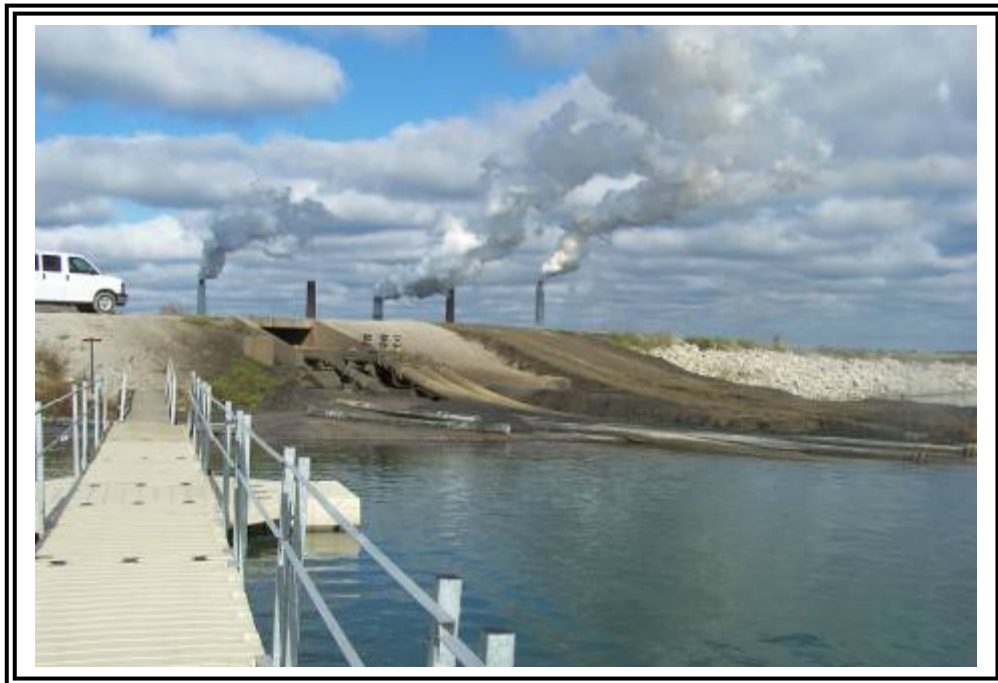
78

Sluice lines through utility corridor to reservoir.

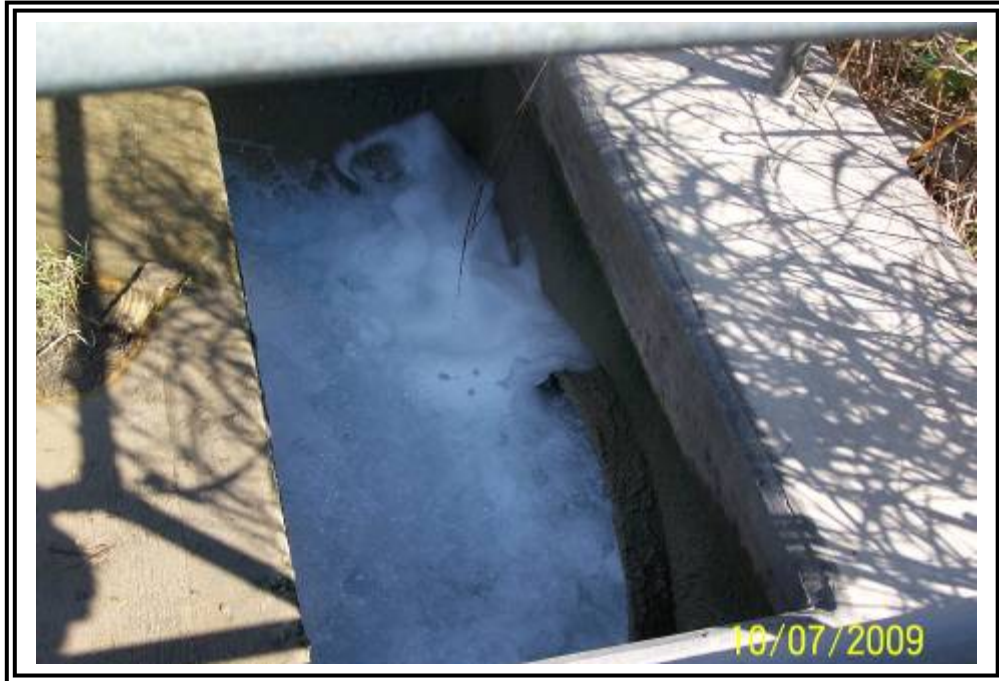
79

Discharge from ATB #2 near ATB #1. Discharges into structure with impact baffle.

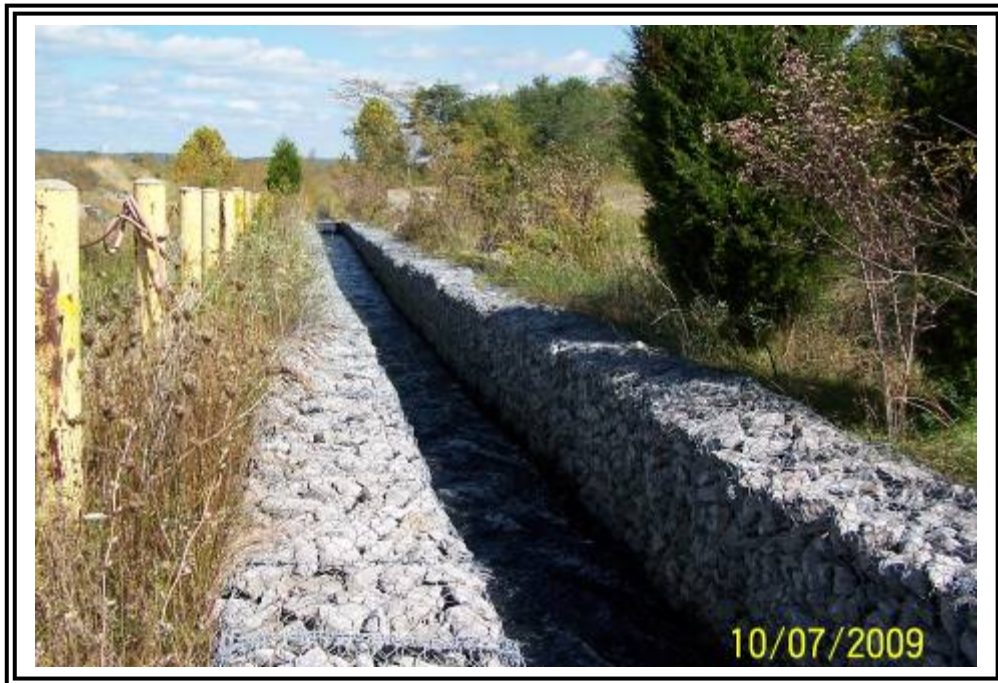
80

Sluiceway from ATB #2 discharge into ATB #1.

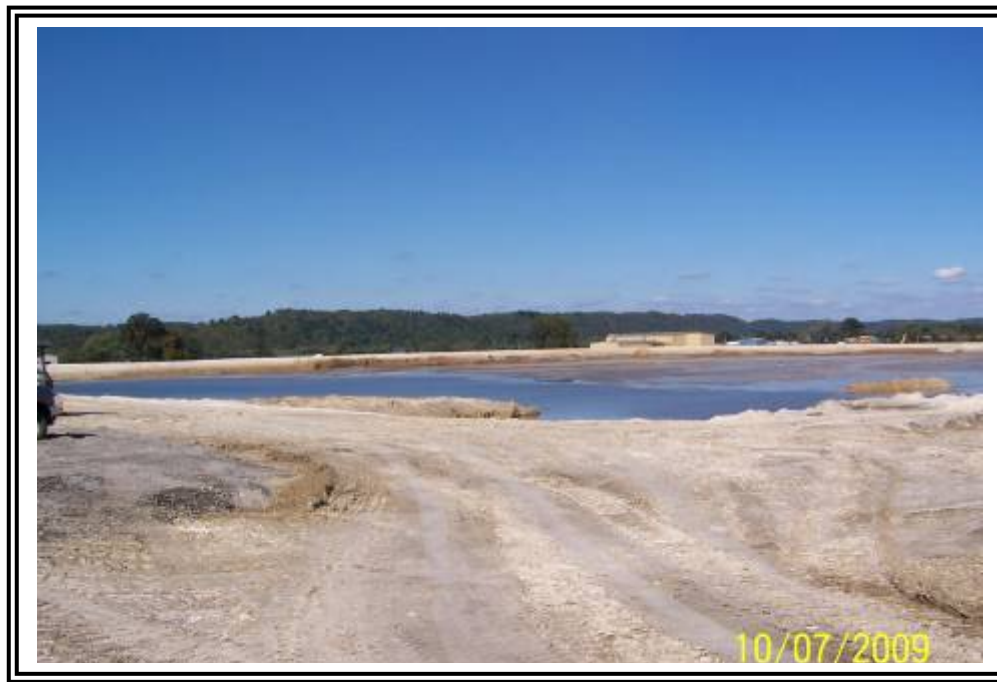
84

North end of gypsum stacking facility, looking northeast.

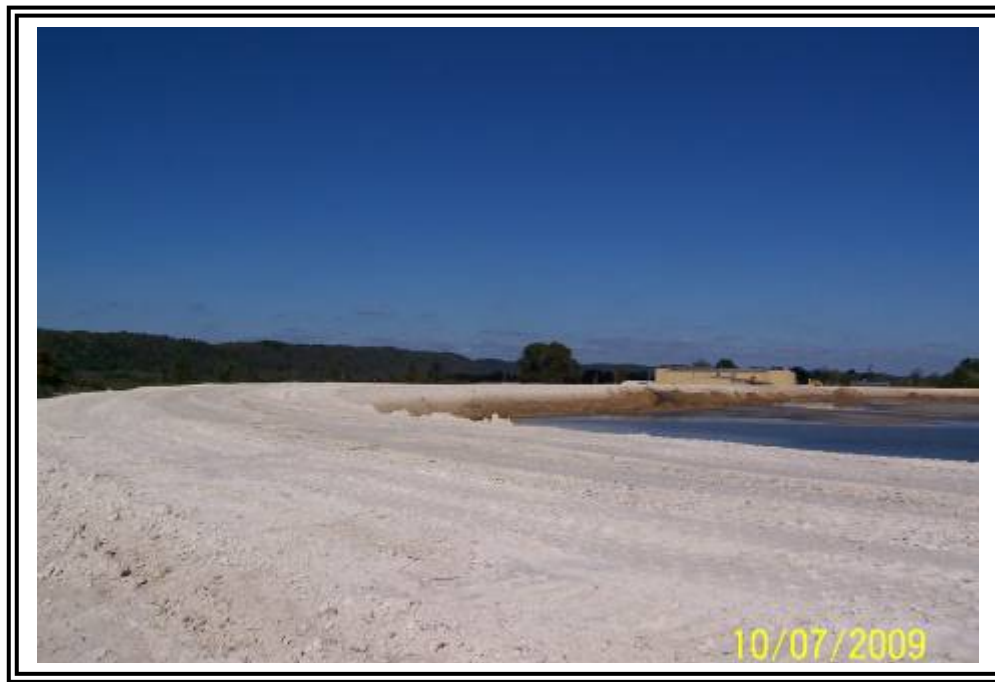
86

Crest of west end of gypsum stacking facility dike, looking northeast (under construction from dewatered gypsum).

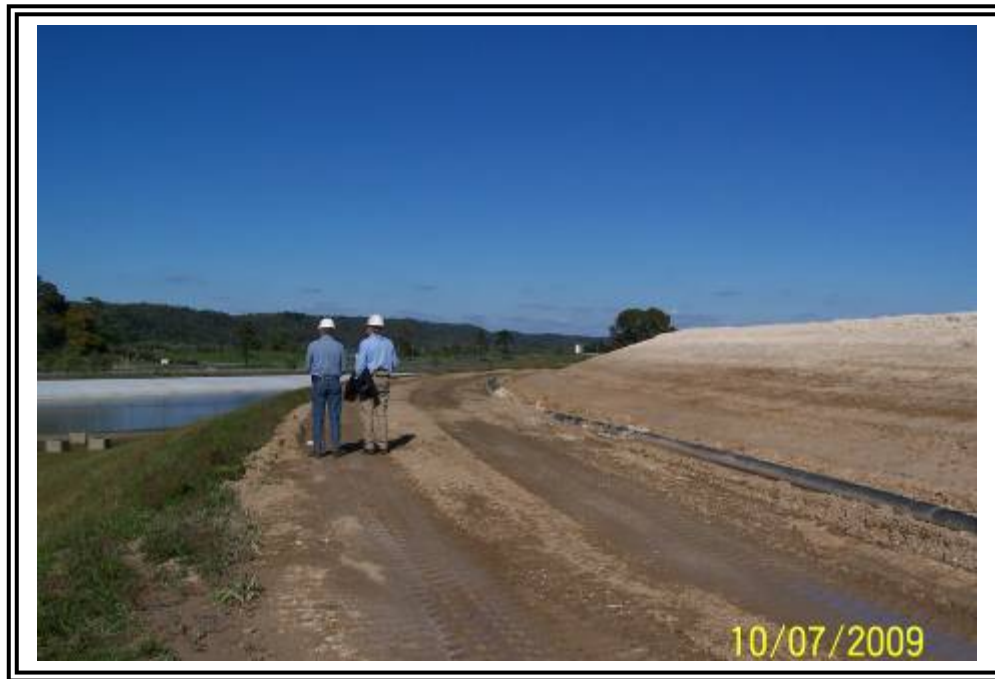
88

Crest of starter dike at northwest corner of gypsum stacking facility dike, looking northeast.

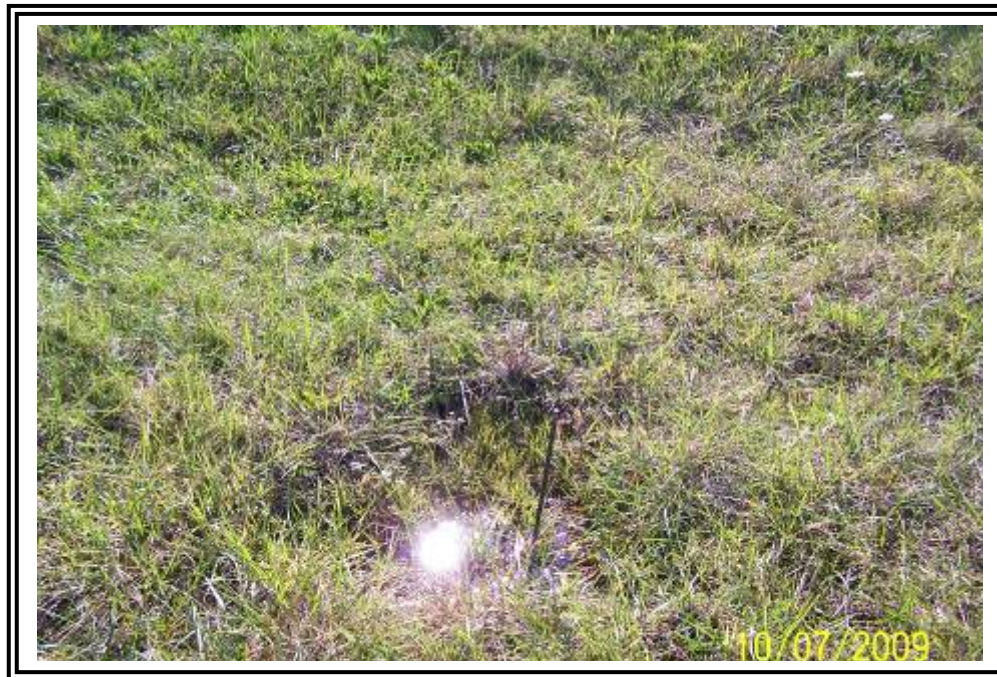
98

Standing water at the toe along the east side of the gypsum stacking facility starter dike. Ground is firm, appears to be surface water drainage.

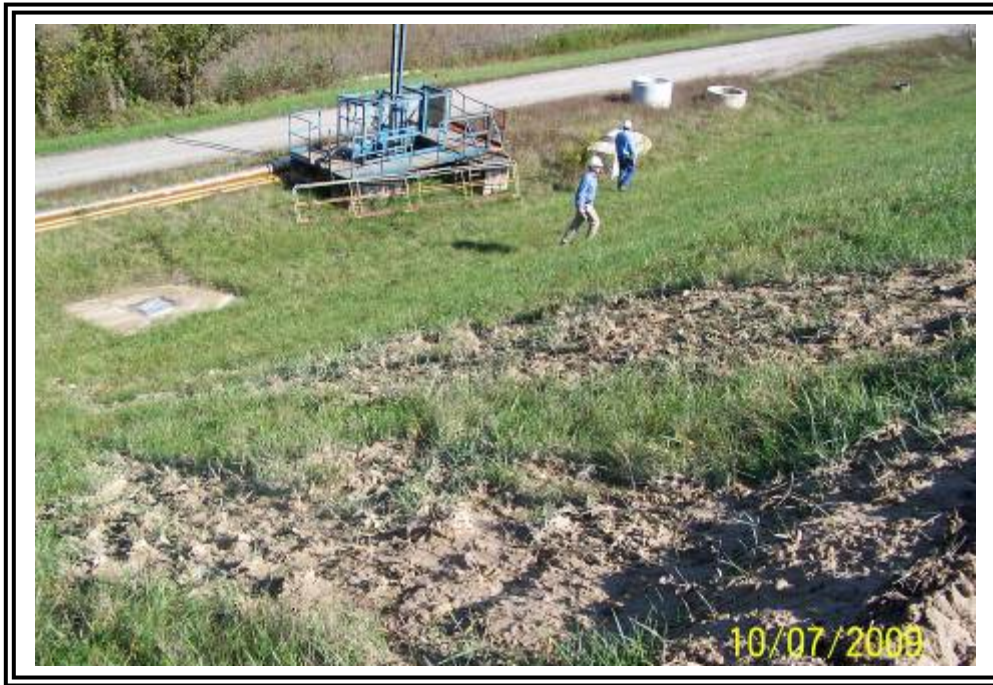
101

Runoff from gypsum stacking facility east dike under construction.

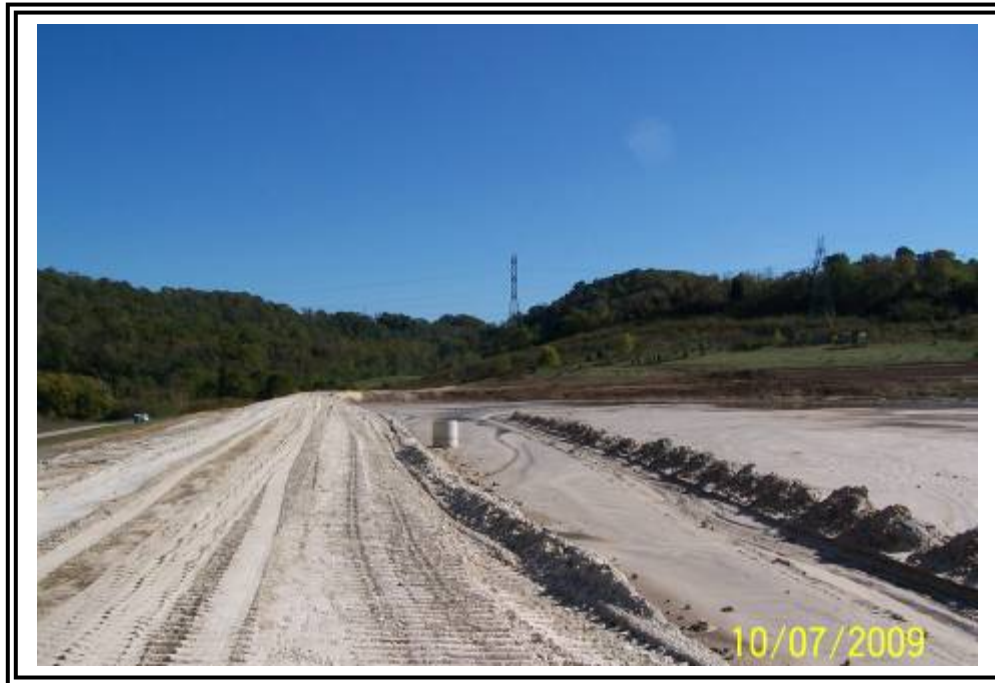
103

Crest of gypsum stacking facility dike east side, looking south.

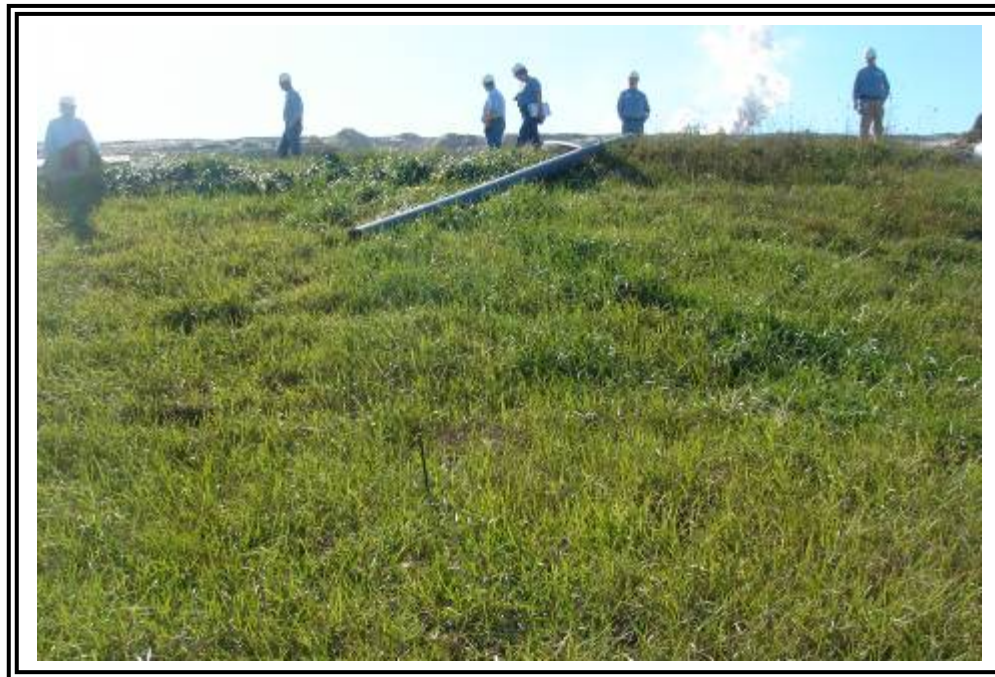
104

Area of seep near top of gypsum stacking facility east starter dike. Kentucky Utilities is working with Stantec (Engineer of Record) to resolve this issue. Seepage is at approximate elevation of current water surface in the pond.

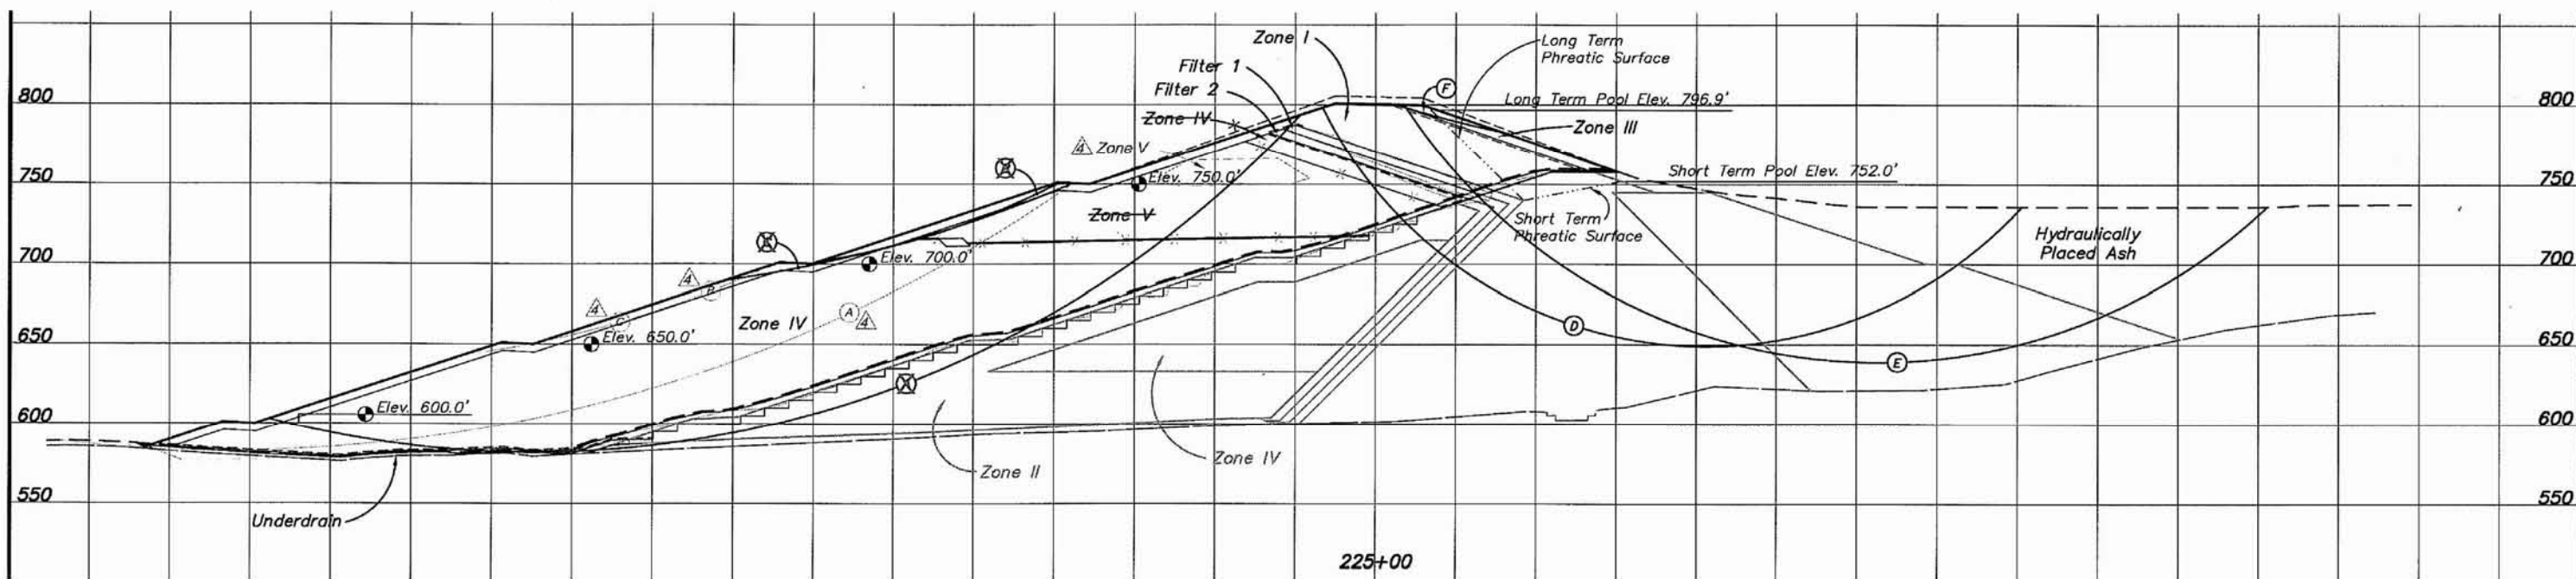
PROJECT NO.  
20085.2030  
 DATE: 12/2009  
 FIGURE 11

CHA was provided with the Engineering Design Report for the raising of ATB #2 as well as record drawings showing the actual placement of zoned material in the embankment. Figure 11 was taken from the record drawings and shows the stability analyses and zones of materials used for the embankment construction. Table 9 summarizes the soil properties used for steady state conditions in analyzing the embankment. Descriptions of the soils represented by zone numbers were taken from technical specs provided in the Engineering Design Report.

SUMMARY OF STABILITY ANALYSIS					
Circle	Loading Condition	X (Feet)	Y (Feet)	R (Feet)	Factor of Safety
A	Downstream Slope - Short Term - Static Loading Crest Elev. 800.0' - Pool Elev. 752.0'	-715	1495	912	2.1
B	Downstream Slope - Long Term - Static Loading Crest Elev. 800.0' - Pool Elev. 796.9'	-650	1280	642	1.6
C	Downstream Slope - Long Term - Dynamic Loading Crest Elev. 800.0' - Pool Elev. 796.9'	-527	1198	503	1.5
D	Upstream Slope - Short Term - Static Loading Crest Elev. 800.0' - Pool Elev. 752.0'	206	915	266	2.0
E	Upstream Slope - Long Term - Static Loading Crest Elev. 800.0' - Pool Elev. 796.9'	313	990	351	4.5
F	Upstream Slope - Long Term - Dynamic Loading Crest Elev. 800.0' - Pool Elev. 796.9'	223	1475	707	1.2

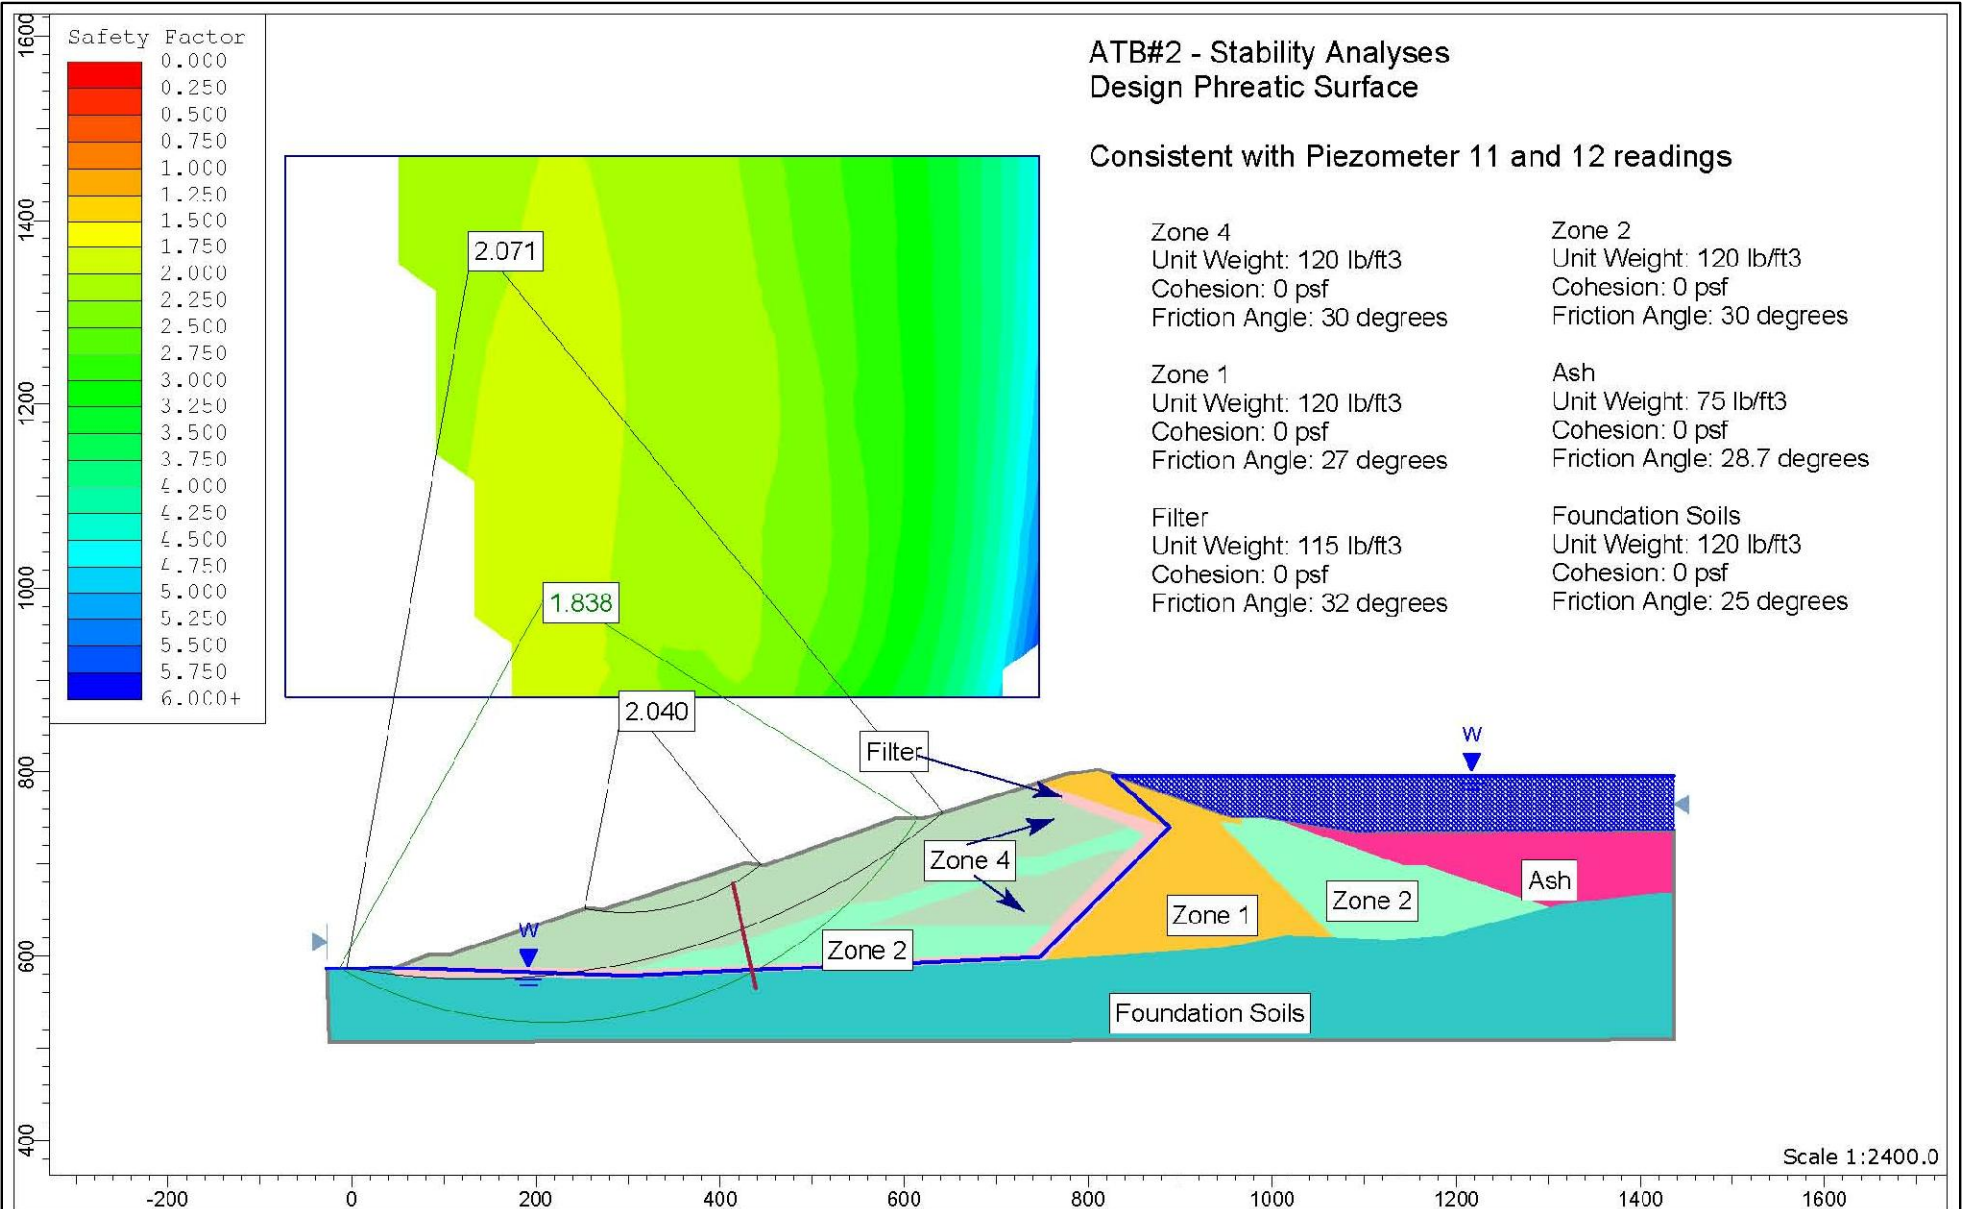
FIGURE 12A

Based on these conditions, CHA computed the minimum factors of safety for the maximum height of ATB #2 summarized in Table 11. Results of CHA’s stability analyses are shown in Figures 12A through 12E.
