# Assessment of Dam Safety Coal Combustion Surface Impoundments (Task 3) Draft Report

**Kentucky Utilities**

**Ghent Generating Station**

December 8, 2009

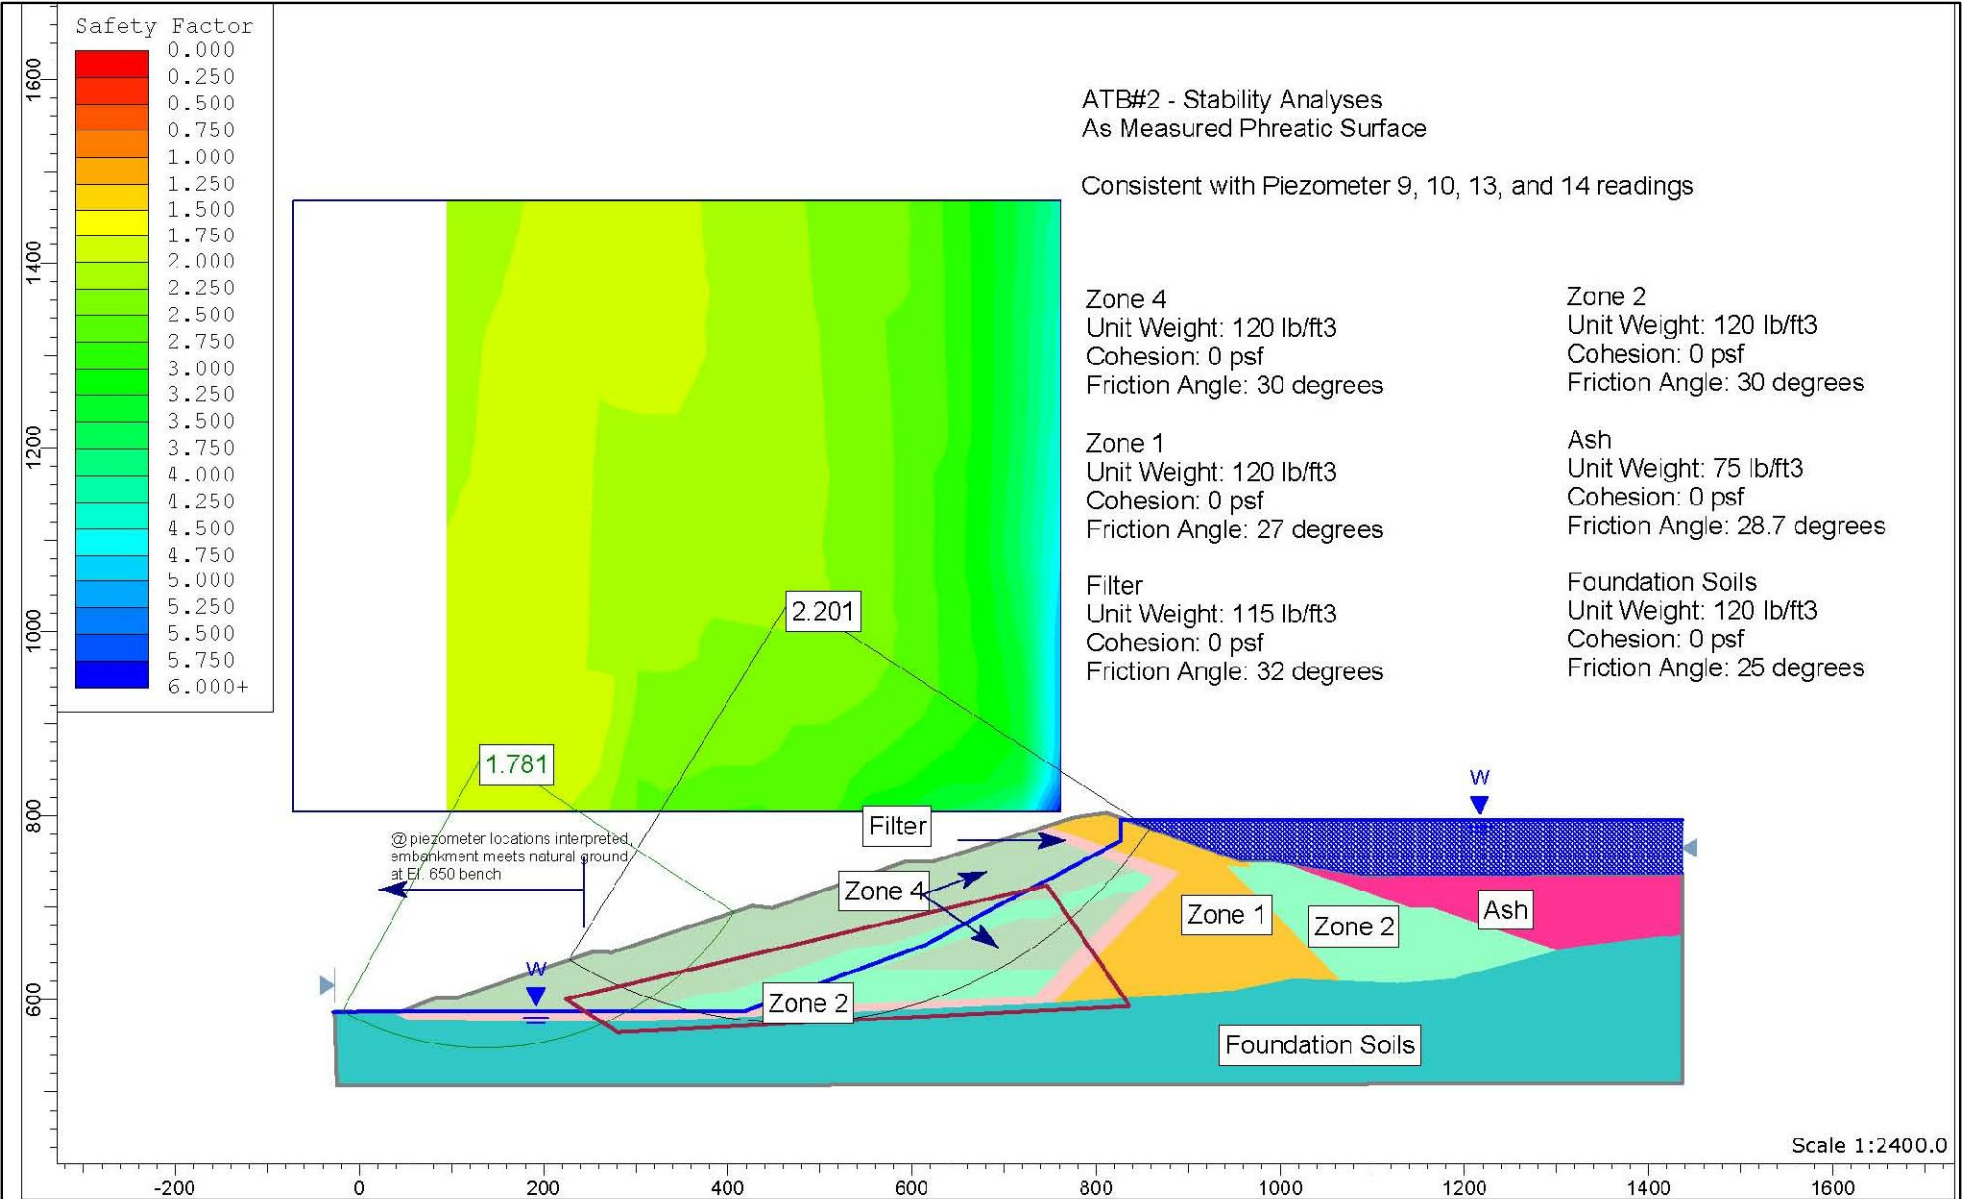
PROJECT NO. 20085.2030
DATE: 12/2009
FIGURE 12B

As discussed in Section 2.5.1, CHA took measurements in piezometers at the northeast corner crest and along the north dike toe, and found water levels to be at, or lower than those used in the stability analyses.

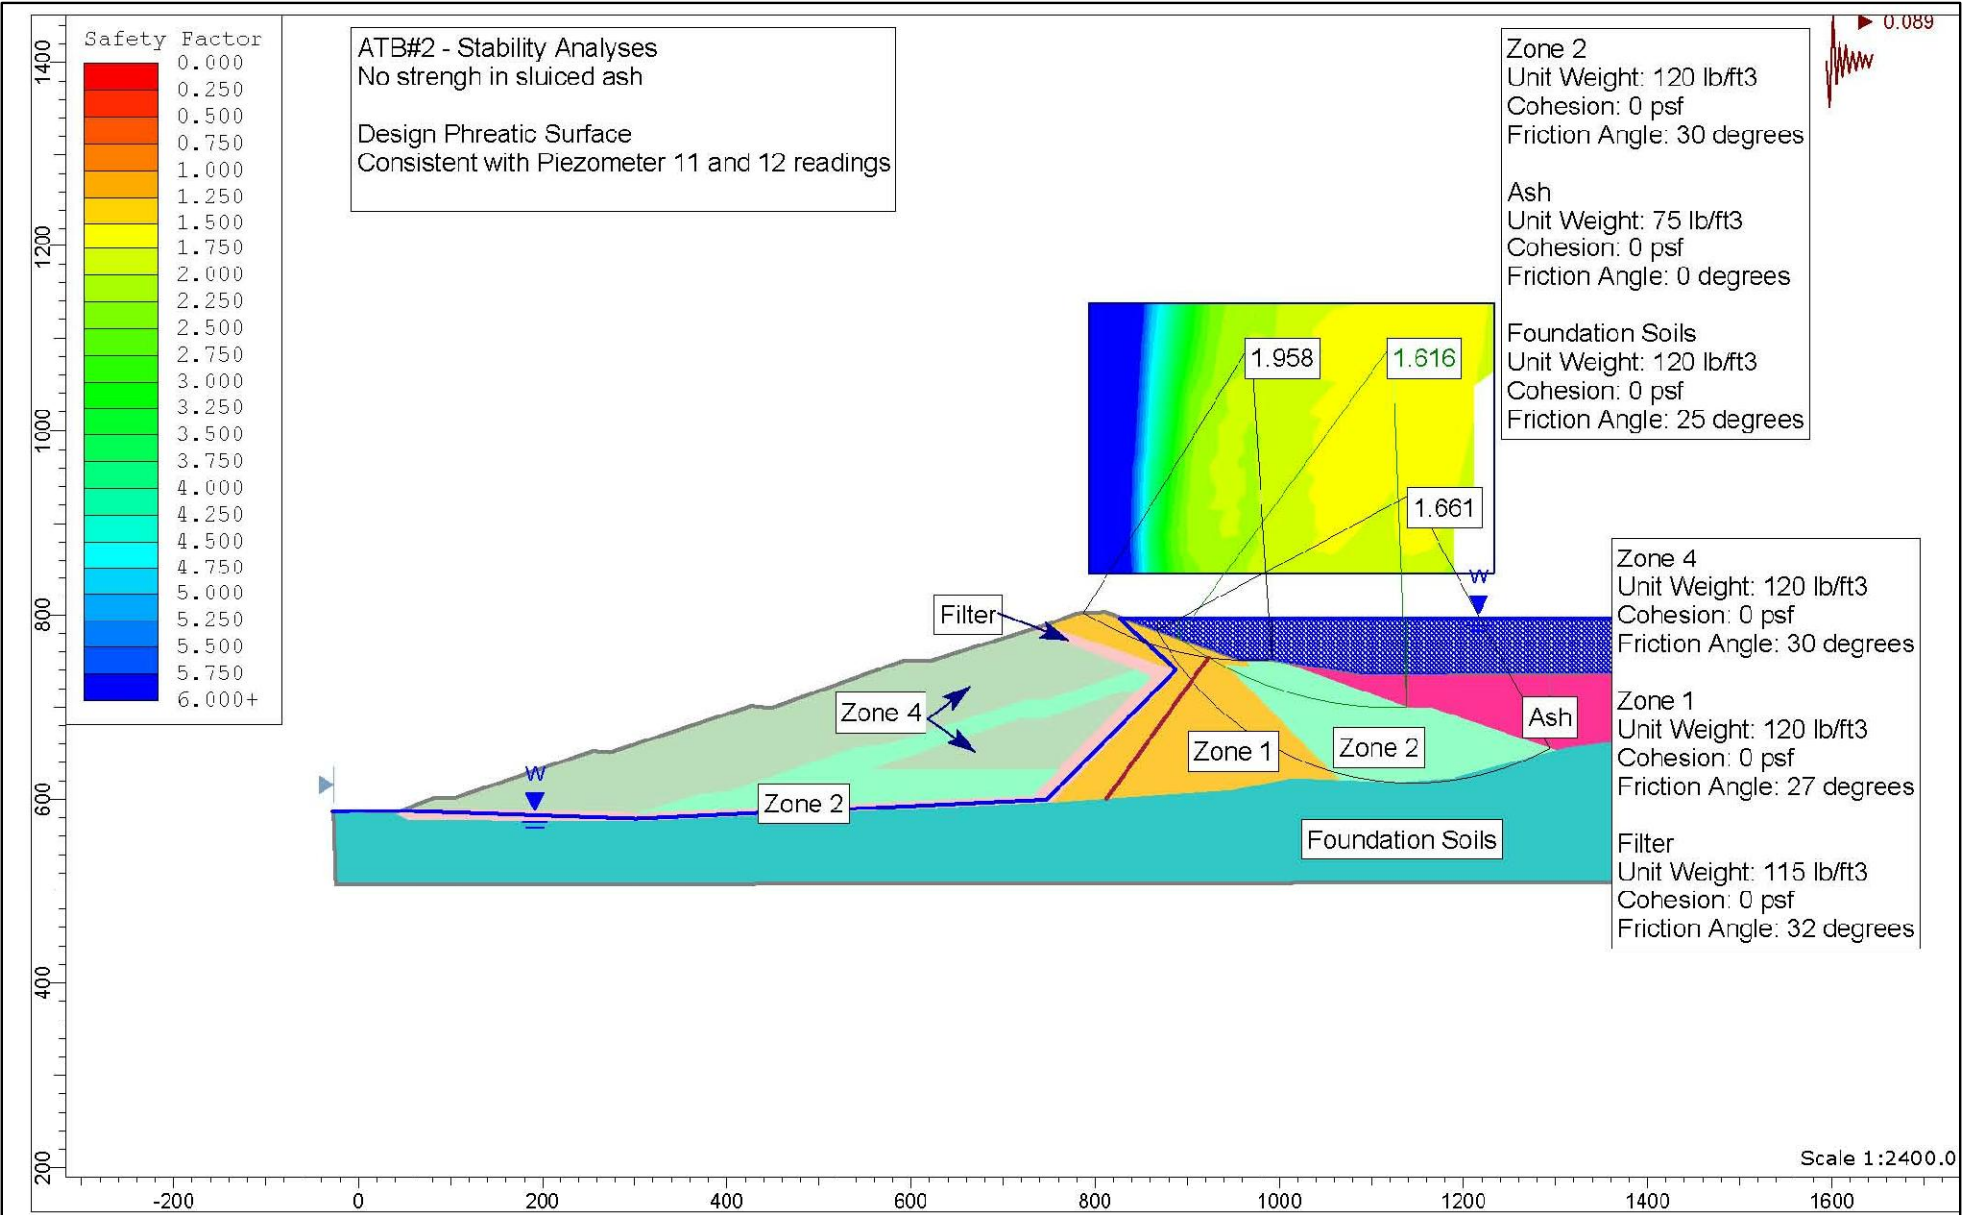
FIGURE 12D

IMAGE REFERENCE: ATB #2 STABILITY ANALYSIS BY CHA, SEISMIC CONDITION- UPSTREAM SLOPE.
