**Pennsylvania Department of Environmental Protection's Comments On:
Draft Report – Little Blue Run Dam Inspection Report
Bruce Mansfield Power Plant
Beaver County, Pennsylvania**

The Draft Report has been prepared for the U.S. Environmental Protection Agency, Washington, D.C., by CHA.

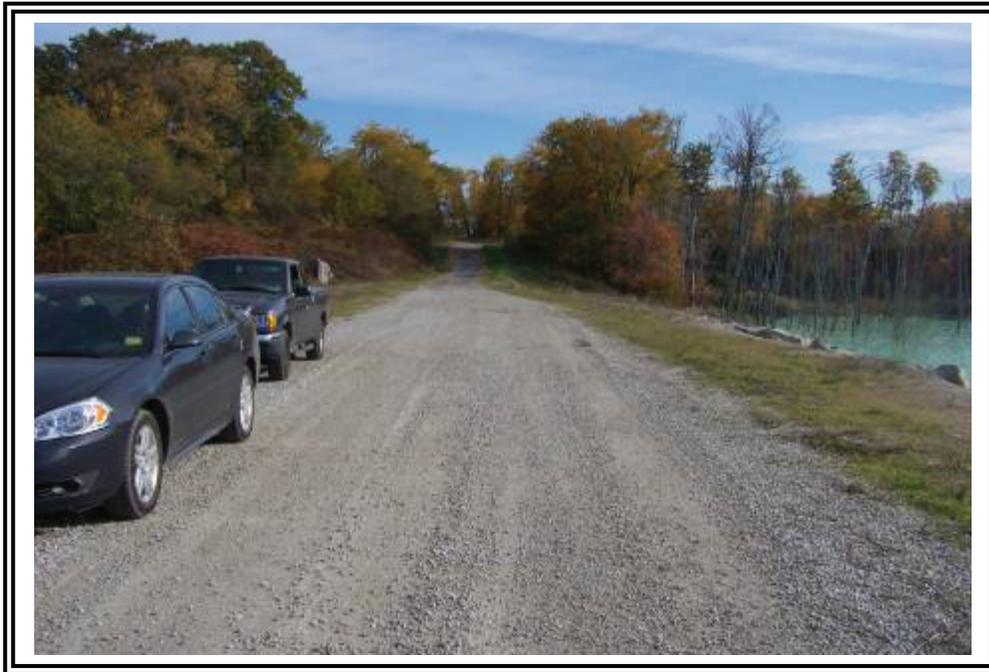
2

Crest and east abutment, looking east.

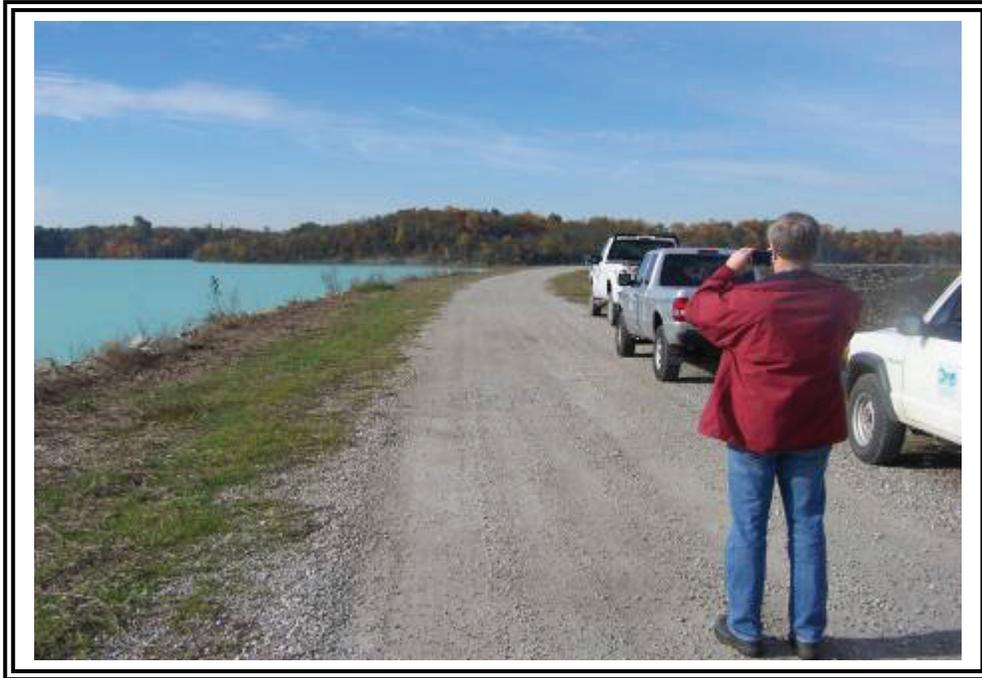
3

Dam crest, looking southwest.

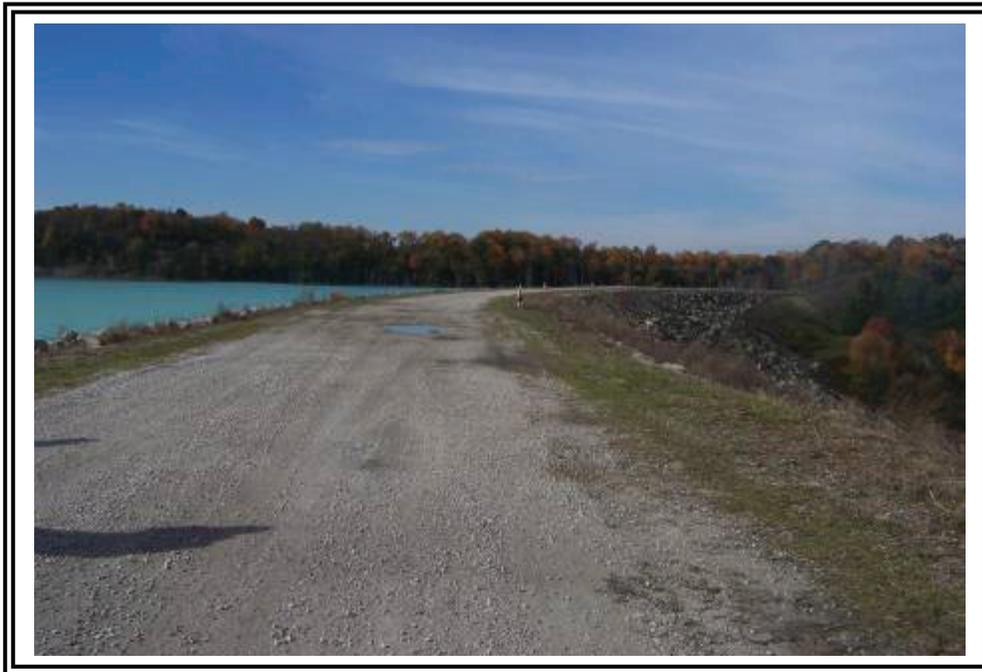
4

Dam crest, looking west.

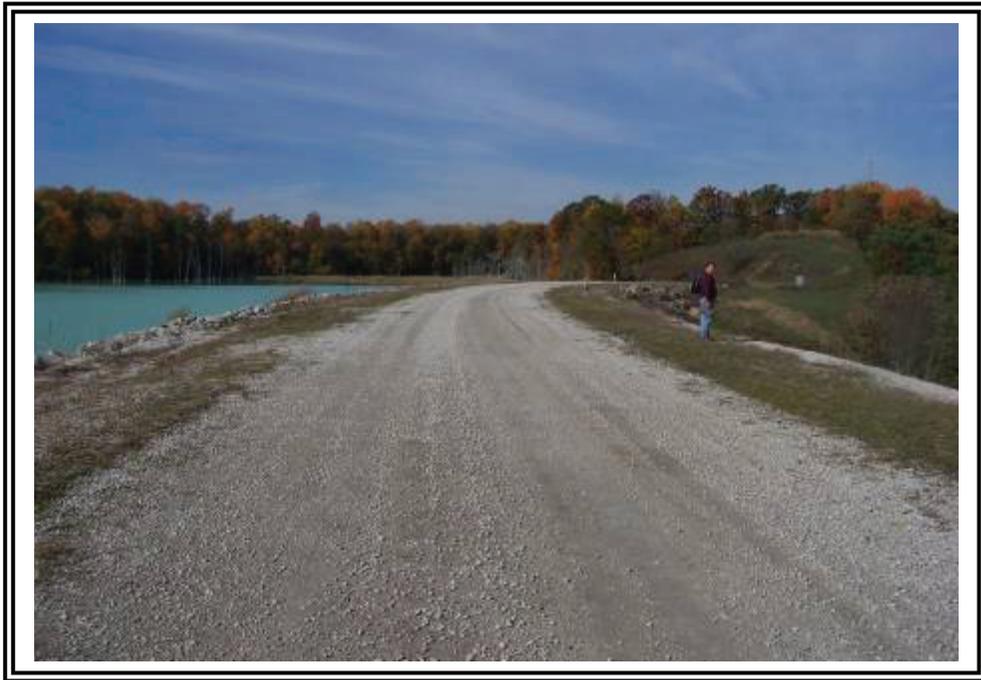
5

Dam crest, looking west.

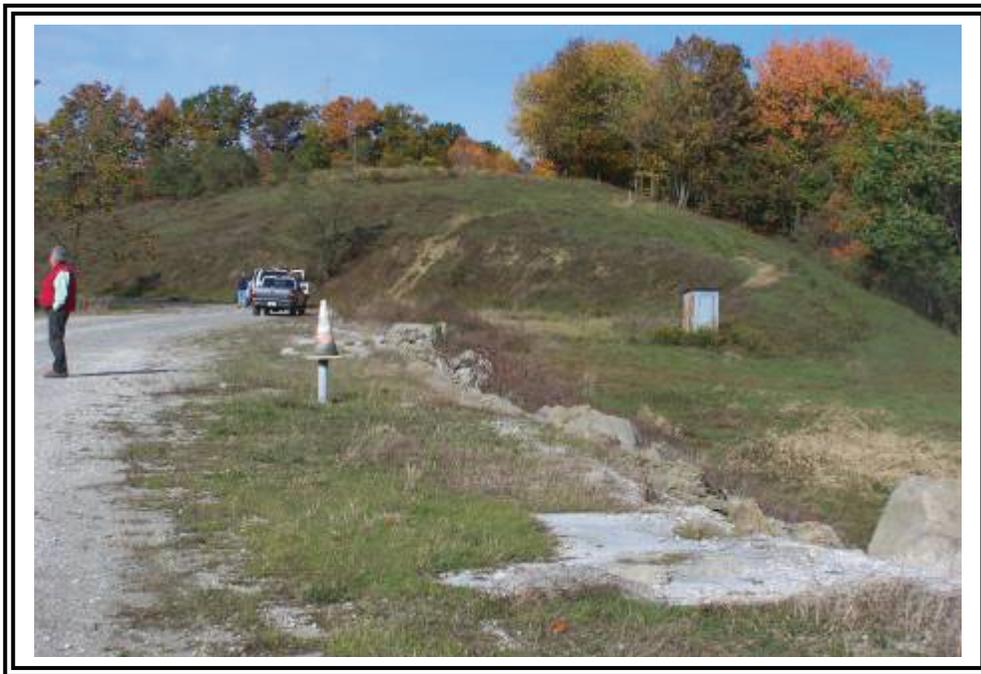
6

West abutment, looking west.

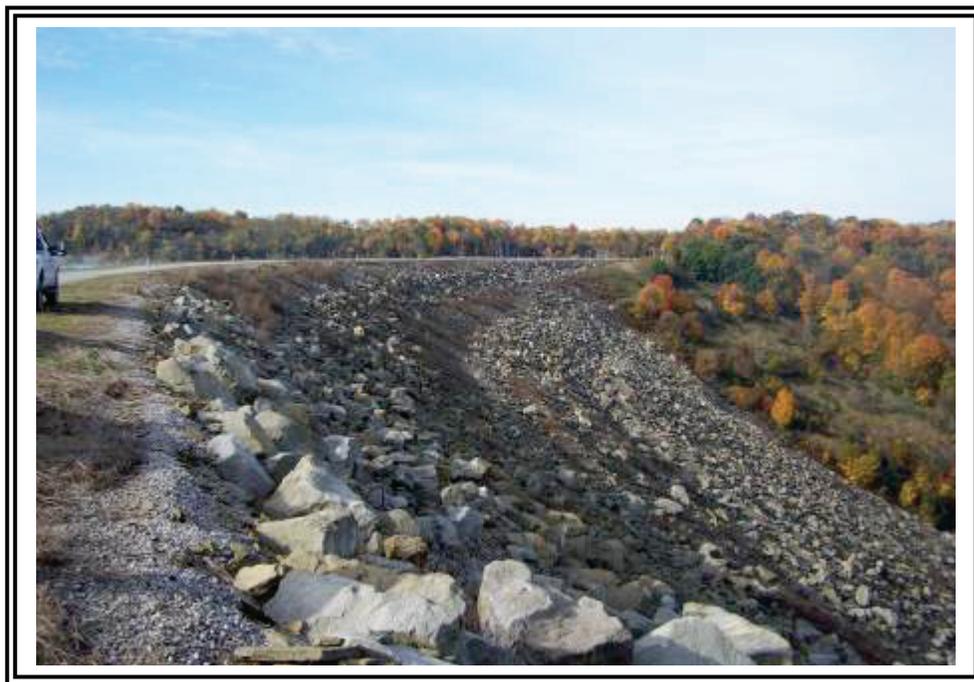
7

Downstream slope, looking west.

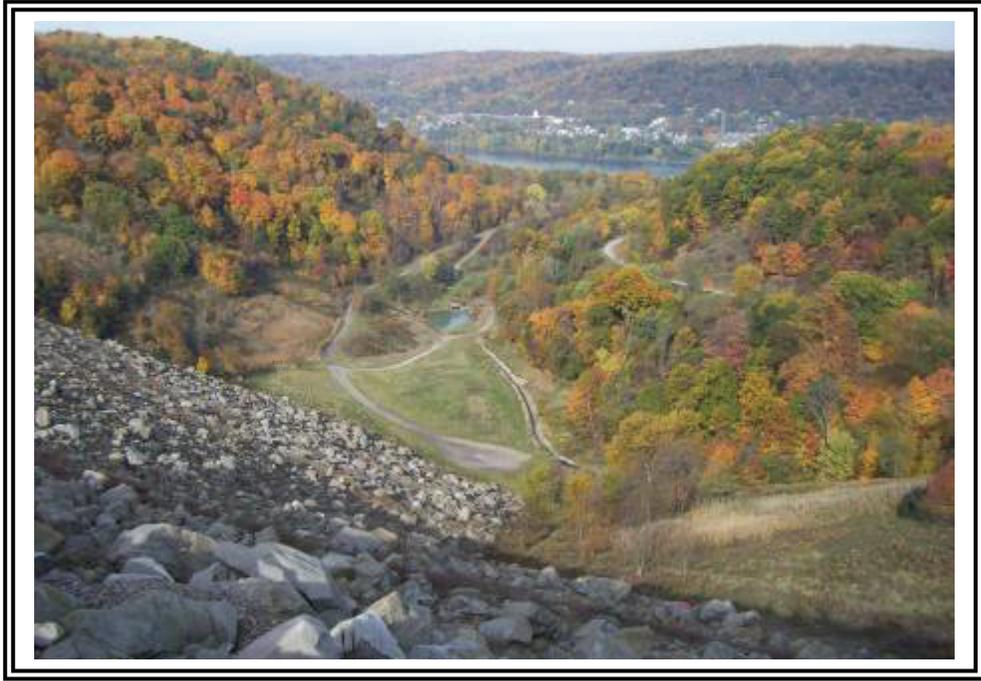
9

Downstream slope looking north at toe and stilling basin.

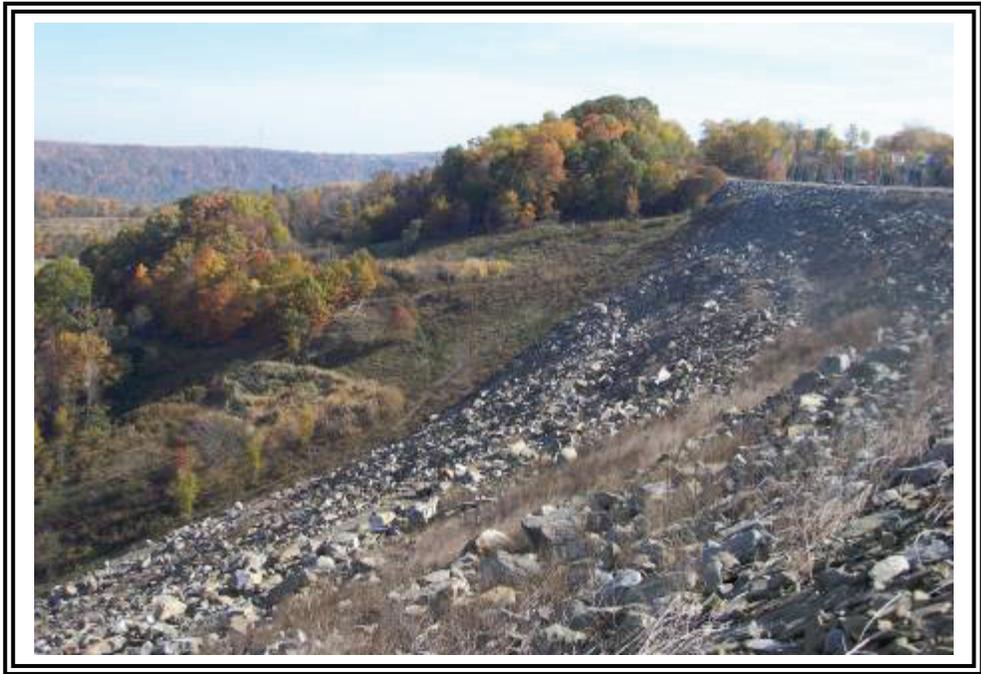
10

East abutment contact with downstream slope, looking east.

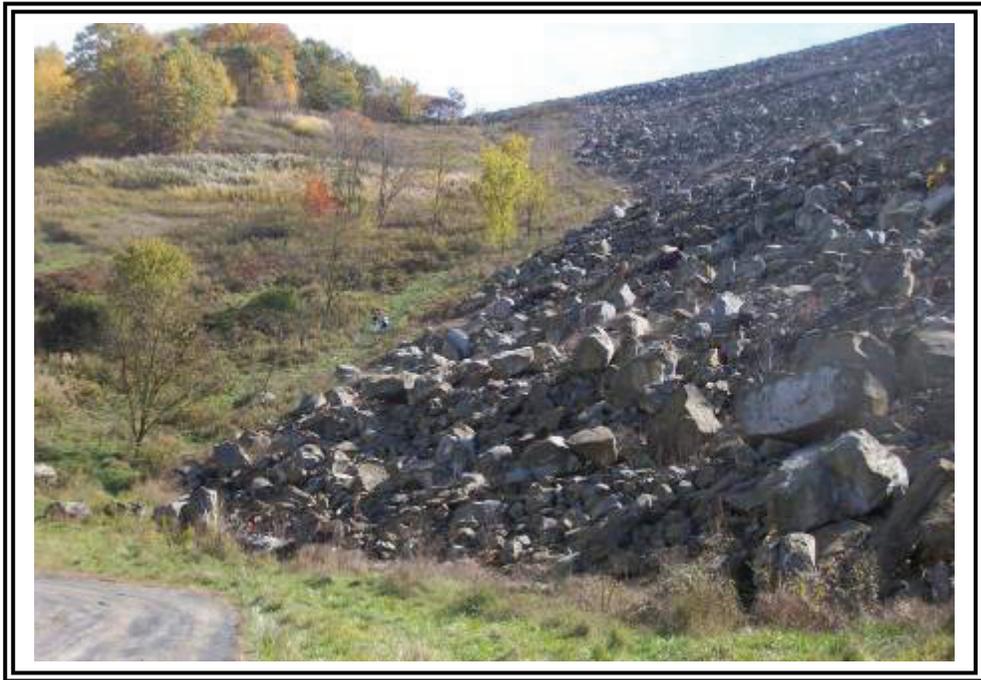
11

East abutment contact with downstream slope, looking up from the toe.

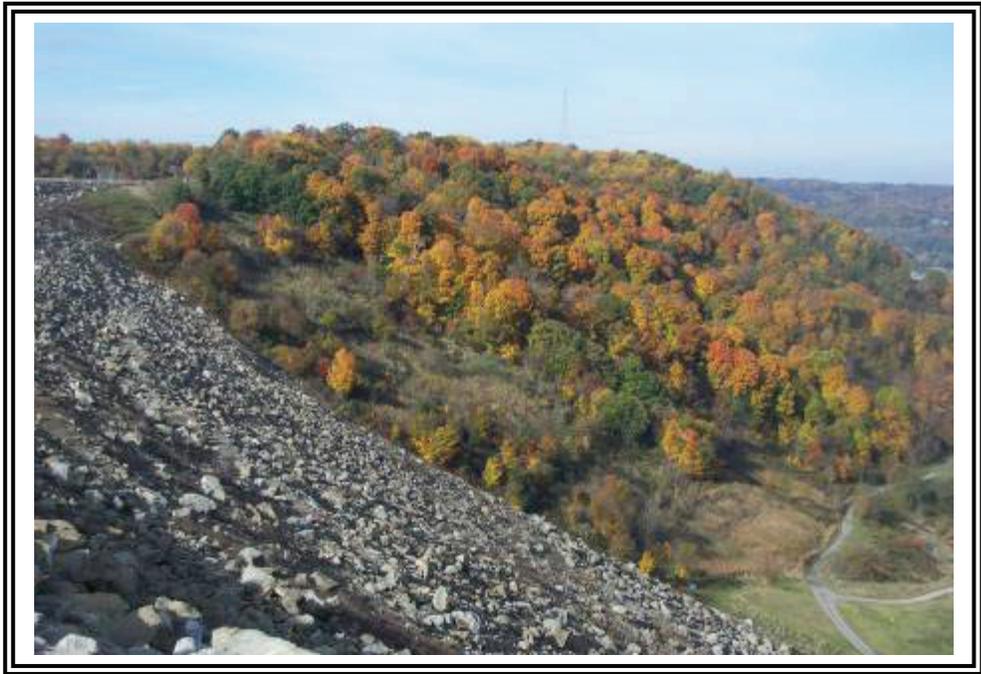
12

West abutment contact with downstream slope, looking west.

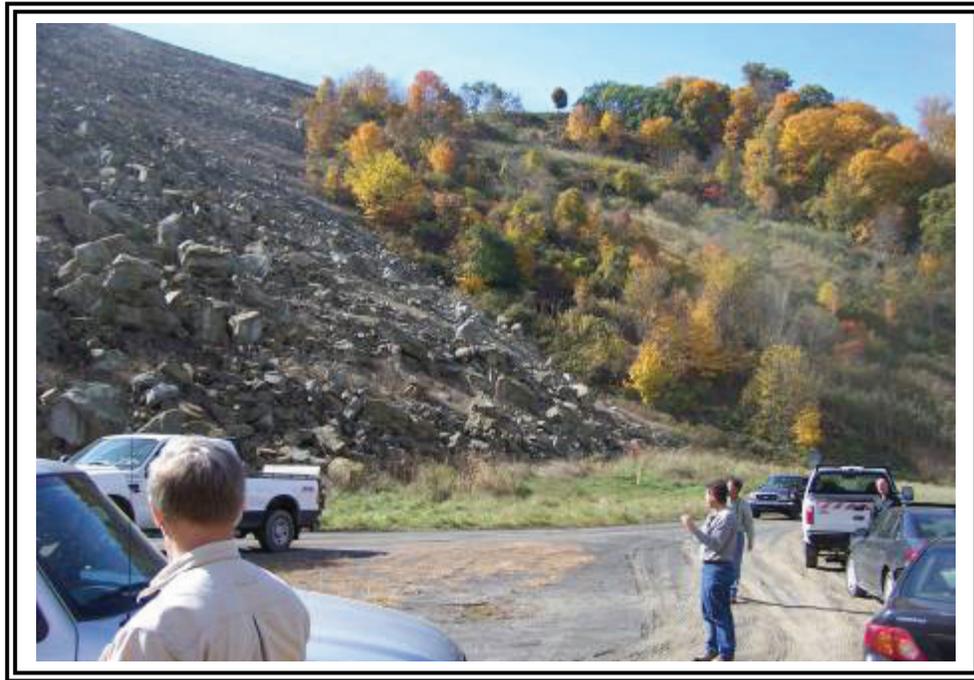
13

West abutment contact with downstream slope, looking up from the toe.

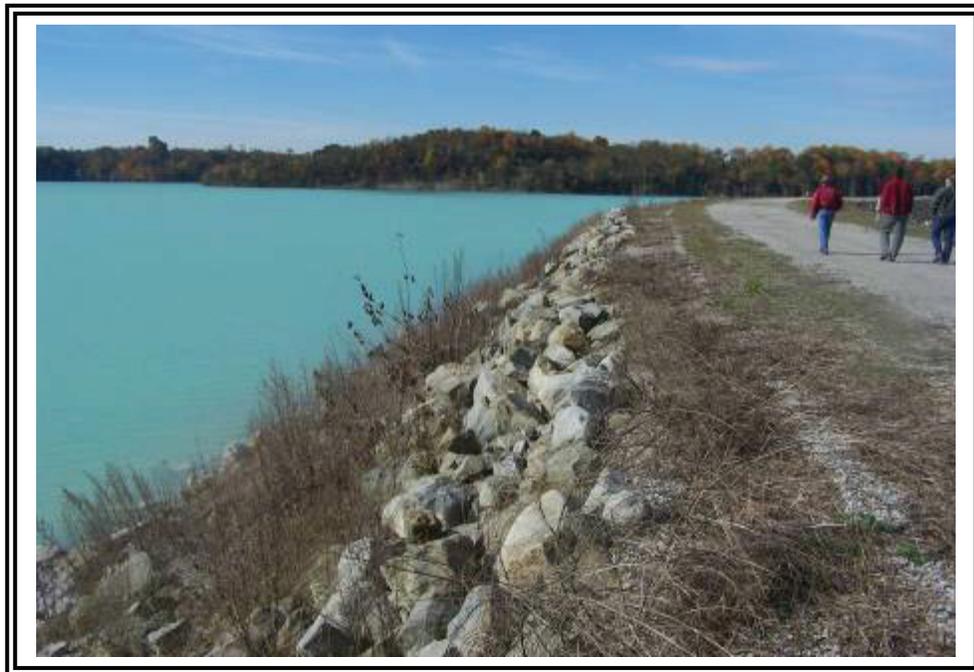
14

Upstream slope, looking southwest.

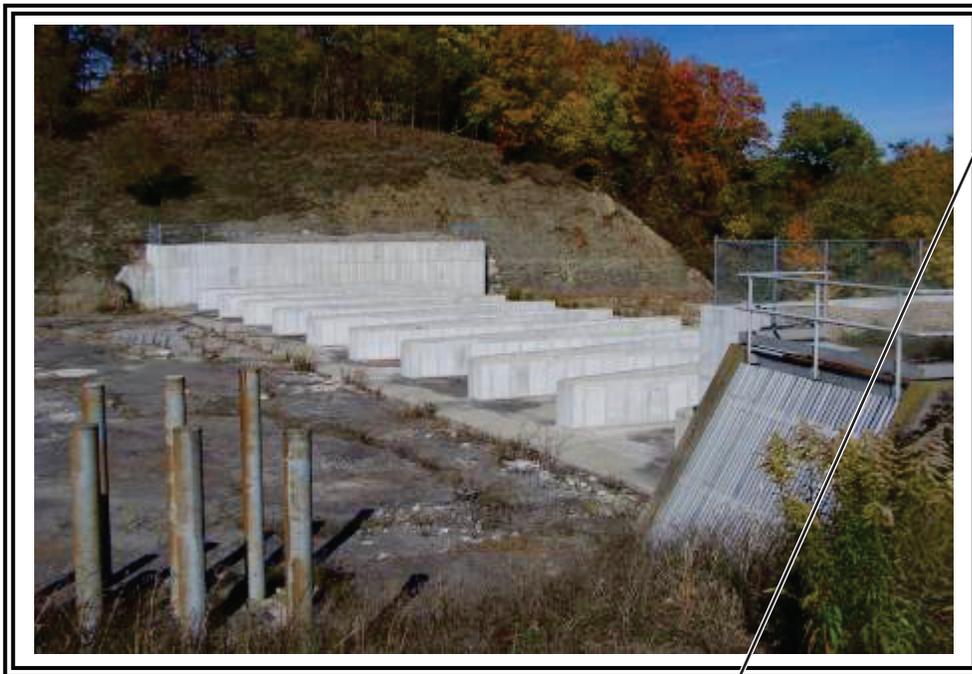
16

Service spillway and emergency spillway.

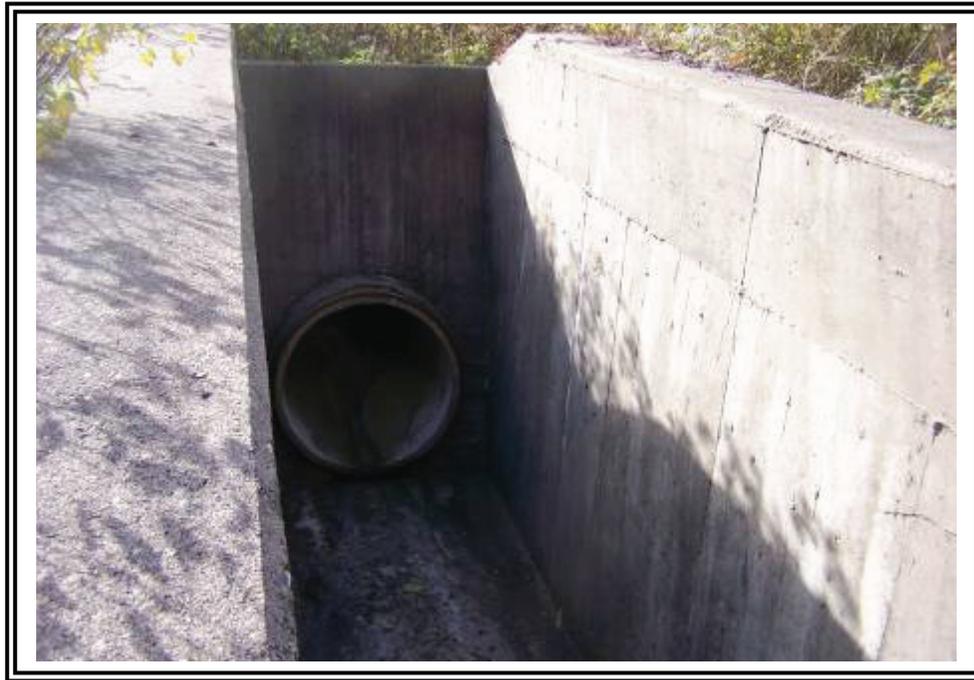
17

Terminus of service spillway at stilling basin.

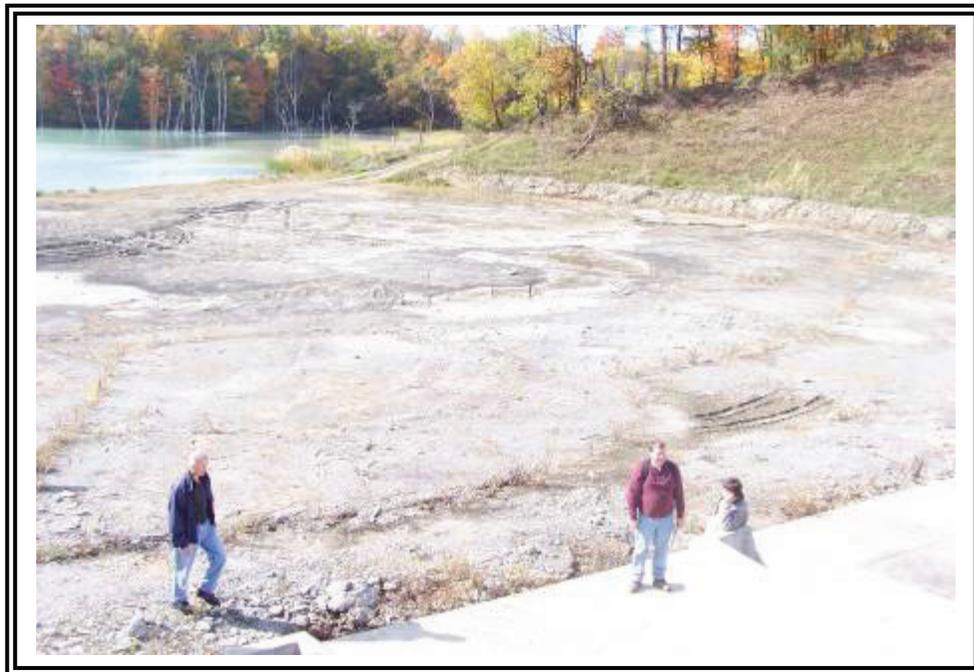
18

Approach to emergency spillway in bedrock.

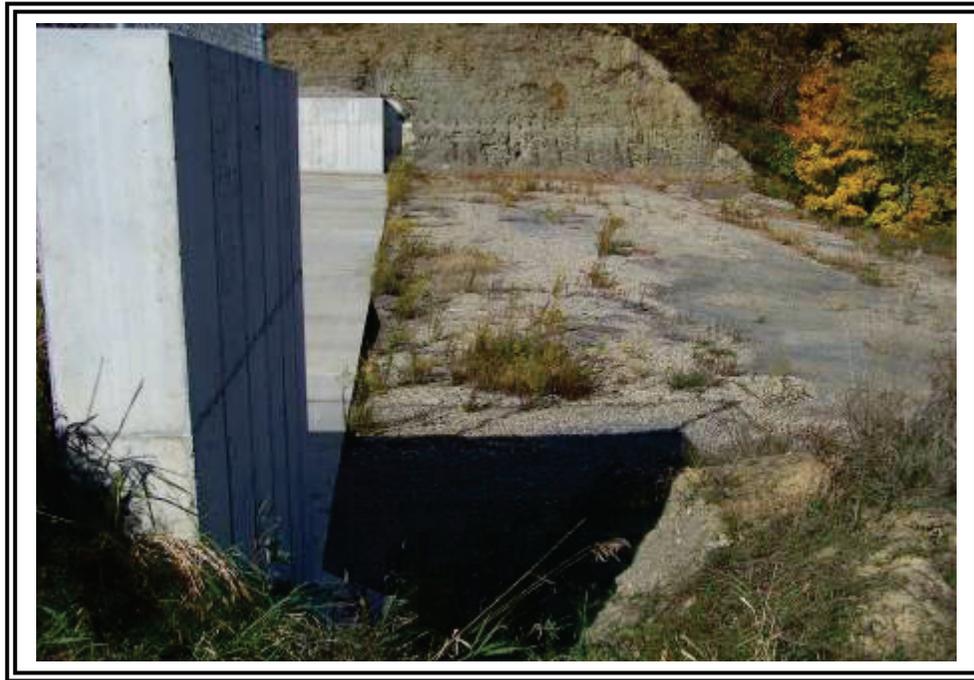
19

Downstream channel of emergency spillway.

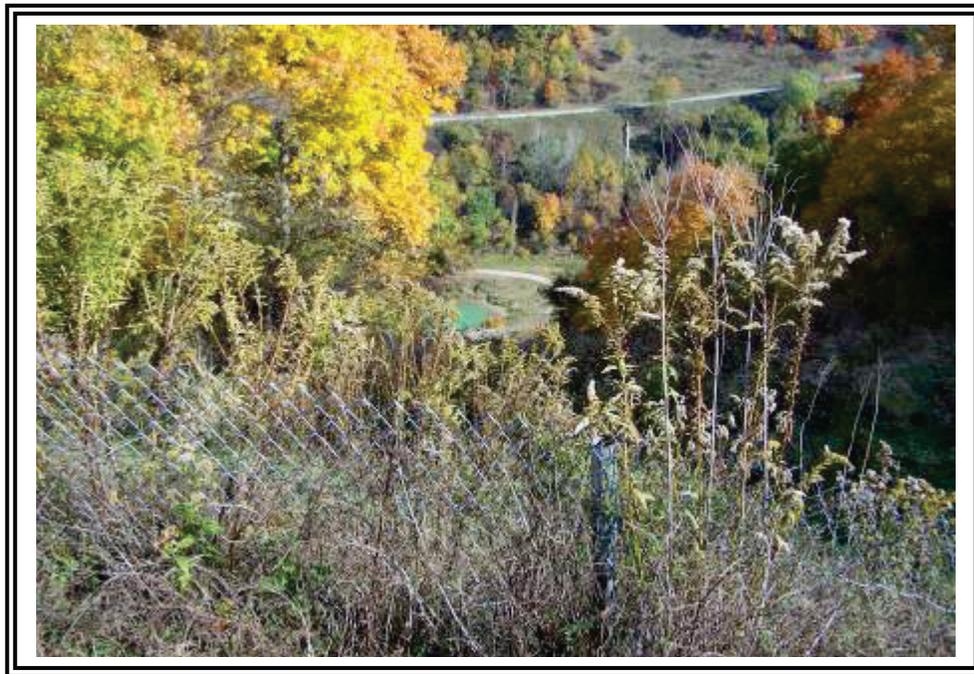
20

Emergency spillway channel over natural slope, looking downstream from the labyrinth weir.

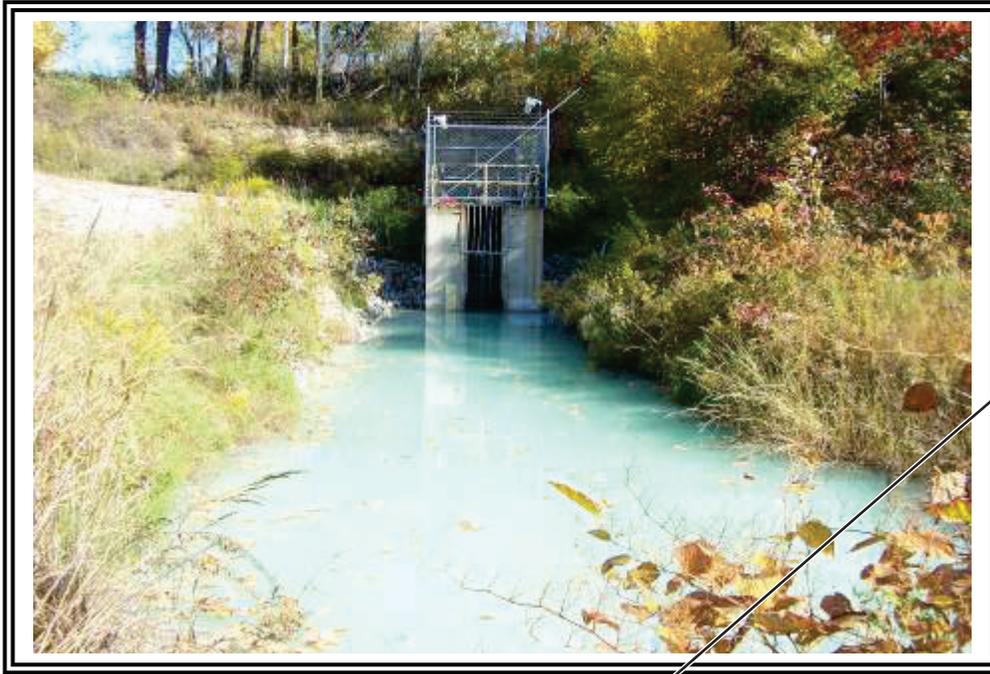
23

Secondary spillway.

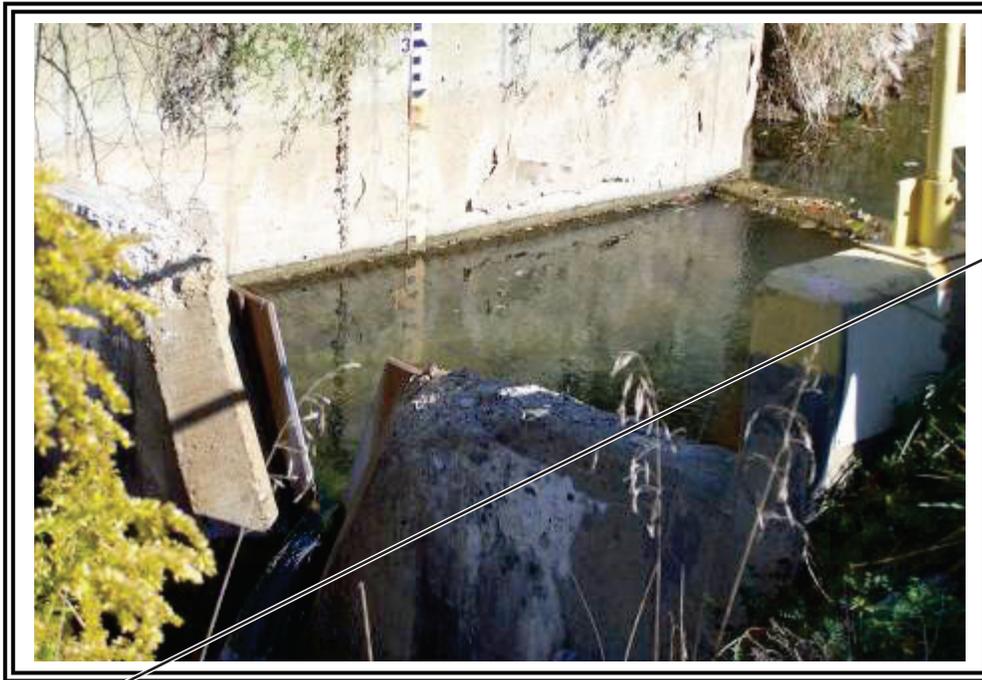
25

V-notch monitoring weir containing secondary spillway and east abutment seepage flow.

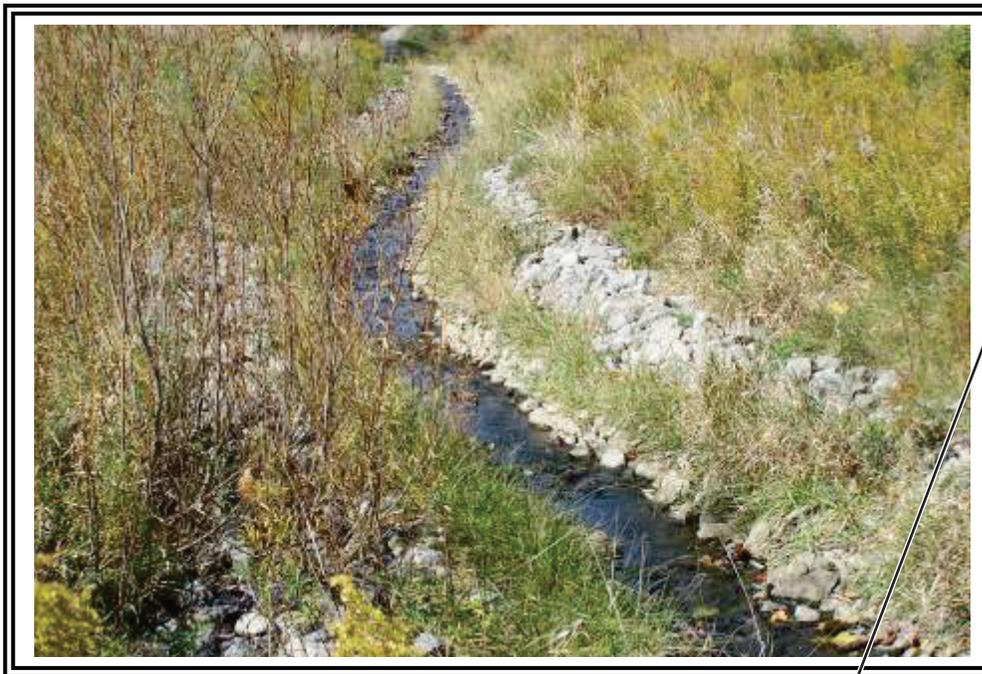
26

Channel downstream of east abutment v-notch to stilling basin.

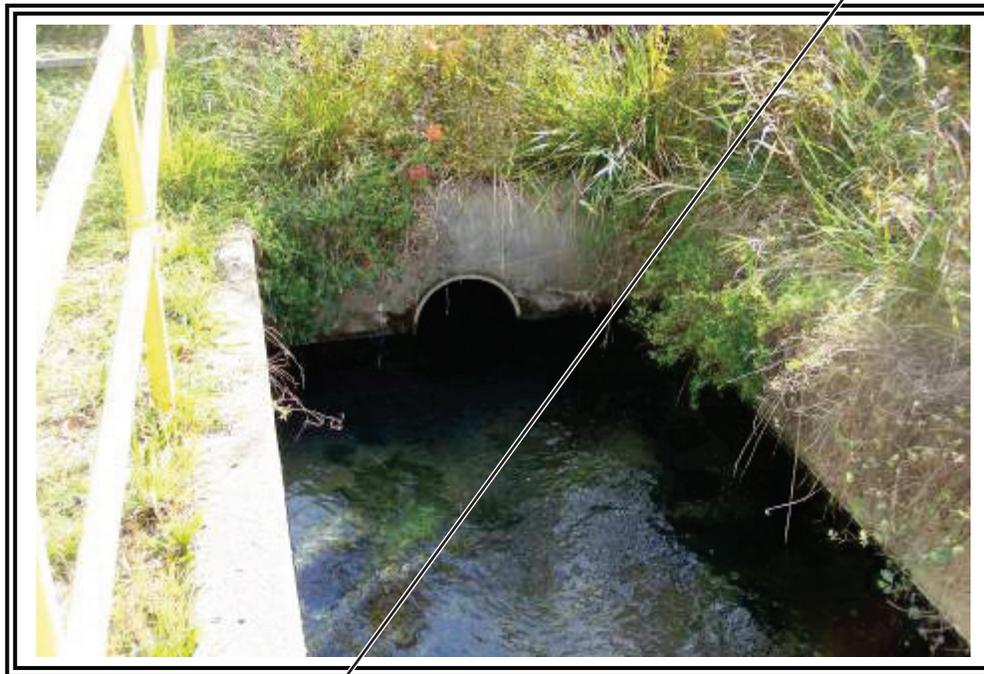
28

Toe drain collection pipe terminating in Parshall Flume.

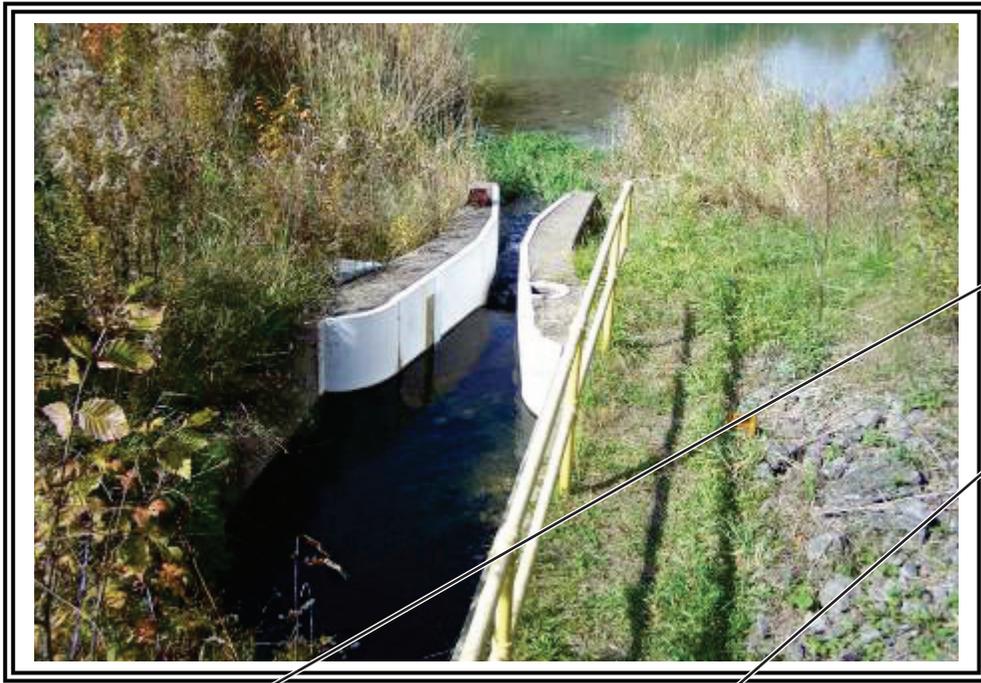
29

Parshall flume monitoring point for blanket drain seepage.

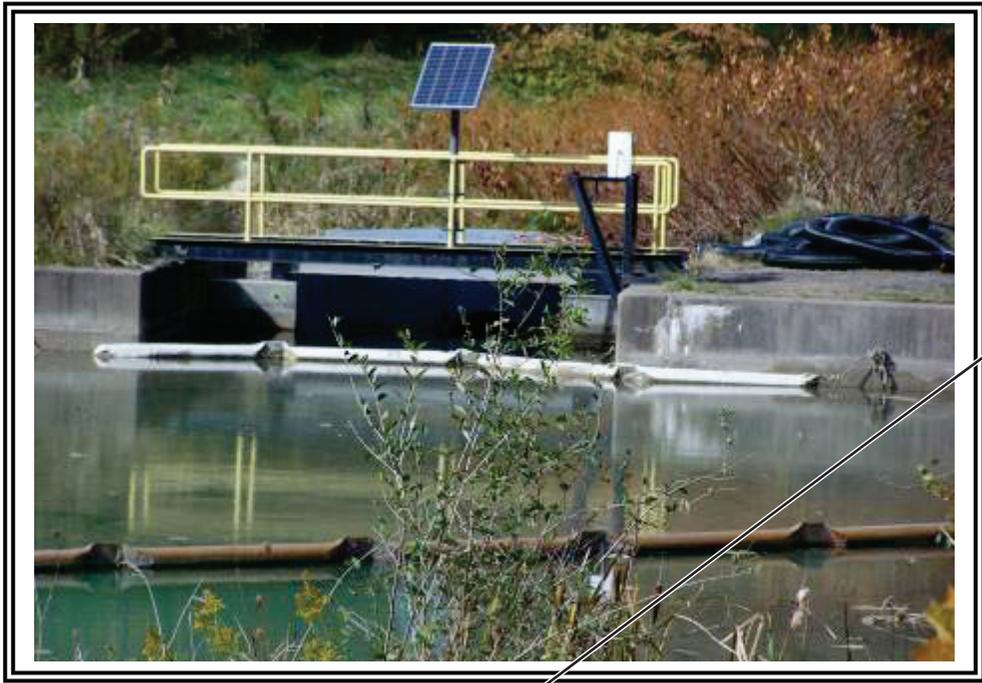
31

Stilling basin sediment control.

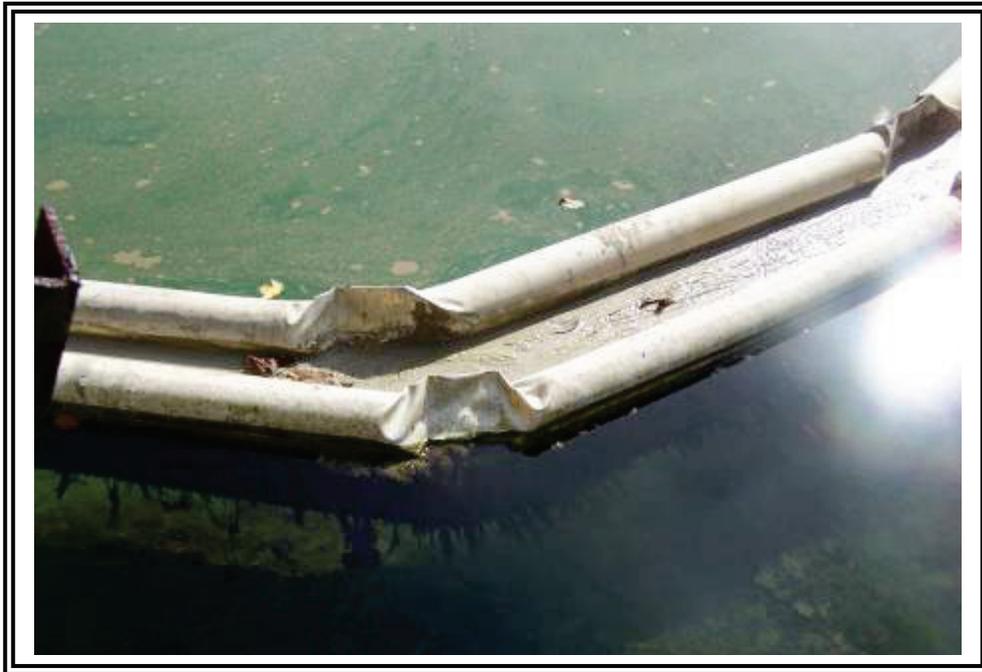
32

Water in stilling basin was clear at the time of our site visit,

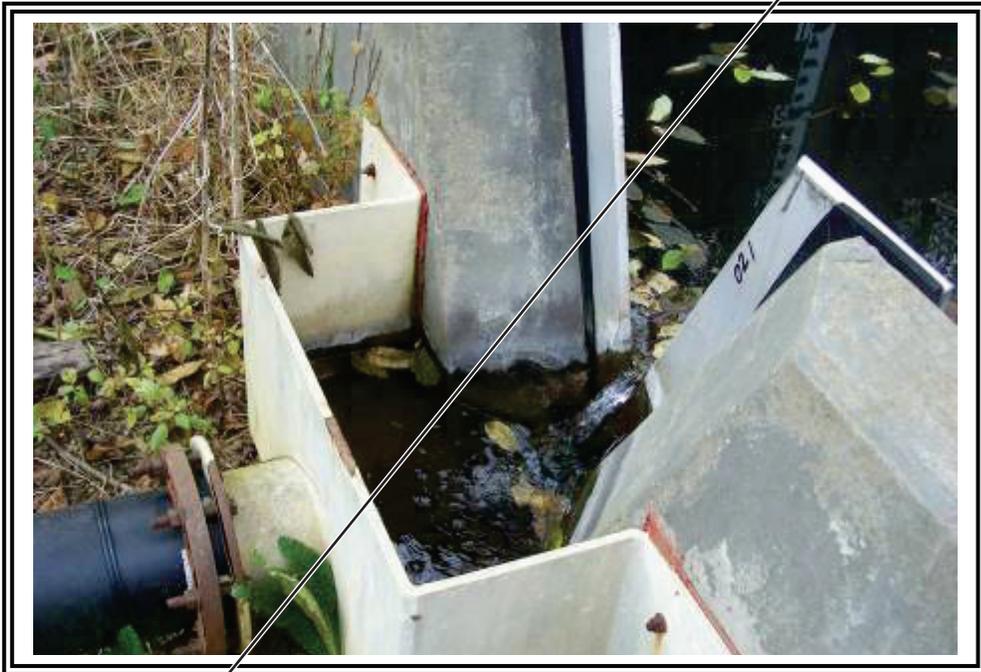
34

V-notch monitoring weir for lower left abutment seepage.

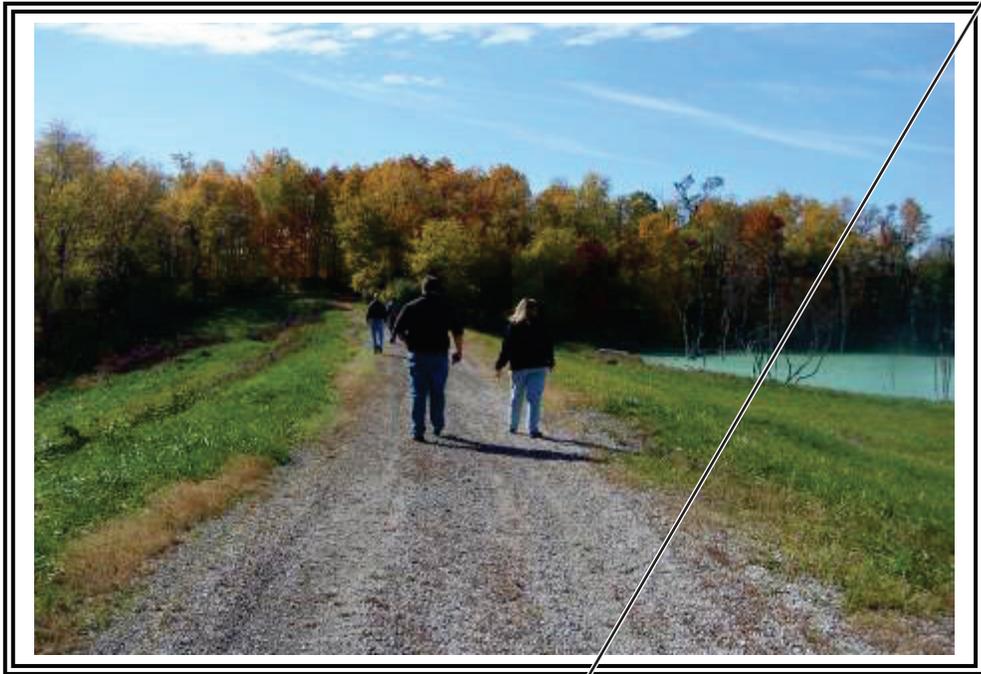
36

Crest of Little Blue Run Saddle ~~Dike~~, looking south.

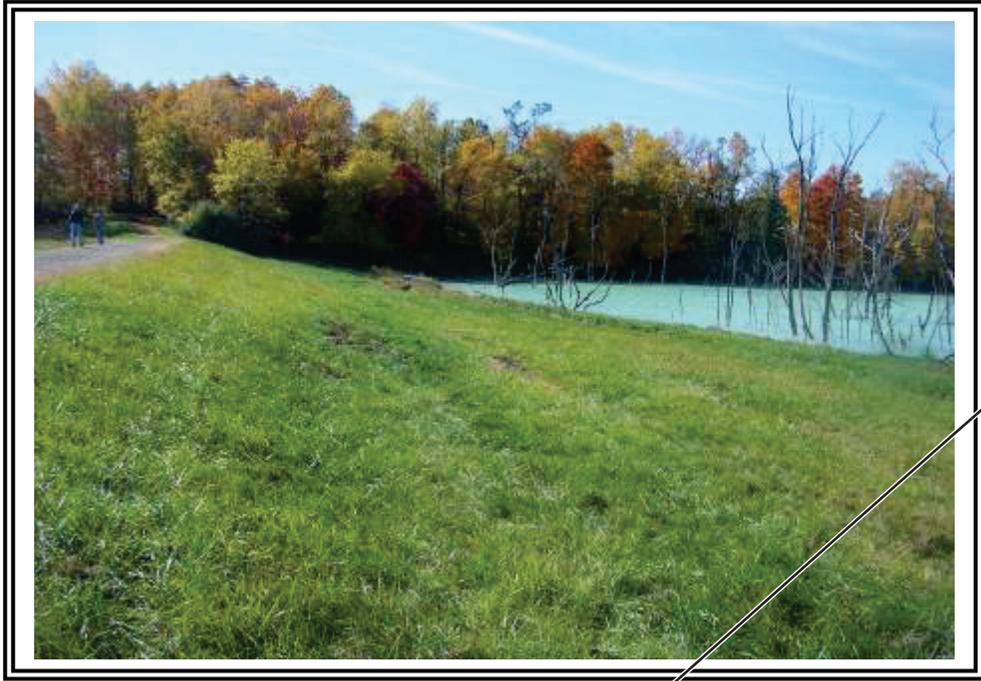
37

Upstream slope of Little Blue Run Saddle Dam, looking south.
