**TRANSMITTAL  
ASSESSMENT OF DAM SAFETY OF  
COAL COMBUSTION SURFACE IMPOUNDMENTS  
DRAFT INSPECTION REPORT  
SITE 30 (BRUCE MANSFIELD)**

**DAM SAFETY INSPECTION NOTICE**

DEP Office	SWRO- PITTSBURGH Phone 4124424000	Dam Permit or ID. #	D04-049
Address	400 WATERFRONT DR BH PA 15222	Dam or Project Name	LITTLE BLUE RUN
Owner or Permittee	FIRST ENERGY GENERATION CORPORATION	County	BEAVER
Complete Mailing Address	BRUCE MANFIELD PLANT PO Box 128 SHIPPINGPORT PA 15077-0128	Municipality	GREENE TOWNSHIP
		Take GPS readings at the center of the crest of the dam.	
		Latitude:	40° 37' 40.14" N
		Longitude:	80° 30' 47.79" W

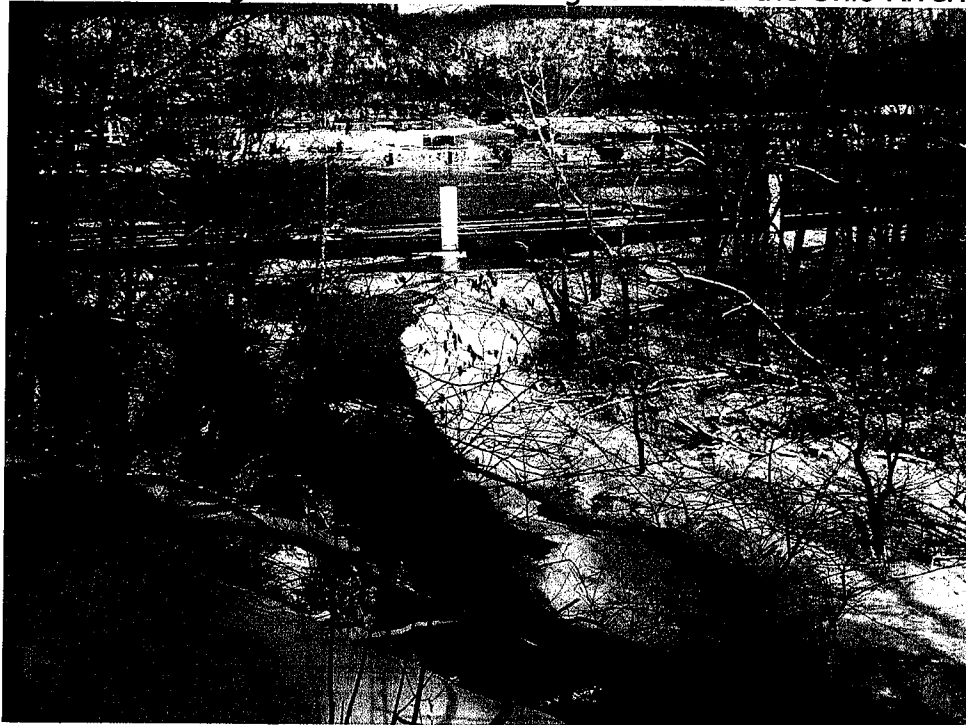
D04-049 01/21/09 Figure 15 View of discharge area near the Ohio River.

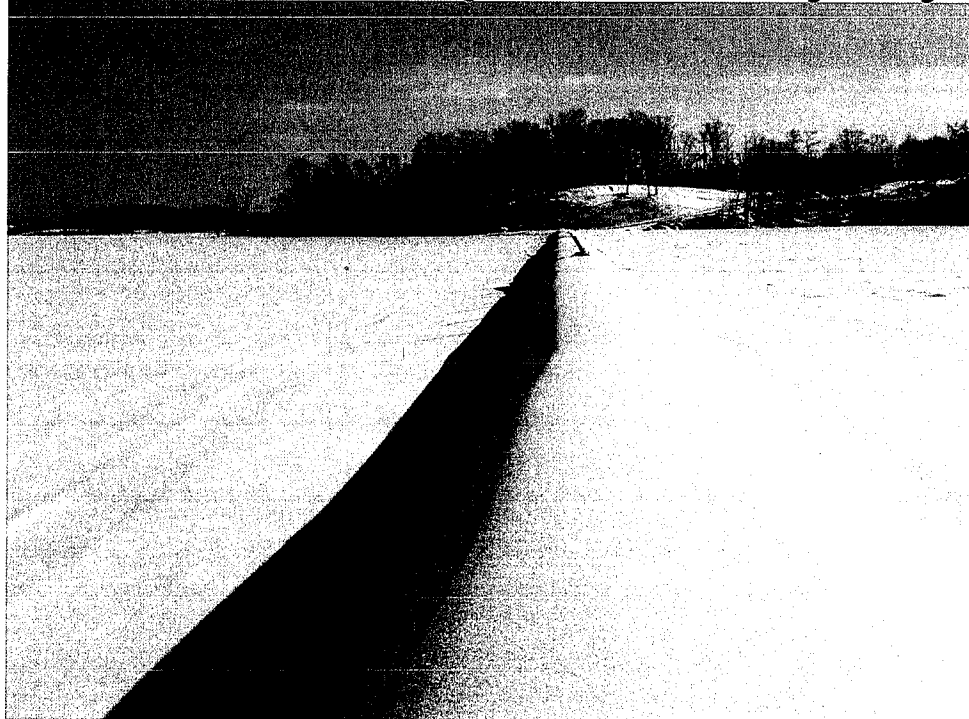
D04-049 01/21/09 Figure 22 View of geotube across West Virginia finger.

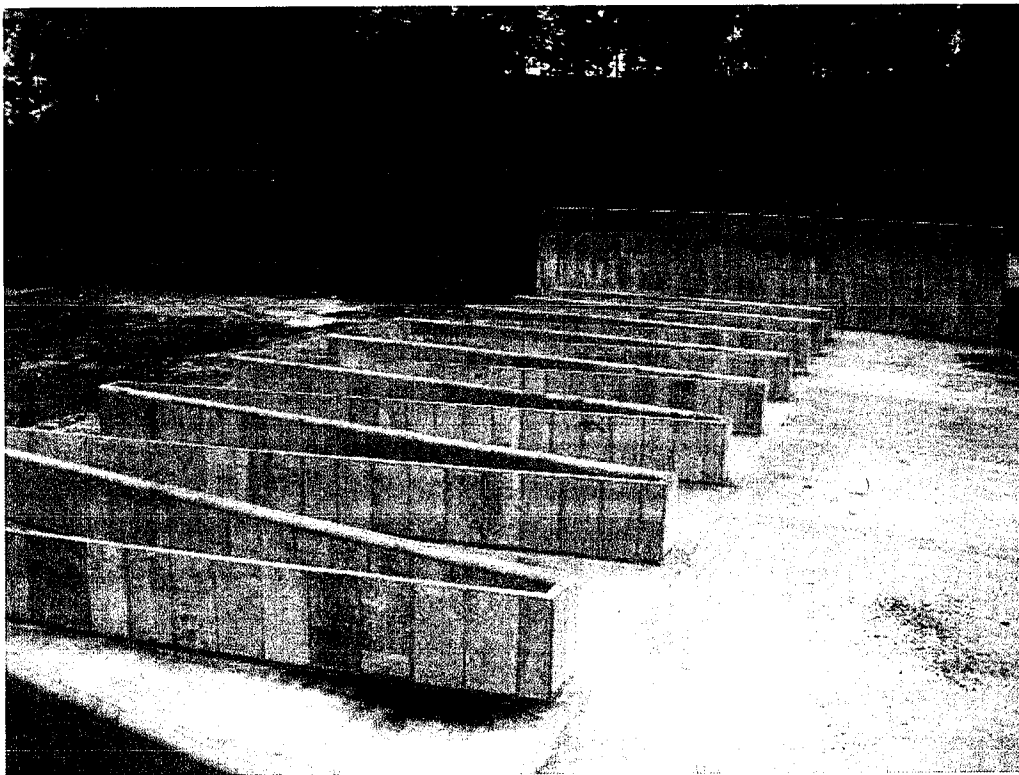
d04-049 10/23/07 DS end of spillway from left

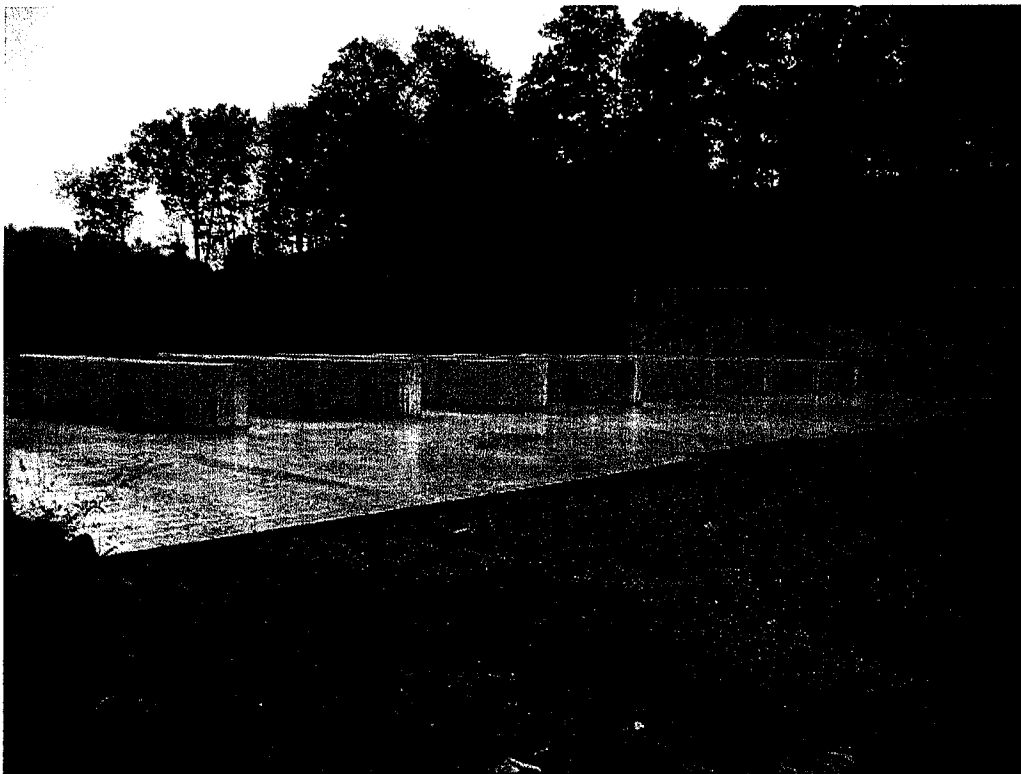
d04-049 10/23/07 DS end of spillway from left

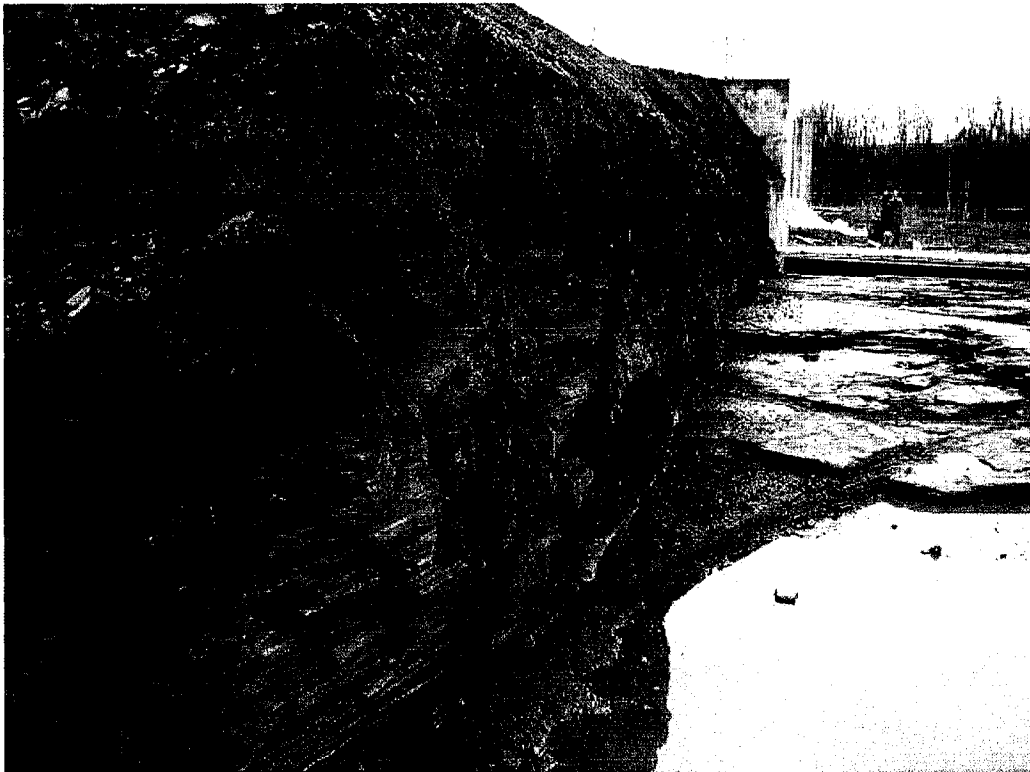
d04-049 11/20/06 looking from right DS notch US to existing wall

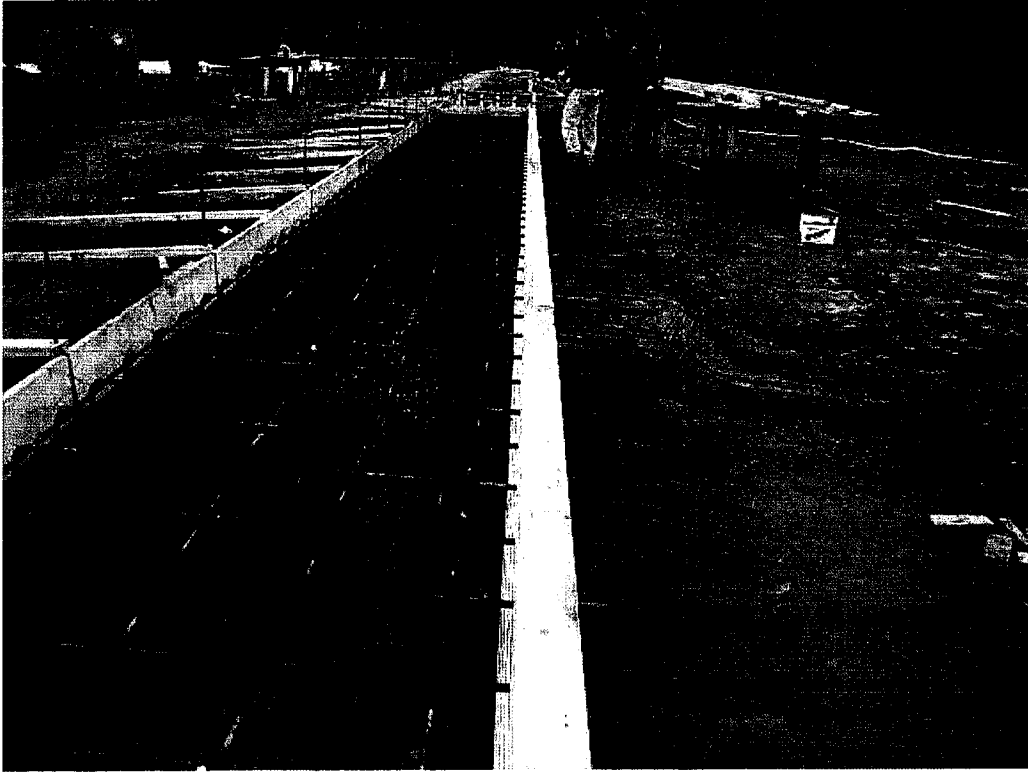
d04-049 11/20/06 forming looking toward left wall

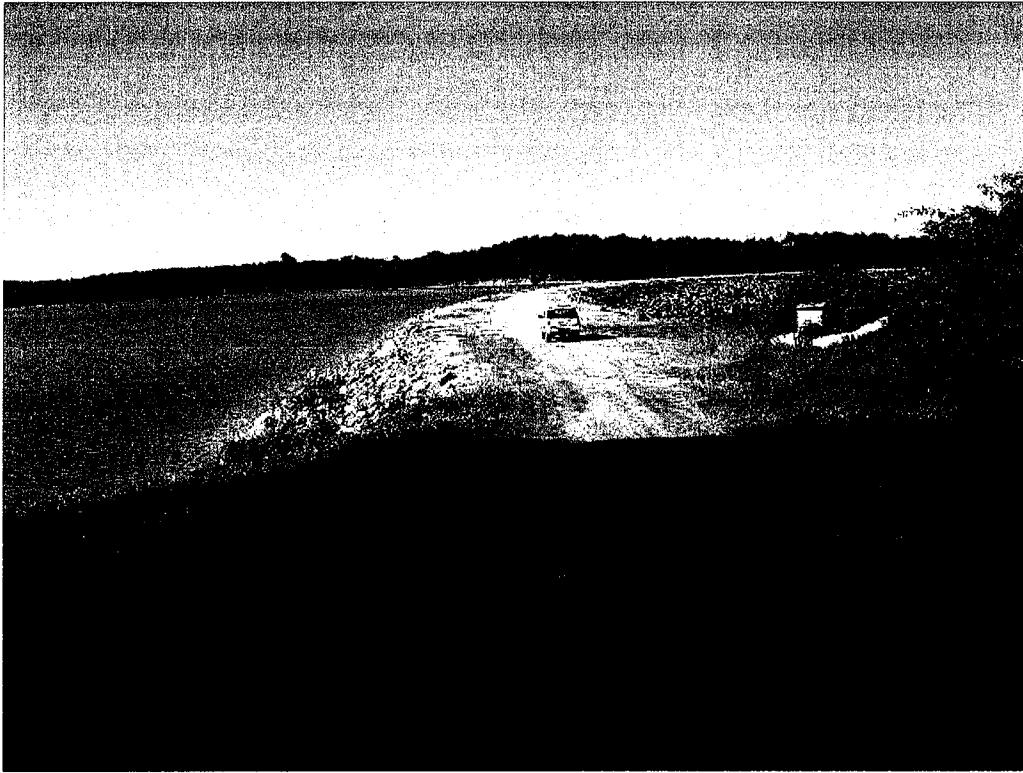
d04-049 9/21/06 US & crest from right

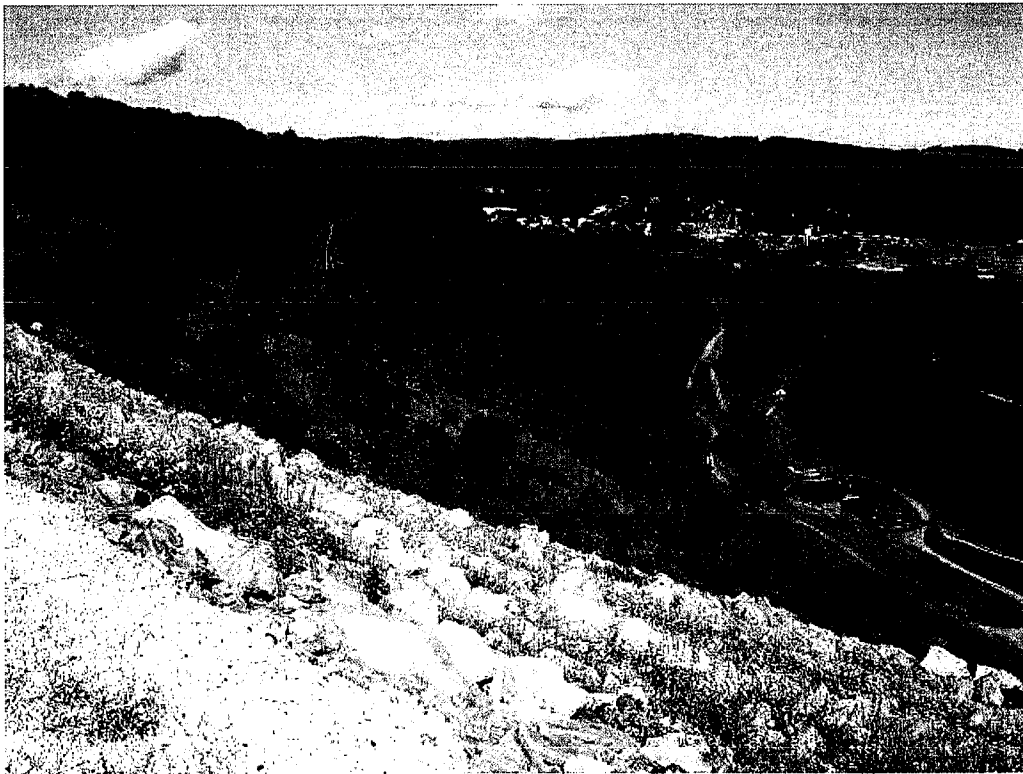
d04-049 9/21/06 left abutment from center crest

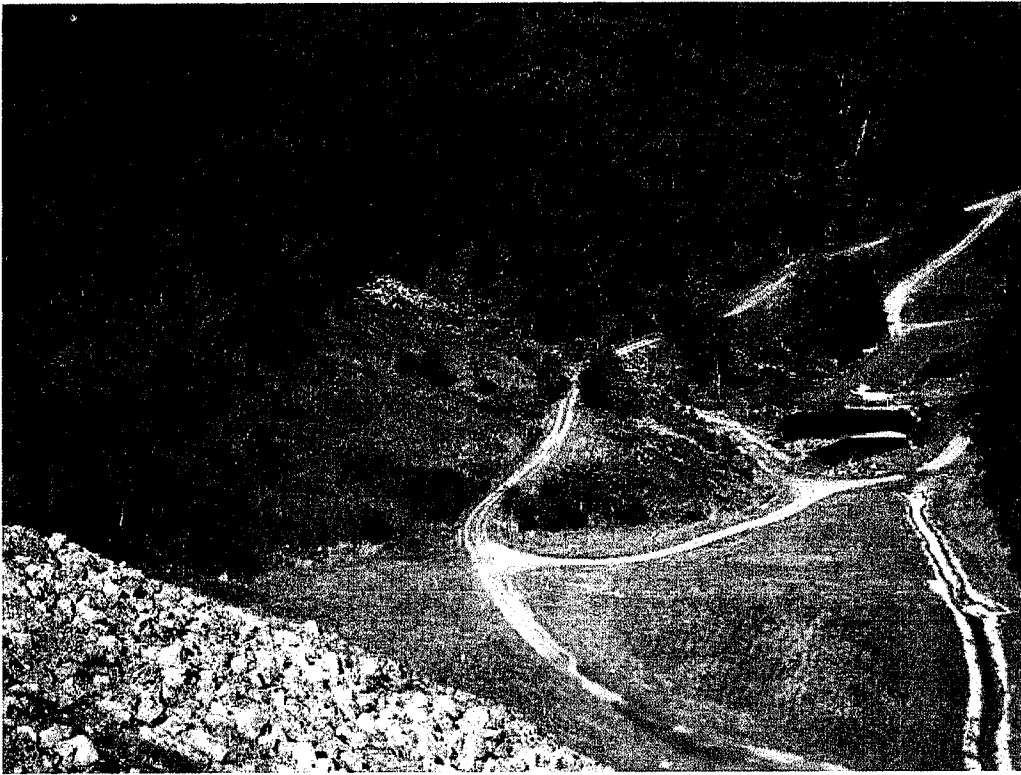
d04-049 9/21/06 toe from center

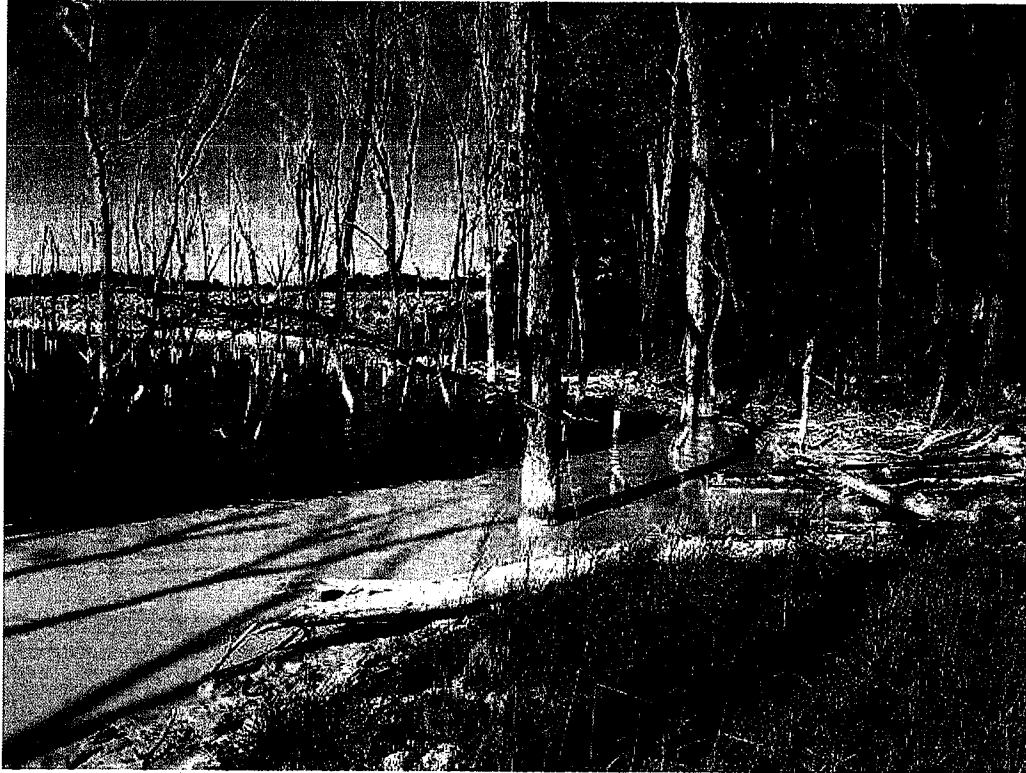
approach to right primary spillway

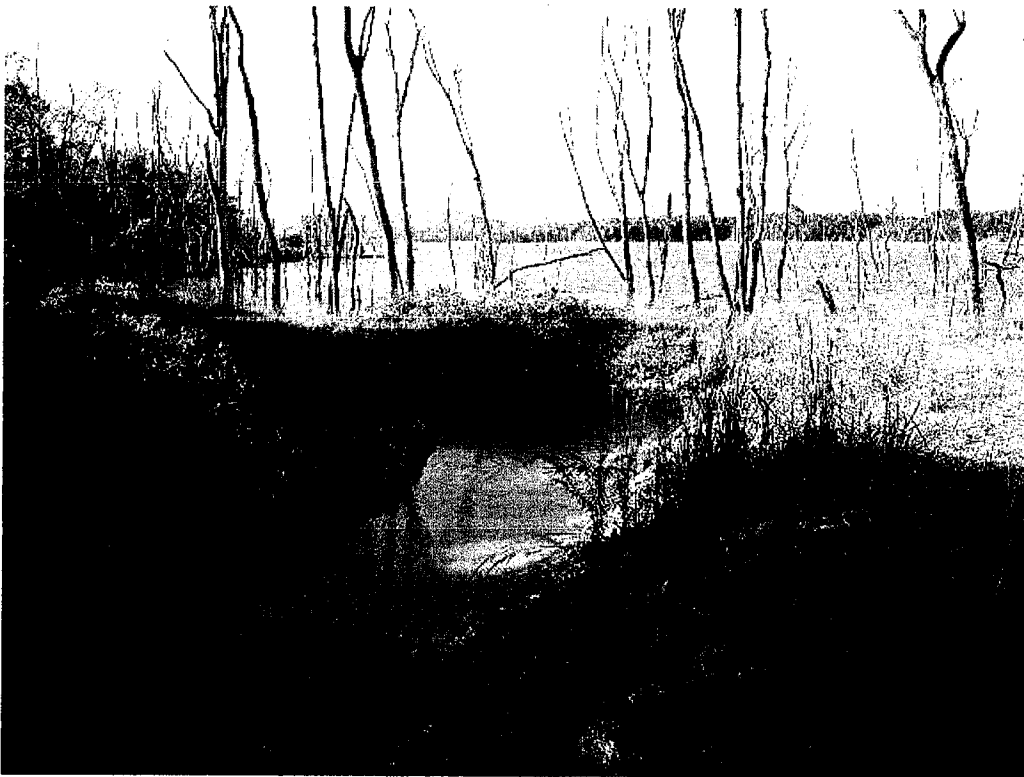
approach to right primary spillway

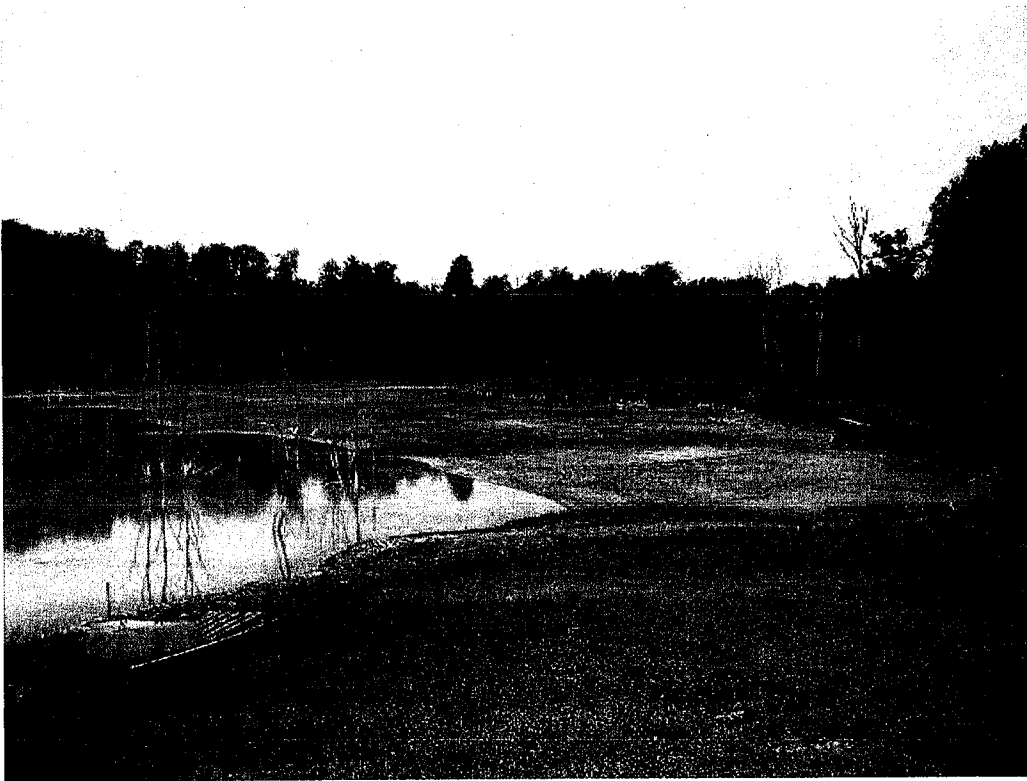
d04-049      8/29/05      left side of impoundment

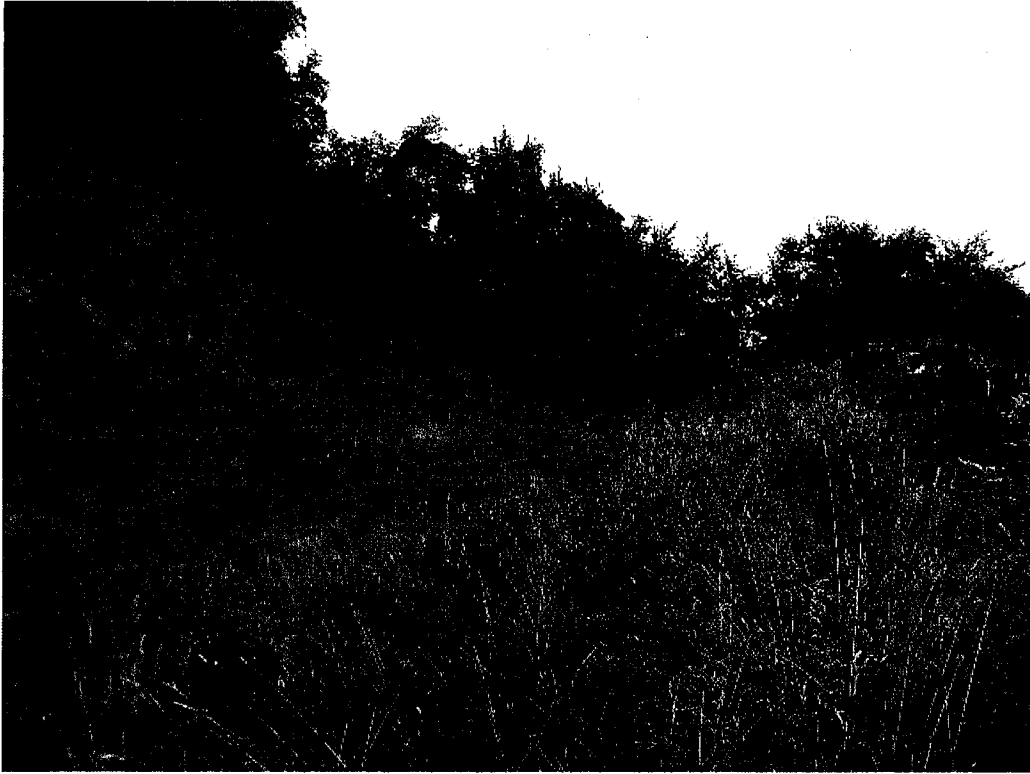
emergency spillway as it flows over left abutment

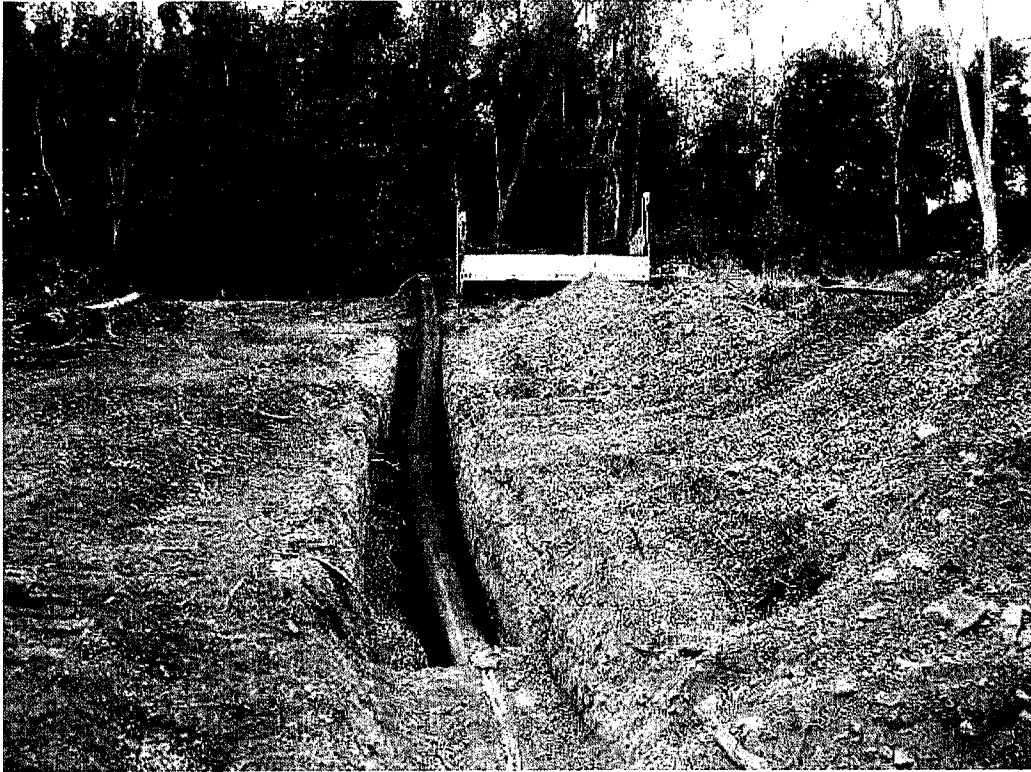
24" HPDE pipe from outlet box at elevation 1000
