# Assessment of Dam Safety

## Coal Combustion Surface Impoundments (Task 3)

Georgia Power  
Company

Plant Branch

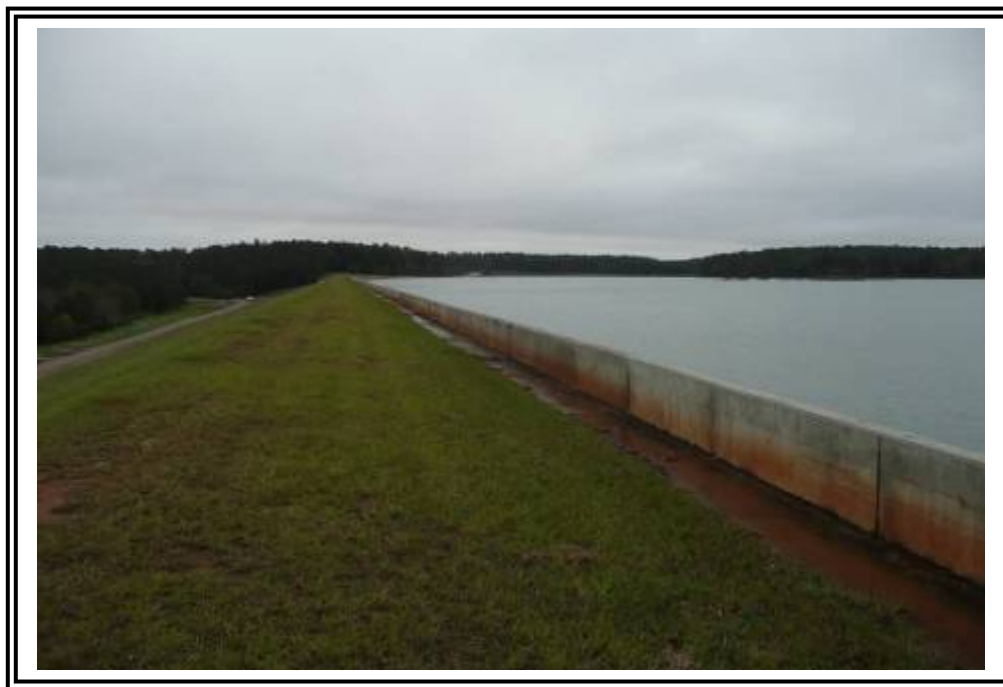
1

Northern end of Ash Pond E dike crest, facing south.

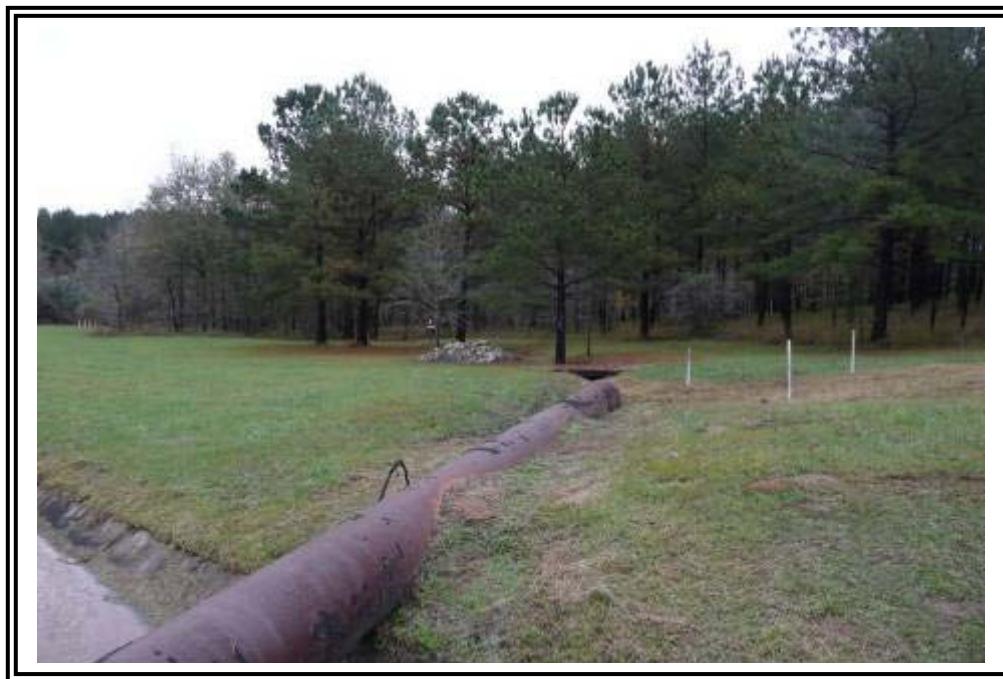
2

Ash Pond E abandoned overflow drain located along southern portion of the dike.  
The drain pipe is constructed of welded steel.

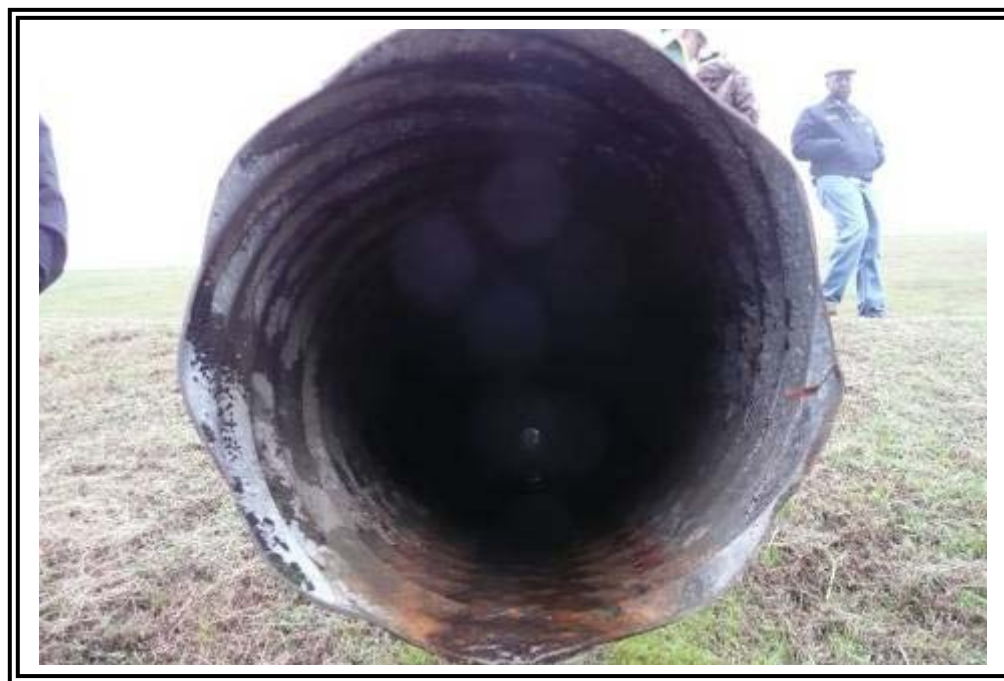
4

Corrugated metal drain pipe located north of Ash Pond E finger drain #11. Light can be seen at the western most end of the drain pipe, indicating a clear drainage channel from upper channel drain to lower channel drain.

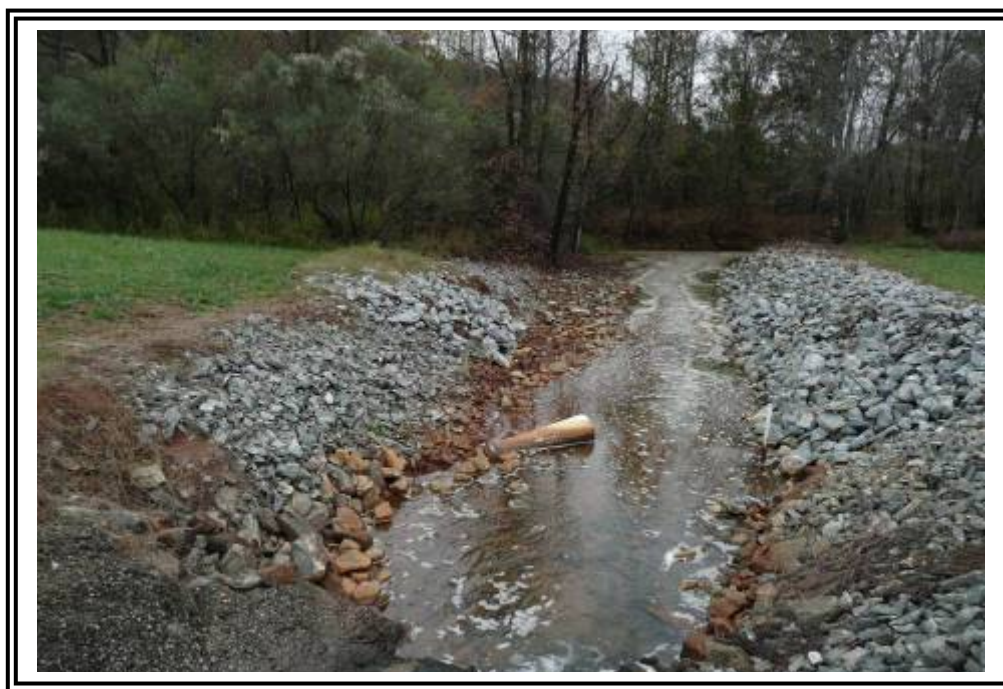
7

Ash Pond E, receiving stream for drainage from the blanket drain system.

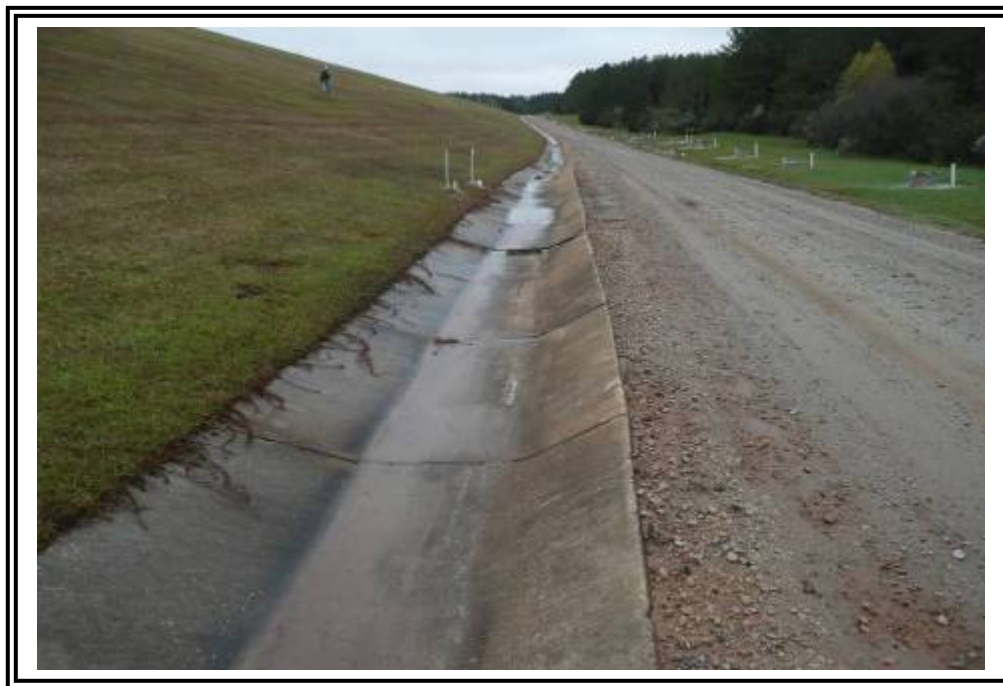
9

Ash Pond E, concrete lined channel drain at the base of the dike (upper channel).

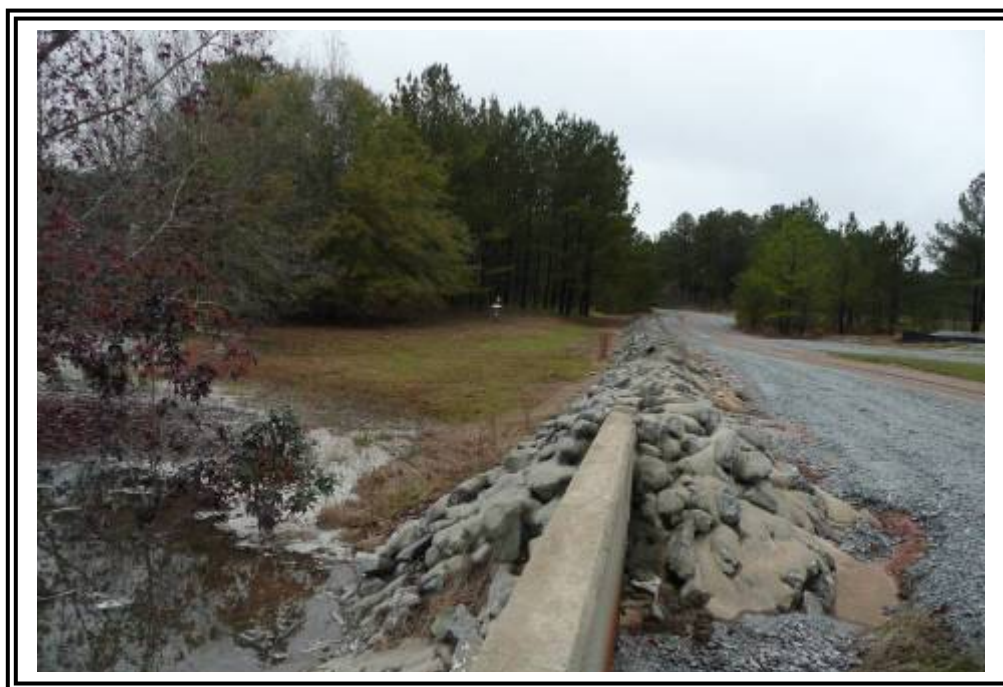
11

Ash Pond E, north end of dike, facing north.

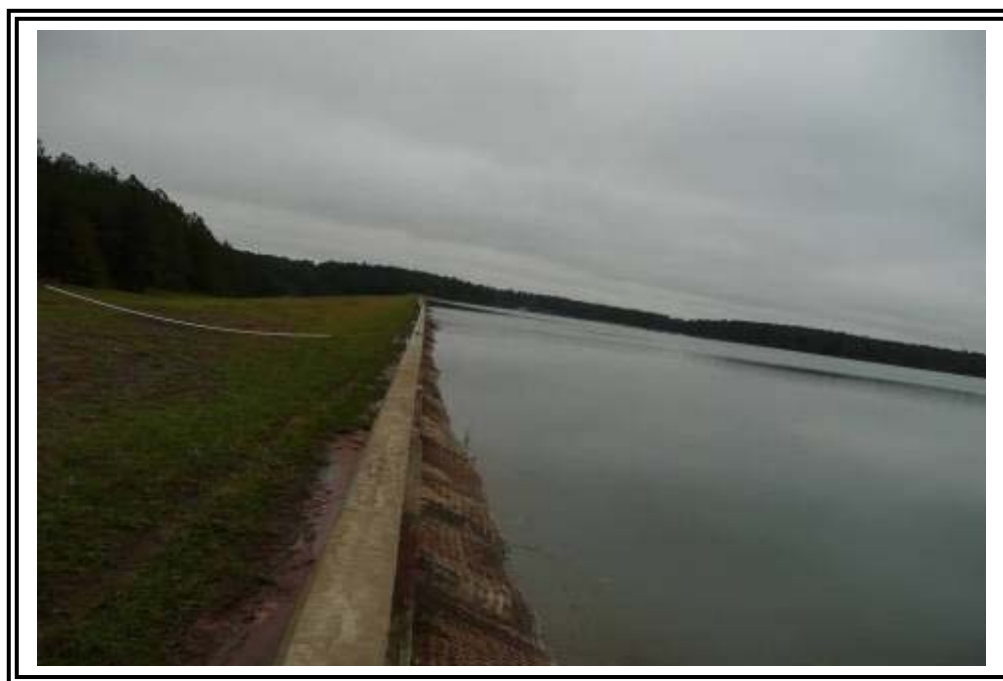
12

Ash Pond E, North end of dike, facing south. Shown above, wave wall and rip-rap placement along upstream edge of pond.

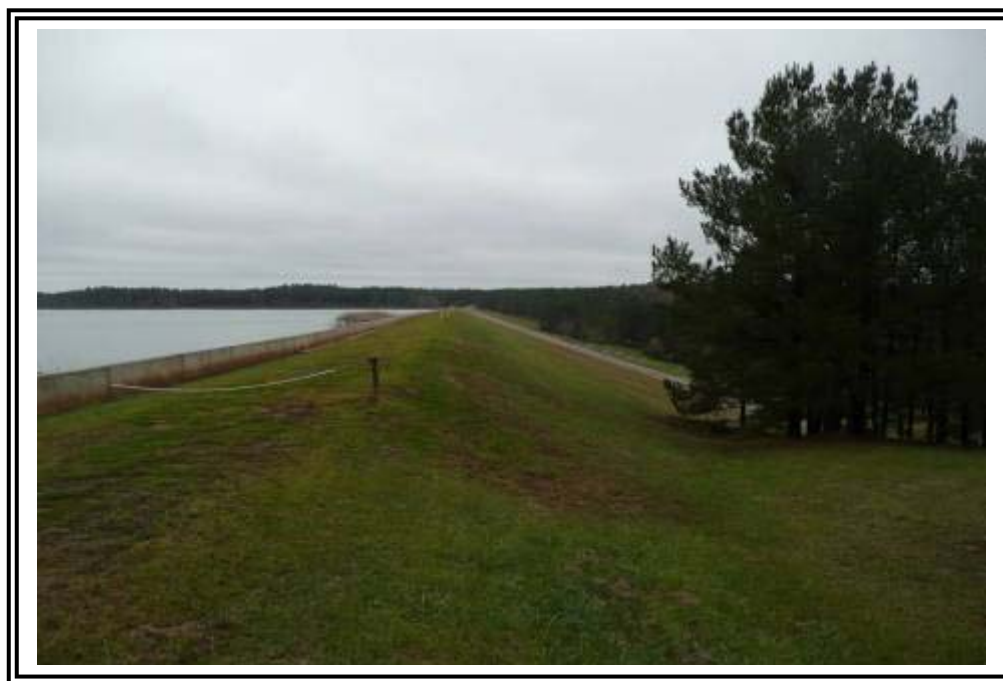
14

Ash Pond E, south end of dike, facing north.

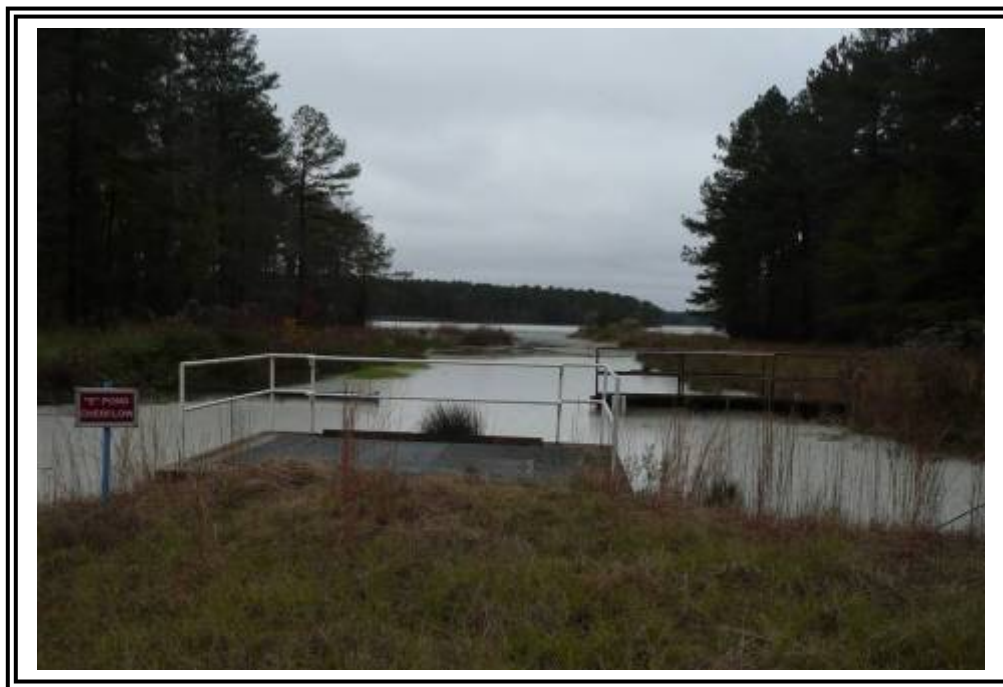
15

Ash Pond E decant spillway structure.

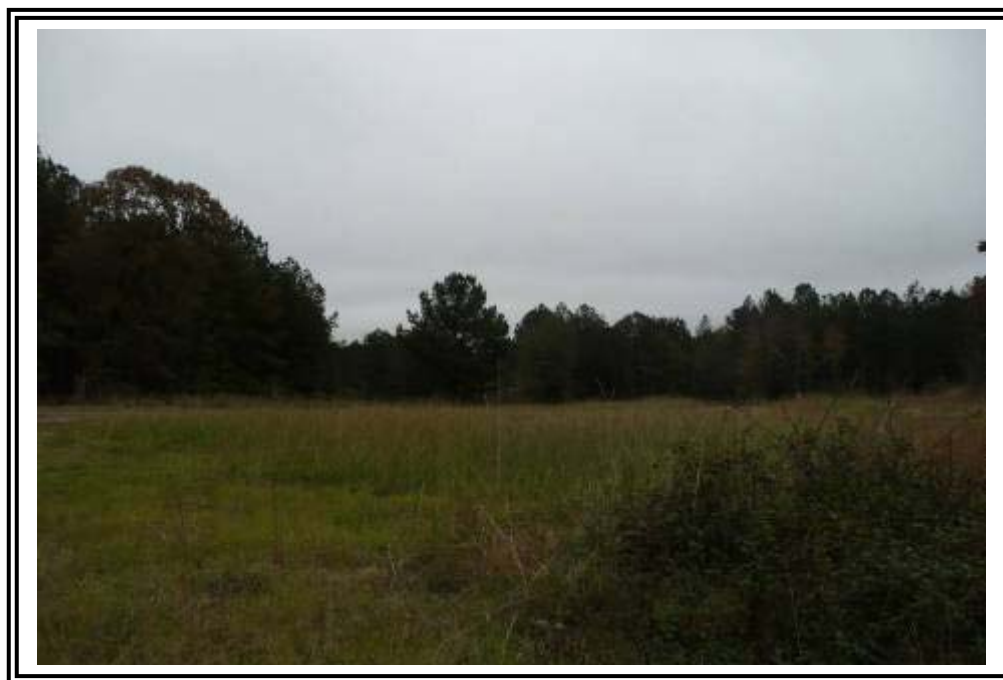
16

Ash Pond E emergency spillway.

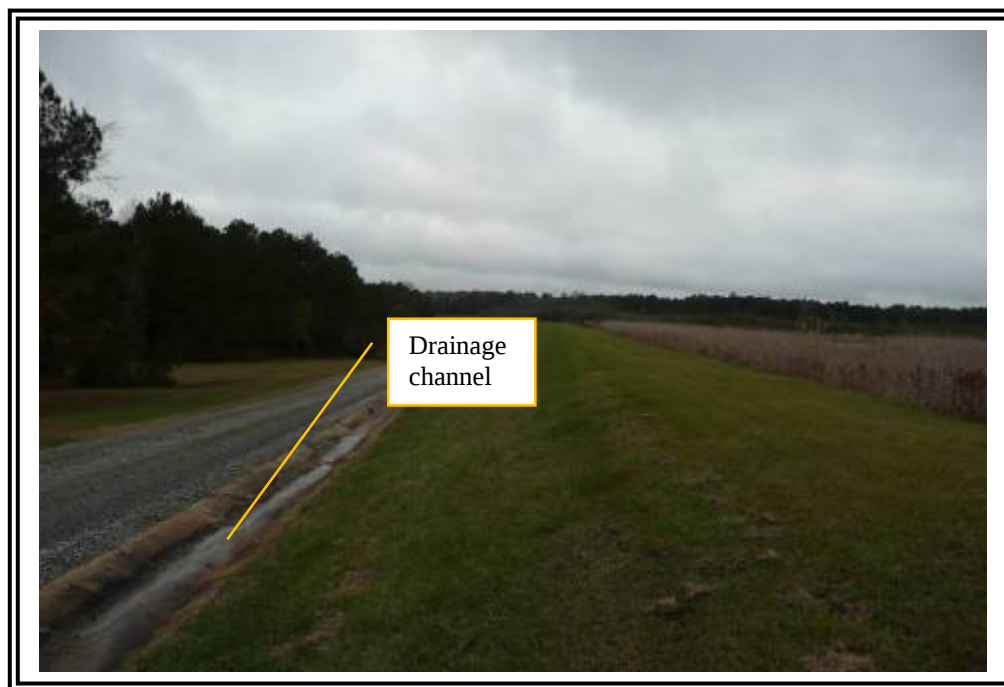
17

Ash Pond D, south edge of dike facing north. Concrete lined drainage channel shown frame left.

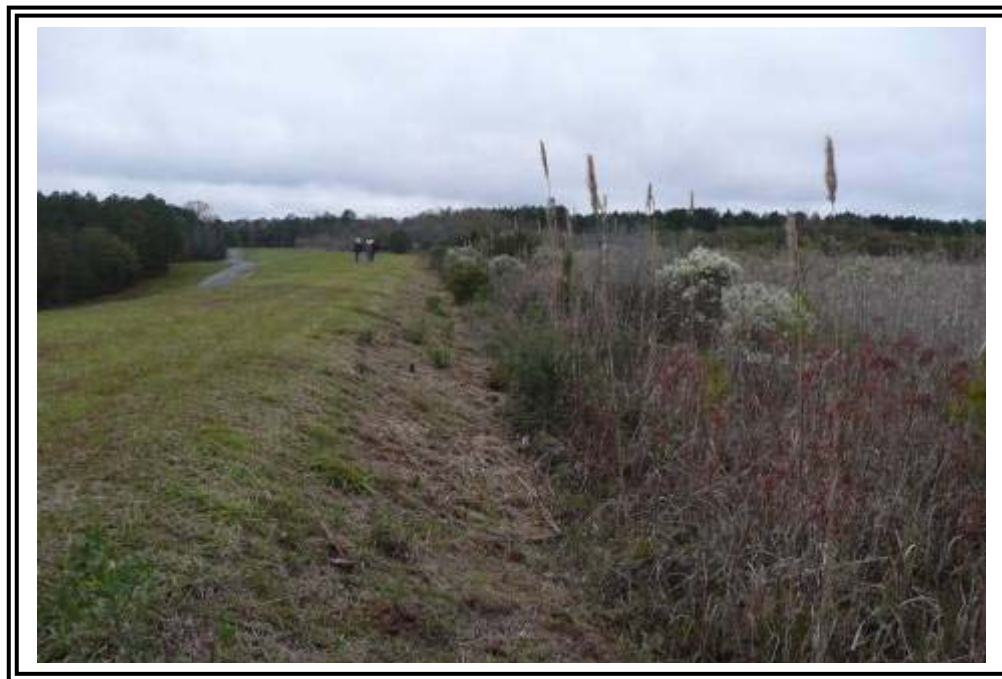
18

Ash Pond D, south end of dike facing north. Upstream slope and vegetation in the pond shown frame right.

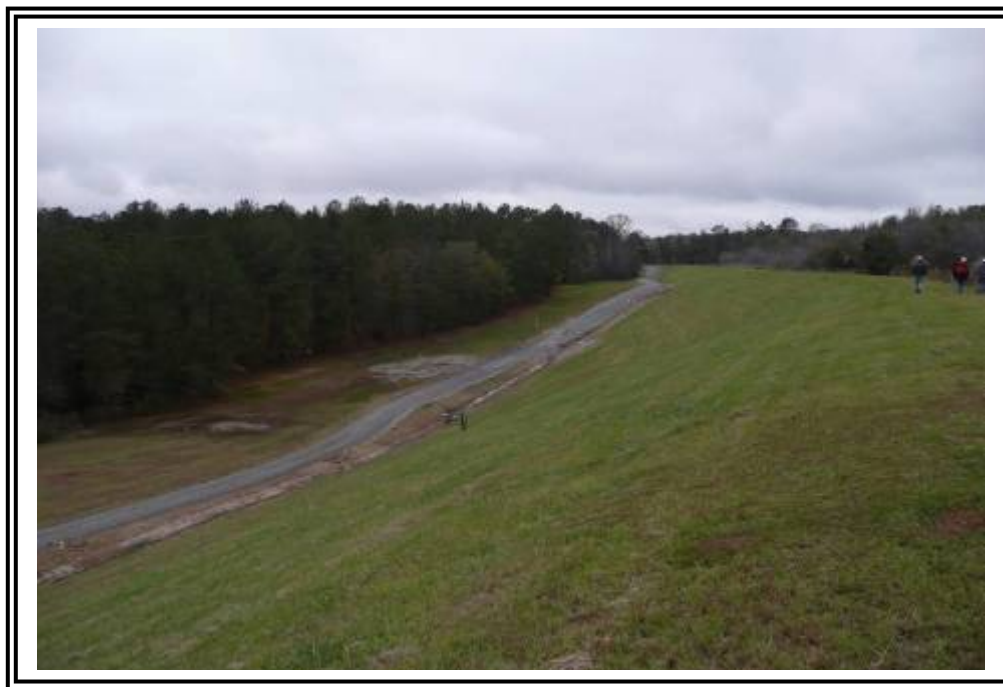
21

Ash Pond D, central portion facing north east.

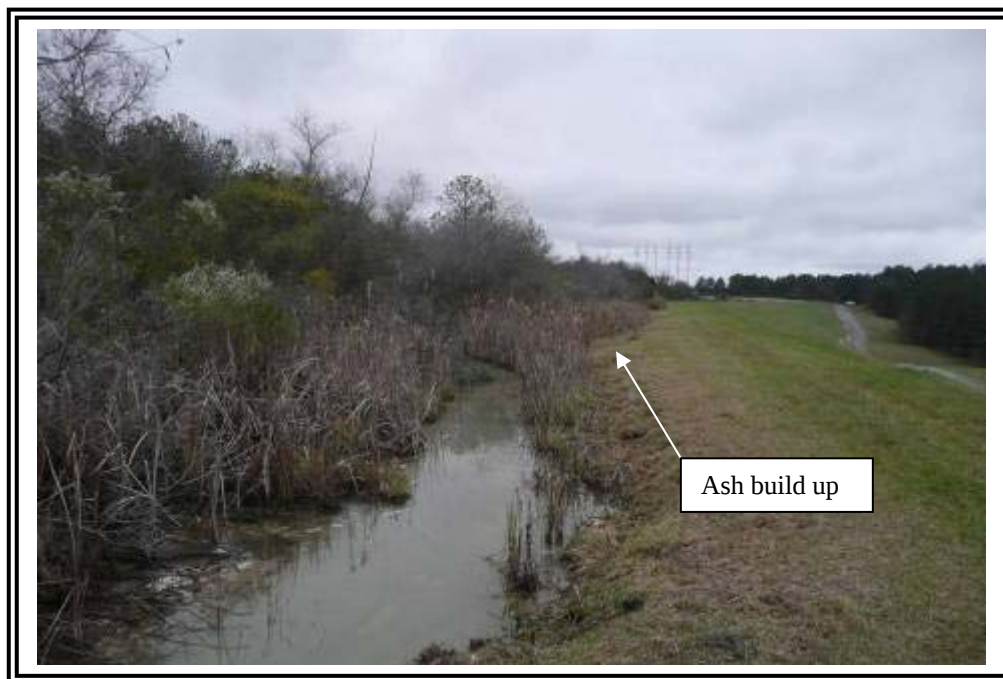
22

Ash Pond D, north edge of dike facing south east. Note widened crest of dike. Crest widening due to build up of ash per Georgia Power personnel.

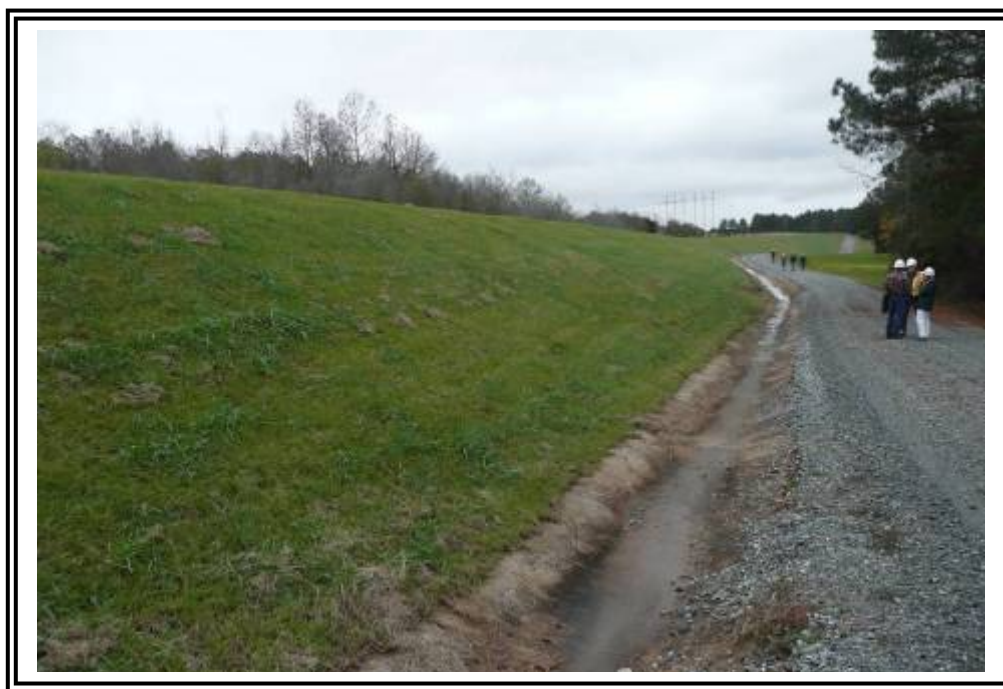
23

Ash Pond D, north end of dike at edge of toe facing southeast showing concrete lined drainage channel along toe of dike.

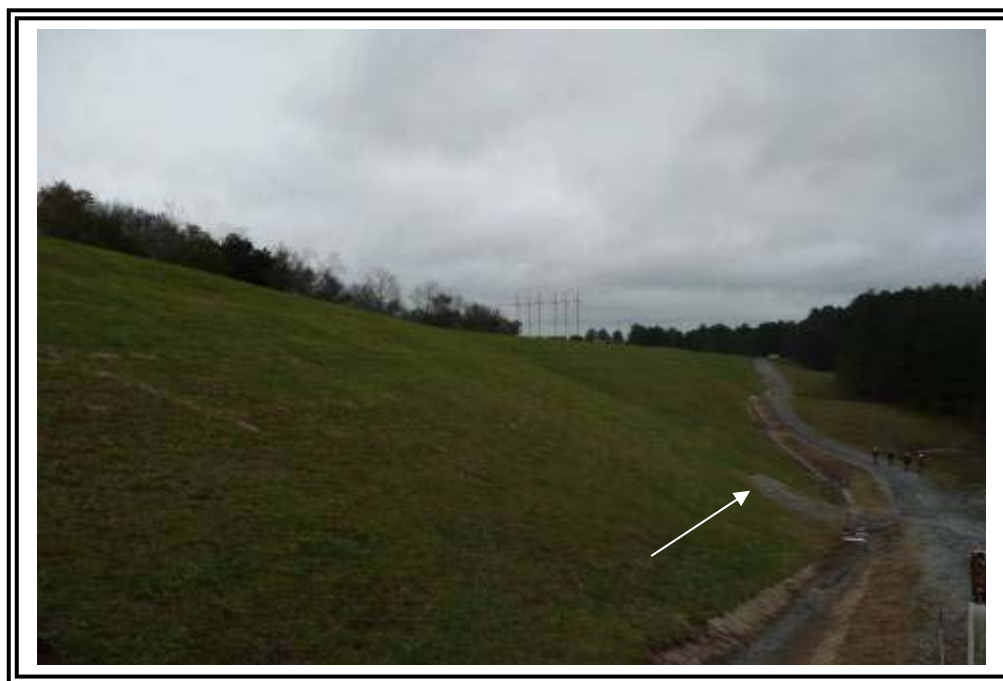
24

Ash Pond D, south central portion of dike facing south east at edge of toe. Dike seepage remediation shown by arrow

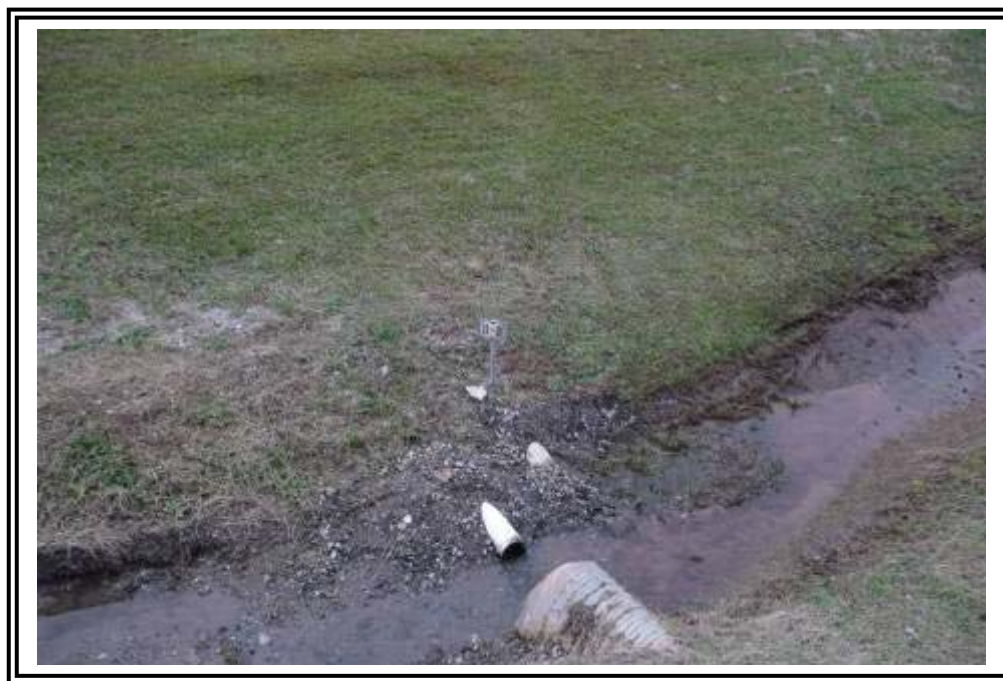
26

Ash Pond D finger drain D-3. Georgia Power personnel indicated that this area was previously remediated and the concrete lined channel was inadvertently razed during remediation.

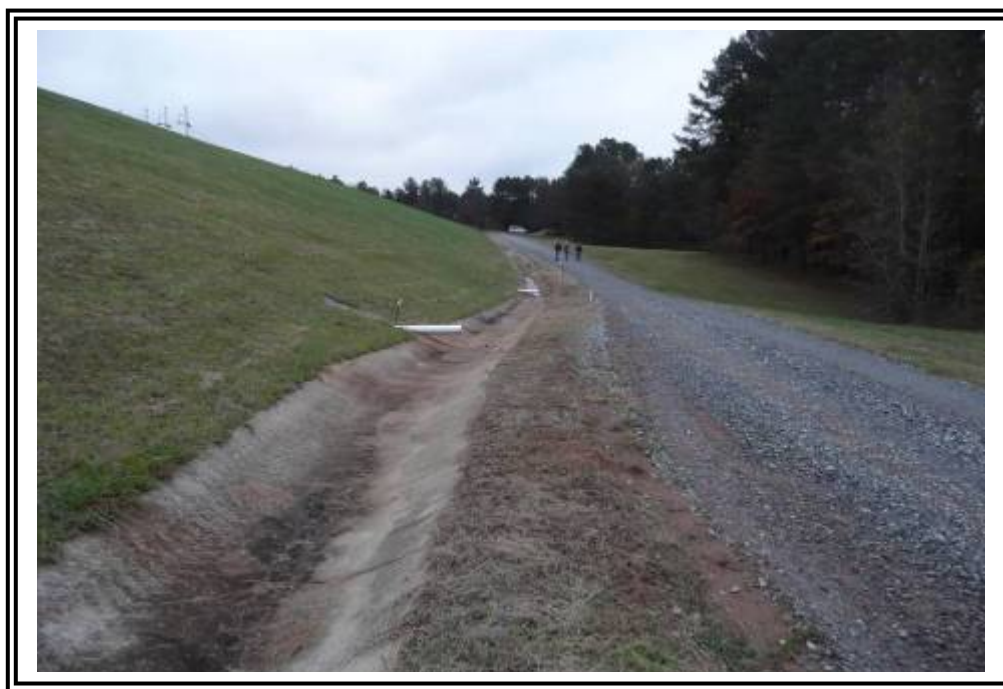
29

Ash Pond D, central portion of dike along toe facing south east.  
Concrete lined channel drain along toe and finger drains shown frame left.

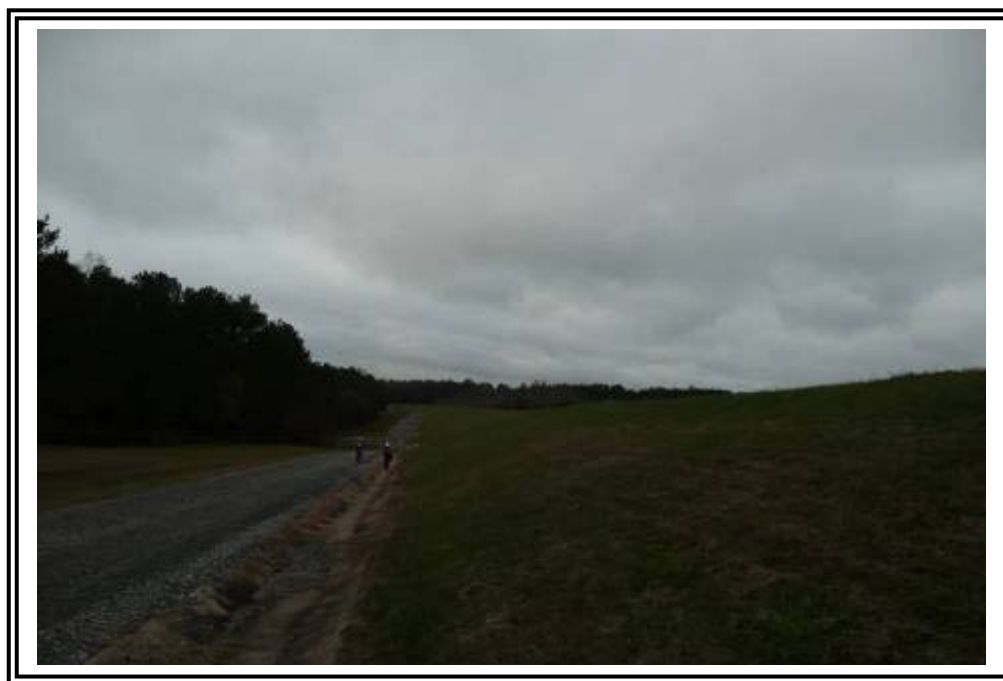
30

Ash Pond D, south end along toe of dike, facing northwest.

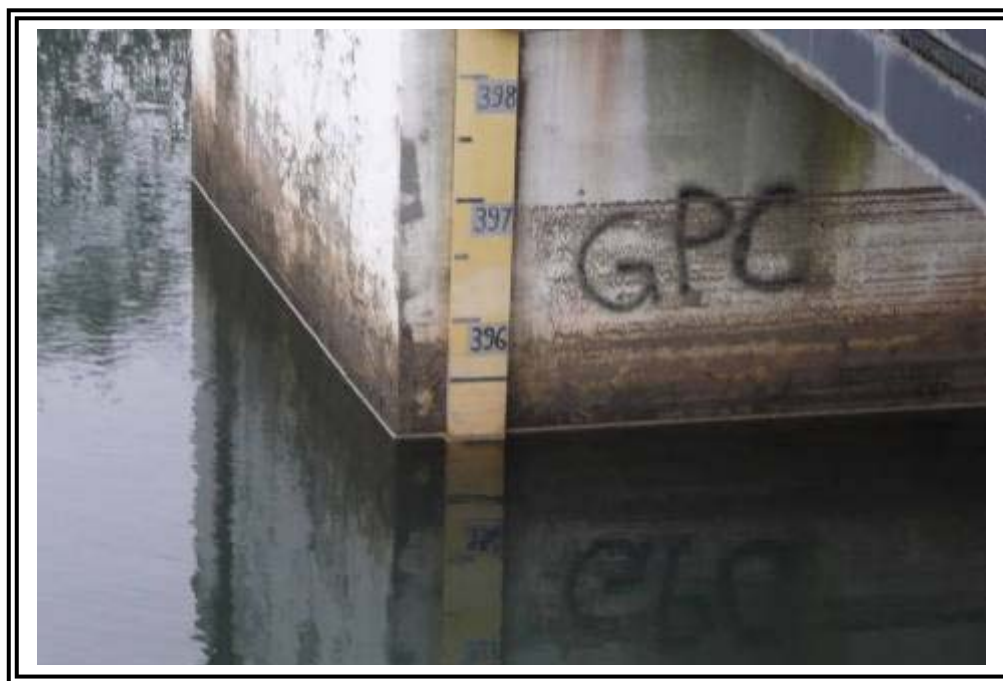
32

During the site reconnaissance of the west dike, a historic discharge system was observed at the south end (Photos 31 and 32). This was originally constructed as the primary outfall via a gravity feed to a treatment facility before the water was recycled or discharged to the lake. It was later replaced with a siphon at this location to provide an emergency outlet should the need arise. This was done around the same time the primary siphon system conveying water to the Pond B was installed. Georgia Power indicated that the historic discharge system facility has been decommissioned; however the plant maintains an NPDES discharge permit at this location.

Ash Pond C water level indicated by the gauge at the historic discharge facility (395.0').

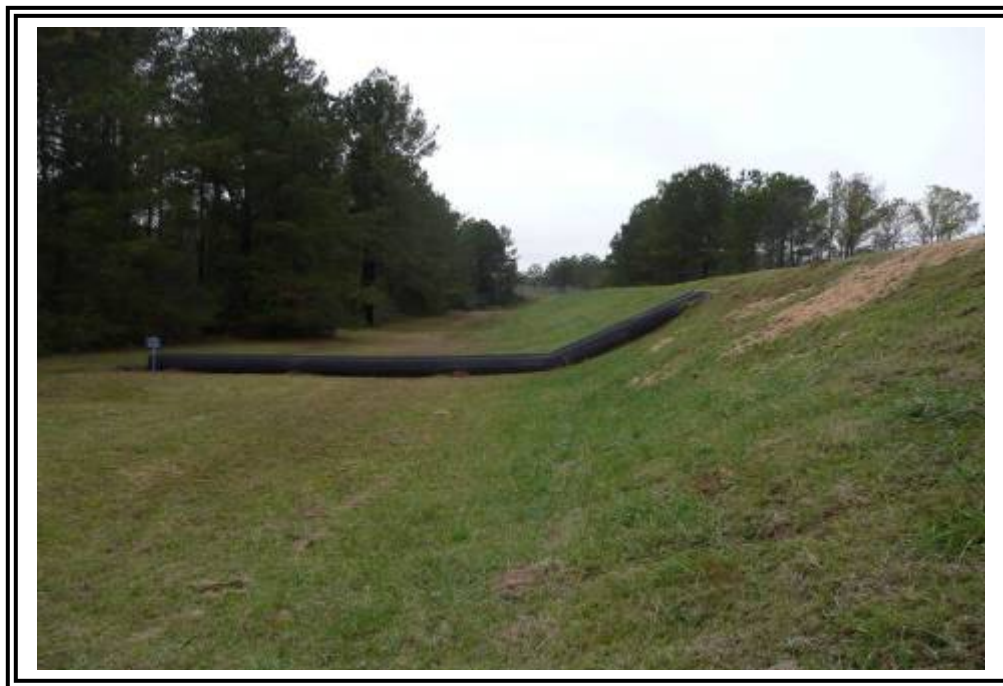
33

Ash Pond C emergency overflow located on southern portion of west dike north of historic discharge facility.

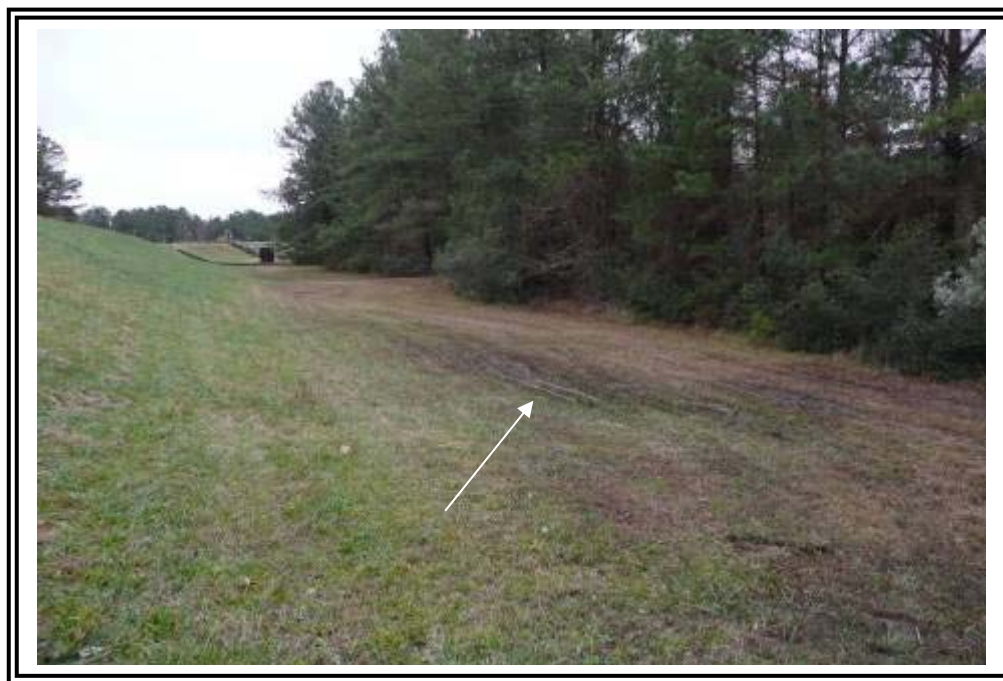
34

Central portion of Ash Pond C west dike toe facing south.  
One of two "soft spot" s indicated by arrow.

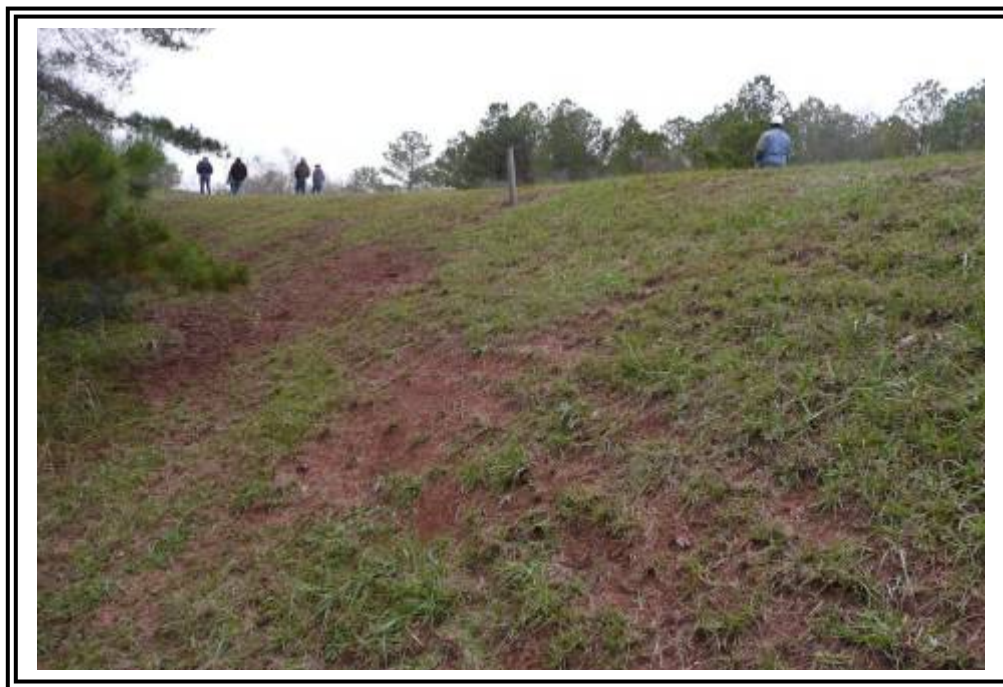
35

Sparse grass cover on north central portion of Ash Pond C west dike toe, facing north.

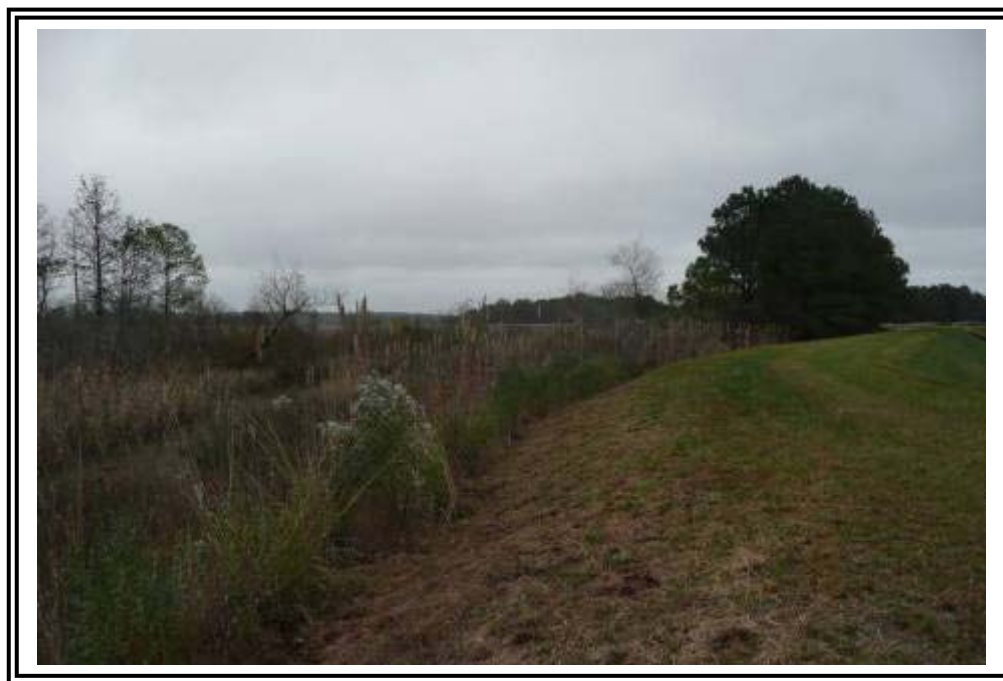
36

Ash Pond C, upstream dike edge shown at north portion of the west dike, facing south.

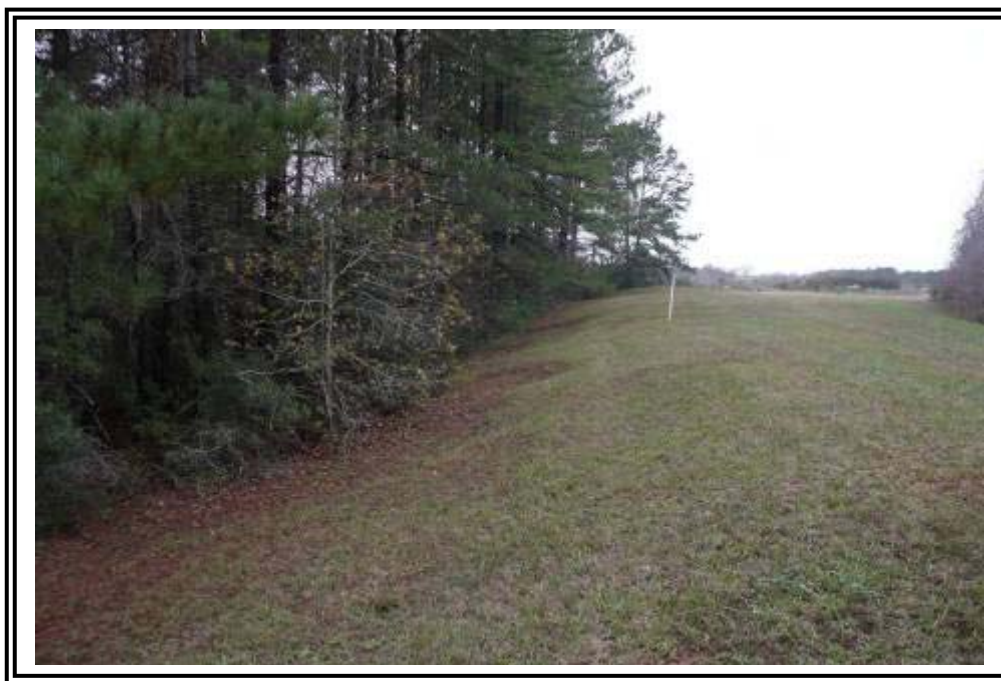
38

Ash Pond C, downstream edge of west dike at north end of dike, facing north.

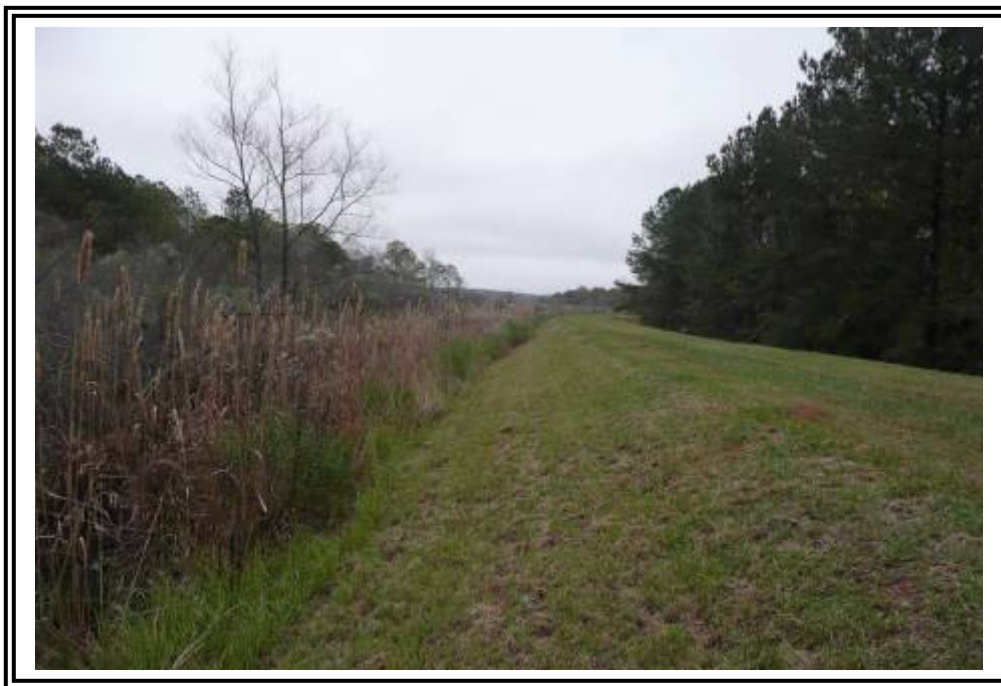
39

Ash Pond C, north end of west dike interior, facing south. Interior edge of dike shown frame left with vegetation present. Exterior edge of dike shown frame right with heavy vegetative cover present.

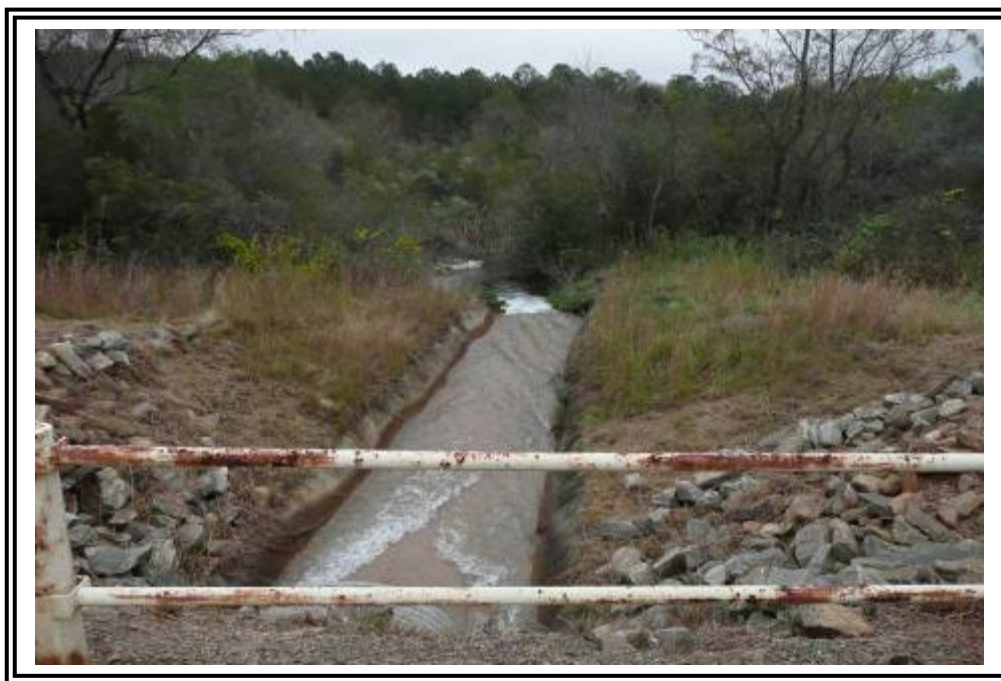
40

Overflow into Ash Pond C from atop the bridge facing south east.

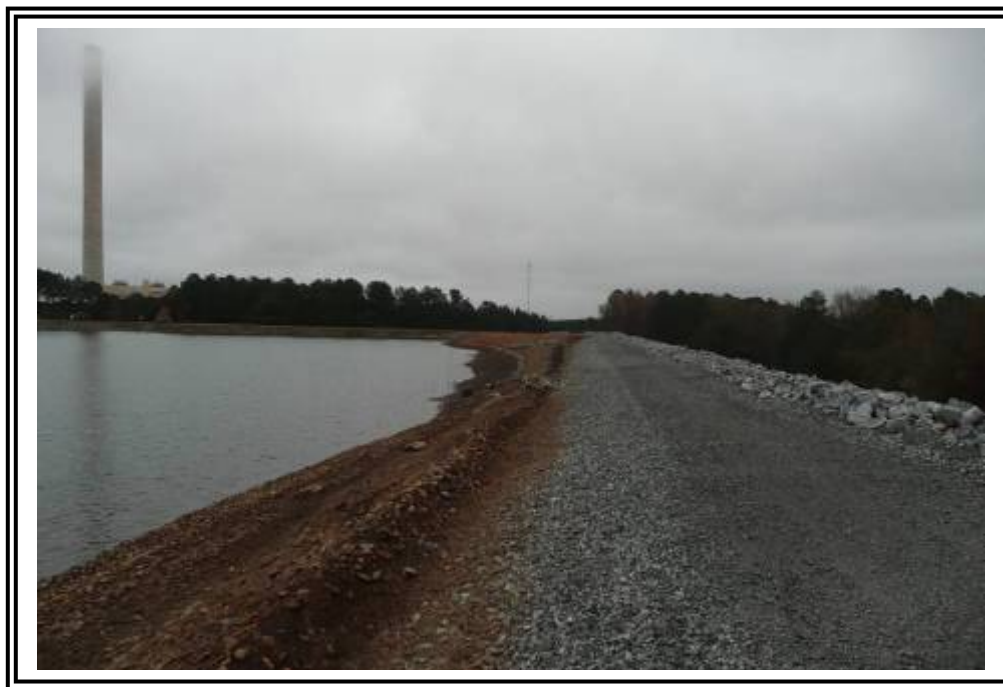
41

Ash Pond C, west end of south dike facing east.

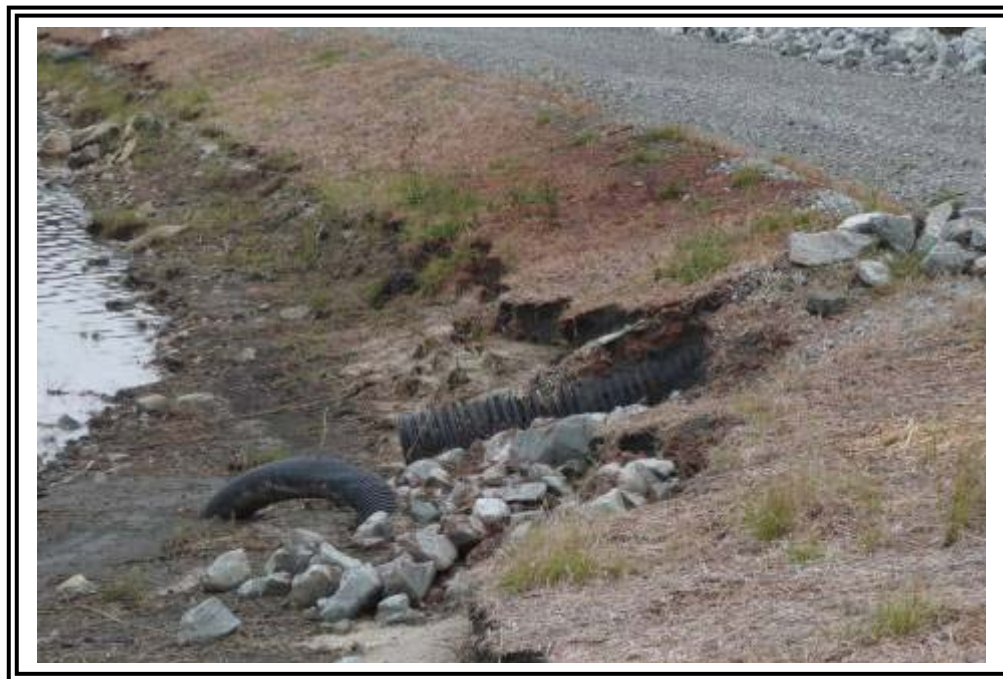
42

Upstream side of Ash Pond C west end of south dike facing east. Crest run-off drain shown.

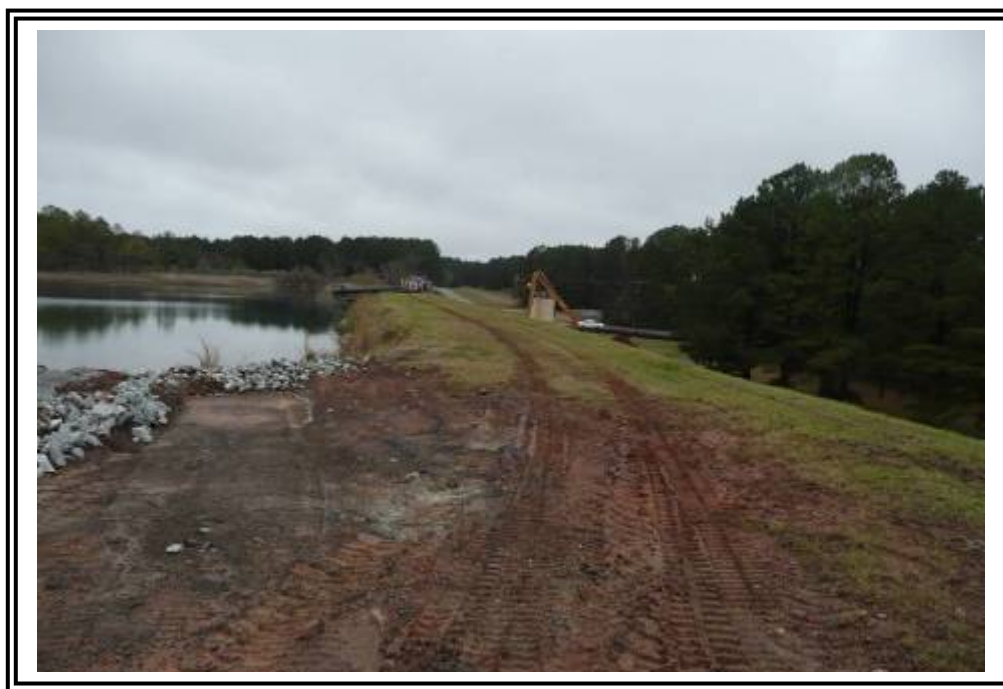
43

Ash Pond C, south end of east dike facing north.

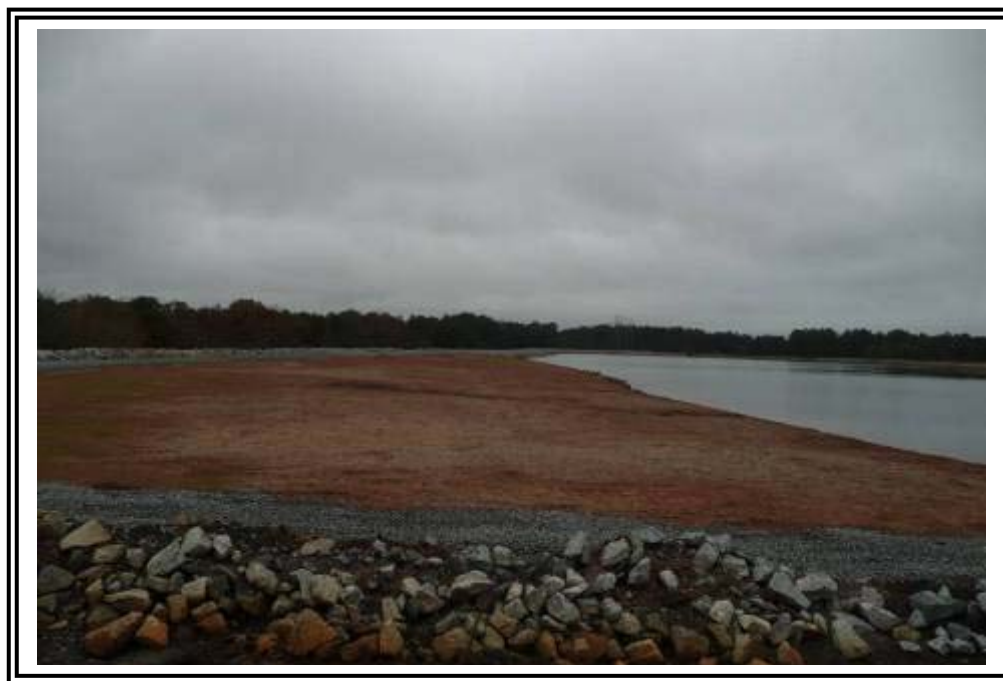
44

Ash Pond C, south end of east dike facing west. South east corner of Ash Pond C shown.

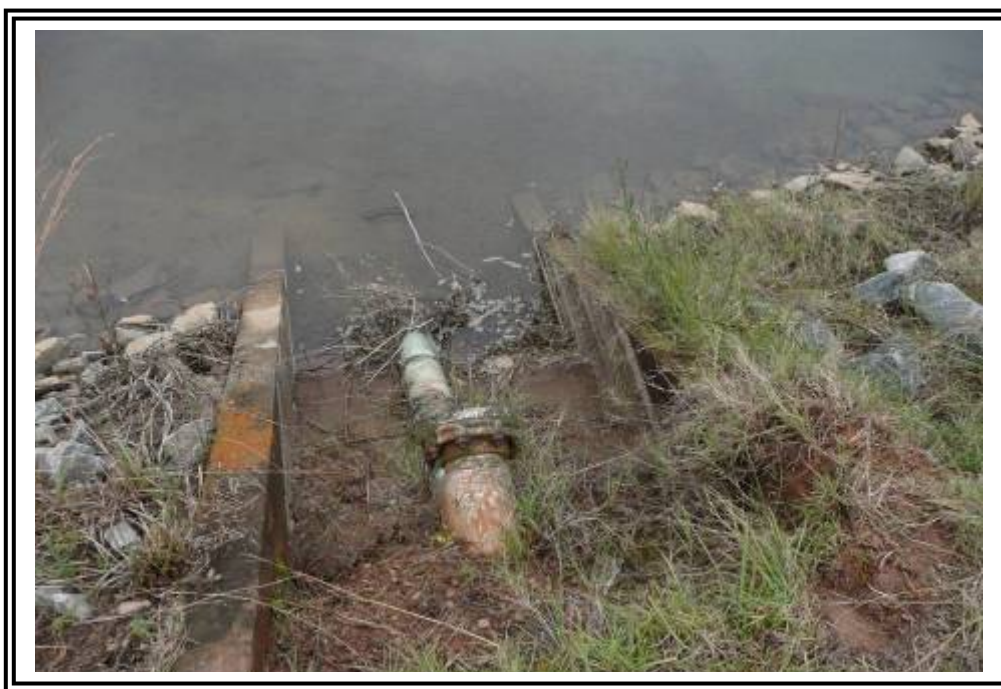
45

Ash Pond C, south end of east dike. Historic drain shown.
