# Assessment of Dam Safety

## Coal Combustion Surface Impoundments (Task 3)

Georgia Power  
Company

Plant Branch

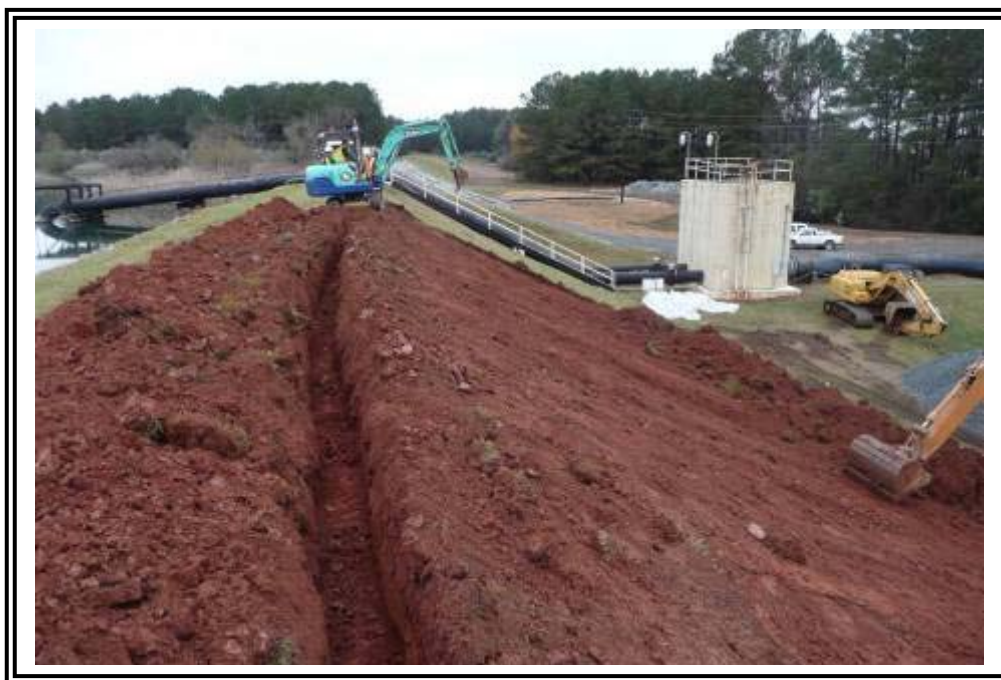
46

Ash Pond C, south central portion of east dike. Downstream dike re-facing with rip-rap under construction.

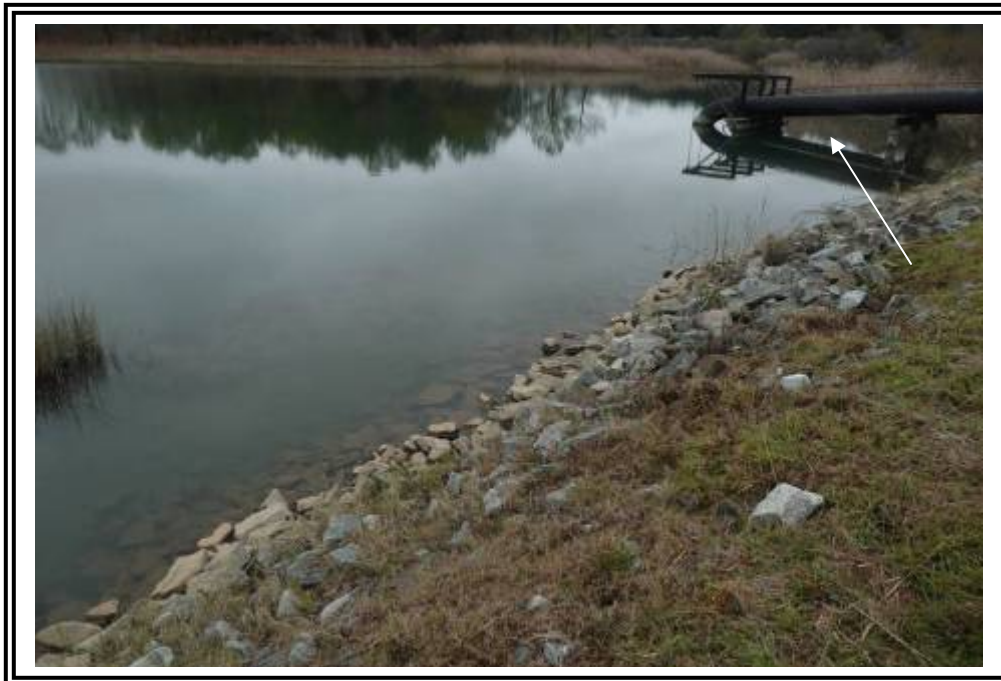
47

South central portion of Ash Pond C east dike, upstream slope shown with rip-rap. Re-cycle water system intake shown frame right

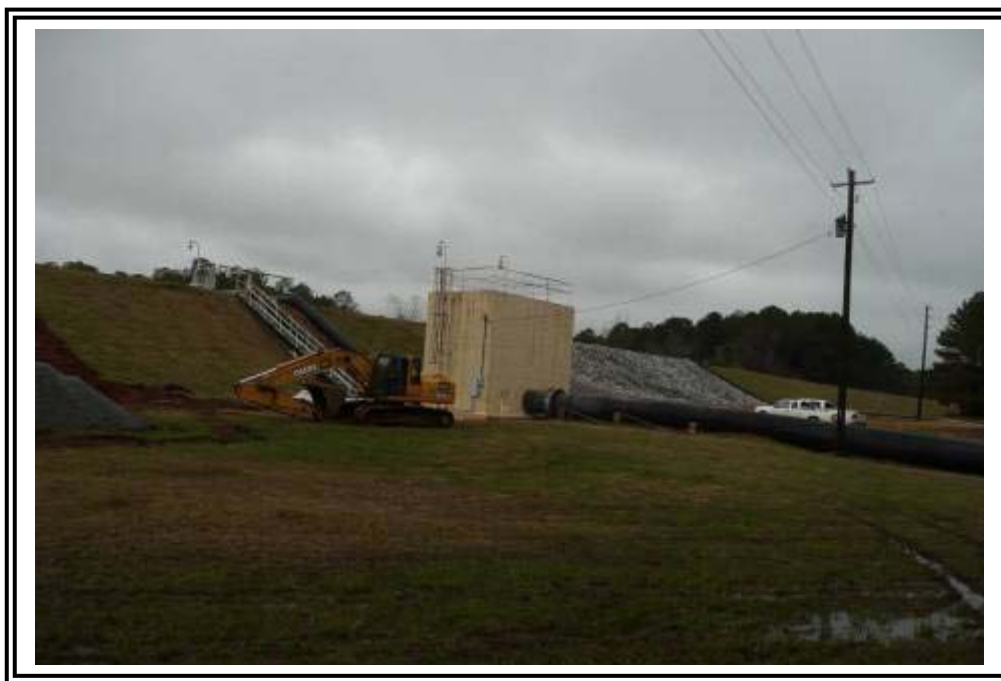
48

Ash Pond C, south central portion of east dike. Recycle water system shown. This system discharges recycle water to Ash Pond B.

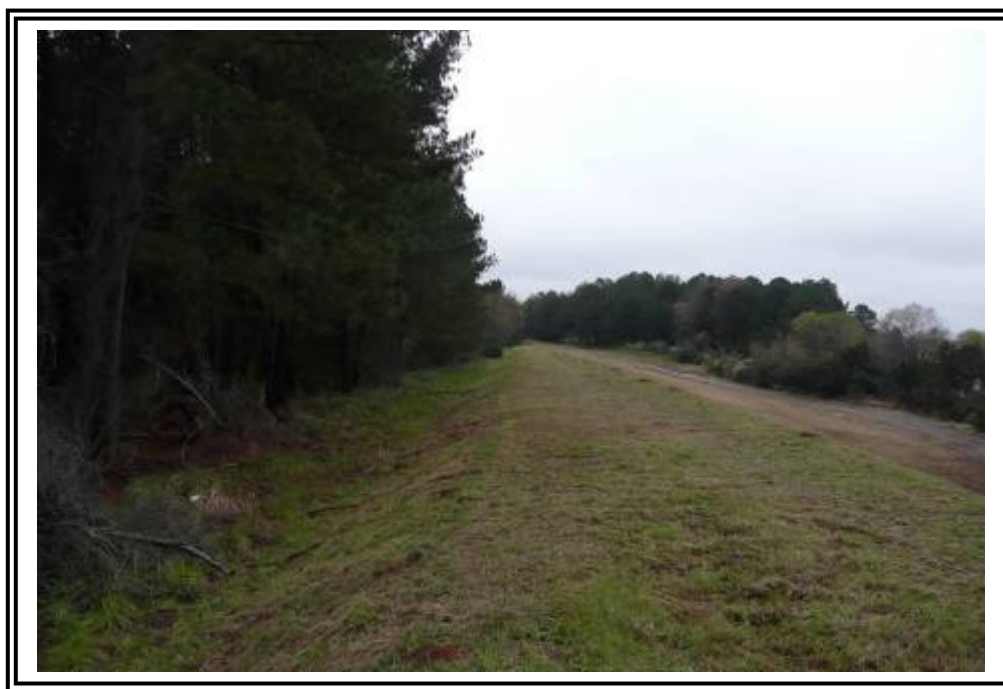
51

Ash Pond C, north portion of east dike facing north.

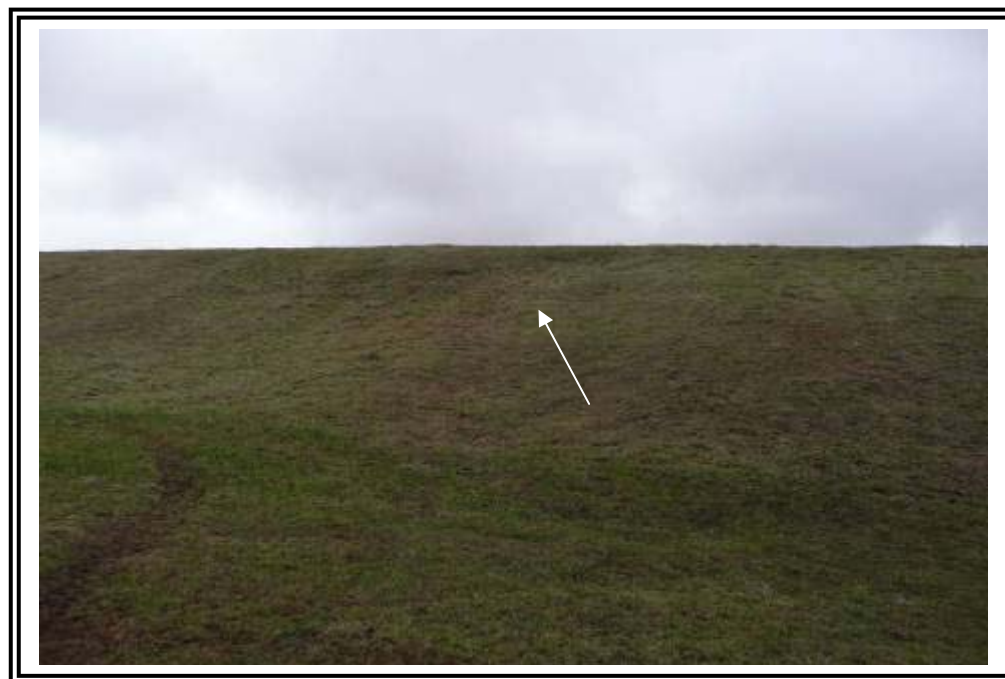
54

Downstream slope of Ash Pond C east dike near the south end showing variations in elevation.

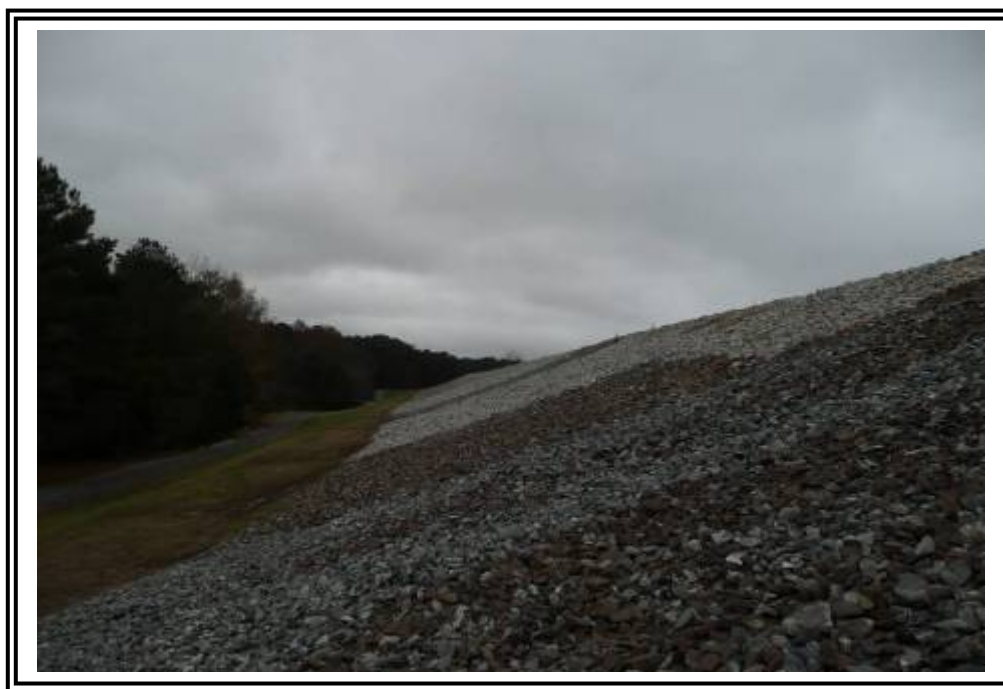
55

Ash Pond C, east end of south dike facing west.  
Downstream slope shown with rip-rap facing.

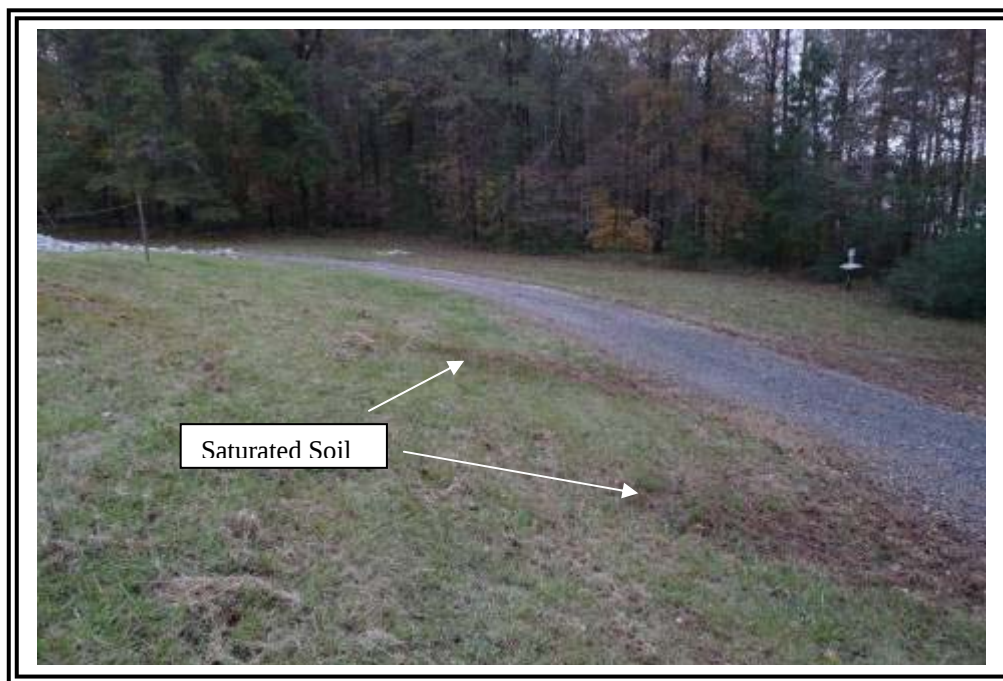
56

Ash Pond C, east end of south dike at the toe, facing east. Two saturated areas shown  
(several located in this area). Saturated areas possibly due to buried drains.

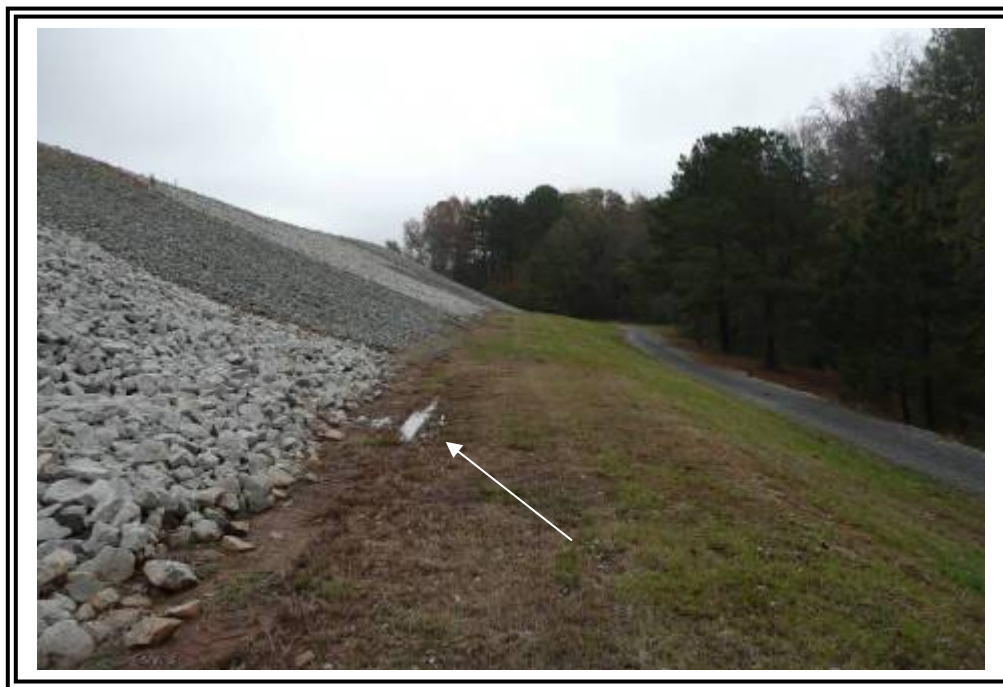
57

Ash Pond C, central portion of south dike along toe facing east.  
Pooled water shown frame left.

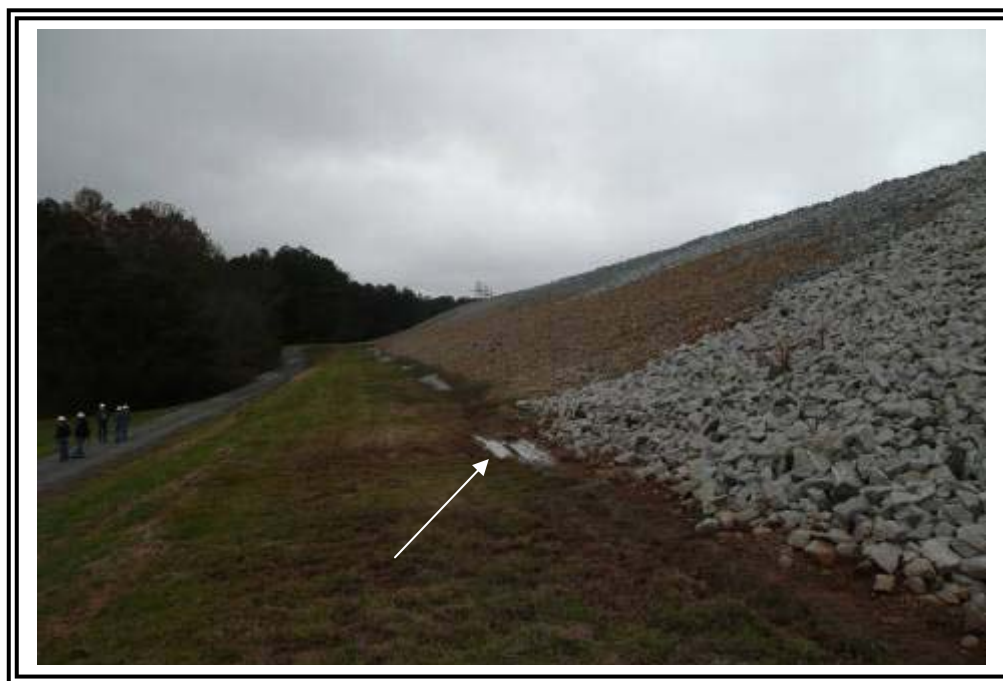
58

Ash Pond C, central portion of south side facing west. Pooled water shown frame right.

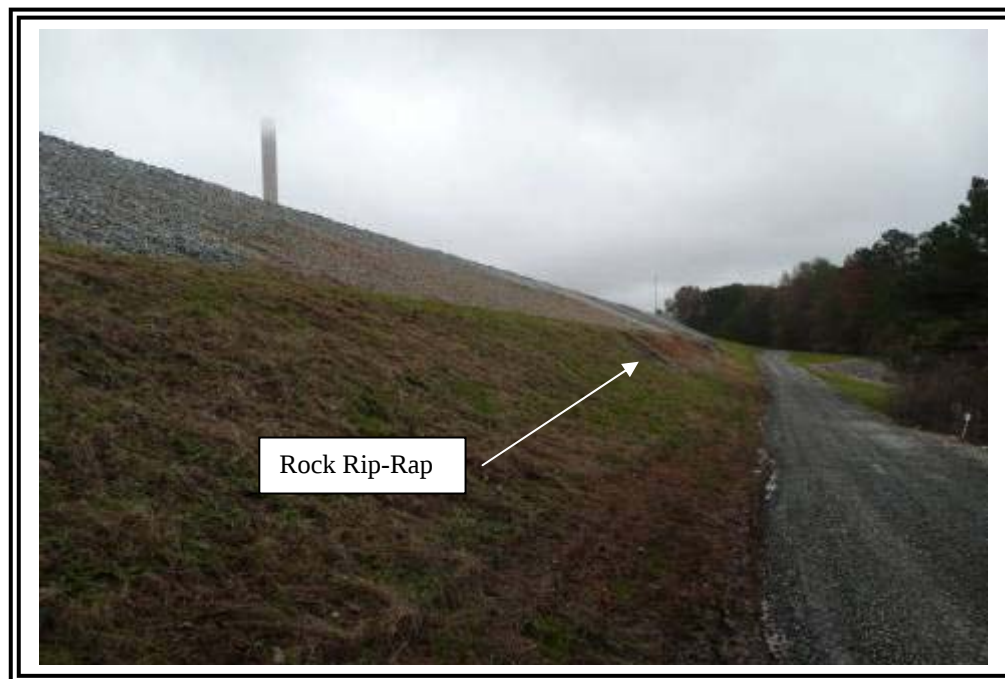
60

Ash Pond C, western central portion of south dike facing east. Toe re-faced utilizing rock rip-rap.

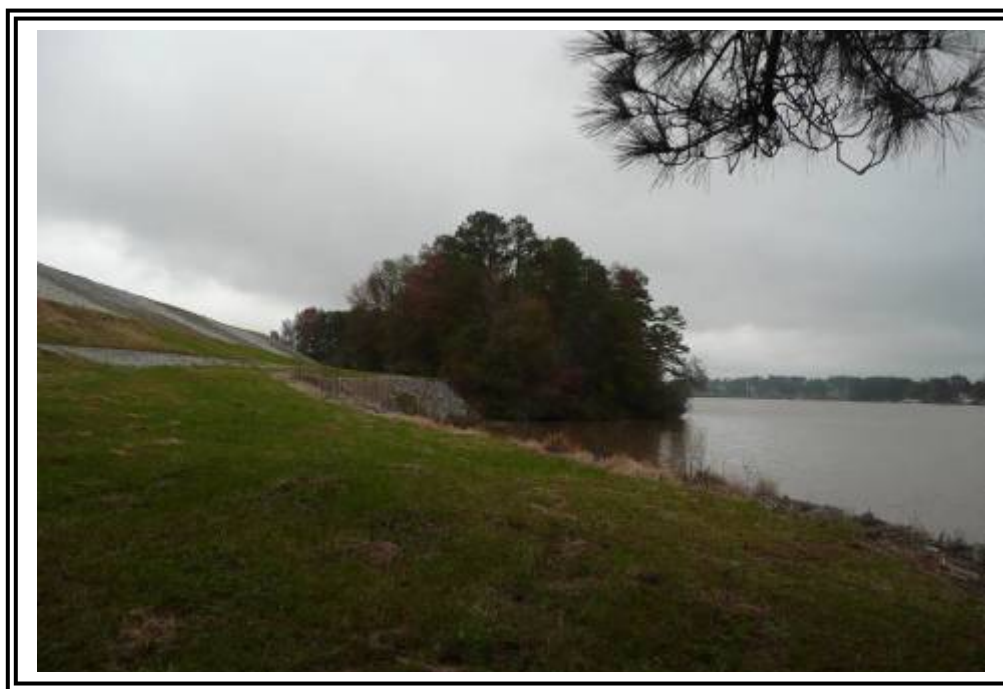
61

Ash Pond C, western central portion of south dike, facing east, adjacent south of toe.

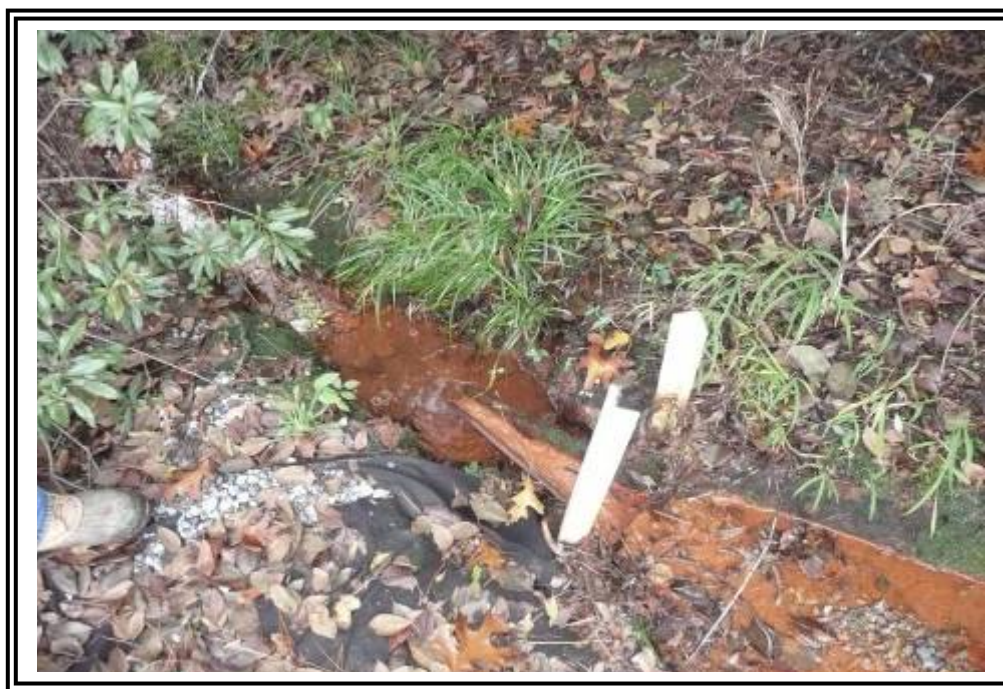
63

Ash Pond C, west end of south dike. Seepage weir shown.

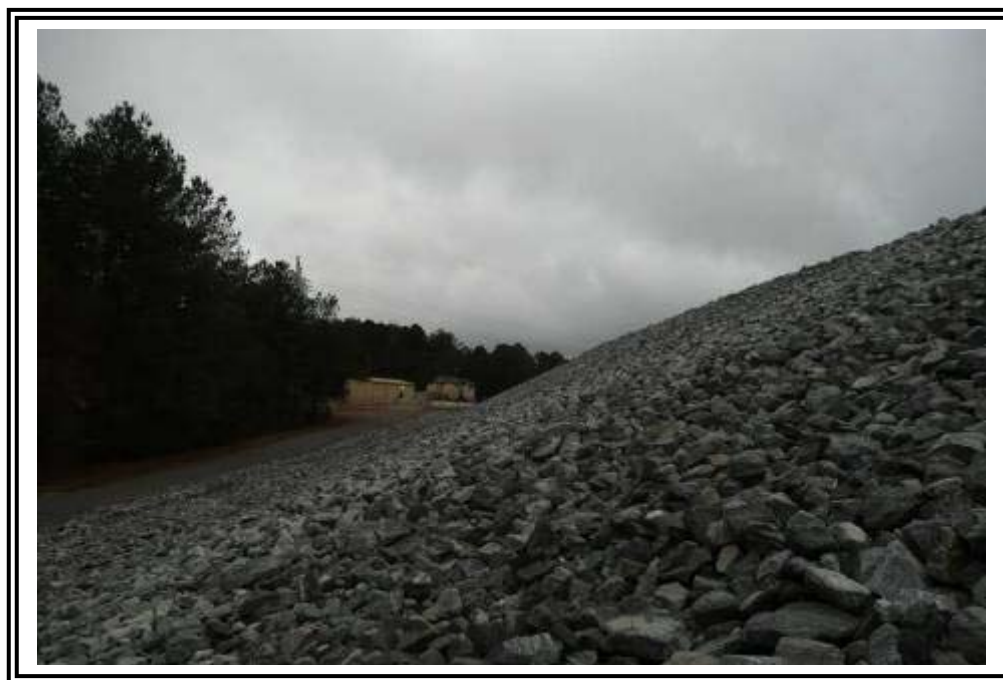
64

Ash Pond C, west end of south dike facing west. Rock rip-rap facing on dike exterior shown.

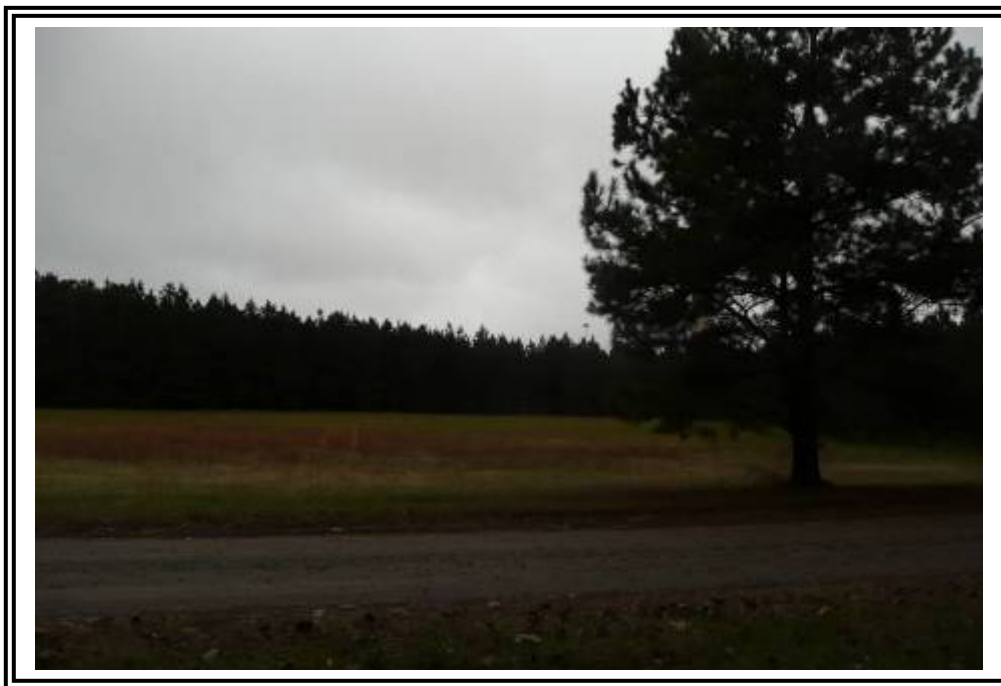
65

Ash Pond B, central portion of dike crest, facing north into area of pond filled with bottom ash and covered with topsoil.

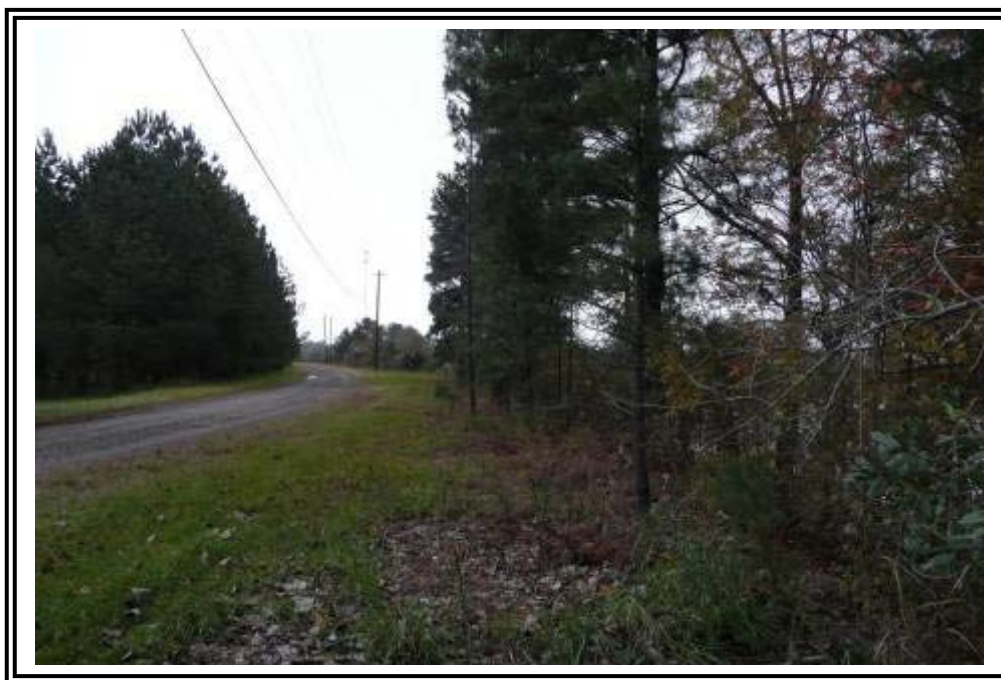
66

Ash Pond B, central portion of dike facing east. Downstream slope of dike shown frame right with vegetation present. Interior edge of dike shown frame left with vegetation (tree cover) present along eastern end of the pond.

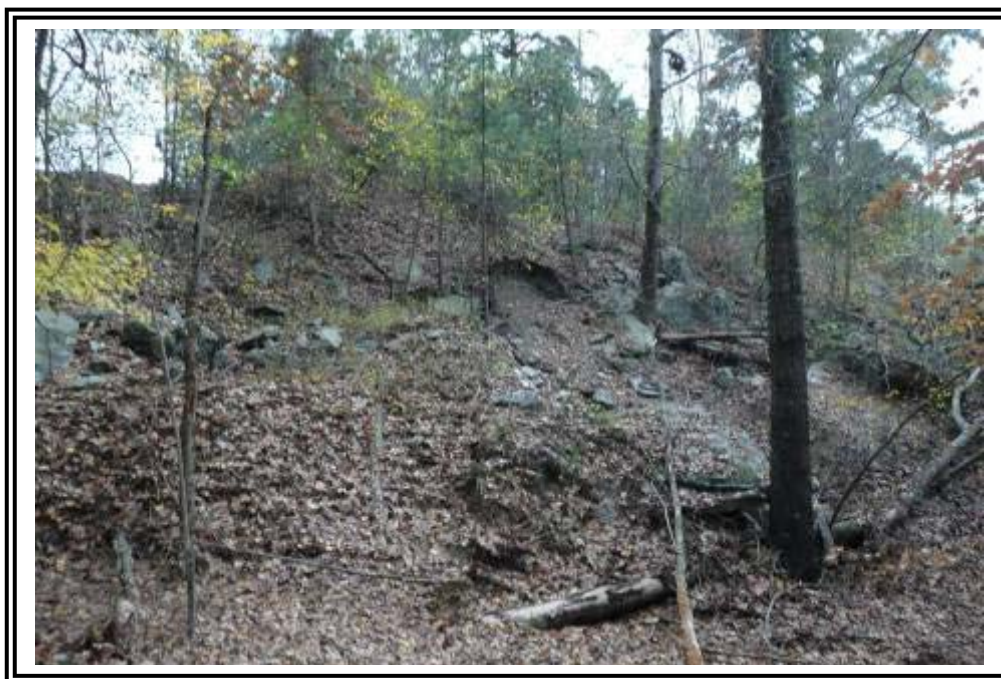
68

Ash Pond B, central portion of dike facing north, along the toe. Exterior of dike shown with large boulders and vegetative growth.

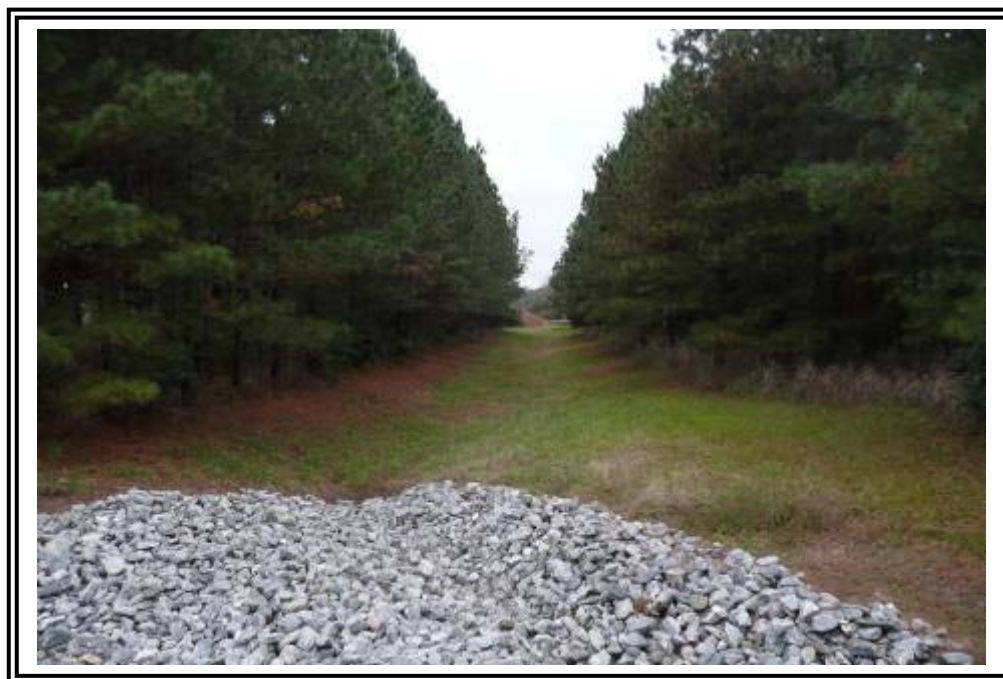
70

Ash Pond B, west end of dike facing north, at emergency spillway and site drainage open channel. Inlet protection for emergency spillway into discharge facility shown..

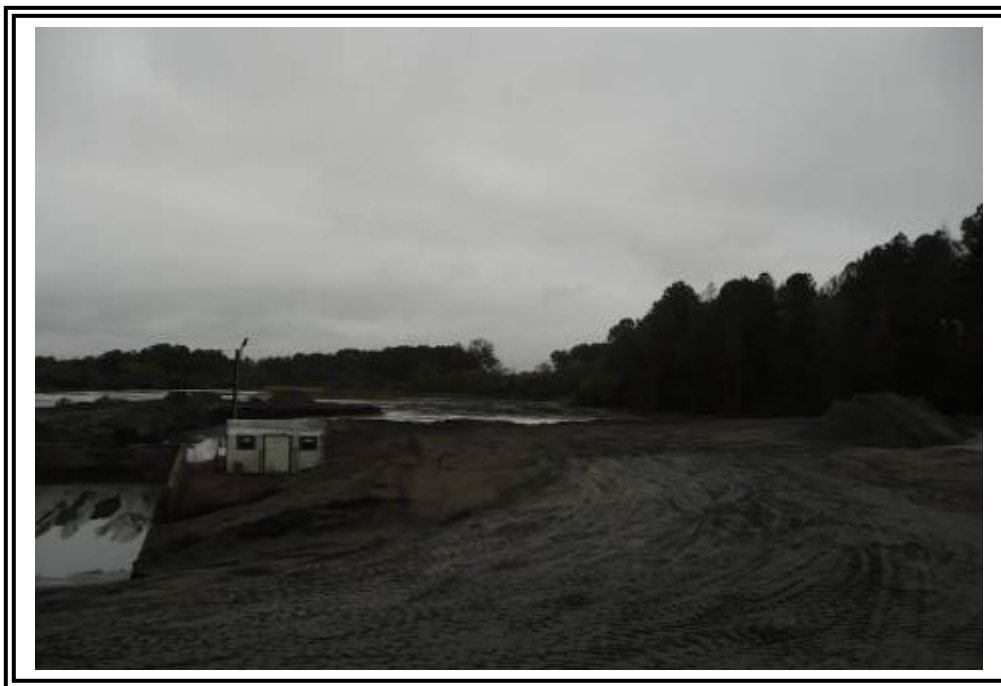
71

Ash Pond B, north end of pond along eastern edge facing west. Shown is the portion of Ash Pond B unfilled with bottom ash. Ash processing facility shown frame left.

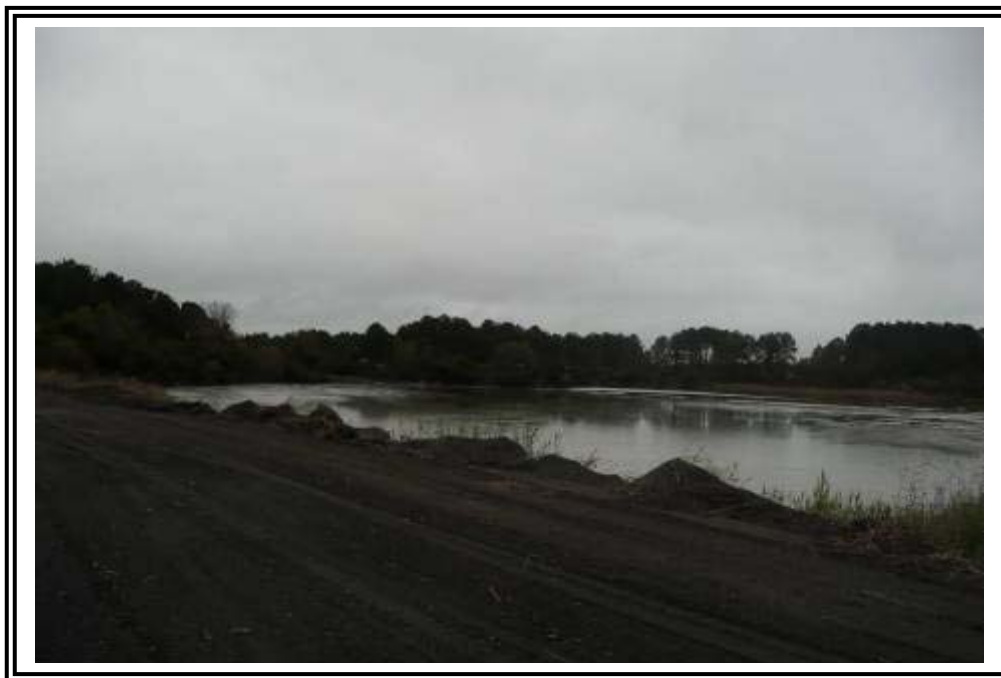
72

Ash Pond B, north end of pond along eastern edge facing south west. Shown is portion of the pond remaining unfilled with bottom ash. Frame left and furthest shows the area of Ash Pond B filled with bottom ash, covered with topsoil, and vegetative cover.
