# Assessment of Dam Safety Coal Combustion Surface Impoundments (Task 3) Draft Report

Georgia Power  
Company

Plant Branch

December 23, 2009

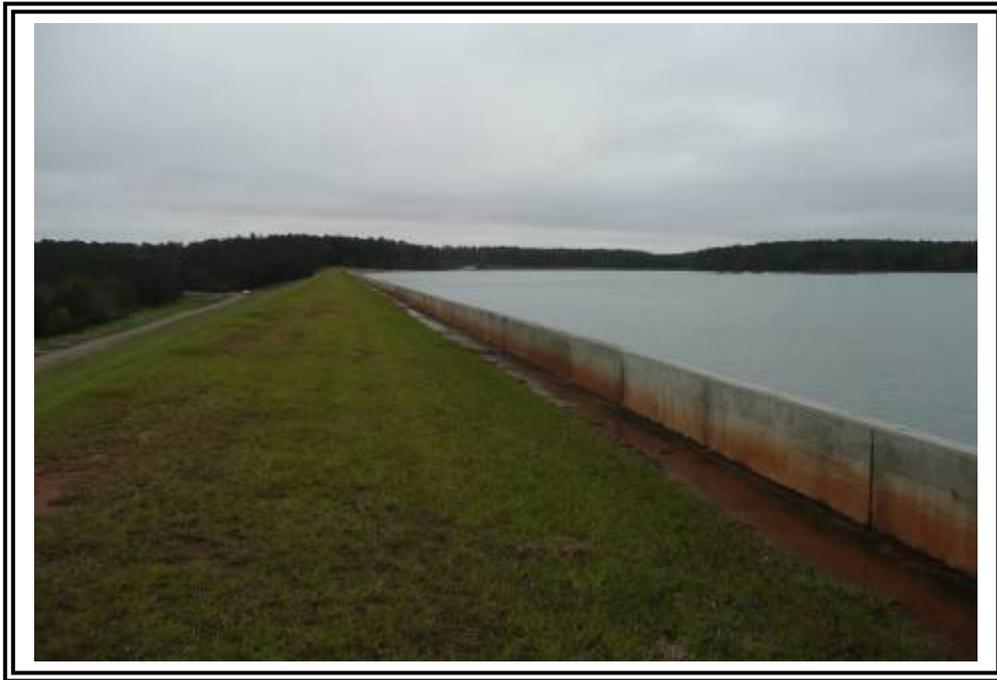
1

Northern end of Ash Pond E dike crest, facing south.

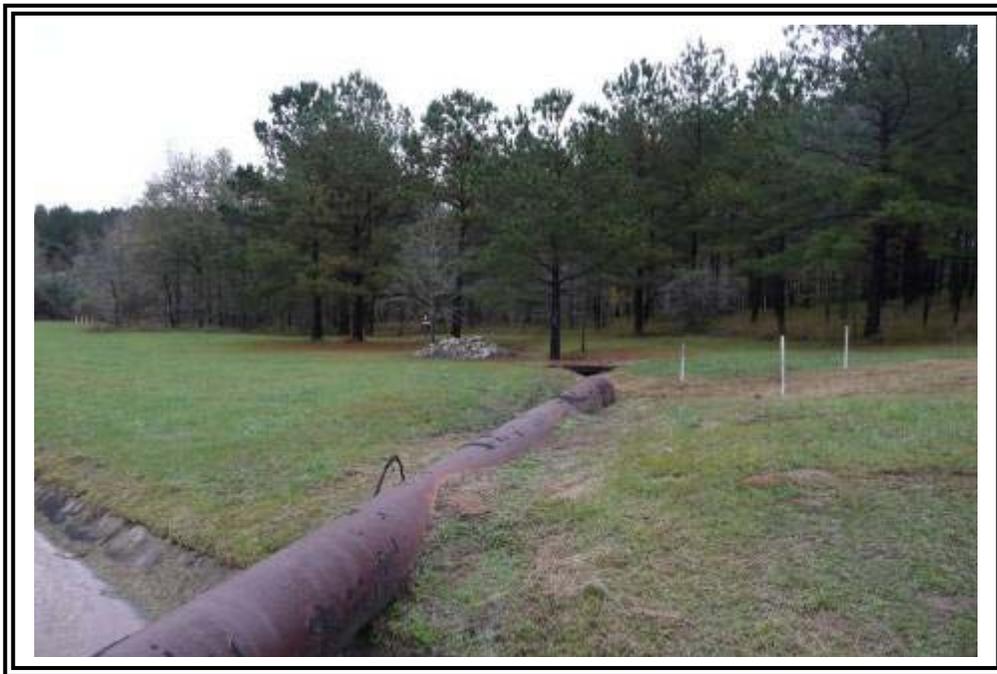
2

Ash Pond E abandoned overflow drain located along southern portion of the dike.  
The drain pipe is constructed of welded steel.

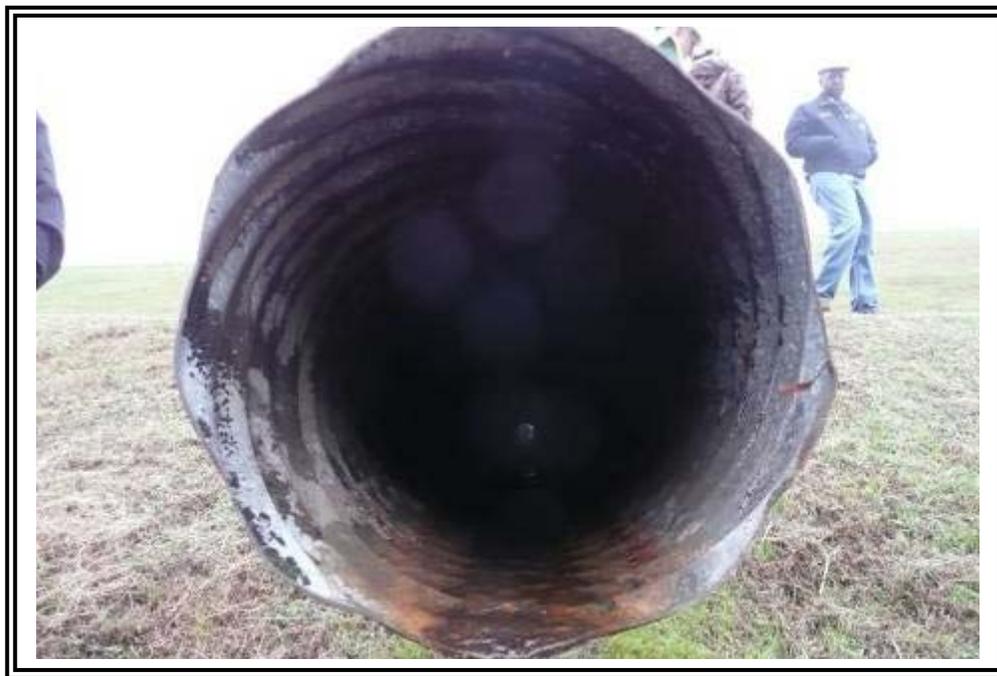
4

Corrugated metal drain pipe located north of Ash Pond E finger drain #11. Light can be seen at the western most end of the drain pipe, indicating a clear drainage channel from upper channel drain to lower channel drain.

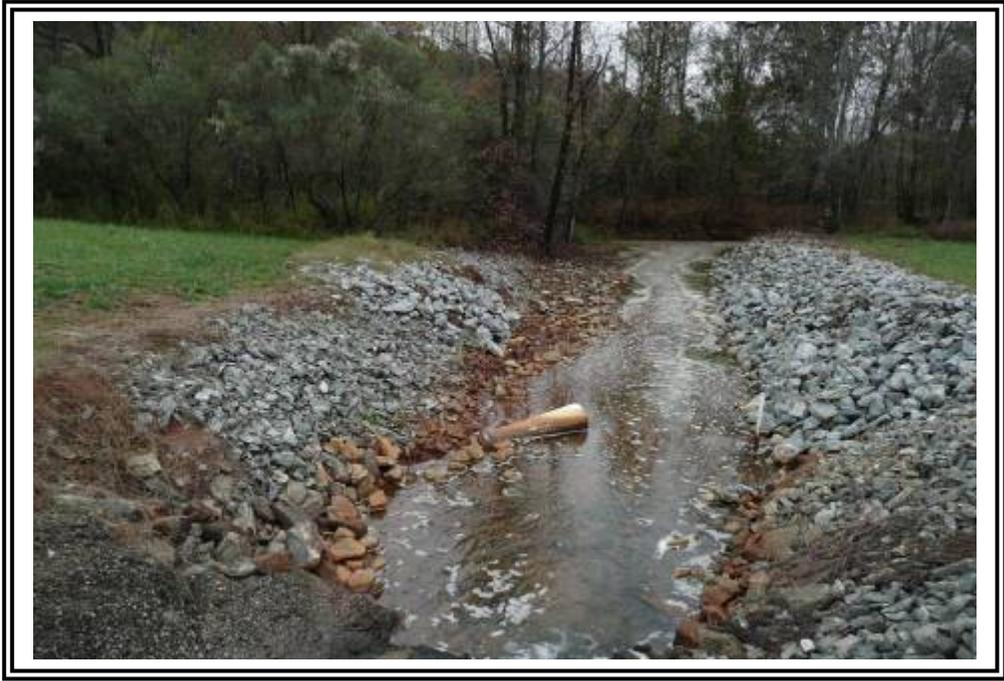
7

Ash Pond E, receiving stream for drainage from the blanket drain system.

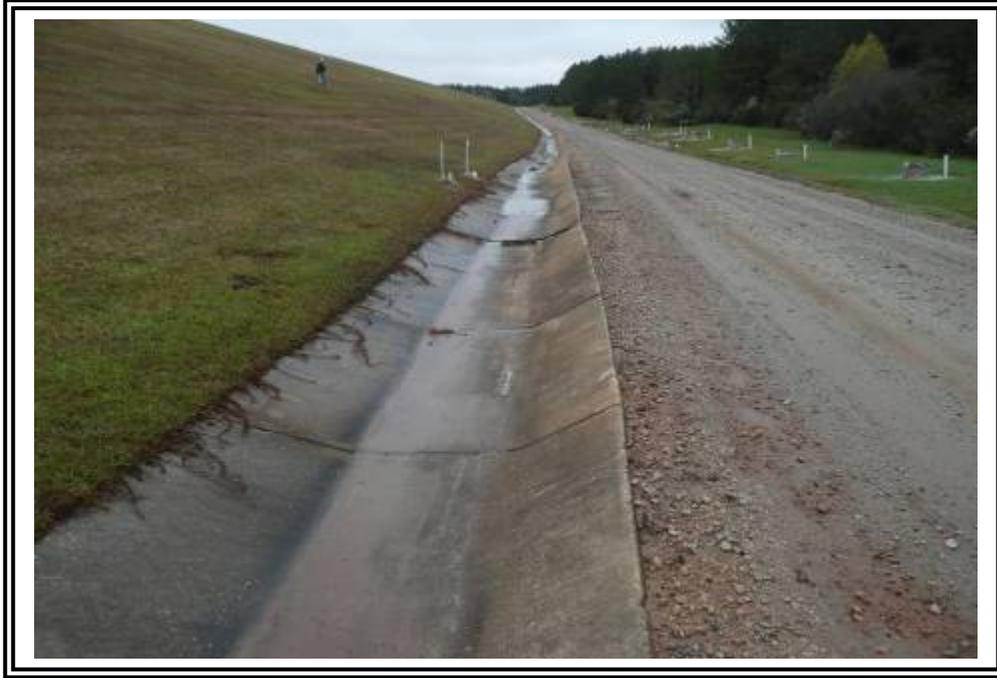
9

Ash Pond E, concrete lined channel drain at the base of the dike (upper channel).

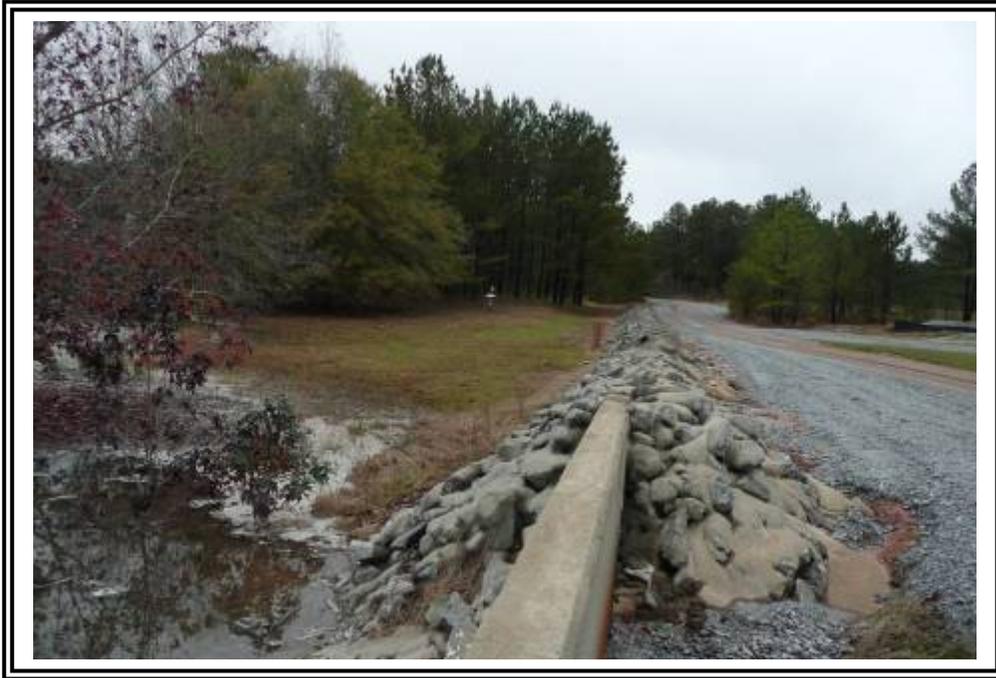
11

Ash Pond E, north end of dike, facing north.

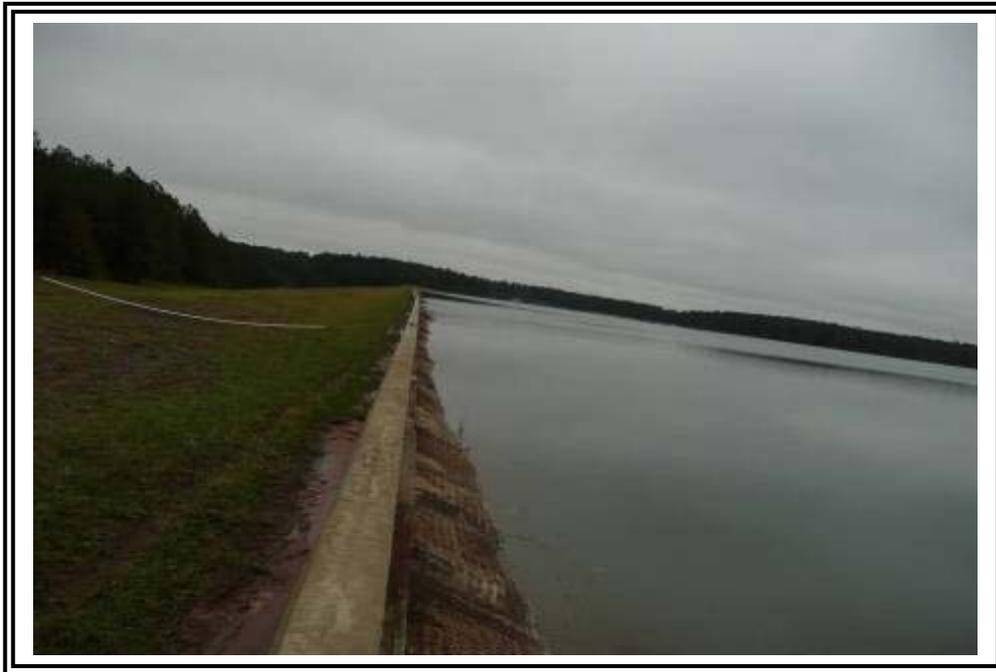
12

Ash Pond E, North end of dike, facing south. Shown above, wave wall and rip-rap placement along upstream edge of pond.

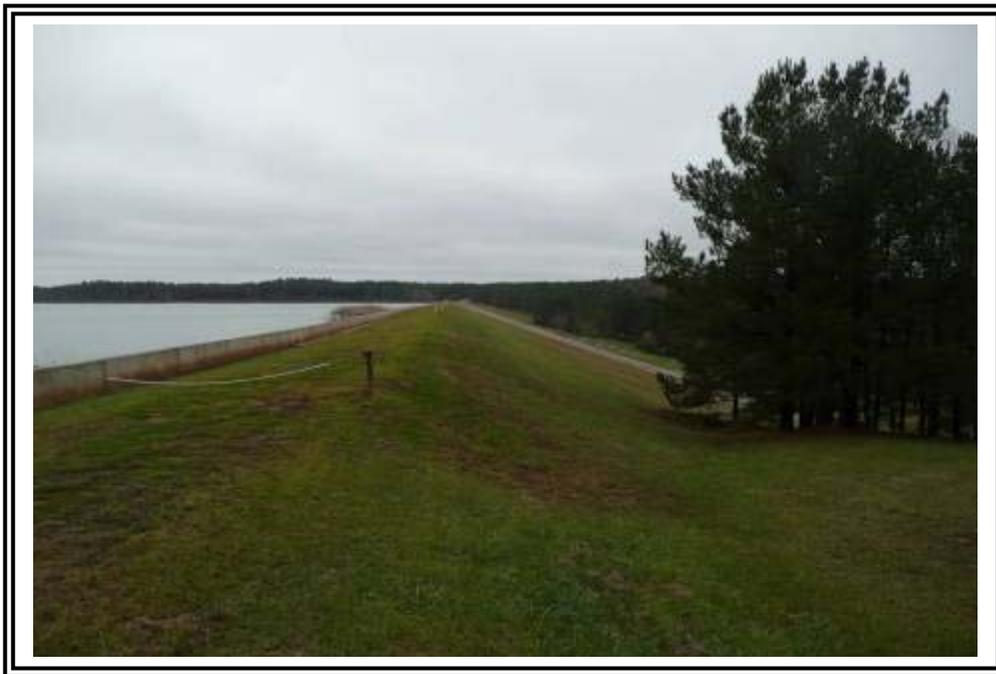
14

Ash Pond E, south end of dike, facing north.

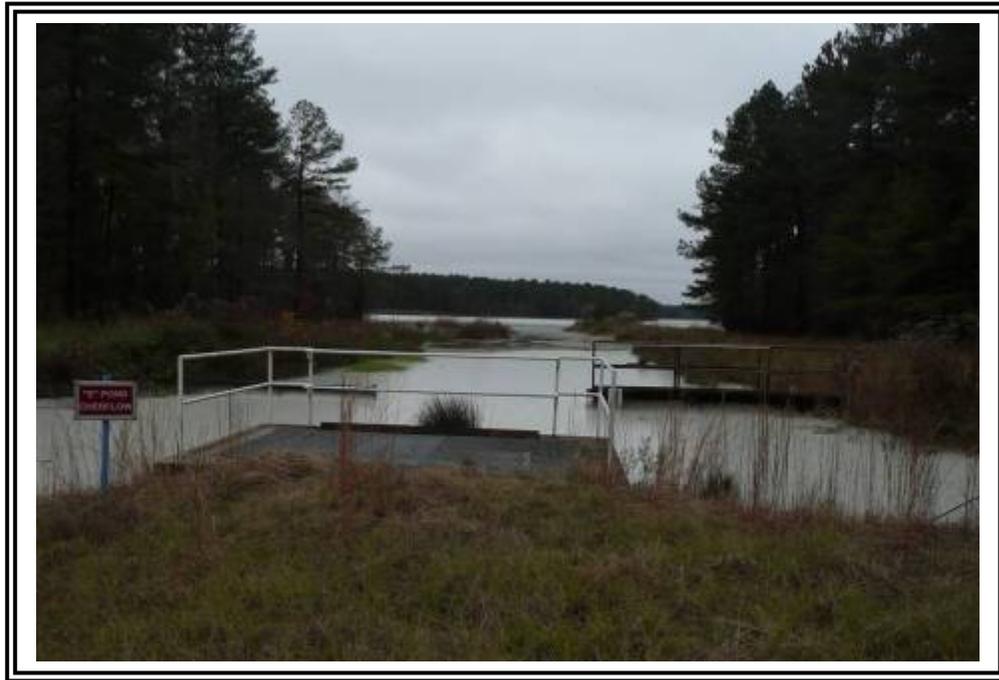
15

Ash Pond E decant spillway structure.

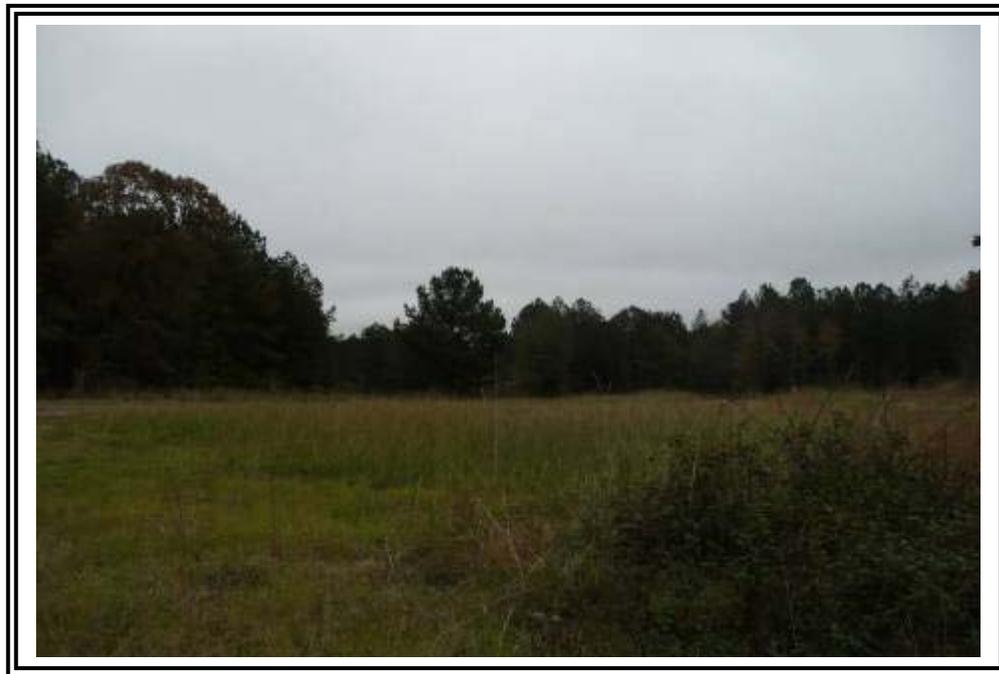
16

Ash Pond E emergency spillway.

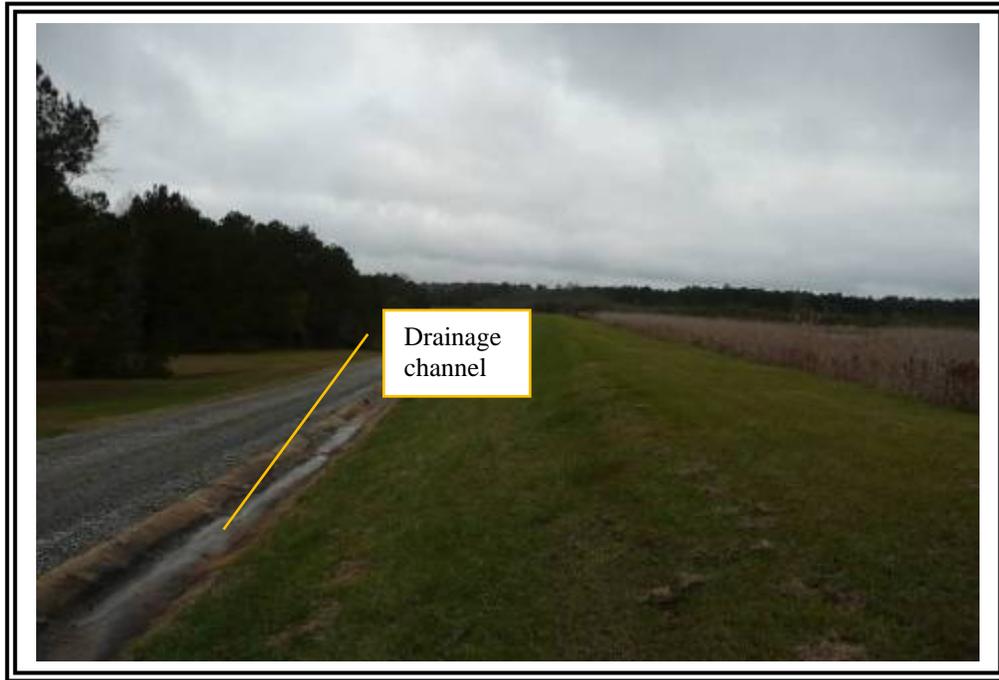
17

Ash Pond D, south edge of dike facing north. Concrete lined drainage channel shown frame left.

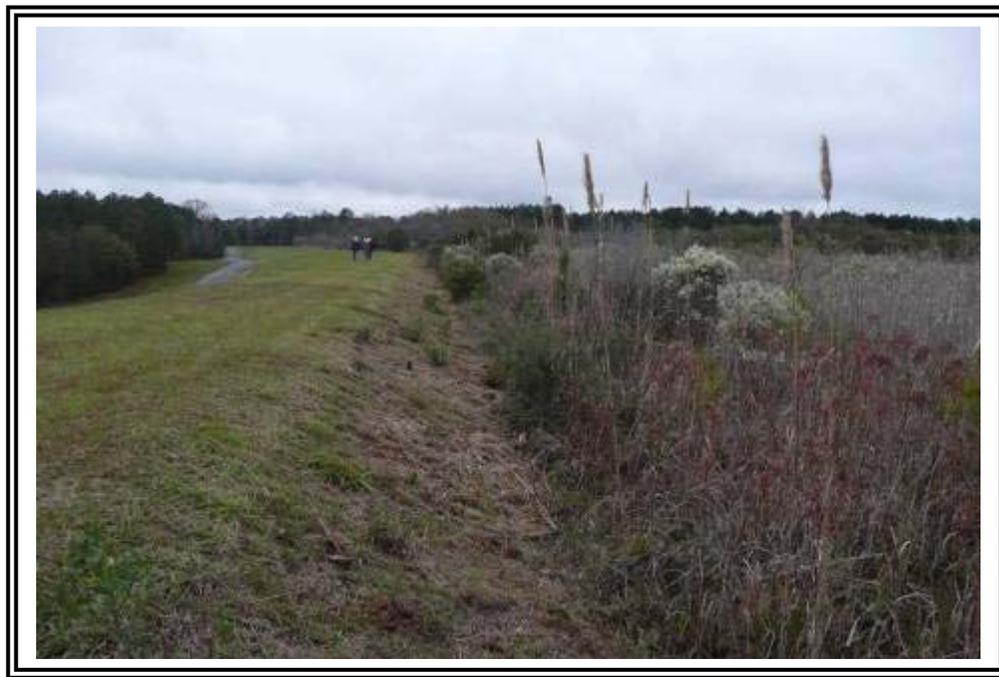
18

Ash Pond D, south end of dike facing north. Upstream slope and vegetation in the pond shown frame right.

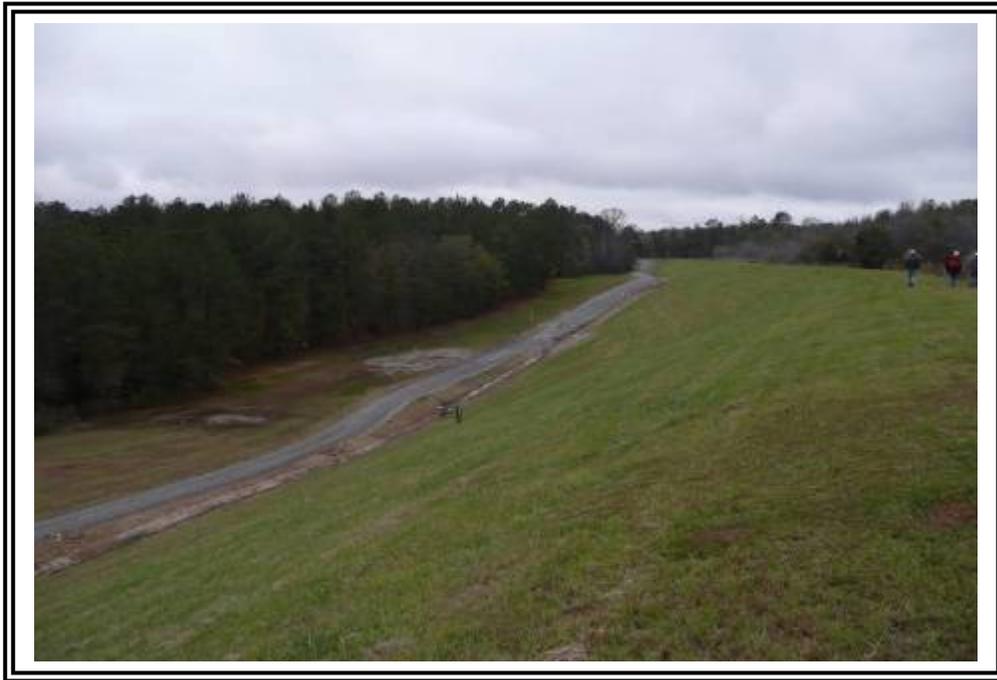
21

Ash Pond D, central portion facing north east.

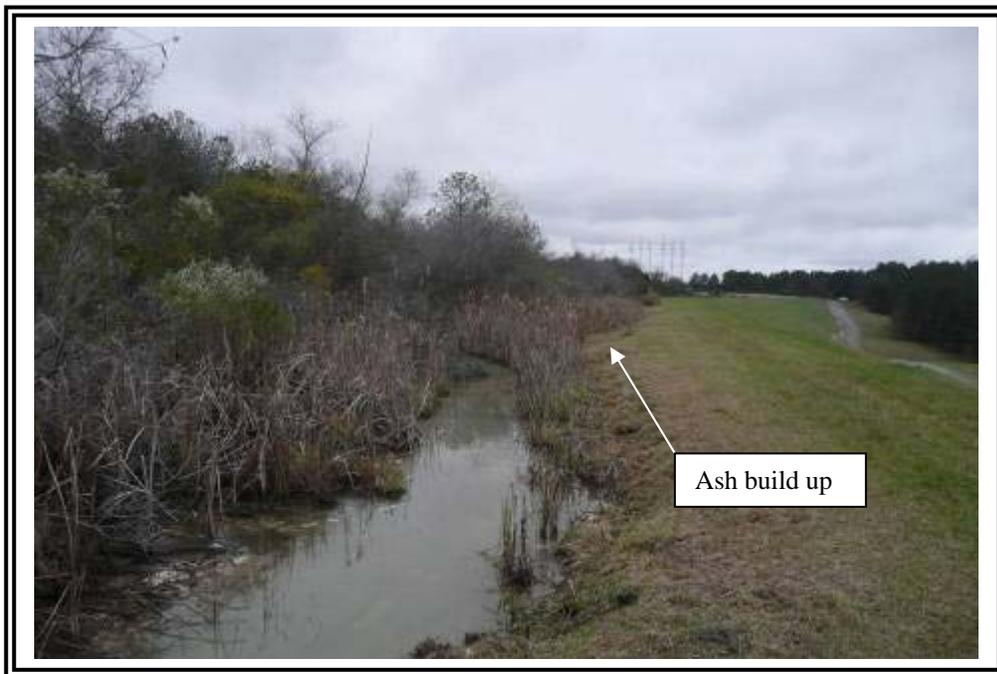
22

Ash Pond D, north edge of dike facing south east. Note widened crest of dike. Crest widening due to build up of ash per Georgia Power personnel.

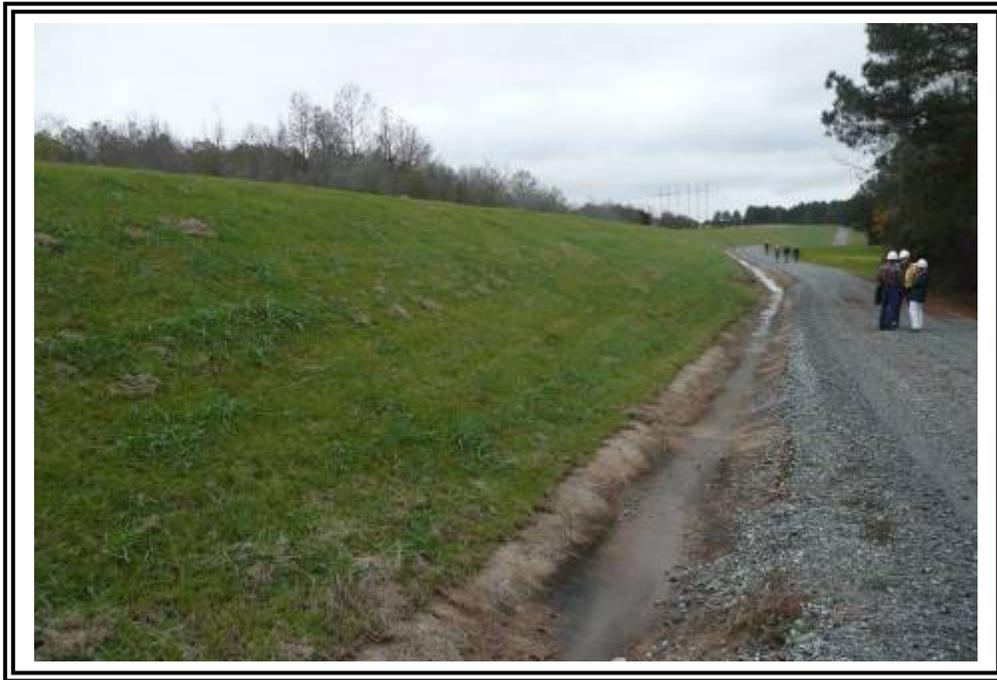
23

Ash Pond D, north end of dike at edge of toe facing southeast showing concrete lined drainage channel along toe of dike.

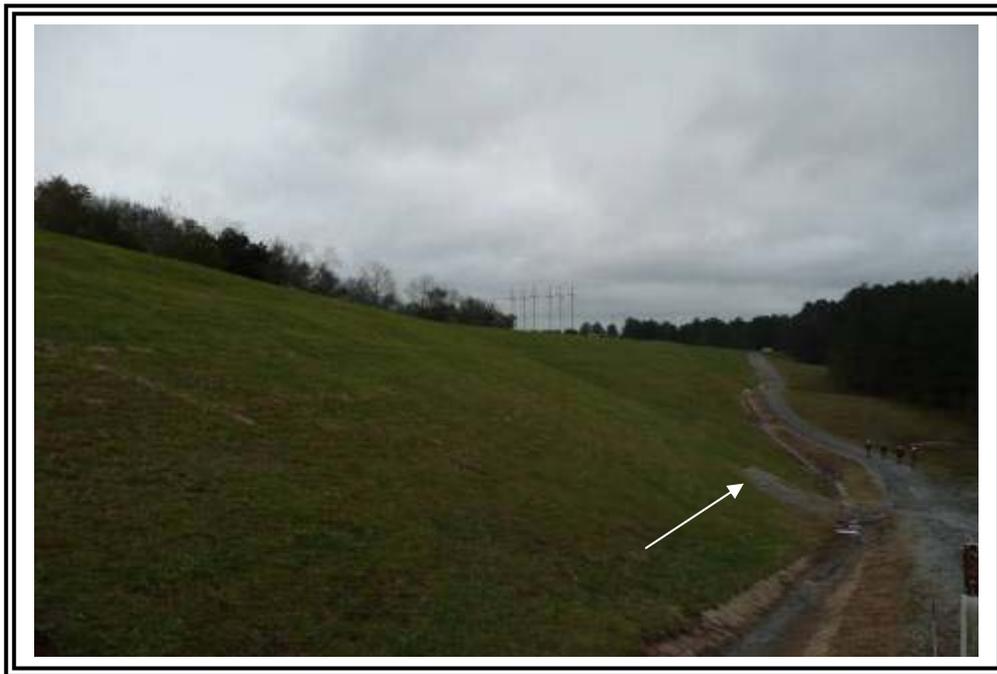
24

Ash Pond D, south central portion of dike facing south east at edge of toe. Dike seepage remediation shown by arrow

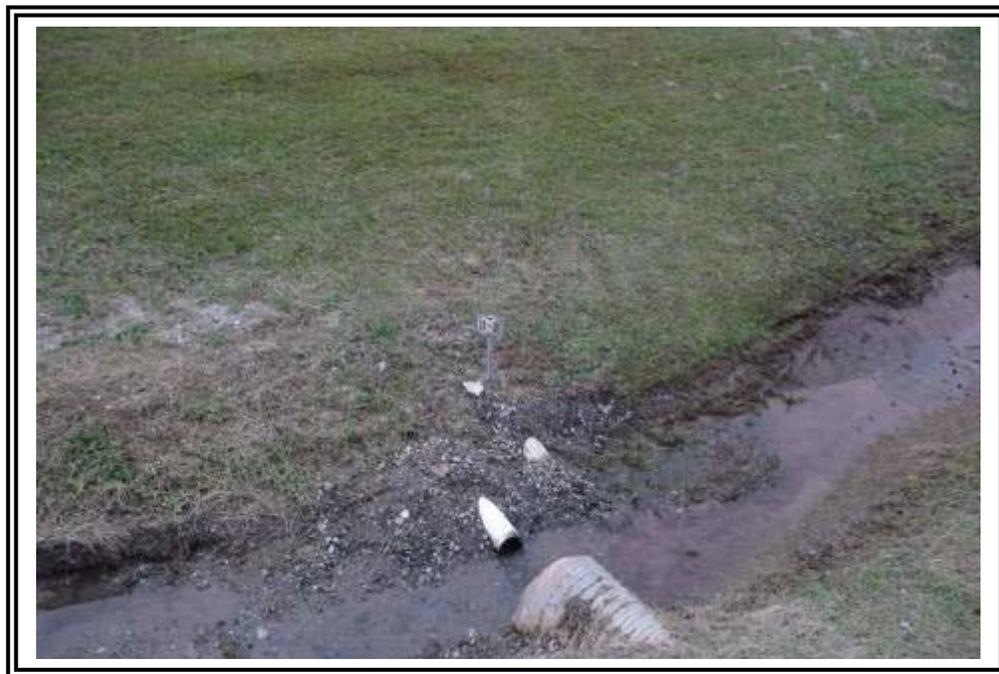
26

Ash Pond D finger drain D-3. Georgia Power personnel indicated that this area was previously remediated and the concrete lined channel was inadvertently razed during remediation.

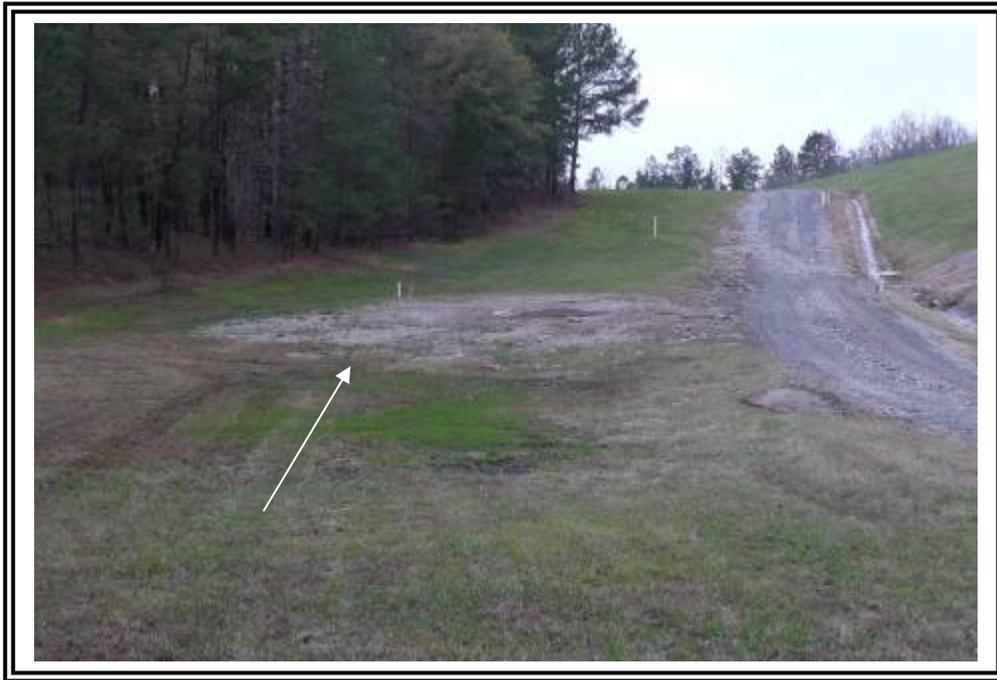
27

Ash Pond D, central portion of dike, west of toe facing north west. "Soft area" covered with rock indicated by arrow.

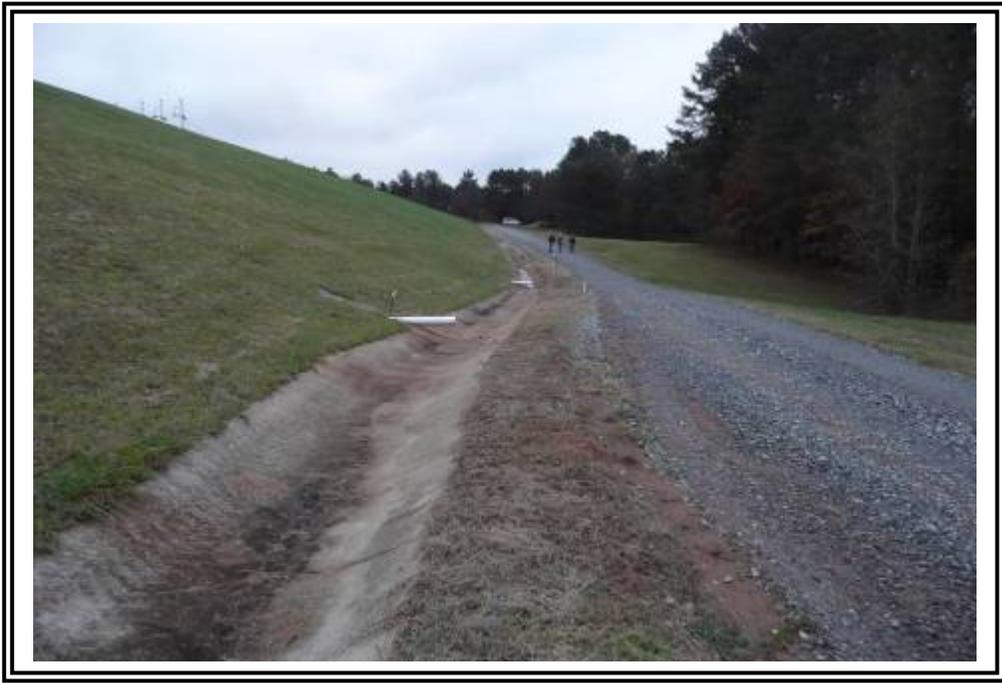
29

Ash Pond D, central portion of dike along toe facing south east.  
Concrete lined channel drain along toe and finger drains shown frame left.

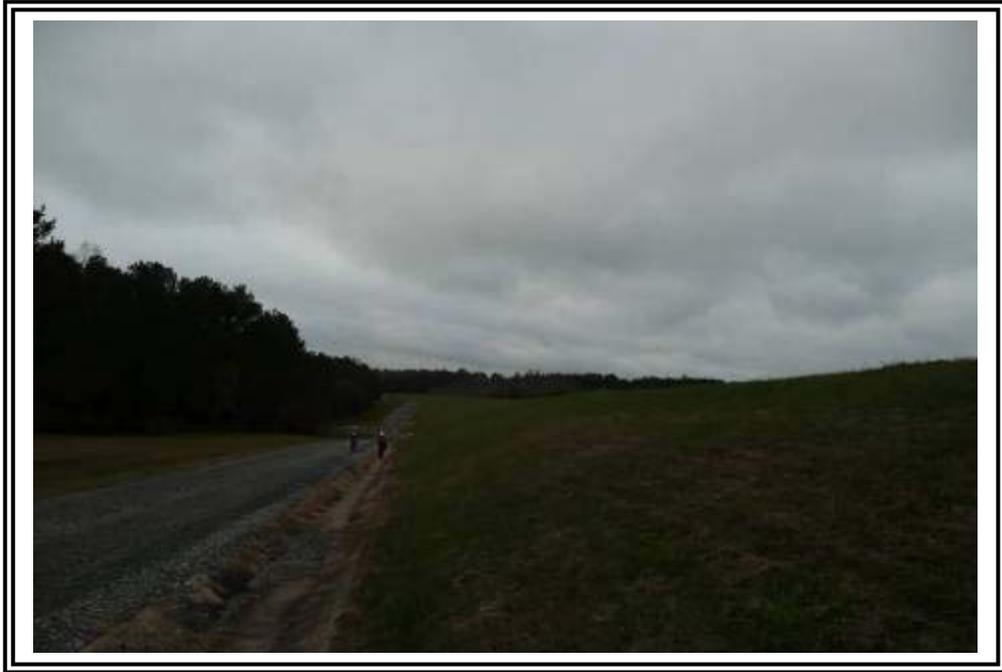
30

Ash Pond D, south end along toe of dike, facing northwest.

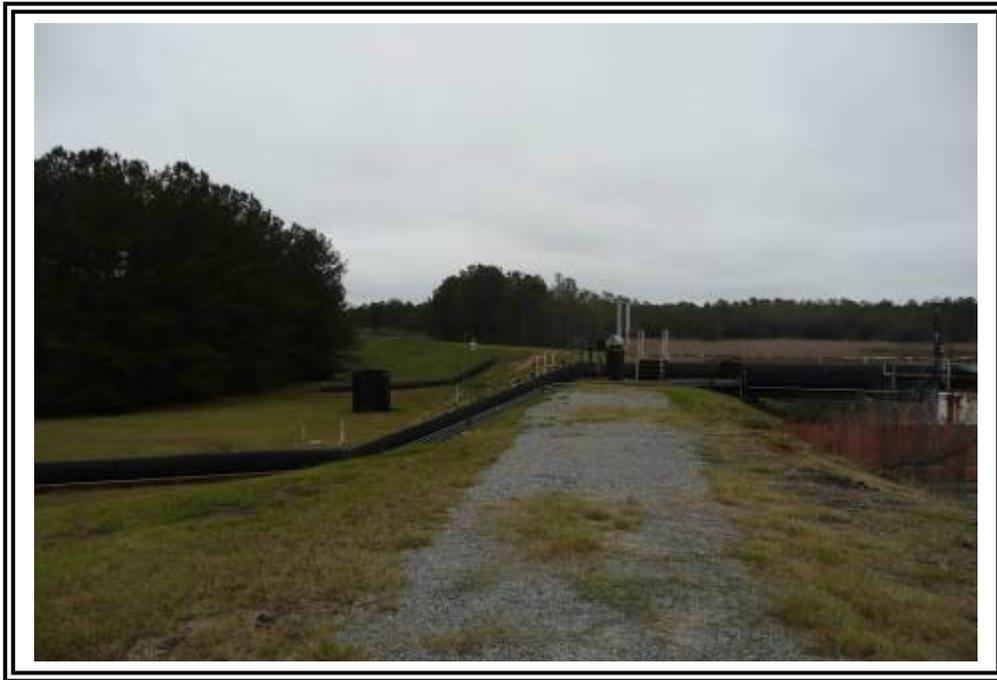
31

Southwest edge of Ash Pond C along west dike crest, facing north. Historic discharge facility shown frame right is no longer in use per Georgia Power personnel.

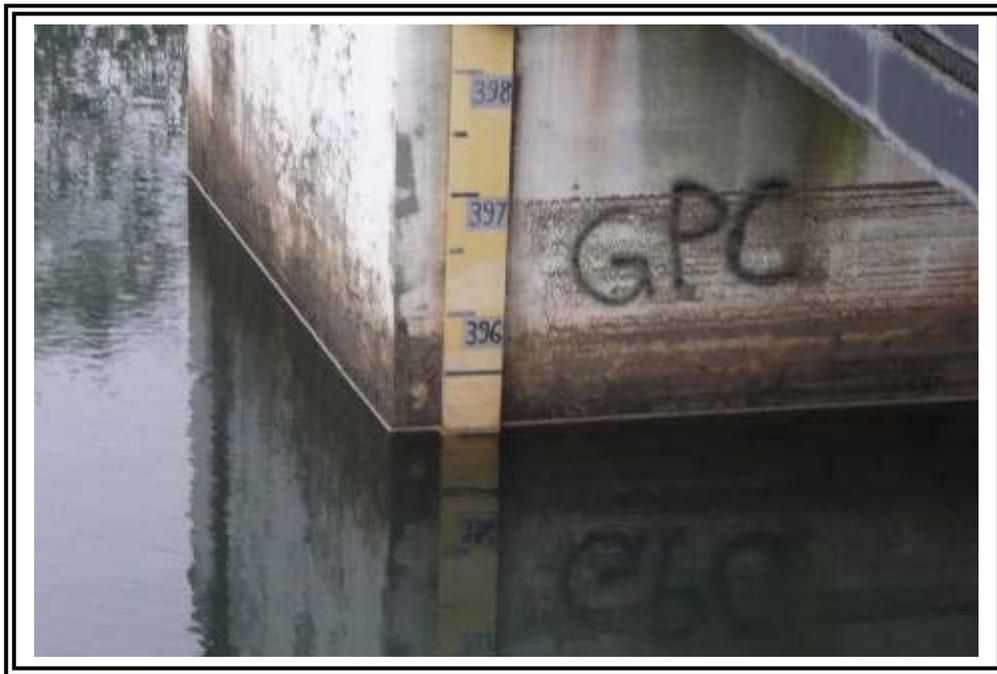
32

Ash Pond C water level indicated by the gauge at the historic discharge facility (395.0').

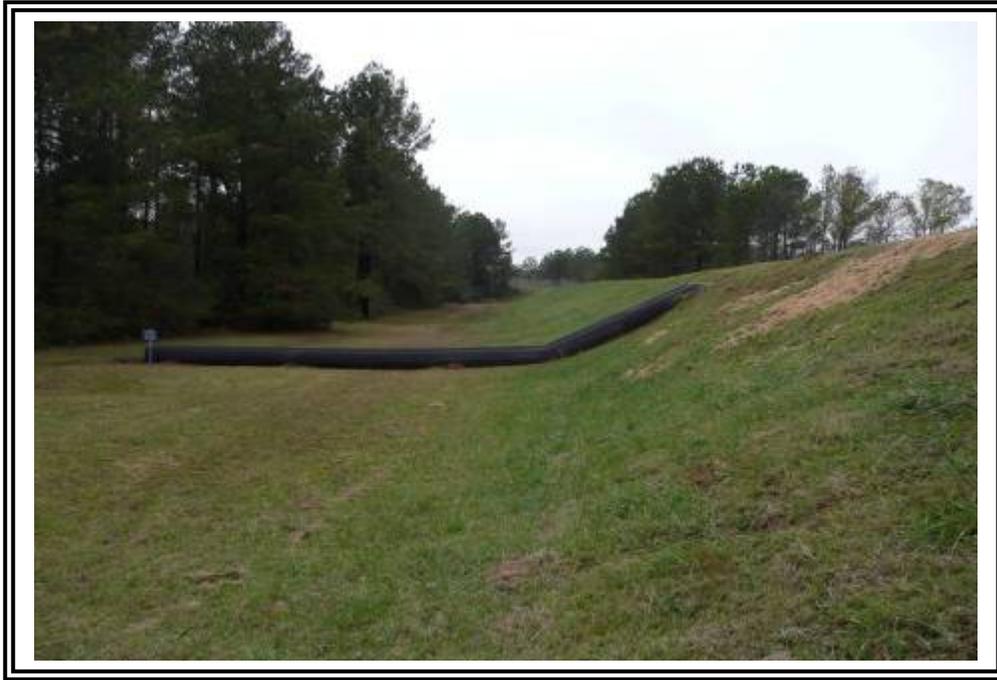
33

Ash Pond C emergency overflow located on southern portion of west dike north of historic discharge facility.

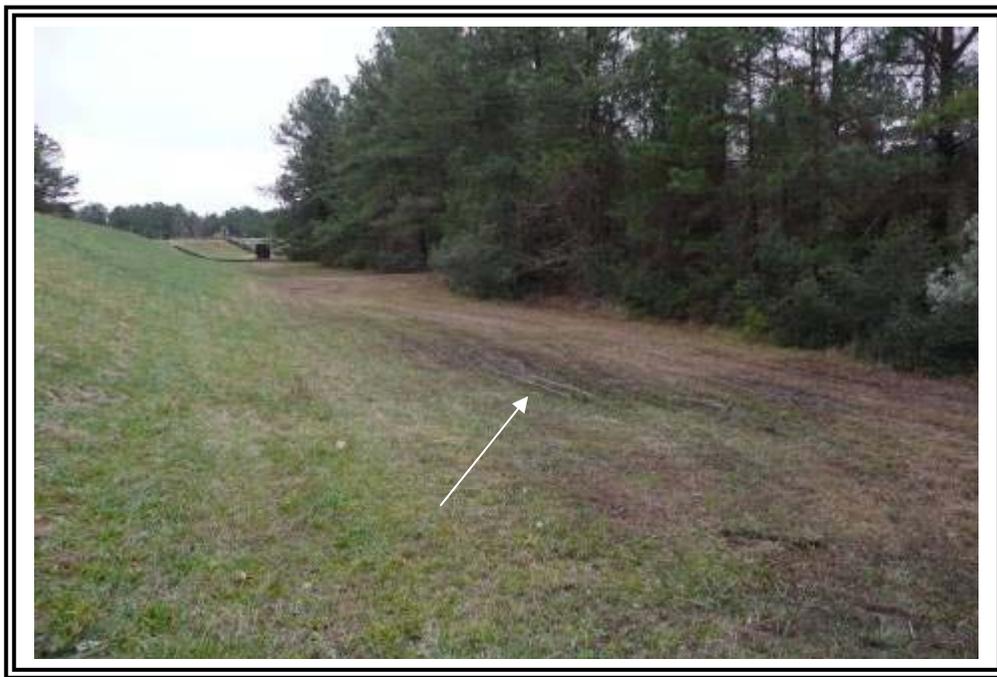
34

Central portion of Ash Pond C west dike toe facing south.  
One of two "soft spot" s indicated by arrow.

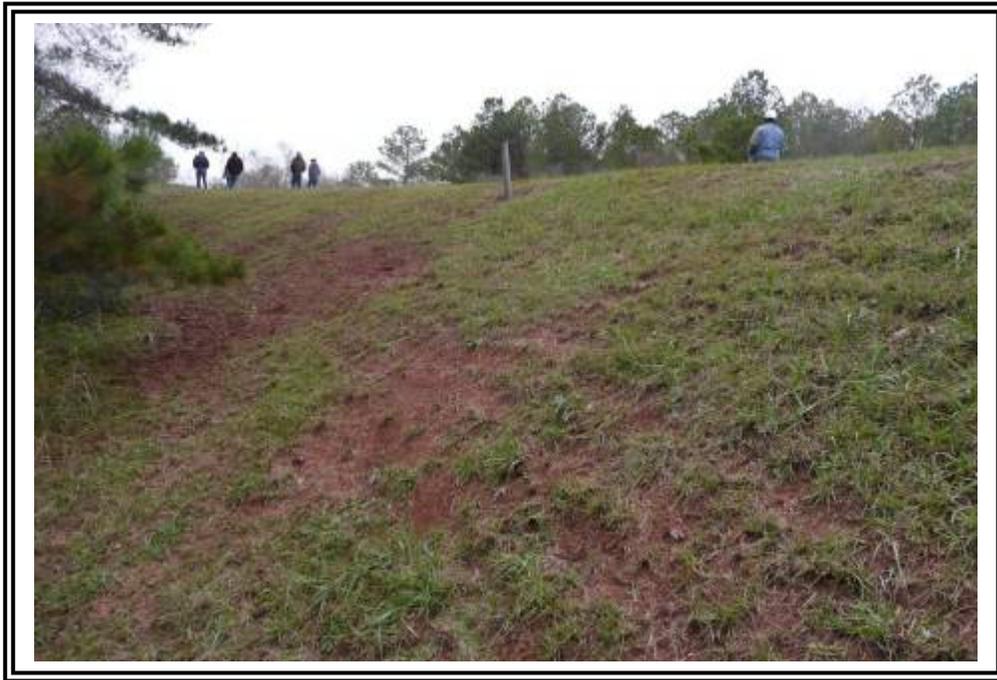
35

Sparse grass cover on north central portion of Ash Pond C west dike toe, facing north.

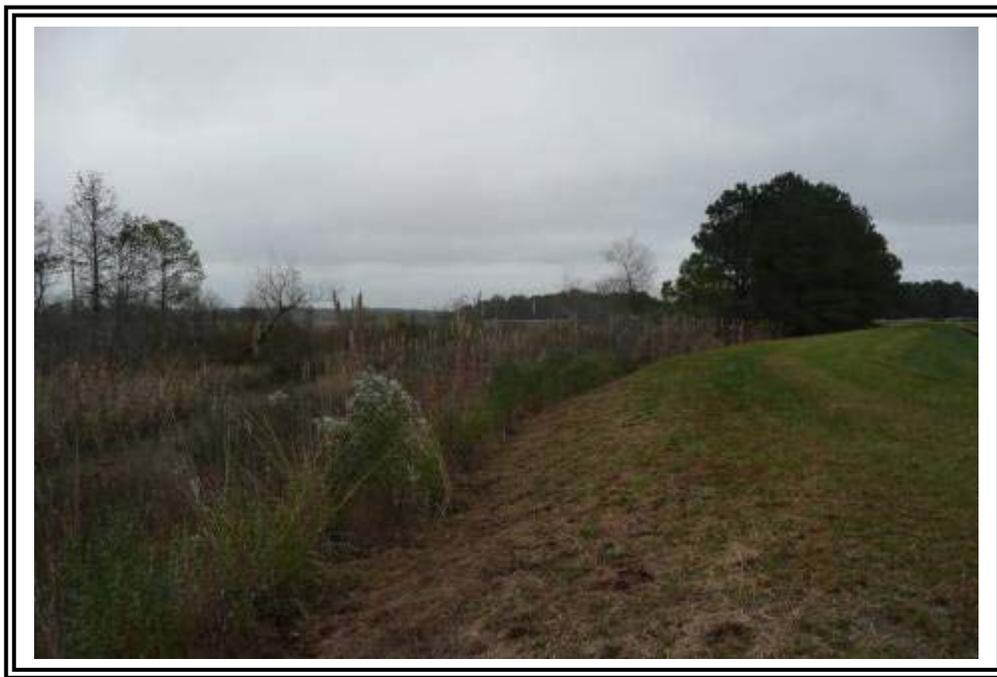
36

Ash Pond C, upstream dike edge shown at north portion of the west dike, facing south.

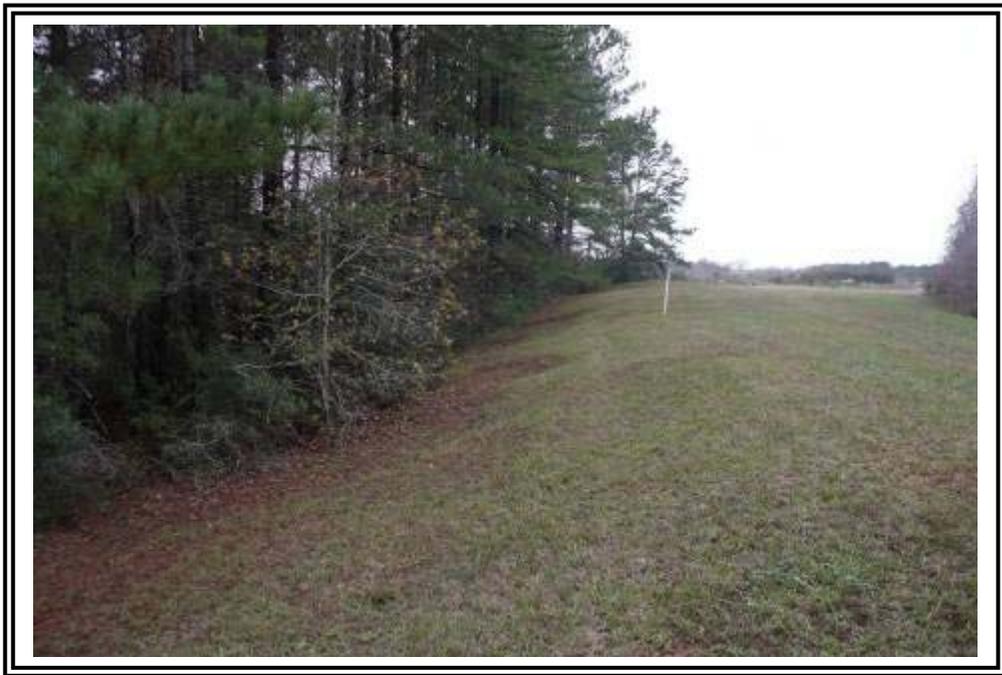
38

Ash Pond C, downstream edge of west dike at north end of dike, facing north.

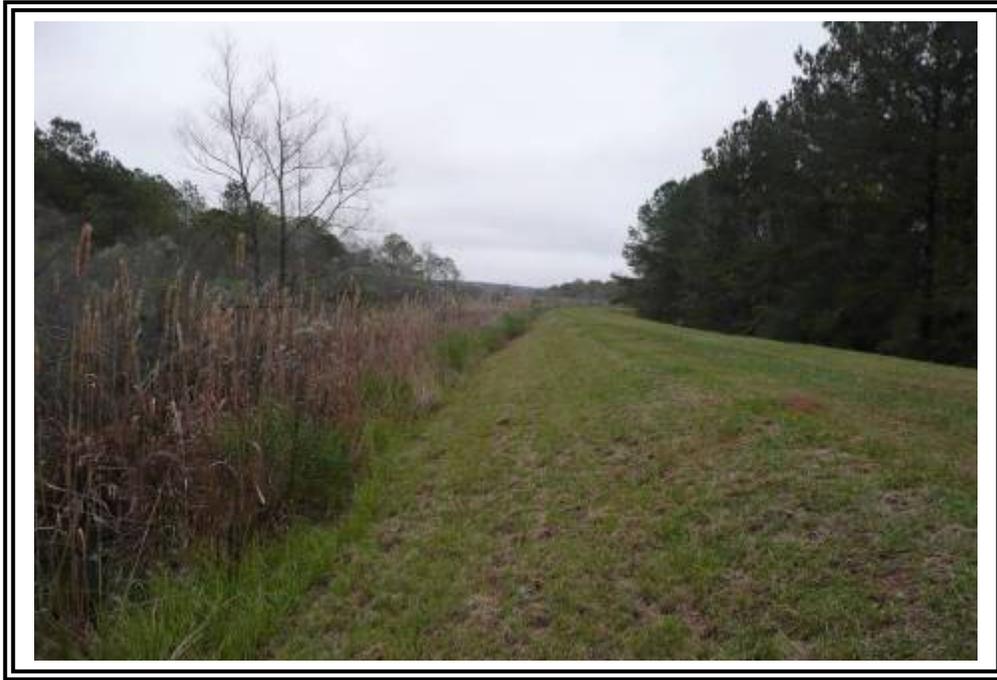
39

Ash Pond C, north end of west dike interior, facing south. Interior edge of dike shown frame left with vegetation present. Exterior edge of dike shown frame right with heavy vegetative cover present.

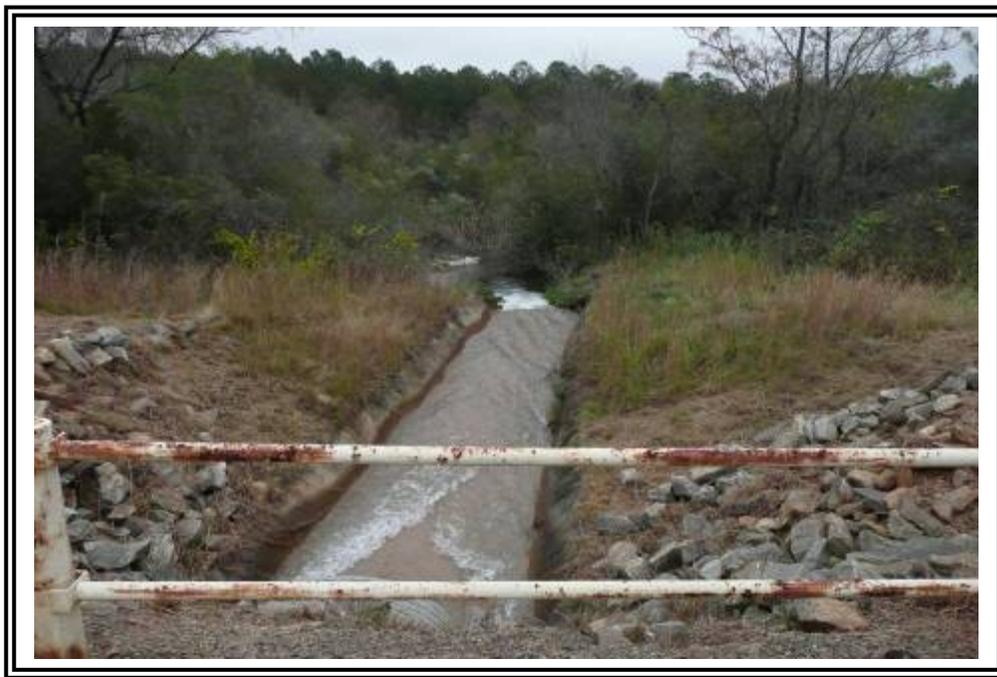
40

Overflow into Ash Pond C from atop the bridge facing south east.

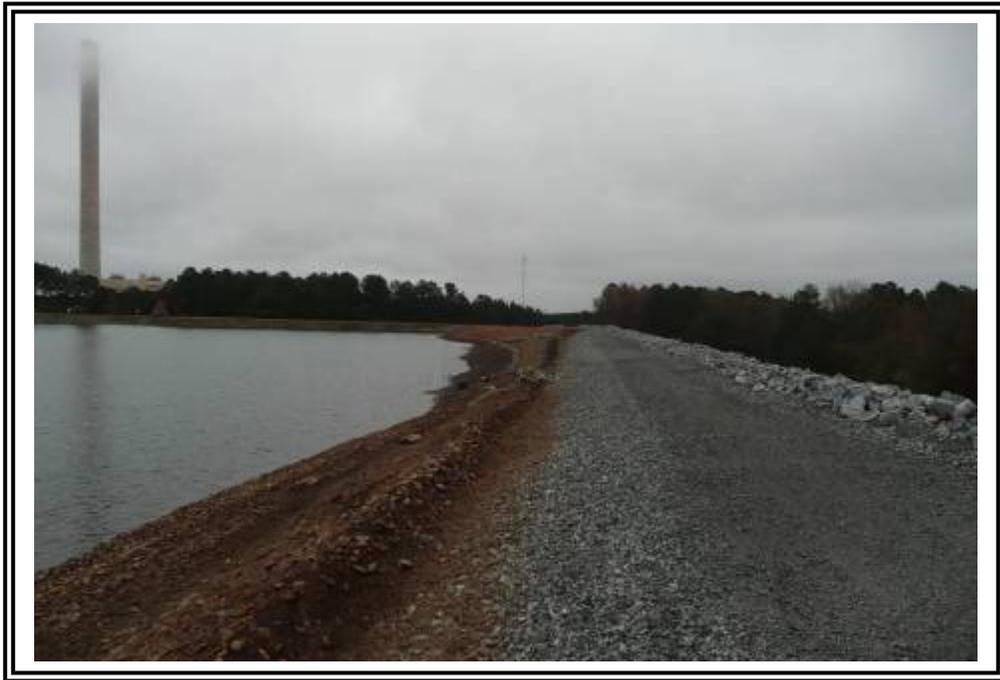
41

Ash Pond C, west end of south dike facing east.

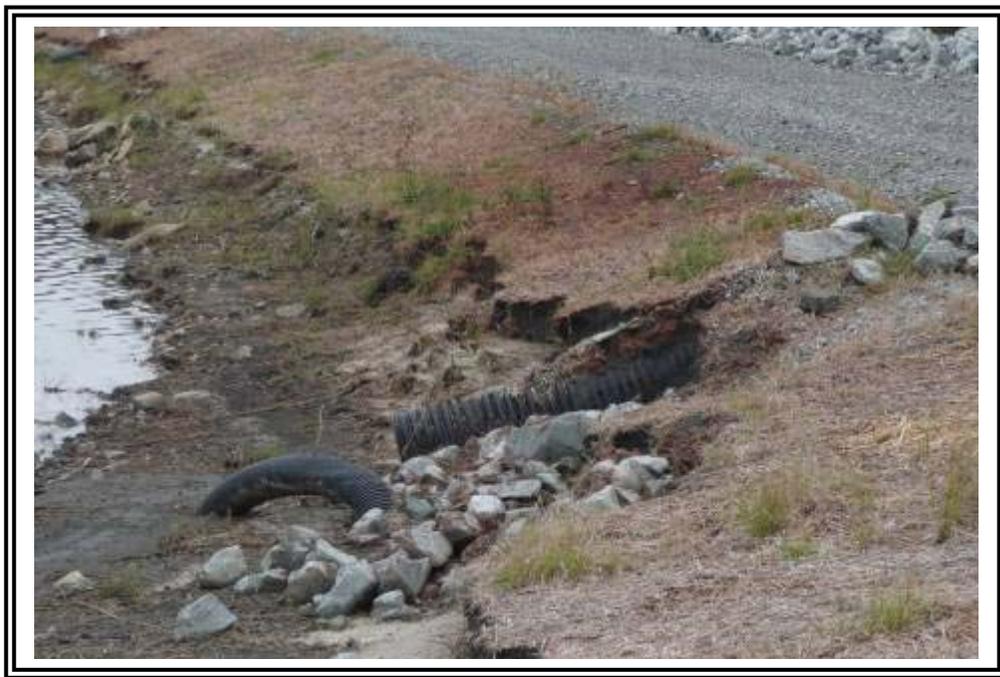
42

Upstream side of Ash Pond C west end of south dike facing east. Crest run-off drain shown.

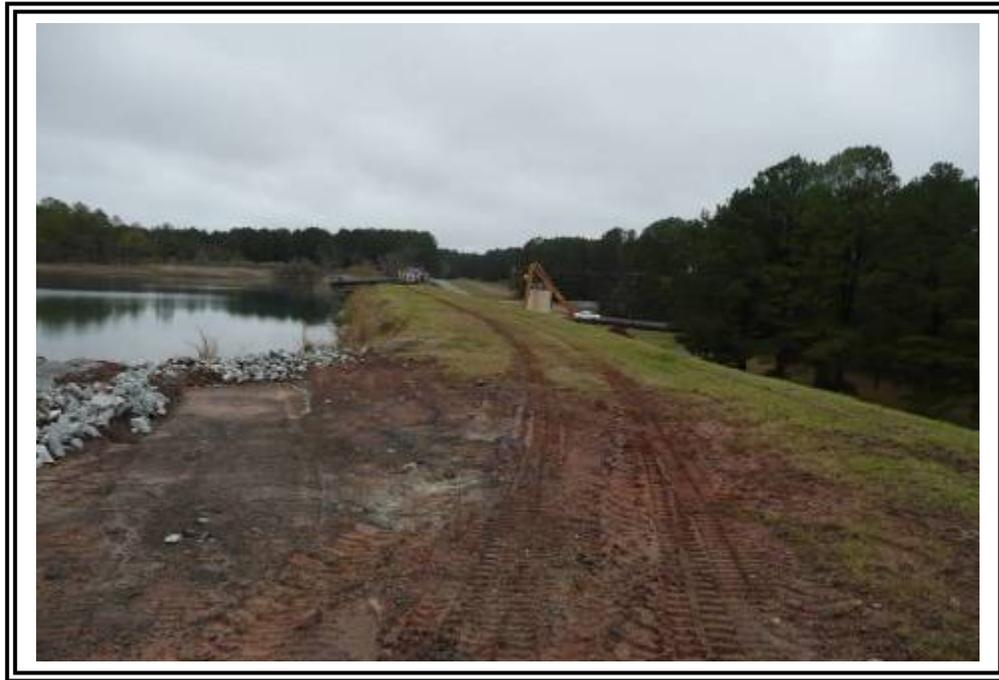
43

Ash Pond C, south end of east dike facing north.

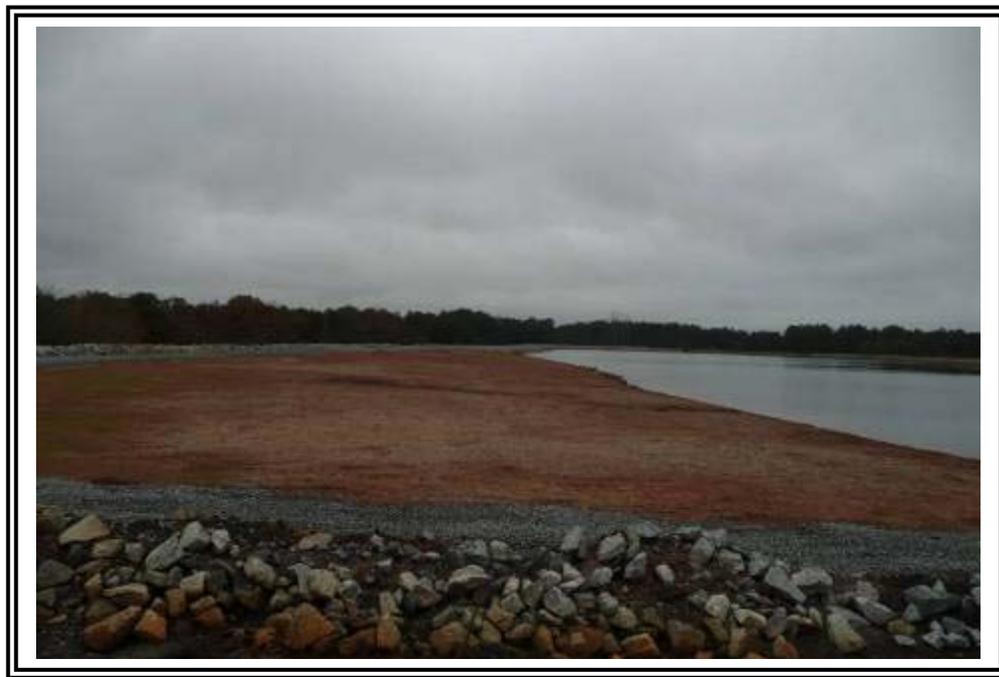
44

Ash Pond C, south end of east dike facing west. South east corner of Ash Pond C shown.
