# Assessment of Dam Safety Coal Combustion Surface Impoundments (Task 3) Draft Report

Georgia Power  
Company

Plant Branch

December 23, 2009

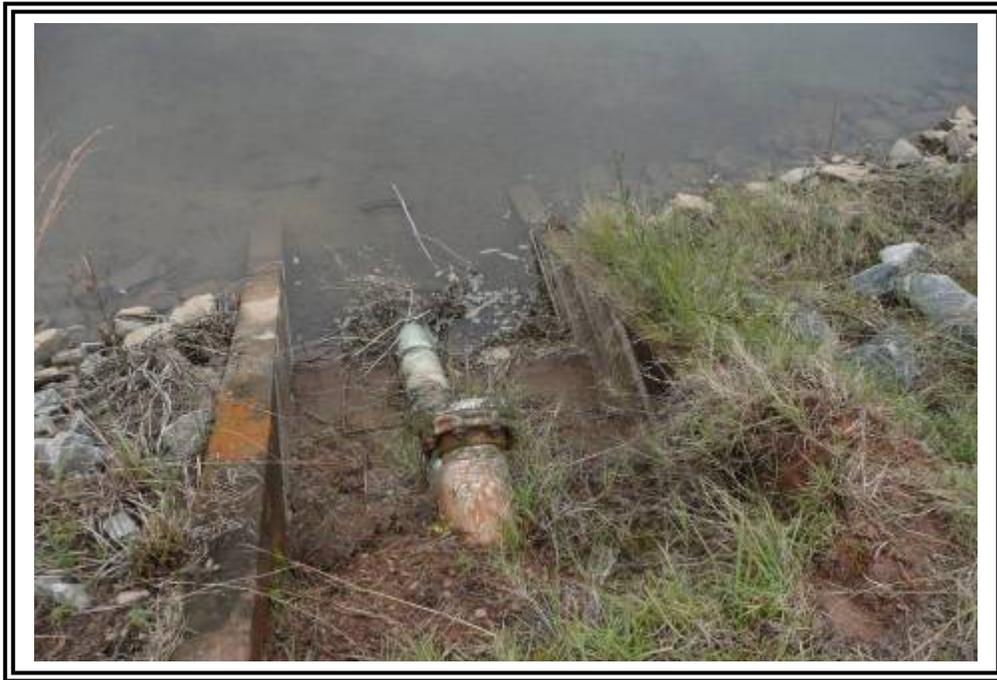
45

Ash Pond C, south end of east dike. Historic drain shown.

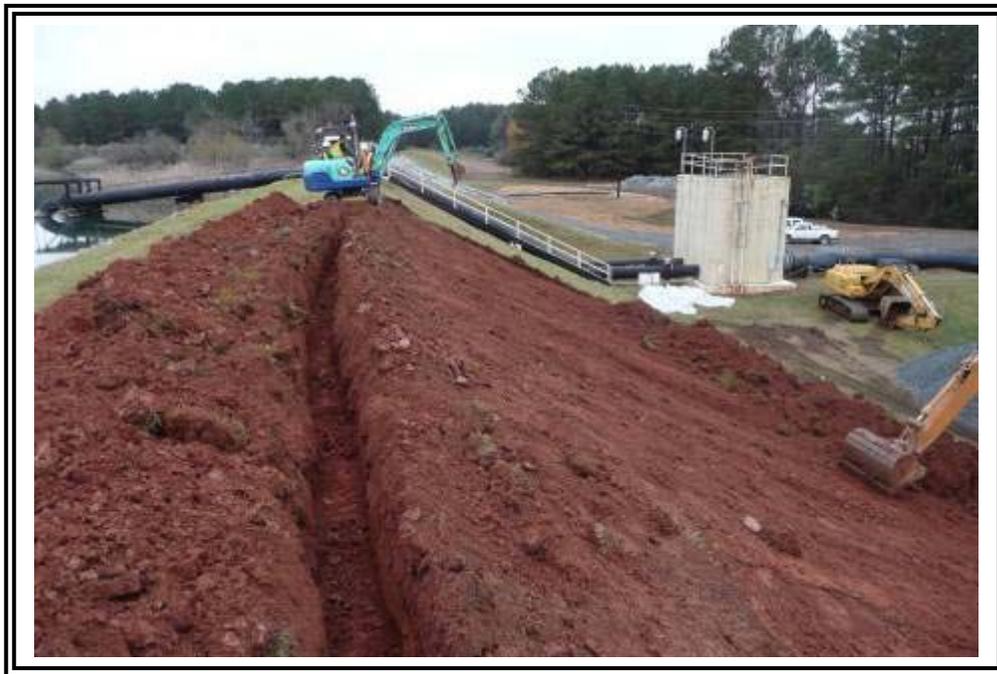
46

Ash Pond C, south central portion of east dike. Downstream dike re-facing with rip-rap under construction.

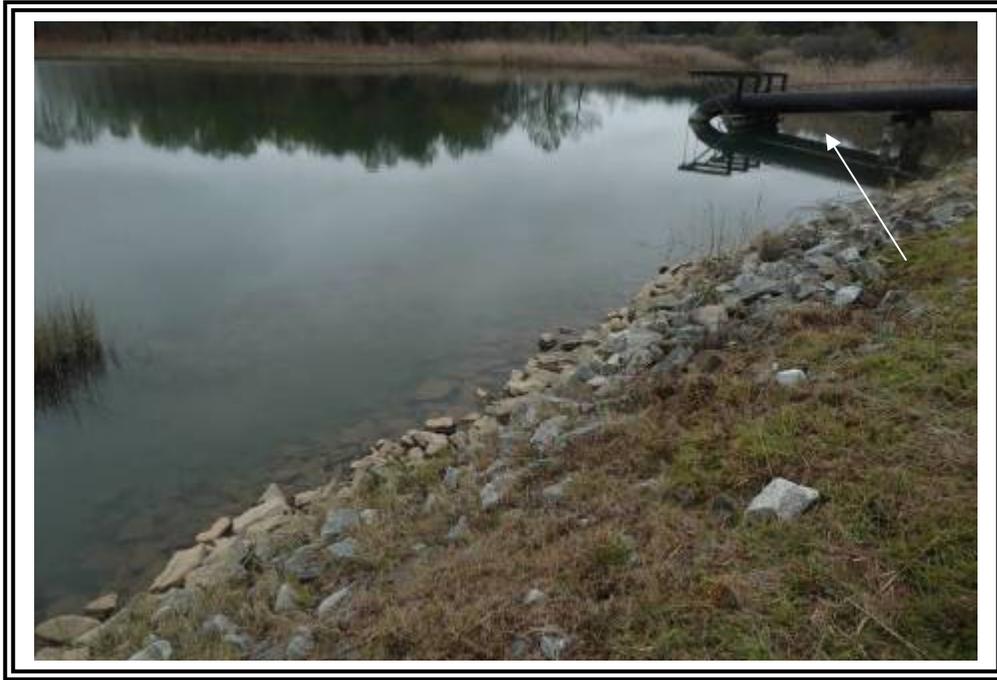
47

South central portion of Ash Pond C east dike, upstream slope shown with rip-rap. Re-cycle water system intake shown frame right

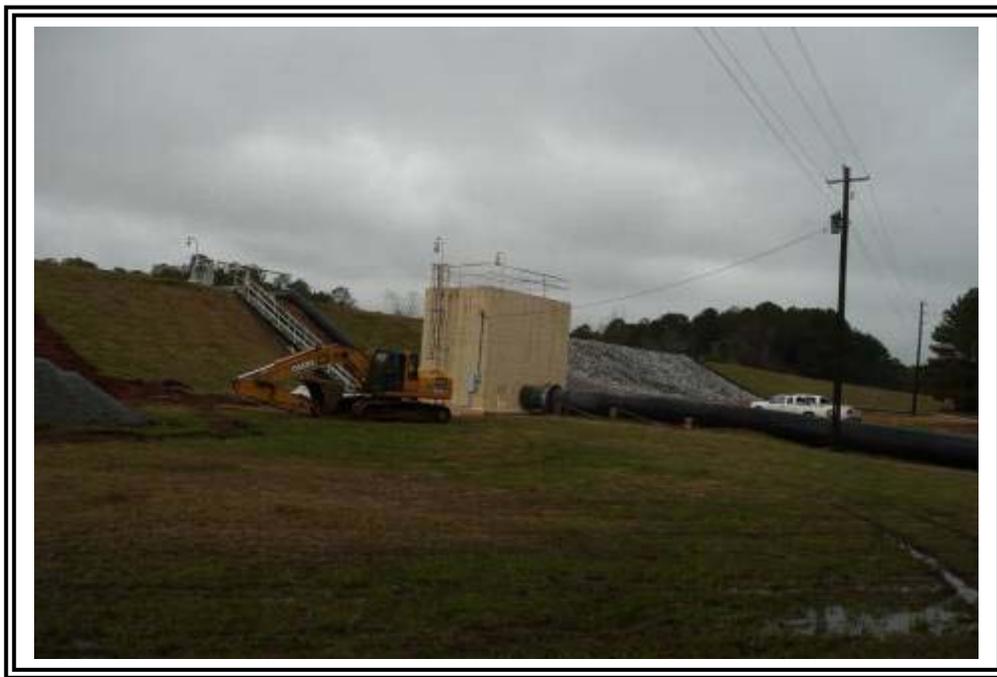
48

Ash Pond C, south central portion of east dike. Recycle water system shown. This system discharges recycle water to Ash Pond B.

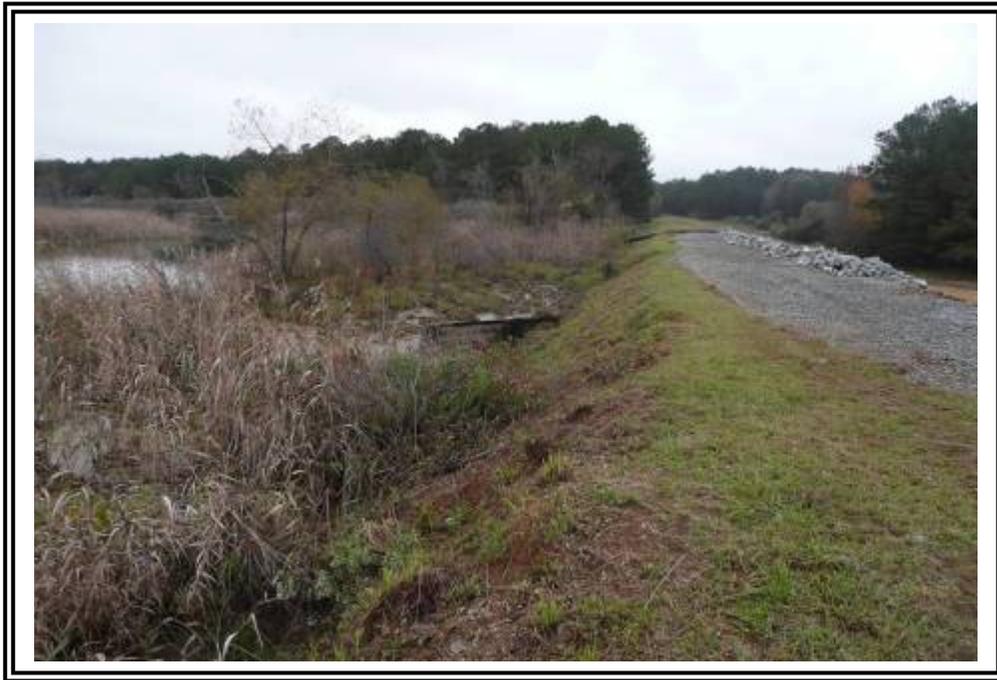
49

Central portion of Ash Pond C east dike facing north. Interior pond edge shown with thick and tall vegetative growth.

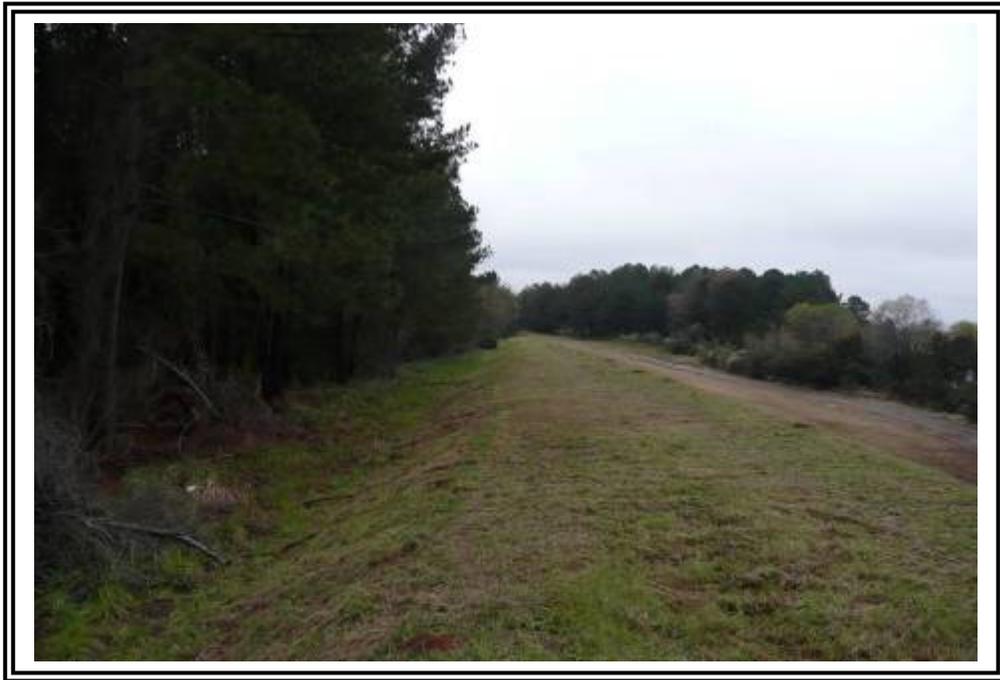
51

Ash Pond C, north portion of east dike facing north.

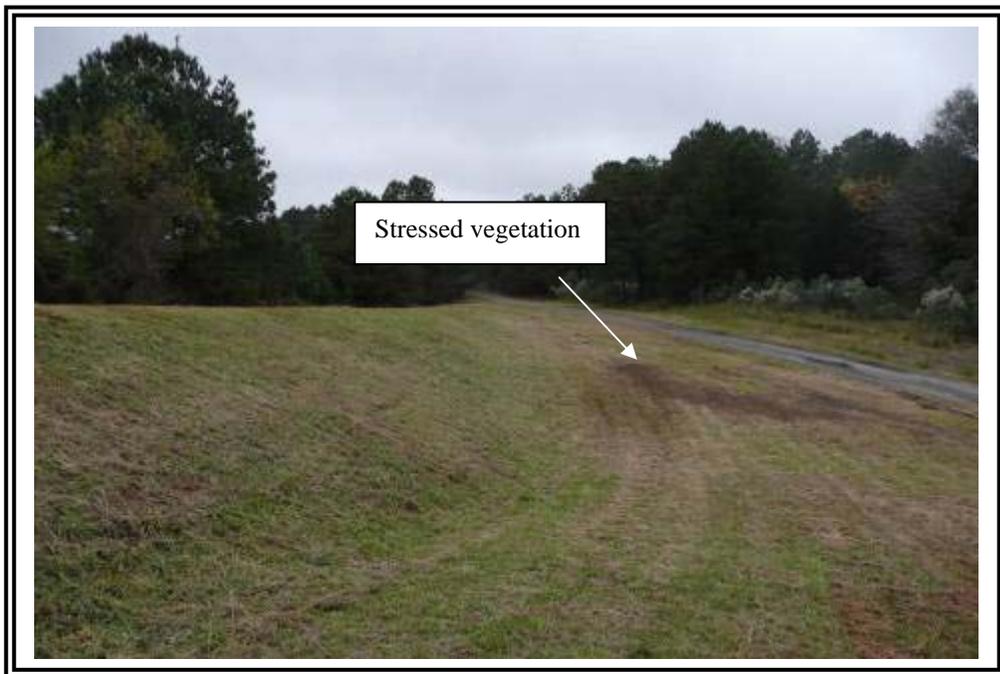
52

Ash Pond C, downstream slope at north end of east dike, facing north. Stressed vegetation shown frame right.

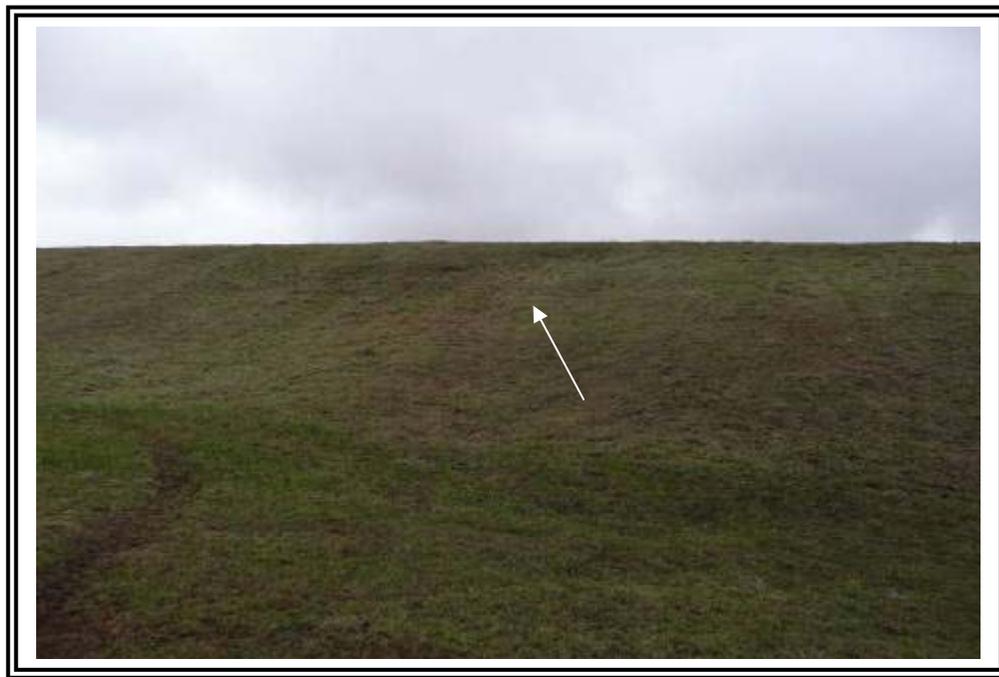
54

Downstream slope of Ash Pond C east dike near the south end showing variations in elevation.

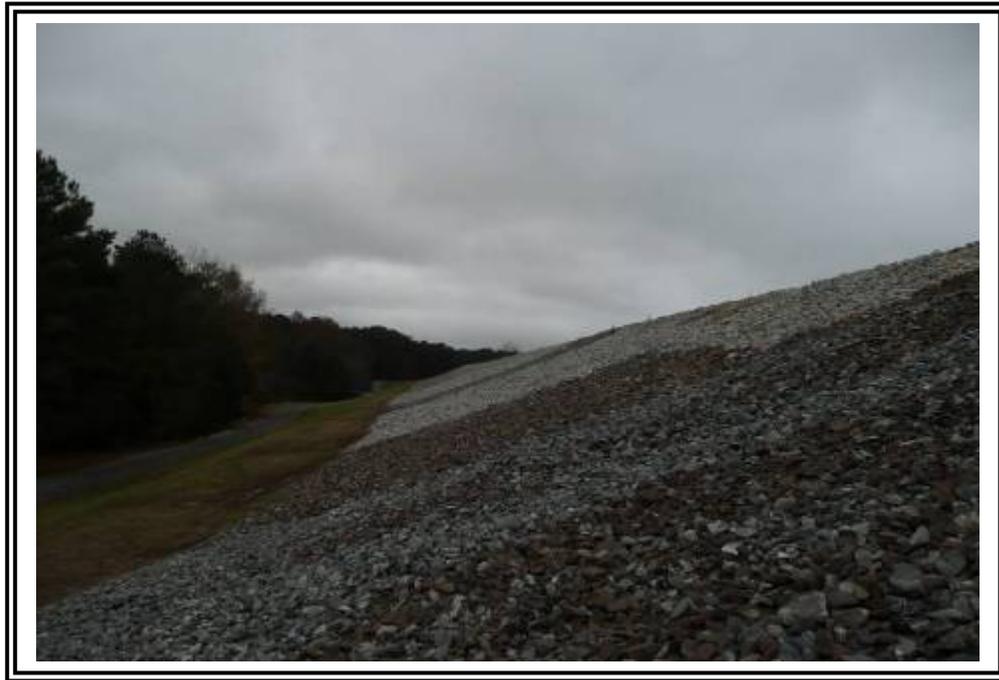
55

Ash Pond C, east end of south dike facing west.  
Downstream slope shown with rip-rap facing.

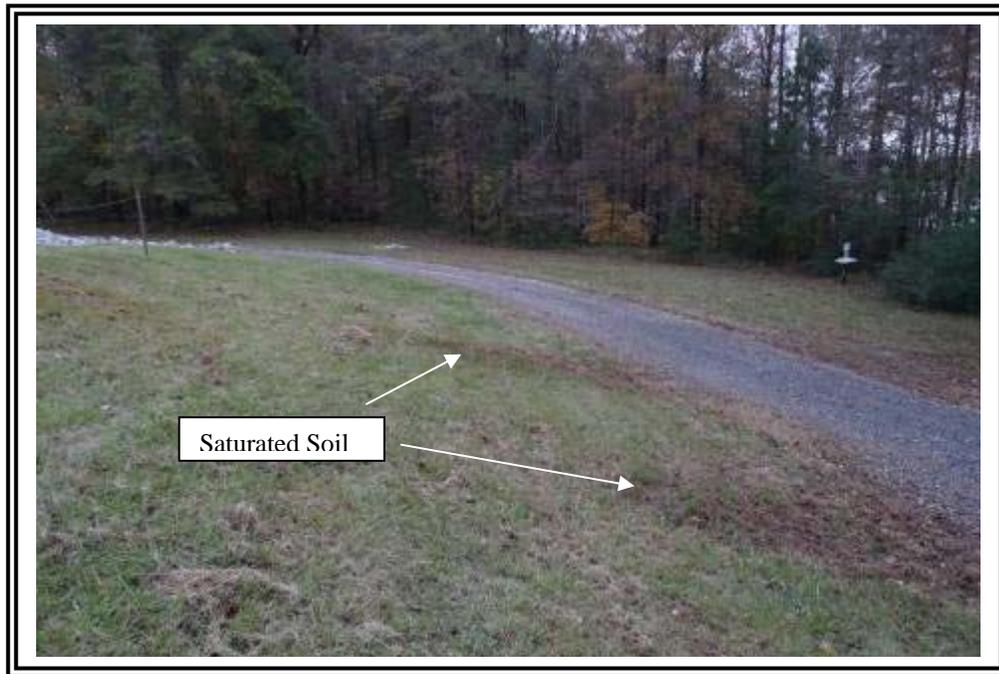
56

Ash Pond C, east end of south dike at the toe, facing east. Two saturated areas shown (several located in this area). Saturated areas possibly due to buried drains.

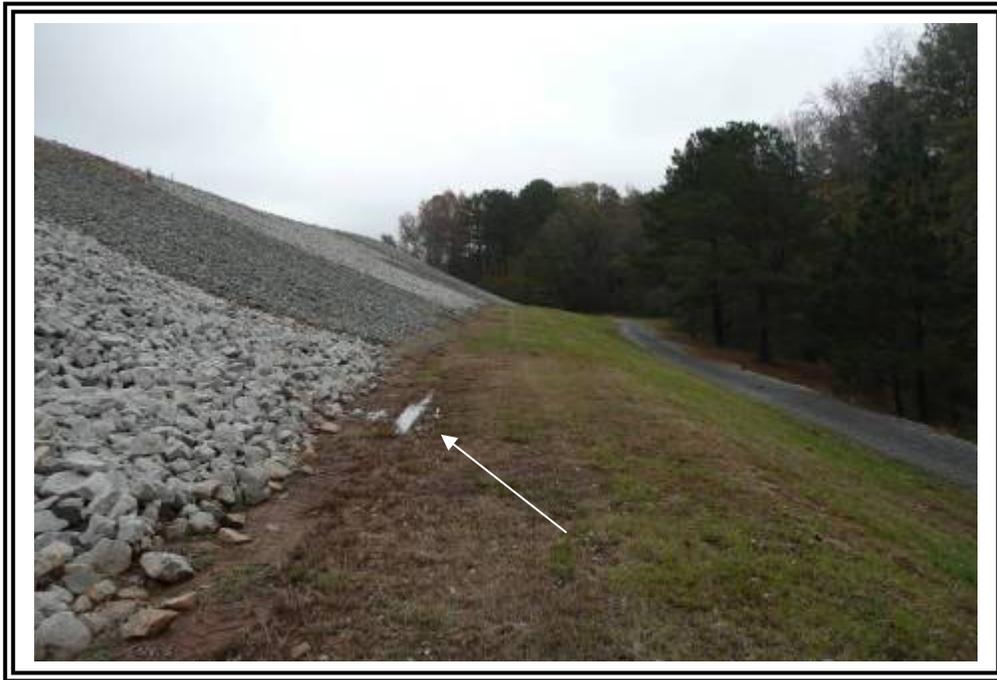
57

Ash Pond C, central portion of south dike along toe facing east.  
Pooled water shown frame left.

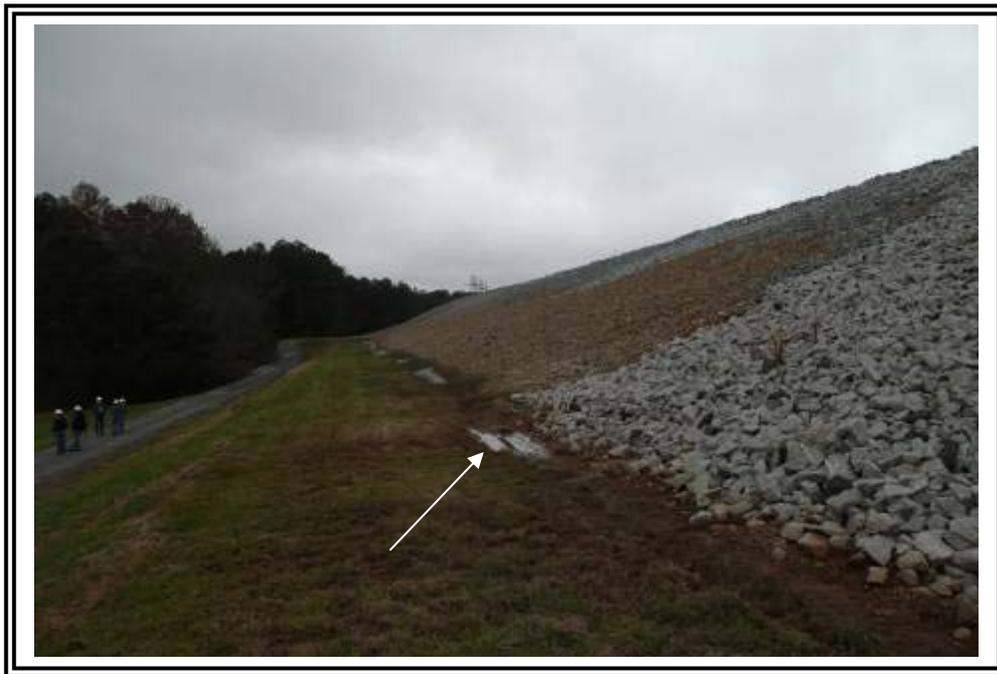
58

Ash Pond C, central portion of south side facing west. Pooled water shown frame right.

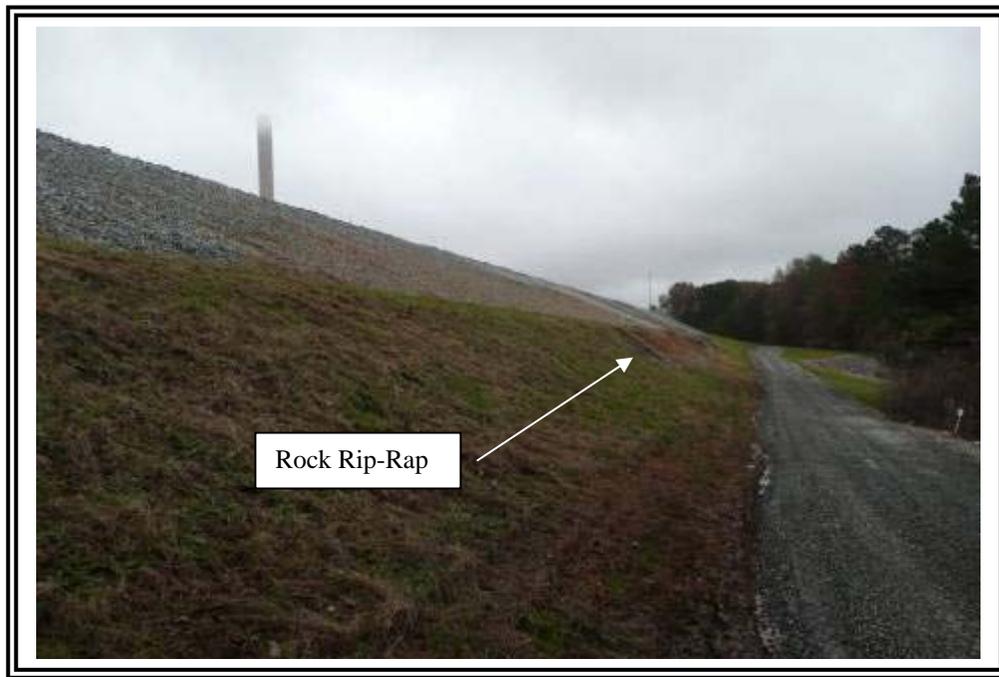
60

Ash Pond C, western central portion of south dike facing east. Toe re-faced utilizing rock rip-rap.

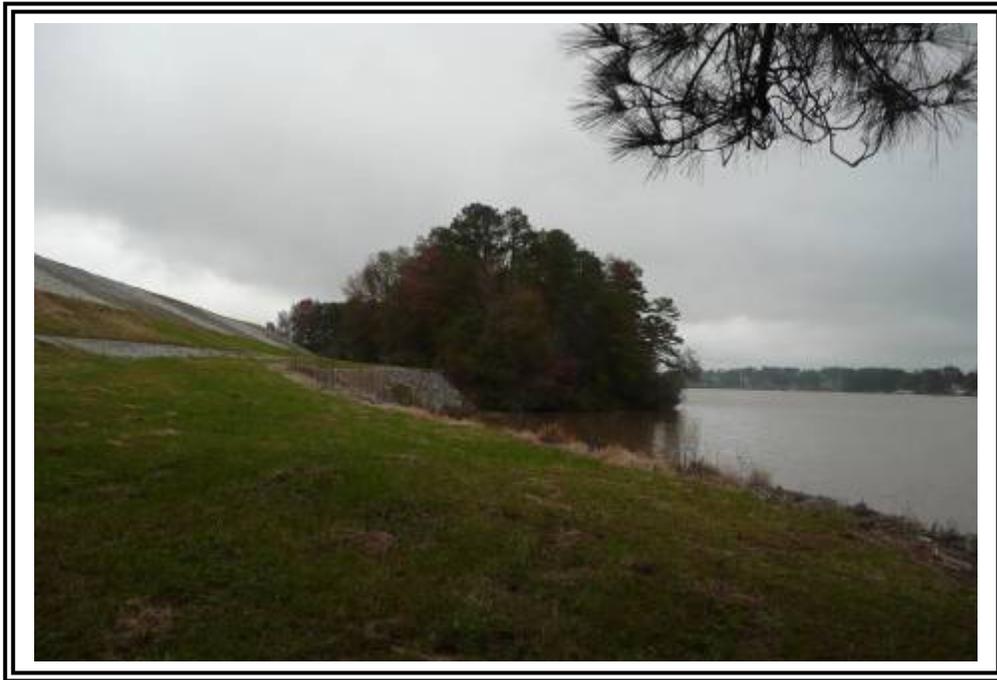
61

Ash Pond C, western central portion of south dike, facing east, adjacent south of toe.

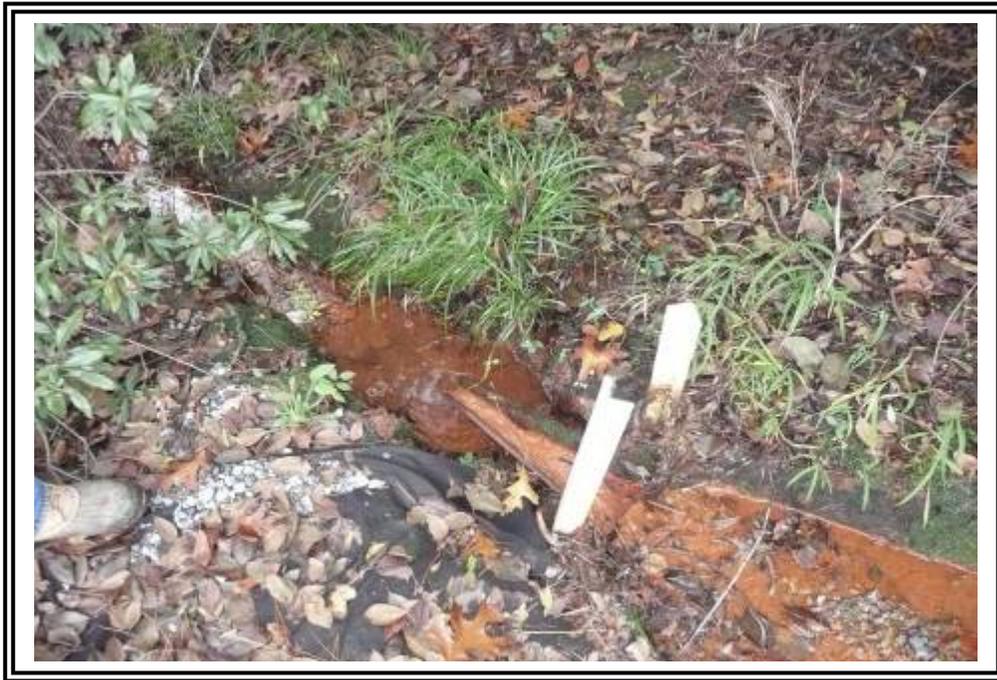
63

Ash Pond C, west end of south dike. Seepage weir shown.

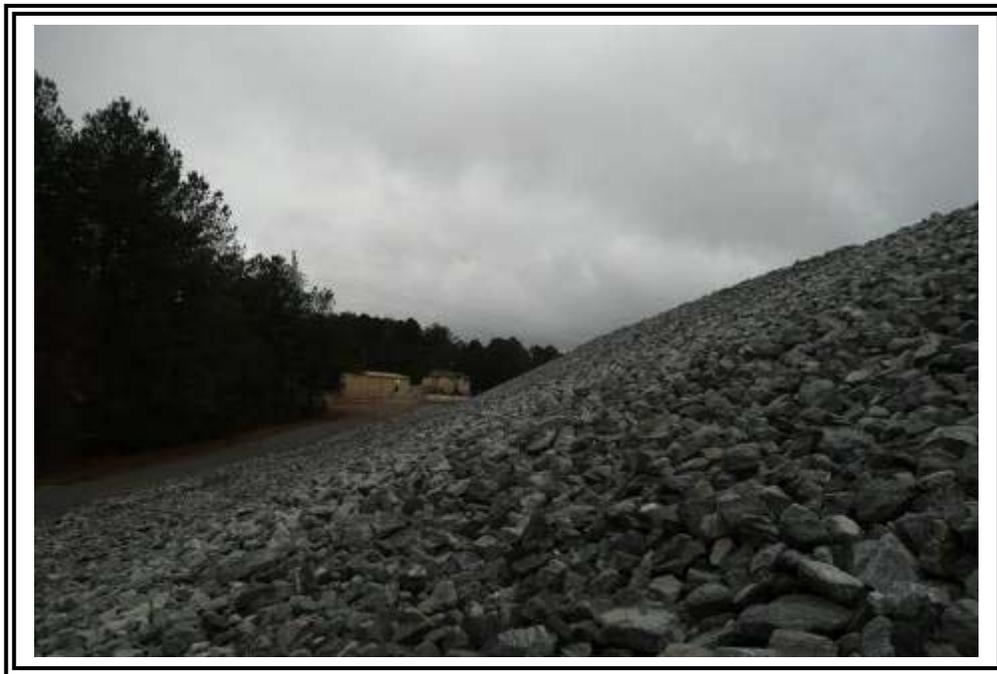
64

Ash Pond C, west end of south dike facing west. Rock rip-rap facing on dike exterior shown.

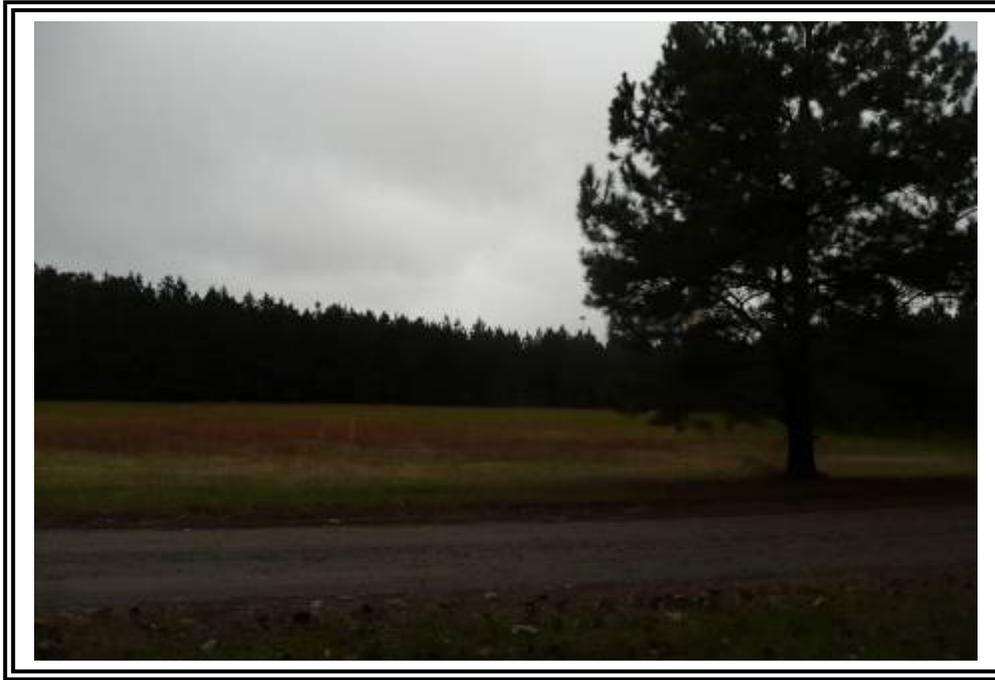
65

Ash Pond B, central portion of dike crest, facing north into area of pond filled with bottom ash and covered with topsoil.

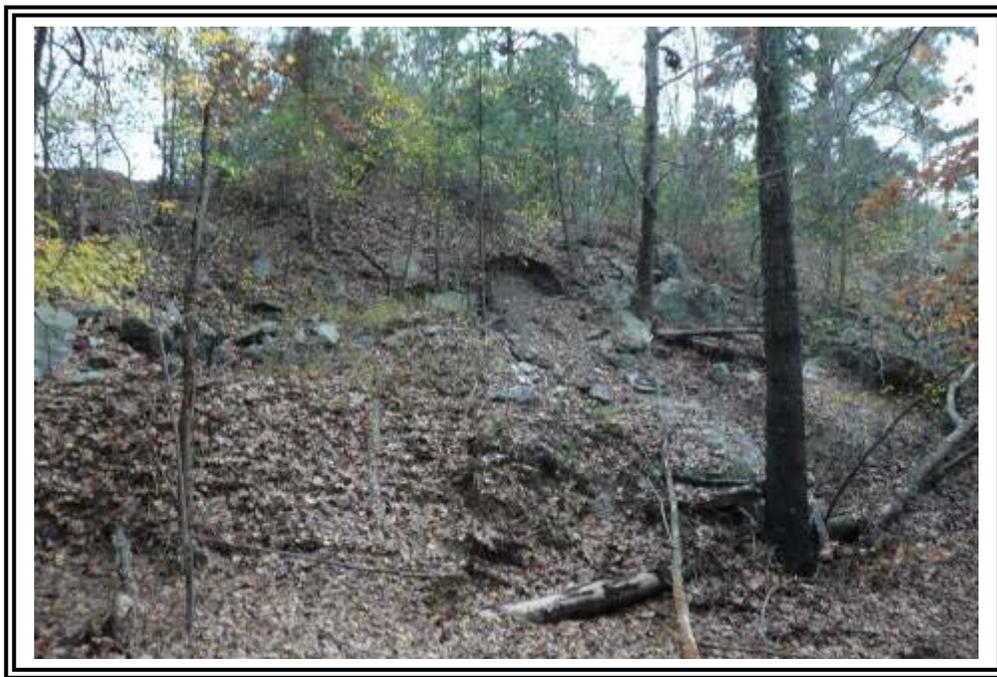
68

Ash Pond B, central portion of dike facing north, along the toe. Exterior of dike shown with large boulders and vegetative growth.

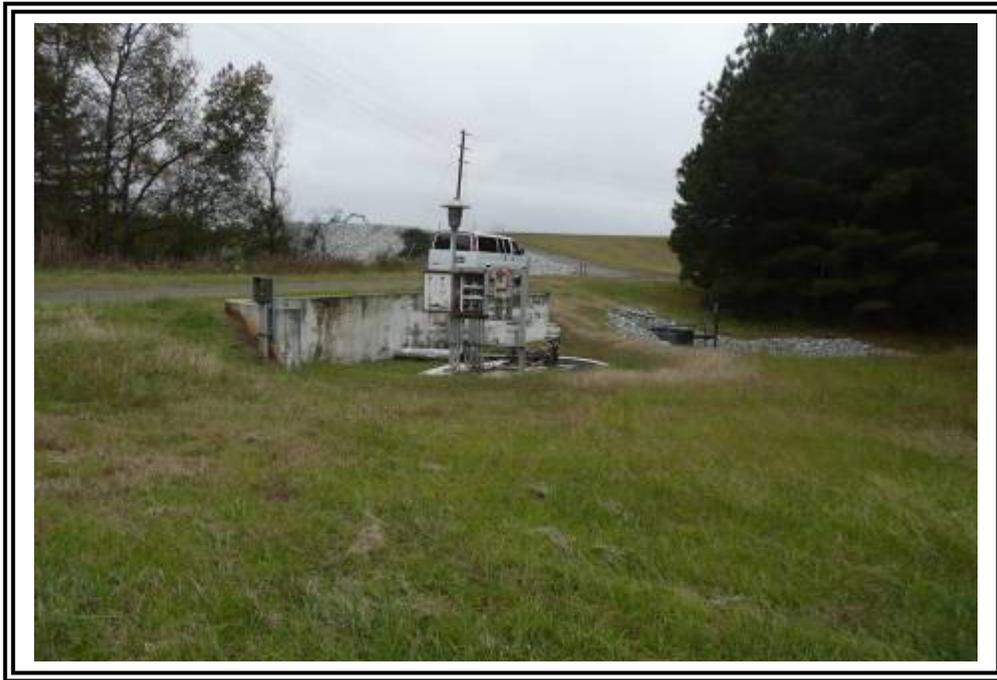
69

Ash Pond B, west end of dike. Emergency spillway (black pipe in background) and abandoned primary discharge facility shown.

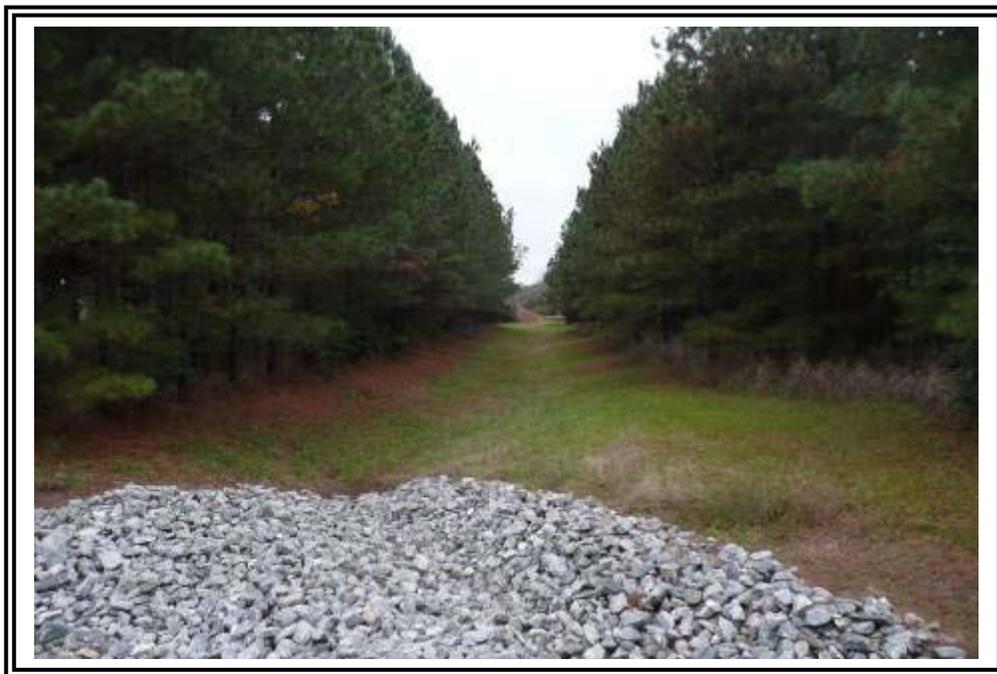
70

Ash Pond B, west end of dike facing north, at emergency spillway and site drainage open channel. Inlet protection for emergency spillway into discharge facility shown..

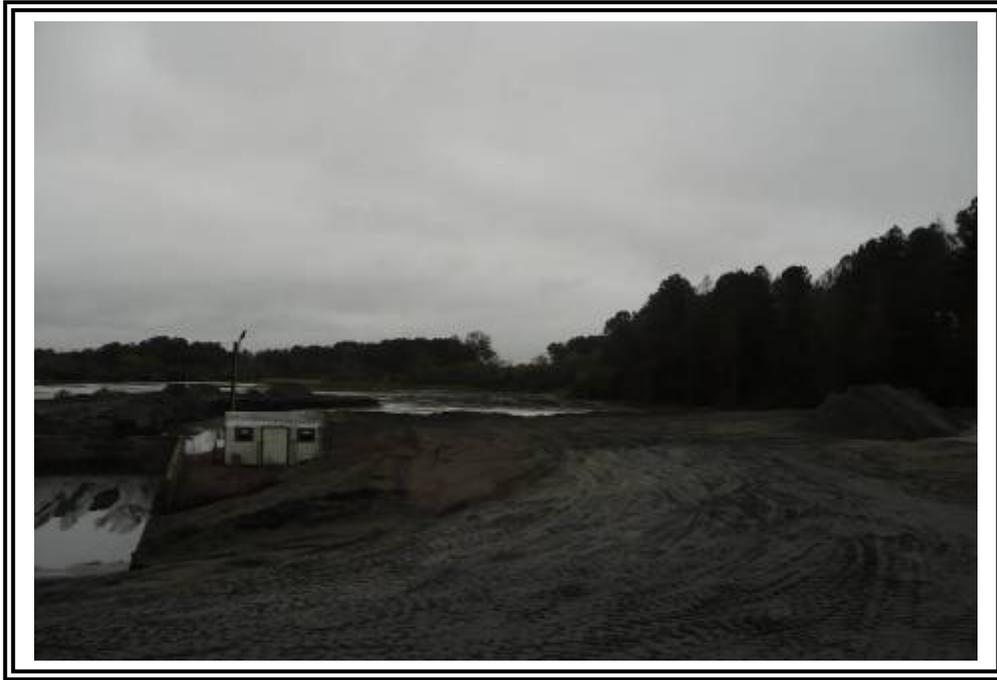
71

Ash Pond B, north end of pond along eastern edge facing west. Shown is the portion of Ash Pond B unfilled with bottom ash. Ash processing facility shown frame left.

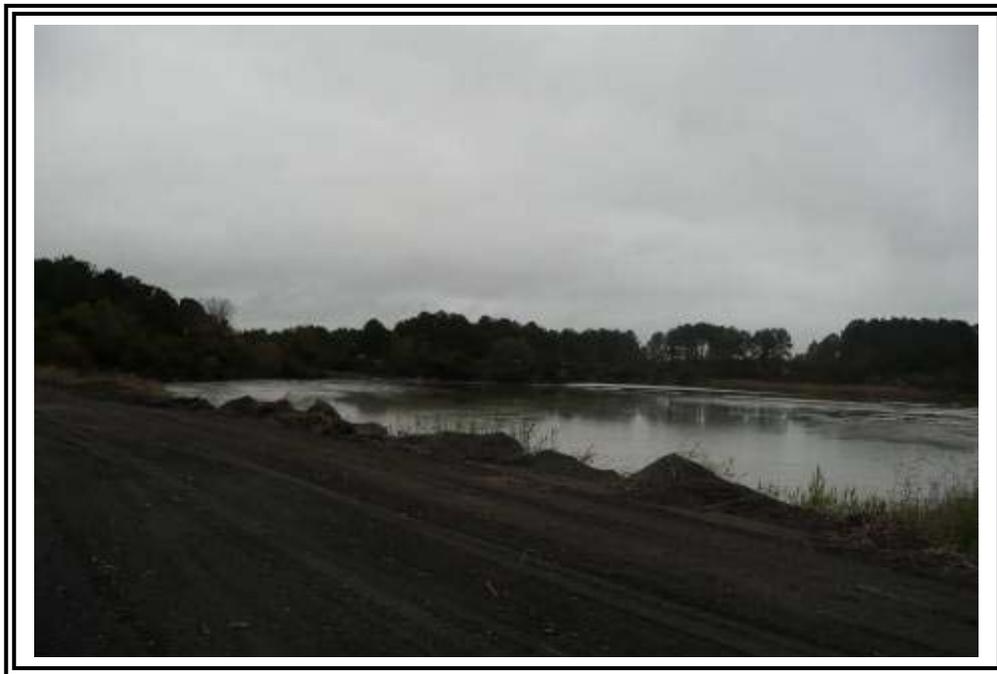
Ash Pond B, north end of pond along eastern edge facing south west. Shown is portion of the pond remaining unfilled with bottom ash. Frame left and furthest shows the area of Ash Pond B filled with bottom ash, covered with topsoil, and vegetative cover.
