Report of Safety Assessment
Coal Combustion Surface Impoundments
Georgia Power
Plant Hammond, Rome, Georgia

AMEC Project No. 3-2106-0174.0500

December 2010

Southern Company, Georgia Power, Plant Hammond: Ash Pond 1, Ash Pond 2, Ash Pond 3, Ash Pond 4

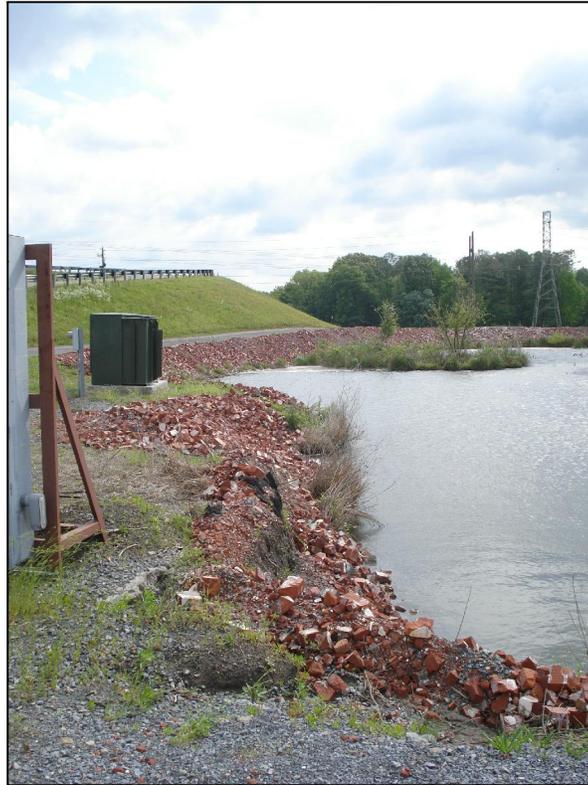
1-3

TYPICAL NORTHERN UPSTREAM FACE

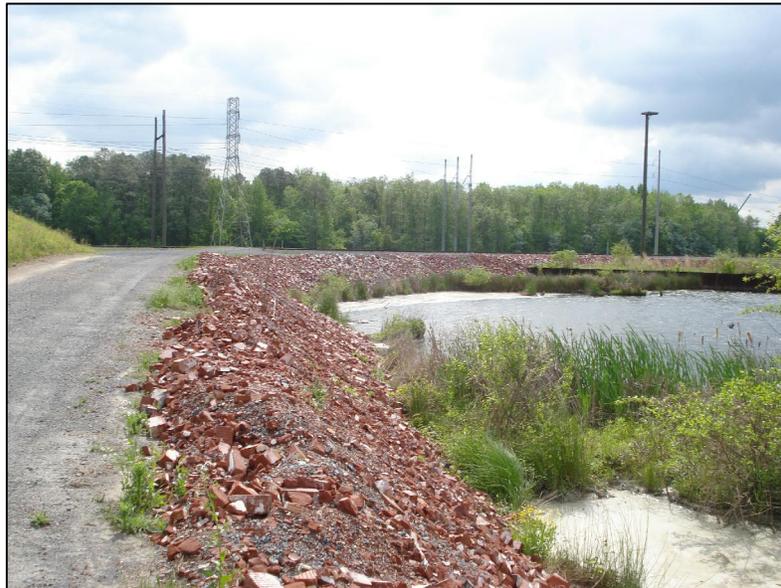
1-4

TYPICAL NORTHERN UPSTREAM FACE

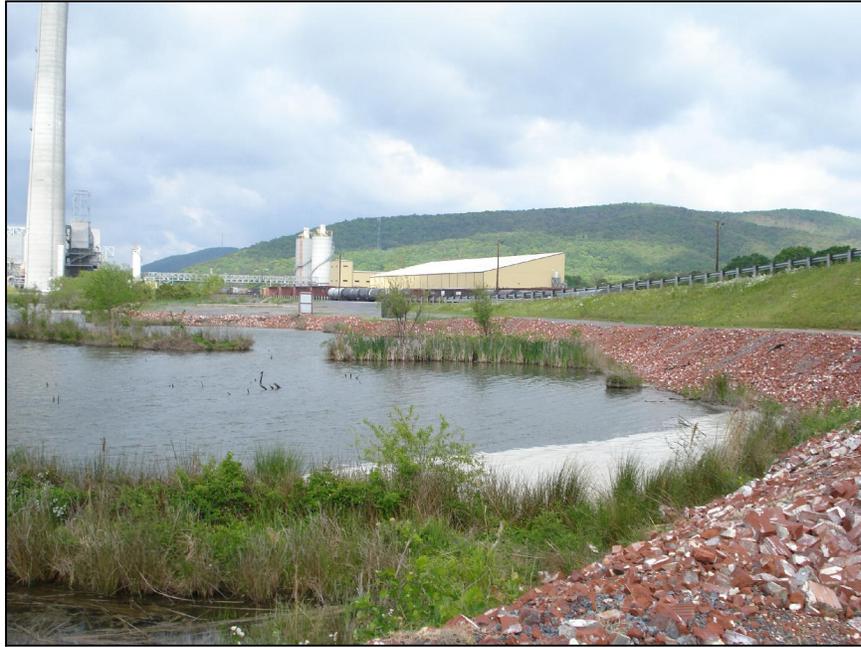
1-5
TYPICAL NORTHERN UPSTREAM FACE

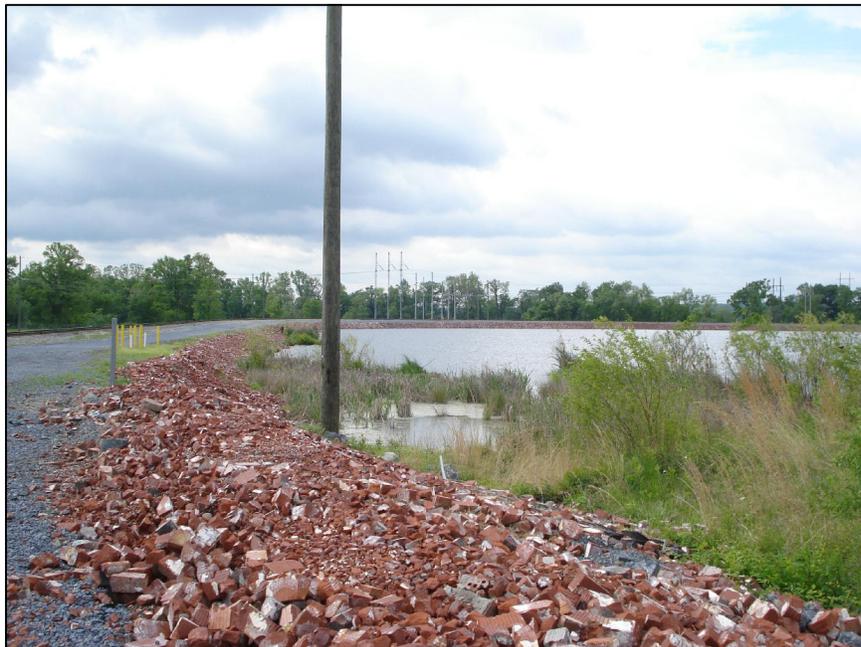
1-6
TYPICAL NORTHERN UPSTREAM FACE

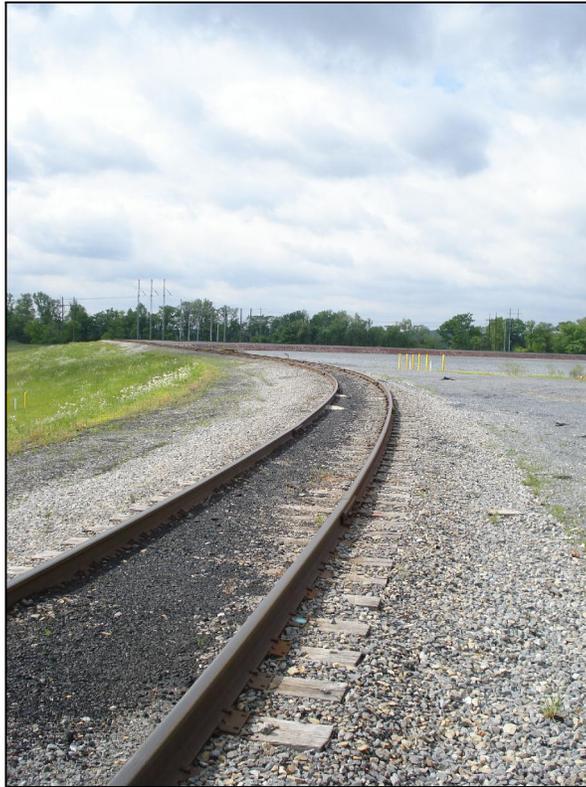
Ash Pond 1, commissioned in 1952, is a co-treatment facility and receives only low volume wastes. At the time of the site visit, railroad tracks were noted located along the eastern and southern dikes (photos 1-9 and 1-14).

RAILROAD TRACKS ALONG CREST OF EASTERN DIKE

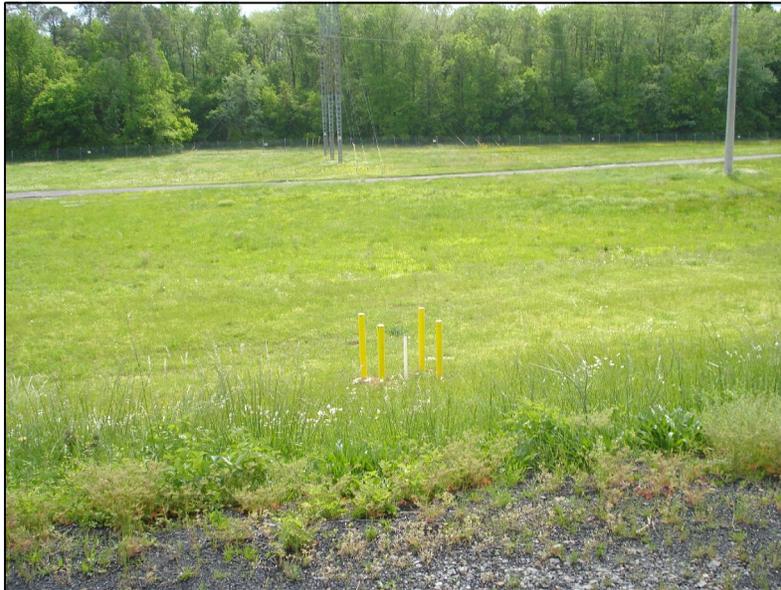
1-10

PIEZOMETER (AP1-1) LOCATION ALONG EASTERN DOWNSTREAM DIKE

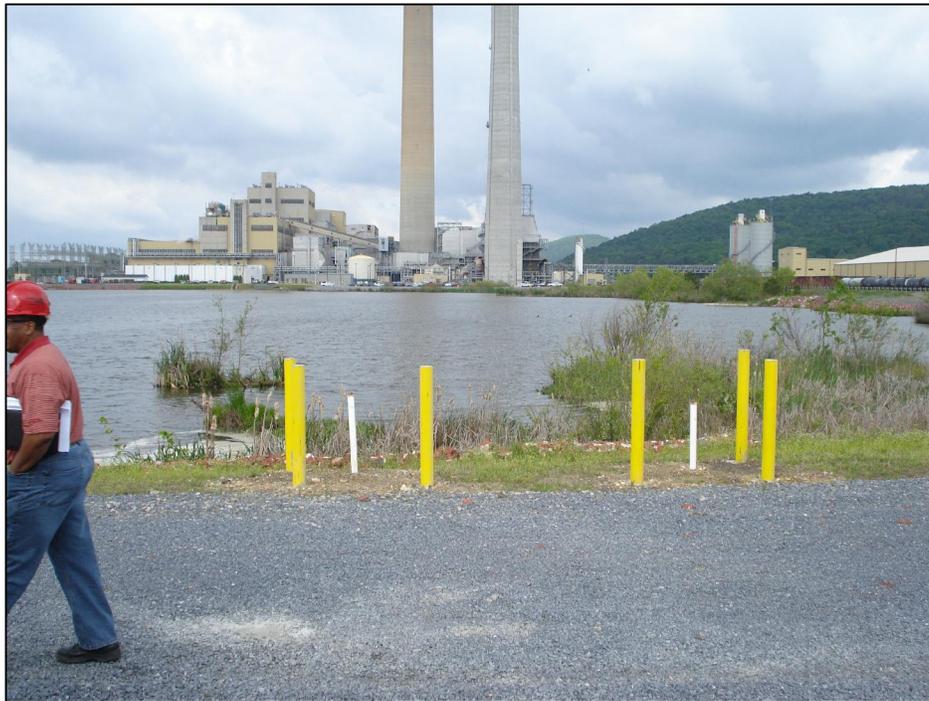
1-11

PIEZOMETER AP1-2 AND AP1-3 LOCATIONS ALONG EASTERN UPSTREAM DIKE

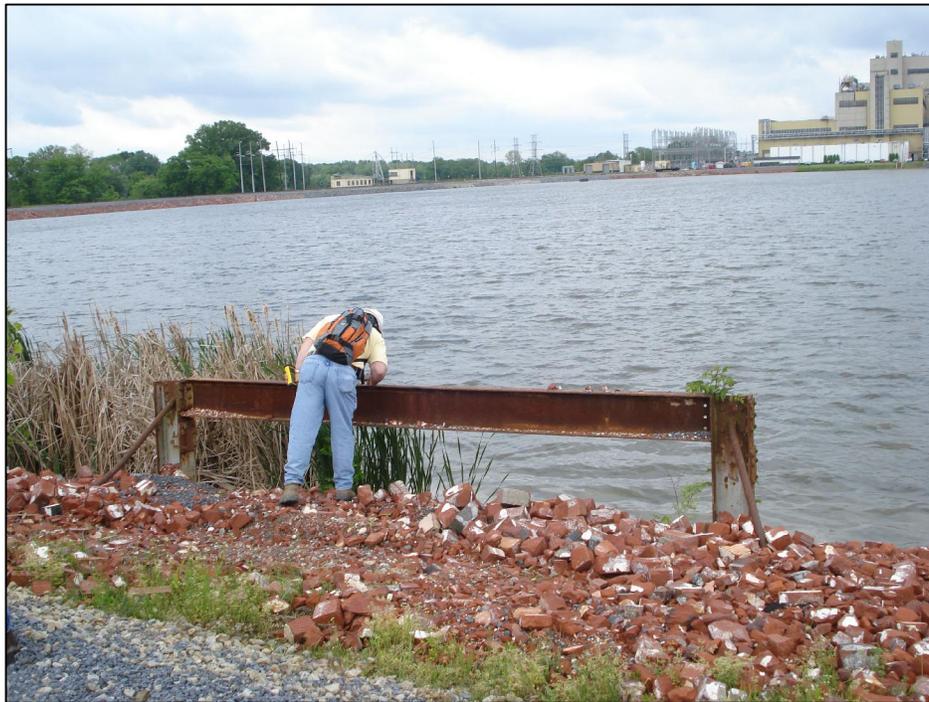
1-12

UNKNOWN STRUCTURE ALONG EASTERN UPSTREAM DIKE

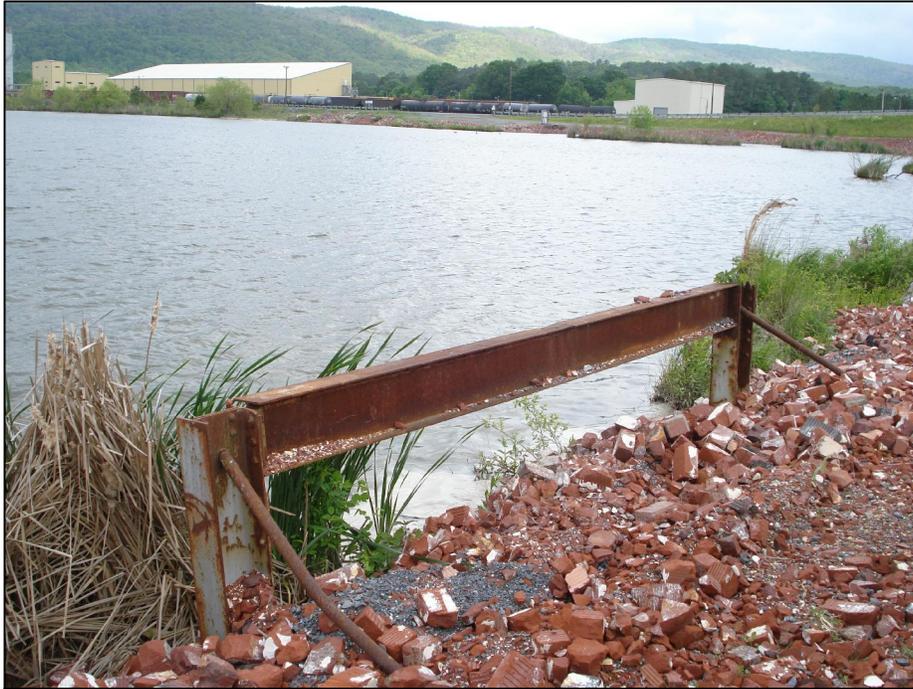
1-13

UNKNOWN STRUCTURE ALONG EASTERN UPSTREAM DIKE

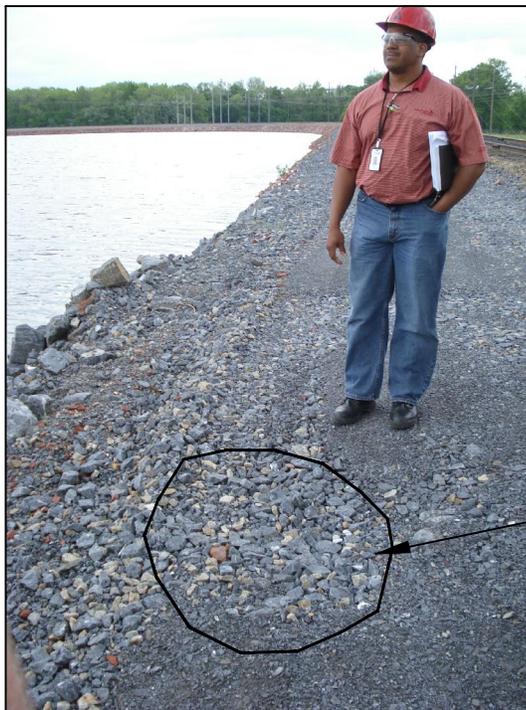
1-16

SLIGHT SURFACE DEPRESSION LIKELY DUE TO VEHICLE TRAFFIC ALONG CREST OF SOUTHERN DIKE

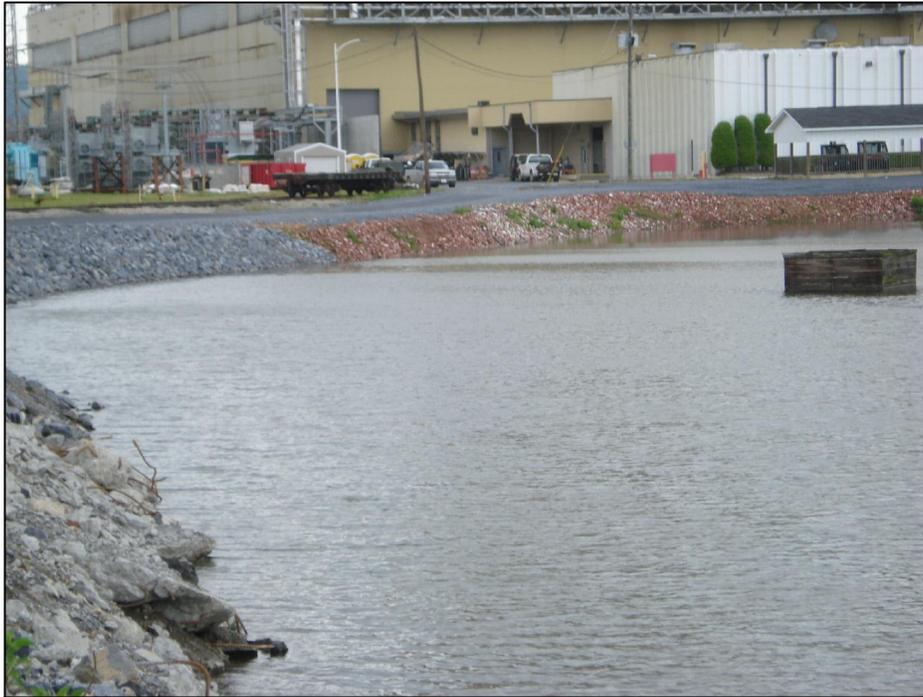
1-17
EMERGENCY OVERFLOW

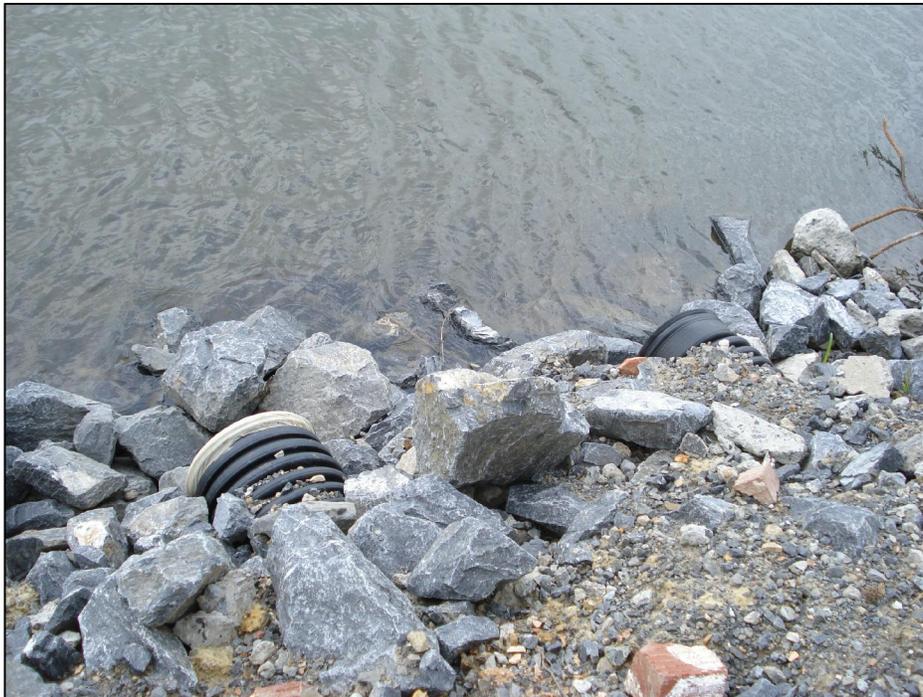
1-18
DRAINAGE POINT FROM SEWER TREATMENT PLANT (ALONG SOUTHERN DIKE)

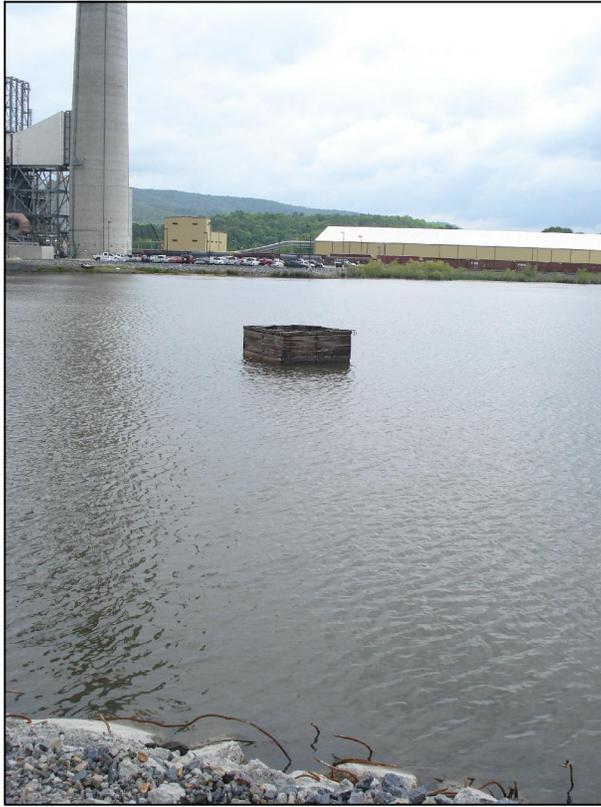
1-19
EMERGENCY OVERFLOW

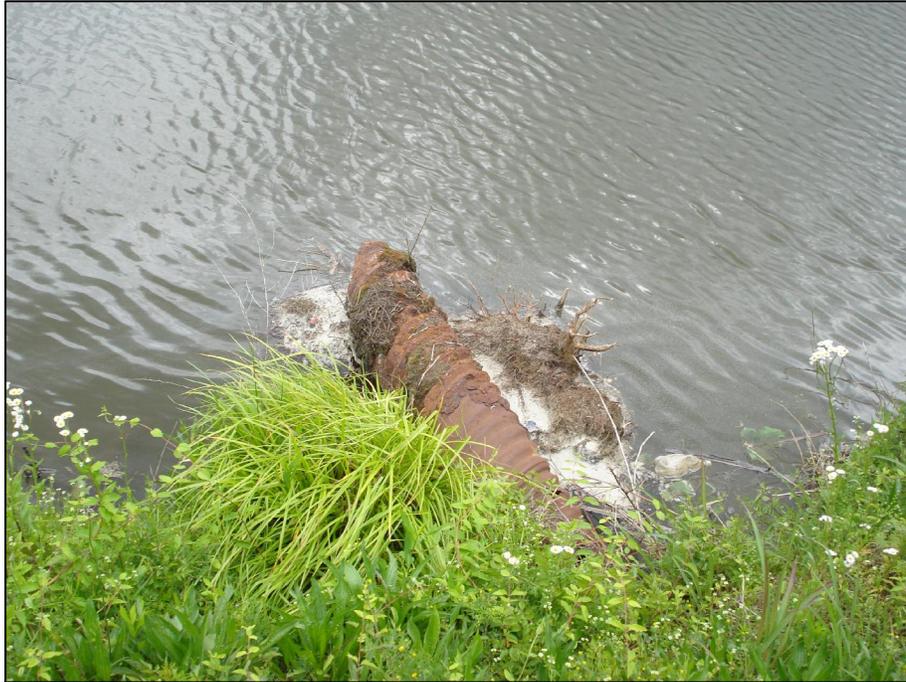
1-21

DRAINAGE POINT FROM ADJACENT PARKING AREAS ALONG WESTERN DIKE

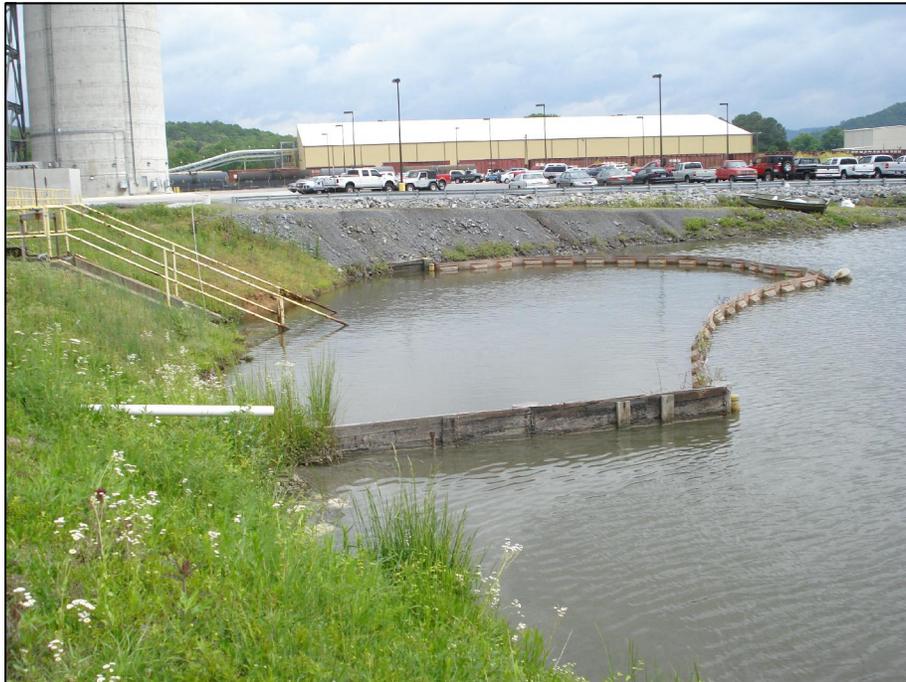
1-22

PRIMARY SPILLWAY ALONG WESTERN DIKE

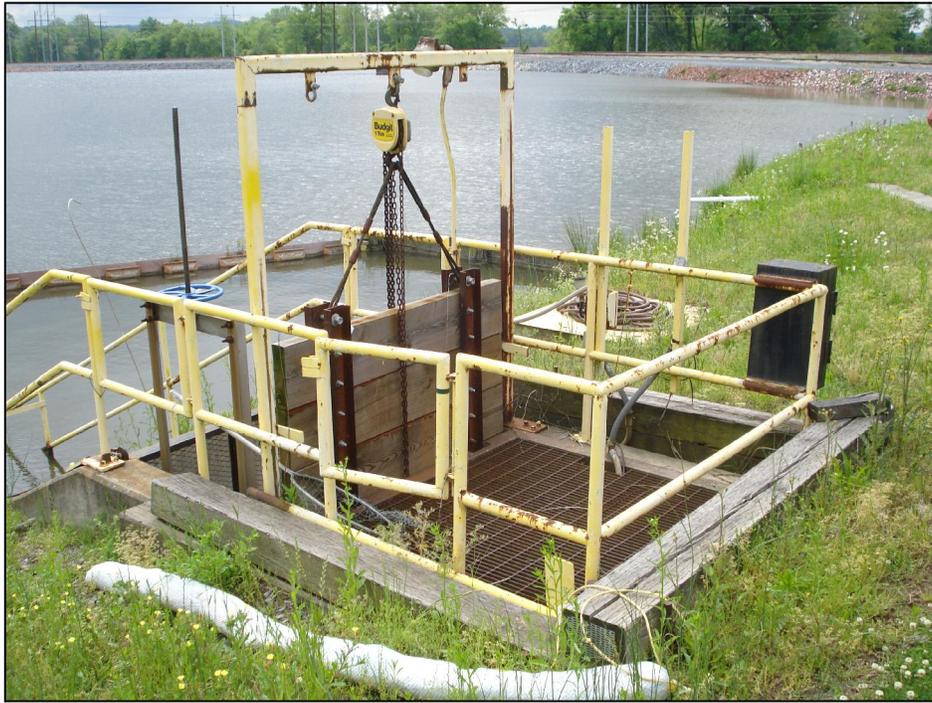
1-23
PRIMARY SPILLWAY ALONG WESTERN DIKE

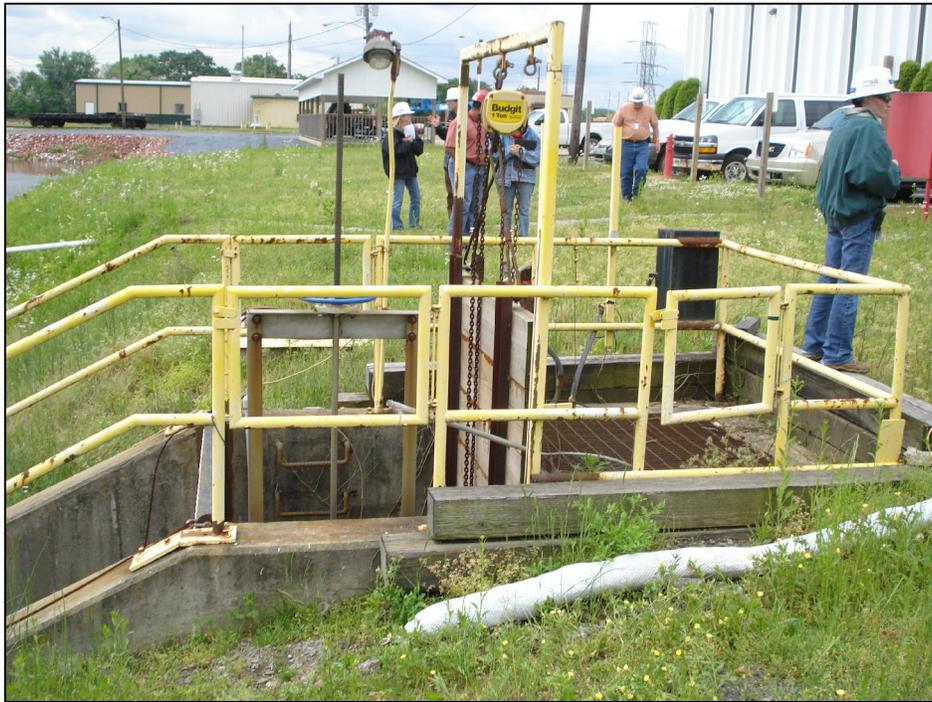
1-24
PRIMARY SPILLWAY ALONG WESTERN DIKE

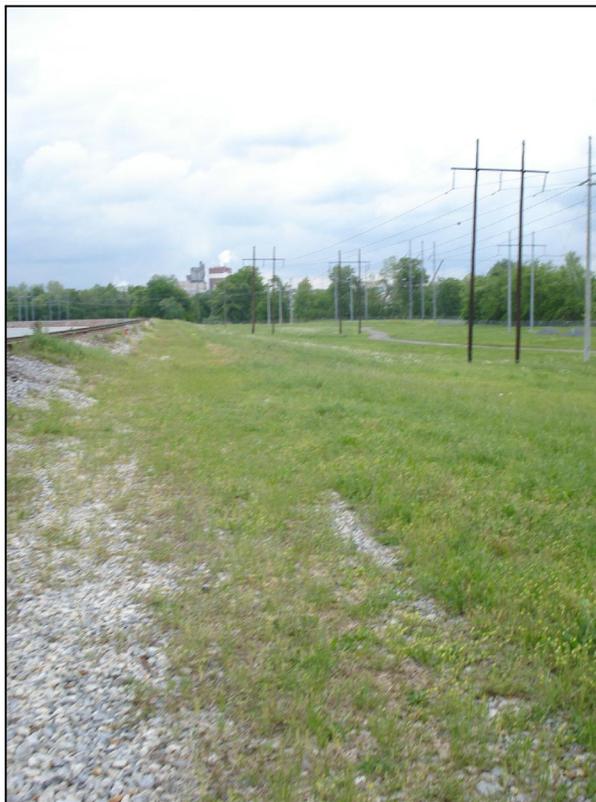
1-27

TYPICAL SOUTHERN DOWNSTREAM FACE

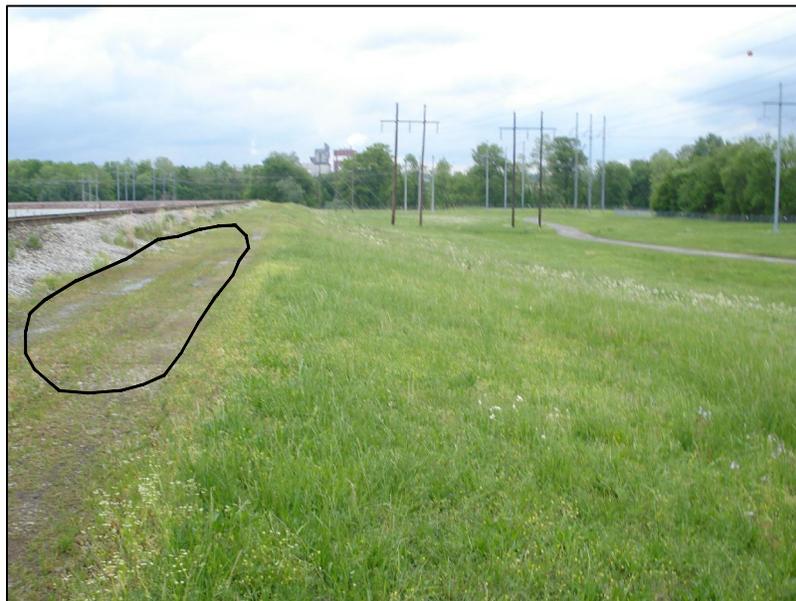
1-28

**SLIGHT SURFACE DEPRESSION LIKELY DUE TO
VEHICLE TRAFFIC ALONG CREST OF SOUTHERN DIKE**

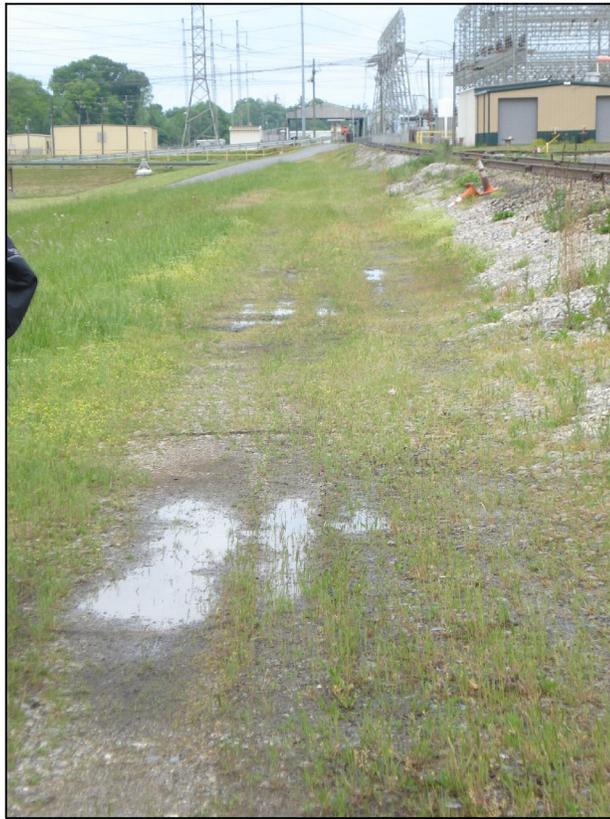
1-29

SLIGHT SURFACE DEPRESSION LIKELY DUE TO VEHICLE TRAFFIC ALONG CREST OF SOUTHERN DIKE

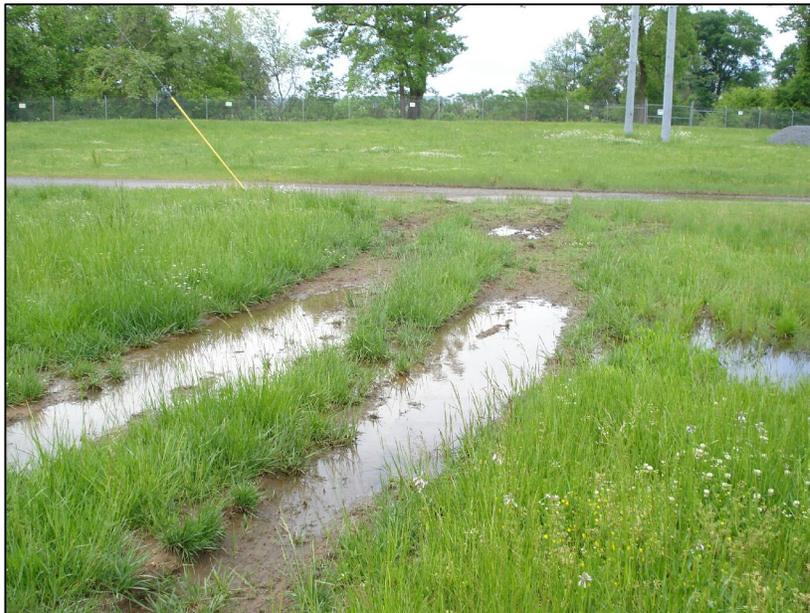
1-30

SURFACE RUN-OFF PONDING DOWNSTREAM OF TOE OF SOUTHERN DIKE, LIKELY DUE TO MAINTENANCE TRAFFIC

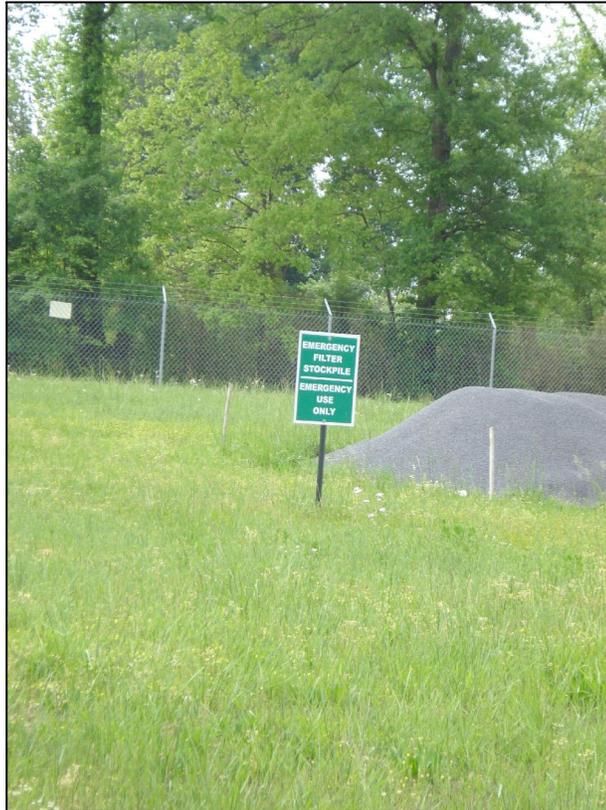
1-37
EMERGENCY FILTER STOCKPILE

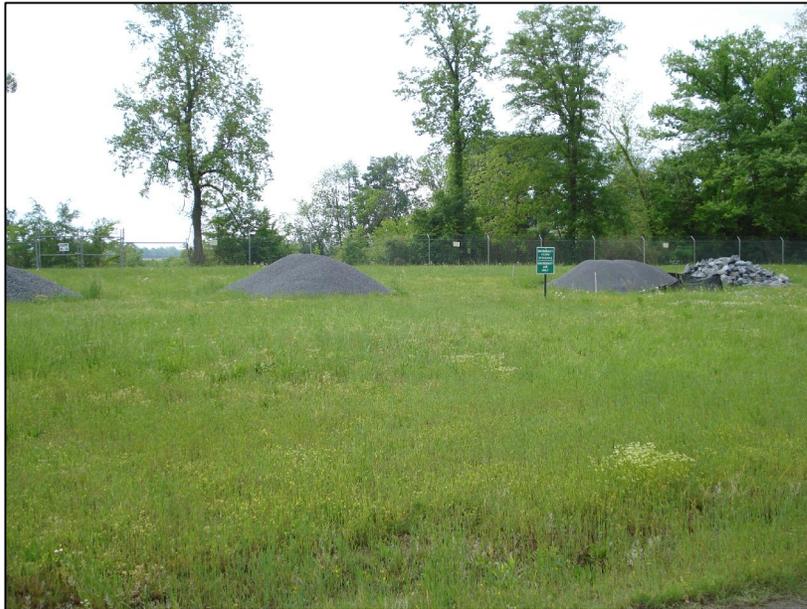
1-38
EMERGENCY FILTER STOCKPILE

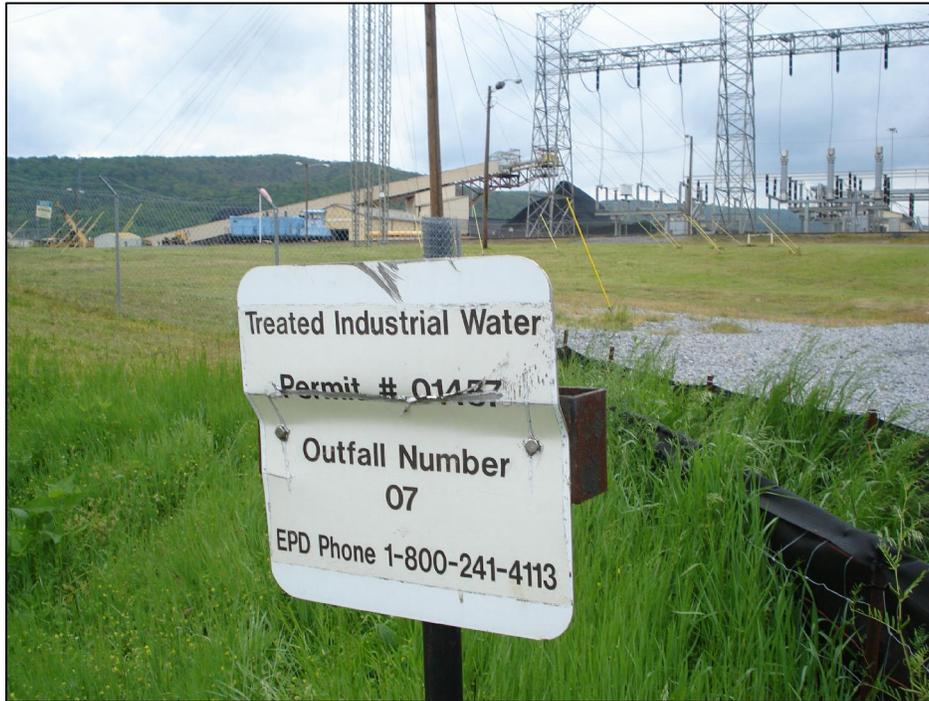
1-39

OUTFALL NUMBER 7, DRAINAGE POINT FOR ASH POND #1 INTO COOSA RIVER

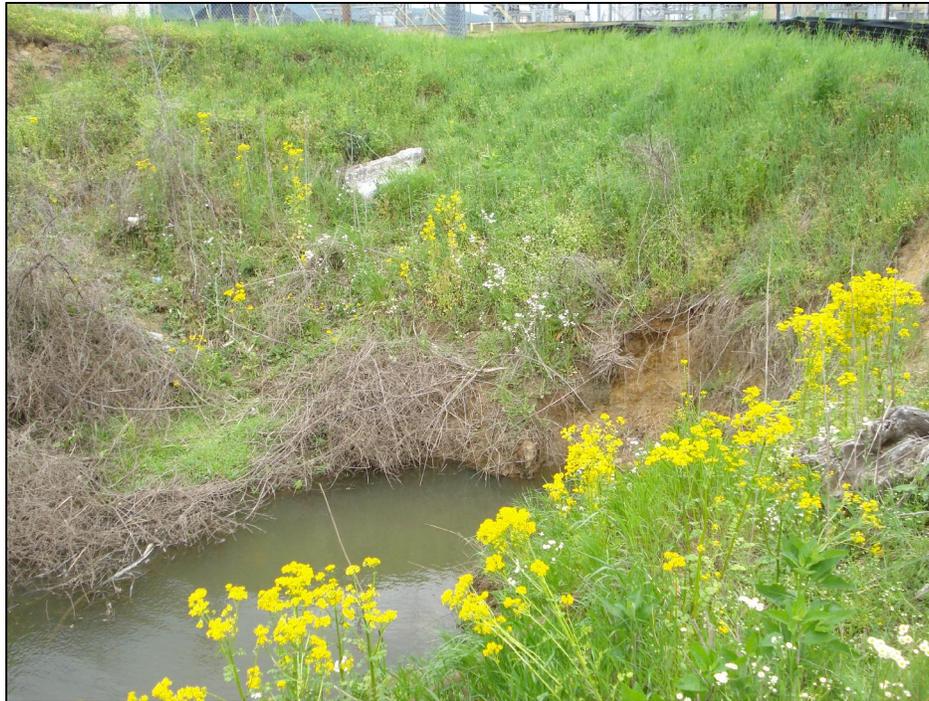
1-40

Inspection Issue #	Comments
20	- Outlet from emergency spillway was not visible due to high tailwater elevation, however emergency spillway sampling point was observed, and appeared to be running clear and unobstructed.

OUTLET FOR ASH POND #1, TAILWATER COVERING OUTLET

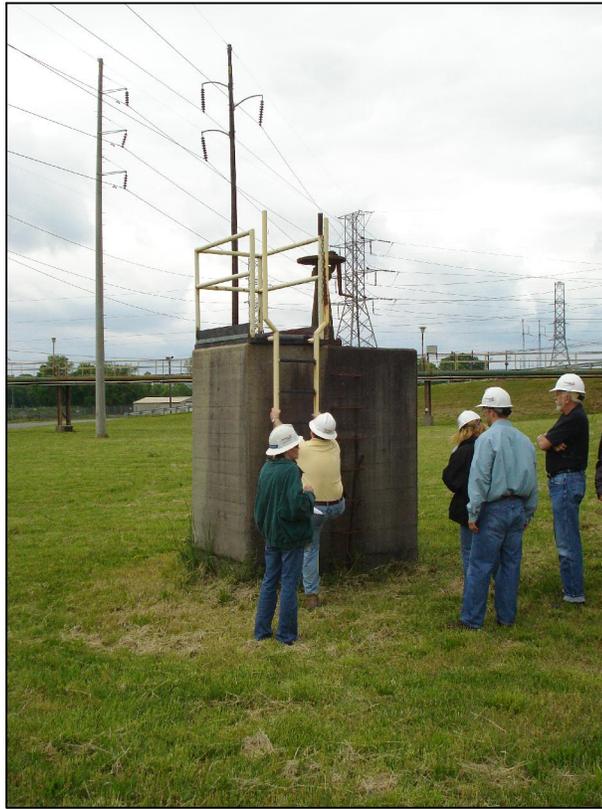
1-41

NUMBER 7 EMERGENCY OVERFLOW SAMPLING POINT

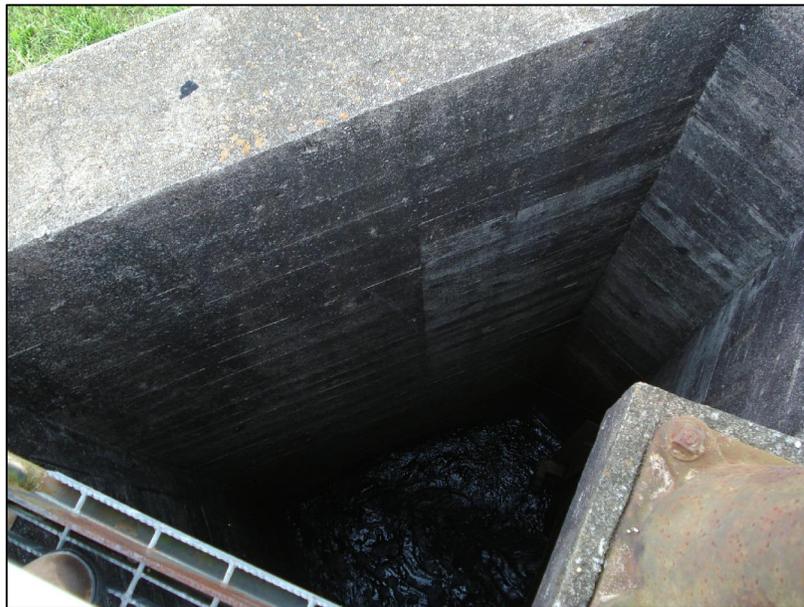
1-42

WATER FLOWING WITHIN NUMBER 7 EMERGENCY OVERFLOW SAMPLING POINT

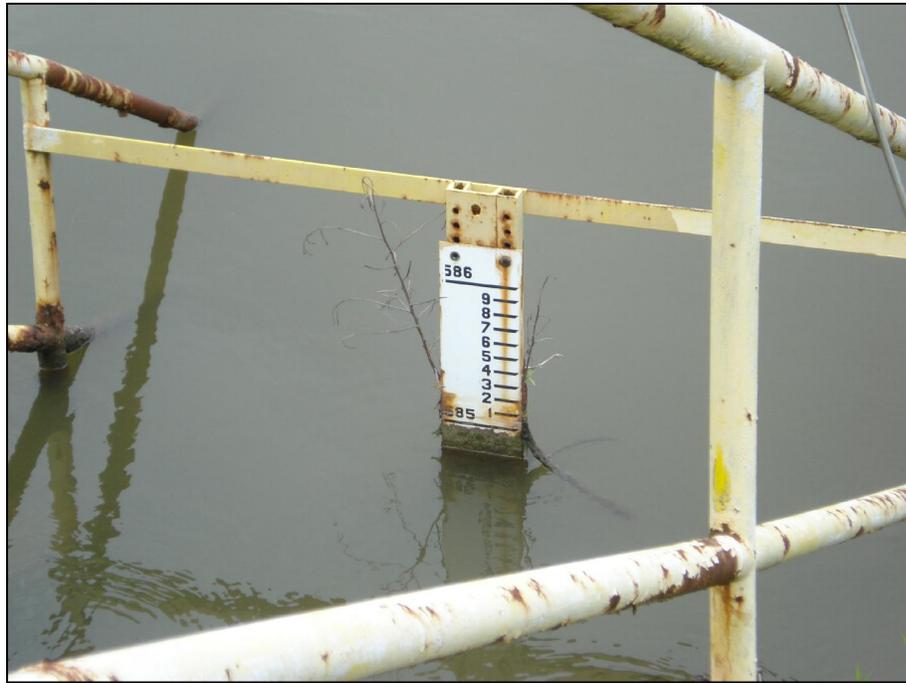
1-43

GAUGE LOCATED ADJACENT TO PRIMARY SPILLWAY

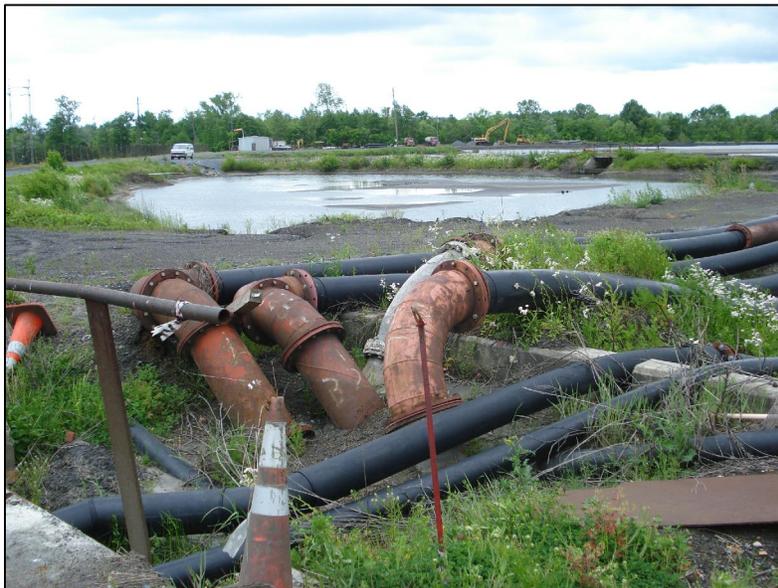
2-5

INLET/OUTLET POINT FROM POWER PLANTS ALONG EASTERN BANK

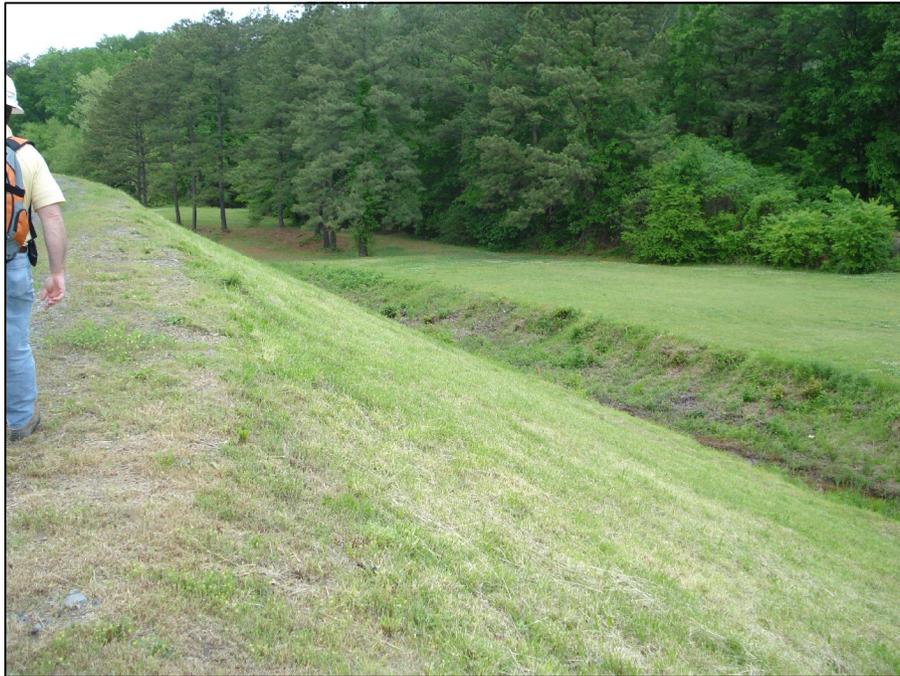
2-9

CREEK ALONG BASE OF NORTHERN DOWNSTREAM TOE

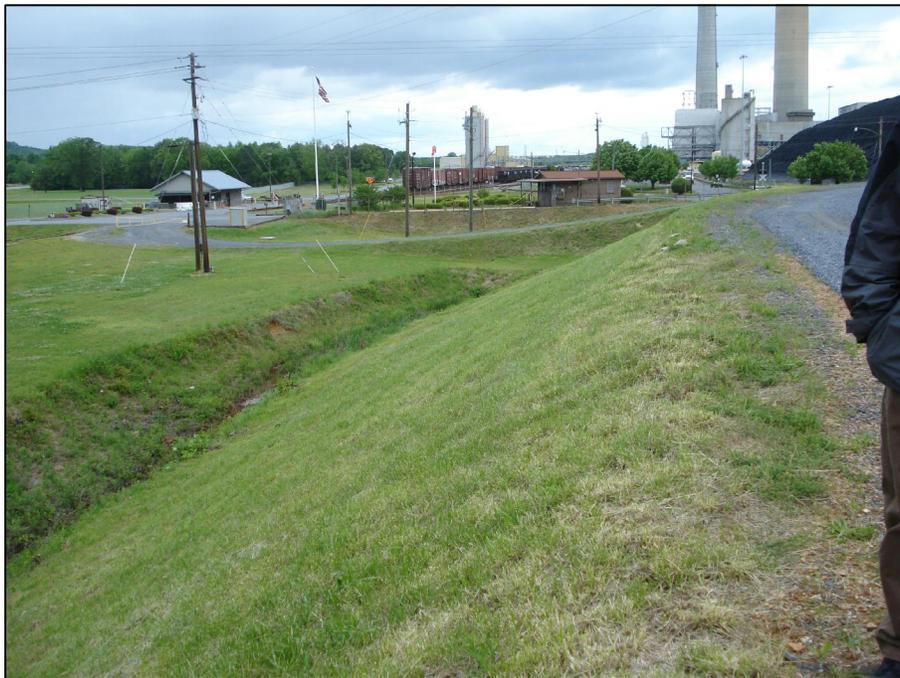
2-10

CREEK ALONG BASE OF NORTHERN DOWNSTREAM TOE

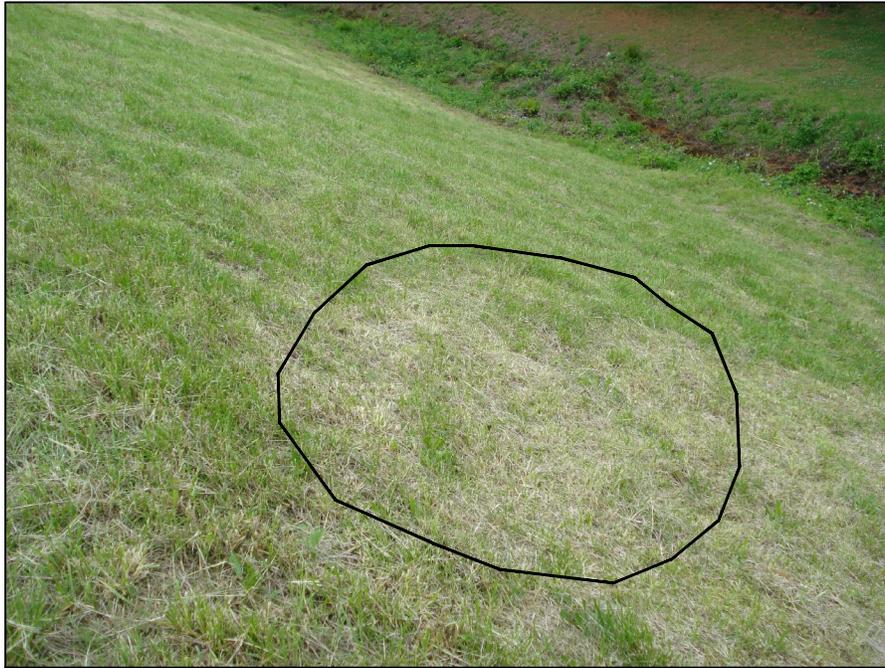
2-11

BULGE ALONG NORTHERN DOWNSTREAM FACE

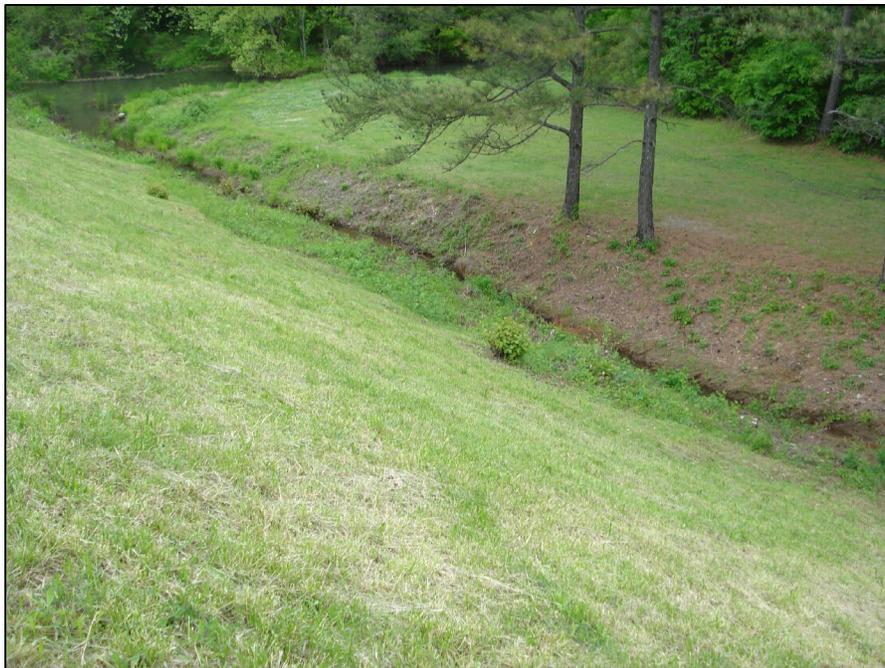
2-12

CREEK ALONG BASE OF NORTHERN DOWNSTREAM TOE

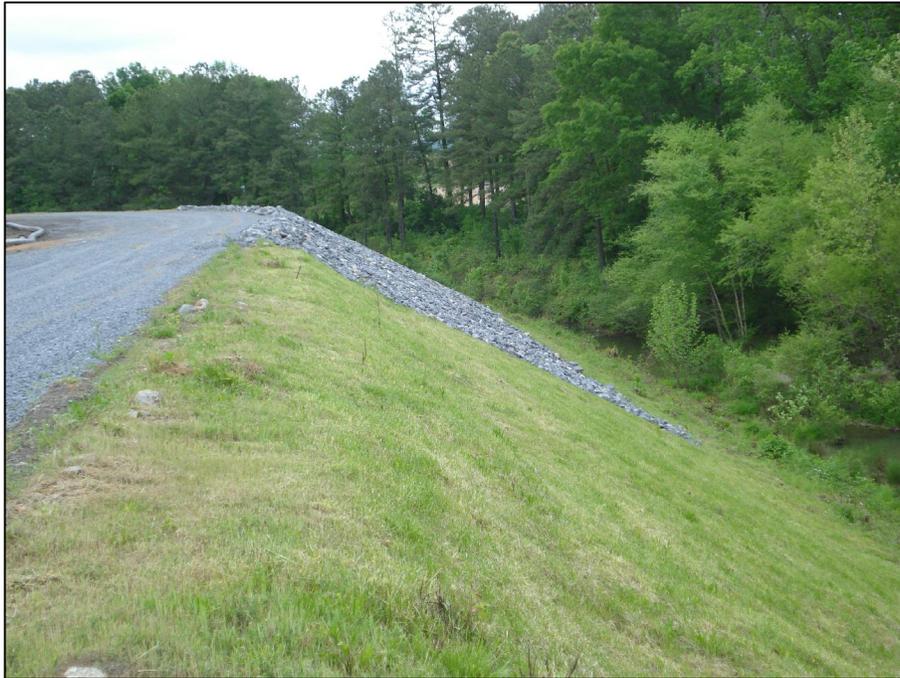
2-13

CONSTRUCTED ROCK FACE ALONG NORTH WESTERN DOWNSTREAM FACE

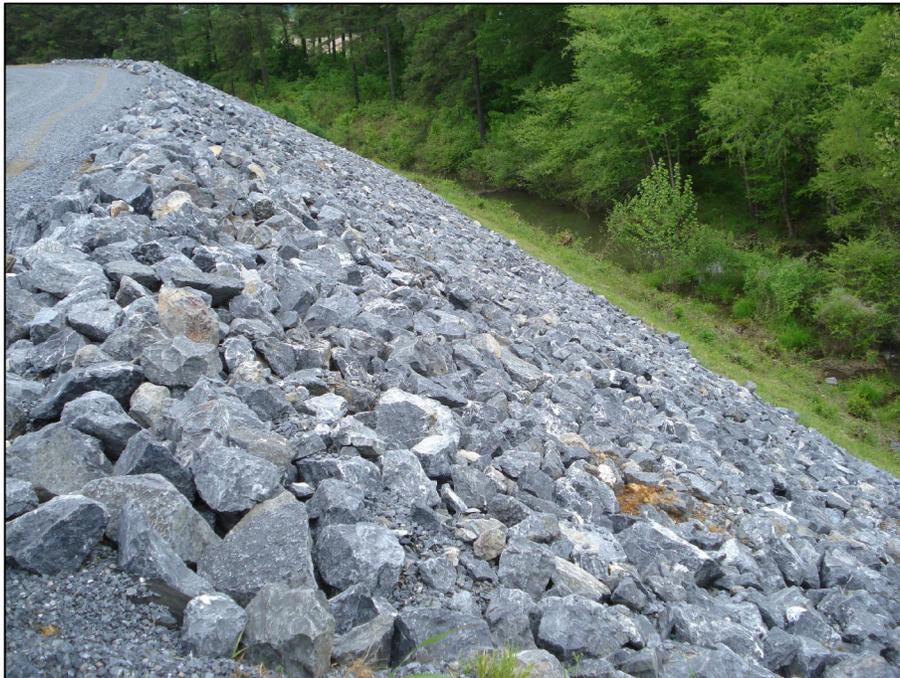
2-14

CONSTRUCTED ROCK FACE ALONG NORTH WESTERN DOWNSTREAM FACE

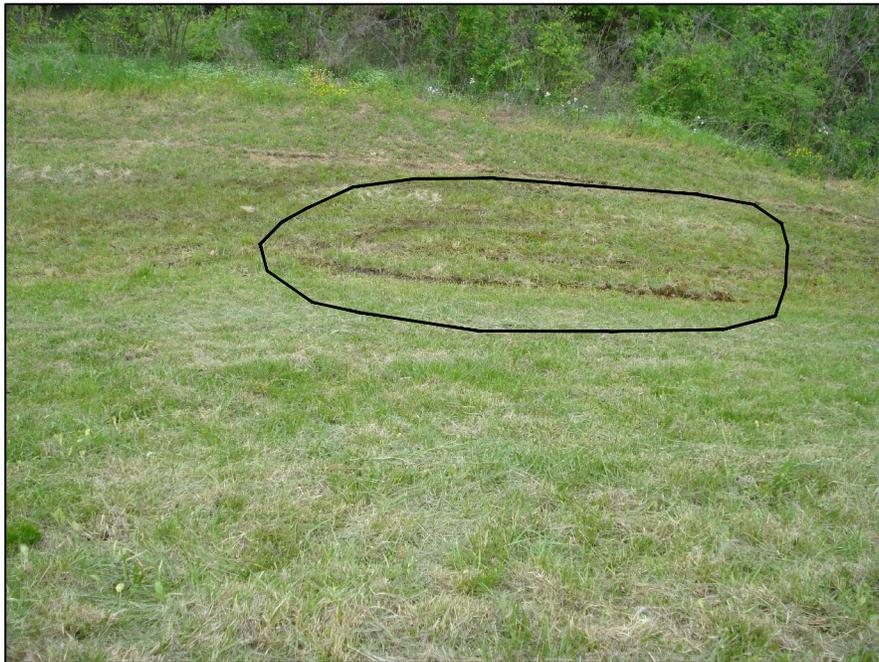
2-15

WET AREA ALONG WESTERN DOWNSTREAM TOE

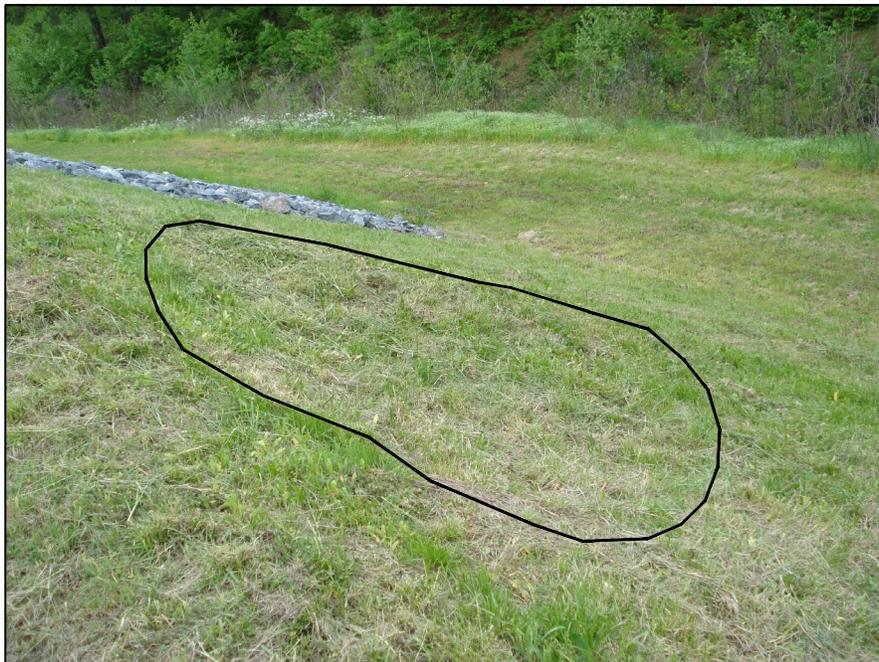
2-16

DEPRESSION ALONG WESTERN DOWNSTREAM FACE

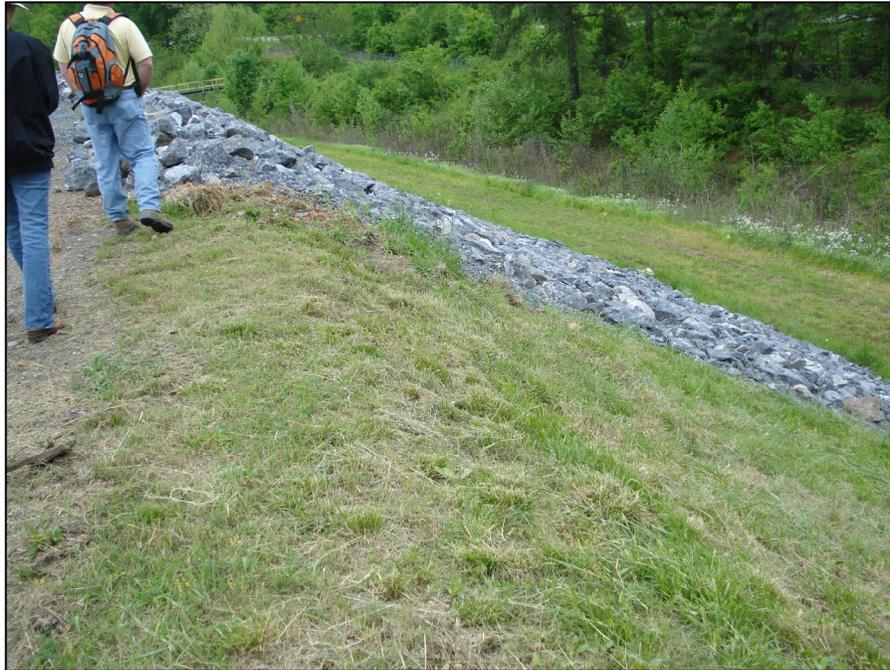
2-17

CONSTRUCTED ROCK FACE ALONG WESTERN DOWNSTREAM SLOPE

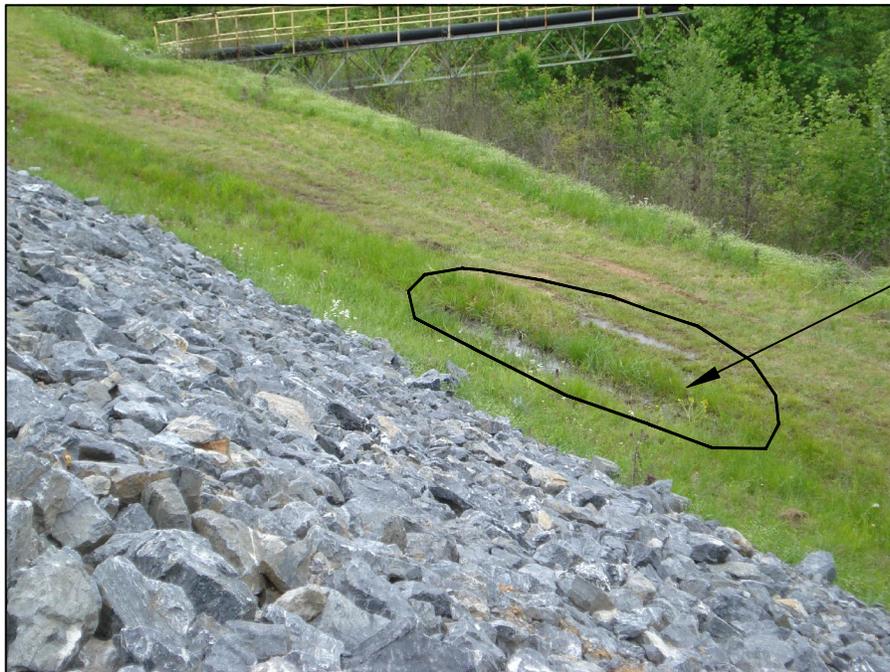
2-18

WET AREA

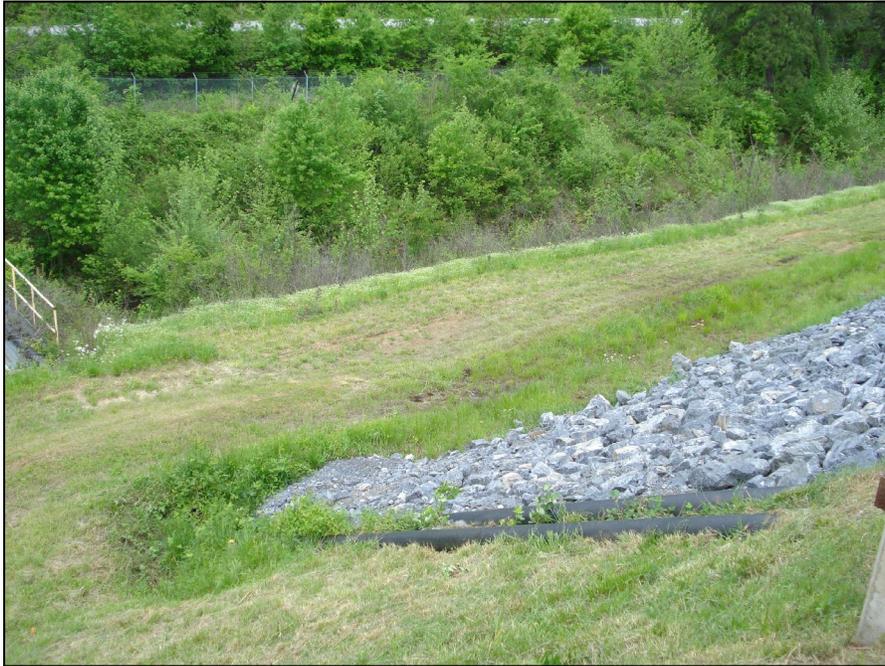
2-19

CONSTRUCTED ROCK FACE ALONG WESTERN DOWNSTREAM SLOPE
