Report of Safety Assessment
Coal Combustion Surface Impoundments
Georgia Power
Plant Hammond, Rome, Georgia

AMEC Project No. 3-2106-0174.0500

December 2010

Southern Company, Georgia Power, Plant Hammond: Ash Pond 1, Ash Pond 2, Ash Pond 3, Ash Pond 4

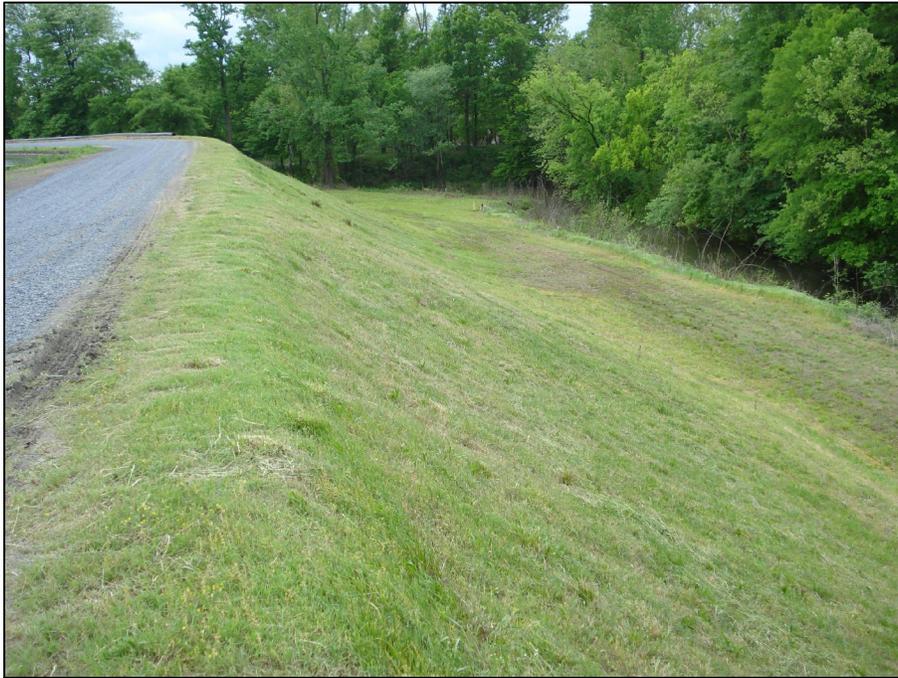
2-21

UNEVEN GROUND SURFACE AREAS ALONG WESTERN DOWNSTREAM SLOPE

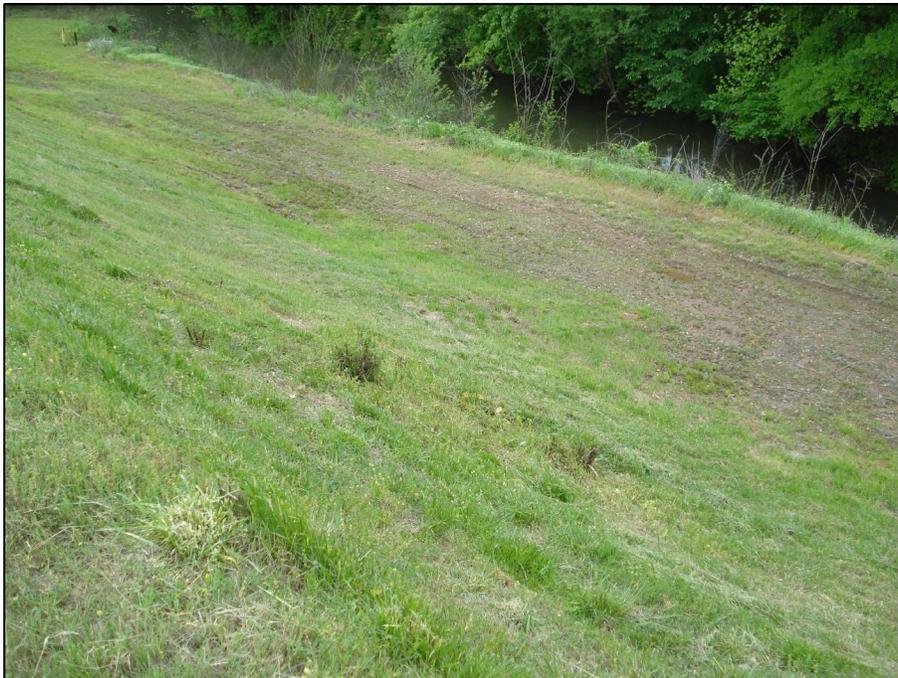
2-22

UNEVEN GROUND SURFACE AREAS ALONG WESTERN DOWNSTREAM SLOPE

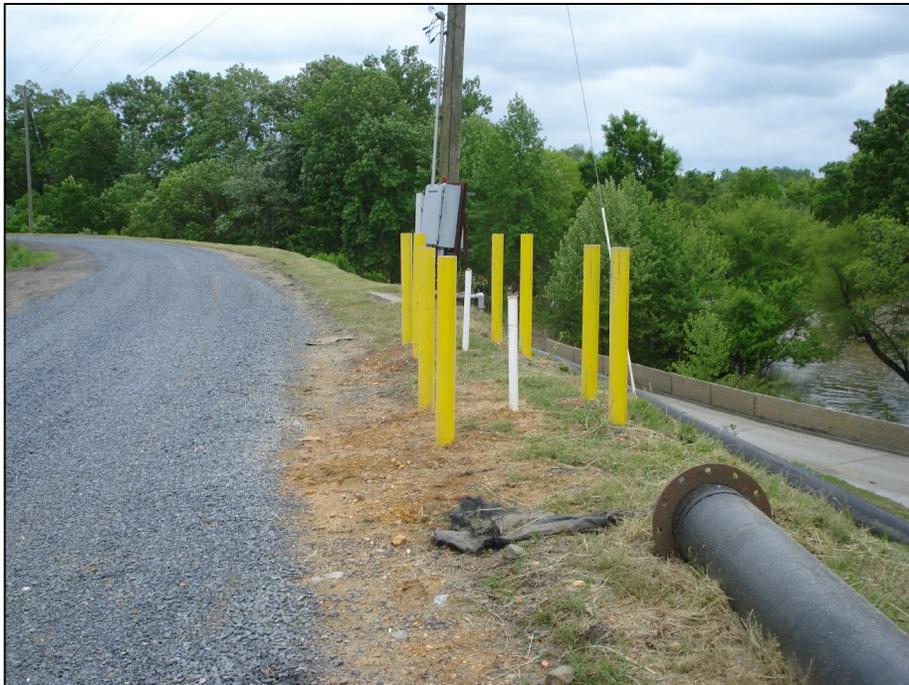
2-24

EXISTING PIEZOMETERS ALONG SOUTHERN BANK (AP2-2 AND AP2-3)

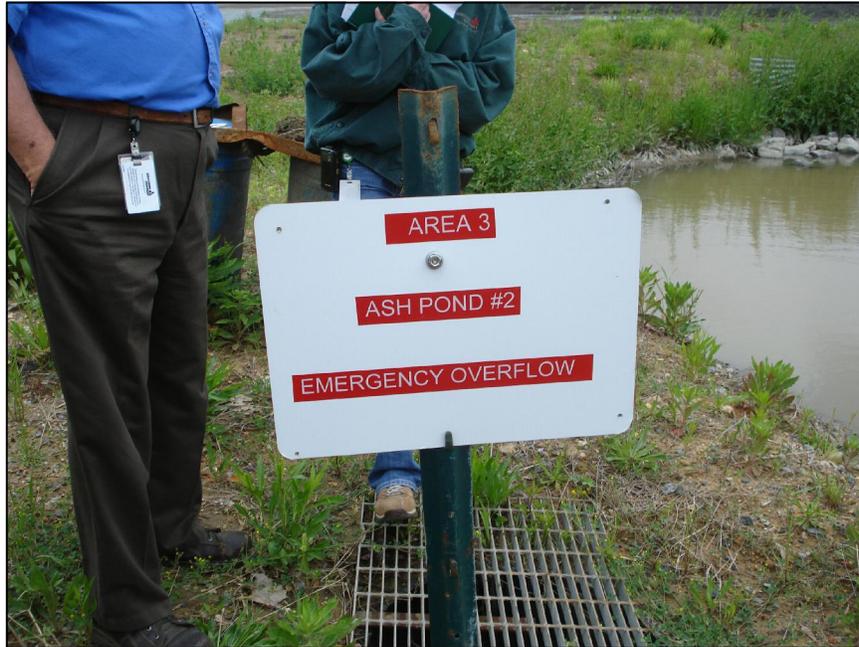
2-25
ASH POND #2 EMERGENCY OVERFLOW

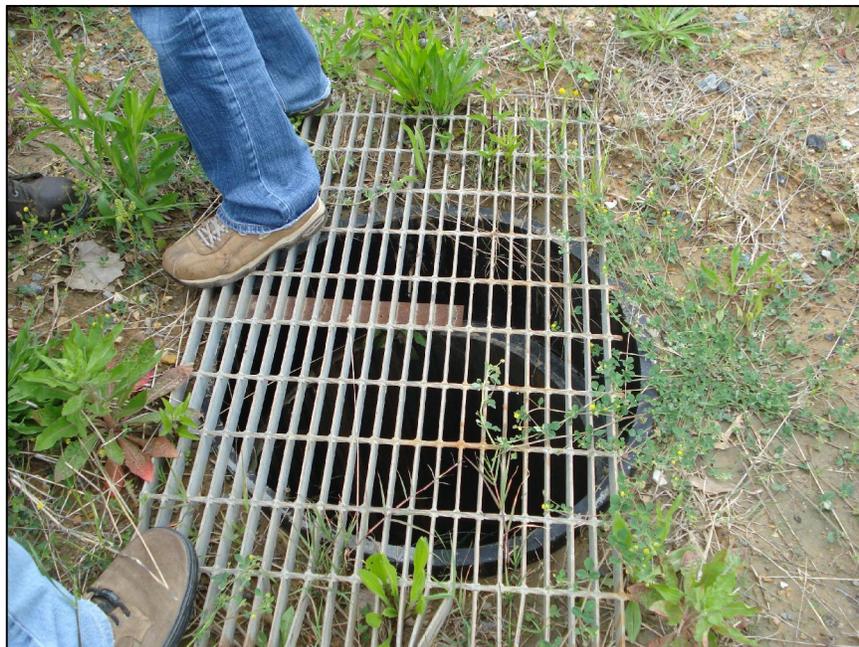
2-26
ASH POND #2 EMERGENCY OVERFLOW

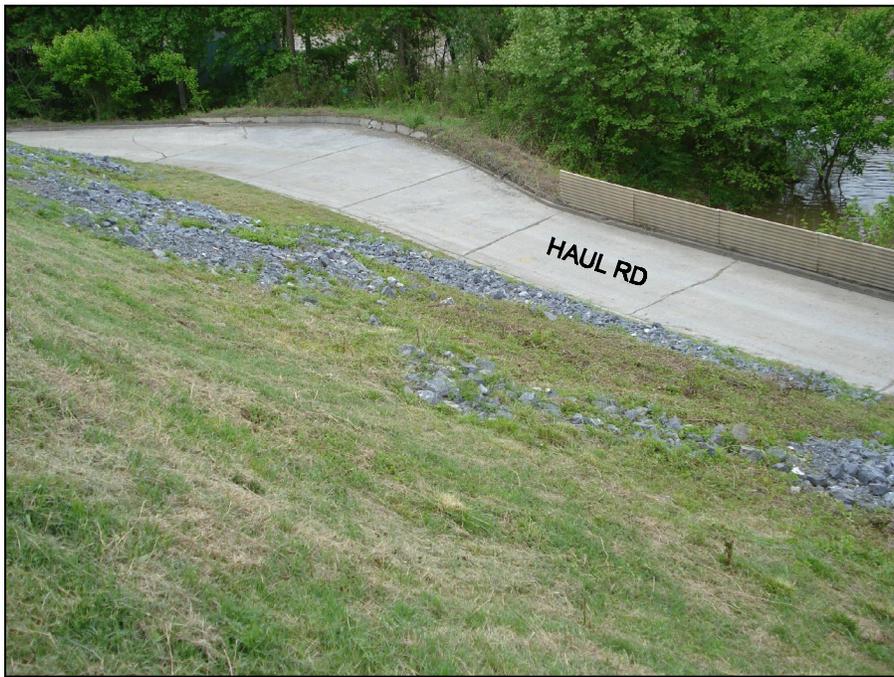
2-27

GRAVEL AREAS LOCATED ALONG SOUTHERN DOWNSTREAM TOE ADJACENT TO HAUL ROAD

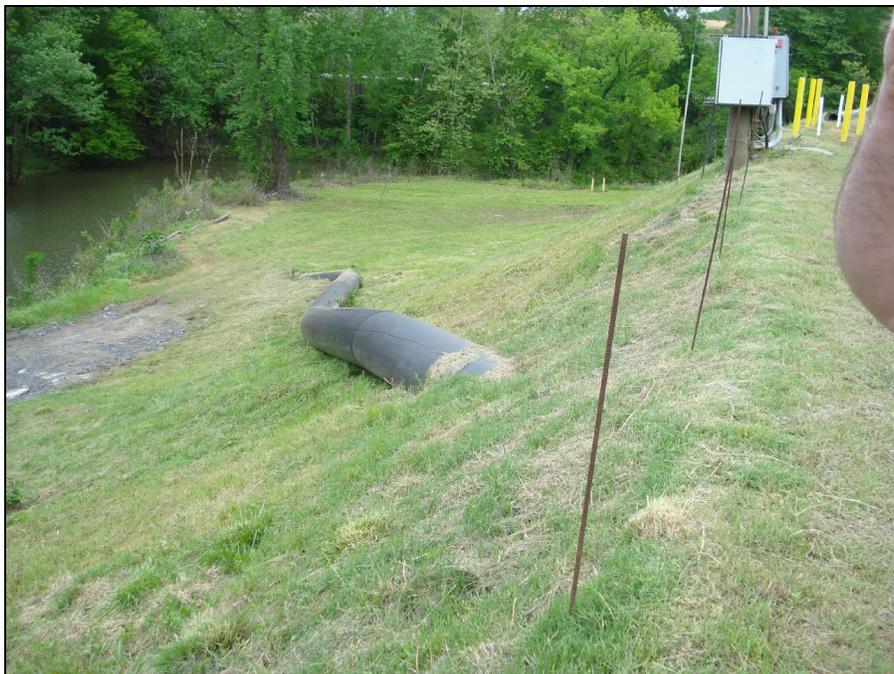
2-28

EMERGENCY OVERFLOW OUTLET PIPE

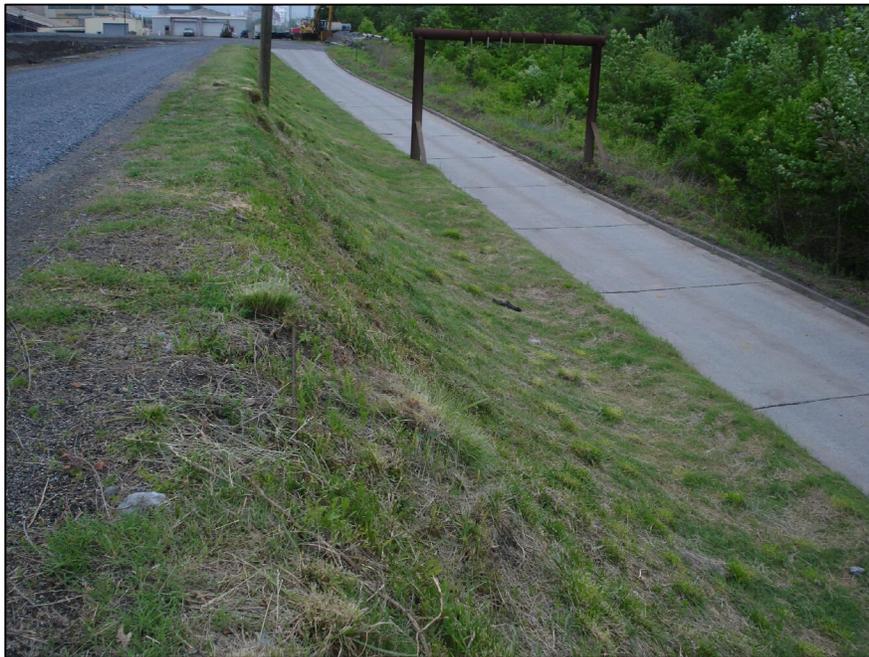
2-30

STEEP SLOPES ALONG SOUTHERN DOWNSTREAM SLOPE

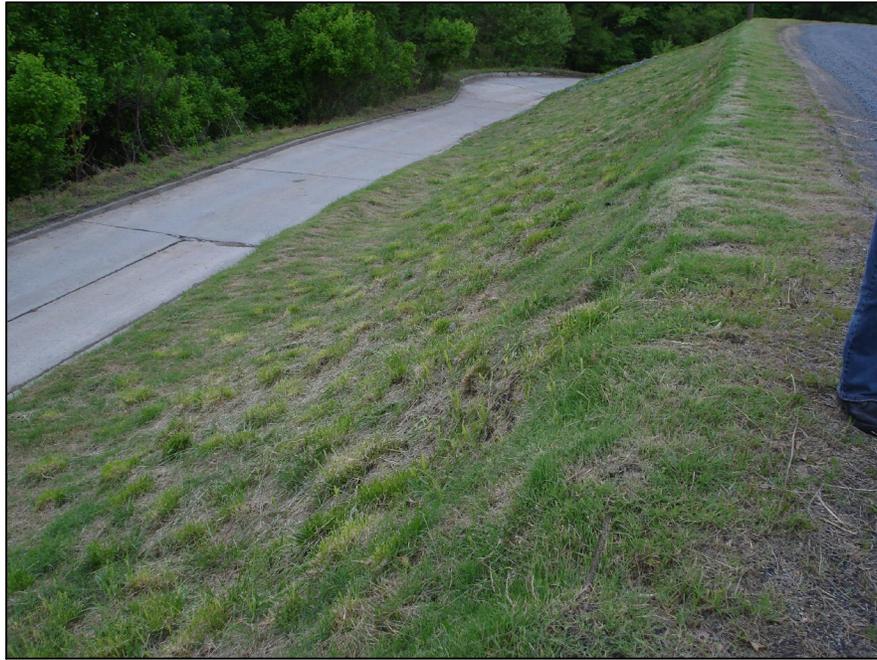
2-31

STEEP SLOPES ALONG SOUTHERN DOWNSTREAM SLOPE

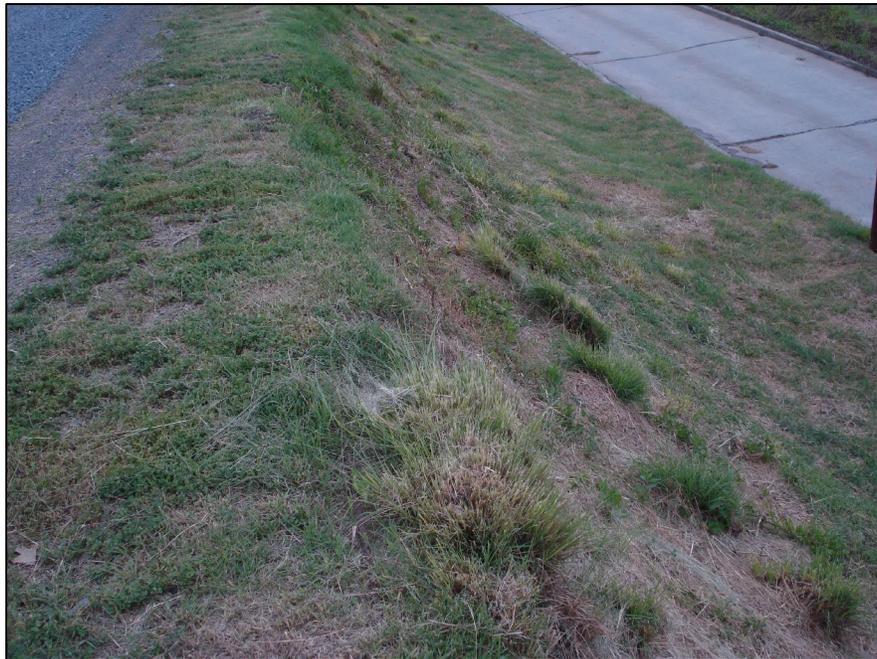
2-32

STEEP SLOPES ALONG SOUTHERN DOWNSTREAM SLOPE

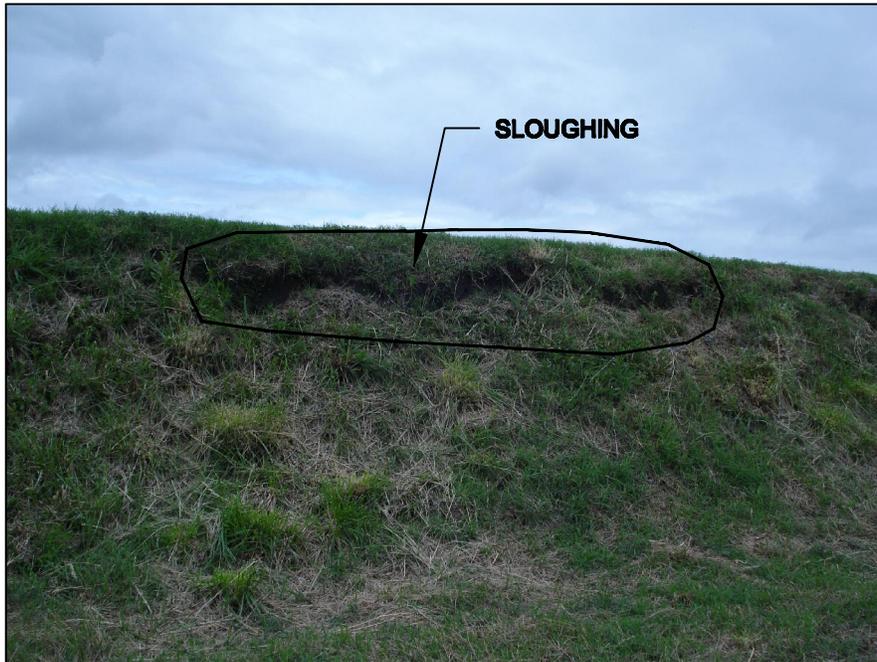
2-33

SLOUGHING ALONG SOUTHERN DOWNSTREAM SLOPE

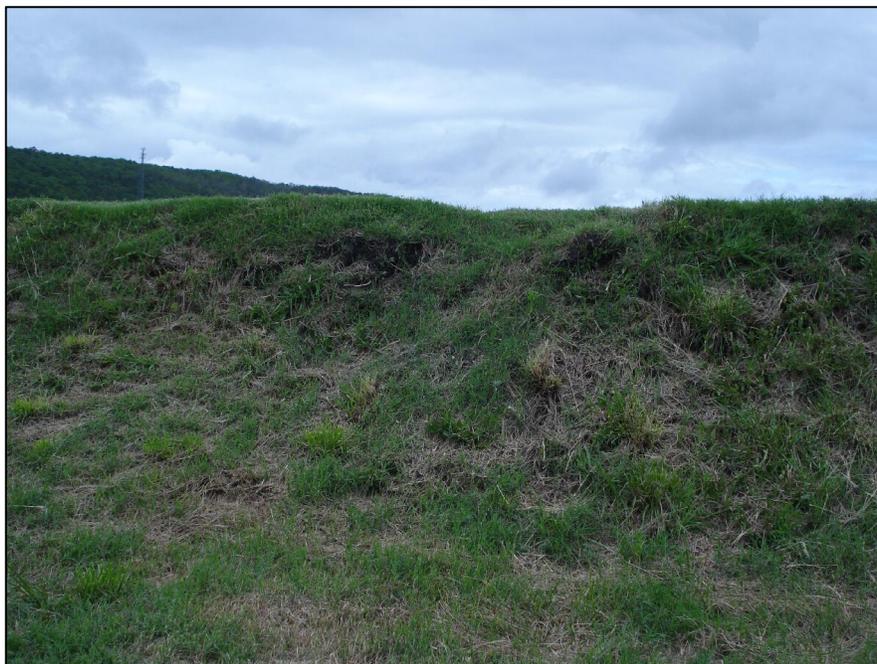
2-34

STEEP SLOPES ALONG SOUTHERN DOWNSTREAM SLOPE

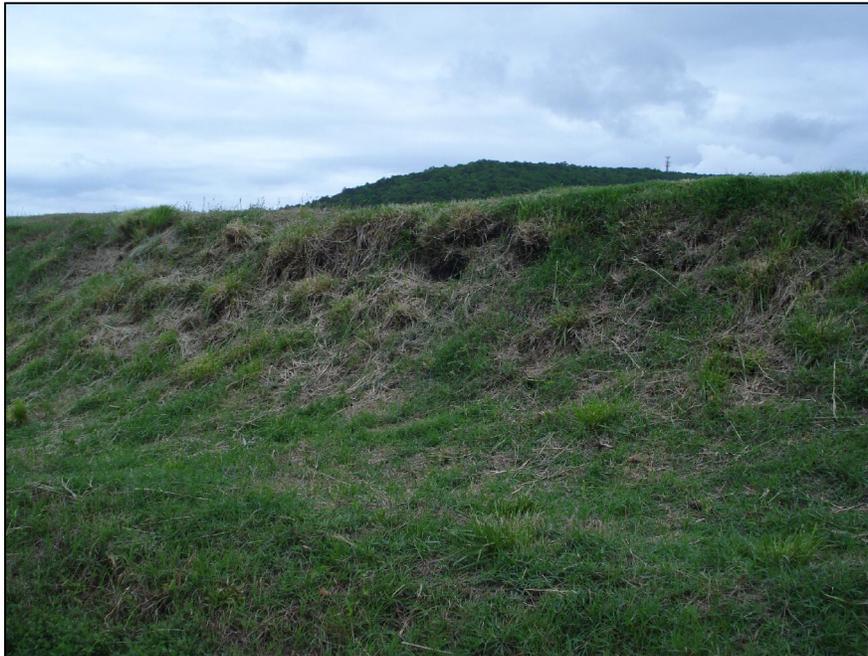
2-35

STEEP SLOPES ALONG SOUTHERN DOWNSTREAM SLOPE

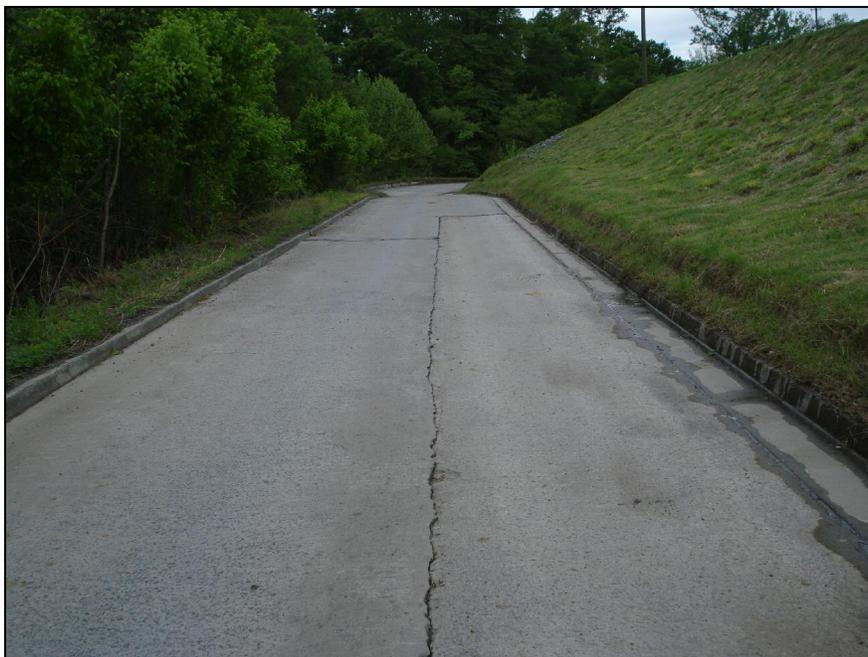
2-36

CRACKS IN HAUL ROAD ALONG SOUTHERN DOWNSTREAM TOE

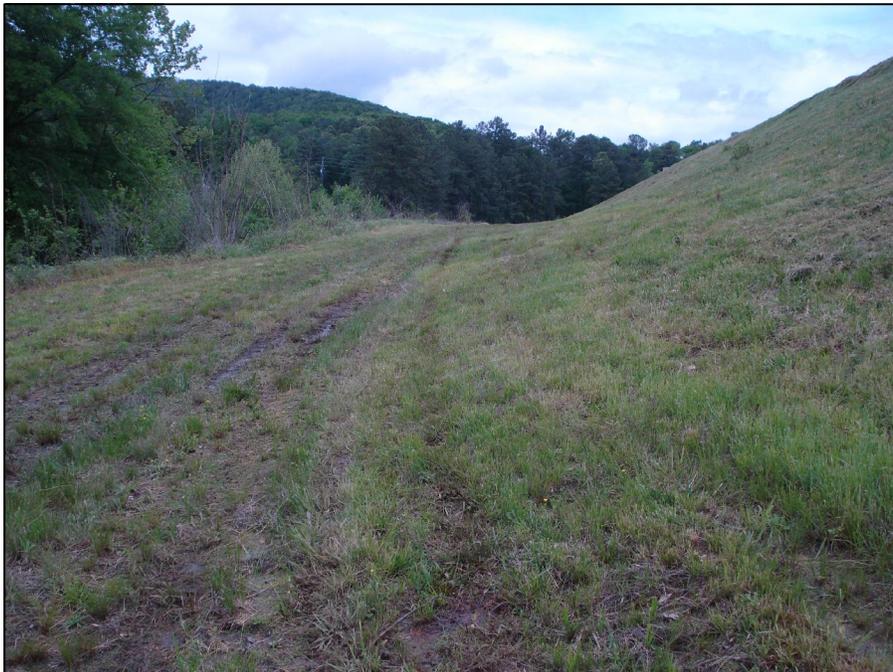
2-38

WET AREA ALONG SOUTH WESTERN DOWNSTREAM TOE

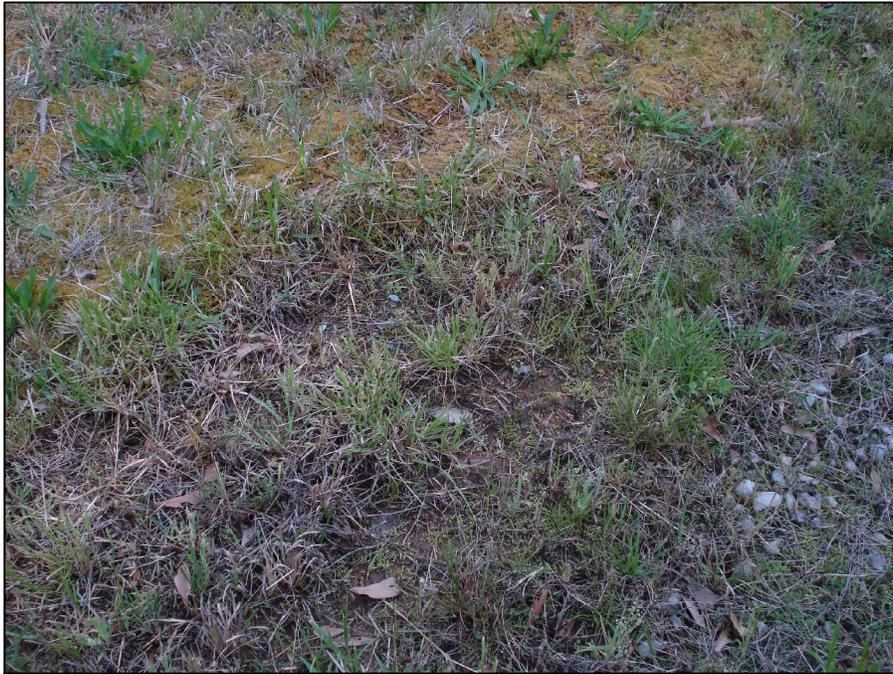
2-39

WET AREA ALONG SOUTH WESTERN DOWNSTREAM TOE

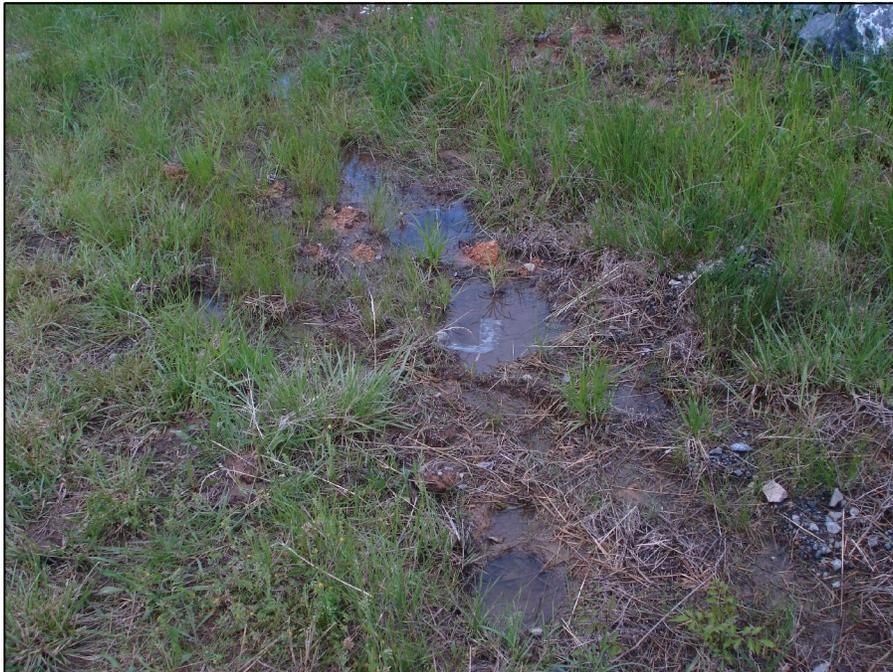
2-40

WET AREAS ALONG WESTERN DOWNSTREAM TOE

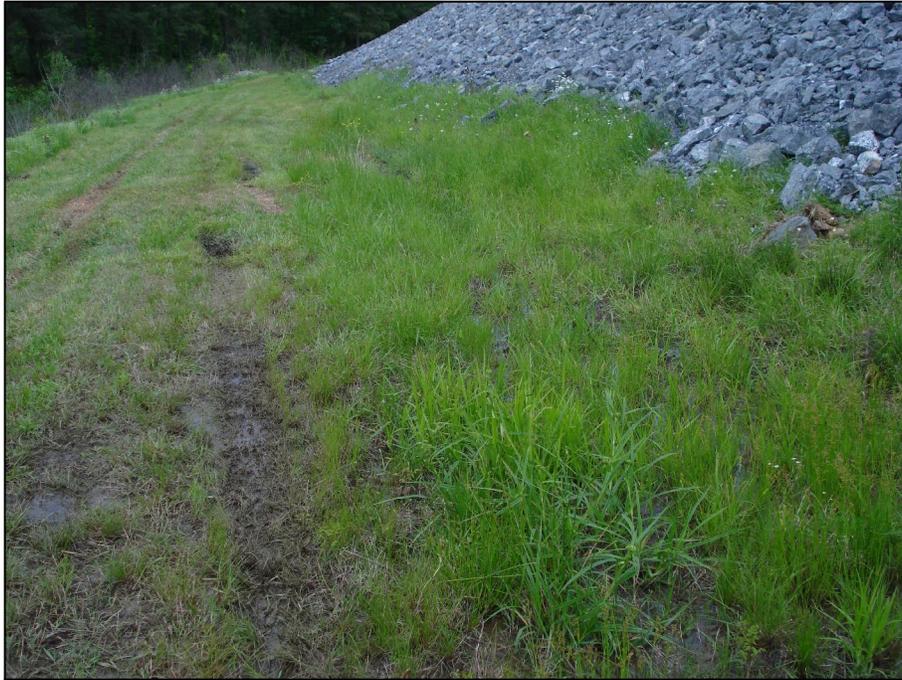
2-41

WET AREAS ALONG WESTERN DOWNSTREAM TOE

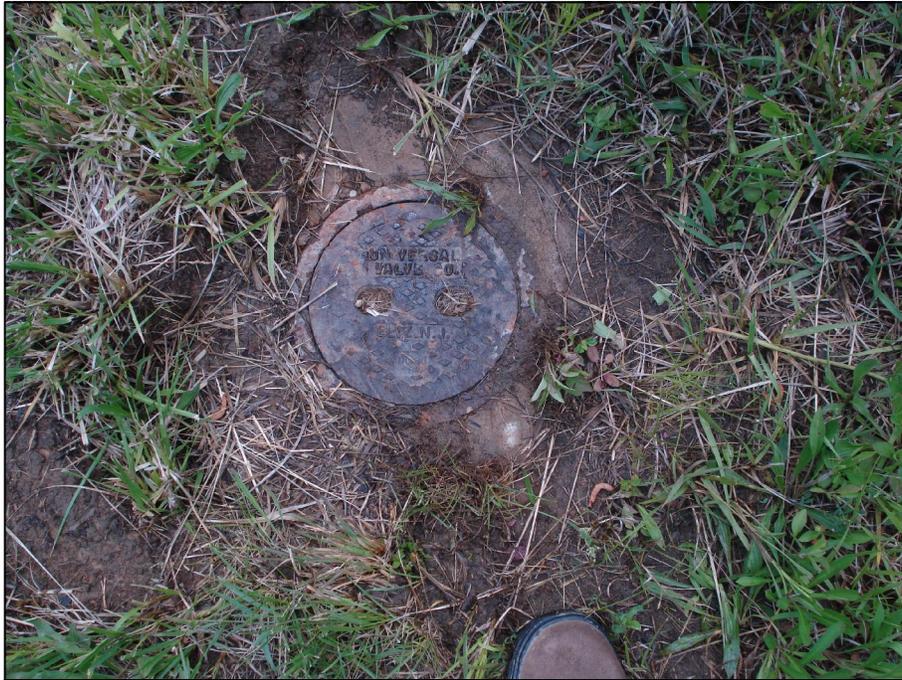
2-42

PREVIOUS PIEZOMETER LOCATION

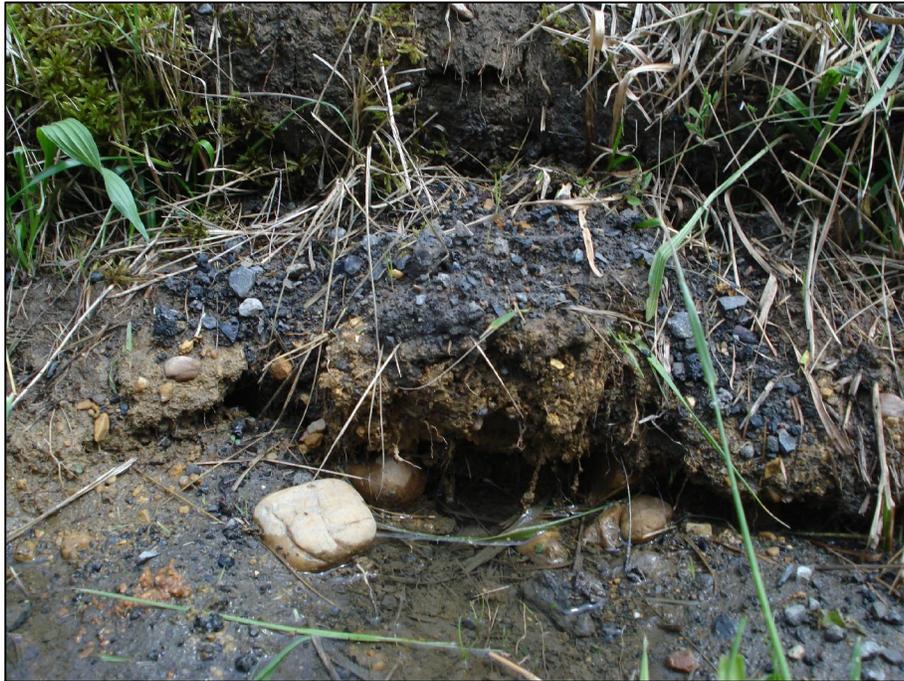
2-43
SLOUGHING AT BASE OF ROCK FACE

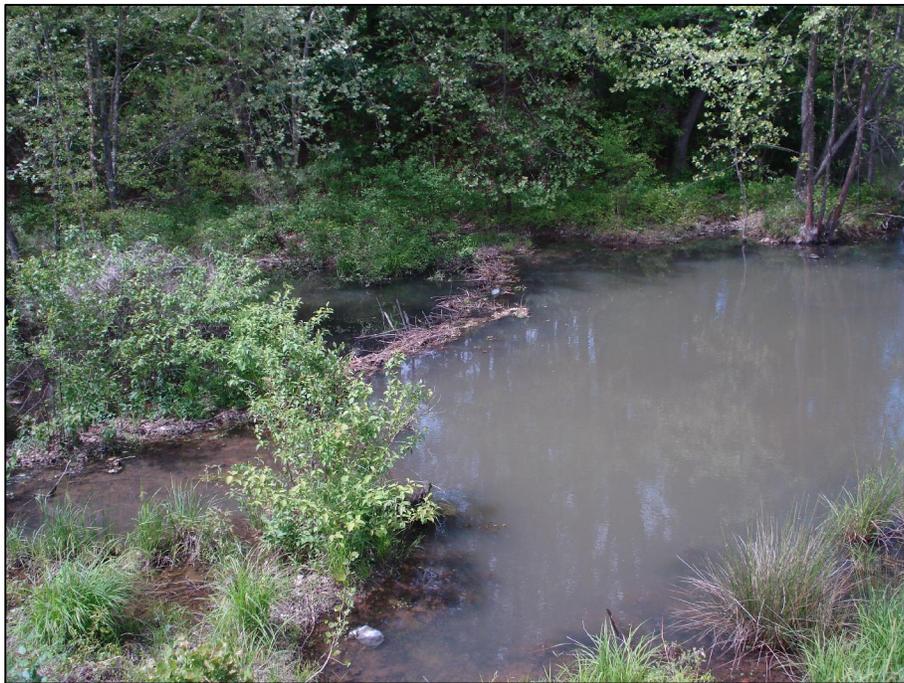
2-44
CREEK ALONG BASE OF NORTHERN DOWNSTREAM TOE

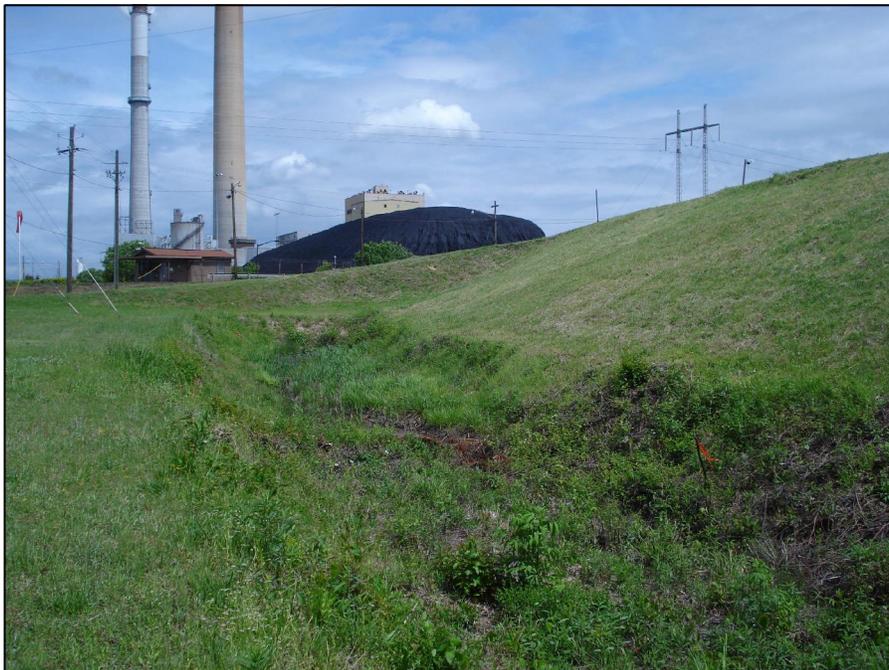
2-46

CREEK ALONG BASE OF NORTHERN DOWNSTREAM TOE

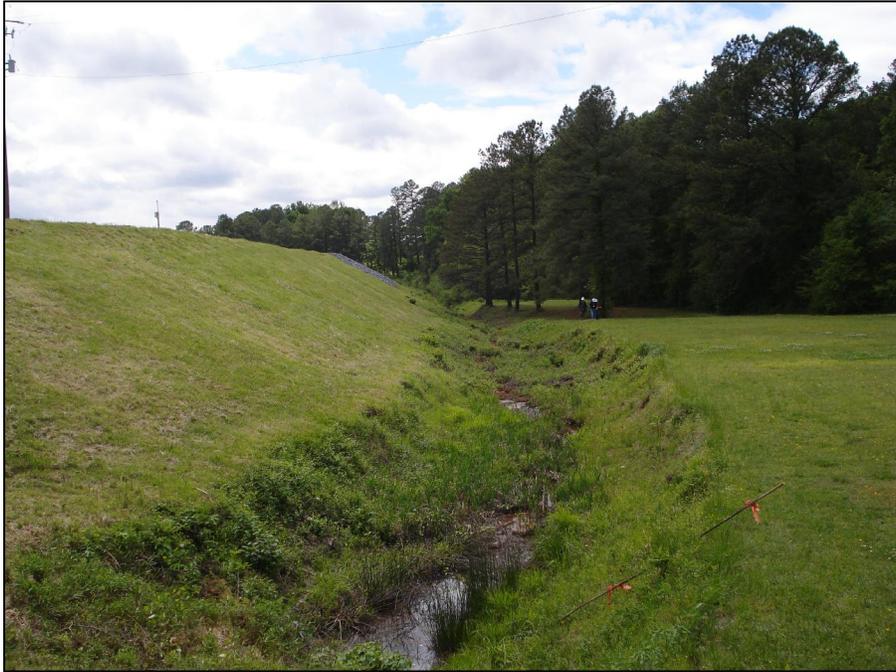
2-47

CREEK ALONG BASE OF NORTHERN DOWNSTREAM TOE

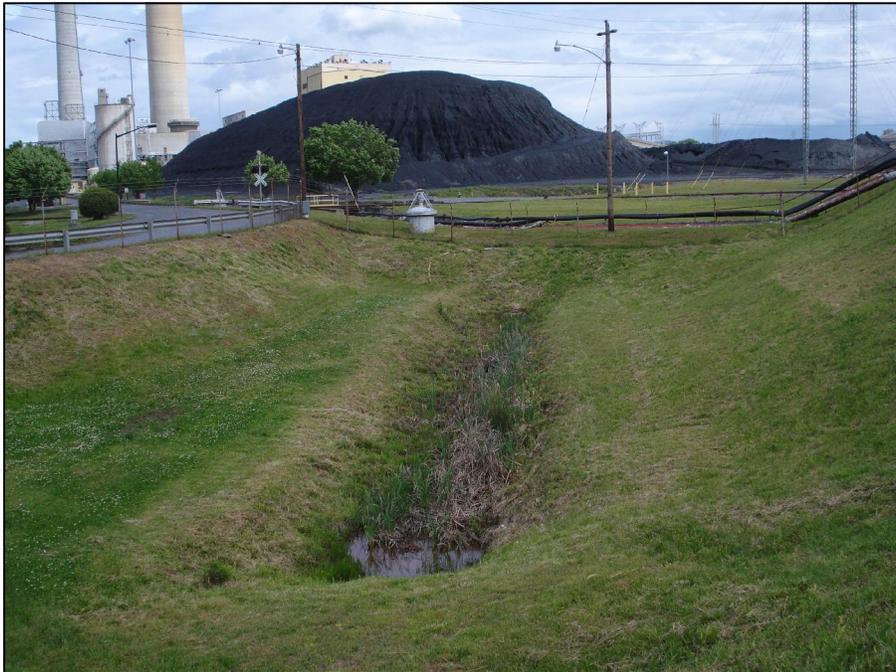
2-48

DRAINAGE DITCH ALONG NORTHERN DOWNSTREAM FACE

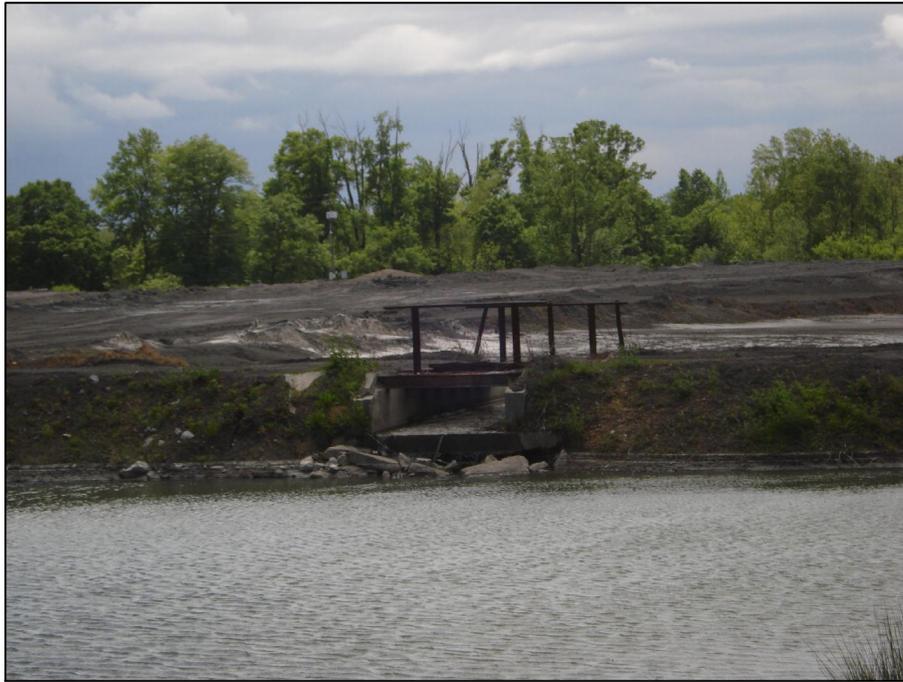
2-49
WEIR STRUCTURE WITHIN ASH POND

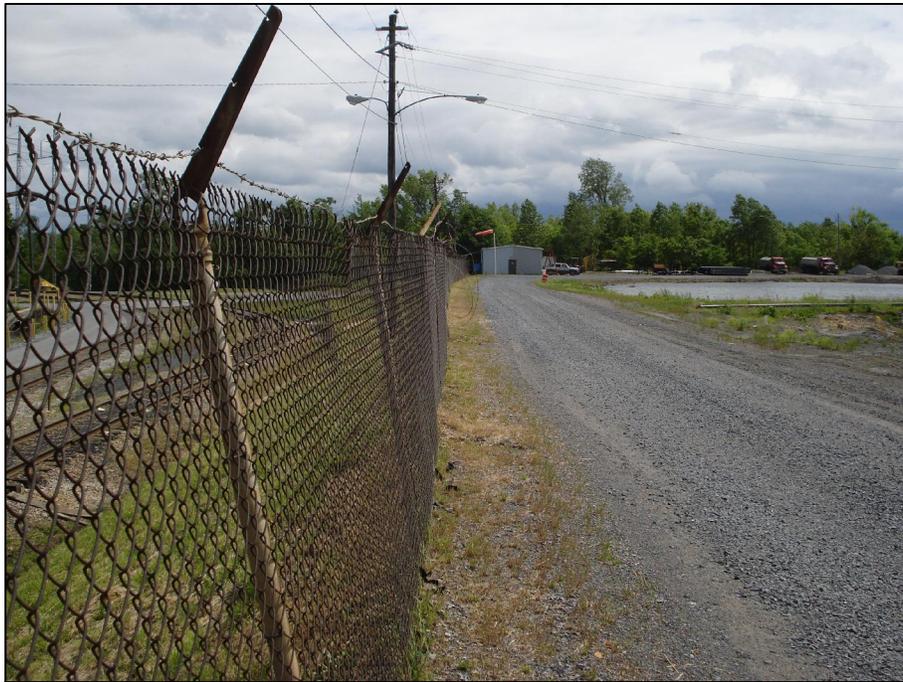
2-50
NOTE FENCE ALIGNMENT ALONG EASTERN BANK

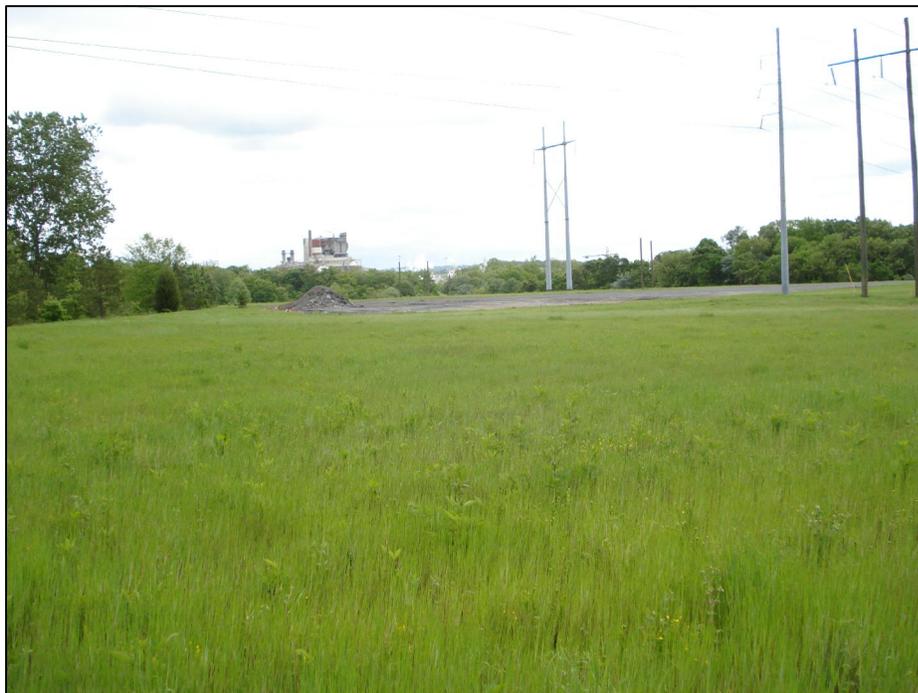
3-6

GENERAL SITE PHOTO FROM WITHIN POND LOOKING NORTH

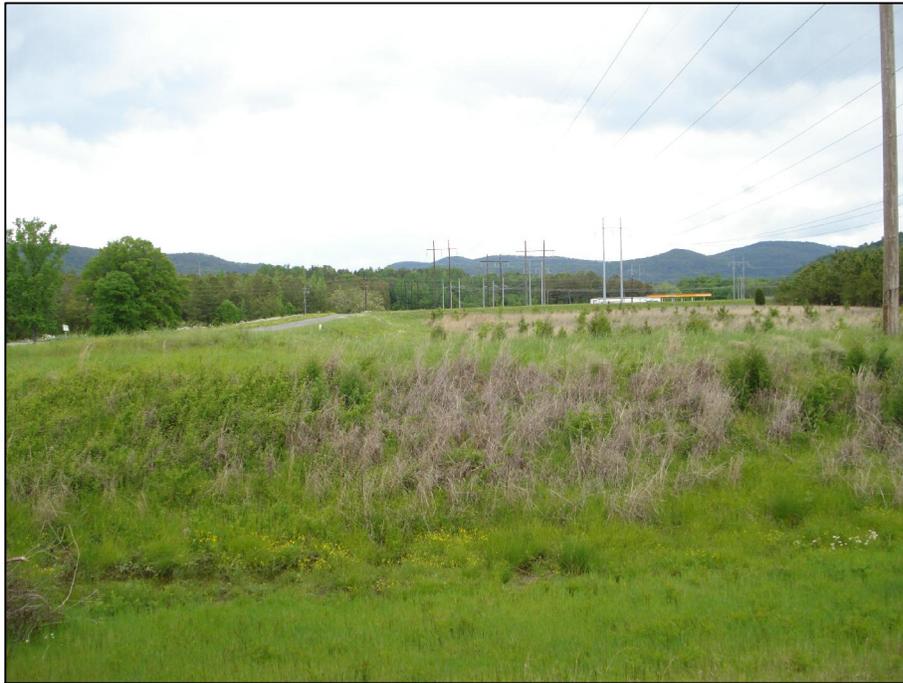
3-7

GENERAL SITE PHOTO FROM WITHIN POND LOOKING NORTH

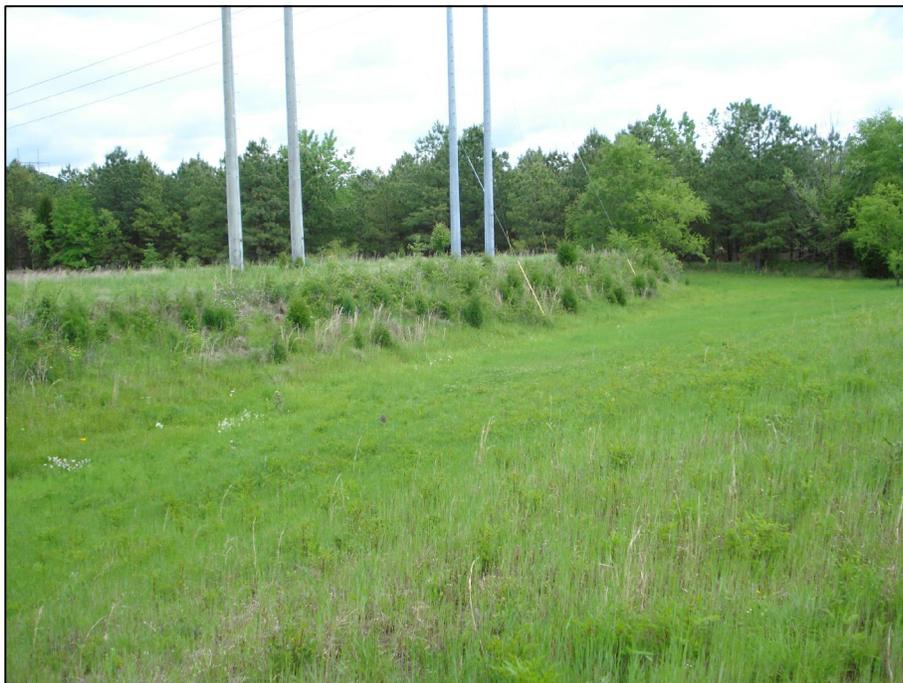
3-8

GENERAL SITE PHOTO FROM WITHIN POND LOOKING NORTH EAST

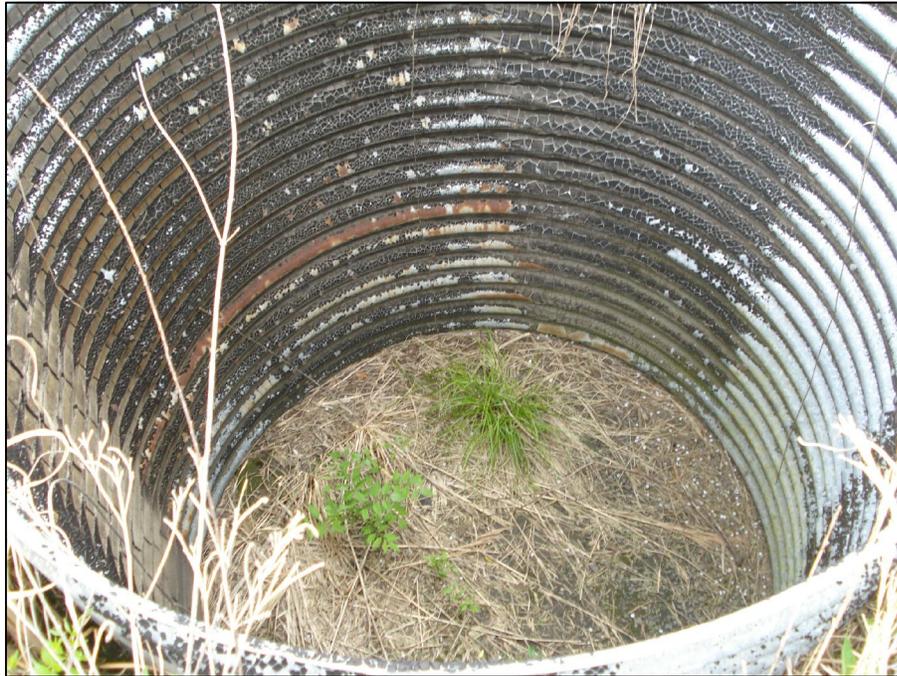
3-9
INACTIVE ASH INLET

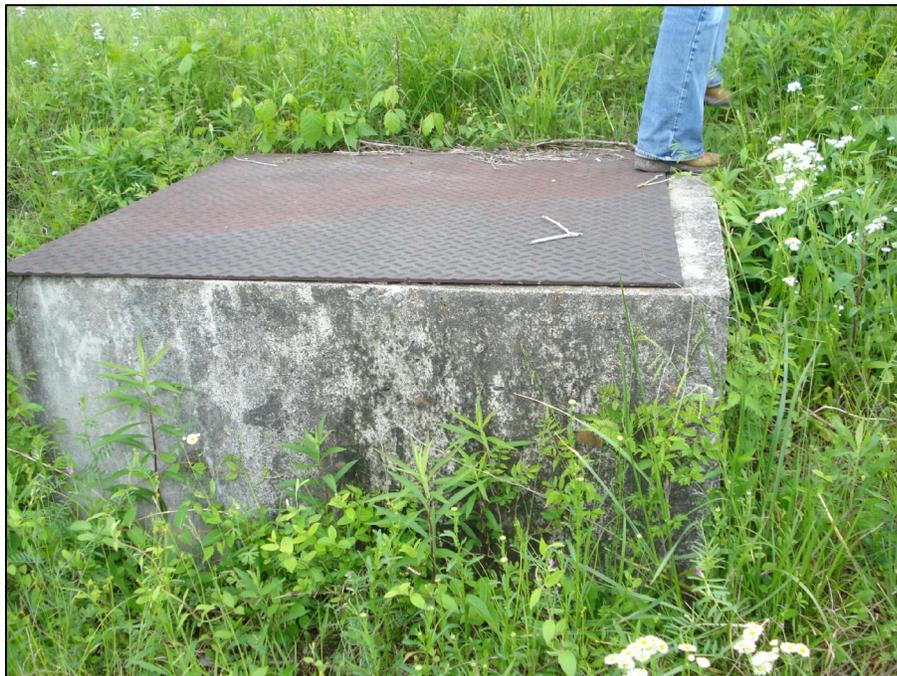
3-10
INACTIVE RETURN

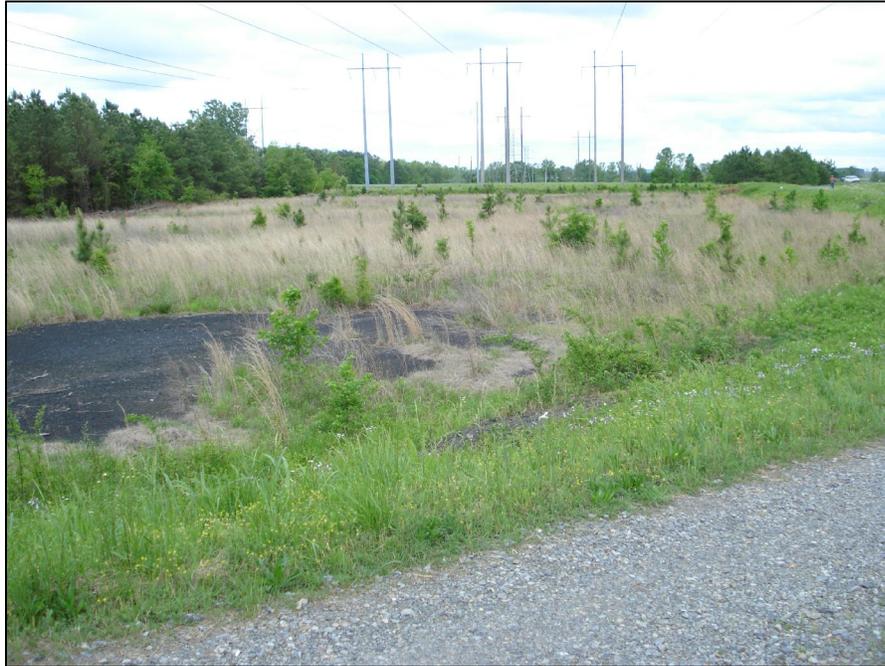
3-11

GENERAL SITE PHOTO ALONG NORTHERN FACE LOOKING SOUTH

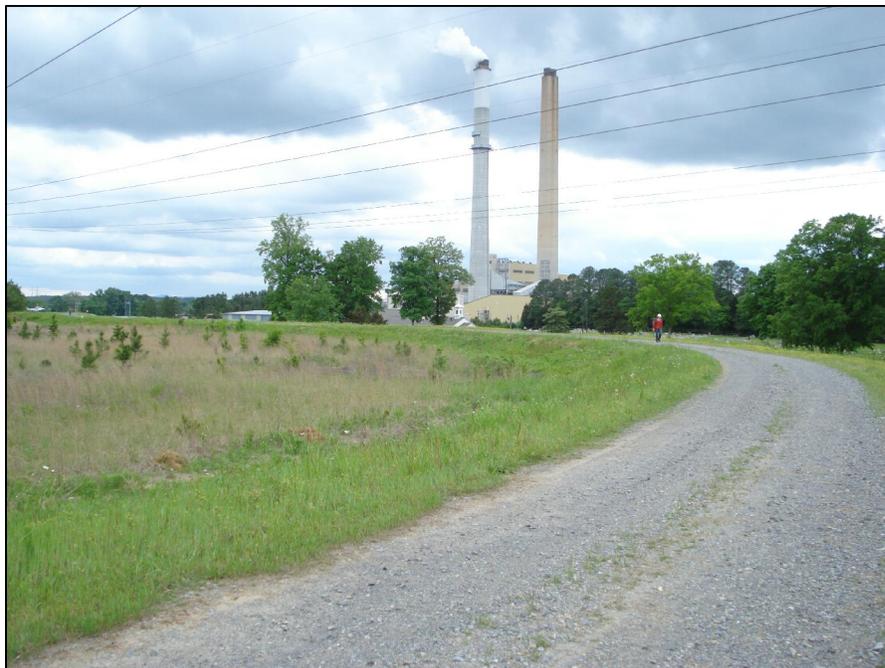
3-12

GENERAL SITE PHOTO ALONG NORTHERN FACE LOOKING WEST

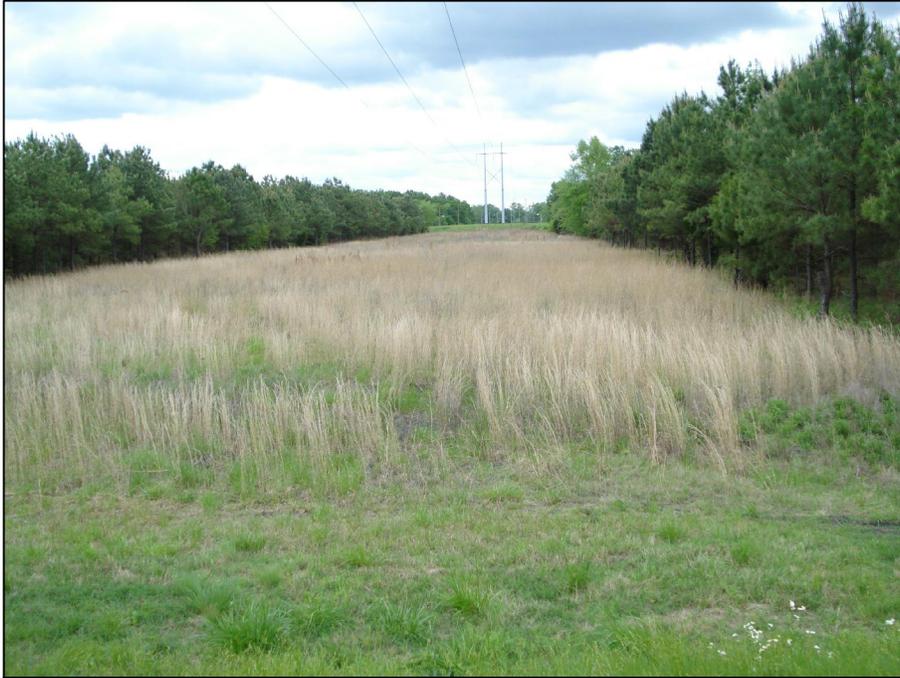
3-13

GENERAL SITE PHOTO ALONG NORTHERN FACE LOOKING SOUTH

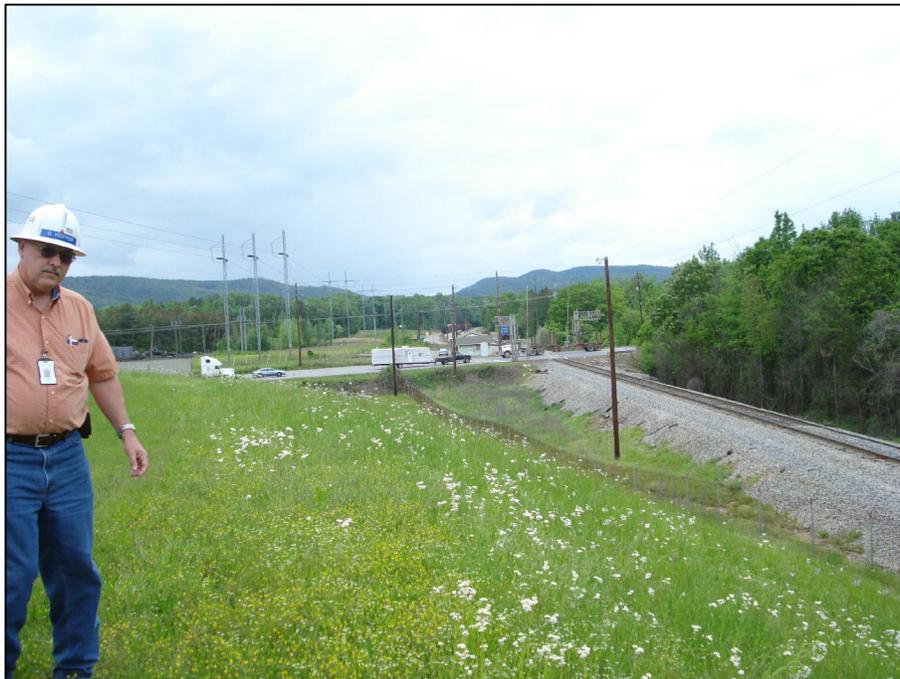
3-14

RAILROAD TRACKS ALONG EASTERN DOWNSTREAM TOE

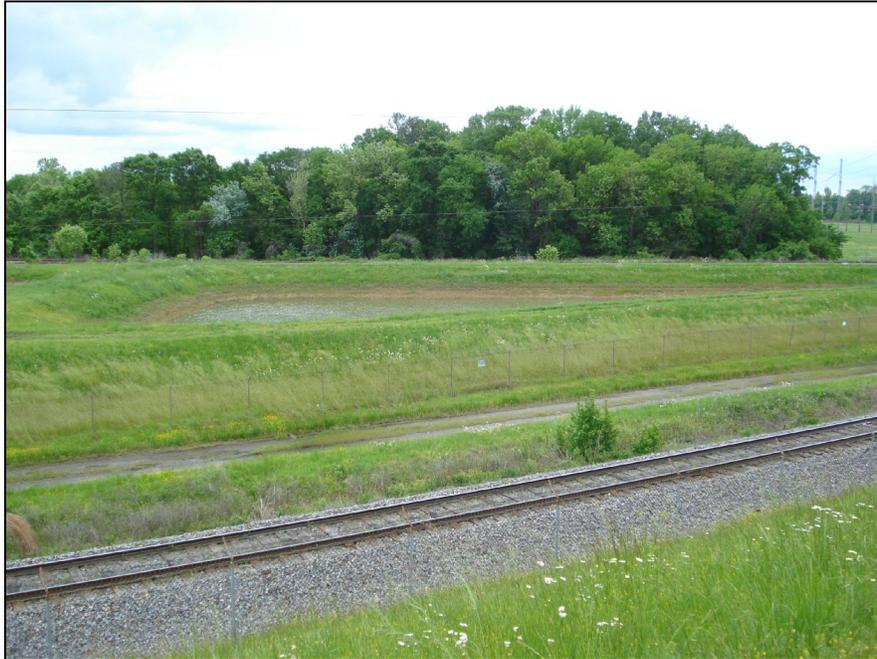
3-15

RAILROAD TRACKS ALONG SOUTHERN DOWNSTREAM TOE

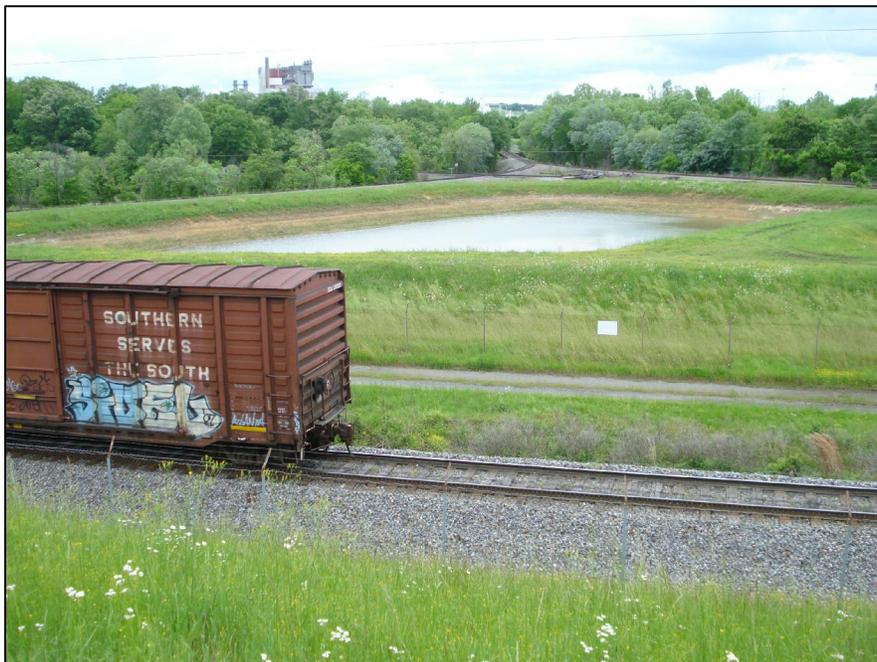
3-16

RAILROAD TRACKS/DETENTION POND ALONG SOUTHERN DOWNSTREAM TOE

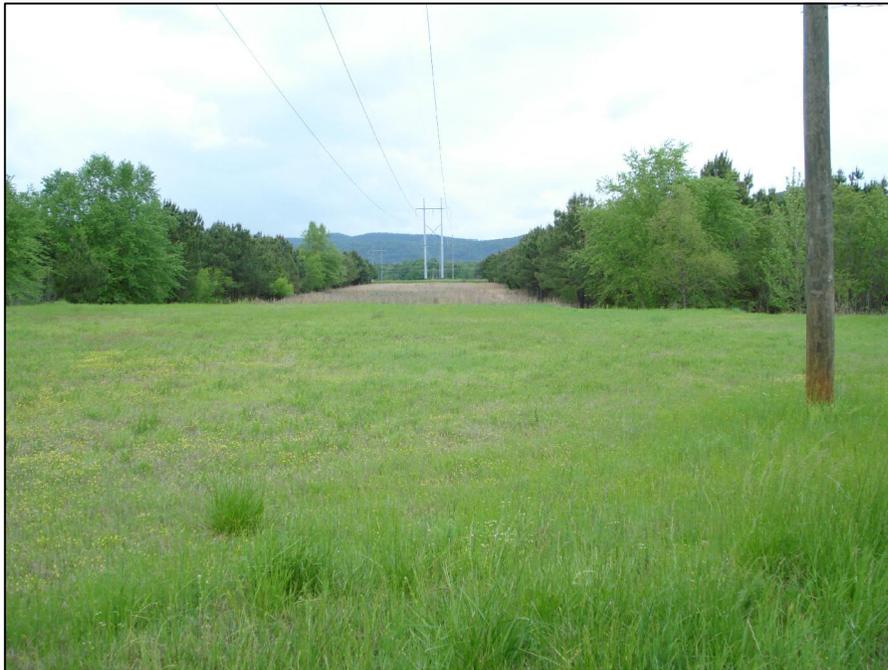
3-17

GENERAL SITE PHOTO FROM SOUTHERN BANK LOOKING NORTH
