Report of Safety Assessment
Coal Combustion Surface Impoundments
Georgia Power
Plant Hammond, Rome, Georgia

AMEC Project No. 3-2106-0174.0500

December 2010

Southern Company, Georgia Power, Plant Hammond: Ash Pond 1, Ash Pond 2, Ash Pond 3, Ash Pond 4

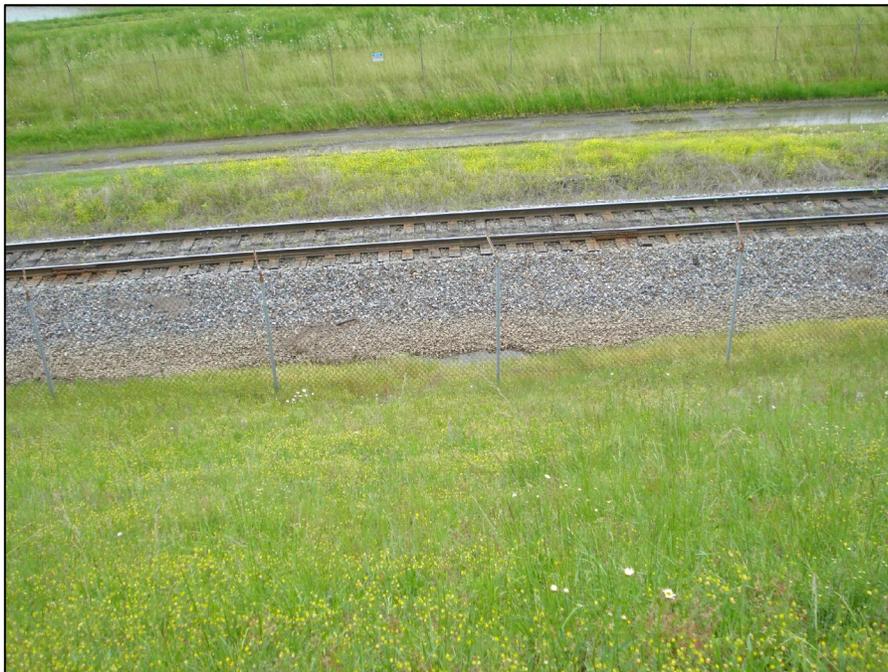
3-18

RAILROAD TRACKS ALONG SOUTHERN DOWNSTREAM TOE

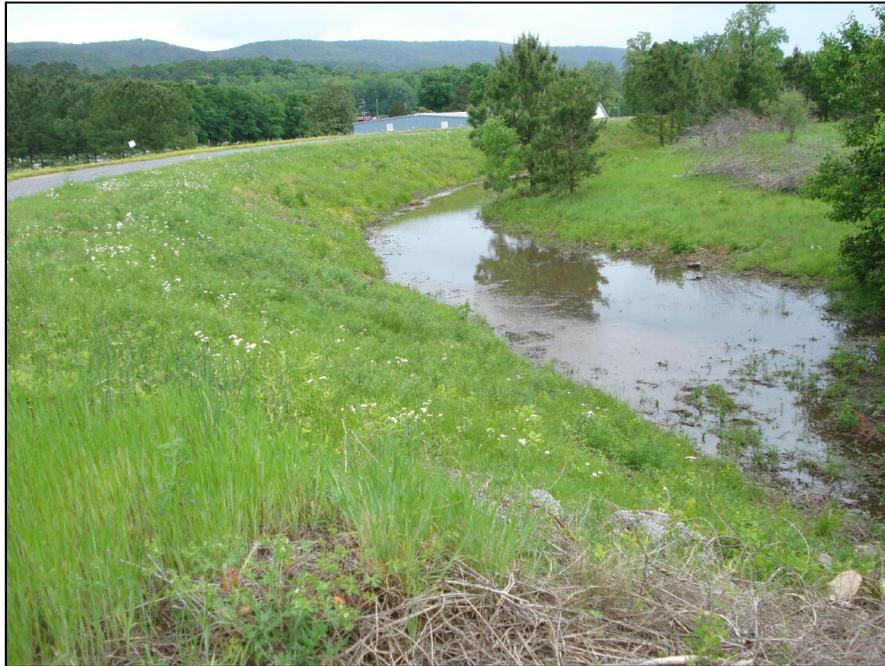
3-19

GENERAL SITE PHOTO ALONG SOUTHERN DIKE LOOKING NORTH WEST

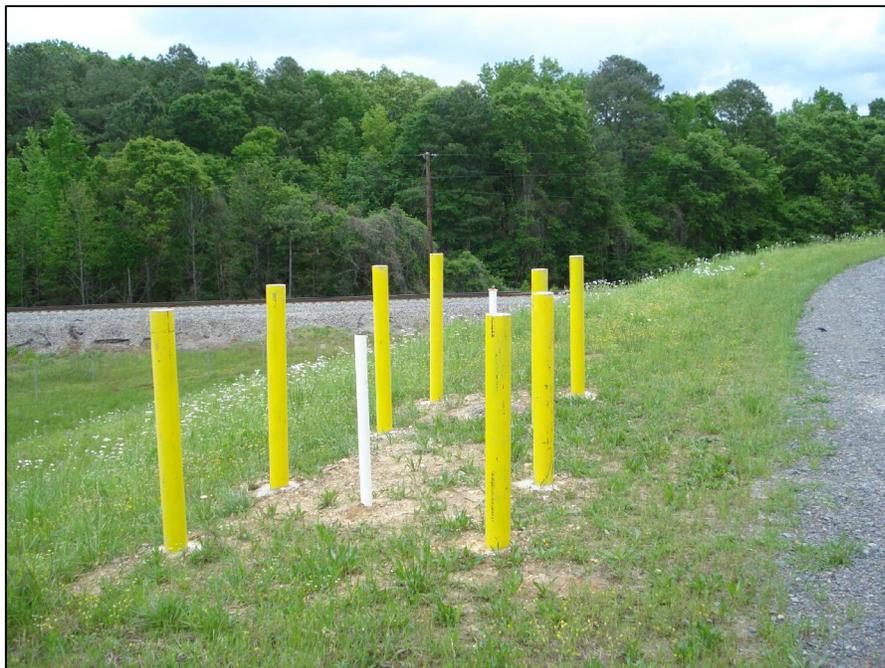
3-20

2 PIEZOMETERS (AP3-2 AND AP3-3) INSTALLED ALONG NORTHERN DOWNSTREAM CREST

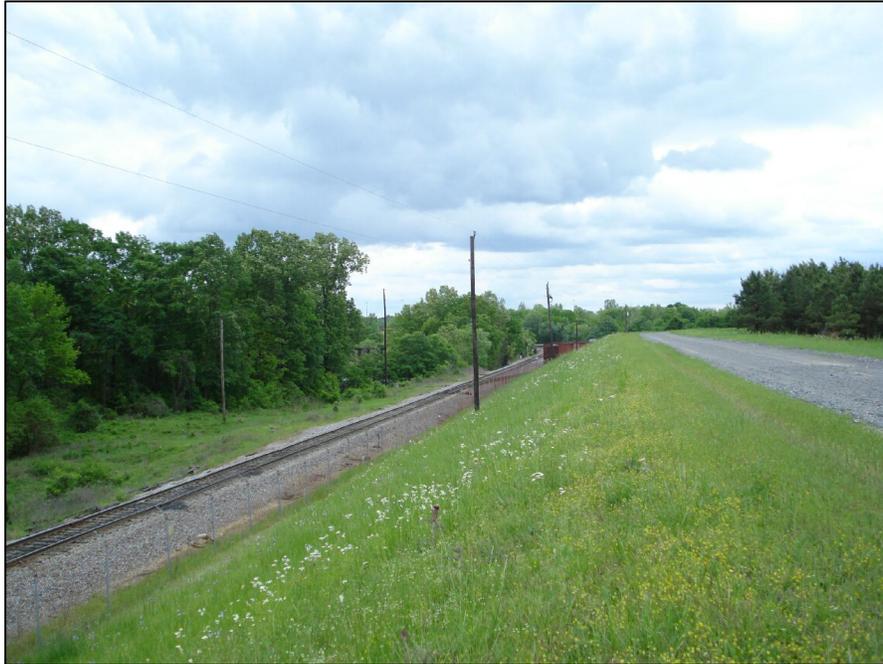
3-21

GENERAL SITE PHOTO ALONG EASTERN BANK

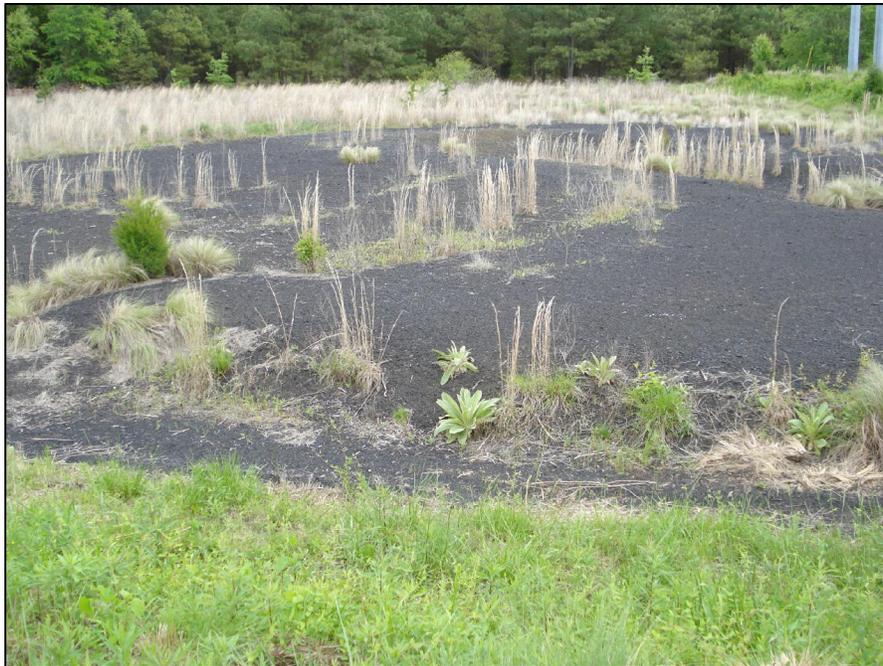
3-22

GENERAL SITE PHOTO ALONG NORTHERN FACE LOOKING SOUTH

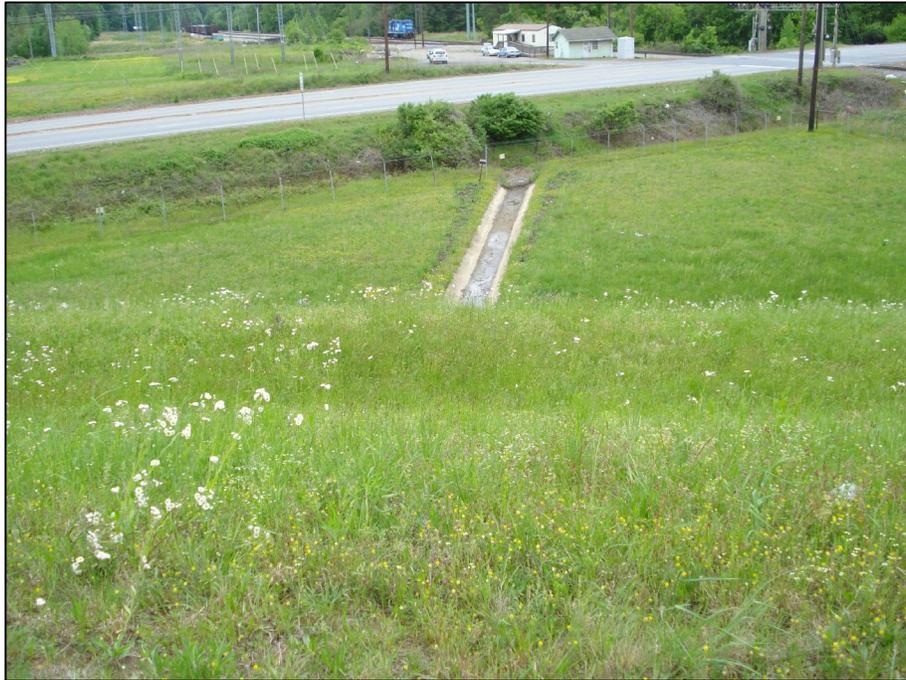
3-23

BASE OF EMERGENCY SPILLWAY

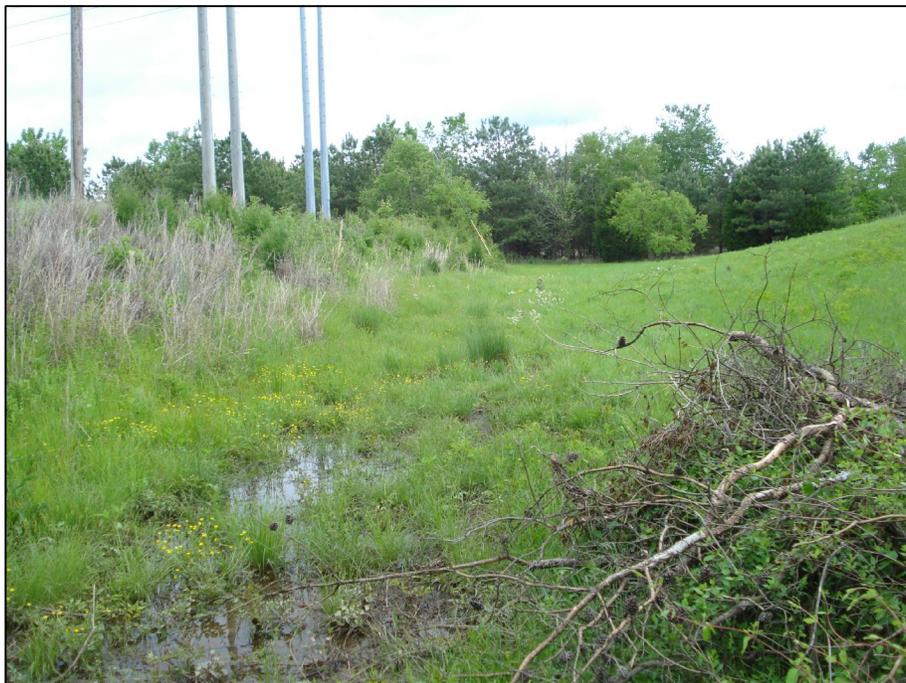
3-24

GENERAL SITE PHOTO FROM WITHIN POND LOOKING EAST

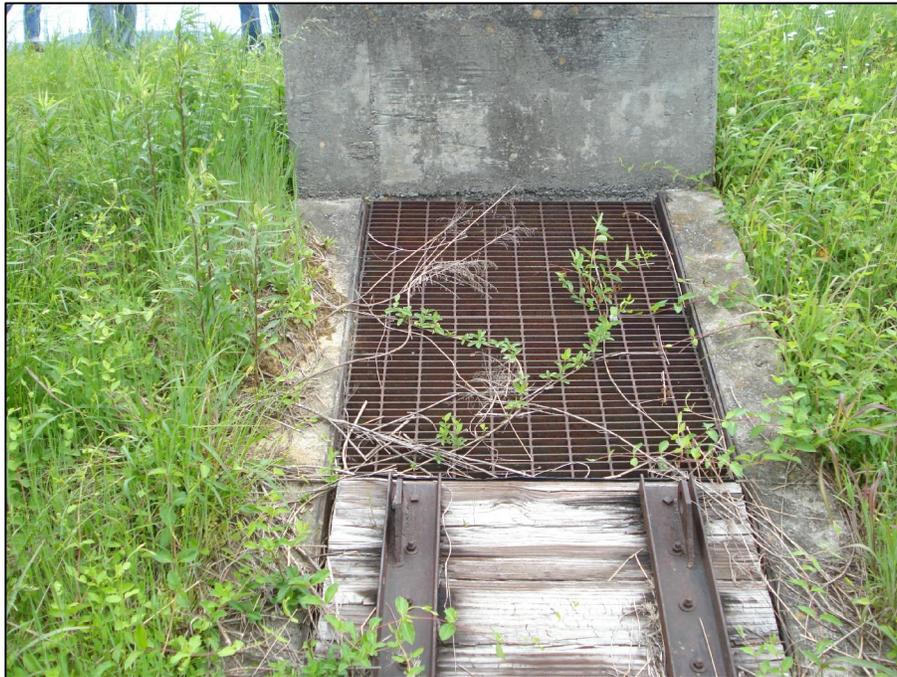
3-25

EMERGENCY SPILLWAY ALONG NORTHERN FACE

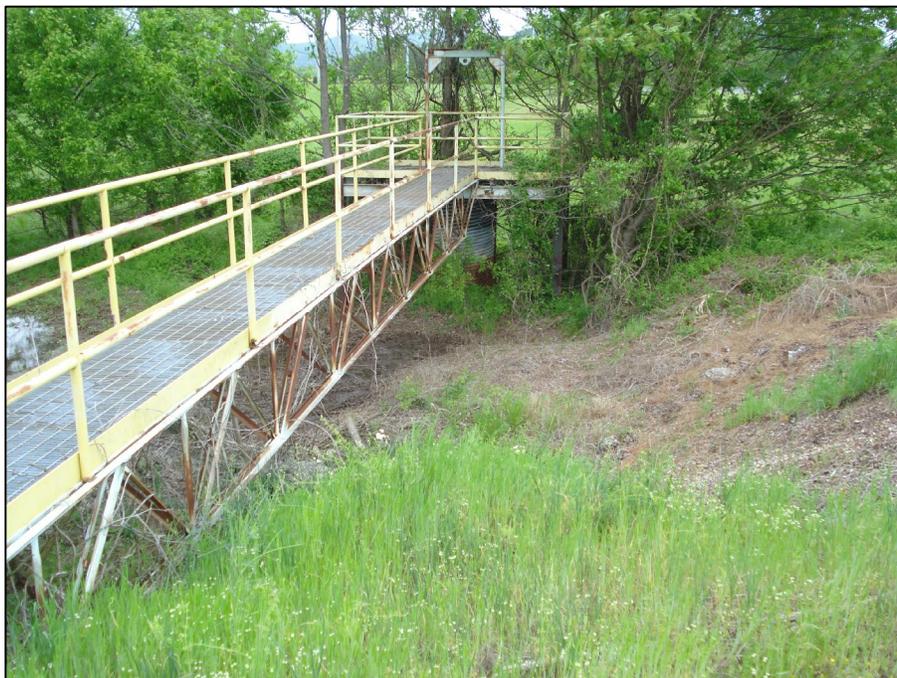
3-26

INLET STRUCTURE (ABANDONED)

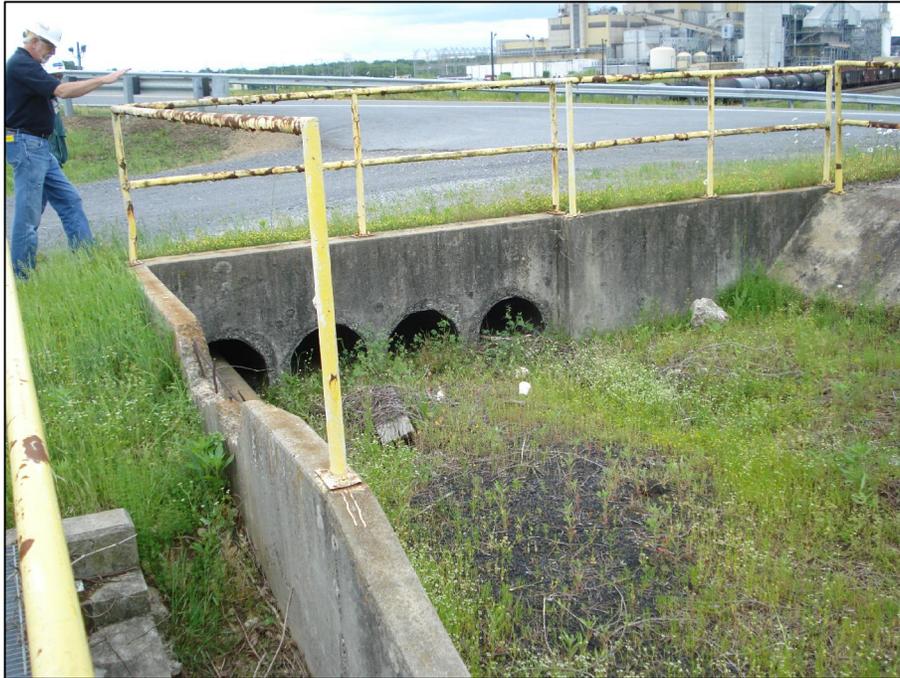
3-27
INLET STRUCTURE (INACTIVE)

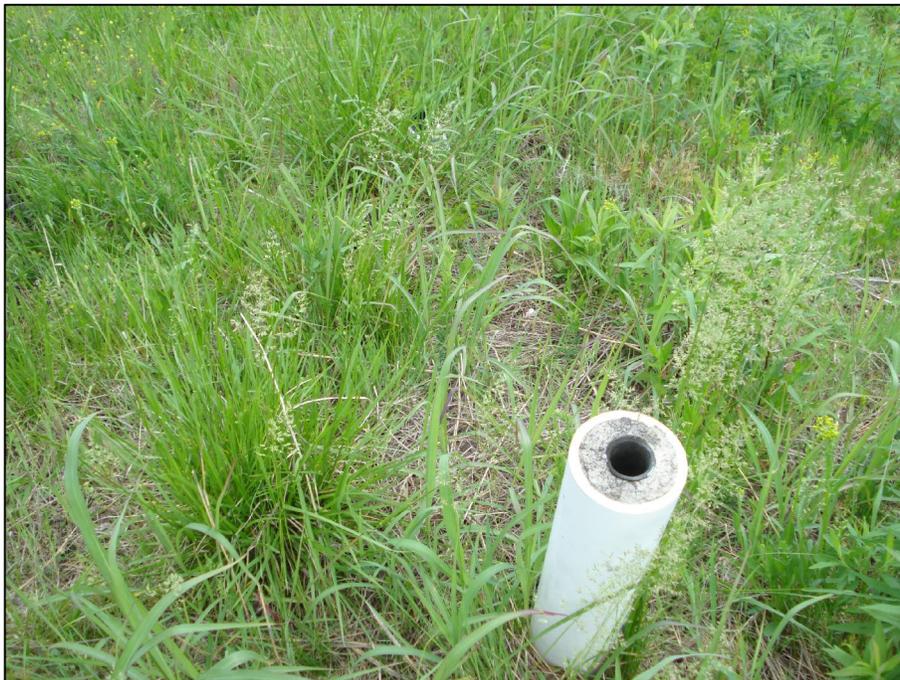
3-28
PREVIOUSLY INSTALLED PIEZOMETER ALONG WESTERN BANK

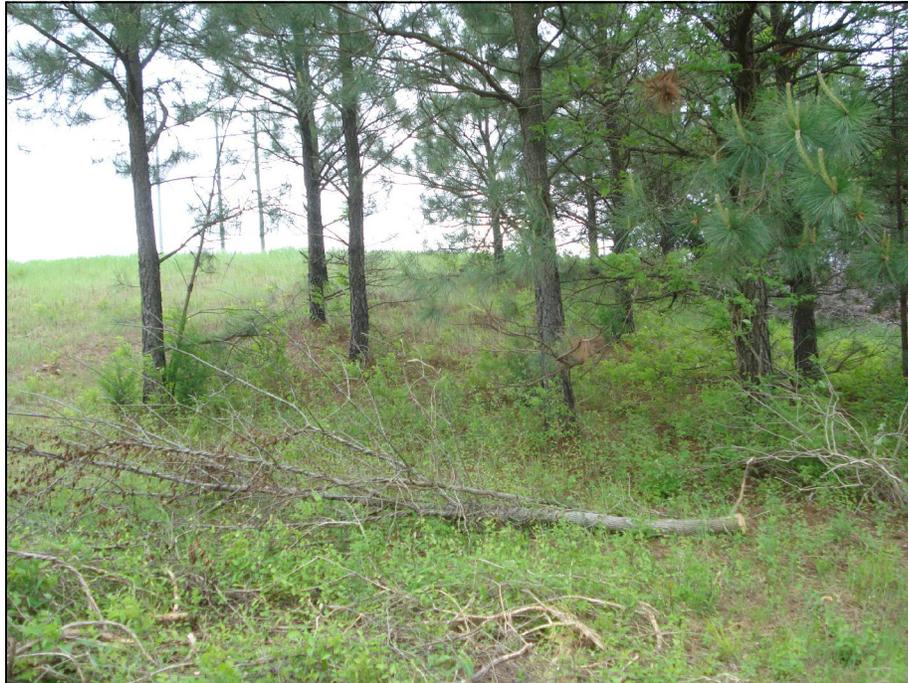
3-30
GENERAL SITE PHOTO ALONG EASTERN BANK

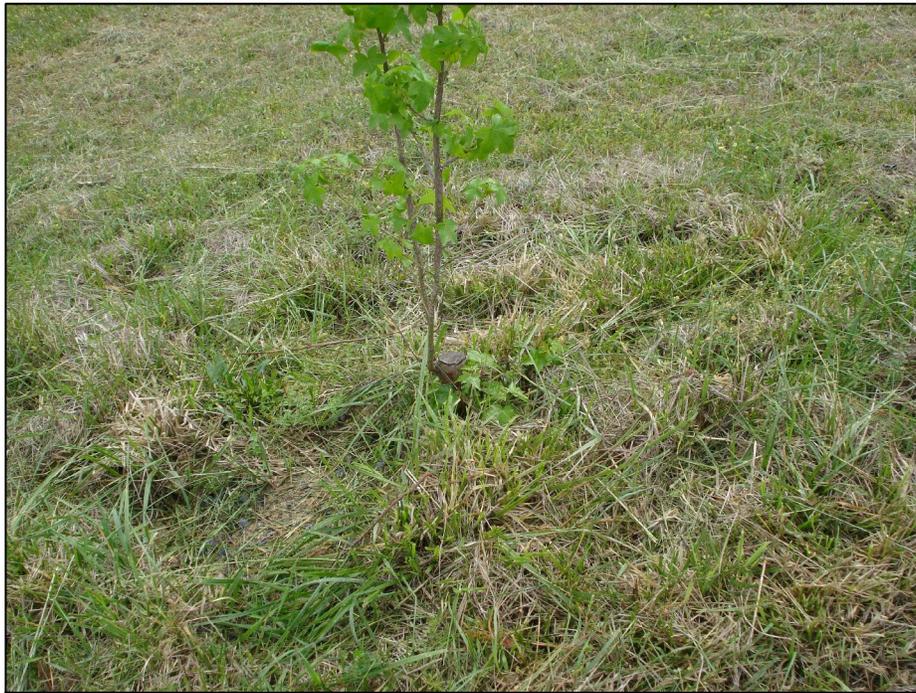
4-1

VEGETATION ALONG EASTERN DOWNSTREAM FACE

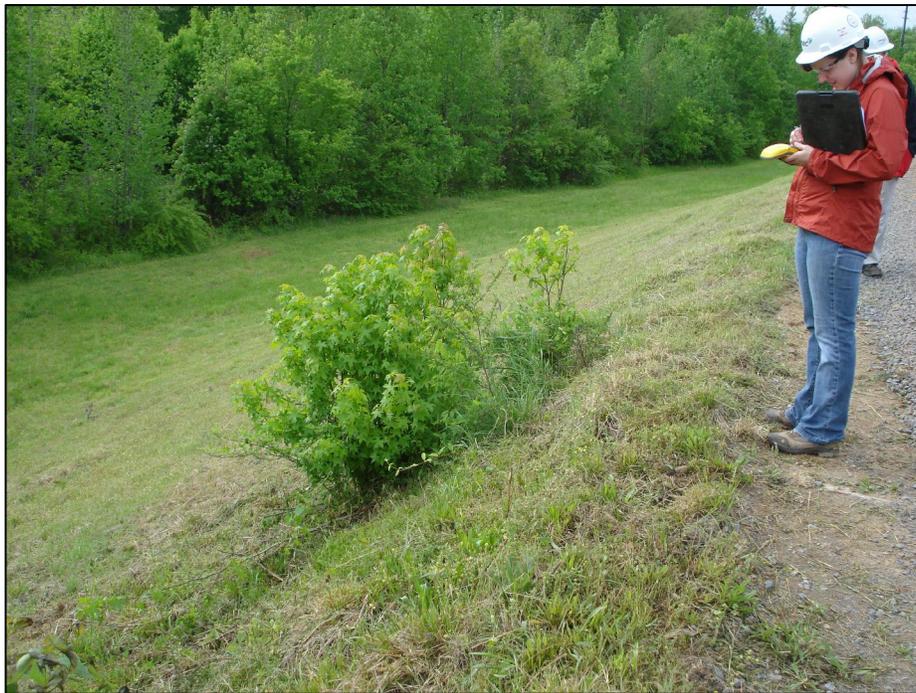
4-2

VEGETATION ALONG EASTERN DOWNSTREAM FACE

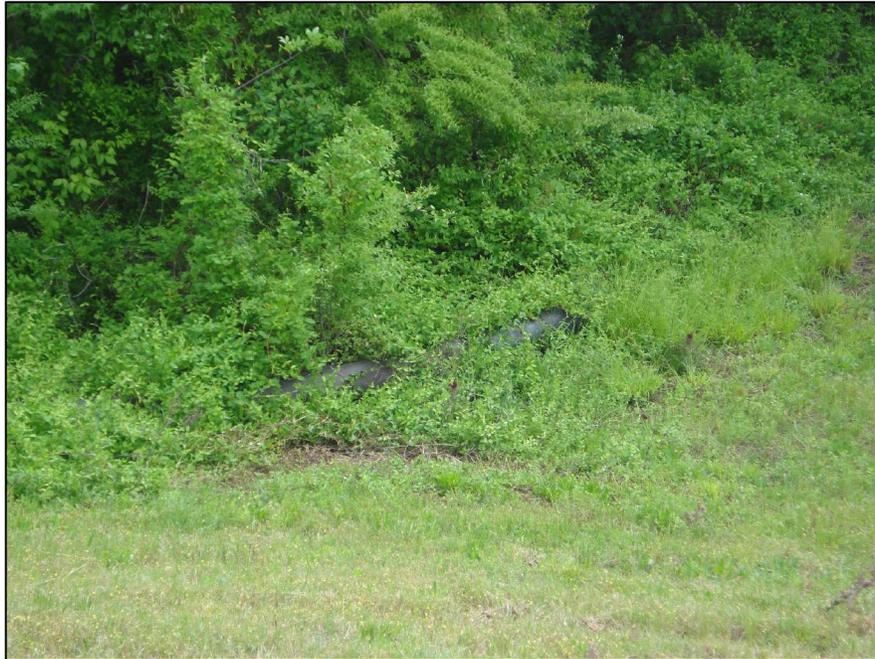
4-3

ABANDONED PIPE ALONG EASTERN DOWNSTREAM FACE

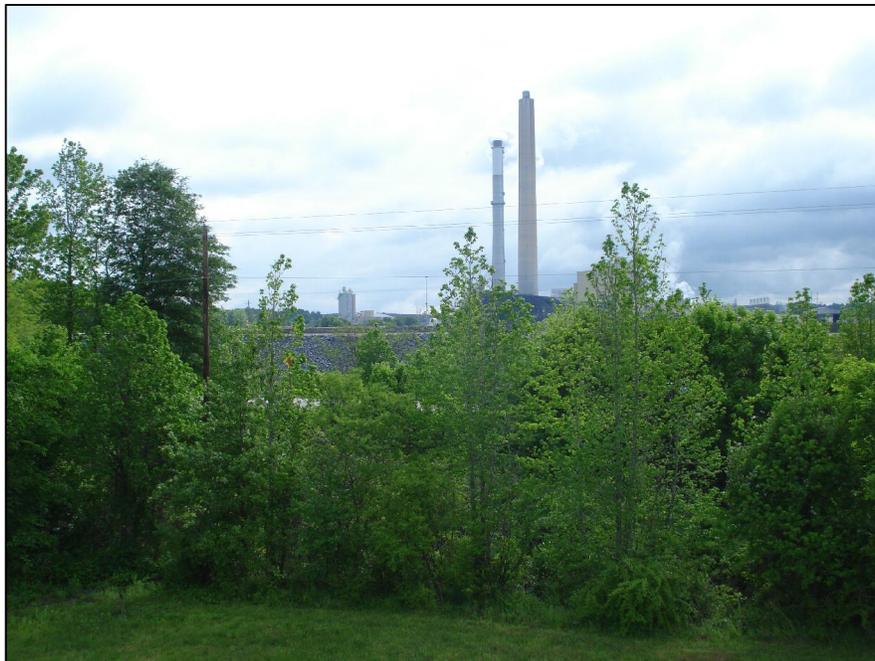
4-4

GENERAL SITE PHOTO LOOKING EAST FROM EASTERN BANK

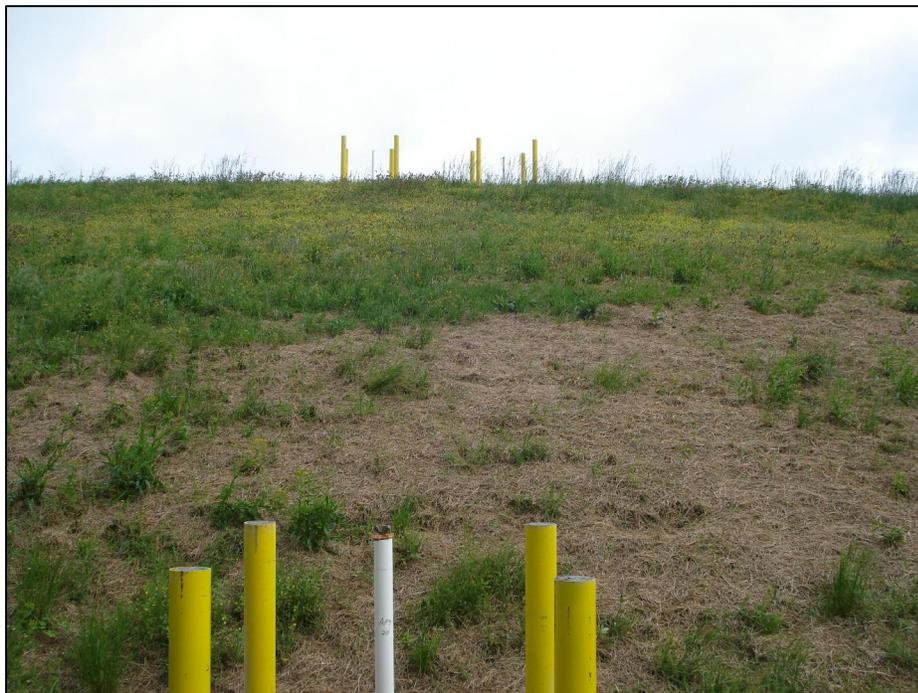
4-6

PIEZOMETER AP4-1 ALONG SOUTHERN DOWNSTREAM TOE

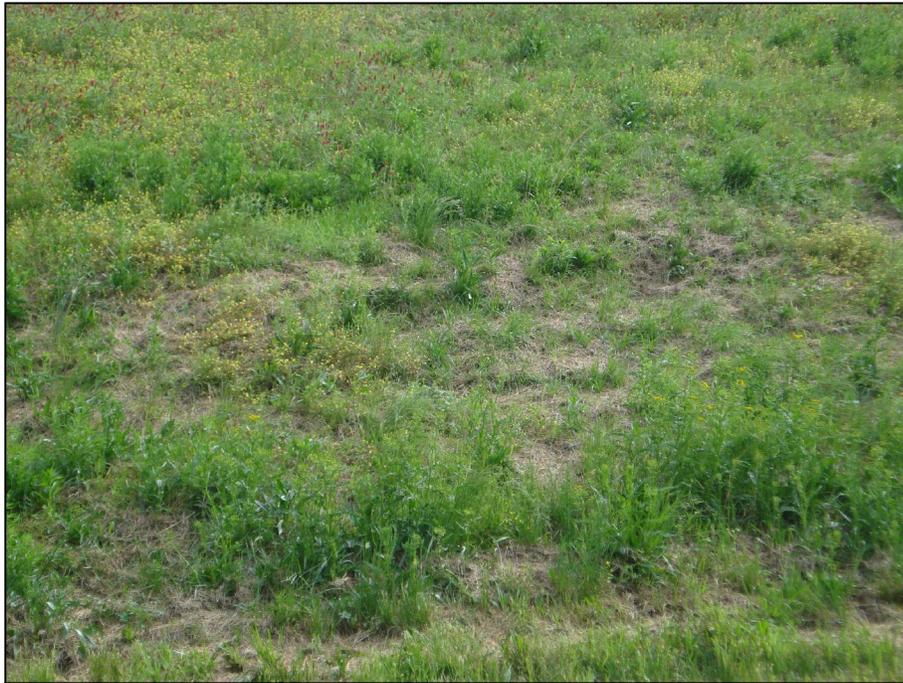
4-7

SLOUGHING ALONG SOUTHERN DOWNSTREAM SLOPE

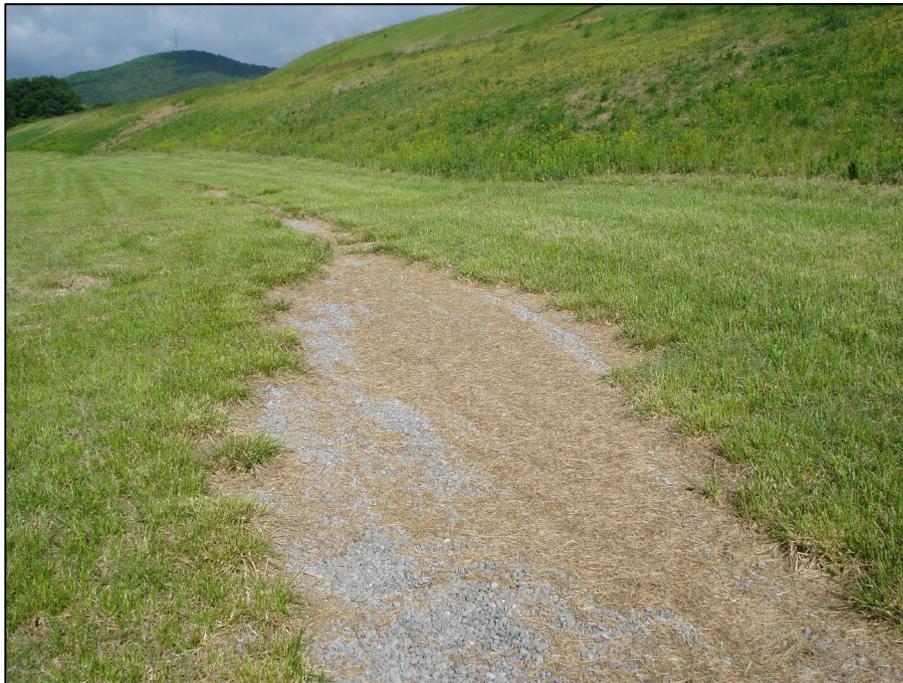
4-8

TRENCH AND FINGER DRAINS ALONG SOUTHERN DOWNSTREAM TOE

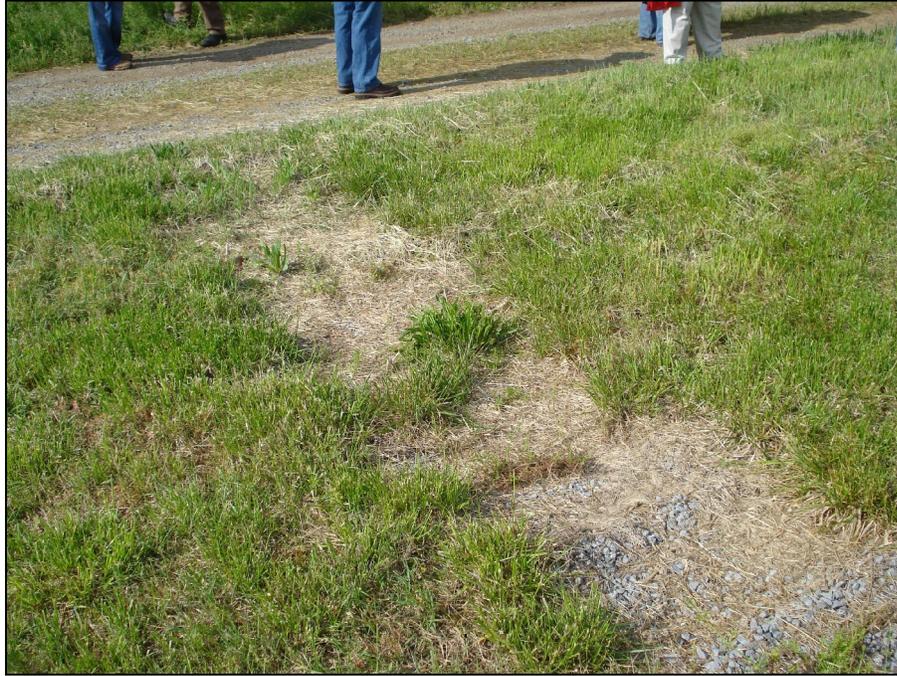
4-9

TRENCH AND FINGER DRAINS ALONG SOUTHERN DOWNSTREAM TOE

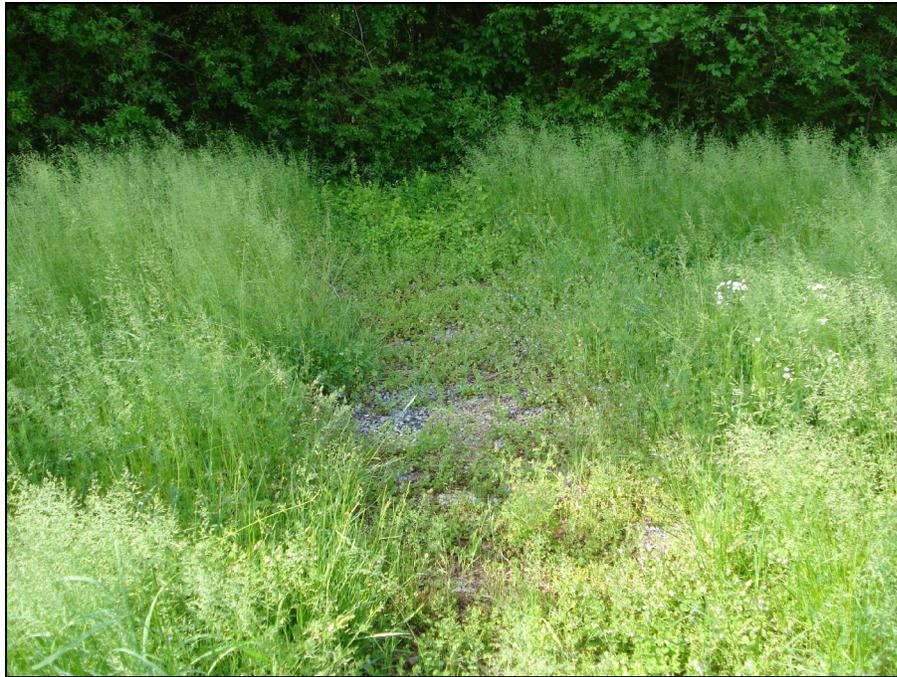
4-10

TRENCH AND FINGER DRAINS ALONG SOUTHERN DOWNSTREAM TOE

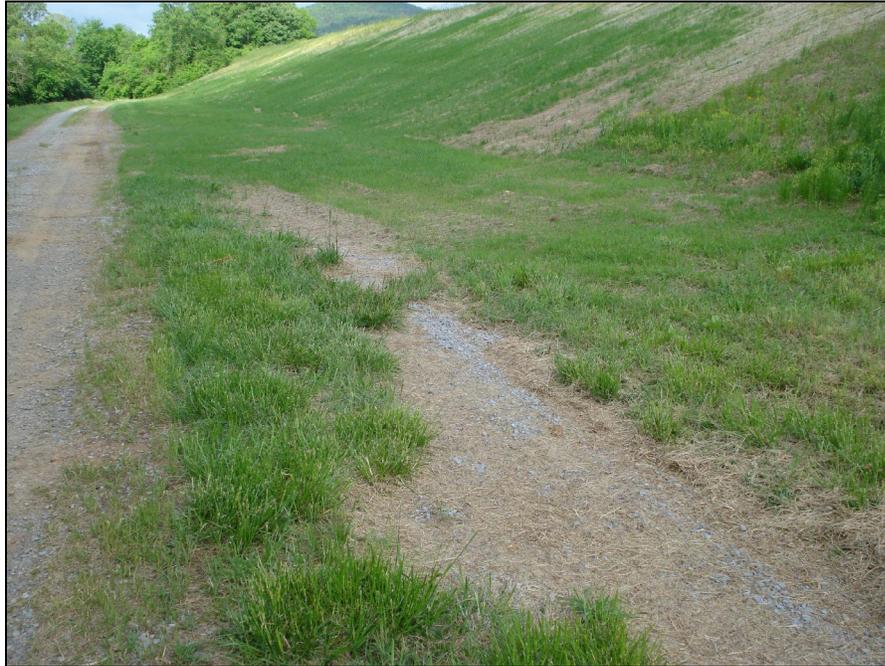
4-11

TRENCH AND FINGER DRAINS ALONG SOUTHERN DOWNSTREAM TOE

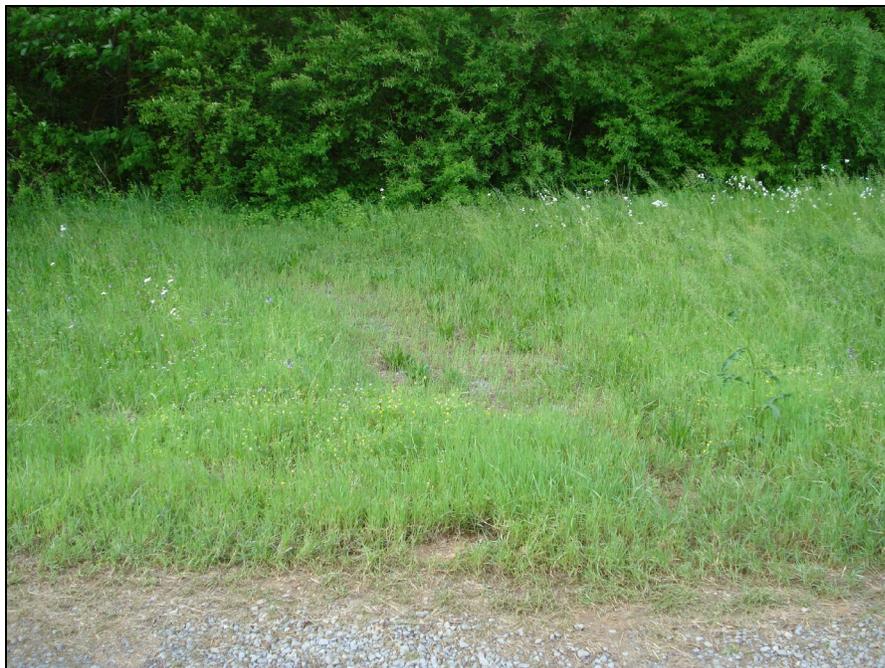
4-12

TRENCH AND FINGER DRAINS ALONG SOUTHERN DOWNSTREAM TOE

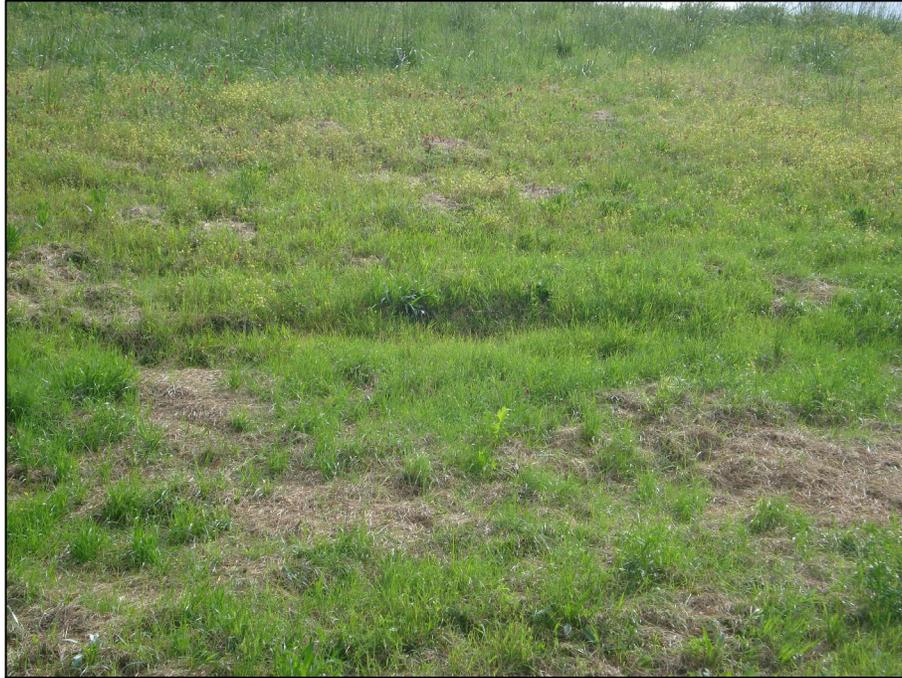
4-13

SLOUGHING ALONG SOUTHERN DOWNSTREAM SLOPE

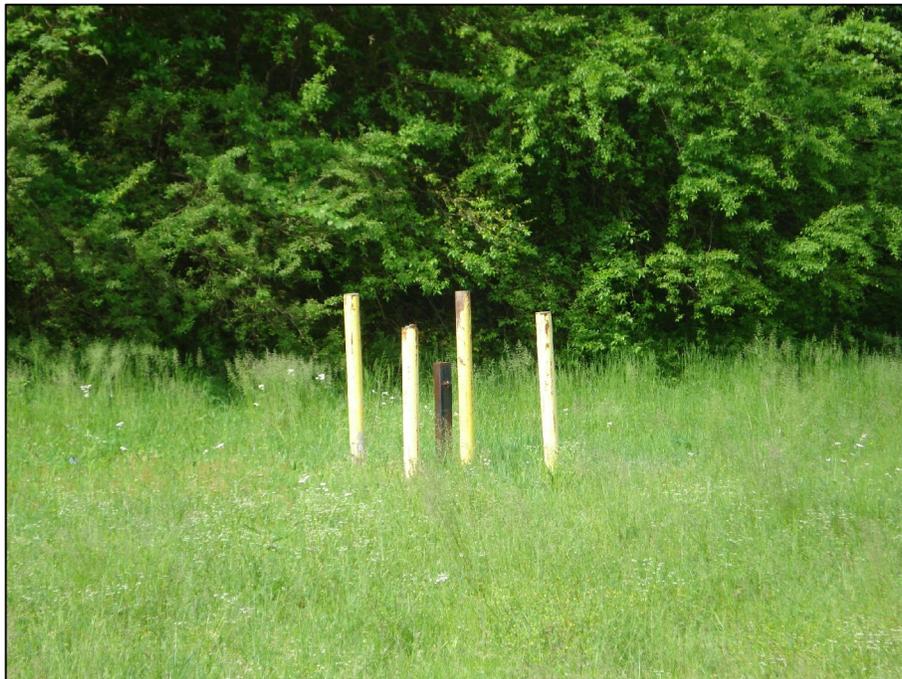
4-14

EXISTING MONITORING WELL

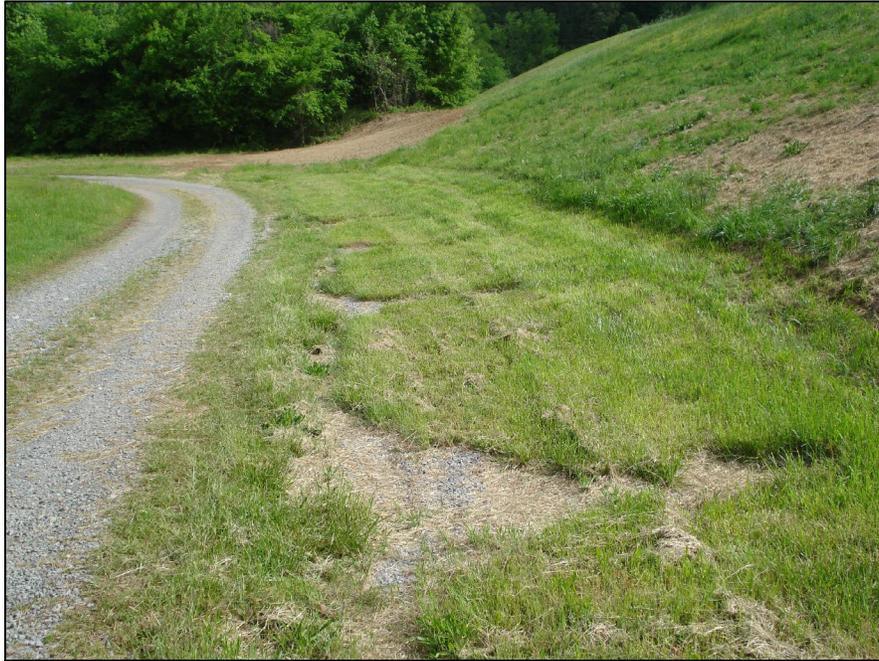
4-15

TRENCH AND FINGER DRAINS ALONG SOUTHERN DOWNSTREAM TOE

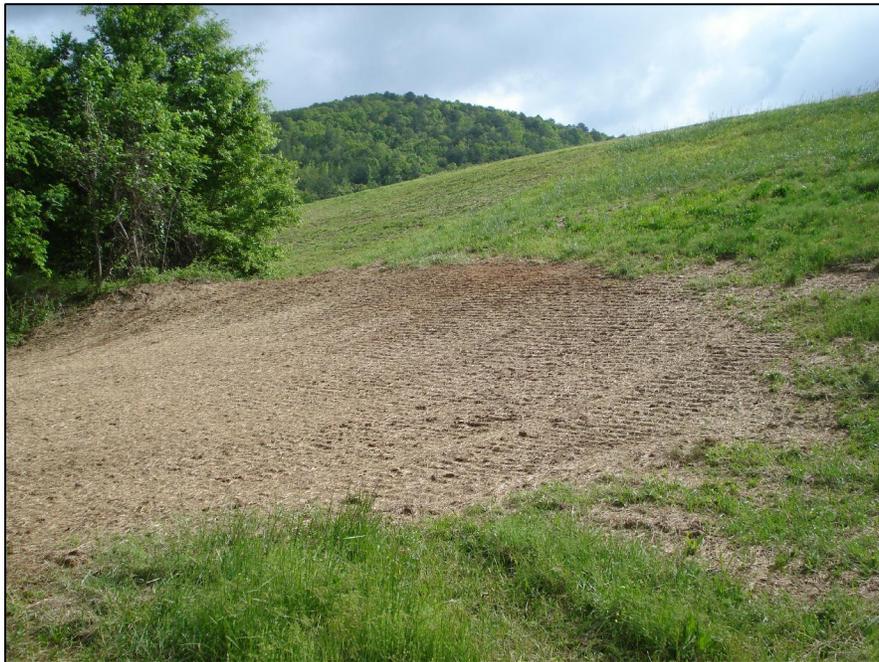
4-16

ABANDONED FIRING RANGE

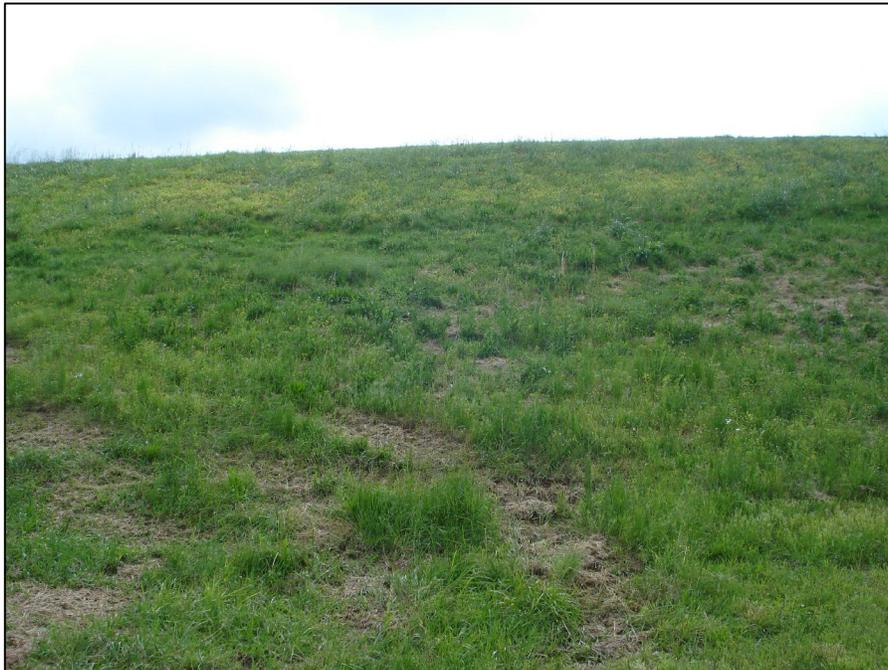
4-17
ABANDONED FIRING RANGE

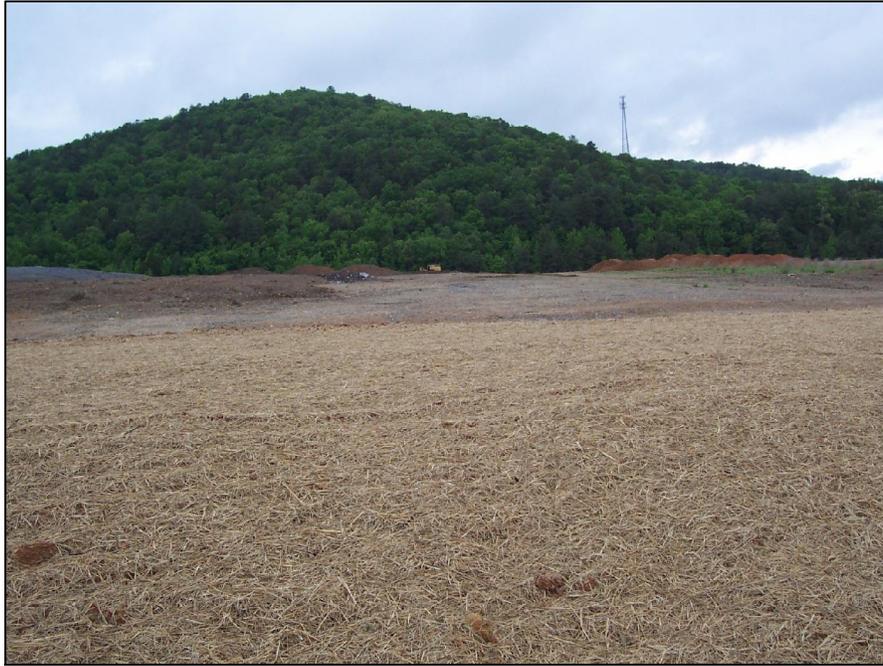
4-21

VIEW FROM TOP OF DRY-STACKED EMBANKMENT

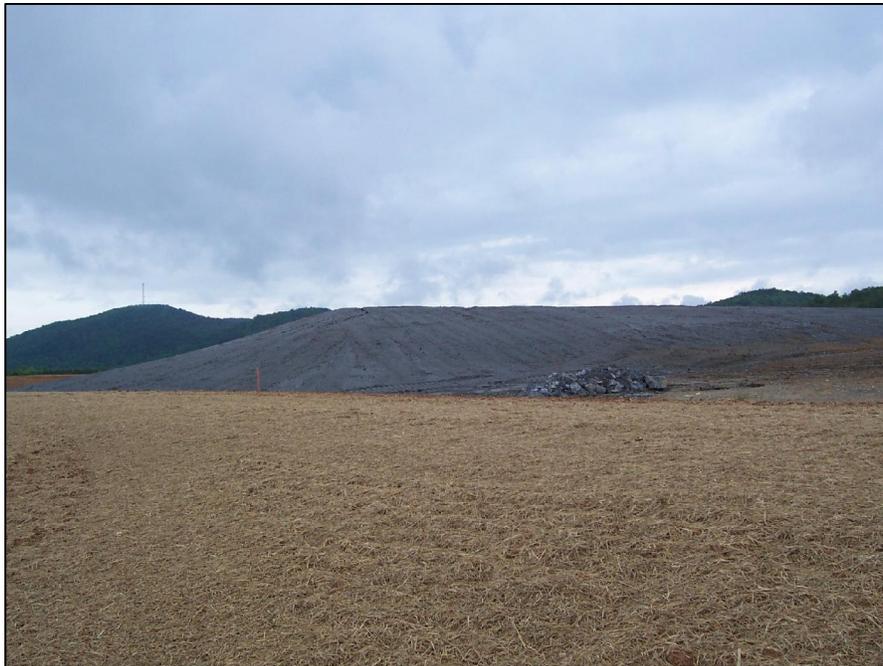
4-22

VIEW FROM TOP OF DRY-STACKED EMBANKMENT

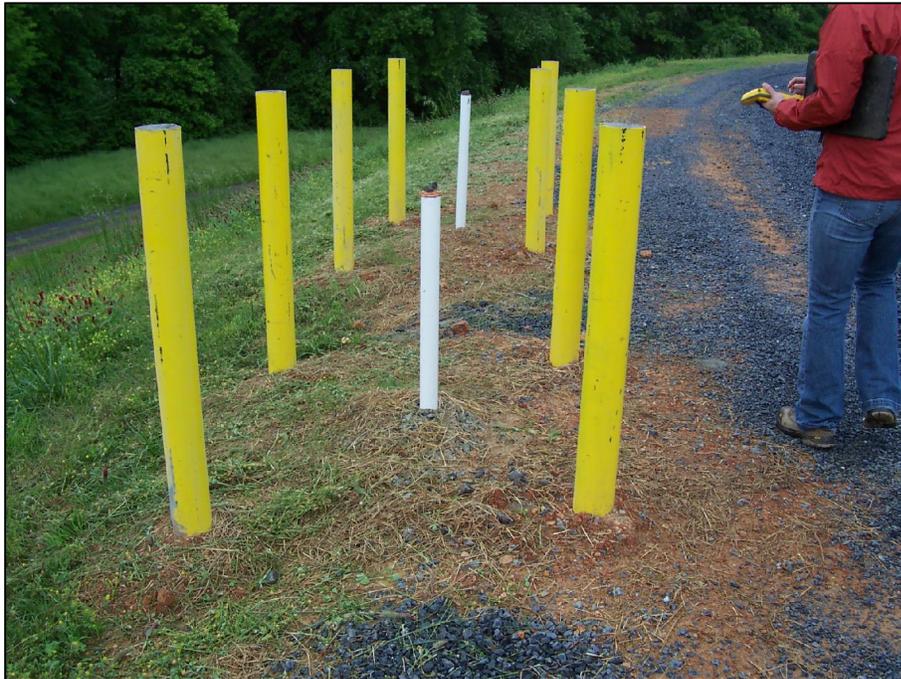
4-23

LOCATIONS OF PIEZOMETERS AP4-2 AND AP4-3 ALONG SOUTHERN DOWNSTREAM CREST

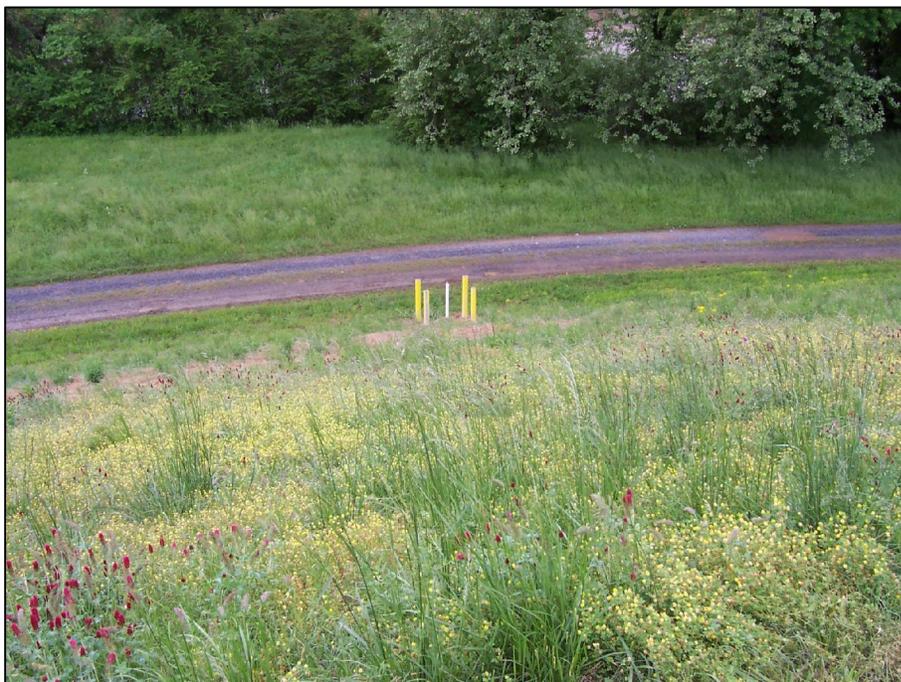
4-24

PIEZOMETER (AP4-1) LOCATED ALONG SOUTHERN DOWNSTREAM TOE

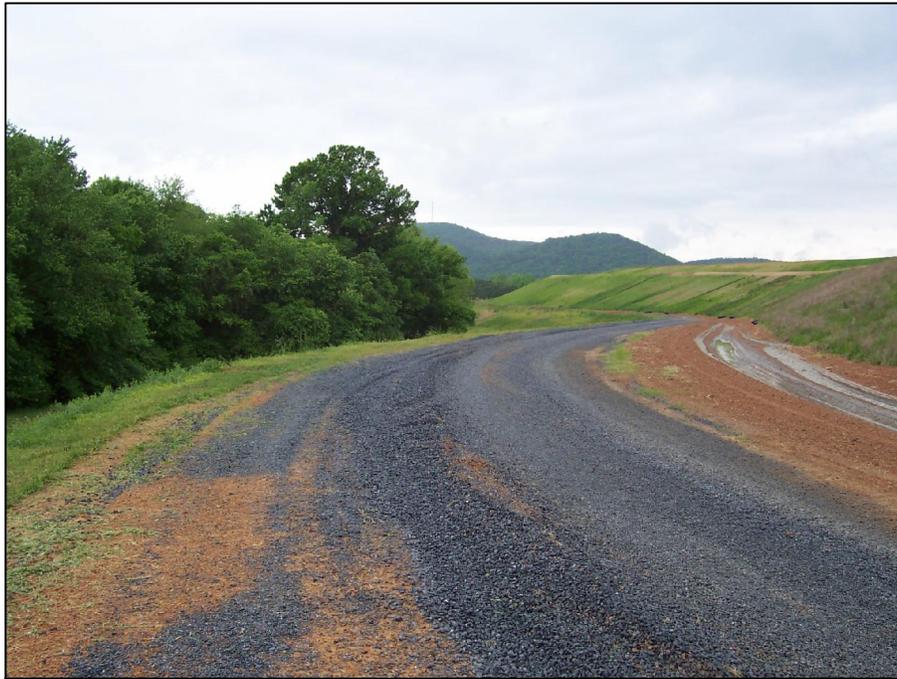
4-25

GENERAL SITE PHOTO ALONG SOUTHERN CREST LOOKING WEST

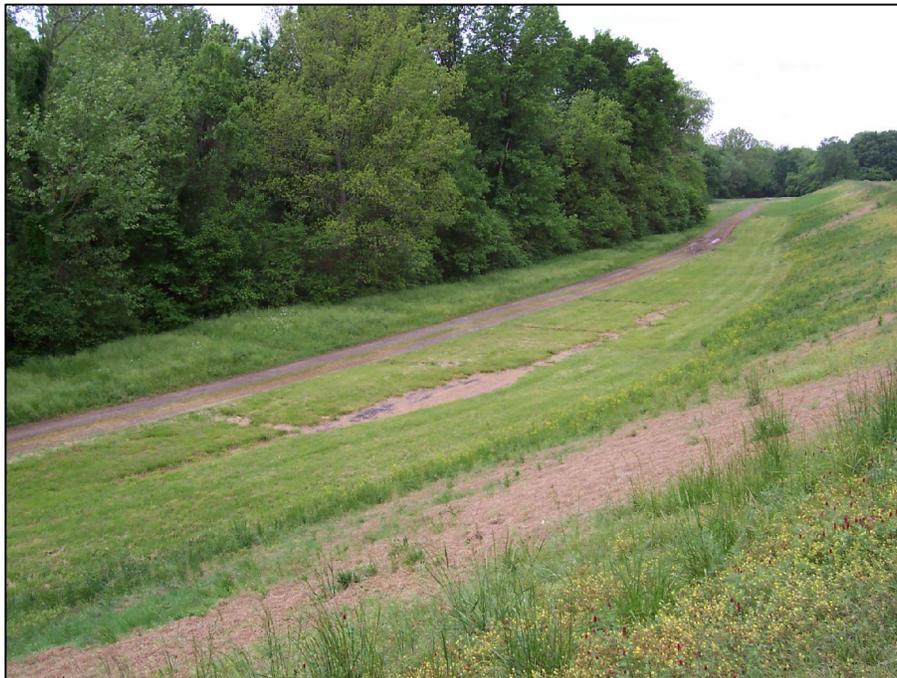
4-26

LACK OF VEGETATION ALONG SOUTHERN DOWNSTREAM SLOPE (NOTE TRENCH AND FINGER DRAINS AT TOE)

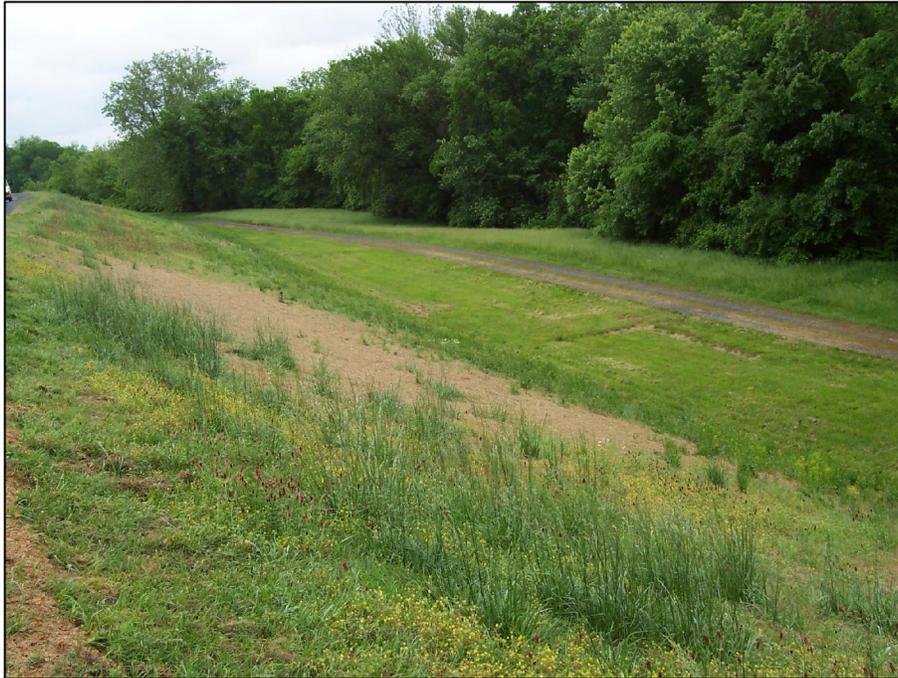
4-27

LACK OF VEGETATION ALONG SOUTHERN DOWNSTREAM SLOPE

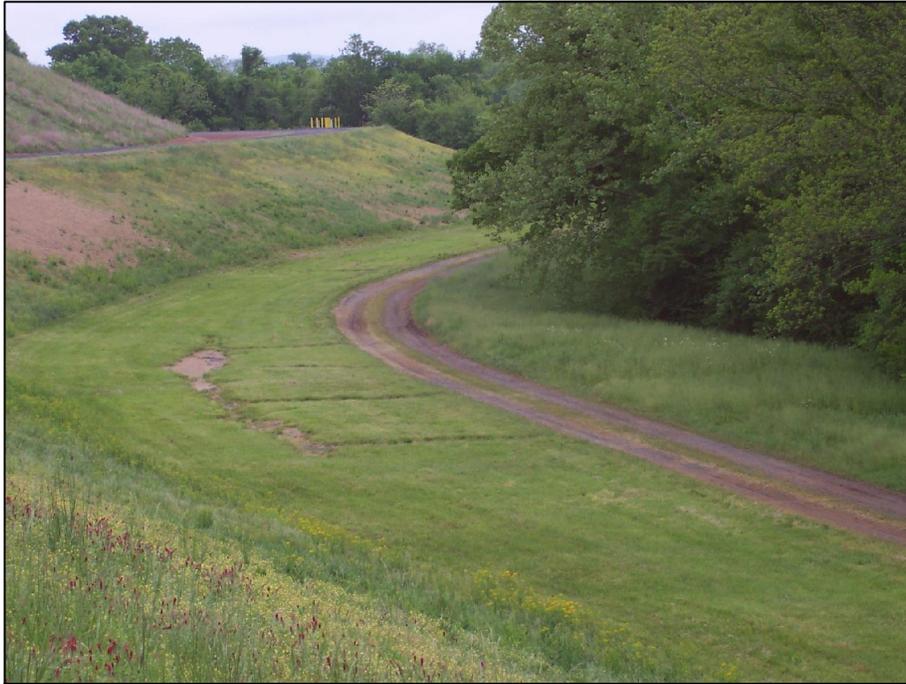
4-29

TRENCH AND FINGER DRAINS ALONG SOUTHERN DOWNSTREAM TOE

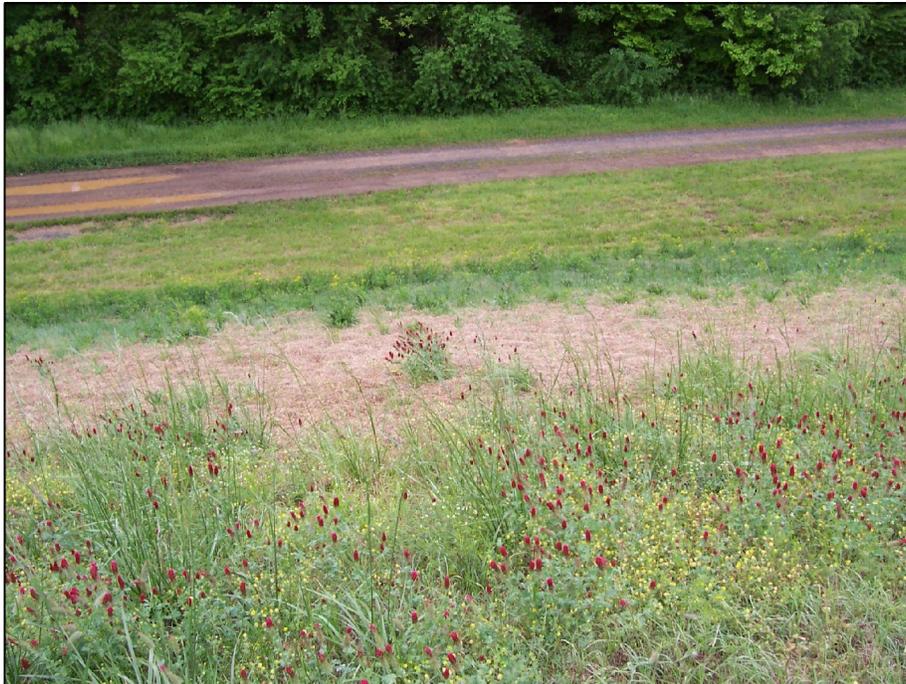
4-30

LACK OF VEGETATION ALONG SOUTHERN DOWNSTREAM SLOPE
