Report of Safety Assessment
Coal Combustion Surface Impoundments
Georgia Power
Plant Hammond, Rome, Georgia

AMEC Project No. 3-2106-0174.0500

December 2010

Southern Company, Georgia Power, Plant Hammond: Ash Pond 1, Ash Pond 2, Ash Pond 3, Ash Pond 4

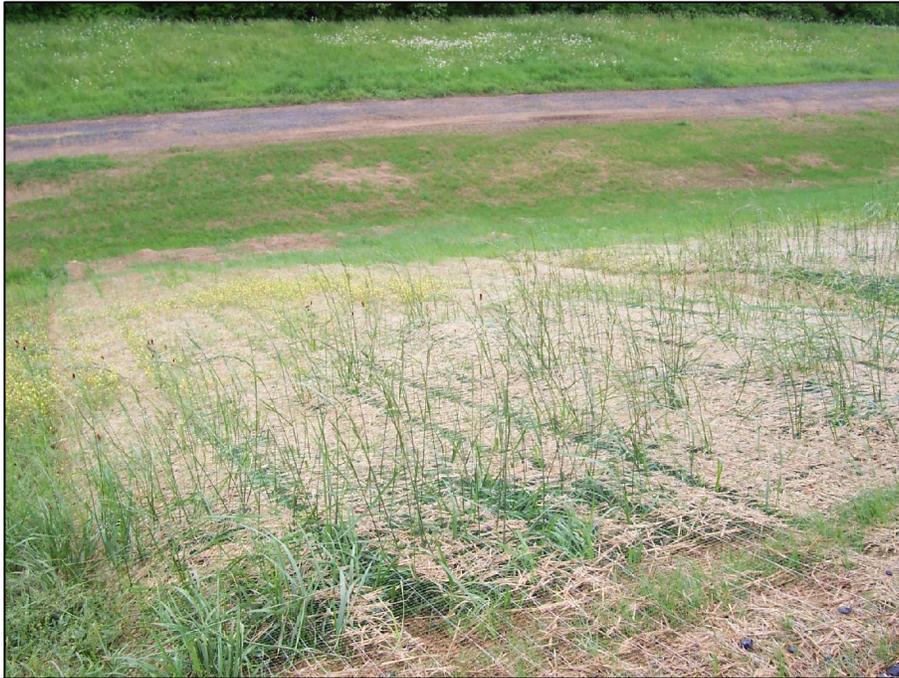
4-31

RESEEDED AREA ALONG SOUTHERN DOWNSTREAM SLOPE

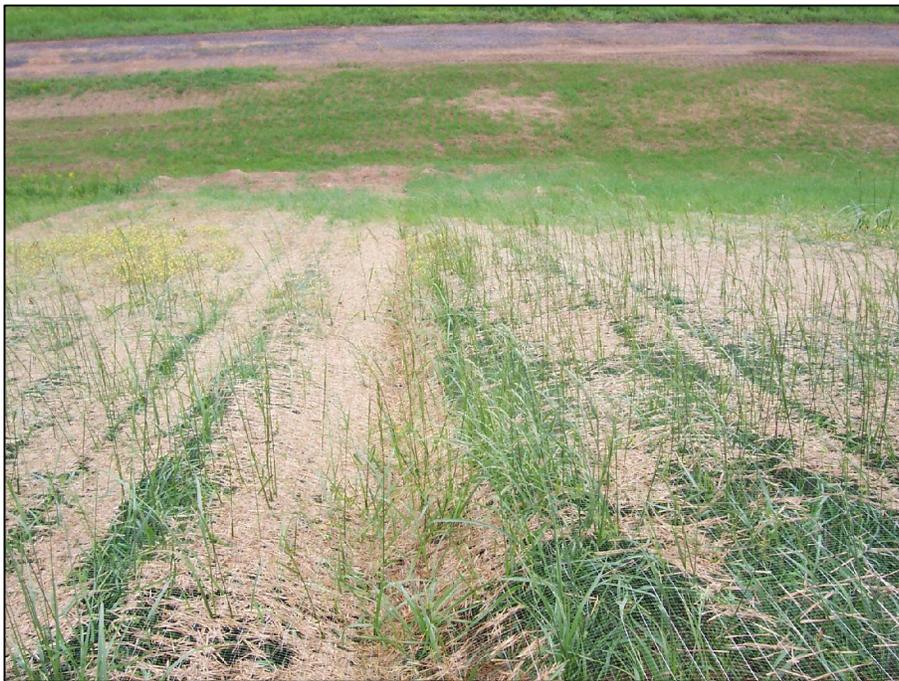
4-32

RESEEDED AREA ALONG SOUTHERN DOWNSTREAM SLOPE

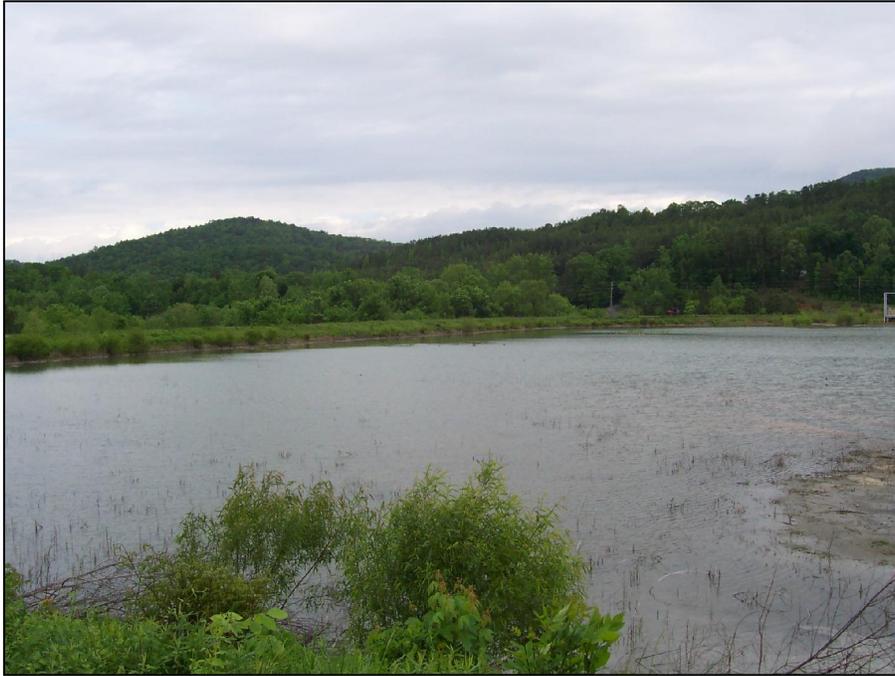
4-33

GENERAL SITE PHOTO ALONG SOUTHERN DIKE LOOKING NORTH

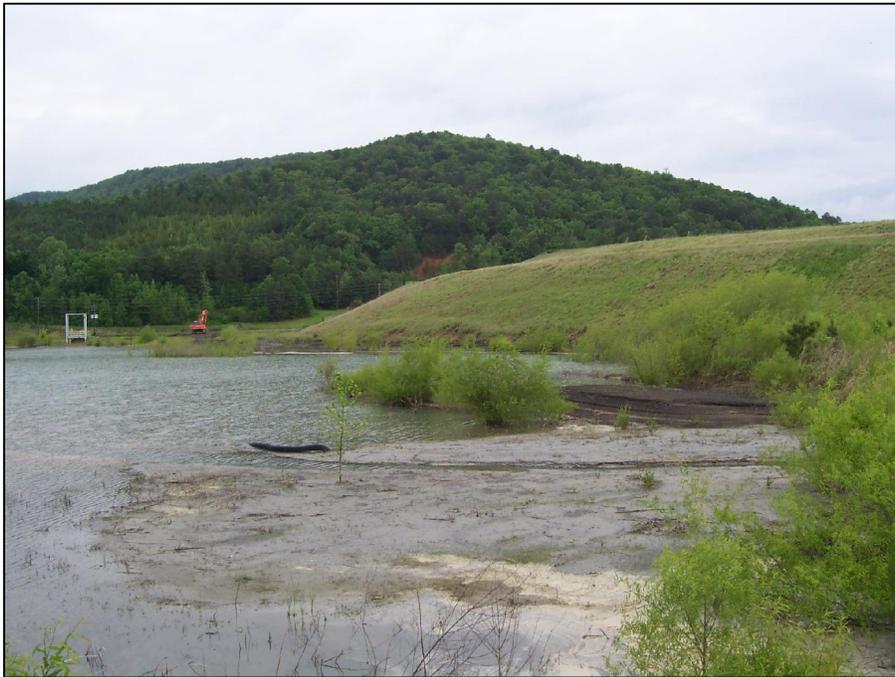
4-34

GENERAL SITE PHOTO ALONG SOUTHERN DIKE LOOKING NORTH

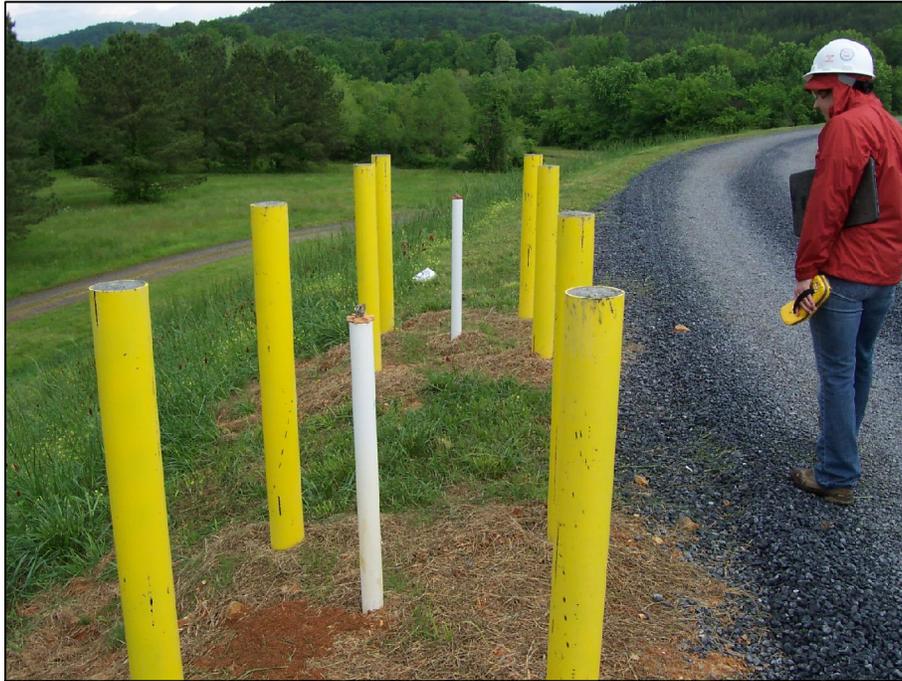
4-35

LOCATIONS OF PIEZOMETERS AP4-4 AND AP4-5 ALONG SOUTHERN DOWNSTREAM CREST

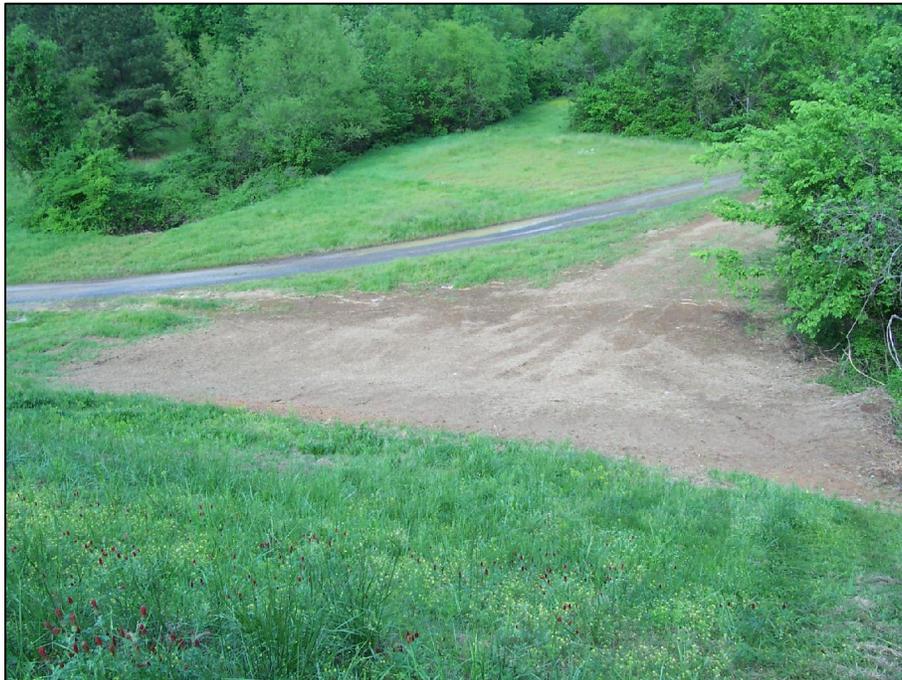
4-36

BARE SOIL AT BASE OF WESTERN DOWNSTREAM TOE

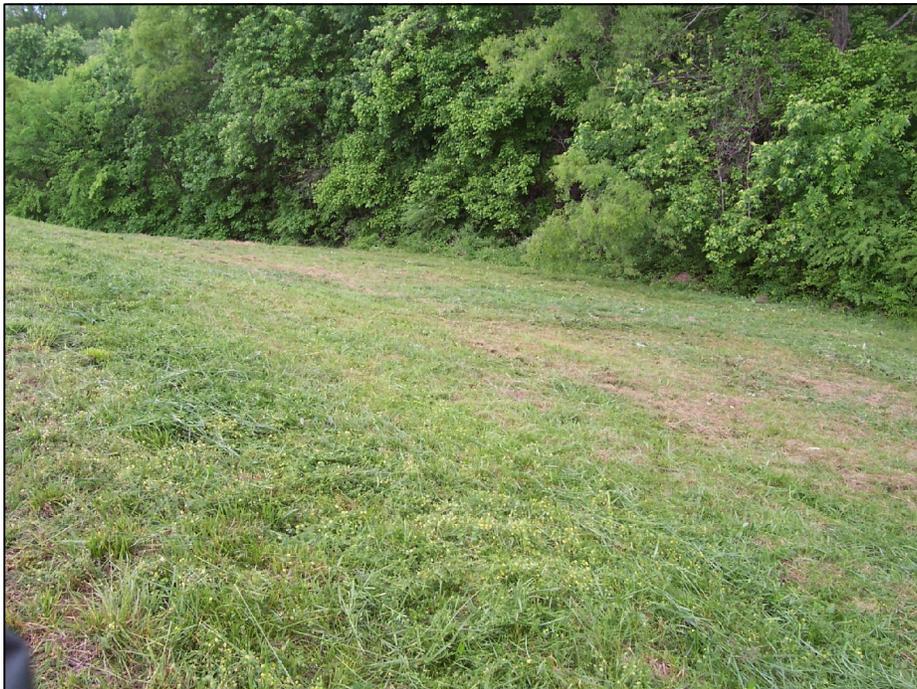
4-38

UNEVEN GROUND SURFACE AREA ALONG WESTERN DOWNSTREAM SLOPE

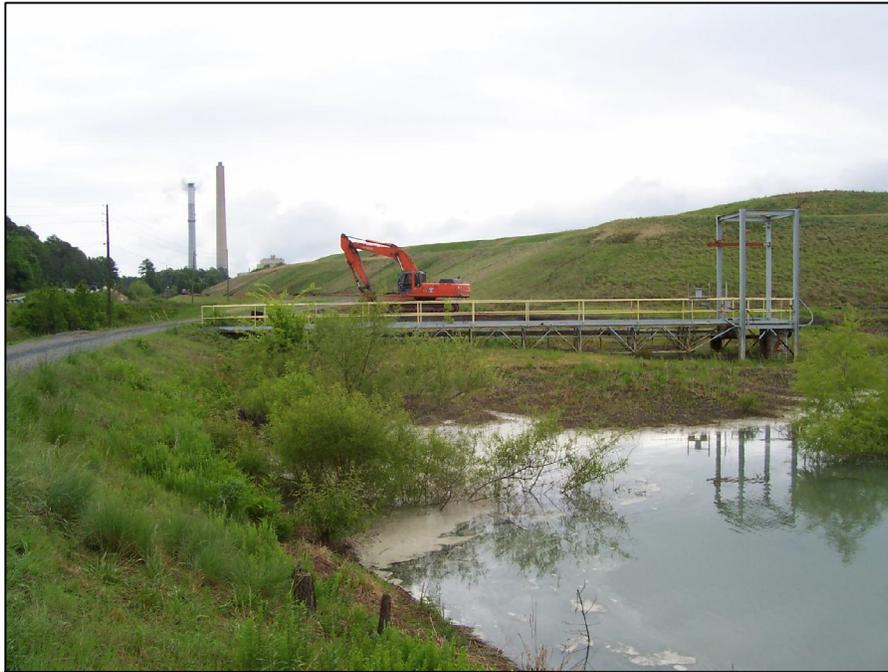
4-39

EMERGENCY OVERFLOW STRUCTURE

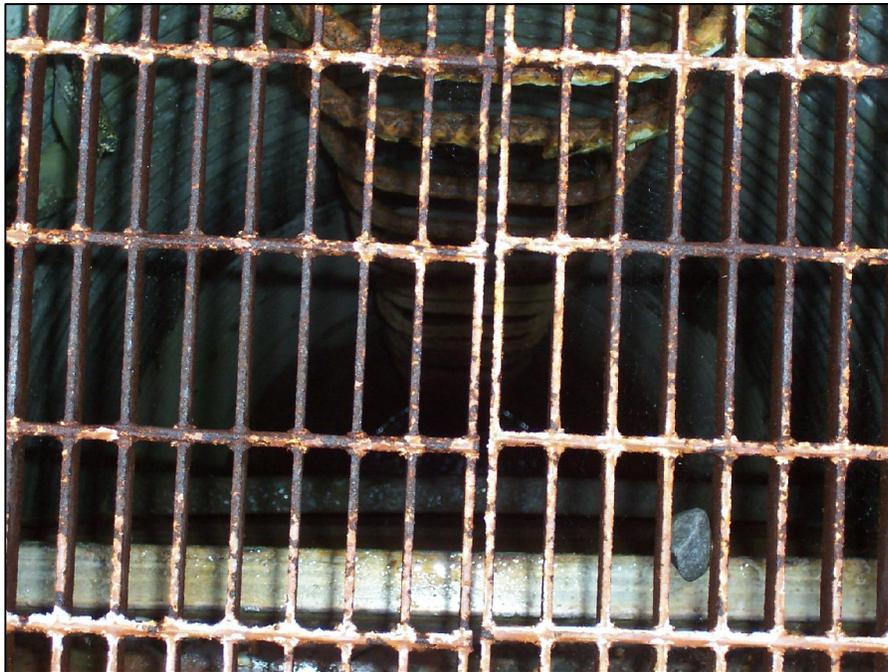
4-40

EMERGENCY OVERFLOW OUTLET

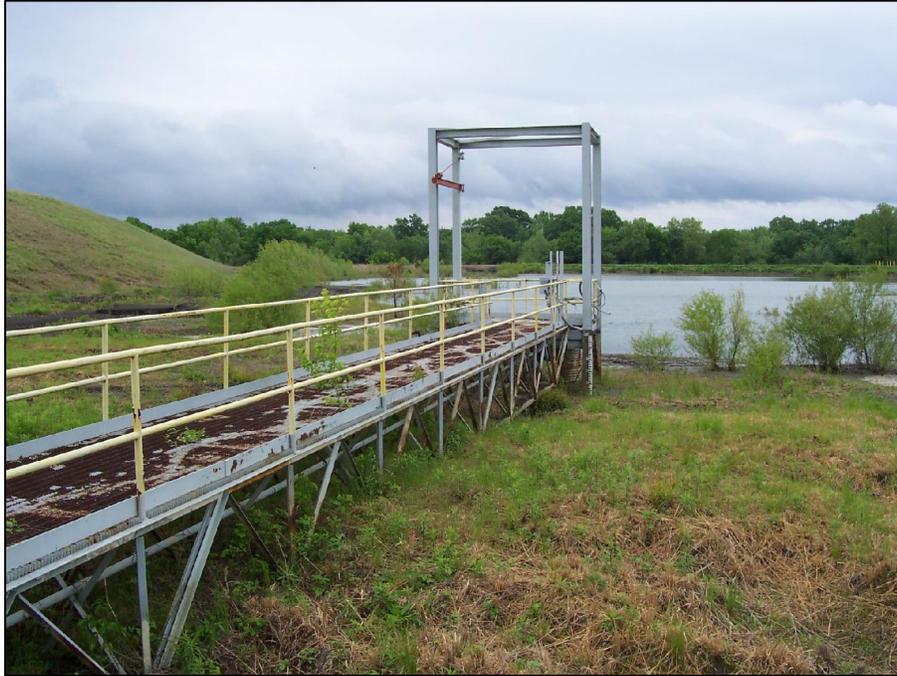
4-41

EMERGENCY OVERFLOW STRUCTURE

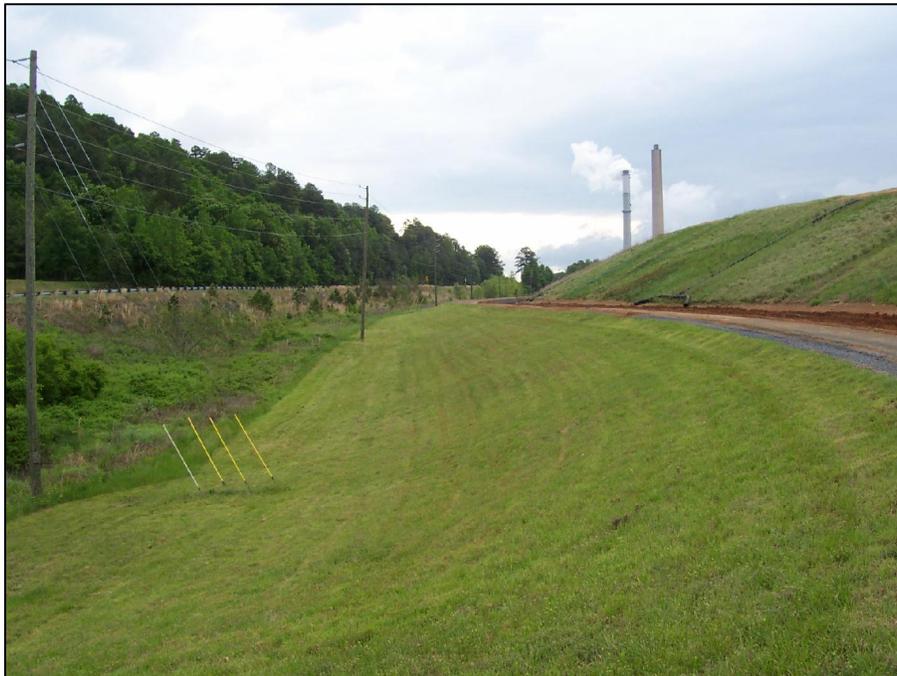
4-42

GENERAL SITE PHOTO ALONG NORTHERN FACE

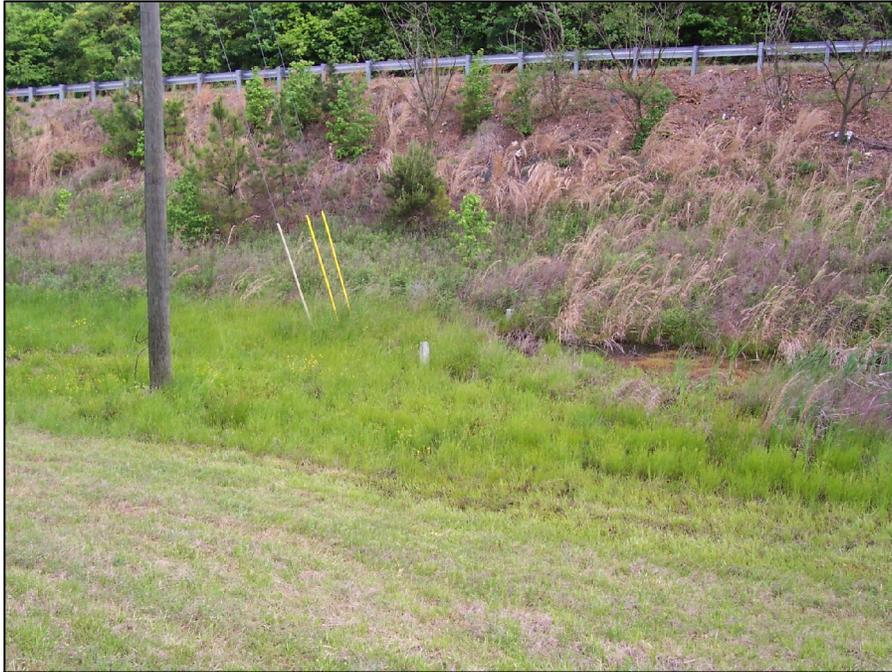
4-43

WET AREAS ALONG NORTHERN DOWNSTREAM TOE

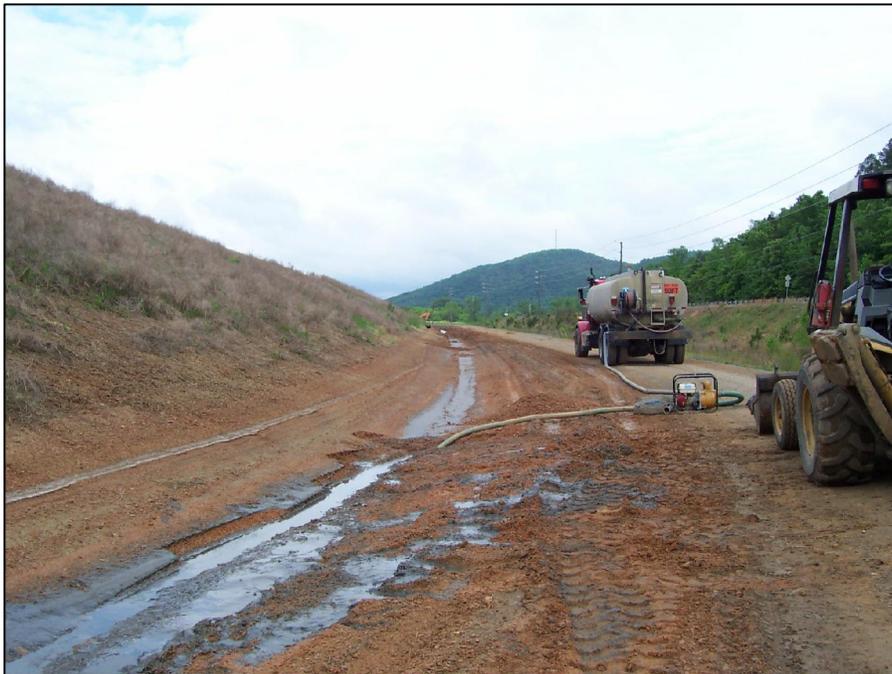
4-44

DEWATERING DRAINAGE DITCH ALONG UPSTREAM CREST
