Report of Geotechnical Investigation  
Dam Safety Assessment of Coal Combustion  
Surface Impoundments  
Georgia Power  
Plant Mitchell, Albany, GA

AMEC Project No. 3-2106-0174.0600

June 2010

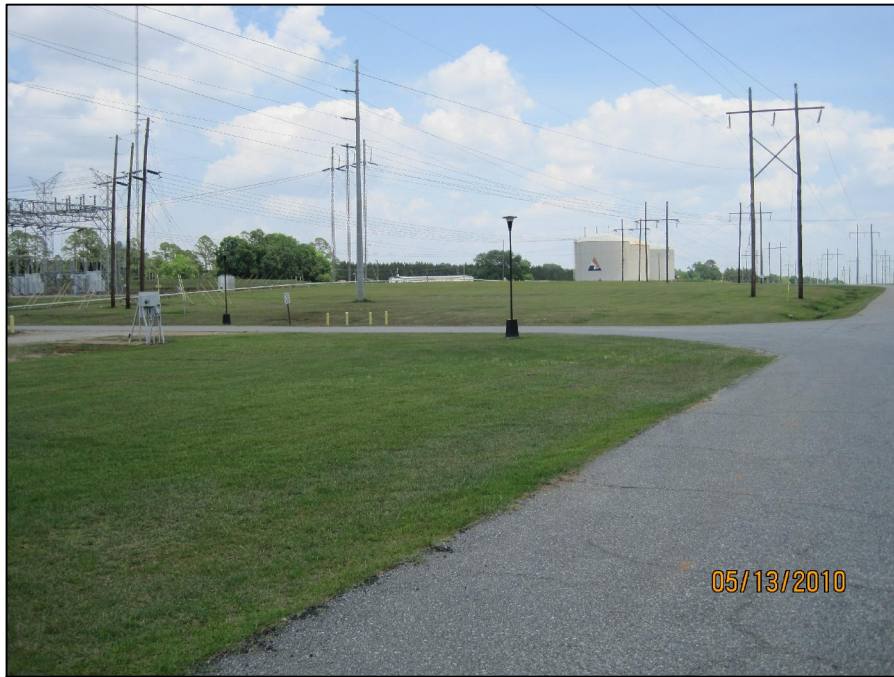
**A-1**

**FROM ROAD NORTH OF ASH POND 1, LOOKING NORTHEAST TOWARD POND A**

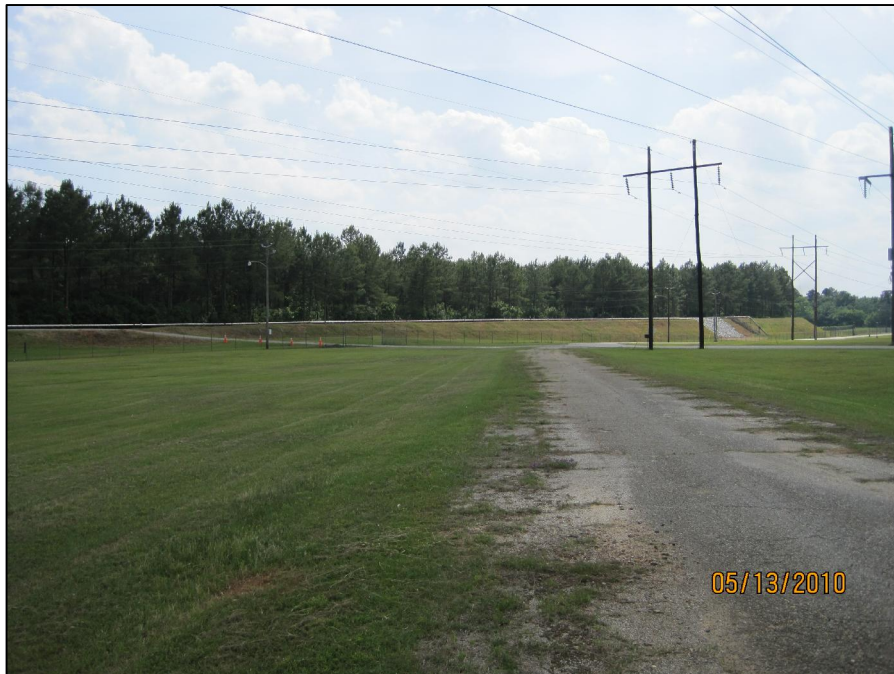
**A-2**

**LOOKING SOUTHWEST FROM APPROXIMATELY NORTH END OF ASH POND A TOWARD WEST END OF ASH POND 1**

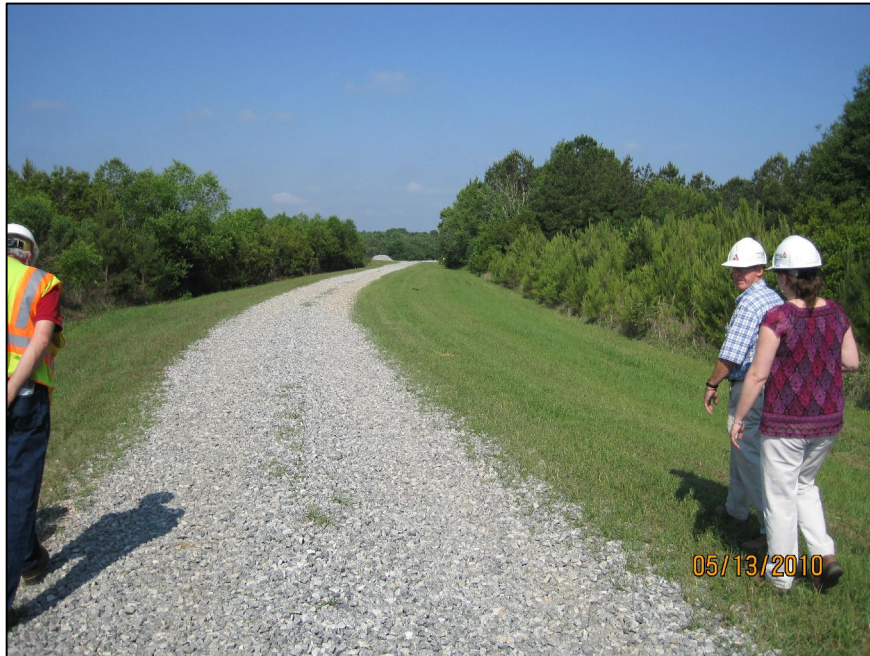
**1-1**

**AT EAST CORNER LOOKING WEST AT DIVIDING/Common EMBANKMENT FOR ASH PONDS 1 AND 2.**

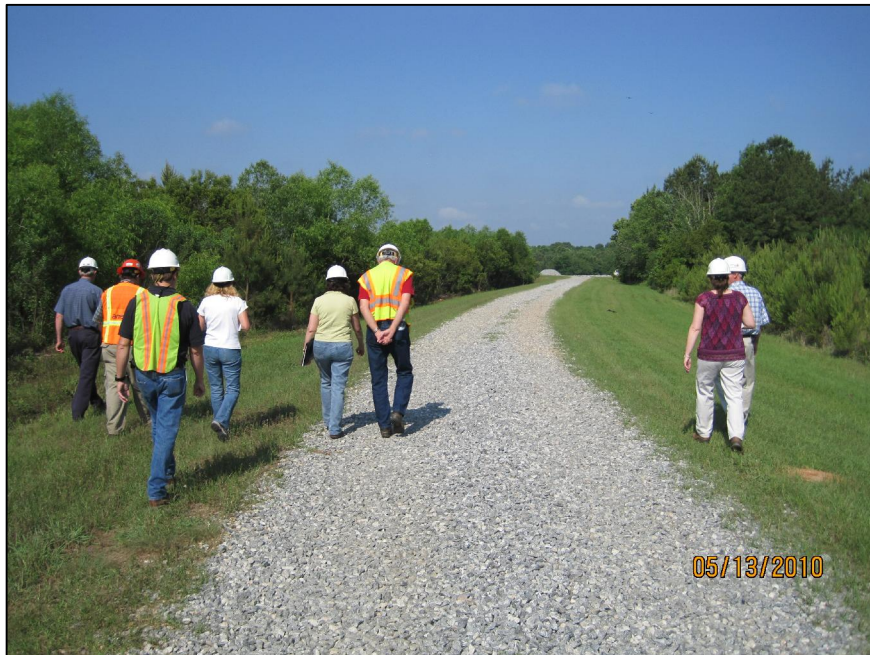
**1-2**

**AT EAST CORNER LOOKING WEST AT DIVIDING/Common EMBANKMENT FOR ASH PONDS 1 AND 2.**

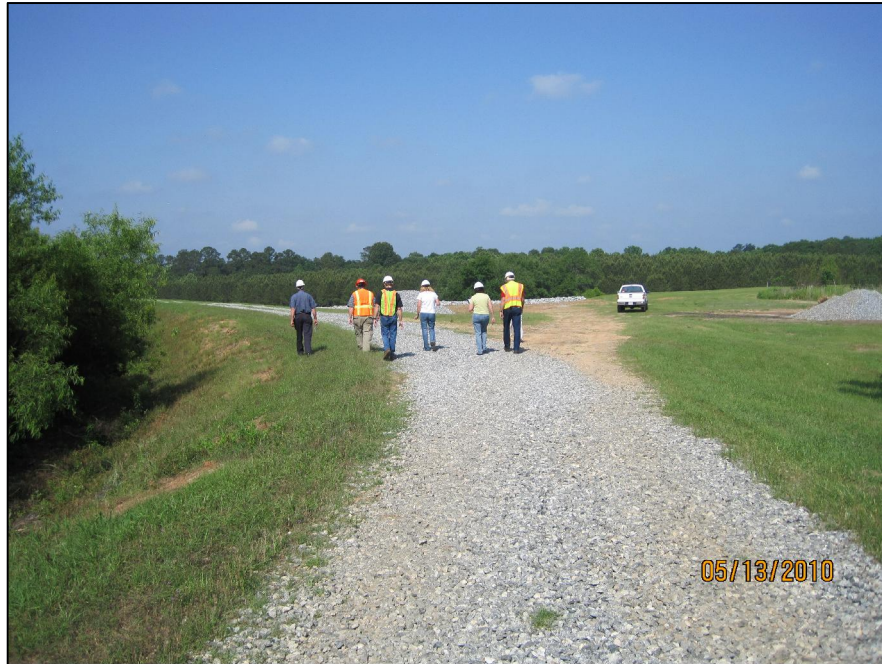
**1-3**

**NORTHWEST CORNER OF ASH POND 2 AND WEST END OF COMMON DIKE**

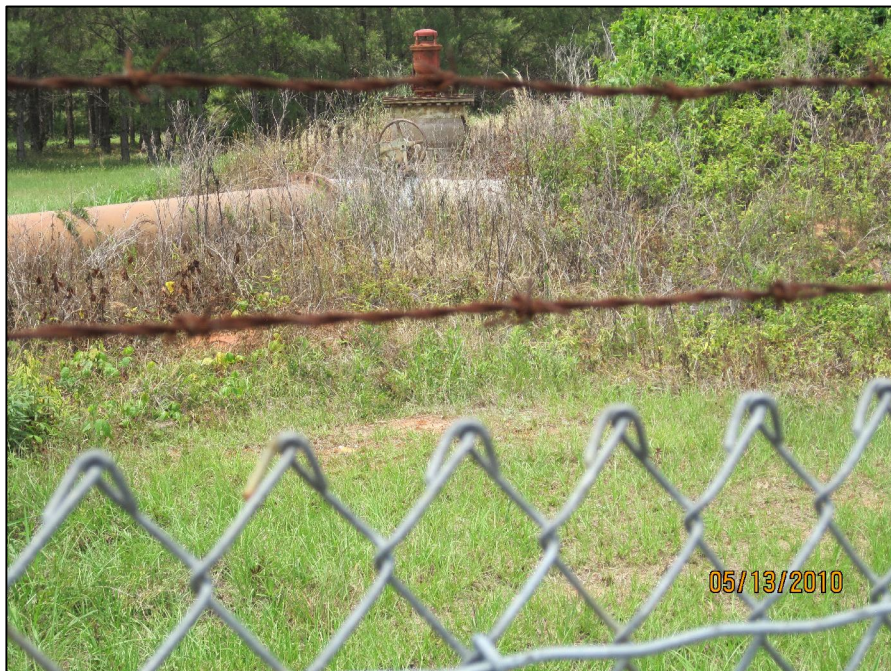
**1-6**

**TIE-IN OF RECYCLE LINES FROM ASH POND 1 AND 2**

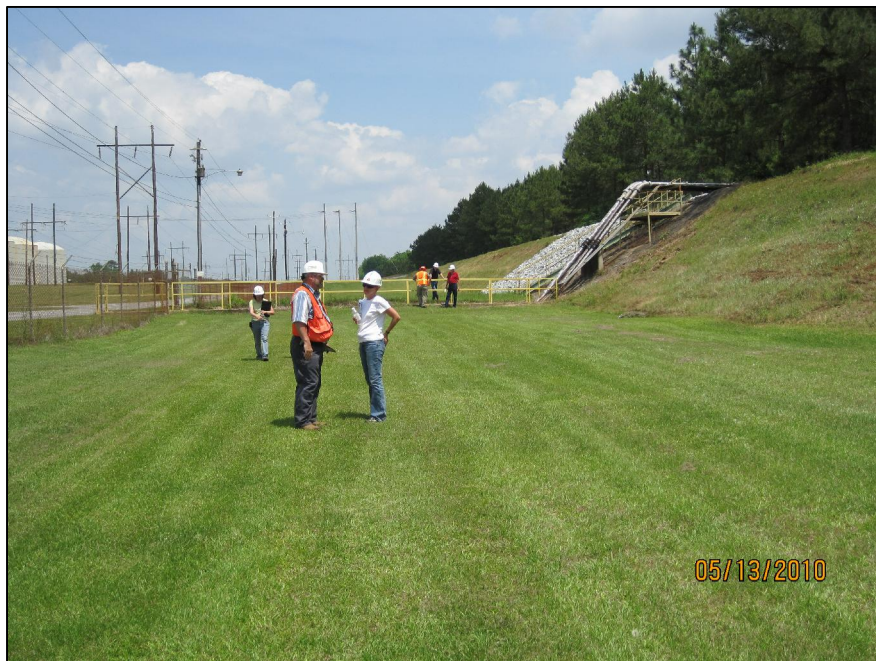
**1-13**

**NORTHWEST END OF ASH POND 1, LOOKING EAST AT ASH SLUICE DISCHARGE LINES FOR UNITS 1, 2 AND 3**

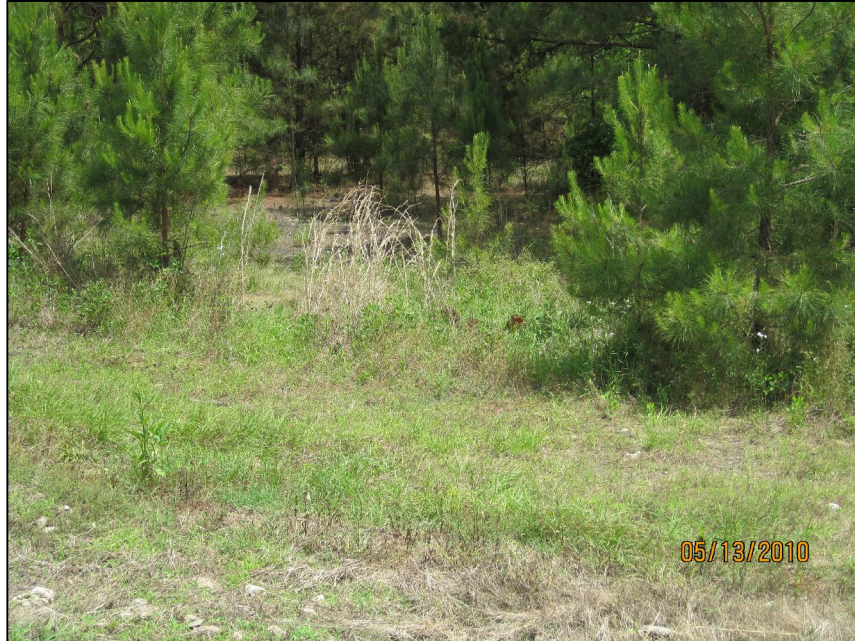
**1-15**

**NORTHWEST END OF ASH POND 1, LOOKING SOUTH AT INTERIOR, SMALL PINETREES**

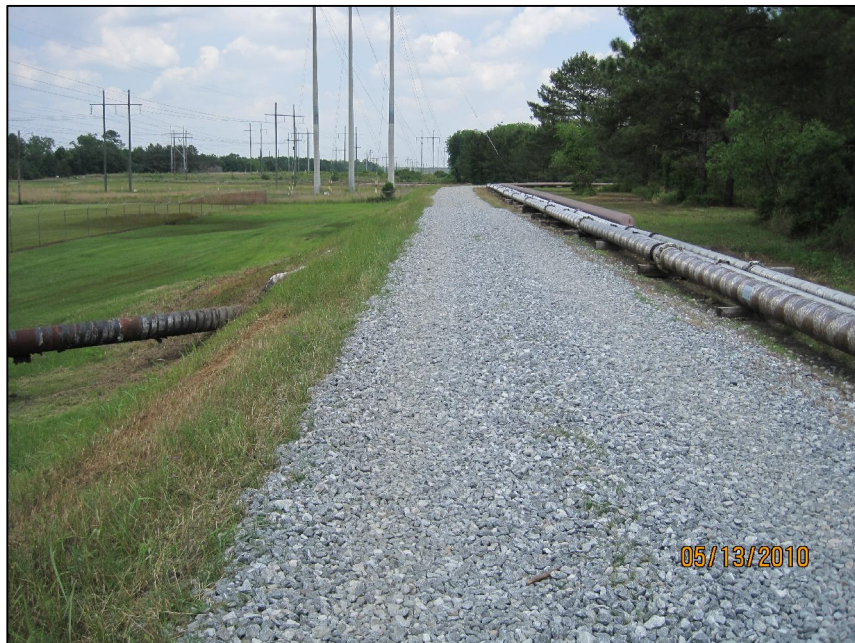
**1-16**

**NORTHEAST END OF ASH POND 1, LOOKING EAST ALONG CREST, PIPE THROUGH EMBANKMENT IS OLD LOW VOLUME SUMP**

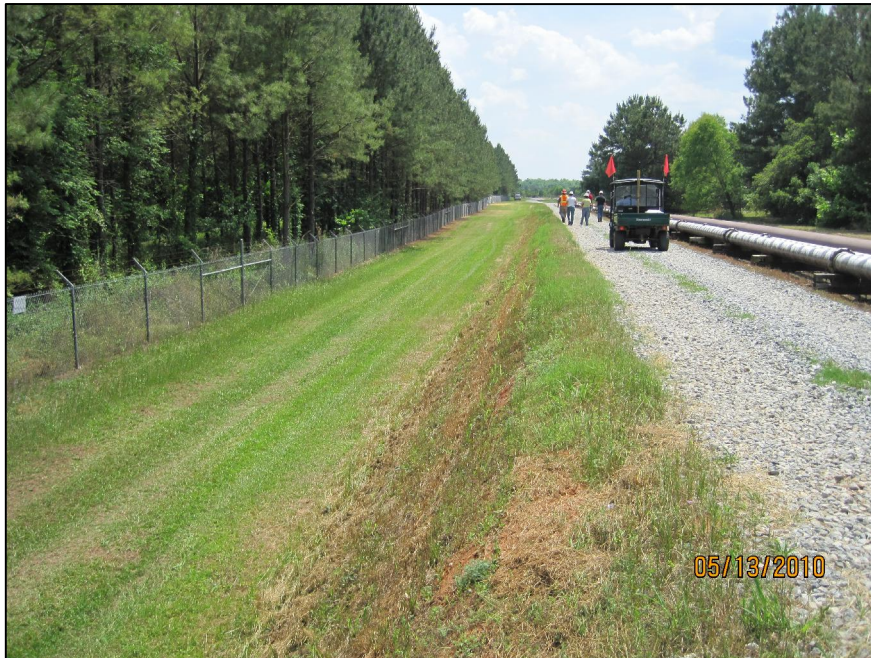
**1-17**

**EAST SIDE OF ASH POND 1, LOOKING SOUTH AT CREST AND DOWNSTREAM SLOPE**

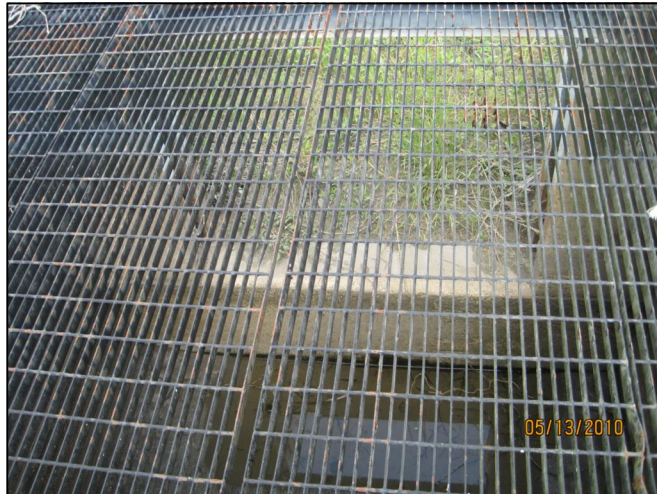
**1-20**

The plant water recycle/primary pond discharge structure inlet is located adjacent to the crest at the south end of the west dike (photos 1-20, 1-21, and 1-22). The structure is a concrete box with a side weir inlet. A 30-inch fiberglass outlet pipe is located at the bottom western wall of the concrete box structure and has an invert elevation of 183 feet. The recycle pipe exits an embankment that is located at the southwest corner of Ash Pond 1 and then ties into the

**SOUTHWEST CORNER OF ASH POND 1, CLOSE UP OF PHOTO 1-20, RECYCLE STRUCTURE INLE**

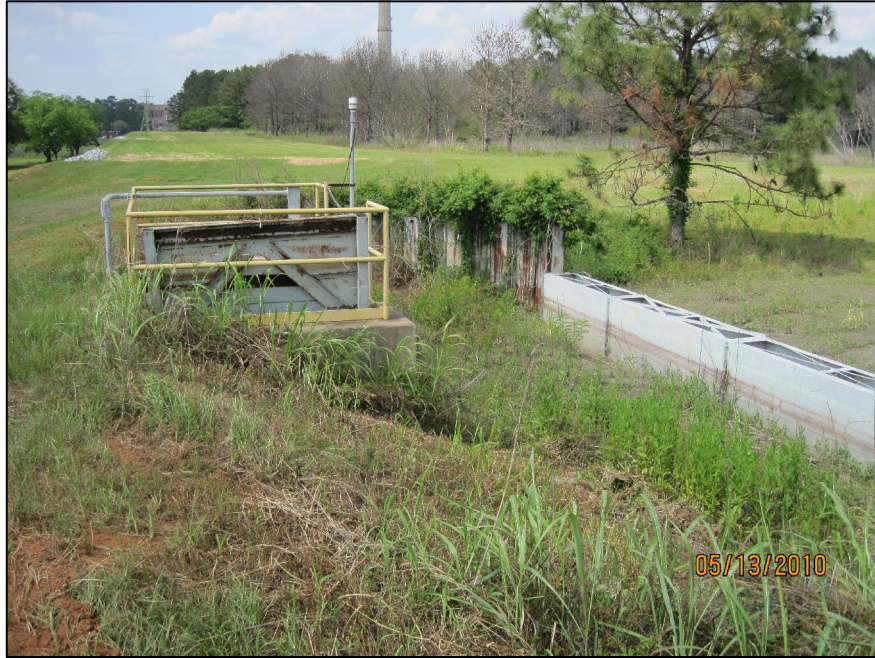
**1-21**

**SOUTHWEST CORNER OF ASH POND 1, LOOKING NORTH AT RECYCLE STRUCTURE INLET AND WEST SIDE CREST**

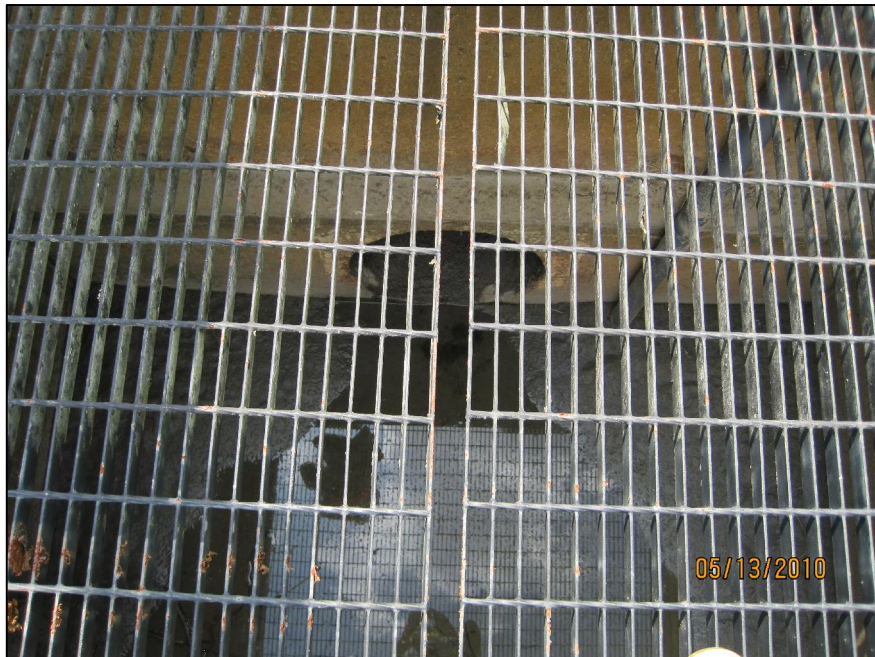
**1-22**

**SOUTHWEST CORNER OF ASH POND 1, CLOSE UP OF PHOTO 1-20, RECYCLE STRUCTURE INLET PIPE**

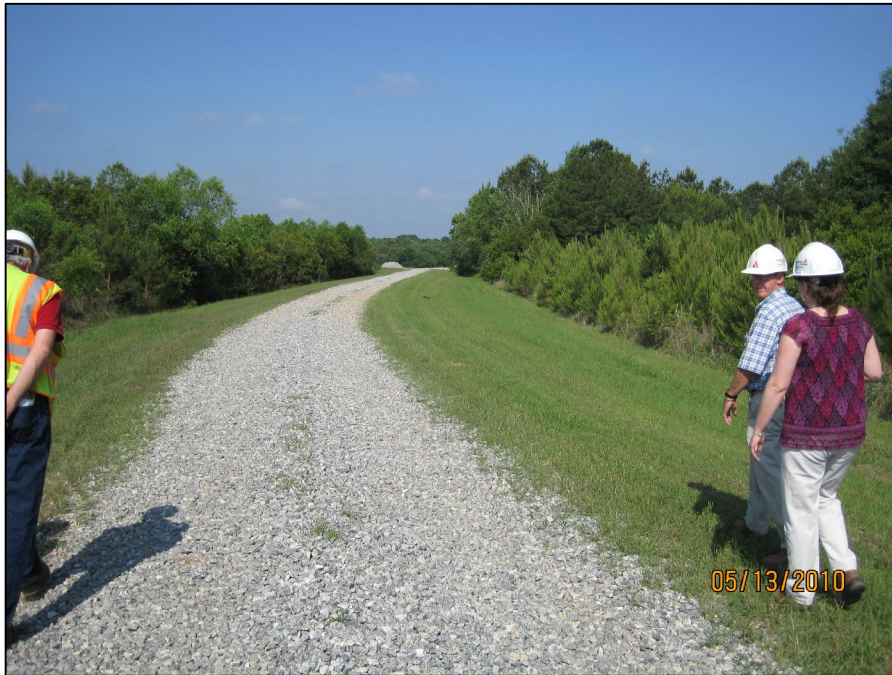
**2-1**

**AT EAST CORNER LOOKING WEST AT DIVIDING/Common EMBANKMENT FOR ASH PONDS 1 AND 2.**

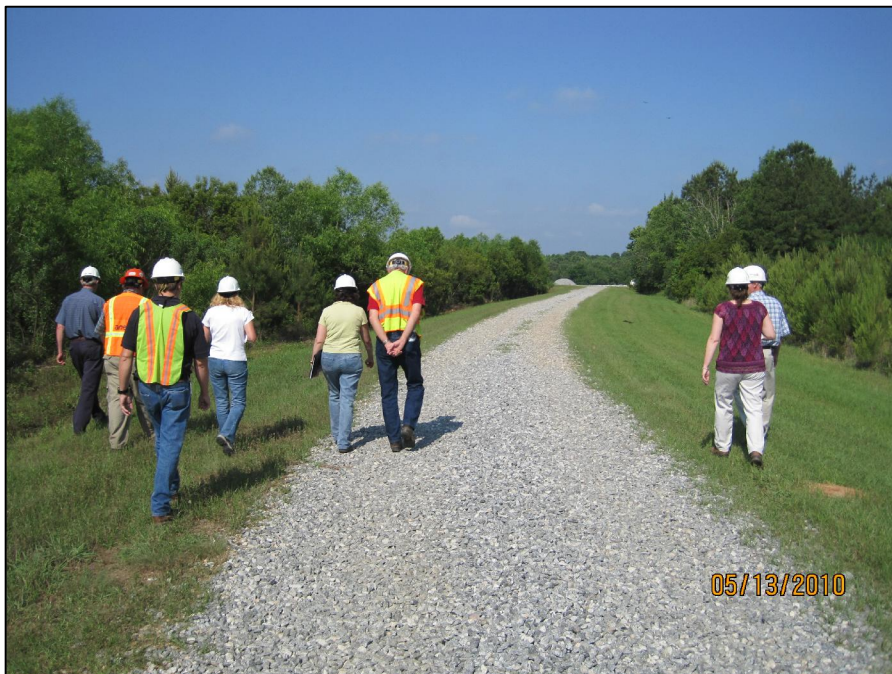
**2-2**

**AT EAST CORNER LOOKING WEST AT DIVIDING/Common EMBANKMENT FOR ASH PONDS 1 AND 2.**

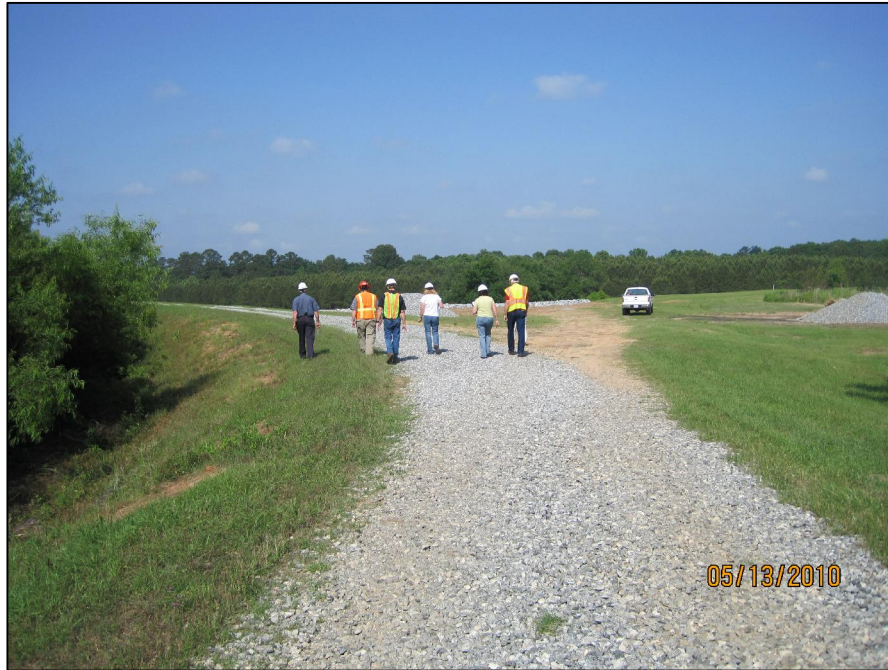
**2-3**

**NORTHWEST CORNER OF ASH POND 2 AND WEST END OF COMMON DIKE**

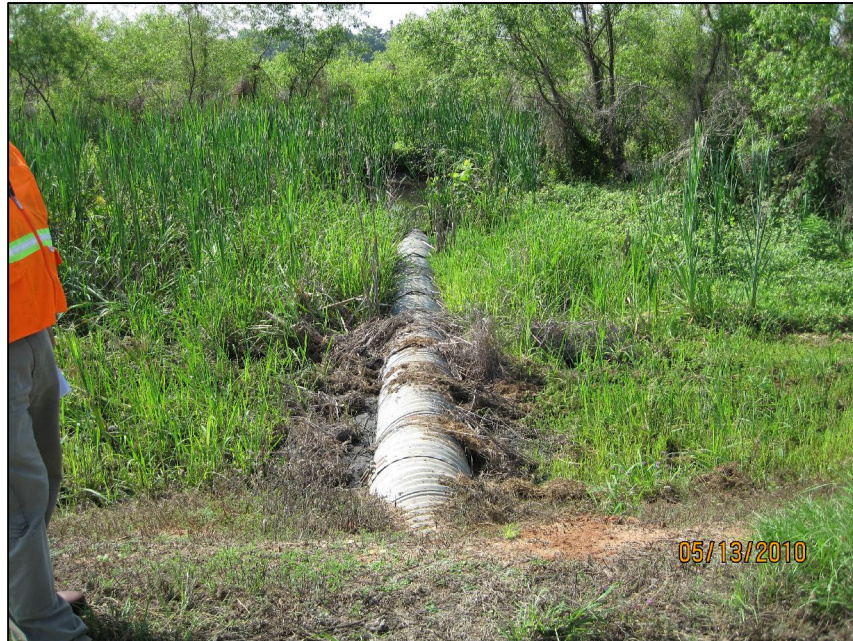
**2-5**

**LOW VOLUME SUMP INLET TO ASH POND #2 (+/- STATION 2+50)**

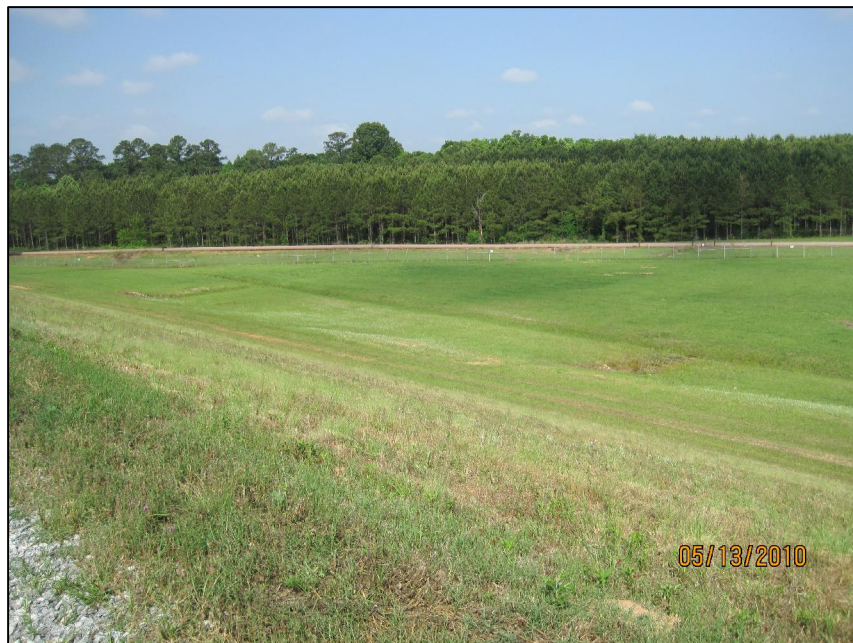
**2-6**

**NORTHWEST SIDE, DOWNSTREAM SLOPE OF ASH POND 2, DRAIN #2 AND #3,  
PIPE IN BACKGROUND IS ASH RECYCLE TO PLANT**

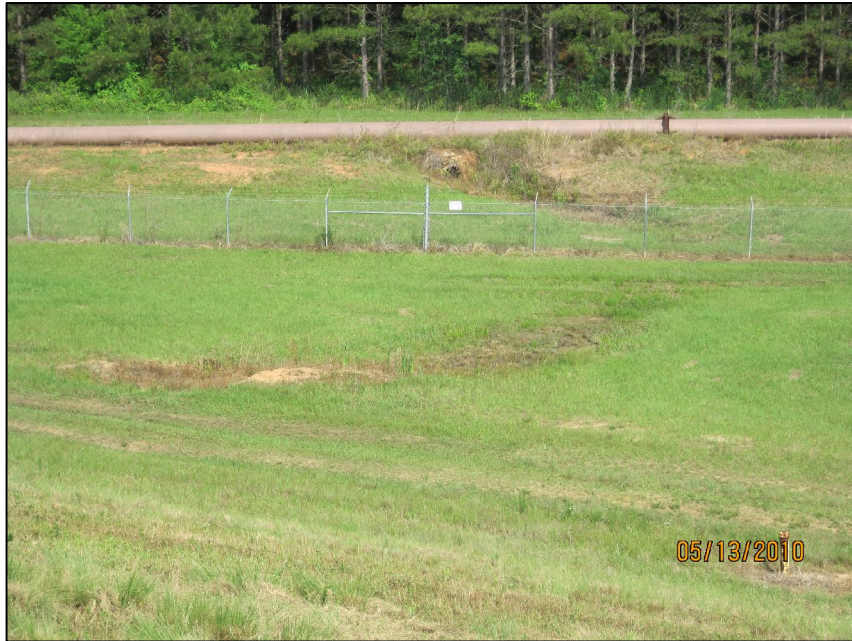
**2-7**

**FROM PZ-10B, UPSTREAM INLET OF SURFACE DRAIN CULVERT OFF SOUTHWEST SIDE OF ASH POND 2**

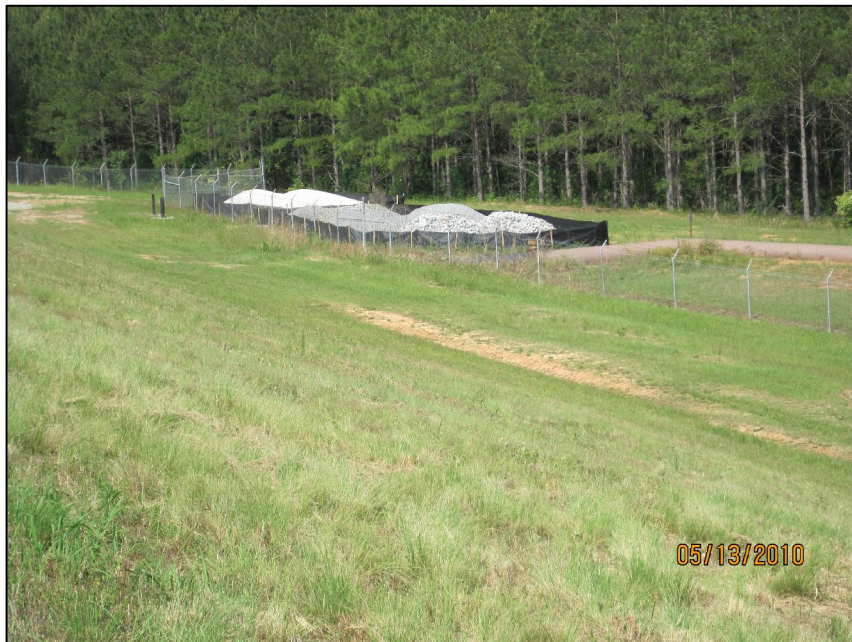
**2-8**

**FROM PZ-10B, EMERGENCY MATERIALS OFF SOUTHWEST SIDE OF ASH POND 2**

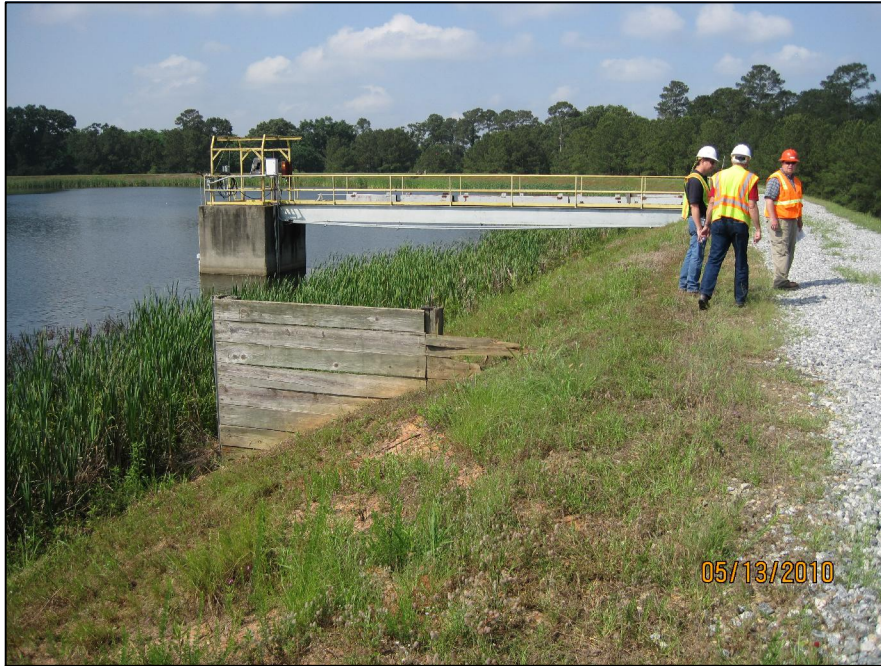
**2-9**

**NEAR SOUTHWEST END OF ASH POND 2, UPSTREAM SLOPE AND RECYCLE INTAKE**

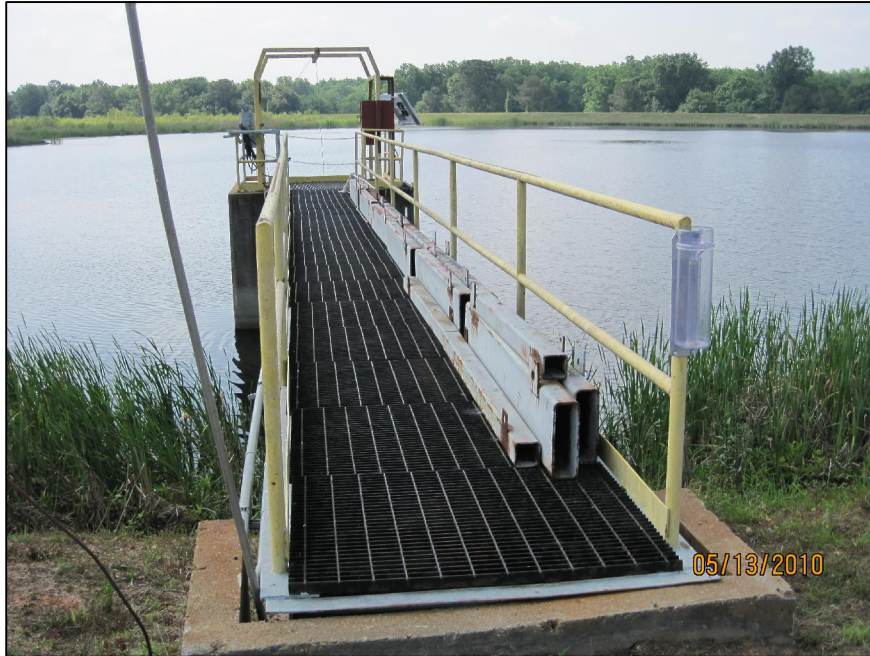
**2-11**

**RECYCLE INTAKE STRUCTURE, STOP LOGS ON CATWALK AND INTERIOR OF ASH POND 2**

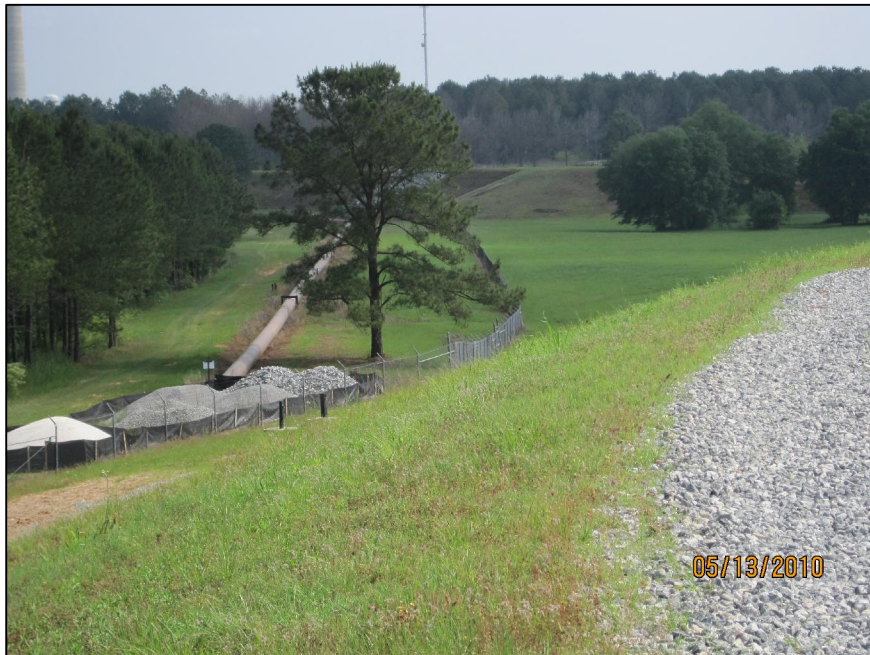
**2-12**

**NEAR SOUTHWEST END OF ASH POND 2, LOOKING NORTH AT RECYCLE LINE TO PLANT**

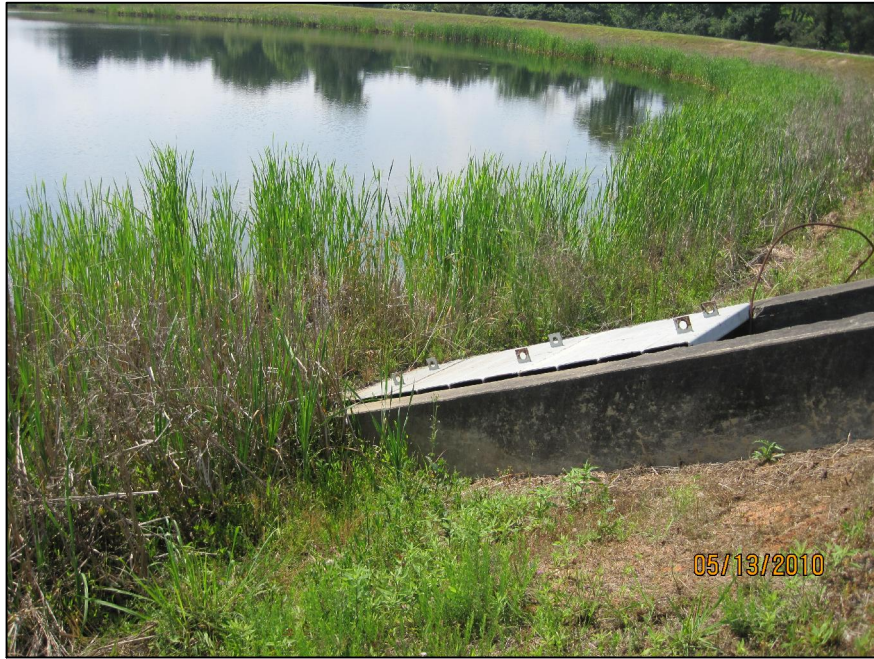
**2-13**

**SOUTHWEST END OF ASH POND 2, EMERGENCY OVERFLOW STRUCTURE,  
POND AND UPSTREAM SLOPES**

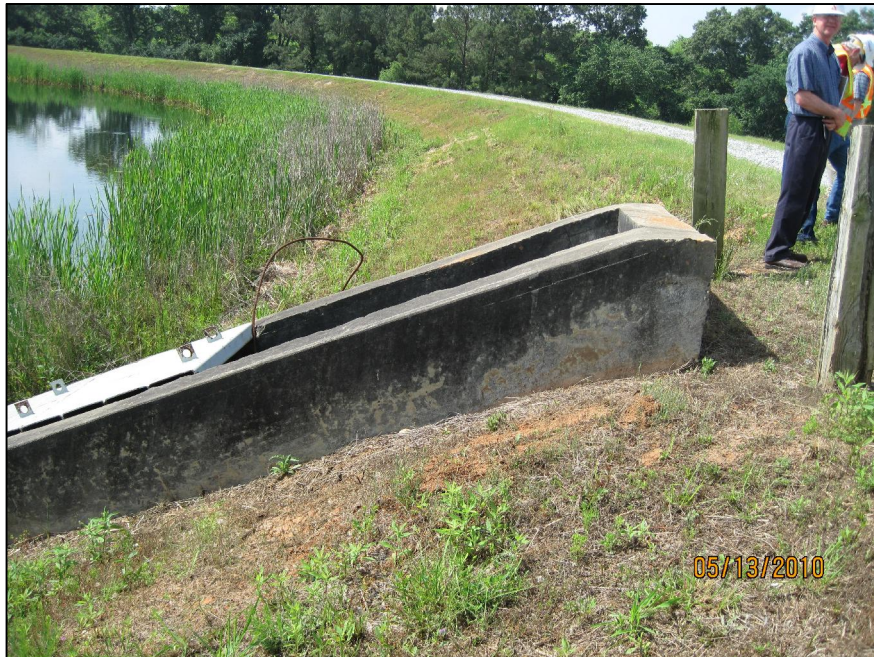
**2-14**

**SOUTHWEST END OF ASH POND 2, EMERGENCY OVERFLOW STRUCTURE,  
POND AND UPSTREAM SLOPES**

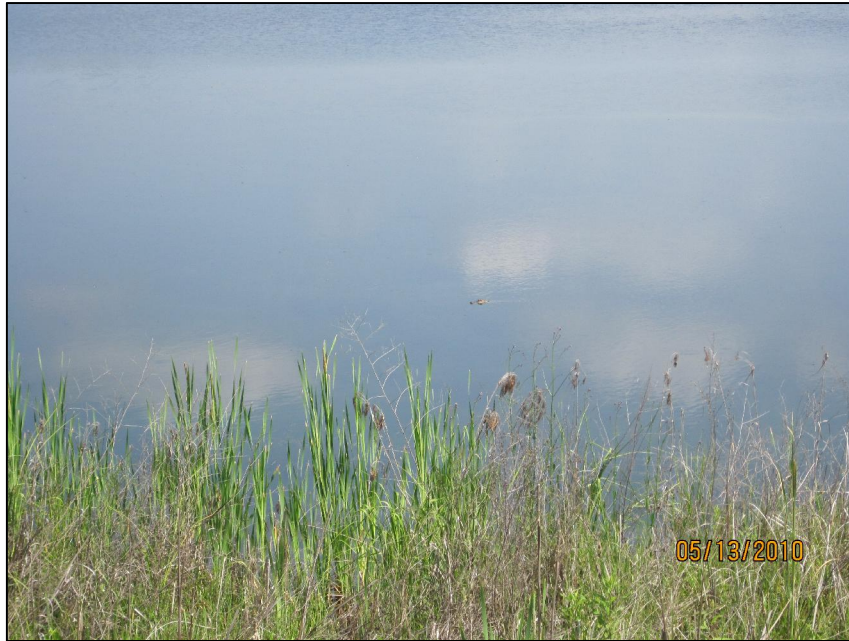
**2-17**  
**SMALL ALLIGATOR IN POND**

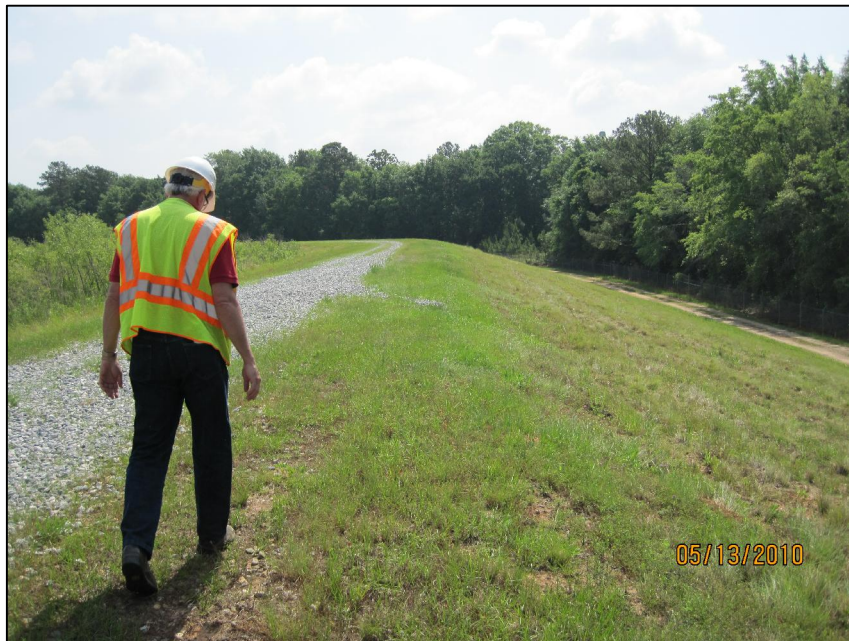
**2-18**  
**SOUTHEAST CORNER OF ASH POND 2**

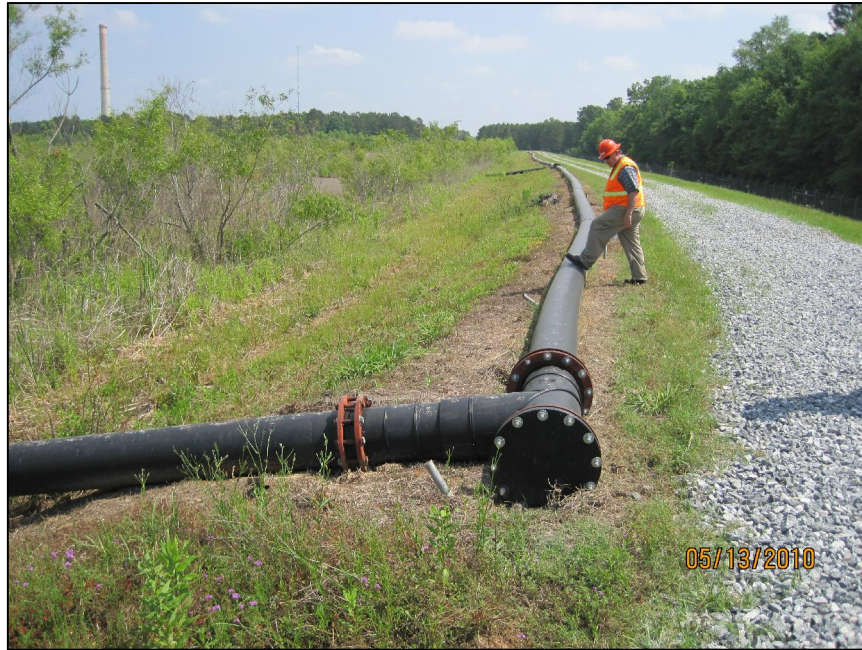
**2-19**

**EAST SIDE OF ASH POND 2 CREST AND UPSTREAM SLOPE, UNIT 3 ASH SLUICE PIPE TO POND**

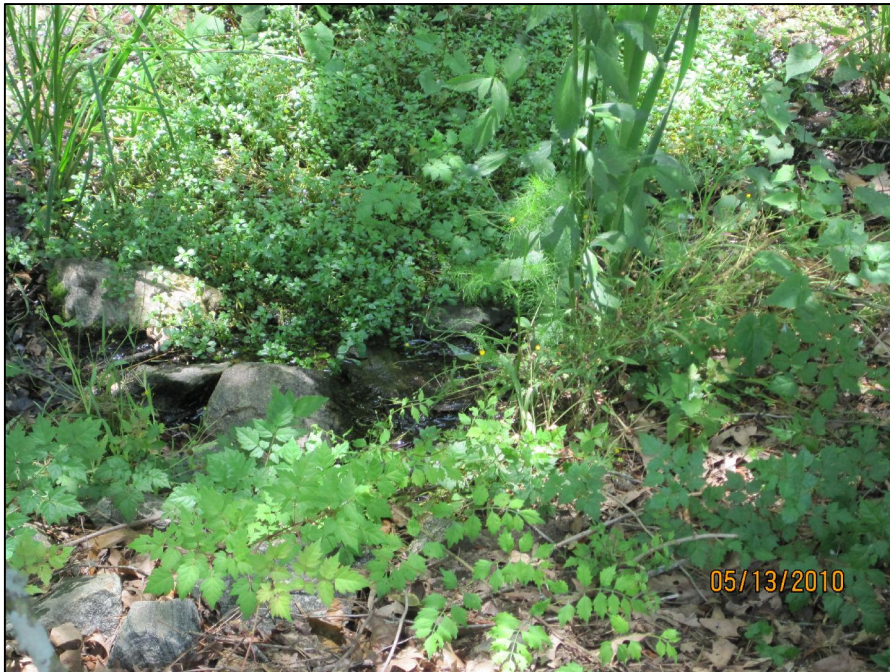
**2-24**

**SOUTH SIDE OF ASH POND 2, EAST OF FENCE BEYOND TOE OF SLOPE,  
TOE BLANKET DRAIN OUTLET D8 (GENERALLY FLOWS YEAR-ROUND)**

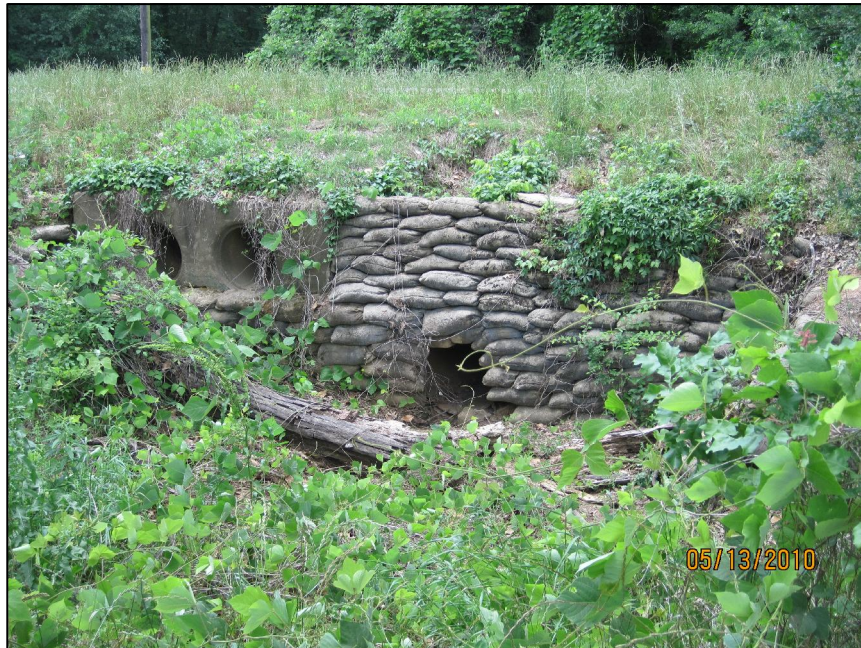
**2-25**

**JUNCTION OF EMERGENCY SPILLWAY #2 AND BLANKET DRAIN DITCH THROUGH  
CULVERTS ACROSS RADIUM SPRINGS ROAD (GA HWY 3)**

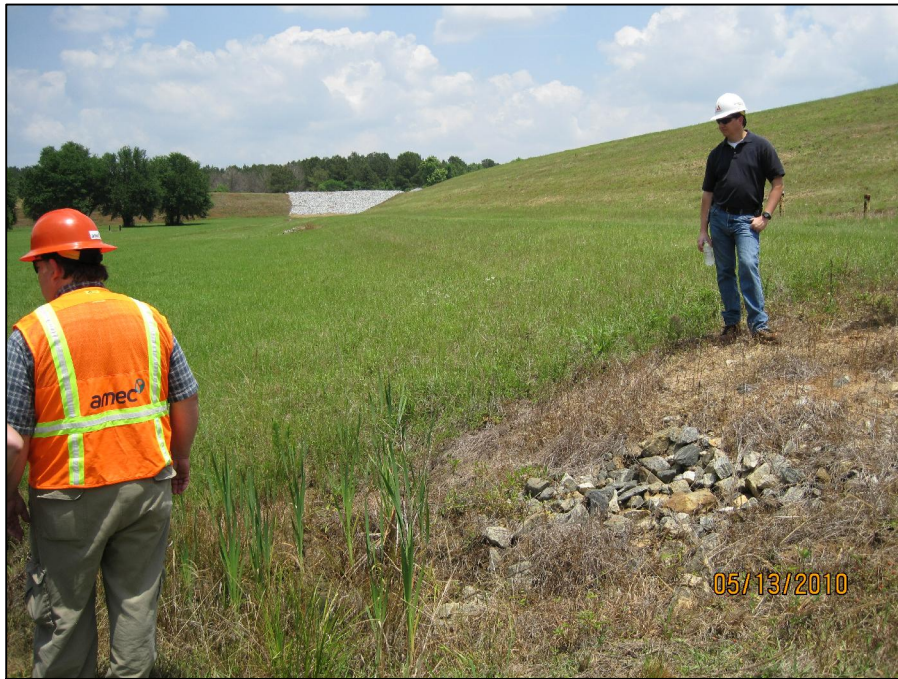
**2-27**

**CENTRAL WEST SIDE OF ASH POND 2, LOOKING NORTH AT  
BLANKET DRAIN OUTLET #4, TOE AND DOWNSTREAM SLOPES**

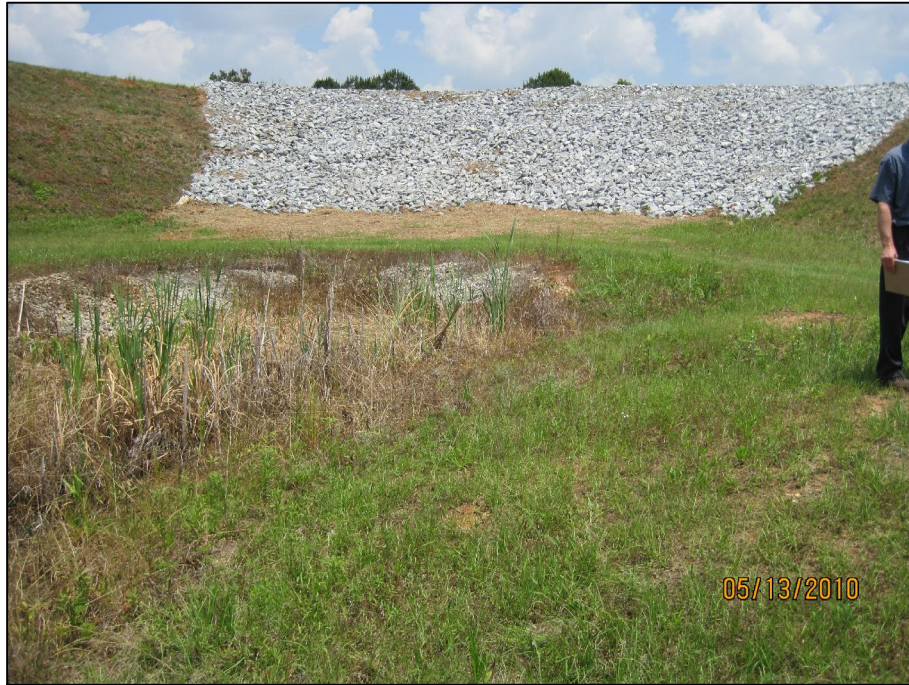
**2-29**

**WEST END OF COMMON DIKE, LOOKING NORTHEAST AT BLANKET DRAIN OUTLET #1  
AND RIP-RAP EMBANKMENT**
