Report of Dam Safety Assessment
Coal Combustion Surface Impoundments
Georgia Power
Plant Mitchell, Albany, GA

AMEC Project No. 3-2106-0174.0600

December 2010

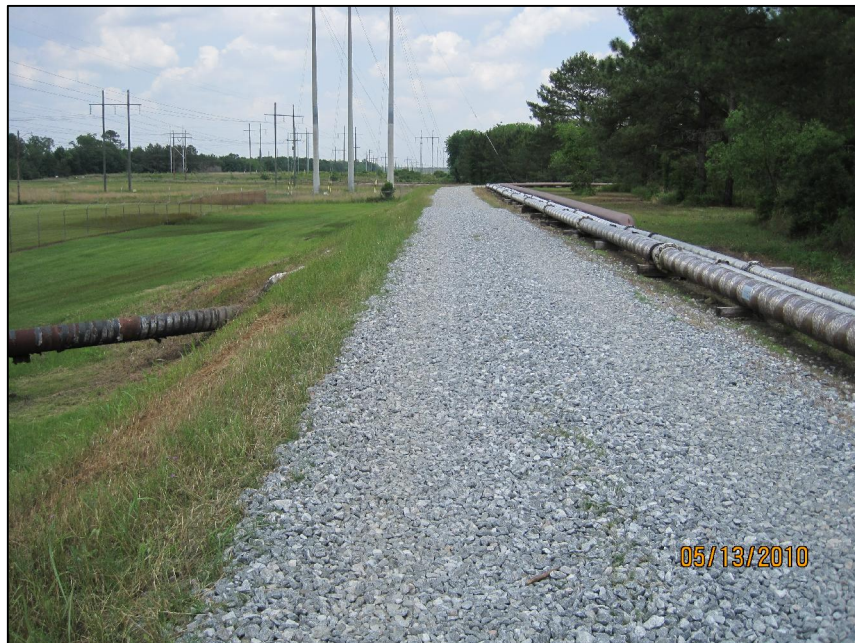
1-16

NORTHEAST END OF ASH POND 1, LOOKING EAST ALONG CREST, PIPE THROUGH EMBANKMENT IS OLD LOW VOLUME SUMP DISCHARGE LINE

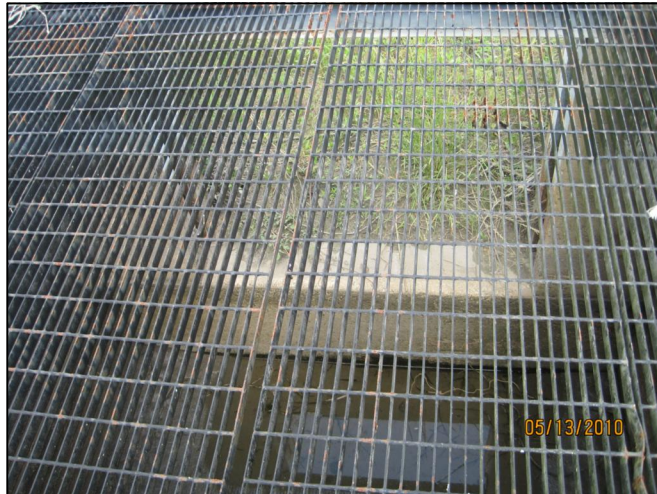
1-20

SOUTHWEST CORNER OF ASH POND 1, CLOSE UP OF PHOTO 1-21, RECYCLE STRUCTURE INLET

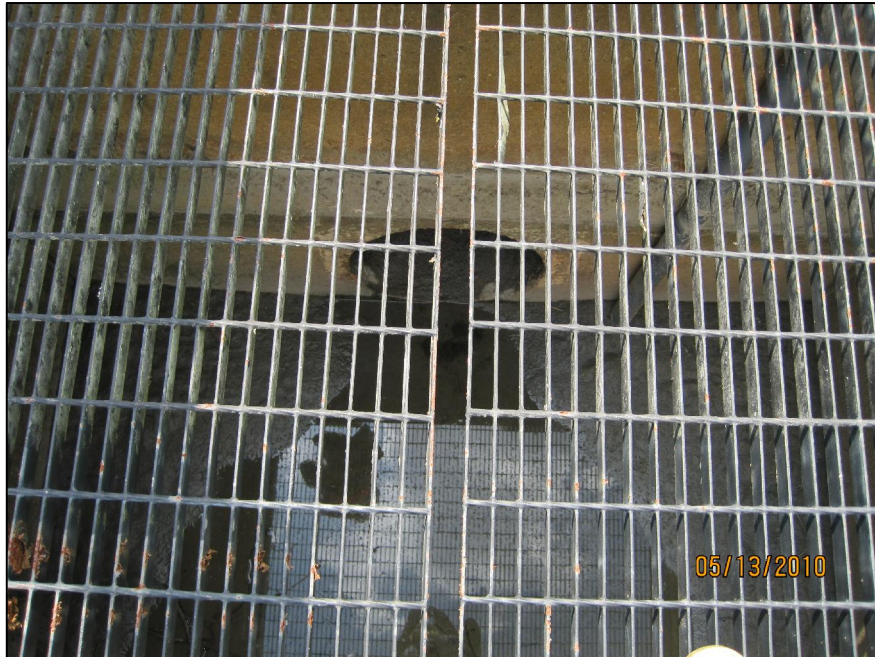
1-22

SOUTHWEST CORNER OF ASH POND 1, CLOSE UP OF PHOTO 1-21, RECYCLE STRUCTURE OUTLET PIPE

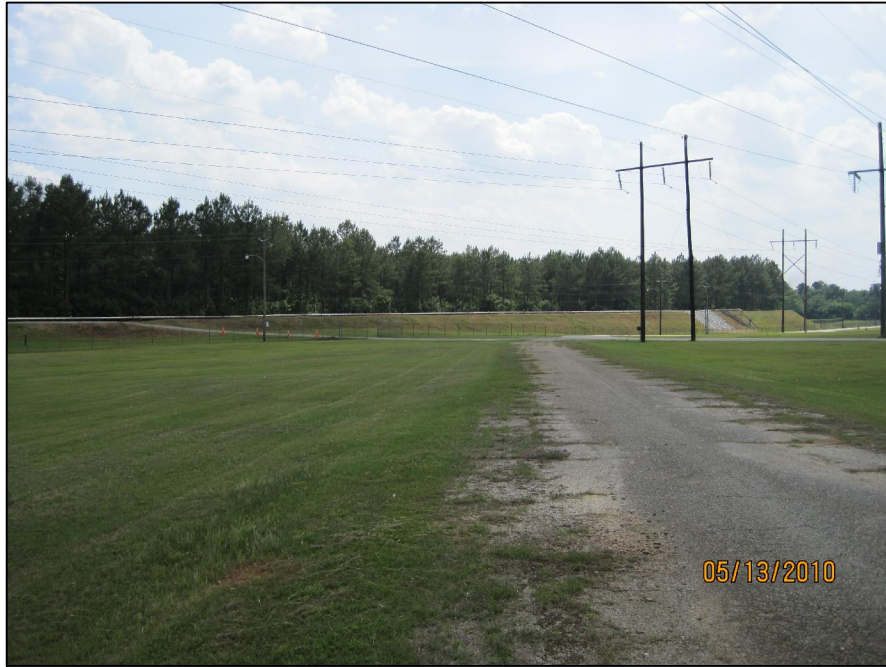
1-23

The north dike faces the plant and the surface cover of the embankment and crest is generally grass (photo 1-23). A newly installed piezometer, AP1-2, is located on the crest at the west end of the north dike (photo 1-18). A slope repair, consisting of rip-rap and located along the northern embankment adjacent to sluiced ash discharge pipes from Unit 3, appears to coincide with areas marked "slough" on drawing H5329, dated 1995 (photos 1-13 and 1-14). The sluiced ash discharge pipes from Unit 3 are located along the northern and eastern crest of Ash Pond 1 (photos 1-12 and 1-13), and continue to the southeast corner of Ash Pond 2. An inactive Low Volume Sump discharge line is located within the embankment (photo 1-16) along the northern section of the eastern dike. At the time of the site visit, the pond was filled to design capacity and was covered with vegetation including grass and pine trees (photo 1-15).

LOOKING SOUTHWEST FROM APPROXIMATELY NORTH END OF ASH POND A TOWARD WEST END OF ASH POND 1

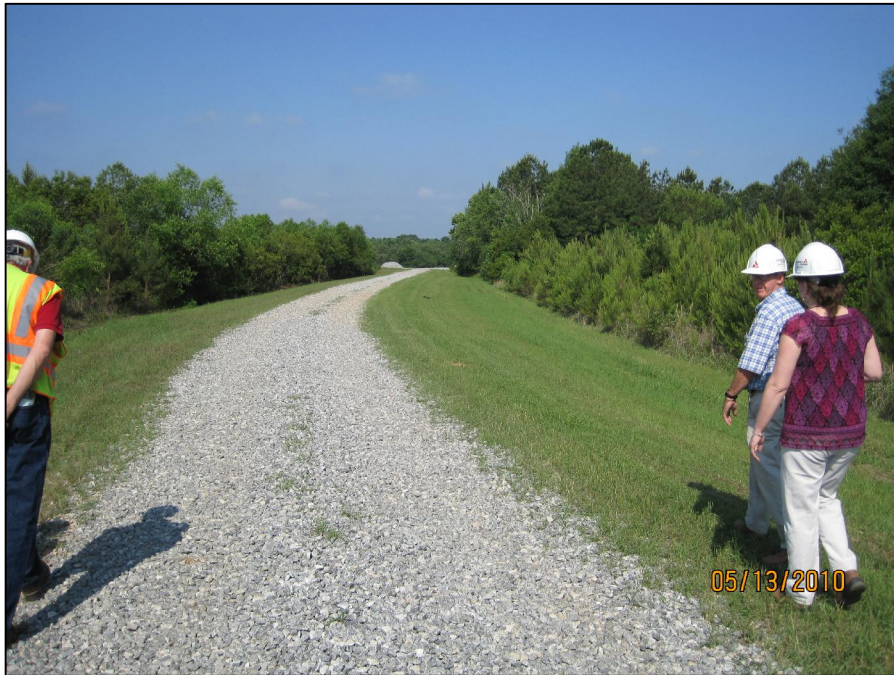
2-1

AT EAST CORNER LOOKING WEST AT DIVIDING/Common EMBANKMENT FOR ASH PONDS 1 AND 2.

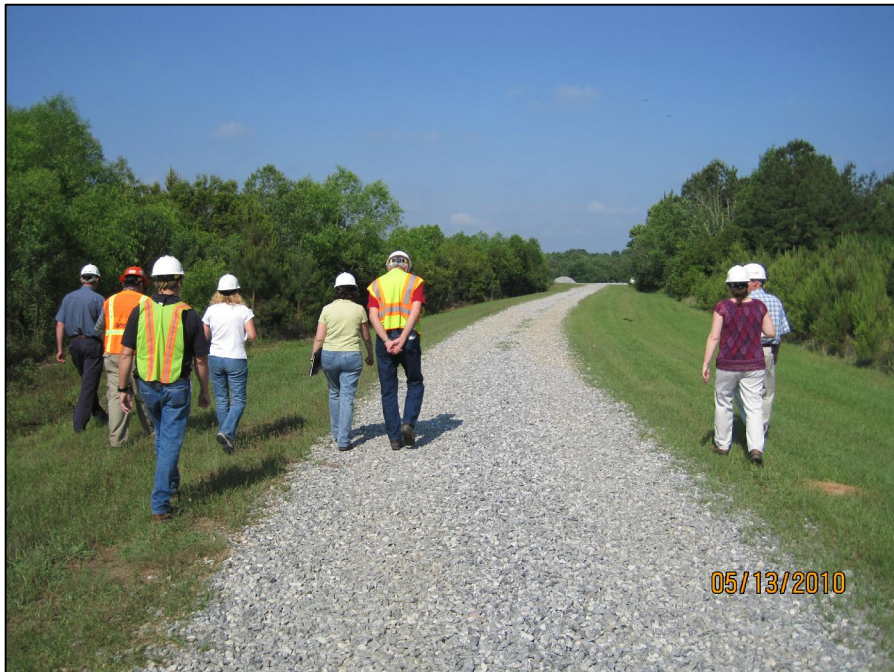
2-2

AT EAST CORNER LOOKING WEST AT DIVIDING/Common EMBANKMENT FOR ASH PONDS 1 AND 2.

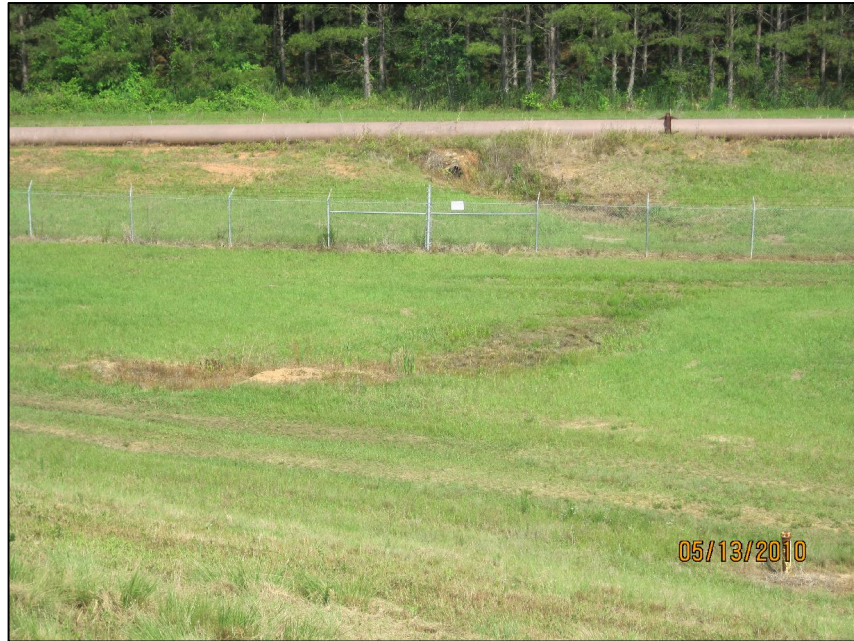
2-7

FROM PZ-10B, UPSTREAM INLET OF SURFACE DRAIN CULVERT OFF SOUTHWEST SIDE OF ASH POND 2

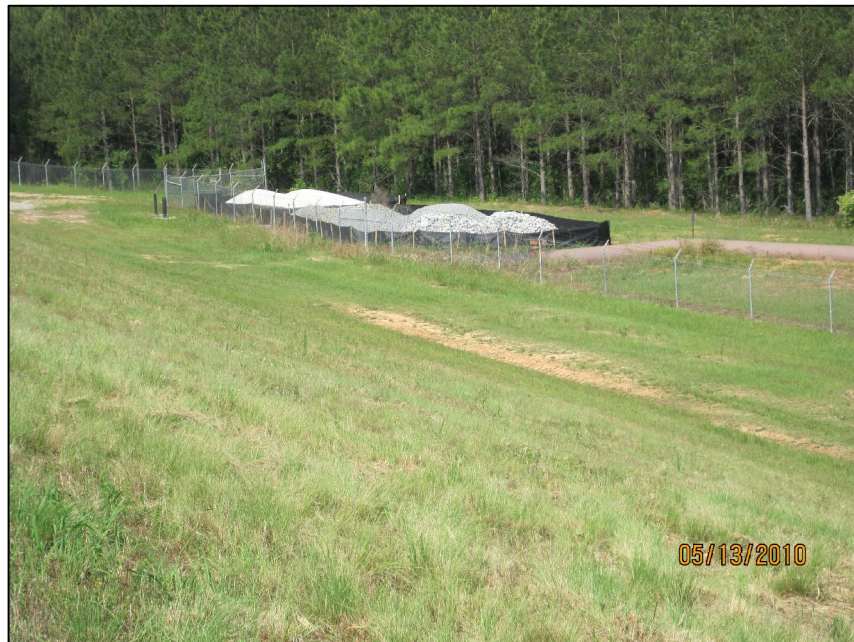
2-8

FROM PZ-10B, EMERGENCY MATERIALS OFF SOUTHWEST SIDE OF ASH POND 2

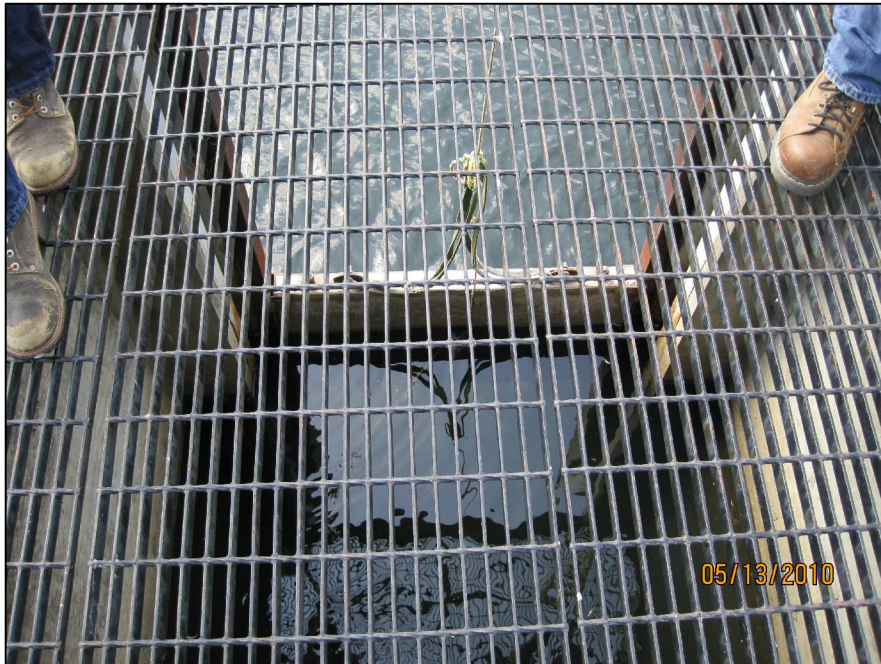
2-10

STOP LOG IN RECYCLE INTAKE

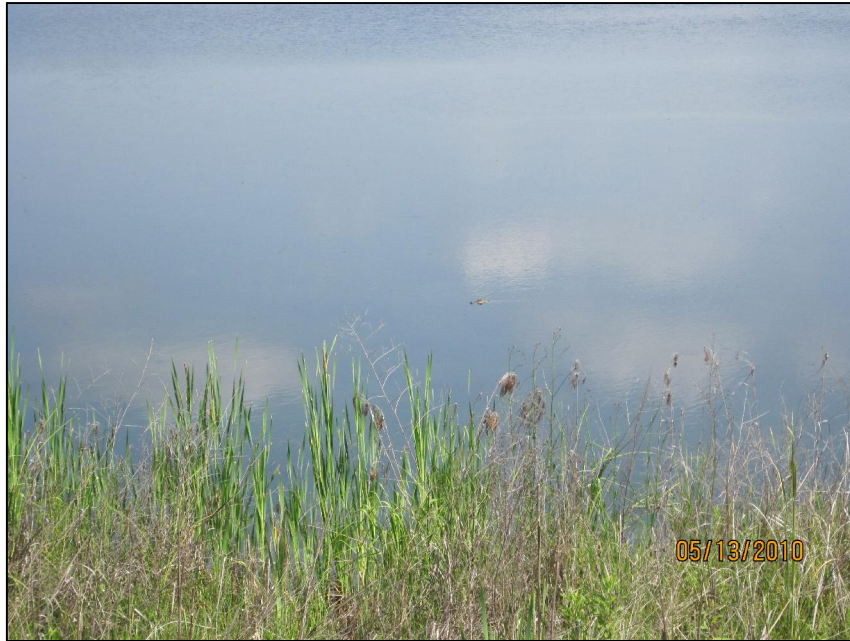
2-17
SMALL ALLIGATOR IN POND

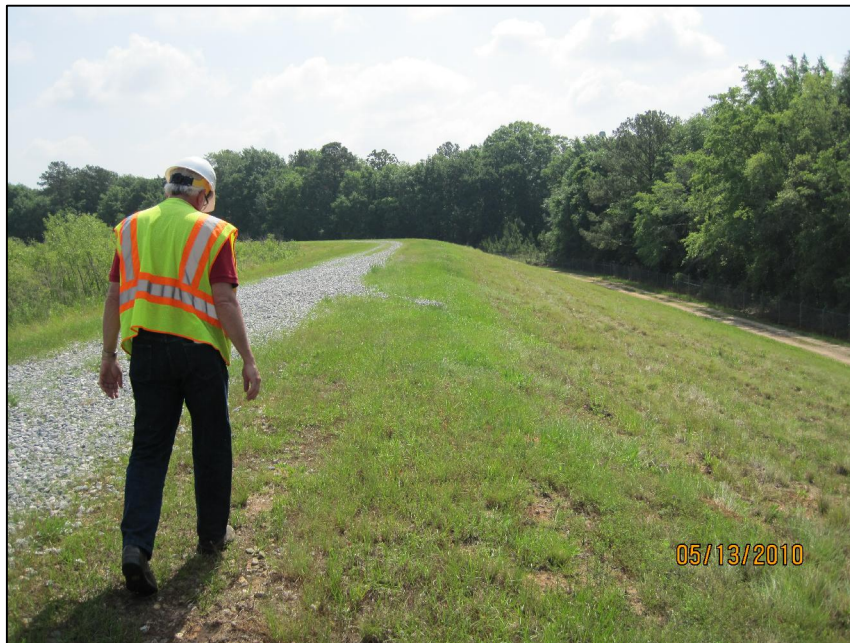
2-18
SOUTHEAST CORNER OF ASH POND 2

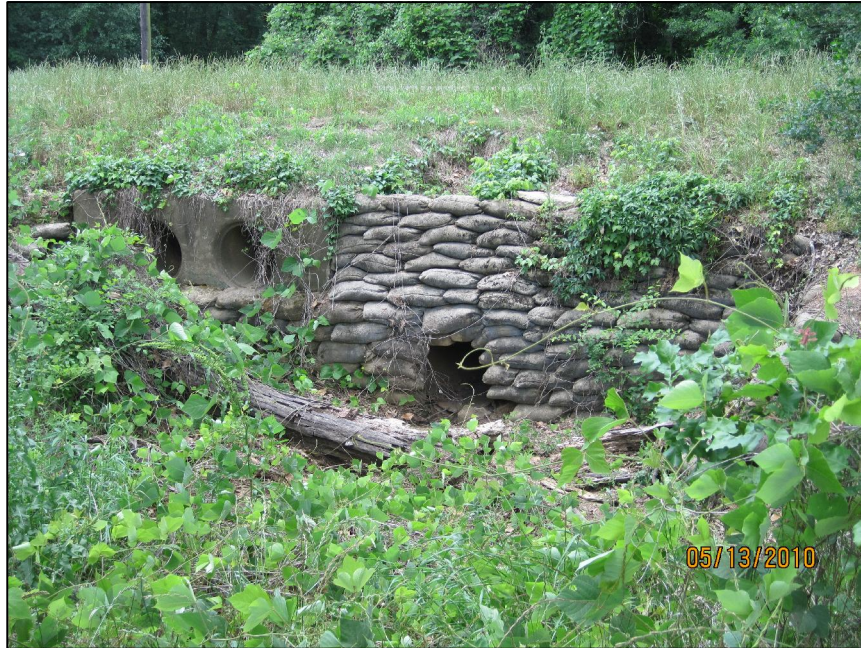
2-25

**JUNCTION OF EMERGENCY SPILLWAY #2 AND BLANKET DRAIN DITCH THROUGH
CULVERTS UNDER RADIUM SPRINGS ROAD (GA HWY 3)**
