**Coal Combustion Waste Impoundment
Round 5 - Dam Assessment Report**

Plant Wansley

Ash Pond Separation Dike

*Georgia Power
Carrolton, Georgia*

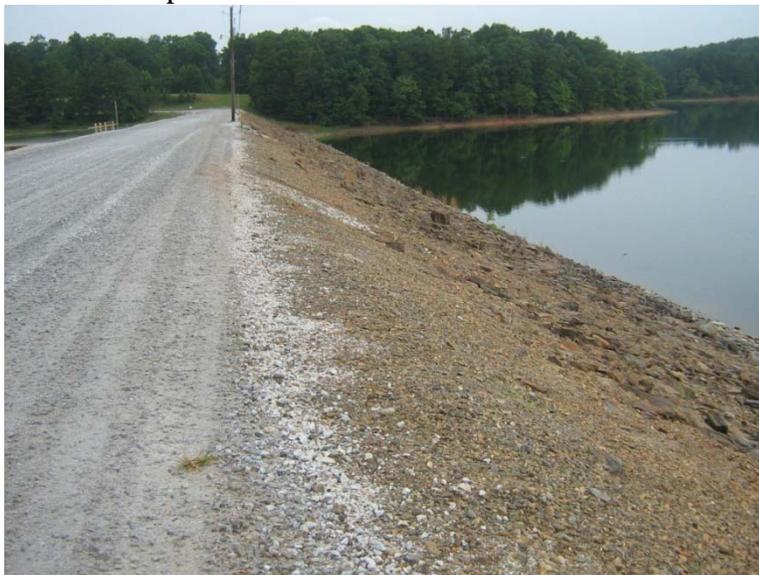
The downstream slope is mostly lined with rip rap and stone. Scarps, sloughs, depressions, bulging or other indications of slope instability or signs of erosion were not observed. Gravel had been placed at a few locations along the embankment as some regular maintenance. The toe of this slope is below the normal pool of the cooling water pond; therefore, visual assessment of seepage could not be performed.

Figure 5.2.3a: Crest and Downstream Slope of ash pond's separation dike.

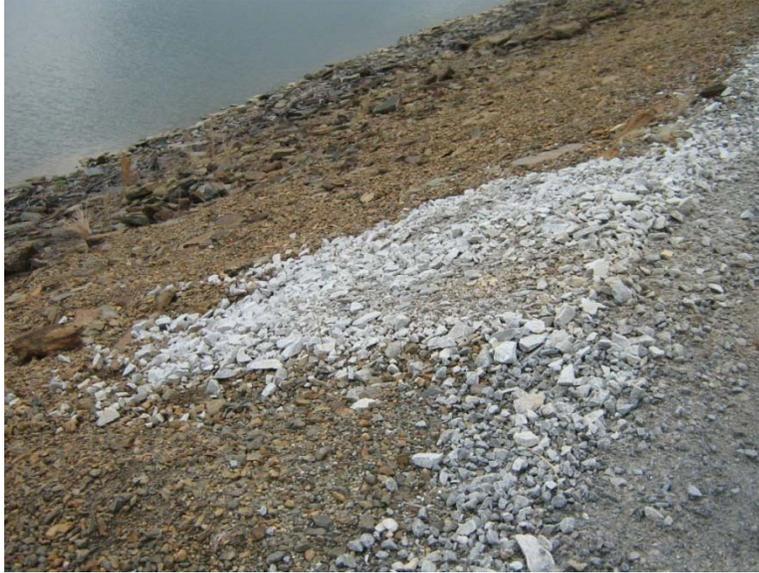
Figure 5.2.3b: Gravel placed along downstream embankment which appeared to be routine maintenance

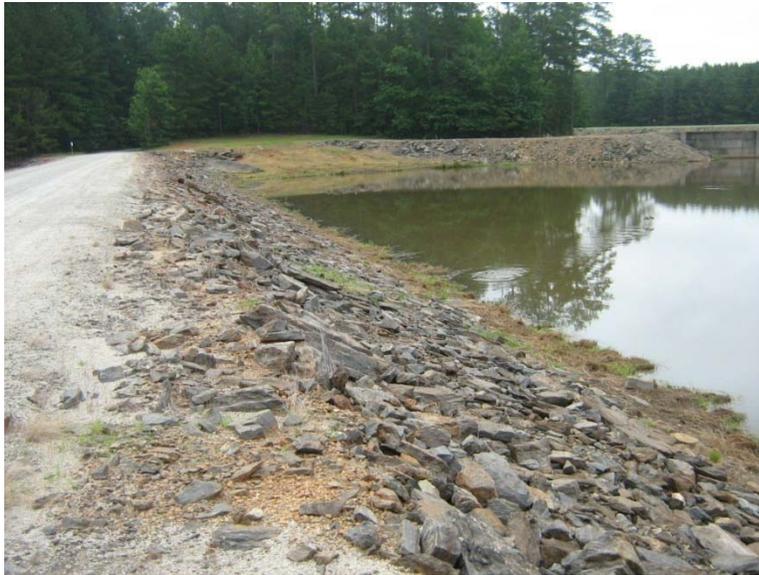
Figure 5.2.3c: Crest and Downstream Slope of ash pond's western dike.

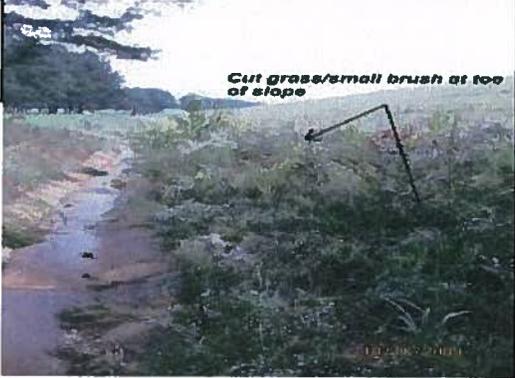
3	Storage Pond - East Dike - Cut grass/brush down along toe of dike.

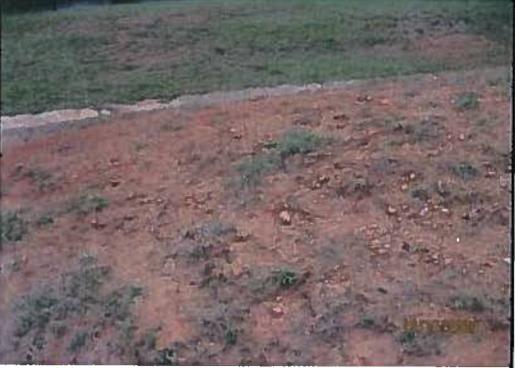
4	Storage Pond - East Dike - Bare areas need to be re-grassed. (Use of a grass mat type product will minimize erosion/wash out during initial growth of grass)

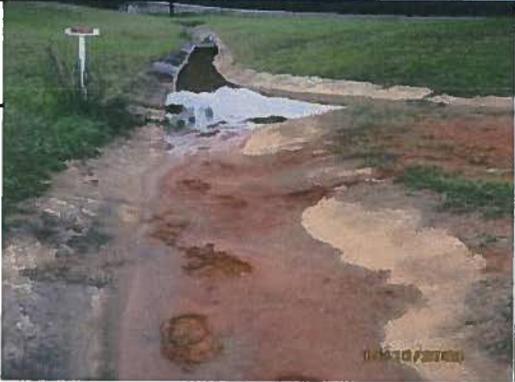
Photo No.	Description	
5	Storage Pond - East Dike - Remove mud/debris from drainage ditches, along east dike.

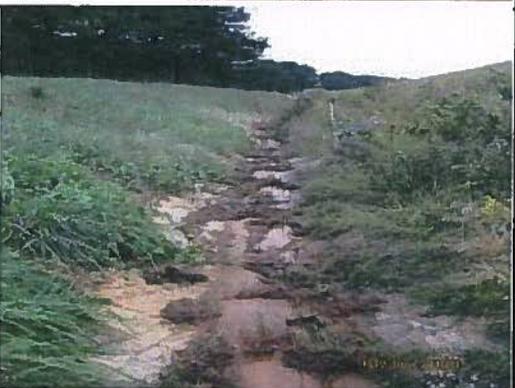
6	Storage Pond - East Dike -Toe Ditch - Remove overgrowth from drainage ditch

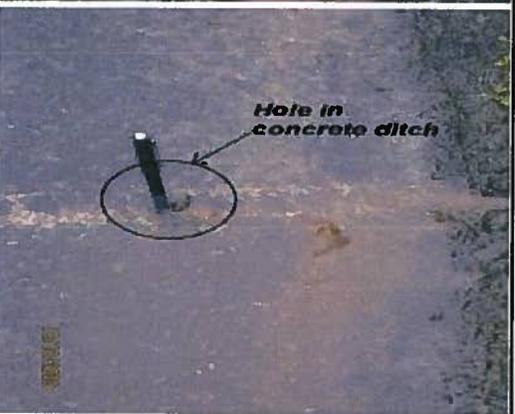
7	Storage Pond - East Dike -Toe Ditch - Localized holes in concrete ditch need to be grouted to prevent water flow beneath concrete and potential ground loss

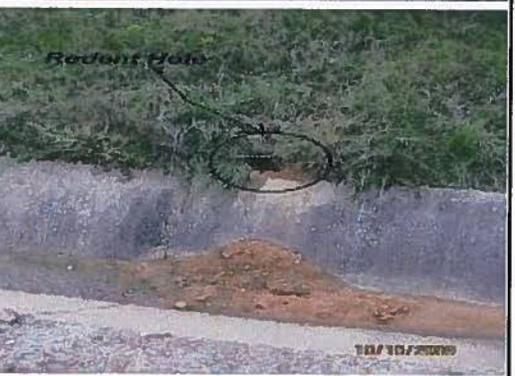
8	Storage Pond- Southeast Dike - Rodent holes on slope need to be filled in.

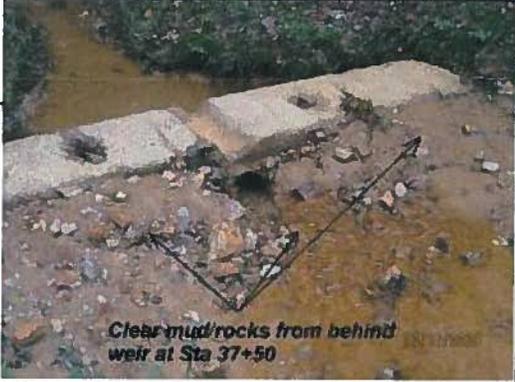
Photo No.	Description	
9	Storage Pond - Southeast Dike - Lower Slope - Sta 37+50. Clear mud/rocks from behind weir.

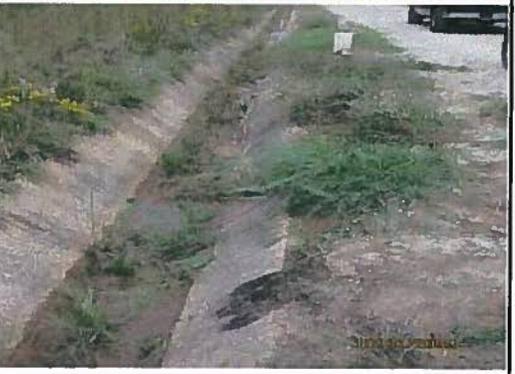
12	Storage Pond- Southeast Dike - Mid-slope Ditch - Mud and vegetation needs to be removed from ditches.

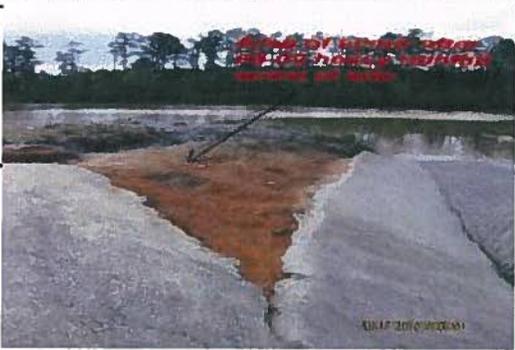
14	Ash Pond- Emergency Overflow - Downstream - Scour adjacent to concrete channel which occurred during Sept-09 heavy rainfall at site. Requires repair.

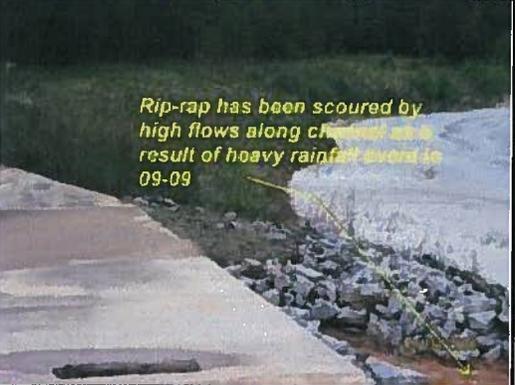
16	Ash Pond- Emergency Overflow - Spillway - Rip-rap was scoured due to high flows in adjacent concrete channel following 09-09 rain event

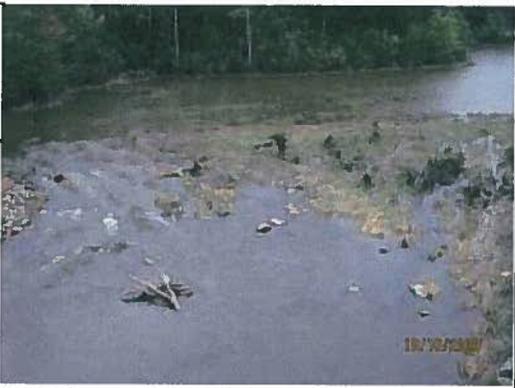
18	Potable Water Pond - Spillway (Upstream) - Rip-rap was scoured due to high flows in adjacent concrete channel following Sept-09 rain event.

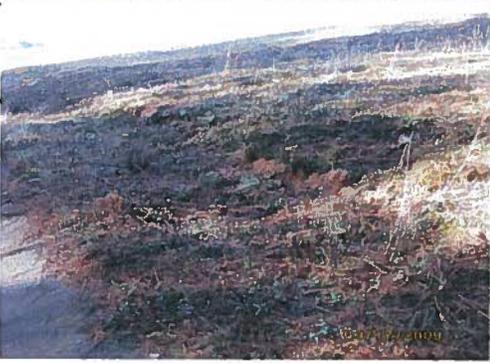
2	Storage Pond - East Dike - Localized erosion and bare areas on dike slope and adjacent to toe ditch. Re-establish grass cover.

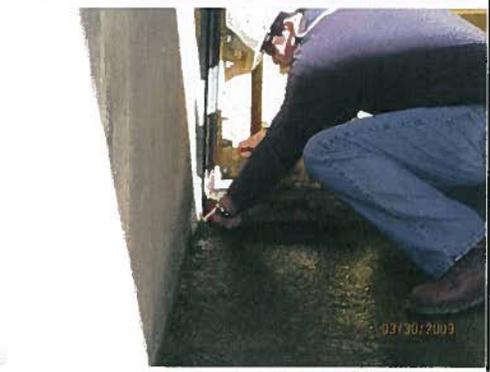
4	Storage Pond - Spillway Gates - Slight gap between wall and edge of gate allowing water through. Plant to investigate.

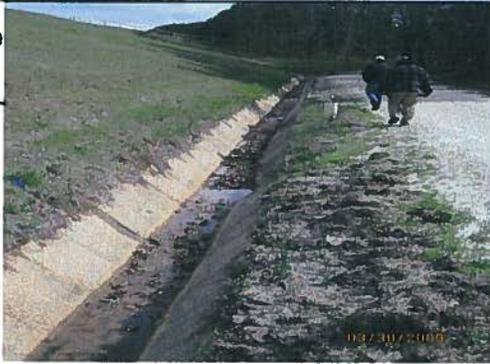
Photo No.	Description	
5	Storage Pond - East Dike -Toe Ditch - Mid-slope - Bare spots on slope need to be re-grassed.

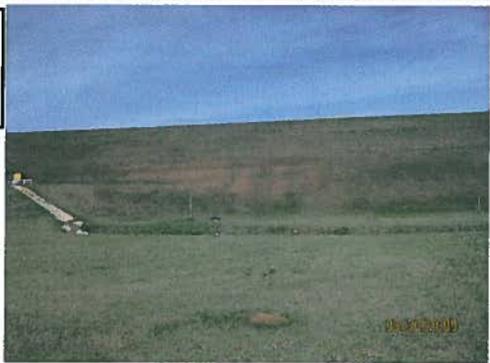
6	Storage Pond - East Dike -Lower Slope - Bare spots on slope need to be re-grassed.

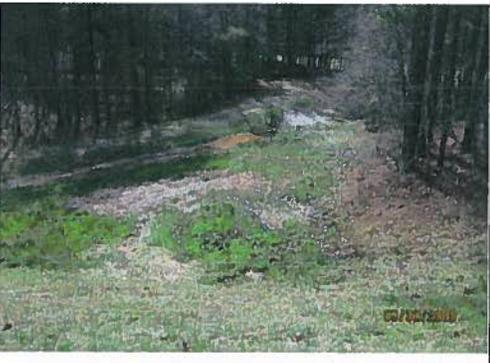
7	Storage Pond - East Dike - Lower Slope - Sta 37+50. Condition unchanged from previous 4th Qtr visit.

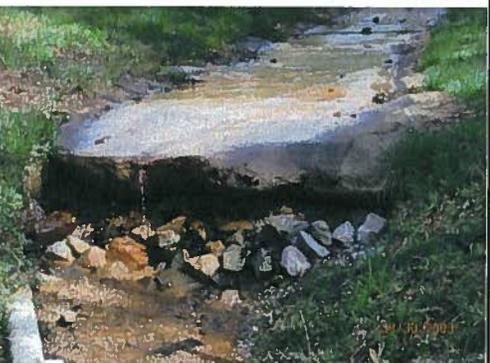
8	Storage Pond - East Dike -Lower Slope - Sta 37+00 - Repair undermining at end of concrete lined ditch

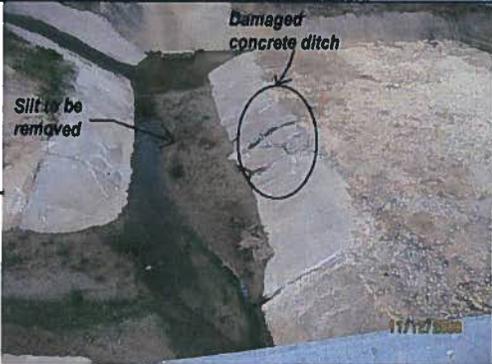
Photo No.	Description	
9	Storage Pond - Southeast Dike - Downstream-Lower Slope -Sta 62+00 - Damaged concrete needs repair and removal of silt removal at bottom of ditch.

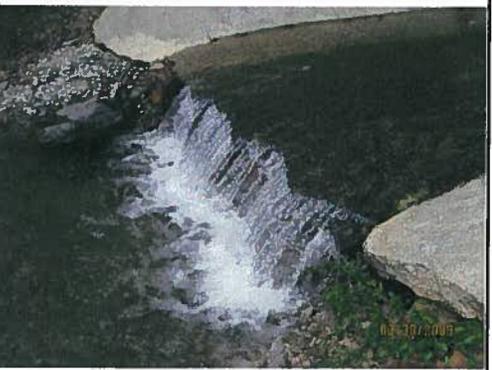
12	Ash Pond- Emergency Overflow - Downstream End - Erosion at end of ditch resulting in undermining of concrete. Needs to be repaired.

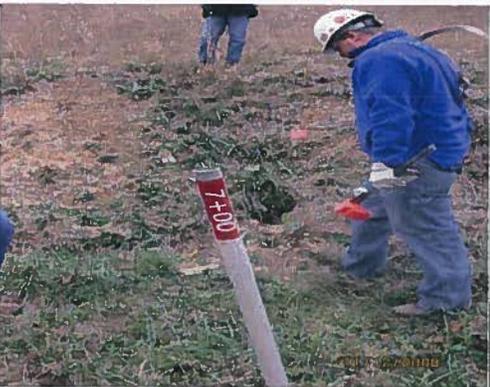
3	Storage Pond - East Dike - Localized rodent holes to be filled in and fire ant mounds to be treated. The rodent holes and fire ant mounds were flagged by plant personnel

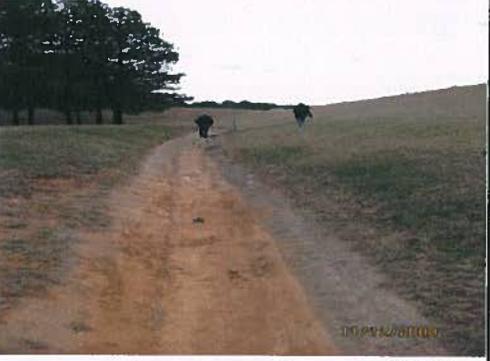
d. Concrete-Lined Drainage Ditch	Concrete in good condition. Localized vegetation growth and debris has been removed from ditches (photo 4). Good job done. Drain pipes at Sta. 19+00 and 22+00 need to be cleaned out and repaired (photos 4 and 5)	4, 5 & 6

4	Storage Pond - East Dike - Ditches cleaned out of debris/silt

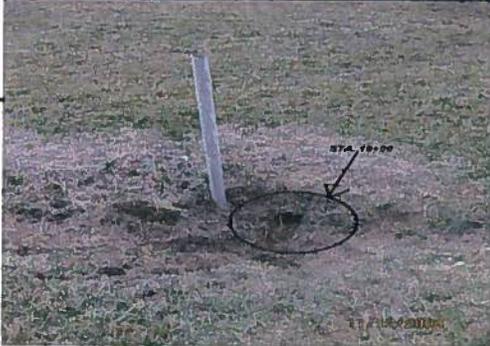
Photo No.	Description	
5	Storage Pond - East Dike - Drain pipe at Station 19+00 needs to be cleaned out. Drain needs to be extended to prevent future clogging

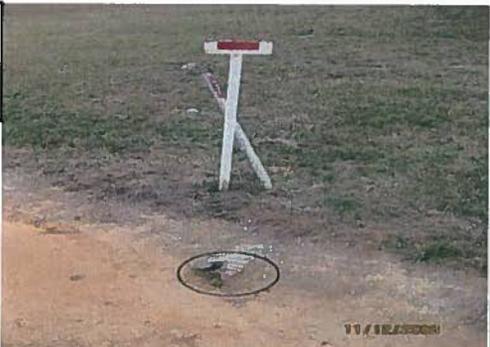
6	Storage Pond - East Dike - Drain pipe at Station 22+00 needs to be fixed. Crushed end to be replaced/repared

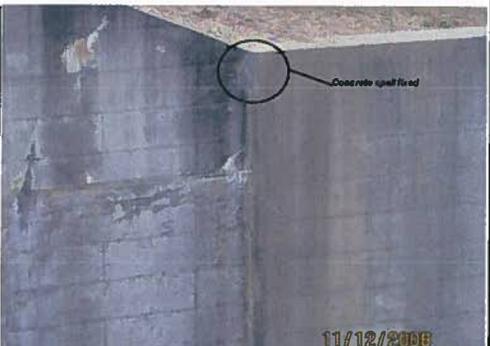
e. Emergency Aggregate Stockpiles	Yes (X) No ()	
III - Storage Pond - Spillway		
Observations - Comments		Photograph No.
1. Spillway Abutment/Deck		
a. Condition	Concrete condition is satisfactory. Per Ga SDP letter 4-3-08, spall at left abutment has been repaired.	7

7	Storage Pond - Spillway - Concrete spall on downstream wall has been fixed.

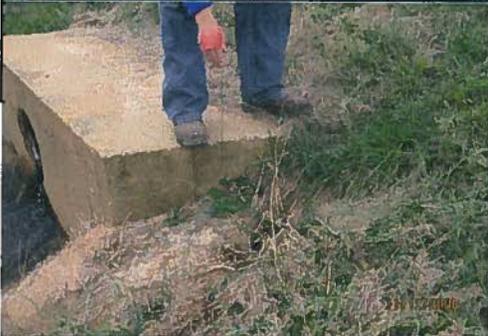
Photo No.	Description	
9	Storage Pond- Southeast Dike - Downstream - Sta 64+00 - Rodent Hole to be repaired.

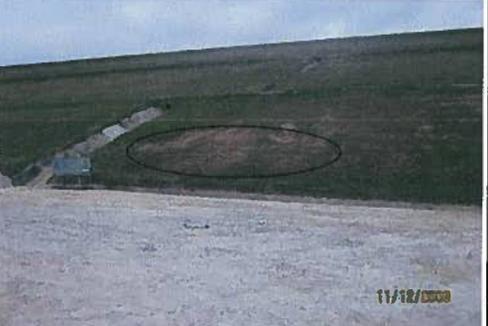
11	Storage Pond- Southeast Dike - Downstream - Near Sta 62+00 - Bare area on slope to be seeded to re-establish grass cover.

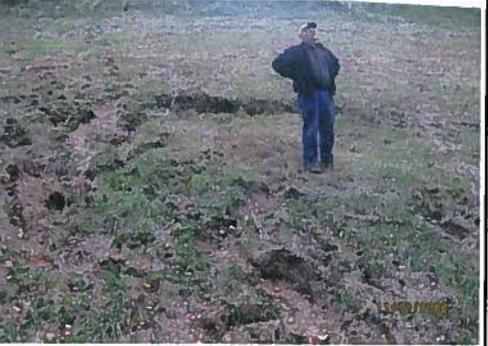
12	Storage Pond - Southeast Dike - Downstream- Lower Slope at Sta 37+ 50. - EPD Safe Dams Program stated that a repair of wet area required by June 2009

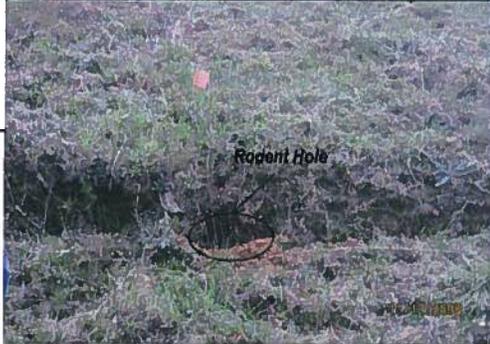
Photo No.	Description	
13	Storage Pond - Southeast Dike - Downstream-Lower Slope at Sta 37+ 50. Rodent hole to be repaired. Flagged by field personnel.

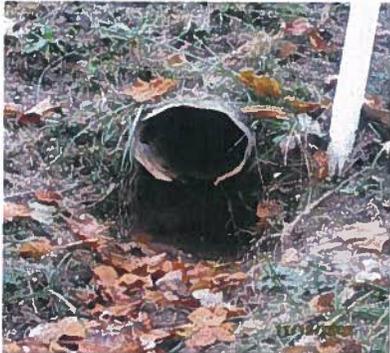
<p style="text-align: center;">Rodent Hole</p>
14	Storage Pond - Southeast Dike - Downstream-Lower Slope at Sta 37+ 50 Drain D - Undermining at end of concrete drainage pipe requires repair.

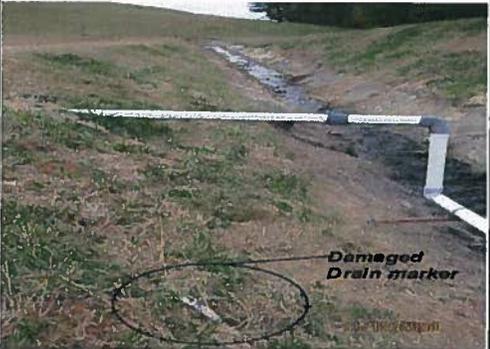
16	Storage Pond - Southeast Dike - Downstream - Lower Slope at Sta 56+00 - Damaged drain marker to be replaced

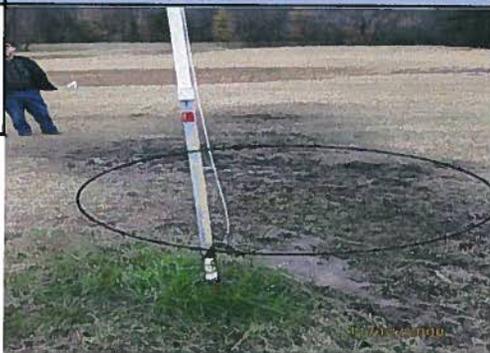
Photo No.	Description	
17	Storage Pond - Southeast Dike - Downstream - Lower Slope - Wet area around Piezometer LLL. Appears that drain valve is leaking. Needs to be repaired.

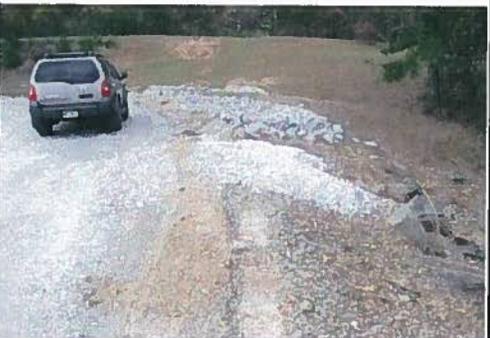
20	Potable Water Pond- Upstream Slope - Small trees and bushes have been cut down at downstream toe.

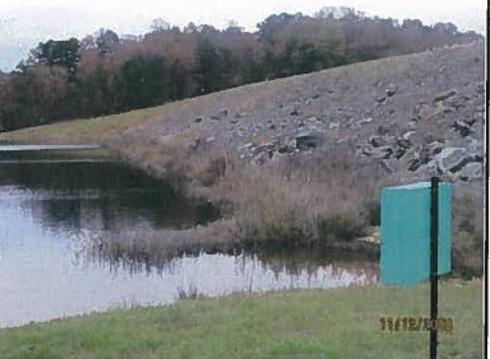
Photo No.	Description	
21	Potable Water Pond- Upstream Slope - Localized bare areas have been re-seeded and grass is starting to grow.

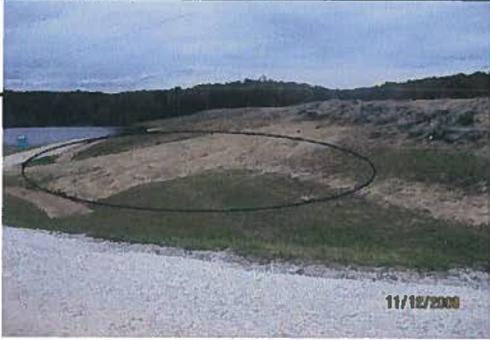
<p style="text-align: right; font-size: small;">11/12/2008</p>
22	Potable Water Pond- Downstream Slope - Localized bare areas need to re-seeded and grass reestablished

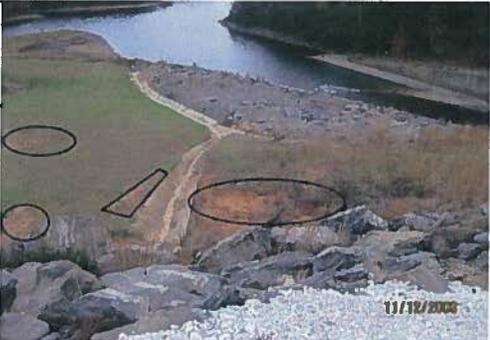
<p style="text-align: right; font-size: small;">11/12/2008</p>
23	Detention Pond - Downstream Slope. Small trees to be removed. Grass and weeds to be cut.

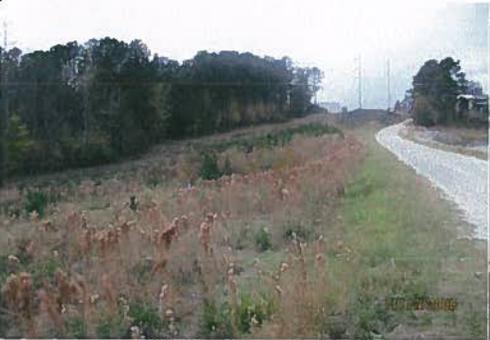
<p style="text-align: right; font-size: small;">11/12/2008</p>
24	Detention Pond- Downstream - Localized wet areas downstream of toe of slope. Need to investigate source of water. Plant to coordinate with Hydro Services.

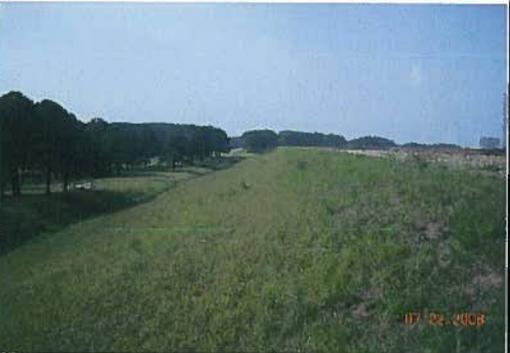
3	Storage Pond - E. Dike - Downstream slope in good condition

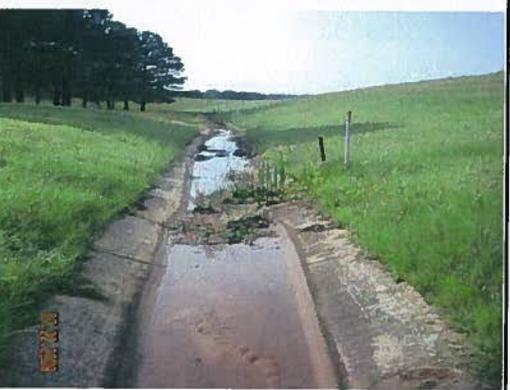
b. Visible Seepage or Wet Spots	Yes () No (X) - No seepage or wet spots observed on slope.	n/a
c. Erosion or Sloughing	Yes () No (X)	n/a
d. Concrete-Lined Drainage Ditch	Concrete in good condition. Localized vegetation growth and debris needs to be removed from ditches so that flow isn't restricted from approx. Sta. 1+60 to 3+50 and Sta. 5+00 to 23+50.	4 & 5

4	Storage Pond - E. Dike - D/S slope - Toe Ditch - Localized vegetation and debris needs removal so that flow isn't restricted. (Sta. 1+60 to 3+50).

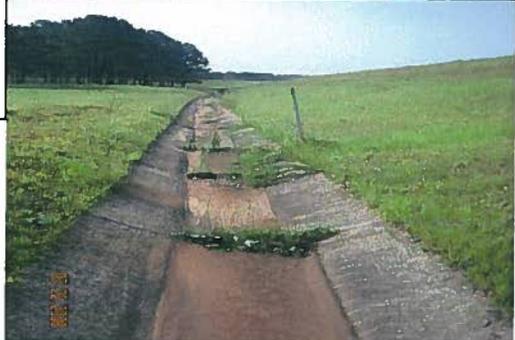
Photo No.	Description	
5	Storage Pond - East Dike - Concrete lined toe ditches - Vegetation/Debris needs to be cleaned out of ditch (Approx Sta. 5+00 to 23+50)

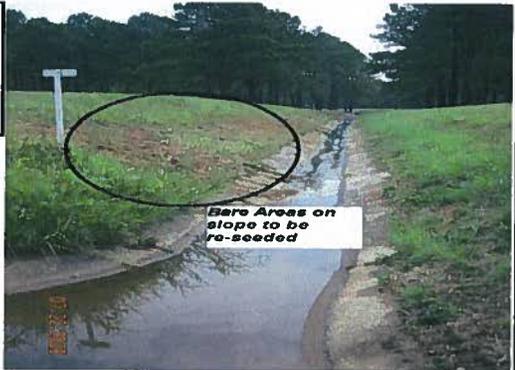
a. Condition	Grass covered - Overall - looks good. Grass cutting in progress. Localized bare spots need to be re-seeded & mulched (photo 6 - Sta 11+20)	3 & 6

6	'Storage Pond - East Dike - Bare spots on slope to be re-seeded to prevent further erosion. Sta 11+20

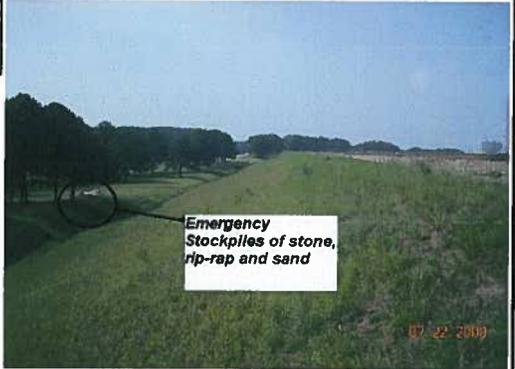
7	Storage Pond - East Dike - Emergency Stockpiles of coarse and fine aggregate

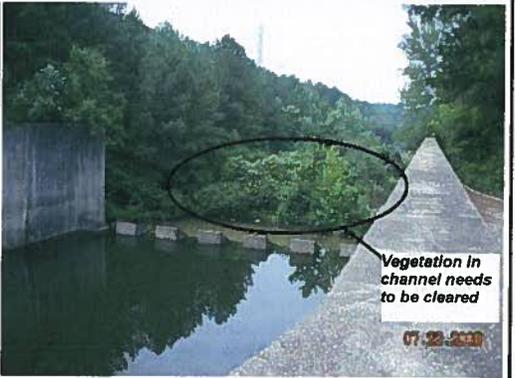
a. Condition	Vegetation downstream of spillway needs to be cleared to prevent blockage/restriction of flow capacity of channel	8

8	Storage Pond -Spillway - Vegetation downstream of end of spillway needs to be cleared.

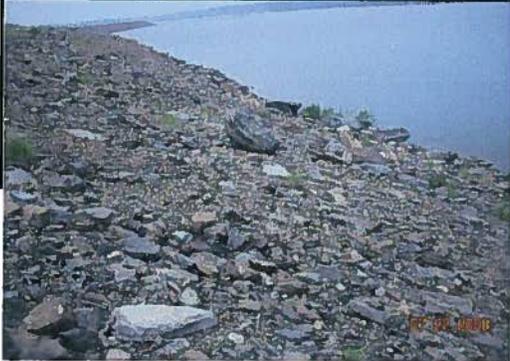
Photo No.	Description	
9	Storage Pond - Southeast Dike - Upstream Slope - Rip-rap varies in size from gravel size to 18"-24", occasional 24" to 36" nominal size. Per GA Safe Dams letter of 4-3-08, this will be addressed by SCG Hydro Services.

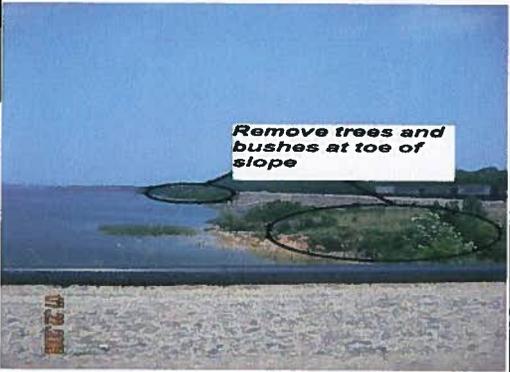
IV - Storage Pond - Southeast Dike (Spillway to Separator Dike)		
Observations - Comments		Photograph No.
1. Upstream Slope		
a. Condition	Rip-rap (size varies) on upstream slope looks acceptable. No instability or beaching evident. (SCG to assess condition per GA EPD-SDP letter 4/3/08). Bushes and trees at toe of slope need to be cut down to prevent potential instability issues at toe of slope (see Photo 10)	9, 10

10	Storage Pond - Southeast Dike - South end near Separator Dike. Bushes and trees need to be removed at toe of slope.

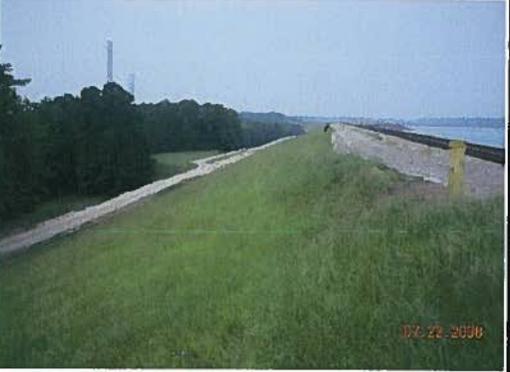
11	Storage Pond - Southeast Dike - Downstream (D/S) - Upper Slope looks satisfactory

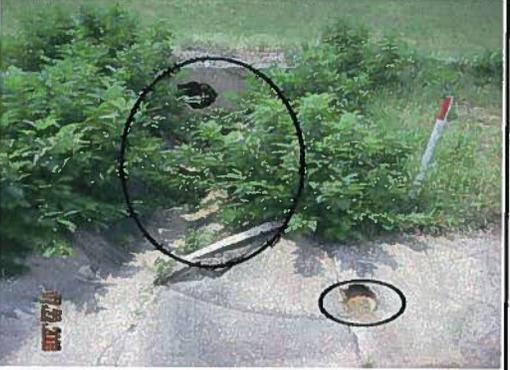
b. Concrete-Lined Drainage Ditch	Concrete in good condition. Vegetation in ditch/around drain at Sta. 73+00 needs to be removed so that flow isn't restricted. Localized areas where grass growing and silt has built up on bottom of drainage ditch. Removal of vegetation and silt required	12
3c - Middle Slope

12	Storage Pond - Southeast Dike- D/S -Silt and debris removal required at outlet of Drain at Sta. 73+00 and 74+00

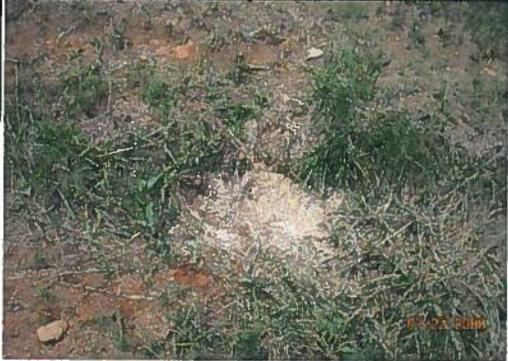
a. Condition	Grass covered. Satisfactory. No visual evidence of instability. Previous rodent hole filled in.	13
b. Visible Seepage or Wet Spots	Yes () No (X)	n/a

Photo No.	Description	
13	Storage Pond - Southeast Dike D/S - Previous rodent hole has been filled in.

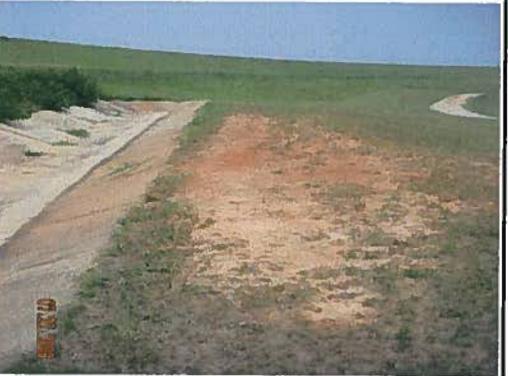
16	Storage Pond - Southeast Dike D/S - Localized bare spots on lower slope that need to be reseeded/mulched to prevent further erosion.

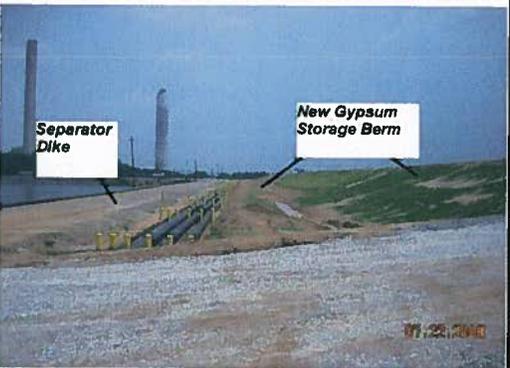
19	Storage/Ash Pond - Separator Dike - South End. Gypsum Storage pond berm on right side of photo.

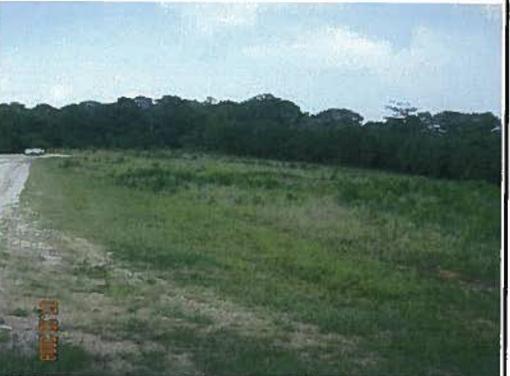
24	Detention Pond - Downstream Slope - Good grass cover, but needs to be cut. Small trees/bushes on slope need to be cut down.

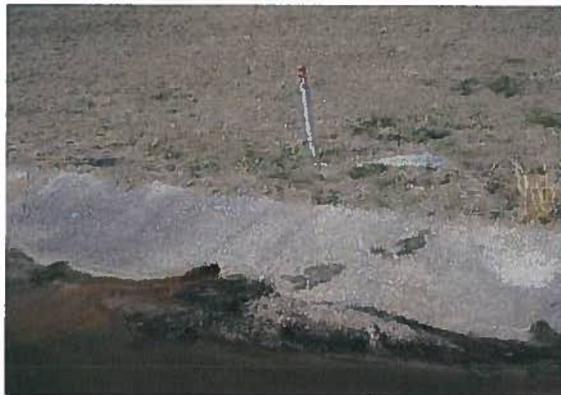
Pt. 131 – Sta. 77+00 – Localized build-up of grass, silt and debris. **Requires clean out of the outlet end of the finger drain.**

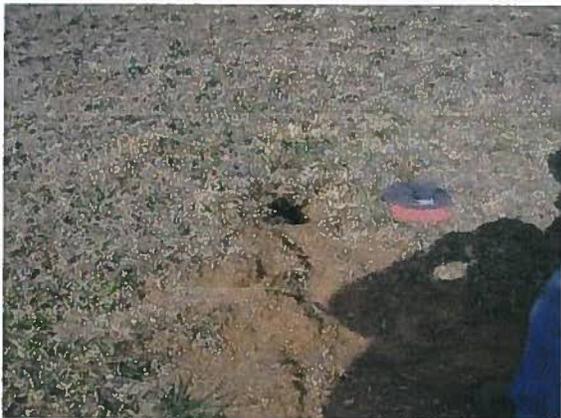
Sta. 76+60 – **Animal Burrow needs to be filled in.**

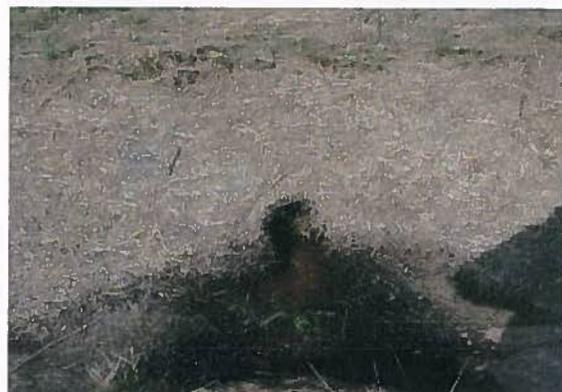
Pt. 132 – Sta. 76+00 - Localized build-up of grass, silt and debris. **Requires clean out of the outlet end of the finger drain.**

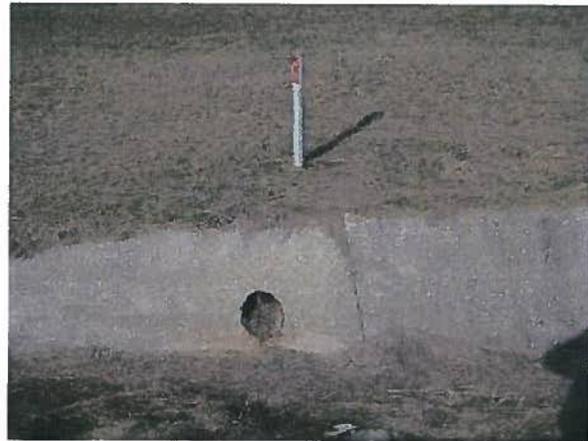
Sta. 75+00 – Localized build-up of grass, silt and debris. **Requires clean out of the outlet end of the toe drain.**

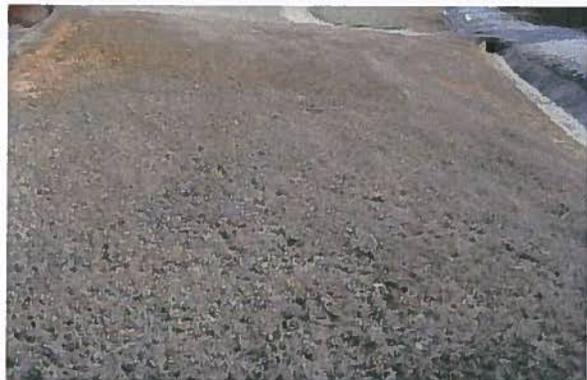
Sta. 73+00 to 74+00 – Bare spots on slope. **Re-seed and mulch areas to re-establish grass cover to mitigate surface erosion.**

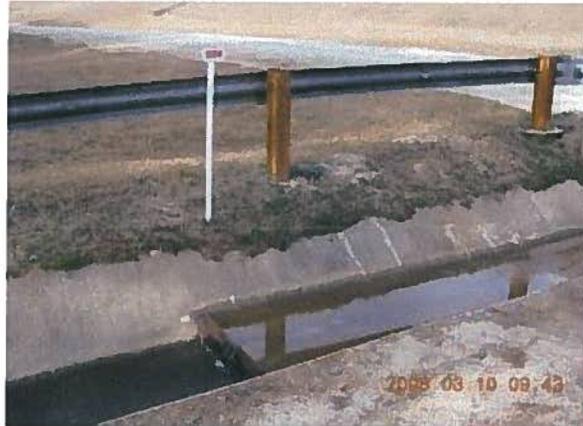
Pt. 138 (Sta 62+00) – Silted up behind weir. Clean out dirt from around weir

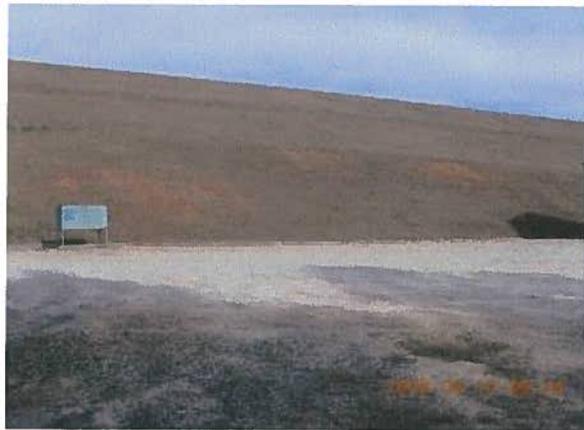
Pt. 139 (~Sta. 62+50) – Bare spots on slope. Re-seed and mulch areas to re-establish grass cover to mitigate surface erosion.

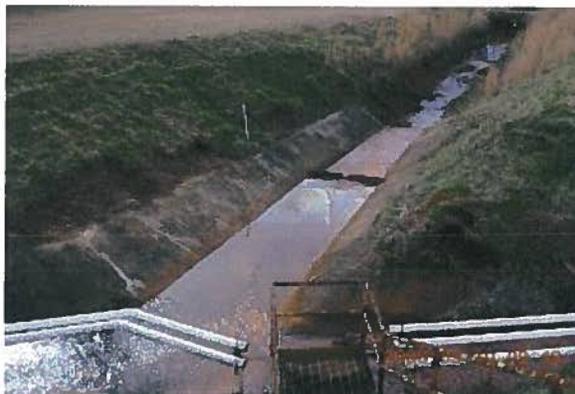
Pt. 140 (~Sta. 57+00) – Build-up of silt at weir. **Clean out dirt around weir.**

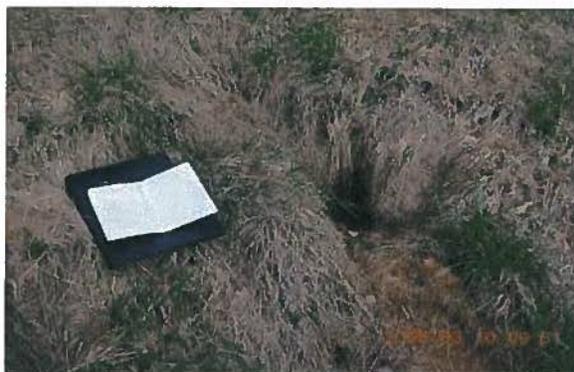
Pt 141 (~Sta 53+00) – **Animal burrow needs to be filled in.**

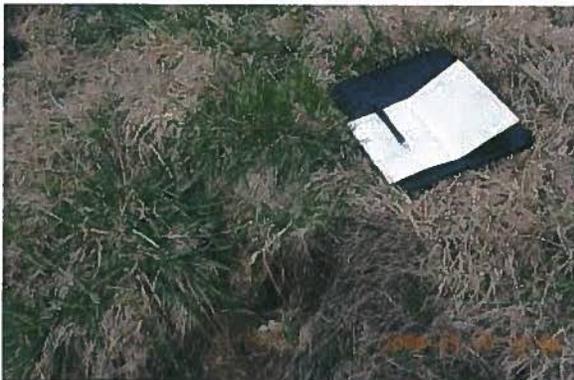
Pt. 142 (~Sta. 45+00) – **Three animal burrows at headwall need to be filled in.**

066 An animal burrow was noted next to the paved ditch at Sta 45+00. There is some woody brush in this area that should also be cut. Brush and tall grass provide cover for burrowing animals and therefore encourage their burrowing. **The animal should be trapped or gassed and the burrow should be packed with gravel and/or foamed. The brush should be cleared.**

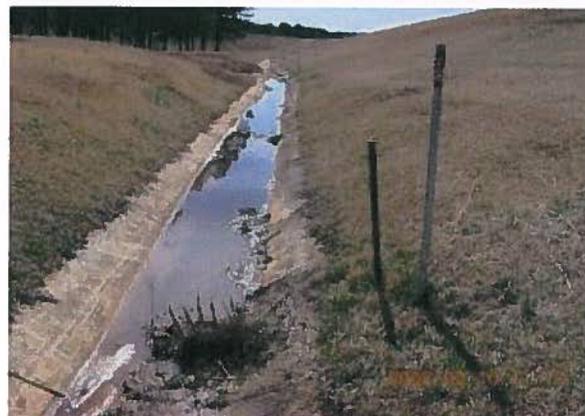
Pt. 145 – Sta. 1+00 to 8+00 – Clear debris from finger drains at Sta. 1+00 & Sta. 7+00 and clean out bottom of concrete lined channel of silt/sand and miscellaneous.

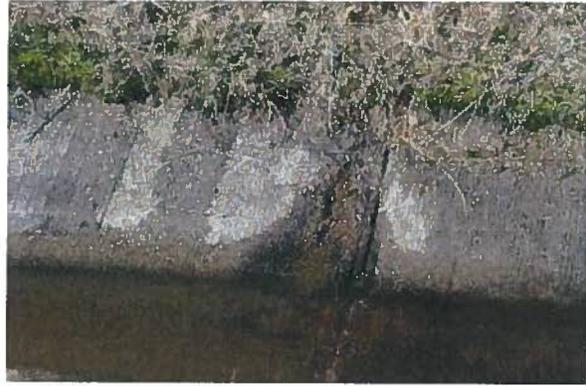
Pt. 147 – Minor seepage into concrete channel (~ Sta. 12+50).

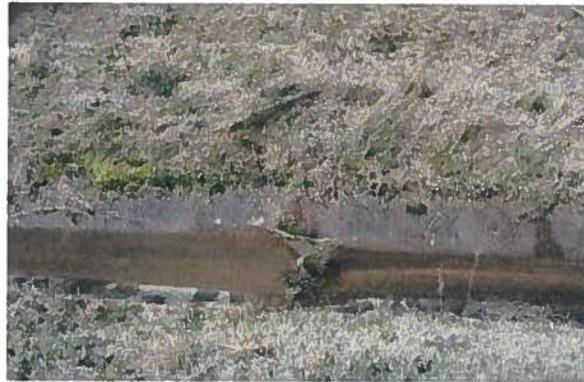
Pt. 148 (~Sta. 15+00) Finger drain dry, but localized seepage into channel. **Localized grass in channel needs to be removed.**

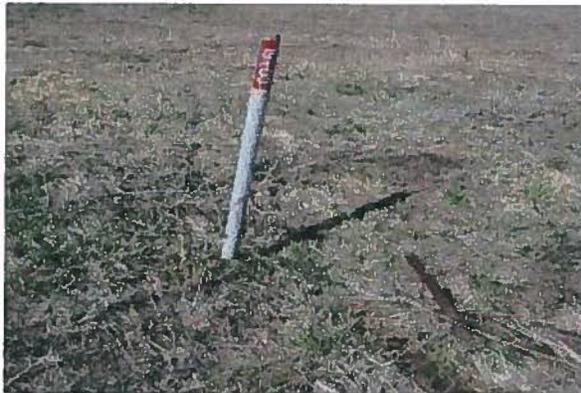
Pt. 149 – (Sta 19+00) – **Finger drain blocked at this location and needs to be cleaned out.**

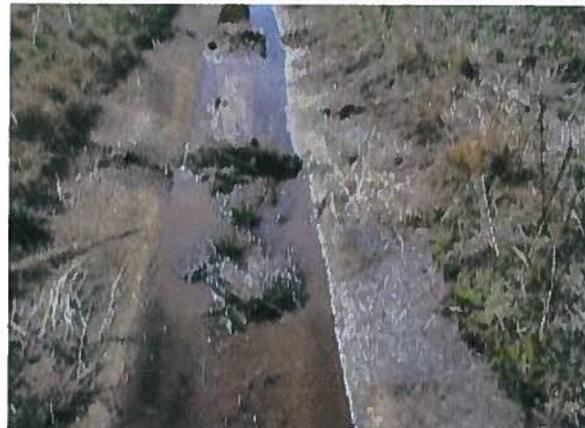
Pt. 150 – Build-up of grass and debris in channel, (restriction of flow through channel). **Debris/grass needs to be cleaned out of channel**

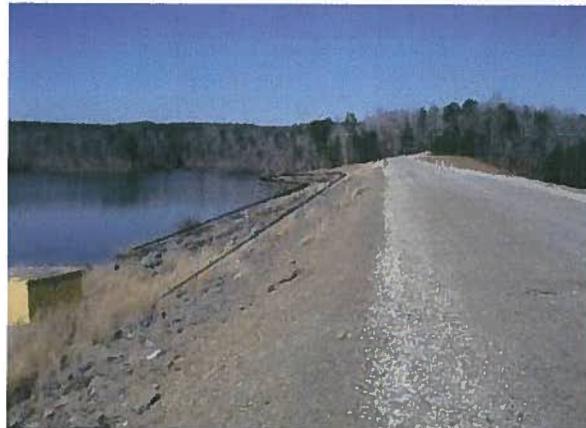
Vegetation growth at toe of upstream slope. Cut down and remove vegetation (grass/bushes)

089 An eroded area was noted on the downstream slope just east of the spillway. This appears to be the result of runoff from the roadway passing through the riprap and running down this area instead of into the adjacent paved ditch. It would be a good idea to add some rock to the eroded area to protect it from further erosion and to add some rock to the riprap at the top of the slope to try to direct the runoff into the existing paved ditch. There are also some small trees growing in this area. These should be cut or poisoned.

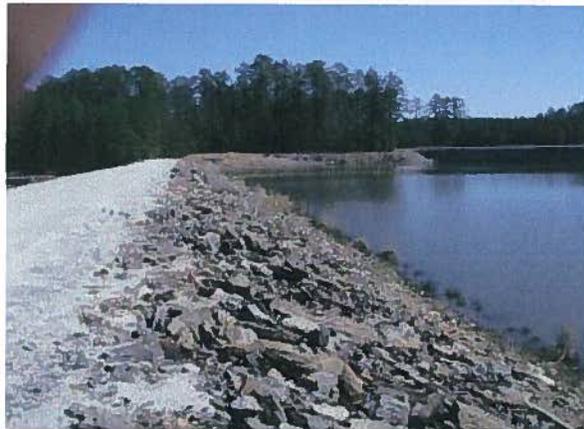
Rip-rap on upstream and downstream slopes overall looks good. No evidence of recent erosion or instability. Brush has been cleared since 3rd Quarter 2007.

095 The upstream spillway of the paved ditch has been repaired with Type III riprap, but **the riprap needs to be dressed to match the contours of the paved ditch.** The current layout could result in uneven flows over the riprap and subsequent erosion
3-10-08 – No change

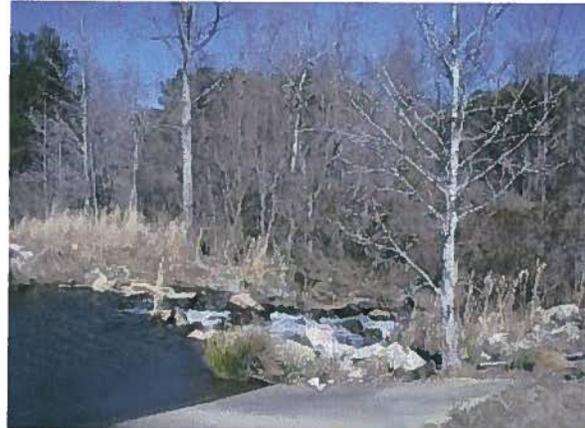
Tree and brush adjacent to spillway should be cleared.

100 The tree and brush growing adjacent to the edge of the spillway should be cleared. **3-10-08 – No work yet.**

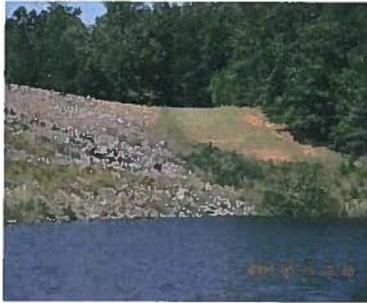
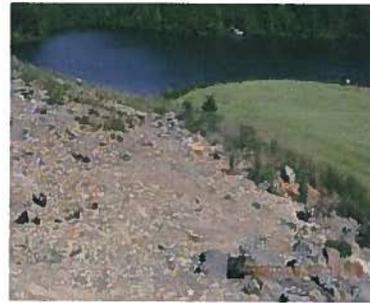
091 On the downstream side of the dike there is a growth of tall grass and woody brush along the east and west contacts of the dike with the natural ground. **This vegetation should be cut or poisoned. 3-10-08 – Brush cleared at both locations**

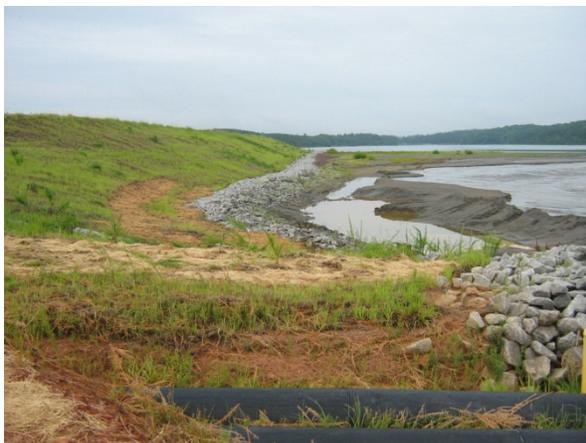
Photo 1: Upstream Slope adjacent to Gypsum Cells

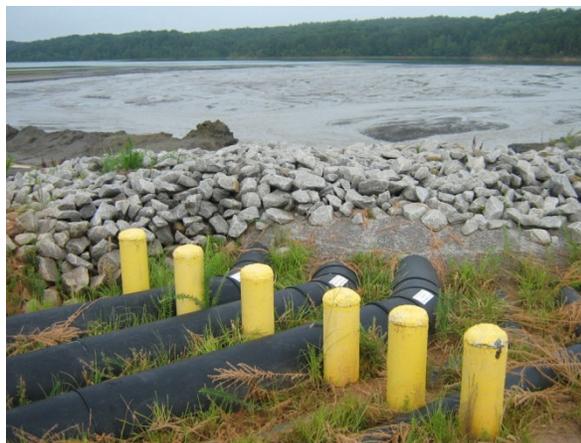
Photo 2: Ash Pond inlet

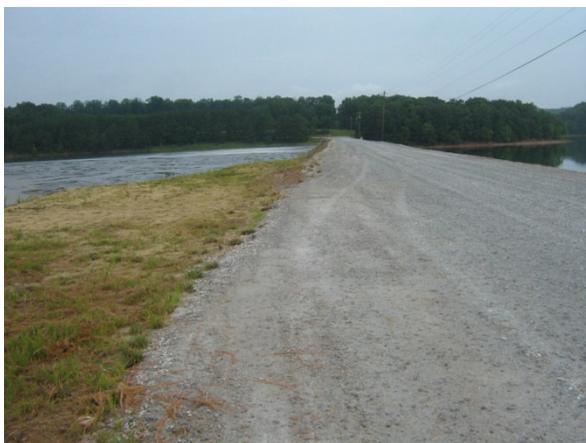
Photo 3: Separation Dike Crest facing North

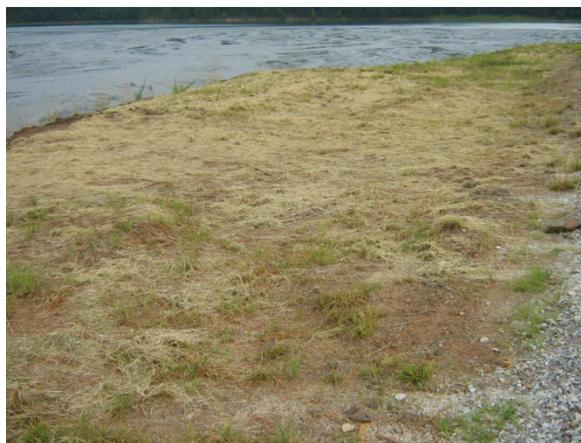
Photo 4: Close up where seeding occurred

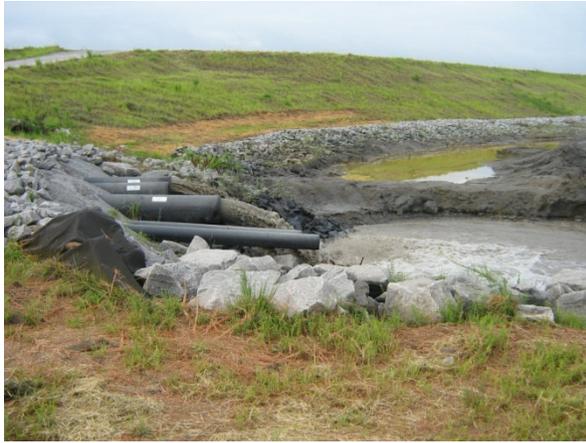
Photo 5: Ash Pond Inlet

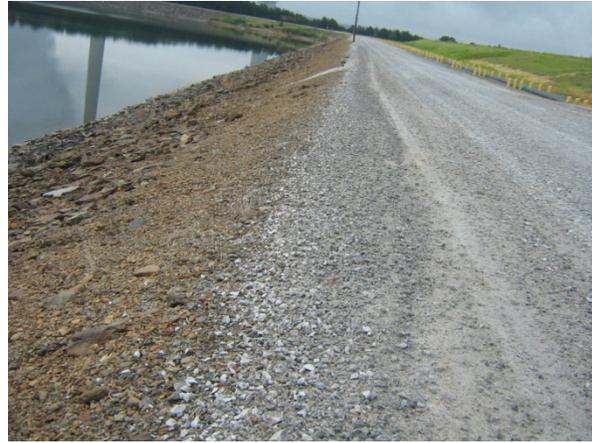
Photo 6: Separation Dike Crest downstream slope

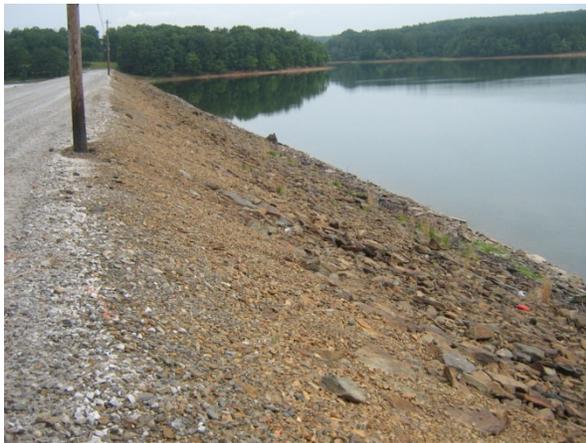
Photo 7: Separation Dike downstream slope

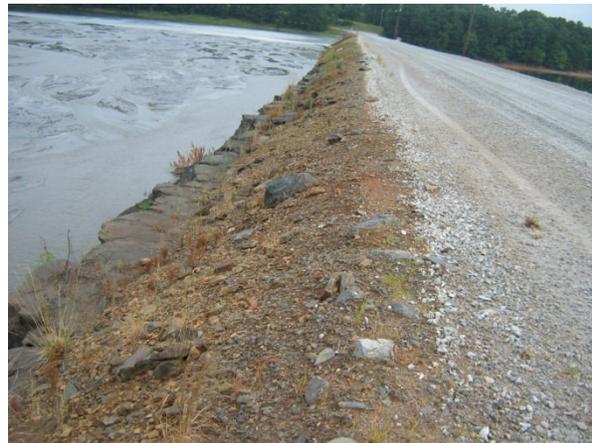
Photo 8: Separation Dike upstream slope

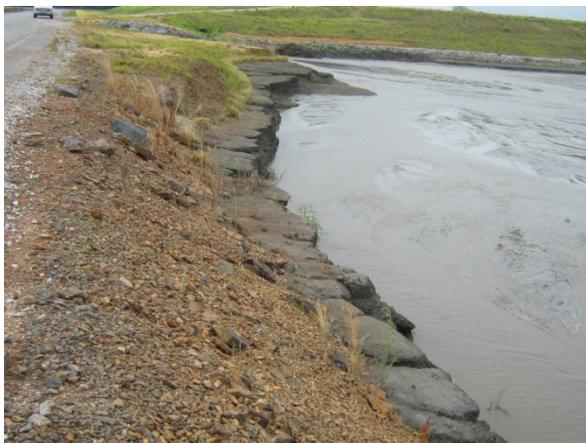
Photo 9: Separation Dike upstream slope

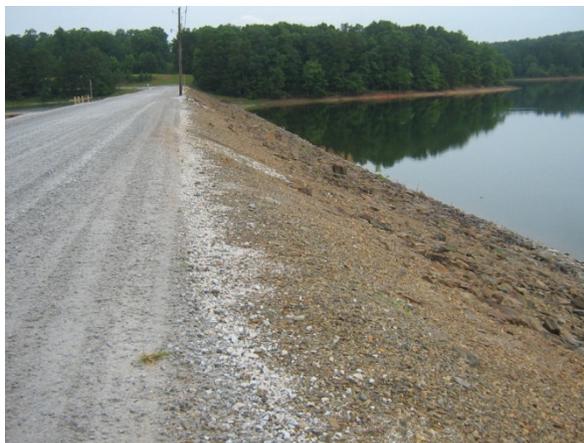
Photo 10: Separation Dike downstream slope

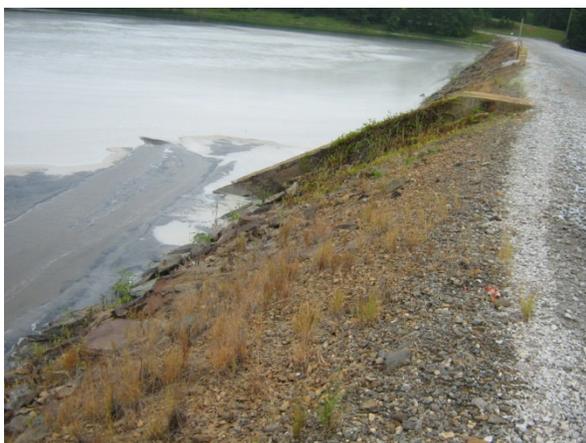
Photo 11: Separation Dike upstream slope

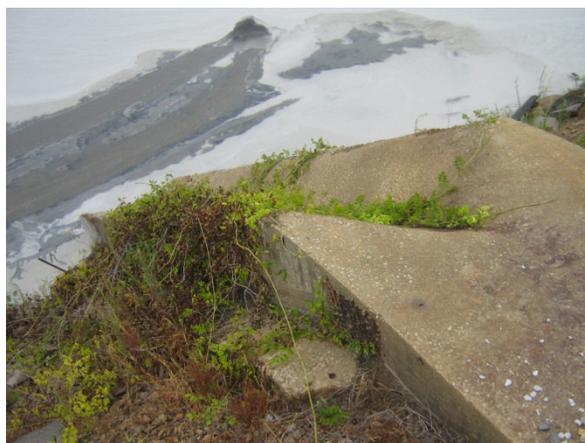
Photo 12: Concrete ash piping support (not in use)

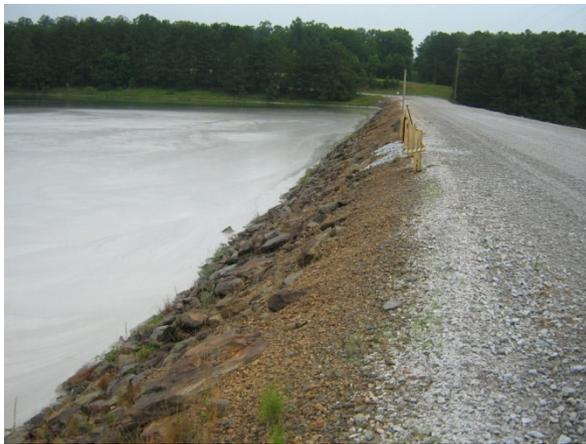
Photo 13: Separation Dike upstream slope

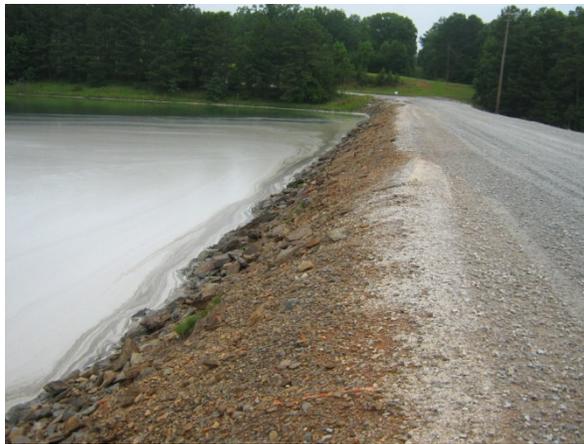
Photo 13B: Separation Dike upstream slope

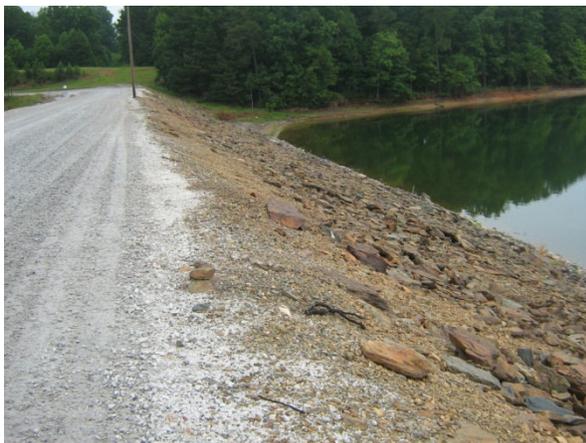
Photo 14: Separation Dike downstream slope

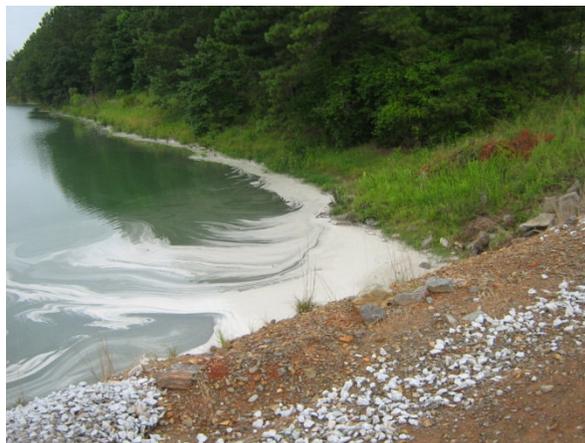
Photo 15: Separation Dike left abutment upstream side

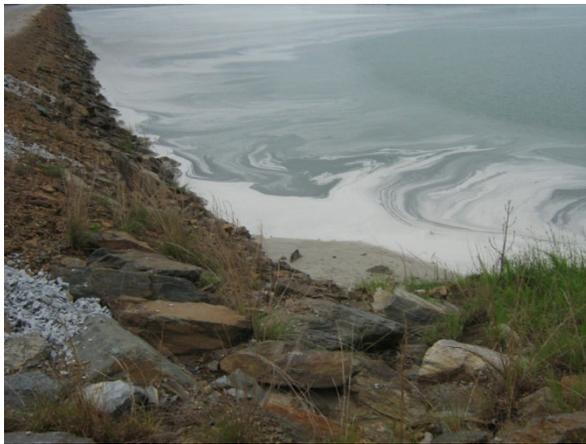
Photo 16: Separation Dike left abutment upstream side
