**Coal Combustion Waste Impoundment
Round 5 - Dam Assessment Report**

Plant Wansley

Ash Pond Separation Dike

*Georgia Power
Carrolton, Georgia*

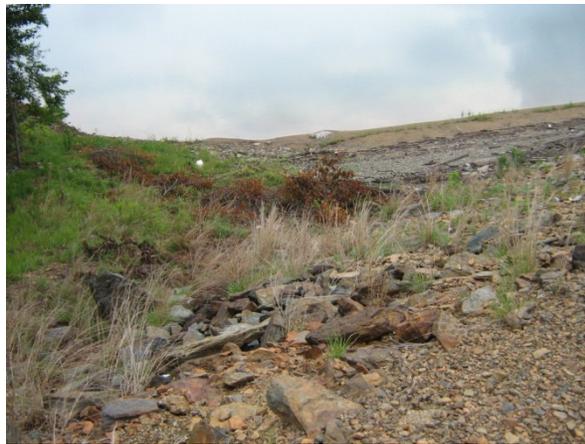
Photo 17: Separation Dike left abutment downstream side

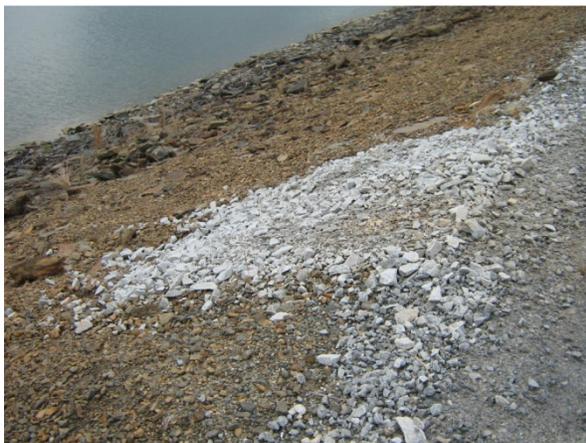
Photo 18: Erosion maintenance

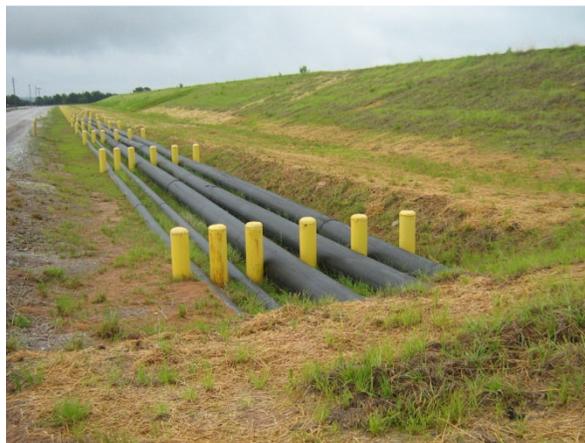
Photo 19: Influent piping

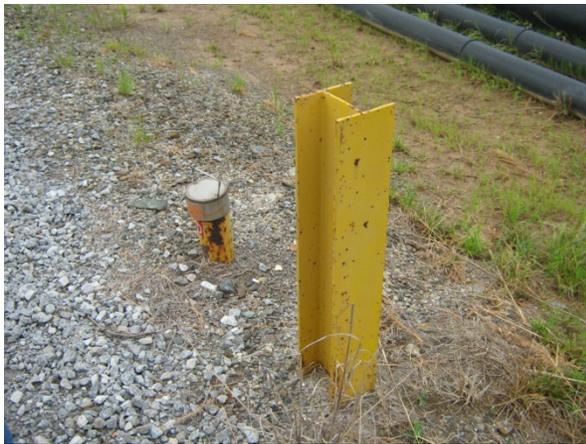
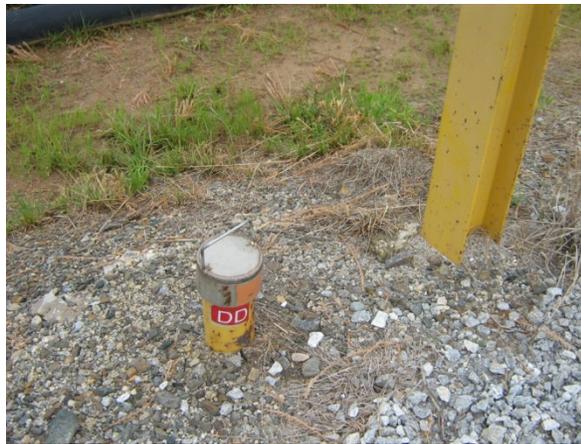
Photo 20: Piezometer DD

Photo 21: Piezometer DD

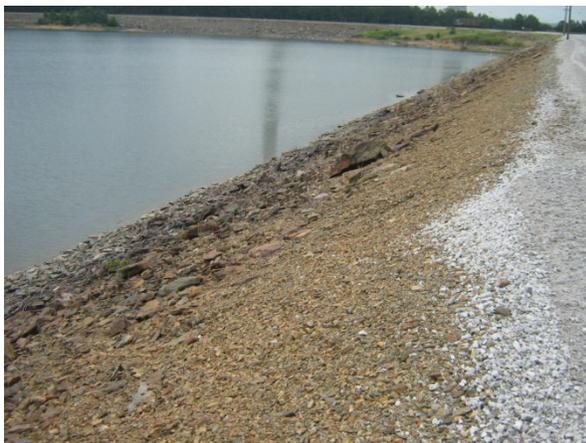
Photo 22: Separation Dike downstream slope

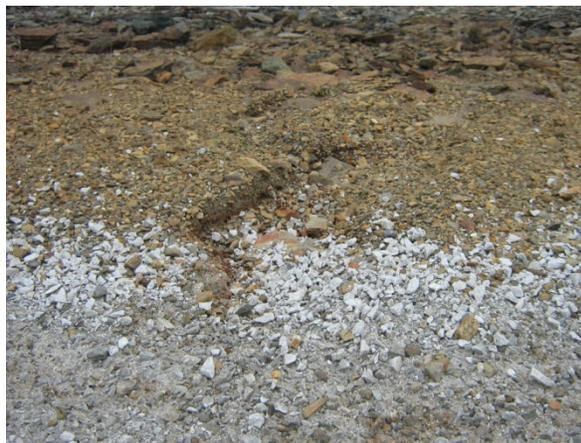
Photo 23: Close up of downstream slope

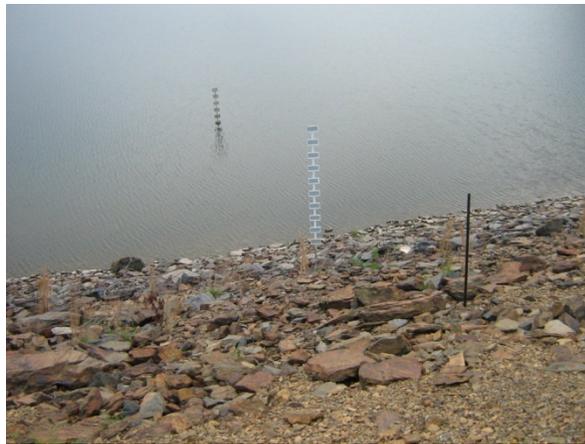
Photo 25: Reservoir pond levels

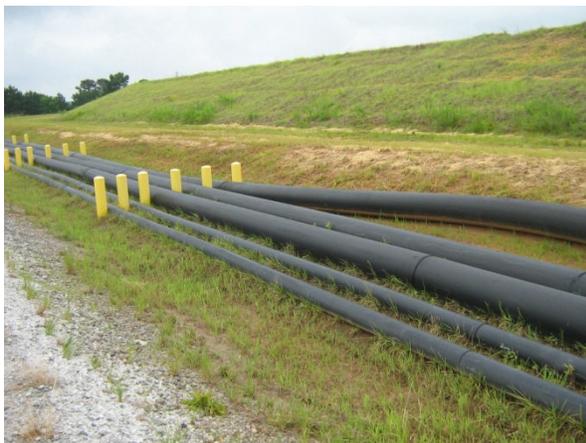
Photo 26: Influent piping facing Gypsum Cells

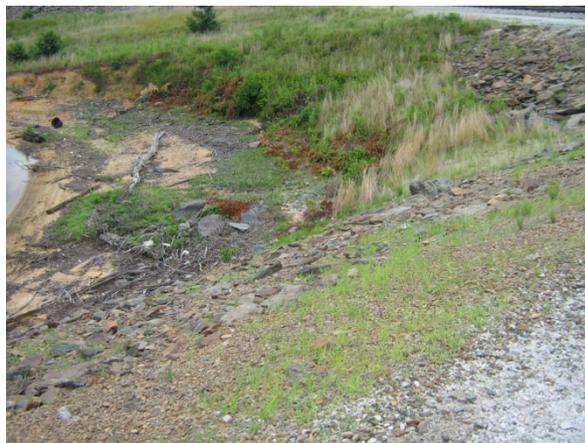
Photo 27: Right abutment downstream slope

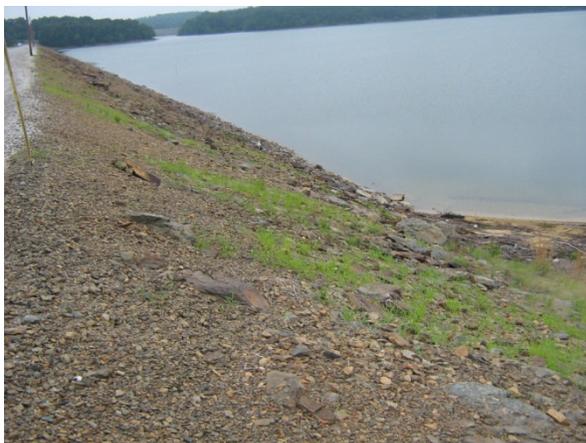
Photo 28: Separation Dike downstream slope

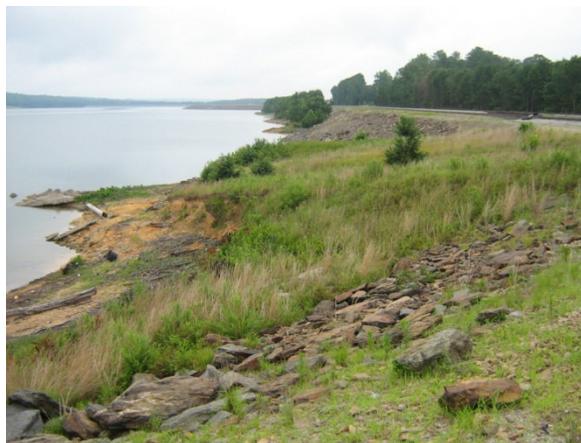
Photo 29: Right abutment facing reservoir

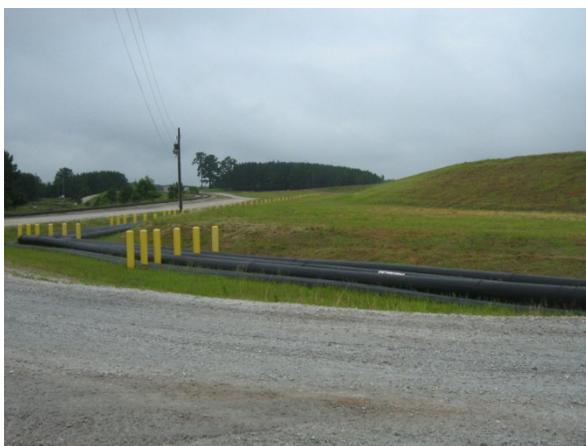
Photo 30: Influent piping

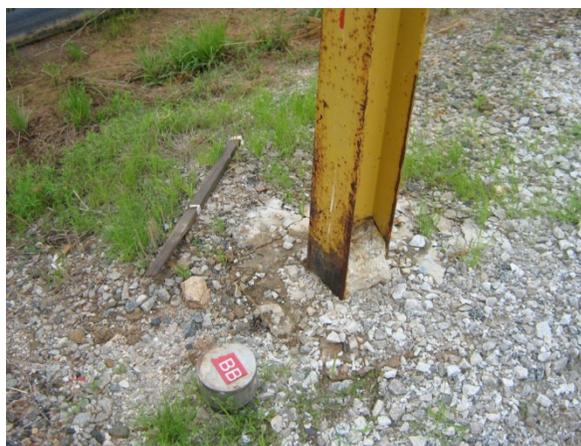
Photo 31: Piezometer BB

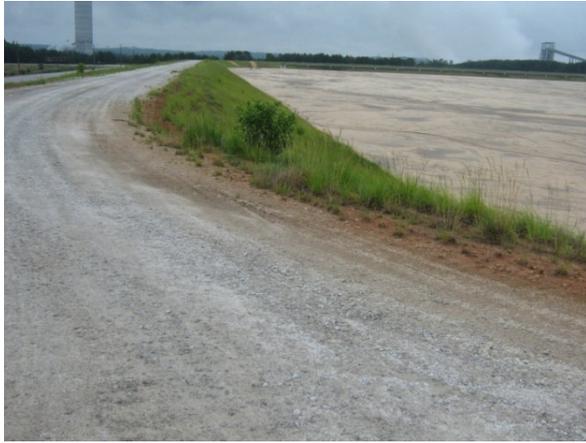
Photo 32: Gypsum Cell upstream slope

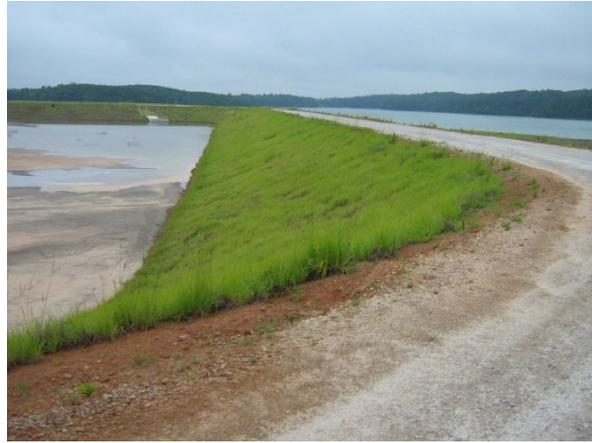
Photo 33: Gypsum Cell upstream slope

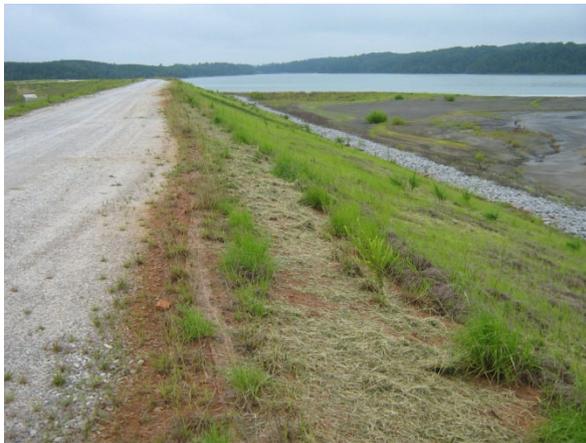
Photo 34: Gypsum Cell downstream slope facing Ash Pond

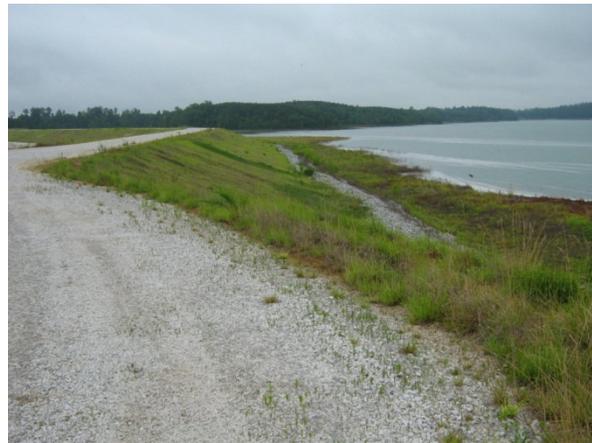
Photo 35: Gypsum Cell downstream slope facing Ash Pond

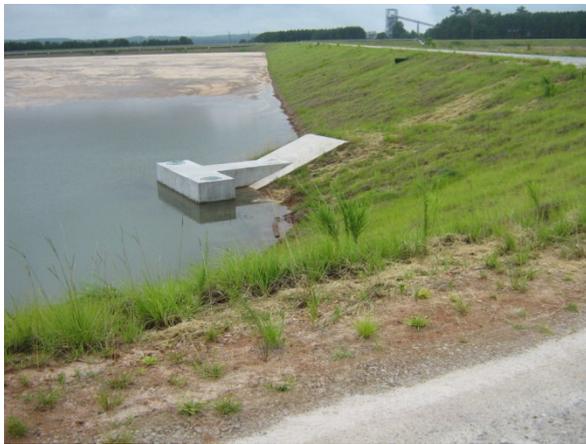
Photo 36: Gypsum Cell Discharge

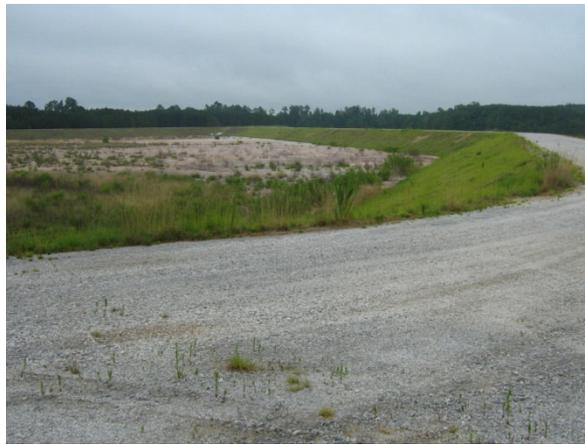
Photo 37: Gypsum Cell upstream slope

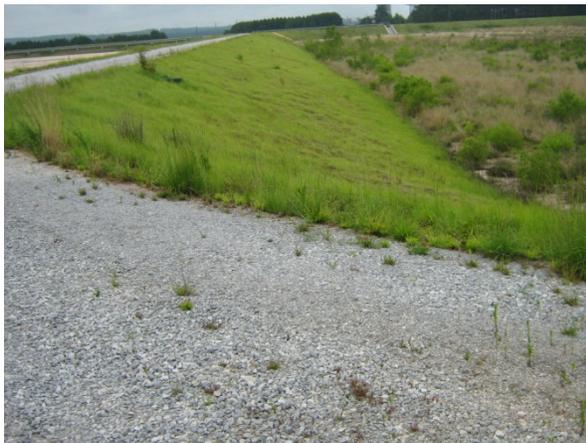
Photo 38: Gypsum Cell upstream slope

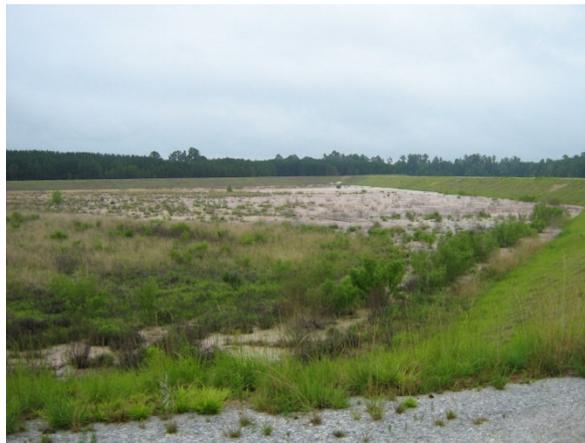
Photo 39: Gypsum Cell upstream slope

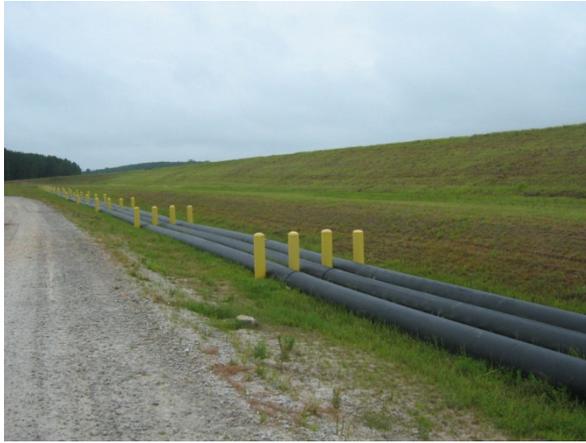
Photo 40: Gypsum Cell downstream slope

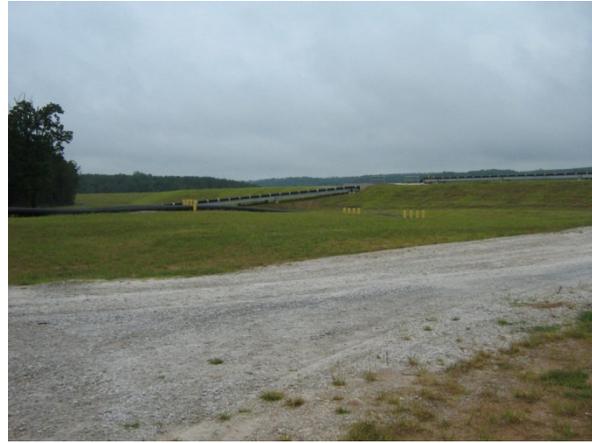
Photo 41: Gypsum Cell downstream slope

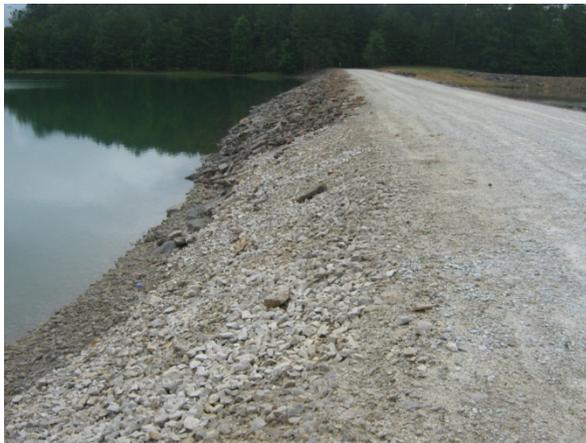
Photo 42: Western Dike downstream slope

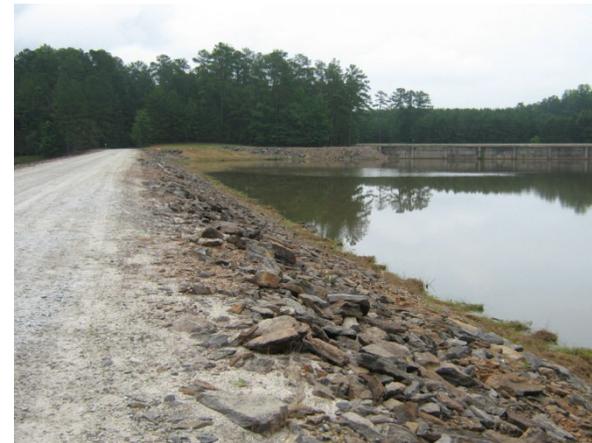
Photo 43: Western Dike downstream slope

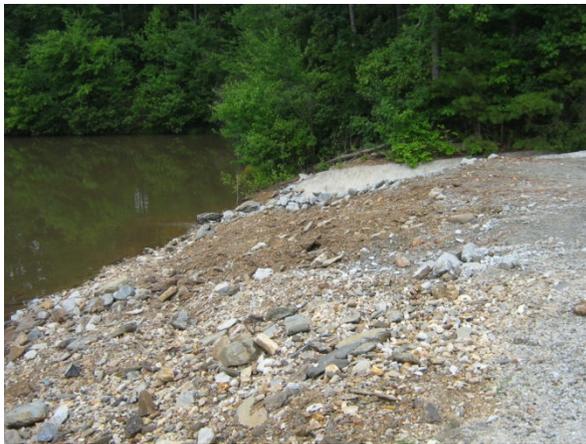
Photo 44: Western Dike downstream slope

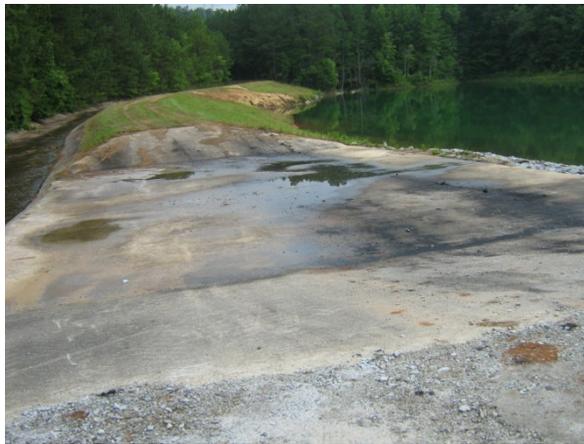
Photo 45: Western Dike overflow spillway

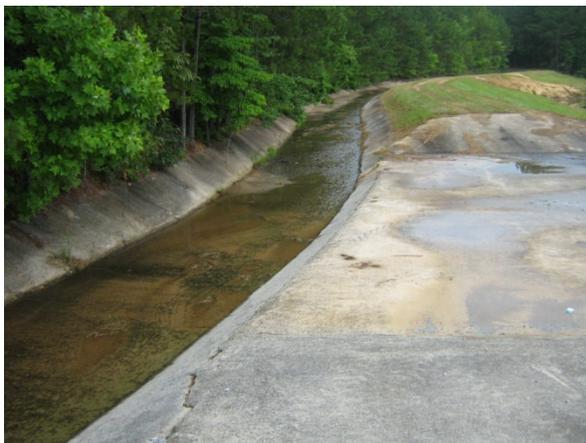
Photo 46: Stormwater channel

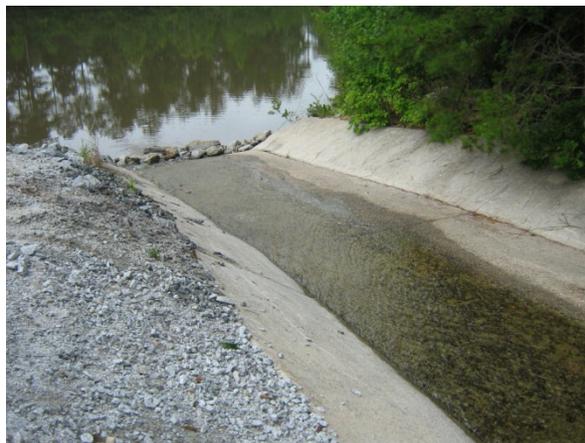
Photo 47: Stormwater channel discharge

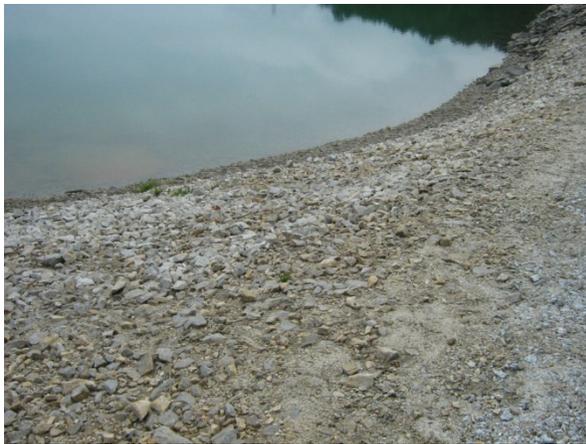
Photo 48: Western Dike upstream slope

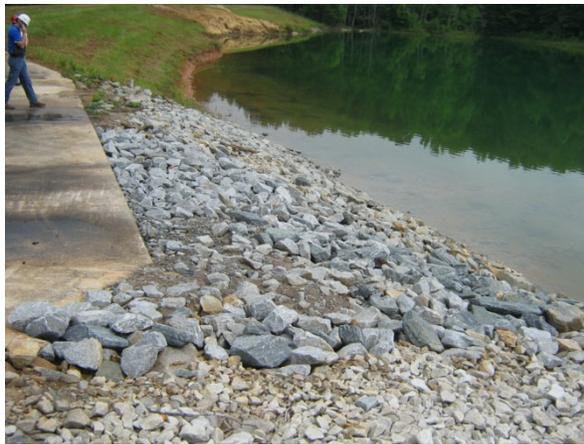
Photo 49: Western Dike upstream slope

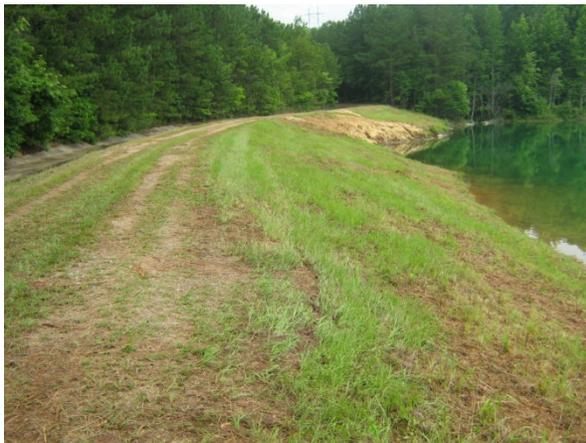
Photo 50: Area adjacent to Western Dike

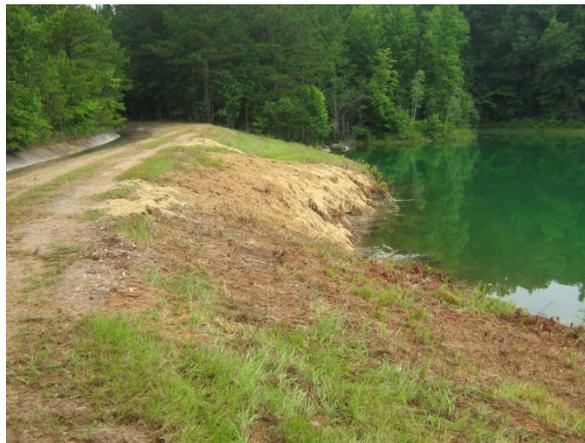
Photo 51: Area adjacent to Western Dike

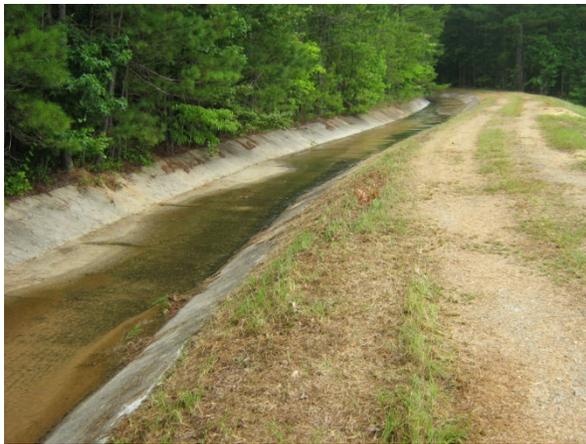
Photo 52: Stormwater Channel

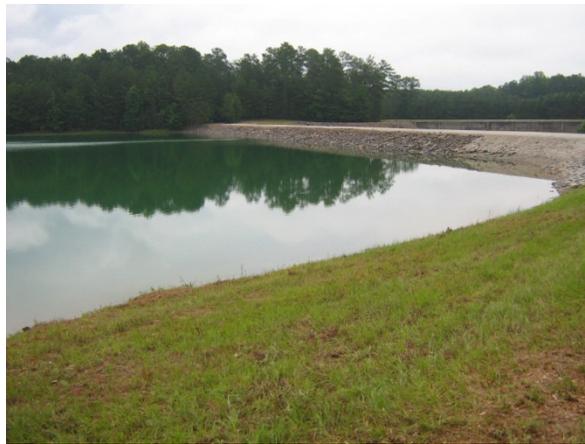
Photo 53: Western Dike upstream slope

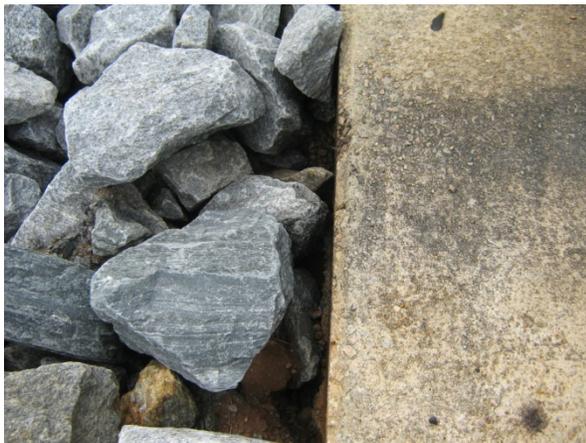
Inspection Issue #	Comments
1.	<u>Daily; Weekly; Quarterly; and Annual</u>
2.	<u>N.P. WSE 795.0</u>
15.	<u>MONITOR U/S UNDERMINING POTENTIAL & CRACKS ALONG CONCRETE CHANNEL (NOT A SAFETY ISSUE AT THIS TIME)</u>
20.	<u>NO DISCHARGE FROM POND (NONE OBSERVED HISTORICALLY)</u>
23.	<u>COOLING WATER POND & STORM WATER MANAGEMENT POND LOCATED ALONG D/S TOE OF E & W DIKE RESPECTIVELY</u>

Photo 54: Potential undermining at overflow

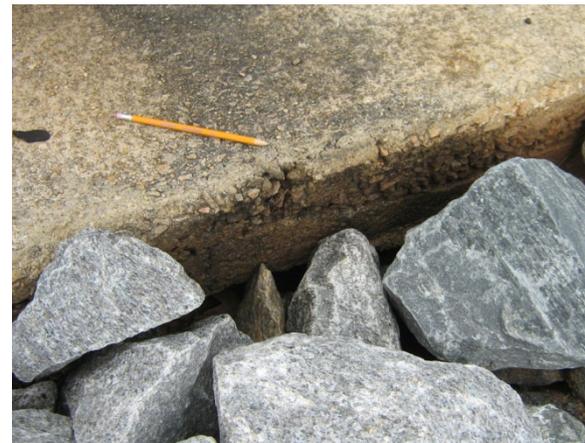
Photo 55: Potential undermining at overflow

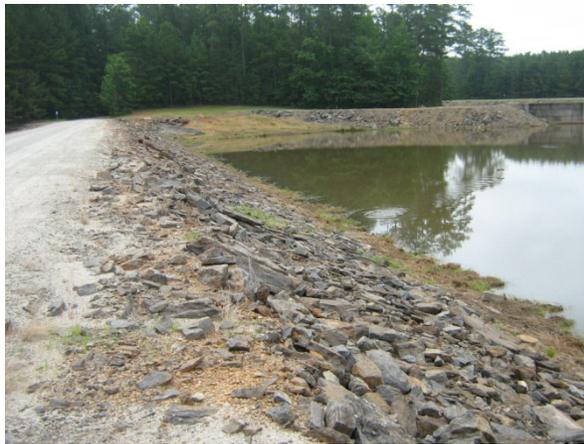
Photo 57: Western Dike downstream slope

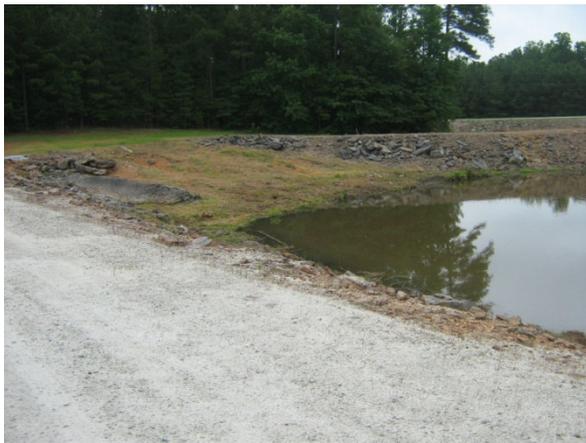
Photo 58: Western Dike downstream slope

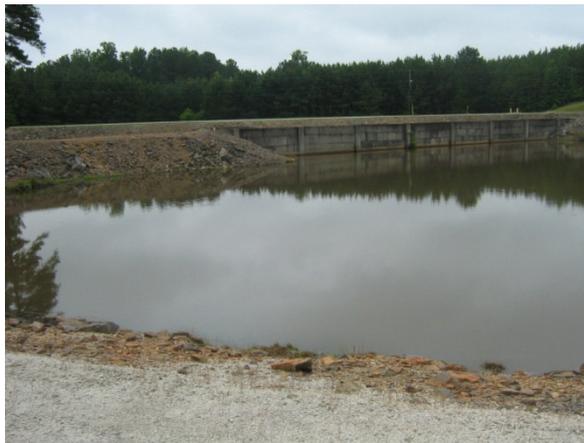
Photo 59: Stormwater Pond Dam

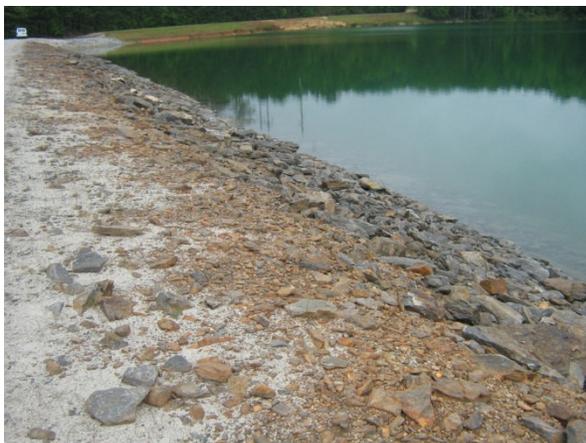
Photo 60: Stormwater pond

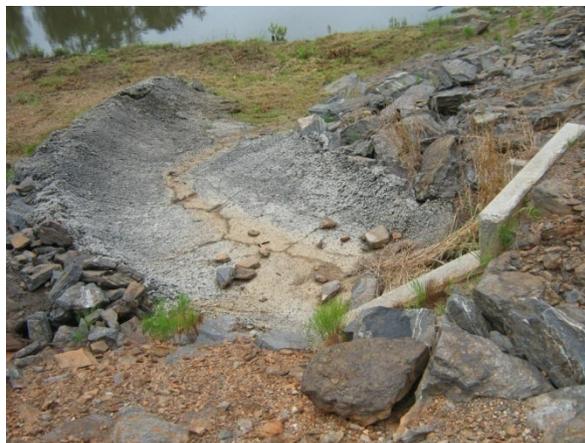
Photo 61: Western Dike outlet at Stormwater pond

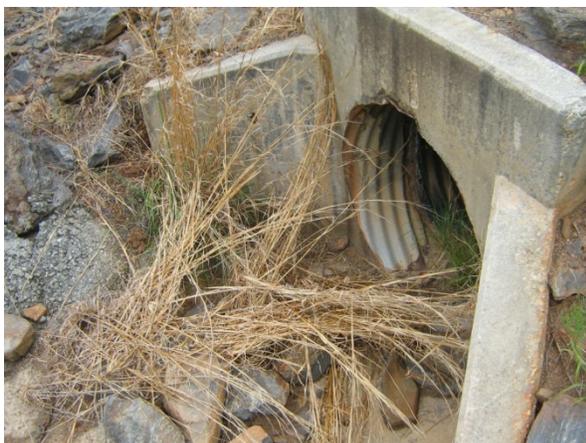
Photo 62: Outlet at Stormwater pond

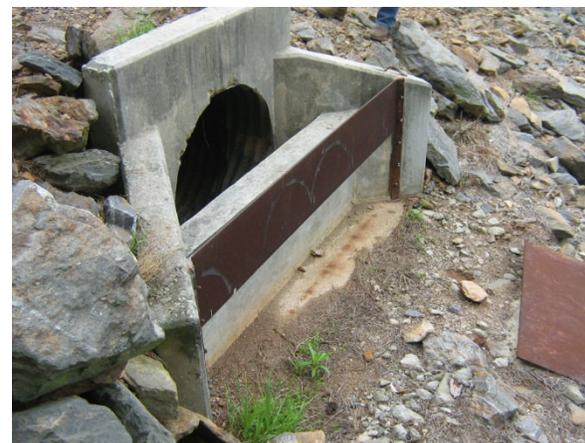
Photo 63: Western Dike outlet

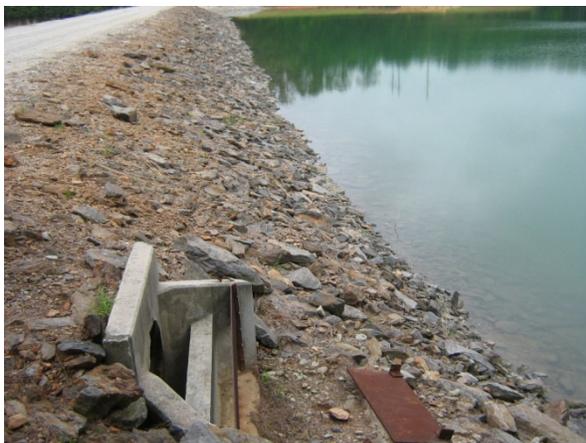
Photo 64: Western Dike upstream slope and outlet
