Report of Geotechnical Investigation  
Dam Safety Assessment of Coal Combustion  
Surface Impoundments  
Georgia Power  
Plant Yates, Newnan, GA

AMEC Project No. 3-2106-0174.0400

June 2010

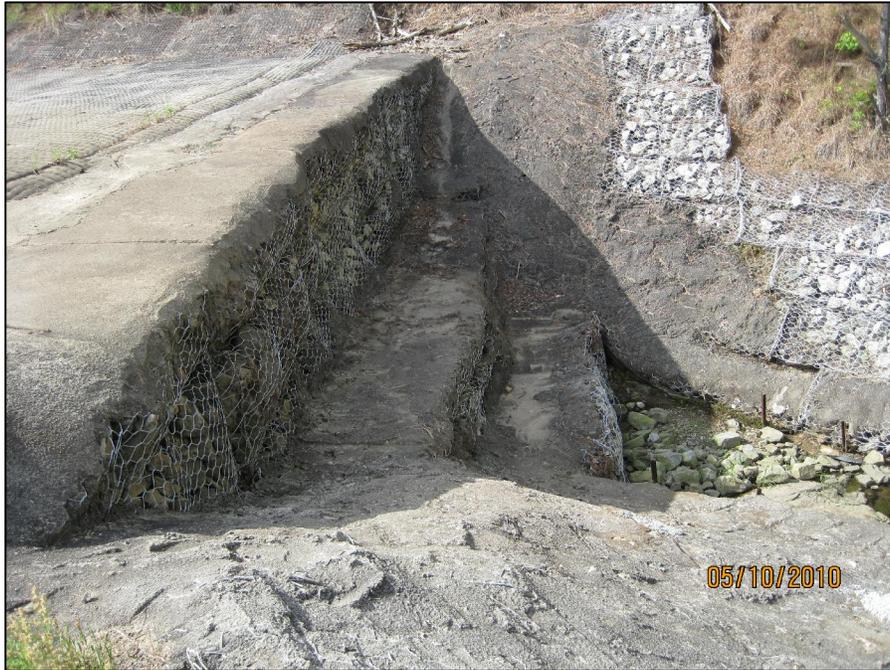
**2-3**  
**SPILLWAY OUTFALL**

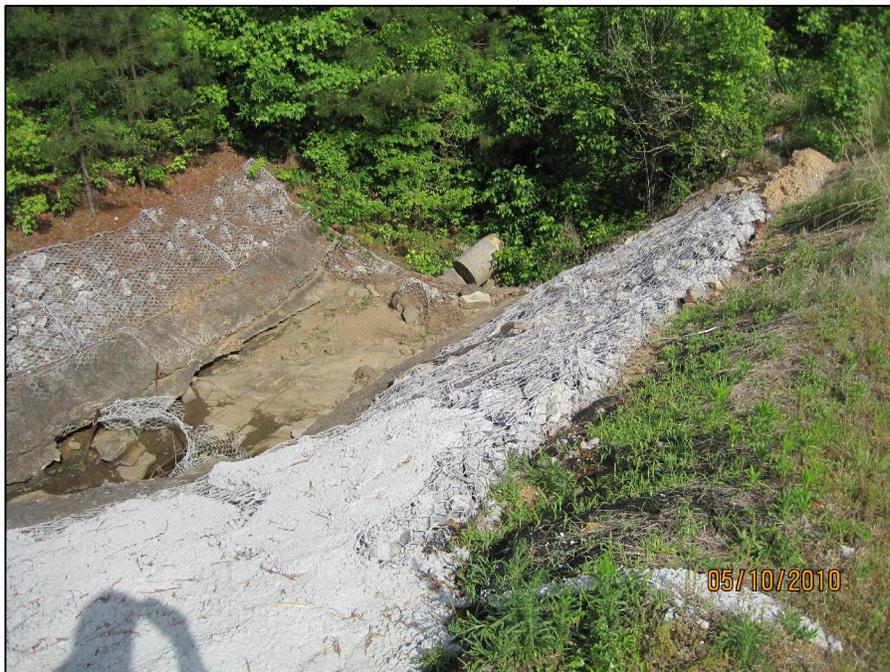
**2-4**  
**SPILLWAY EXIT, ROCK IN BOTTOM**

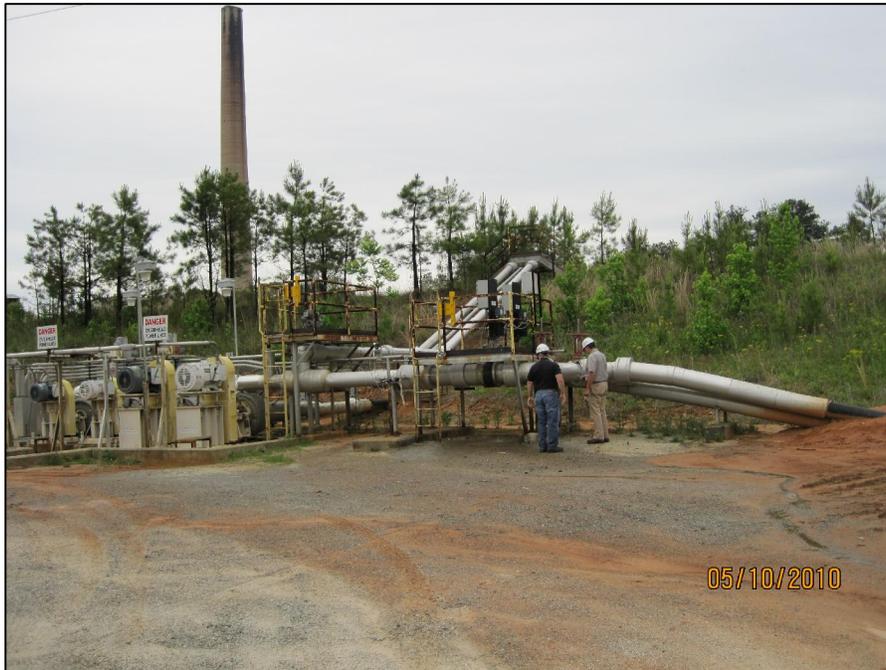
**GP-4**

**GP PUMP STATION AND PIPING LOCATED TO THE EAST OF LOWER BASIN**

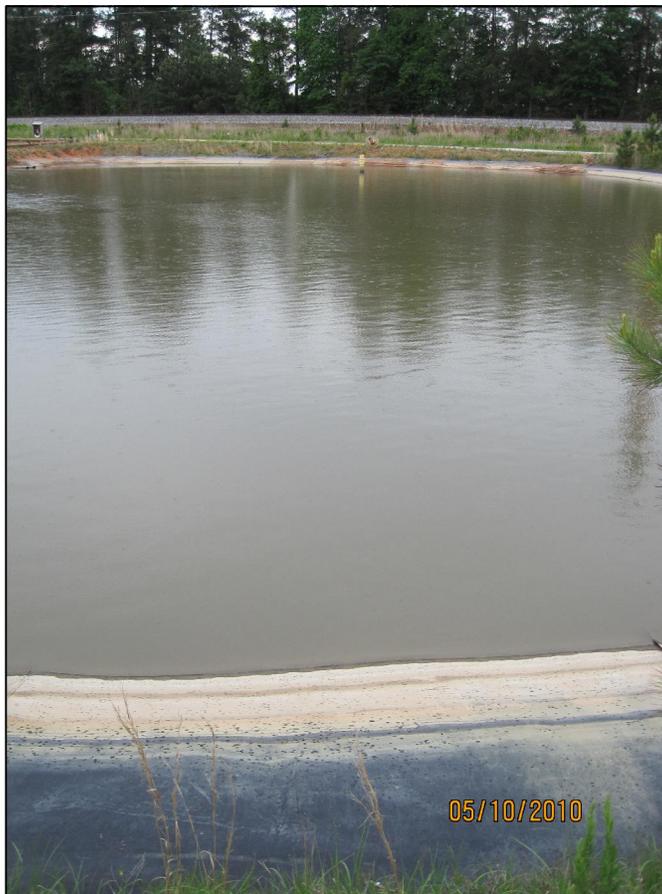
**GP-6**  
HDPE LINED LOWER BASIN

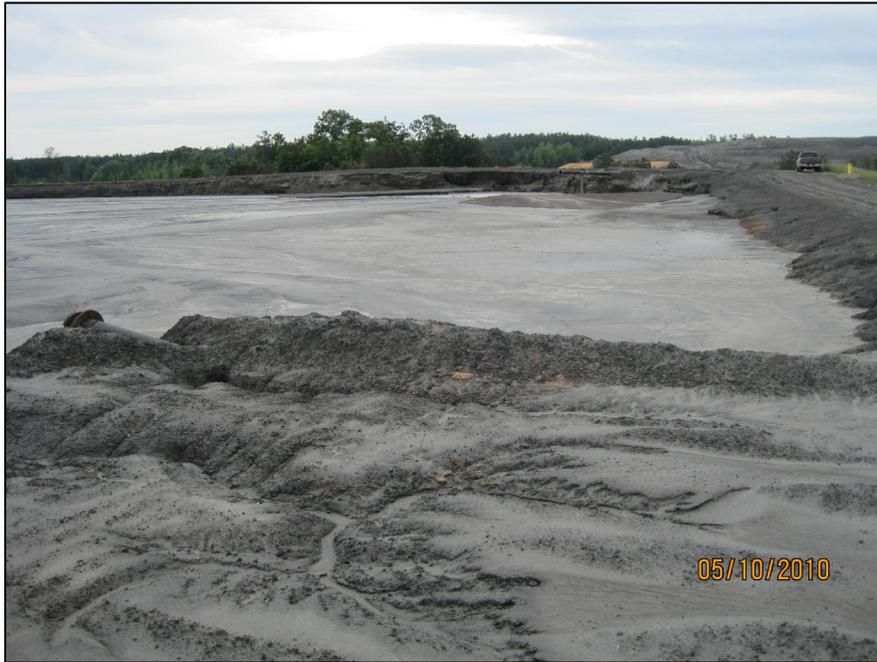
**B`-1**  
MIDDLE CELL

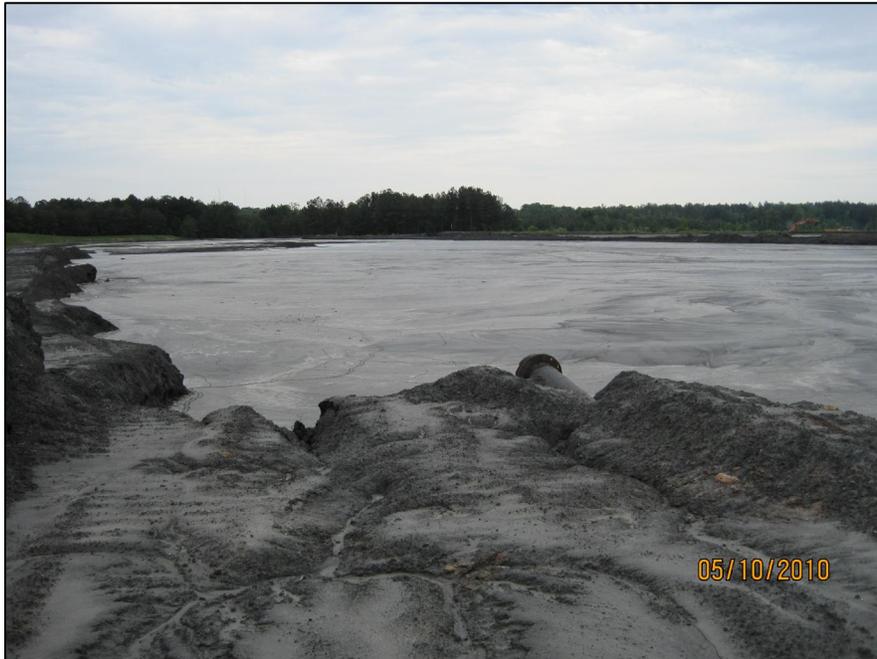
**B`-2**  
MIDDLE CELL

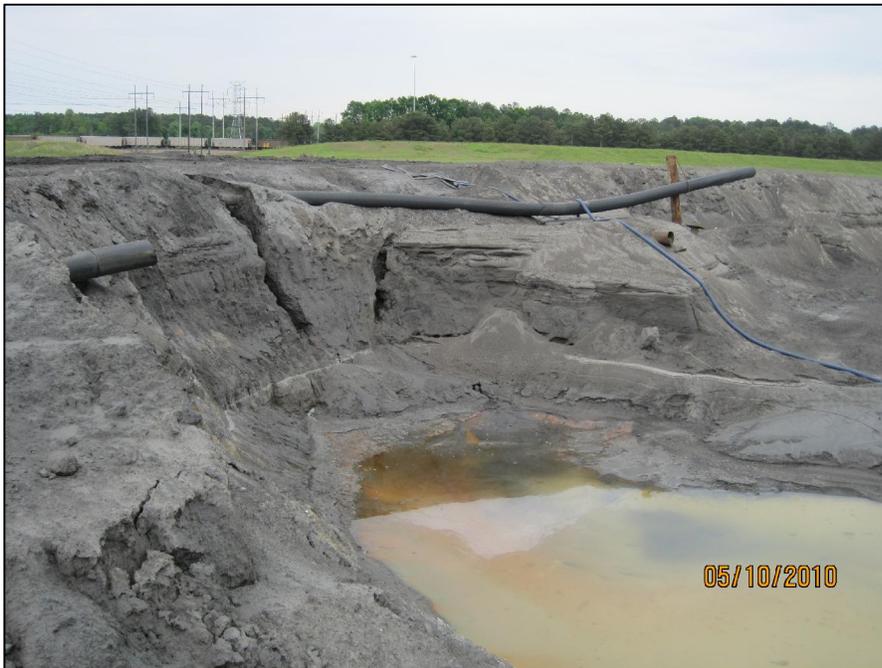
**B`-6**  
**SOUTH CELL**

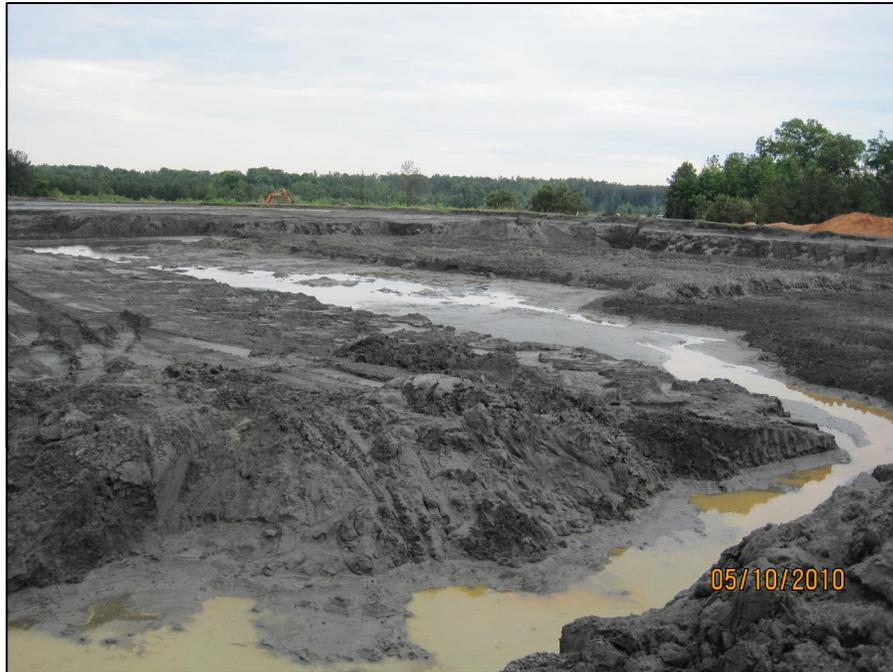
**B`-7**  
**SOUTH CELL**

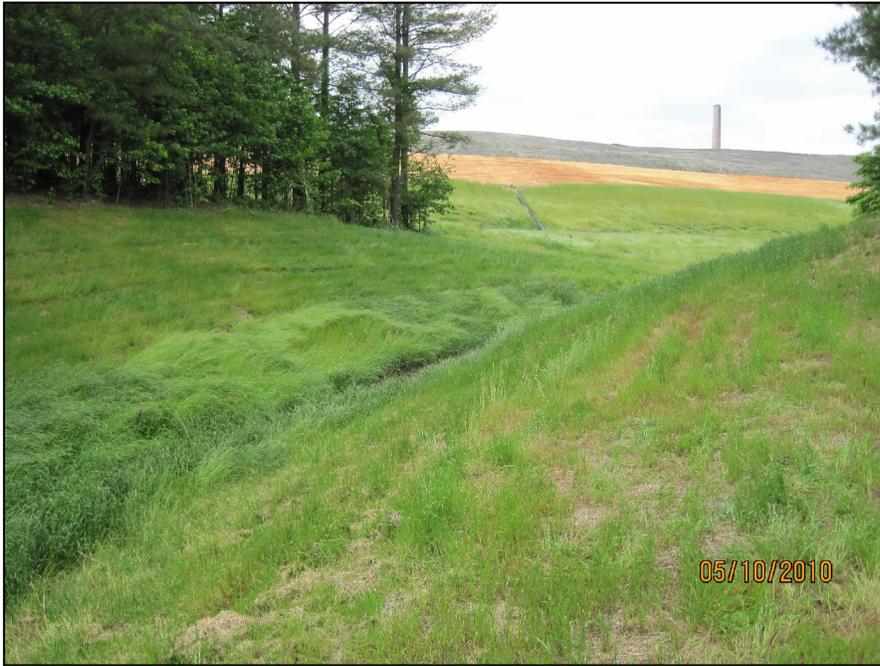
**3-3**  
**EMERGENCY SPILLWAY**

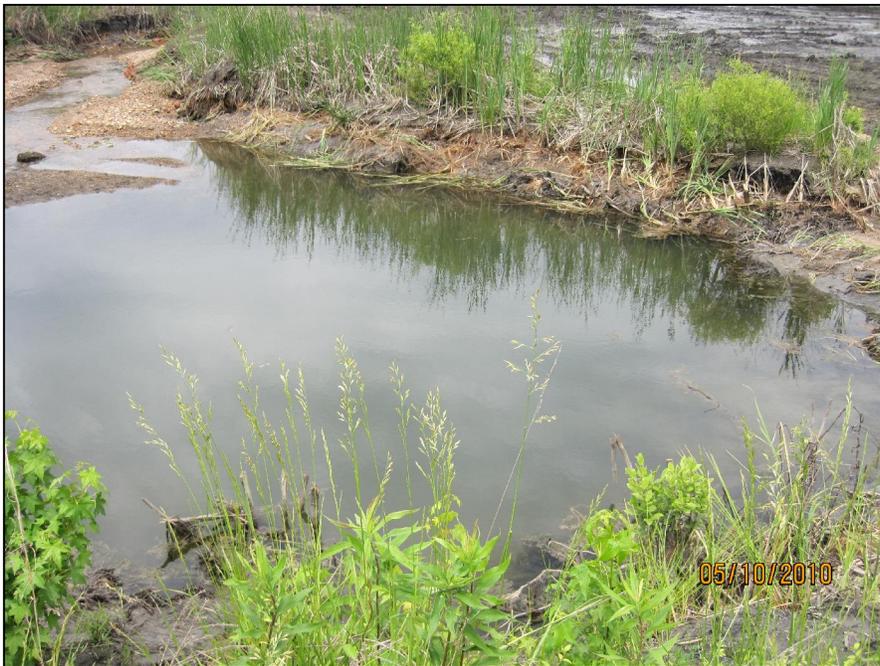
**3-4**  
**OUTLET OF DECANT PIPE TO DITCH**
