Report of
Dam Safety Assessment of Coal Combustion
Surface Impoundments
Georgia Power
Plant Yates, Newnan, GA

AMEC Project No. 3-2106-0174.0400

December 2010

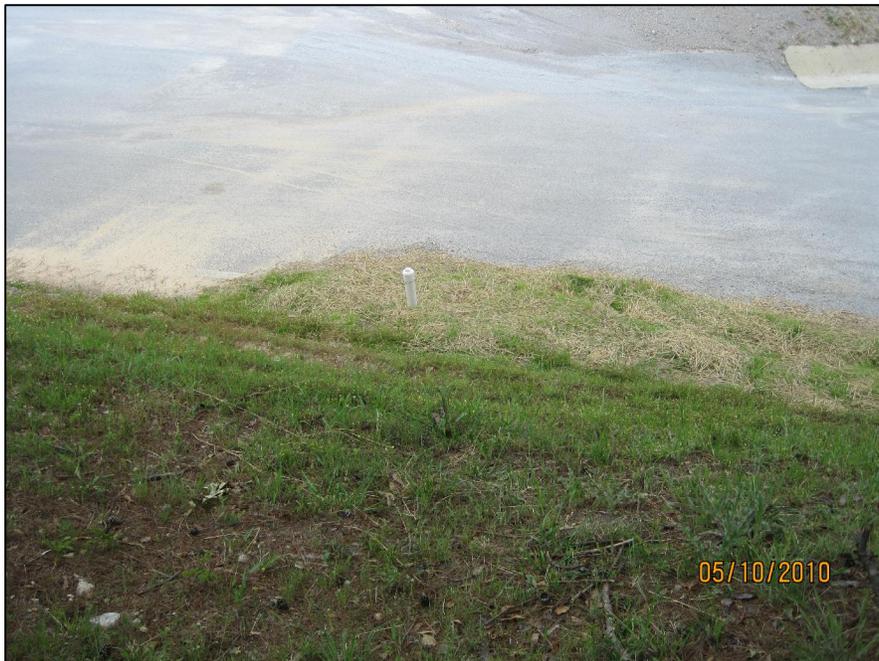
1-4

NEW PZ AT SEEPAGE REPAIR AREA ON ROAD AT TOE OF DOWNSTREAM SLOPE

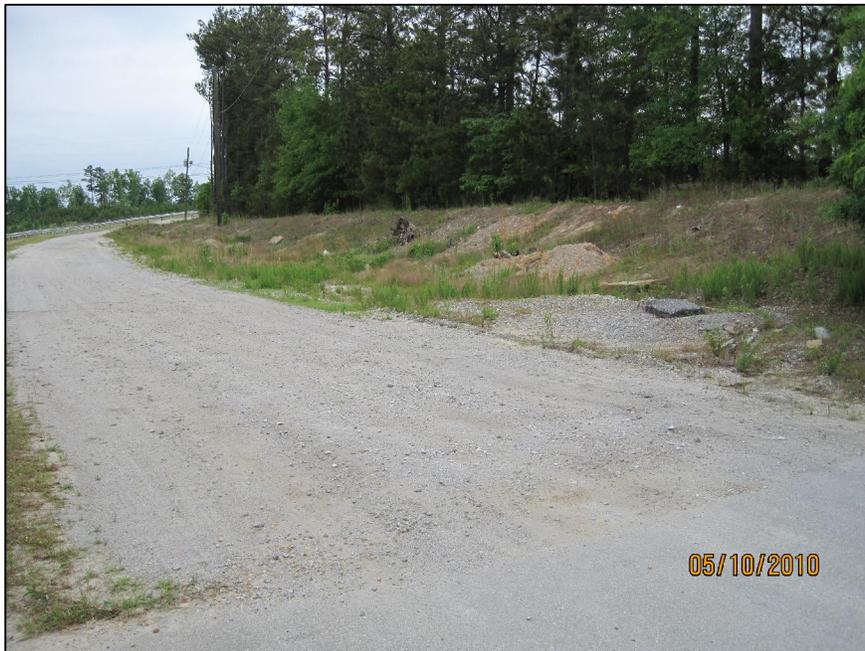
1-6

UPPER DOWNSTREAM SLOPE, DEBRIS PILES AND BARE AREAS

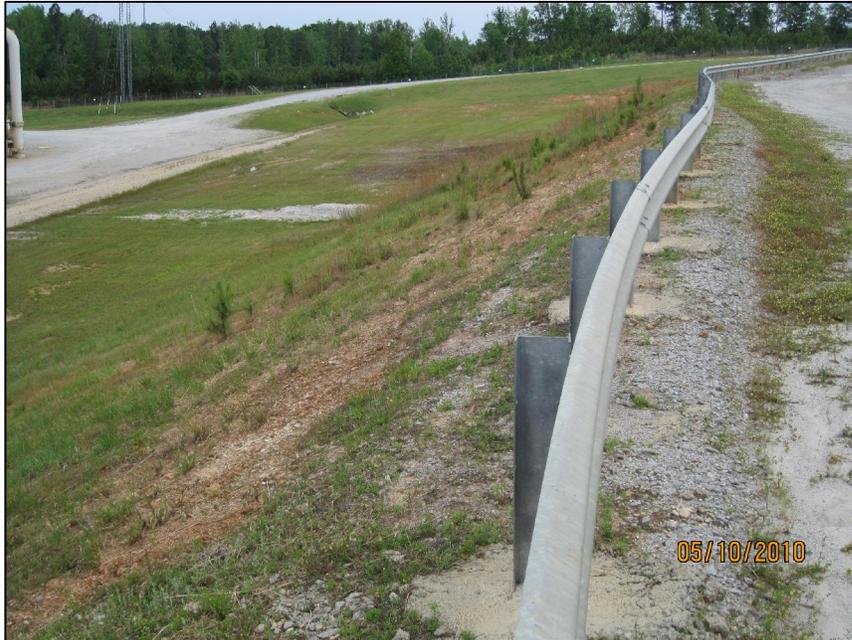
1-7

DOWNSTREAM SLOPE WEST OF ROAD AND ABOVE COOLING TOWERS, EROSION/STEEP SLOPE

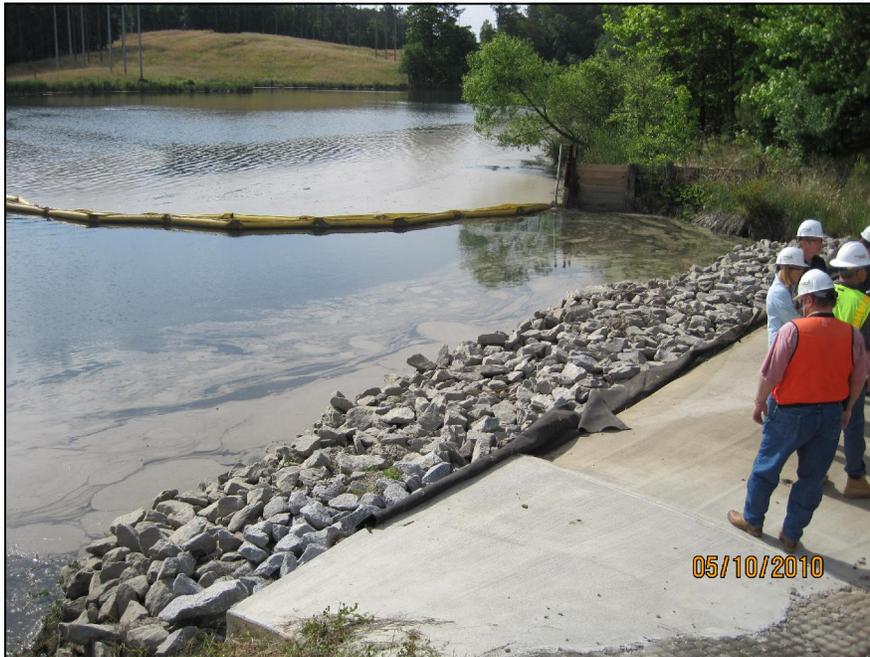
2-1
SPILLWAY ENTRANCE

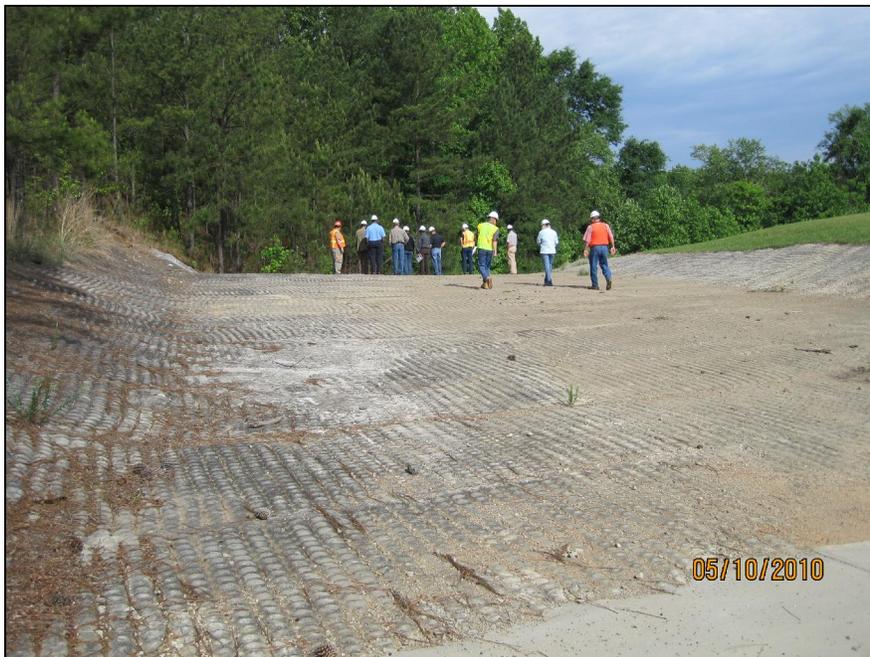
2-2
SPILLWAY CHANNEL LINED WITH CONCRETE FILLED FABRI-FORM®

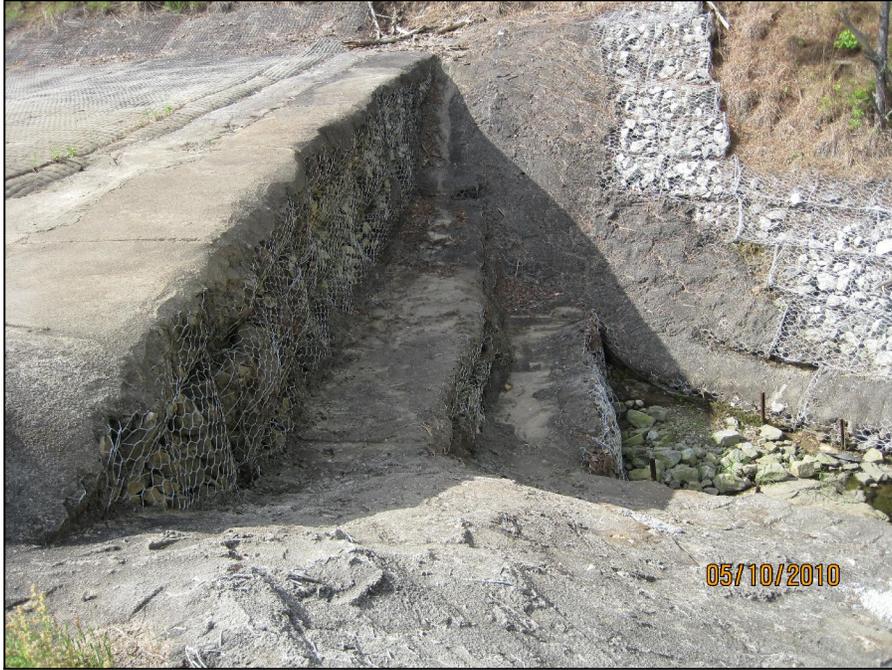
2-3
SPILLWAY OUTFALL

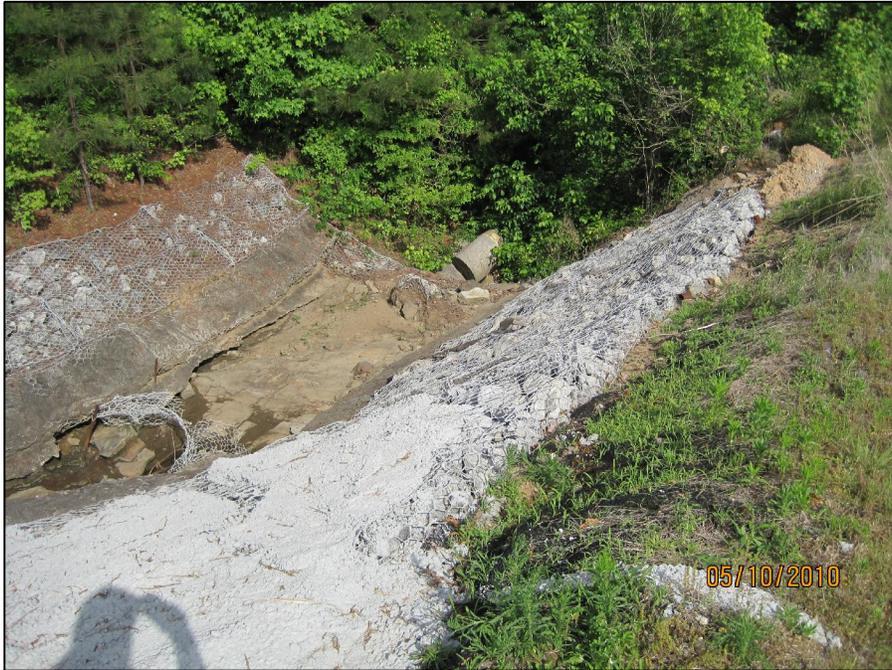
2-4
SPILLWAY EXIT, ROCK IN BOTTOM

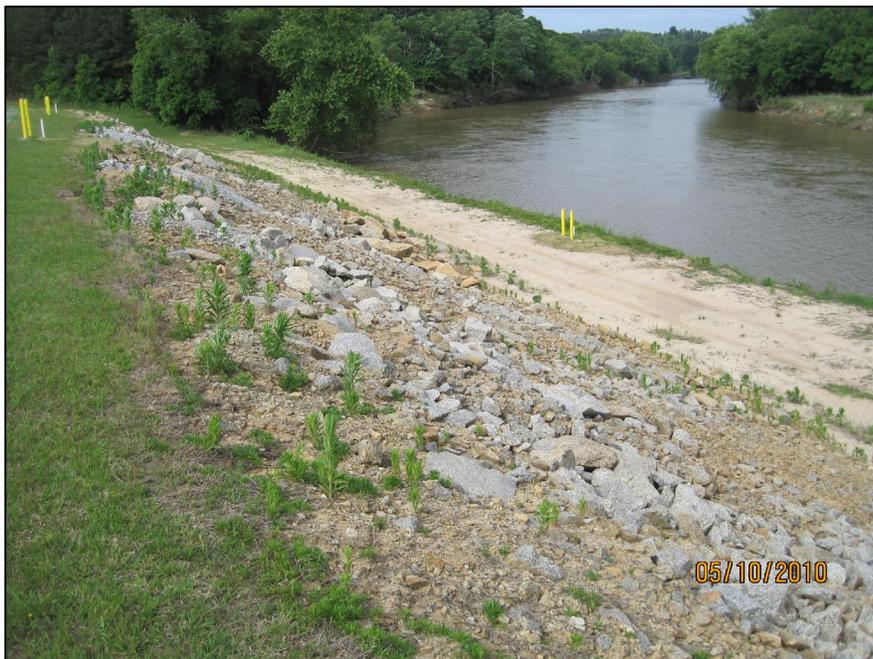
2-6

MIDDLE DOWNSTREAM SLOPE, PZ LOCATIONS TOP AP2-2D & AP2-2S

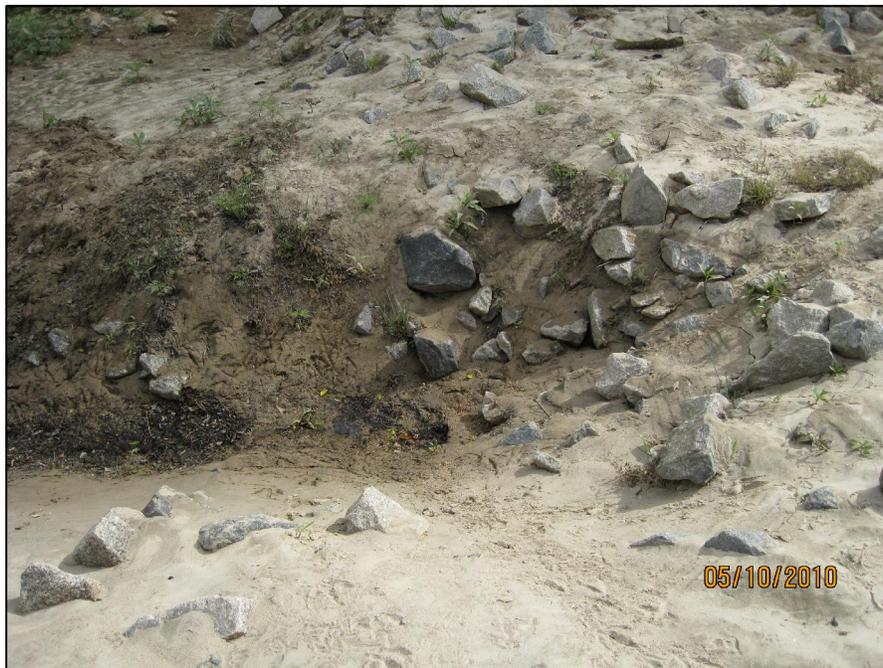
2-8

SILT IN SURFACE DRAIN OUTLET AT RIVER IN LEFT ABUTMENT AREA

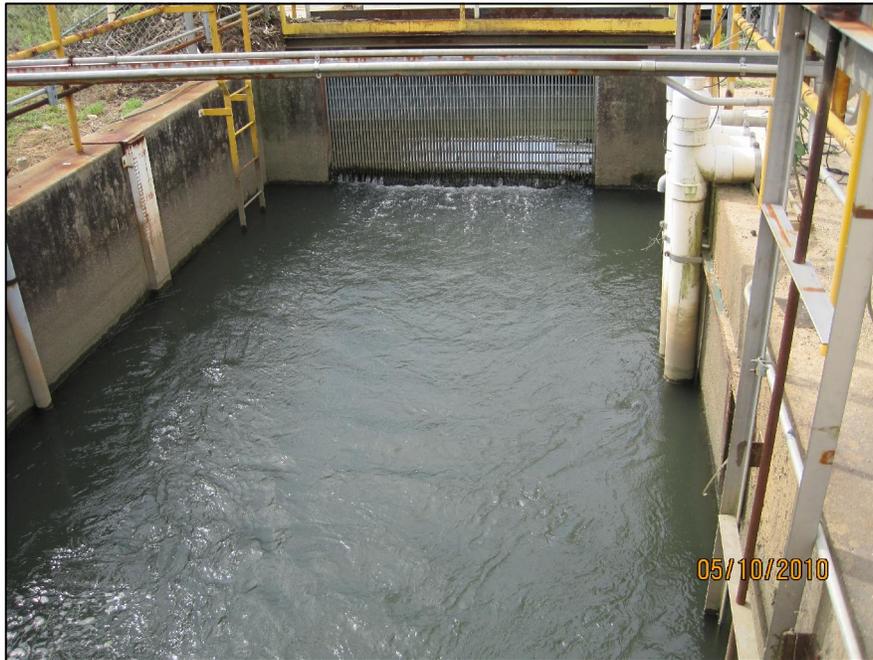
2-11
OUTLET POND #2 HOLDING TANK (PLANT DISCHARGE THROUGH #2)

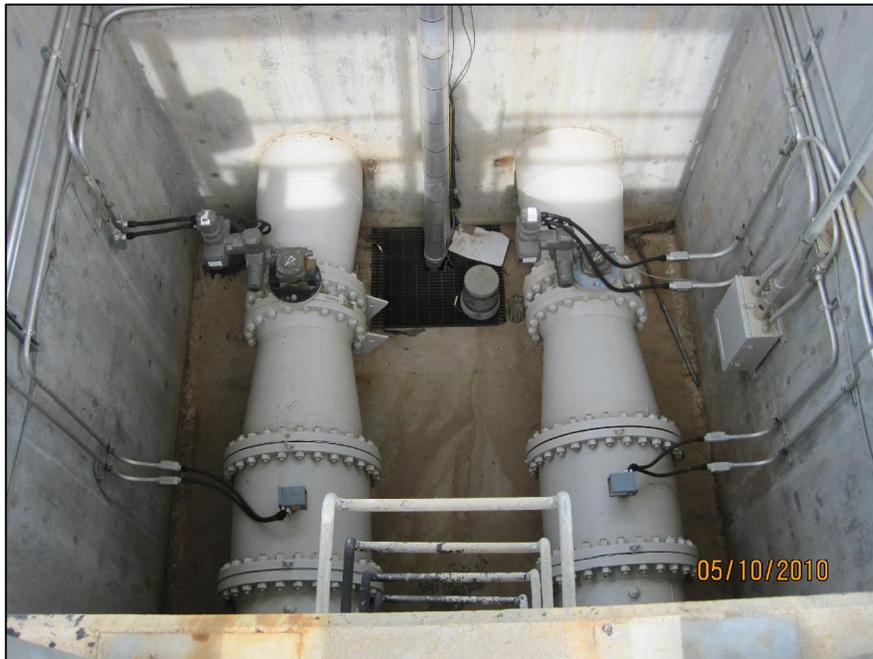
2-12
OUTLET POND #2 PIPE AND VALVES IN PIT

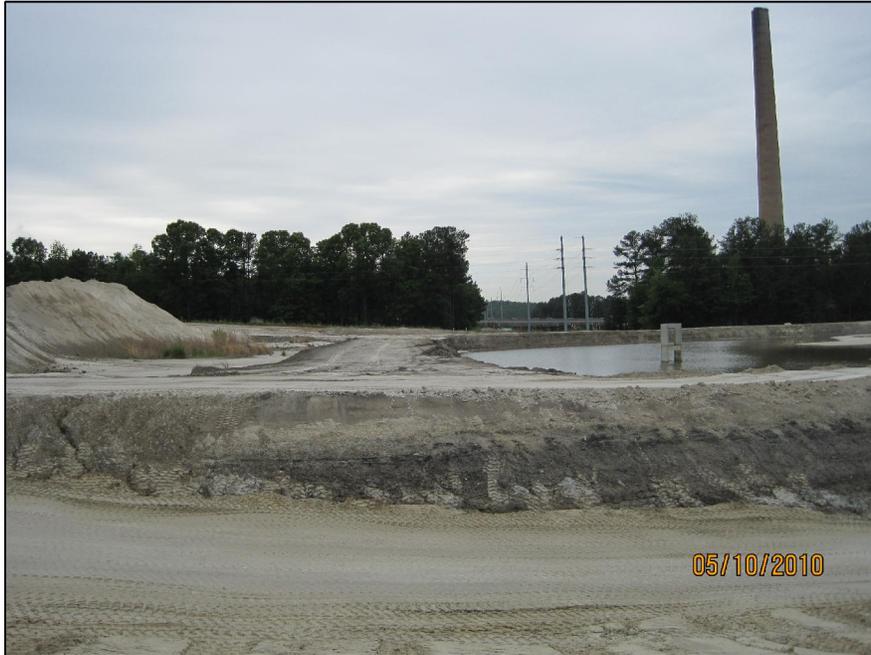
GP-1
TOP OF UPPER BASIN

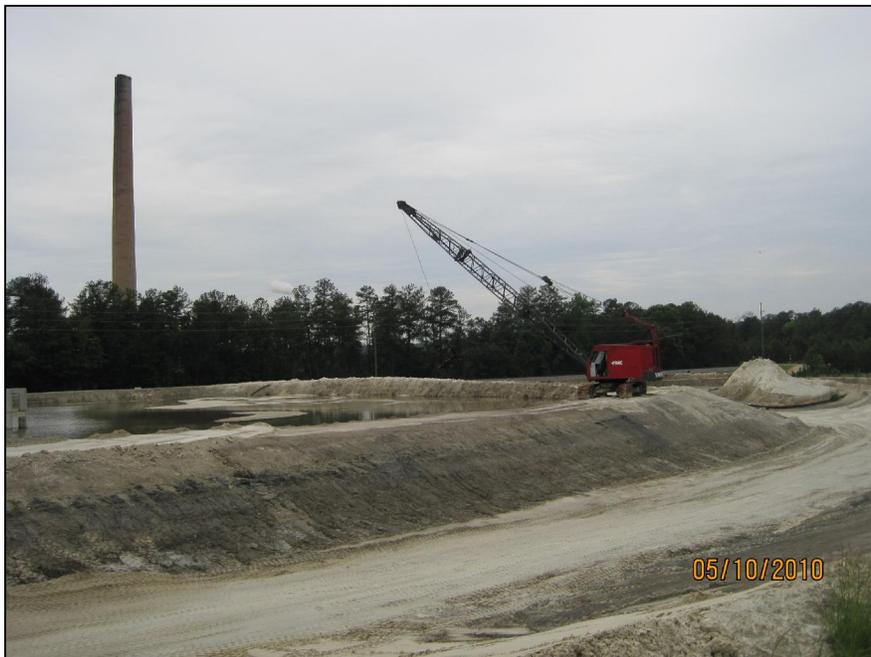
GP-2
BOTTOM OF UPPER BASIN - MIDDLE AND LOWER BASIN (NOT VISIBLE) TO RIGHT

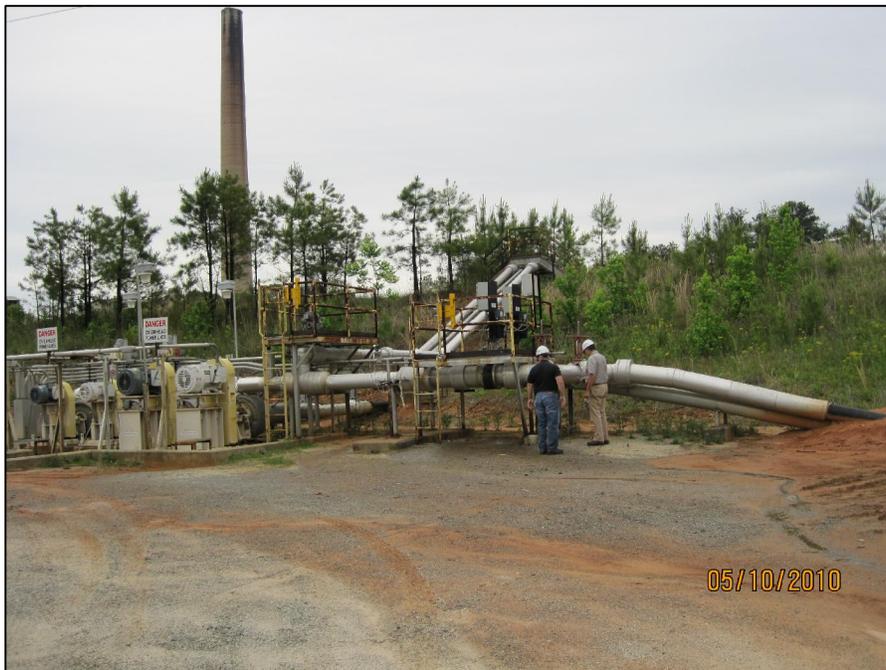
GP-4

GP PUMP STATION AND PIPING LOCATED TO THE EAST OF LOWER BASIN

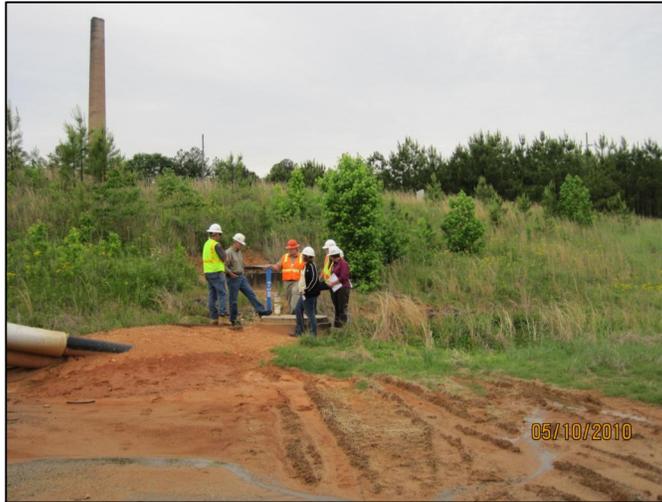
GP-5
SLOPE TO EAST OF LOWER BASIN

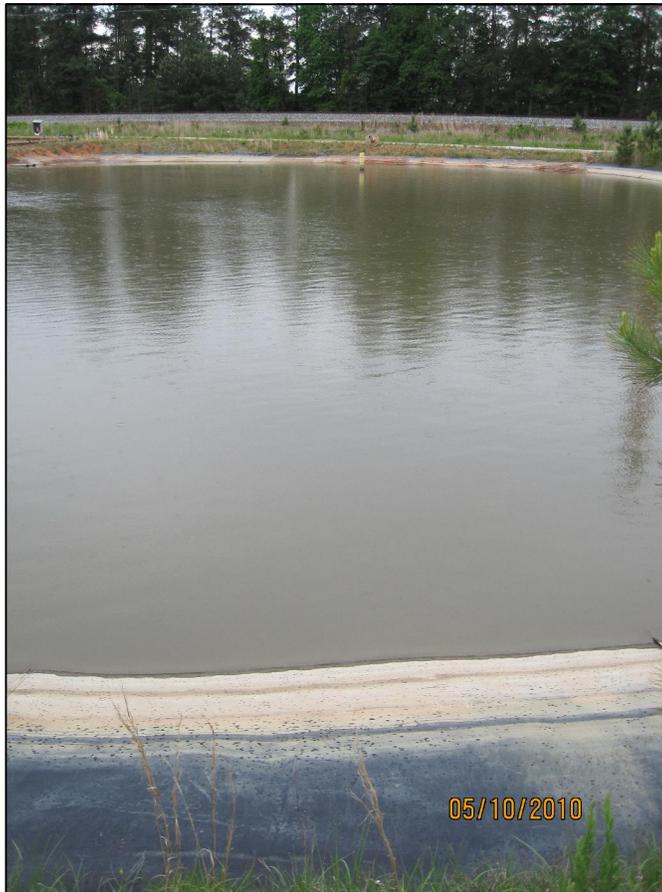
GP-6
HDPE LINED LOWER BASIN

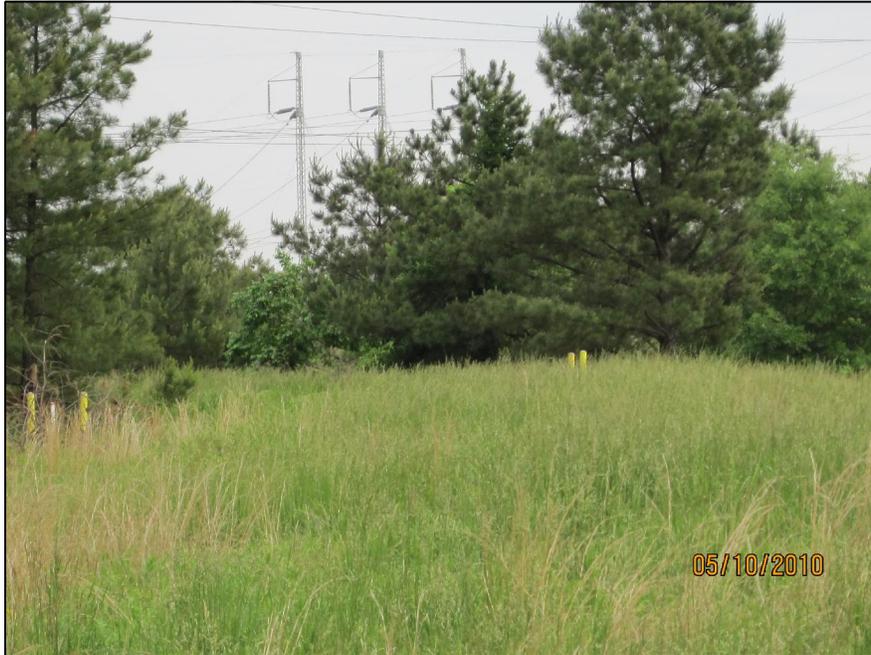
A-1
FROM LEFT ABUTMENT LOOKING EAST, PZ'S APA-1 AND APA-2

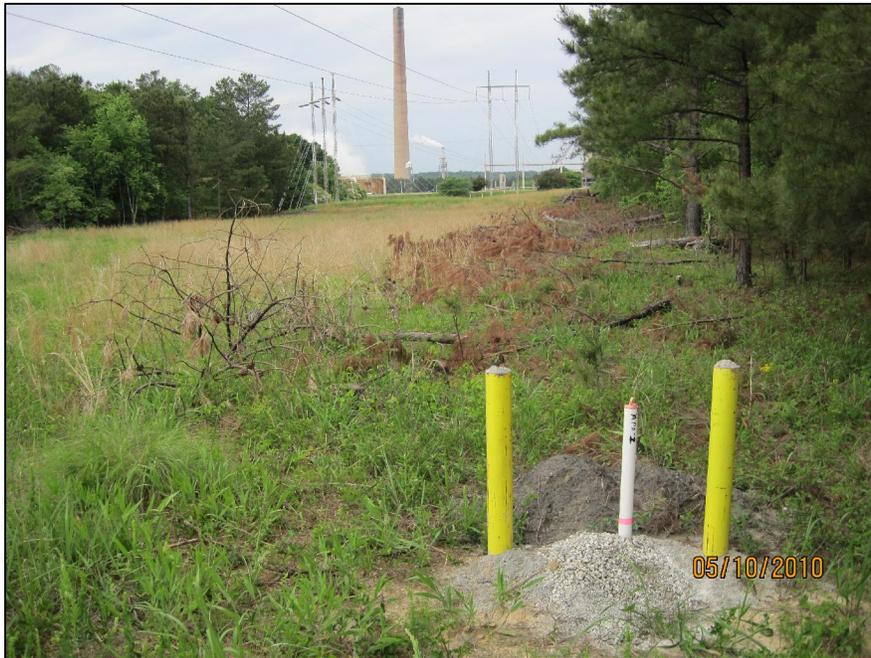
A-2
LOOKING NORTHWEST, INTERIOR OF POND AND PZ APA-1

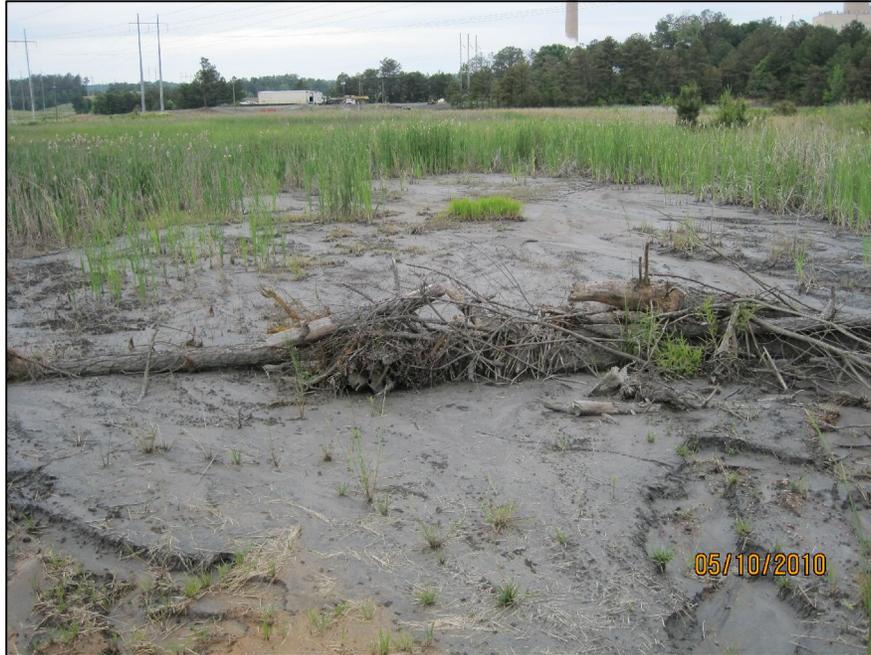
B-1

LOOKING FROM TOE AT B' TO WEST ACROSS POND B

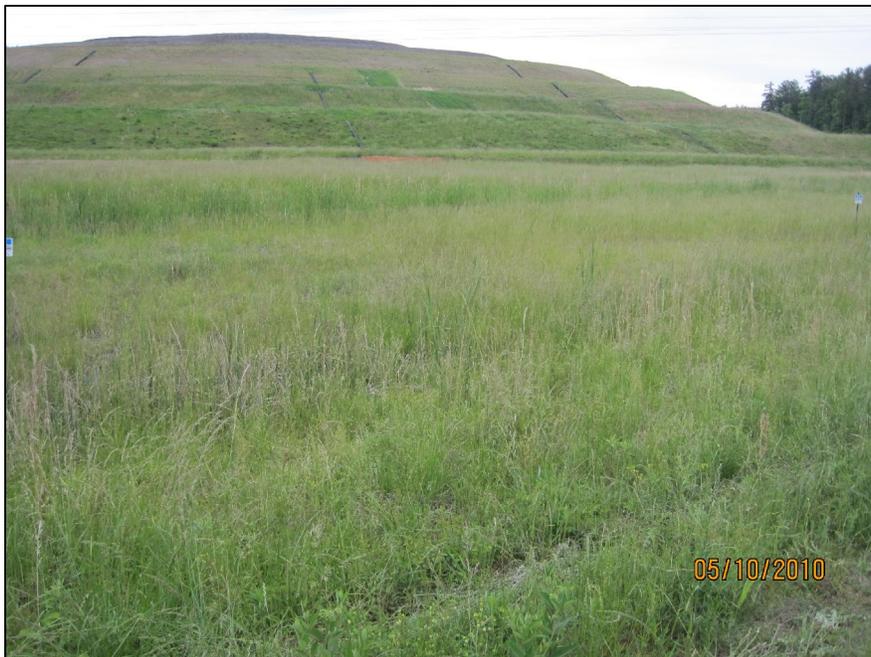
C-2

LOOKING SOUTHEAST ACROSS POND C, R6 LANDFILL IN BACKGROUND

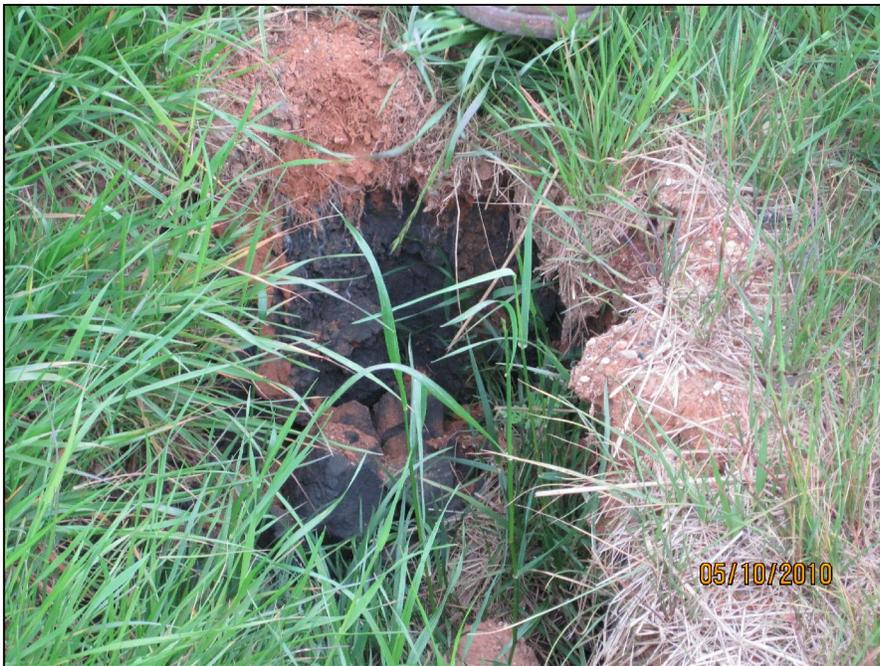
B`-4

EXPOSED 1-FOOT ASH LAYER BENEATH THIN SURFACE NEAR TOP OF LOWER EMBANKMENT ON NORTH DAM

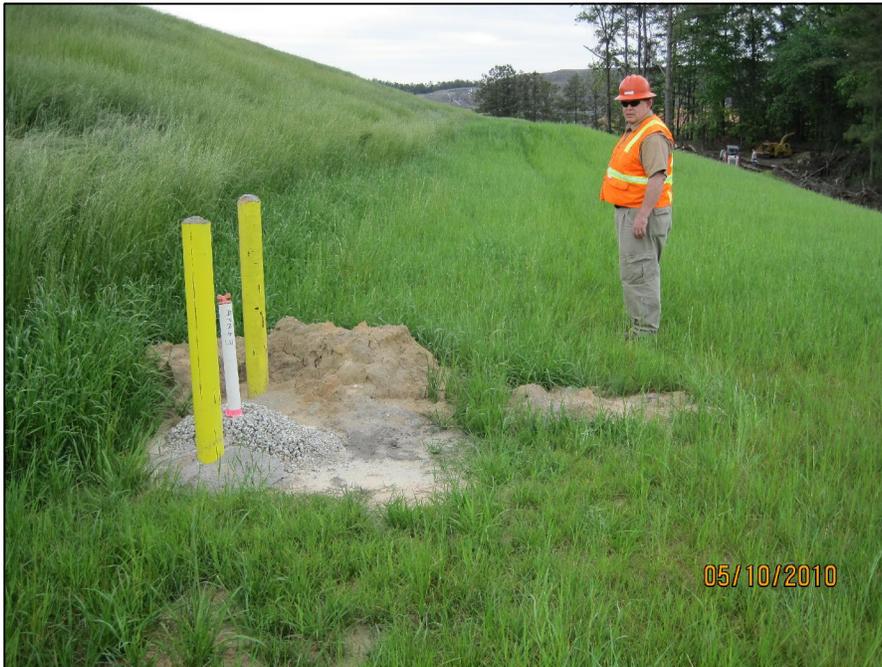
B`-5
MIDDLE BENCH OF NORTH DAM AND PZ APB#3

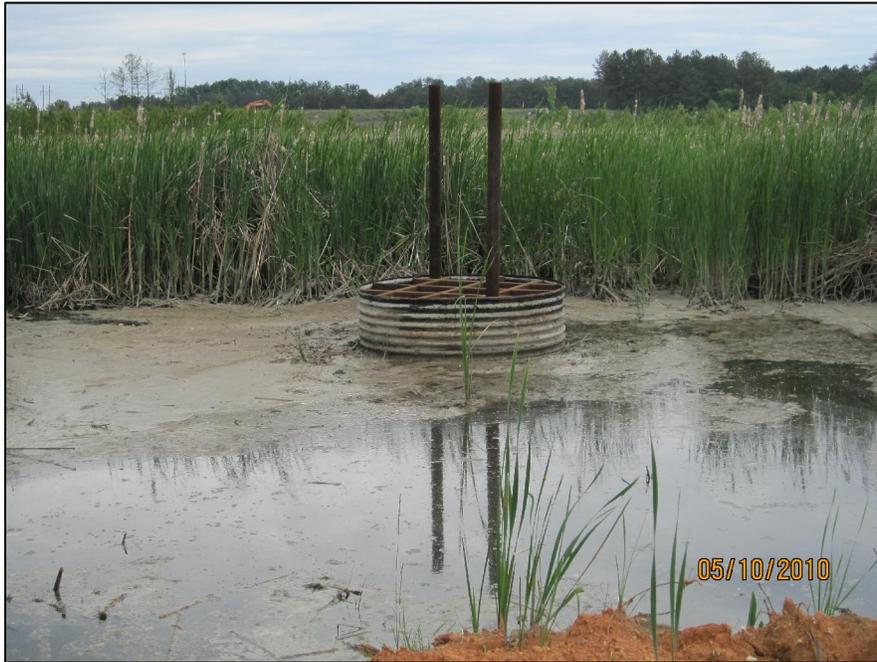
3-1
DECANT CMP PIPE OUTLET WITH TRASH RACK

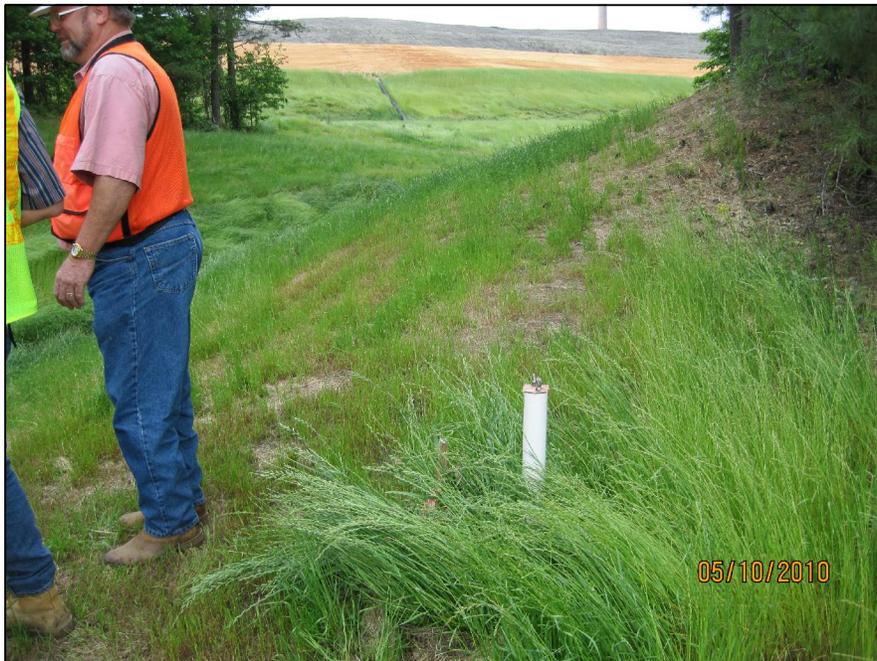
3-2
PZ AND EXIT CHANNEL FOR EMERGENCY SPILLWAY

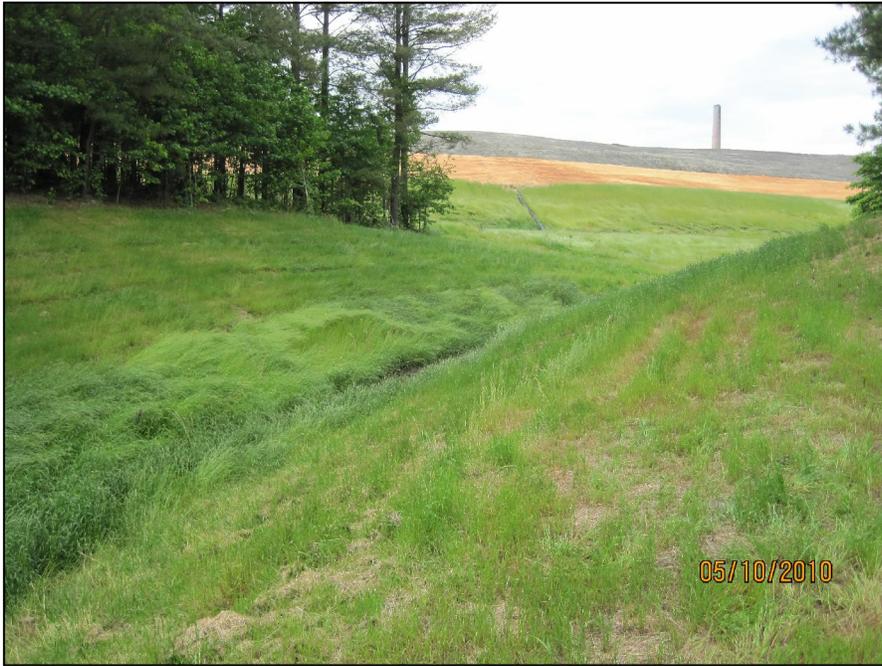
3-3
EMERGENCY SPILLWAY

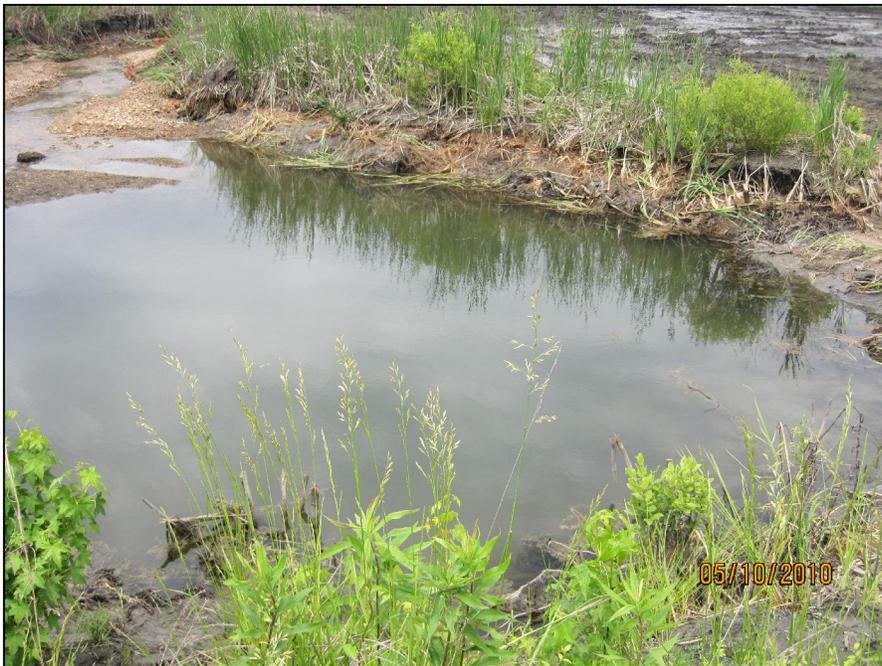
3-4
OUTLET OF DECANT PIPE TO DITCH

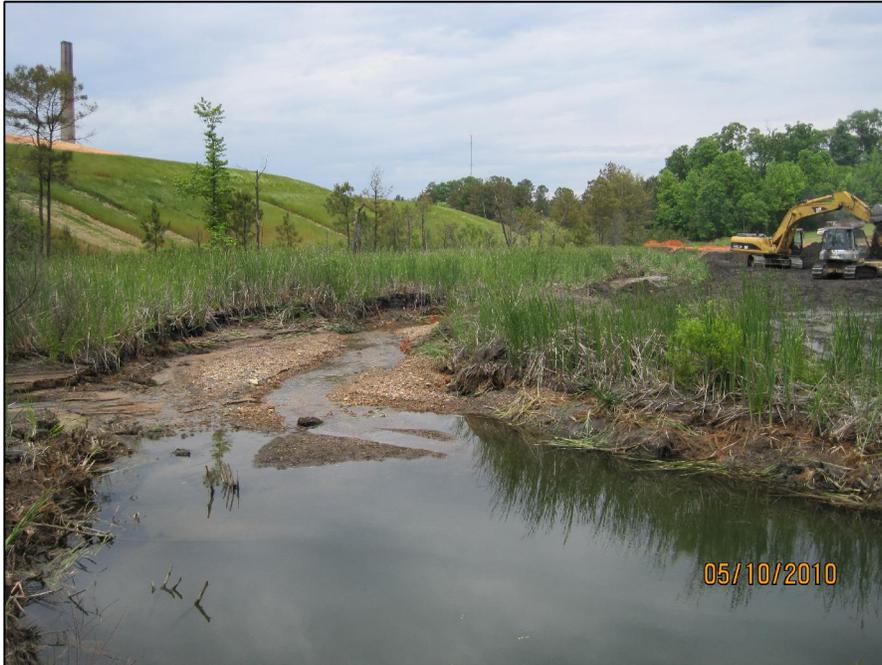
3-5
OUTLET DITCH FROM POND #3 (DRAINS TO POND #2)

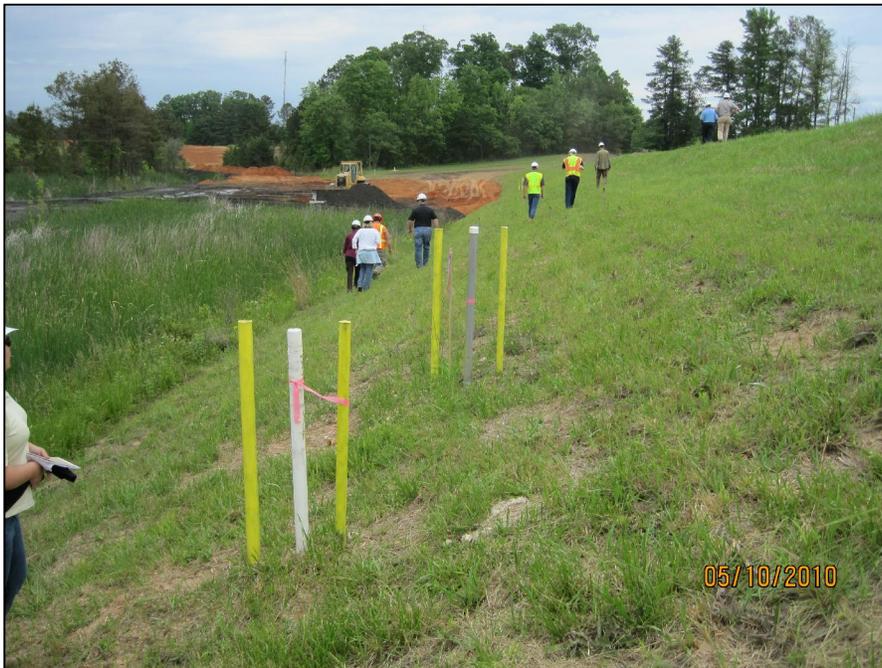
3-6
LOOKING WEST ACROSS DOWNSTREAM SLOPE (PZ'S EP-3 AND EP-4)

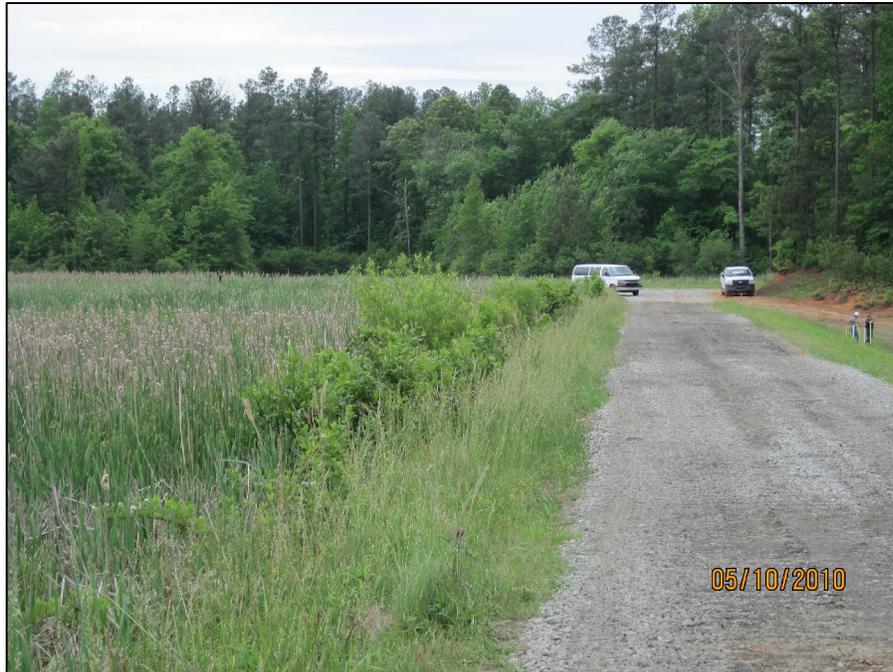
3-7

MINOR WOODY VEGETATION (APPROX. 1-INCH DIAMETER) ON UPSTREAM SLOPE
