**Coal Combustion Waste Impoundment  
Round 5 - Dam Assessment Report**

*Lansing Smith Plant (Site #07)*

*Ash Pond Embankments  
Gulf Power Company  
Southport, Florida*

**July 2010**

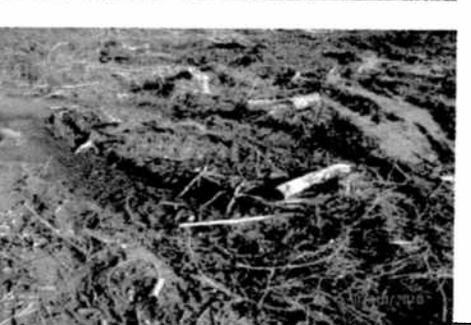
4	West Ash Pond Dike - Close-up of area of seepage circled in Photo 3 above.

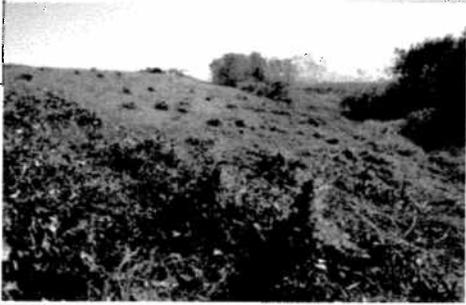
Photo No.	Description	
5	South Ash Pond Dike - Showing cleared downstream slope, facing east. Some grass beginning to grow.

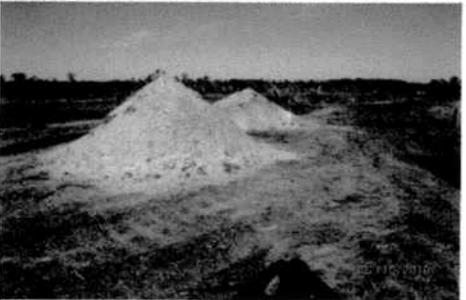
6	South Ash Pond Dike - Emergency granular stockpiles. Additional stockpiles are located near the west side of the plant.

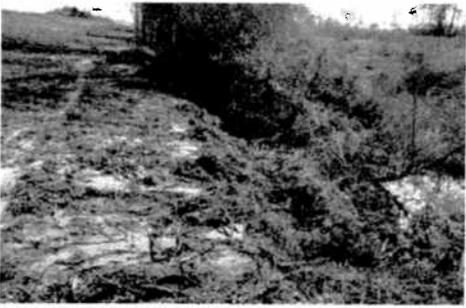
7	South Ash Pond Dike - Toe of slope showing ~ 2' to 3' drop-off to wetlands/marsh, facing east.

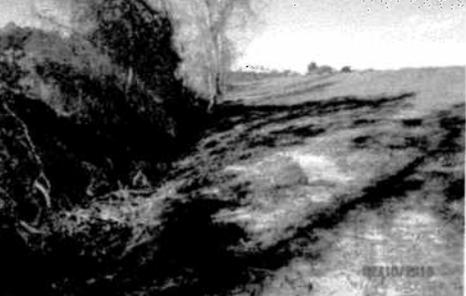
8	South Ash Pond Dike - Downstream slope showing ~2' to 3' drop-off to wetlands/marsh at toe, facing west.

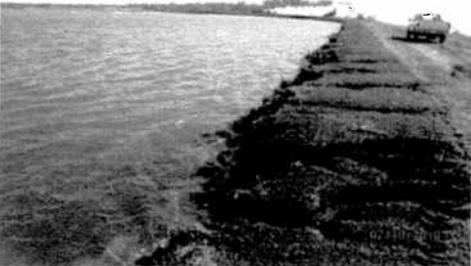
Photo No.	Description	
9	South Ash Pond Dike - Showing Crest and erosion of upstream 'slope', facing east.

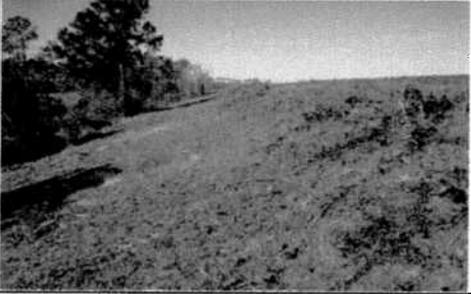
10	South Ash Pond Dike - Downstream slope showing grass beginning to grow after clearing, facing west.

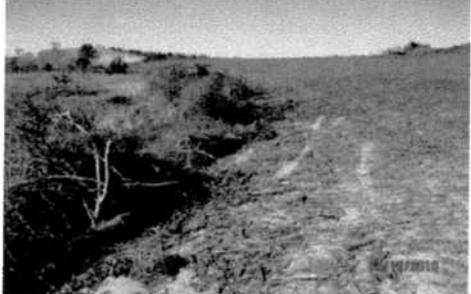
11	South Ash Pond Dike - Downstream slope showing ~2' to 3' drop-off to wetlands/marsh at toe, facing southwest.

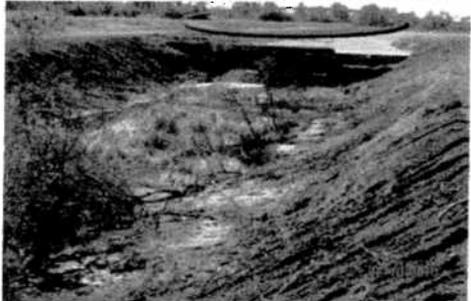
12	Discharge Structure - Showing cleared area around structure, facing south. Area of the East Dike in the background (circled).

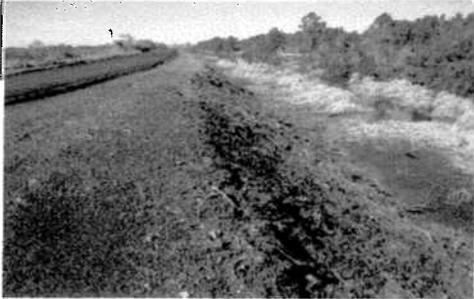
Photo No.	Description	
13	North Ash Pond Dike and Perimeter Ditch - Showing cleared dike and ditch, facing west, plant in the background.

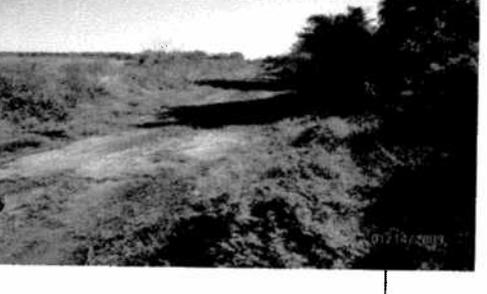
3	Crest of the South Dike showing vegetation on the upstream and downstream slopes, and the ash berms along both sides of the crest. Ash Pond is to the left.

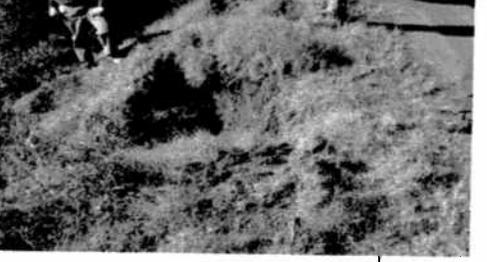
4	Erosion on the downstream slope from runoff at a low point in the South Dike. Crest should be graded to drain into the pond to prevent this.

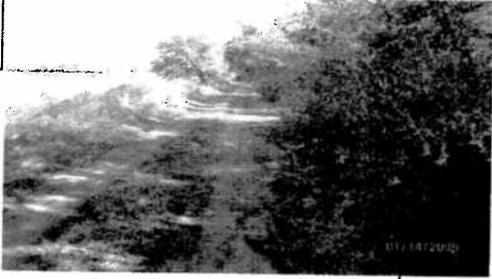
Photo No.	Description	
5	Trees and other vegetation along both sides of the crest of the South Dike. Ash Pond is to the left.

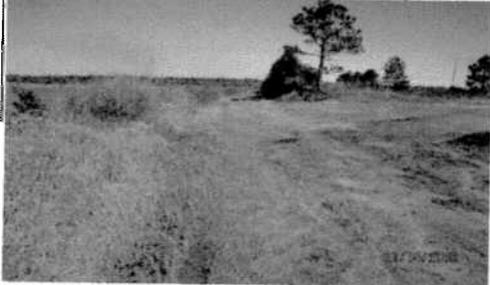
6	East portion of dike on natural ground with the ash stack to the right, pond to the left.

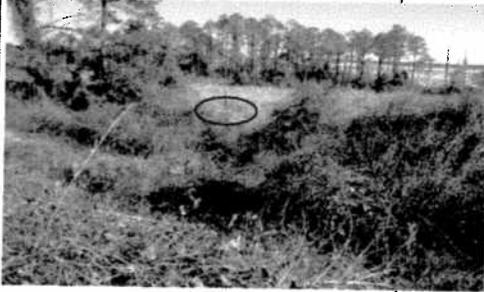
7	View from the South Dike looking out toward the bay, facing generally southeast. A monitoring well location is shown by the oval.

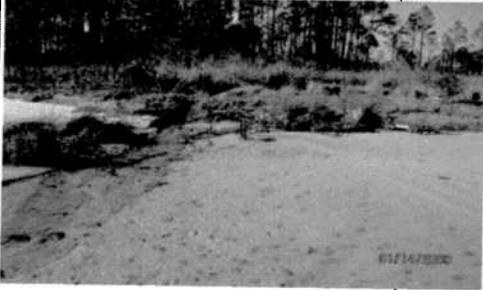
8	Outfall from the swampy area along the toe of the South Dike into the bay, at low tide.

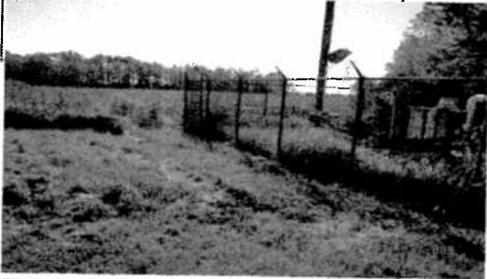
Photo No.	Description	
9	View across the retention pond, facing southeast.

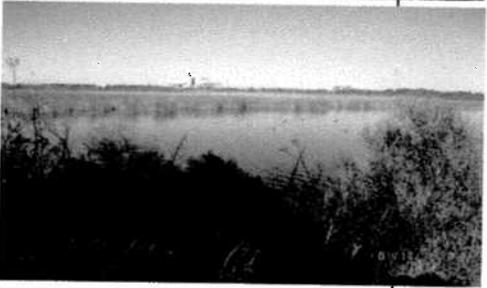
10	View across the ash pond, with the plant in the background. Facing northwest.

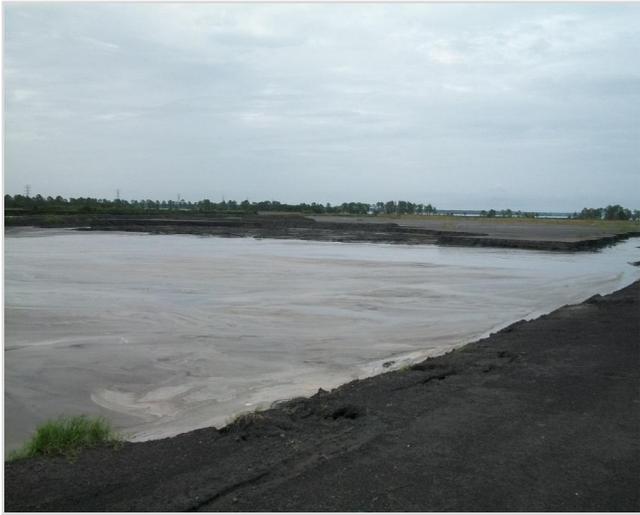
Photo 1  
Ash Pond near North West Access Road - looking South East

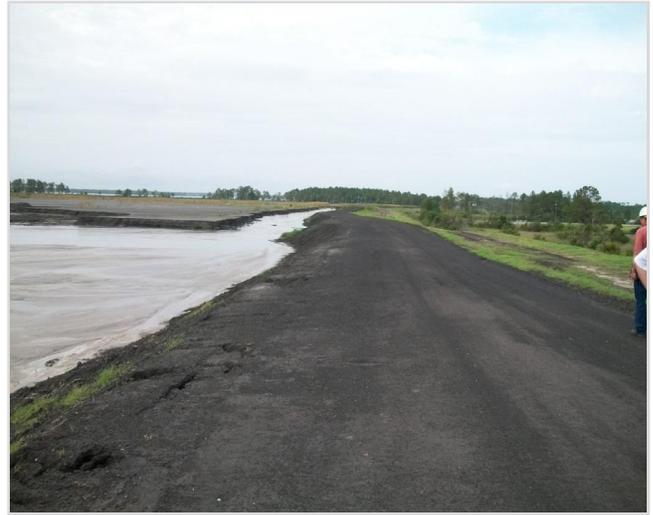
Photo 2  
Ash Pond near North West Access Road – looking South

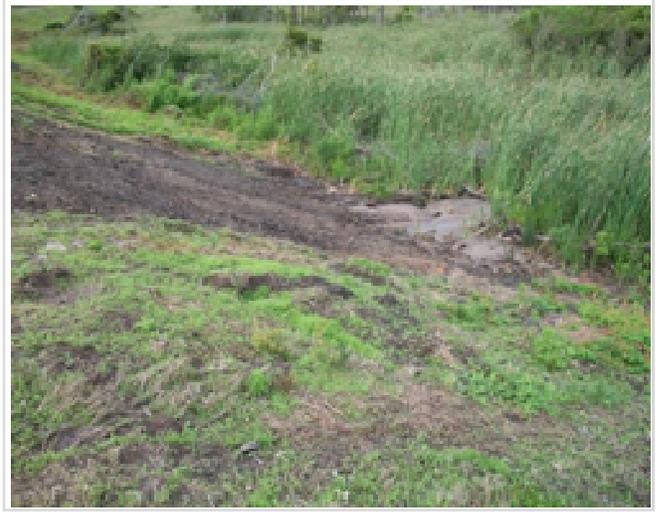
Photo 8  
Recently fixed Sloughing on West embankment

No.	Description	Location	Photo No.
1	Plant (hydroseed) additional grass on all dike slopes for summer growth. (This will complete previous recommendation #1, see below)	All dikes.	3, 5, 8 and 10
2	Monitor seepage in this area of the West Dike as part of weekly plant inspection. Any sloughing or loss of material observed during the weekly inspection (or at anytime) should be reported to SCG Hydro Services immediately.	West Dike	3 and 4
3	Sign to be placed at granular stockpiles to mark them for "Emergency Dike Repair Use Only".	South end of the West Dike	6

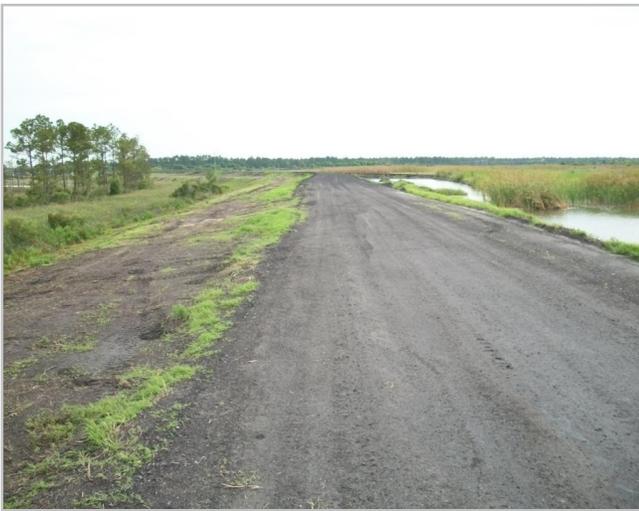
Photo 9  
West embankment at South West corner of Ash Pond – looking North

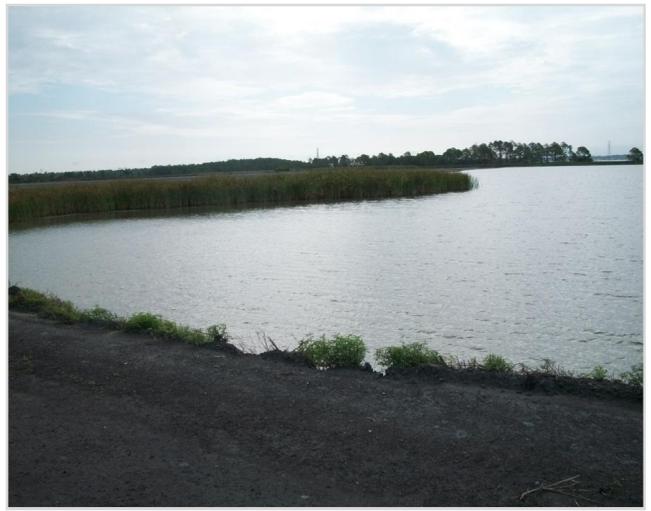
Photo 10  
Ash Pond at South West Corner – looking North East

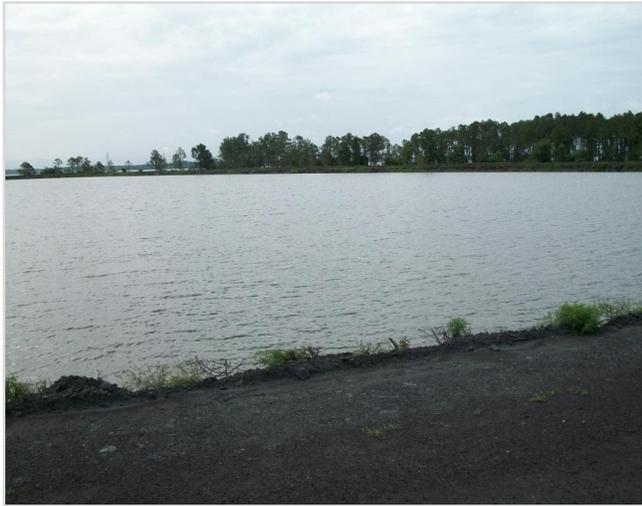
Photo 11  
Ash Pond at South West corner – looking South East

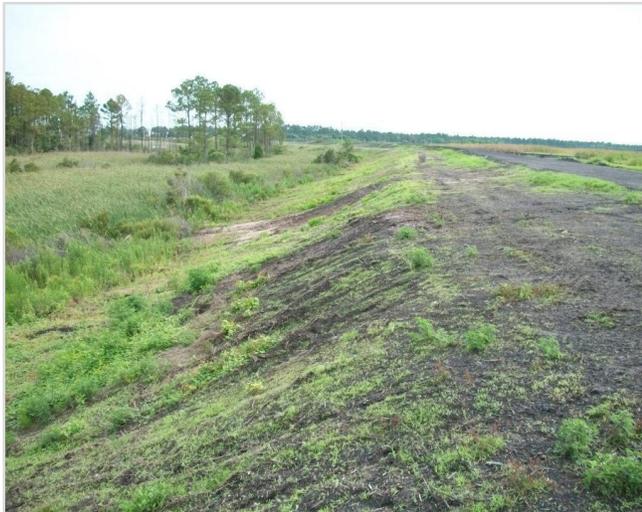
Photo 13  
West embankment at South West corner – looking North note slope rilling

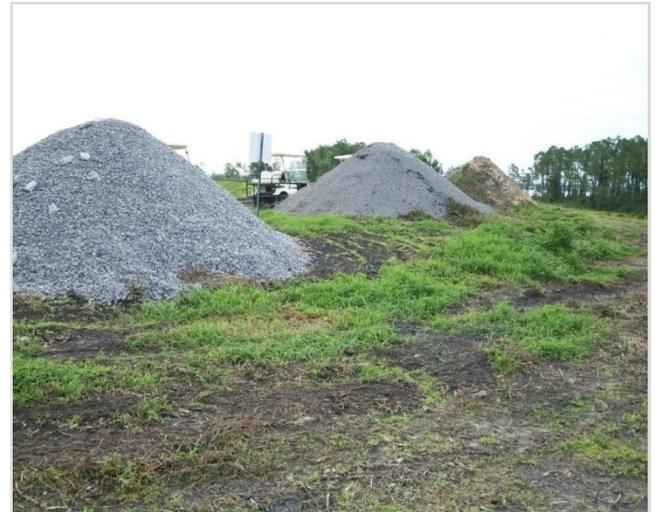
Photo 14  
Emergency repair stockpile at South West corner of pond

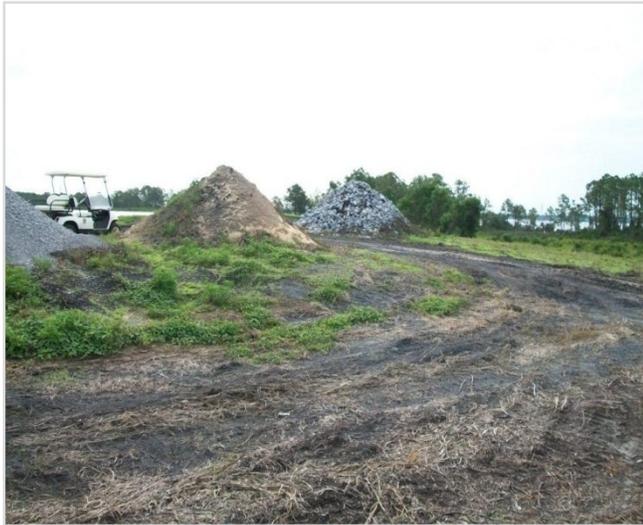
Photo 15  
Emergency repair stockpile at South West corner of pond

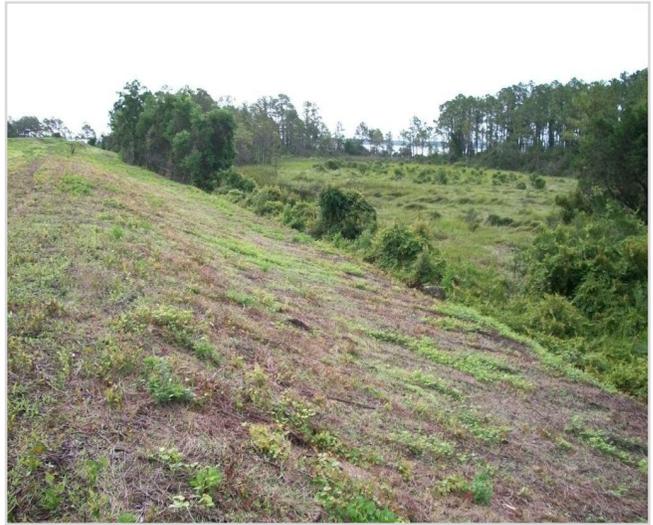
Photo 16  
South embankment - looking East

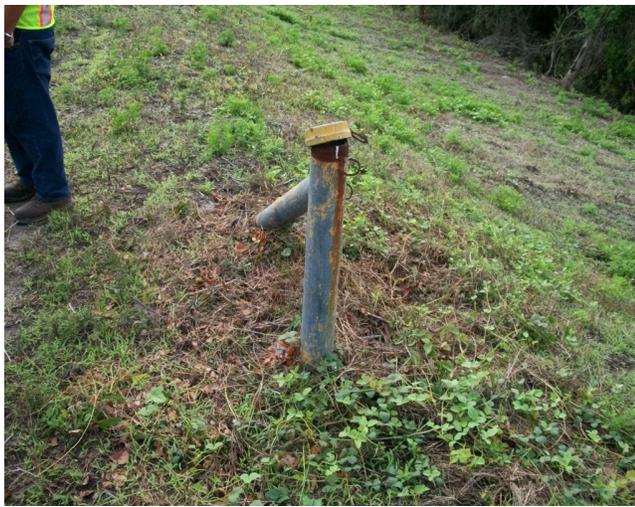
Photo 17  
Abandoned test well at top of banks on South embankment

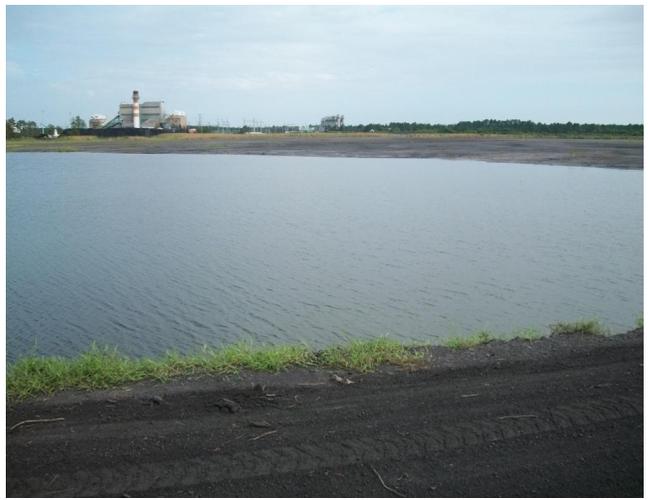
Photo 18  
Ash Pond at internal dike on South embankment - looking North West

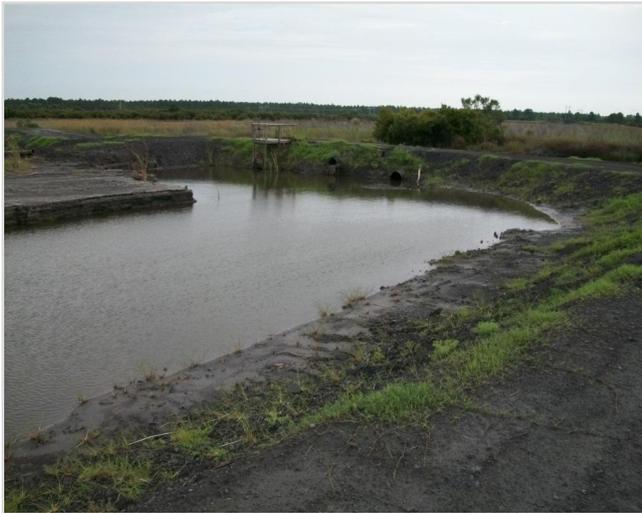
Photo 19  
Internal drainage near center of South embankment

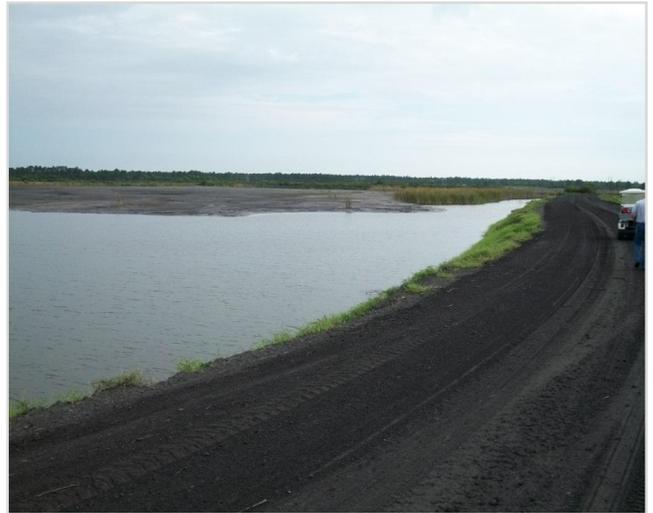
Photo 20a  
Ash Pond near center of South embankment – looking East

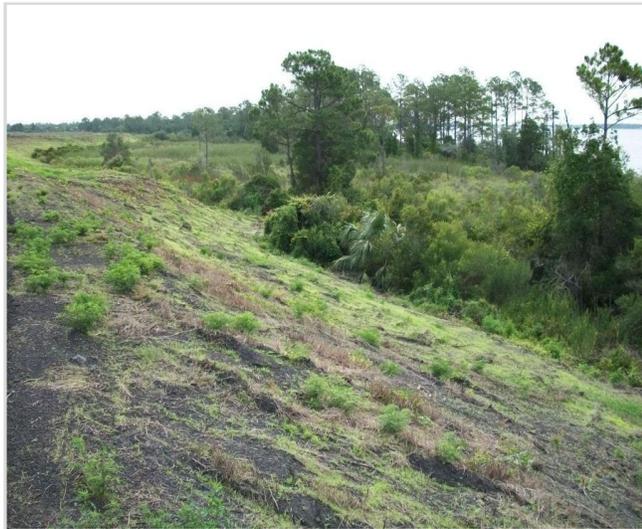
Photo 20b  
South embankment near center

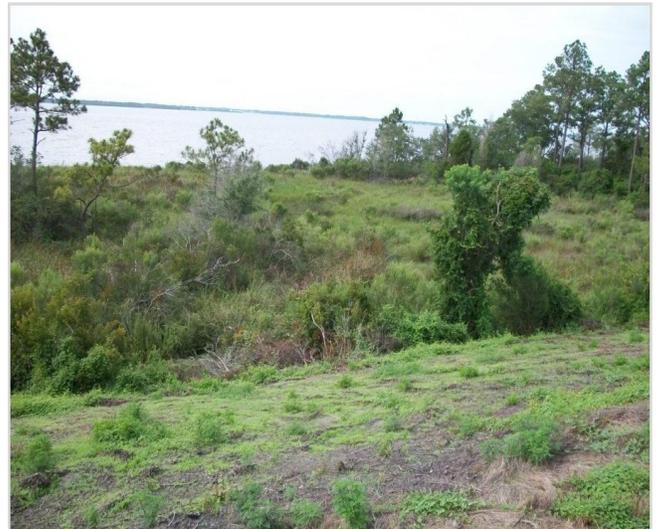
Photo 21  
Wetlands and bay South of Ash Pond

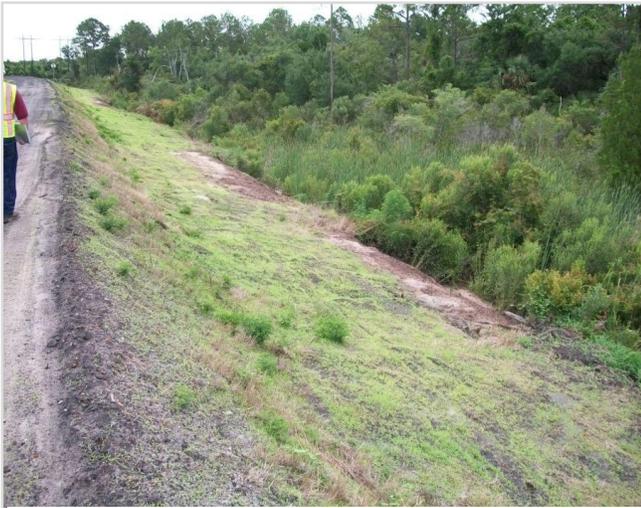
Photo 22  
South embankment – looking East

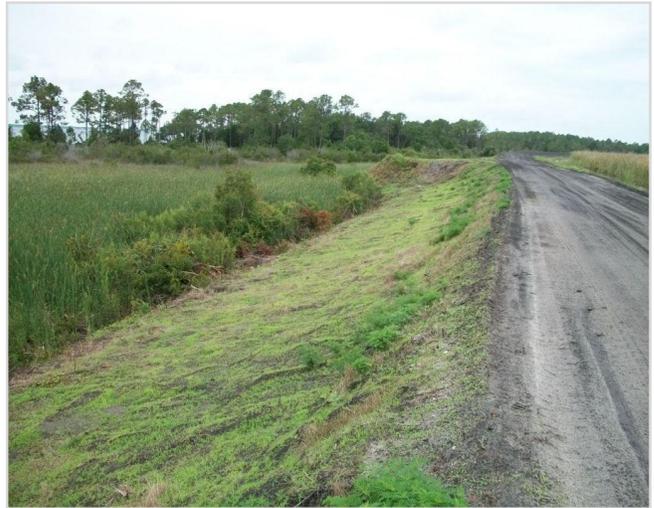
Photo 23  
South embankment – looking West

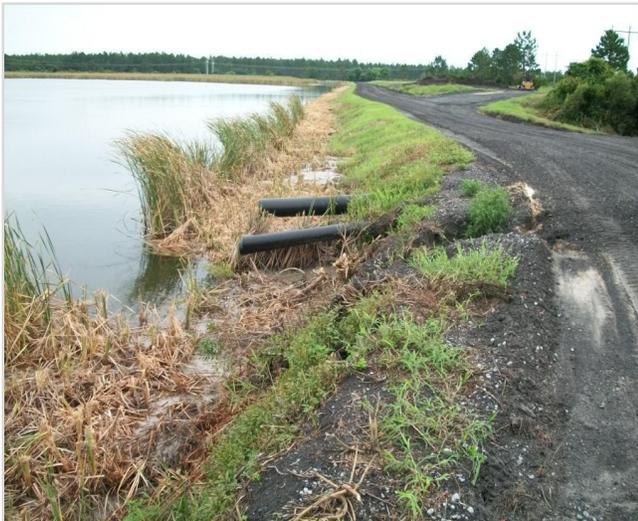
Photo 24  
East embankment – looking North - note inflow  
pipe from stormwater management facility

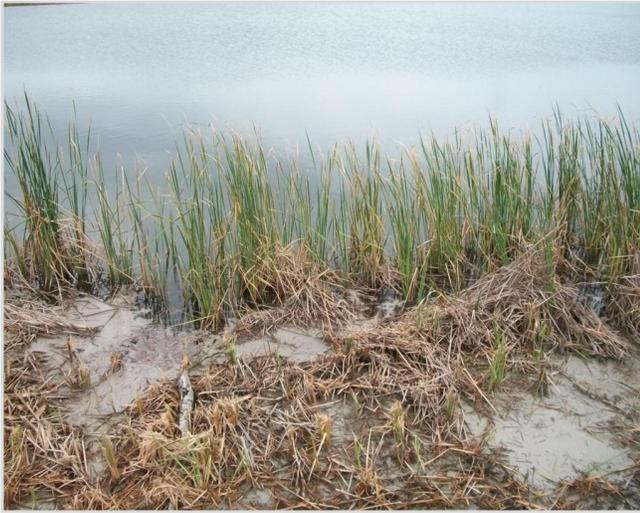
Photo 26  
Cattails recently trimmed on East embankment interior

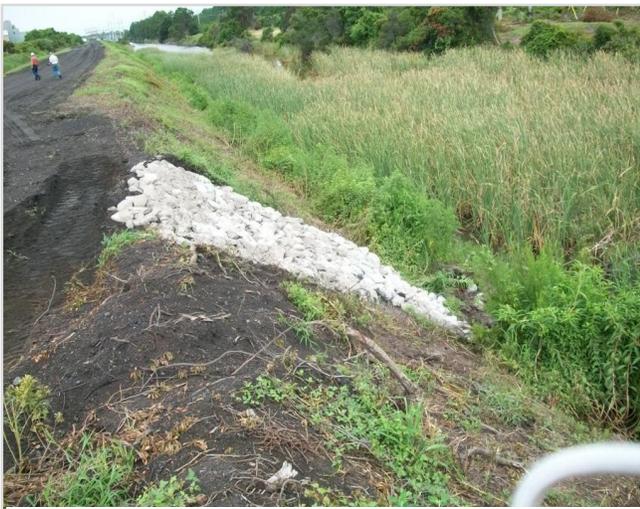
Photo 28  
Rip rap repair of North embankment near North East corner and adjacent to recycle canal
