ASSESSMENT OF DAM SAFETY OF COAL COMBUSTION SURFACE IMPOUNDMENTS – DRAFT REPORT

Gulf Power Plant Crist Pensacola, Florida

Prepared for
*U.S. Environmental
Protection Agency
Washington, D.C.*

October, 2012
Revision 1, November 2013

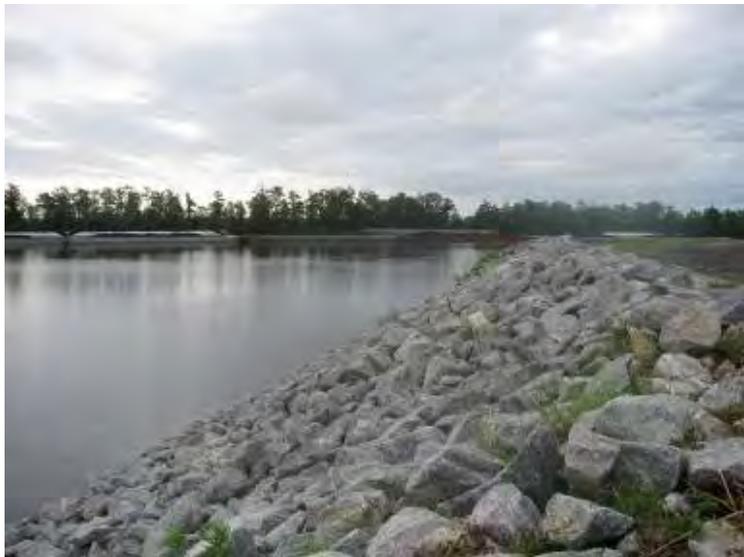
The exterior slopes appear to be in **SATISFACTORY** condition. The exterior slopes of the embankments are approximately 2H:1V. The exterior slopes of the embankments are covered with short grass, approximately 4 to 6 inches tall. The Escambia River (River) flows along the northeast embankment. Riprap armoring has been placed on the northeast corner and the lower portion of the northeast embankment adjacent to the River (Photographs 1 and 7-11). Areas of erosion and shallow

Photo 1: Ash Pond – (typical) riprap along exterior slope of north embankment adjacent to Escambia River looking east.

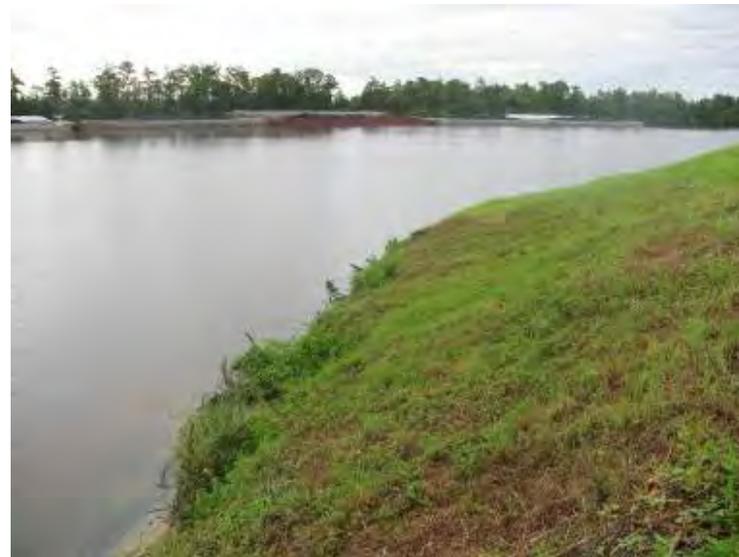
Photo 2: Ash Pond - Minor scour/erosion along toe of exterior slope of northeast embankment looking east.

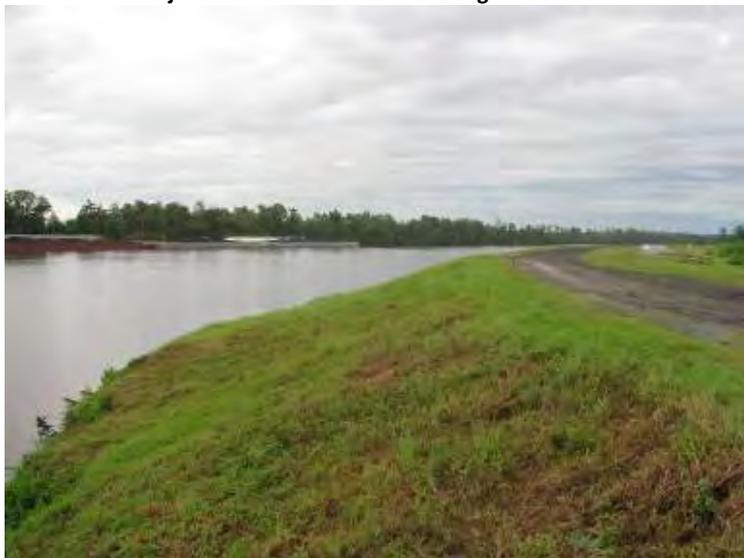
Photo 3: Exterior slope and crest of north embankment of Ash Pond showing minor scarp at toe of slope looking east.

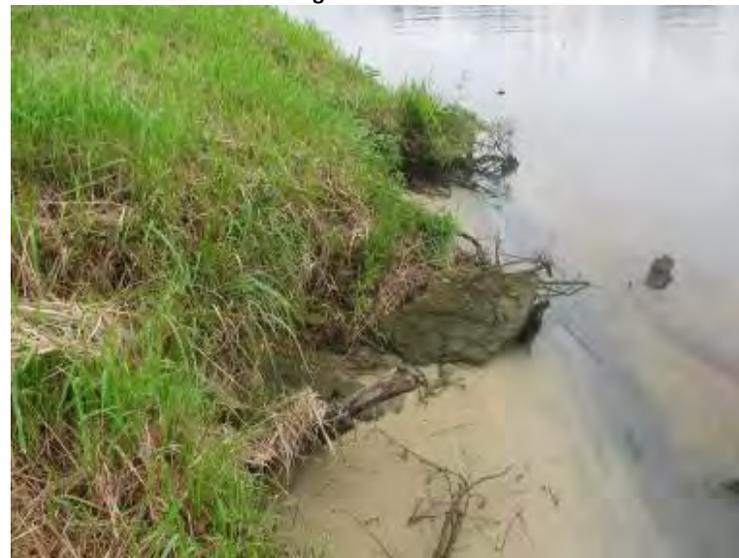
Photo 4: Close up of eroded area at exterior toe of slope adjacent to Escambia River looking northwest.

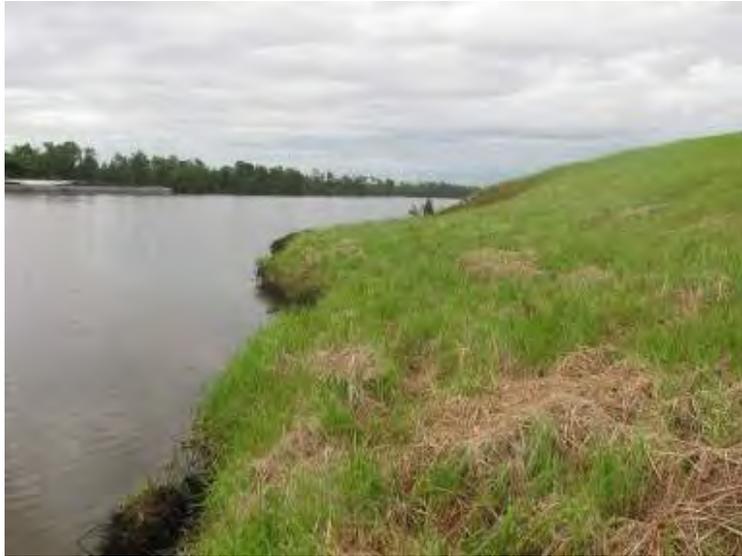
Photo 5: Scarps and erosion along the exterior slope of Ash Pond north embankment looking east.

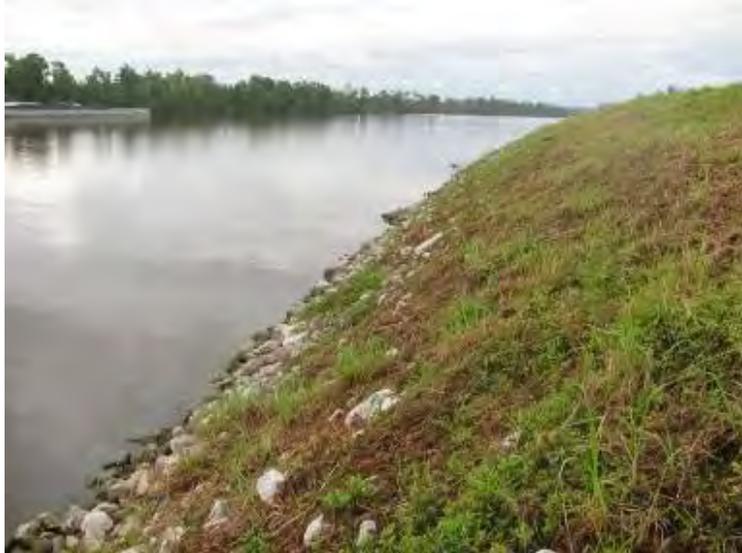
Photo 7: Ash Pond north embankment looking southeast. Note steep slope and apparent remedial works (riprap) where previous sloughing occurred.

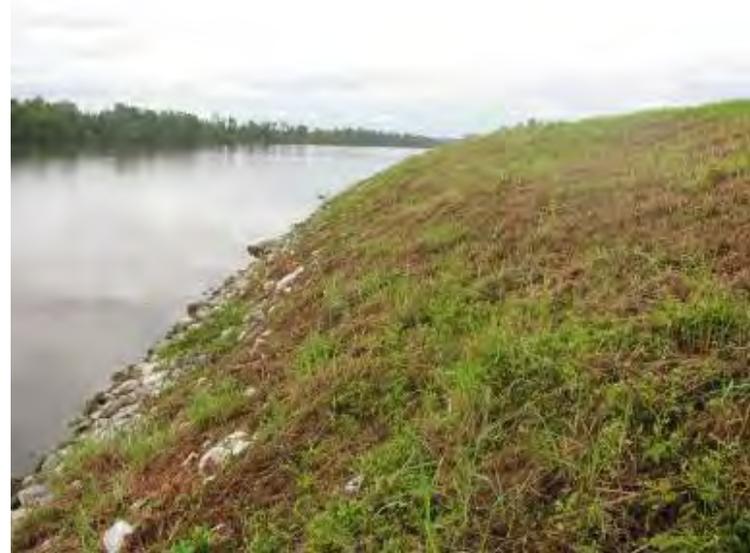
Photo 8: Ash Pond north embankment looking southeast. Note steep slope and apparent remedial works (riprap) where previous sloughing occurred.

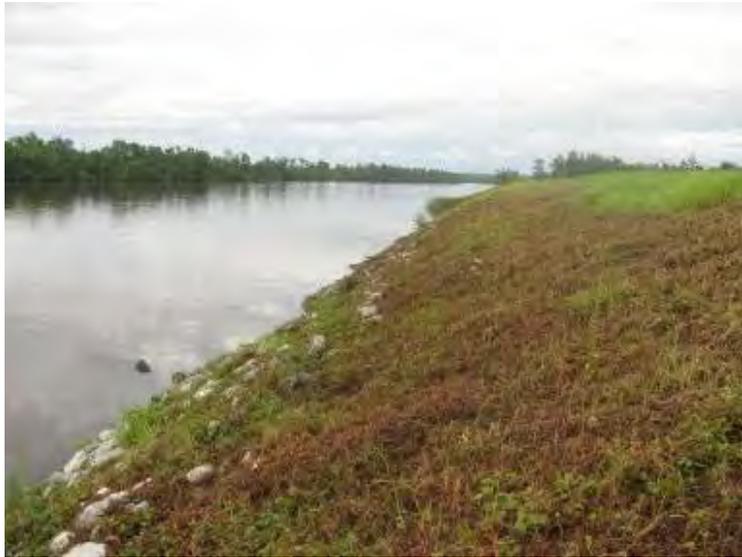
Photo 9: View of exterior slope of Ash Pond north embankment looking east.

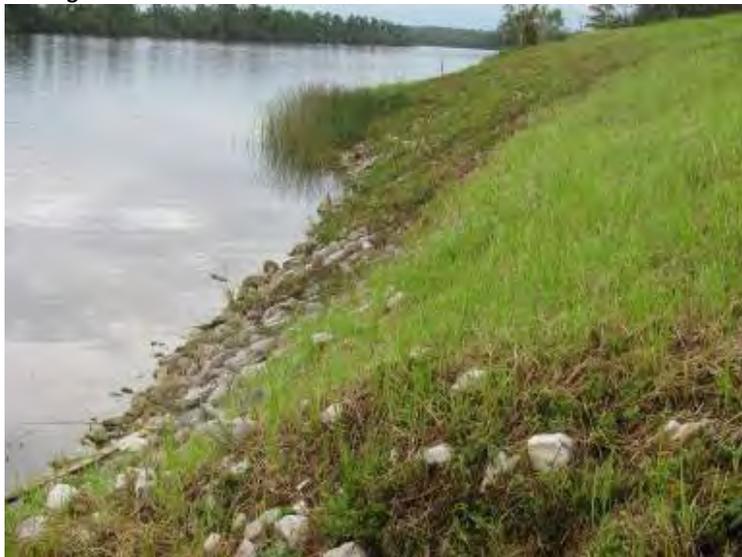
Photo 11: General view of exterior slope of Ash Pond northeast embankment looking southeast.

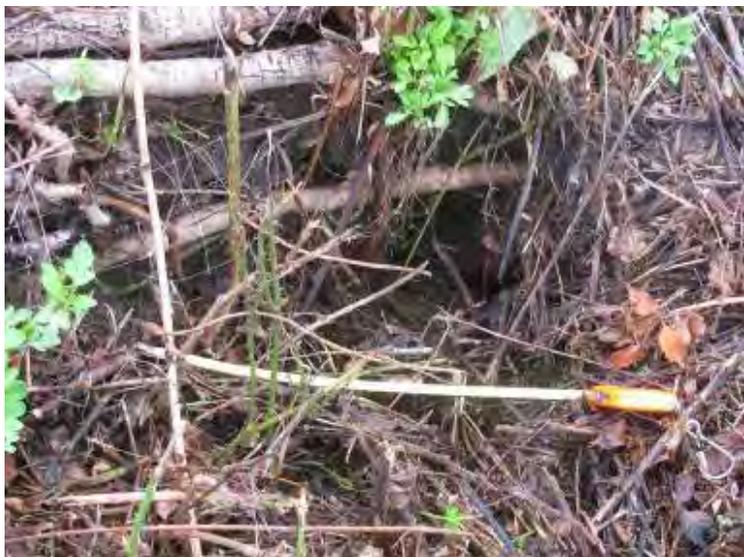
scarps were observed along the toe of the northeast embankment's exterior slope, where riprap armoring had not been placed (Photographs 15 to 19). Animal burrows (Photographs 13, 14 and 23) were observed on the northeast slope as well as near the southeast corner of the pond. Tree stumps between 6 and 18 inches in diameter from previous vegetation clearing were also observed (Photographs 20 and 21).

Photo 13: Animal burrow on exterior slope of Ash pond northeast embankment.

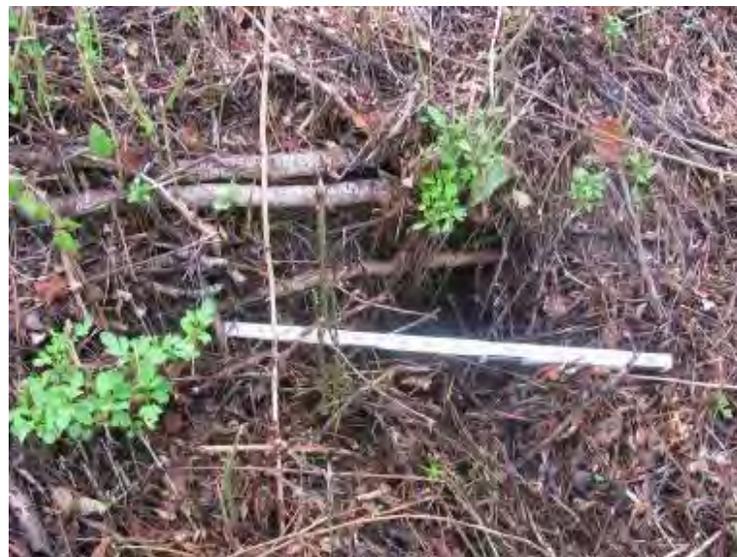
Photo 14: Animal burrow on exterior slope of Ash pond northeast embankment.

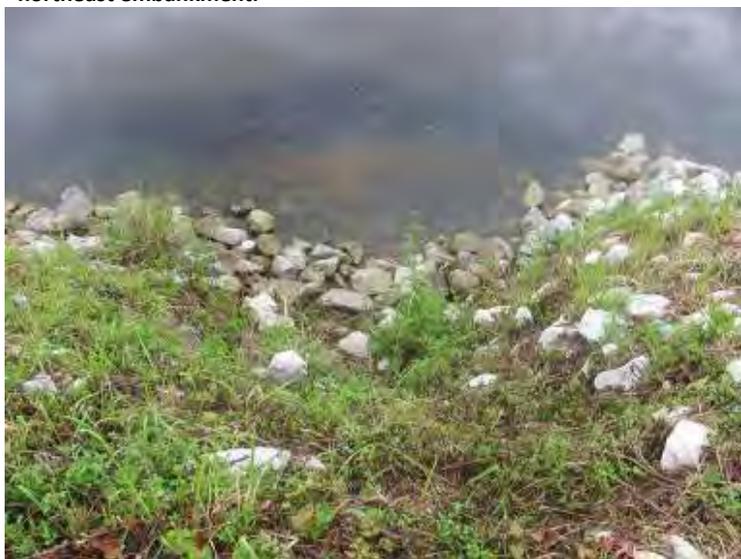
Photo 15: View of rill at exterior toe of slope of Ash Pond along Northeast embankment looking east.

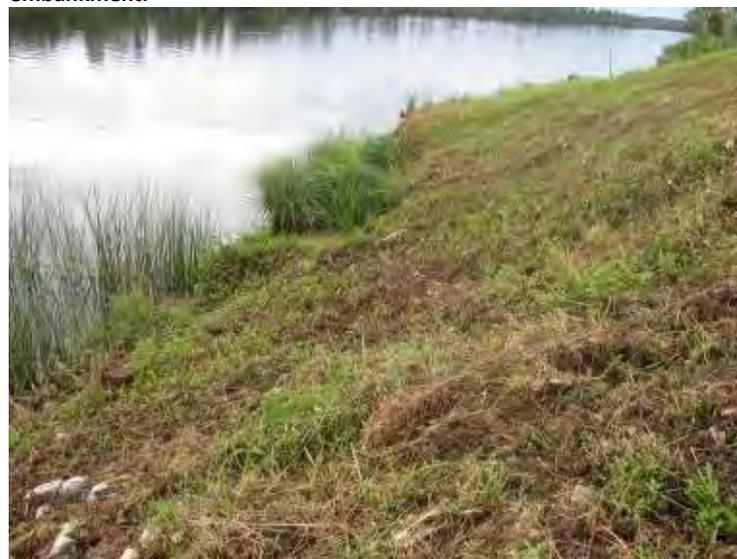
Photo 16: Erosion along toe of slope Ash Pond northeast embankment looking southeast.

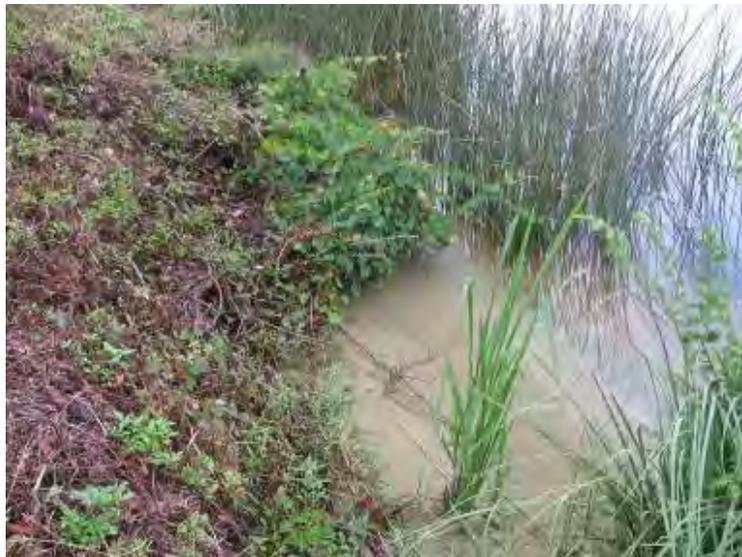
Photo 17: Scarp with sand fan at toe of slope of Ash Pond along northeast embankment.

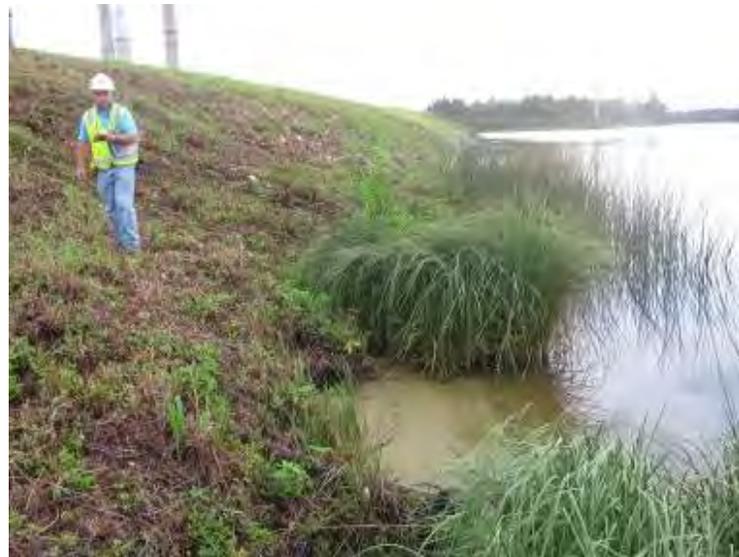
Photo 18: Scarp with sand fan at toe of slope of Ash Pond along northeast embankment.

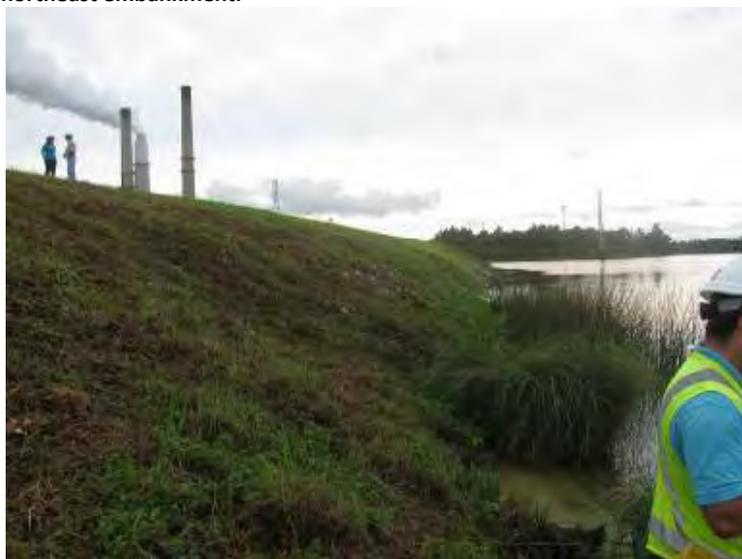
Photo 19: Exterior slope of Ash Pond along northeast embankment showing scarp with sand fan at toe of slope looking northwest.

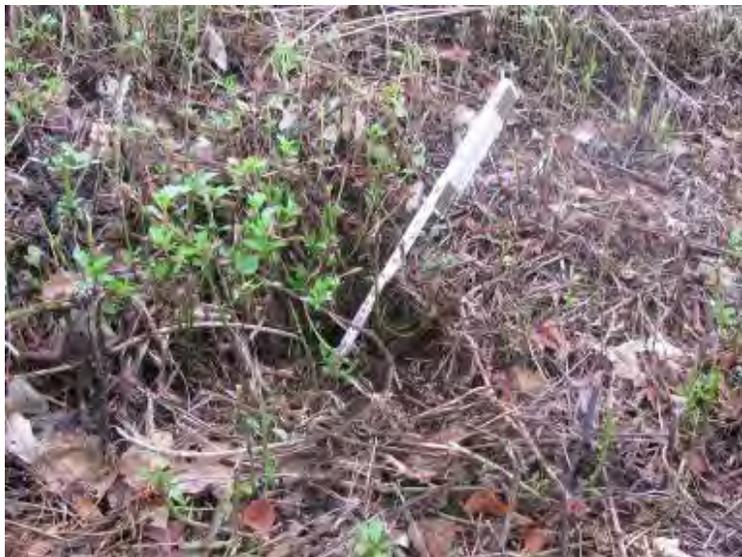
Photo 23: Animal Burrow at southeast corner of Ash Pond.

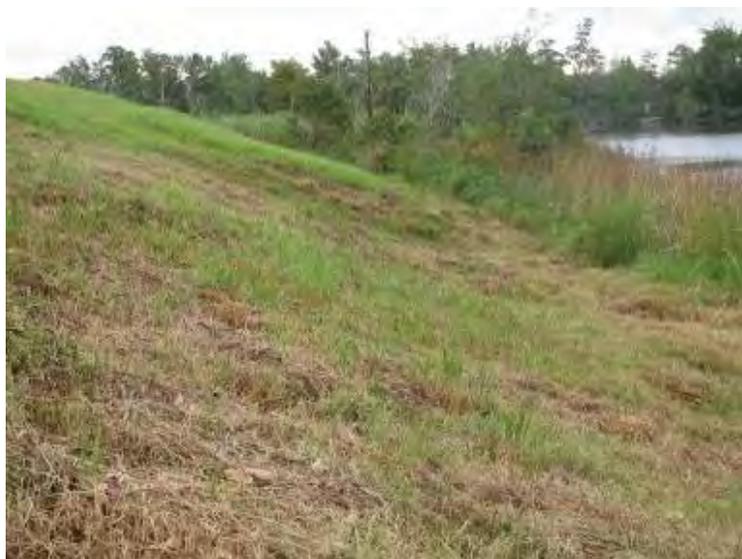
Wet soils were observed at the toe of slope, near the southeast corner of the pond (Photographs 22), but no seepage or flowing water appeared to be associated with this wet area. Due to recent rainfall the observed standing water could not be clearly identified as seepage. Shallow depressions and scarps (Photographs 27 and 29) were observed on the slope and at the toe of slope, respectively, on the southwest corner.

Photo 27: Exterior slope of Ash Pond along southeast embankment looking southwest. Note depression due to erosion.

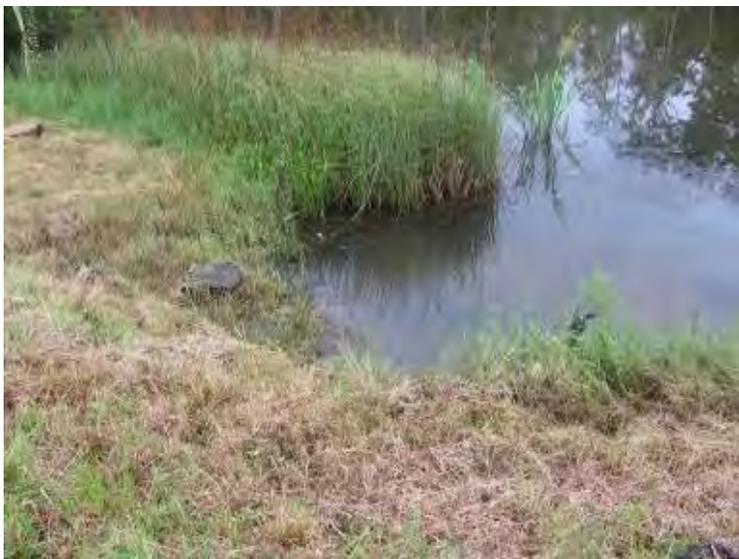
Photo 29: Scarp at toe of slope of Ash Pond along southwest corner.

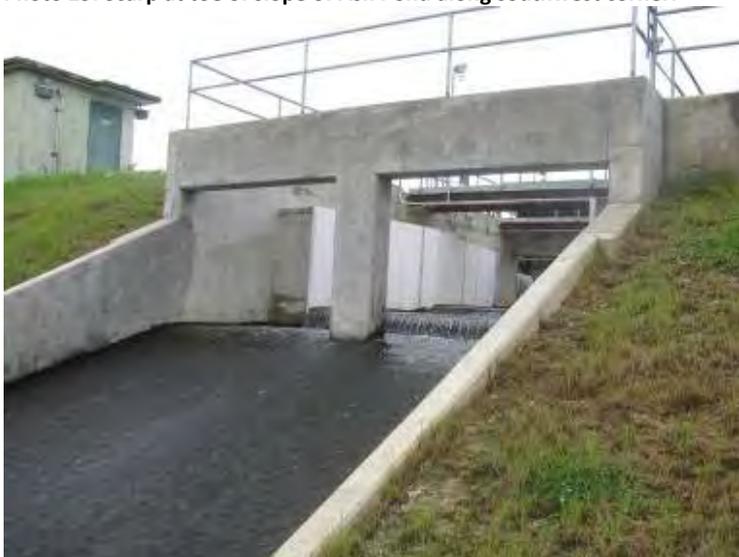
The outlet structure consists of a concrete spillway (Photographs 31 to 34) located near the south corner of the pond. The spillway has reportedly been in operation for about 2 years. The structure appears to be in **SATISFACTORY** condition. There are no signs of settlement or compromised structural integrity.

Photo 31: Spillway and discharge channel of outfall structure.

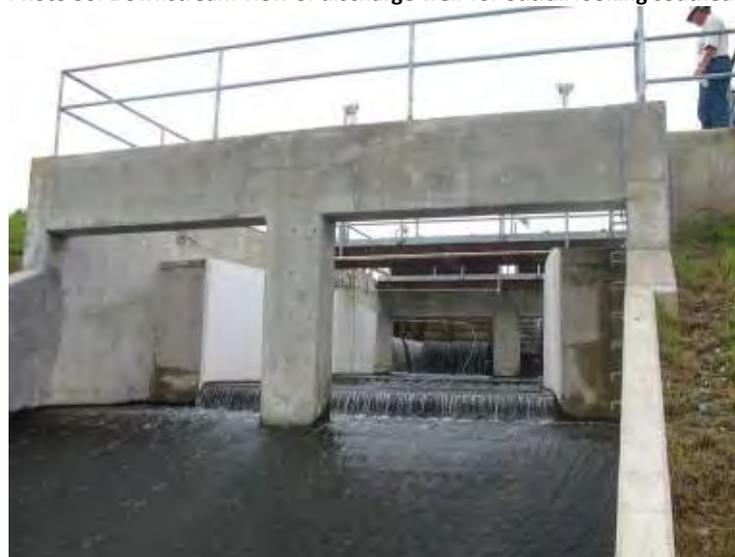
Photo 32: Spillway and discharge channel of outfall structure.

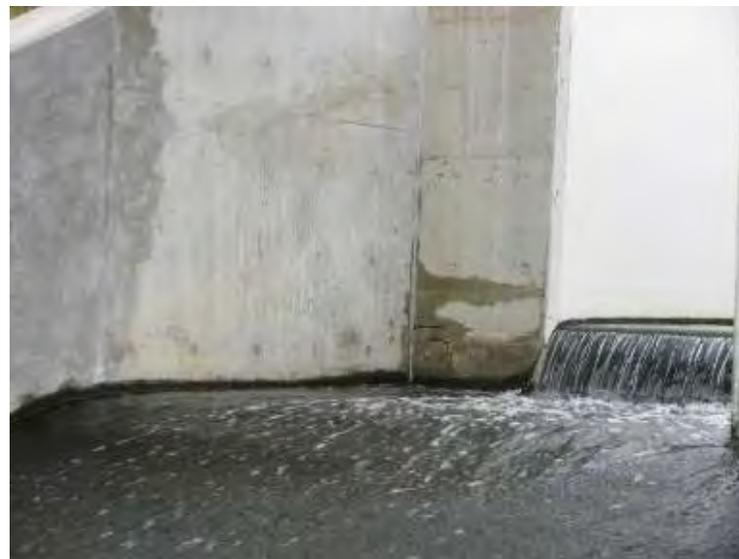
Photo 34: Ash Pond spillway looking north.

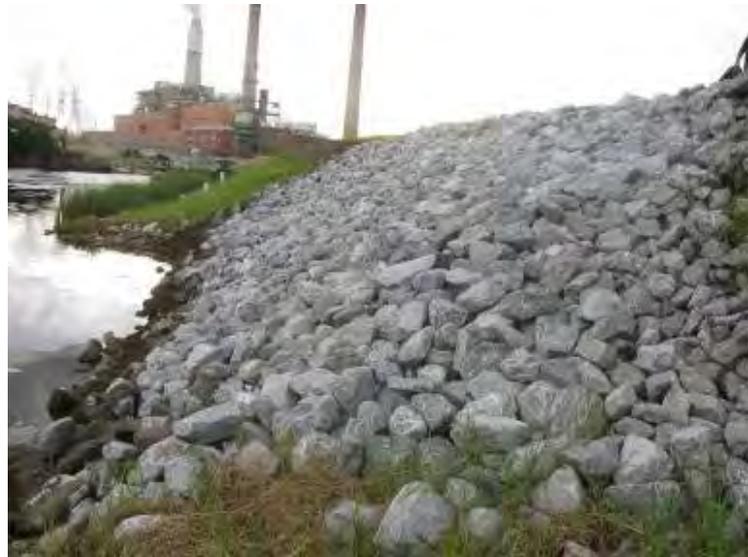
Photo 46: Exterior toe of slope of Ash Pond along southwest embankment looking northwest.

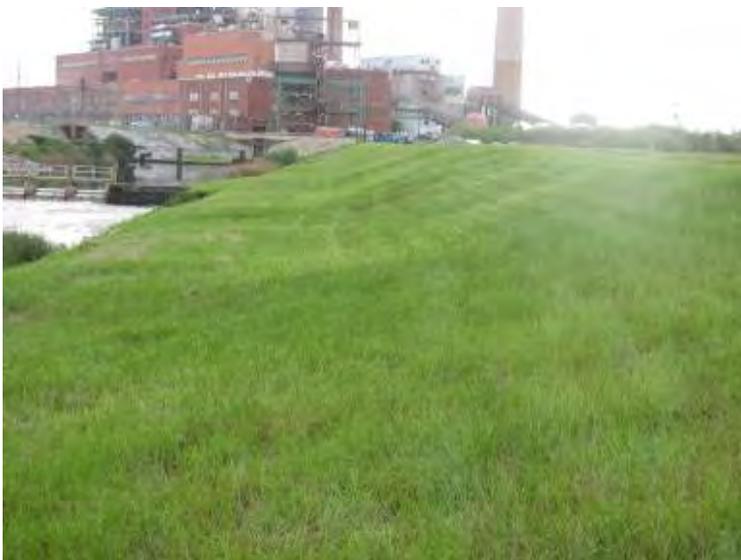
Photo 47: Exterior embankment slope of Ash Pond along southwest embankment.

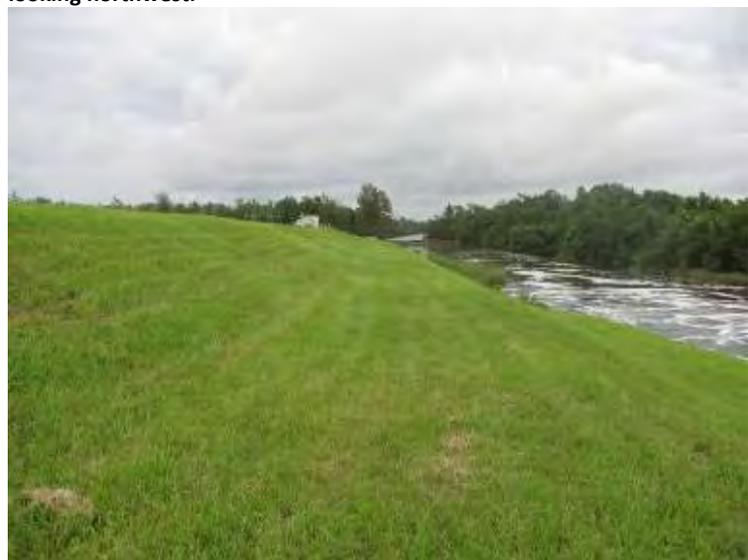
Photo 48: Exterior slope of Ash Pond along southwest embankment looking southeast.

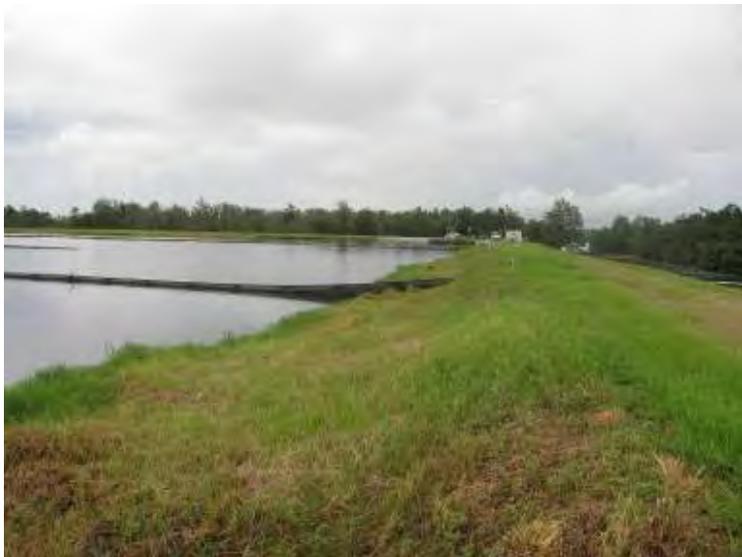
Photo 49: Interior slope and crest of Ash Pond along southwest embankment looking southeast.

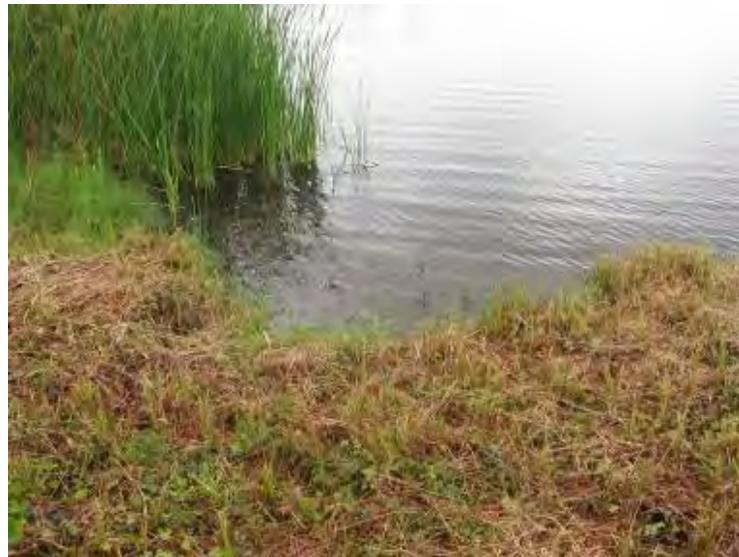
Photo 50: Interior slope of Ash Pond looking north.

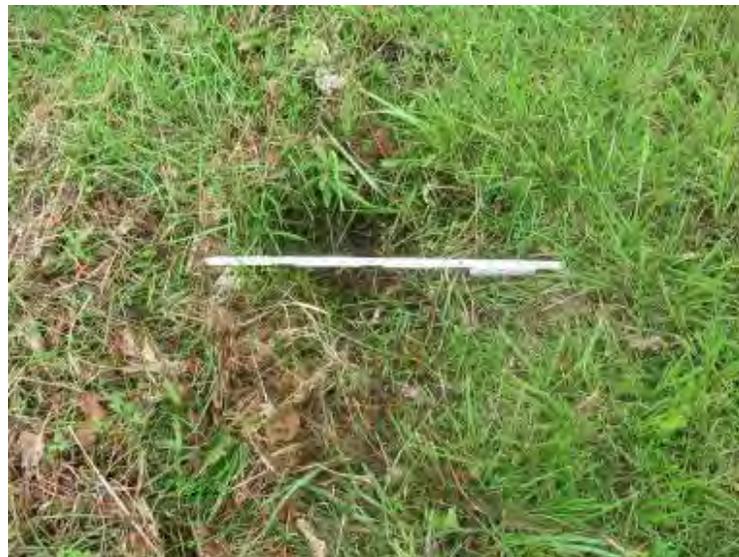
The crest of the Ash Pond appeared to be in **SATISFACTORY** condition (Photographs 55, 56 and 66-69). The crest width ranged from 15 to 25 feet. The crest surface consists of compacted granular soils and gravel and is exposed to vehicle traffic. Puddles and shallow ruts (Photograph 57) were observed on the southwest portion of the crest. The crest along the northwest divider embankment between the Ash Pond and the settling ponds is grass covered, with the grass approximately up to 24 inches high (Photographs 84 and 85). A shallow depression caused by erosion on the crest was observed near the south corner of the pond in the vicinity of the former outfall structure (Photographs 59 to 61). The area is located behind the existing sheet pile wall along the interior slope. No other depressions or evidence of settlement were observed on the crest. An animal burrow was also observed in the southwest crest (Photograph 52).

Photo 52: Animal burrow located on crest of Ash Pond.

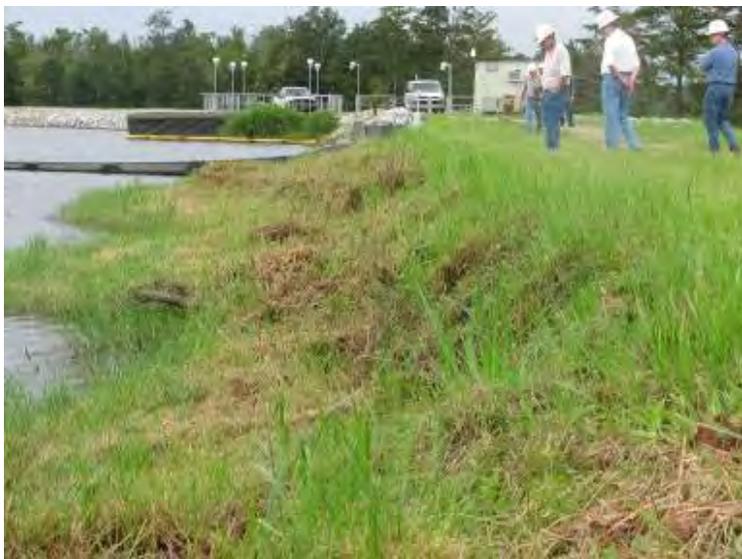
The interior slopes appear to be in **FAIR** condition. The exposed portions of the interior slopes on the southwest embankment are steeper than 2H:1V at approximately 1H:1V. Short grass up to 6 inches tall covers the interior slopes. Significant erosion of the embankment starting at the waterline was observed near the south corner of the pond in the southeast embankment (Photograph 64). Scarps and eroded areas were observed along the interior slopes of the southwest embankment (Photographs 49, 53 and 58). A delta is located along the interior slope of the northeast embankment (Photographs 72 and 73).

Photo 53: Interior slope scarps along Ash Pond southwest embankment looking southeast.

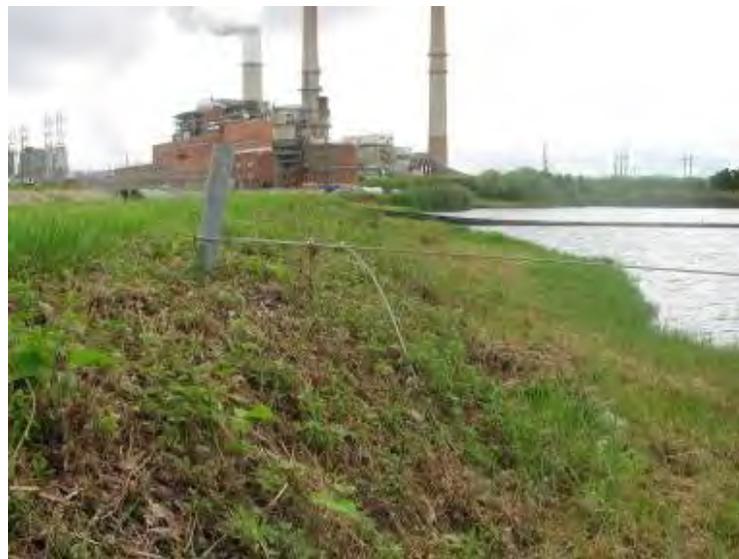
Photo 54: Interior slope scarps along Ash Pond southwest embankment looking northwest. Note steepness and discontinuity of eroded slope.

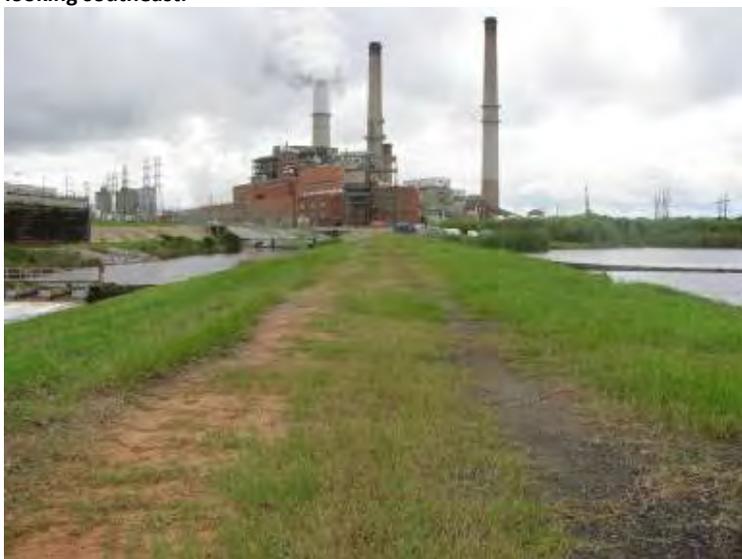
Photo 55: Crest of Ash Pond along southwest embankment looking northwest.

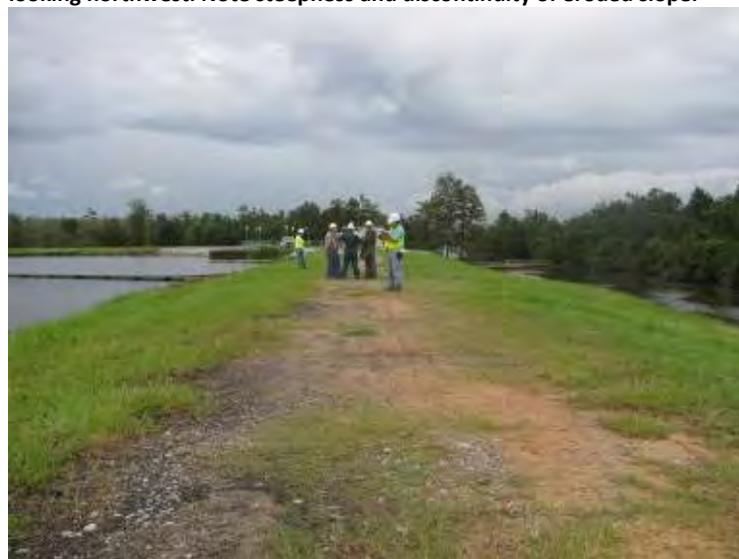
Photo 56: Crest of Ash Pond along southwest embankment looking southeast.

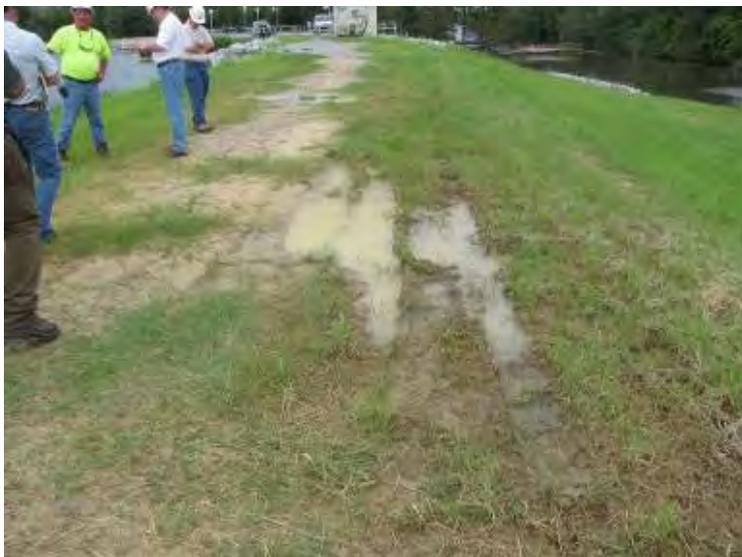
Photo 57: Ruts and ponding of water on crest southwest embankment of Ash Pond.

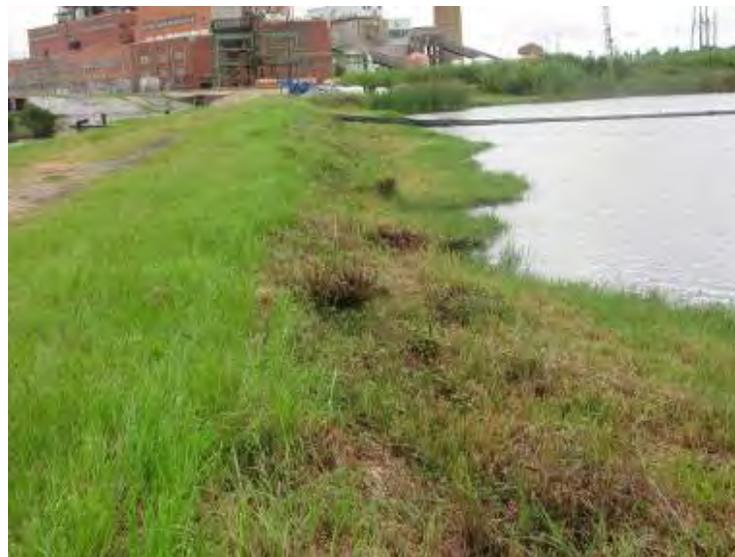
Photo 58: Southwest embankment interior slope looking northwest. Note scarp and erosion at waterline.

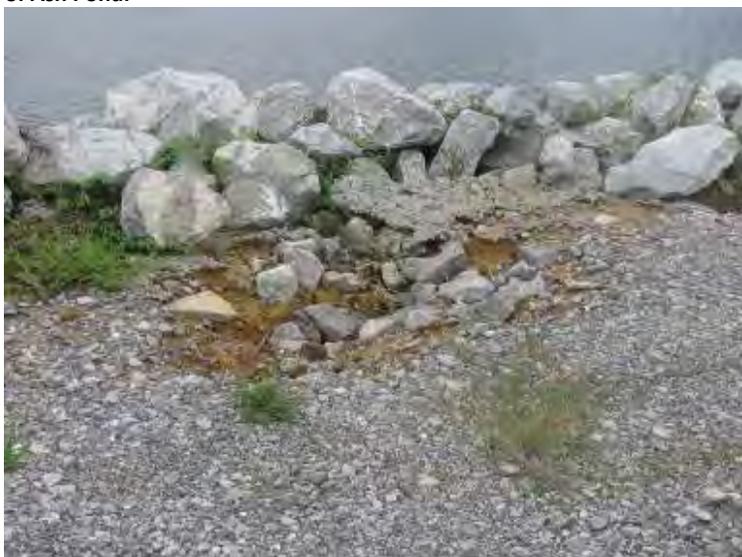
Photo 59: Settlement erosion behind sheet pile wall and riprap on crest of Ash Pond southwest embankment. Note isolated area of loss of soil support.

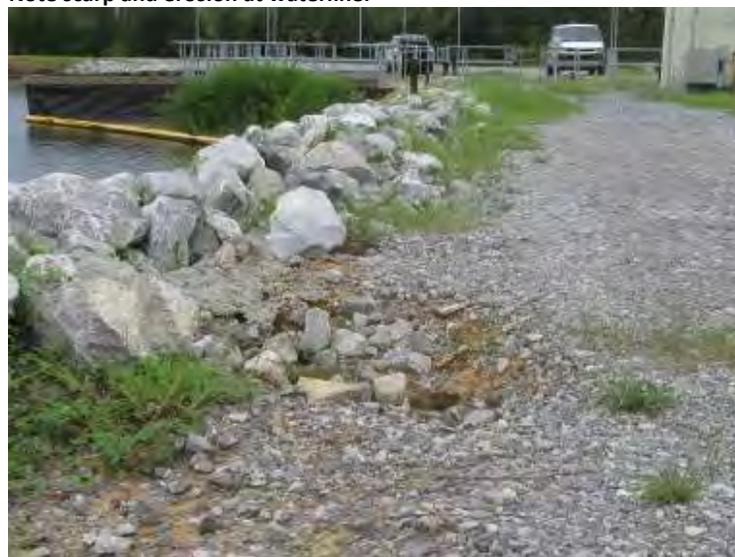
Photo 60: Settlement erosion area behind sheet pile wall and riprap on crest of Ash Pond southwest embankment. Note isolated area of loss of soil support.

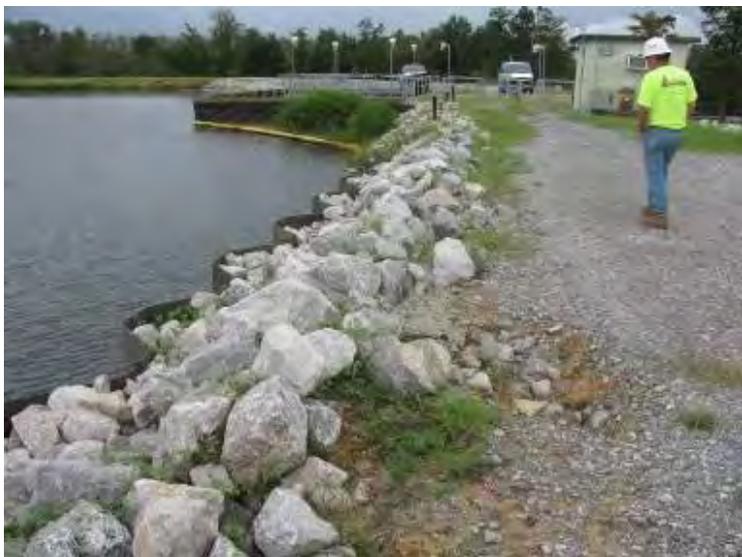
Photo 61: Erosion area behind sheet pile wall and riprap on crest of Ash Pond southwest embankment. Note isolated area of loss of soil support.

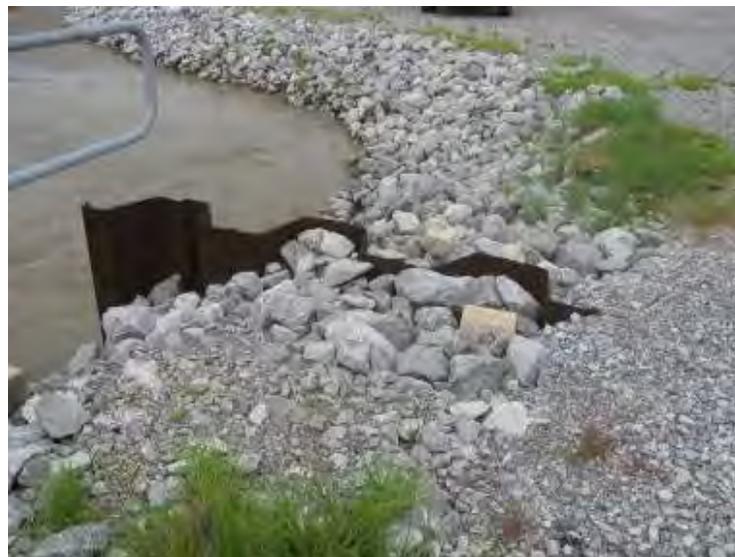
Photo 62: Portion of abandoned sheet pile cofferdam left in place on south side of spillway used to construct spillway.

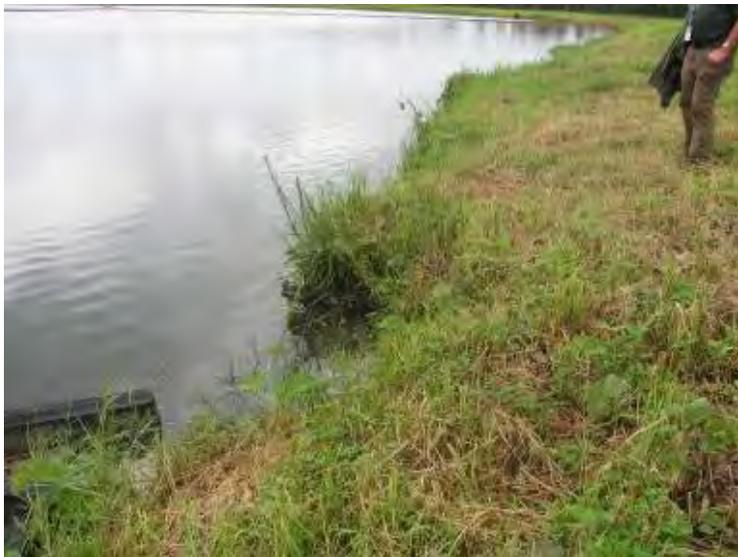
Photo 65: Erosion at interior slope and crest of Ash Pond along southeast embankment looking northeast.

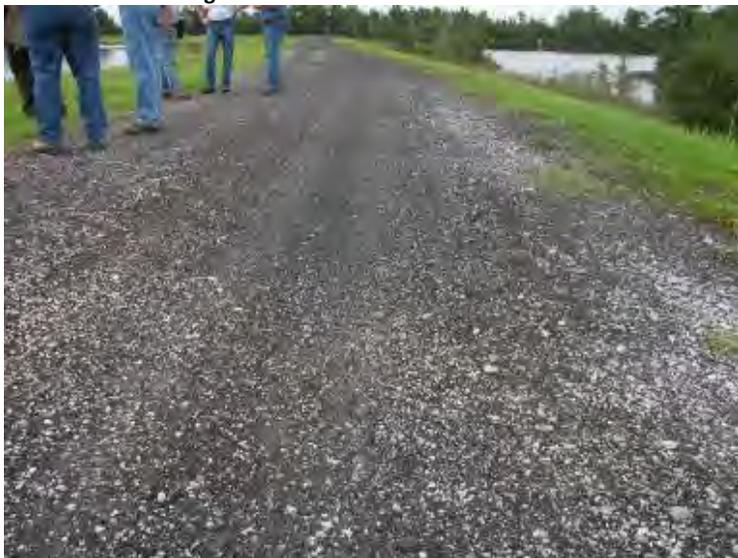
Photo 67: Crest of Ash Pond near south corner of pond looking northeast.

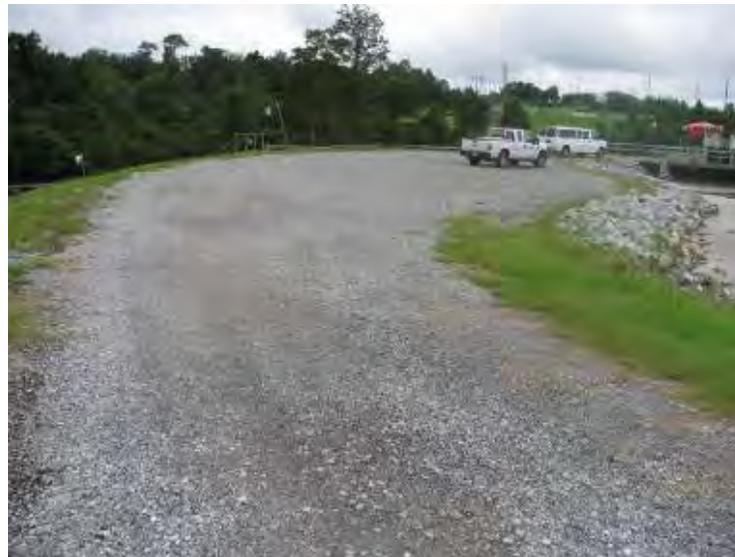
Photo 66: Crest of Ash Pond near south corner of pond looking west.

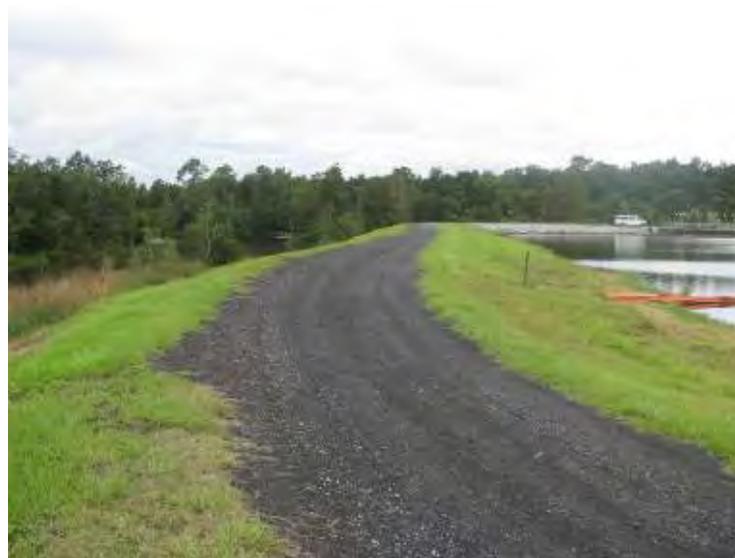
Photo 68: Crest of Ash Pond near east corner of pond looking southwest.

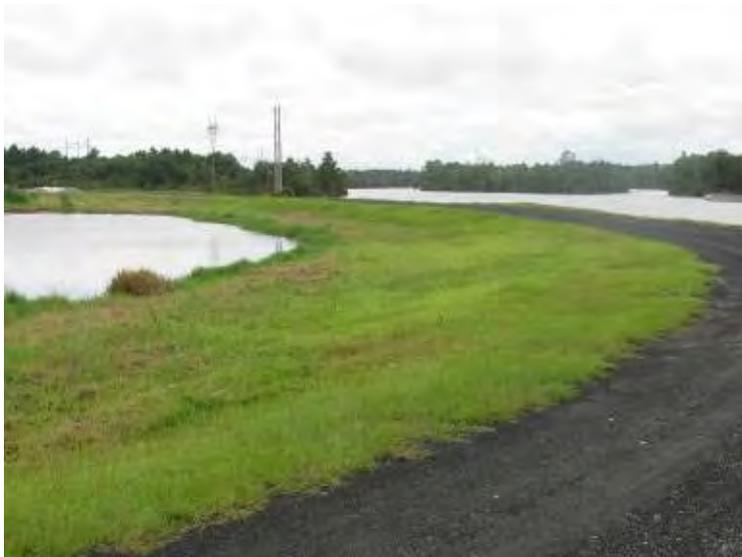
Photo 69: Crest of Ash Pond near east corner of pond looking north.

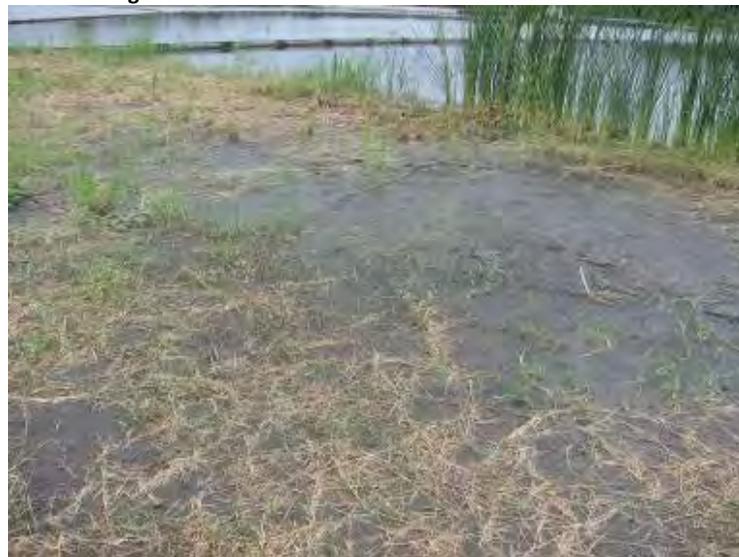
Photo 72: Ash delta located along interior slope of northeast embankment of Ash Pond looking south.

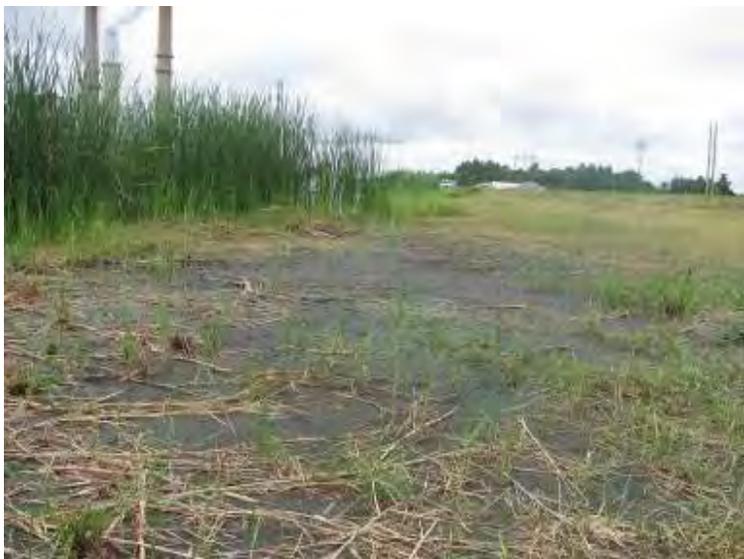
Photo 73: Ash delta located along interior slope of northeast embankment of Ash Pond looking northwest.

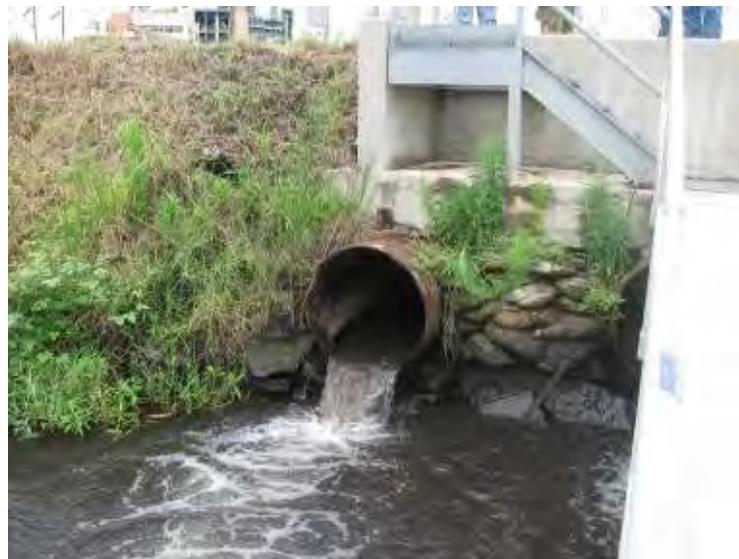
Inlet pipes are located at the north corner of the Ash Pond and consist of two 30-inch-diameter steel pipes (Photographs 78 and 81 to 83).

The outlets appear to be in **SATISFACTORY** condition. The outlets from the Ash Decant/Settling Ponds consist of two 30-inch-diameter steel pipes located near the east corner of Pond #5. The pipe inverts were submerged at the time of inspection. Water appeared to be flowing freely through the outlet pipes to the Ash Pond (Photograph 78).

Photo 78: 30-inch diameter inlet pipes at north corner of Ash pond looking northwest.

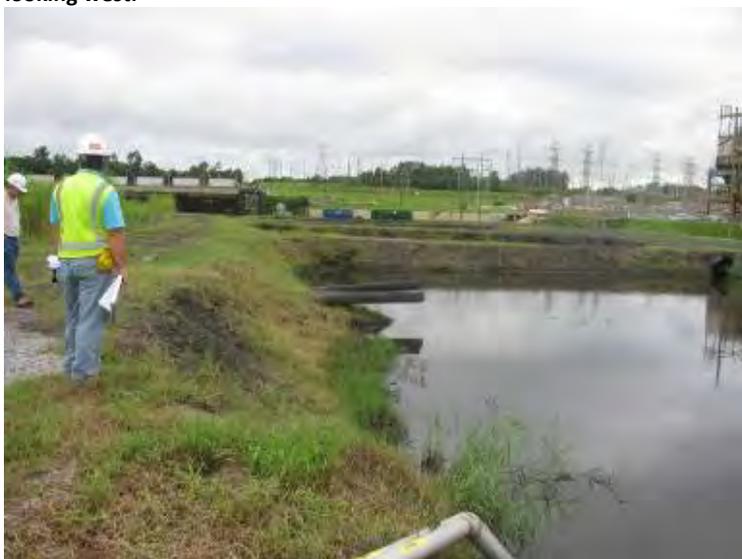
The crests of the Ash Decant/Settling Pond embankments appear to be in **POOR** condition. The average crest width is approximately 15 feet. The crests of the divider embankments between ponds show signs of significant erosion due to concentrated rainfall runoff (Photographs 79, 88 and 98). No depressions, ruts, or evidence of settlement were observed on the crests. Dense vegetation and trees up to 4 inches in diameter were observed on the southeast divider embankment between Ash Decant/Settling pond 7 and the Ash Pond (Photograph 85).

Photo 79: Crest and southeast interior slope of Decant/Settling Pond #5.

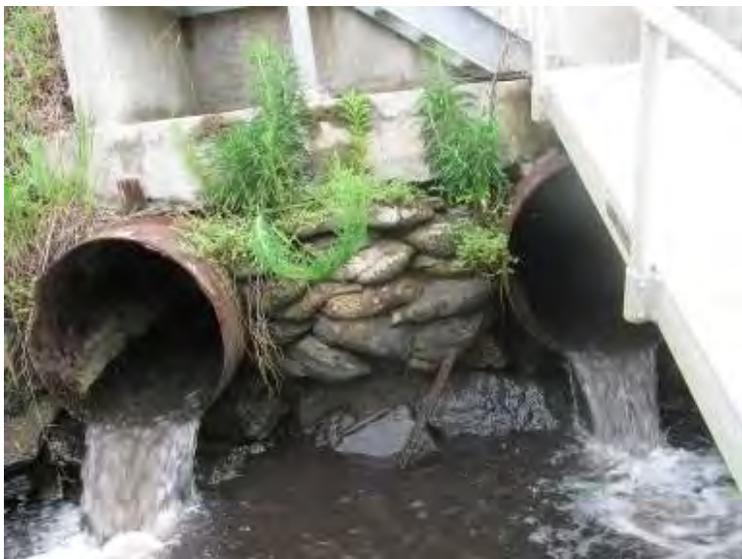
Photo 81: 30-inch diameter inlet pipes located below walkway/catwalk at north corner of Ash pond looking northwest.

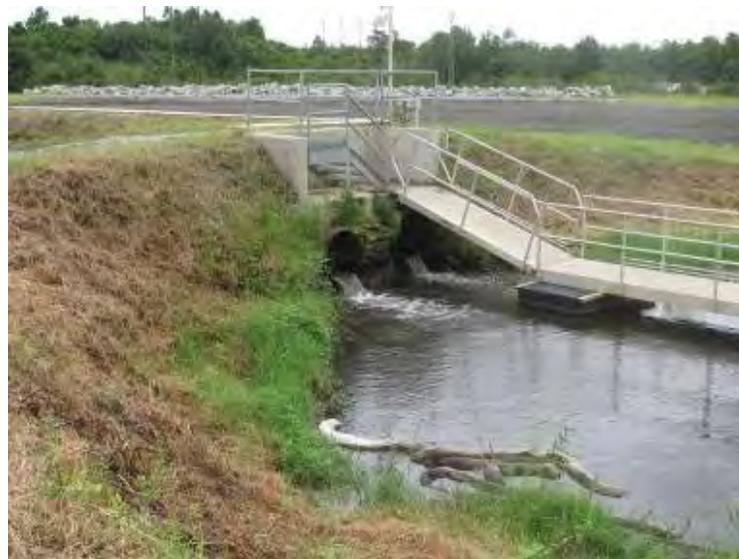
Photo 82: 30-inch diameter inlet pipes located below walkway/catwalk at north corner of Ash pond looking northwest.
