ASSESSMENT OF DAM SAFETY OF COAL COMBUSTION SURFACE IMPOUNDMENTS – DRAFT REPORT

Gulf Power Plant Crist Pensacola, Florida

Prepared for
*U.S. Environmental
Protection Agency
Washington, D.C.*

October, 2012
Revision 1, November 2013

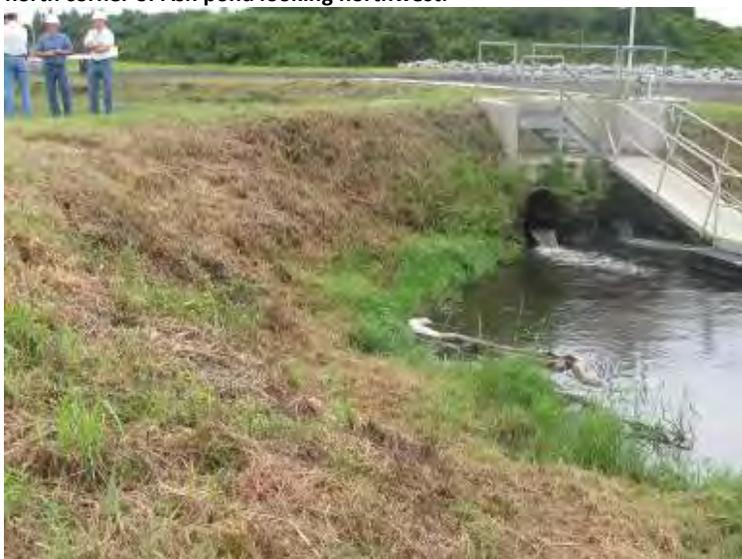
Inlet pipes are located at the north corner of the Ash Pond and consist of two 30-inch-diameter steel pipes (Photographs 78 and 81 to 83).

Photo 83: 30-inch diameter inlet pipes located below walkway/catwalk at north corner of Ash pond looking northwest.

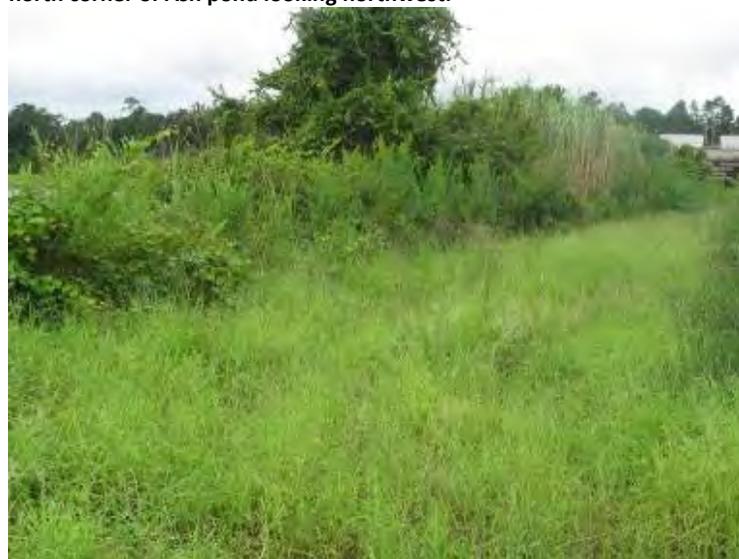
Photo 84: Crest of Ash Pond along northwest side. Note dense vegetation.

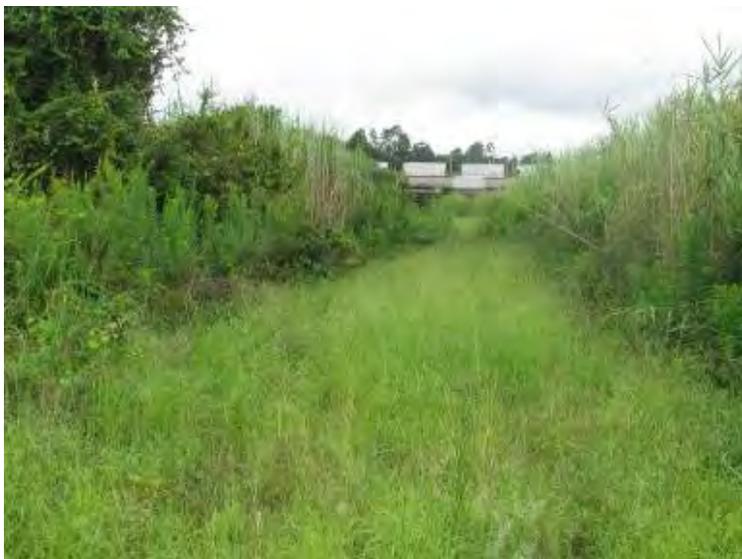
Photo 85: Crest of Ash Pond along northwest side. Note dense vegetation.

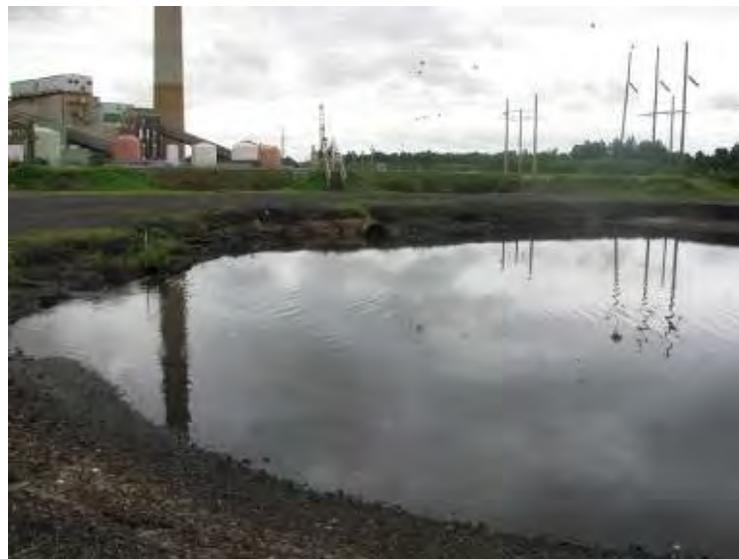
Photo 86: Interior slopes and surface of Decant/Settling Pond #1 looking north.

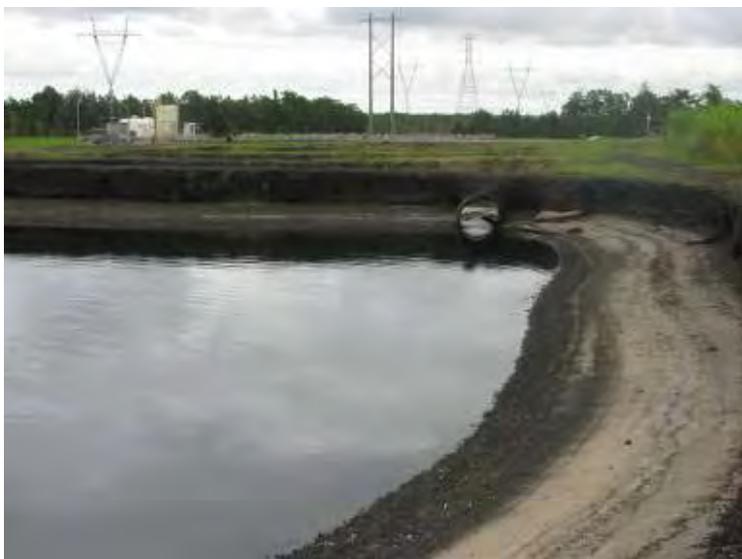
Photo 87: Interior slopes and surface of Decant/Settling Pond #1 looking northeast. Note equalizer pipe between ponds.

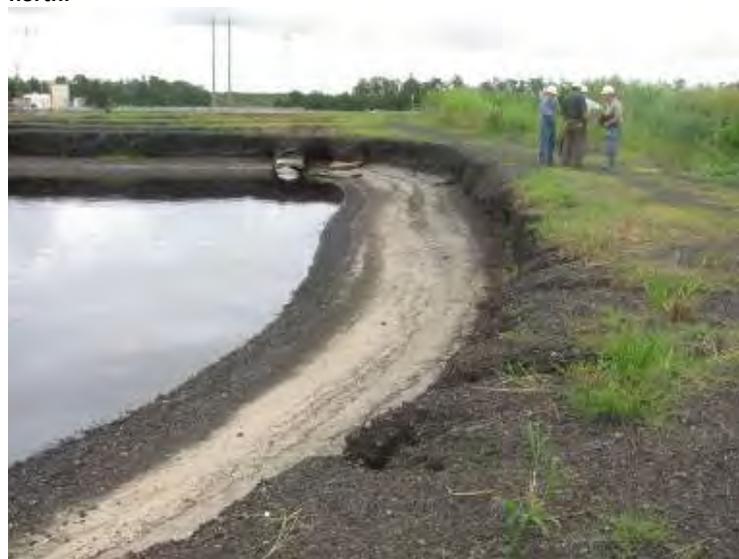
The crests of the Ash Decant/Settling Pond embankments appear to be in **POOR** condition. The average crest width is approximately 15 feet. The crests of the divider embankments between ponds show signs of significant erosion due to concentrated rainfall runoff (Photographs 79, 88 and 98). No depressions, ruts, or evidence of settlement were observed on the crests. Dense vegetation and trees up to 4 inches in diameter were observed on the southeast divider embankment between Ash Decant/Settling pond 7 and the Ash Pond (Photograph 85).

Photo 88: Interior slopes and surface of Decant/Settling Pond #1 looking northeast.

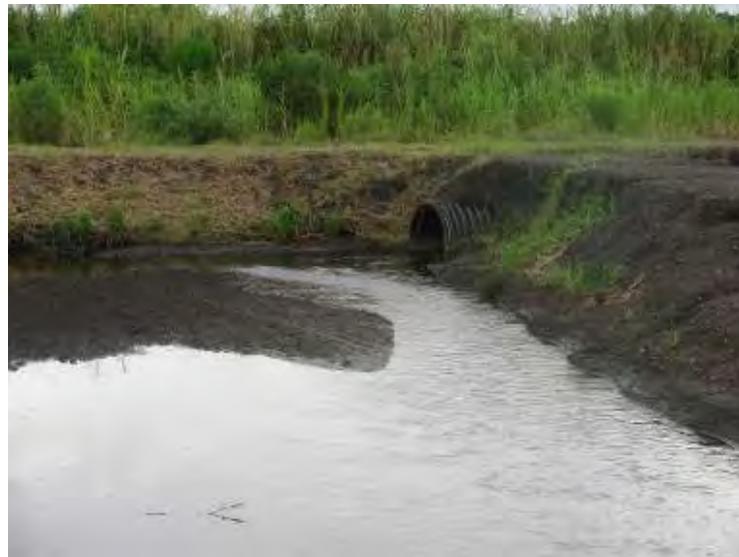
Photo 90: Interior slopes, divider and surface of Decant/Settling Pond #2 looking southeast. Note presence of ash/CCW.

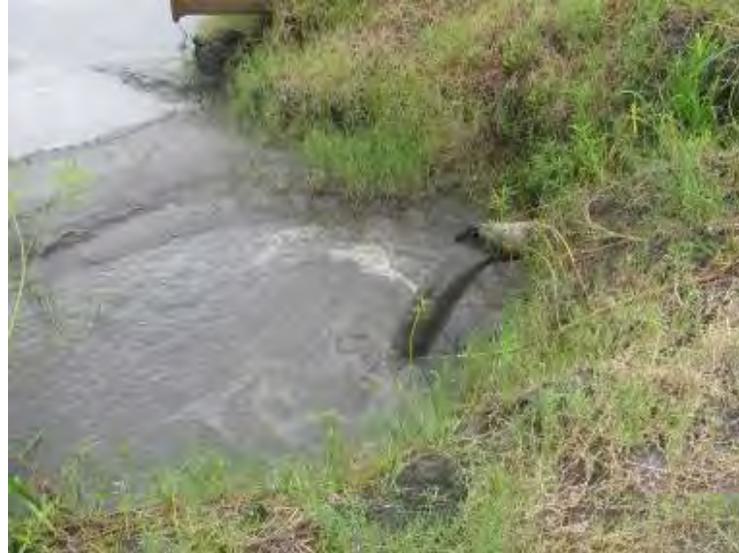
The interior slopes appear to be in **POOR** condition. The exposed slopes vary from approximately 1H:1V to 1.5H:1V. Vegetative cover on the interior slopes is sparse. Erosion rills were observed on the interior slopes of all the Decant/Settling Ponds. Interior slopes show signs of deterioration, erosion and scarped areas. The embankments' interior toe is generally buried (Photographs 98, 99 and 100). At the time of assessment, Pond #3 was receiving discharge water from plant operations (Photograph 92).

Photo 92: Discharge water from plant operations into Decant/Settling Pond #3.

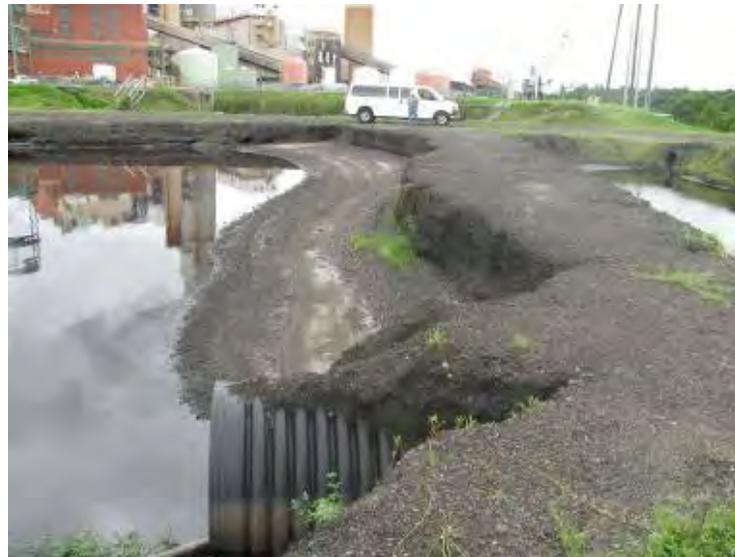
Photo 98: Divider dike between Decant/Settling Ponds #1 and #2 looking northwest.

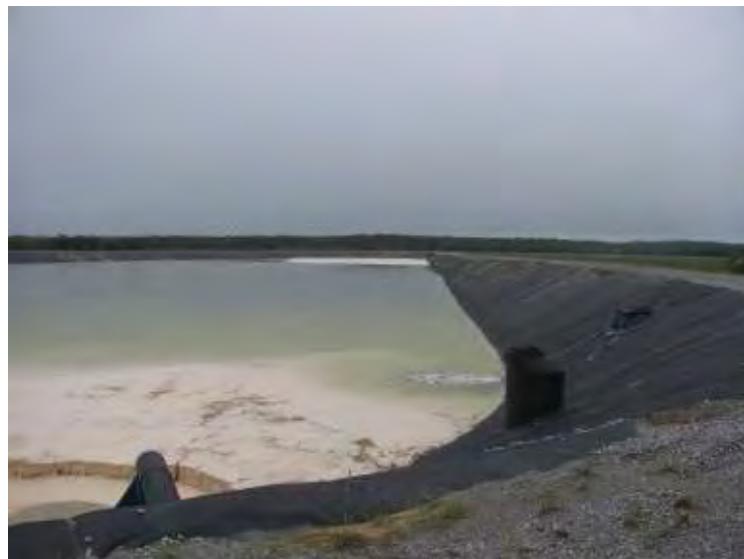
Photo 102: View of surface and south interior slope of Gypsum Pond looking northwest. Note discharge pipe and deposition of gypsum in foreground.

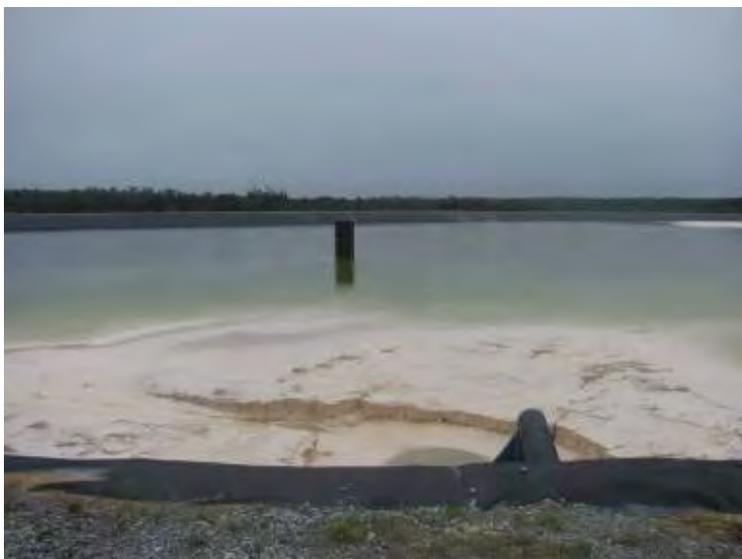
Photo 103: View of surface of Gypsum Pond looking west. Note discharge pipe & deposition of gypsum in foreground and Decant Riser in center of photo.

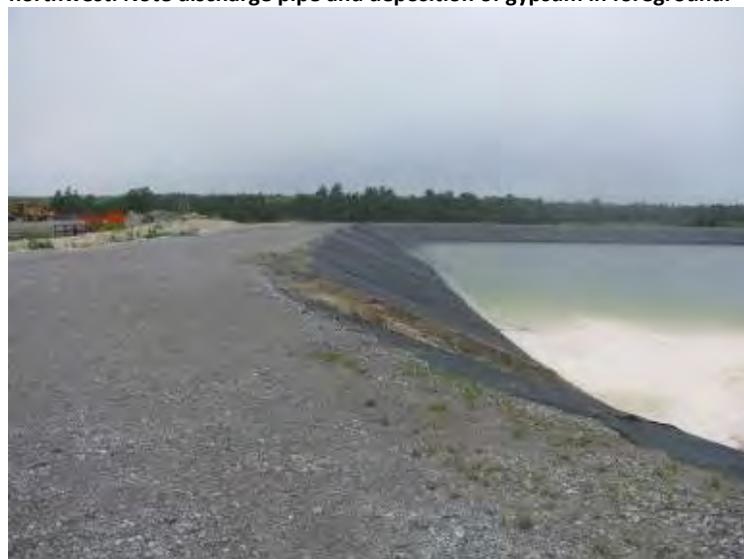
The crest of the Gypsum Storage Pond embankments appears to be in **SATISFACTORY** condition (Photographs 104, 172 and 173). The average crest width is approximately 20 feet. The crest surface is gravel-covered without vegetation. No depressions, misalignments, cracks, ruts, or evidence of settlement were observed along the crests of the Gypsum Storage Pond.

Photo 104: Crest and interior slope of south embankment of Gypsum Pond looking southwest.

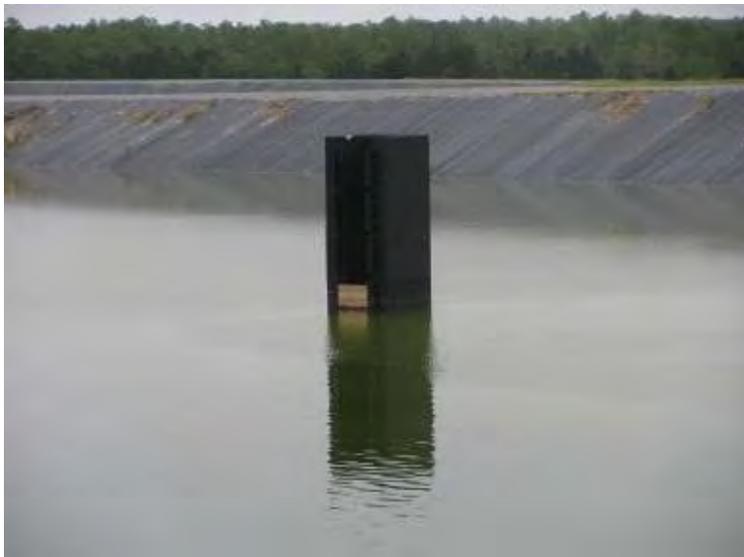
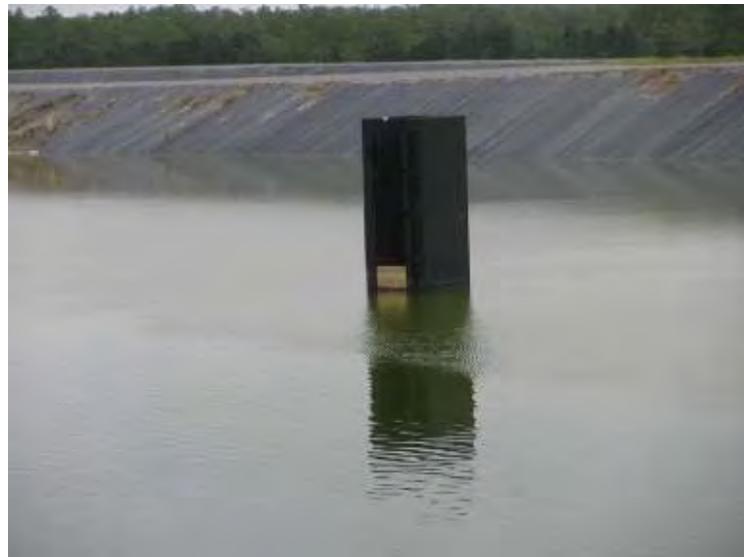
The Gypsum Storage Pond outlet structure consists of a decant riser (Photographs 105 and 106) located approximately 220 feet from the crest of the northeast embankment. From the limited view due to the distance, the riser appeared to be free of debris and in good operating condition.

Photo 105: Surface of Gypsum O Pond and Decant Riser looking north.

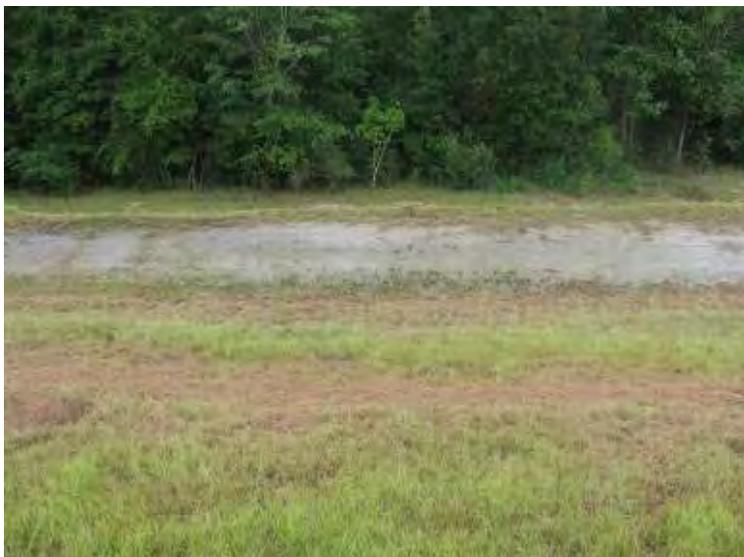
Two areas of possible seepage were observed. The first is located near the toe of slope of the southwest embankment, adjacent to the south corner (Photographs 109 to 112). The second is located at the toe of slope of the east embankment (Photographs 155 to 158). The first area consisted of saturated soils and standing water on the perimeter road/maintenance bench, and the second area consisted of saturated soils and ponded water observed within the voids of the riprap. No underlying filter fabric was observed in this area.

Photo 109: Perimeter road/maintenance bench at toe of southwest slope of Gypsum O Pond looking southwest. Note standing water at toe.

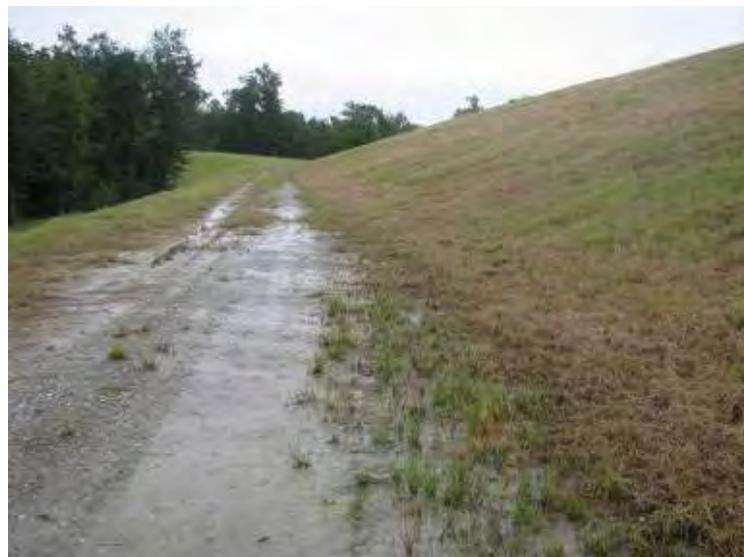
Photo 110: Perimeter road/maintenance bench at toe of SW slope of Gypsum O Pond looking northwest. Note standing water at toe.

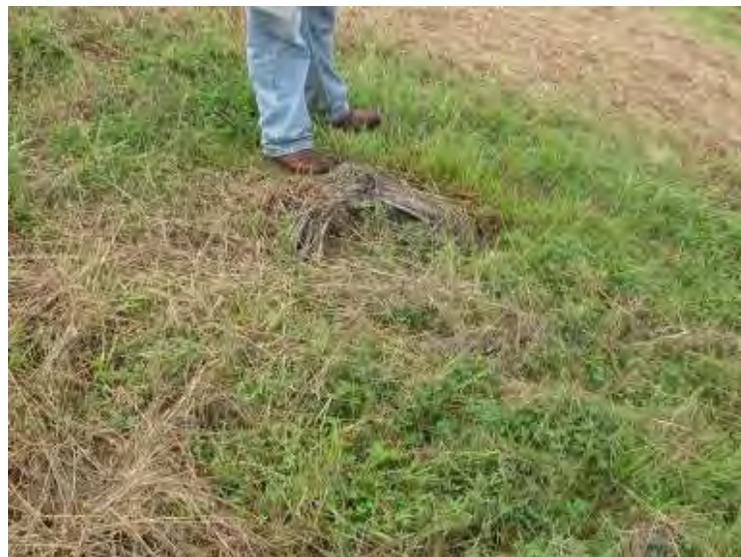
Photo 114: Trash and grass cuttings on southwest exterior slope of Gypsum Pond.

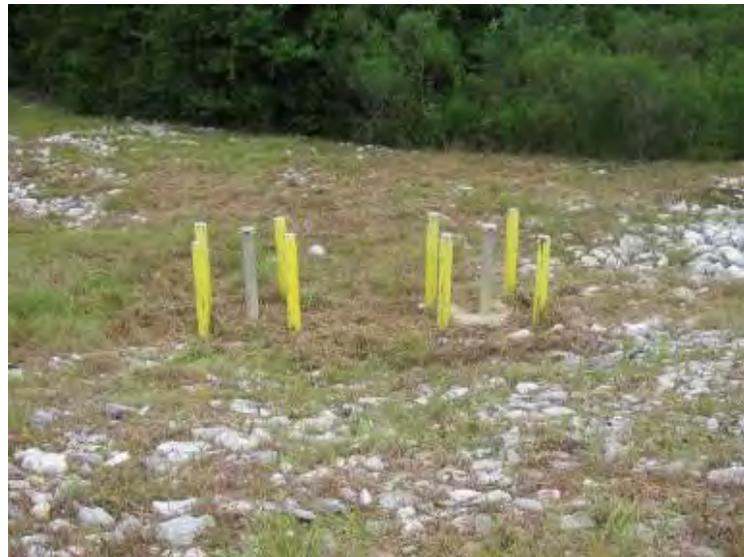
Monitoring wells were observed beyond the toe of slope of the west and north embankments (Photographs 118 and 139).

Photo 118: Monitoring Wells located beyond exterior toe of slope on west side of Gypsum Pond.

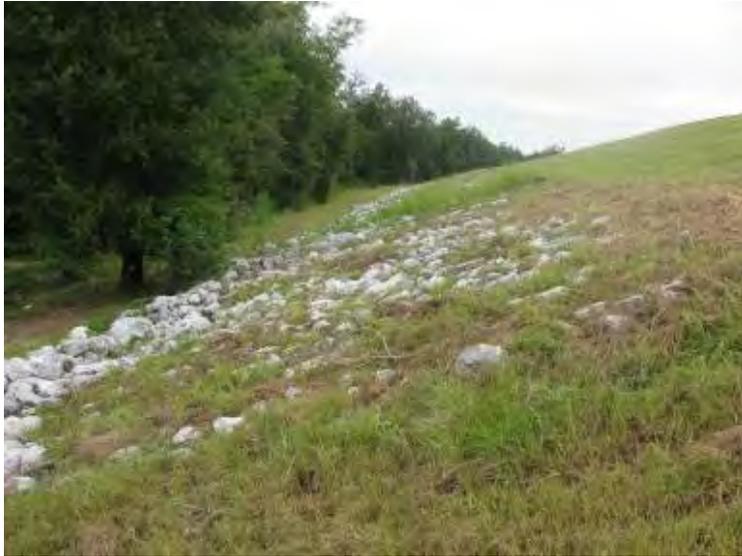
In general, the exterior slopes of the Gypsum Storage Pond appear to be in **SATISFACTORY** condition. Slopes are approximately 3H:1V with the exception of the west embankment slope which appears to be approximately 2.5H:1V. Embankment vegetation consisted mainly of well-maintained grass approximately 4 to 6 inches tall, with the exception of the west and northwest embankments (Photographs 117, 119 and 120). The exterior slopes of the west and northwest embankments are armored with a layer of riprap from the toe of the slope, extending approximately 30 feet up the slope. The balance of the west and northwest embankments consisted of well-maintained grass approximately 4 to 6 inches tall (Photographs 121 to 125).

Photo 121: Start of riprap slope protection along toe of west exterior Slope of Gypsum O Pond looking north. Slope in this area is about 2.5H:1V.

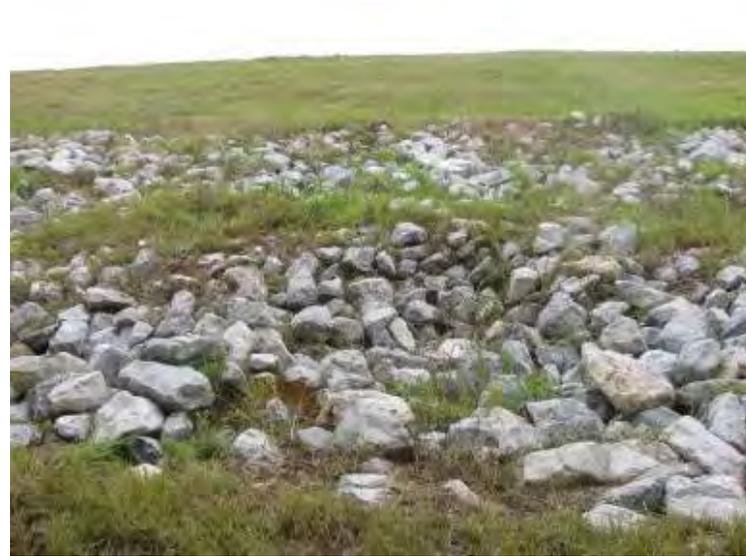
The alignment of the slopes appears to be relatively uniform and consistent. Animal burrows (Photographs 129, 130 and 154) were observed on the northwest and east embankments. Discontinuities and collapsed areas of the riprap-covered slope (Photographs 122 and 123) and areas where the underlying filter fabric was exposed (Photographs 124 and 125) were also observed on the west embankment.

Photo 122: Riprap slope protection along toe of west exterior slope of Gypsum O Pond looking east. Note depressed area at center.

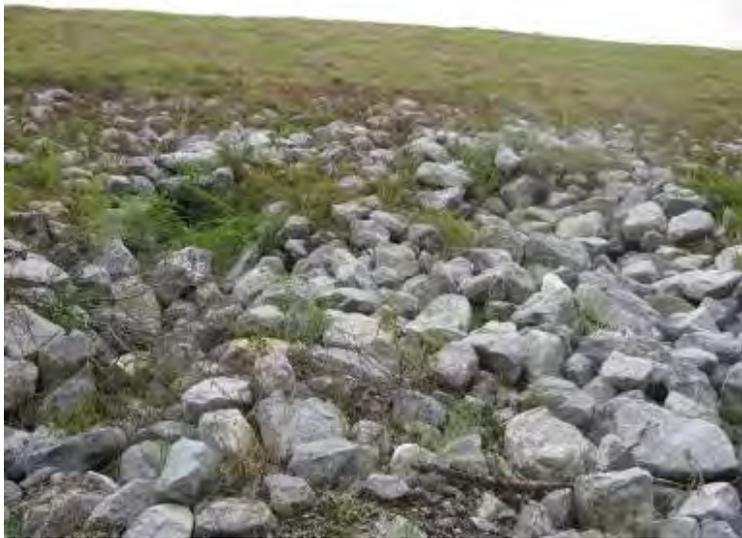
Photo 123: Riprap slope protection along toe of west exterior slope of Gypsum O Pond looking east. Note depressed area at center.

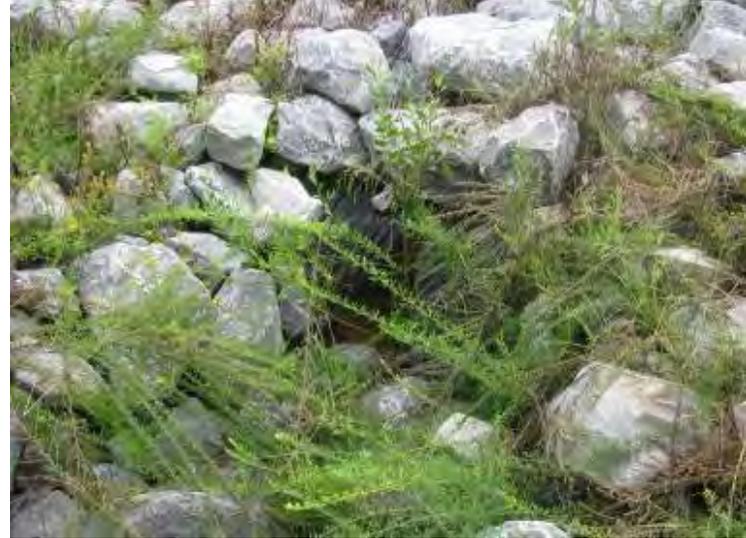
Photo 124: Riprap slope protection along toe of west exterior slope of Gypsum O Pond looking east. Note exposed filter fabric.

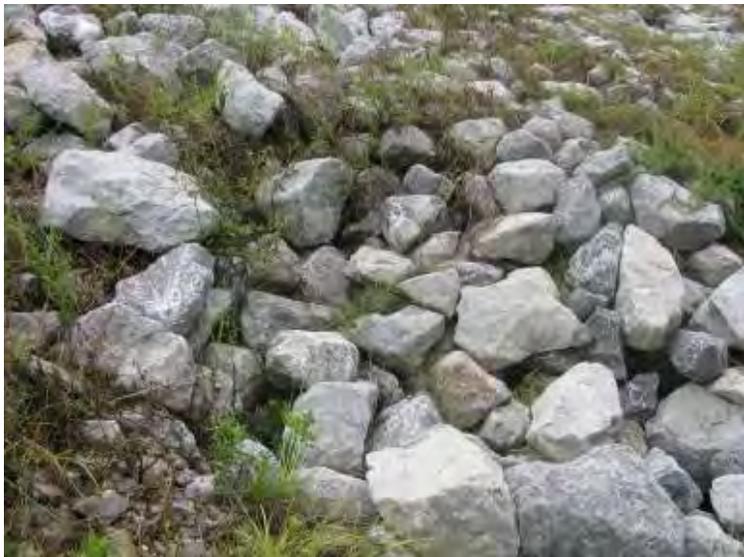
Photo 125: Riprap slope protection along toe of west exterior slope of Gypsum O Pond looking east. Note exposed filter fabric.

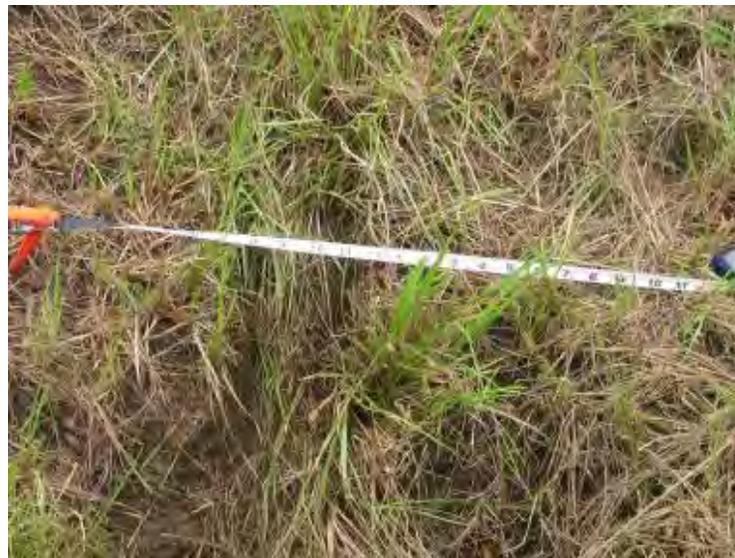
Photo 128: Rill located at approximate mid-face of west exterior slope of Gypsum O Pond. Depth is about 4 to 6 inches.

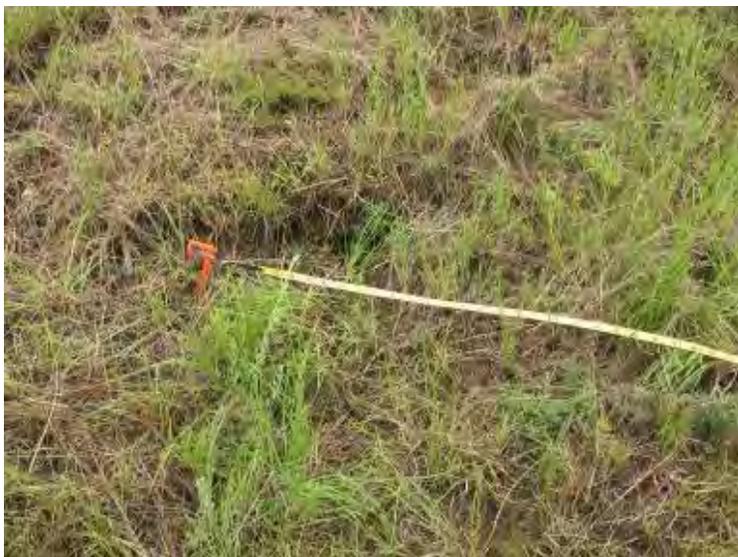
Photo 129: Animal burrow located at approximate mid-face of west exterior slope of Gypsum Pond.

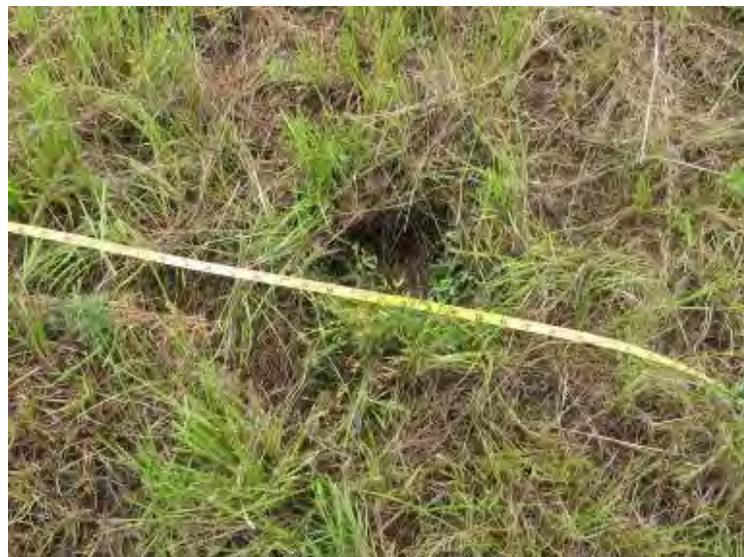
Photo 130: Animal burrow on west exterior slope of Gypsum Pond.

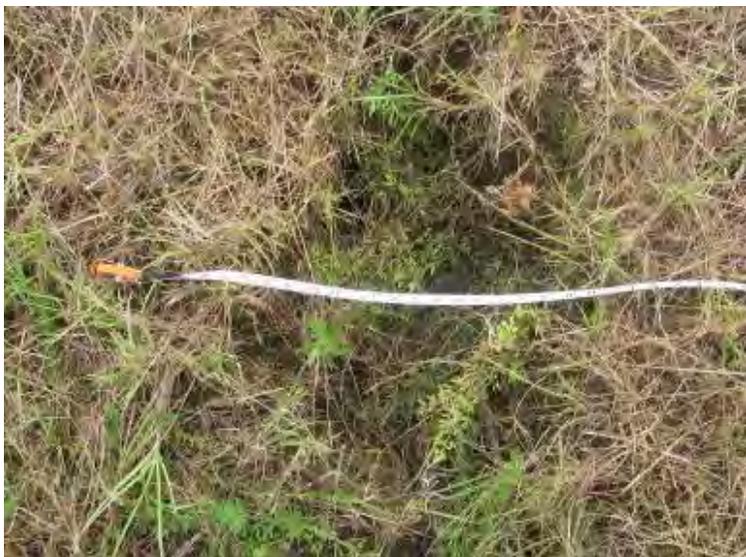
The alignment of the slopes appears to be uniform and consistent. No signs of bulging, sloughing or slope failure were observed. Shallow to intermediate surface erosion and erosion rills were observed on the northeast slope (Photographs 132 to 138). No animal burrows were observed. Filter fabric beneath the riprap slope treatment was exposed at several locations (Photograph 141) on the northwest embankment.

Photo 133: Approximate 16-foot long rill erosion on north exterior Slope of Process Sedimentation Pond (width is about 1 foot).

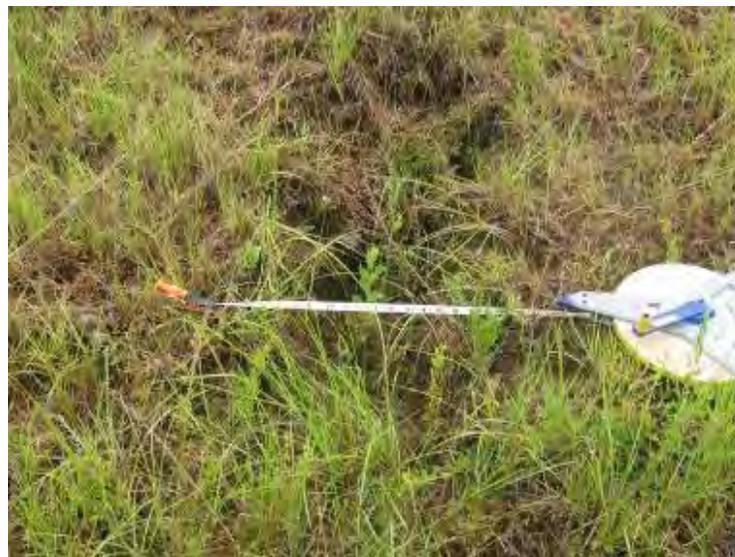
Photo 134: Rill located on north exterior slope of Process Sedimentation Pond (typical of six).

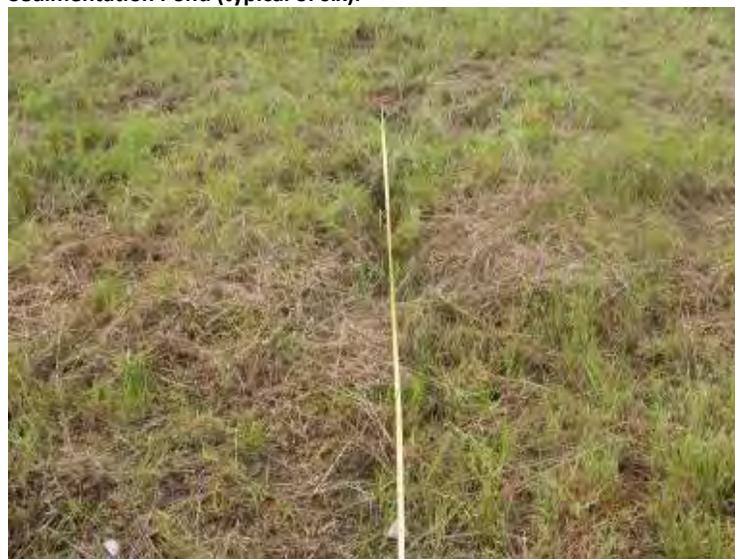
Photo 136: Rill located near toe of north exterior slope of Process Sedimentation Pond looking southeast (up slope).

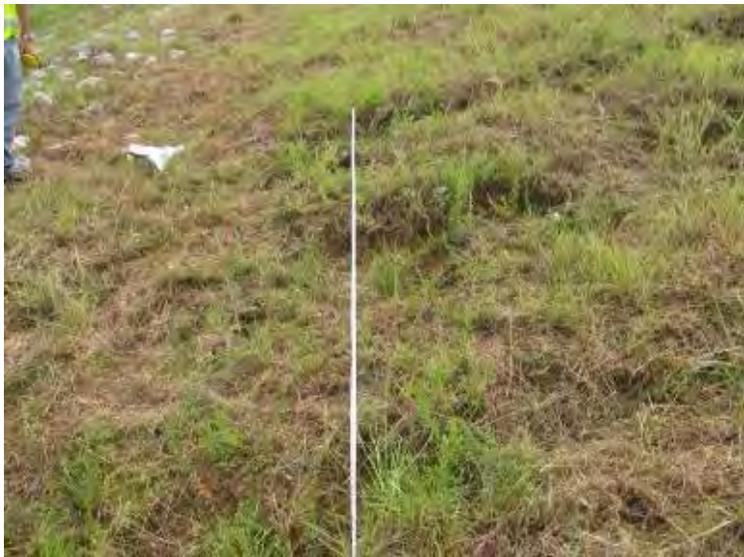
Photo 137: Three rills located along toe of north exterior slope of Process Sedimentation Pond looking east.

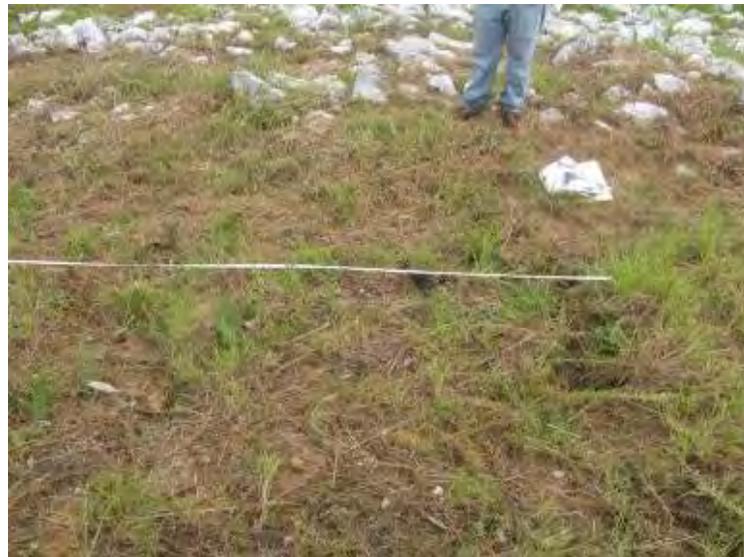
Photo 138: Three rills located along toe of north exterior slope of Process Sedimentation Pond looking north (down slope).

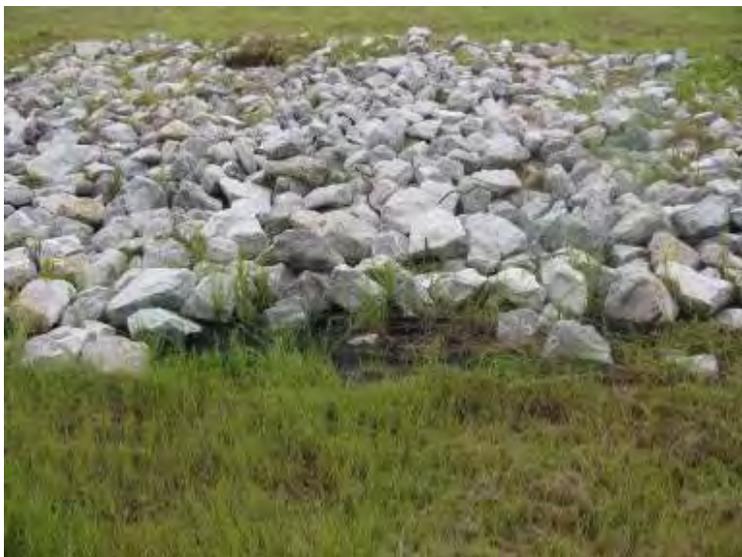
Photo 141: Exposed filter fabric beneath riprap where a depression is located.

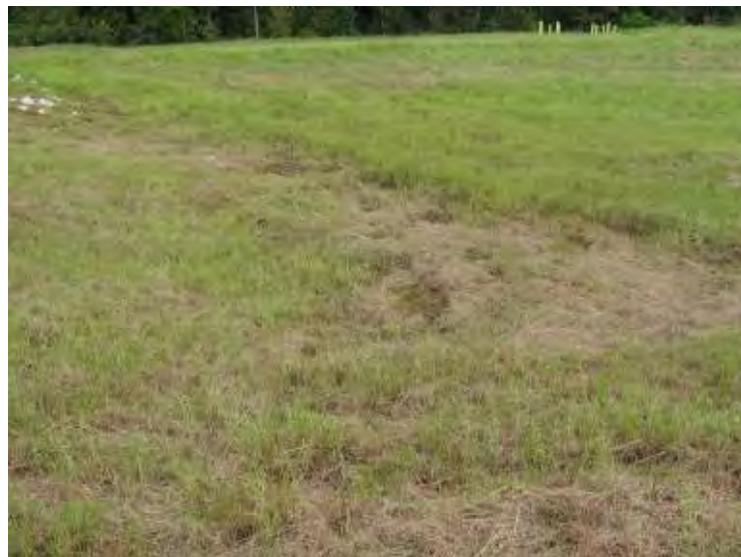
Areas of possible seepage were observed on the northeast corner on both sides of the access road to the crest. These areas were saturated and standing water was observed at the toe of slope (Photographs 142 to 144).

Photo 142: Wet area/saturation located at toe of slope adjacent to access road on northeast exterior slope of Process Sedimentation Pond looking north.

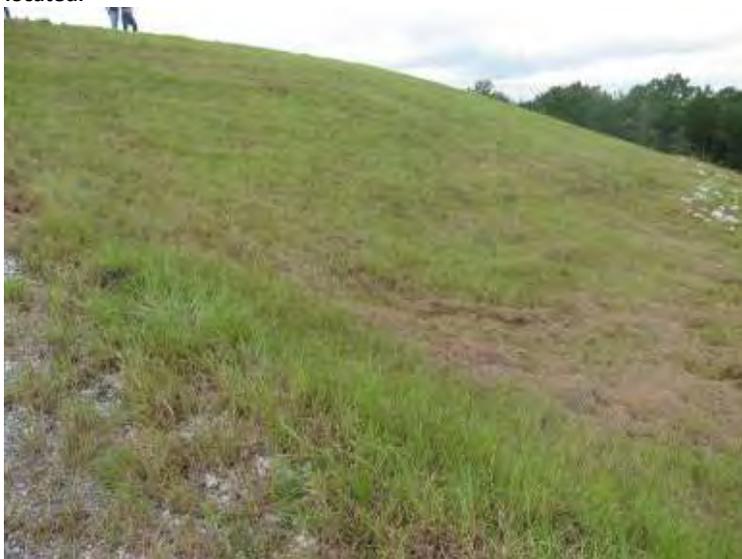
Photo 143: Wet area/saturation located at toe of slope adjacent to access road on northeast exterior slope of Process Sedimentation Pond looking east.

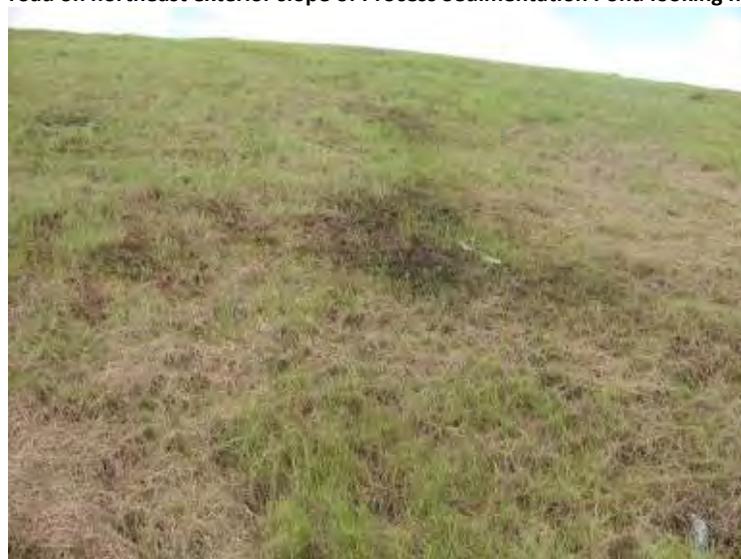
Photo 144: Wet area/possible seepage located approximately mid-slope along east exterior slope of Process Sedimentation Pond looking west.

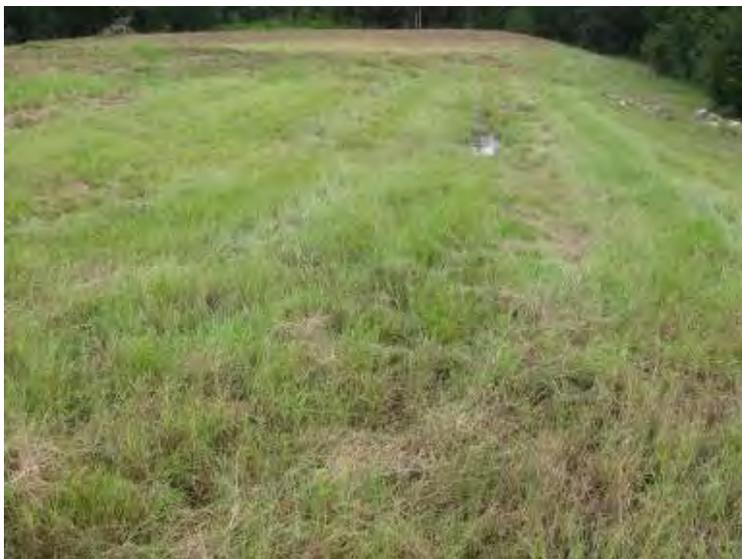
Photo 145: Area of wet area/possible seepage located approximately mid-slope along east exterior slope of Process Sedimentation Pond looking east.

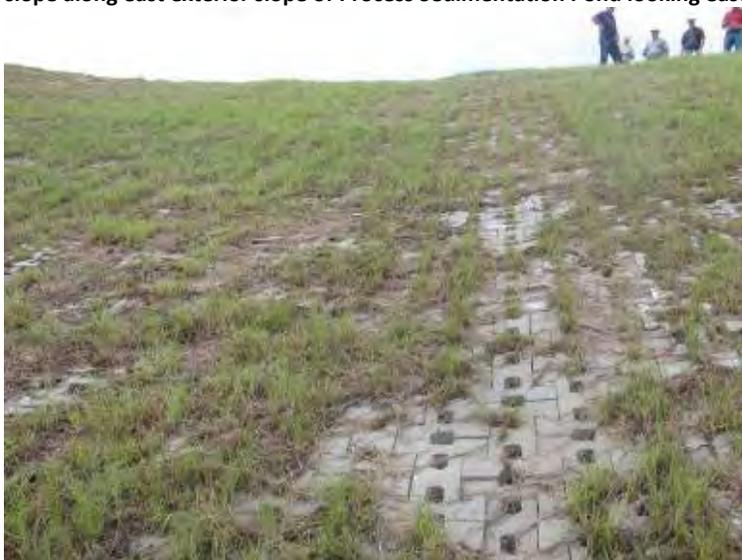
The downstream side of the emergency overflow spillway is armored with interlocked articulated concrete block mattresses (Photographs 147 to 150). The mattresses appeared to be in good condition with grass and vegetation growing in the open spaces in and between the blocks.

Photo 147: Emergency spillway/articulated concrete block mattress located on east ext.slope of Process Sed. Pond looking west (up slope).

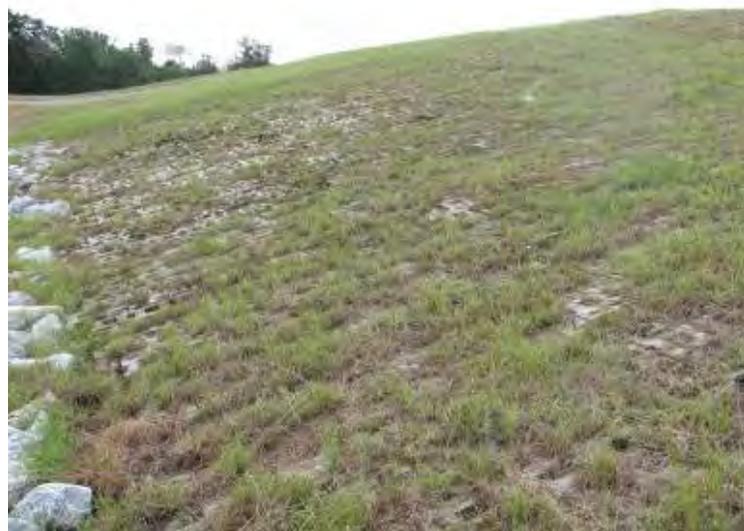
Photo 148: Emergency spillway/articulated concrete block mattress located on east ext. slope of Process Sed. Pond looking south.

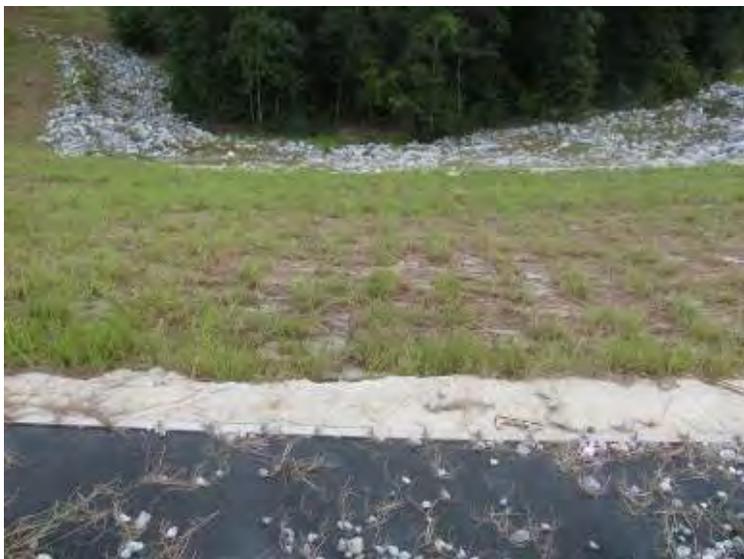
Photo 149: Emergency spillway/ articulated concrete block mattress located on east exterior slope of Process Sedimentation Pond looking east (down slope).

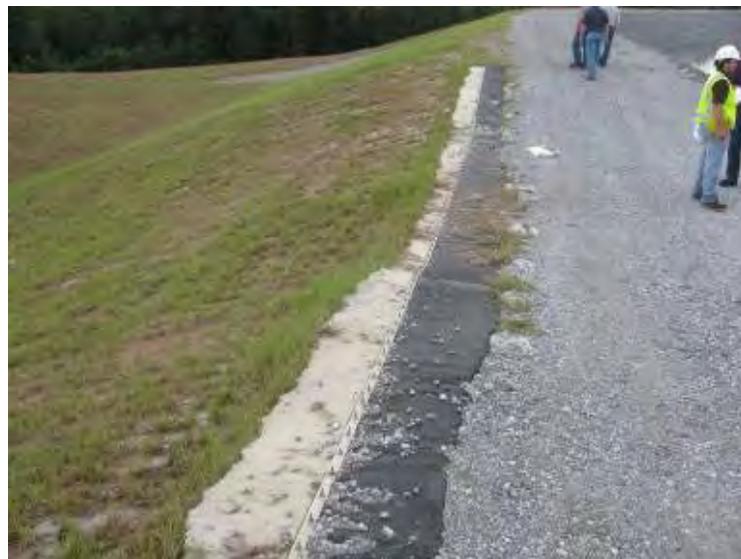
The crest of the Process Sedimentation Pond appeared to be in **SATISFACTORY** condition (Photograph 164). The average crest width is approximately 20 feet. The crest surface is gravel-covered without vegetation. No depressions, ruts, or evidence of settlement were observed on the crest. An emergency spillway, approximately 56 feet wide, is located near the northeast corner of the pond. The spillway crest is depressed approximately 3 feet (Photograph 150).

Photo 150: Top of emergency spillway along crest of east embankment of Process Sedimentation Pond.

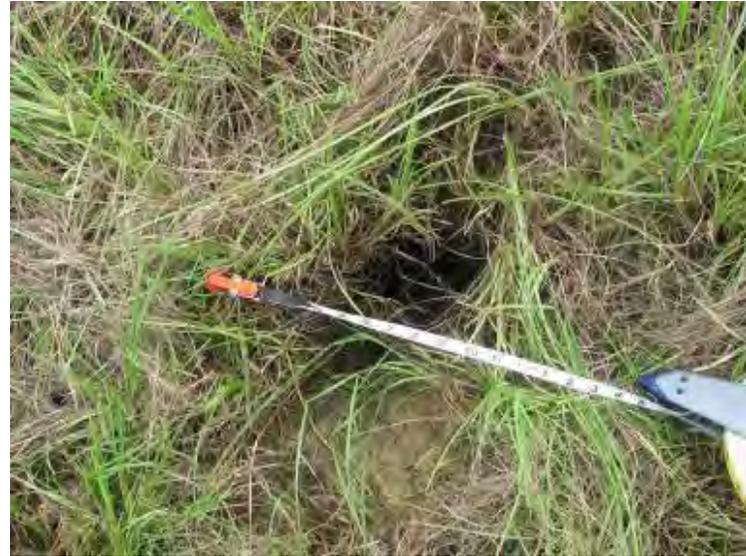
Photo 154: Animal burrow located at toe of slope east exterior slope of Gypsum Storage Pond.

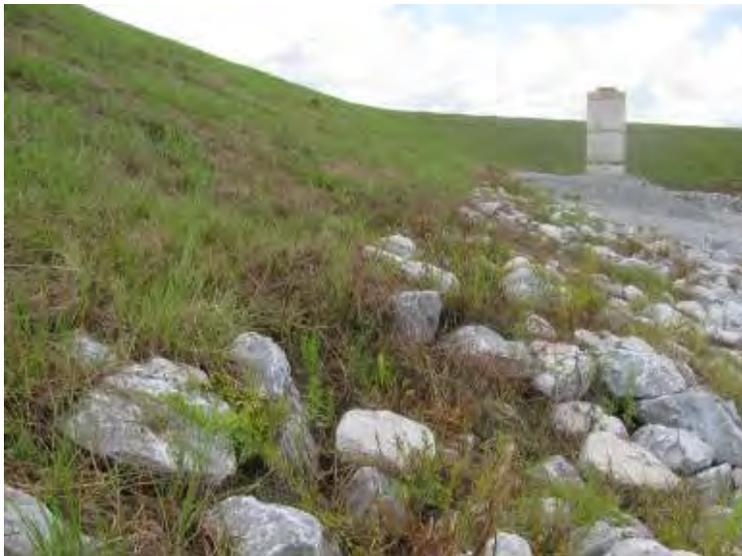
Photo 155: Wet area at toe of slope along east exterior slope of Gypsum Storage Pond looking northwest.

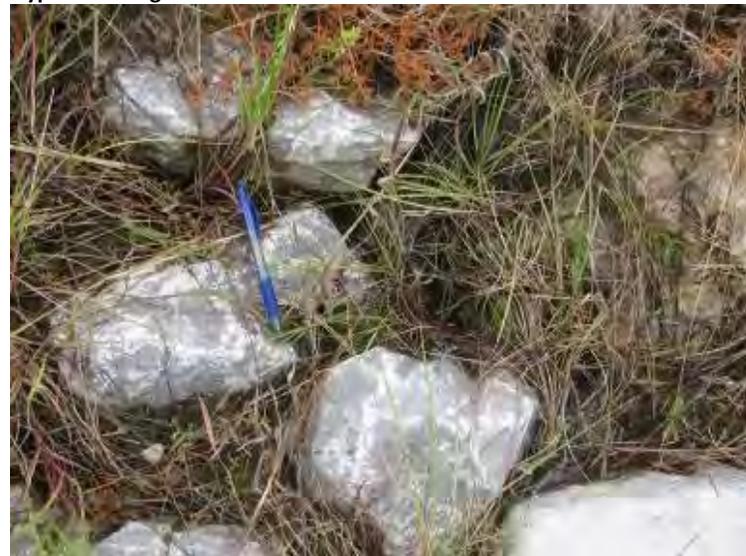
Photo 156: Wet area at toe of slope along east exterior slope of Gypsum Storage Pond.

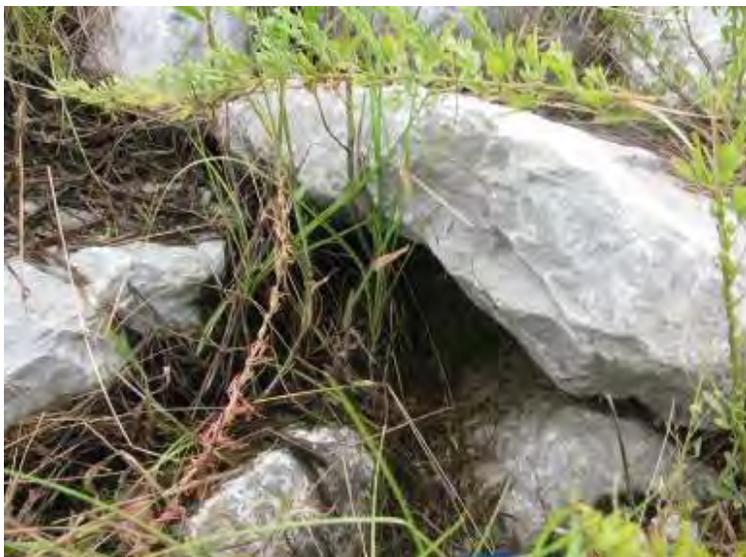
Photo 157: Wet area at toe of slope along east exterior slope of Gypsum Storage Pond.

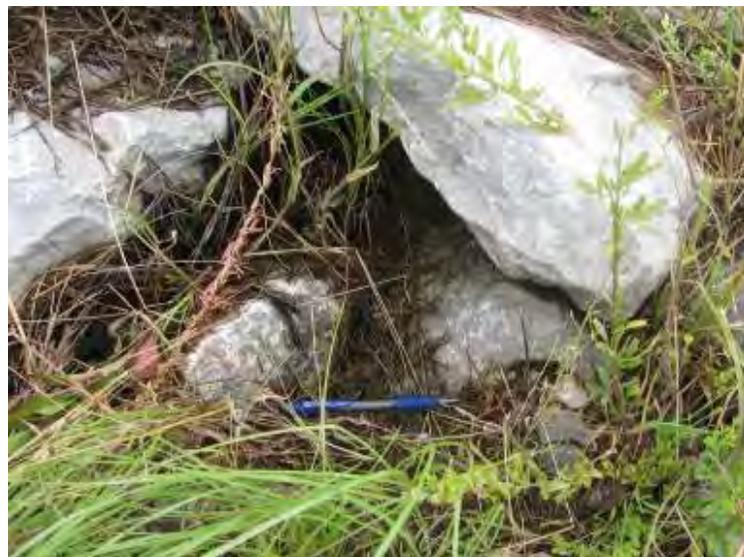
Photo 158: Wet area at toe of slope along east exterior slope of Gypsum Storage Pond.

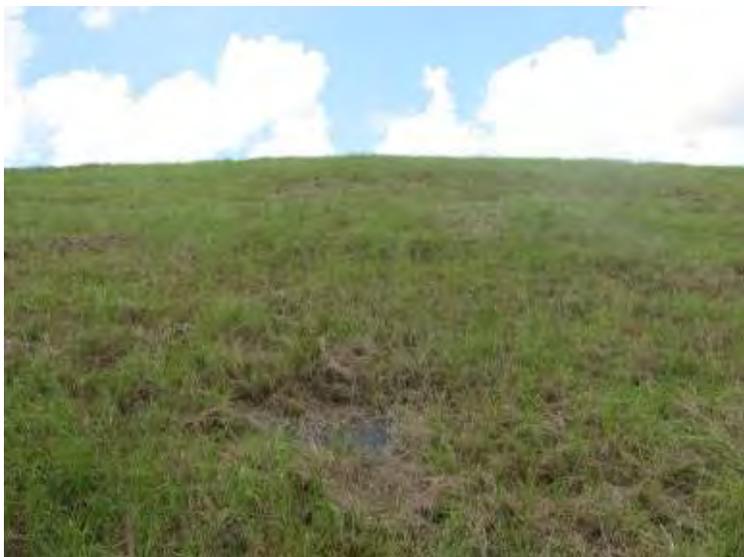
Photo 161: Scarp located on exterior slope of southeast embankment of Process Sedimentation Pond looking northwest.

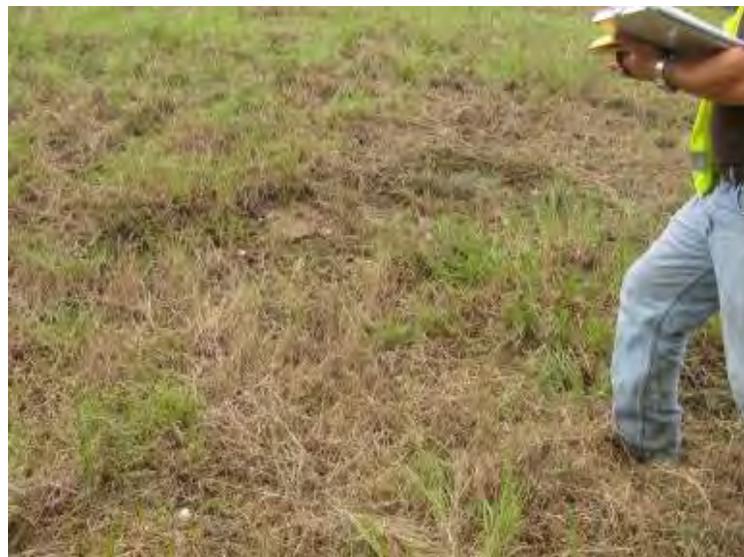
Photo 162: Wet area/potential seepage located on exterior slope near southeast corner Process Sedimentation Pond.

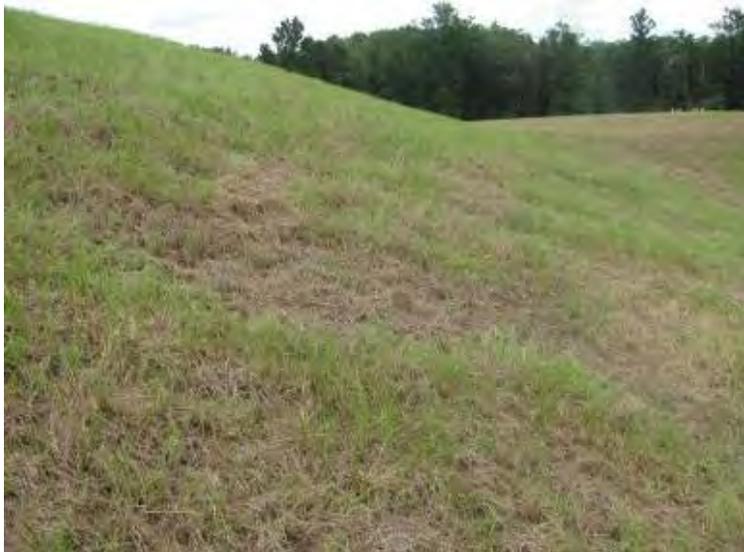
Photo 163: East exterior slope of Process Sedimentation Pond showing sloughed area looking north.
