ASSESSMENT OF DAM SAFETY OF COAL COMBUSTION SURFACE IMPOUNDMENTS – DRAFT REPORT

Gulf Power Plant Crist Pensacola, Florida

Prepared for
*U.S. Environmental
Protection Agency
Washington, D.C.*

October, 2012
Revision 1, November 2013

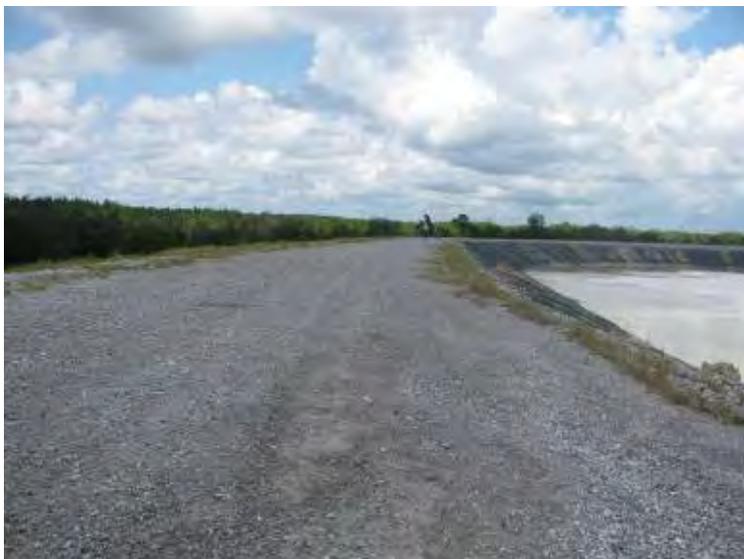
Photo 173: Crest of west embankment of Gypsum Storage Pond looking north.

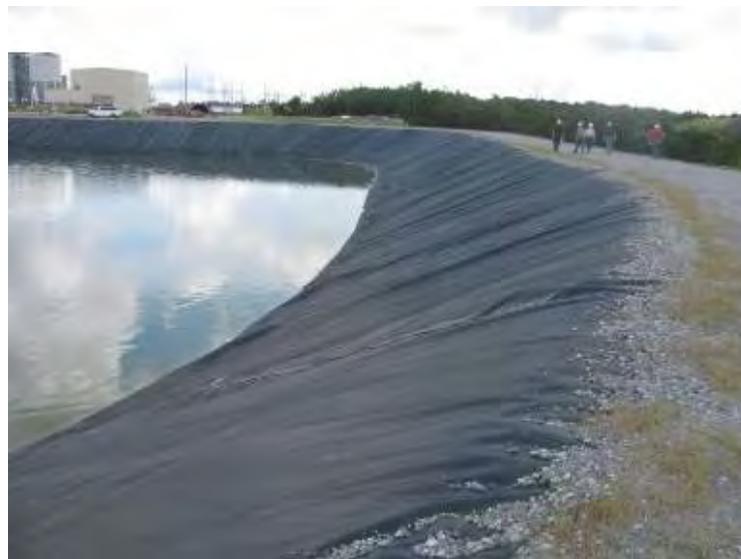
The textured composite HDPE liner (Photographs 174 and 175) is exposed on the interior slopes of the embankments. No signs of tears, leaks, or excessive wear were observed. The interior slopes generally appear to be approximately 2H:1V. The embankment interior slopes appear to be in **SATISFACTORY** condition. Slopes appear to be straight and uniform and no signs of bulging were observed.

Photo 174: Textured HDPE liner on interior slope of Gypsum Storage Pond looking southeast (typical of entire pond).

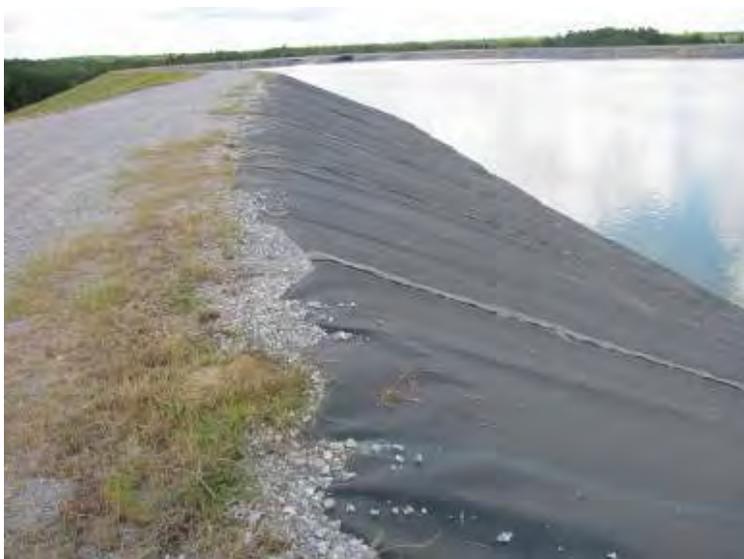
Photo 175: Textured HDPE liner on interior slope of Gypsum Storage Pond looking northwest (typical of entire pond).

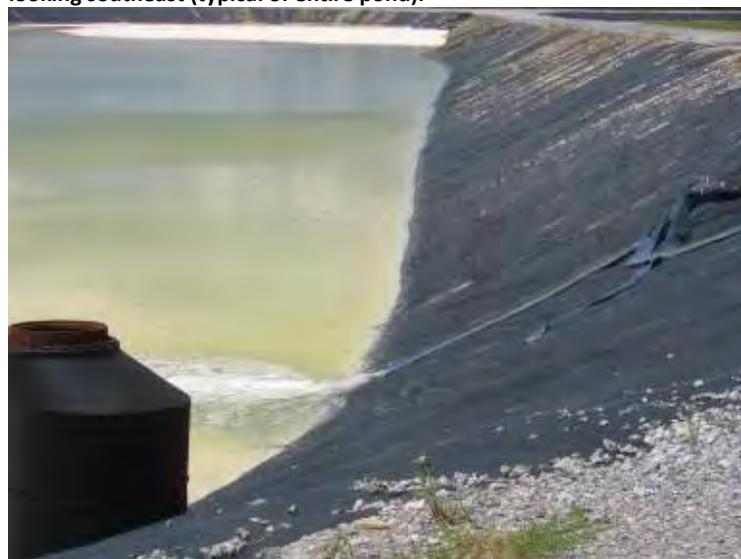
Photo 176: Inflow of water into Gypsum Storage Pond looking northwest. Note presence of textured HDPE liner on interior slope of (typical of entire pond).

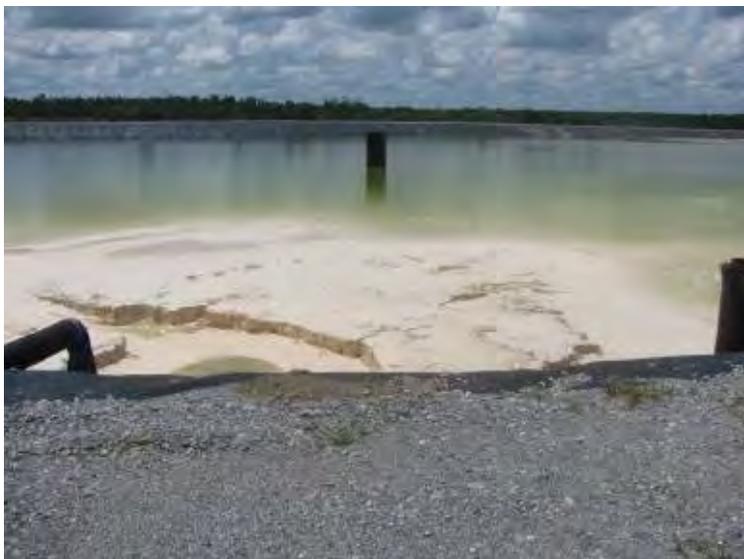
Photo 177: Surface of Gypsum Storage Pond looking west.

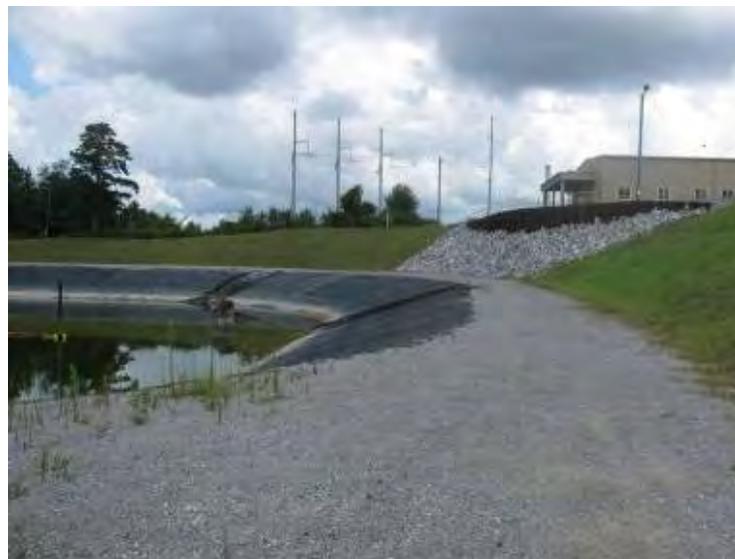
The interior slopes appear to be in **SATISFACTORY** condition. The textured HDPE liner (Photographs 178 and 181) is exposed on the interior slopes of the pond. No signs of tears, leaks, or excessive wear were observed. The interior slopes are approximately 2.5H:1V. Slopes appear to be straight and uniform and no signs of bulging were observed.

Photo 178: South crest and interior slope of Process Return Water Pond looking east. Note presence of textured HDPE liner on interior slope (typical).

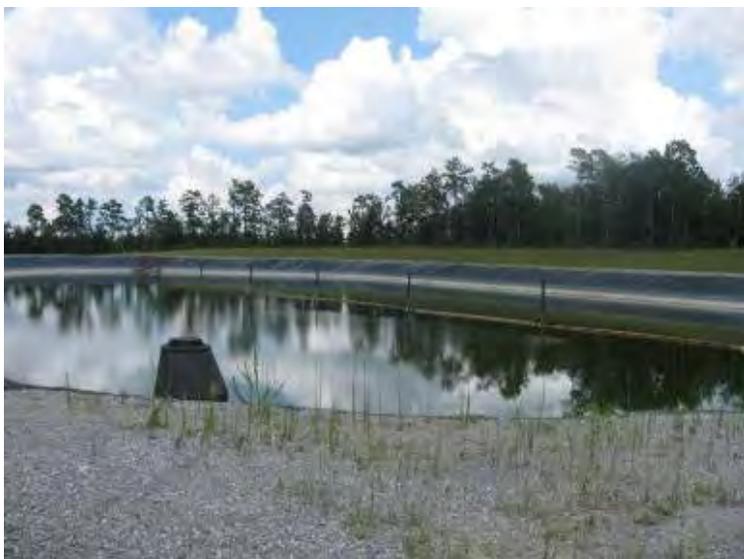
Photo 179: Surface of Process Return Water Pond looking northeast.

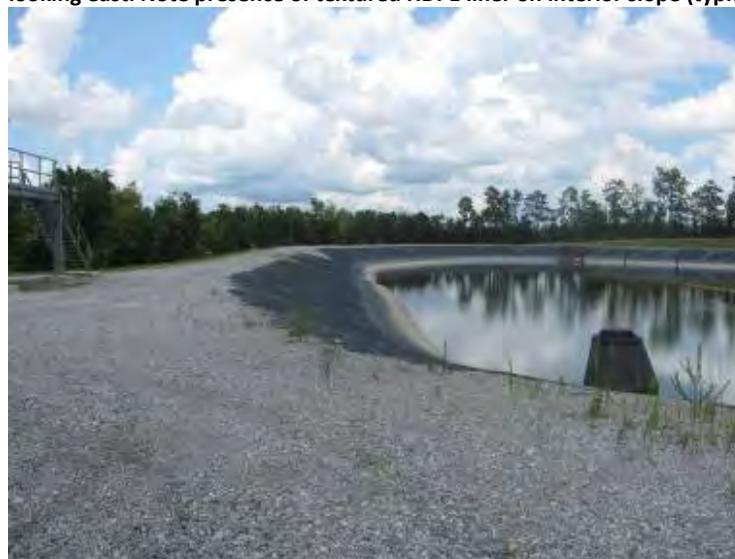
Photo 180: West crest and interior slope of Process Return Water Pond looking north.

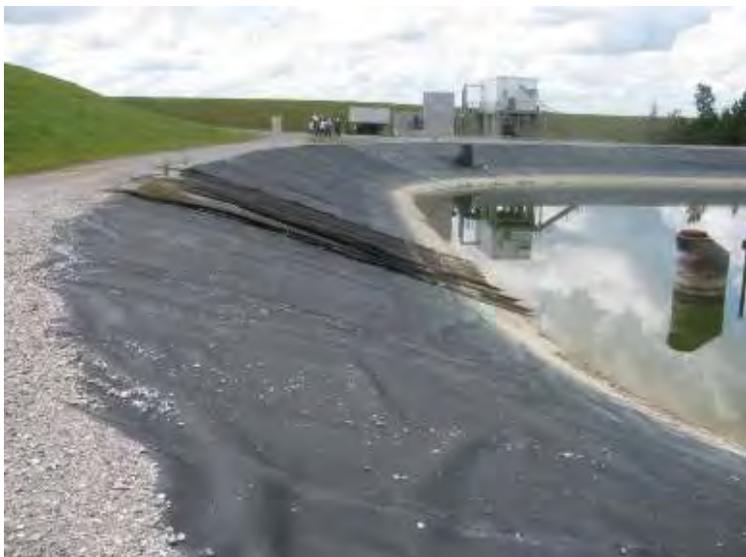
Photo 181: South crest and interior slope of Process Return Water Pond looking west.

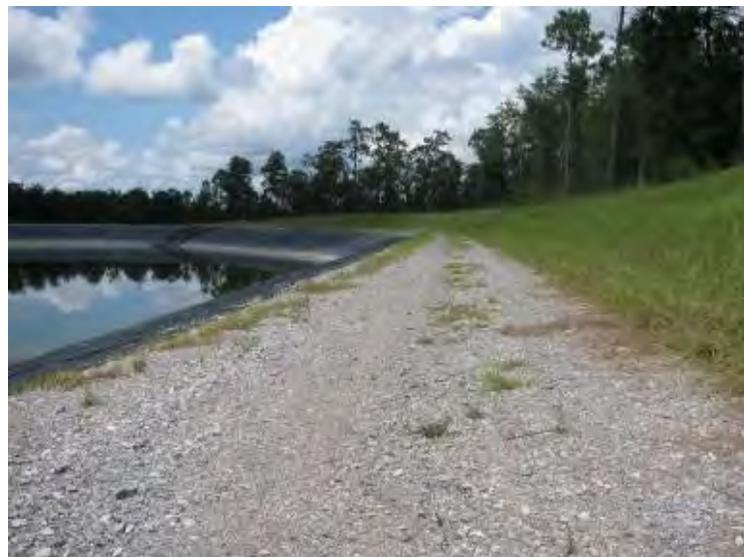
Photo 182: East crest and interior slope of Process Return Water Pond looking north.

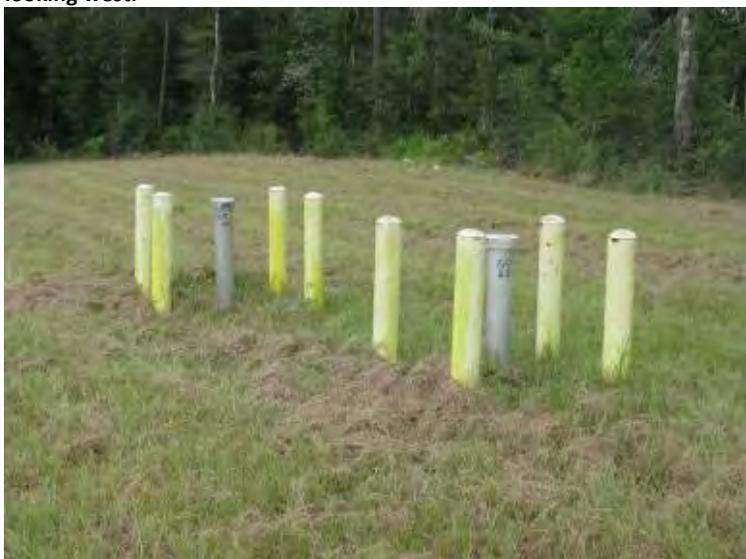
Monitoring wells were observed beyond the toe of slope on the north embankment (Photograph 183).

Photo 183: Monitoring well pairs located beyond exterior toe of slope of Process Return Water Pond looking north.

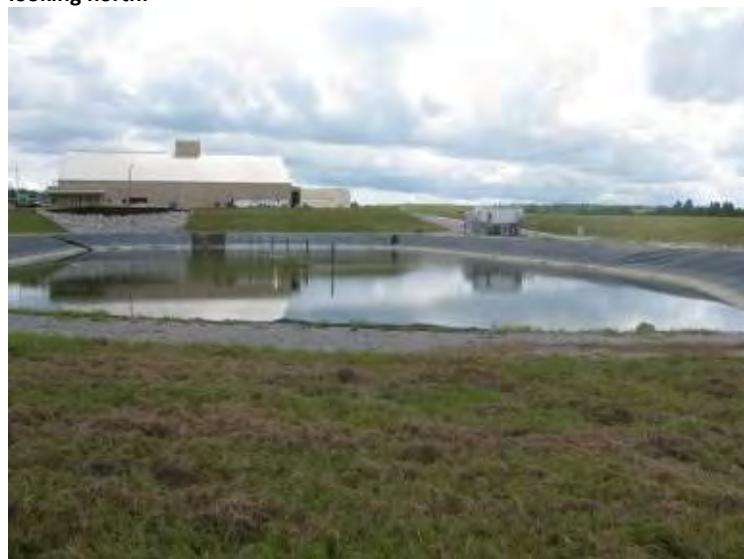
The crest appeared to be in **SATISFACTORY** condition (Photographs 184, 186 and 188). The average crest width is approximately 20 feet. The crest surface is gravel-covered without vegetation. No depressions, ruts, or evidence of settlement were observed on the crests. An emergency spillway, approximately 55 feet wide, is located approximately midway along the west embankment of the pond. The spillway crest is depressed approximately 2 feet (Photographs 187 and 188).

Photo 184: General view of Process Return Water Pond looking south.

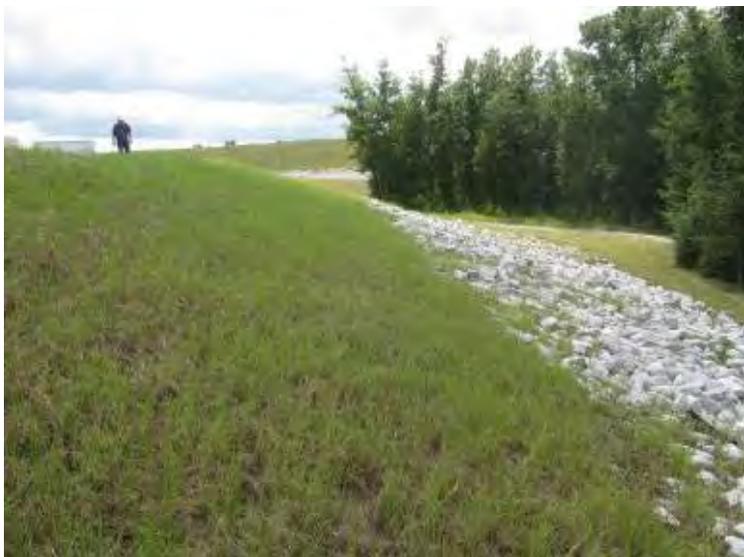
Photo 185: Northwest exterior slope of Process Return Water Pond looking southwest.

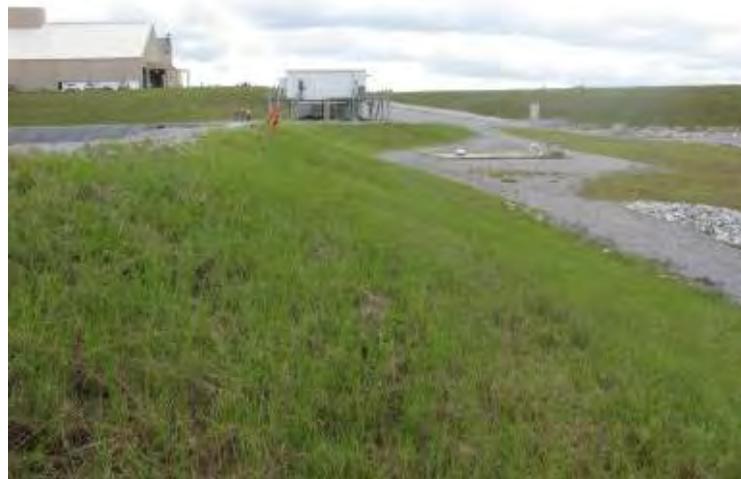
Photo 186: West exterior slope of Process Return Water Pond looking south.

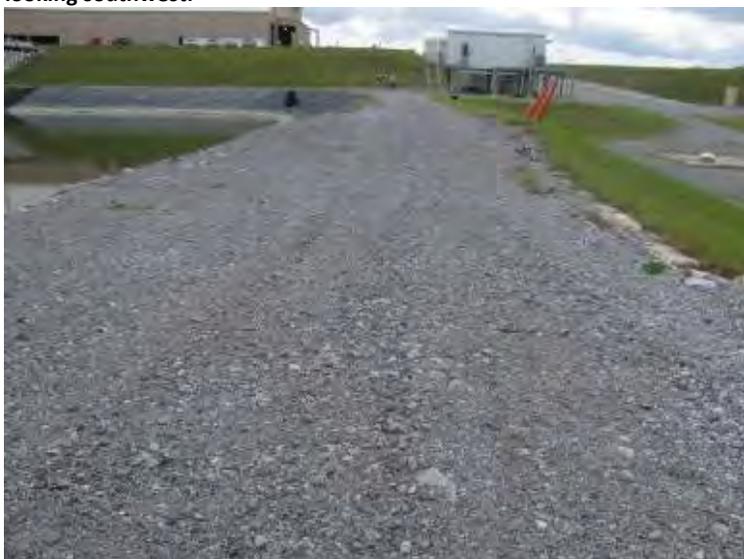
Photo 187: Crest and emergency spillway along west embankment of Process Return Water Pond looking south.

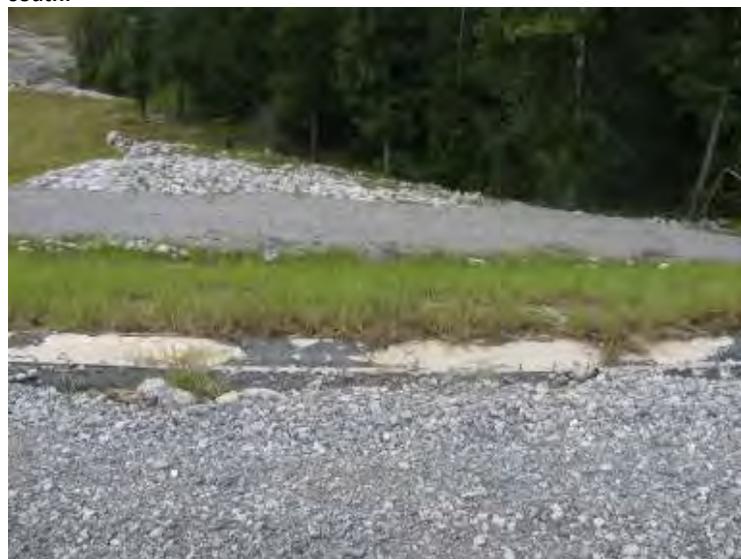
Photo 188: Emergency spillway/ACBM located on west exterior Slope of Process Return Water Pond looking west (down slope).

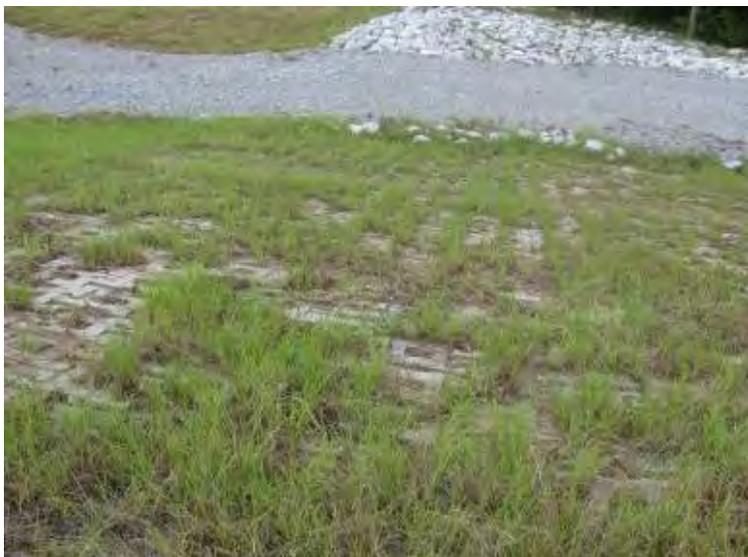
The downstream side of the emergency spillway is armored with interlocked articulated concrete block mattresses (Photographs 189 to 190). The mattresses appeared to be in good condition with grass and vegetation growing in the open spaces in and between the blocks.

Photo 189: Emergency spillway/ACBM located on west exterior slope of Process Return Water Pond looking west (down slope).

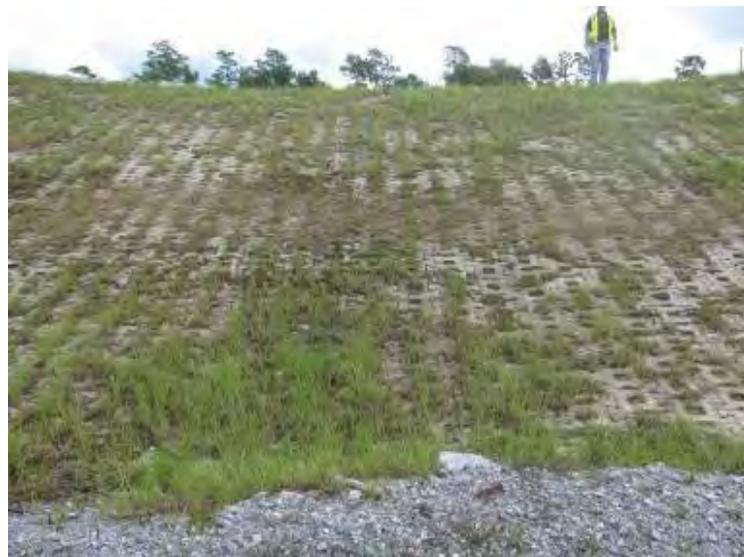
Photo 190: Emergency spillway/ACBM located on west exterior slope of Process Return Water Pond looking east (up slope).

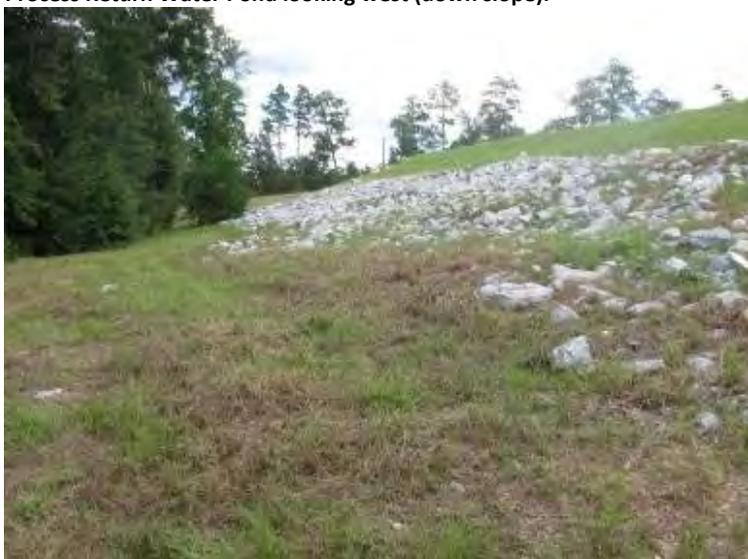
Exterior slopes of the west and northwest embankments appear to be in **SATISFACTORY** condition. Slopes are approximately 2H:1V. The exterior slopes of the northwest embankment are armored with a layer of riprap (Photographs 191 and 192) from the toe of slope extending approximately 20 feet up the slope. The balance of the northwest embankment consists of well-maintained grass approximately 4 to 6 inches tall (Photograph 185). The west embankment exterior slope is covered with well-maintained grass approximately 4 to 6 inches tall.

Photo 191: Riprap slope treatment along toe of slope of northwest, exterior of Process Return Water Pond looking north.

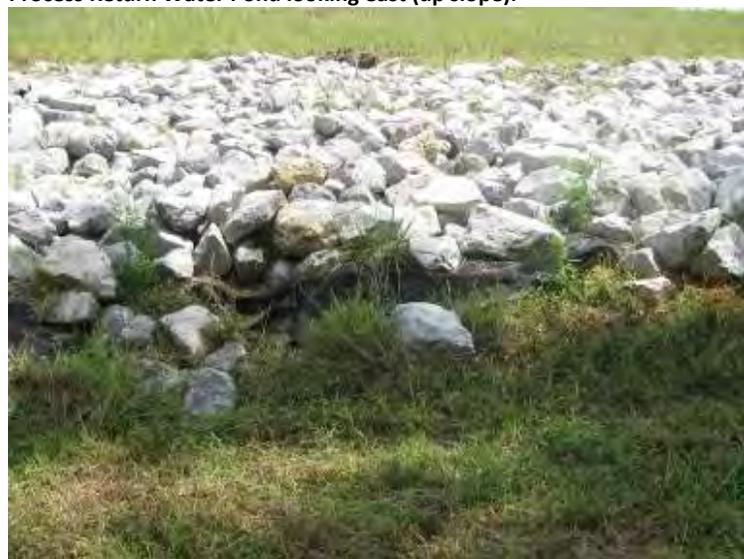
The alignment of the slopes appears to be uniform and consistent. No signs of erosion or animal burrows were observed in this area. Filter fabric beneath the riprap slope treatment was exposed at several locations (Photograph 192) on the northwest embankment.

Photo 192: Riprap slope on toe of slope of northwest, exterior of Process Return Water Pond looking north. Note exposed filter fabric.

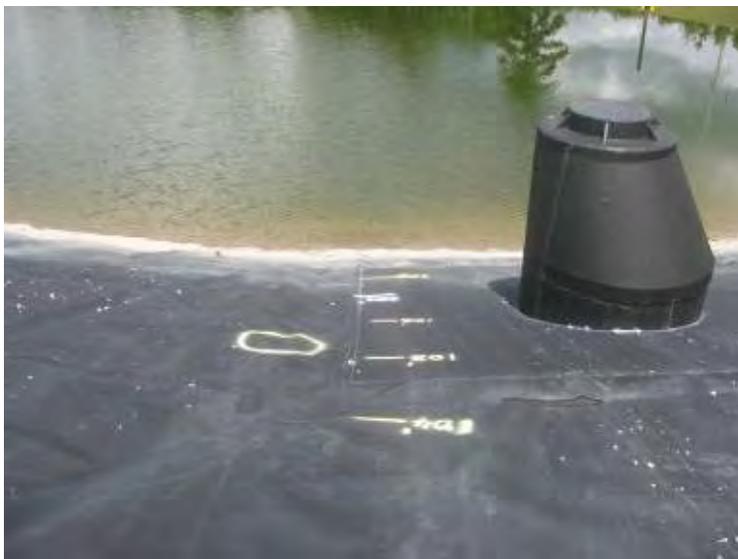
Photo 193: Manhole structure located at southwest corner of Process Return Water Pond looking east.

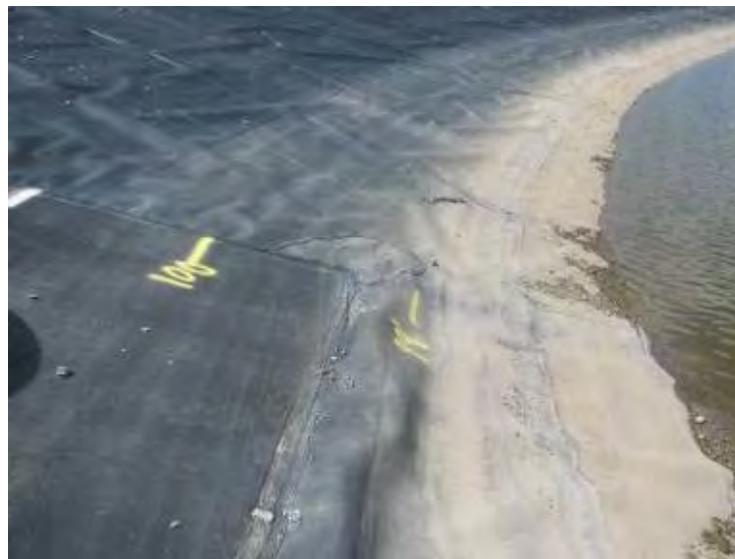
Photo 194: Textured HDPE liner on interior slope of Process Return Water Pond looking north. Note elevation data on slope.

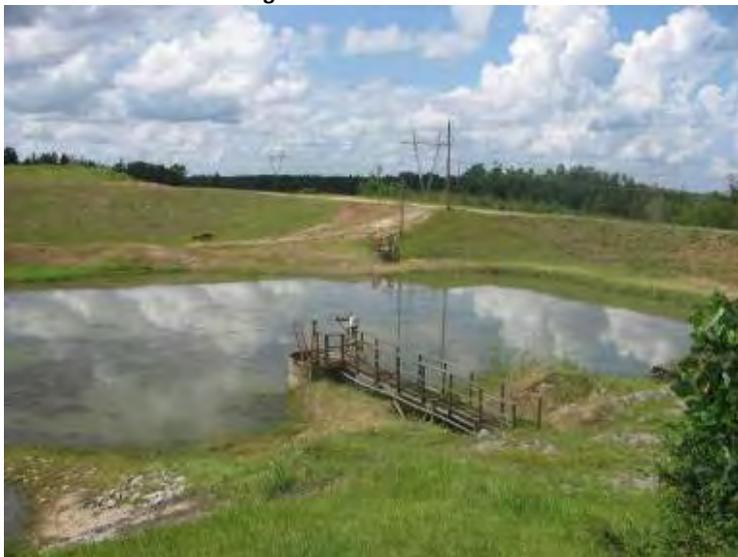
Photo 195: General view of fly Ash Landfill stormwater pond area looking northwest.

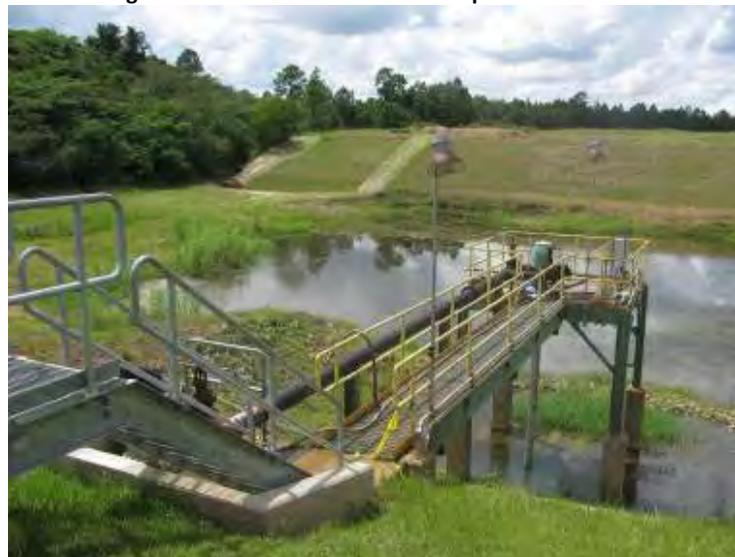
Photo 196: General view of fly Ash Landfill stormwater pond area looking west.
