COAL ASH IMPOUNDMENT SITE ASSESSMENT DRAFT REPORT

Coal Creek Station Great River Energy Underwood, North Dakota

KLEINFELDER PROJECT NUMBER 118953-1

June 21, 2012

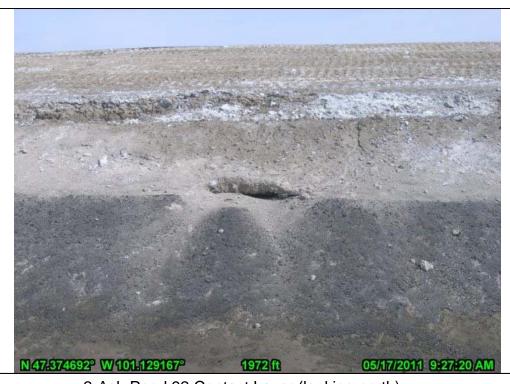
2-Ash Pond 92 Contact Layer (looking north)

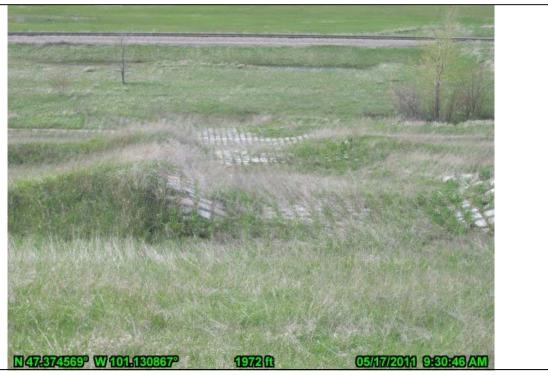
3-Ash Pond 92 ACM Run-down on South Slope (looking south)

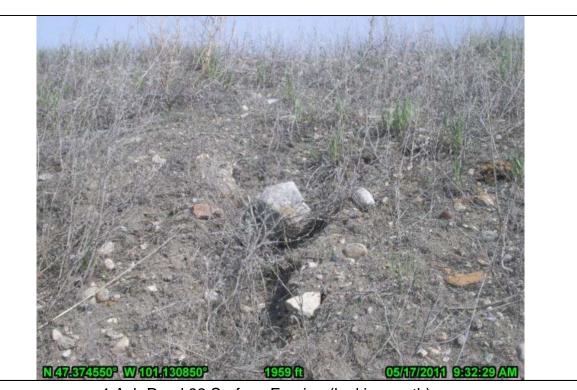
4-Ash Pond 92 Surface Erosion (looking north)

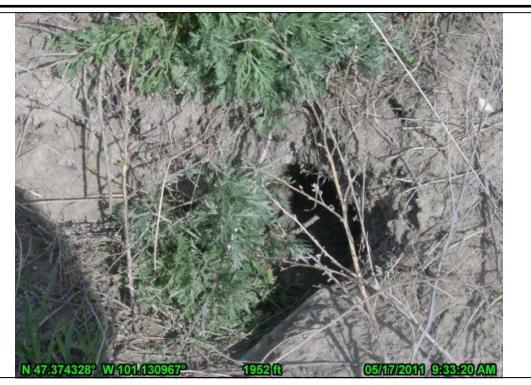
5-Ash Pond 92 Animal Burrows on ACM

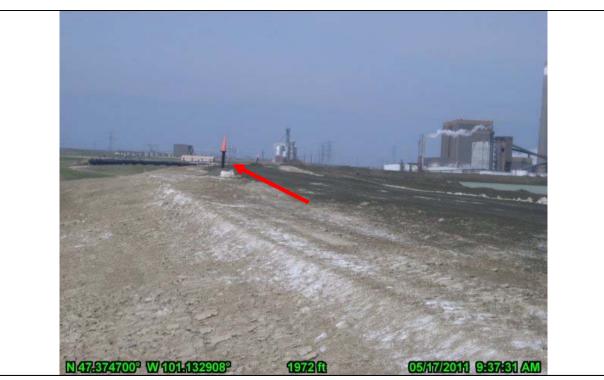
Overall, the crest of the impoundment was in Satisfactory condition. Photos 6, 26, 27, and 37 show the condition of the crest. Specific observations include:

- The impoundment crest is a drivable road weather permitting.
- Essentially no vegetation was observed on the crest.
- No major depressions or rutting was noted on the impoundment crest.
- Some very minor erosion was noted on the crest. This erosion was typically less than six inches in depth and typically appeared on the edges of the crest where grade breaks occurred when transitioning to embankment slopes. That condition is not of great concern because the crest is temporary and continually being raised.

6-Ash Pond 92 Crown on South Side with Piezometer (looking west)

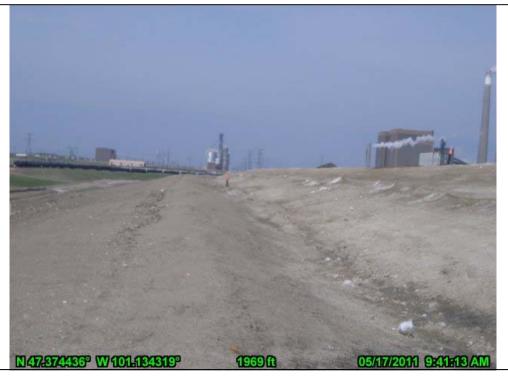
7-Ash Pond 92 Bench on South Side with Piezometers (looking west)

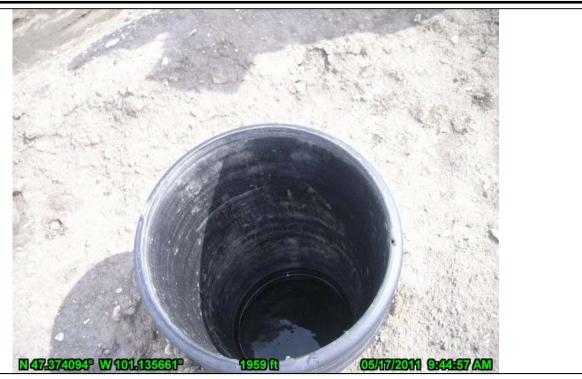
9-Ash Pond 92 Vertical Pipe with Cap, Water 4 Feet Down

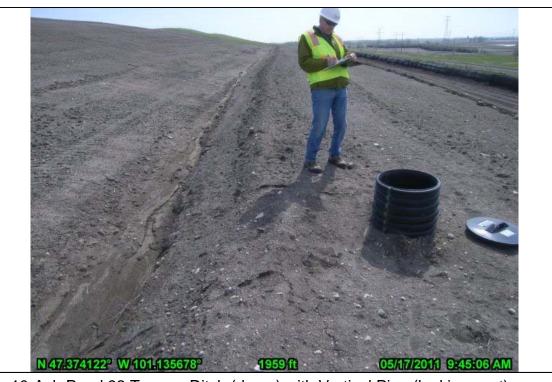
10-Ash Pond 92 Terrace Ditch (damp) with Vertical Pipe (looking east)

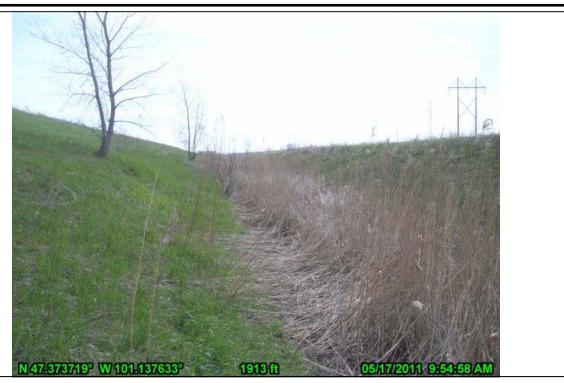
11-Ash Pond 92 South Embankment Toe (looking east)

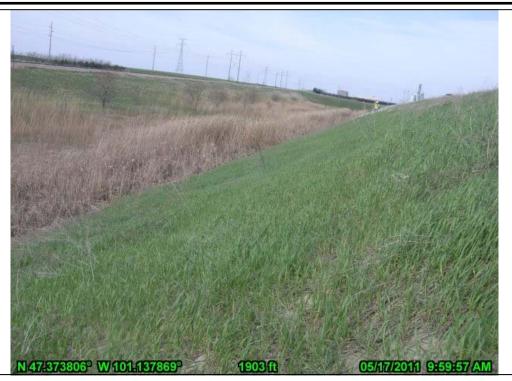
13-Ash Pond 92 South Embankment Toe (looking west)

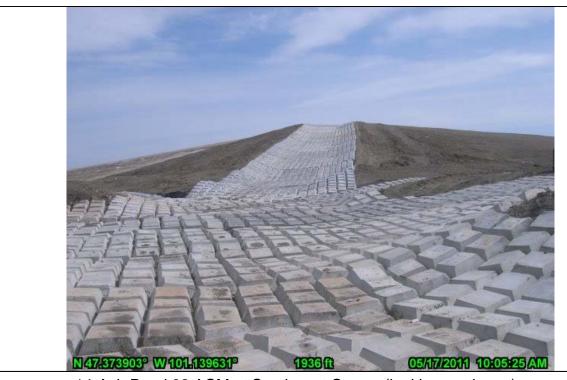
14-Ash Pond 92 ACM at Southwest Corner (looking northeast)

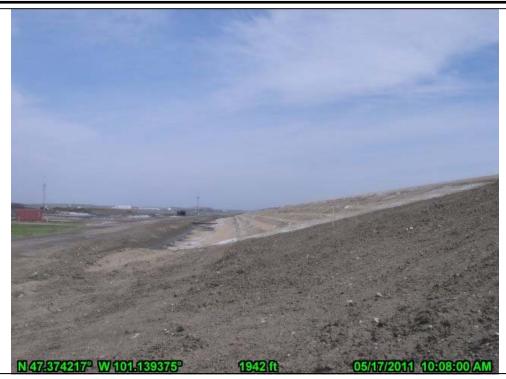
15-Ash Pond 92 West Landside Slope (looking north)

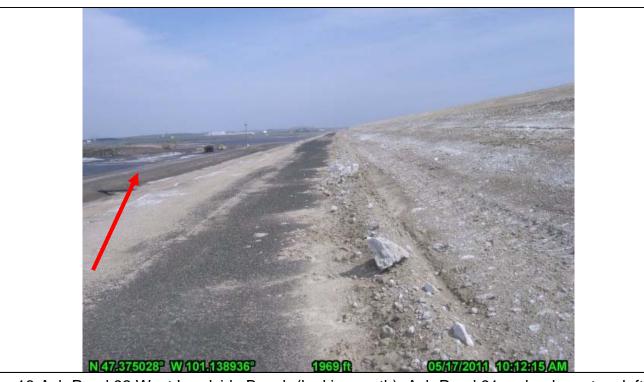
16-Ash Pond 92 West Landside Bench (looking north). Ash Pond 91 embankment on left

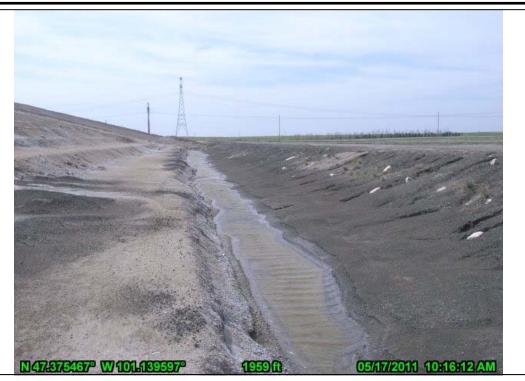
17-Ash Pond 92 Ditch on West Toe (looking south). Ash Pond 91 Embankment on Right

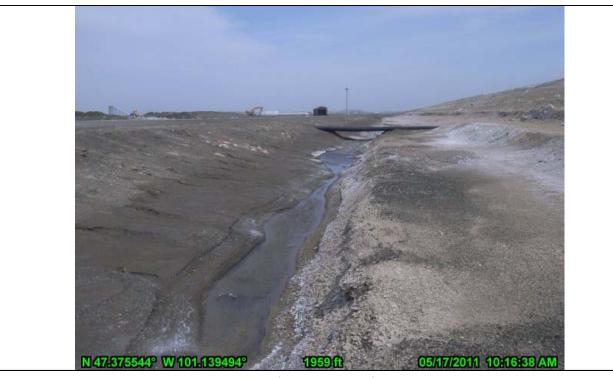
18-Ash Pond 92 Ditch on West Toe (looking north). Ash Pond 91 Embankment on Left

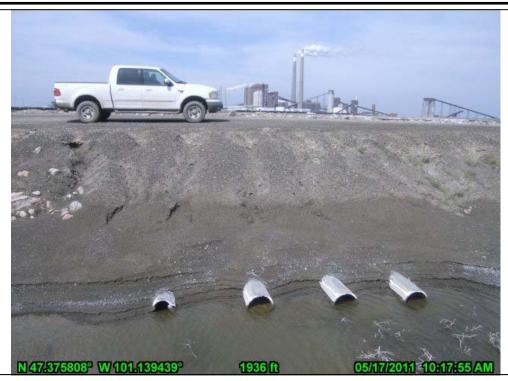
19-Gravity Drains from Ash Pond 92 Ditch to Ash Pond 91 (looking west)

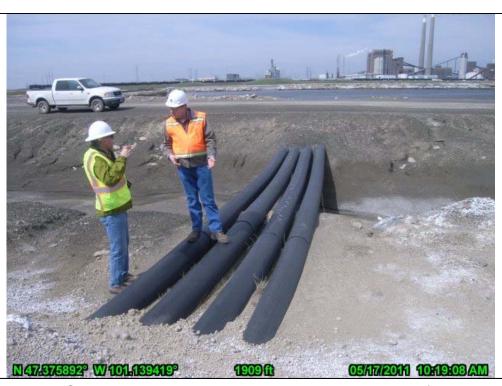
20-Ash Pond 92 Southern 12" HDPE Decant Pipes to Ash Pond 91 (looking west)

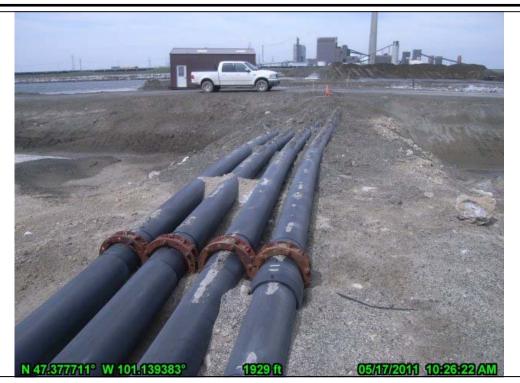
21-Ash Pond 92 Northern 12" HDPE Decant Pipes to Ash Pond 91 (looking west)

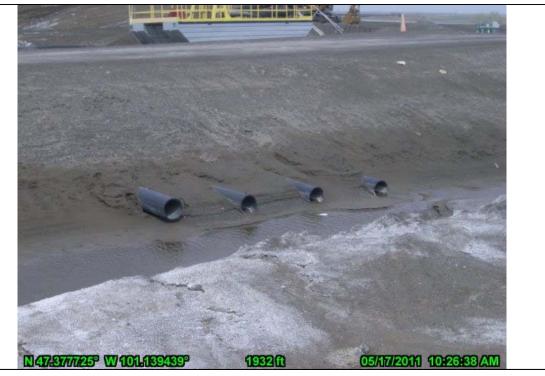
22-Gravity Drains from Ash Pond 92 Ditch to Ash Pond 91 (looking northwest)

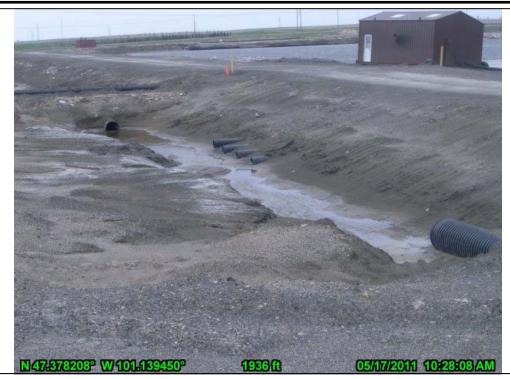
23-Ash Pond 92 Drainage Culverts on West Toe (looking south)

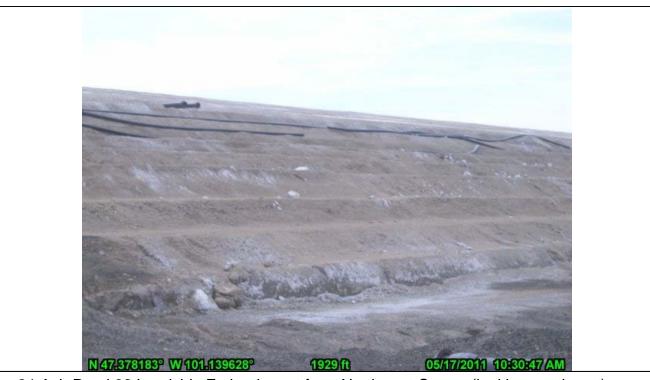
24-Ash Pond 92 Landside Embankment from Northwest Corner (looking southeast)

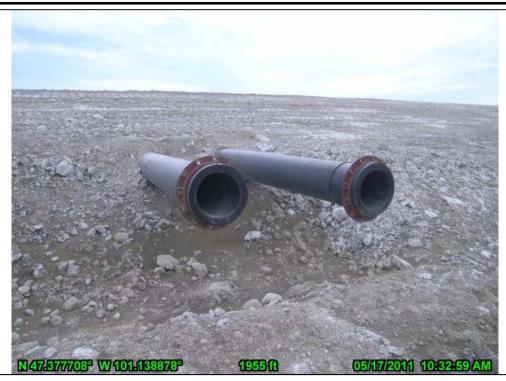
25-Ash Pond 92 Pipe Penetration on West Embankment

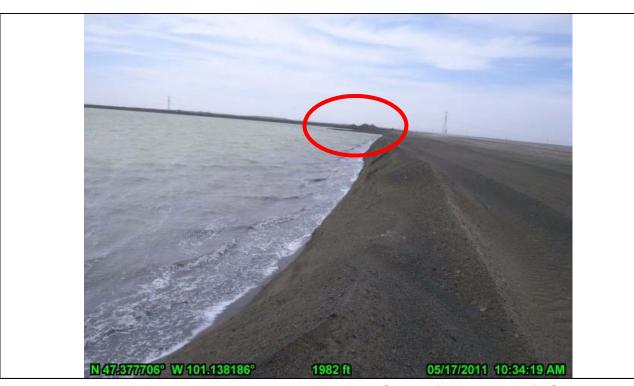
Overall, the upstream slope of the impoundment was in Satisfactory condition. Photos 26 and 27 show the conditions of the upstream slope. Specific observations include:

26-Ash Pond 92 Waterside Embankment at NW Corner (looking south). Outlet Decant Pipes in Background

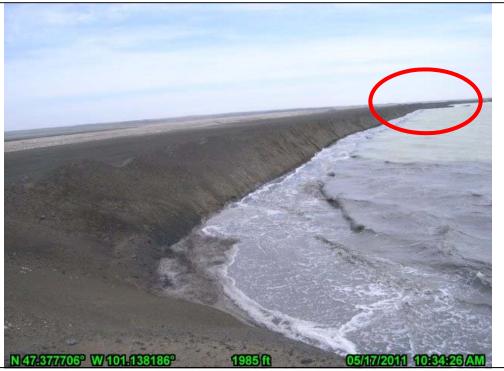
27-Ash Pond 92 Waterside Embankment at NW Corner (looking east). Pipe is Discharging Into Pond in Background.

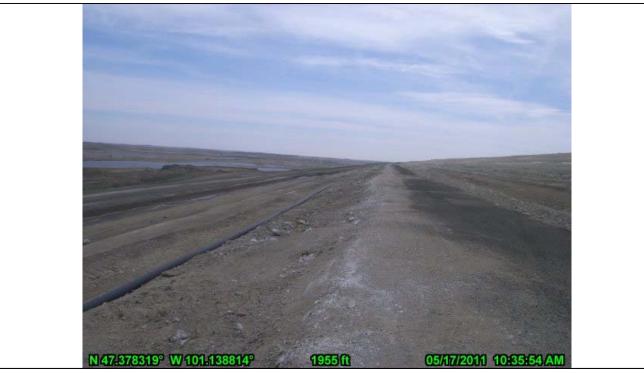
28-Ash Pond 92 Landside Embankment Bench (looking east)

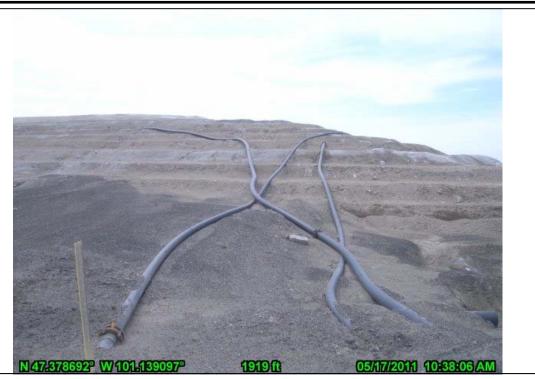
29-Ashpond 92 Movable Inlet Pipes on Northwest Corner (looking south)

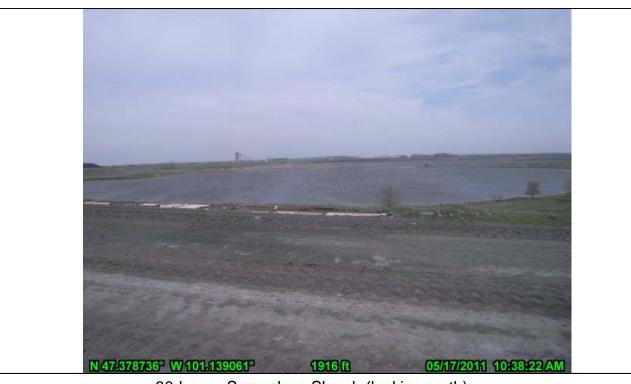
30-Lower Samuelson Slough (looking north)

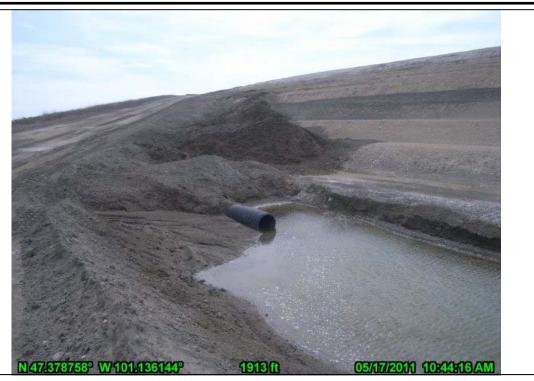
31-Ash Pond 92 North Embankment 18" HDPE Toe Drain Outlet (looking east)

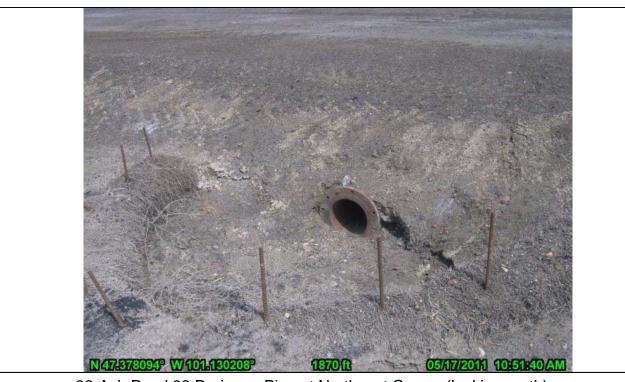
32-Ash Pond 92 Drainage Pipe at Northeast Corner (looking north)

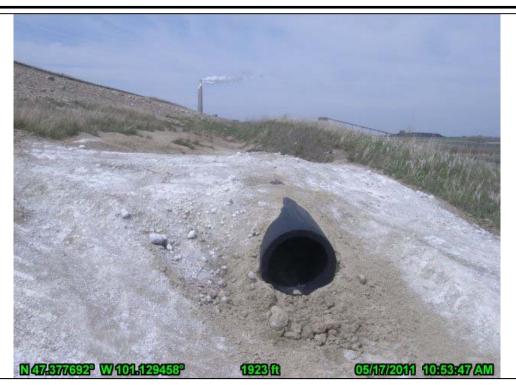
33-Ash Pond 92 18" Drainage Pipe on North Embankment Upper Ditch (looking west)

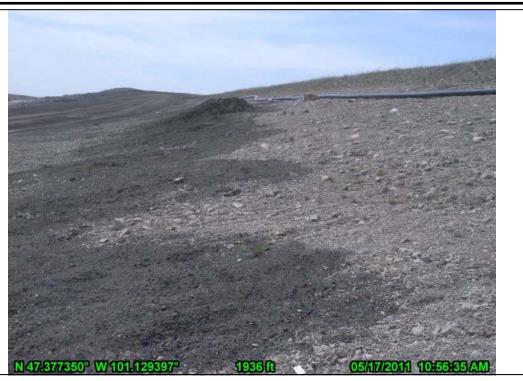
35-Ash Pond 92 East Landside Embankment (looking south)

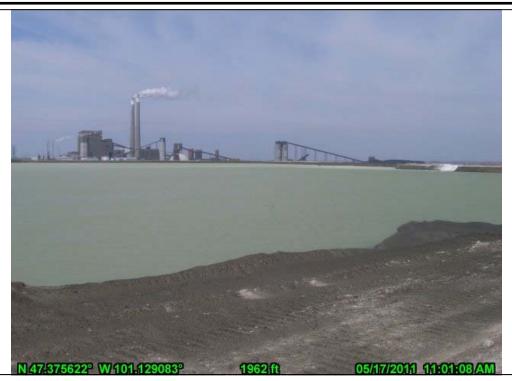
37-Ash Pond 92 View from Crest on Southeast Corner (looking west)

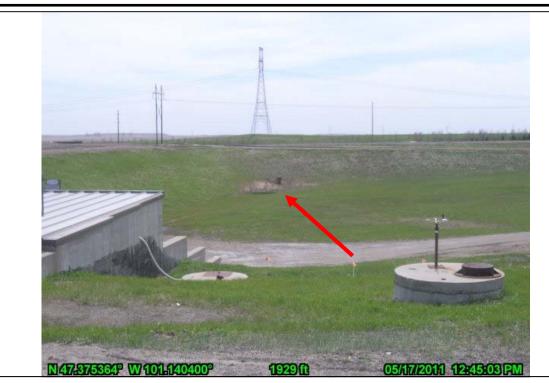
39-Detention Basin and Gate at Southeast Corner of Ash Pond 91 (looking south)

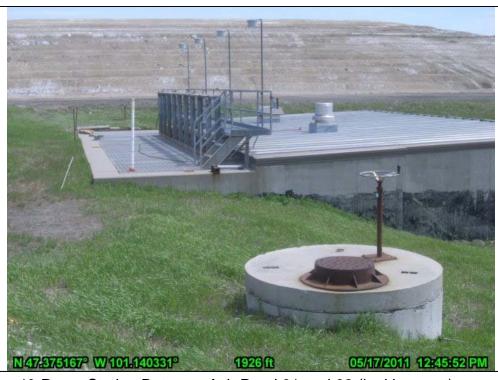
There is one permanent pump station structure adjacent to Ash Pond 91 at Coal Creek Station. The structure is located in the downstream embankment at the southeast corner of the pond. The structure was not assessed in detail, but appeared visually to be in Satisfactory condition with no evidence of movement or any structural distress. The pump station is used to pump water from Ash Pond 91 up into the Upstream Raise.

40-Pump Station Between Ash Pond 91 and 92 (looking east)

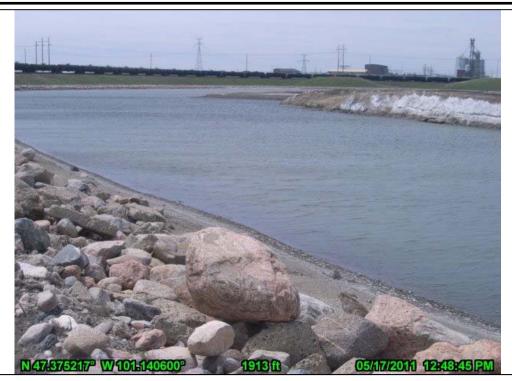
41-Ash Pond 91 Waterside Embankment from Southeast Corner (looking west)

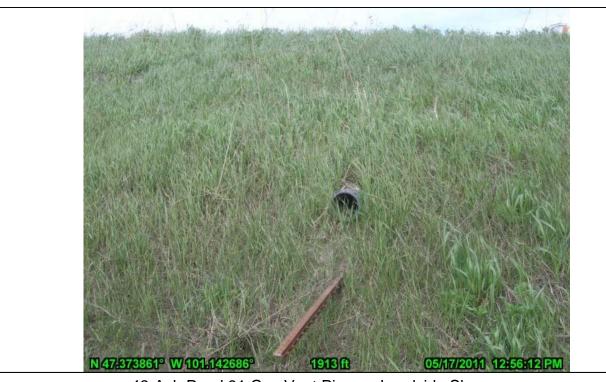
42-Ash Pond 91 Gas Vent Pipe on Landside Slope

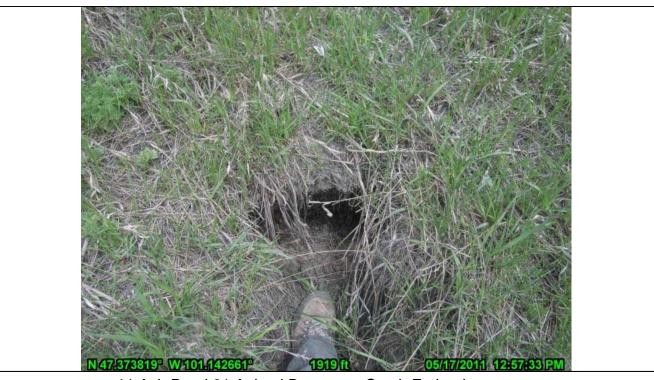
44-Ash Pond 91 Animal Burrow on South Embankment

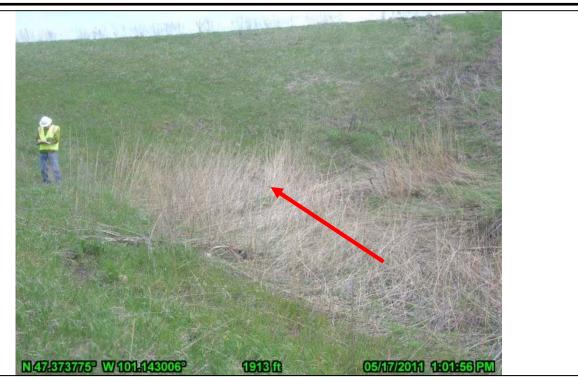
45-Ash Pond 91 Southern Landside Toe and Culvert Under Ramp (looking east)

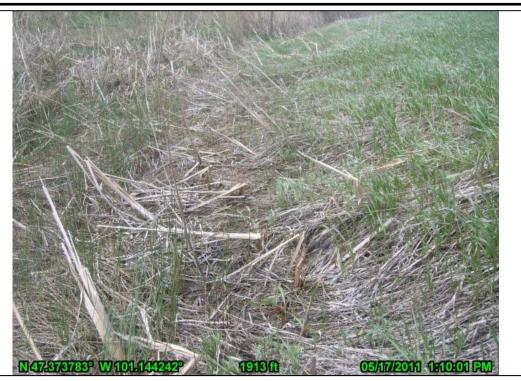
47-Ash Pond 91 Possible Seepage Area Along Southern Landside Toe (looking west)

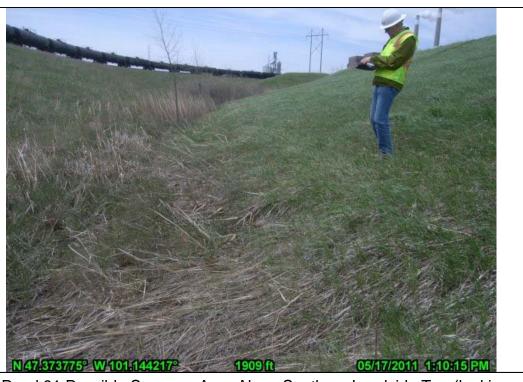
48-Ash Pond 91 Possible Seepage Area Along Southern Landside Toe (looking west)

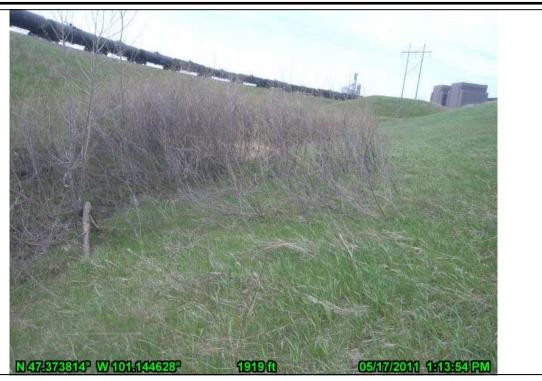
49-Ash Pond 91 Vegetation on Landside Toe (looking west)

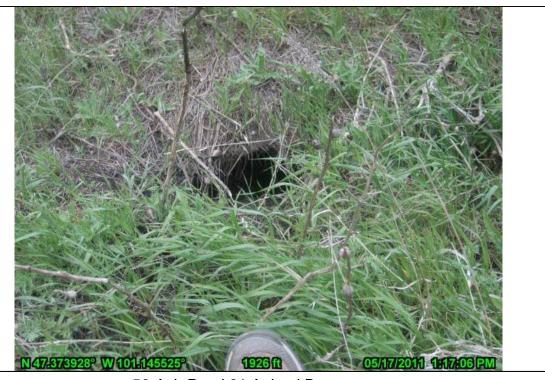
50-Ash Pond 91 Animal Burrow

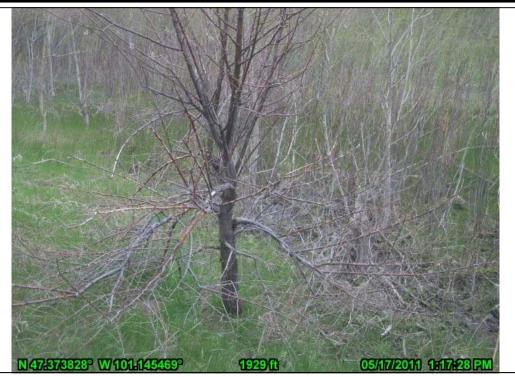
51-Ash Pond 91 Tree at Landside Toe on Southern Embankment

- A few small trees exist at the toe of slope of both Ash Pond 91 and the Upstream Raise/Ash Pond 92. When trees die and the stumps remain, those can decompose over time and eventually create preferential paths for uncontrolled seepage. This is likely not problematic for the Upstream Raise because the fly ash material in the embankment creates a very hard material for the embankment that is unlikely to have significant root penetration. This condition would be considered more serious for Ash Pond 91 since it is an earth and clay embankment.

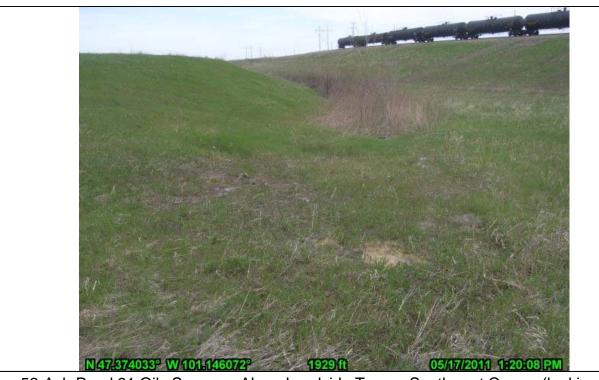
52-Ash Pond 91 Oily Seepage Along Landside Toe on Southwest Corner (looking SE). Source Unknown

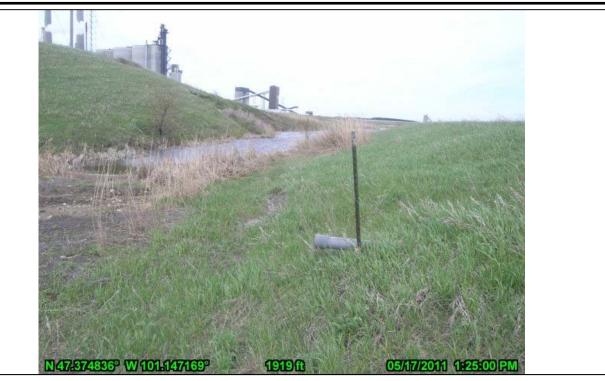
53-Ash Pond 91 Gas Vent Pipe and Slough Along West Embankment (looking north)

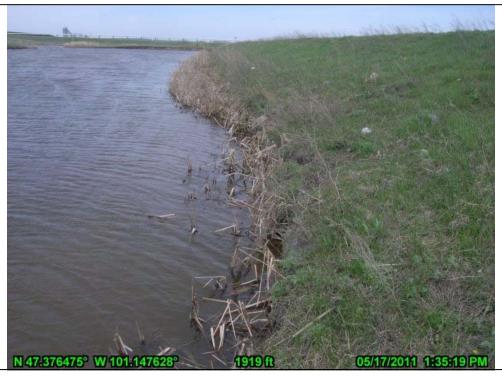
55-Ash Pond 91 Landside Toe Scarp Adjacent to Slough (looking north)

- The Ash Pond 91 west embankment toe appears to have a permanent slough feature adjacent to the downstream toe. The toe along the west slough was observed to have small scarps along the slough water line likely caused by wave action and saturated conditions. Erosion at the toe can shorten seepage paths and decrease stability of the embankment. Since the slough likely

- keeps the toe in a saturated condition, a seepage and stability analysis should be performed on the west embankment. The west embankment toe should be repaired and armored based on results of the analysis.
- An Emergency Action Plan (EAP) is not currently in place at the site to mitigate damage in the event of an emergency related to failure of the impoundment(s). While a failure of an embankment would not constitute a life threatening situation, a document should be prepared to formally outline the procedures to undertake in the event of such a failure.
- We understand that an Operation and Maintenance (O&M) Manual is not currently in place for the site. Developing an O&M manual which includes a section that discusses the safety inspection and monitoring program would be recommended to standardize safety inspection and monitoring practice.

- paths and decrease stability of the embankment. Since the slough likely keeps the toe in a saturated condition a seepage and stability analysis should be performed on the west embankment and the toe should be repaired and armored based on results of the analysis.

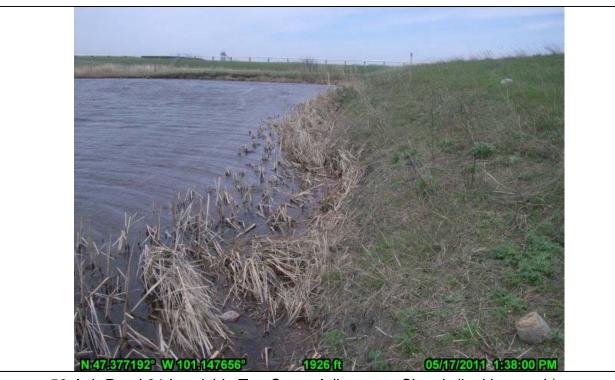
56-Ash Pond 91 Landside Toe Scarp Adjacent to Slough (looking north)

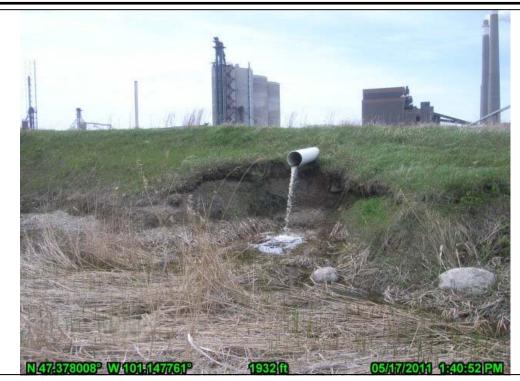
57-Spillway for Slough West of Ash Pond 91 (looking west)

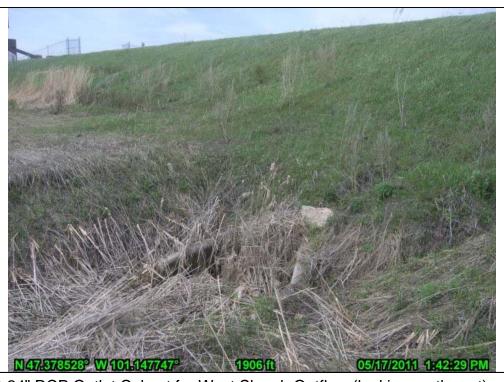
58-24" RCP Outlet Culvert for West Slough Outflow (looking northwest)

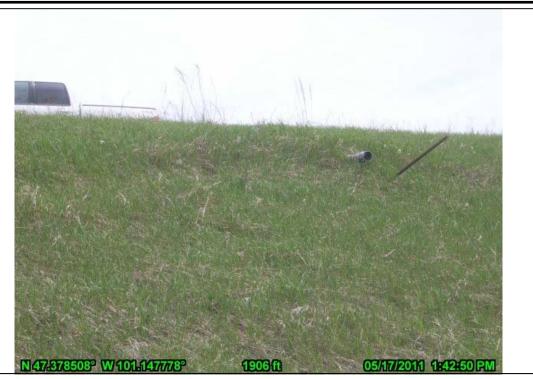
59-Ash Pond 91 Vent Pipe on Northwest Corner

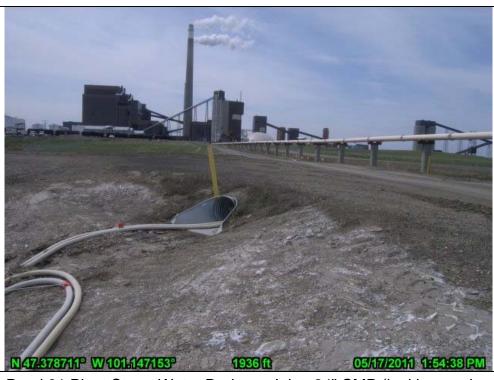
60-Ash Pond 91 Plant Storm Water Drainage Inlet, 24" CMP (looking northwest)

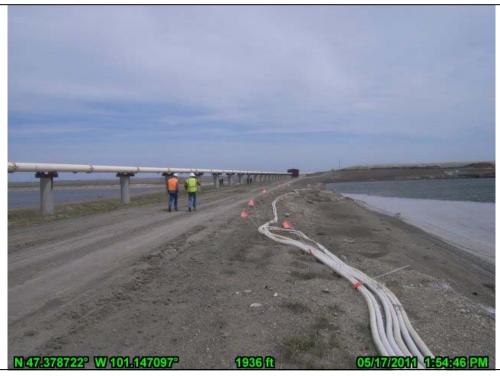
61-Ash Pond 91 North Waterside Embankment (looking east)

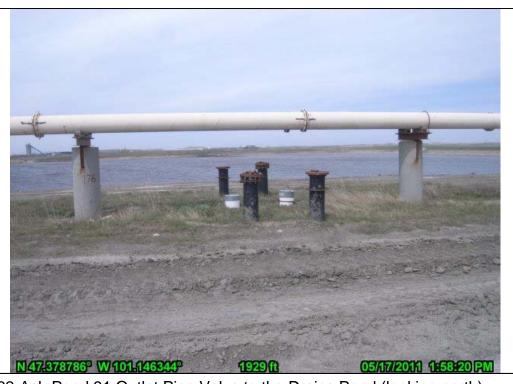
62-Ash Pond 91 Outlet Pipe Valve to the Drains Pond (looking north)

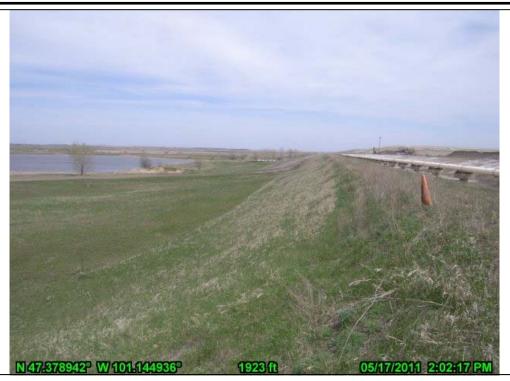
63-Ash Pond 91 Landside of North Embankment (looking east)

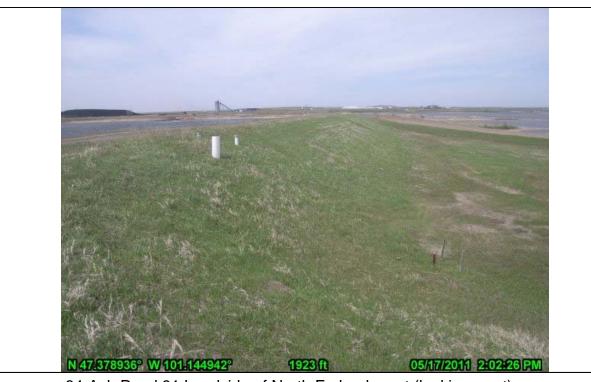
64-Ash Pond 91 Landside of North Embankment (looking west)

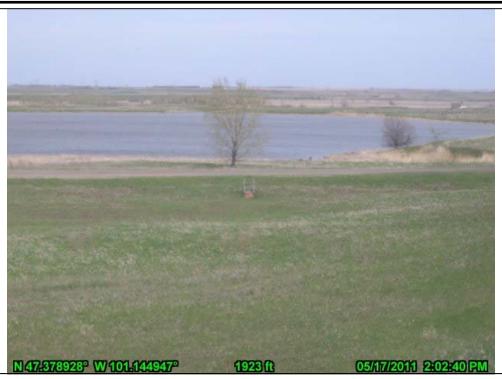
65-Detention Basin North of Ash Pond 91 with Outlet Gate (looking north)

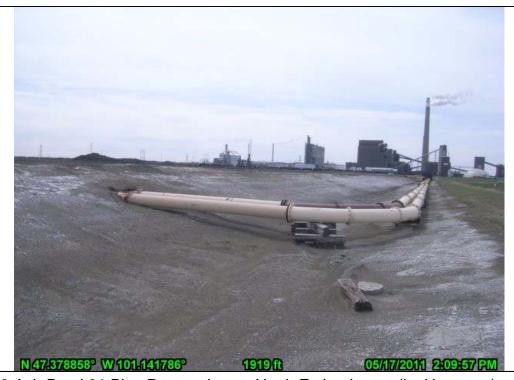
66-Ash Pond 91 Pipe Penetration on North Embankment (looking west)

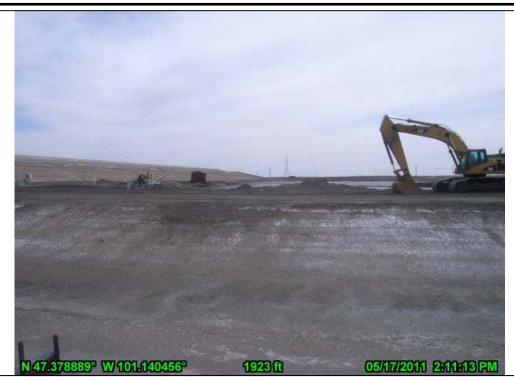
67-Ash Pond 91 View from Northeast Corner (looking south)

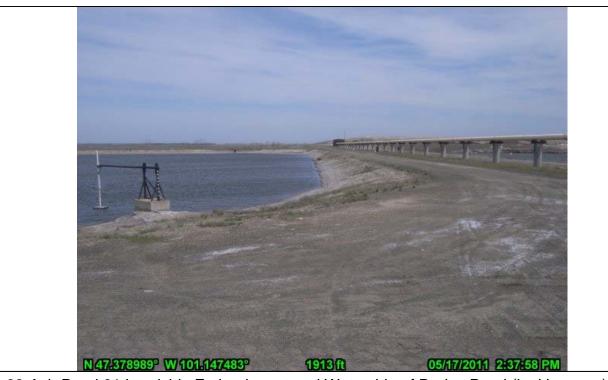
68-Ash Pond 91 Landside Embankment and Waterside of Drains Pond (looking east)

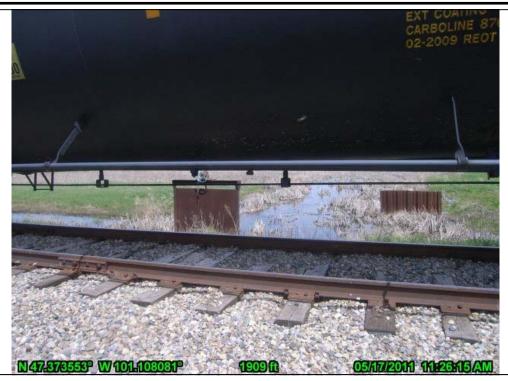
We inquired if Great River Energy had developed an Emergency Action Plan (EAP) related to a potential failure of the impoundments. We understand that an EAP has not been developed for the site because of no expected loss of human life and considering that any pond contents released during a failure could be contained on the GRE property by means of a gated structure at the railroad culvert to the east on Samuelson Slough (photos 69 and 70).

69-Inlet to Slough Outlet Gate Under Railroad Embankment (looking north)

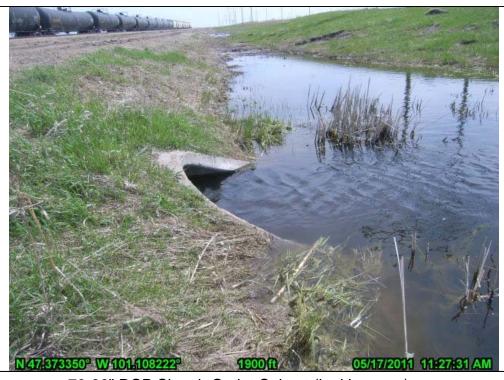
70-30" RCP Slough Outlet Culvert (looking east)

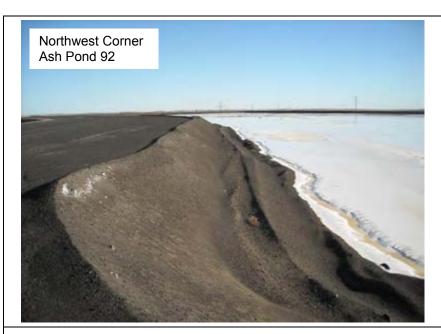
Upstream Bottom Ash Slope and Sludge (1 of 4)

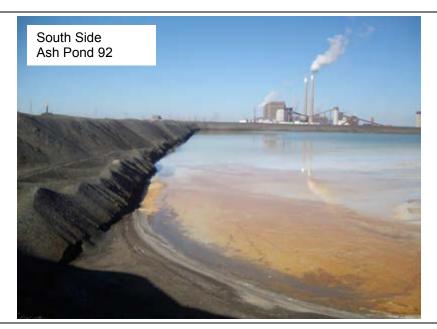
Upstream Bottom Ash Slope and Sludge (2 of 4)

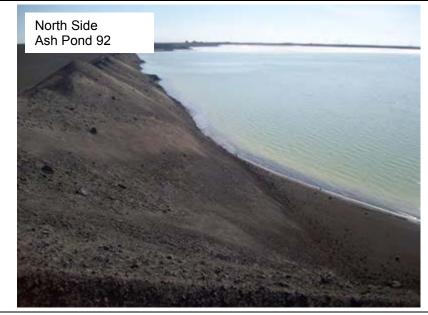
Upstream Bottom Ash Slope and Sludge (3 of 4)

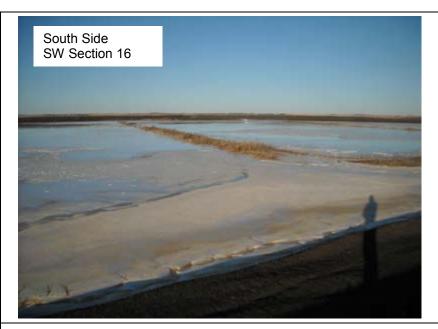
FGD Sludge (1 of 2)

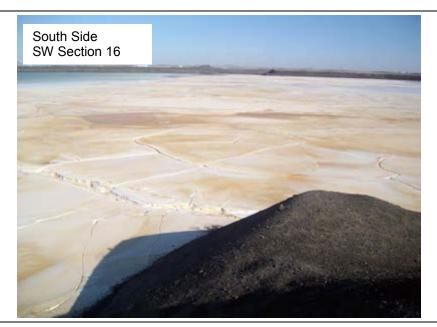
FGD Sludge (2 of 2)

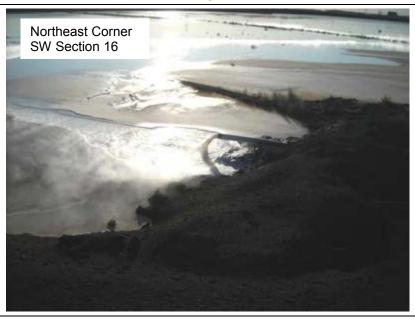
FGD Sludge Inflow (1 of 2)

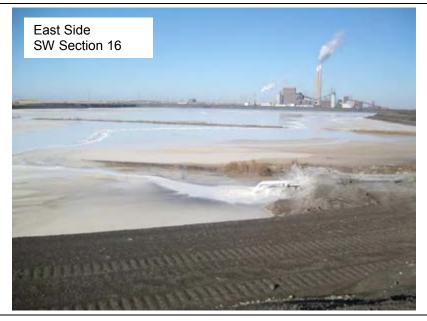
FGD Sludge Inflow (2 of 2)

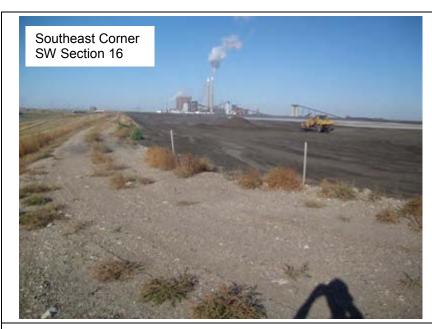
Crest of Facility – Southeast Corner (looking west)

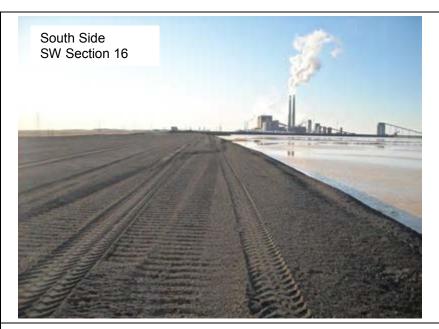
Crest of Facility – South Side (looking west)

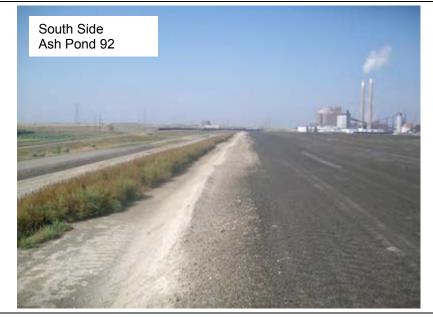
Crest of Facility – South Side (looking west)

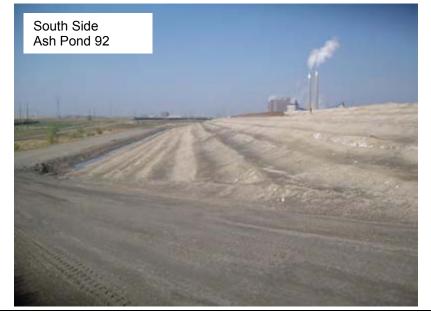
Fly Ash Exterior Slope 2 of 3 – South Side (looking west)

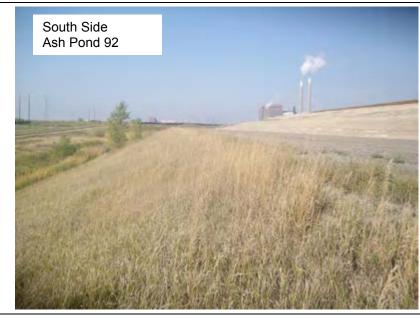
Downstream Slope Below Perimeter Road – South Side (looking west)

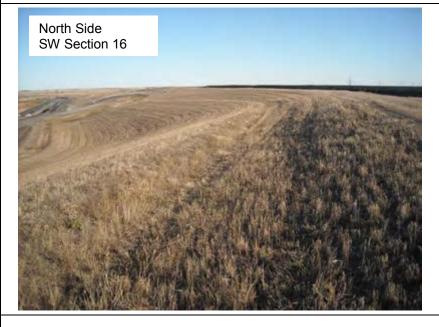
Downstream Slope – North Side (looking east)

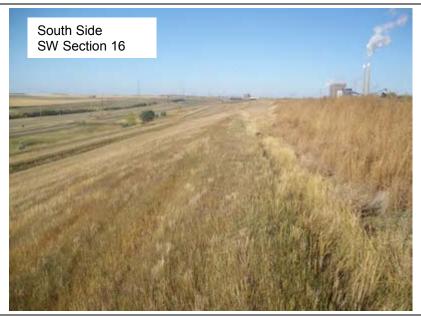
Downstream Slope – Southeast Side (looking west)

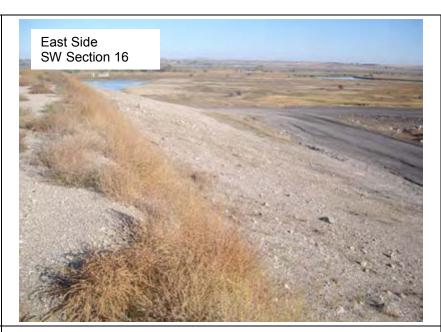
Downstream Slope – East Side (looking north)

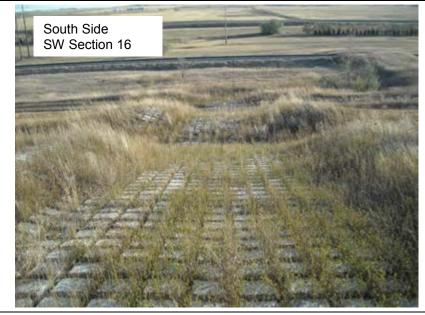
Outfall Drainage Tiles – South Side (looking downstream)

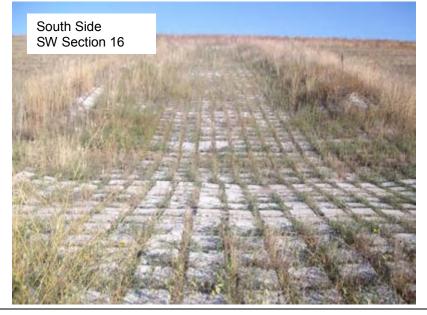
Outfall Drainage Tiles – South Side (looking upstream)

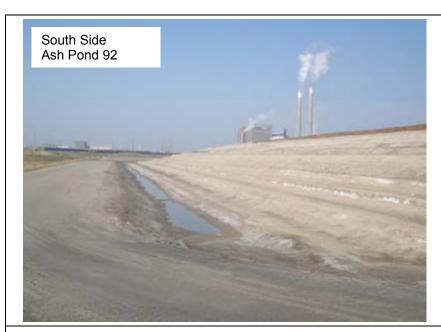
Toe of Slope Ditch Below Fly Ash Shell 1 of 2 – South Side (looking west)

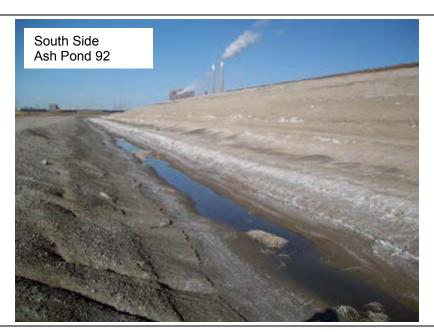
Toe of Slope Ditch Below Fly Ash Shell 2 of 2 – South Side (looking west)

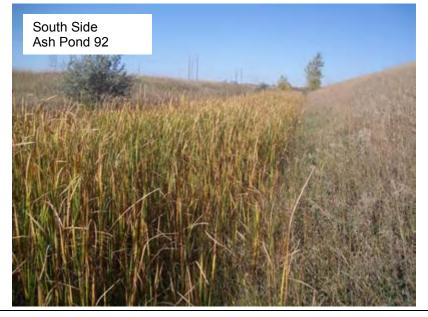
Toe of Slope – South Side Ash Pond 92 (looking west)

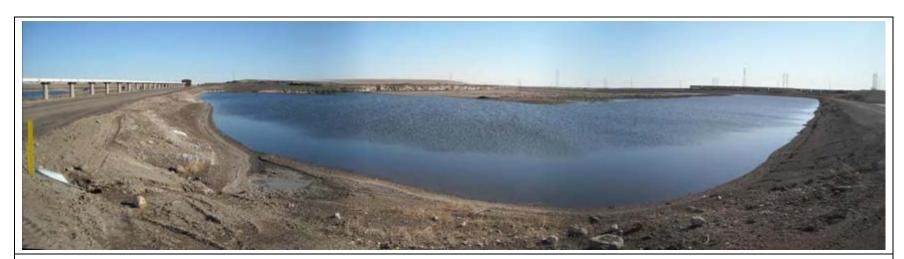
Ash Pond 91 from NW Corner

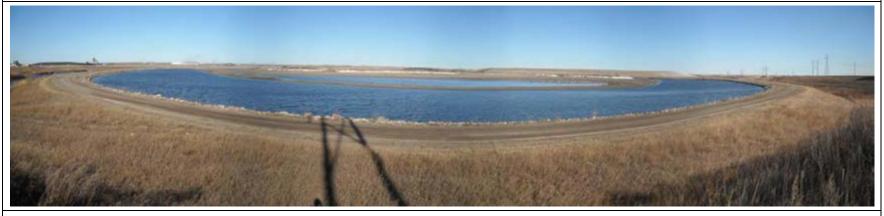
Ash Pond 91 from SW Corner

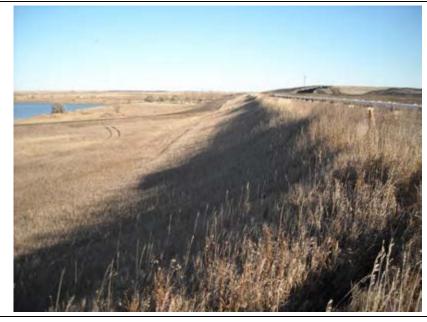
Downstream Slope – North Side (looking east)

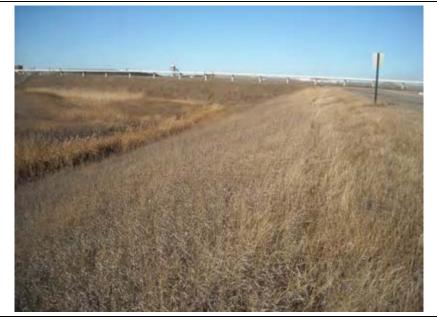
Downstream Slope – West Side (looking north)

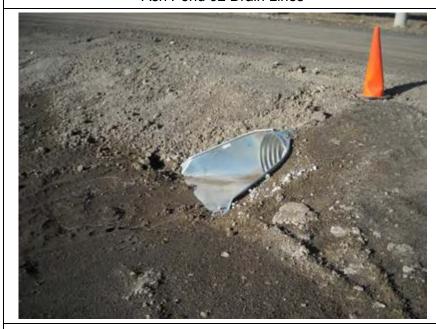
Surface Water Culvert from Ash Line Ditch (North side)

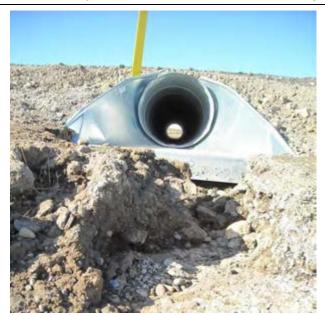
Surface Water Culvert from Ash Line Ditch (NW corner)

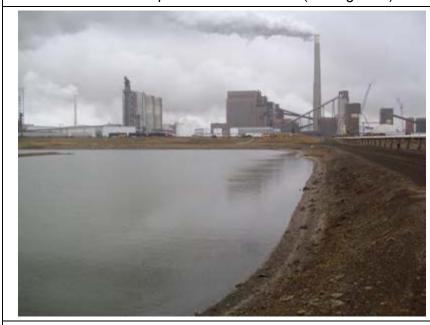
Upstream Slope – North Side (looking west)

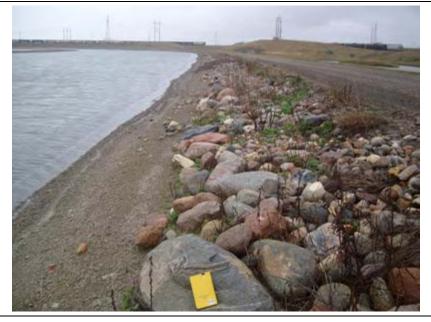
Riprap and Cemented Fly Ash on Upstream Slope (west side)

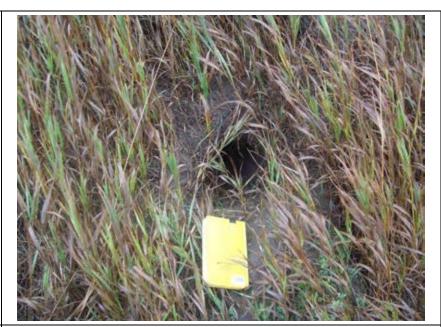
Small Animal Burrow

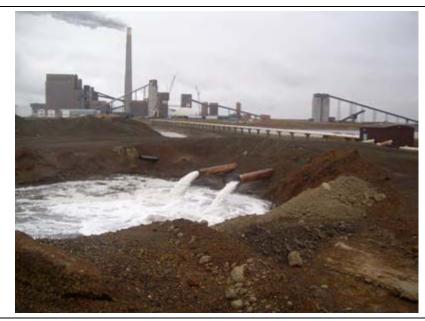
Pulverizer Rejects and Economizer Ash Discharge

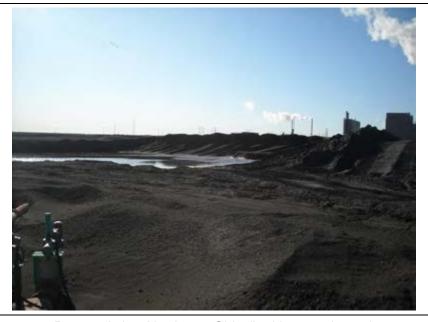
Bottom Ash – Northeast Side (looking southwest)
