**COAL ASH IMPOUNDMENT
SITE ASSESSMENT FINAL REPORT**

**Coal Creek Station
Great River Energy
Underwood, North Dakota**

KLEINFELDER PROJECT NUMBER 118953-1

October 31, 2012

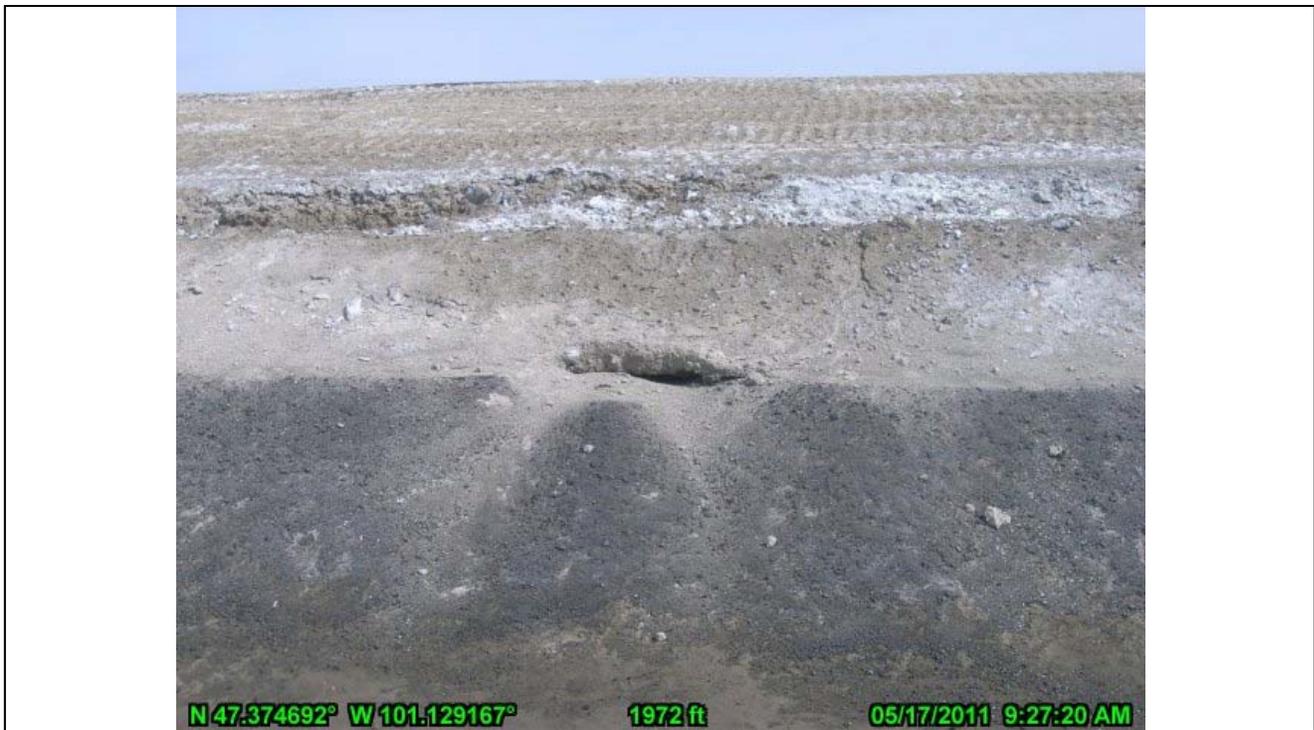
2-Ash Pond 92 Contact Layer (looking north)

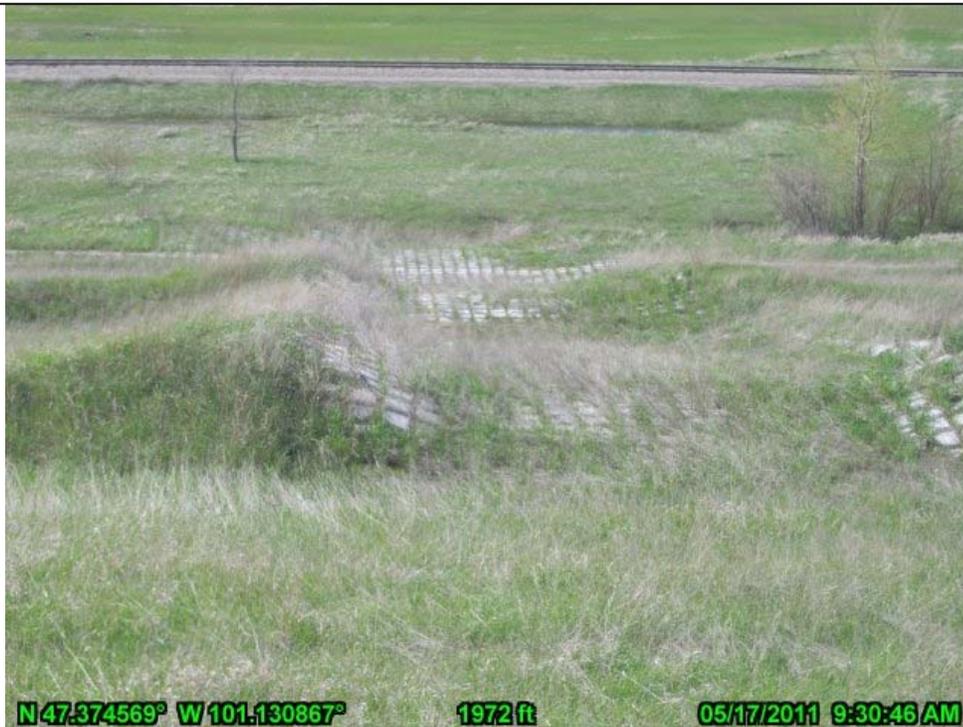
3-Ash Pond 92 ACM Run-down on South Slope (looking south)

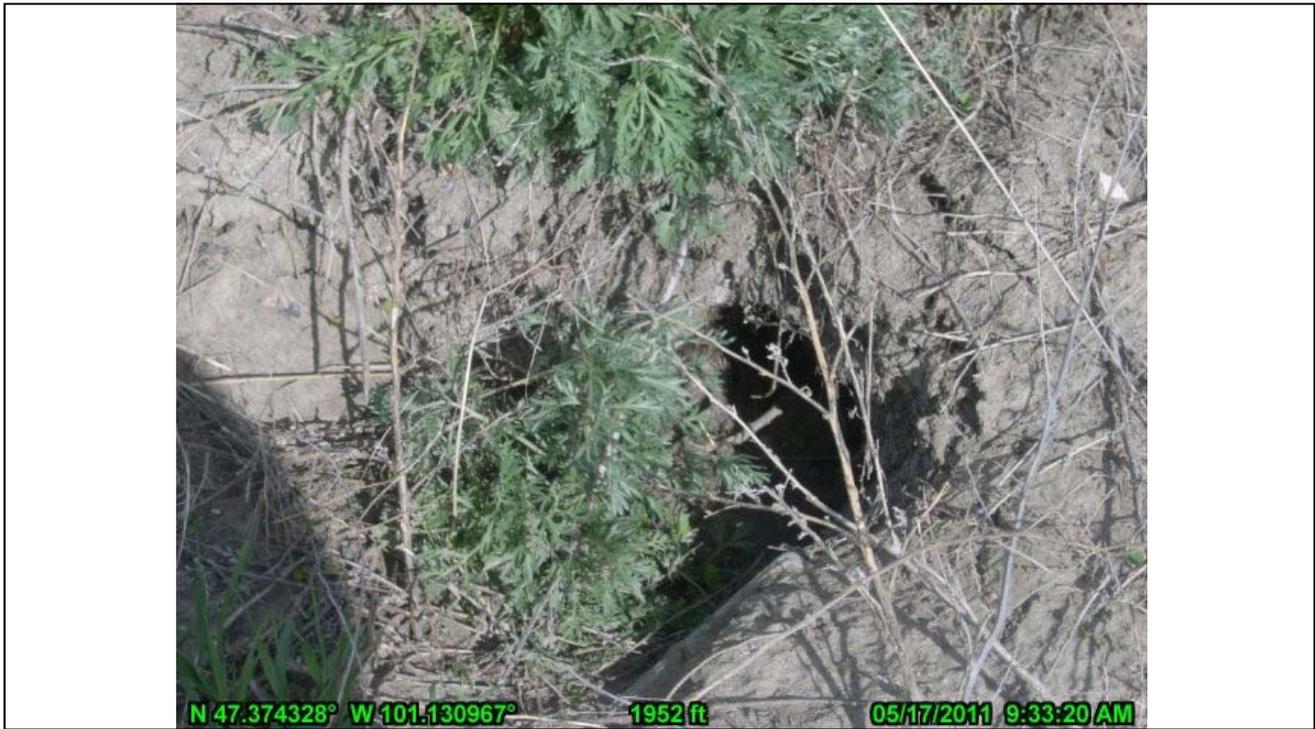
5-Ash Pond 92 Animal Burrows on ACM

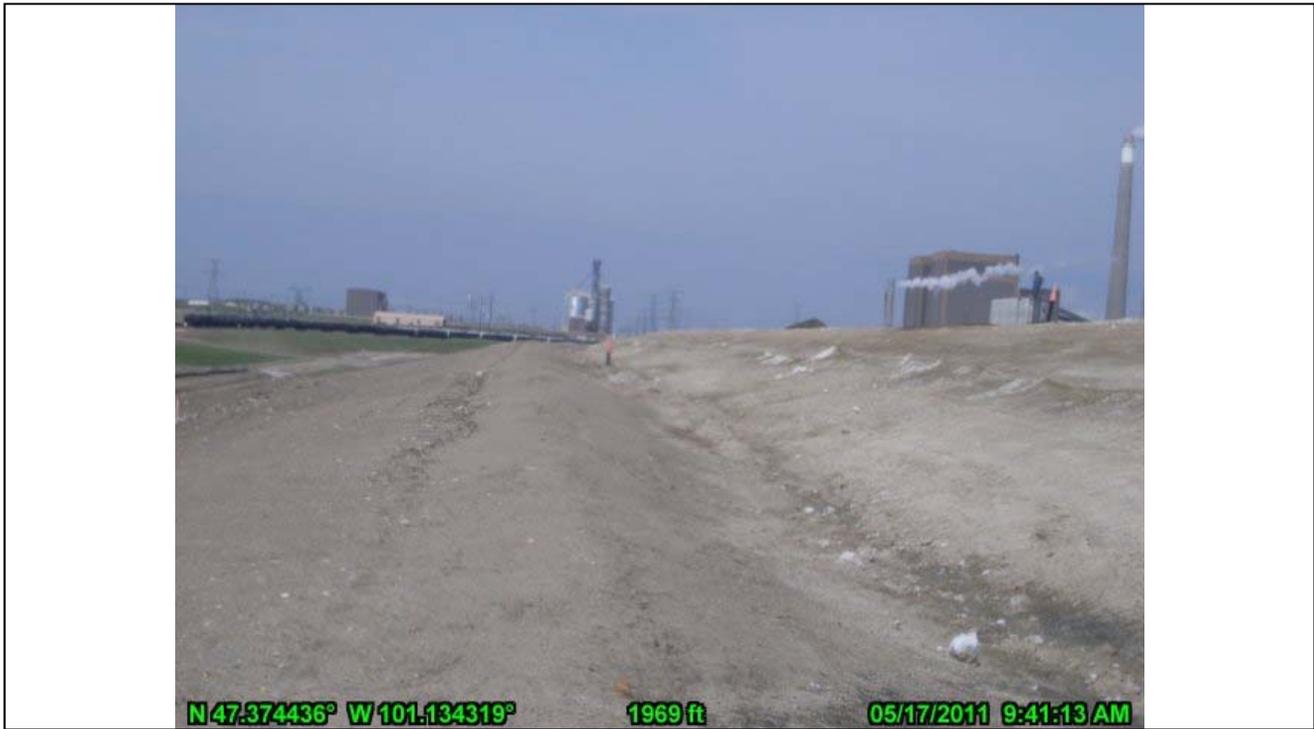
7-Ash Pond 92 Bench on South Side with Piezometers (looking west)

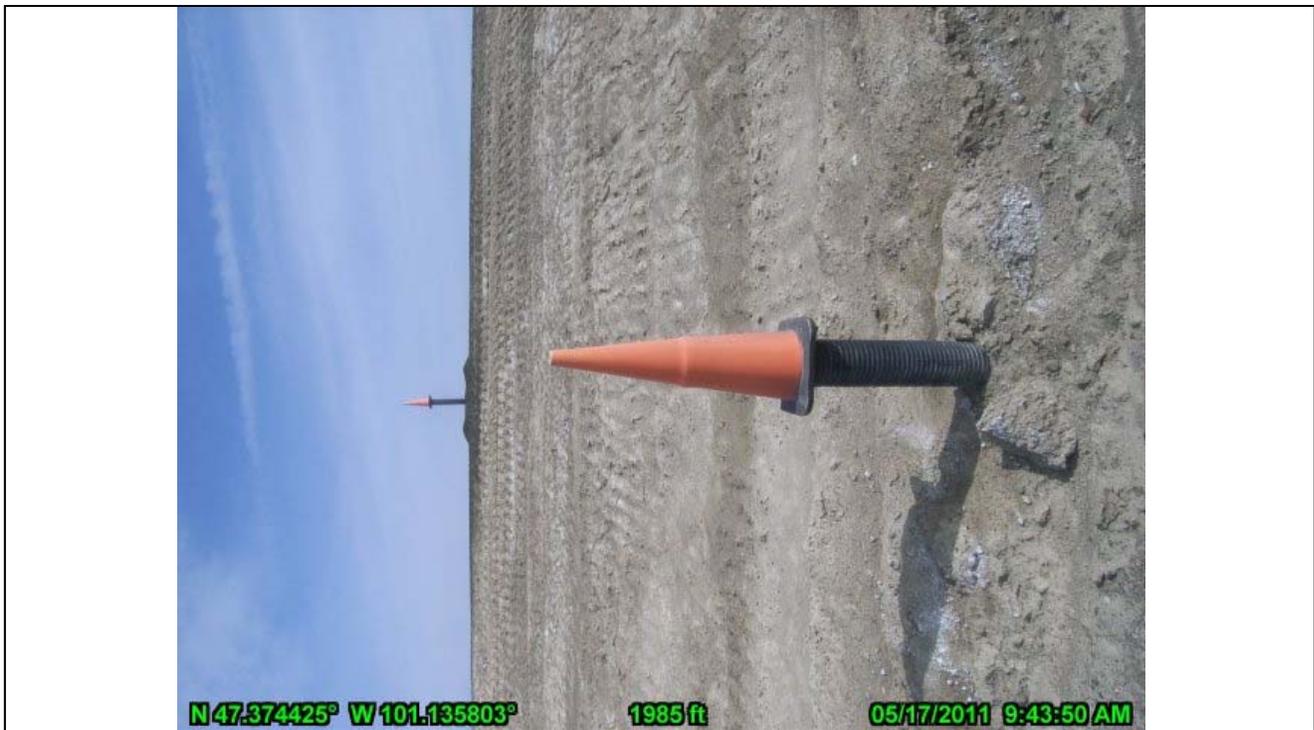
8-Ash Pond 92 Upslope View of Piezometers (looking north)

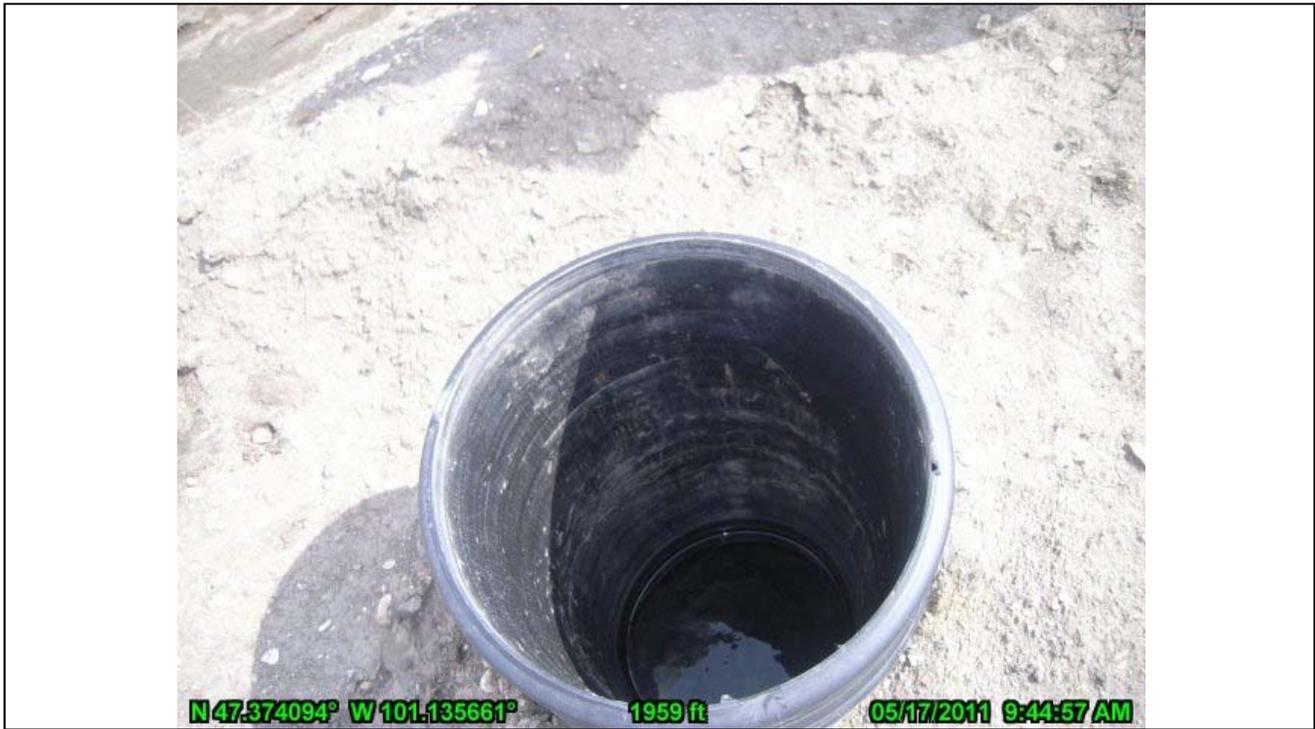
9-Ash Pond 92 Vertical Pipe with Cap, Water 4 Feet Down

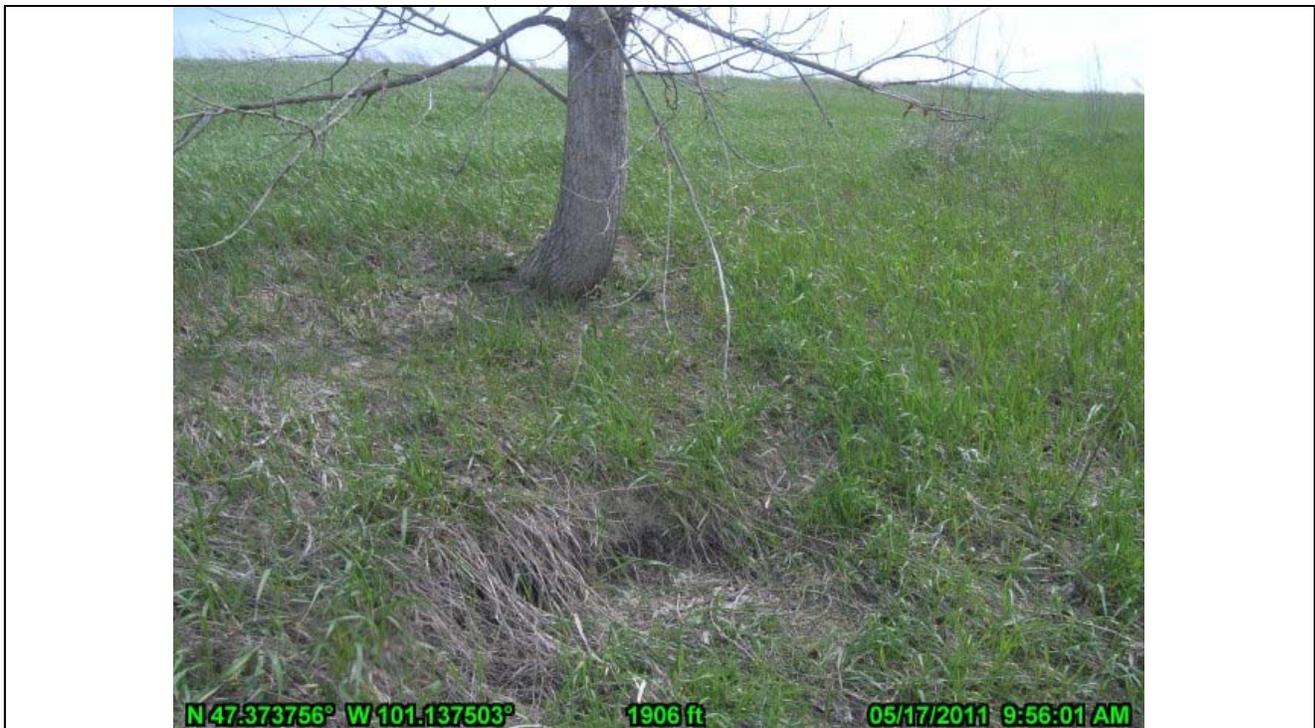
The toe areas of the embankment were in Fair condition. See Photos 11, 12, 13, 17, 18, and 31 for the typical condition of these areas. Key features and observations of these areas include:

12-Ash Pond 92 Tree and Scarp in South Embankment (looking north)

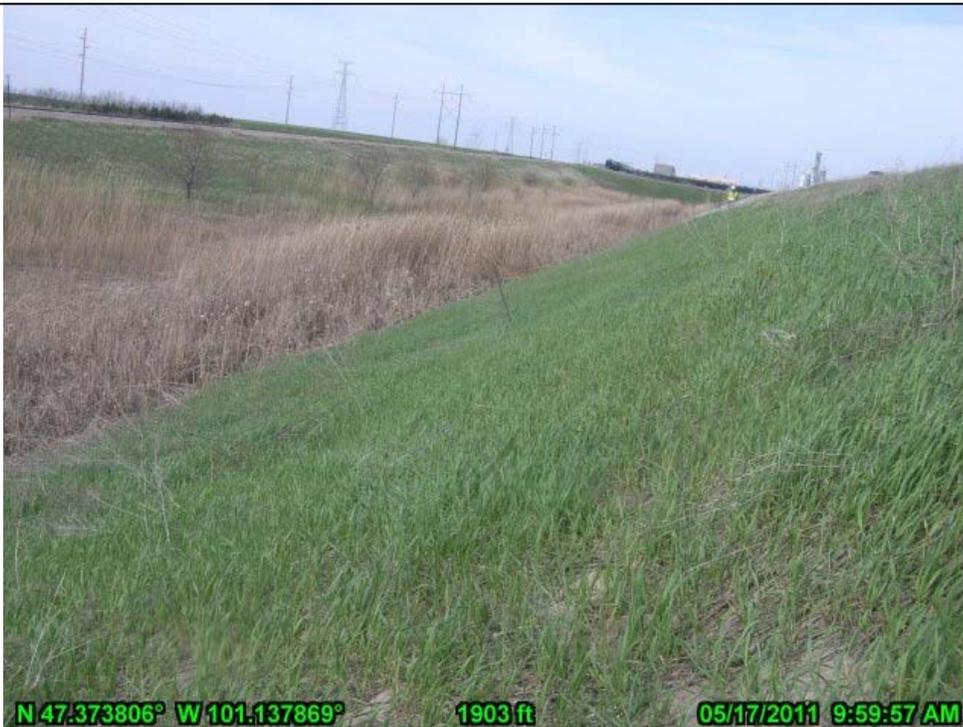
- The embankment toe was located along a drainage ditch on both the south and west sides. It did not appear that any noticeable seepage was occurring along the south side, but that condition would be difficult to detect with ponded stormwater water present. The west side ditch is intended to collect

13-Ash Pond 92 South Embankment Toe (looking west)

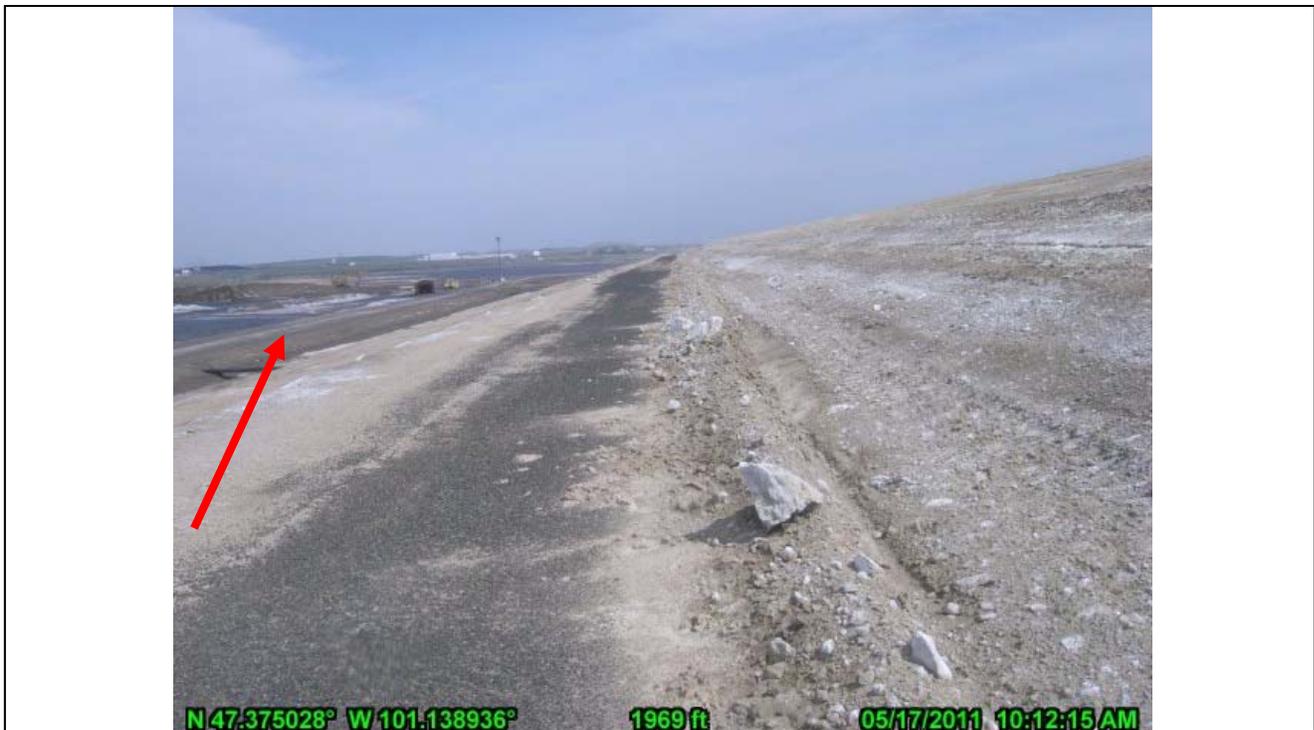
Overall, the downstream slope was in Satisfactory condition. Photos 3, 5, 10, 15, 16, 24, 34, and 35 show the conditions of the downstream slope. Specific observations include:

16-Ash Pond 92 West Landside Bench (looking north). Ash Pond 91 embankment on left

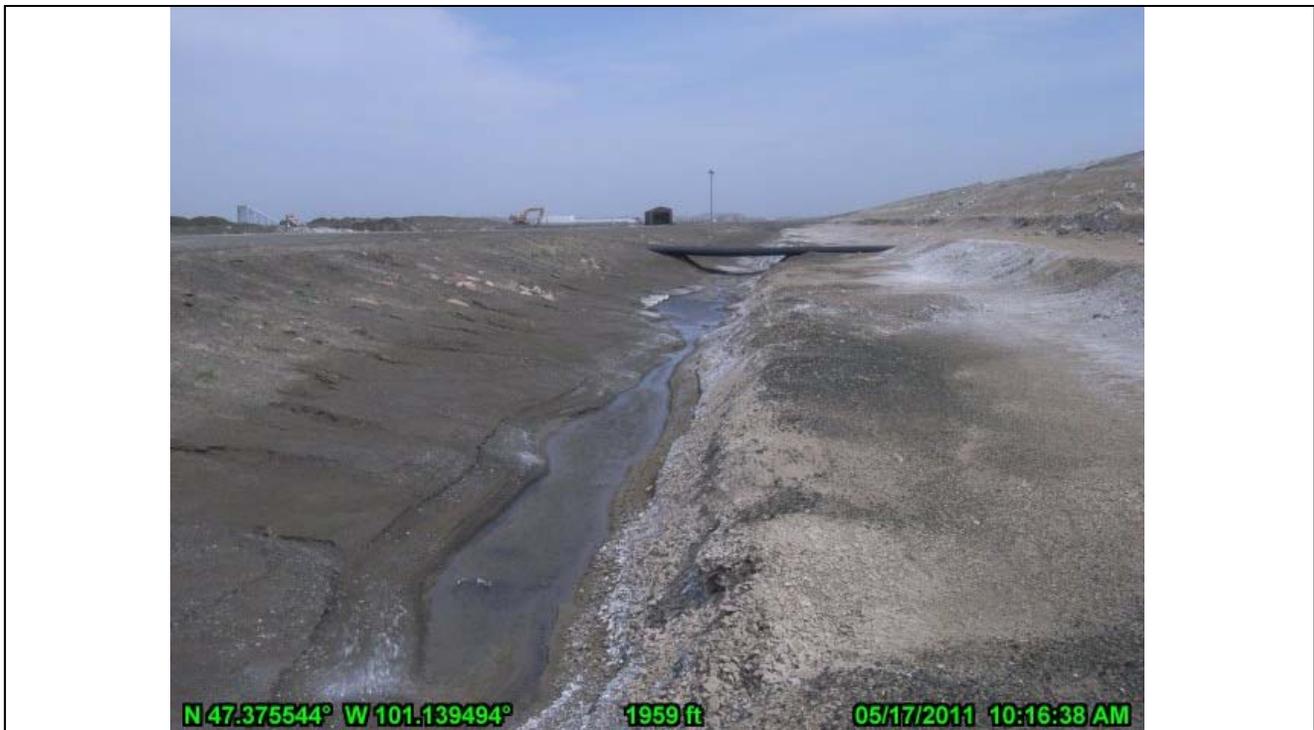
18-Ash Pond 92 Ditch on West Toe (looking north). Ash Pond 91 Embankment on Left

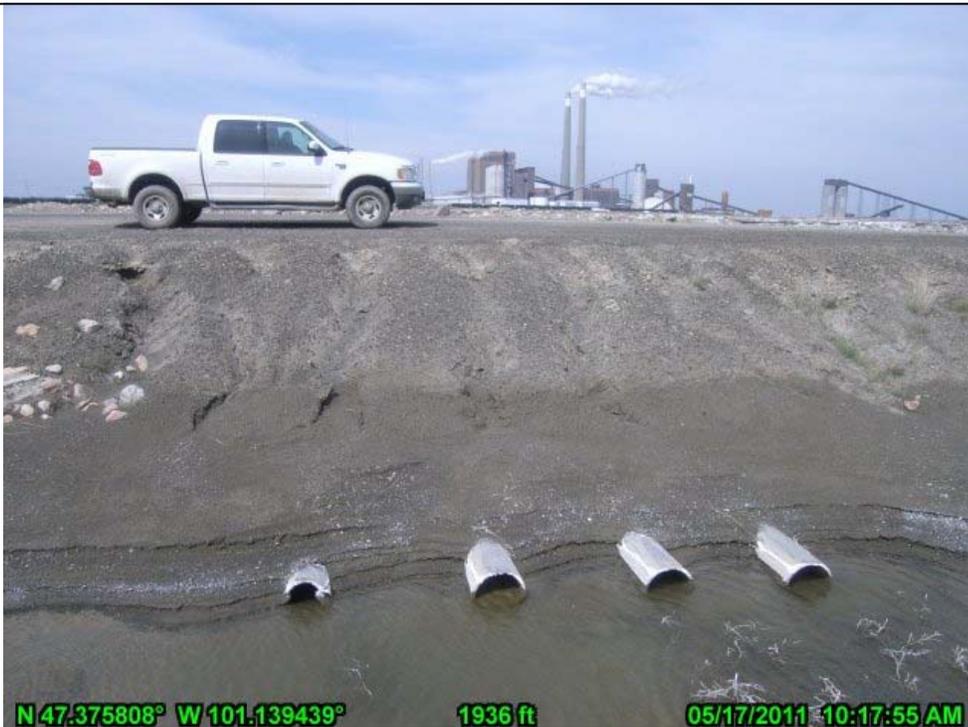
19-Gravity Drains from Ash Pond 92 Ditch to Ash Pond 91 (looking west)

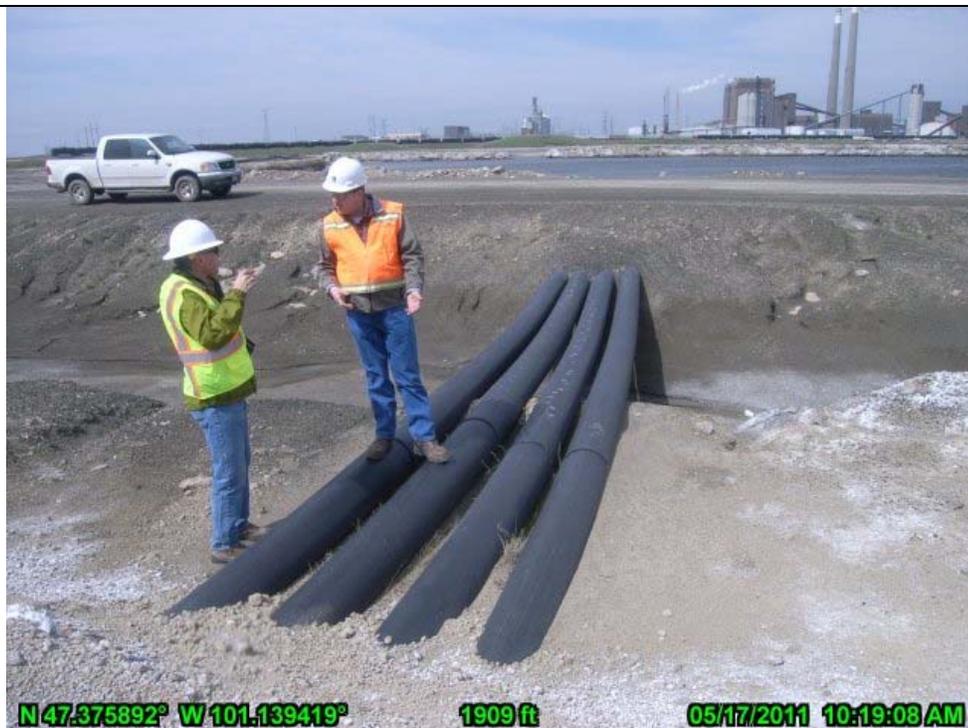
20-Ash Pond 92 Southern 12" HDPE Decant Pipes to Ash Pond 91 (looking west)

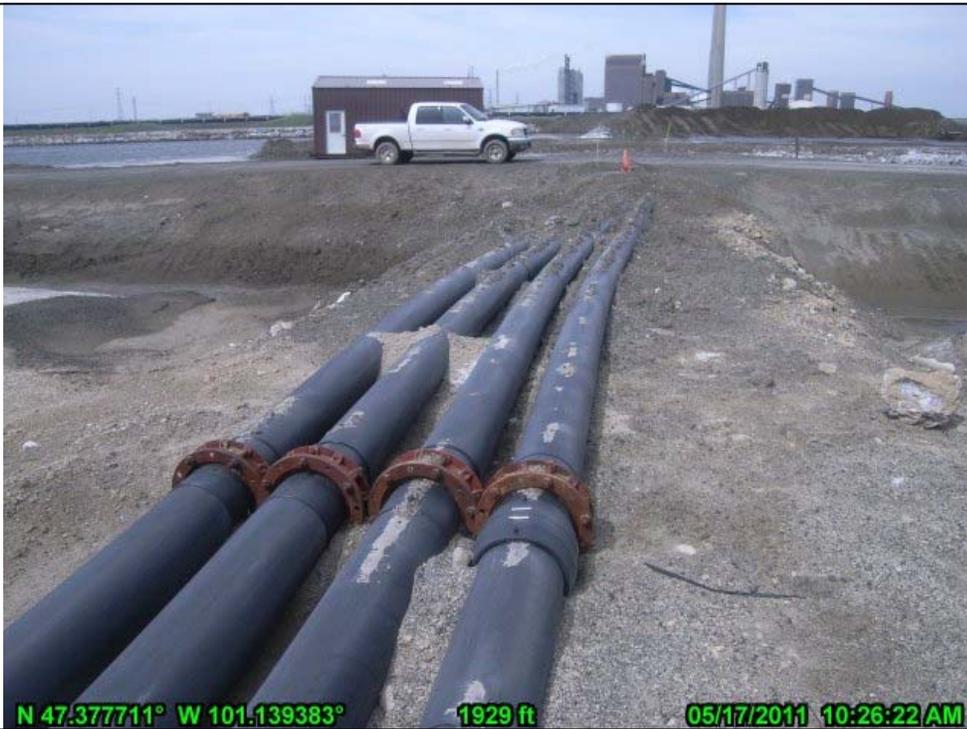
21-Ash Pond 92 Northern 12" HDPE Decant Pipes to Ash Pond 91 (looking west)

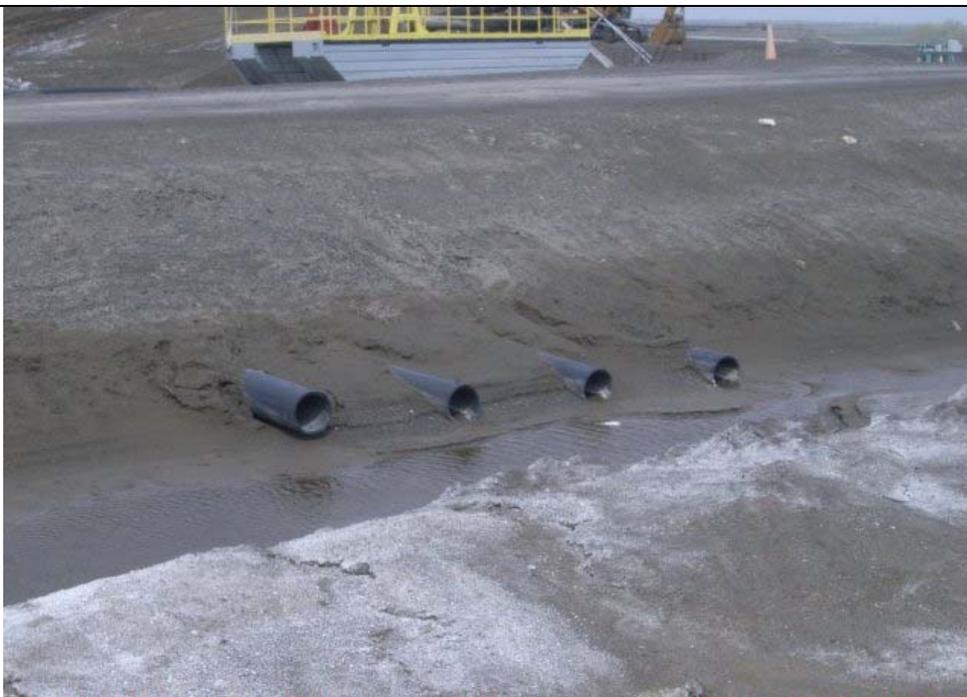
22-Gravity Drains from Ash Pond 92 Ditch to Ash Pond 91 (looking northwest)

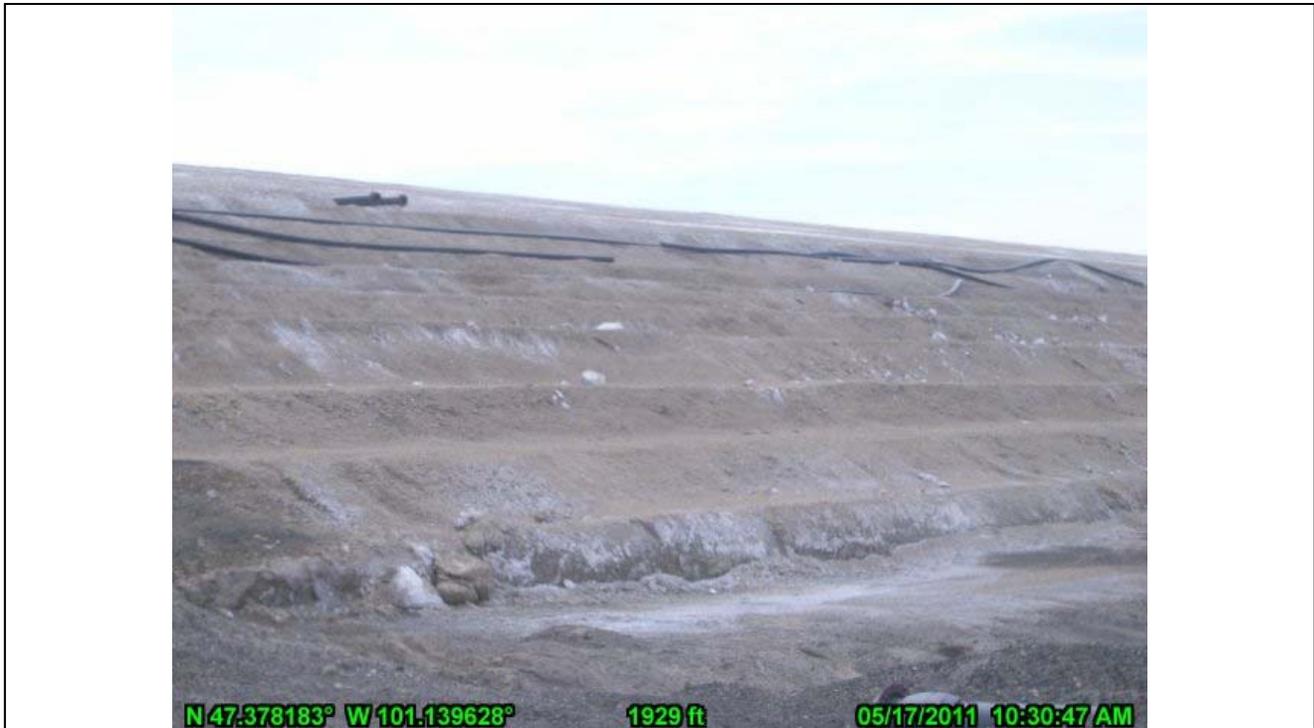
24-Ash Pond 92 Landside Embankment from Northwest Corner (looking southeast)

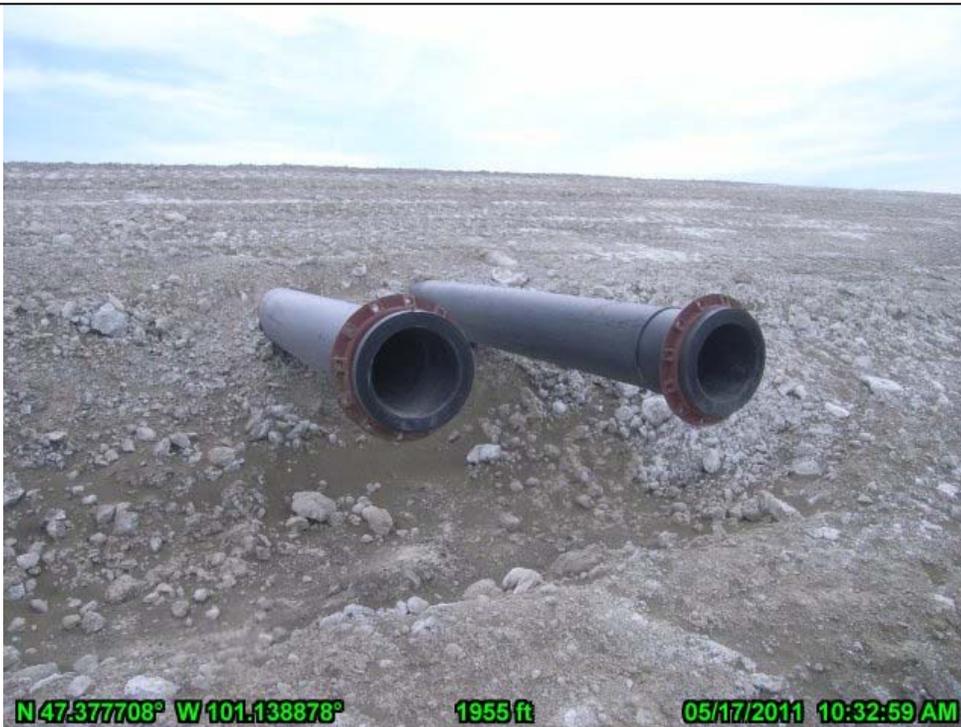
25-Ash Pond 92 Pipe Penetration on West Embankment

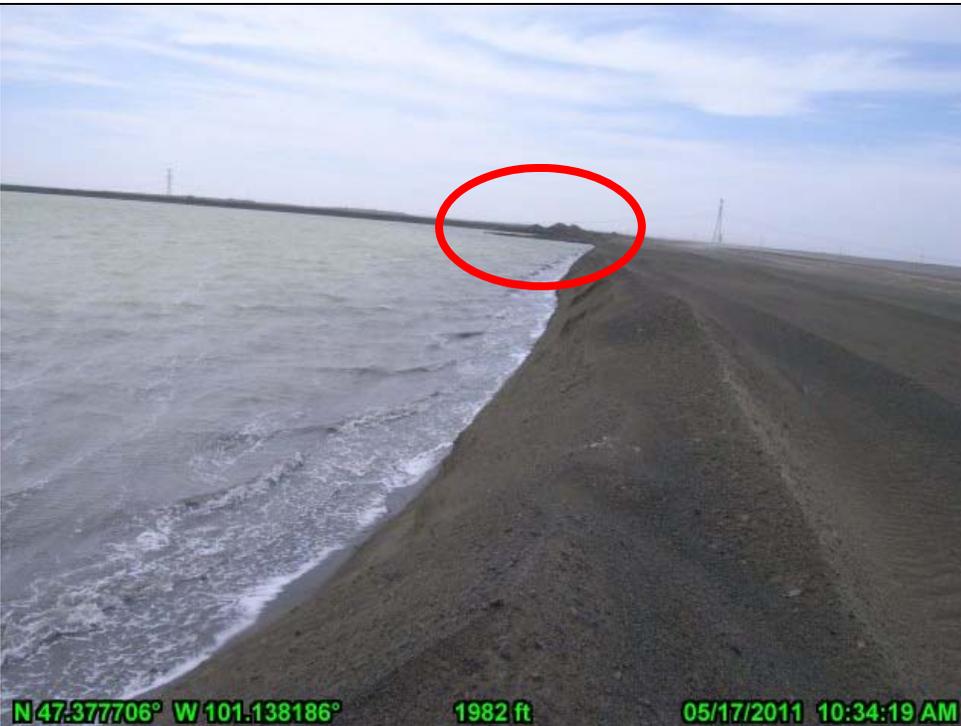
Overall, the upstream slope of the impoundment was in Satisfactory condition. Photos 26 and 27 show the conditions of the upstream slope. Specific observations include:

26-Ash Pond 92 Waterside Embankment at NW Corner (looking south). Outlet Decant Pipes in Background

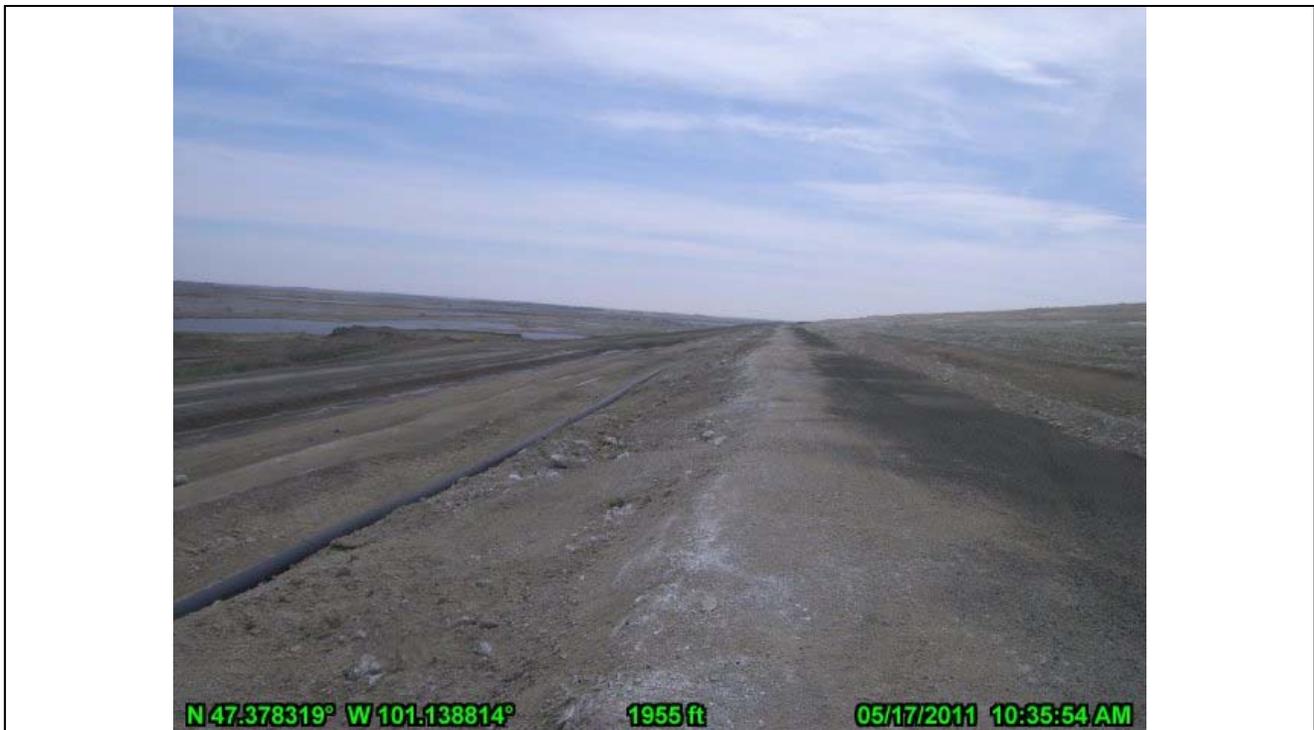
28-Ash Pond 92 Landside Embankment Bench (looking east)

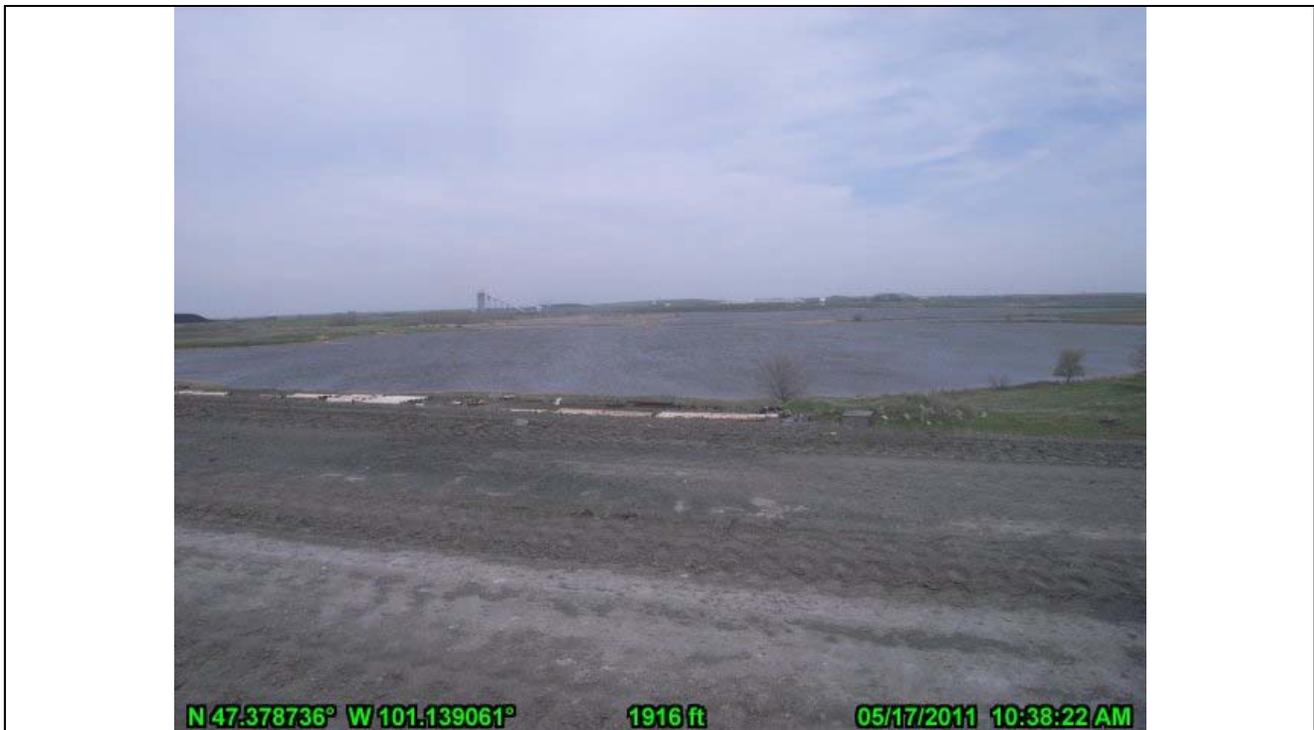
30-Lower Samuelson Slough (looking north)

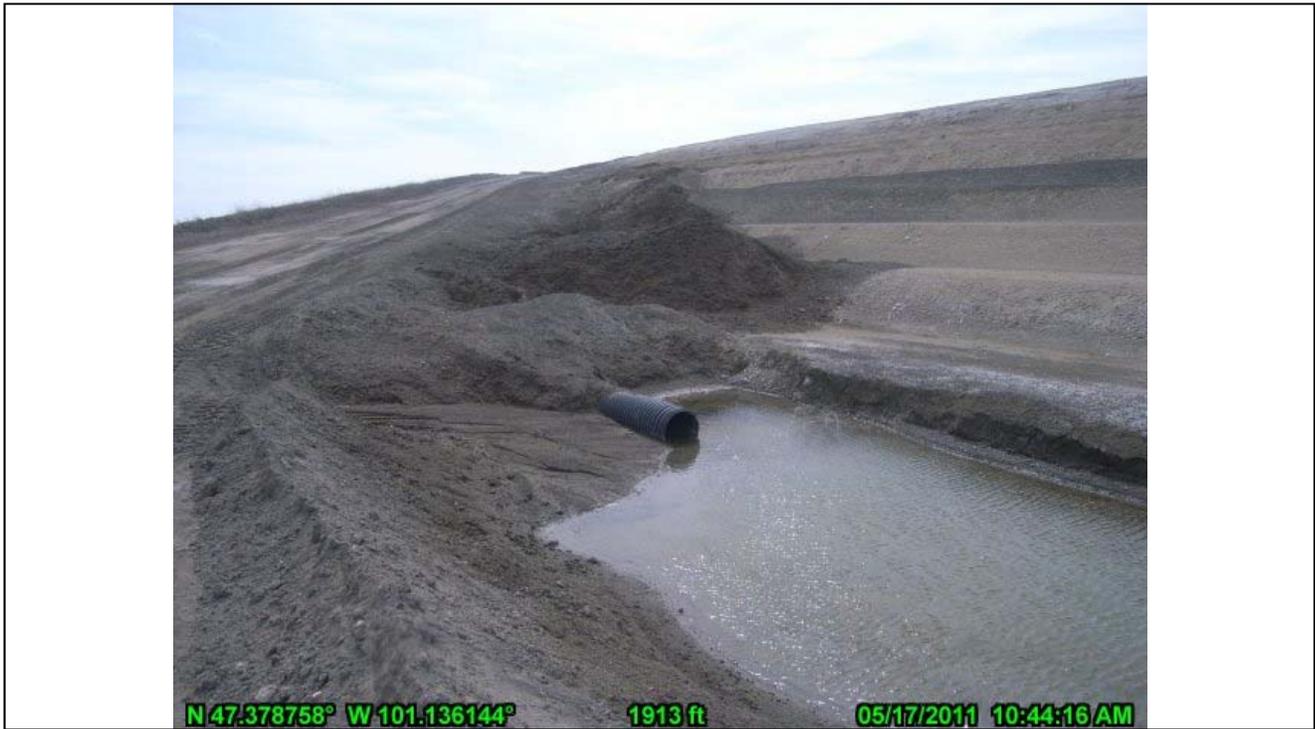
31-Ash Pond 92 North Embankment 18" HDPE Toe Drain Outlet (looking east)

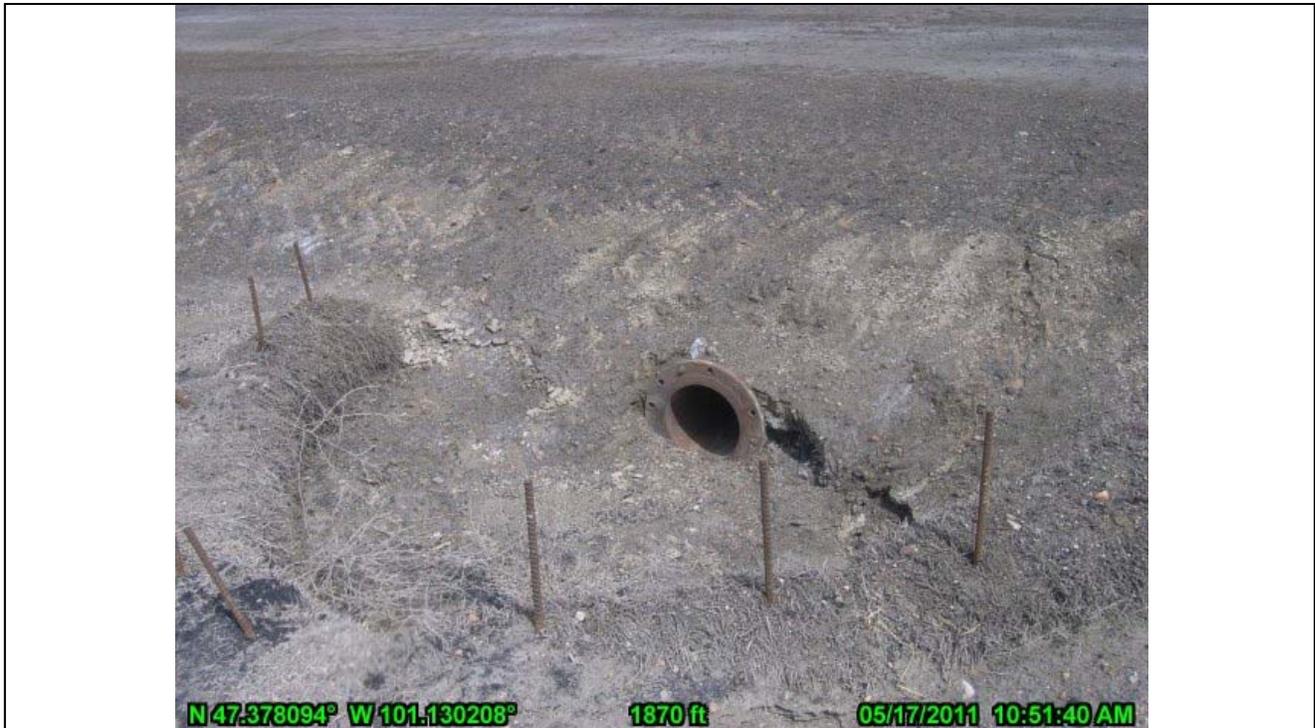
32-Ash Pond 92 Drainage Pipe at Northeast Corner (looking north)

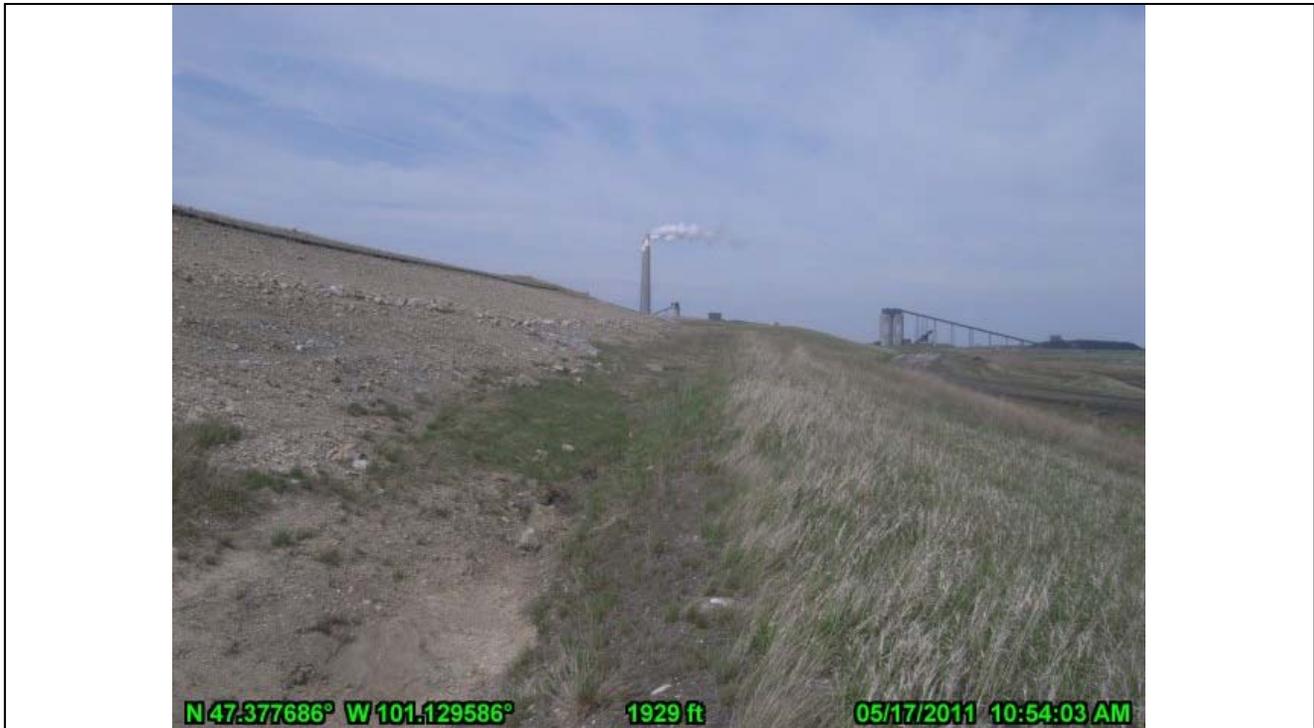
34-Ash Pond 92 Landside Embankment from Northeast Corner (looking west)

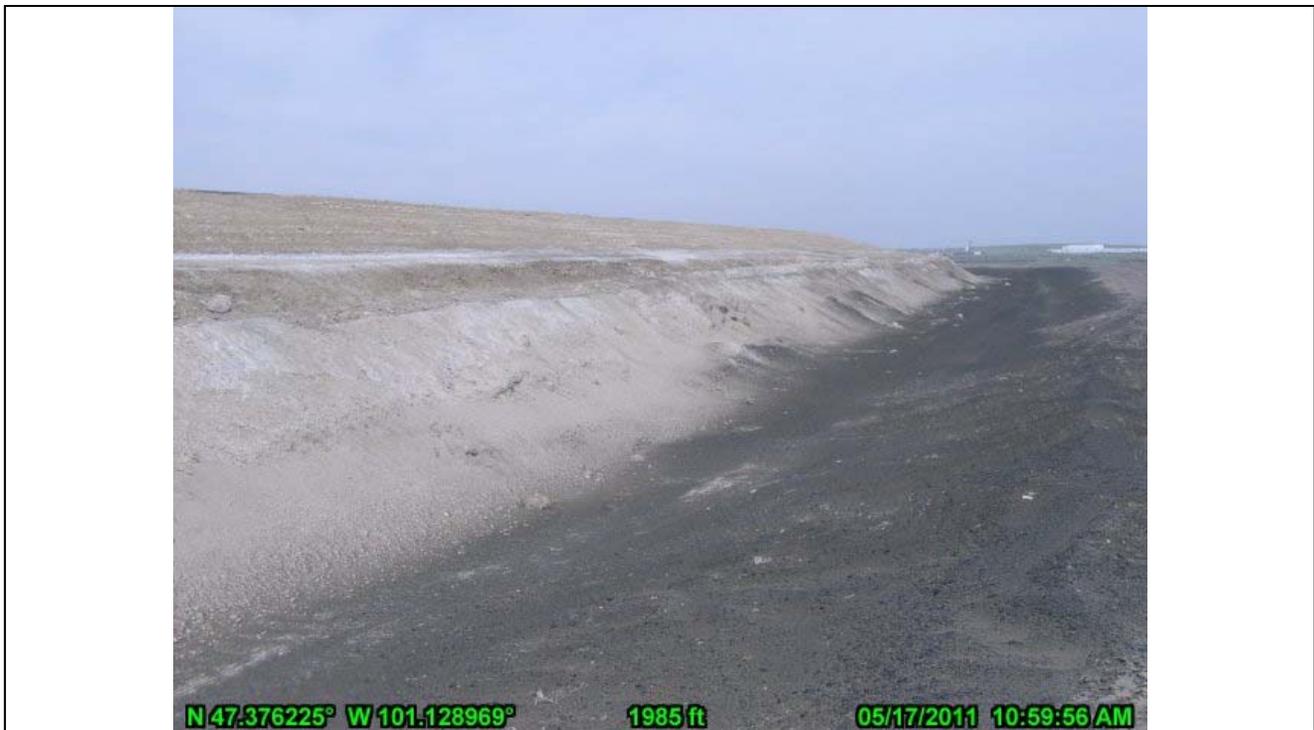
36-Ash Pond 92 East Landside Drainage Ditch (looking north)

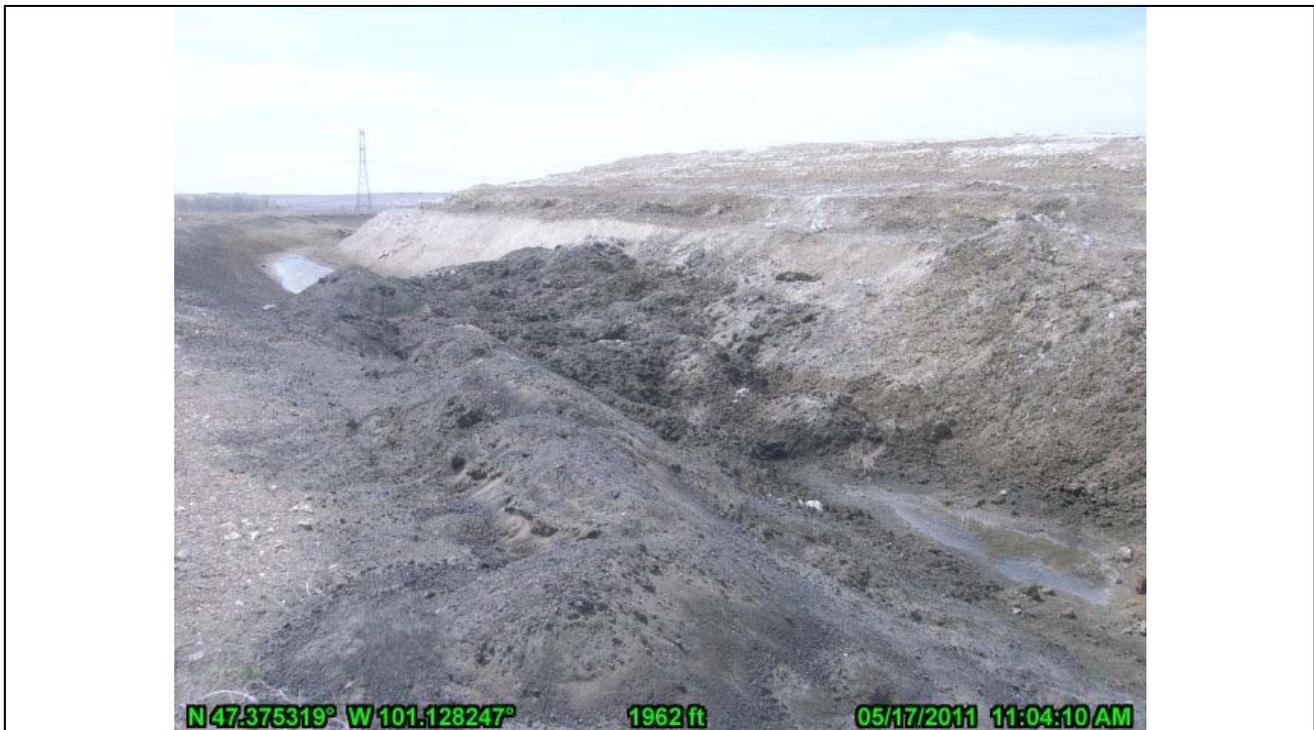
38-Ash Pond 92 Pile of Ash in Drainage Ditch on Southeast Corner (looking north)

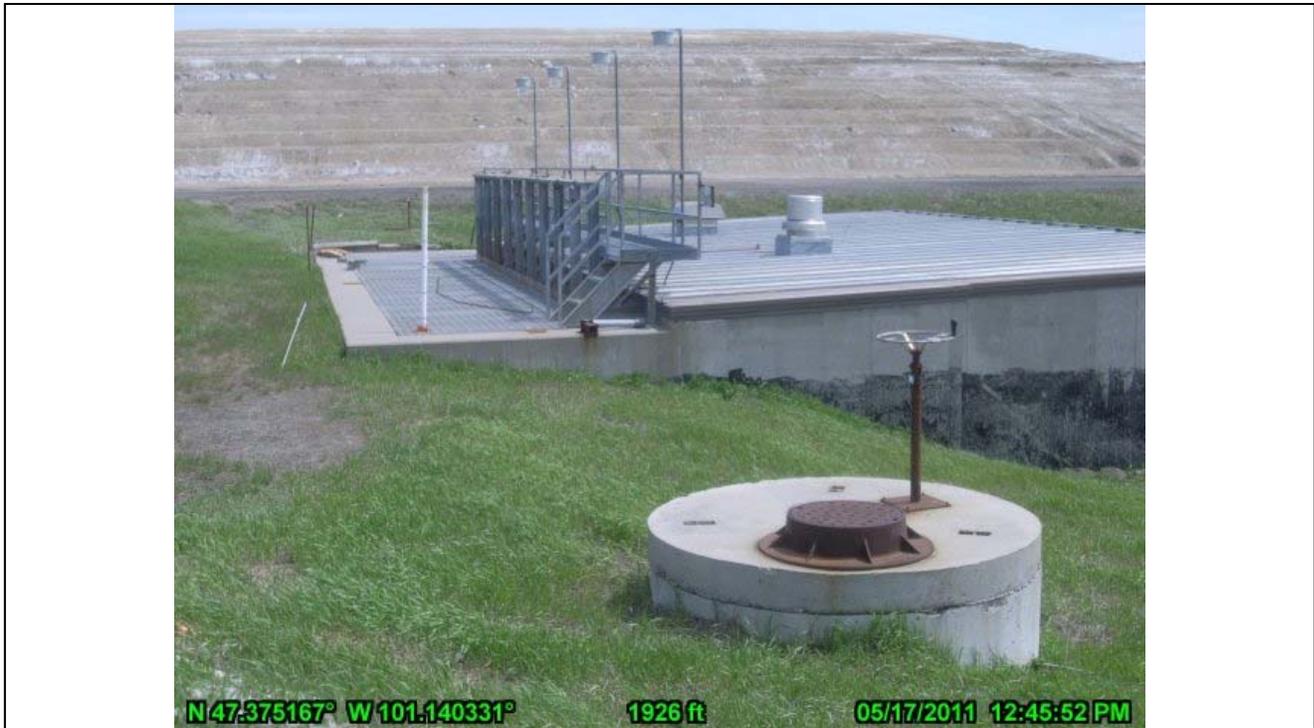
There is one permanent pump station structure adjacent to Ash Pond 91 at Coal Creek Station. The structure is located in the downstream embankment at the southeast corner of the pond. The structure was not assessed in detail, but appeared visually to be in Satisfactory condition with no evidence of movement or any structural distress. The pump station is used to pump water from Ash Pond 91 to the Drains Pond or Plant.

40-Pump Station Between Ash Pond 91 and 92 (looking east)
