**COAL ASH IMPOUNDMENT
SITE ASSESSMENT FINAL REPORT**

**Coal Creek Station
Great River Energy
Underwood, North Dakota**

KLEINFELDER PROJECT NUMBER 118953-1

October 31, 2012

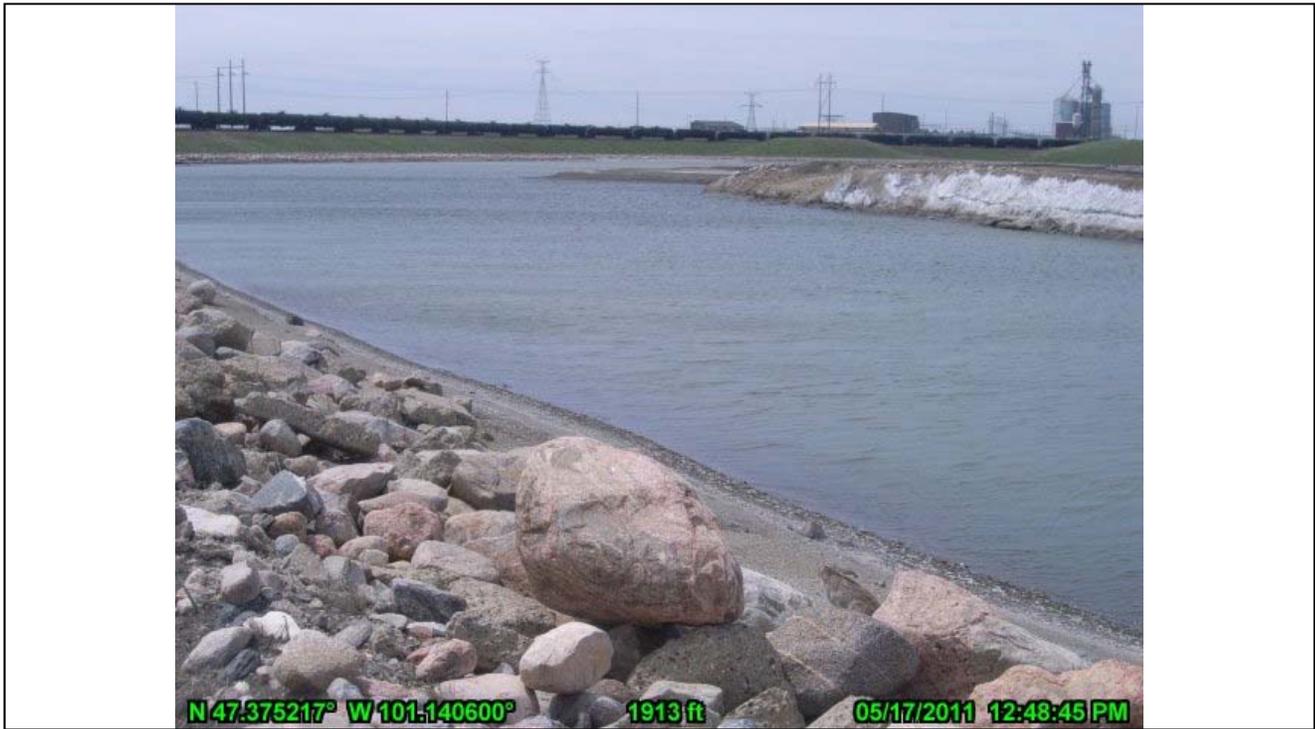
Overall, the upstream slope of the impoundment was in Satisfactory condition. Photos 41, 54, and 61 show the conditions of the upstream slope. Specific observations include:

41-Ash Pond 91 Waterside Embankment from Southeast Corner (looking west)

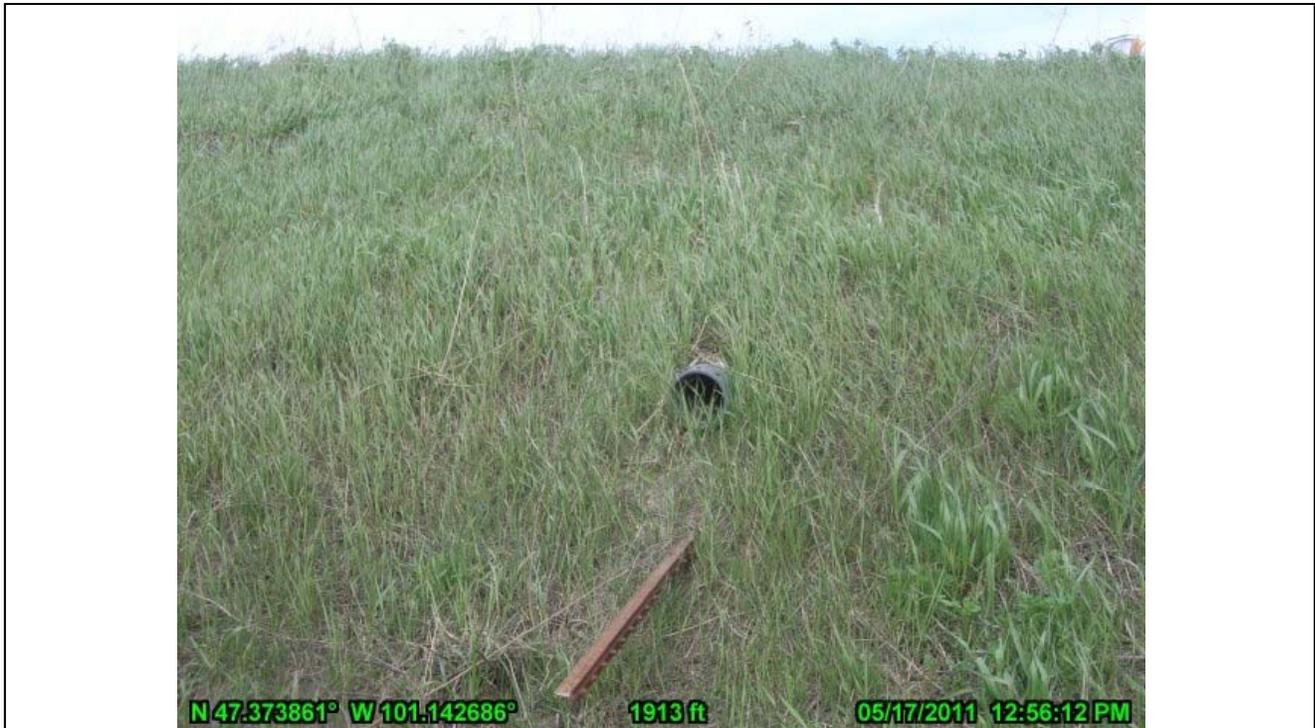
42-Ash Pond 91 Gas Vent Pipe on Landside Slope

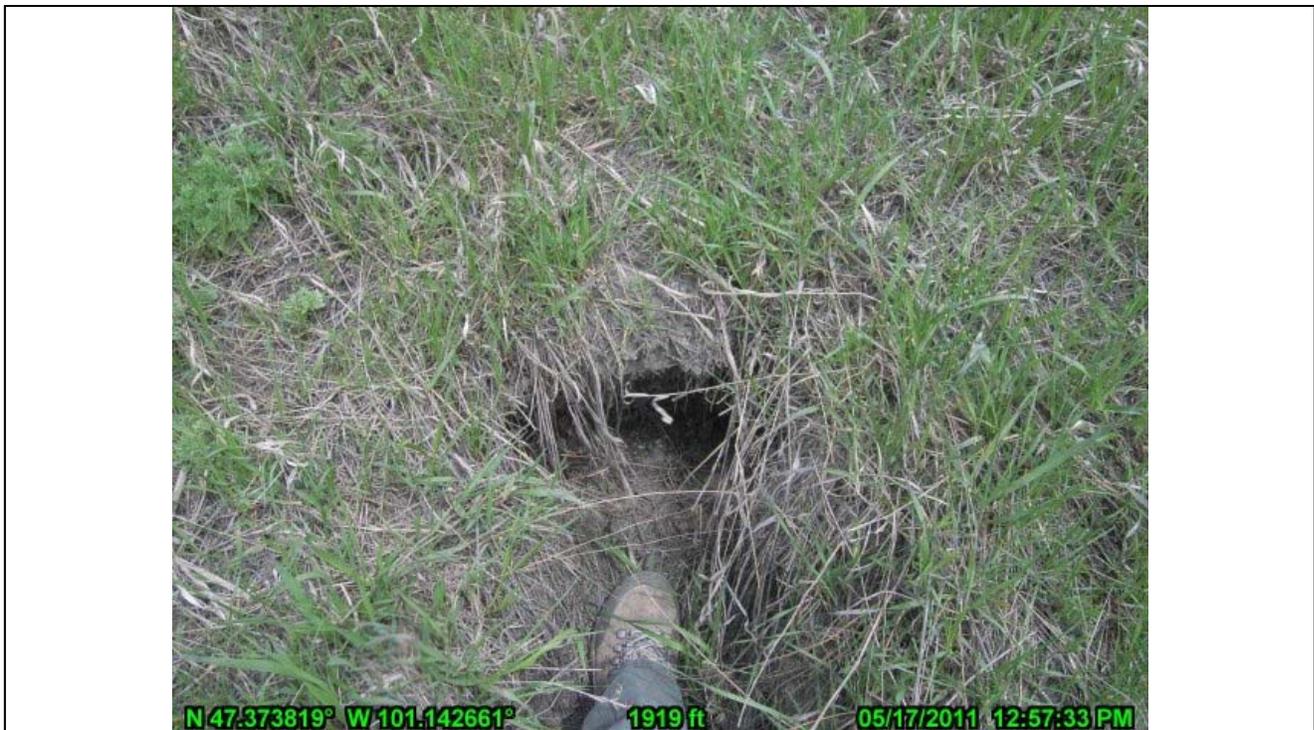
Overall, the downstream slope was in Satisfactory condition. Photos 43, 44, 48, 50, 53, 54, 63, and 64 show the conditions of the downstream slope. Specific observations include:

- The slopes were well vegetated and appeared stable.
- Some minor areas of erosion on the slope were observed.
- A few animal burrows were noted.
- The east embankment abuts directly to the toe of the Upstream Raise/Ash Pond 92, with a drainage ditch between the two ponds that collects surface runoff and Upstream Raise underdrain seepage. The east embankment is essentially denuded. See photos 16, 17, and 18 for the Ash Pond 91 east embankment location.

44-Ash Pond 91 Animal Burrow on South Embankment

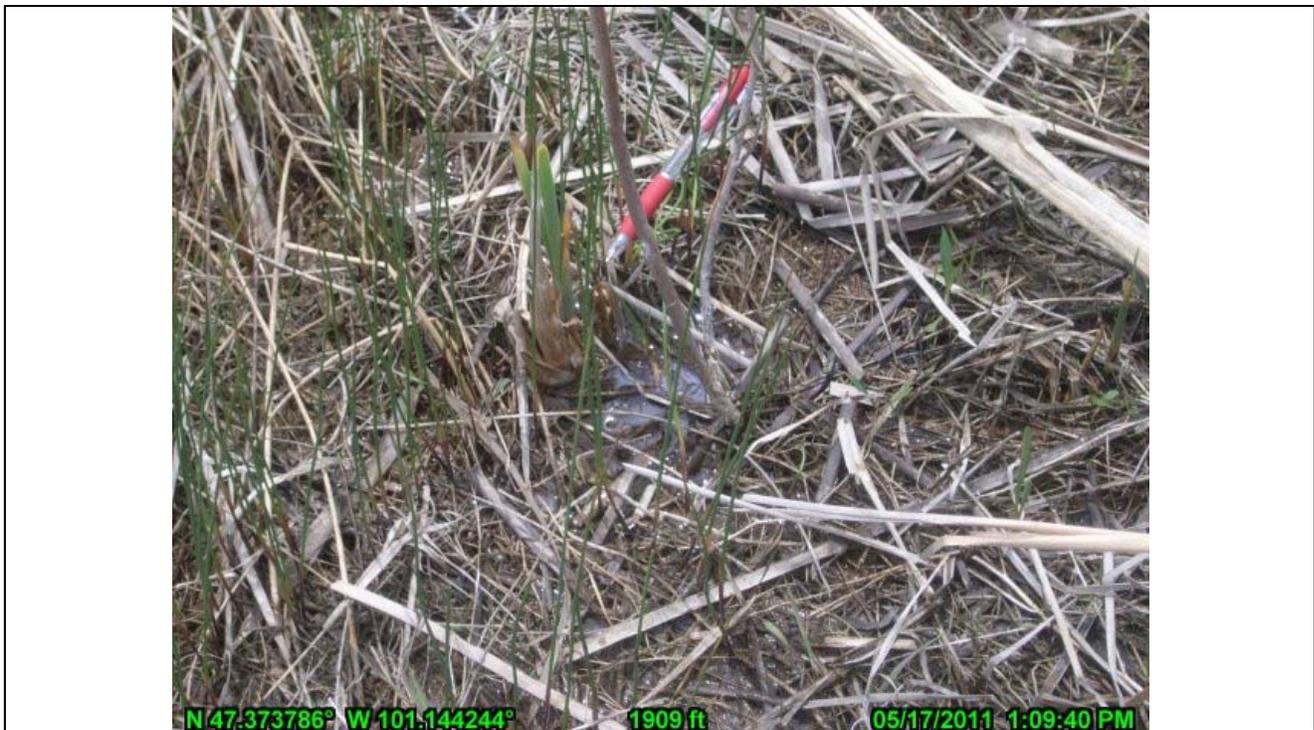
46-Ash Pond 91 Possible Seepage at Southern Landside Toe

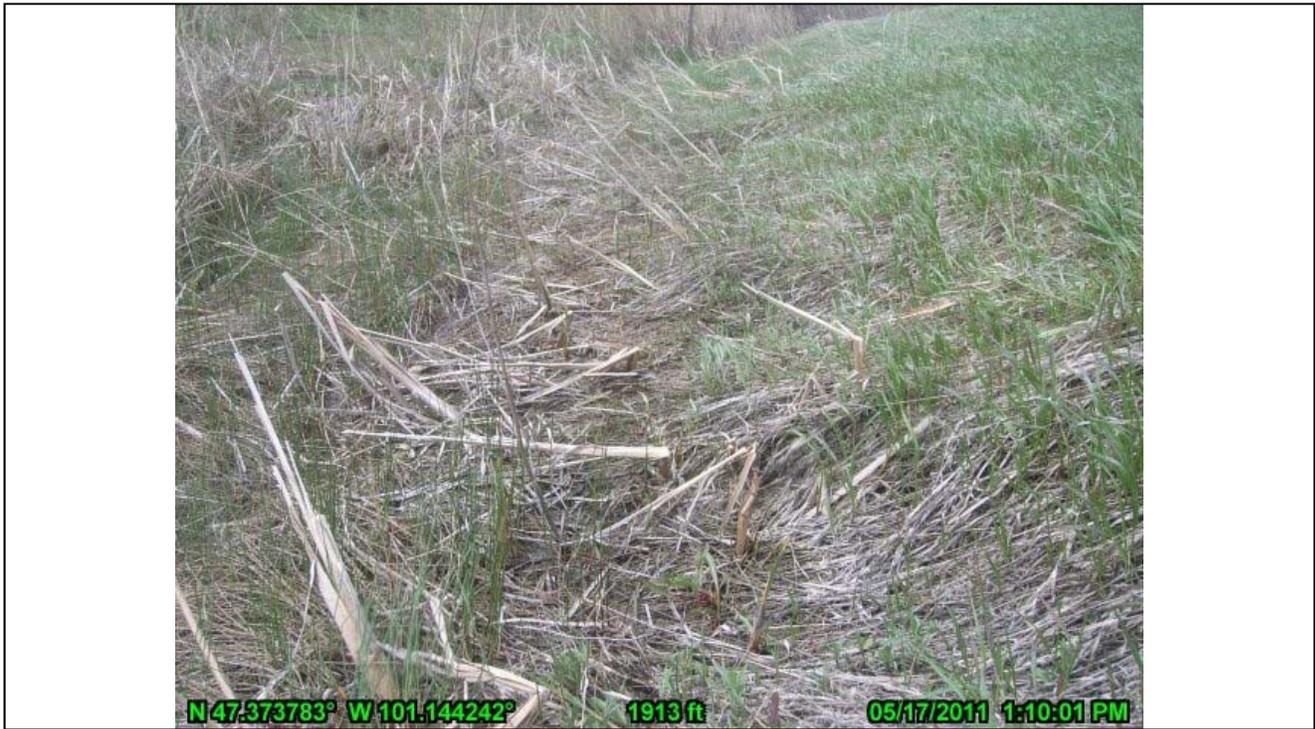
47-Ash Pond 91 Possible Seepage Area Along Southern Landside Toe (looking west)

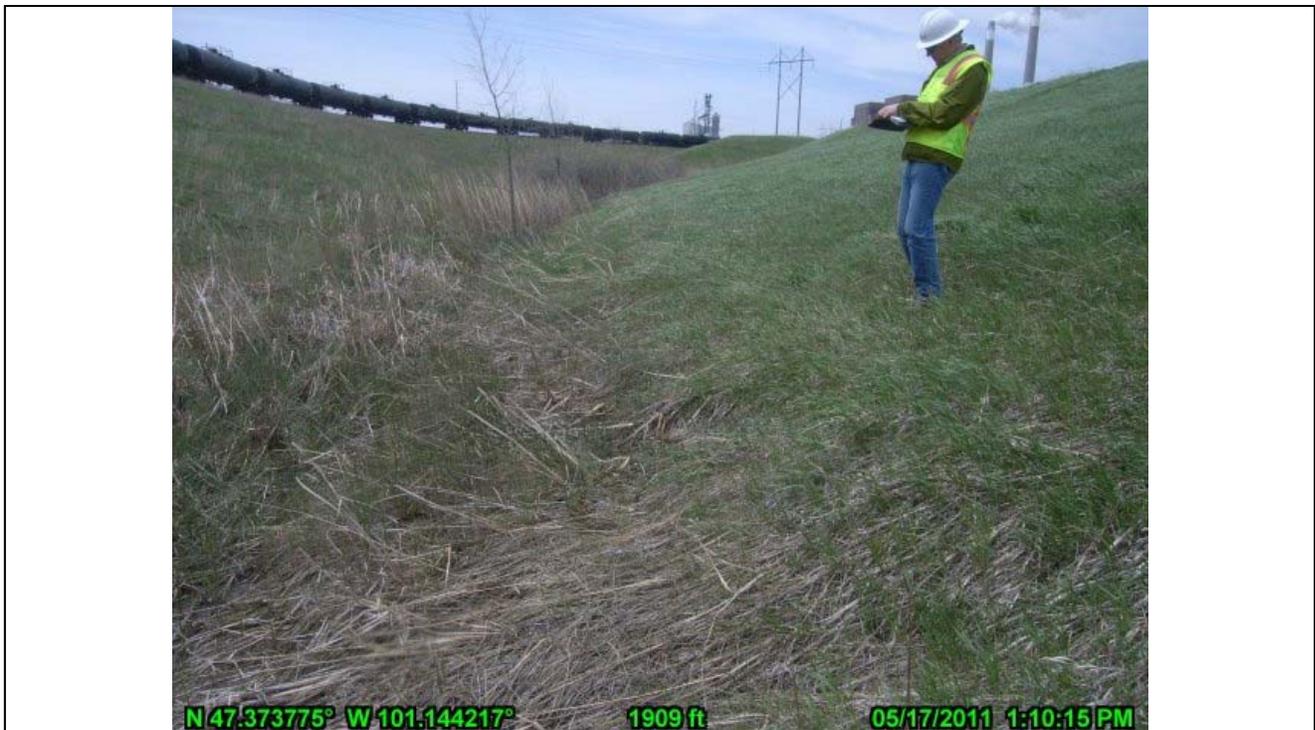
48-Ash Pond 91 Possible Seepage Area Along Southern Landside Toe (looking west)

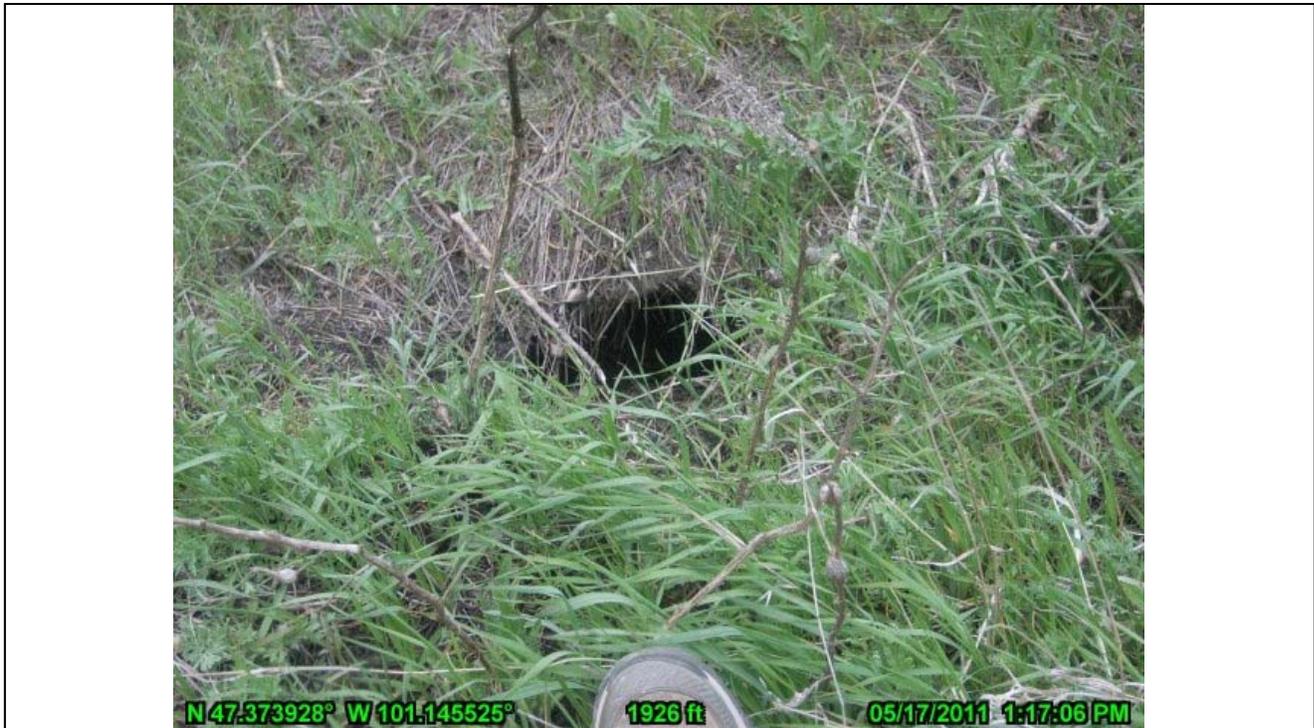
50-Ash Pond 91 Animal Burrow

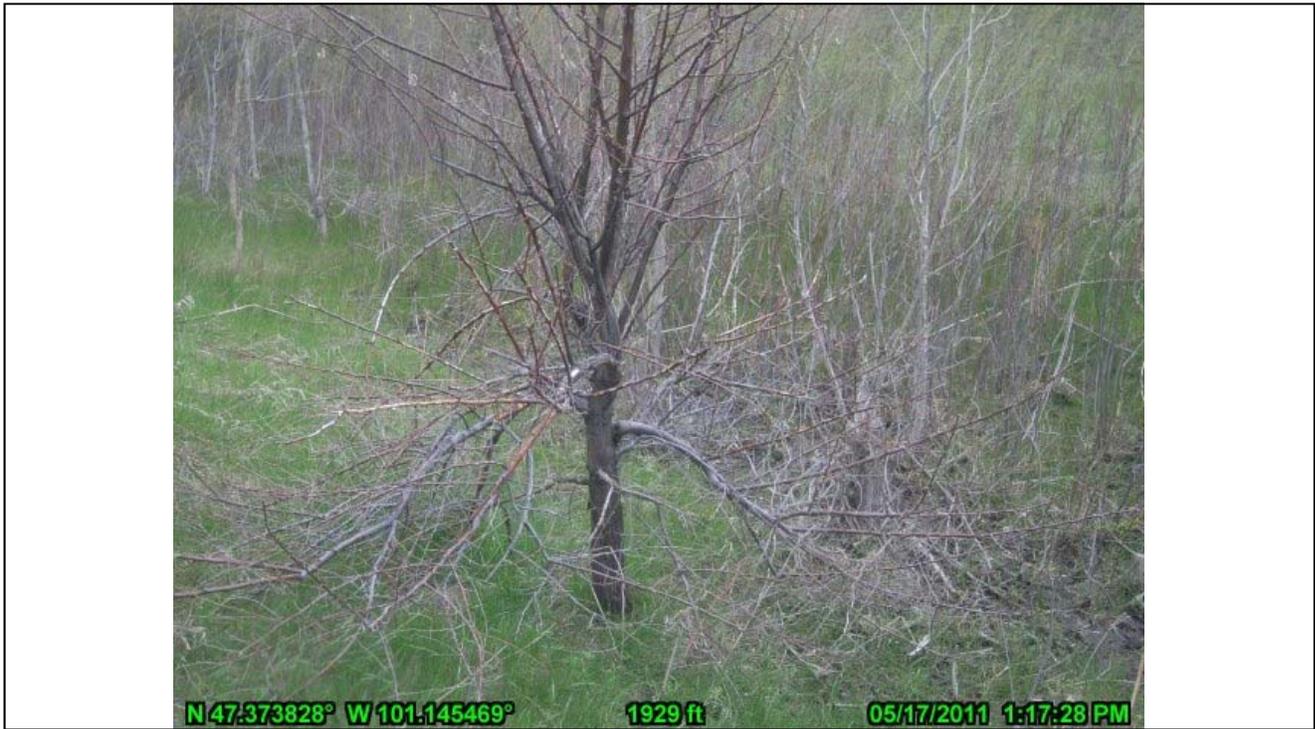
51-Ash Pond 91 Tree at Landside Toe on Southern Embankment

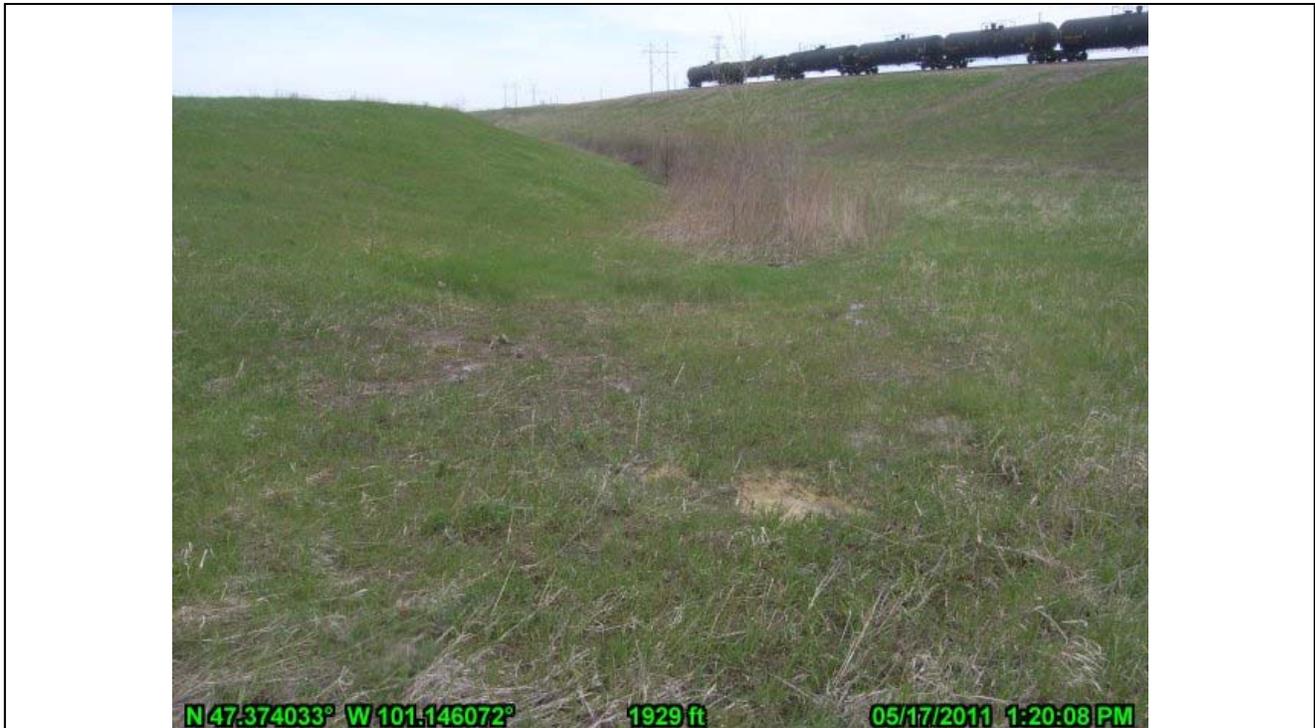
52-Ash Pond 91 Oily Seepage Along Landside Toe on Southwest Corner (looking SE).
Source Unknown

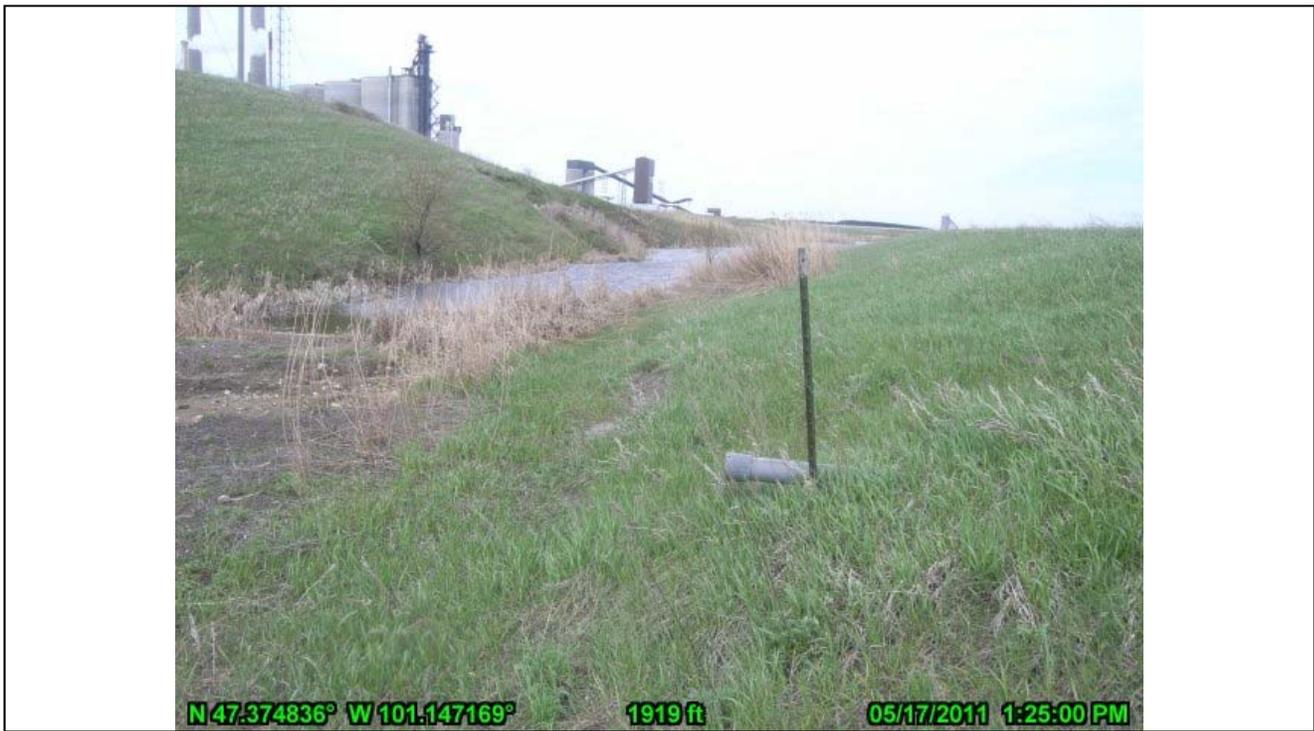
53-Ash Pond 91 Gas Vent Pipe and Slough Along West Embankment (looking north)

- The Ash Pond 91 west embankment toe appears to have a permanent slough feature adjacent to the downstream toe. The toe along the west slough was observed to have small scarps along the slough water line likely caused by wave action and saturated conditions. Erosion at the toe can shorten seepage paths and decrease stability of the embankment. Since the slough likely keeps the toe in a saturated condition, a seepage and stability analysis should be performed on the west embankment. The west embankment toe should be repaired and armored based on results of the analysis.

2. **Evaluate and repair erosion at the toe on west embankment of Ash Pond 91 by July 31, 2013.** Ash Pond 91 west embankment toe appears to have a permanent slough feature adjacent to the downstream toe and was observed to have scarps along the slough water line. Erosion at the toe can shorten seepage paths and decrease stability of the embankment. Since the slough likely keeps the toe in a saturated condition a seepage and stability analysis should be

performed on the west embankment and the toe should be repaired and armored based on results of the analysis.

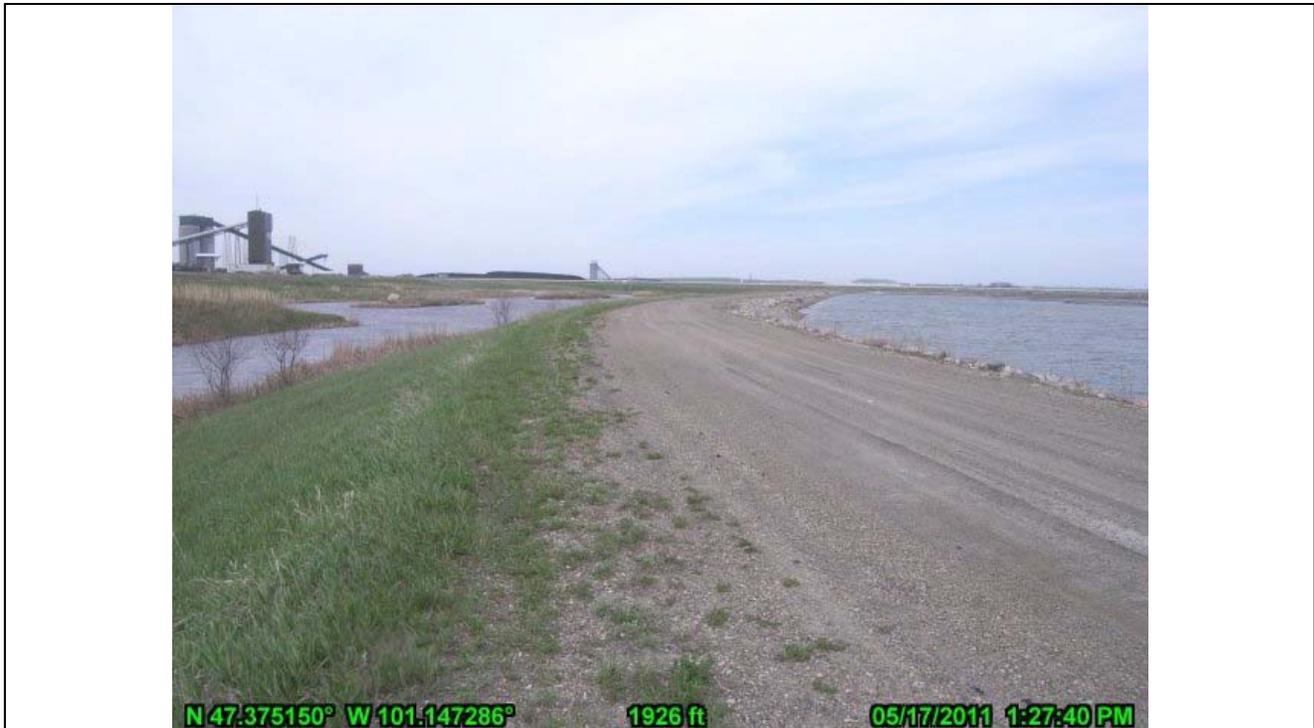
54-Ash Pond 91 West Crest with Slough on Left (looking north)

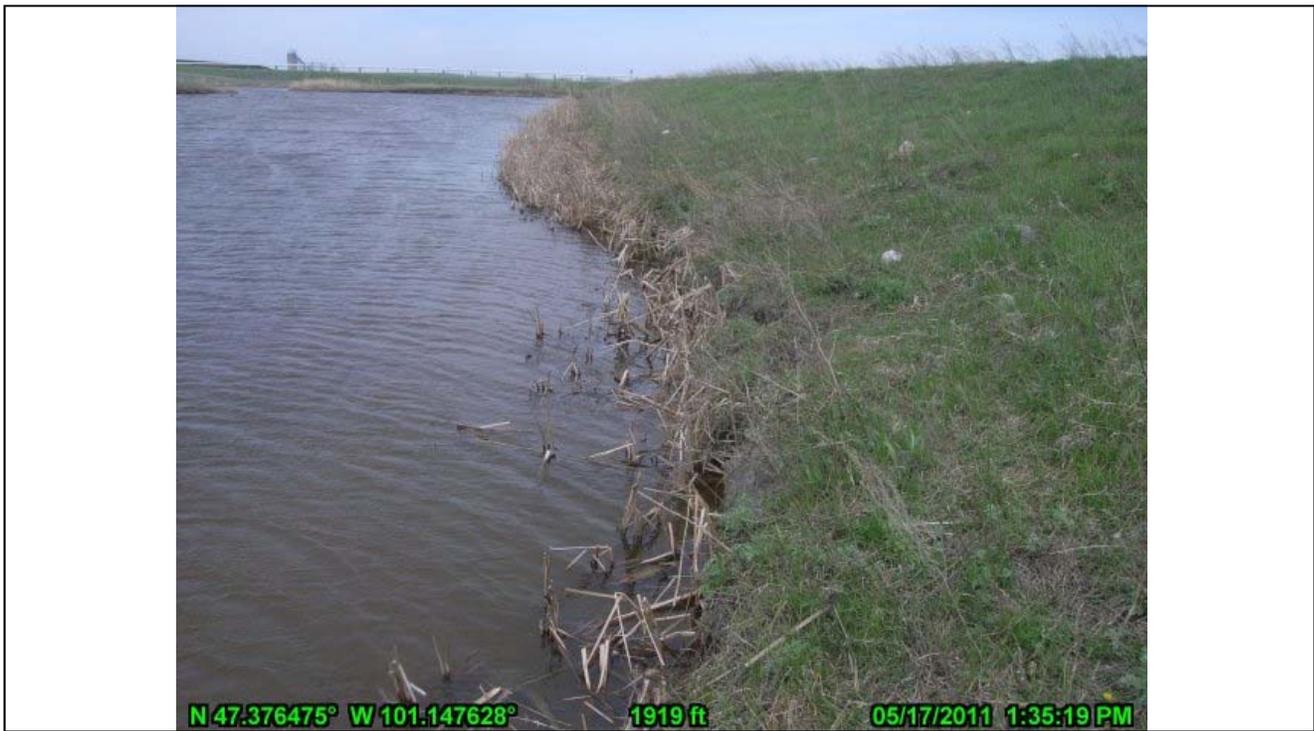
55-Ash Pond 91 Landside Toe Scarp Adjacent to Slough (looking north)

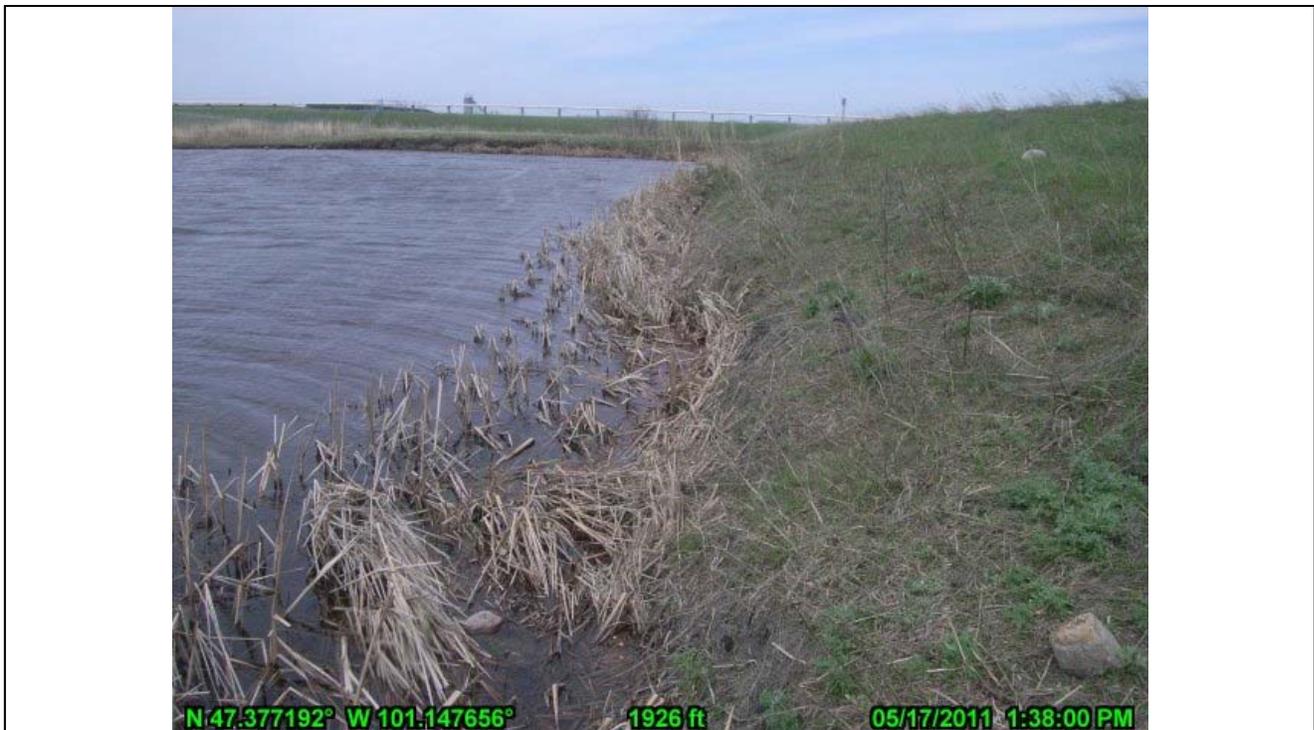
56-Ash Pond 91 Landside Toe Scarp Adjacent to Slough (looking north)

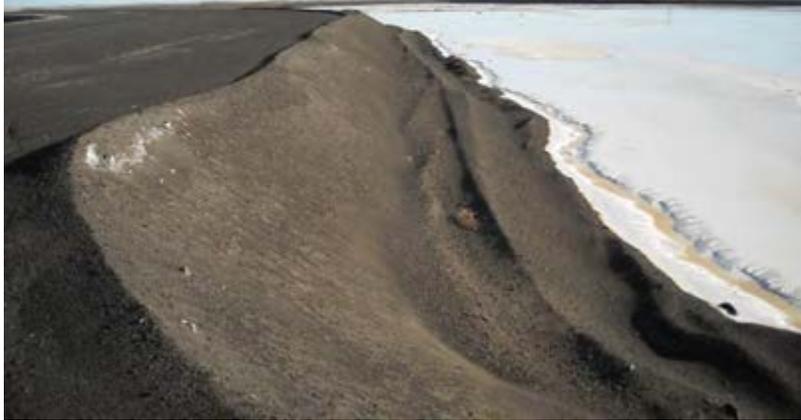
Northwest Corner
Ash Pond 92

Upstream Bottom Ash Slope and Sludge (1 of 4)

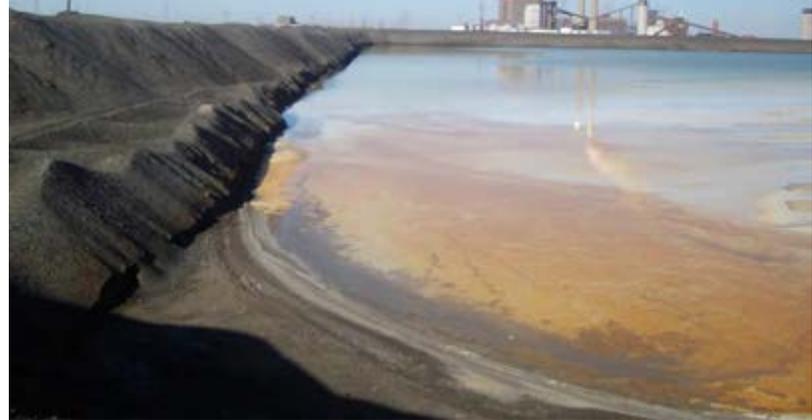
South Side
Ash Pond 92

Upstream Bottom Ash Slope and Sludge (2 of 4)

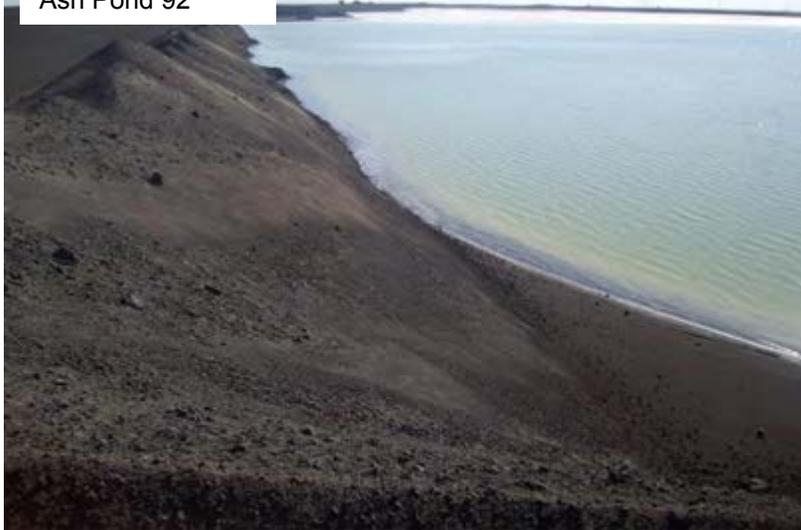
North Side
Ash Pond 92

Upstream Bottom Ash Slope and Sludge (3 of 4)

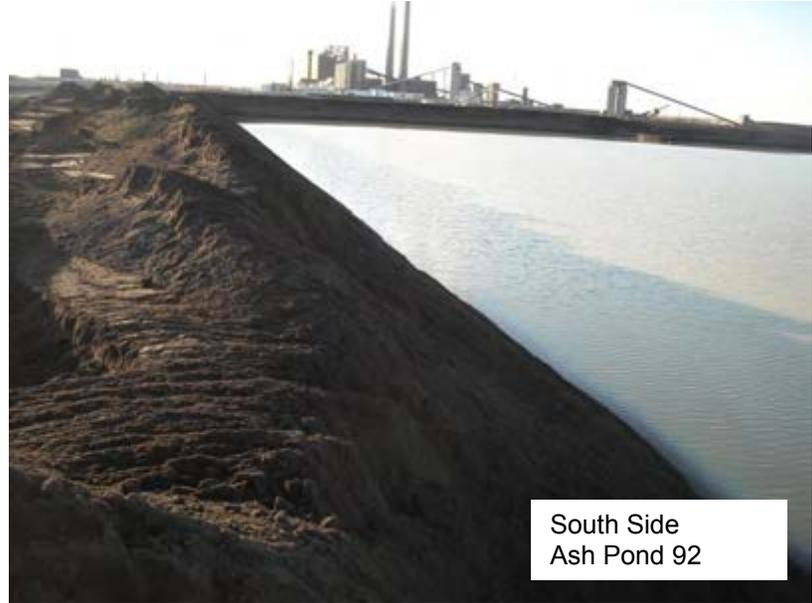
South Side
Ash Pond 92

Upstream Bottom Ash Slope and Sludge (4 of 4)

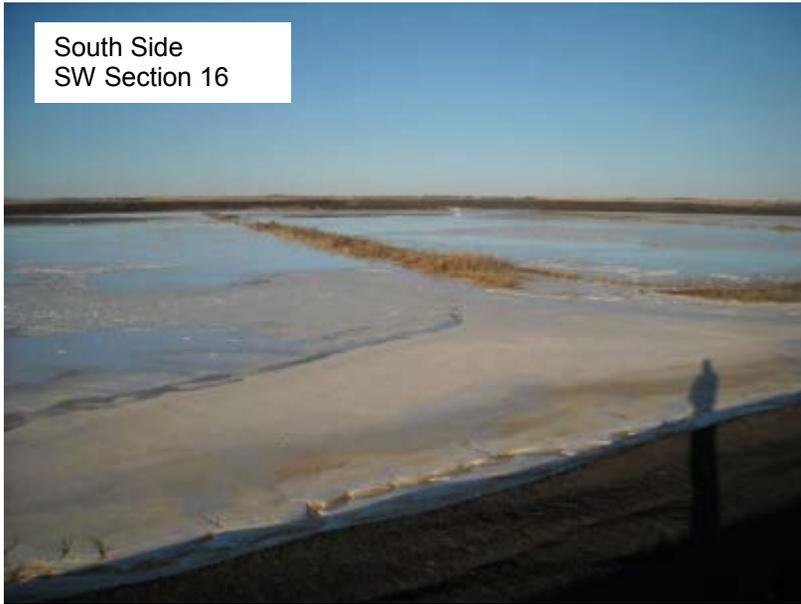
South Side
SW Section 16

FGD Sludge (1 of 2)

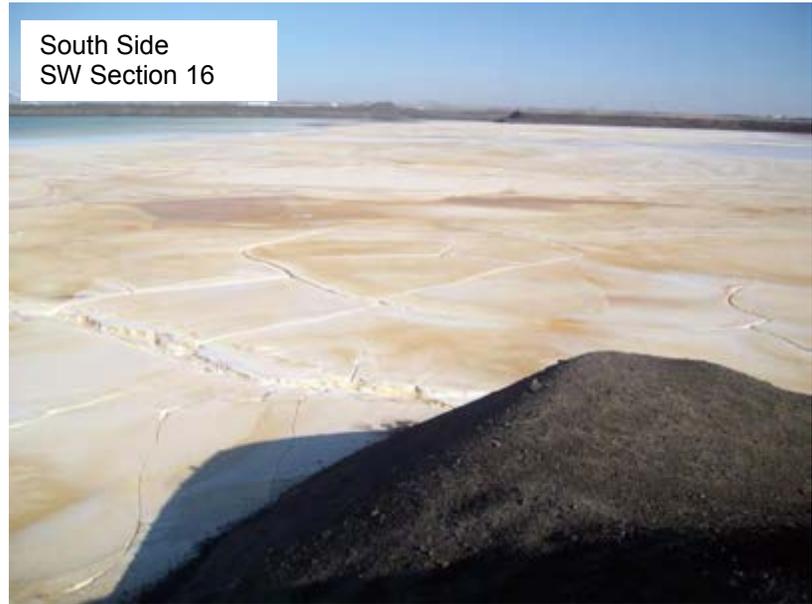
South Side
SW Section 16

FGD Sludge (2 of 2)

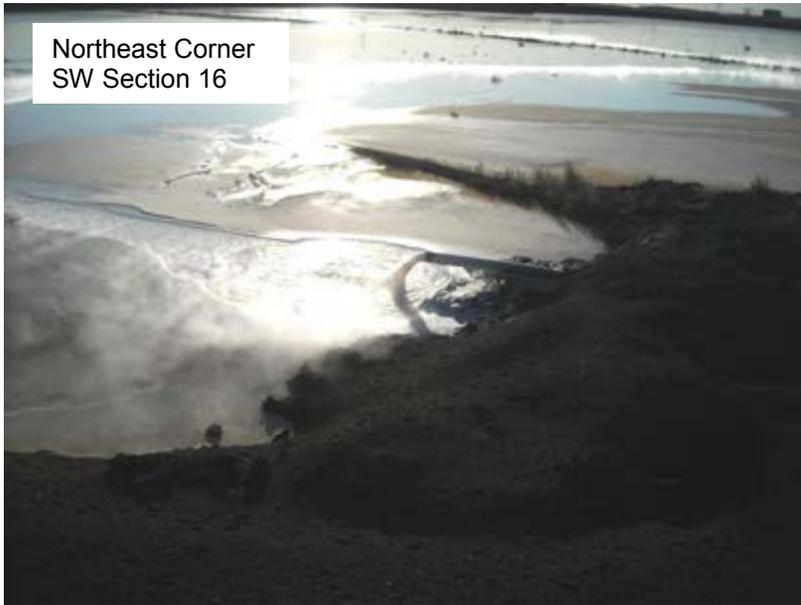
Northeast Corner
SW Section 16

FGD Sludge Inflow (1 of 2)

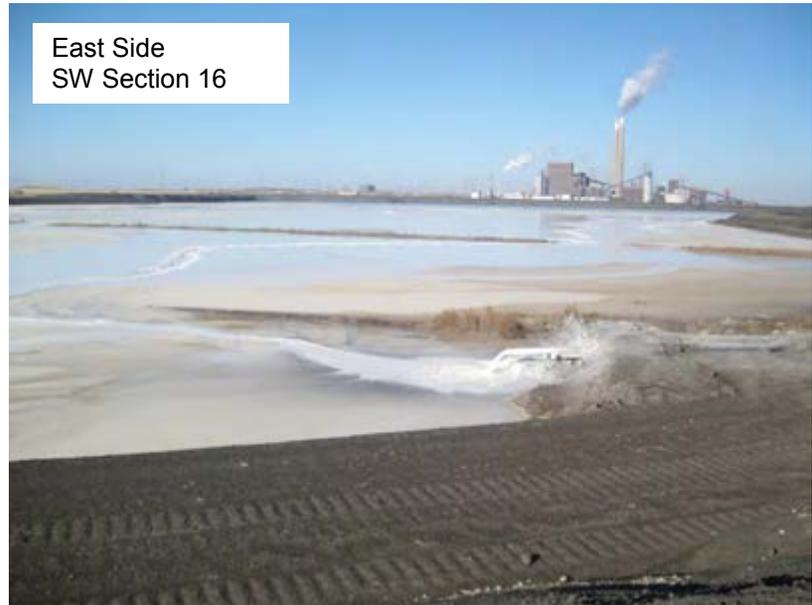
East Side
SW Section 16

FGD Sludge Inflow (2 of 2)

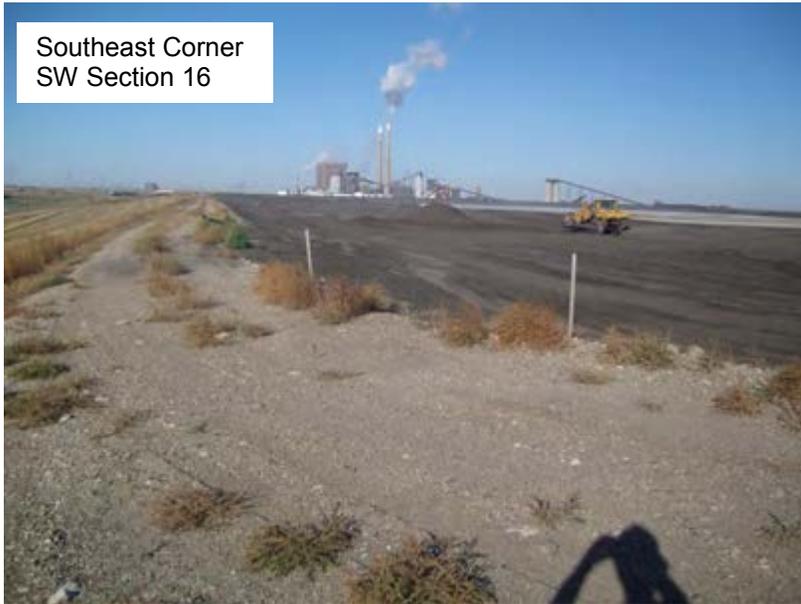
Southeast Corner
SW Section 16

Crest of Facility – Southeast Corner (looking west)

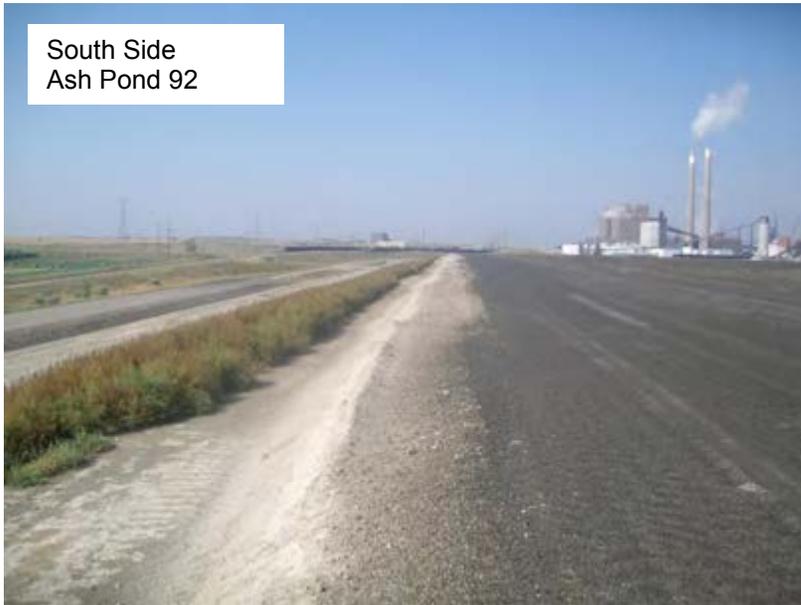
South Side
Ash Pond 92

Crest of Facility – South Side (looking west)

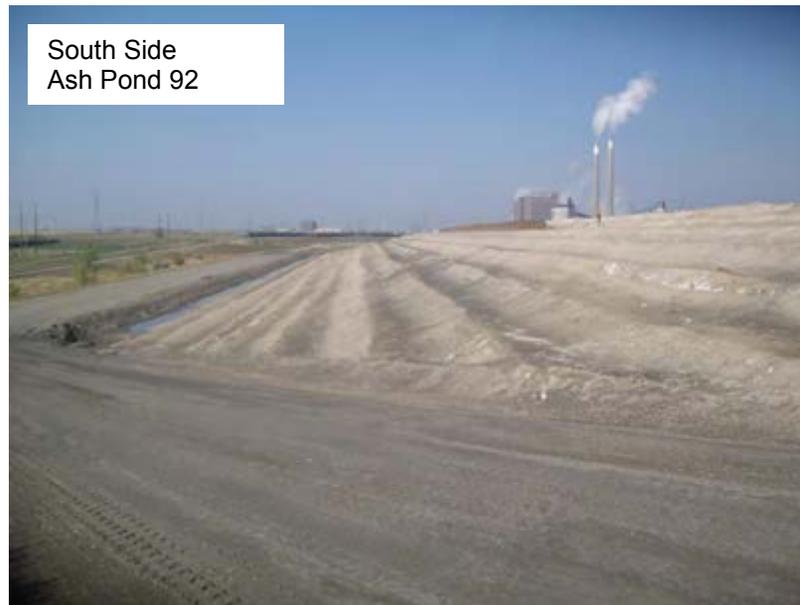
South Side
Ash Pond 92

Fly Ash Exterior Slope 2 of 3 – South Side (looking west)

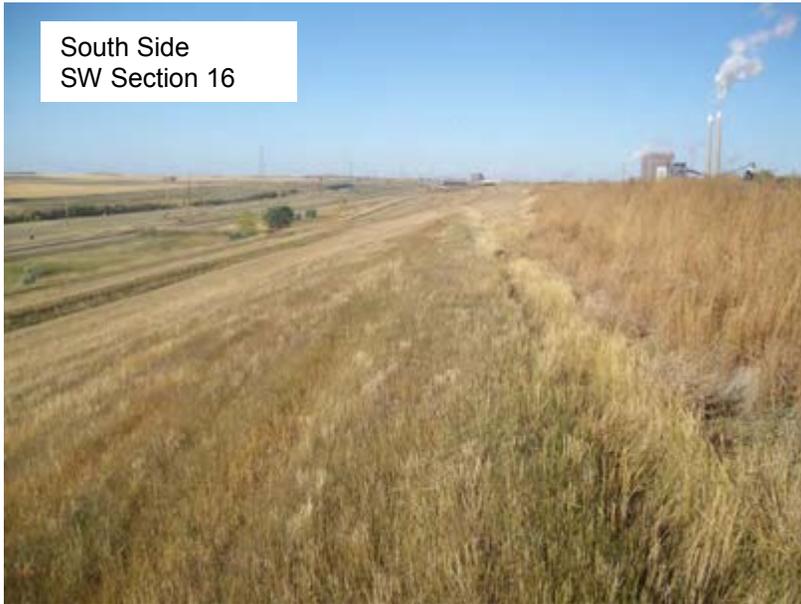
South Side
SW Section 16

Downstream Slope – Southeast Side (looking west)

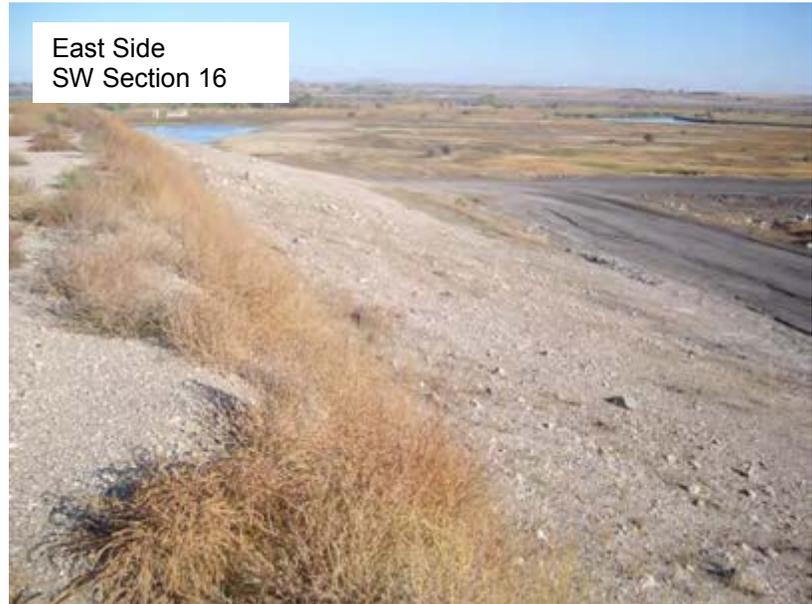
East Side
SW Section 16

Downstream Slope – East Side (looking north)

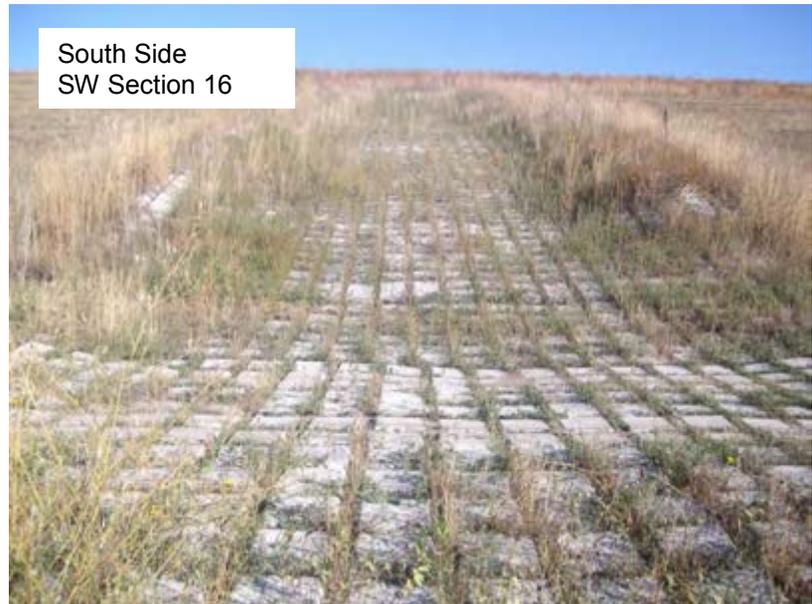
South Side
SW Section 16

Outfall Drainage Tiles – South Side (looking upstream)

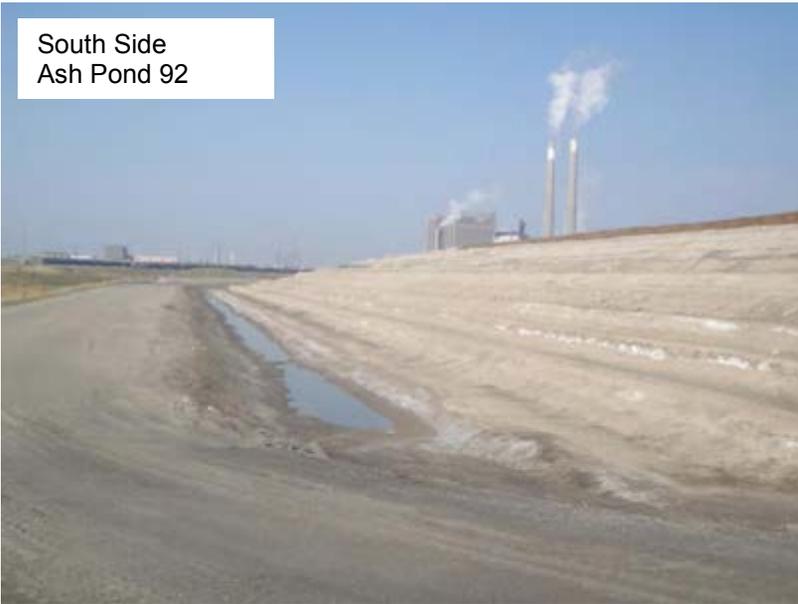
South Side
Ash Pond 92

Toe of Slope Ditch Below Fly Ash Shell 1 of 2 – South Side
(looking west)

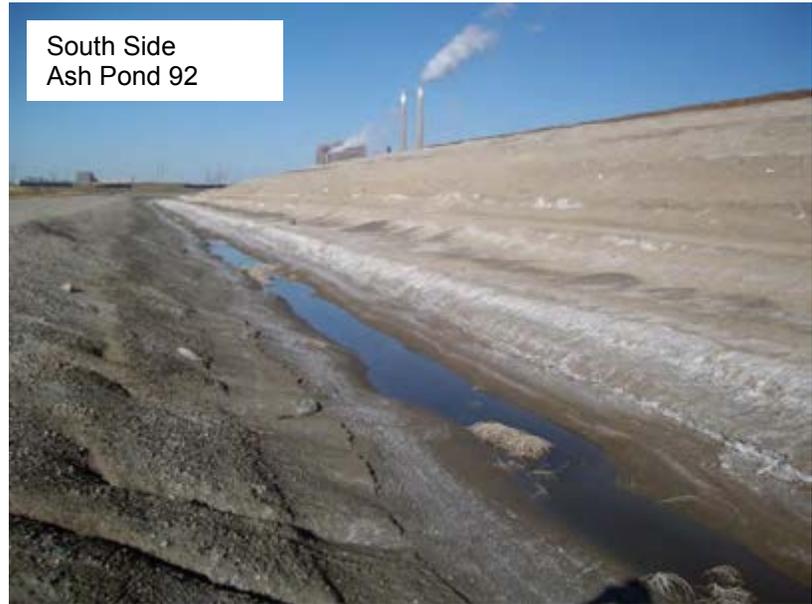
South Side
Ash Pond 92

Toe of Slope Ditch Below Fly Ash Shell 2 of 2 – South Side
(looking west)

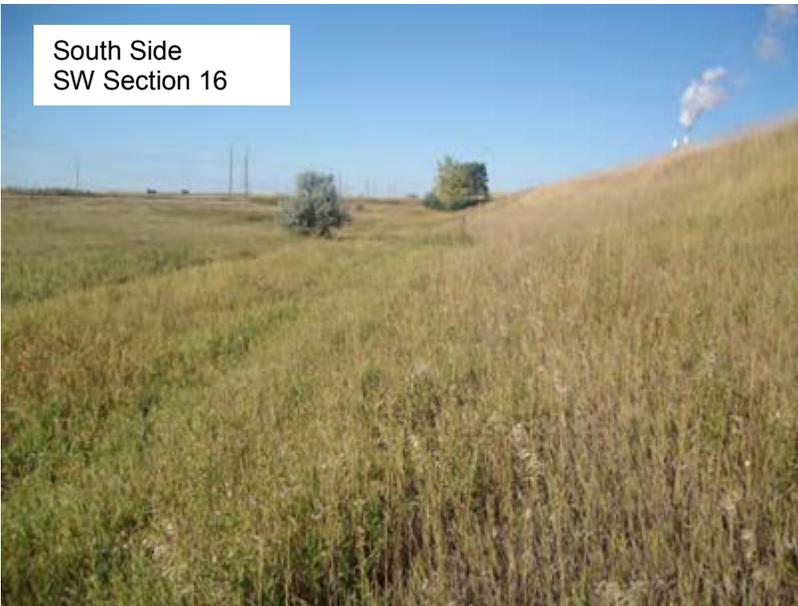
Toe of Slope – South Side SW Section 16 (looking west)

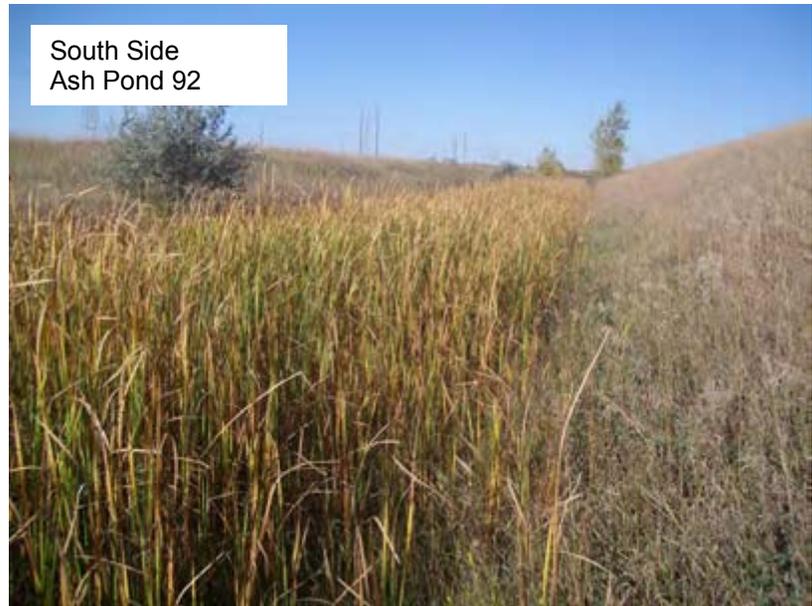
Toe of Slope – South Side Ash Pond 92 (looking west)

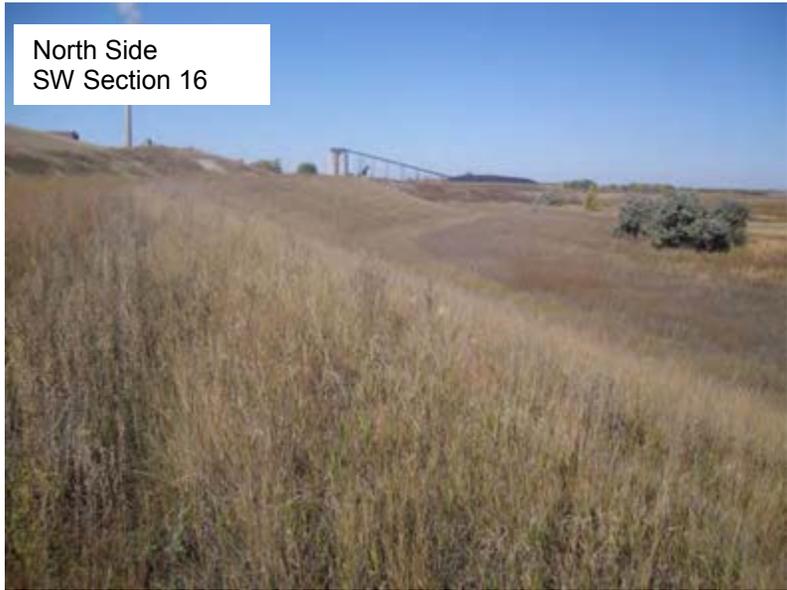
Toe of Slope – North Side SW Section 16 (looking west)

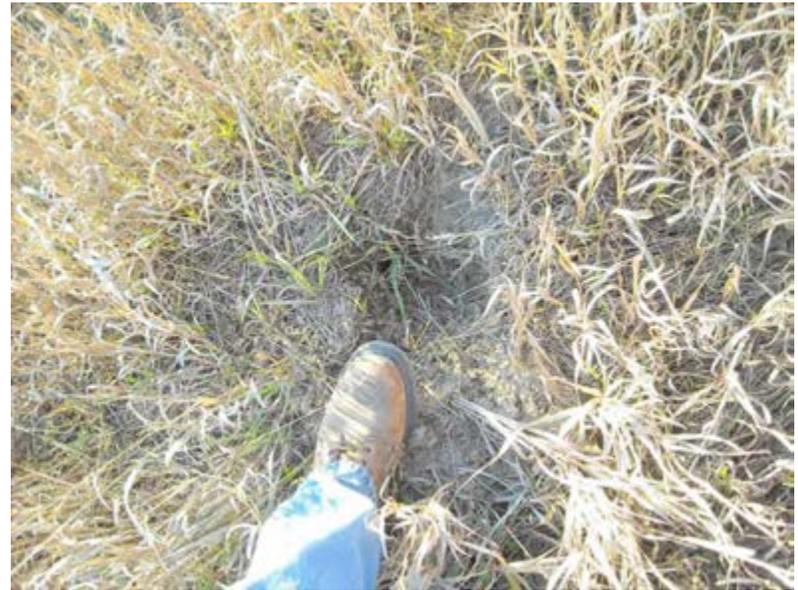
Animal Burrow

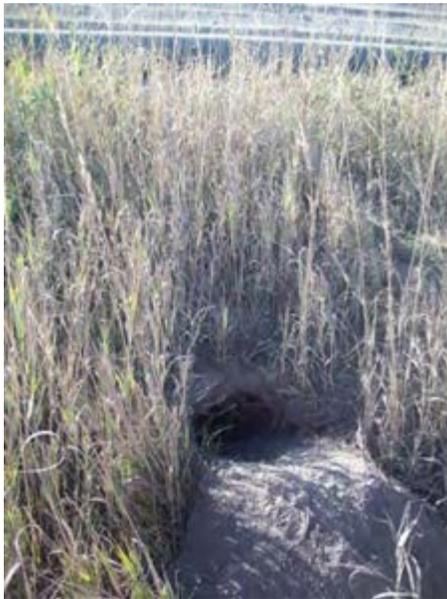
Animal Burrow
