**COAL ASH IMPOUNDMENT
SITE ASSESSMENT FINAL REPORT**

**Coal Creek Station
Great River Energy
Underwood, North Dakota**

KLEINFELDER PROJECT NUMBER 118953-1

October 31, 2012

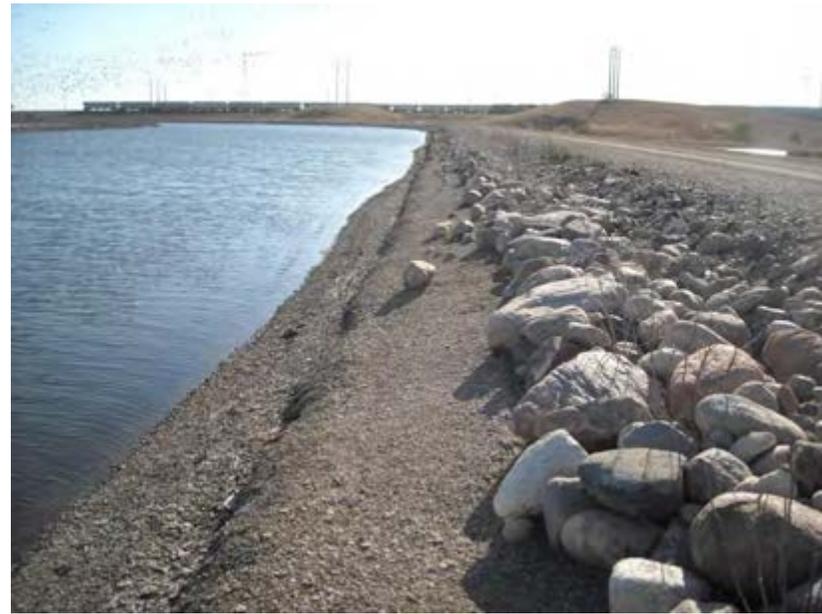
Riprap and Fly Ash Upstream Slope Protection

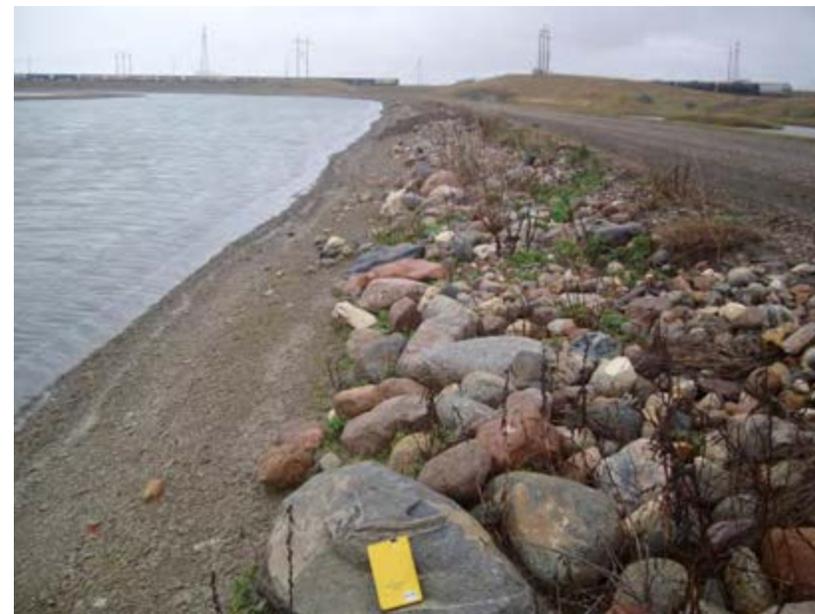
Riprap and Cemented Fly Ash on Upstream Slope (west side)

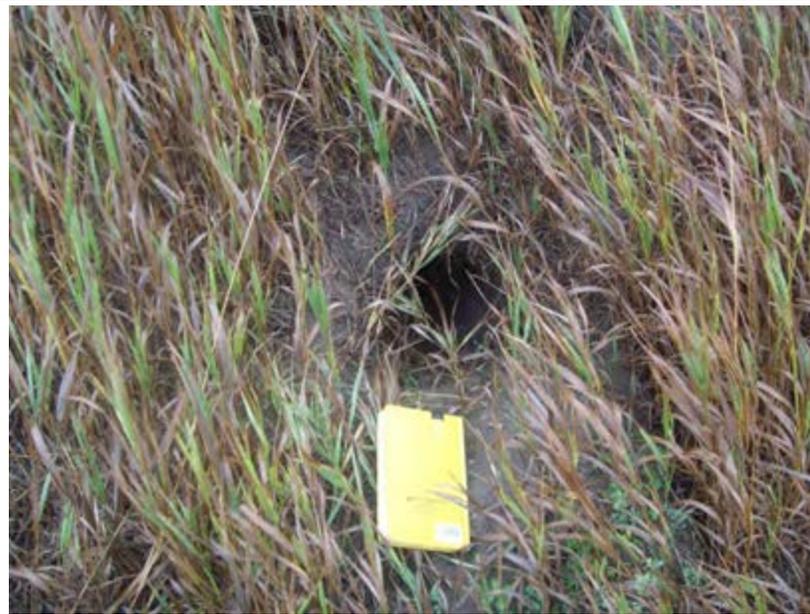
Small Animal Burrow
