**COAL ASH IMPOUNDMENT
SITE ASSESSMENT DRAFT REPORT**

**Stanton Station
Great River Energy
Stanton, North Dakota**

KLEINFELDER PROJECT NUMBER 118953-2

May 10, 2012

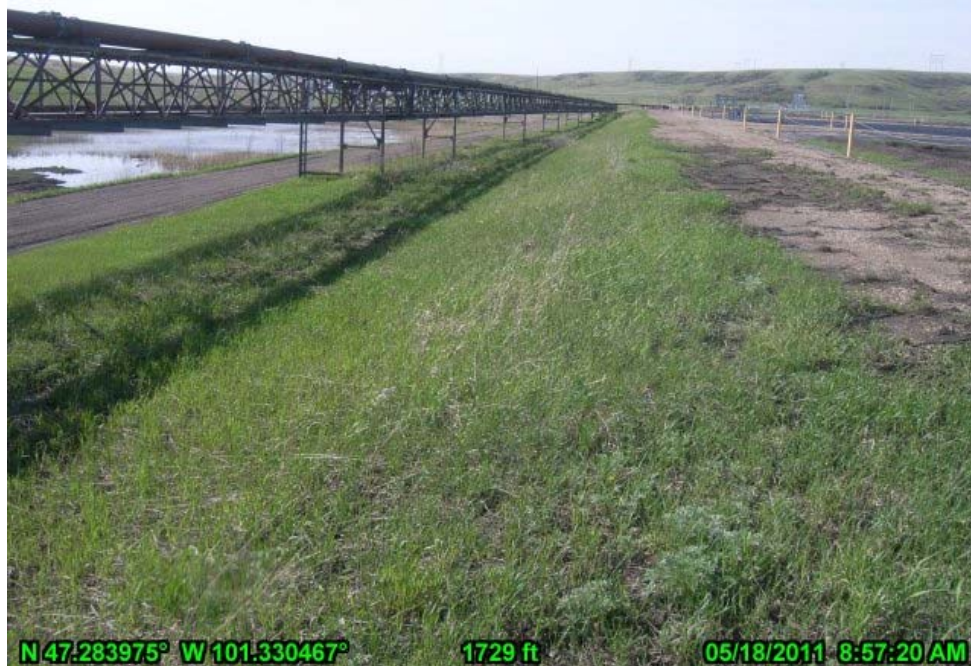
- The impoundment crest also serves as a gravel road.
- No major depressions, erosion, or rutting was noted on the impoundment crest.
- Transecting the crest near the northeast corner with minimal cover are two bottom ash sluice lines. Photo 1 shows these sluice lines.
- Sluice pipe structure support columns for the pipeline that runs along the east lower bench of the North Ash Pond and the Center Drainage Pond rest on small concrete foundation pads that penetrate the crest in multiple locations, as shown in photo 2.

2-Landside View of East Embankment Modification and Sluice Pipes (looking south)

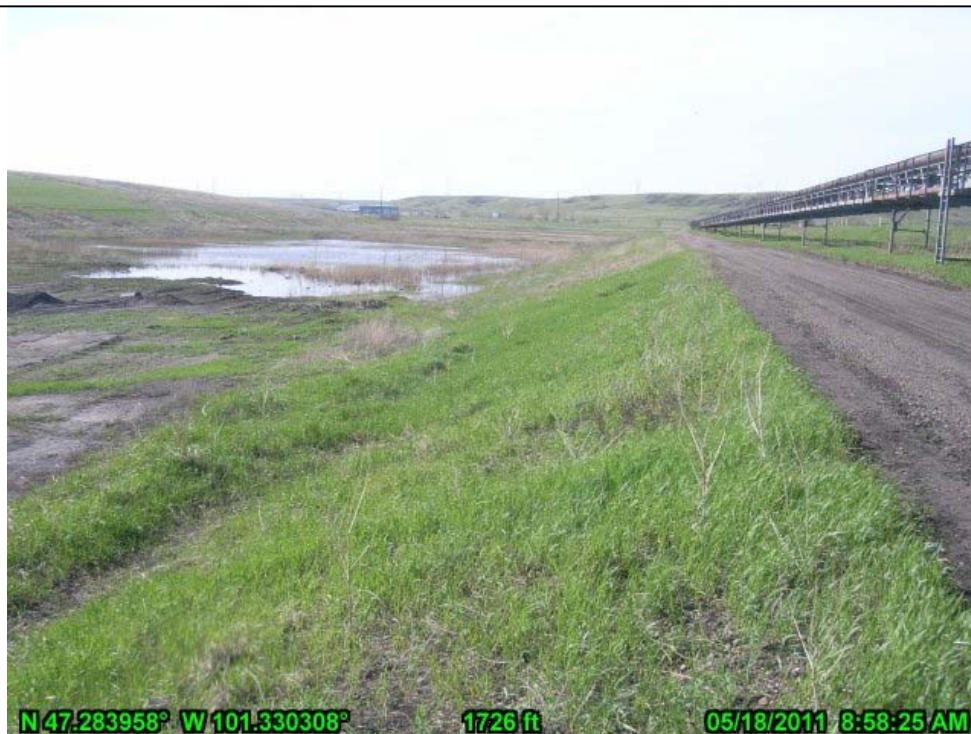
3-Landside View of Original (Lower) East Embankment (looking south)

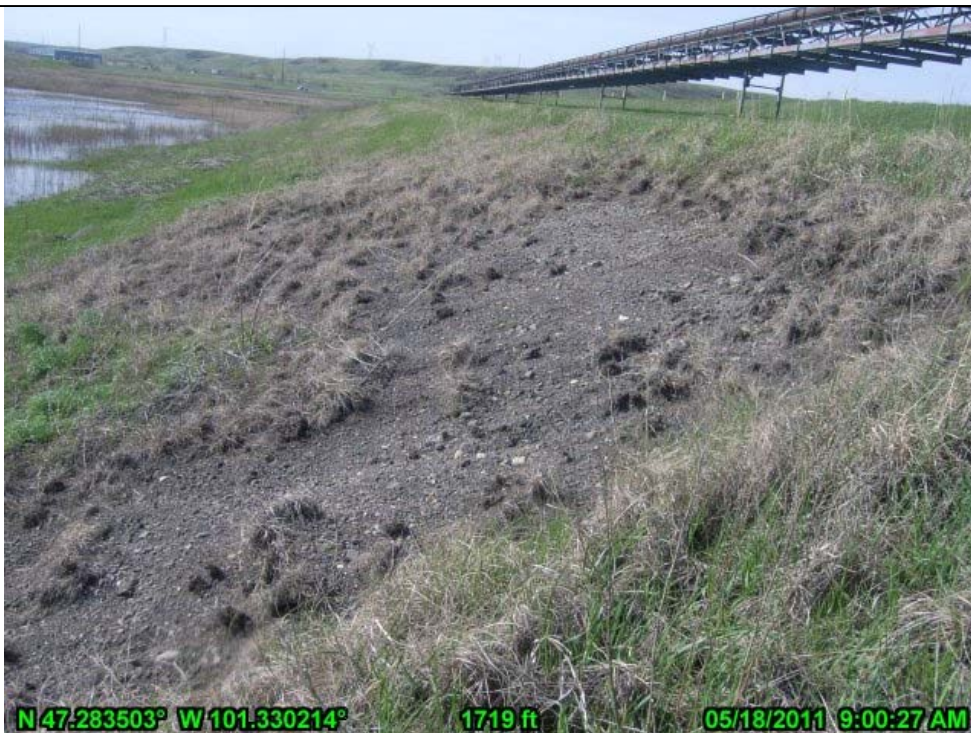
4-Landside Erosion on Original East Embankment
from Sluice Pipe Blow-out (looking south)

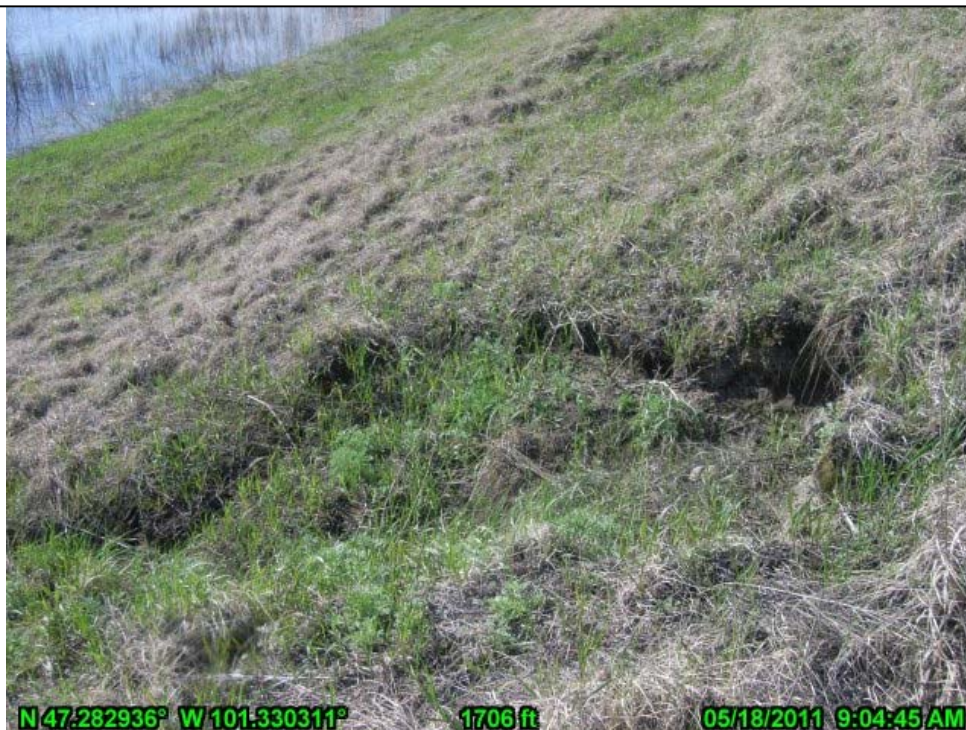
- The slopes were well vegetated and appeared stable.
- The east embankment has a small scarp feature on the slope. While that condition does not appear to present an imminent threat to the embankment stability, the area should be repaired and revegetated to prevent progressive failures.
- A few animal burrows were noted.

5-Scarp on Original Landside East Embankment (looking southwest)

1. Repair embankment scarps and sloughs by October 31, 2012.
2. Maintain a log of maintenance and other activities at the impoundments and supporting facilities by October 31, 2012.
3. Update the Operation and Maintenance (O&M) Manual for the impoundments and the facility by October 31, 2012.
4. Perform video assessments of culvert piping by October 31, 2012.

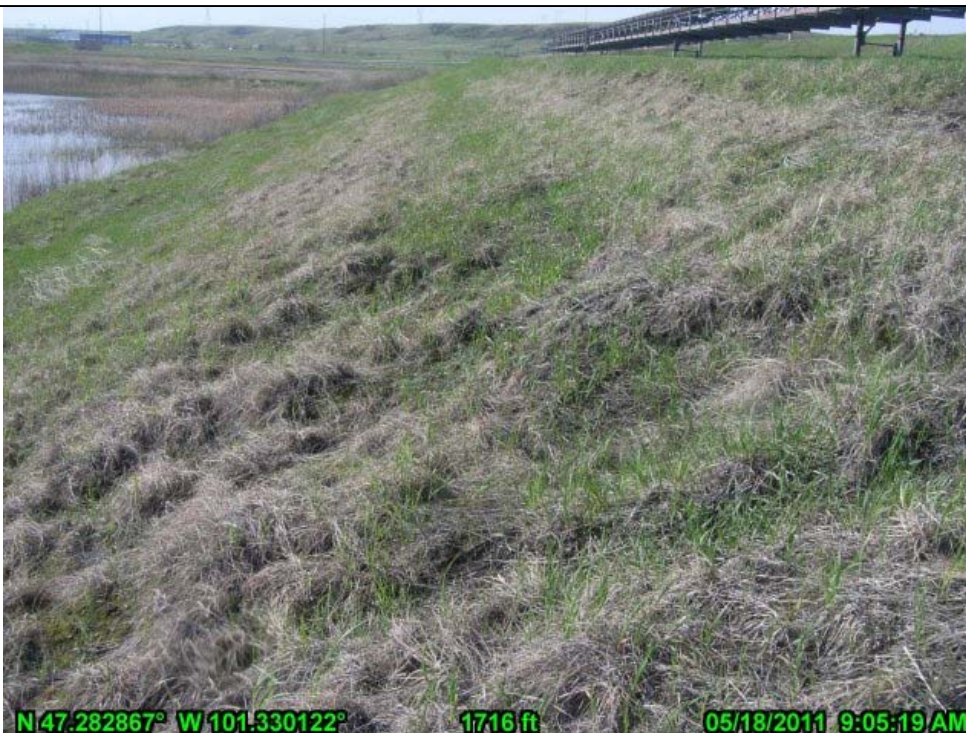
6-Surface Erosion on Original Landside East Embankment (looking south)

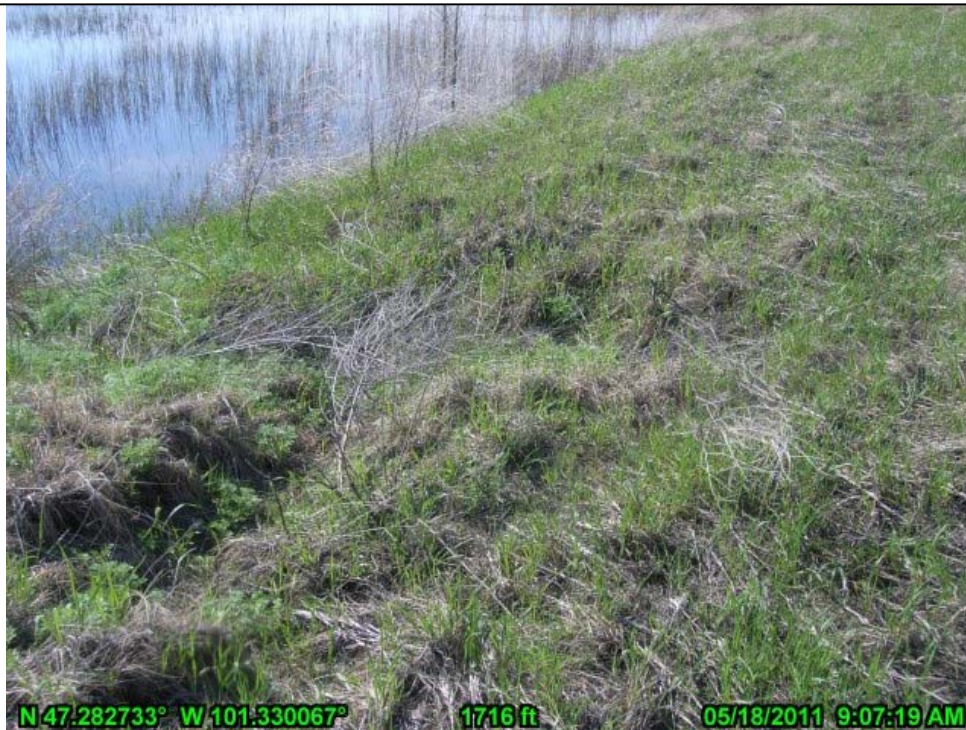
7-Erosion on Original Landside East Embankment (looking southeast)

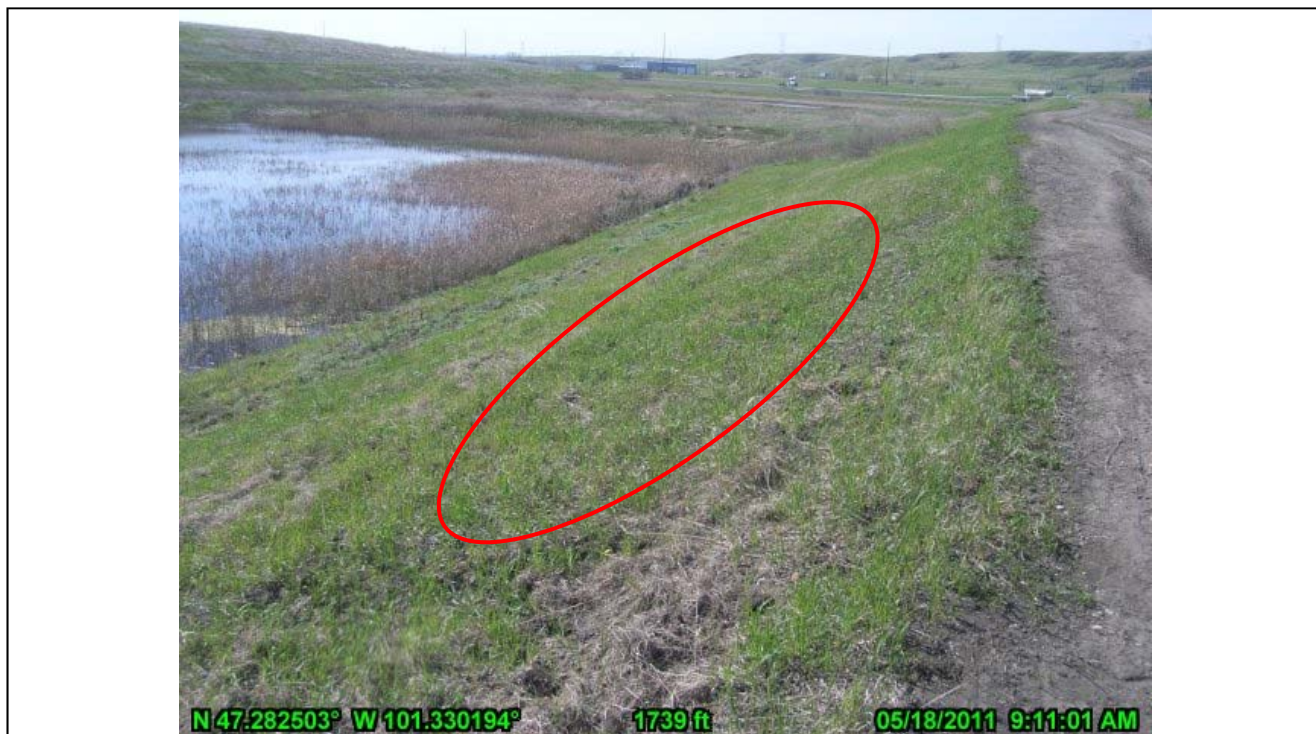
9-Bulging of Original Landside East Embankment (looking south)

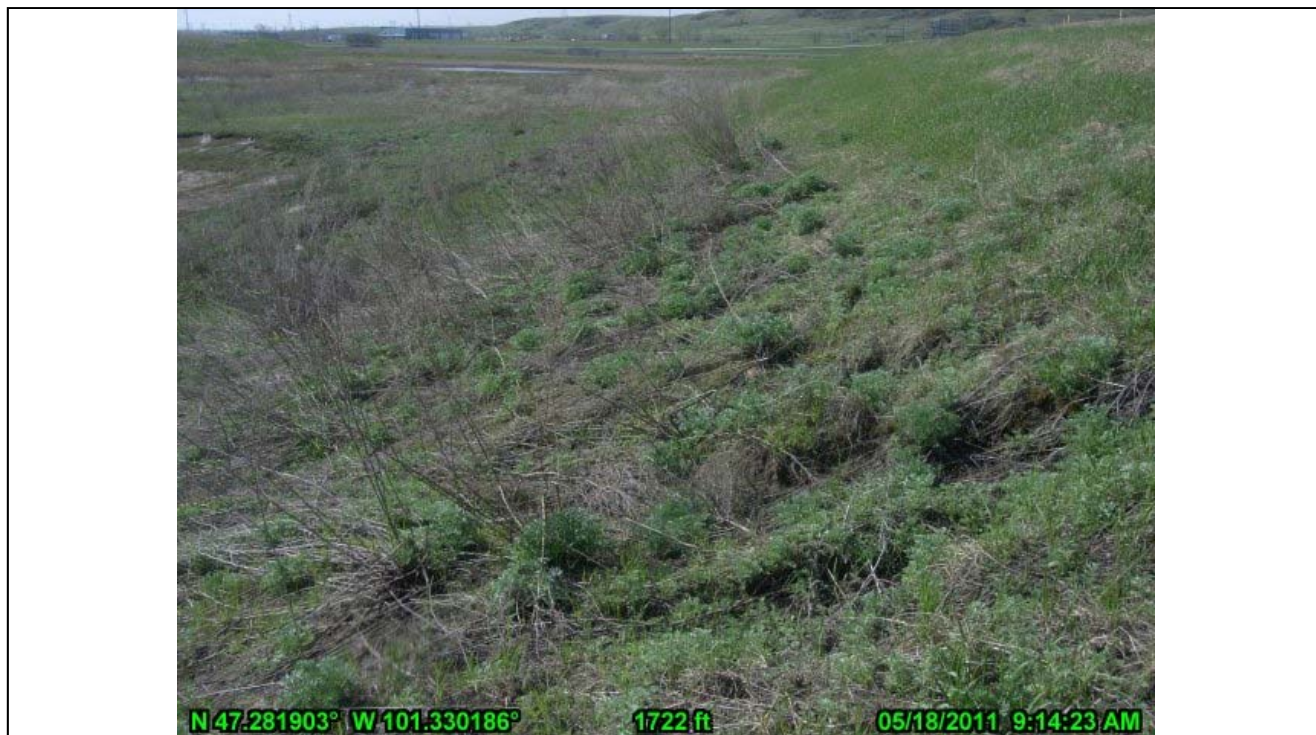
10-Erosion and Vegetation on Slope of Original Landside East Embankment (looking south)

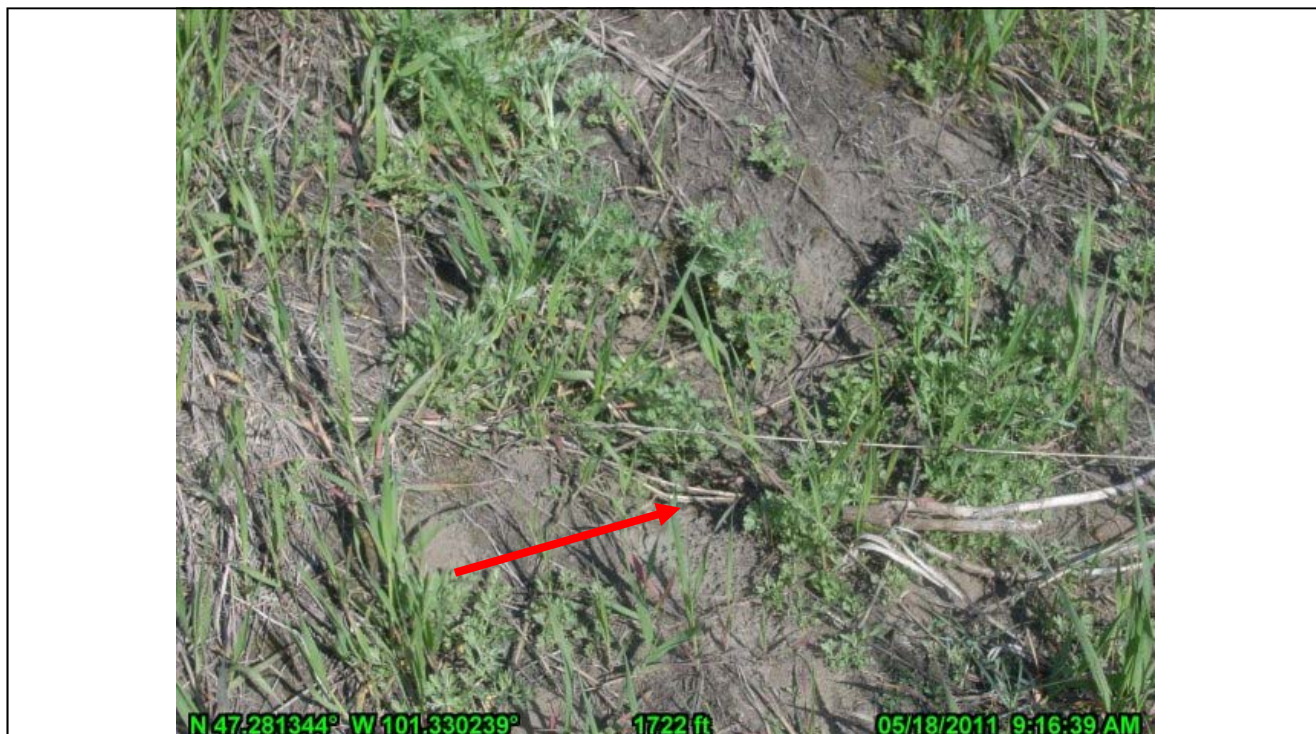
11-Animal Burrow on Landside East Embankment

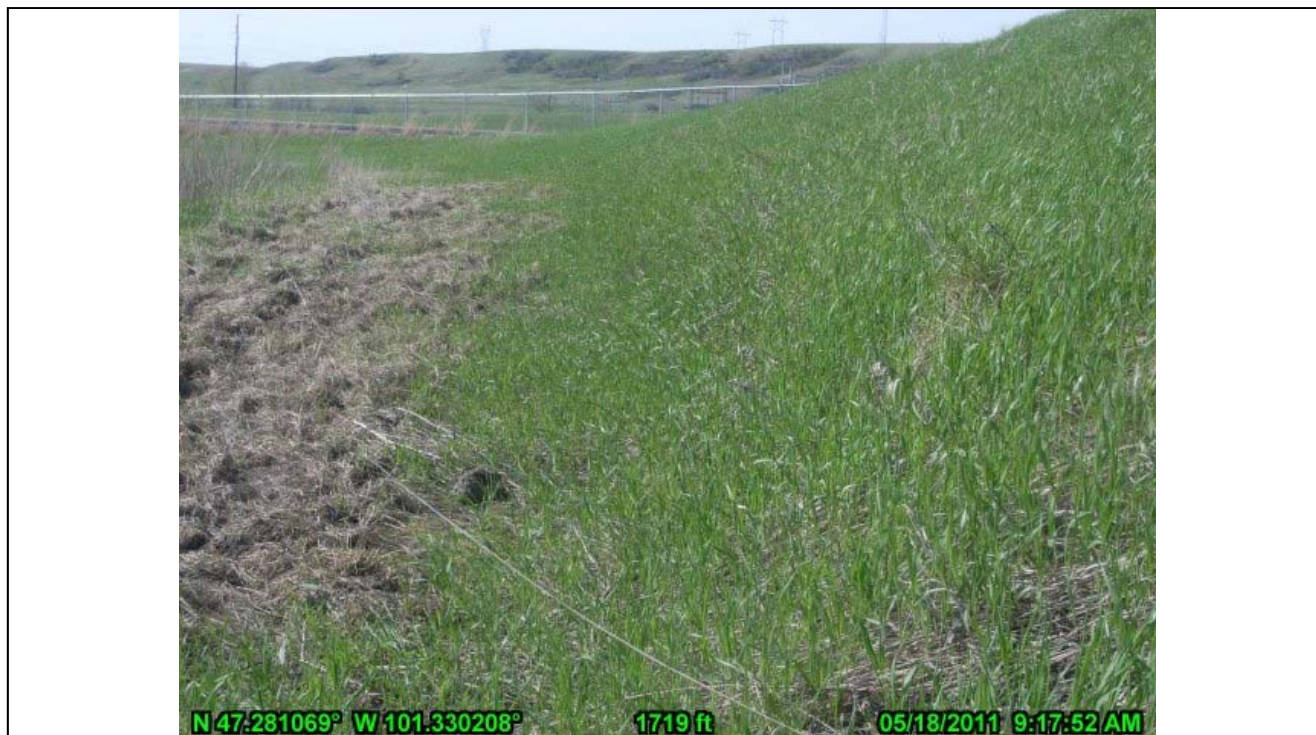
12-Toe of Original East Embankment Over Steepened (looking south)

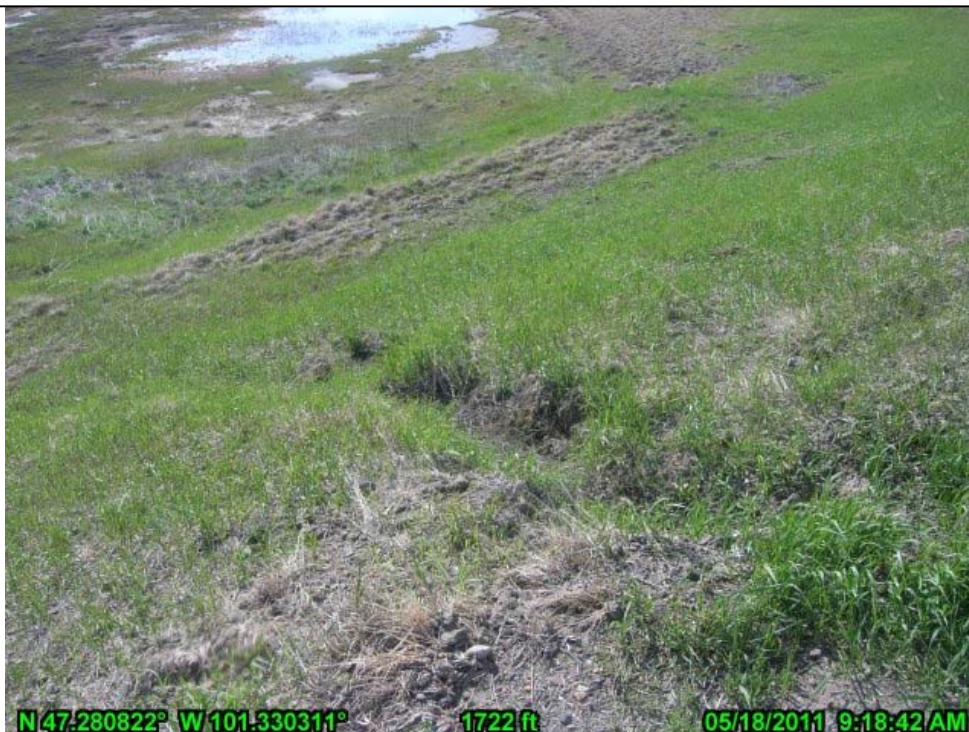
13-Erosion Channel on Original Landside East Embankment (looking east)

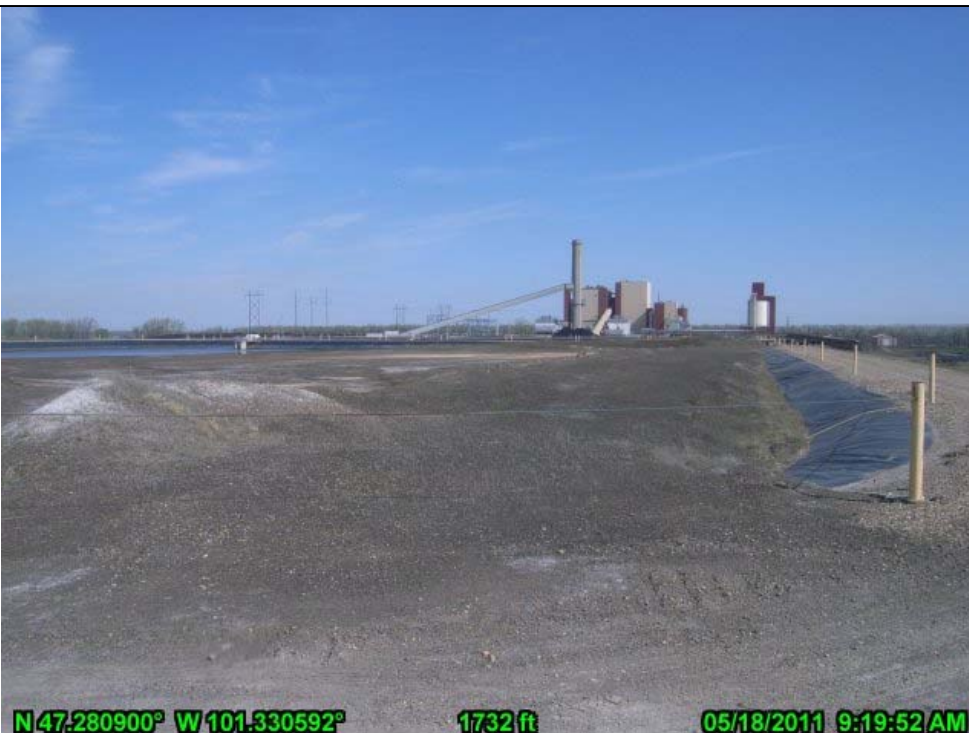
14-South Ash Pond Waterside East Embankment, Not in Use (looking north)

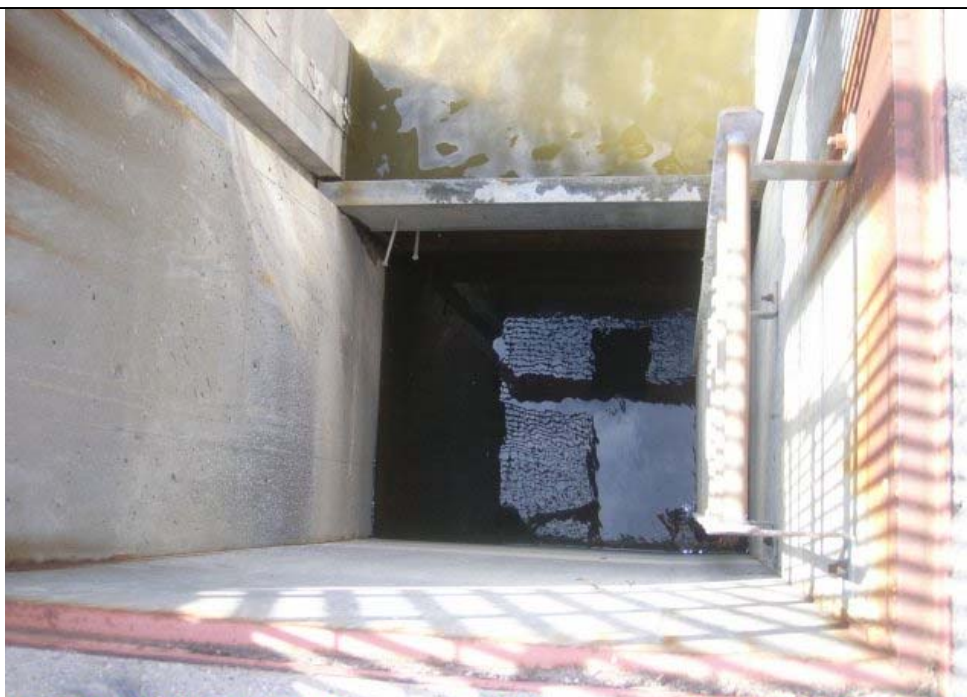
18-South Pond Decant Inlet Structure, Not in Use

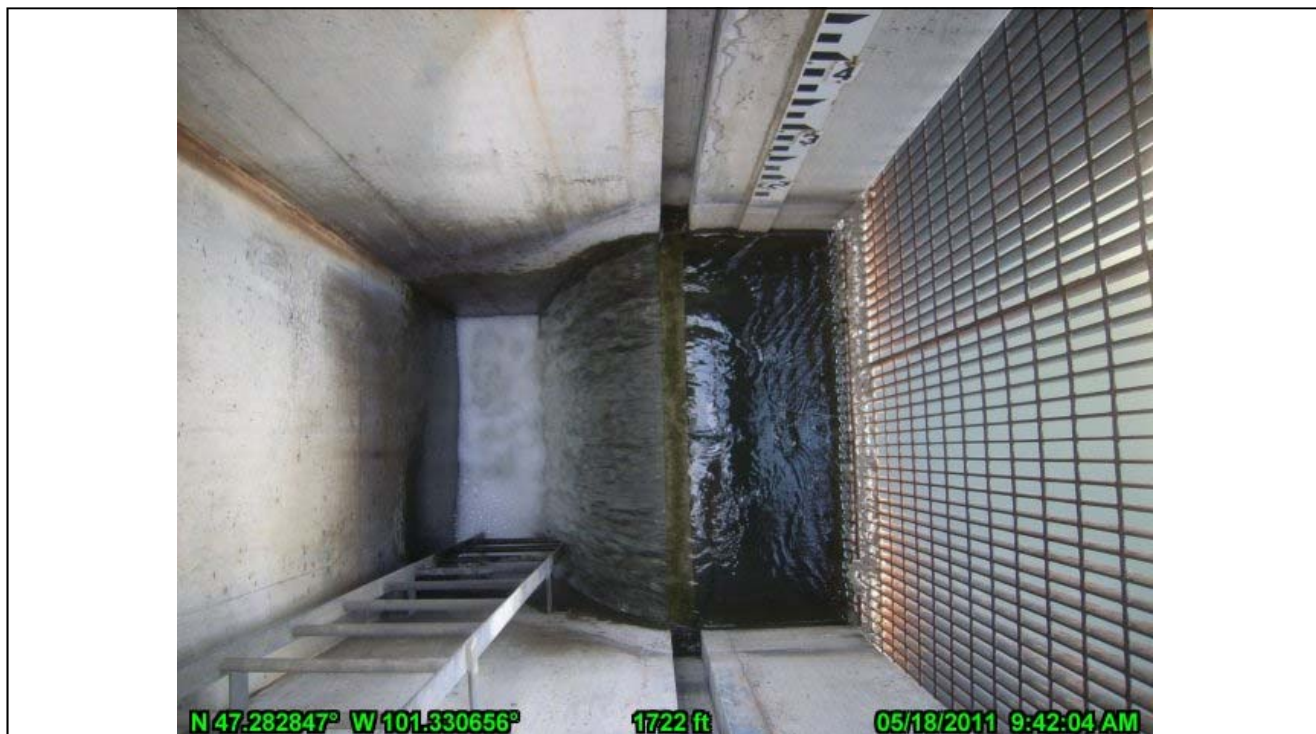
23-Center Pond Outfall Structure and Trashrack

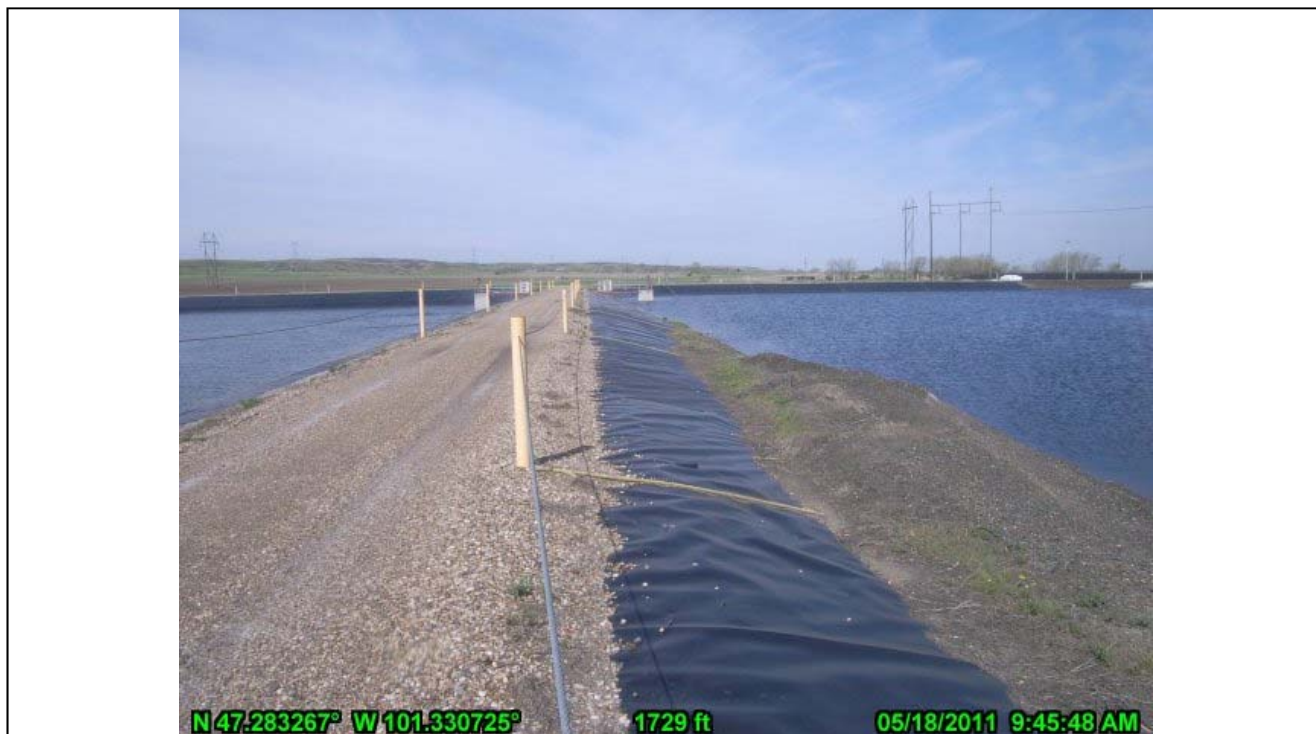
Overall, the upstream slope of the impoundment was in Satisfactory condition. Photos 1, 25, 29, and 30 show the conditions of the upstream slope. Specific observations include:

- The upstream slope is in Satisfactory condition, appears stable, and is in general accordance with the 1994 design report and drawings prepared by Stone & Webster.
- The upstream slope has a geomembrane liner that appears to be in Satisfactory condition above the water surface. The portion of liner below the water surface was not visible and could not be assessed. The liner is free of grasses and woody brush over the entire inside perimeter of the impoundment.
- There is no riprap placed on the upstream slope.

25-Divider Dike Liner on South Side of North Pond (looking west)

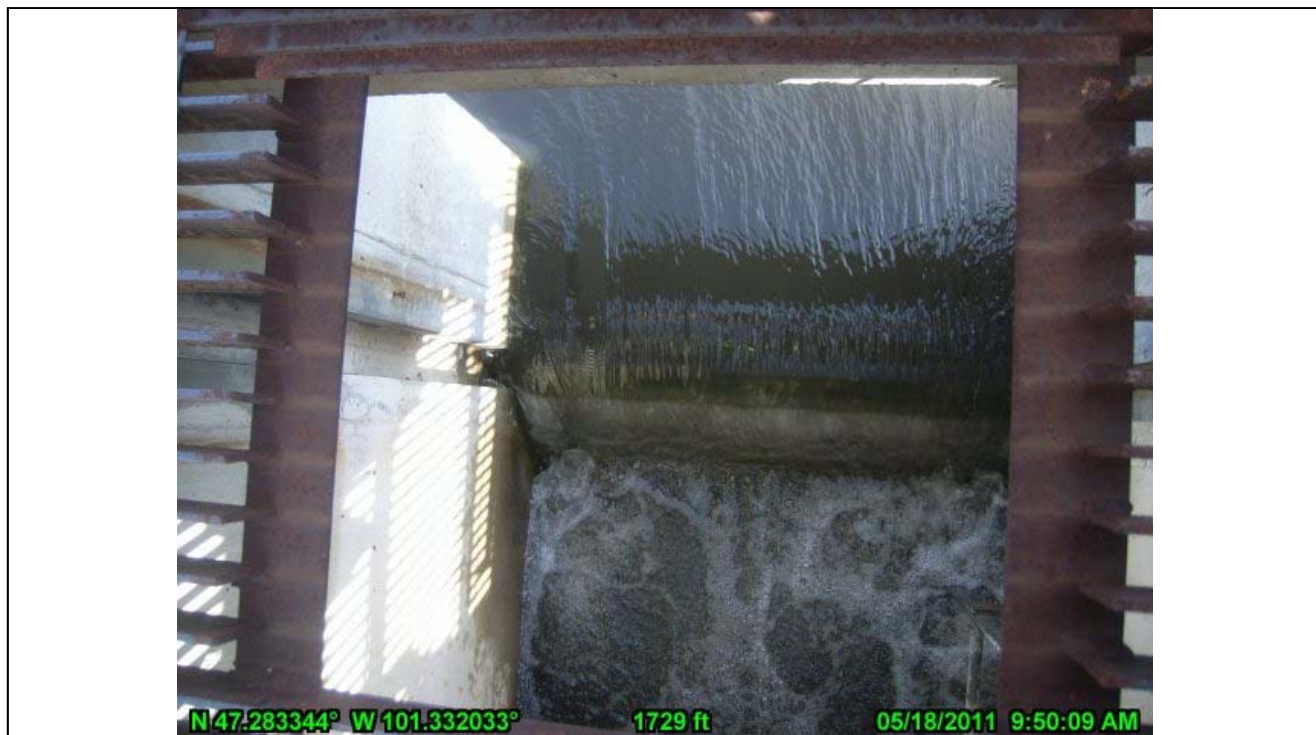
- The intake portion of the outlet pipe was not able to be observed because it was inundated at the time of the assessment.
- The intake tower of the outlet structure had stop logs in place to set the water level, and did not have any trashrack in place (nor did one seem necessary).

26-North Pond Decant Intake with Stop Logs

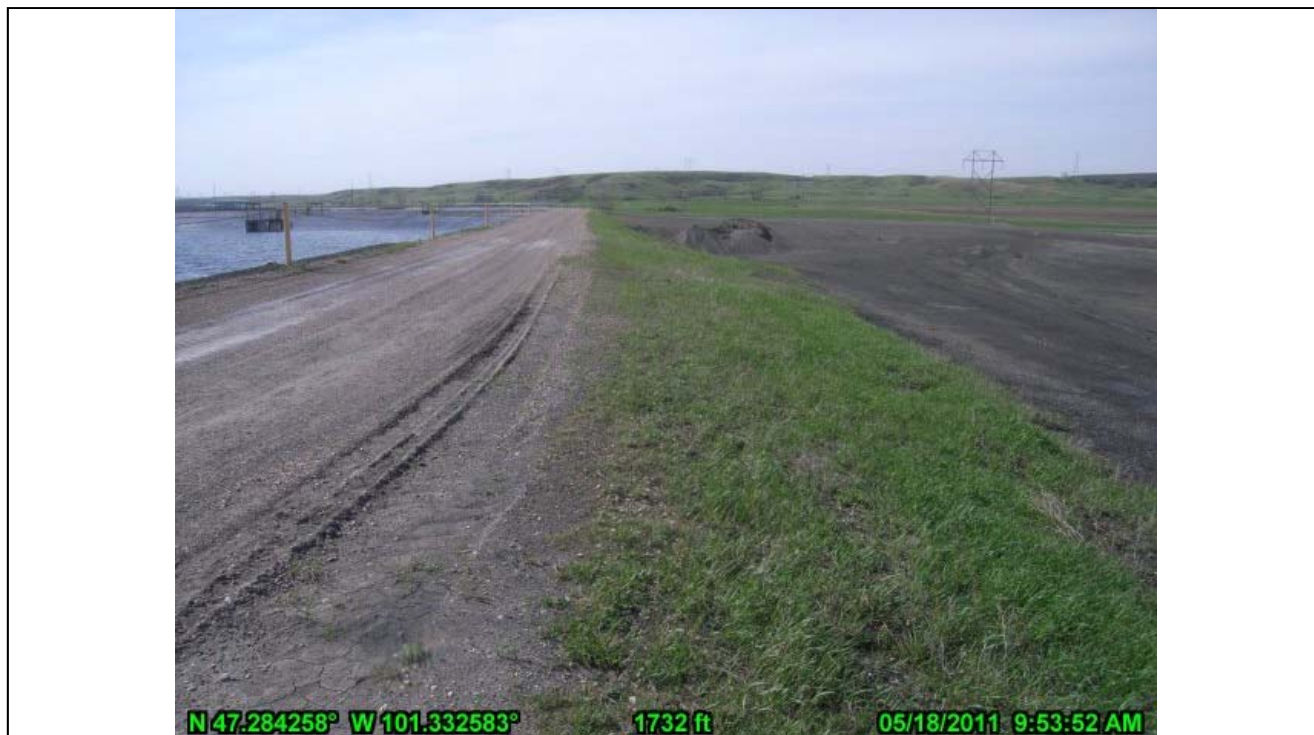
Overall, the crest of the impoundment was in Satisfactory condition. Photos 25, 28, and 29 show the condition of the crest. Specific observations include:

28-Landside of West Embankment (looking south)

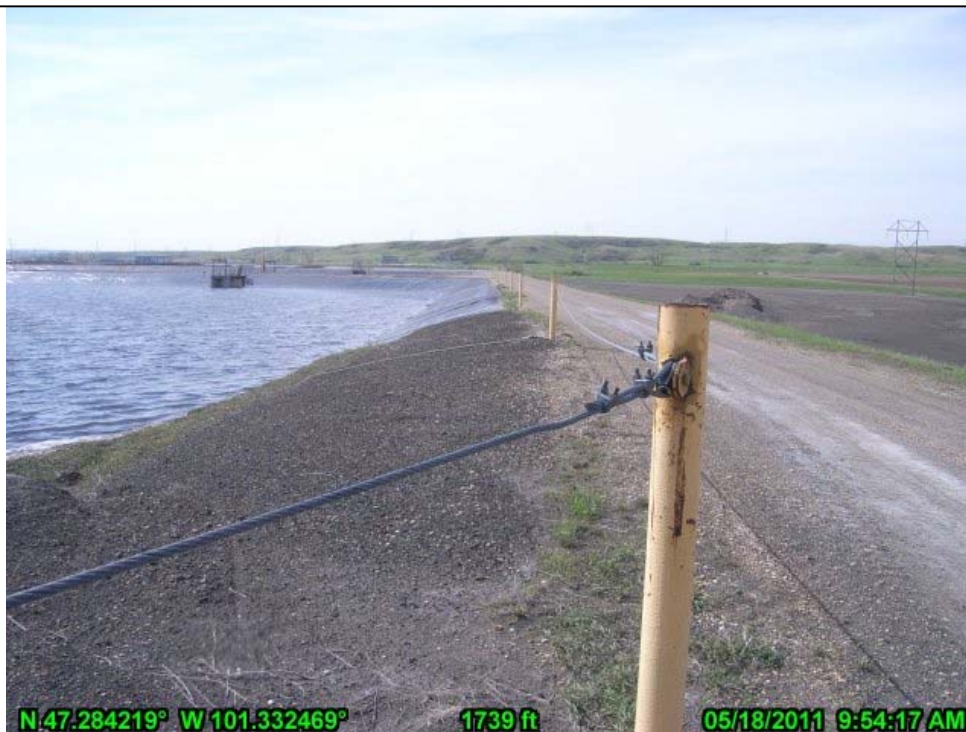
29-North Pond Waterside West Embankment (looking south)

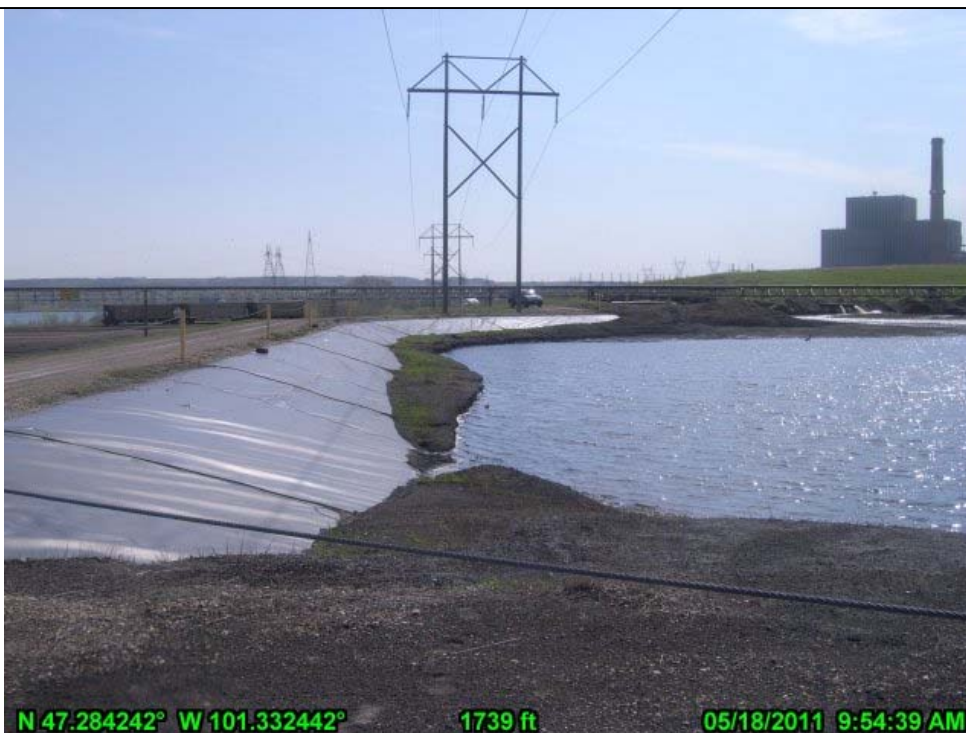
30-North Pond Waterside North Embankment (looking east)

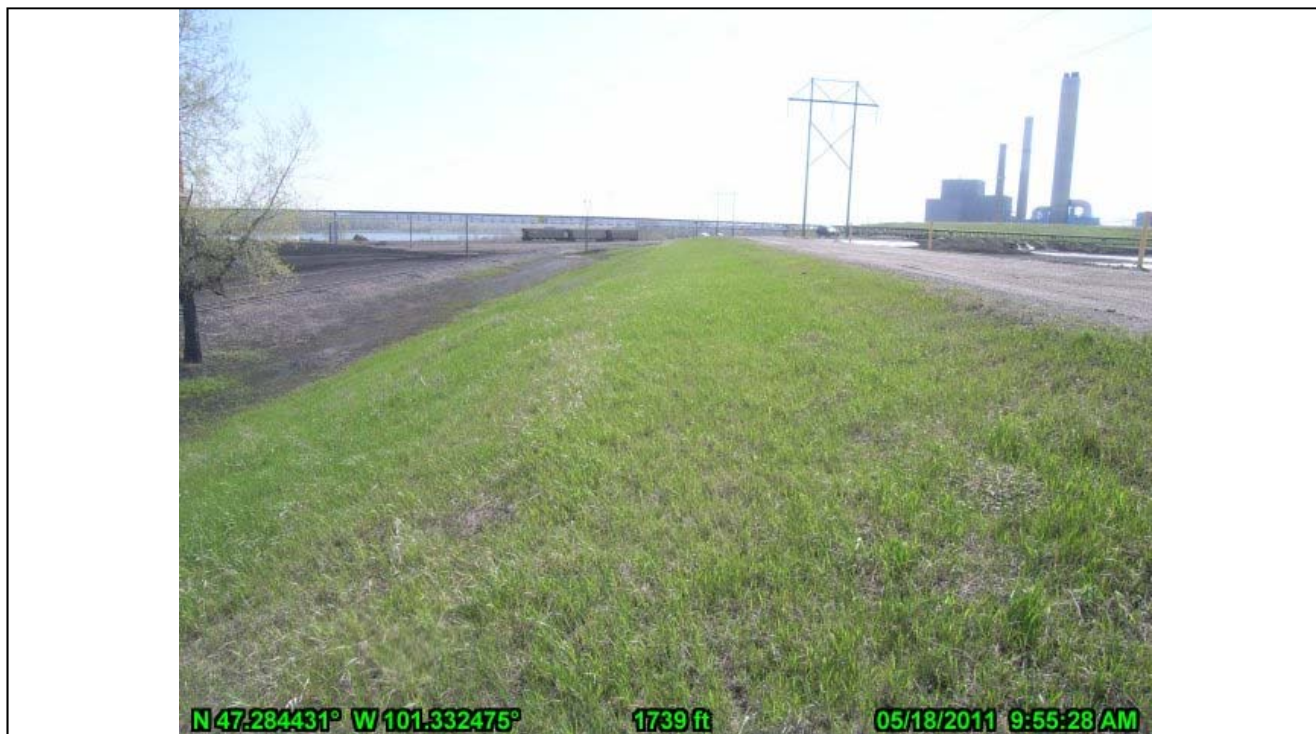
Overall, the downstream slope was in Fair condition. Photos 3, 4, 31, and 32 show the conditions of the downstream slope. Specific observations include:

31-Landside of North Embankment (looking east)

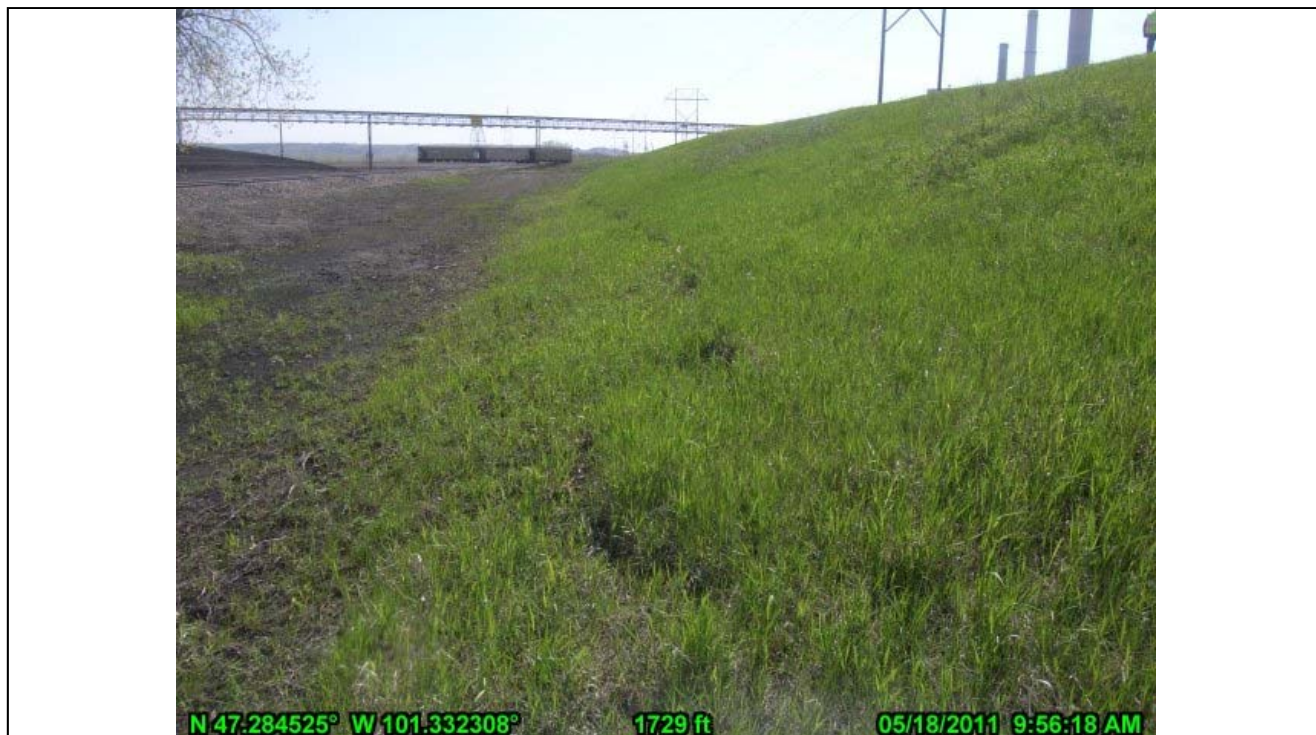
The toe areas of the embankment were in Fair condition. See photos 3, 32, and 33 for the condition of these areas. Key features and observations of these areas include:

32-Approximately 100' Long Scarp Along Toe of North Embankment (looking east)

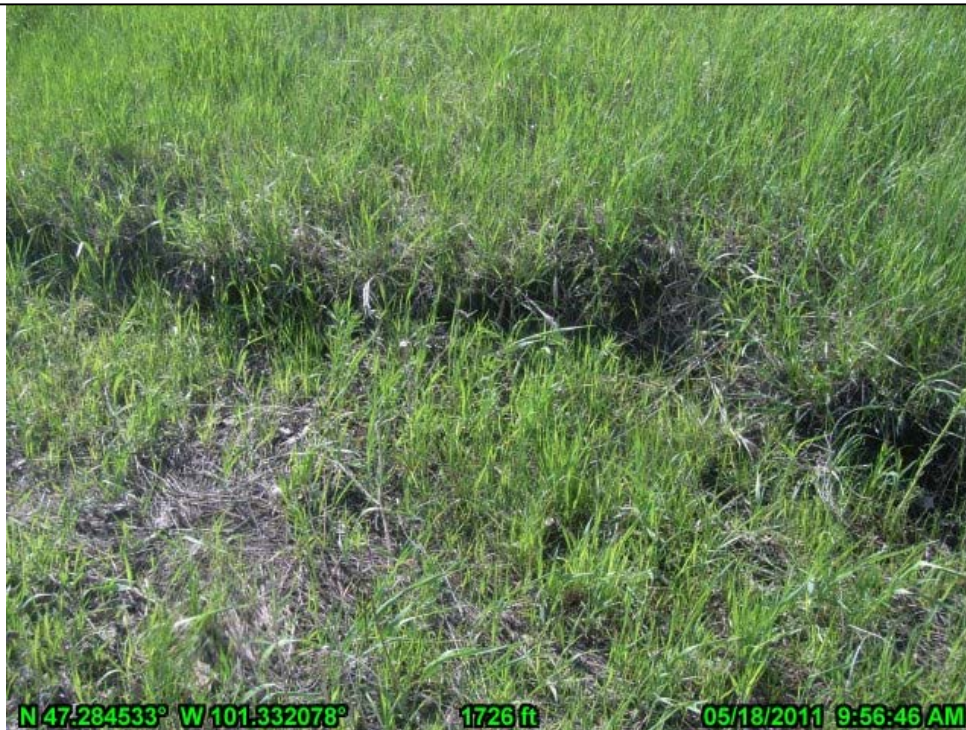
33-Scarp at Toe of North Embankment Approximately 8" Deep

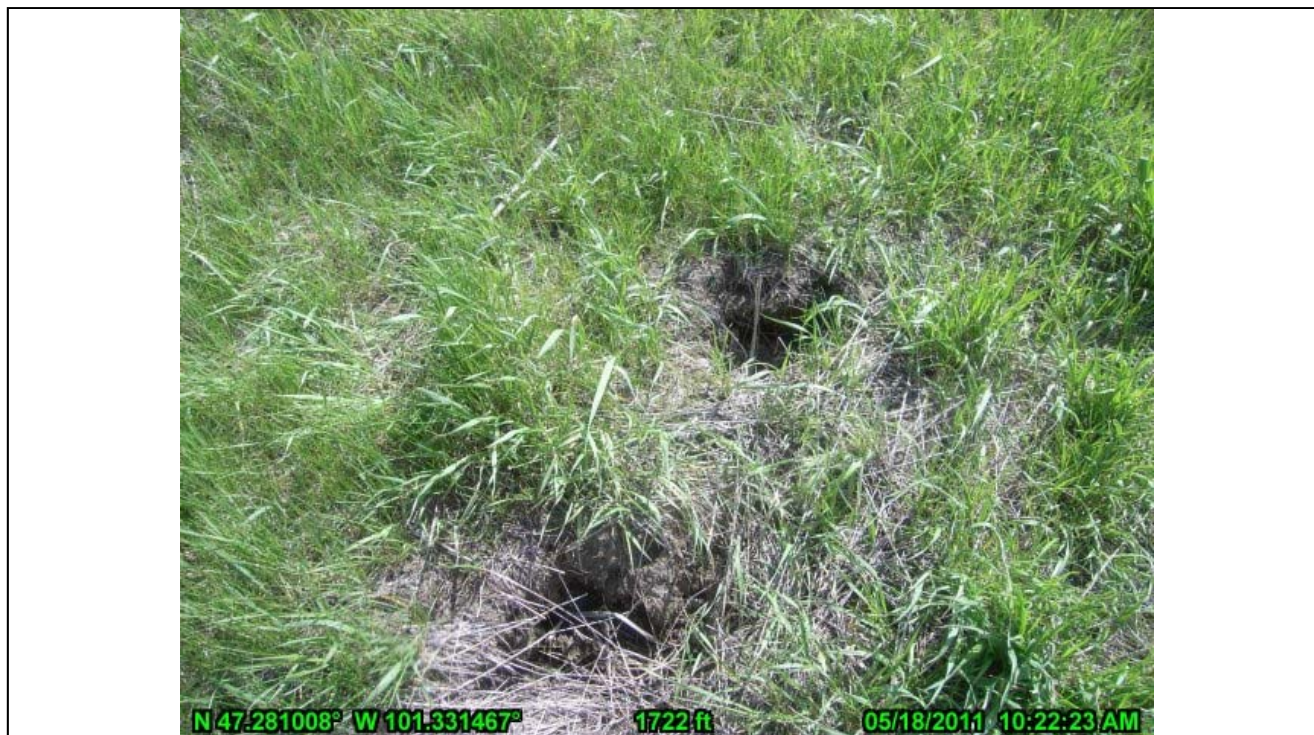
36-Animal Burrows Approximately 6" to 12" Diameter

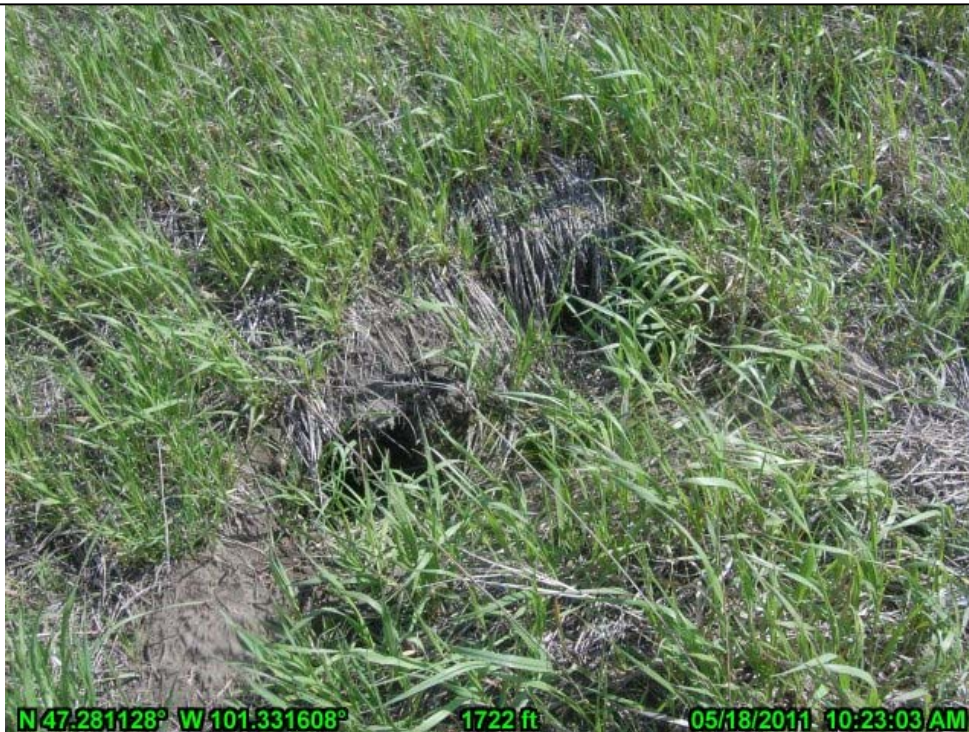
37-Animal Burrows Approximately 6" to 12" Diameter

- Several animal burrows were observed. Some of the burrows were quite large – up to a 10-inch diameter opening. This condition should be remedied with a more aggressive animal control program, as the entire pond complex is constructed of earth and clay embankment. While the ponds do have a plastic liner on the inside of the pools, that component could be torn or chewed through.

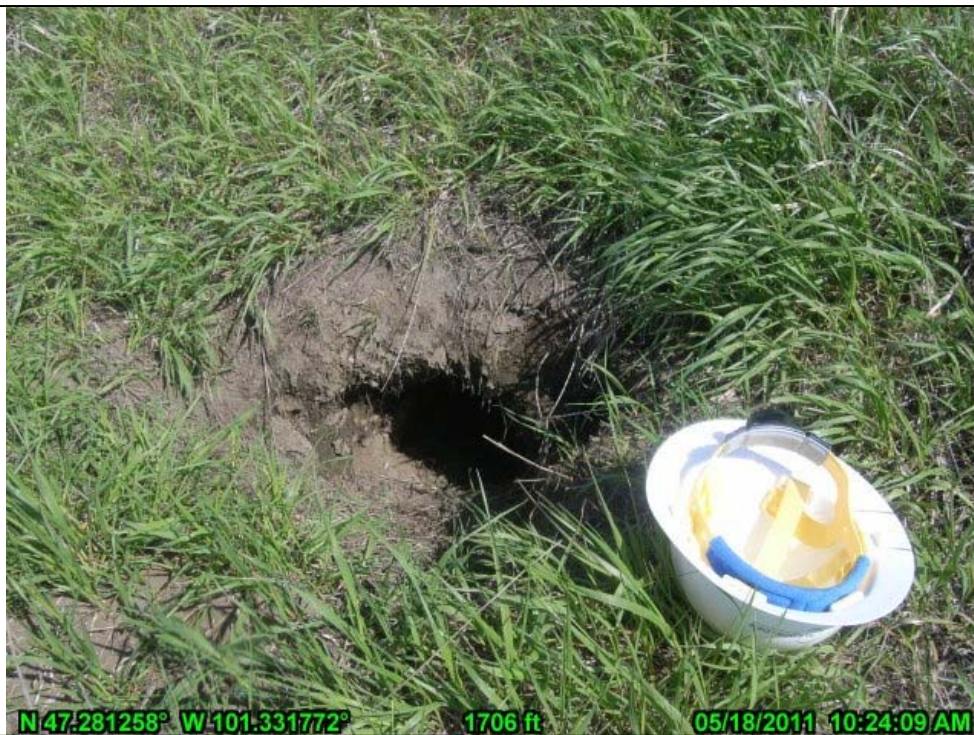
Overall, the downstream slope was in reasonably Fair condition. Photos 10, 35, 38, and 39 show the conditions of the downstream slope. Specific observations include:

38-Animal Burrows Approximately 6" to 12" Diameter

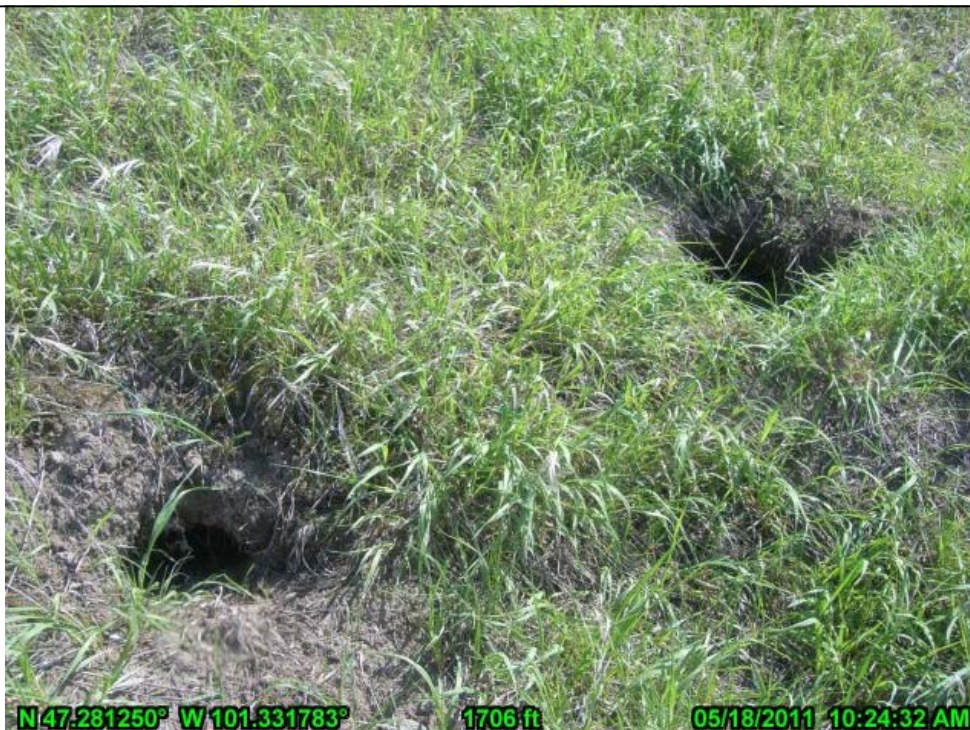
39-Animal Burrows Approximately 6" to 12" Diameter
