**COAL ASH IMPOUNDMENT
SITE ASSESSMENT DRAFT REPORT**

**Stanton Station
Great River Energy
Stanton, North Dakota**

KLEINFELDER PROJECT NUMBER 118953-2

May 10, 2012

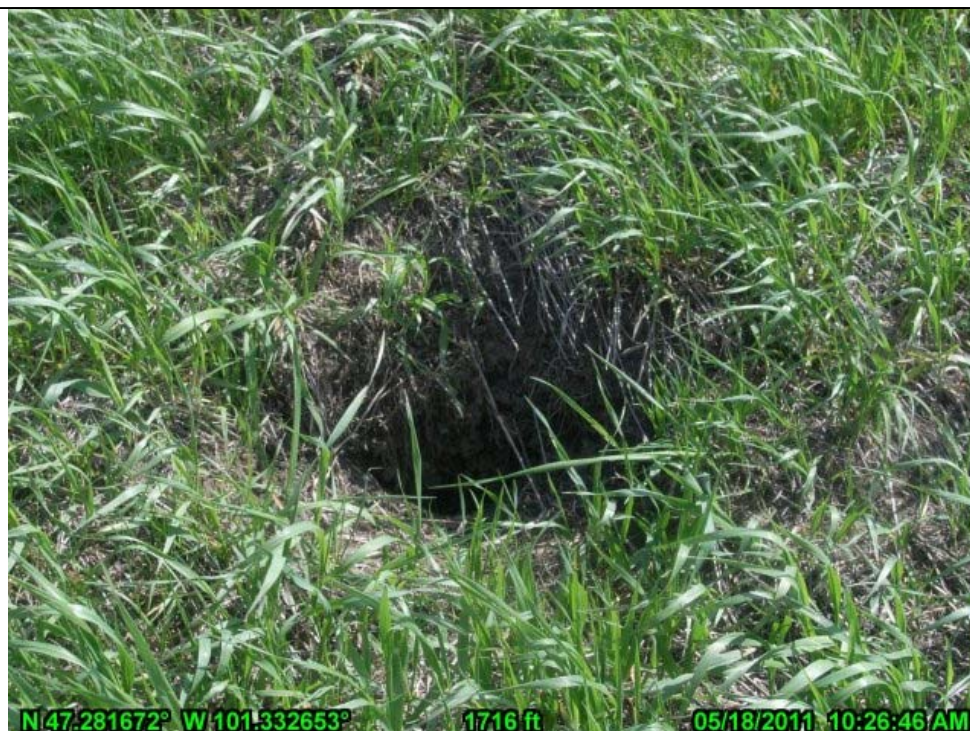
40-Animal Burrows Approximately 6" to 12" Diameter

- Several animal burrows were observed. Some of the burrows were quite large – up to a 10-inch diameter opening. This condition should be remedied with a more aggressive animal control program, as the entire pond complex is constructed of earth and clay embankment. While the ponds do have a plastic liner on the inside of the pools, that component could be torn or chewed through.

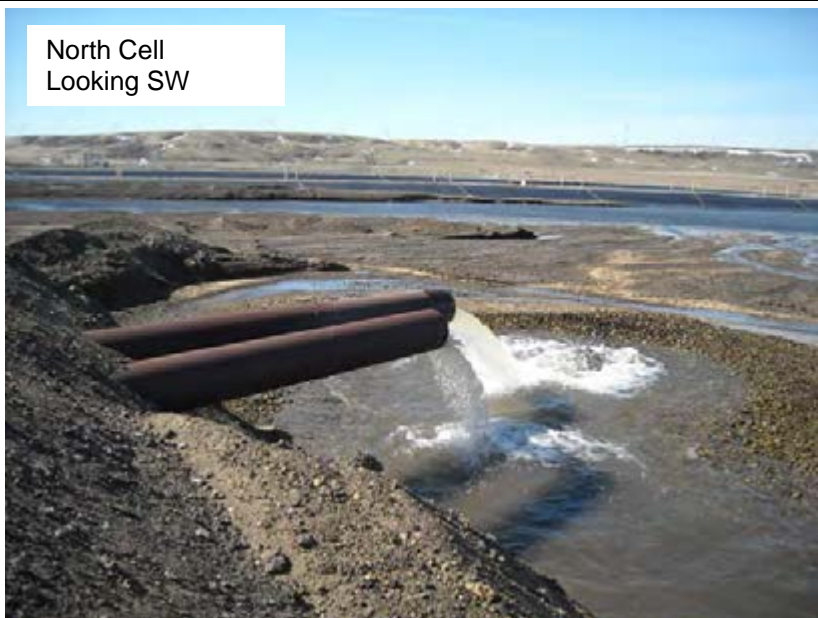
North Cell
Looking SW

Bottom Ash Inlet Pipes (001)

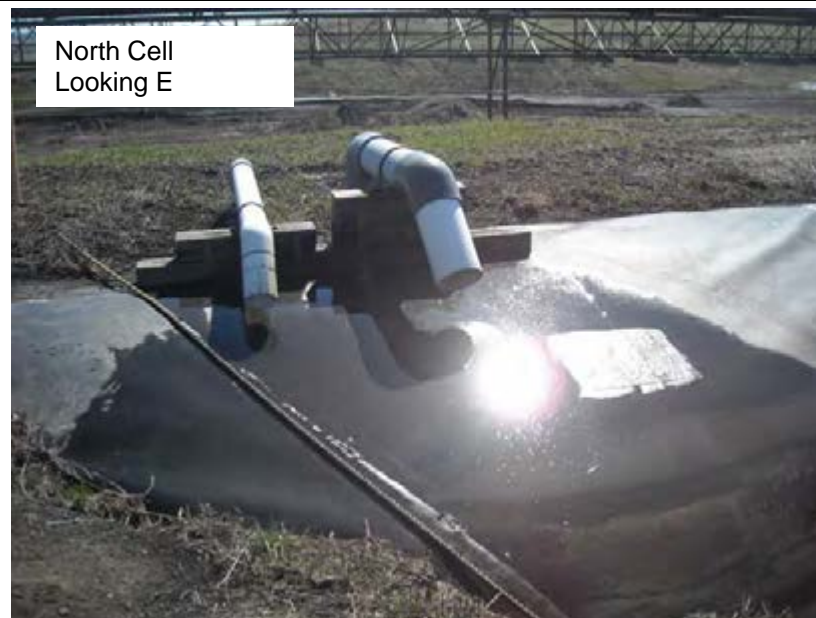
North Cell
Looking E

Coal Pit and Retention Ponds Inlets (002)

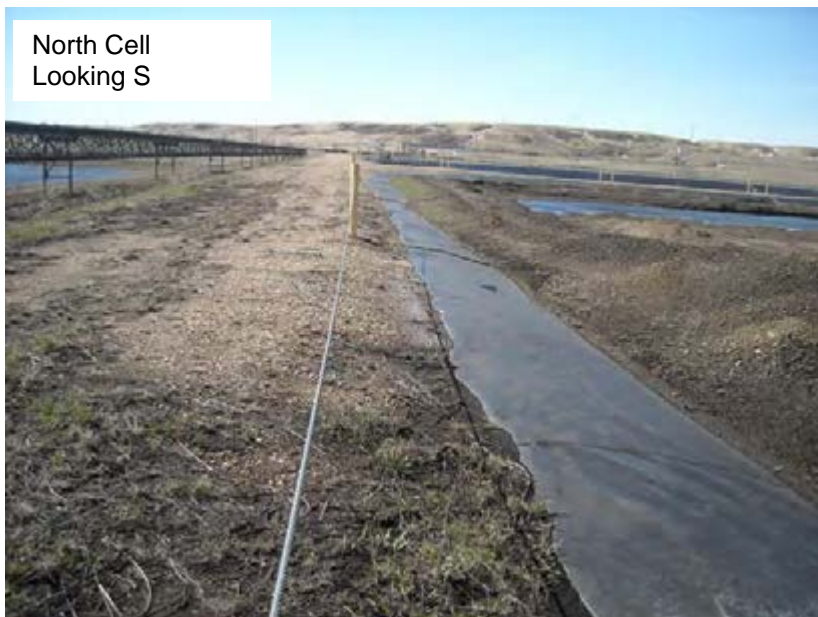
North Cell
Looking S

Exposed Geomembrane on East Upstream Slope (004)

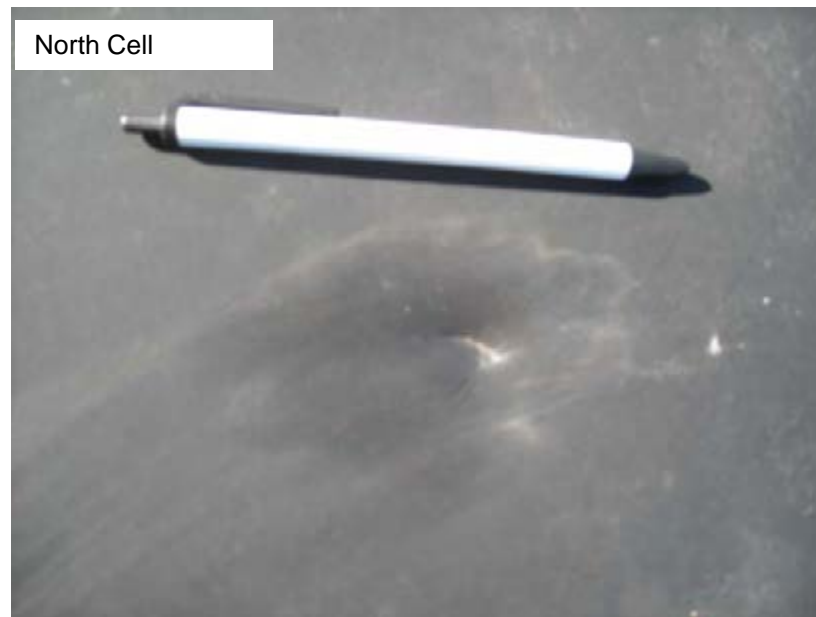
North Cell

a. Erosion - liner exposed?	X			Some small punctures in exposed GM
b. Rodent burrows		X		
c. Vegetation		X		
d. Cracks/settlement/scarps		X		
e. Riprap/other erosion protection			X

Small Puncture in Geomembrane Liner (006)

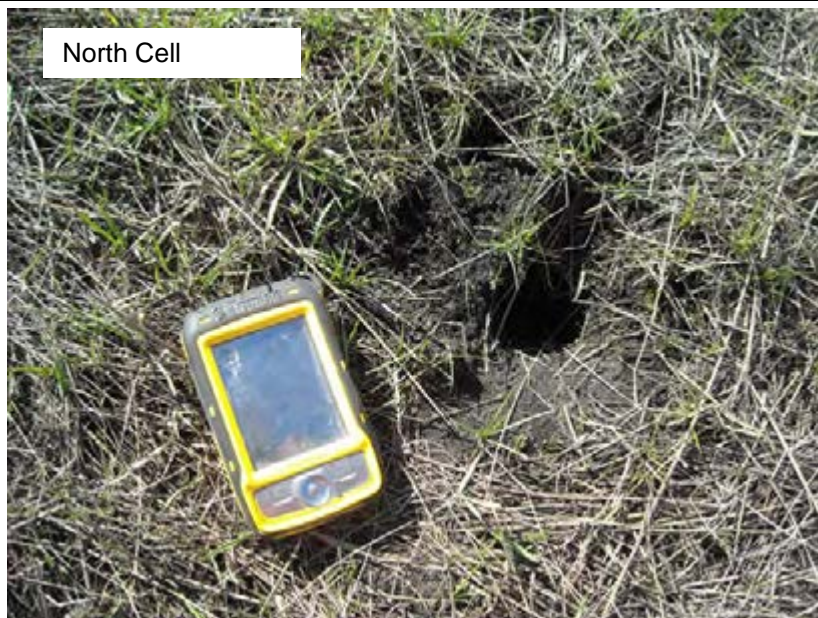
Small Animal Burrow on North Downstream Slope (024)

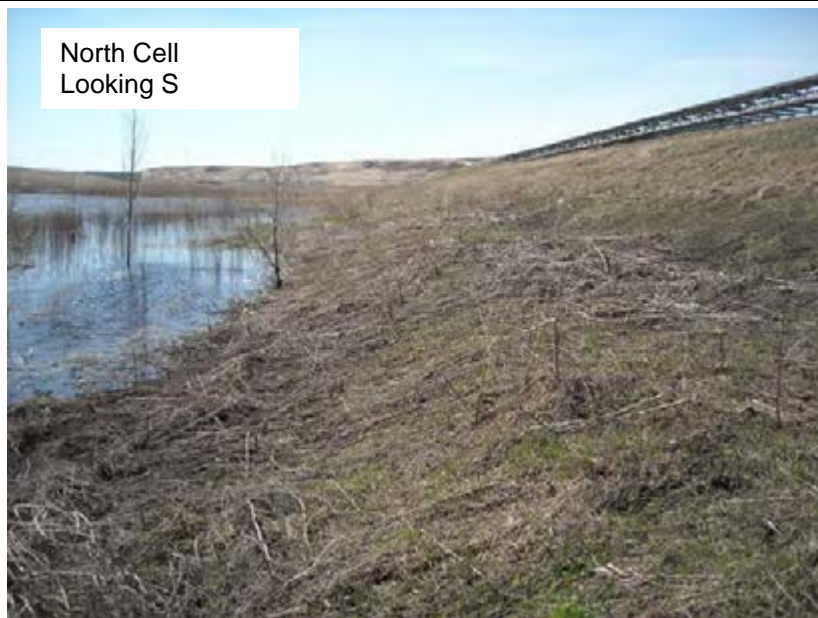
Ponded Water at Toe of East Downstream Slope (028)

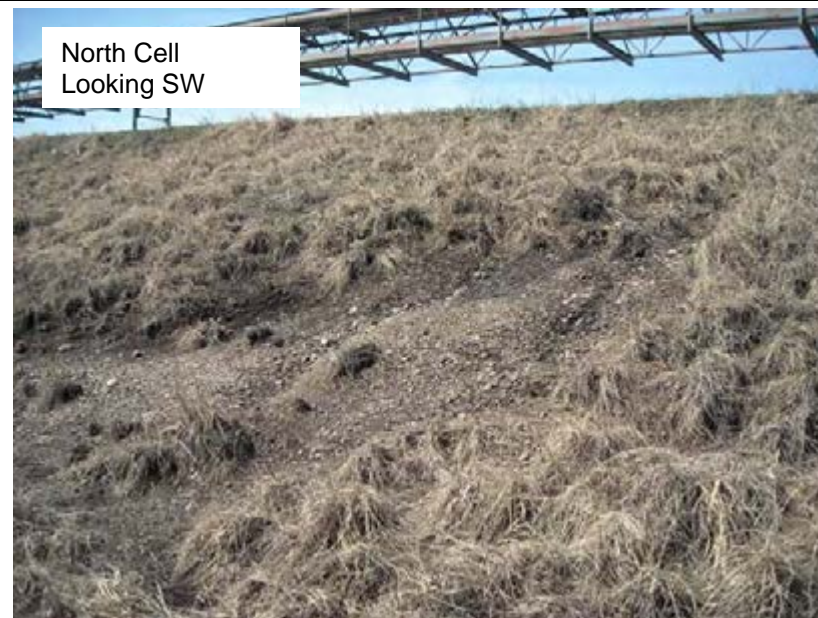
Erosion and Bottom Ash on East Downstream Slope (027)

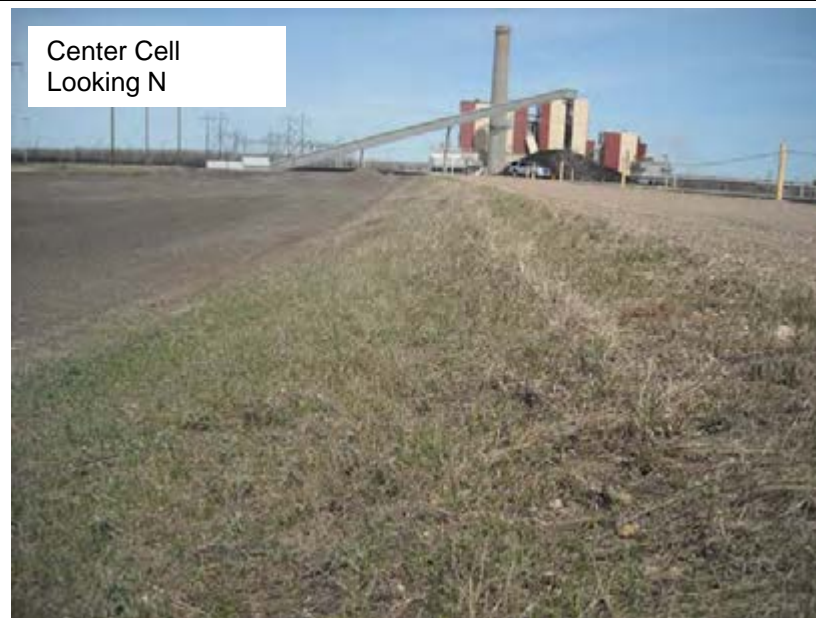
Center Cell

Small Animal Burrow on West Downstream Slope (048)

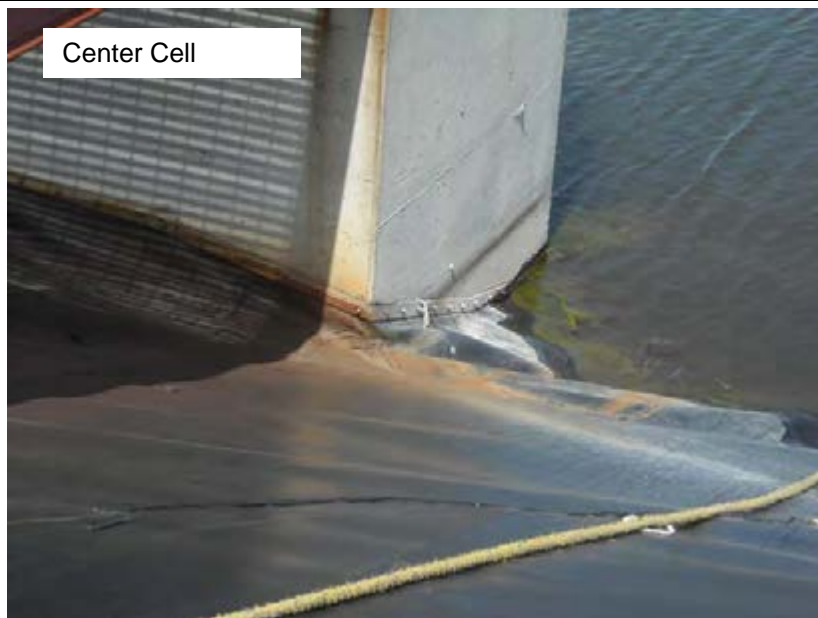
b. Rodent burrows		X		
c. Vegetation		X		
d. Cracks/settlement	X			Lower half of slopes have displaced
e. Riprap/other erosion protection			X	
5. Crest

- Lower half of upstream slopes have displaced (consolidation, settlement, shallow failure)
- Erosion, small scarps & animal burrows on downstream slopes
- Small punctures in exposed geomembrane liner

Displacement of Lower Upstream Slope, East Berm (054)

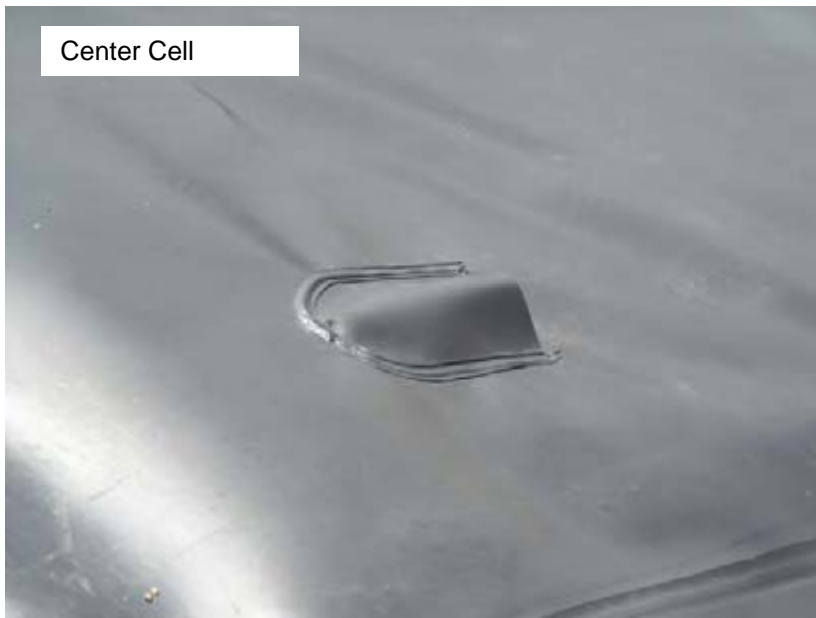
Vent in Geomembrane Liner (057)

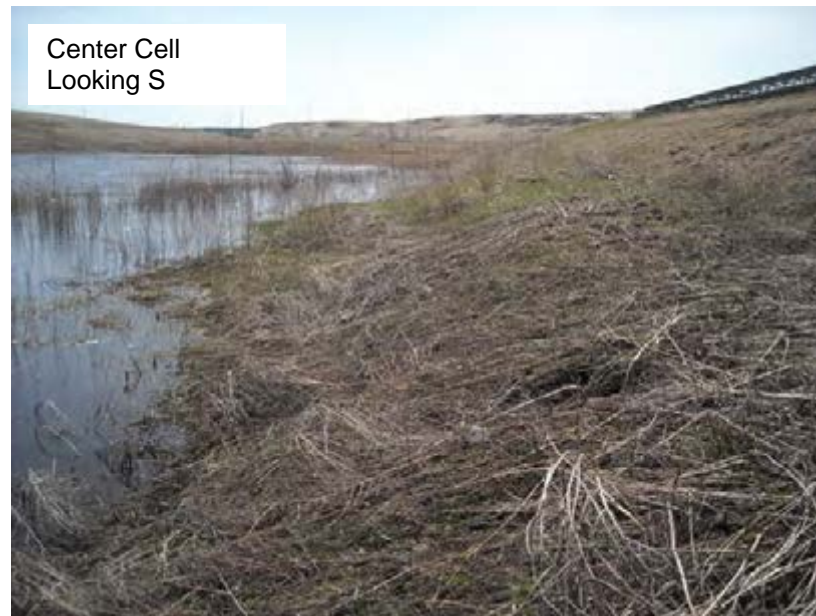
Toe of East Downstream Slope (062)

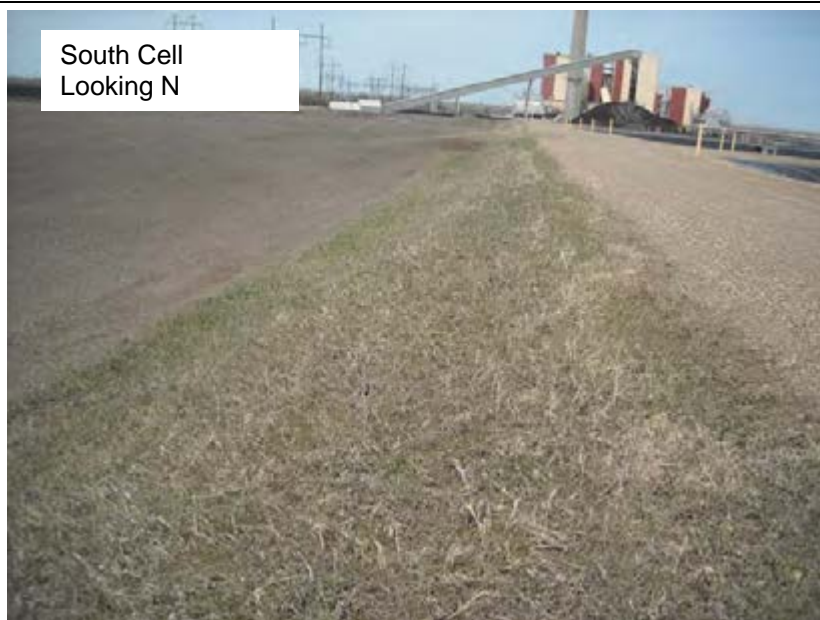
Small Animal Burrow in East Downstream Slope (079)

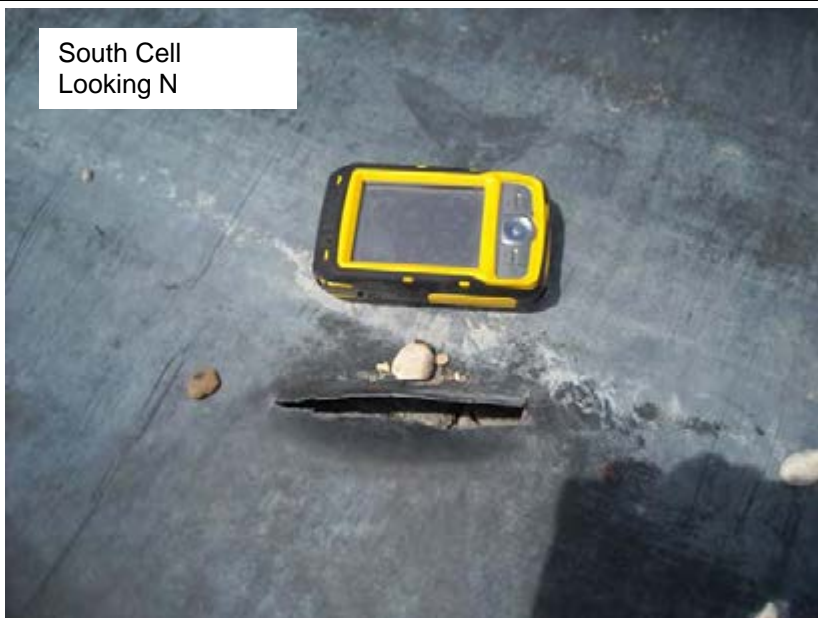
Puncture of Geomembrane Liner on North Upstream Slope (088)

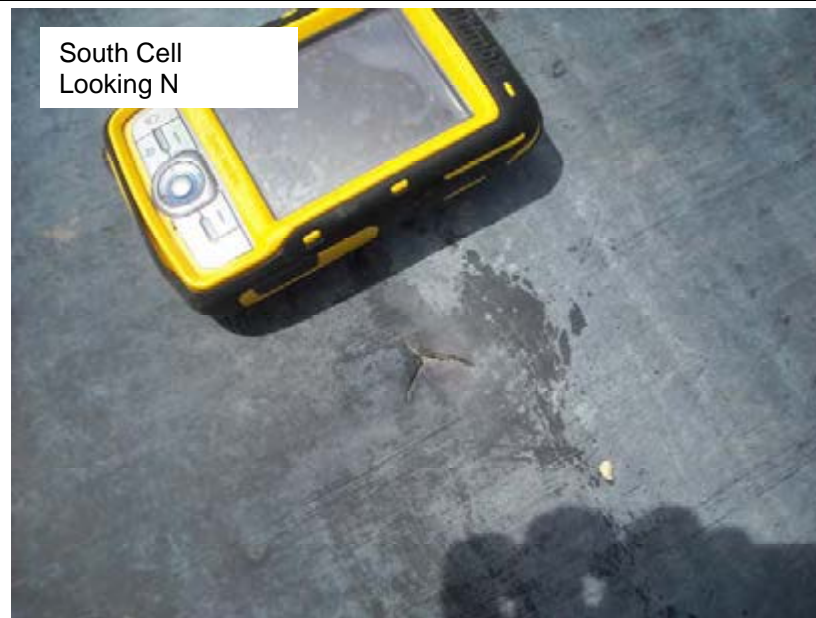
Puncture of Geomembrane Liner on North Upstream Slope (089)

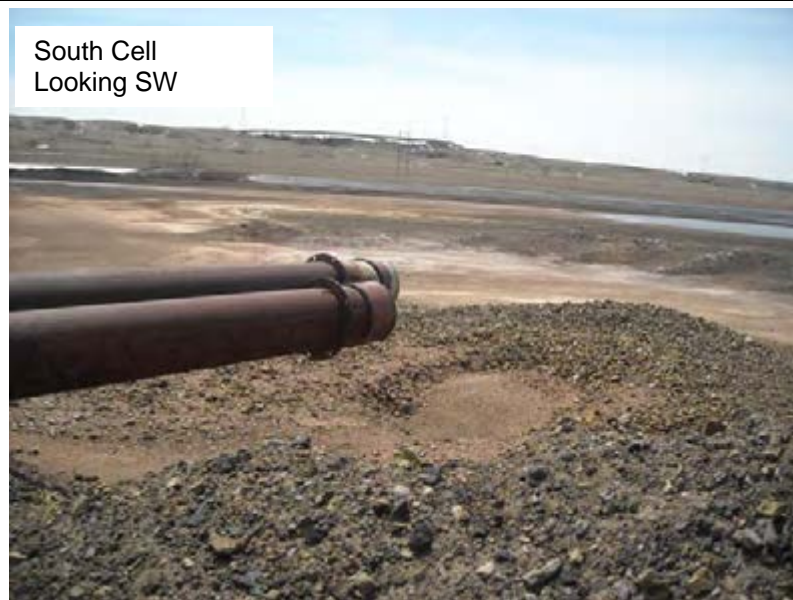
Coal Pit and Retention Ponds Inlets (090)
Trapped Water Between Geomembrane and Clay Liners

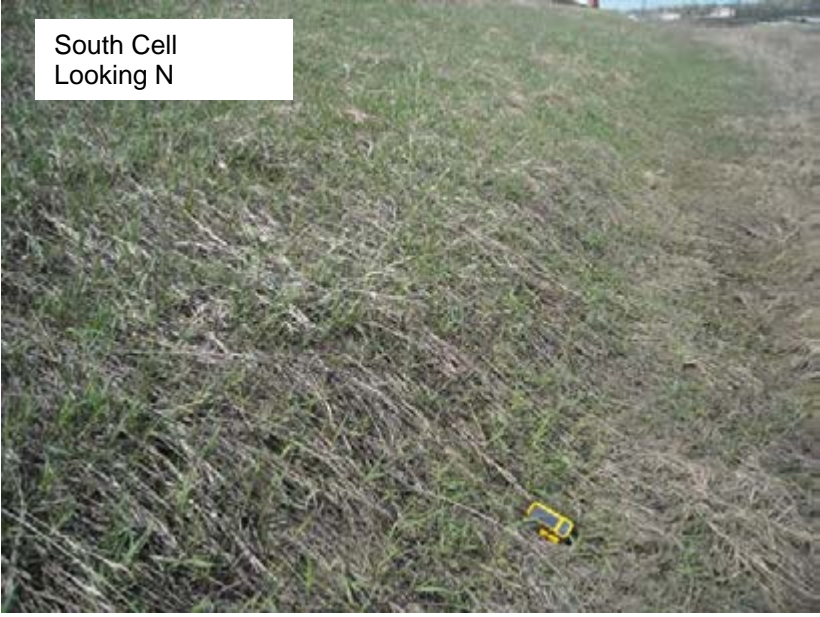
<p>Downstream Slope of East Berm, Road at 1715 (097)</p>	<p>Erosion Rill/Slough/Scarp on East Downstream Slope (098)</p>
<p>South Cell Looking N</p>

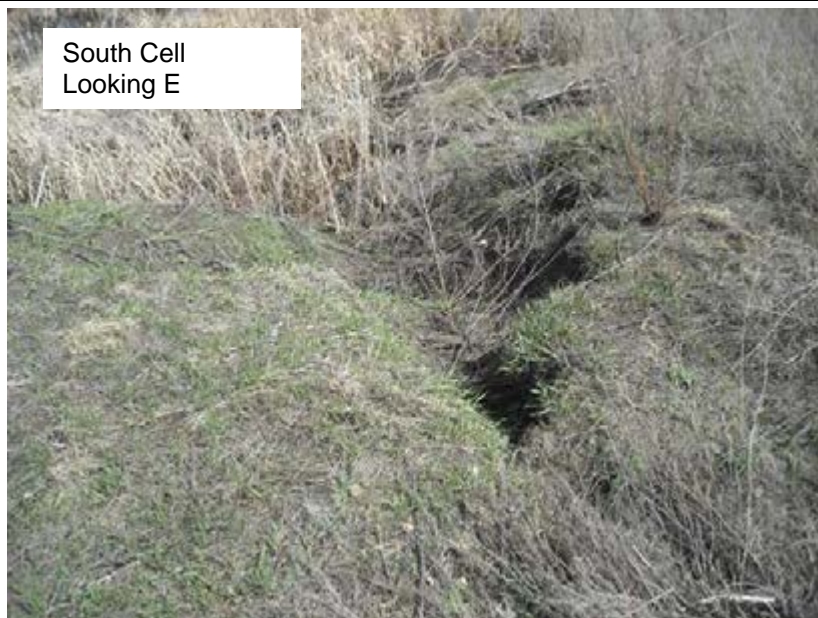
<p>Steepened Toe of East Downstream Slope (099)</p>	<p>Erosion Rill/Slough/Scarp on East Downstream Slope (101)</p>

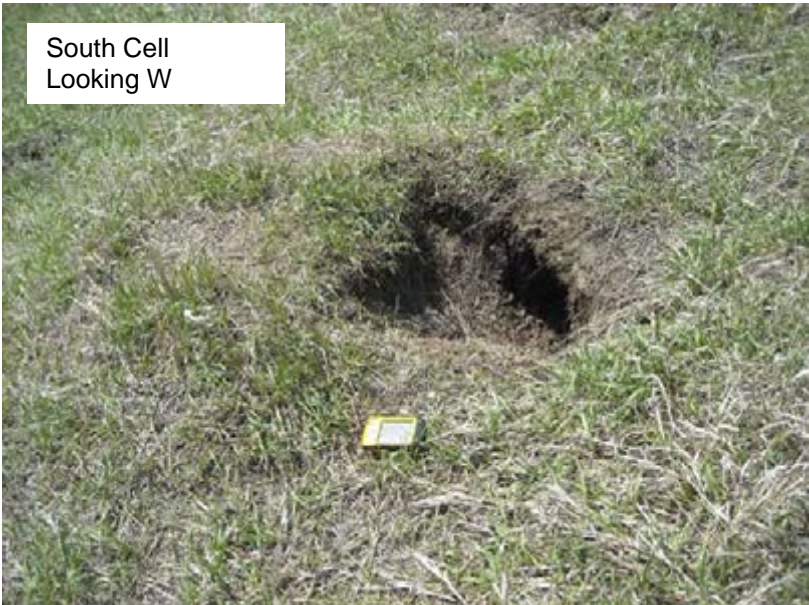
<p>South Cell Looking W</p>
<p>Larger Animal Burrow on South Downstream Slope (110)</p>	<p>Larger Animal Burrow on South Downstream Slope (112)</p>

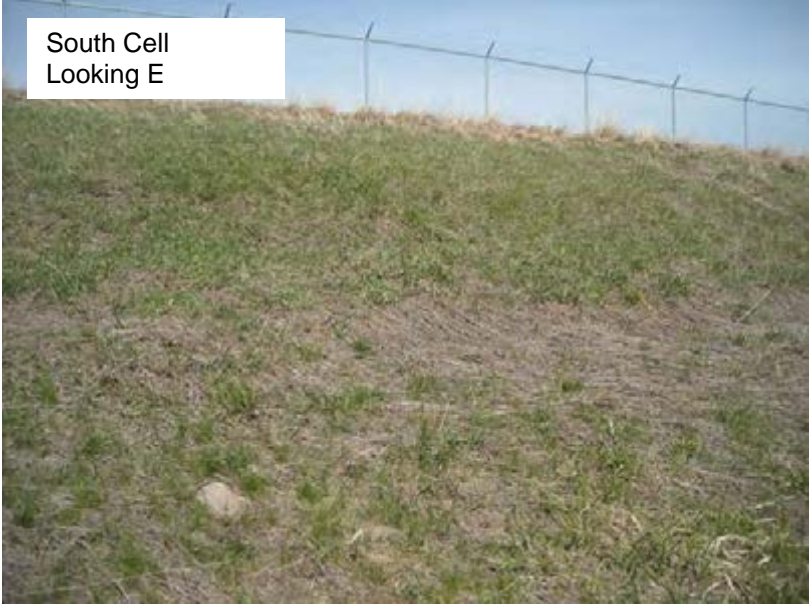
<p>South Cell Looking E</p>
<p>Bottom Ash on South Downstream Slope (113)</p>	<p>Slough/Scarp Line Along South Downstream Slope (114)</p>
