# **Assessment of Dam Safety of Coal Combustion Surface Impoundments**

**Indianapolis Power & Light Company**

**Eagle Valley Generating Station**

**June 4, 2010**

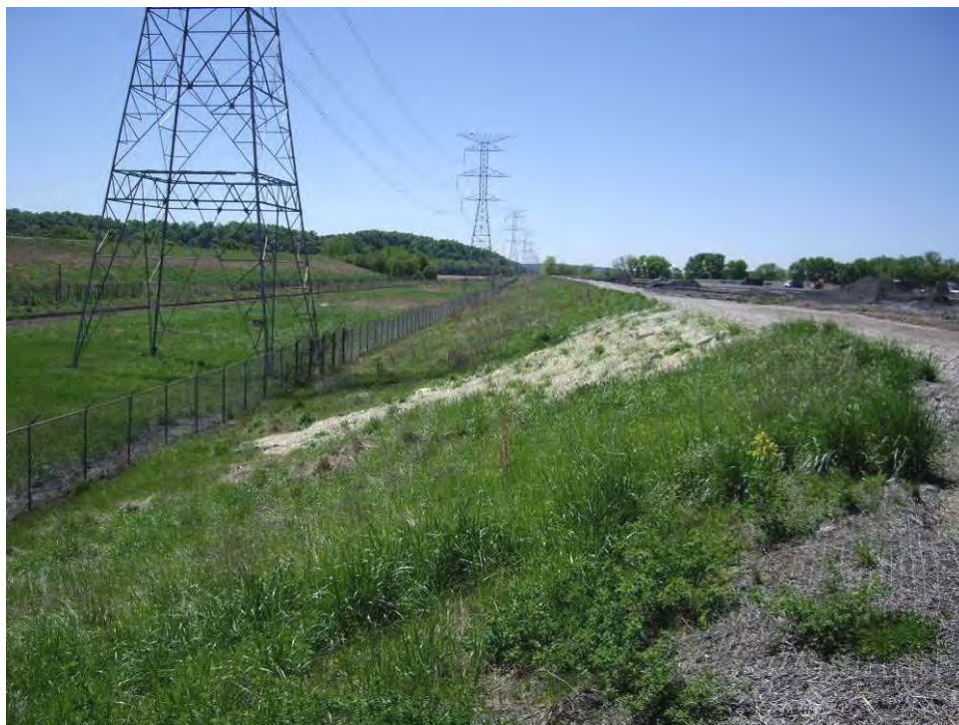
One erosion repair on the northeast corner of the east embankment was observed (Photos 1, 3, and 4). The repair consists of an erosion control blanket. The erosion control blanket did not appear to be installed consistent with typical manufacturer's recommendations. Stakes did not appear to be installed properly, and the blankets were not overlapped or keyed into an anchor trench in the slope. Approximately 1- to 3-inch gaps were observed below the blanket. Another erosion rill was observed on the west embankment (Photo 26). Some crushed stone was placed near the crest of the embankment in an effort to reduce further erosion.

1. Pond A - East embankment exterior slope looking south.

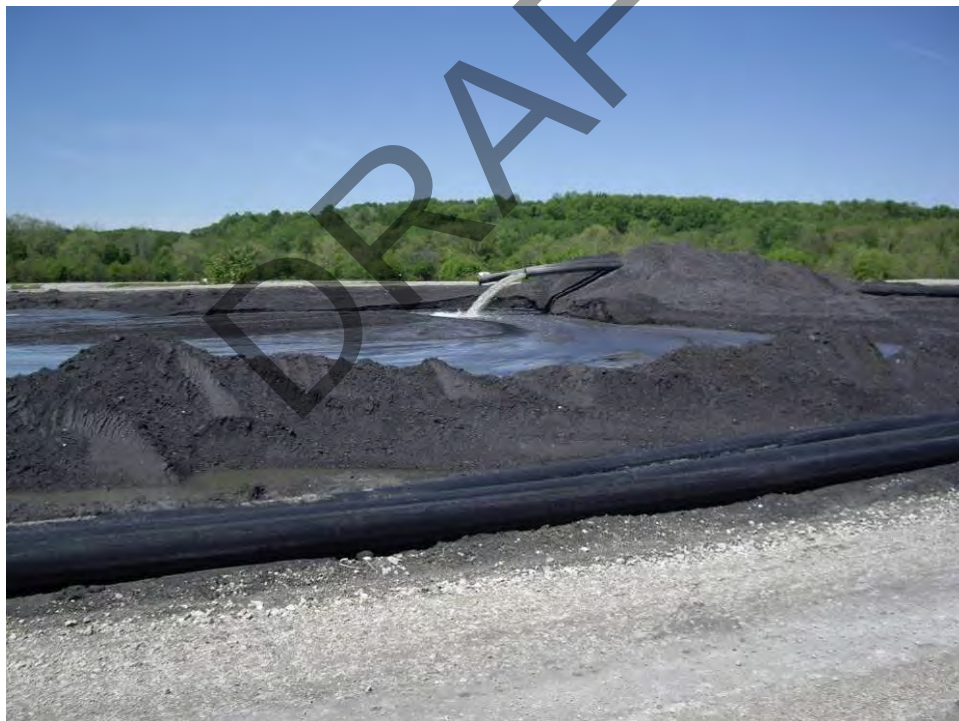
Two (2) 10-inch-diameter High Density Polyethylene (HDPE) pipes sluice CCW waste into Pond A (Photo 6). In addition, a third 10-inch-diameter HDPE pipe sluices plant wastes into Pond A (Photo 10). Pond A is used as the primary settling pond. Floating booms were installed in the pond to direct flow and increase the settling time in the pond. Pond A is connected to Pond B by two (2) 30-inch-diameter Corrugated Metal (CMPs ) with an invert elevation of El. 626 (Photo 28, 29 and 30). At the pipe inlets, there is a floating boom wrapped around the inlets and vertical pipe T's are connected to the ends to serve as a hood to reduce the potential for surface debris from clogging the pipes. IPL staff stated that a low spot in the crest in Pond A is an emergency overflow spillway (Photo 28). The spillway is approximately 50 feet wide with the crest at El. 628. This "emergency spillway" is not included on any design plans.

6. Overview of two 10-inch-diameter HDPE discharge pipes into Pond A, looking northwest.

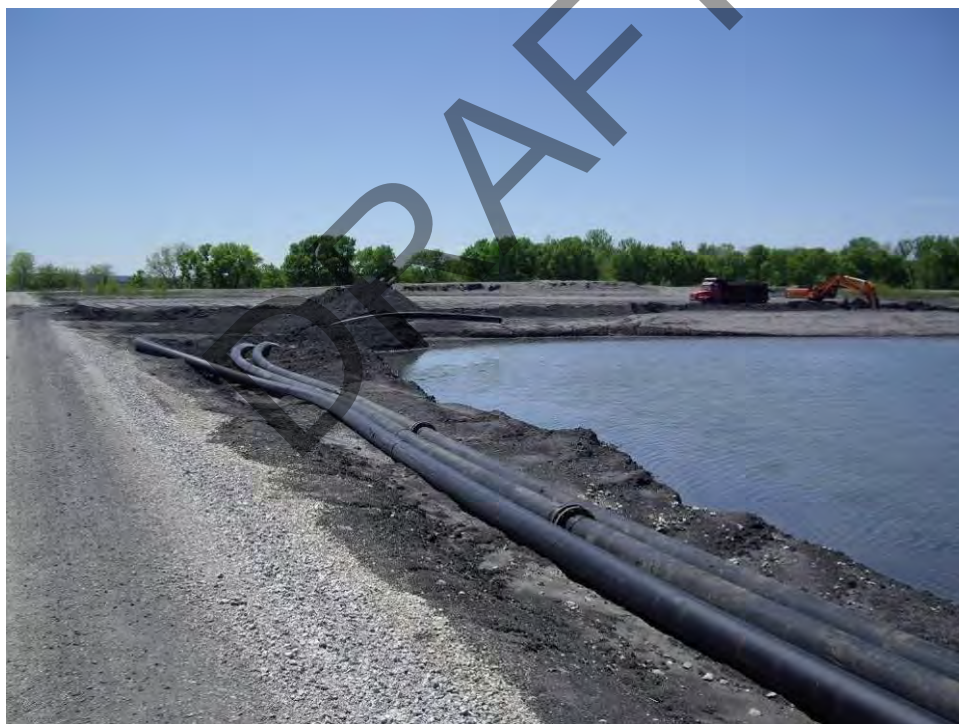
8. Overview of three 10-inch-diameter HDPE discharge pipes into Pond A, looking southwest.  
Note two right-most pipes are disconnected.

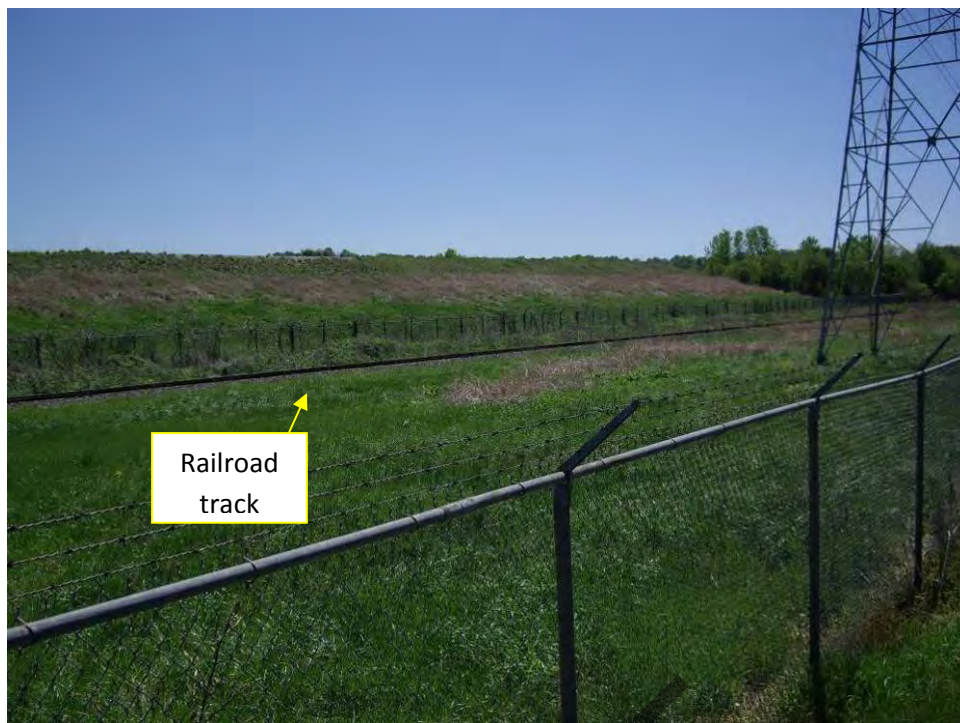
9. Overview of Pond D west embankment exterior slope from toe of Pond A east embankment. Note change in vegetation type at the three vertical expansions.

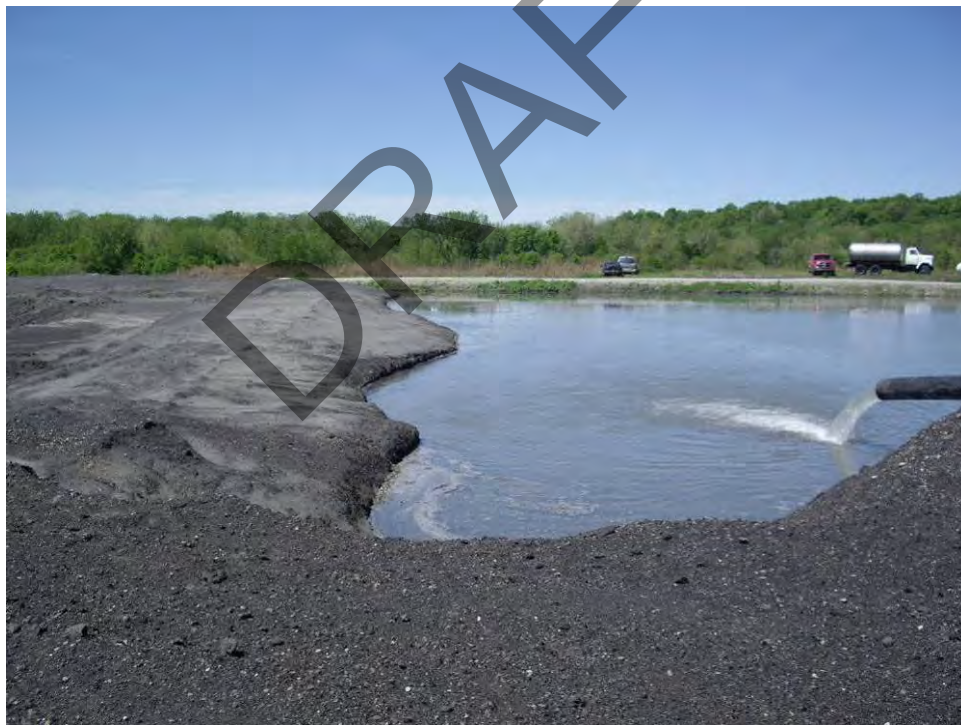
10. Overview of 10-inch-diameter HDPE discharge pipe into Pond A, looking west.

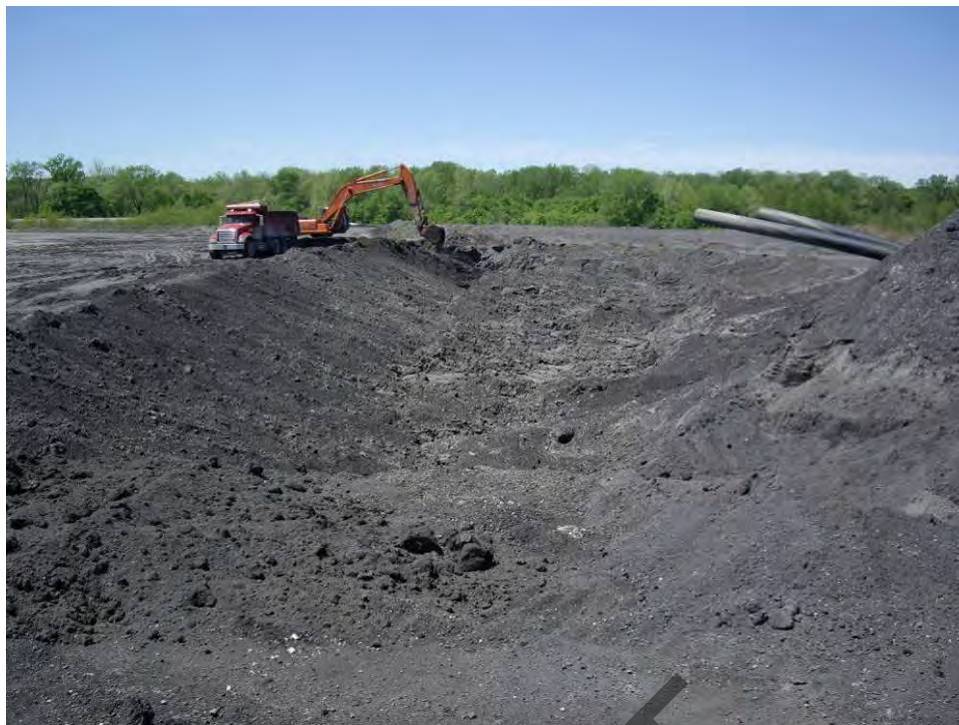
11. Overview of ash excavation in Pond A looking west. Ash being used as fill to repair Ponds D and E..

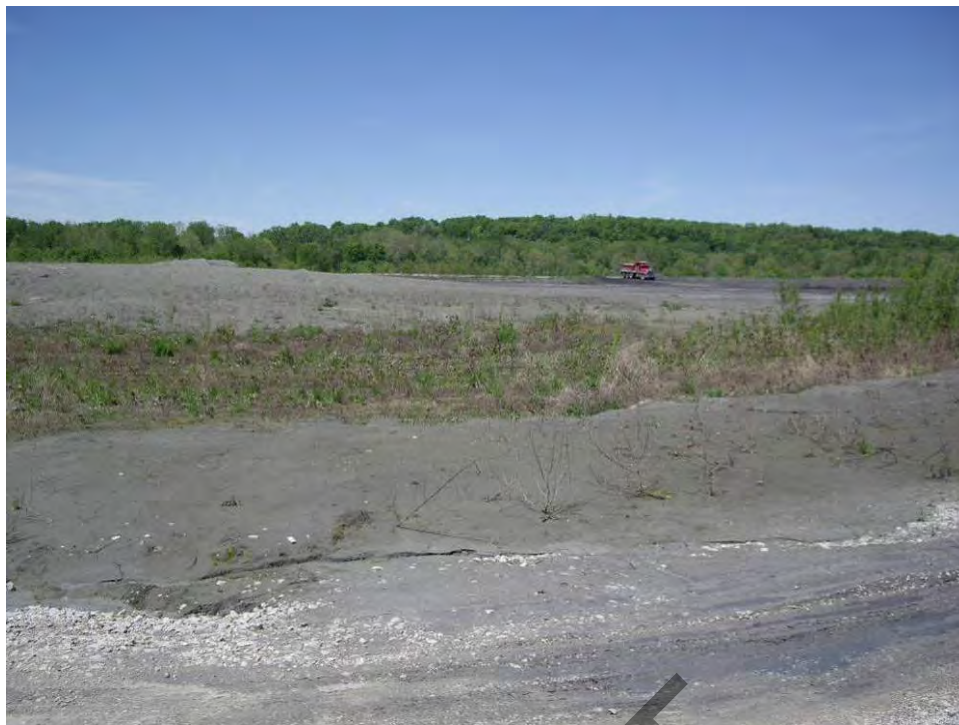
13. Overview of Pond A from crest of southeast corner looking northwest.

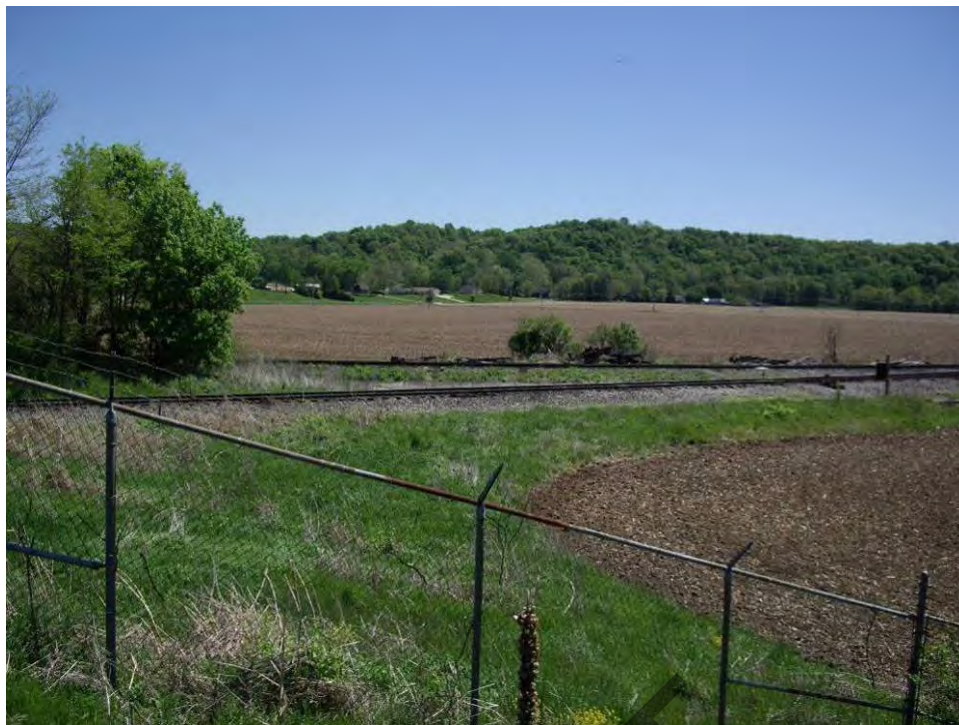
17. Pond A - Downstream area of east embankment looking southeast.

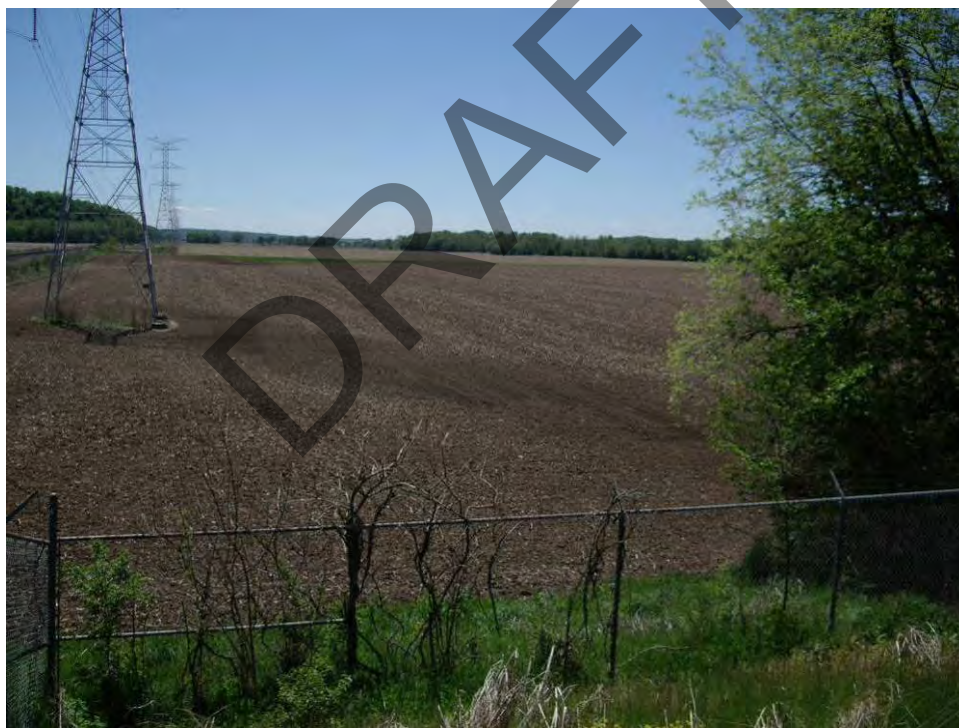
18. Pond A - Downstream area of east embankment at southeast corner of embankment looking south.

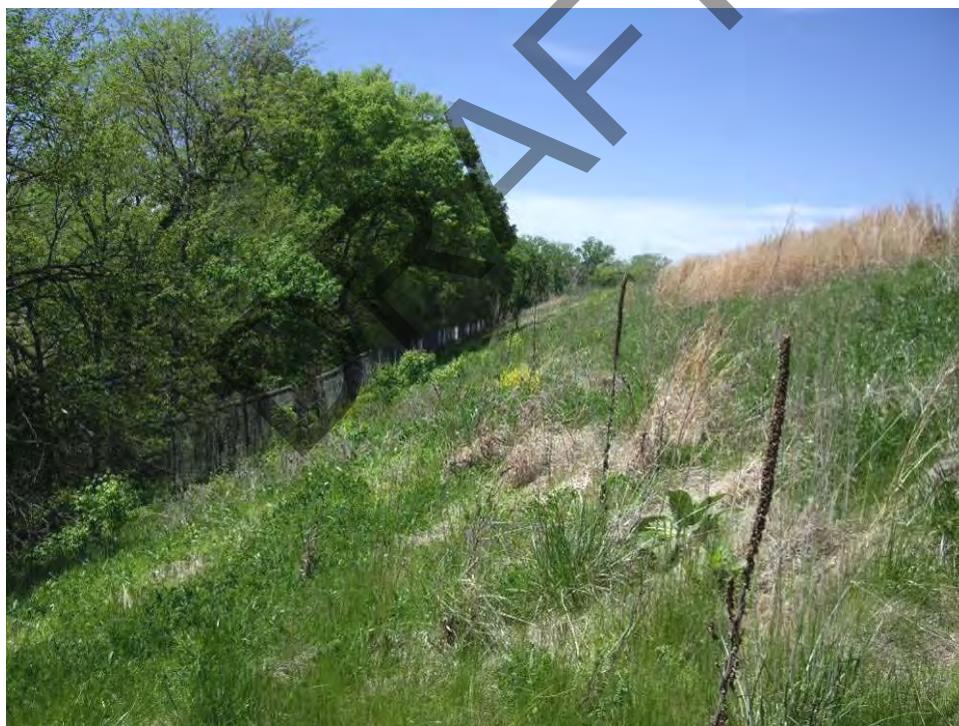
The exterior slopes of the Pond A embankments appear to be in fair condition. The exterior slopes on the north, south, east, and west embankments ranged from approximately 2.5H:1V to 3H:1V (Photos 1, 15, 20, 23, 25, 45, and 46). The exterior slope on the embankment between Pond A and Pond B (divider embankment A/B) and embankment between Pond A and Pond C (divider embankment A/C) ranged from approximately 2H:1V to 3H:1V (Photos 28, 33, 34, 38, 40, and 42).

20. Pond A – South embankment exterior slope looking west.

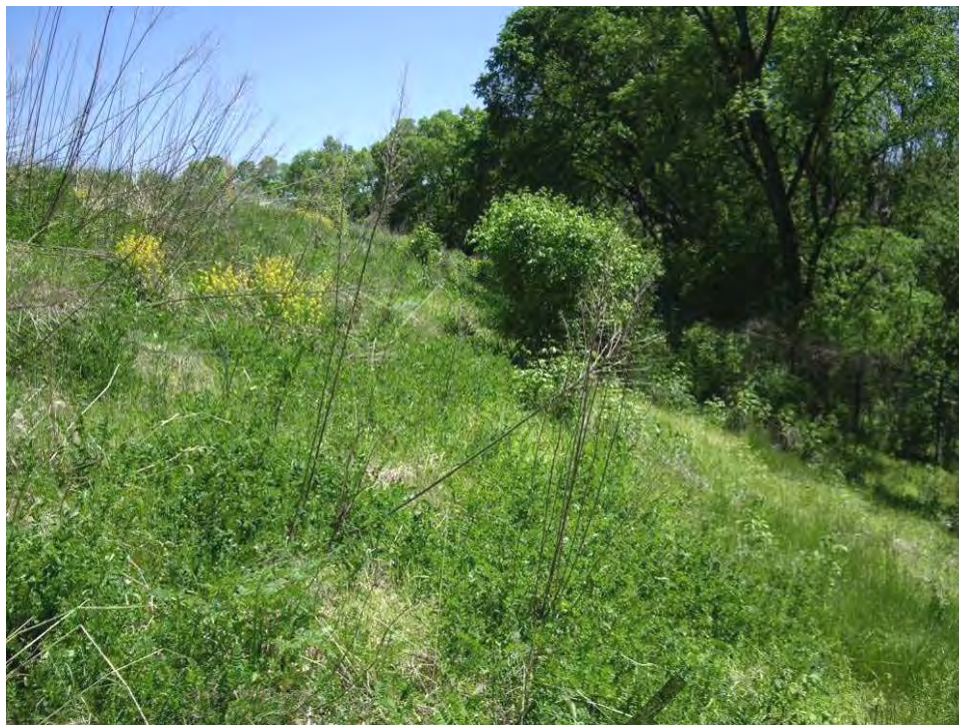
23. Pond A – South embankment exterior slope, looking southeast.

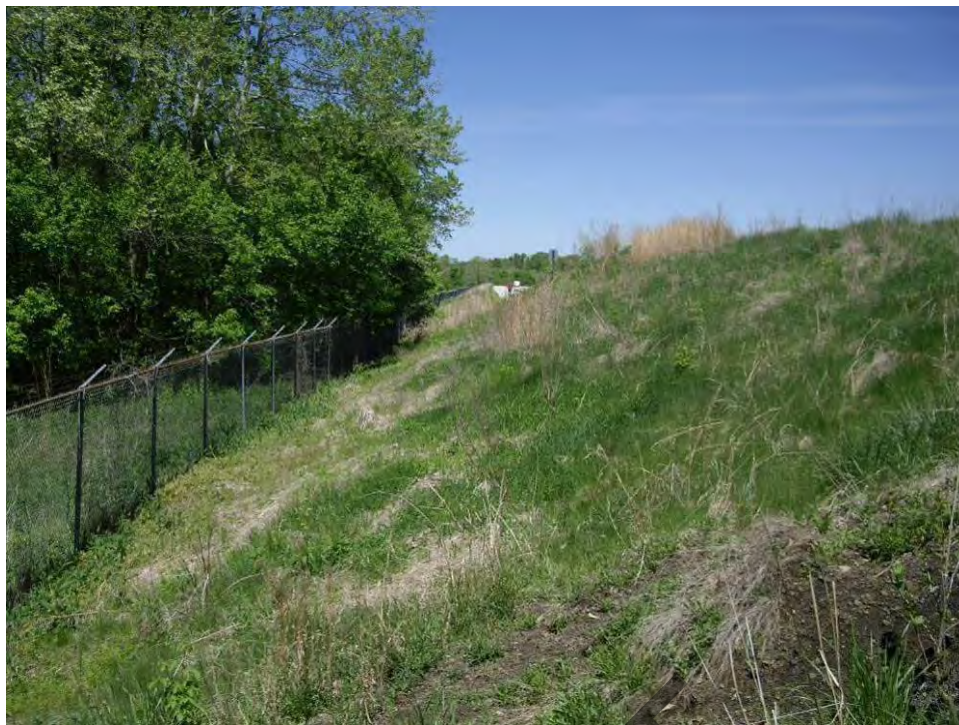
25. Pond A – West embankment exterior slope, looking north.

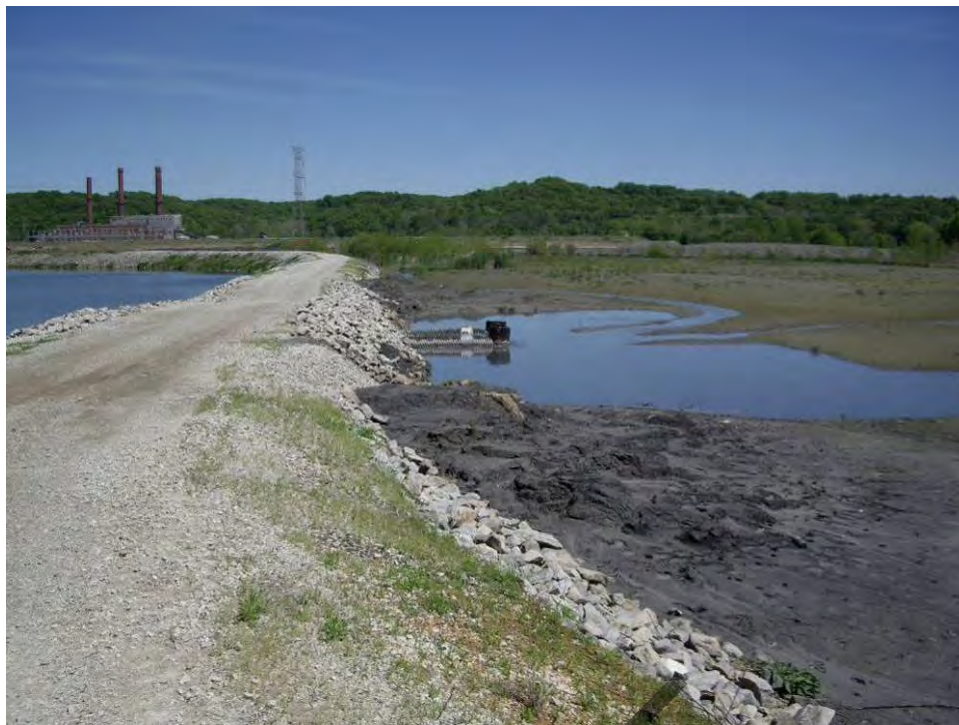
29. Pond A/B - south slope of divider embankment, looking east.

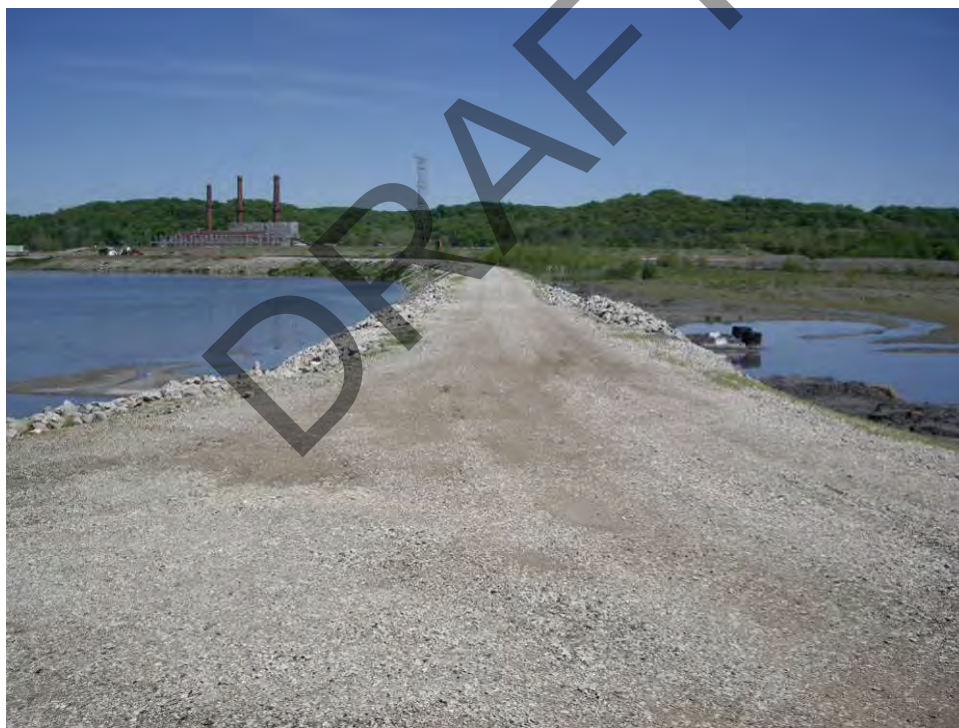
30. Pond A/B - crest of divider embankment, looking east.

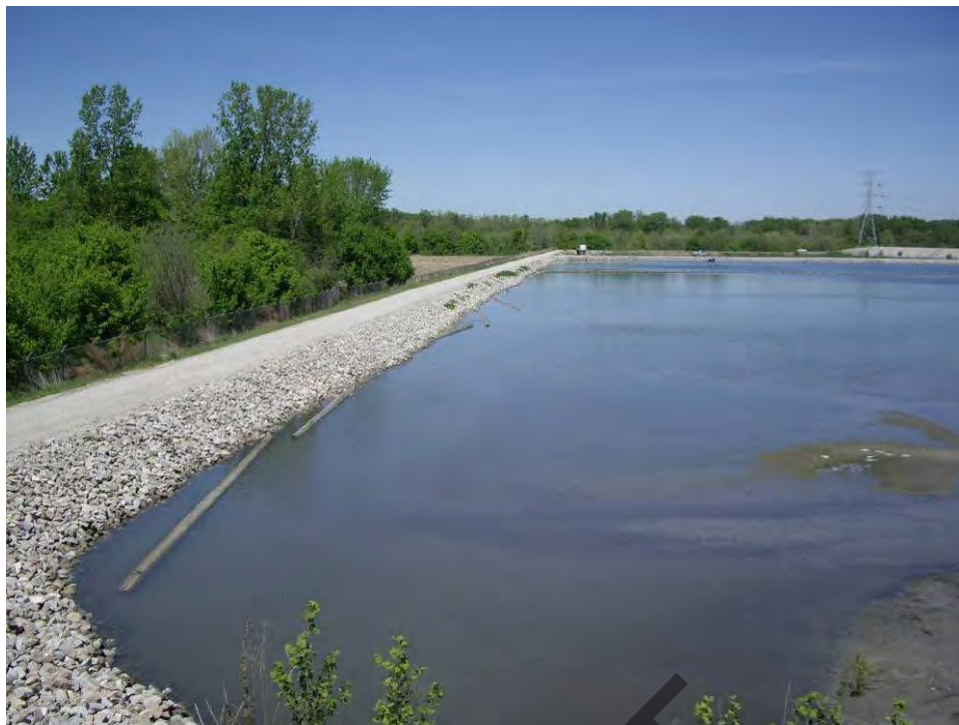
31. Overview of Pond B & C from crest of Pond A, looking northeast.

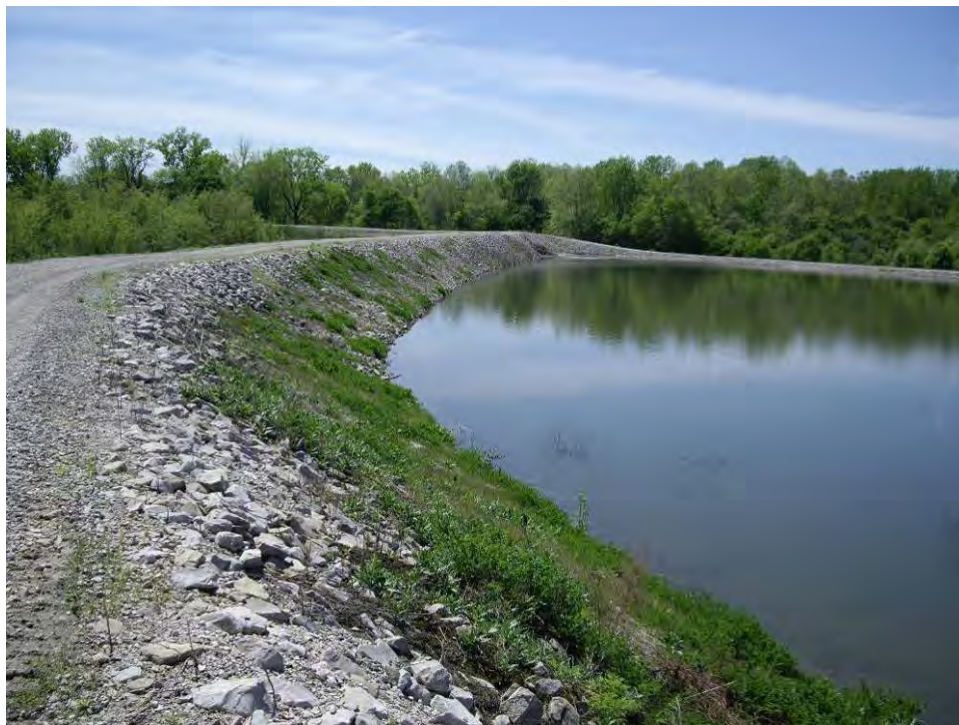
33. North slope of divider embankment A/B and Pond B west embankment, looking southwest.

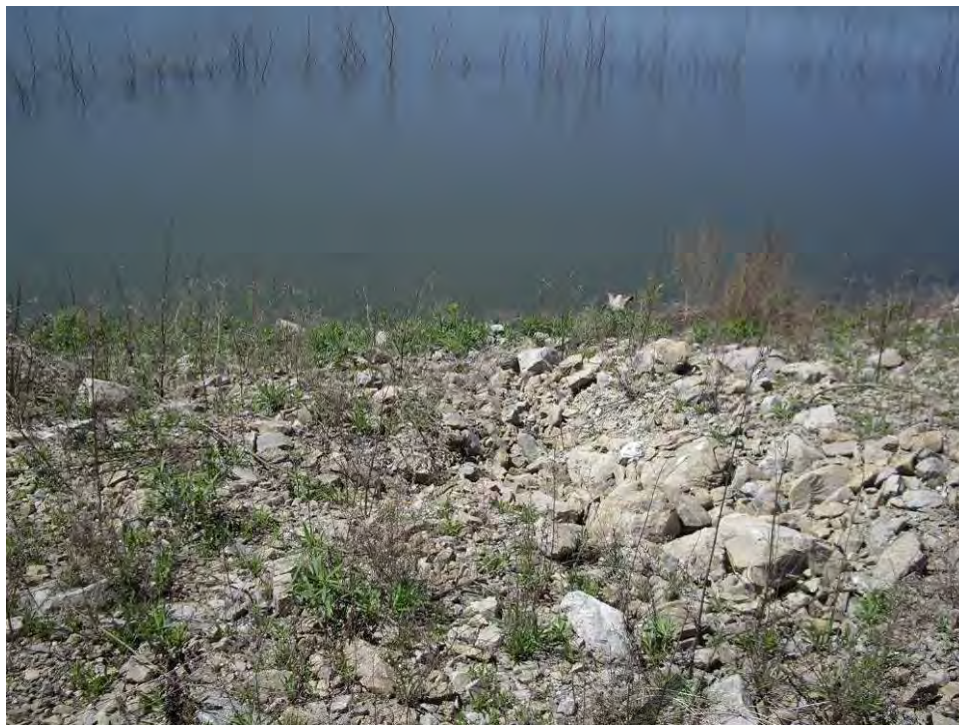
35. Erosion feature and depression in north slope of divider embankment A/B.

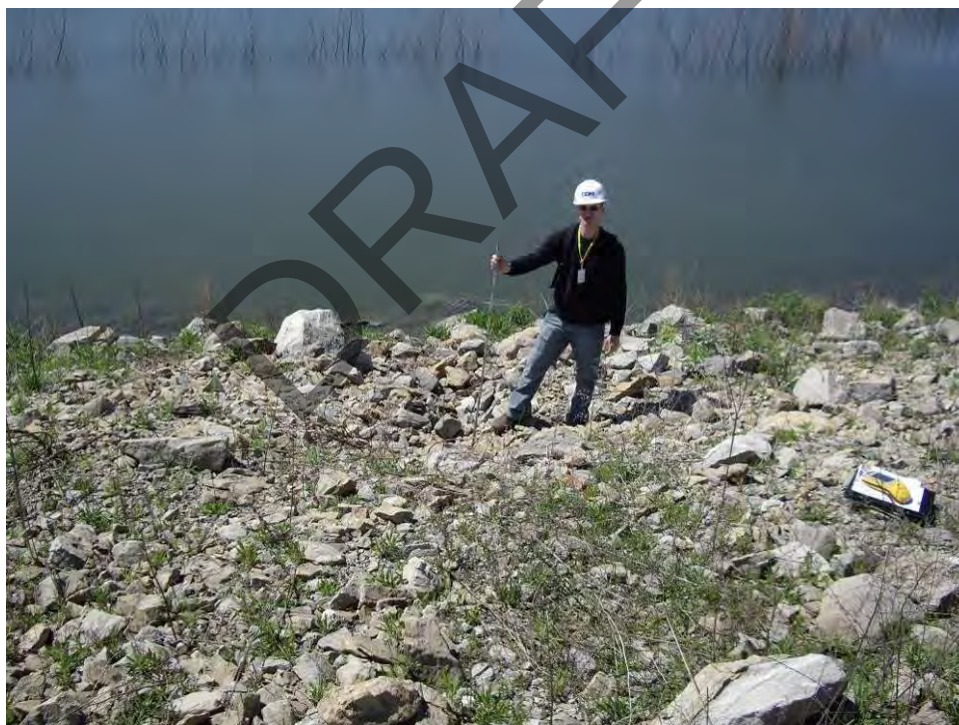
36. Depression in north slope of divider embankment A/B.

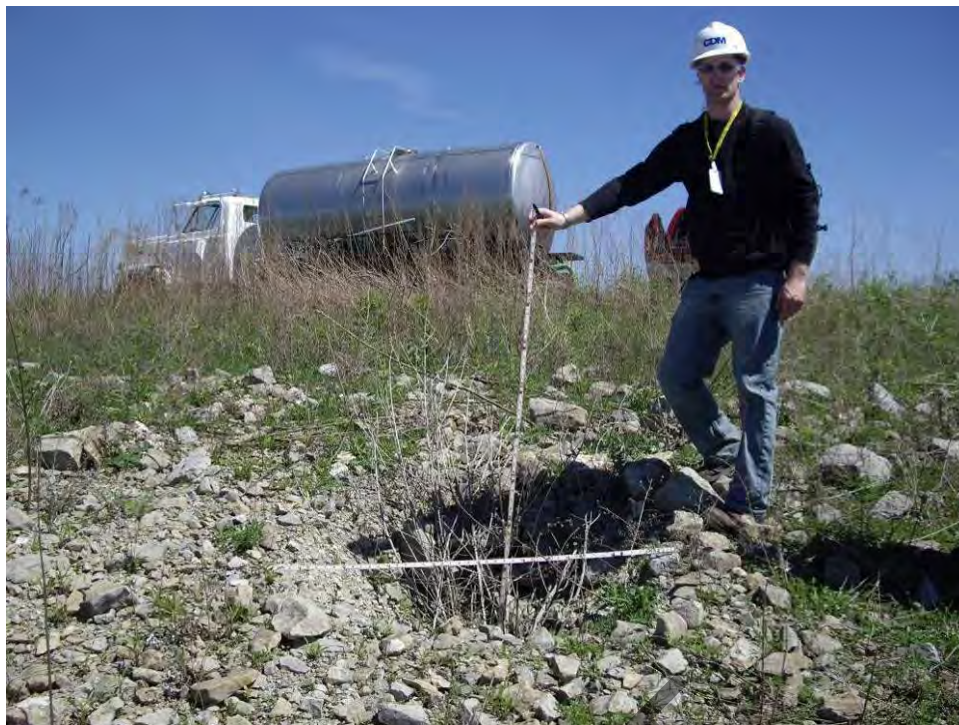
37. Depression in northwest slope of divider embankment A/B.

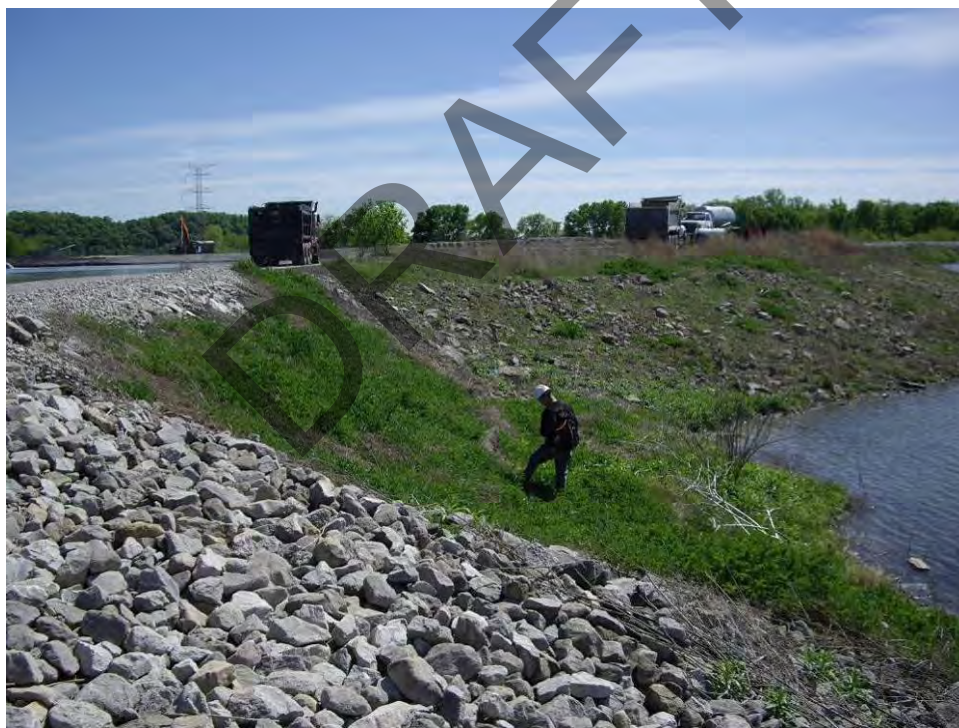
38. Northwest slope of divider embankment A/B, looking south.

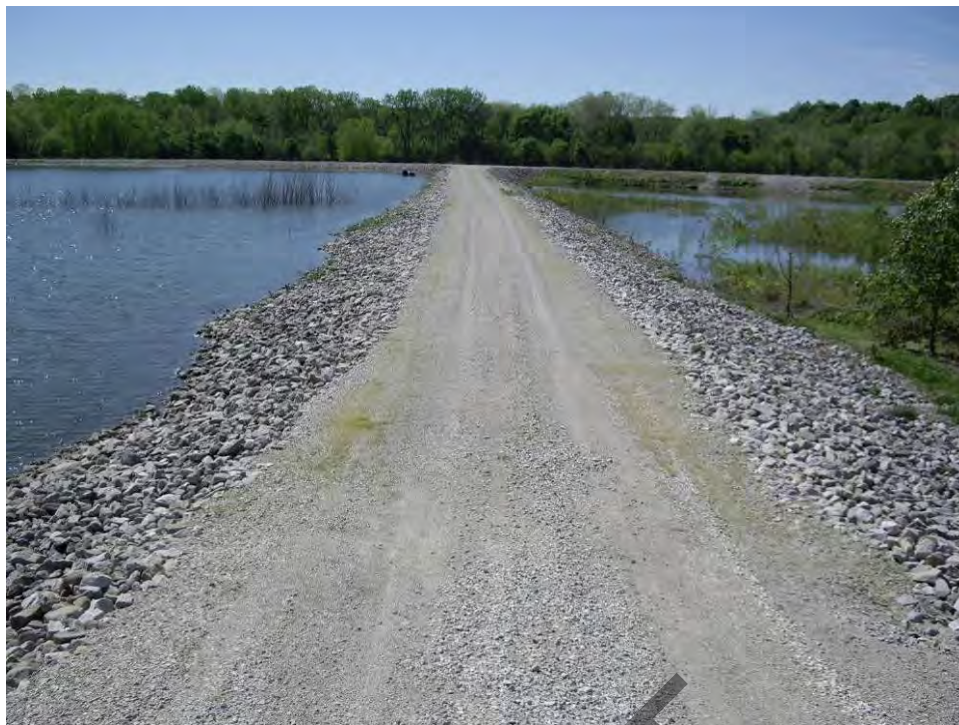
39. Crest of divider embankment B/C from crest of Pond A, looking west.

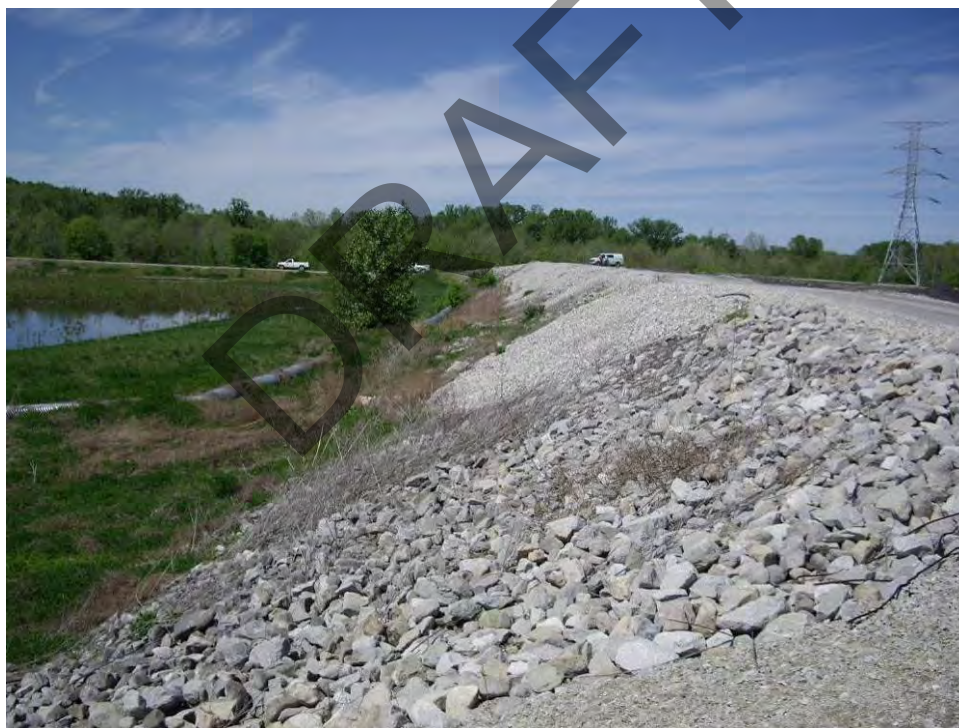
40. West slope of divider embankment A/C from Pond B, looking north.

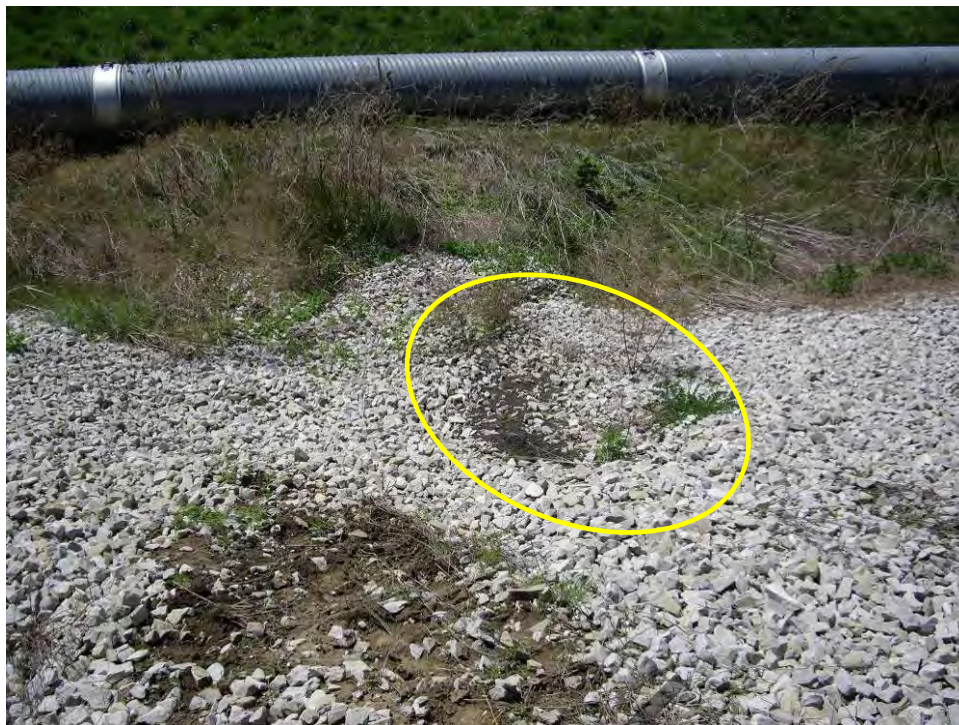
41. Minor sloughing and erosion feature on west slope of divider embankment A/C.

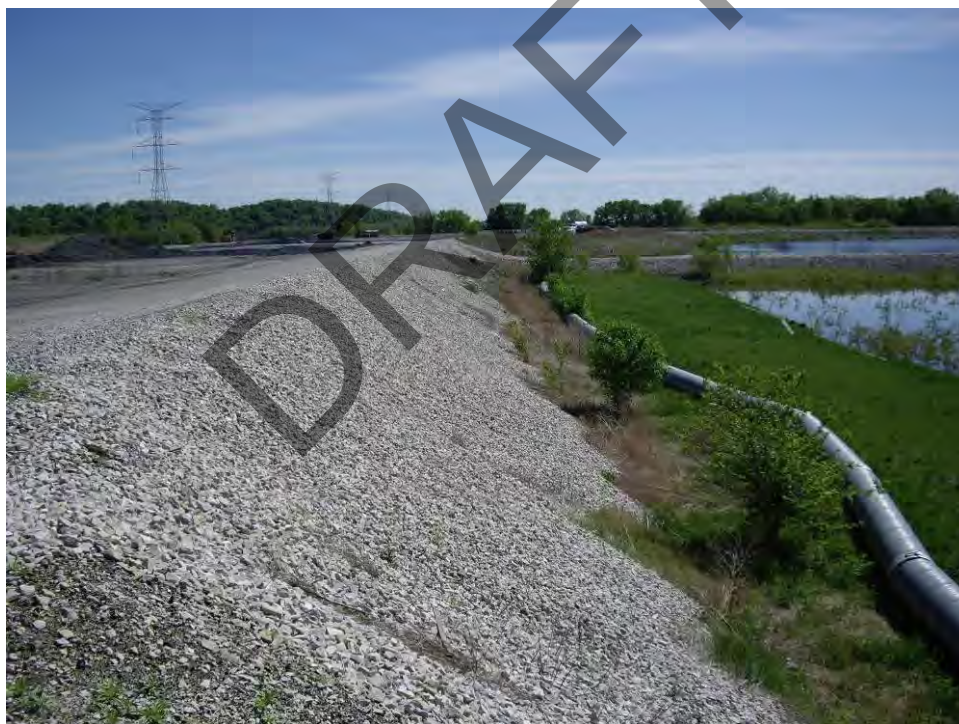
42. West slope of divider embankment A/C from Pond C north embankment, looking south.

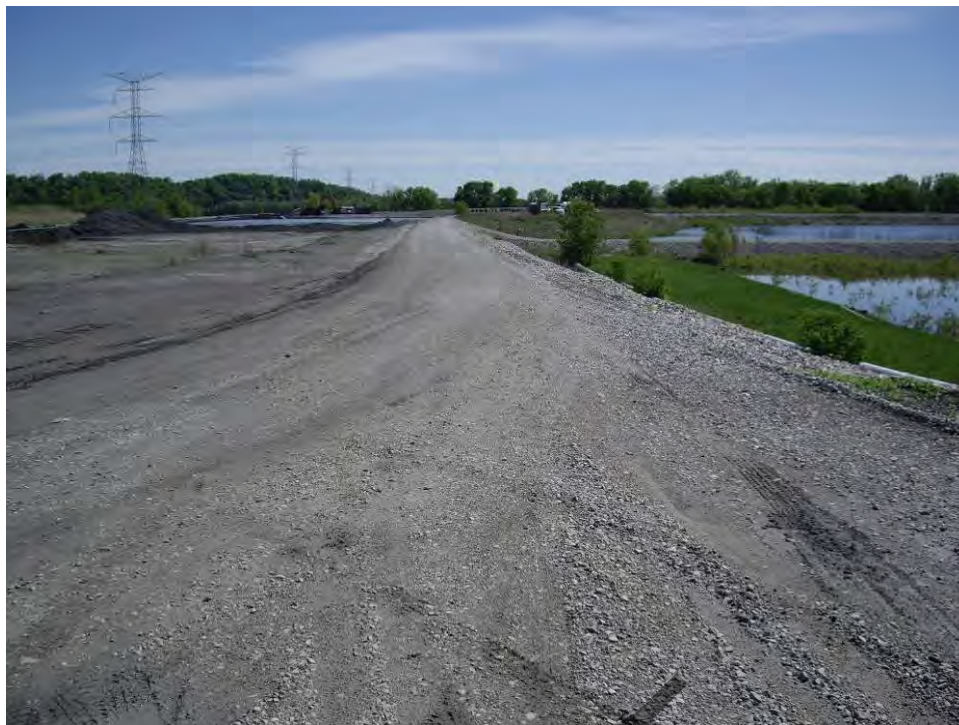
43. Crest of divider embankment A/C from Pond C north embankment, looking south.

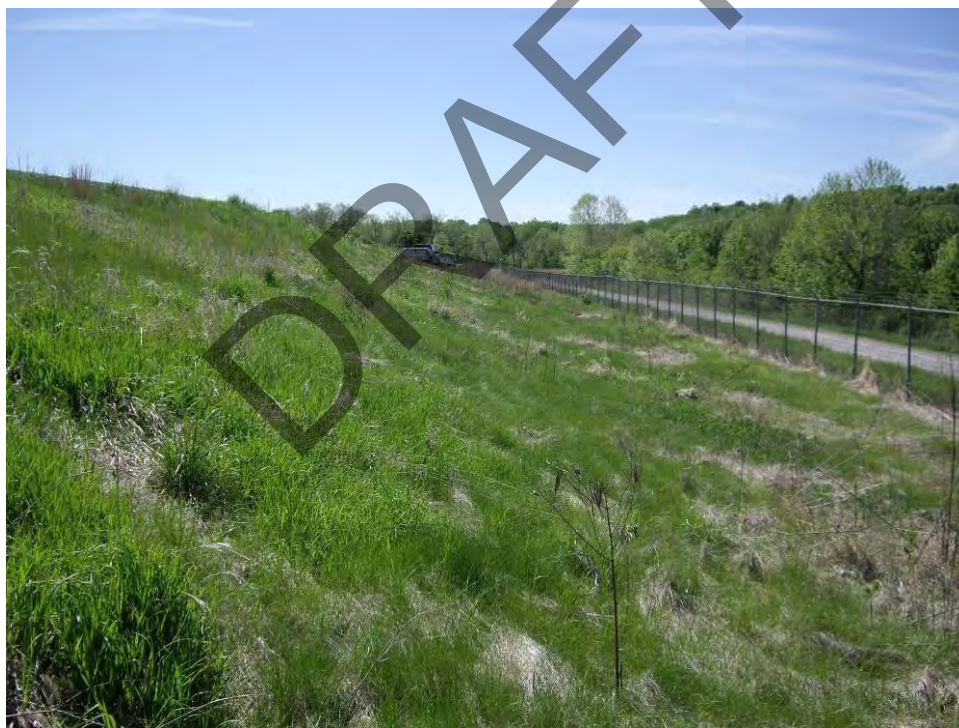
46. Pond C - North embankment exterior slope, looking west.

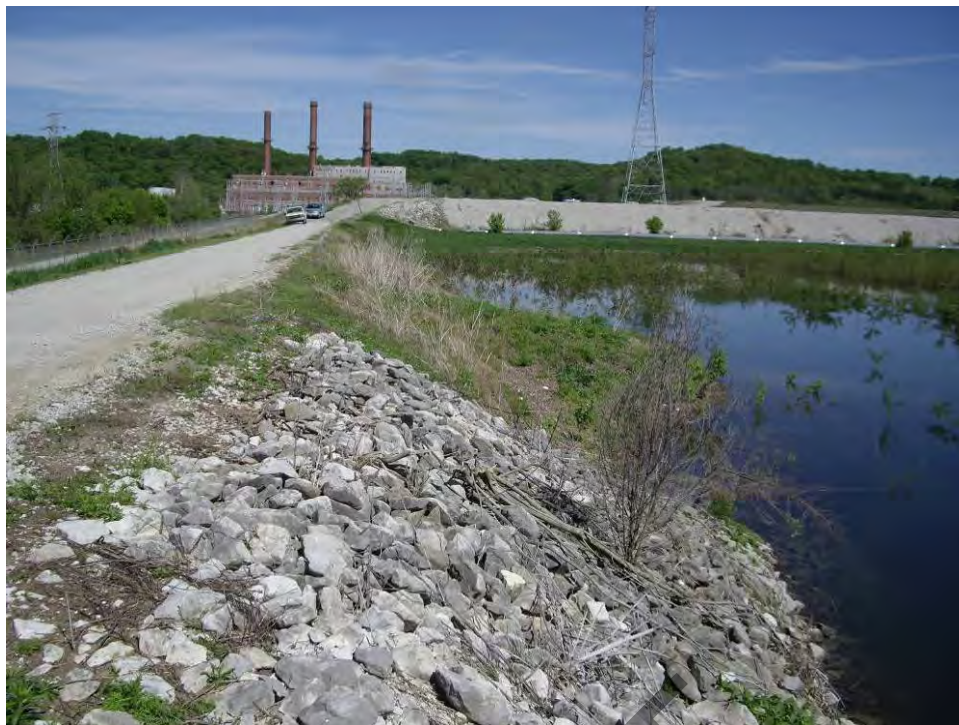
49. Pond C - North embankment interior slope, looking east. Note brush and limited riprap on slope.

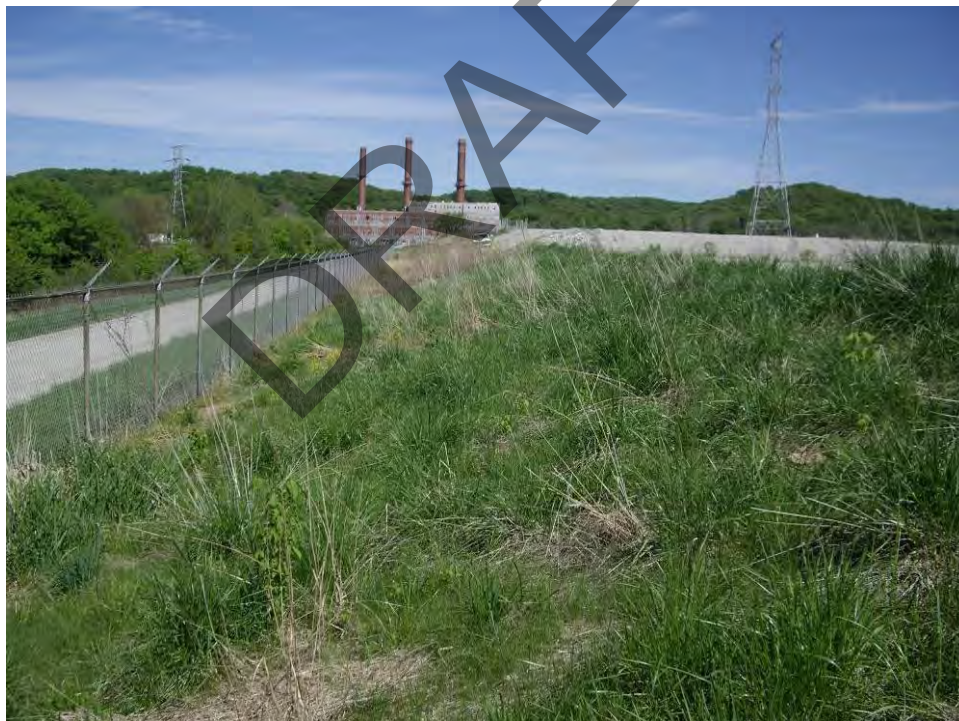
50. Pond C - North embankment exterior slope, looking east.

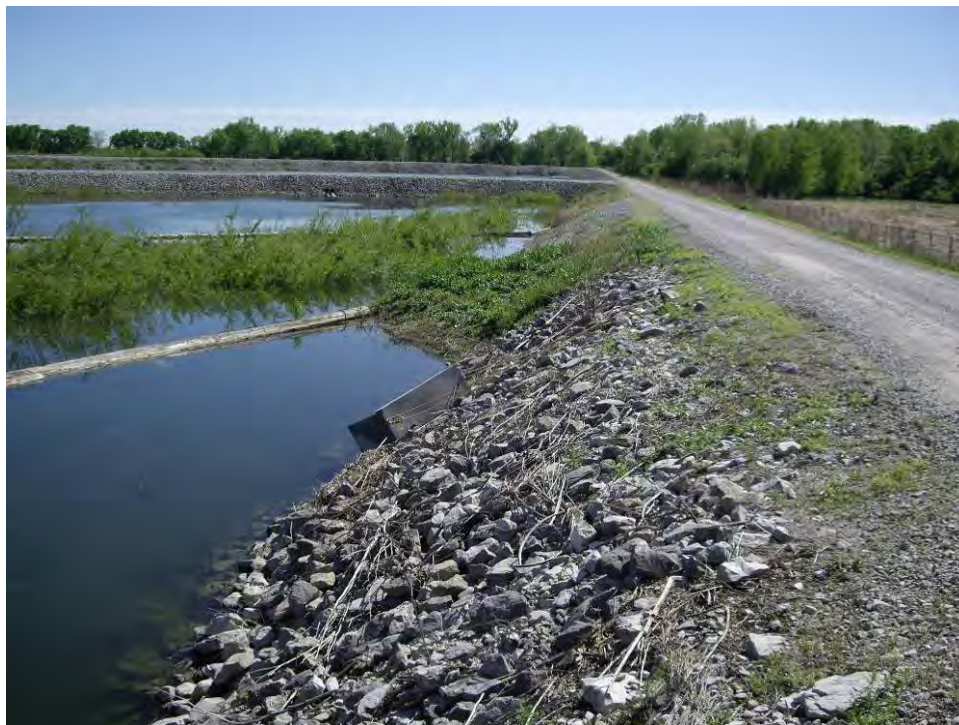
51. Pond C - West embankment interior slope, looking south.

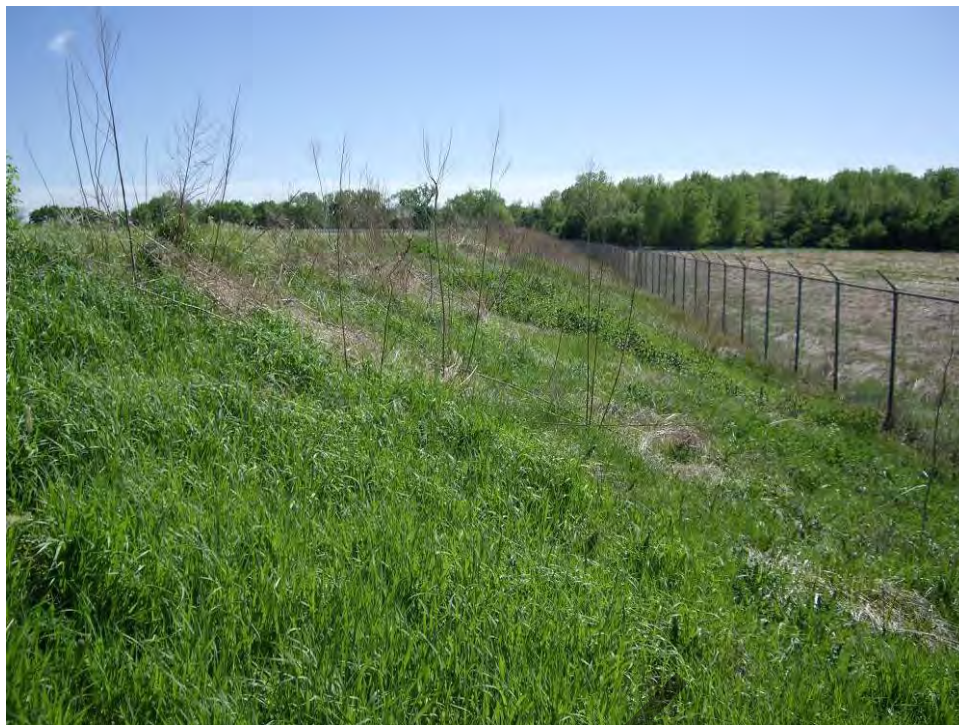
53. Pond C – West embankment exterior slope, looking south.

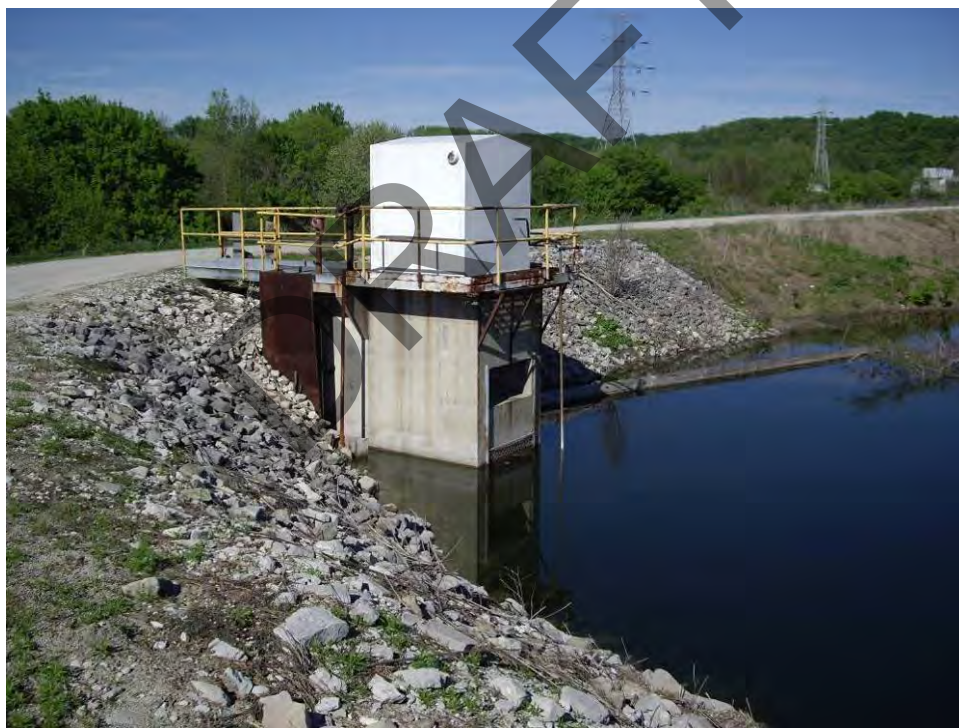
54. Pond C – Outlet structure gatehouse. Note stoplogs and butterfly valve in catwalk.
