# **Assessment of Dam Safety of Coal Combustion Surface Impoundments**

**Indianapolis Power & Light Company**

**Eagle Valley Generating Station**

**June 4, 2010**

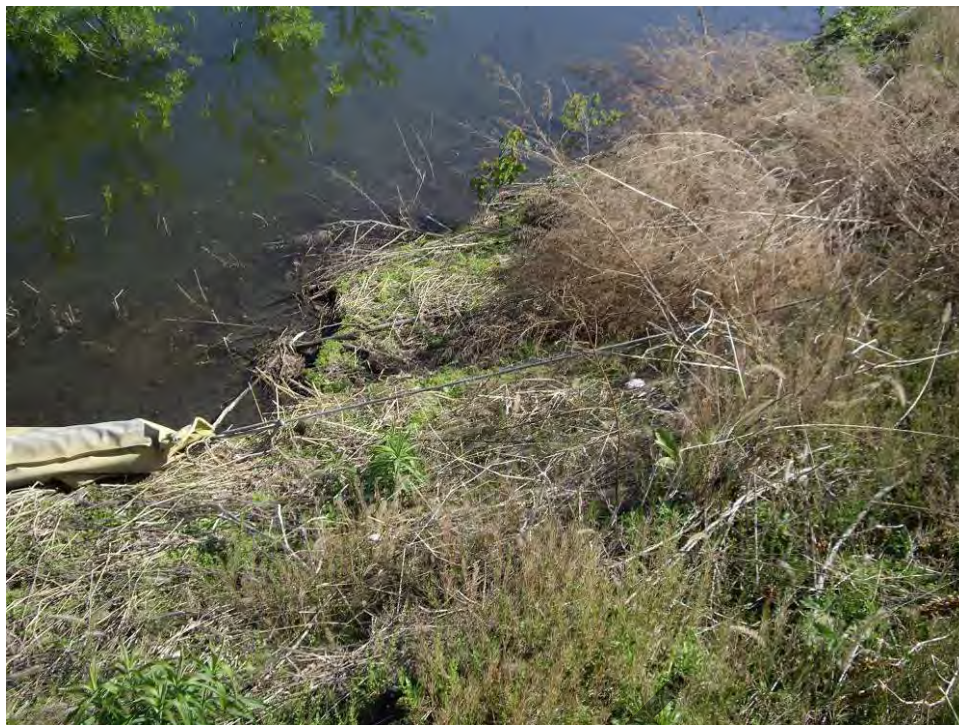
55. Pond C - Erosion feature from diversion boom tie line.

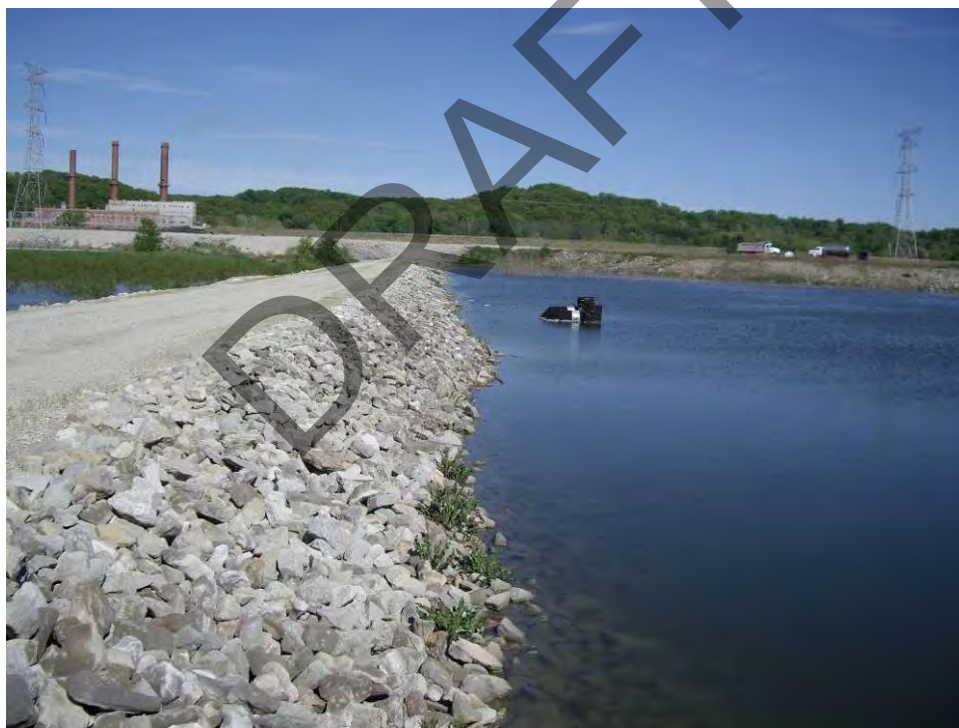
58. South slope of divider embankment B/C, looking east.

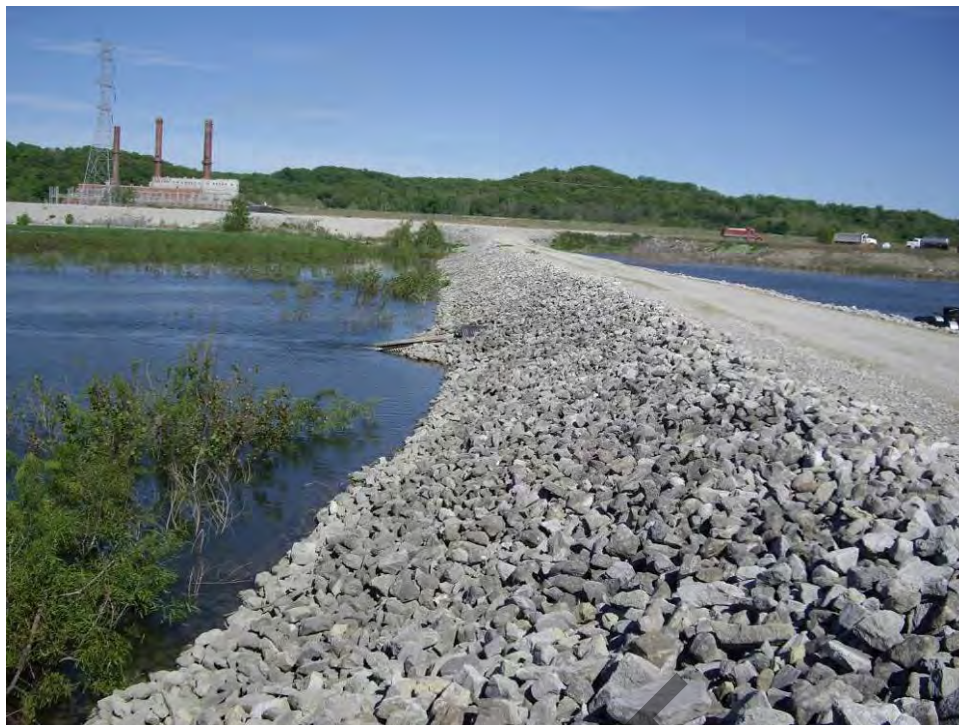
59. North slope of divider embankment B/C looking east.

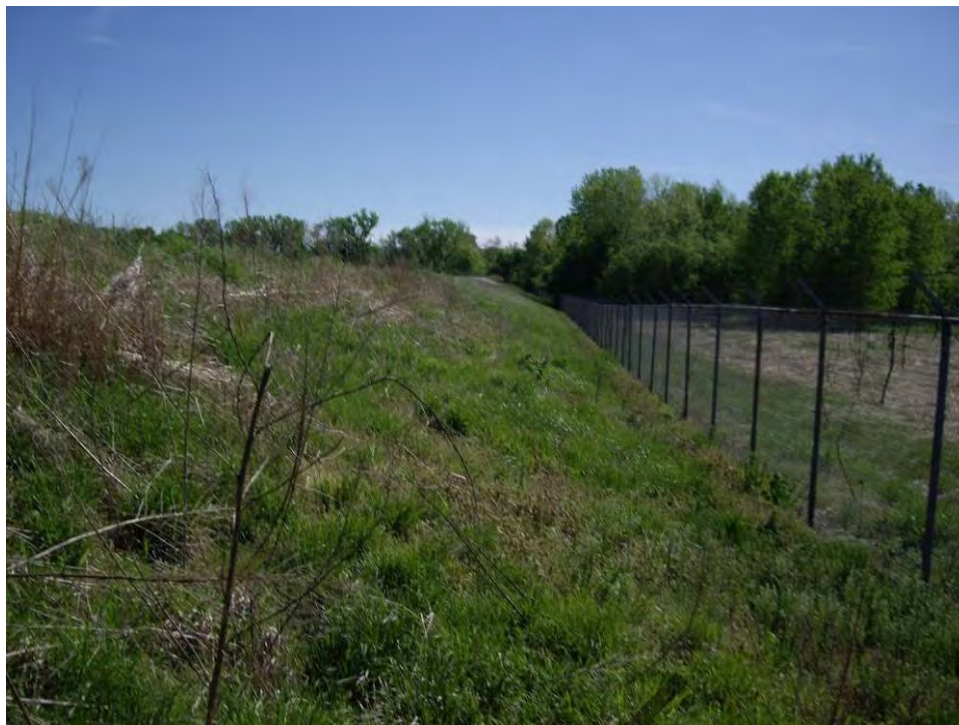
61. Pond B - west embankment exterior slope, looking south.

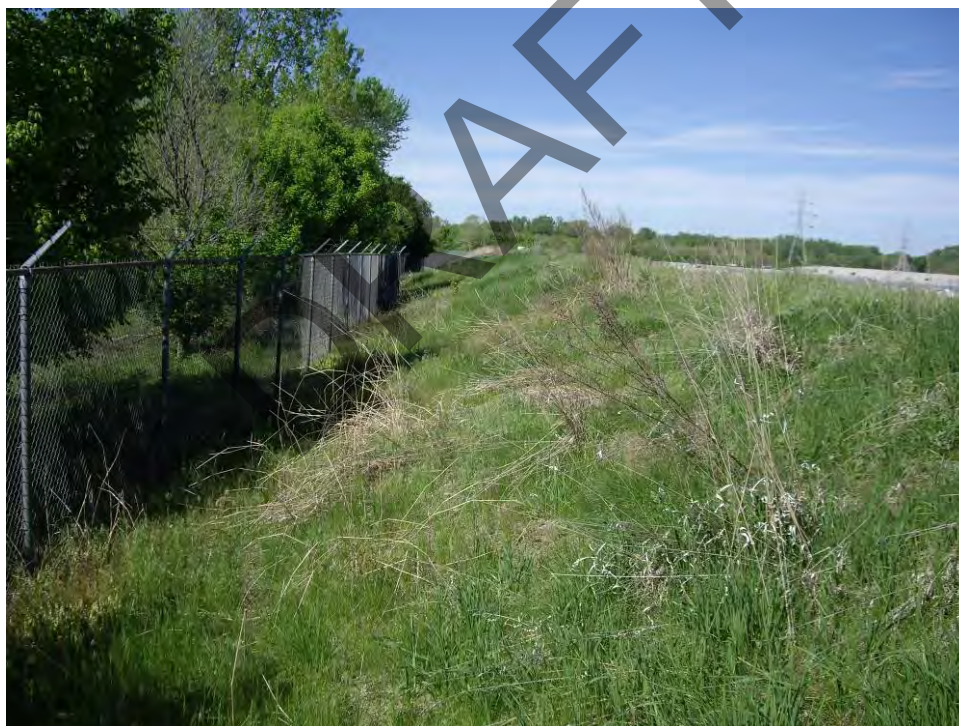
64. Pond B – west embankment exterior slope, looking north

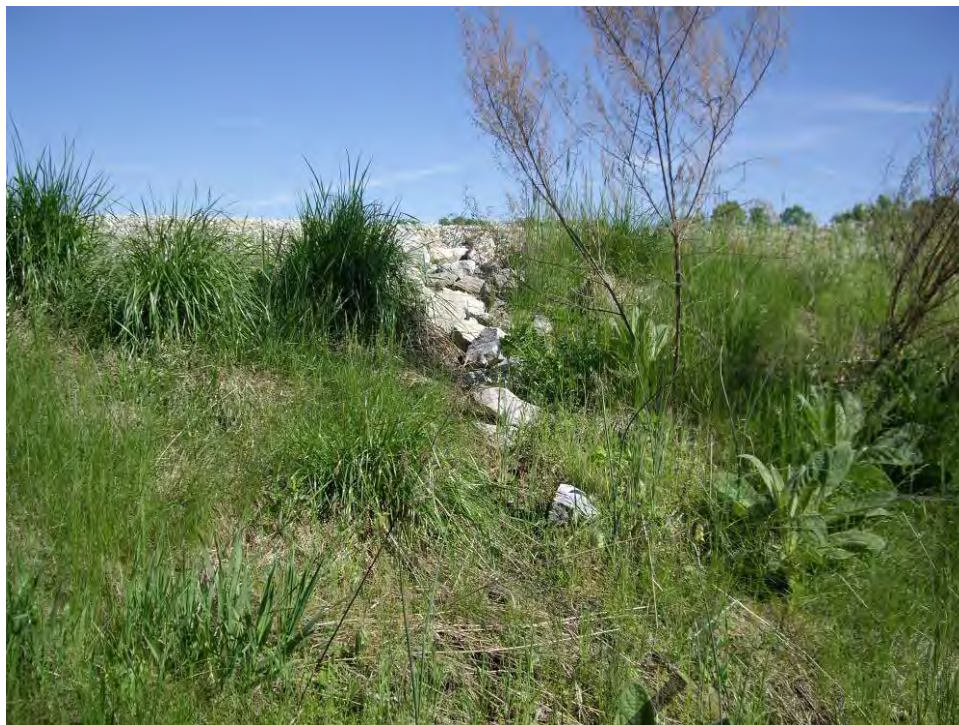
65. Pond B - erosion rill on exterior slope recently filled in with riprap, looking east.

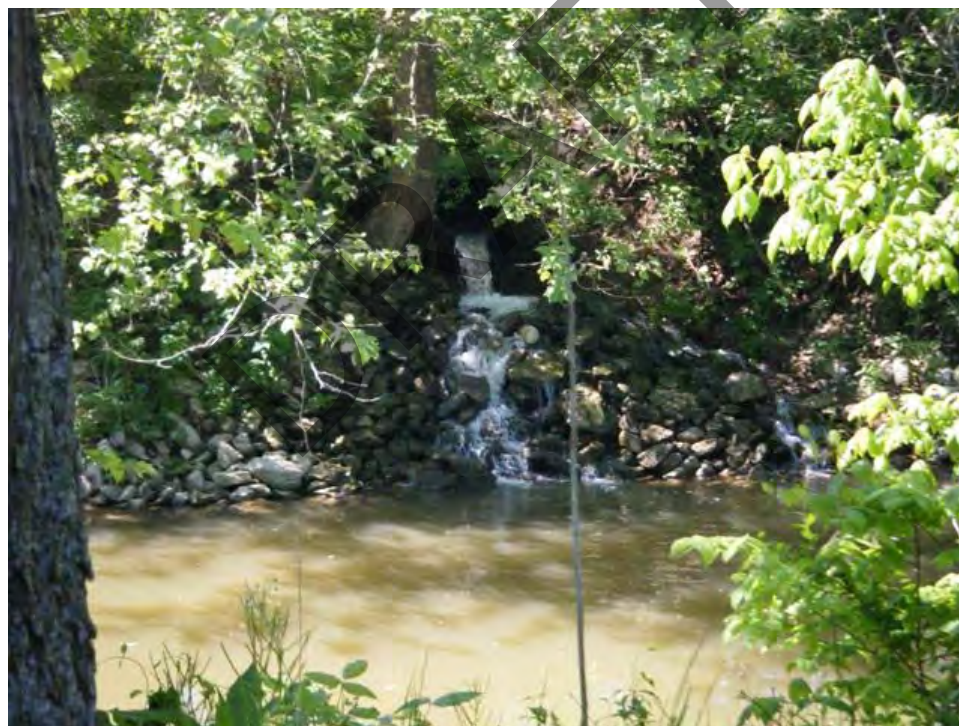
66. Pond C - Outlet structure outfall to discharge canal, looking south.

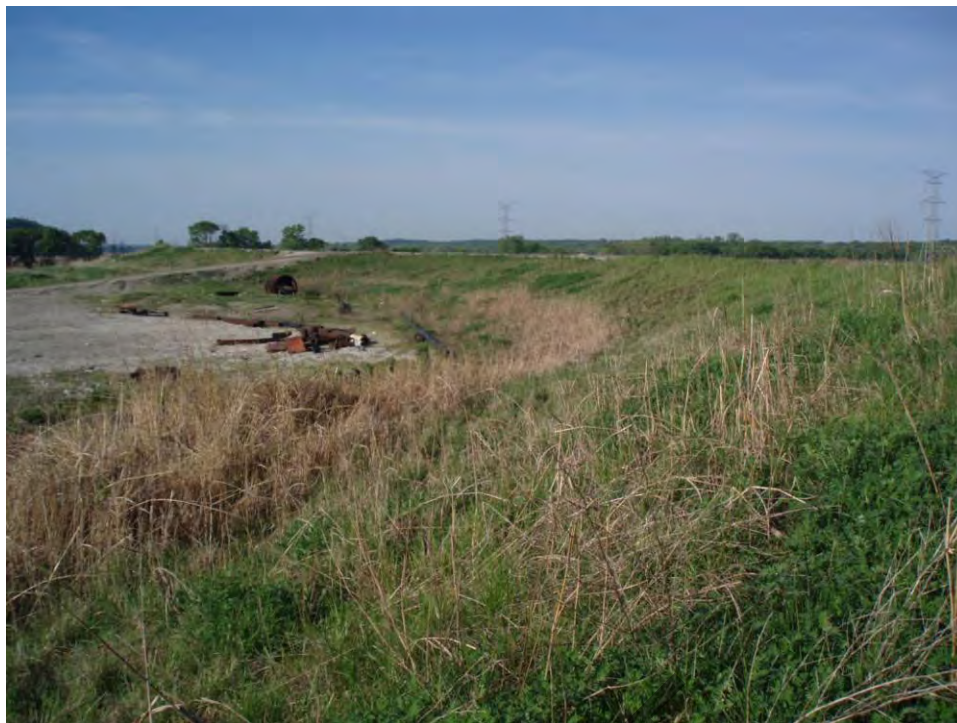
67. Pond D - east embankment exterior slope, looking southwest.

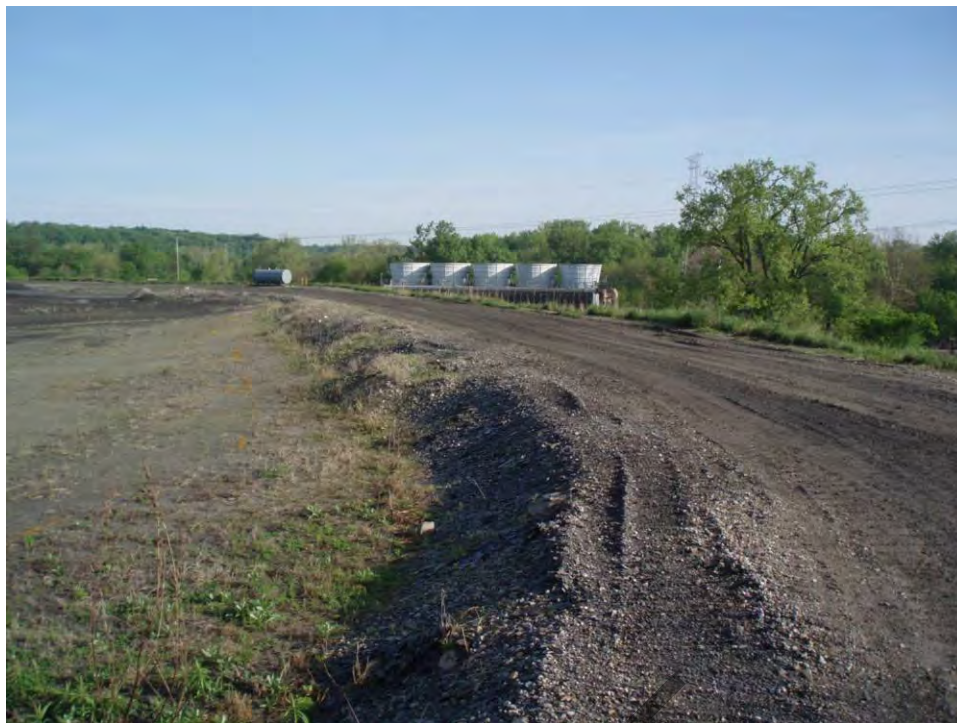
69. Pond D - north embankment crest, looking northwest.

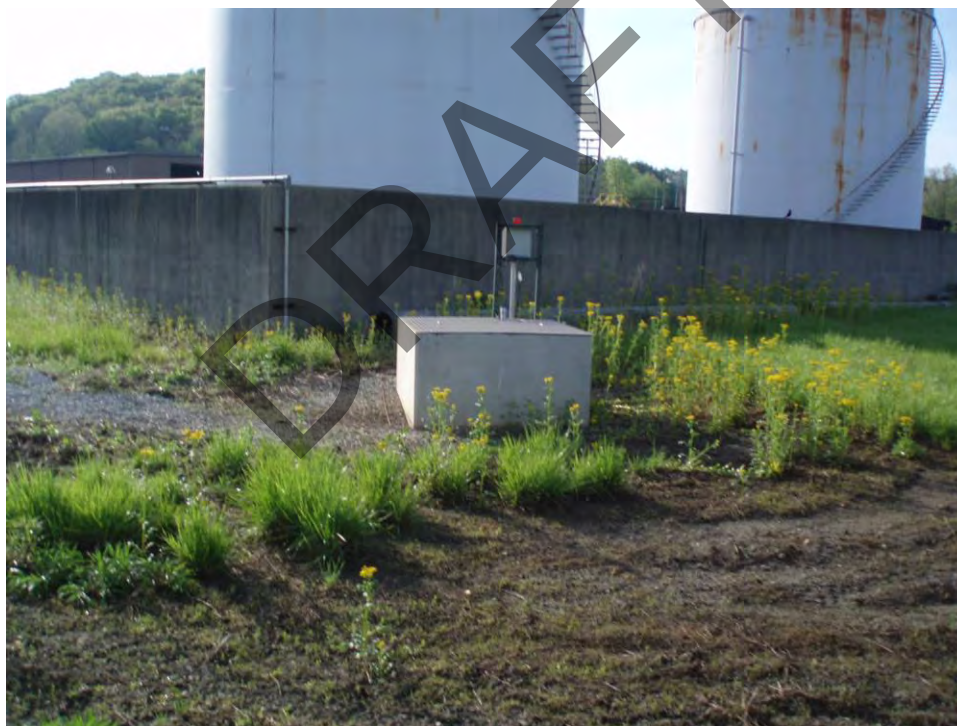
70. Pond D - north embankment toe drain sump pit located in northeast downstream area.

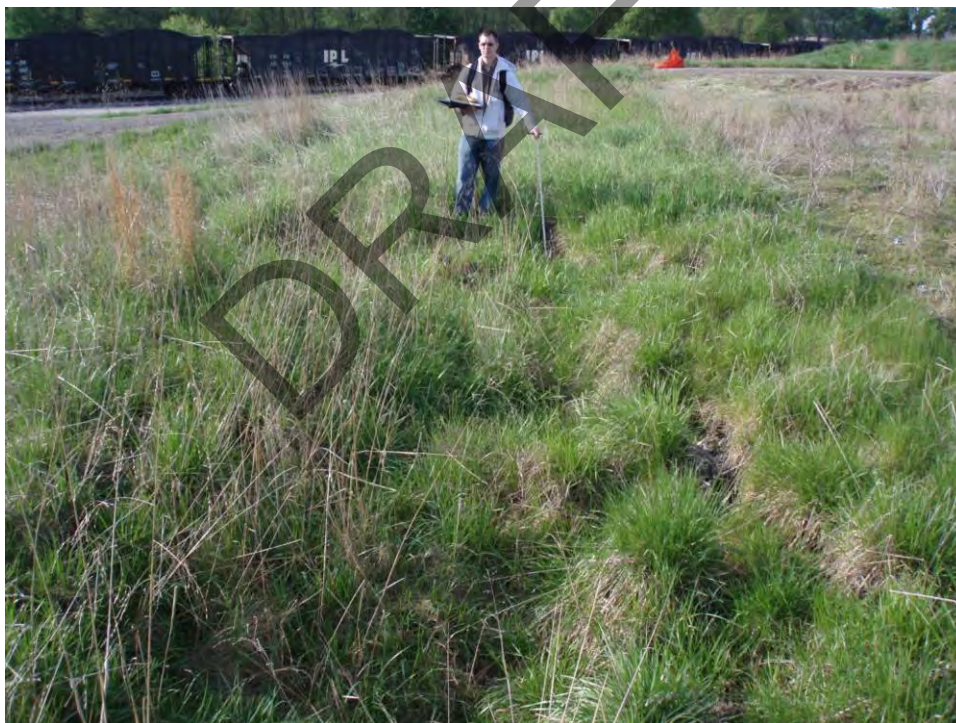
72. Pond D - Erosion rill and depression on east embankment buttress berm, looking south.

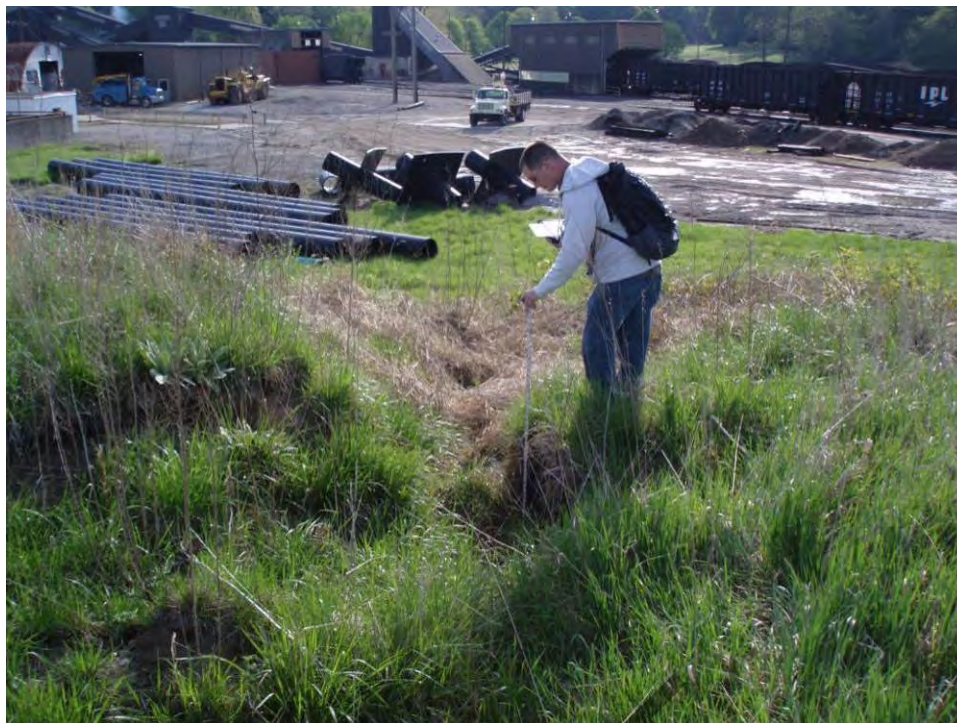
73. Pond D - Erosion rill on east embankment buttress berm, looking northeast

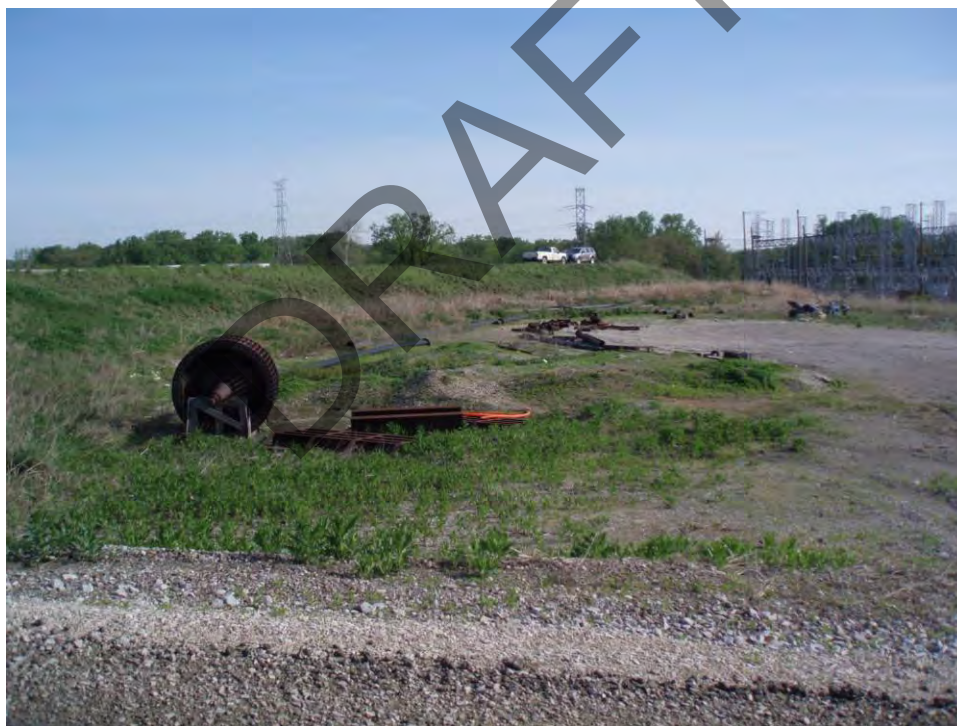
74. Pond D - Crest of east embankment buttress berm, looking north

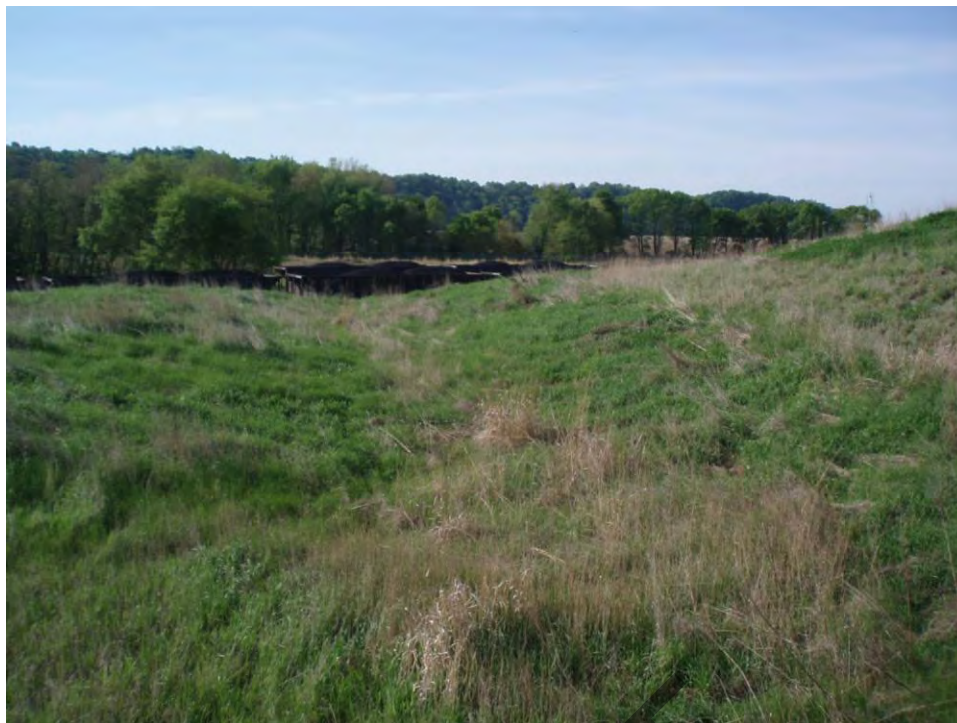
75. Pond D - Crest of east embankment buttress berm, looking south

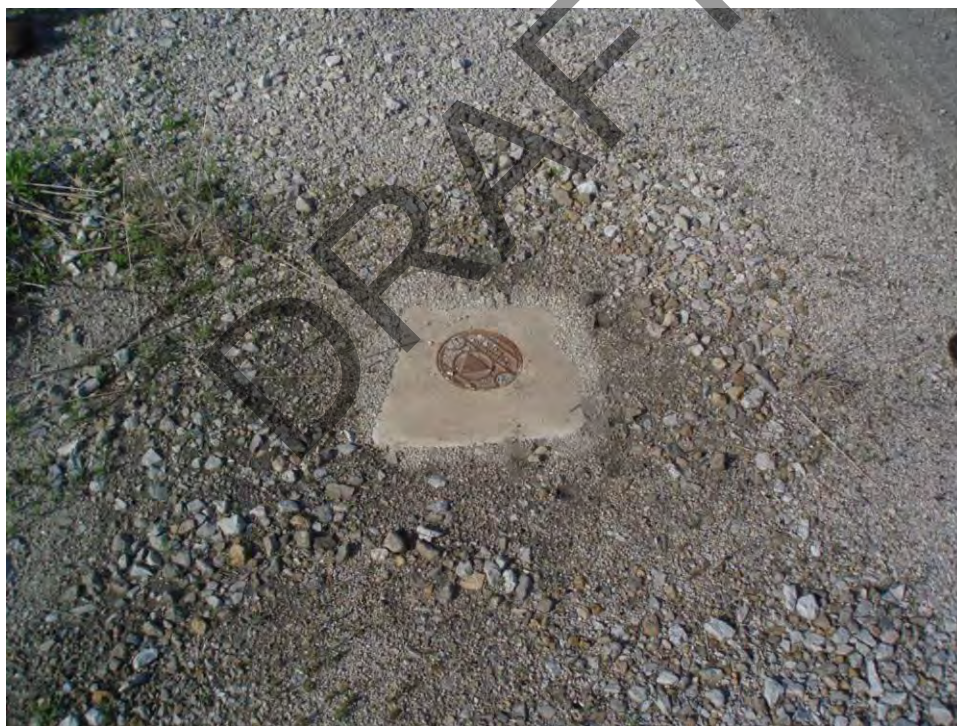
78. Piezometer PZ-2 on Pond D east embankment crest installed by BT<sup>2</sup> on 6/12/08.

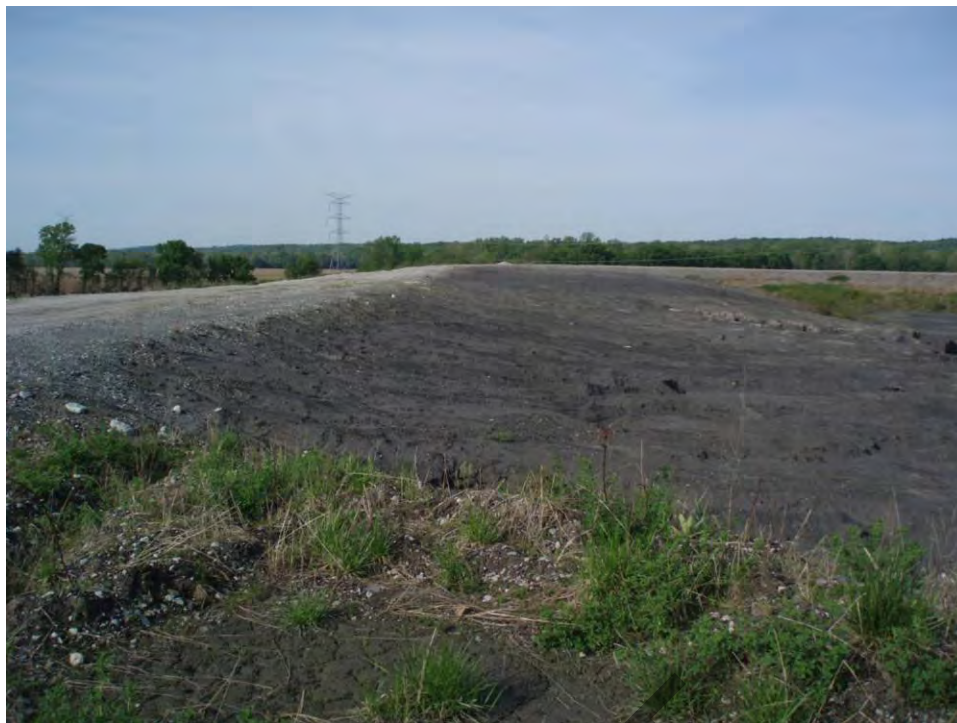
79. Pond D – Southeast embankment interior area, looking southwest

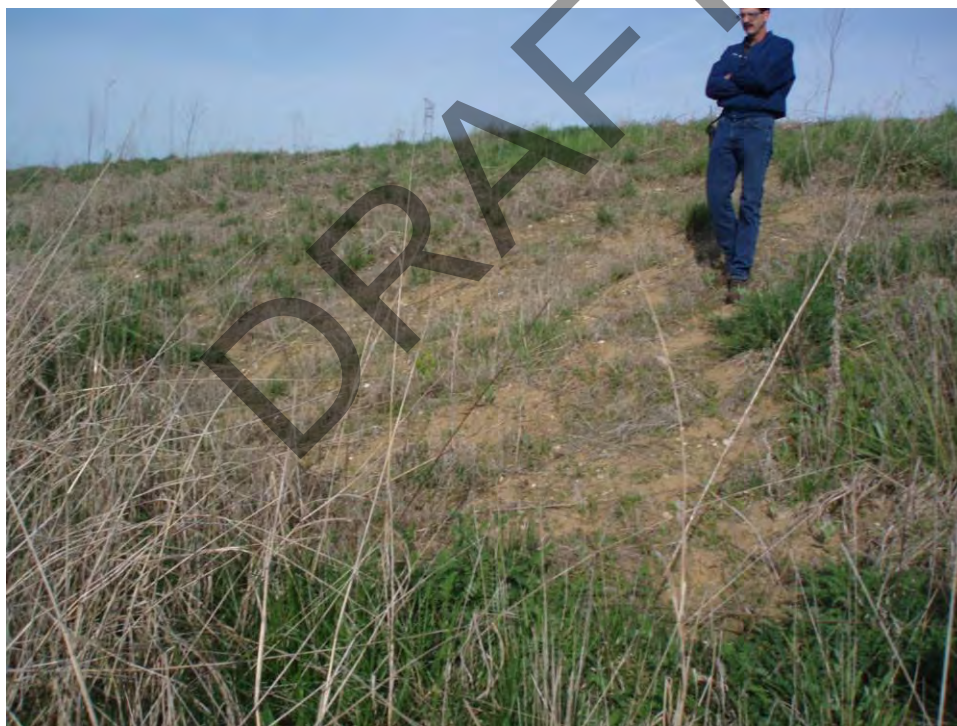
80. Pond D - Large bare spot on upper third of southeast embankment exterior slope, looking northwest.

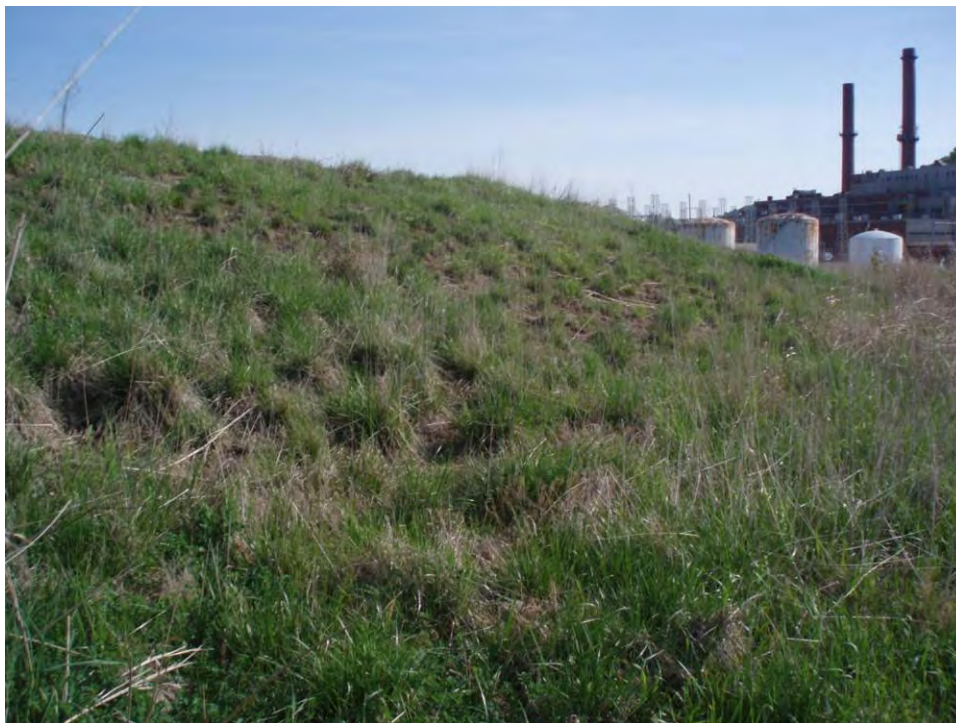
81. Typical bare spots on upper third of Pond D exterior embankment (last expansion).

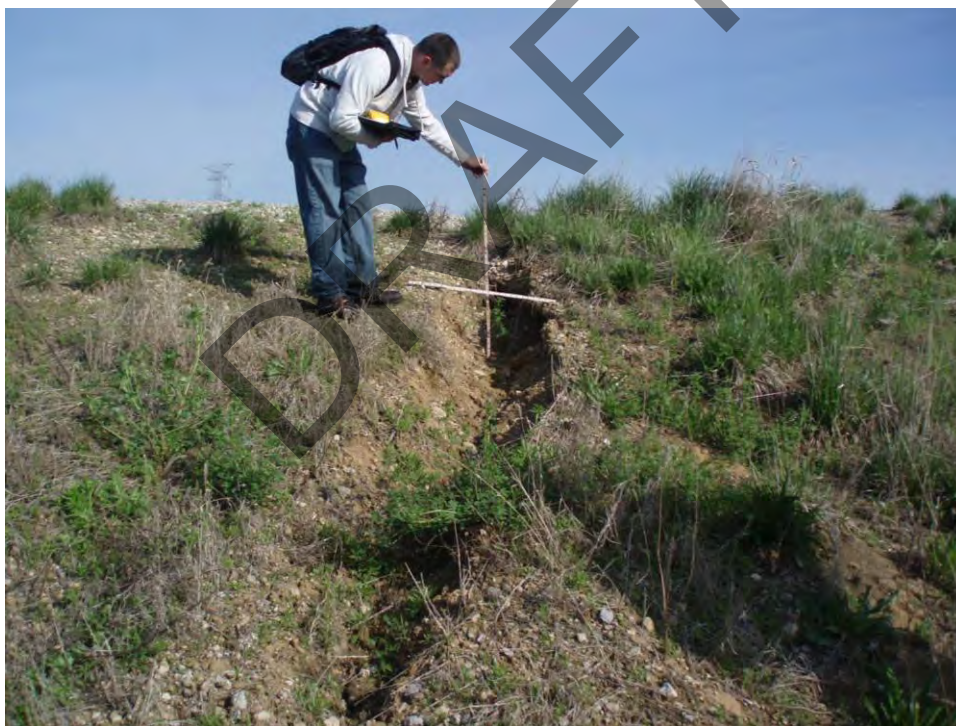
82. Pond D - Erosion rill on southeast embankment exterior slope, looking northwest.

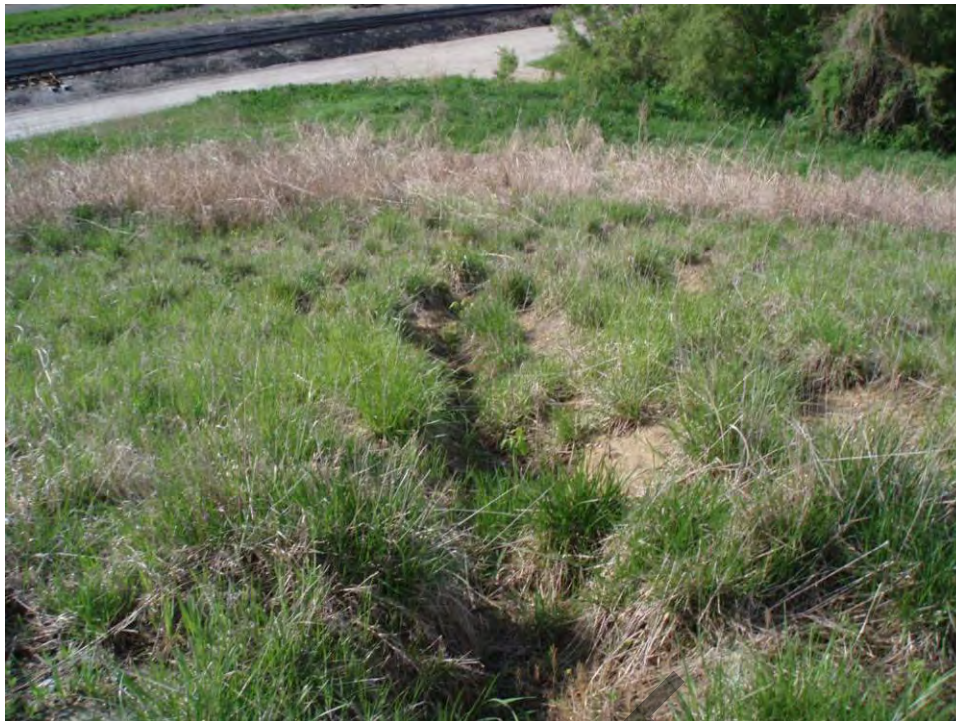
85. Pond D - Erosion rill on southeast embankment exterior slope, looking southeast.

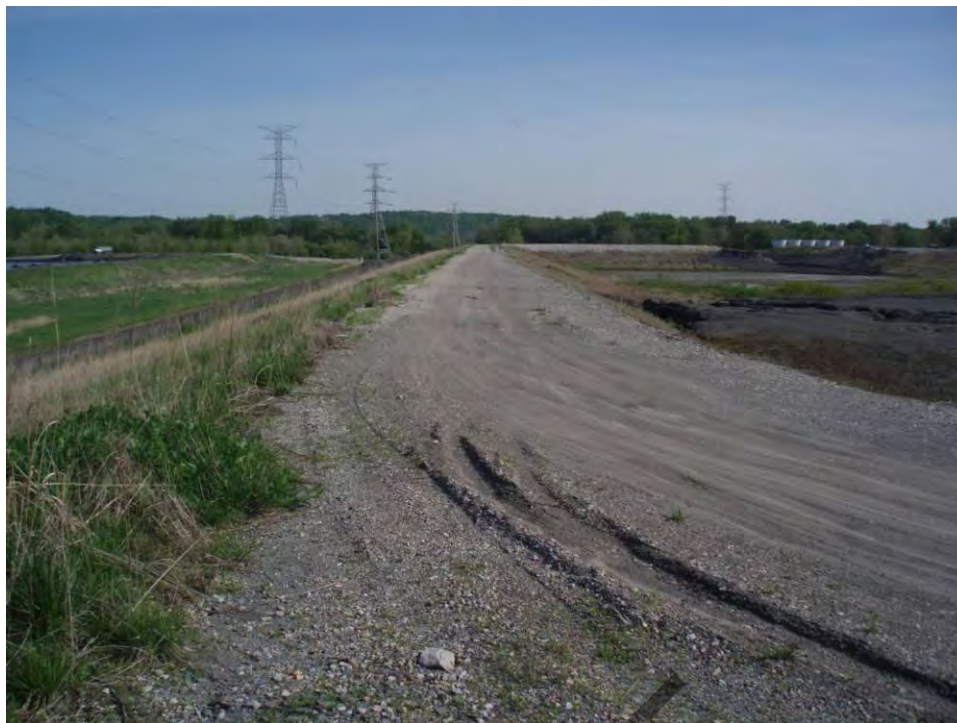
87. Pond D - West embankment crest, looking north

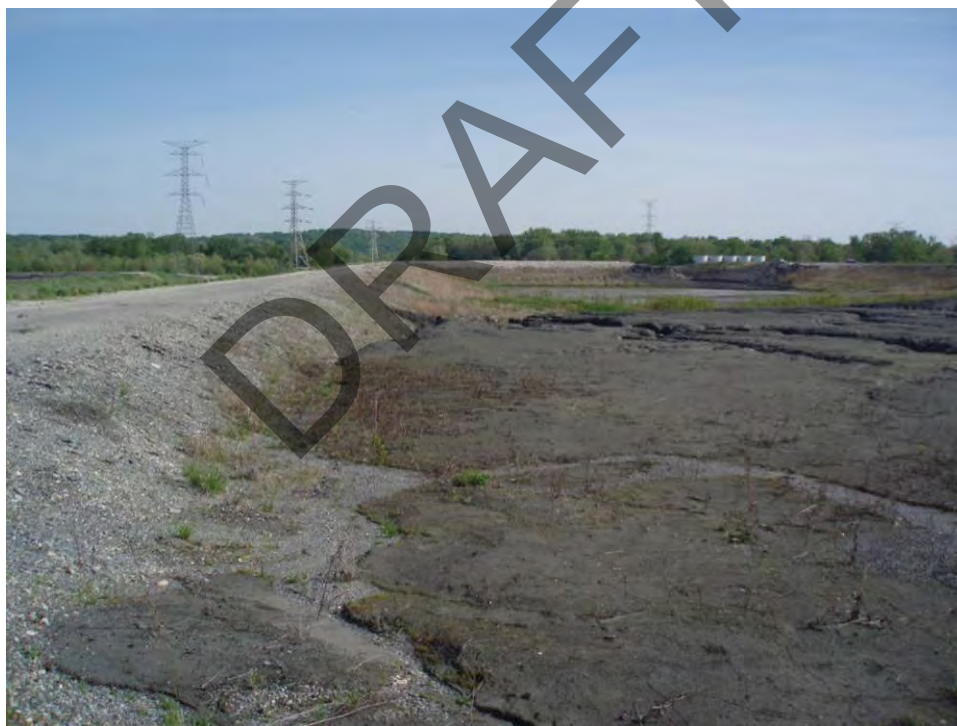
88. Pond D - West embankment interior slope, looking north.

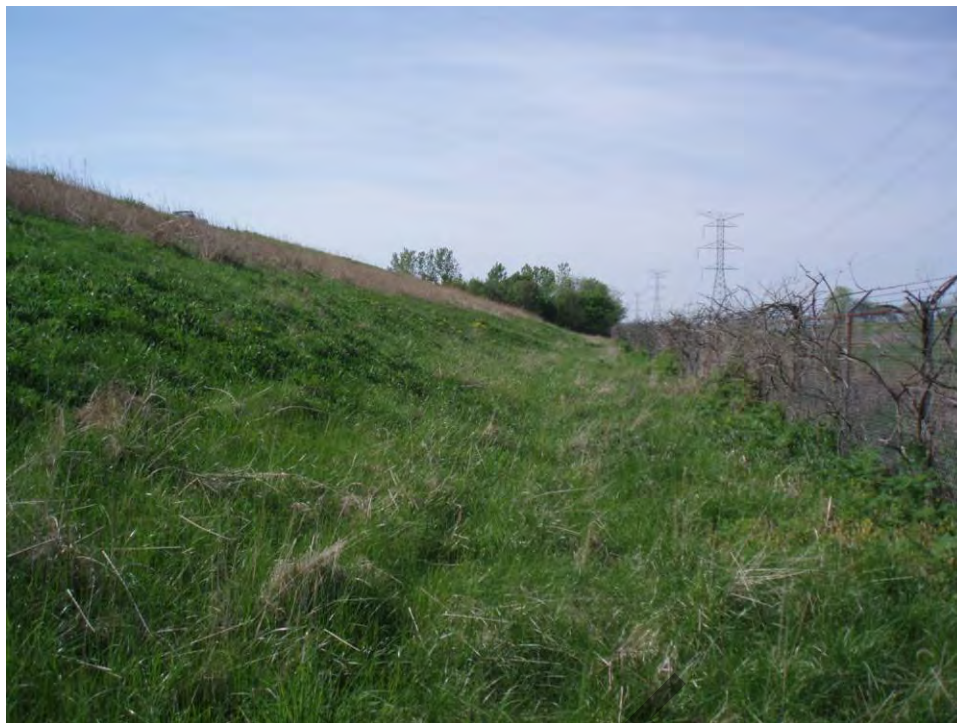
91. Pond D – West embankment exterior slope, looking south.

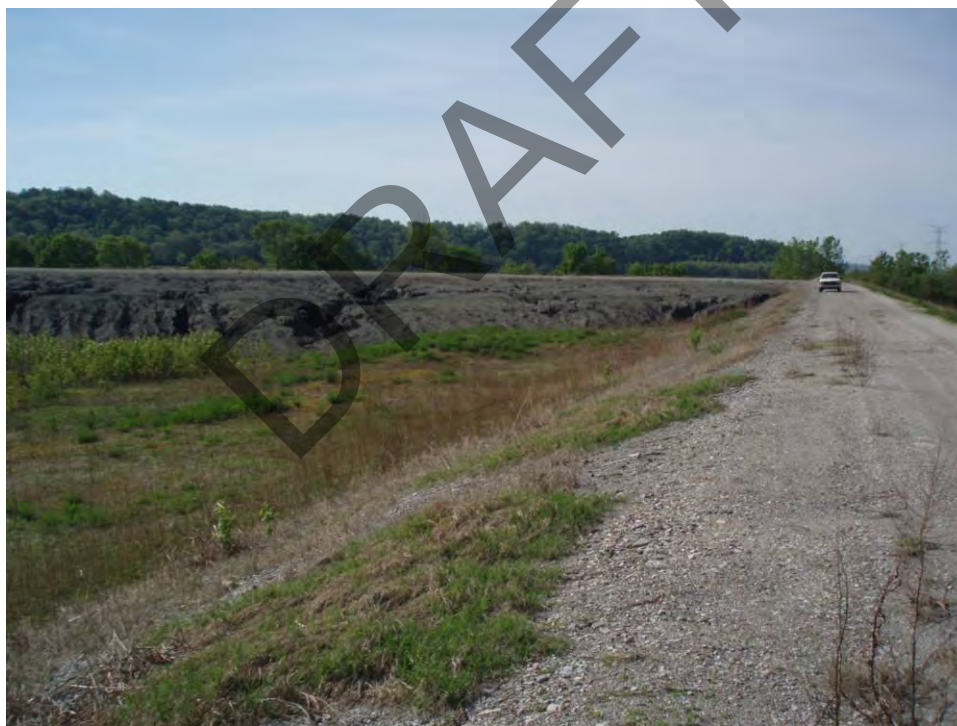
92. Pond D – West embankment interior slope, looking south at edge of ash limit prior to Pond D/E embankment failure.

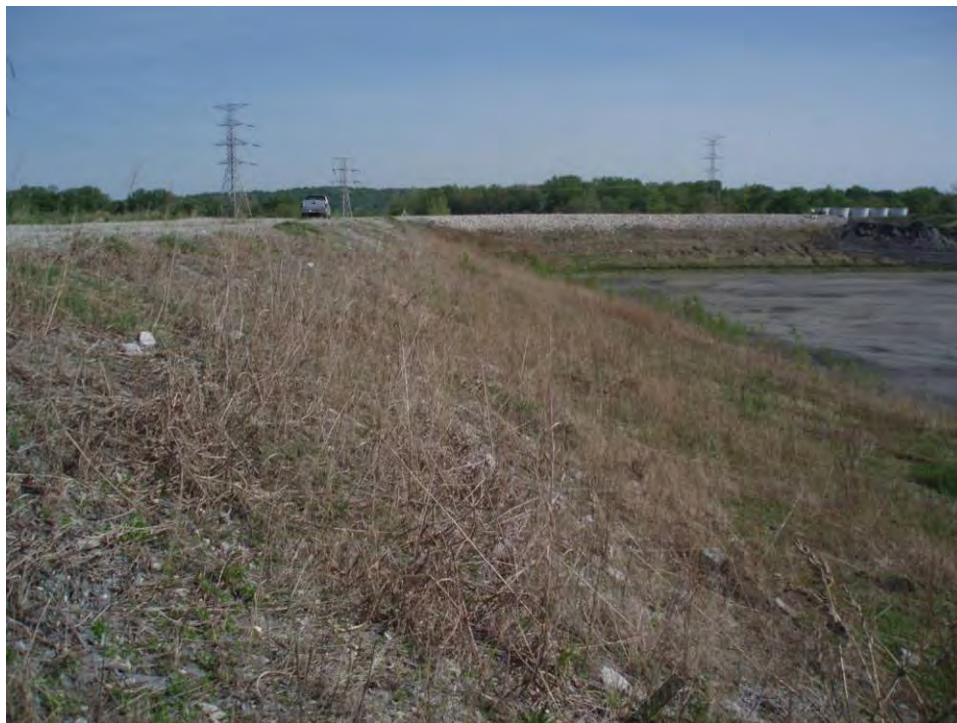
93. Pond D – West embankment interior slope, looking north toward divider embankment D/E.

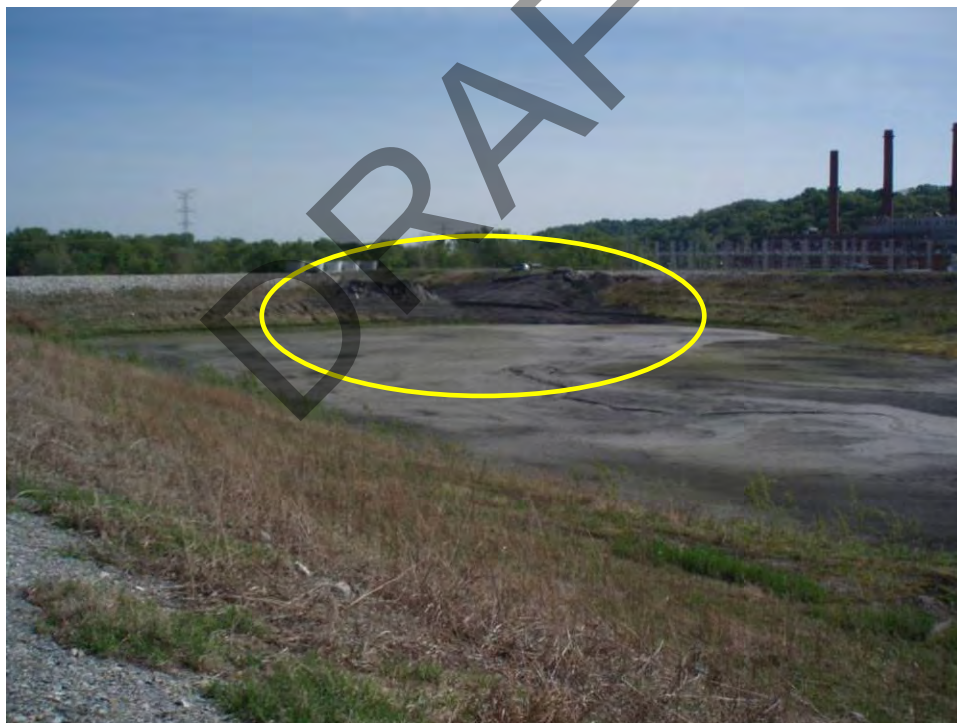
The north divider embankment D/E failed for the first time on February 14, 2007. Based on reports by BT<sup>2</sup>, water in Pond D was probably at the level of the invert of the outlet pipes that were constructed through north divider embankment D/E (Elevation El. 639.5). Failure appeared to occur at the eastern reach of divider embankment D/E resulting in a semi-circular bowl shaped feature that formed at the north toe of divider embankment D/E and east towards the intersection of northern divider embankment D/E with the western divider embankment D/E and Pond D diversion embankment. Failure of divider embankment D/E caused the north and west embankment of Pond E to be overtopped and then the north embankment of Pond E breached into the discharge canal. BT<sup>2</sup> attributed the failure of divider embankment D/E to slope stability combined with piping erosion of the flyash at the north toe of divider embankment D/E.

94. Overview of Pond D, south slope of divider embankment D/E, and west slope of Pond D diversion embankment. Note breach (circled) in divider embankment D/E.

IPL began reconstruction of divider embankment D/E and the north embankment of Pond E in the summer of 2007. Construction was completed in November 2007 and the facility was put back in service. Pond D was filled with water to elevation 639.5 by the end of December 2007, and flow of water through the outlet pipes into Pond E began to occur. On January 30, 2008, the north divider embankment D/E failed for a second time. Failure of divider embankment D/E caused the north and west embankment of Pond E to be overtopped and then the north embankment of Pond E breached into the discharge canal. BT<sup>2</sup> completed the design of repairs that are currently under construction.

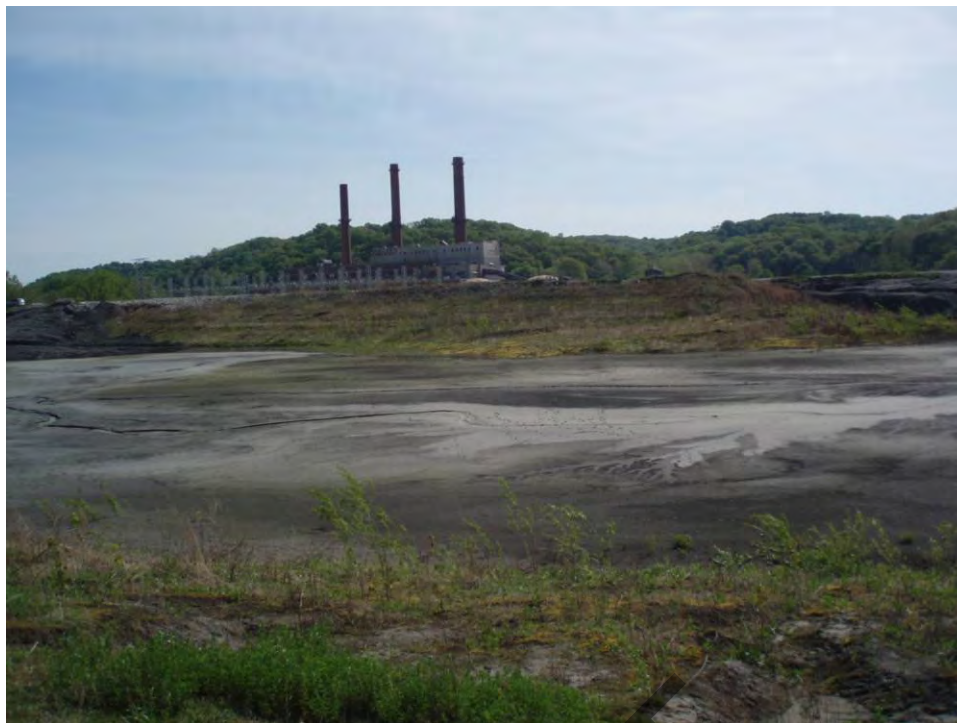
95. Overview of Pond D and west slope of Pond D diversion embankment, looking east.

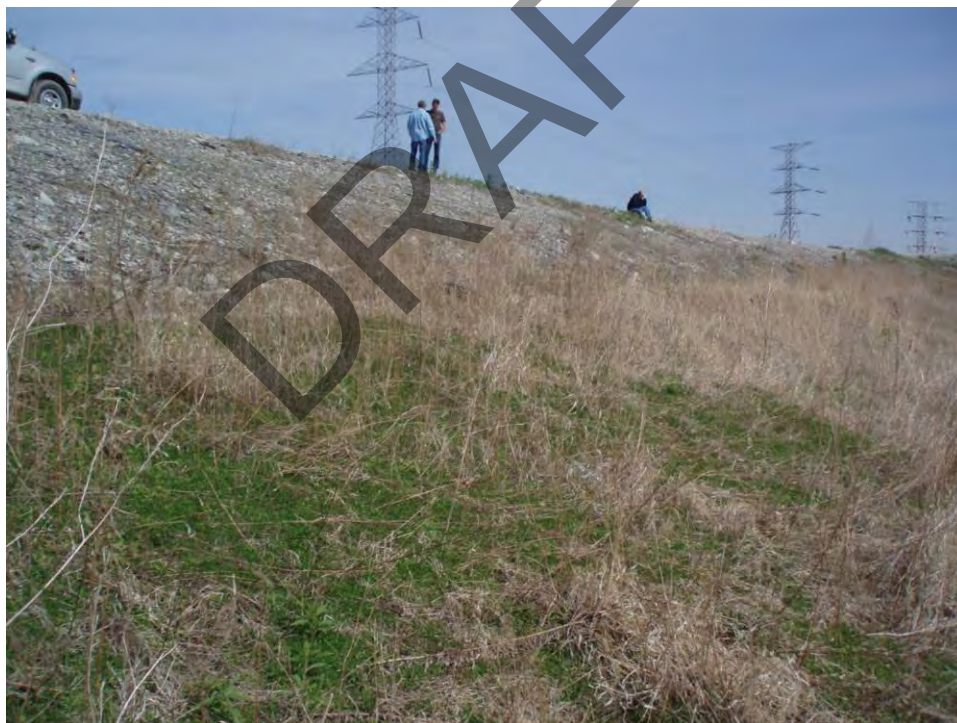
96. Pond D - West embankment typical interior slope with shale armor near crest.

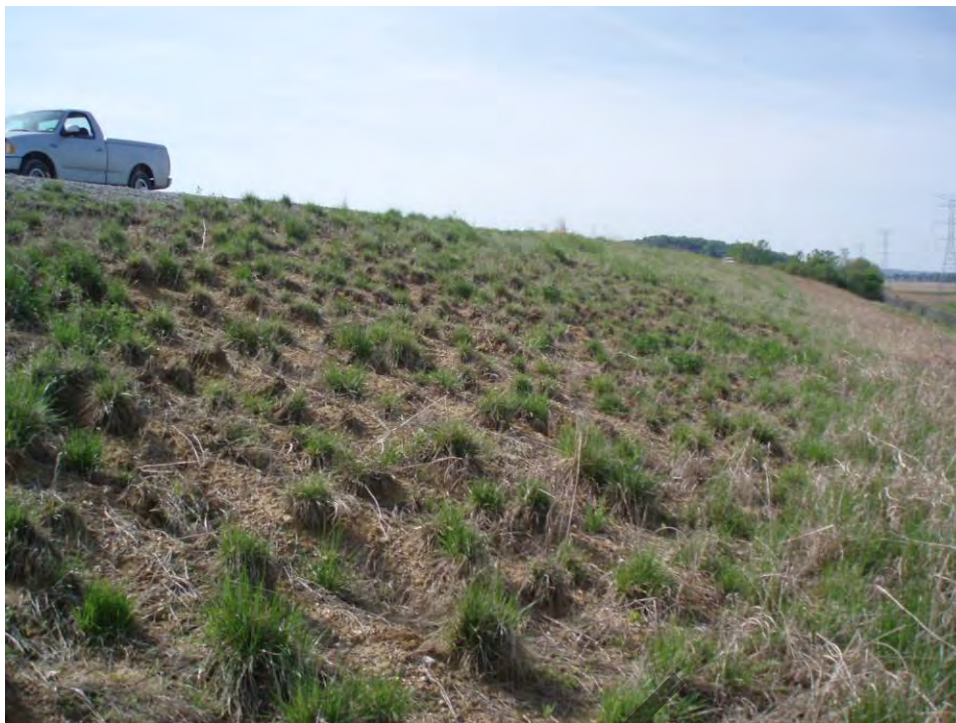
97. Pond D - Typical bare spot and erosion on west embankment exterior slope, looking southeast.

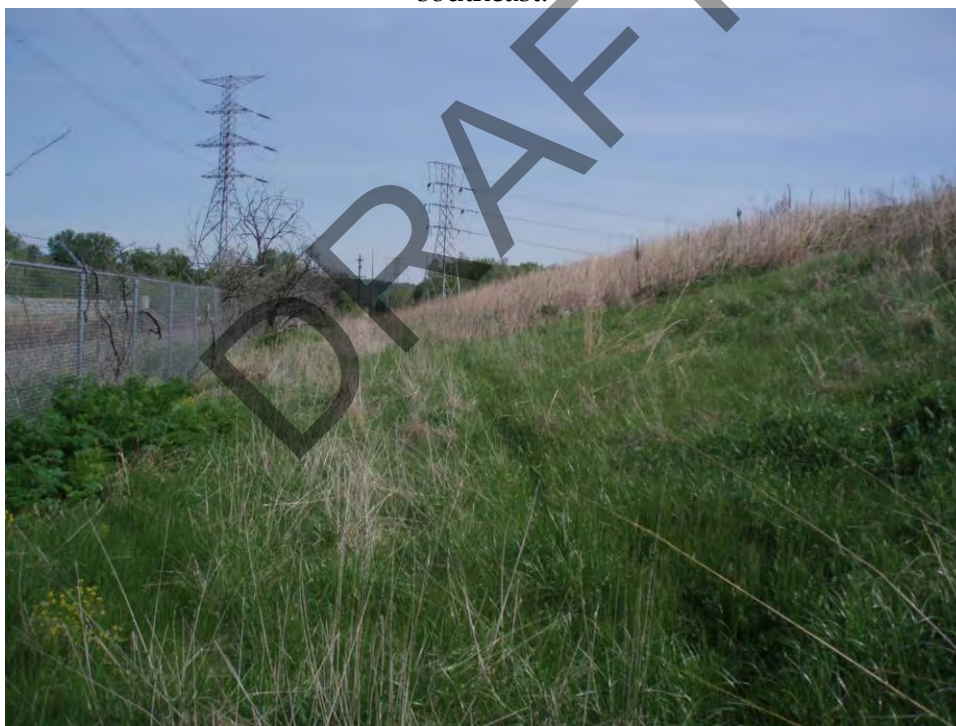
98. Pond D - West embankment exterior slope at toe, looking north.

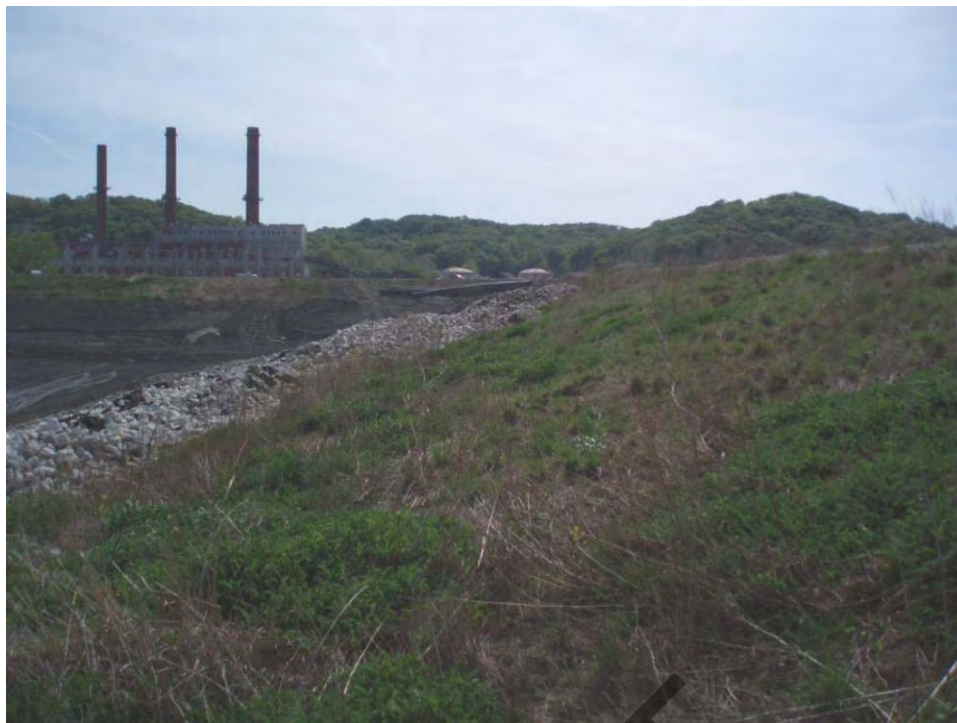
99. North slope of divider embankment D/E, looking east.
