# **Assessment of Dam Safety of Coal Combustion Surface Impoundments**

**Indianapolis Power & Light Company**

**Eagle Valley Generating Station**

**June 4, 2010**

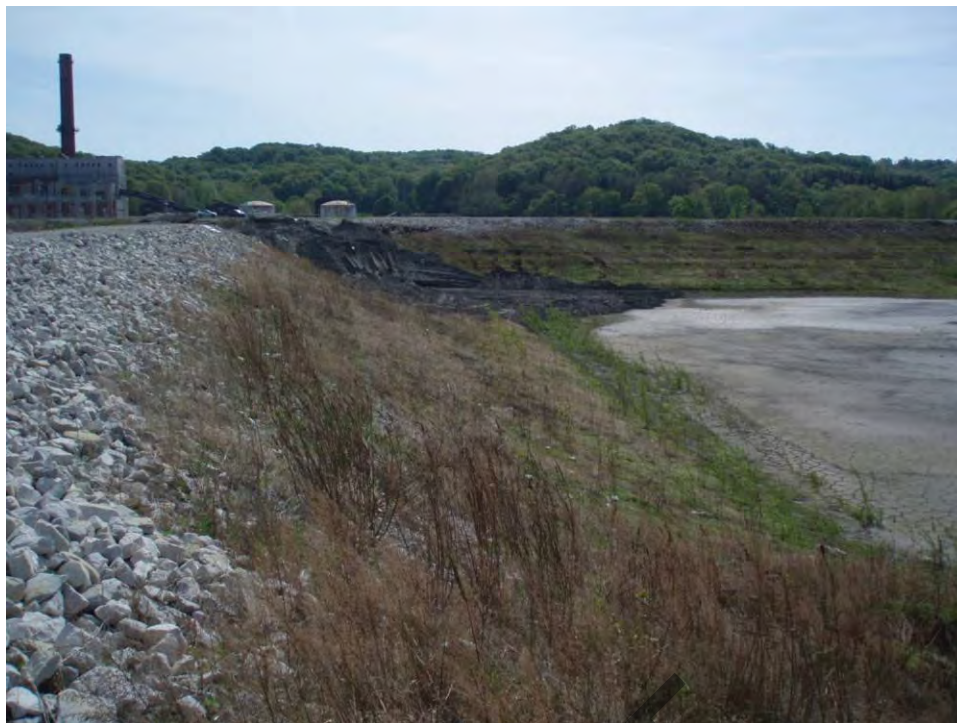
101. South slope of divider embankment D/E, looking east.

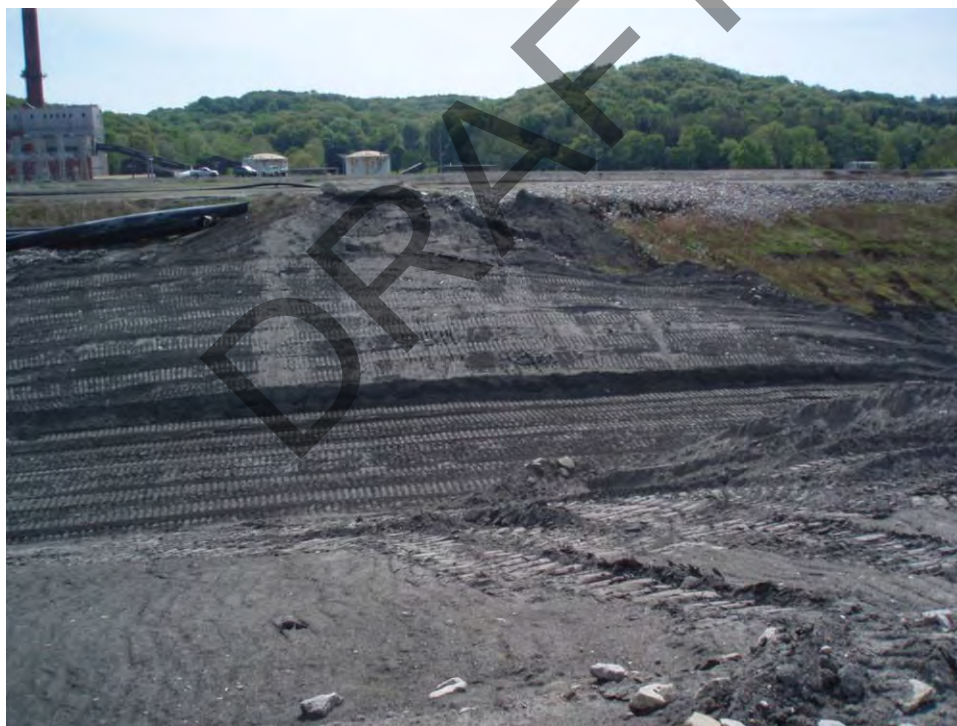
102. Overview of cut in divider embankment D/E for repair work.

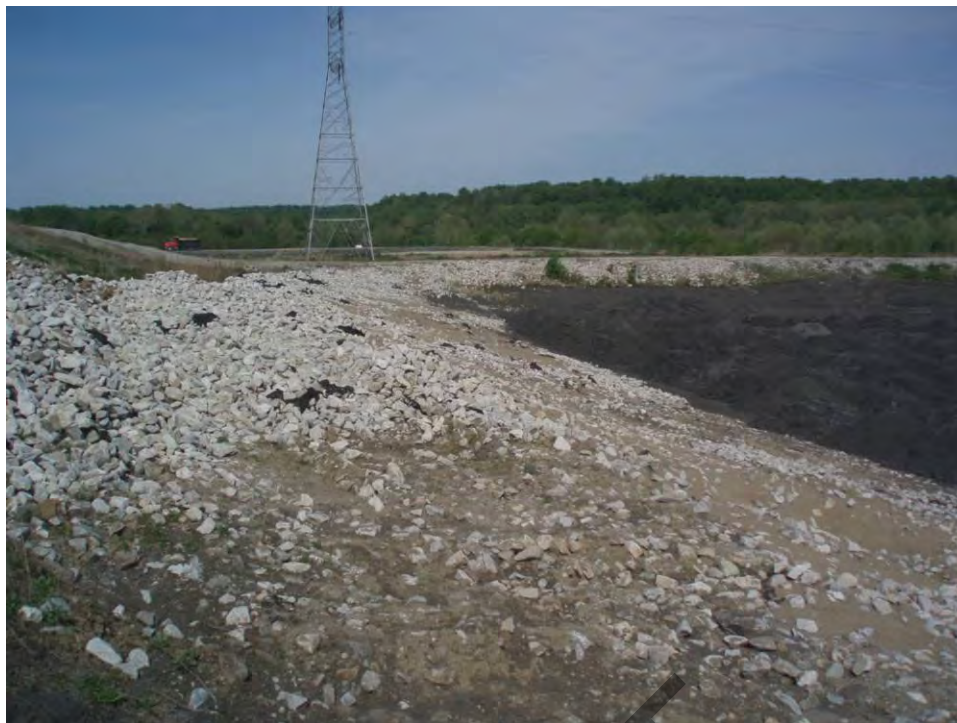
103. North slope of divider embankment D/E, looking west.

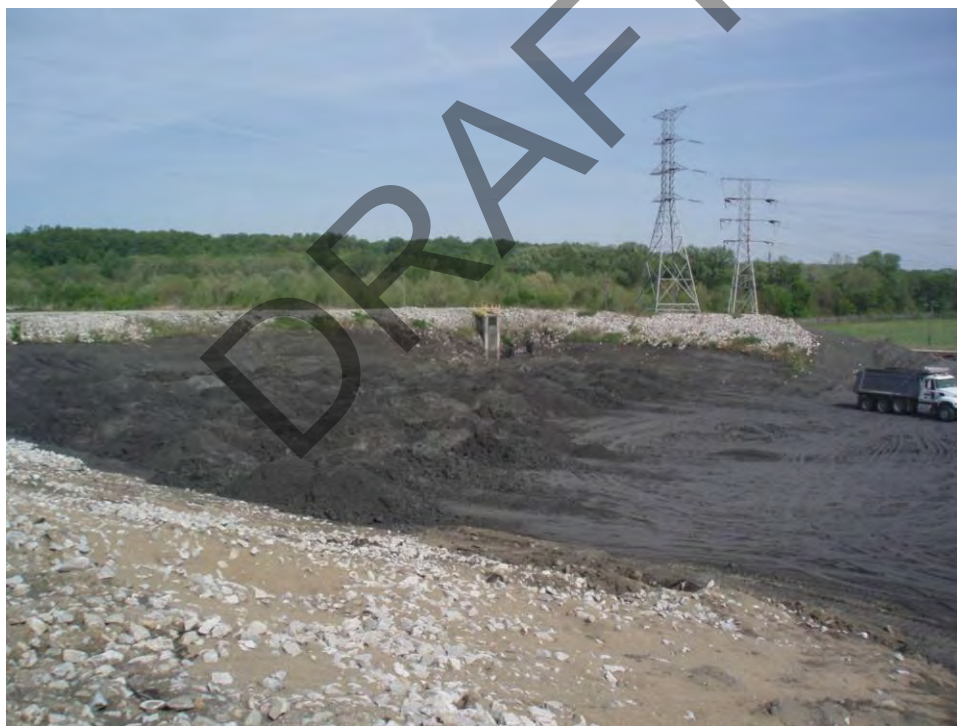
104. Overview of Pond E backfilling operation and Pond E outlet structure, looking northwest.

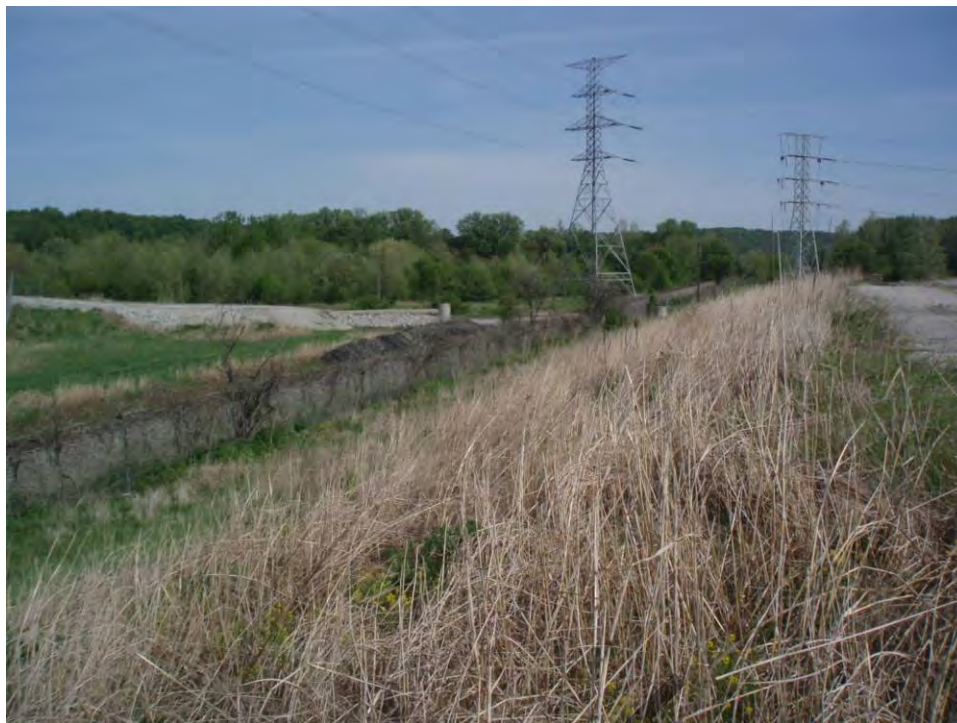
105. Pond E - West embankment exterior slope, looking north.

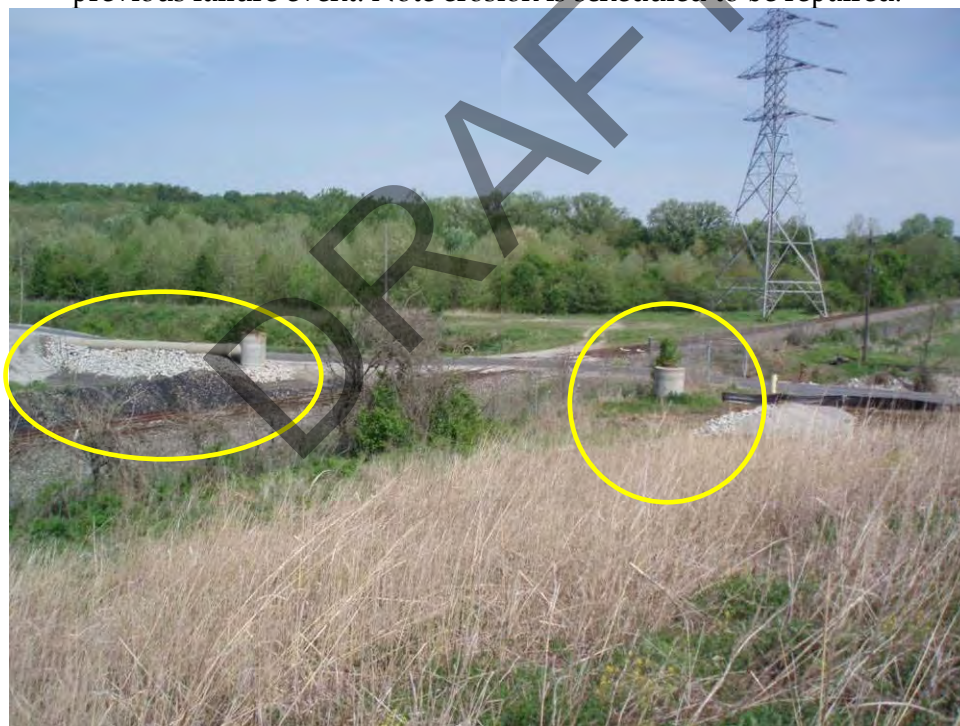
108. Overview of discharge manholes from Pond E into Pond C, looking northwest.

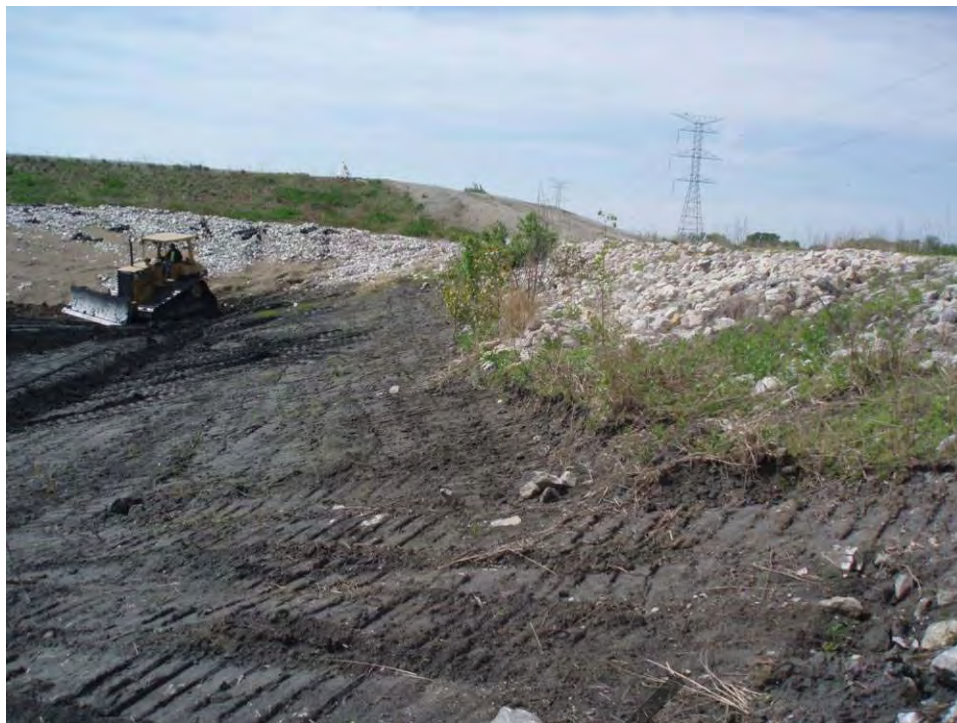
109. Pond E - West embankment interior slope, looking south.

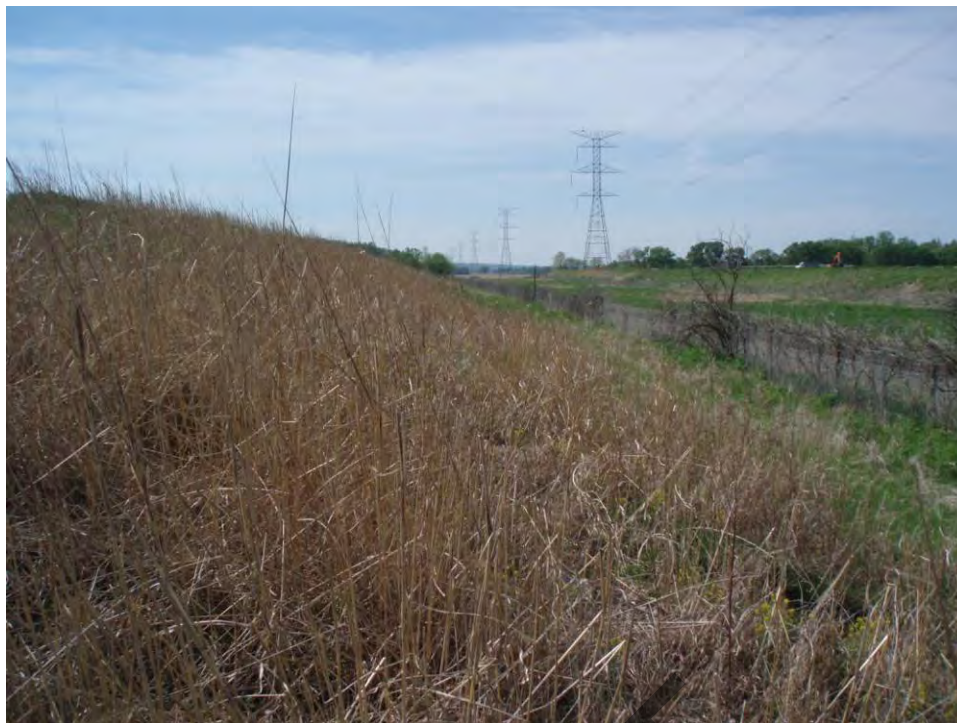
111. Pond E - West embankment exterior slope, looking south.

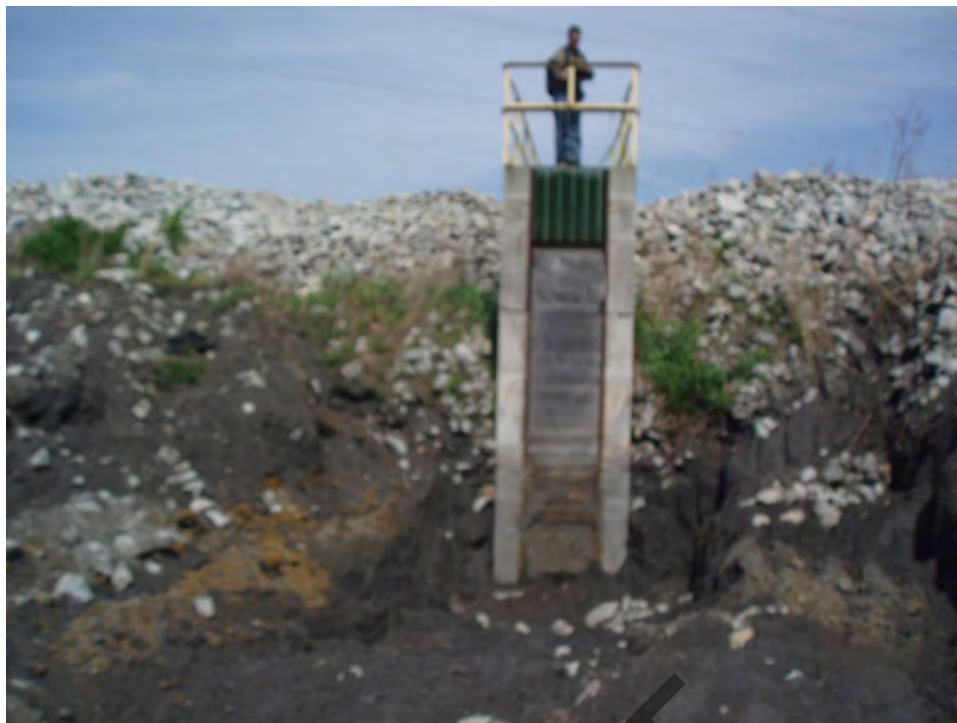
115. Pond E - Overview of outlet control structure with stoplogs and butterfly valve, looking northwest.

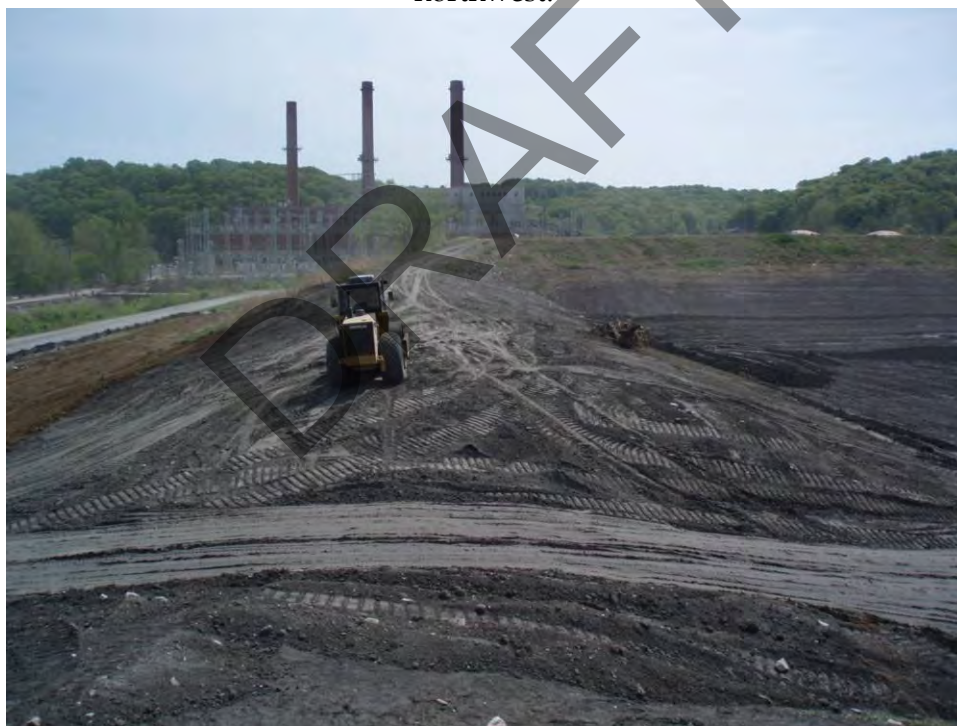
116. Pond E - Overview of north embankment reconstruction, looking east.

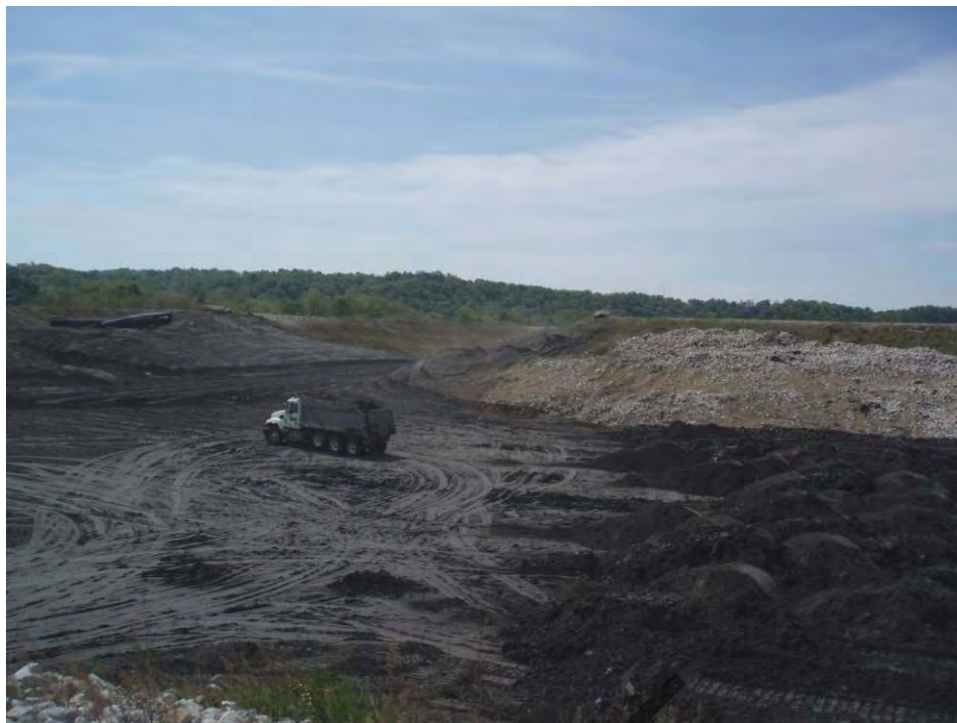
117. Overview of divider embankment D/E reconstruction and Pond E filling operation, looking south.

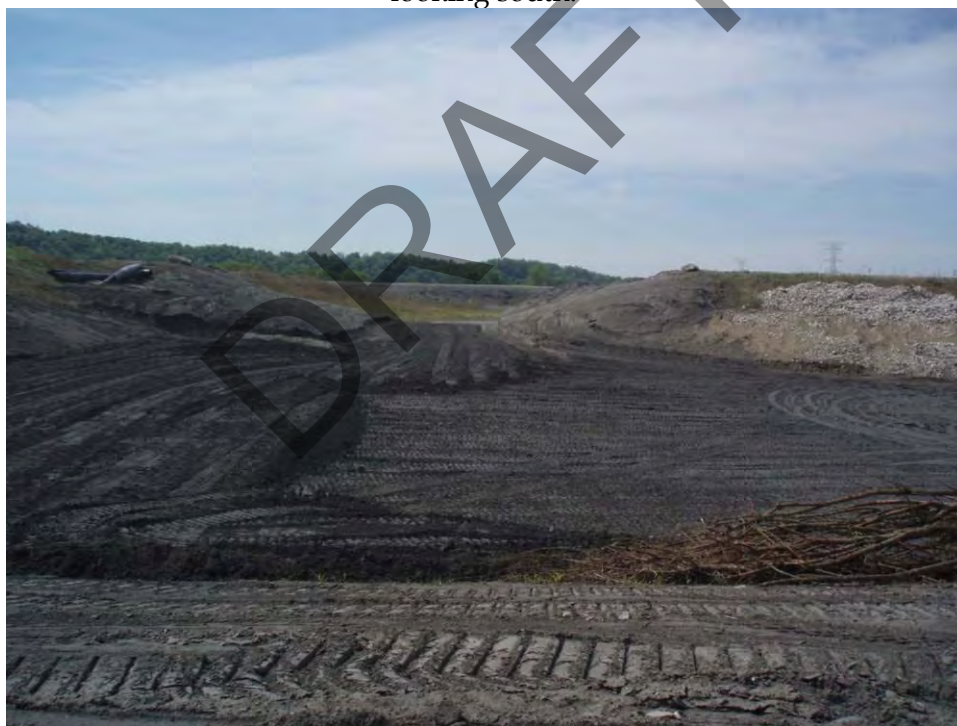
118. Overview of divider embankment D/E reconstruction, looking south.

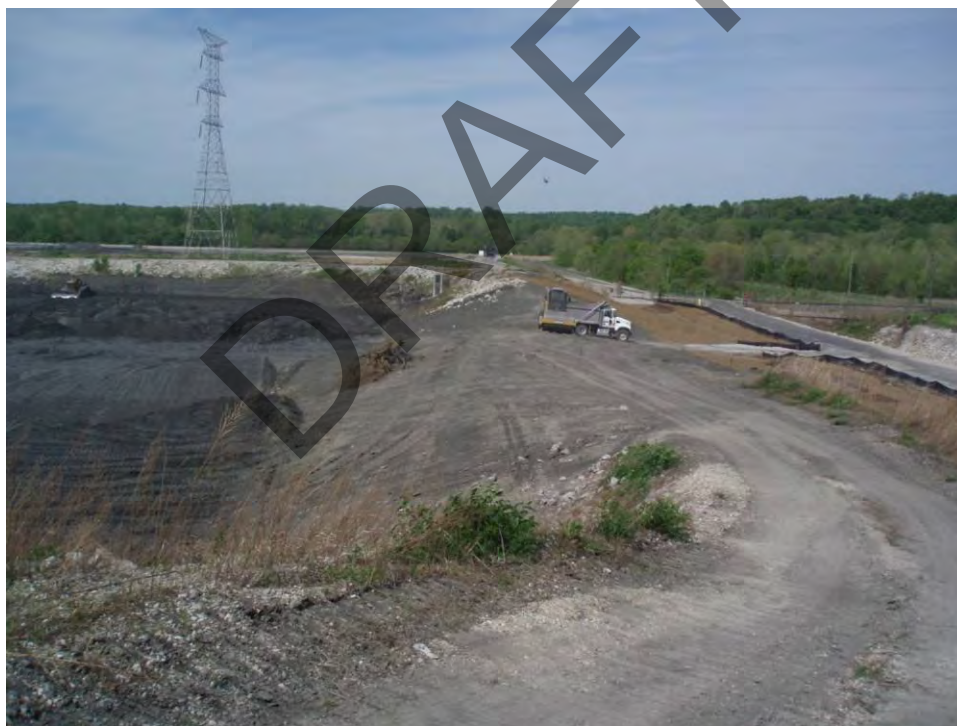
120. Pond E - Overview of north embankment reconstruction, looking west.

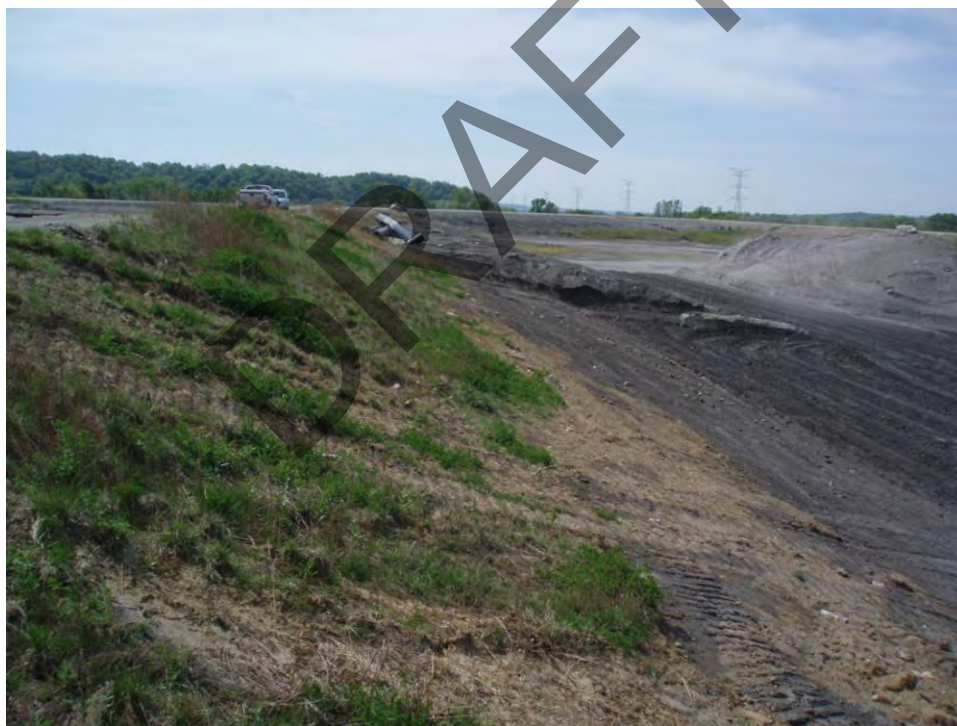
122. West slope of divider embankment D/E, looking south.

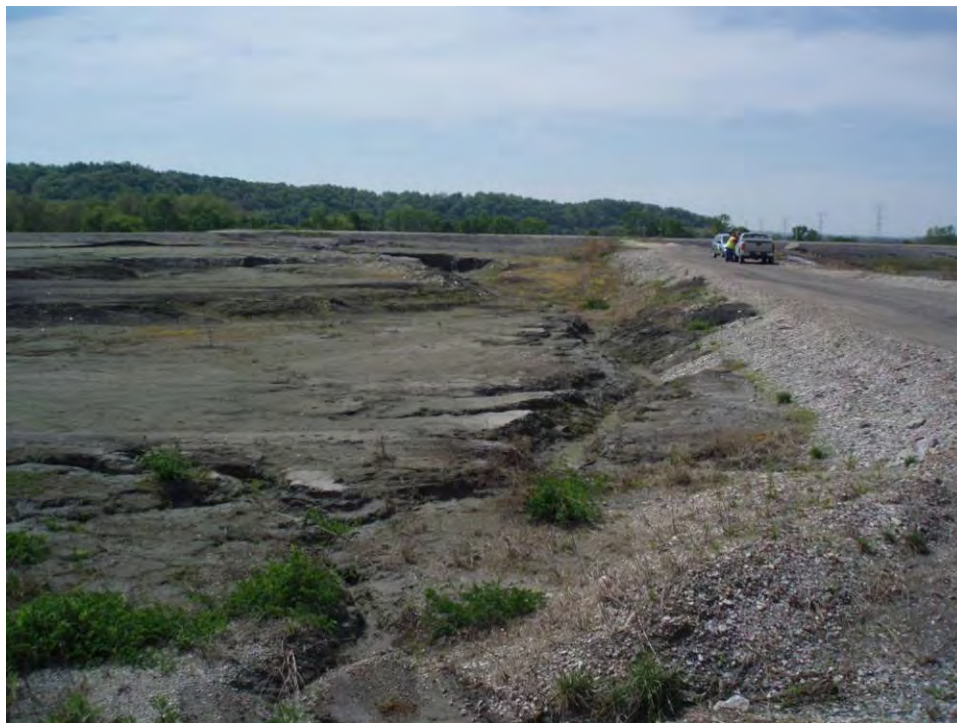
123. East slope of divider embankment D/E, looking south.

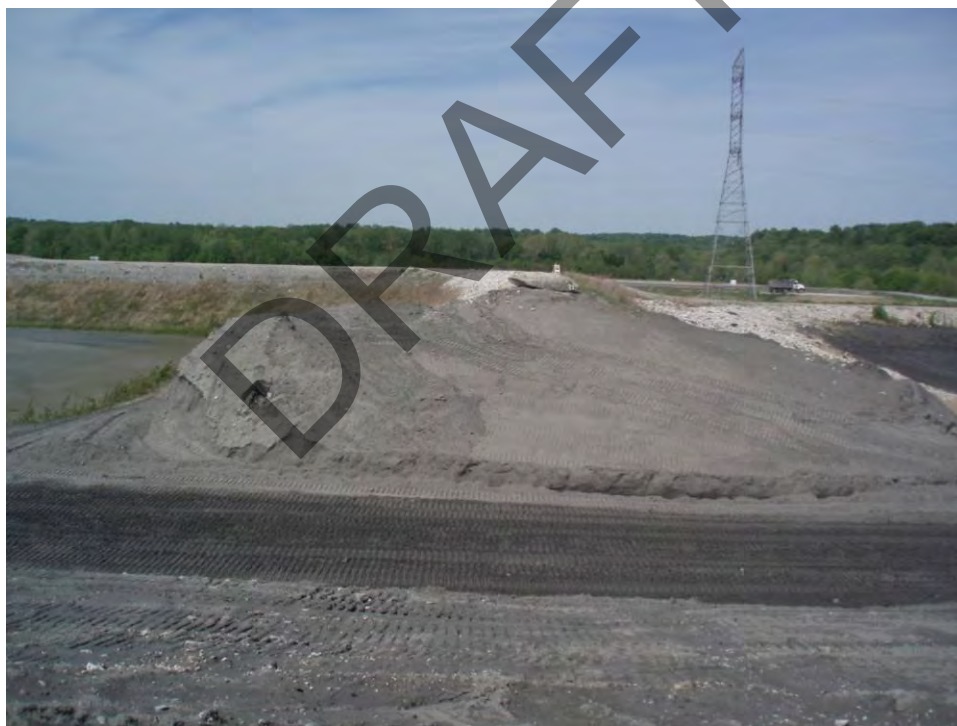
124. Overview of divider embankment D/E reconstruction, looking west.

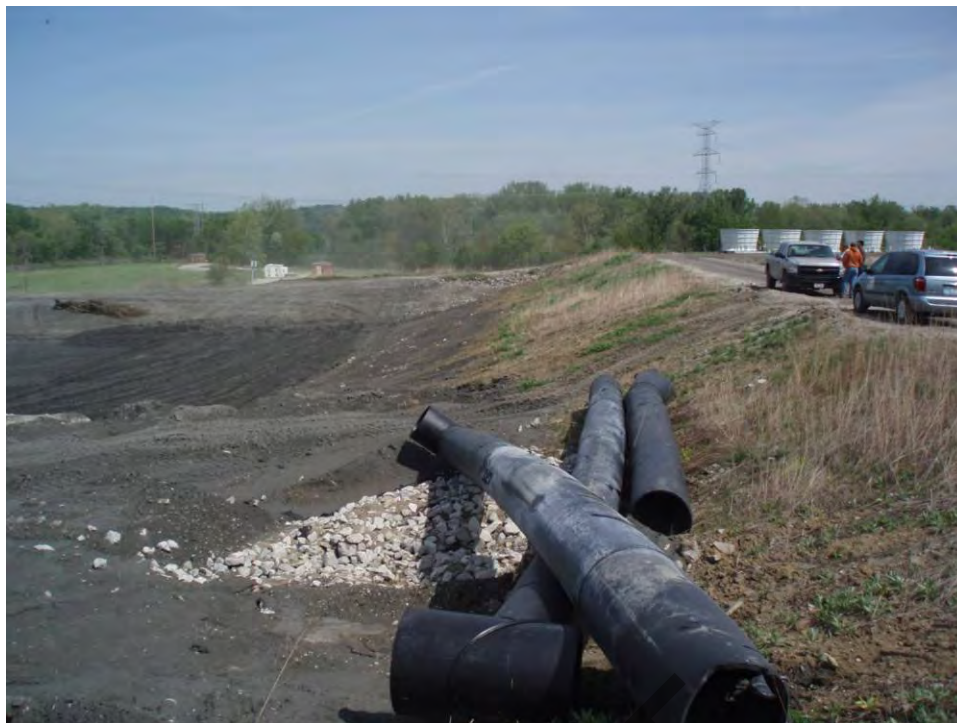
125. West slope of divider embankment D/E, looking north. Note pipes removed from embankment after breach.

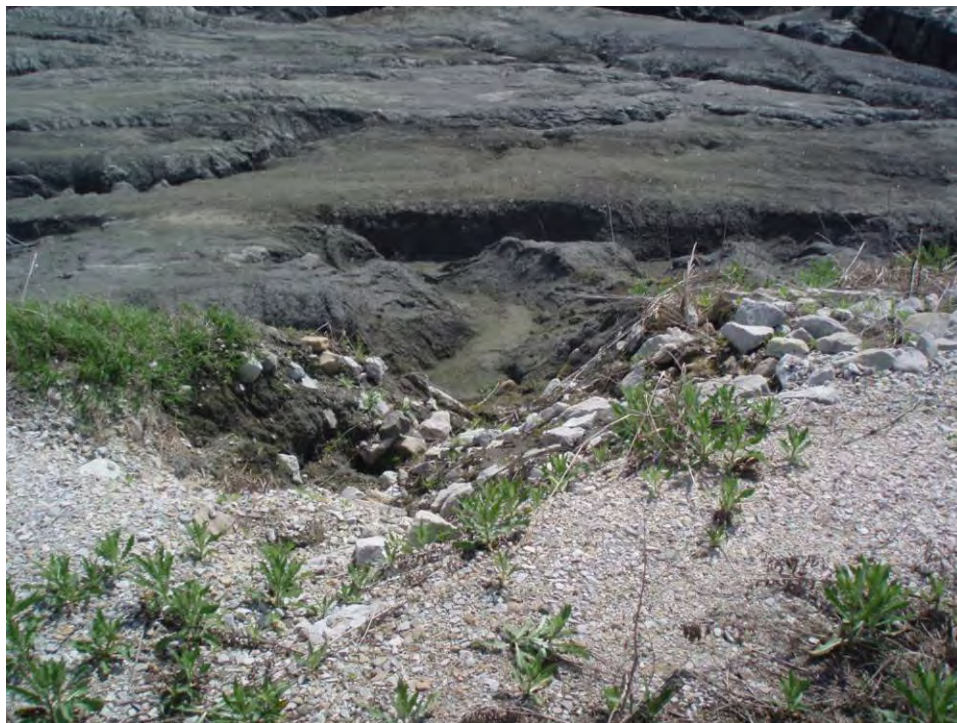
127. Pond D - Erosion feature on east slope of diversion embankment, looking east.

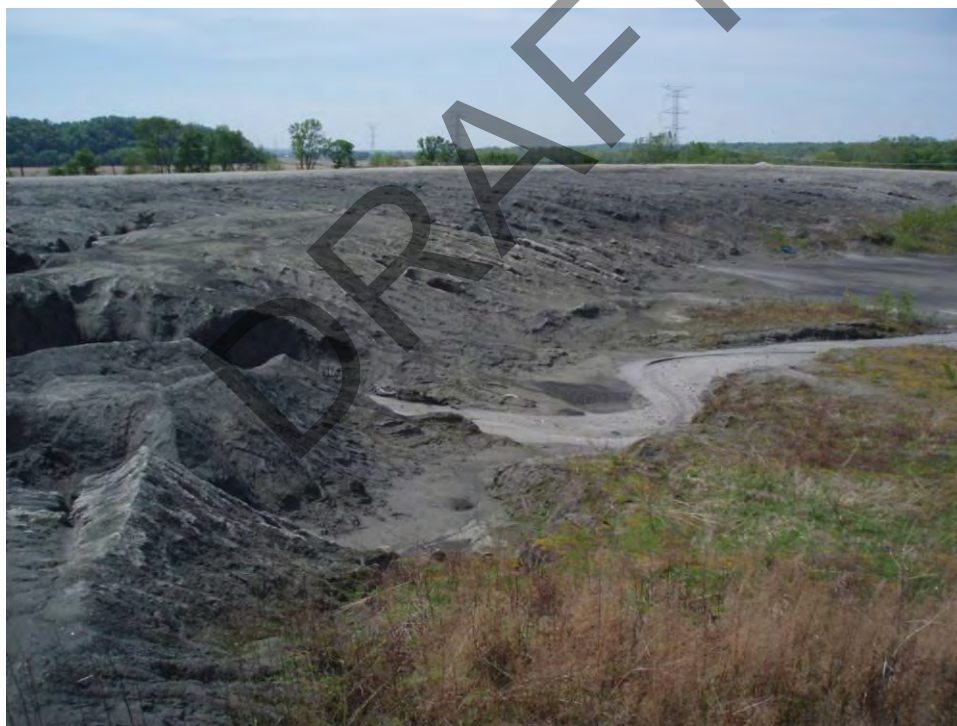
128. Pond D - Limit of ash at end of diversion embankment prior to failure, looking southwest.

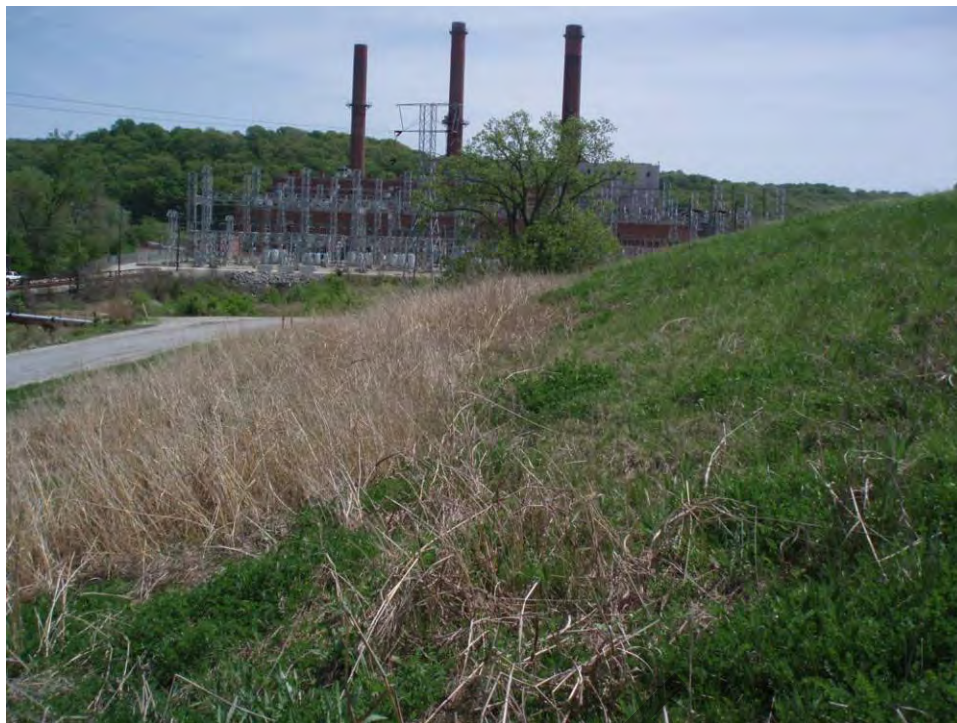
131. Pond D - North embankment exterior slope, looking east.

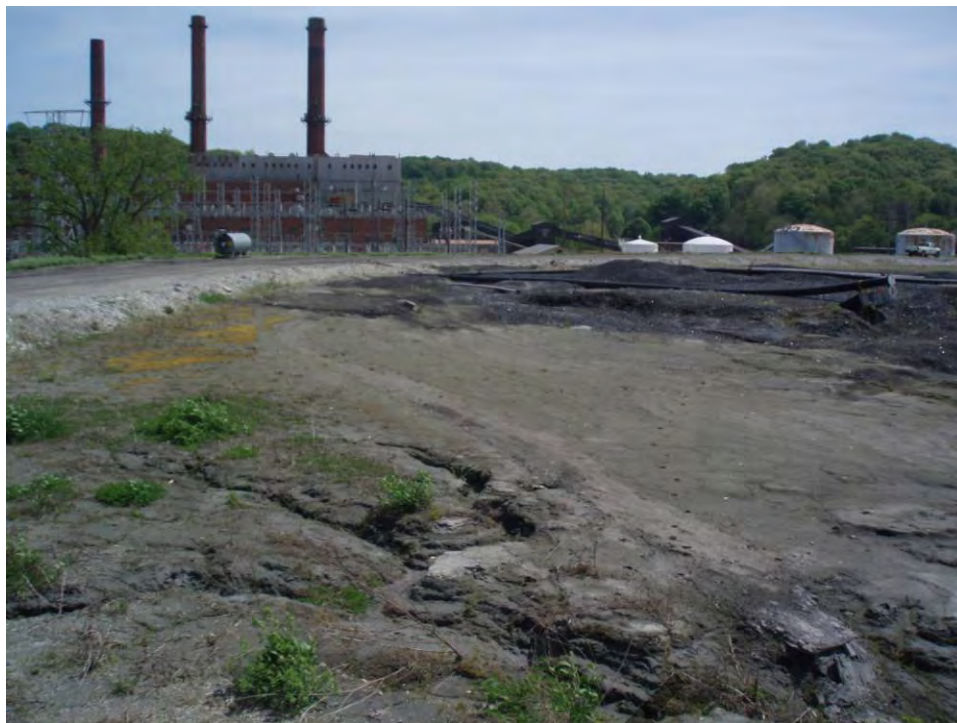
133. Pond D - North embankment interior slope, looking east.

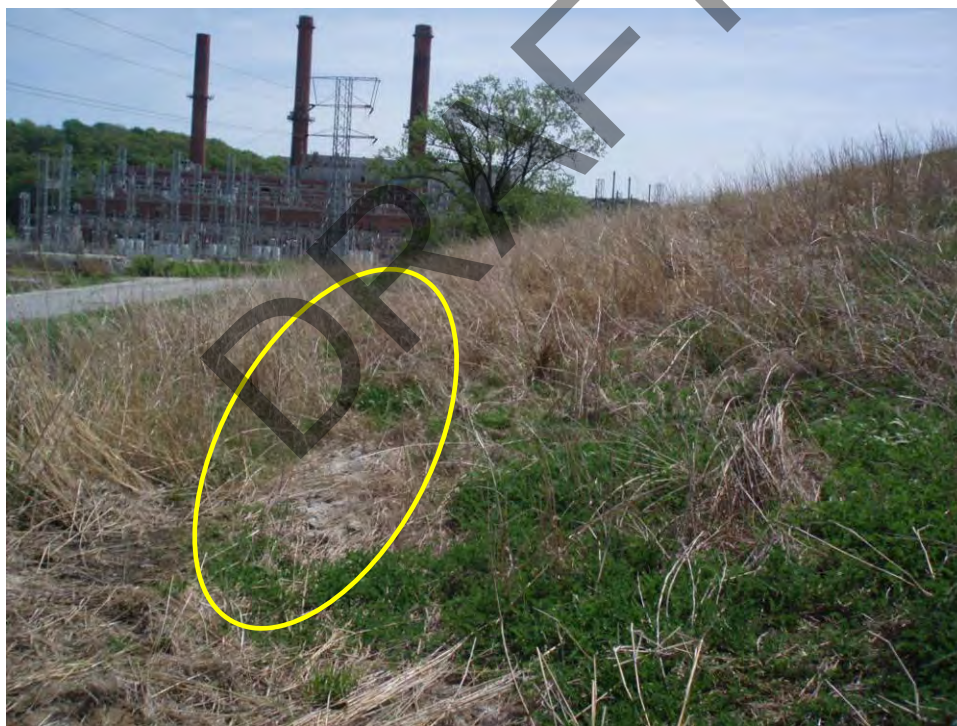
134. Pond D - Toe of north embankment, looking east. Note drainage ditch with seepage collector pipe.

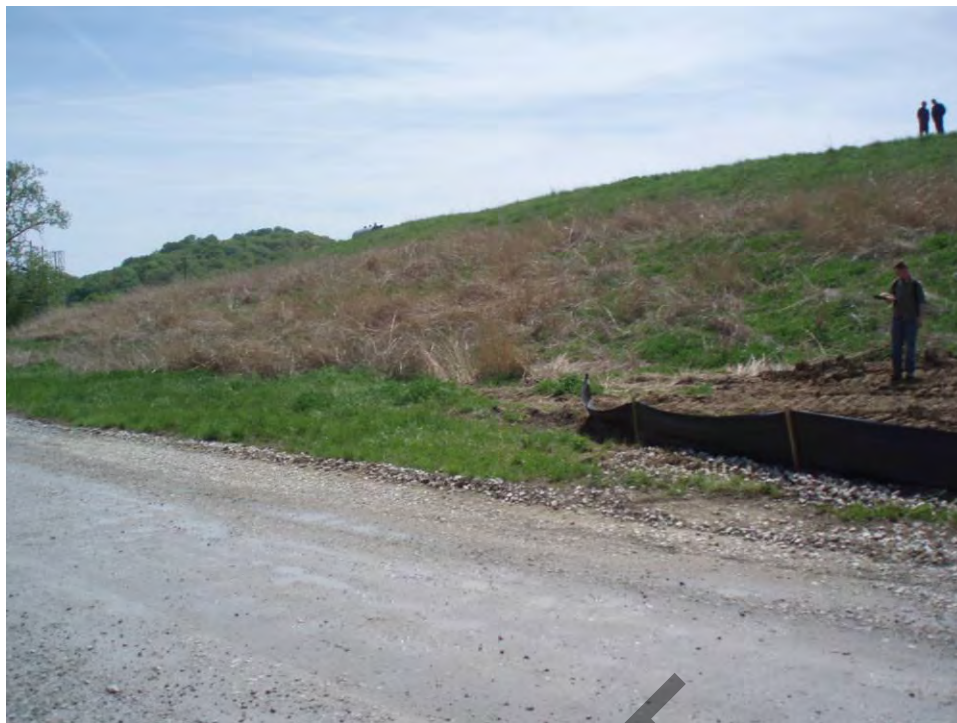
135. Pond D - North embankment exterior slope, looking southeast.

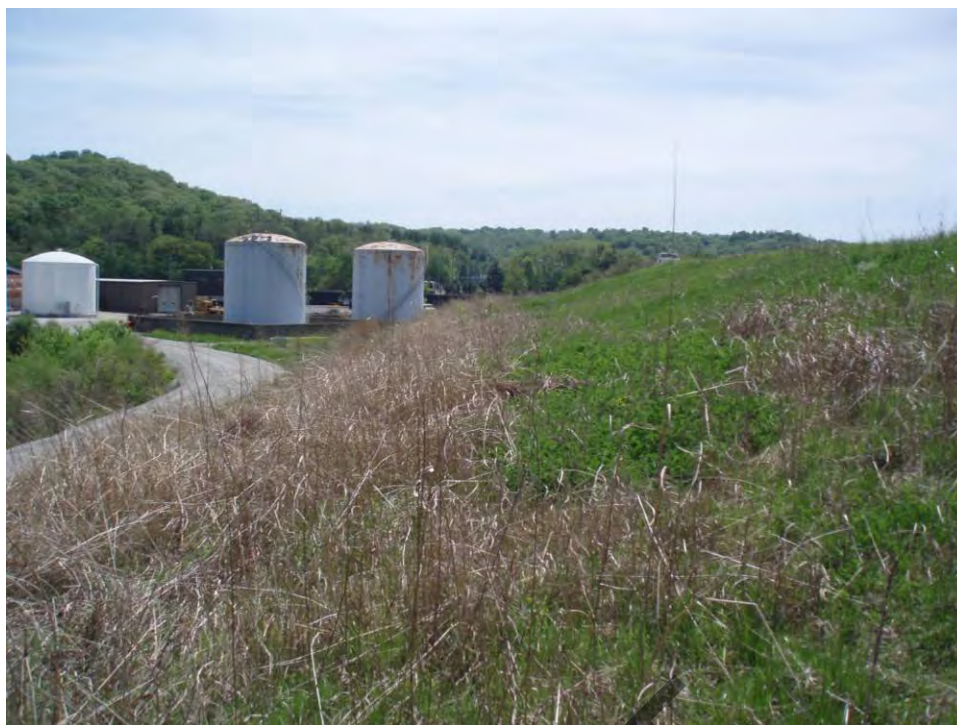
137. Pond D - Northeast embankment exterior slope, looking southeast.

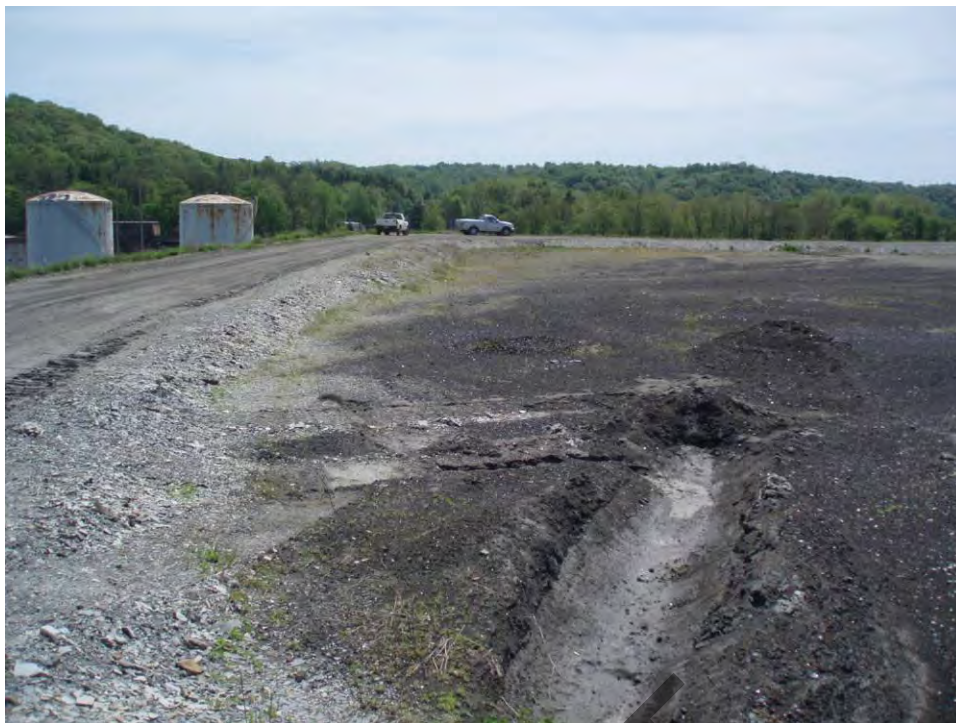
139. Pond D - Northeast embankment interior slope, looking southeast.

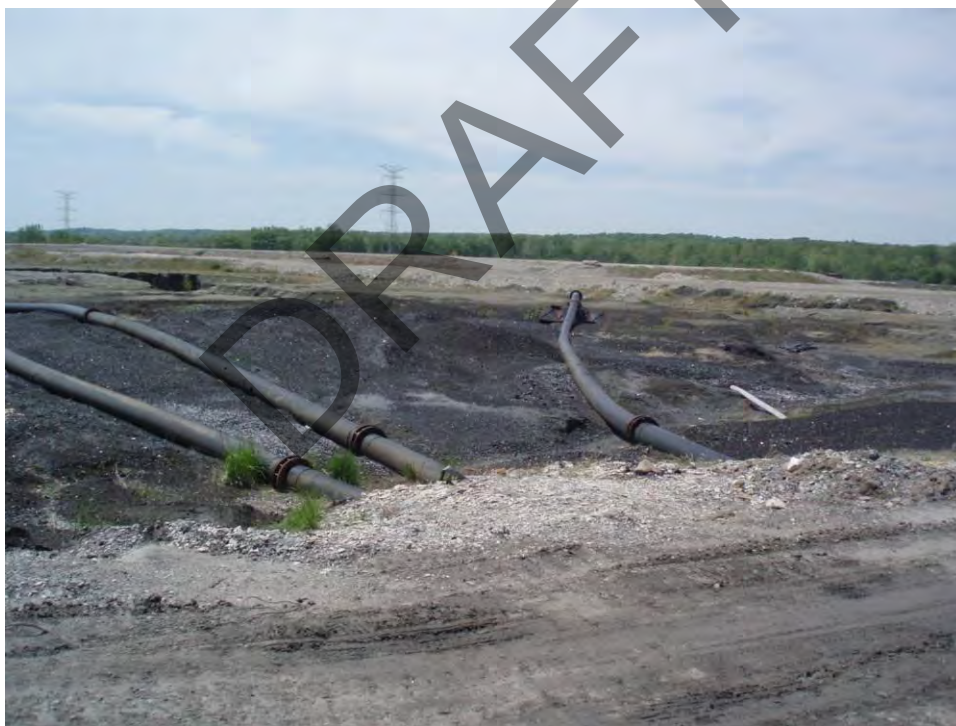
140. Overview of three 10-inch-diameter HDPE discharge pipes into Pond D, looking southwest.

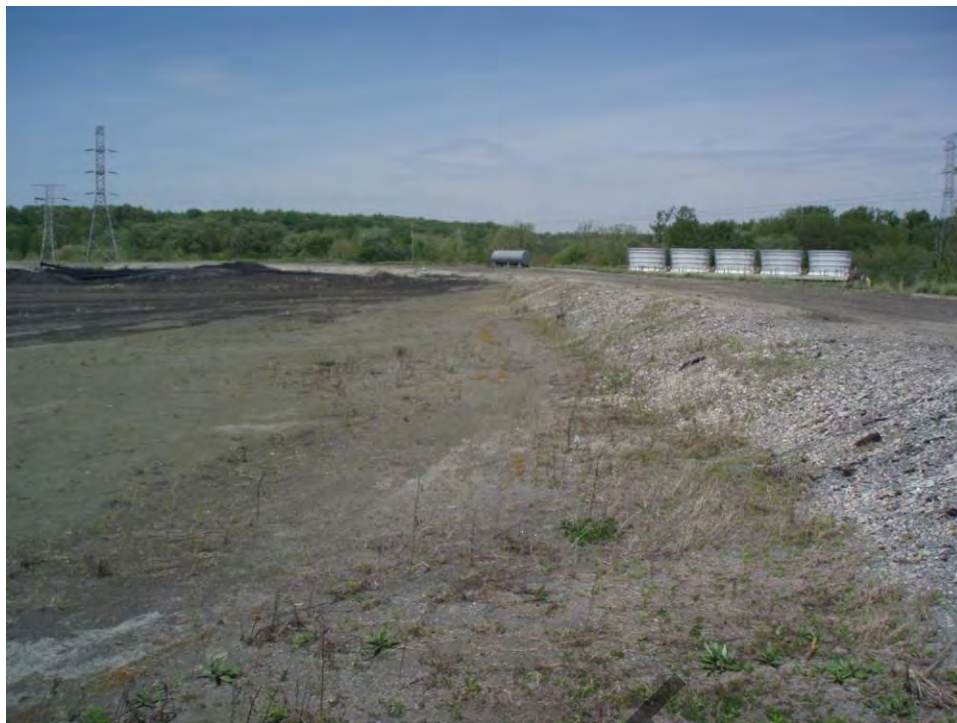
141. Pond D - Northeast embankment interior slope, looking northwest.

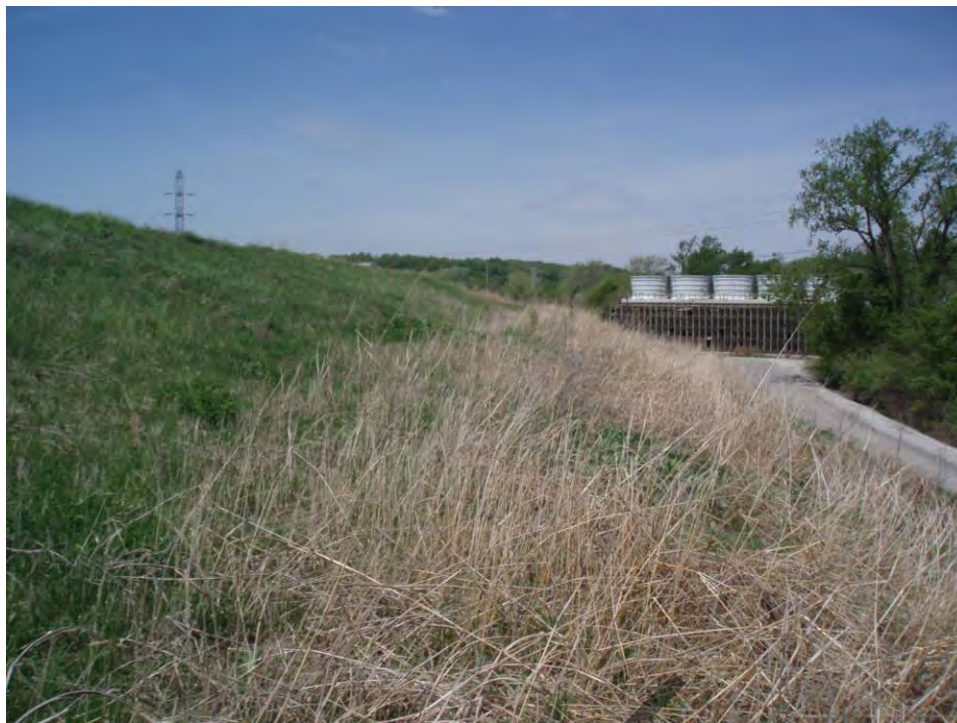
143. Pond D - Northeast embankment exterior slope, looking northwest.

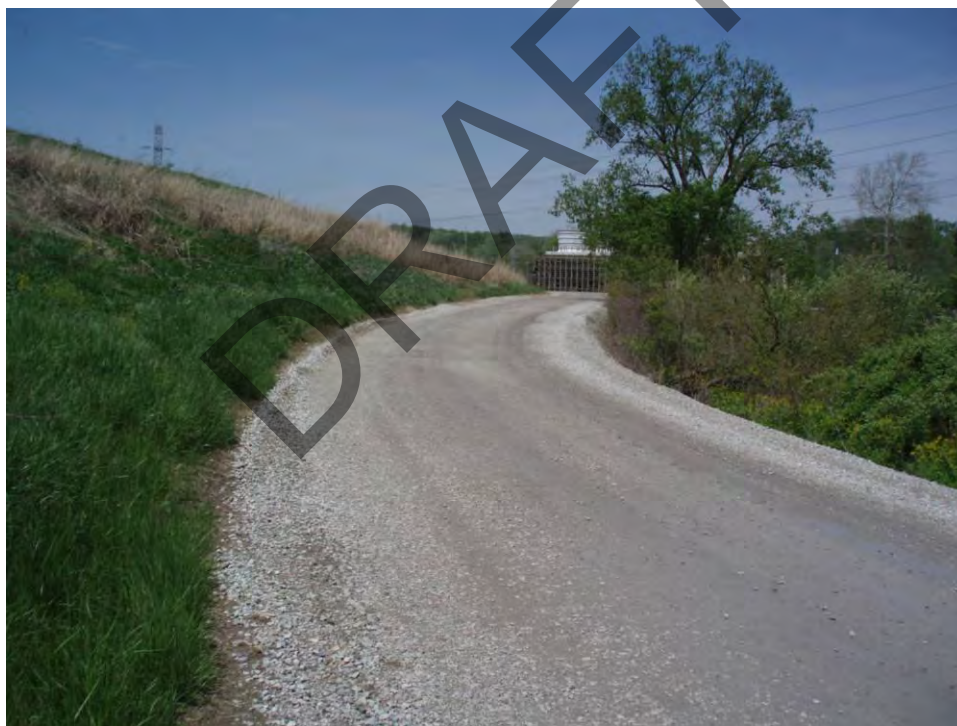
144. Access road and discharge canal adjacent to toe of Pond D, looking northwest.

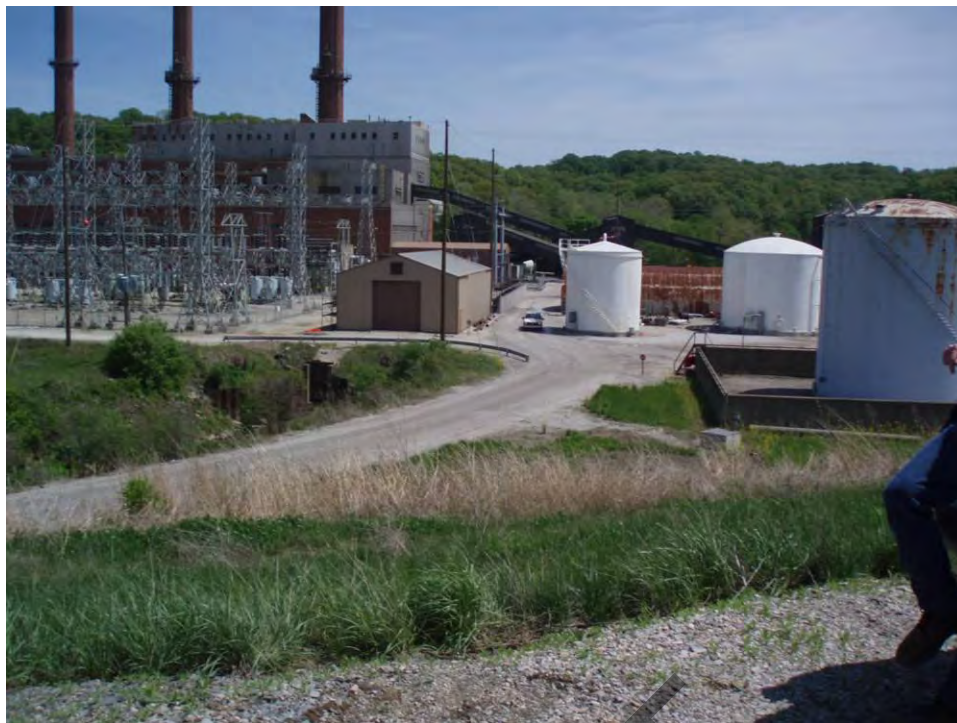
145. Downstream area of Pond D northeast embankment, looking east.

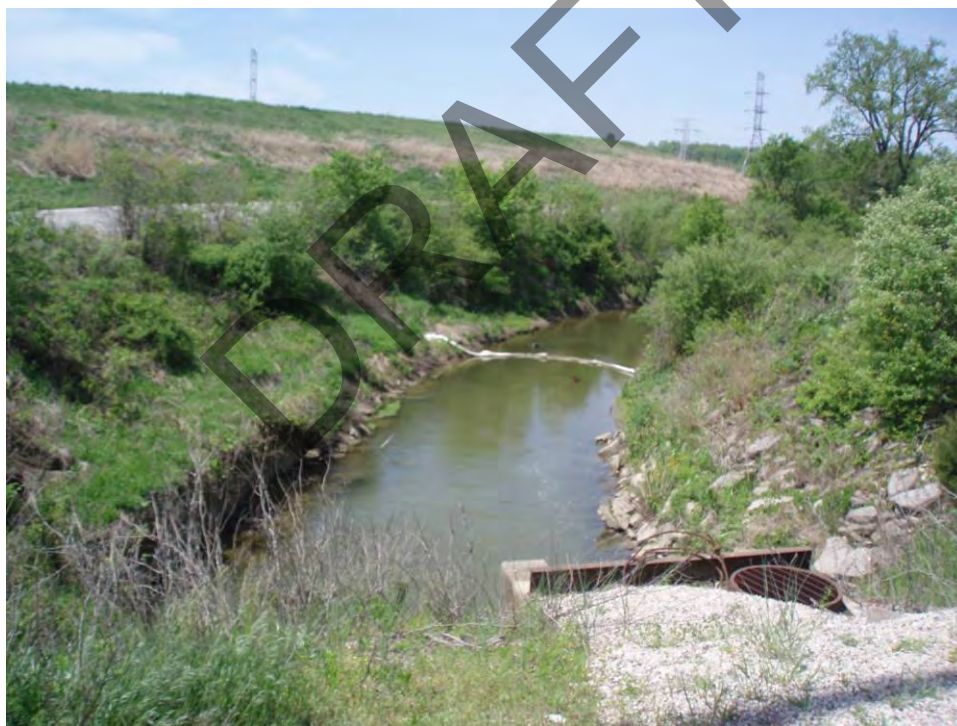
146. Overview of typical discharge canal adjacent the north embankments of Ponds A, C, D, and E.
