# **Assessment of Dam Safety of Coal Combustion Surface Impoundments**

**Indianapolis Power & Light Company**

**Eagle Valley Generating Station**

**November 15, 2010**

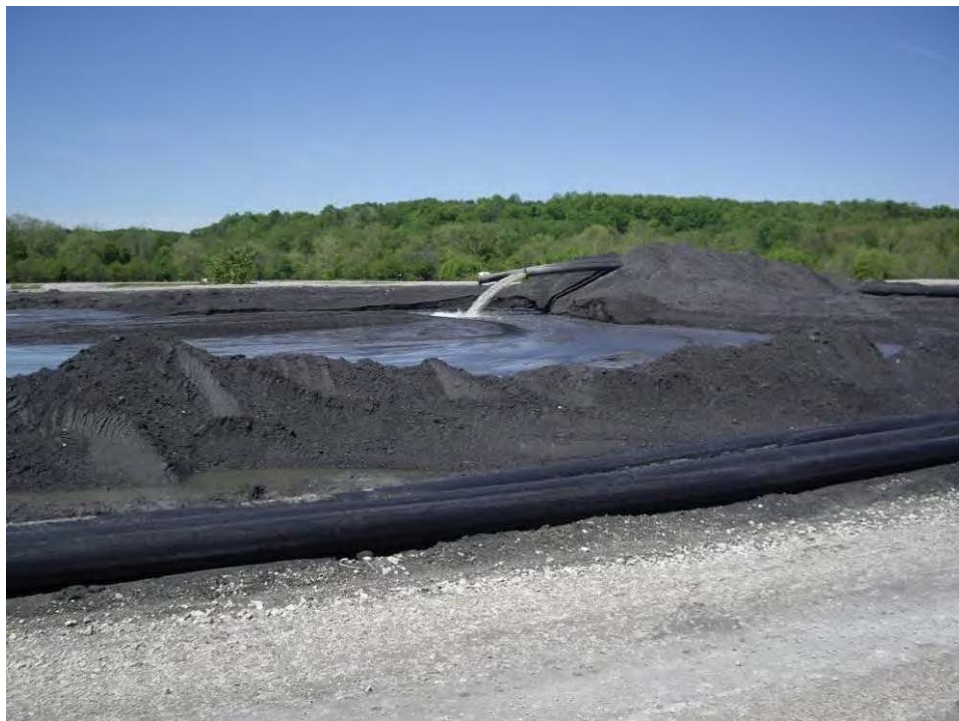
Two (2) 10-inch-diameter High Density Polyethylene (HDPE) pipes sluice CCW waste into Pond A (Photo 6). In addition, a third 10-inch-diameter HDPE pipe sluices plant wastes into Pond A (Photo 10). Pond A is used as the primary settling pond. Floating booms were installed in the pond to direct flow and increase the settling time in the pond. Pond A is connected to Pond B by two (2) 30-inch-diameter Corrugated Metal (CMPs ) with an invert elevation of El. 626 (Photo 28, 29 and 30). At the pipe inlets, there is a floating boom wrapped around the inlets and vertical pipe T's are connected to the ends to serve as a hood to reduce the potential for surface debris from clogging the pipes. IPL staff stated that a low spot in the crest in Pond A is an emergency overflow spillway (Photo 28). The spillway is approximately 50 feet wide with the crest at El. 628. This "emergency spillway" is not included on any design plans.

6. Overview of two 10-inch-diameter HDPE discharge pipes into Pond A, looking northwest.

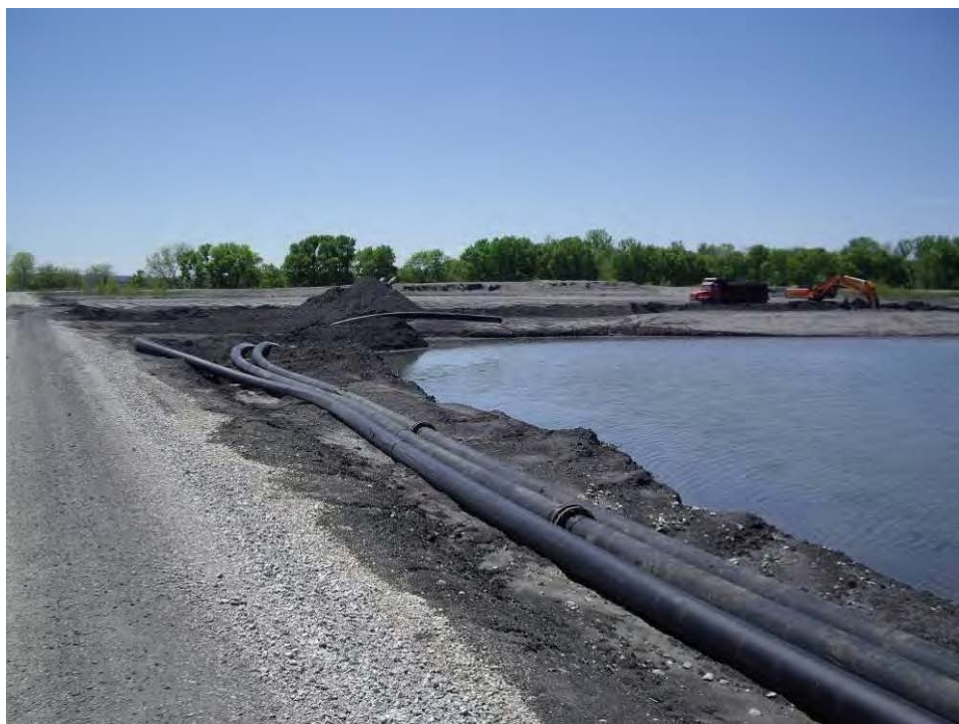
8. Overview of three 10-inch-diameter HDPE discharge pipes into Pond A, looking southwest.  
Note two right-most pipes are disconnected.

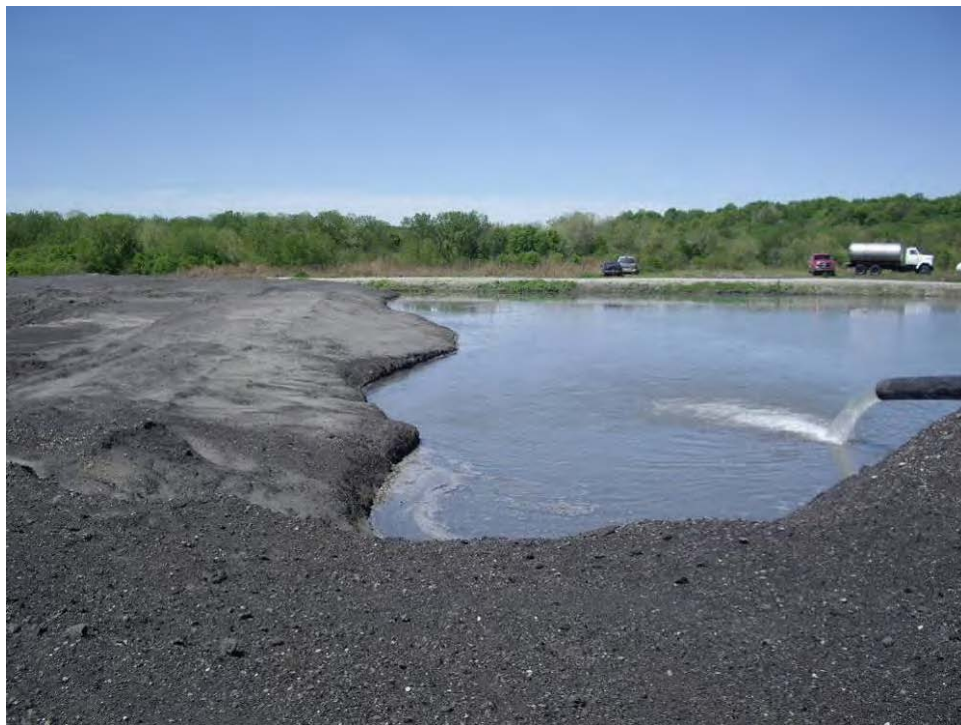
10. Overview of 10-inch-diameter HDPE discharge pipe into Pond A, looking west.

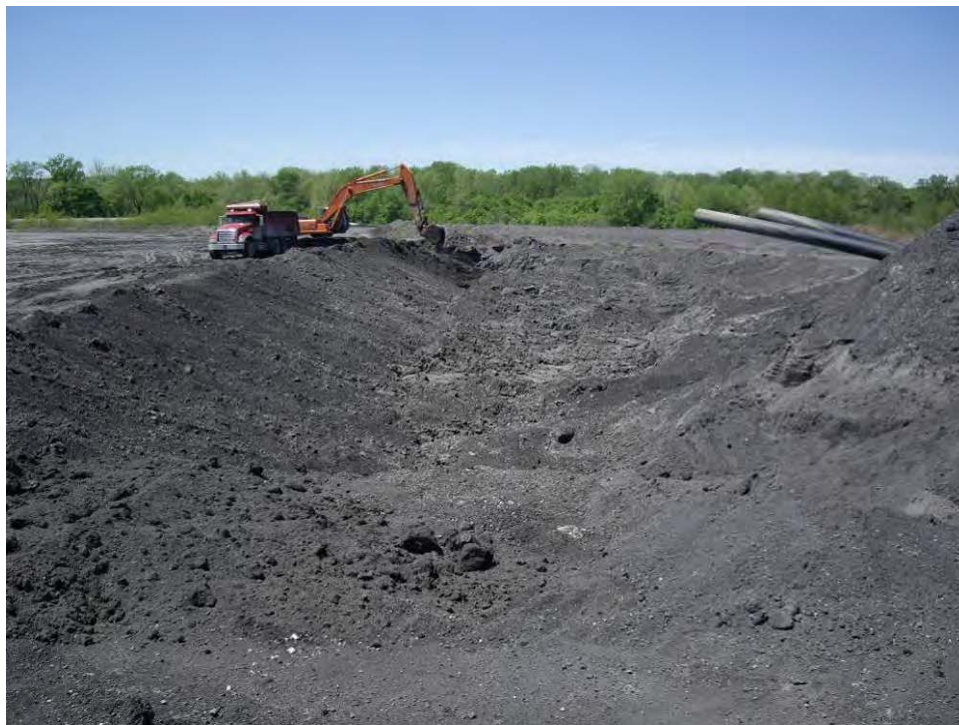
11. Overview of ash excavation in Pond A looking west. Ash being used as fill to repair Ponds D and E..

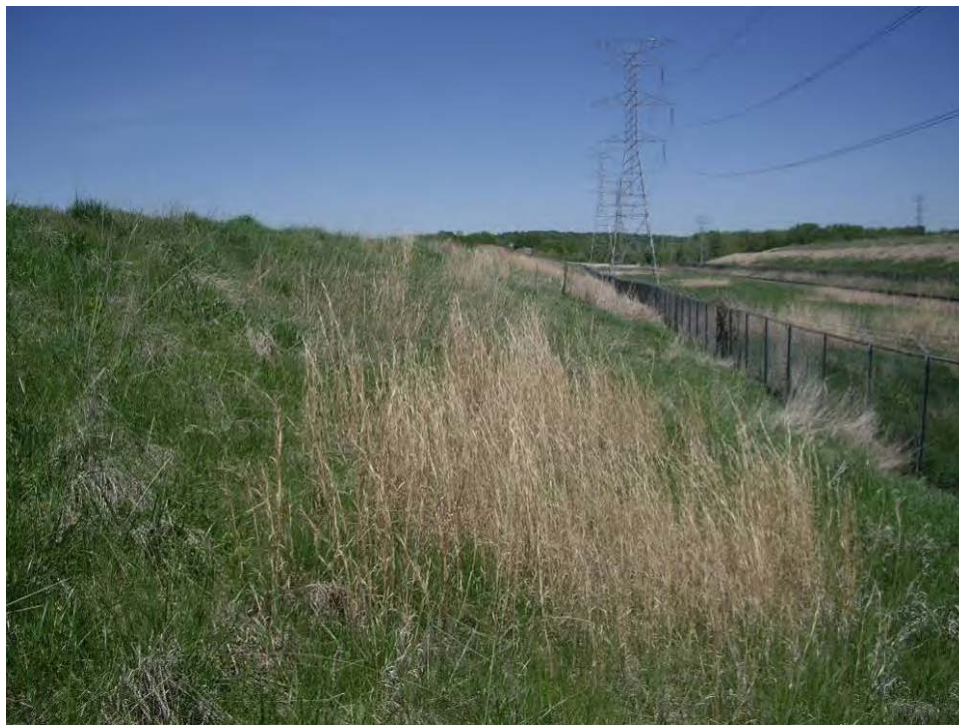
The exterior slopes of the Pond A embankments appear to be in fair condition. The exterior slopes on the north, south, east, and west embankments ranged from approximately 2.5H:1V to 3H:1V (Photos 1, 15, 20, 23, 25, 45, and 46). The exterior slope on the embankment between Pond A and Pond B (divider embankment A/B) and embankment between Pond A and Pond C (divider embankment A/C) ranged from approximately 2H:1V to 3H:1V (Photos 28, 33, 34, 38, 40, and 42).

15. Pond A – East embankment exterior slope looking north.

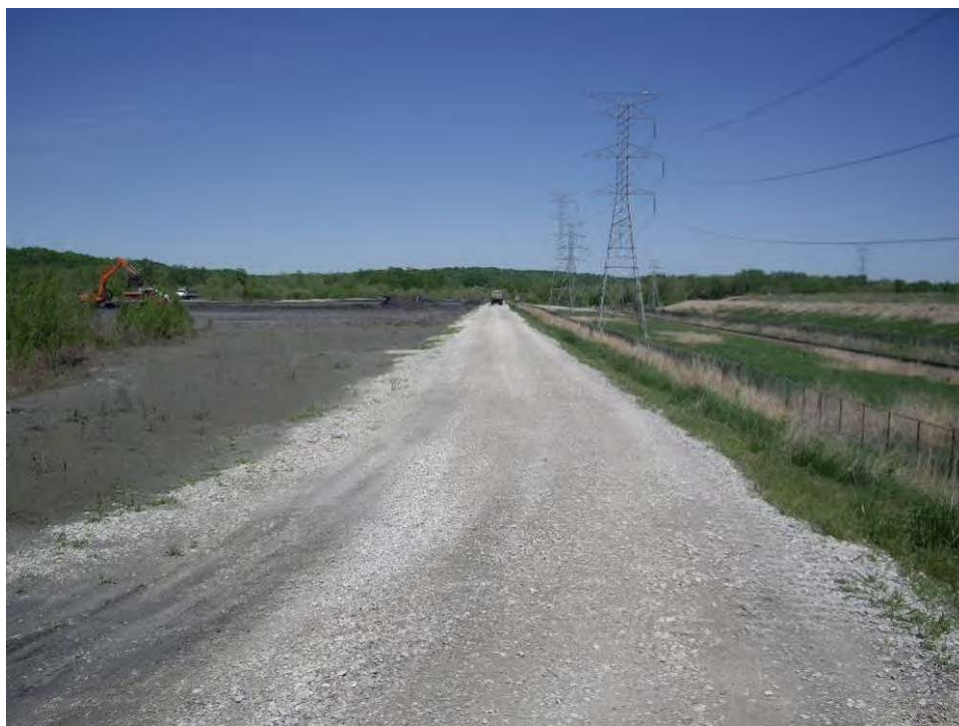
The crest of the Pond A embankments appeared to generally be in fair condition (Photos 2, 8, 14, 16, 19, 22, 24, 27, 30, 34, 43, and 44). The crest was approximately 15 feet wide with exception of the truck turn around area where the crest was significantly wider. The crest consists of a compacted gravel access road around the perimeter. Three low spots were observed in the crest (Photos 2, 14, and 28). Two of the low spots appear to be from recent truck traffic rutting the crest. The low spot on the east embankment observed on 4/28/10 was filled in by an IPL contractor to improve conditions for traffic purposes. IPL indicated that the low spot on the divider embankment near the outlet pipes (Photo 28) is an overflow spillway. There are no records in the information provided to CDM to indicate this was a design feature. There were no deficiencies observed in this area.

16. Pond A – East crest looking north.

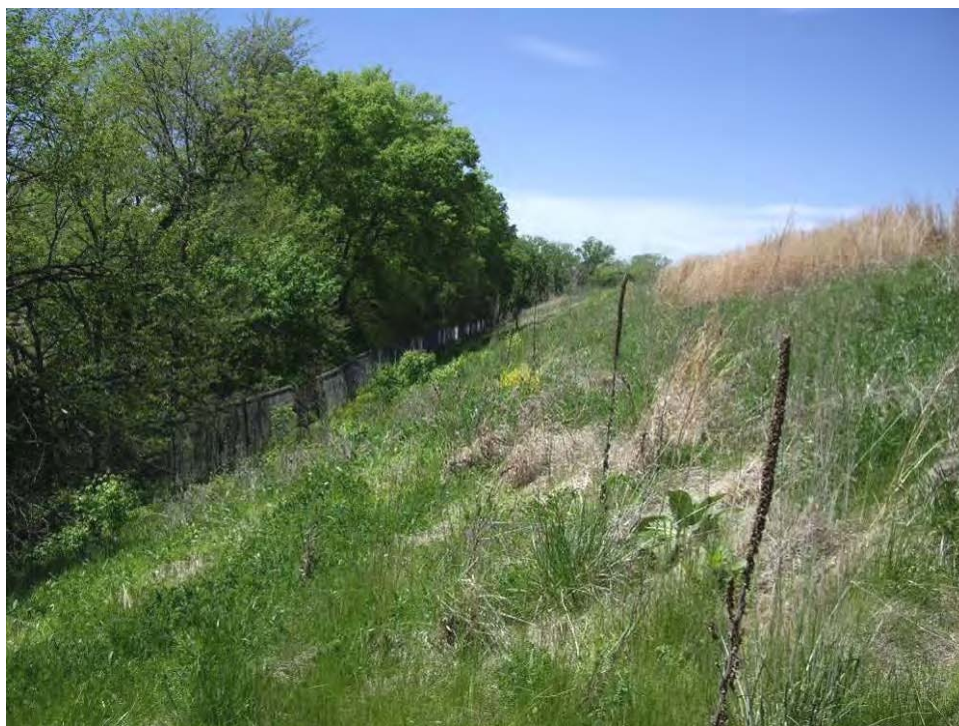
20. Pond A – South embankment exterior slope looking west.

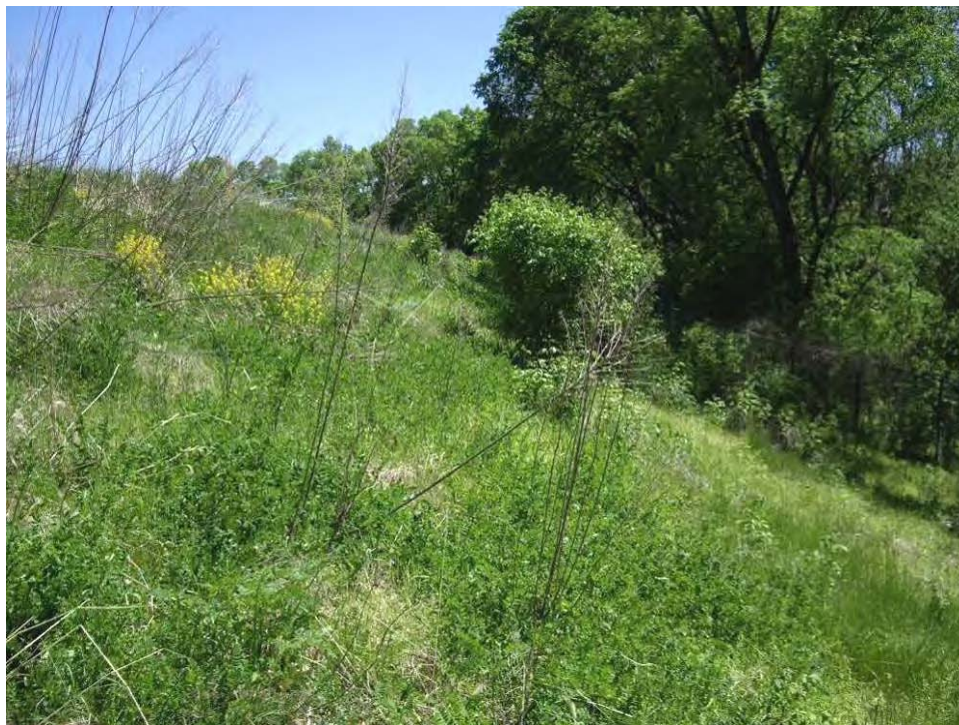
23. Pond A – South embankment exterior slope, looking southeast.

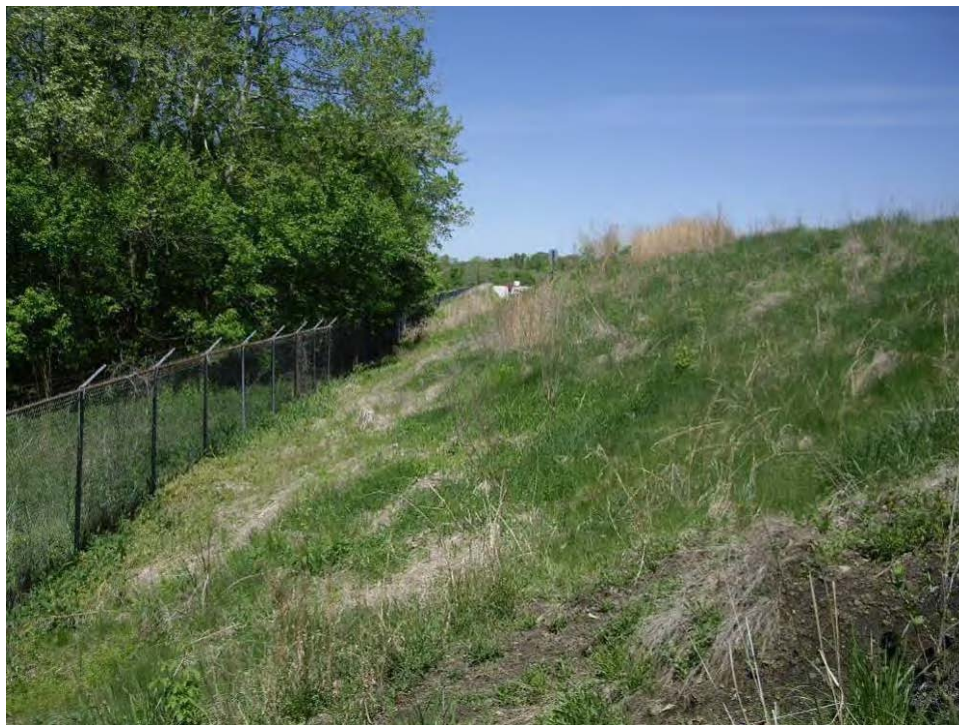
25. Pond A – West embankment exterior slope, looking north.

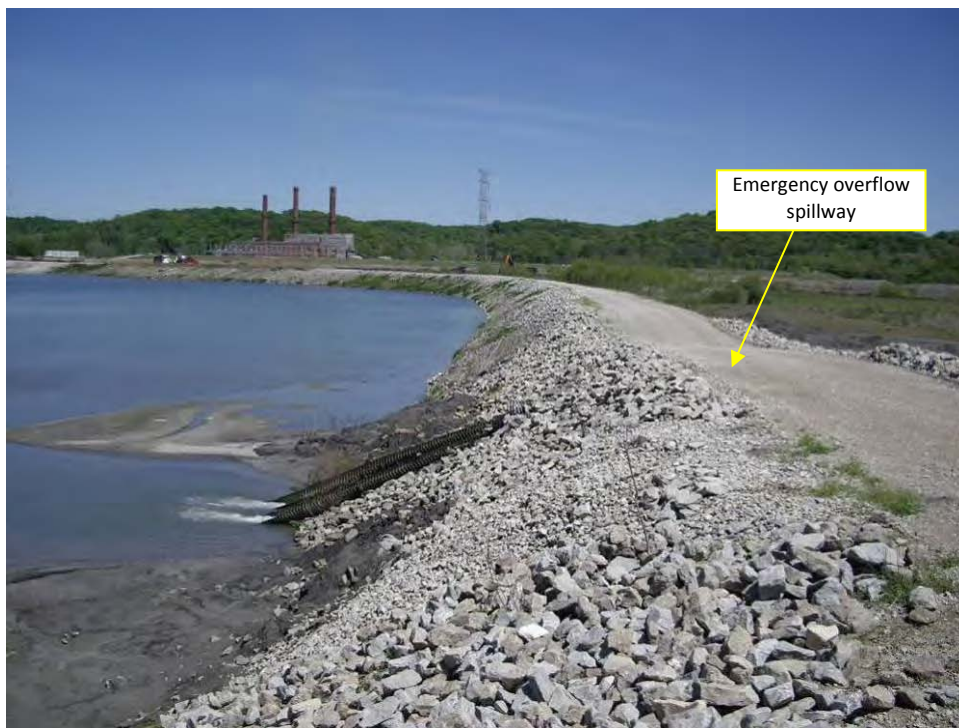
28. Pond A/B – north slope of divider embankment, looking east.

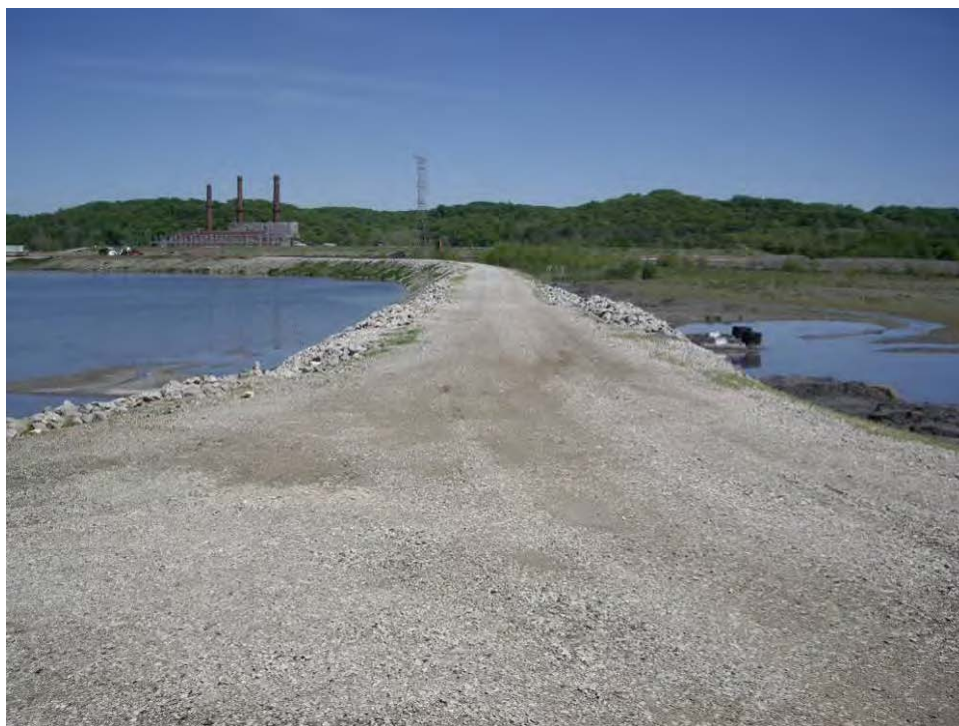
30. Pond A/B - crest of divider embankment, looking east.

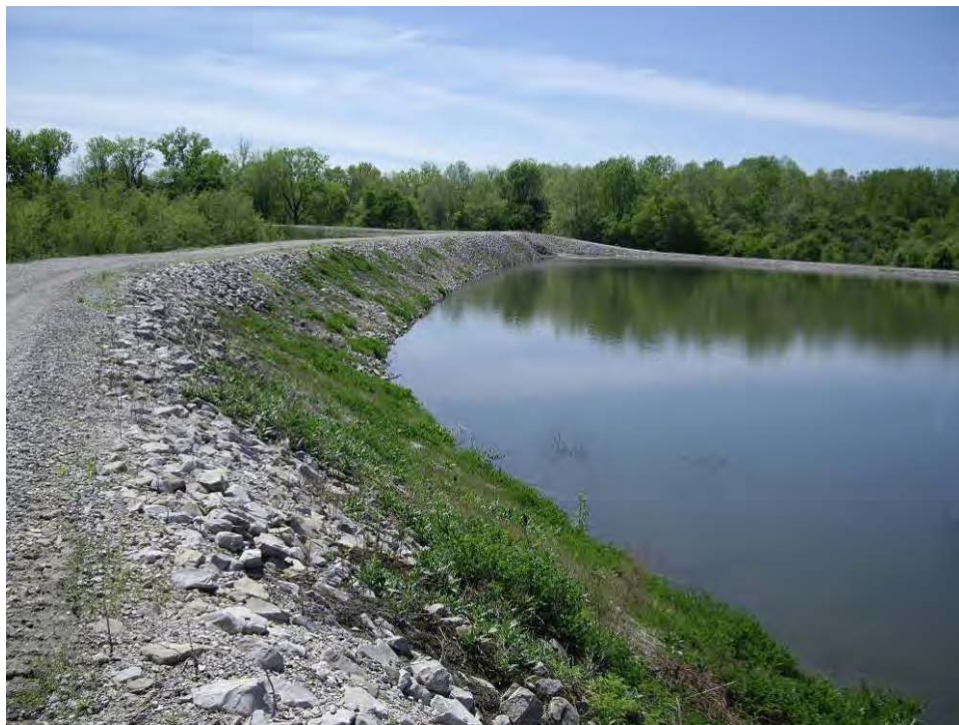
33. North slope of divider embankment A/B and Pond B west embankment, looking southwest.

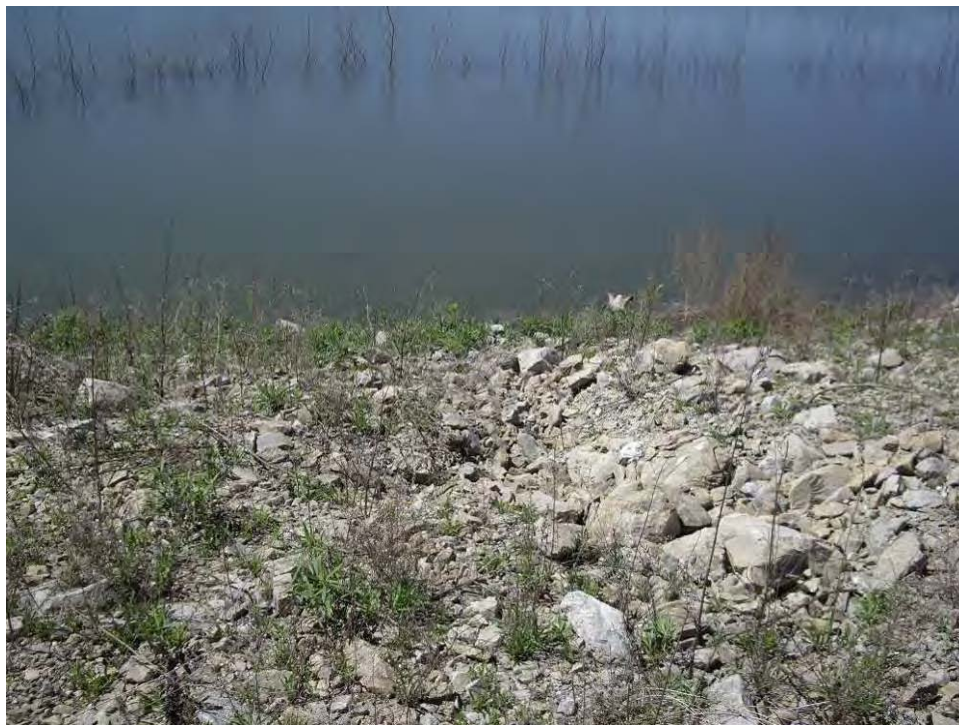
35. Erosion feature and depression in north slope of divider embankment A/B.

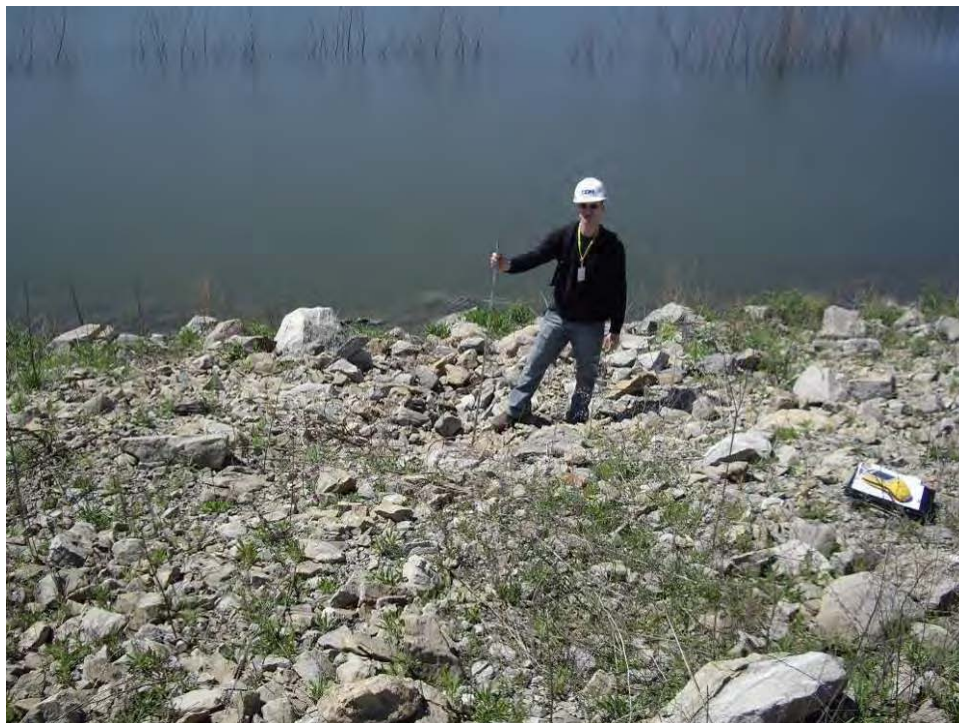
36. Depression in north slope of divider embankment A/B.

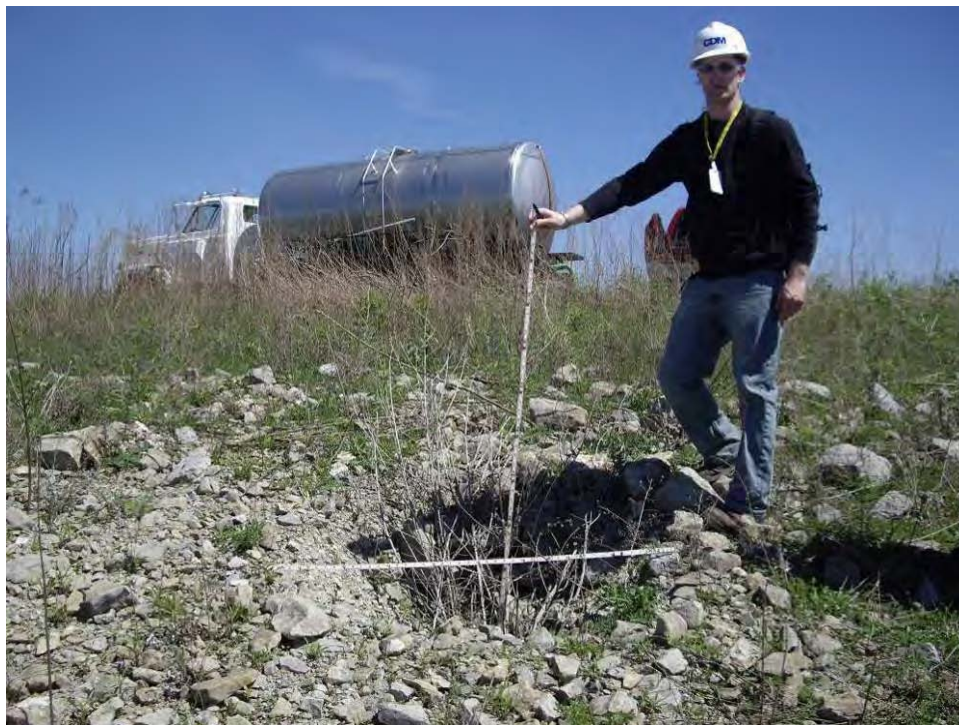
37. Depression in northwest slope of divider embankment A/B.

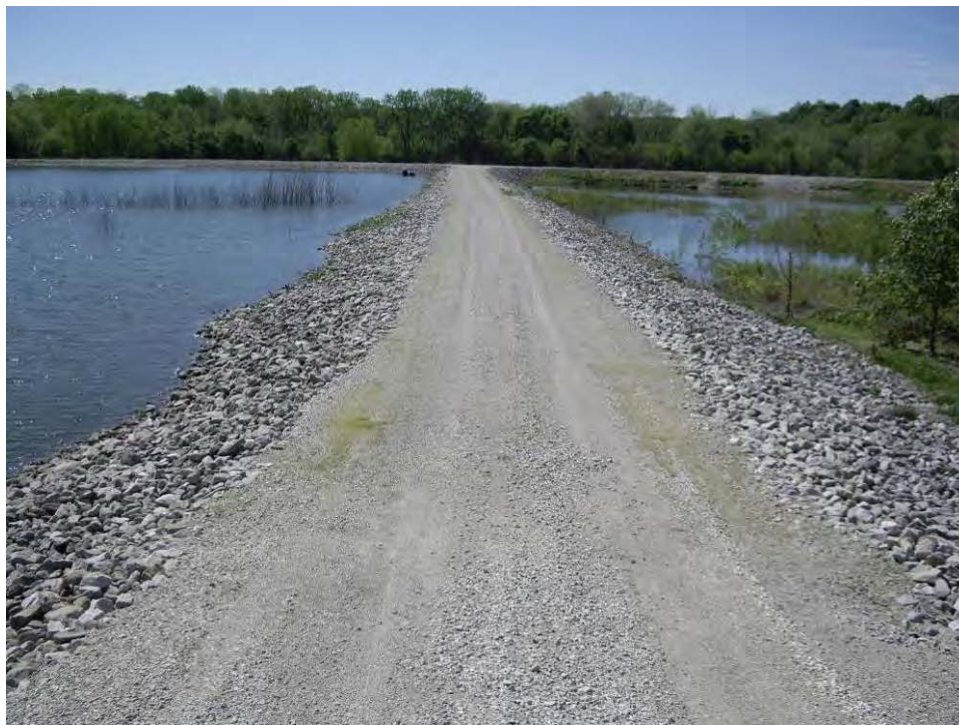
39. Crest of divider embankment B/C from crest of Pond A, looking west.

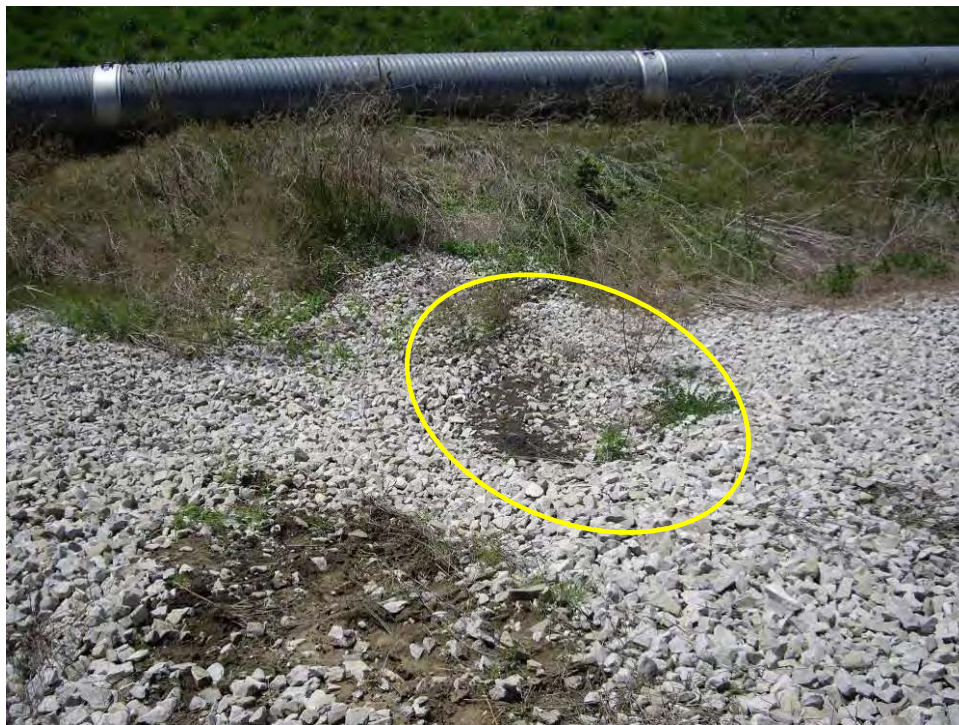
41. Minor sloughing and erosion feature on west slope of divider embankment A/C.

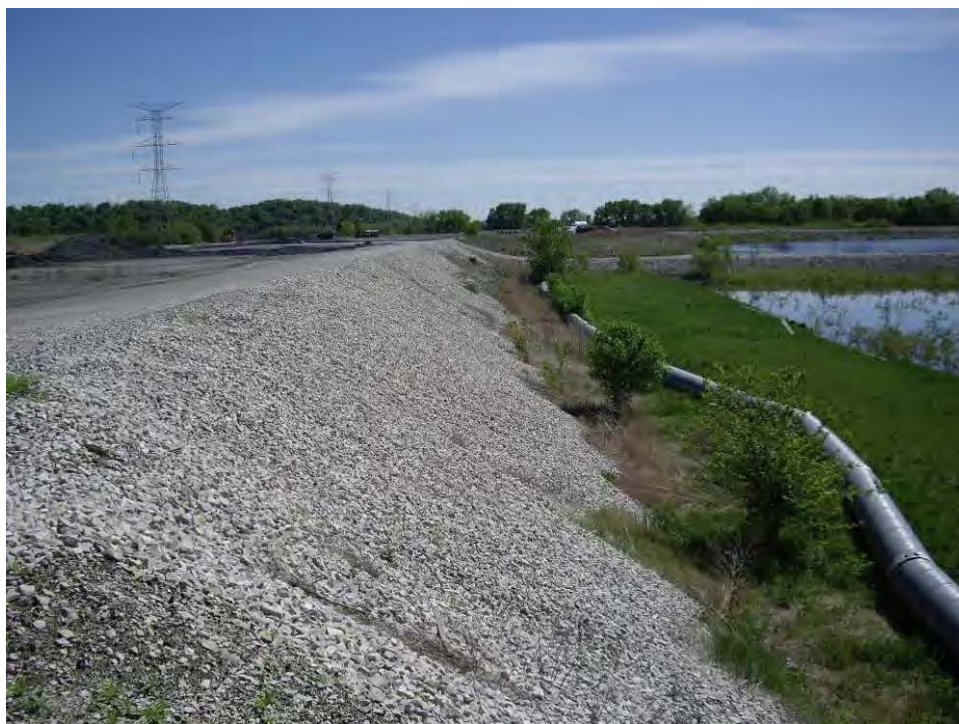
42. West slope of divider embankment A/C from Pond C north embankment, looking south.

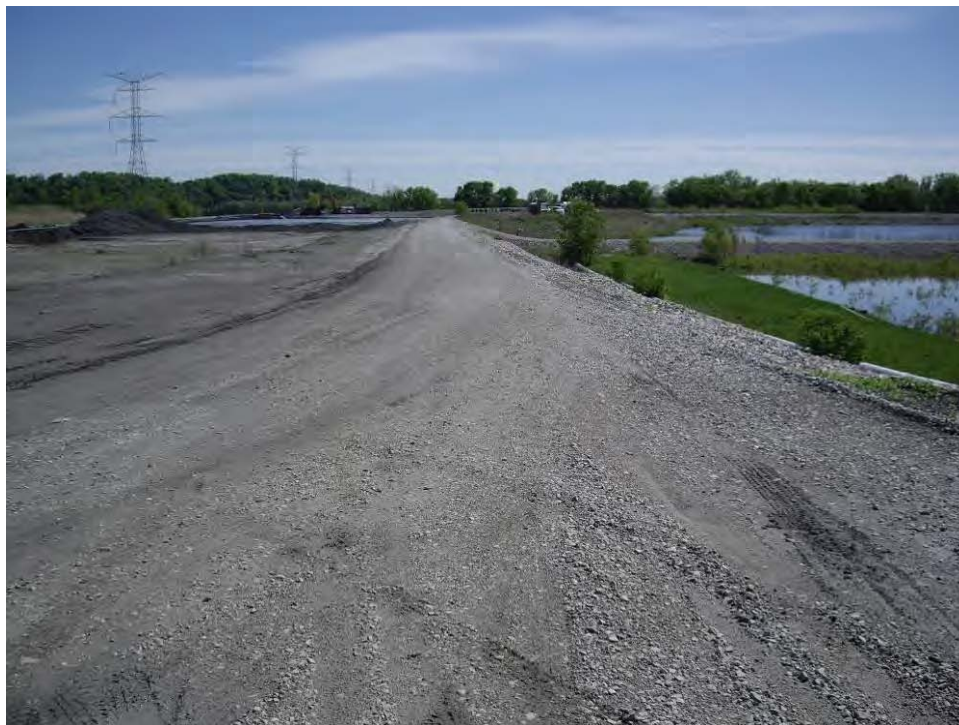
43. Crest of divider embankment A/C from Pond C north embankment, looking south.

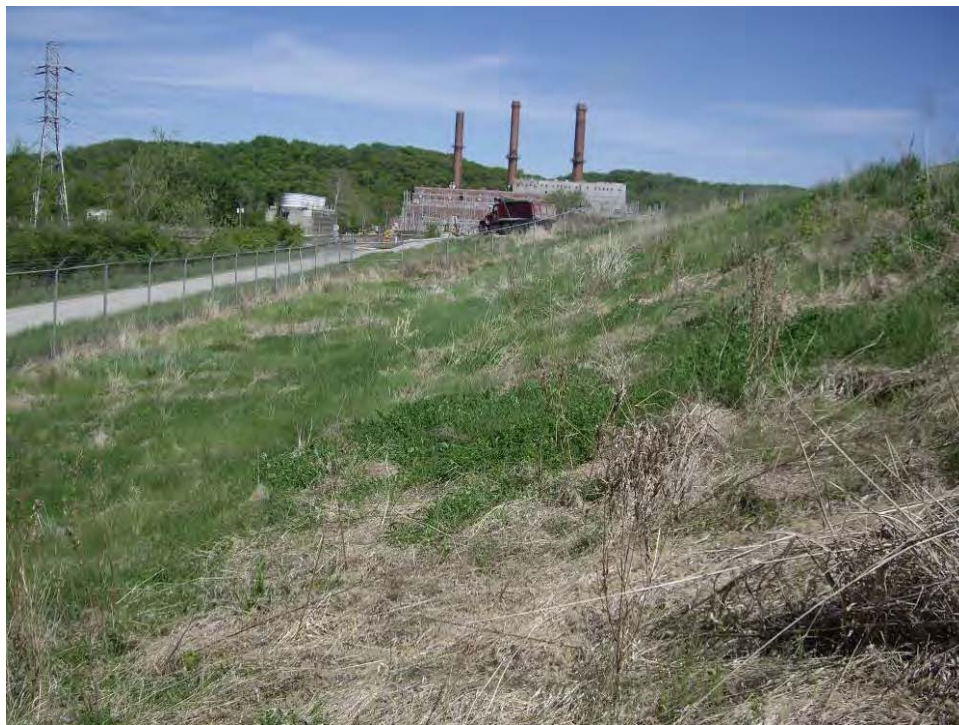
45. Pond A - North embankment exterior slope, looking east.

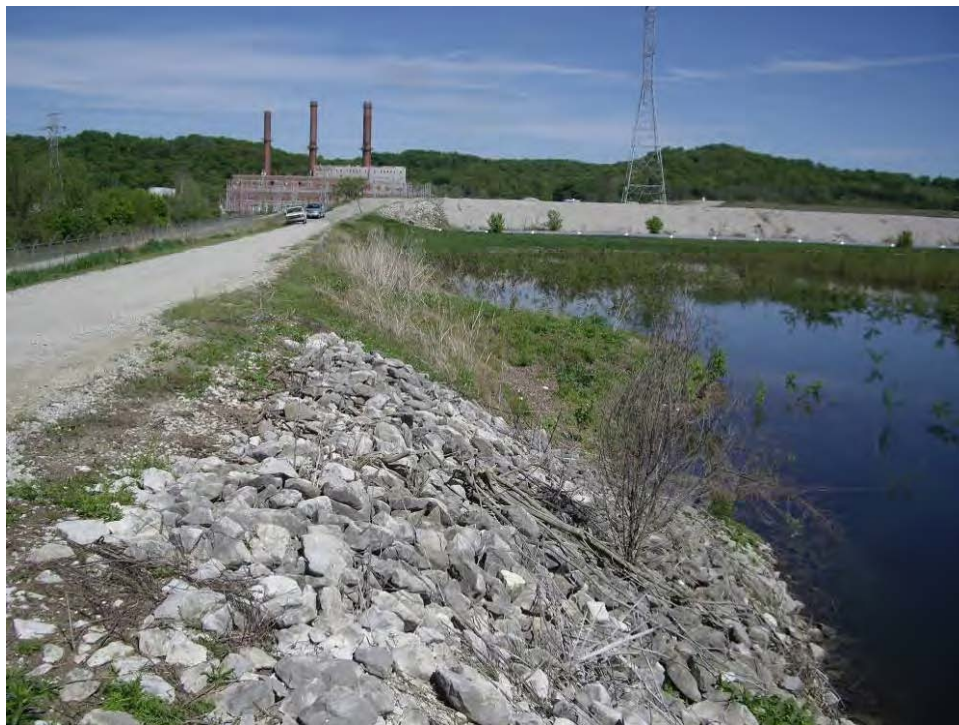
49. Pond C - North embankment interior slope, looking east. Note brush and limited riprap on slope.

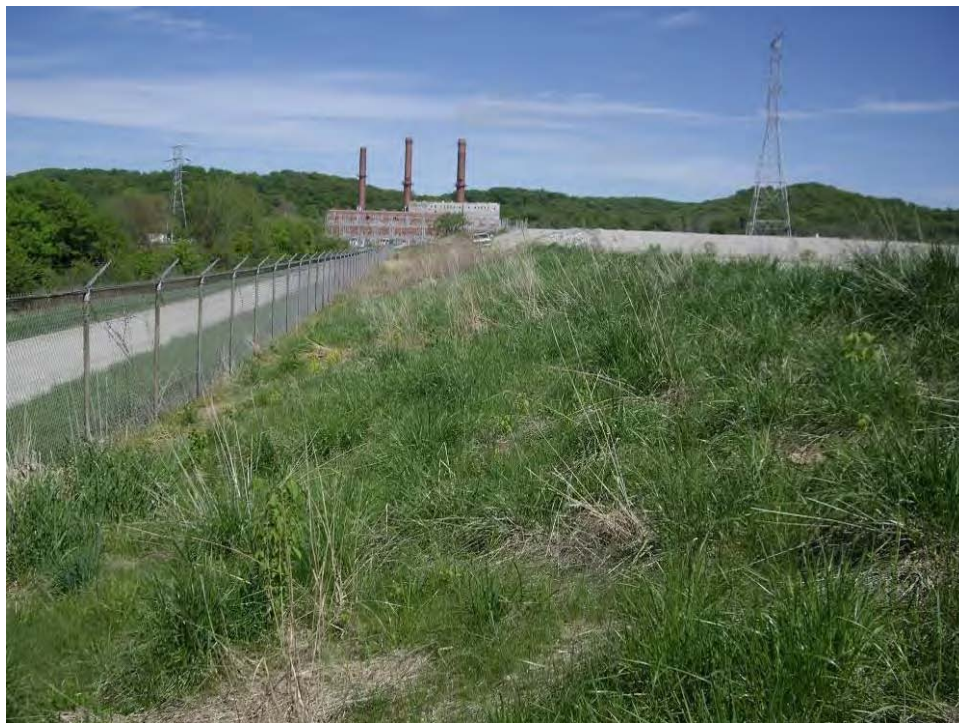
50. Pond C - North embankment exterior slope, looking east.

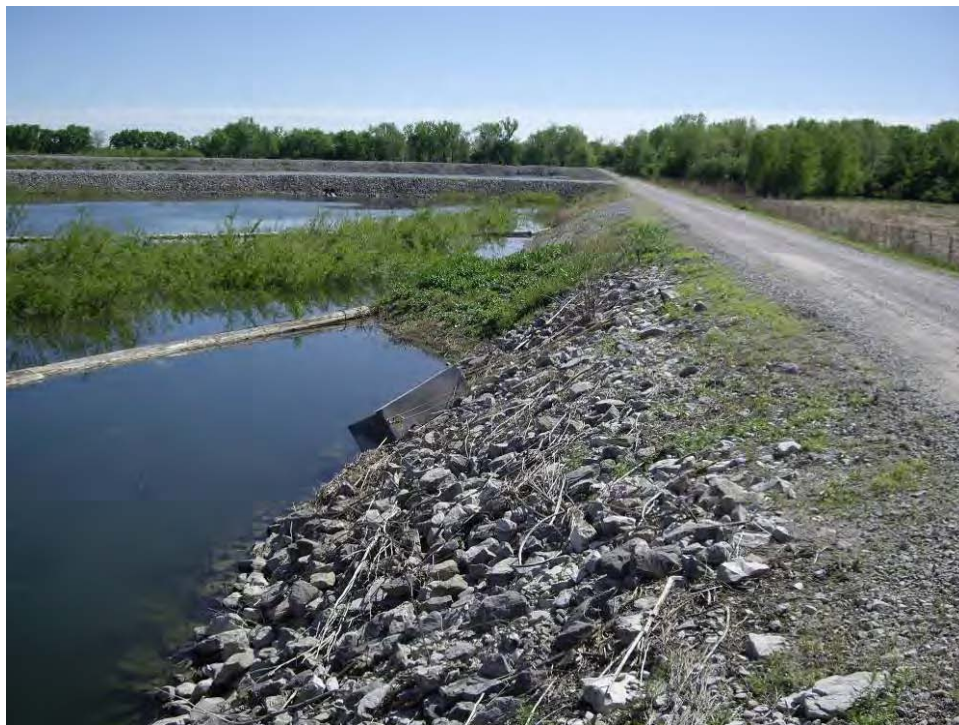
51. Pond C - West embankment interior slope, looking south.

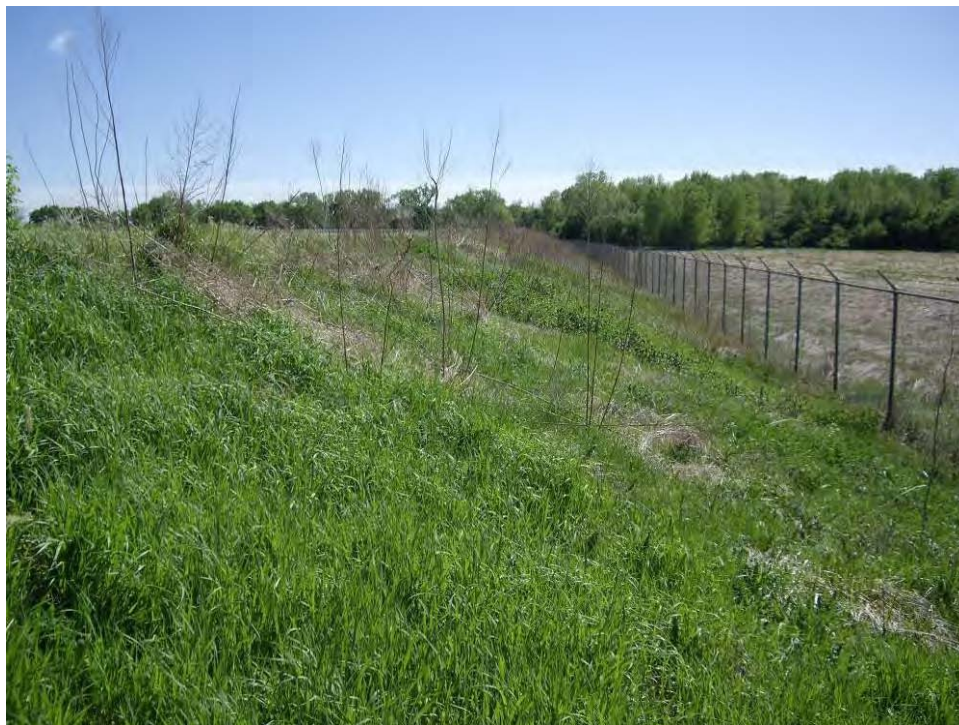
53. Pond C – West embankment exterior slope, looking south.

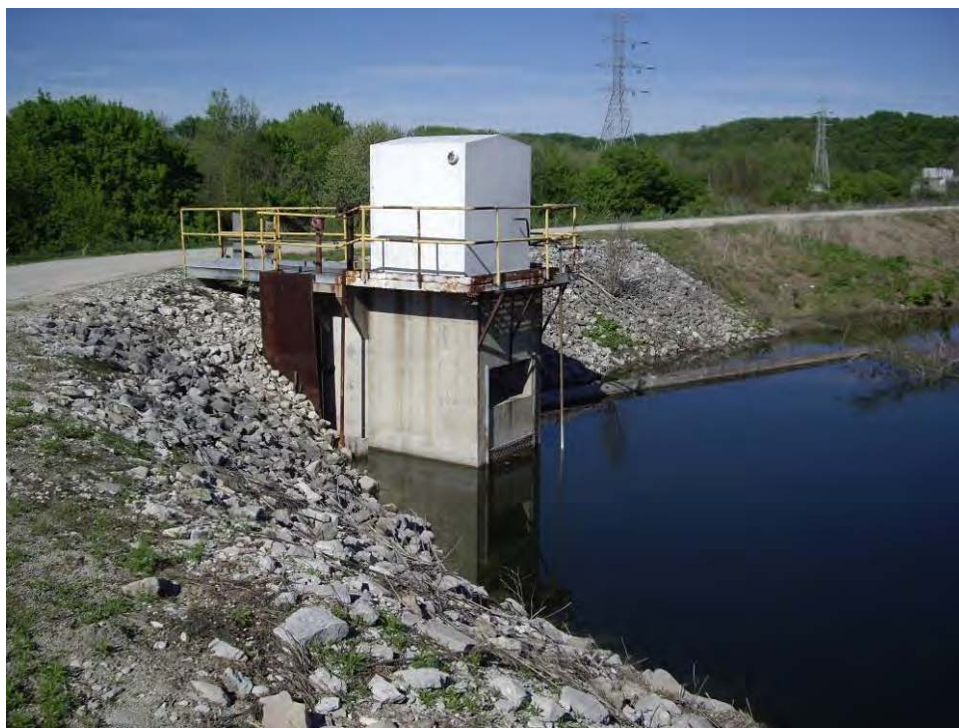
54. Pond C – Outlet structure gatehouse. Note stoplogs and butterfly valve in catwalk.

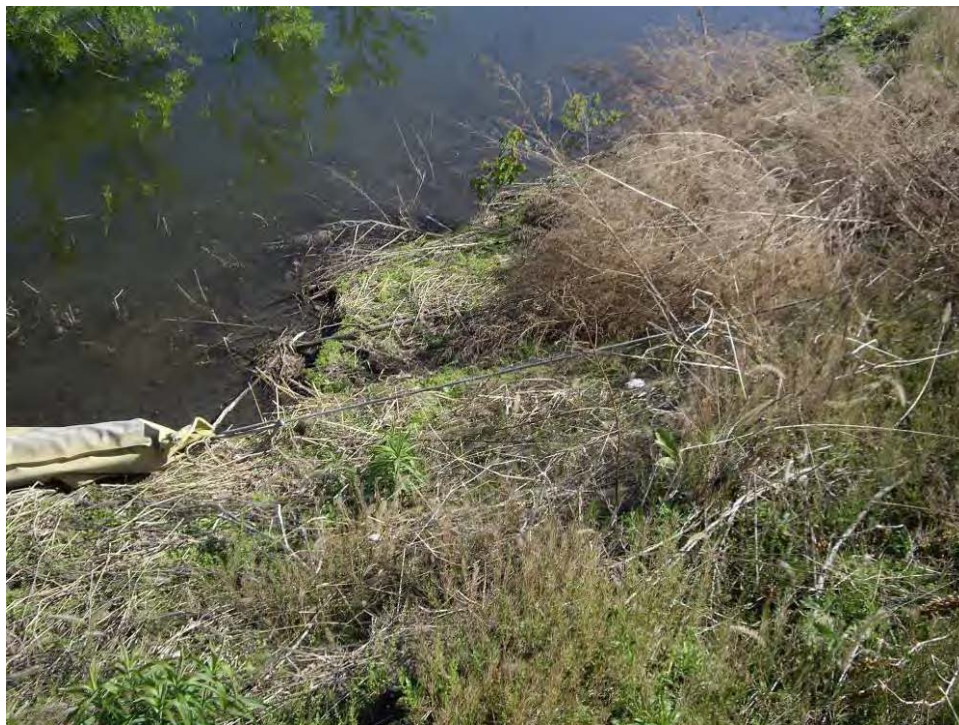
55. Pond C - Erosion feature from diversion boom tie line.

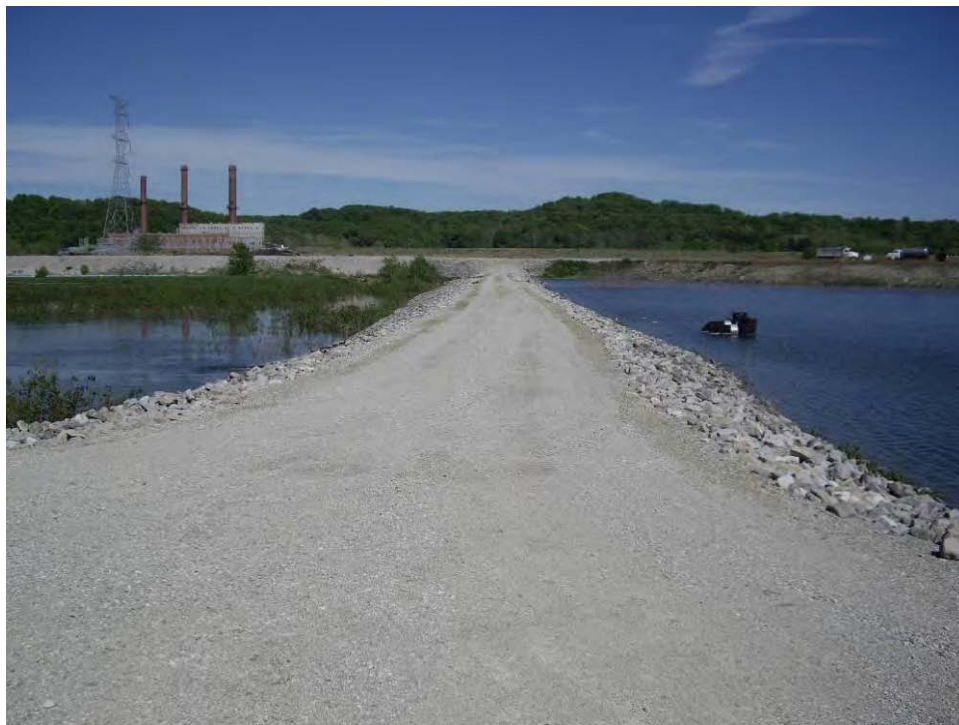
57. Crest of divider embankment B/C, looking east.

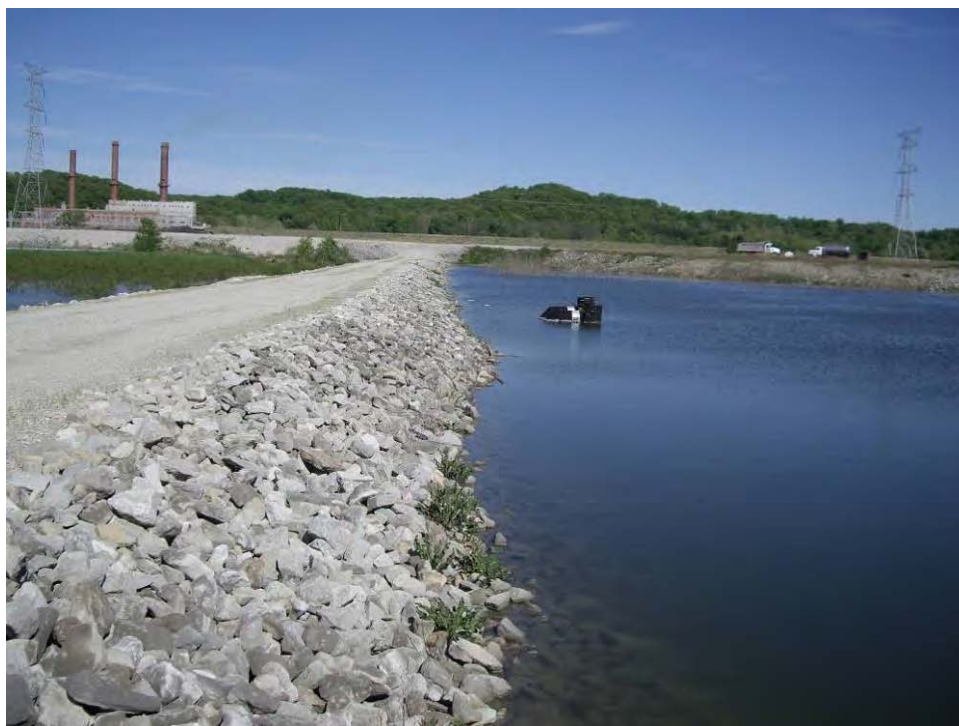
58. South slope of divider embankment B/C, looking east.

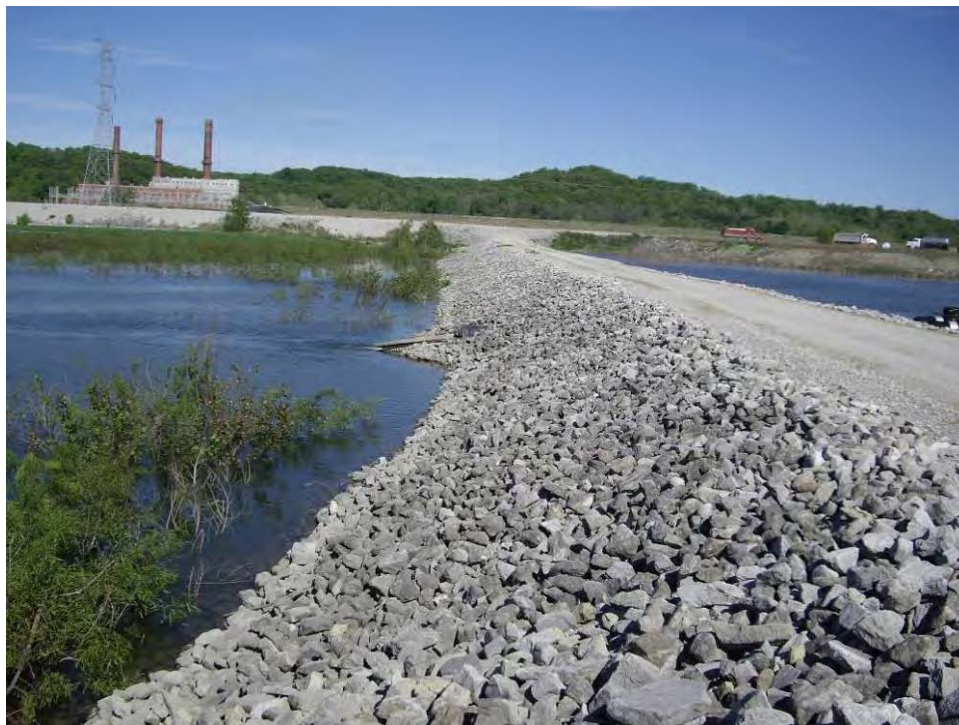
59. North slope of divider embankment B/C looking east.

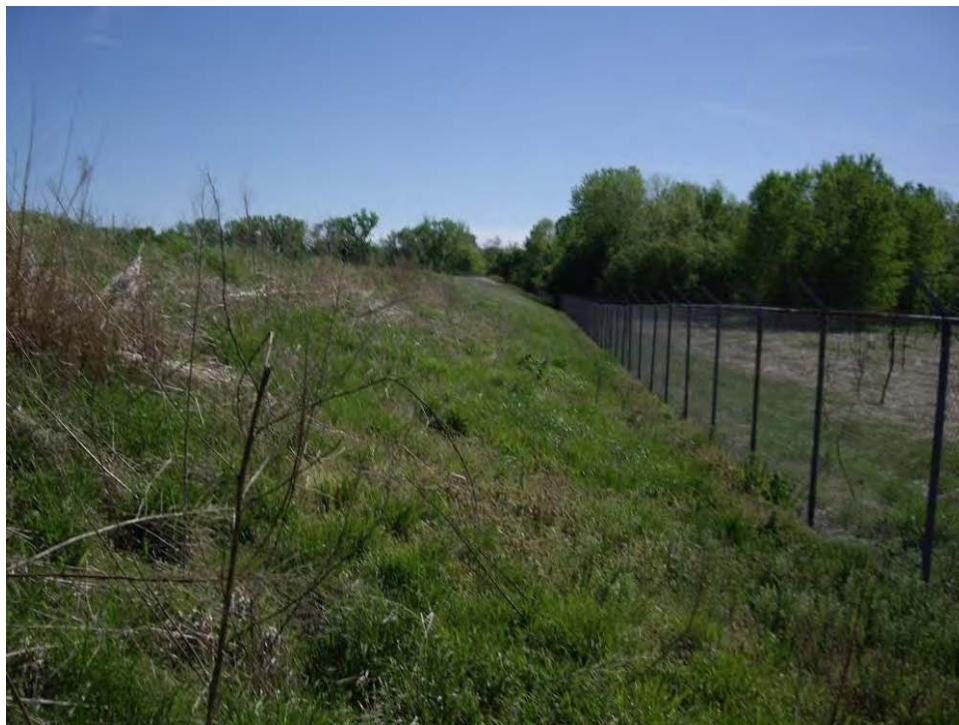
61. Pond B – west embankment exterior slope, looking south.

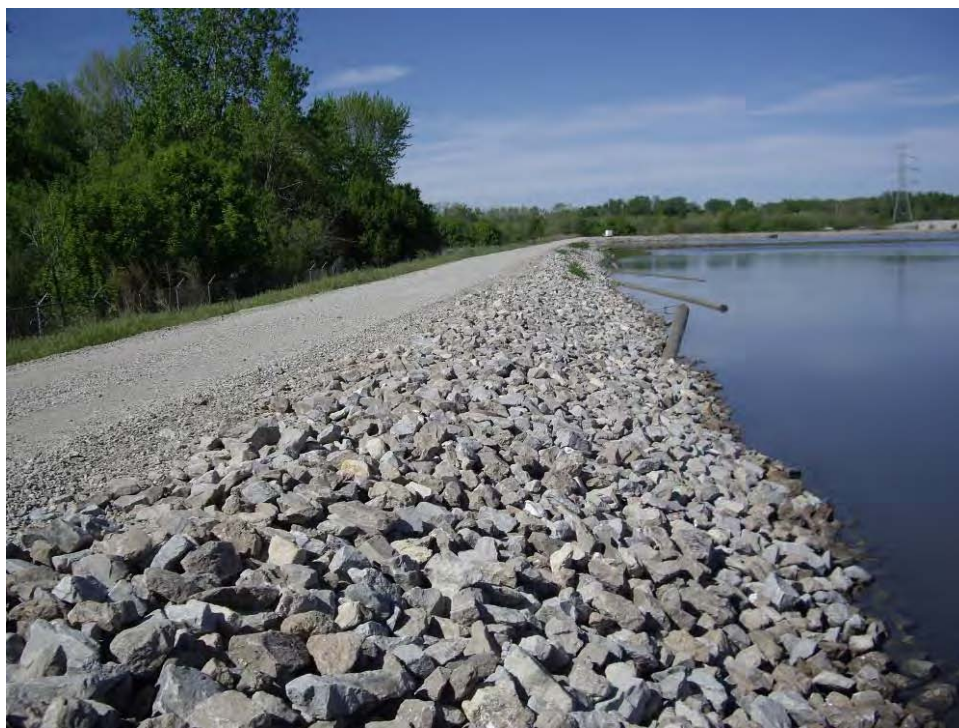
62. Pond B – west embankment interior slope, looking north
