# **Assessment of Dam Safety of Coal Combustion Surface Impoundments**

**Indianapolis Power & Light Company**

**Eagle Valley Generating Station**

**November 15, 2010**

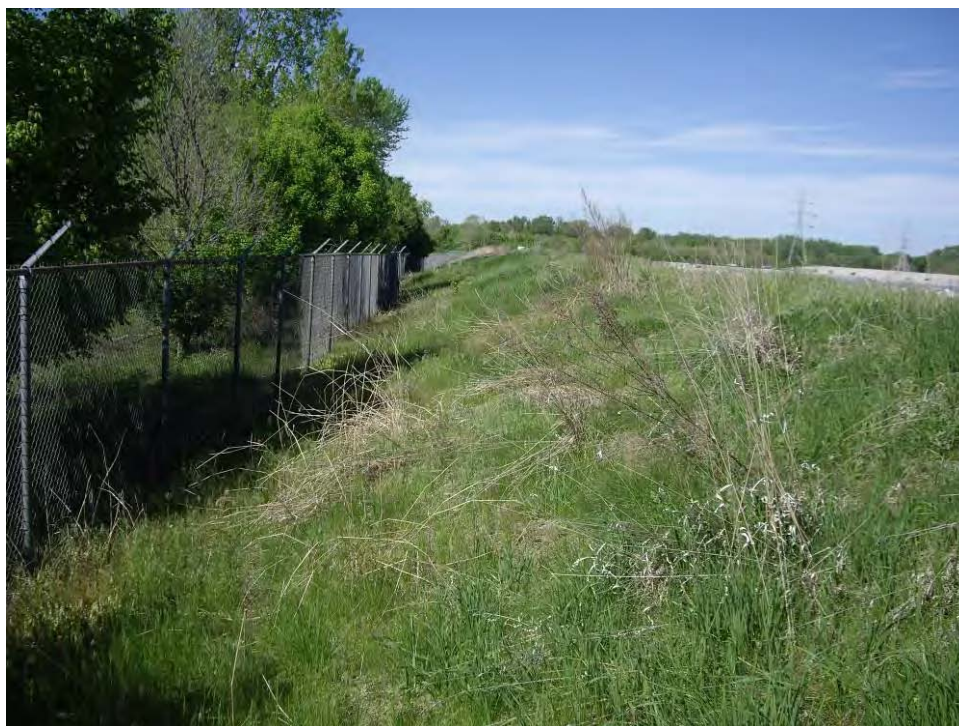
64. Pond B – west embankment exterior slope, looking north

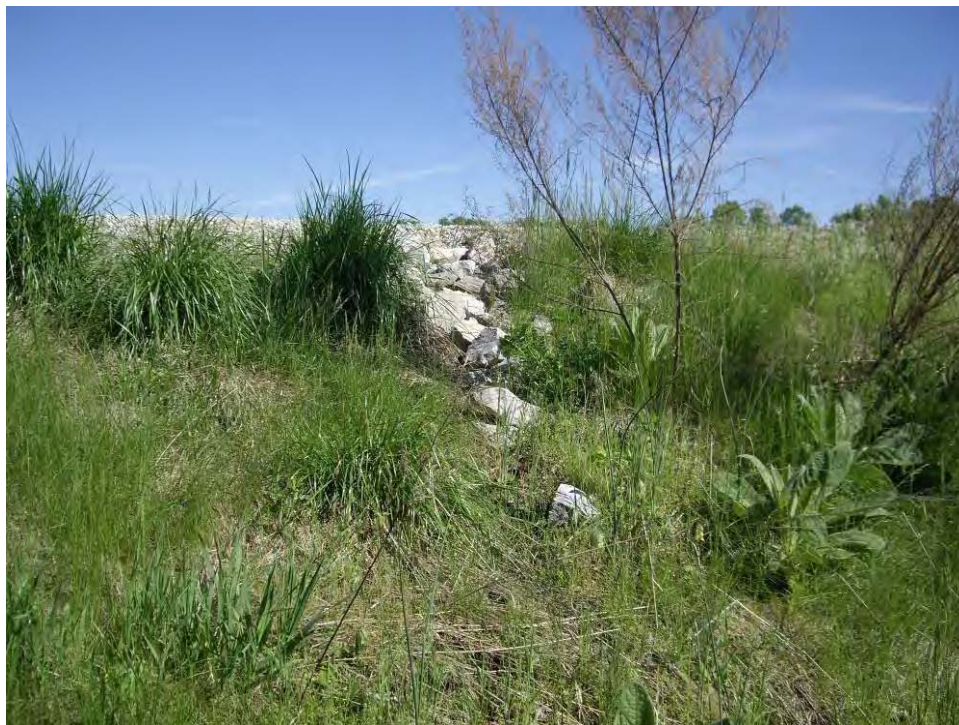
65. Pond B - erosion rill on exterior slope recently filled in with riprap, looking east.

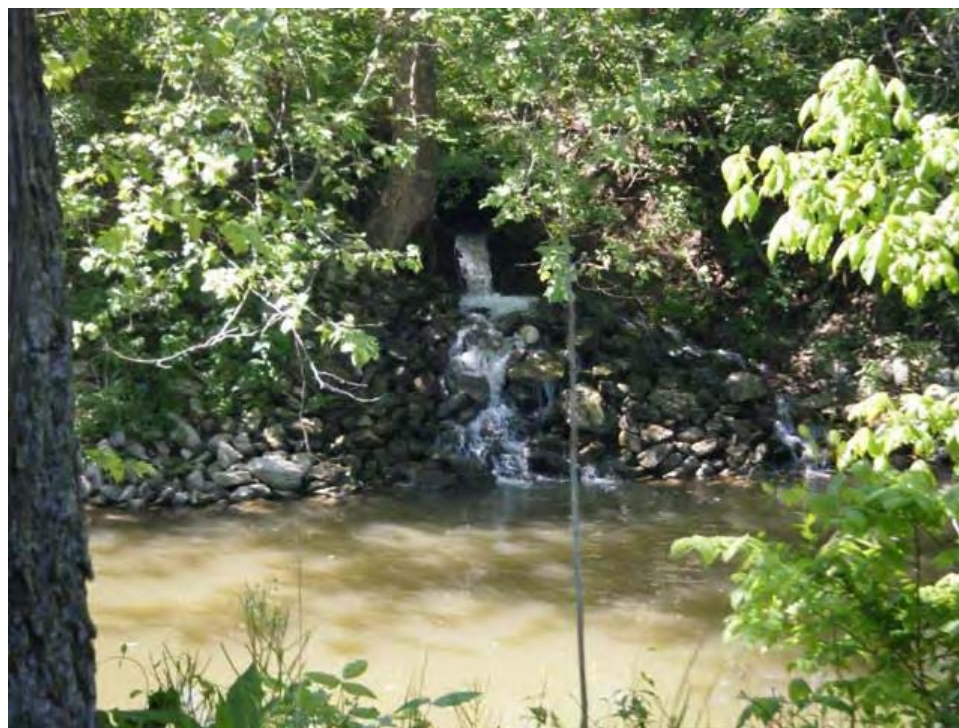
66. Pond C - Outlet structure outfall to discharge canal, looking south.

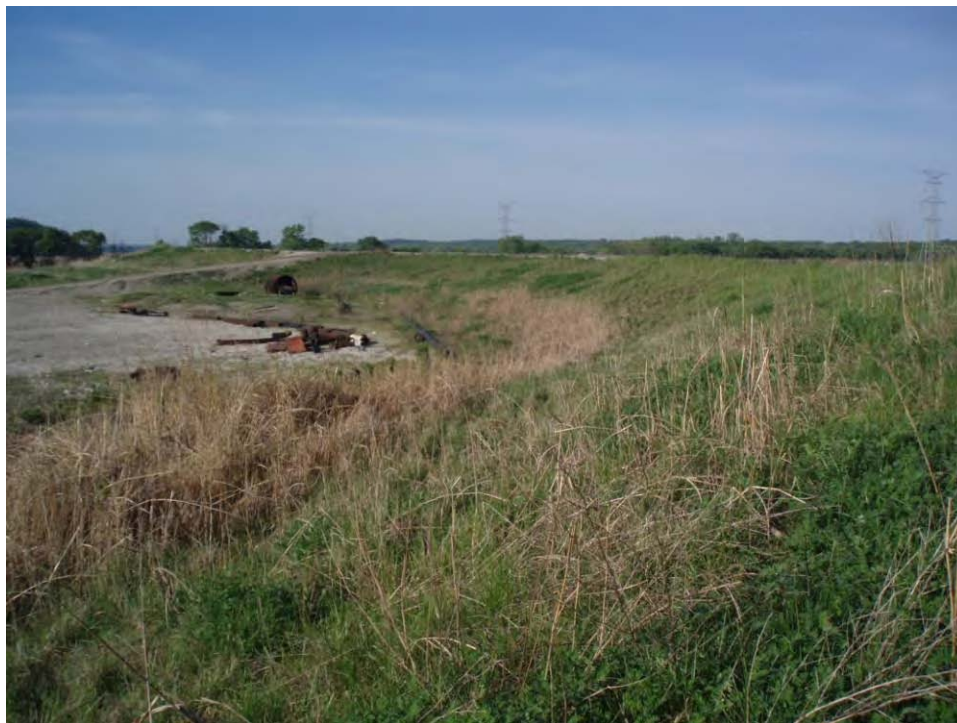
67. Pond D - east embankment exterior slope, looking southwest.

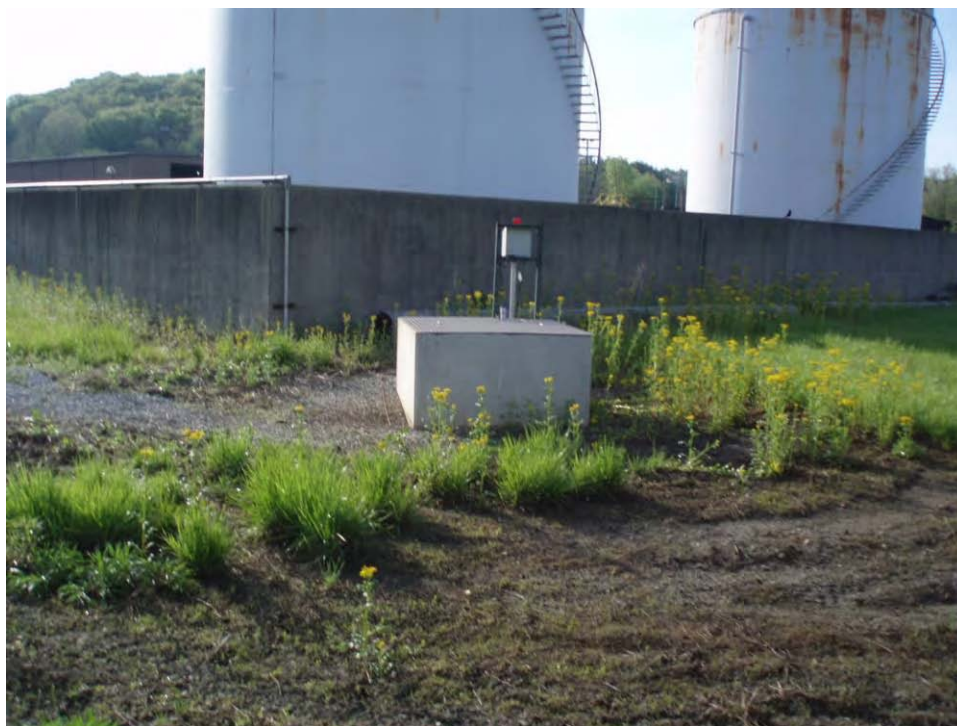
70. Pond D - north embankment toe drain sump pit located in northeast downstream area.

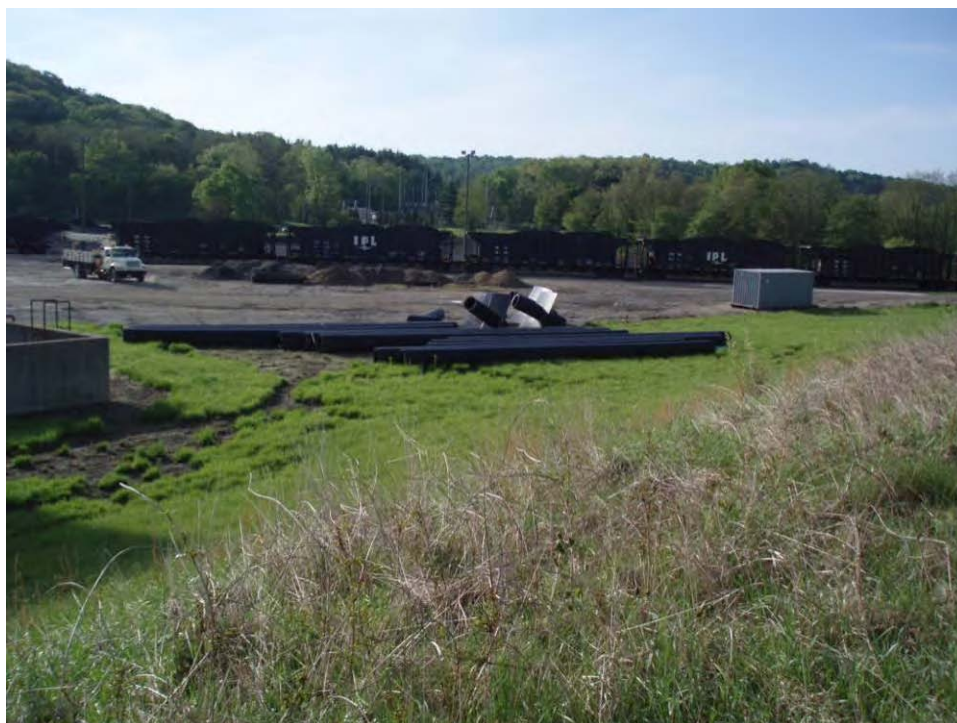
71. Pond D - East embankment downstream area looking southeast. Note new piping for Ponds D & E.

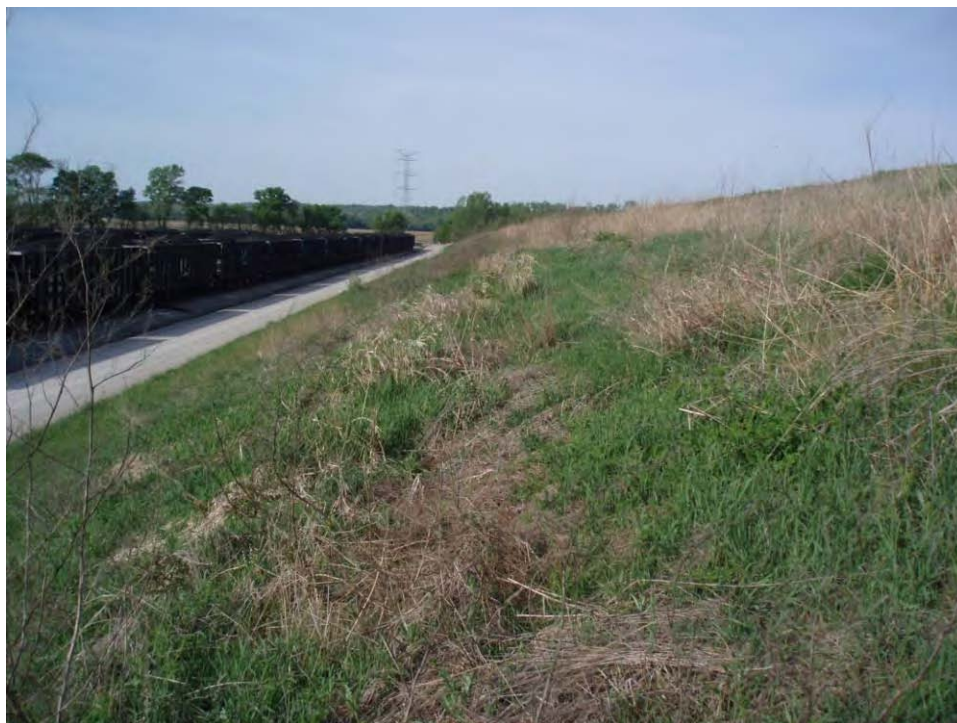
76. Pond D - Southeast embankment exterior slope, looking southwest.

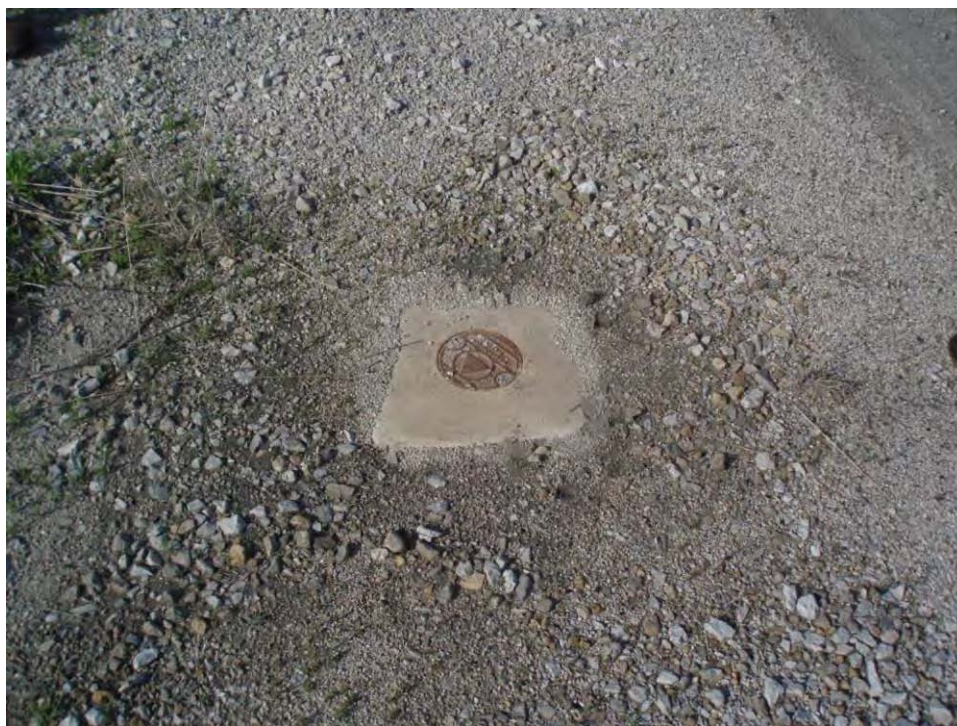
78. Piezometer PZ-2 on Pond D east embankment crest installed by BT<sup>2</sup> on 6/12/08.

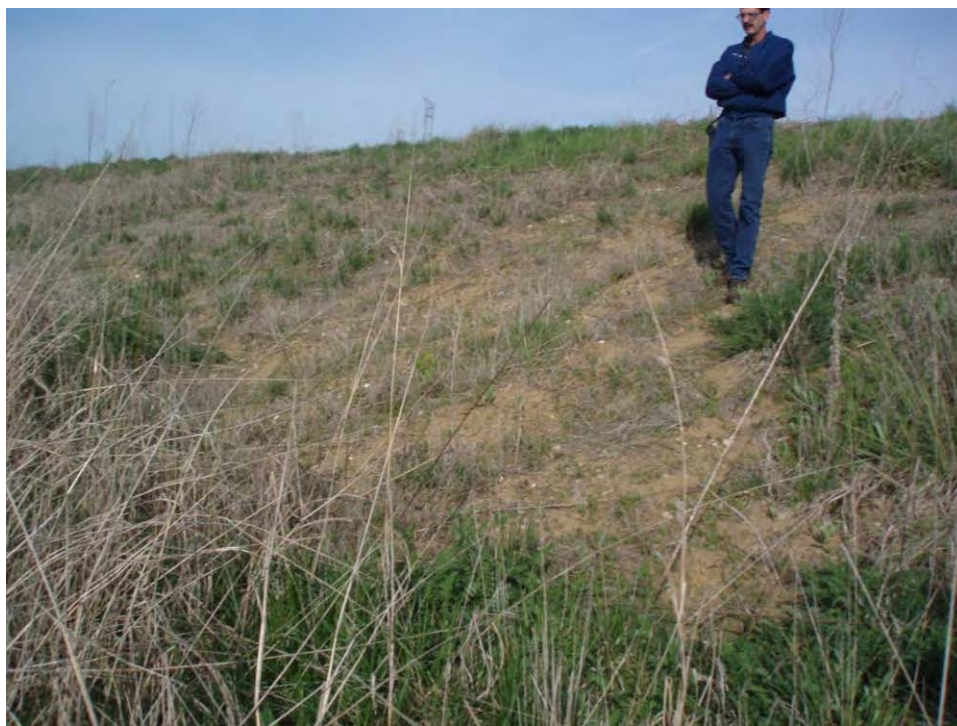
80. Pond D - Large bare spot on upper third of southeast embankment exterior slope, looking northwest.

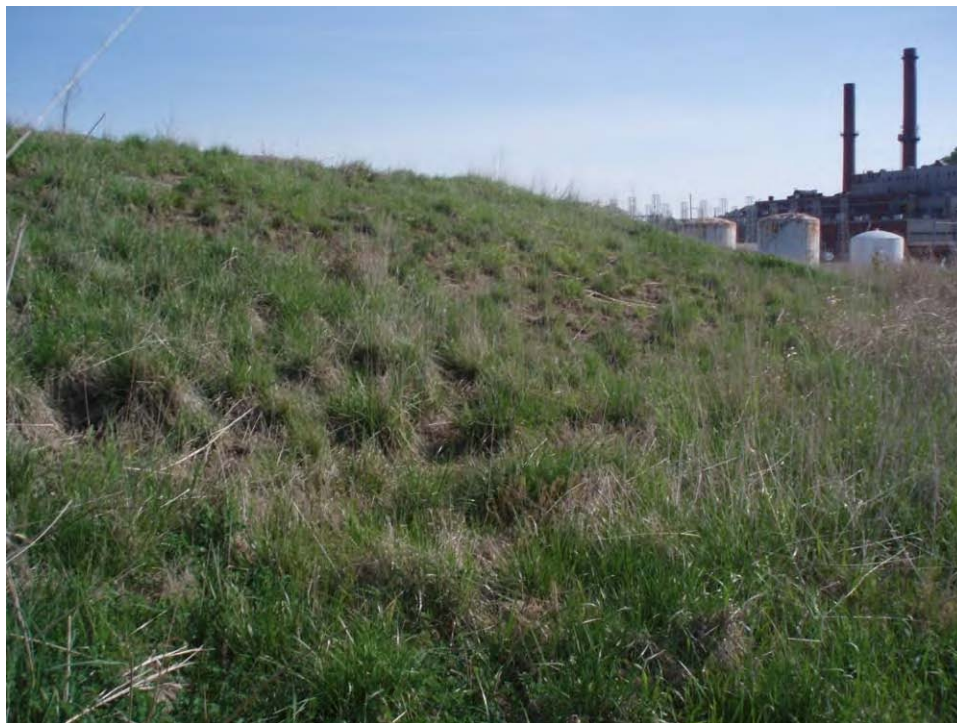
81. Typical bare spots on upper third of Pond D exterior embankment (last expansion).

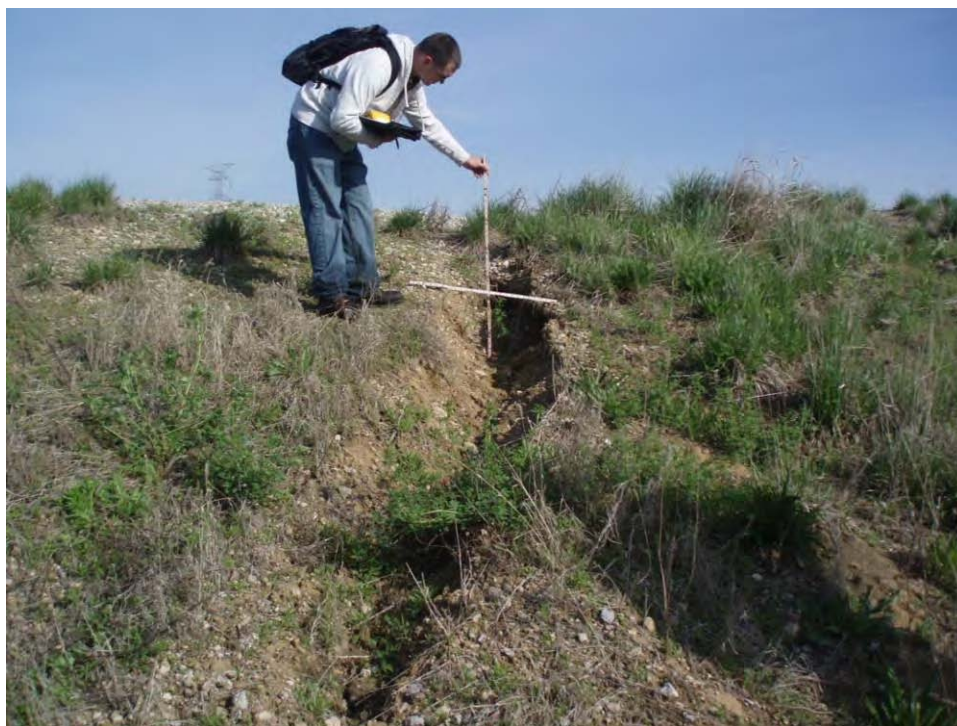
82. Pond D - Erosion rill on southeast embankment exterior slope, looking northwest.

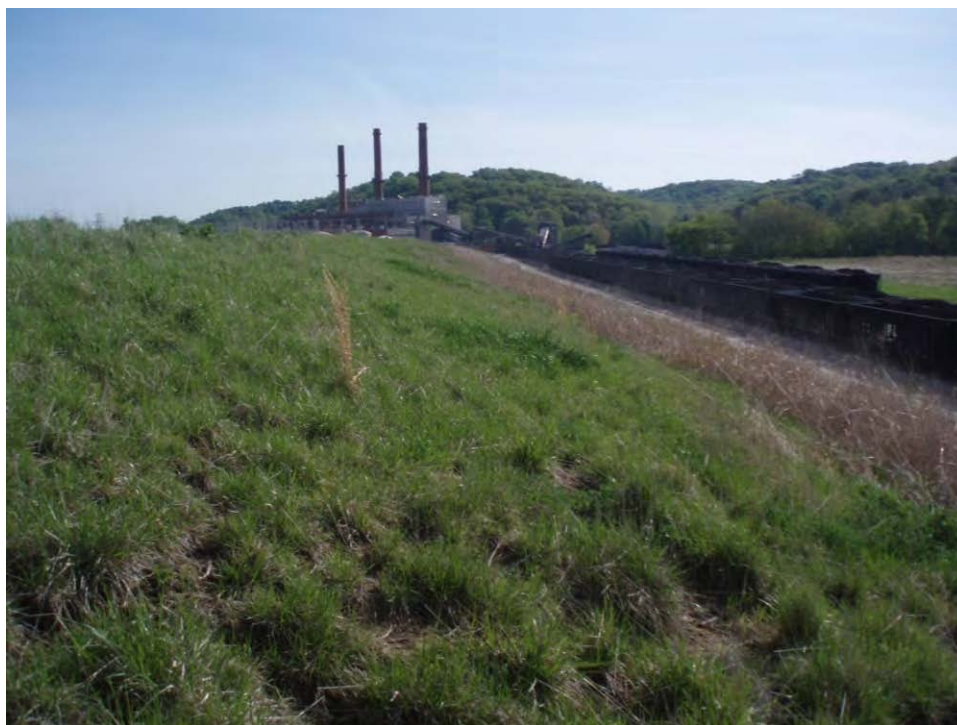
83. Pond D - Southeast embankment exterior slope, looking northeast.

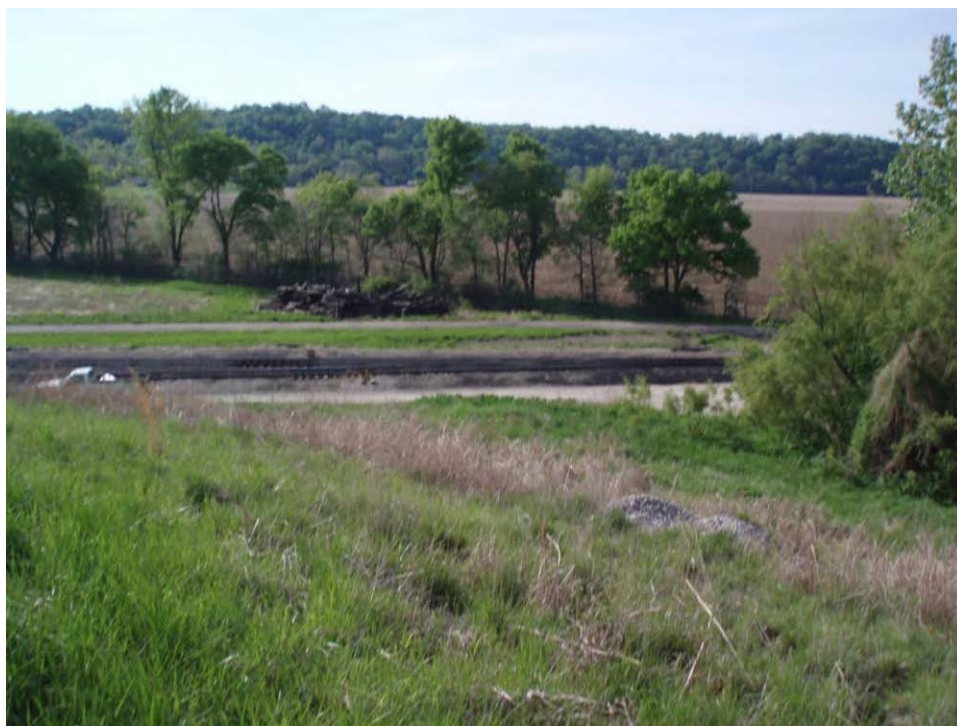
86. Pond D - Southwest corner of southeast embankment exterior slope downstream area, looking southeast.

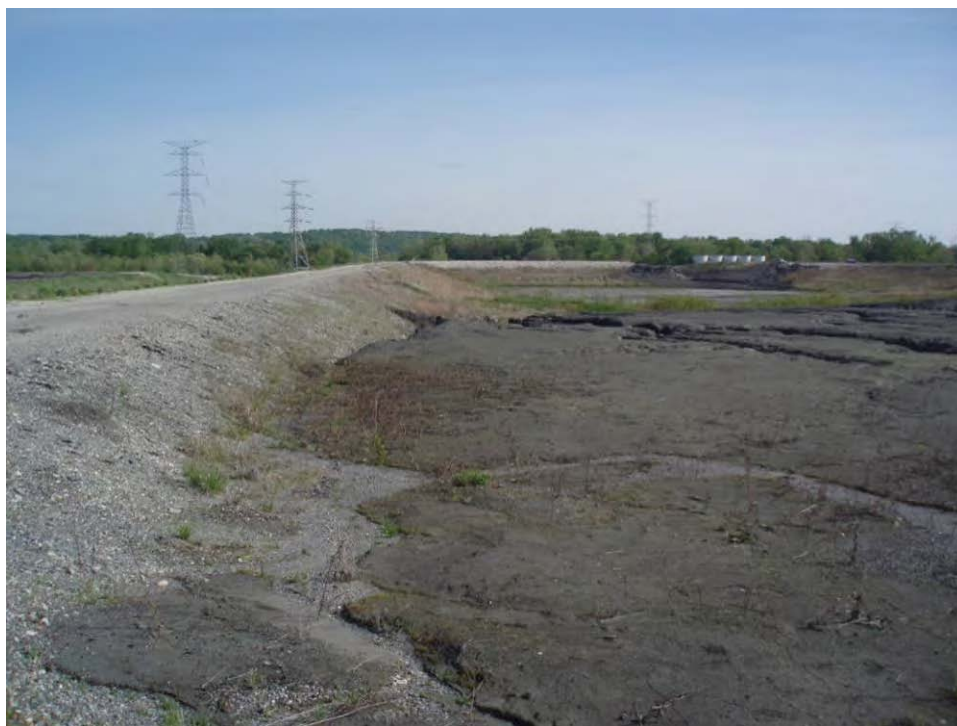
88. Pond D - West embankment interior slope, looking north.

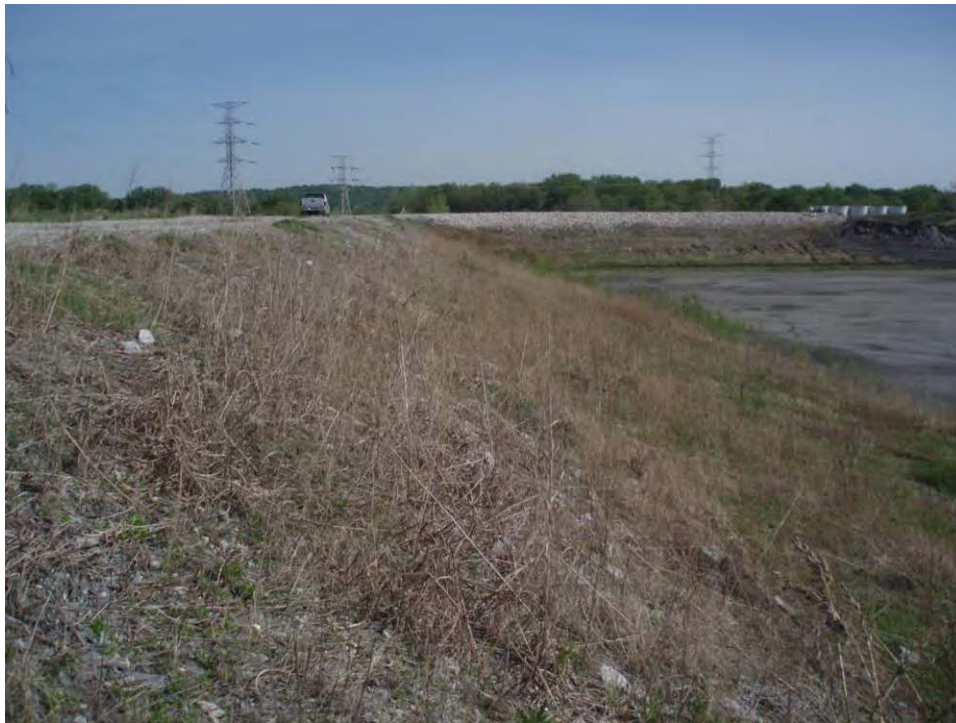
93. Pond D - West embankment interior slope, looking north toward divider embankment D/E.

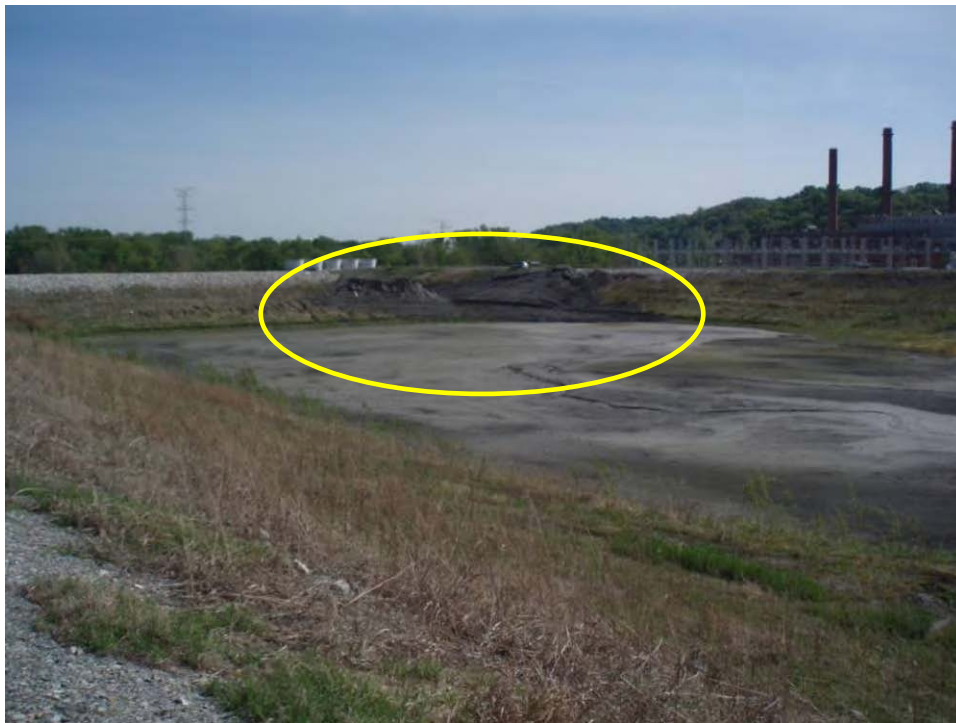
| Inspection Issue # | Comments |
|---|---|
| 19. | Divider embankment D/E breached on 1/30/08. Breach resulted in Pond E north embankment being overtopped. North embankment breached. Large erosion features on west and north embankment exterior slope. Embankment and erosion being repaired. Repair designed by independent consultant Professional Engineer. |

94. Overview of Pond D, south slope of divider embankment D/E, and west slope of Pond D divider embankment. Note breach (circled) in divider embankment D/E.

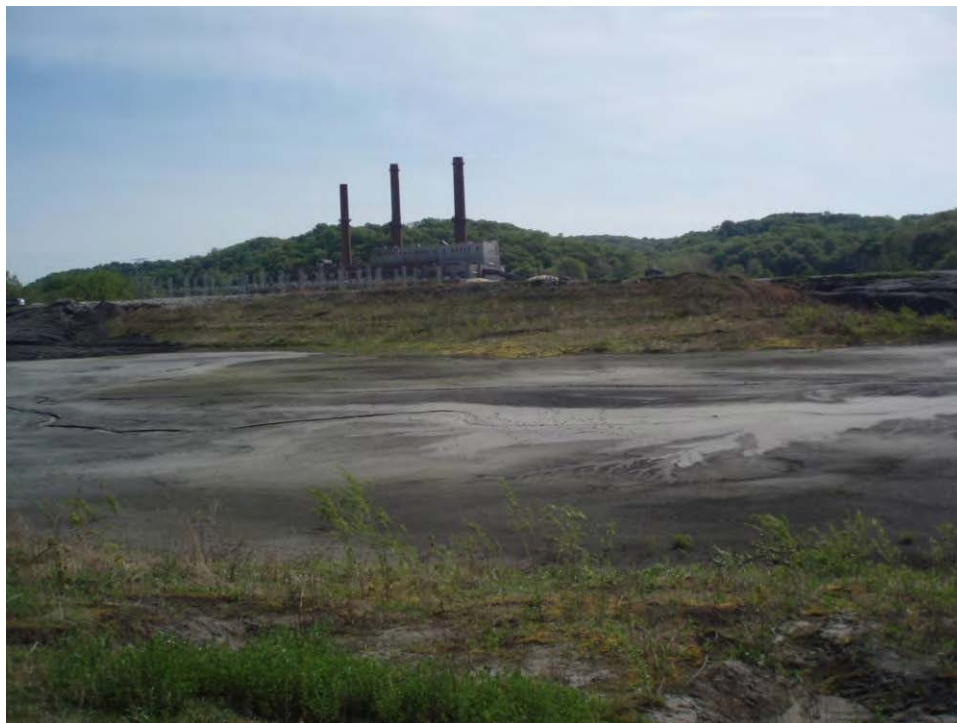
95. Overview of Pond D and west slope of Pond D divider embankment, looking east.

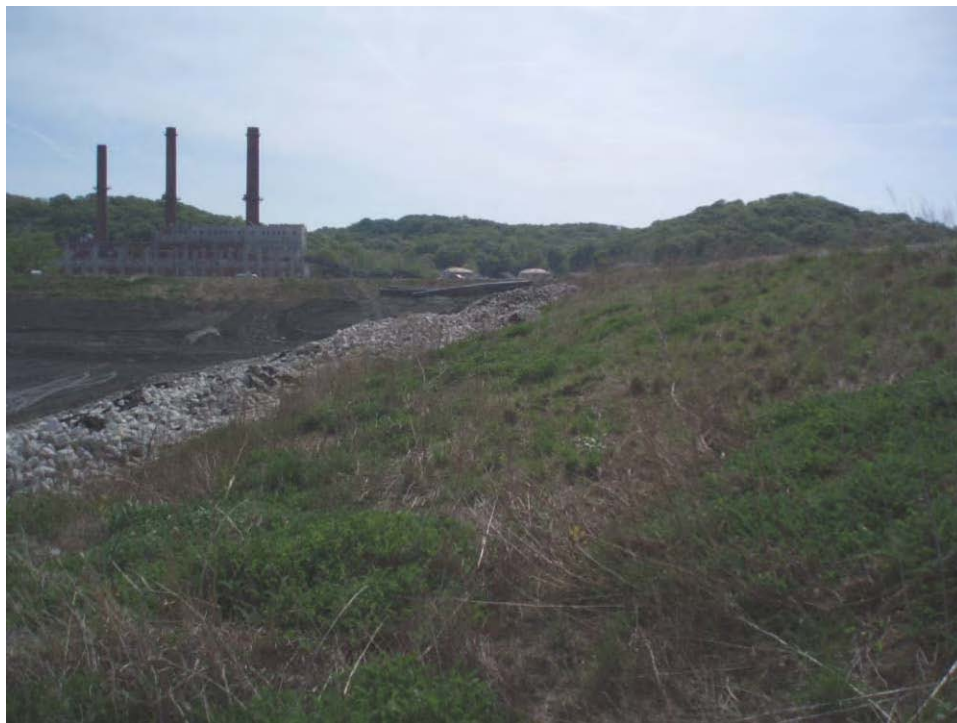
99. North slope of divider embankment D/E, looking east.

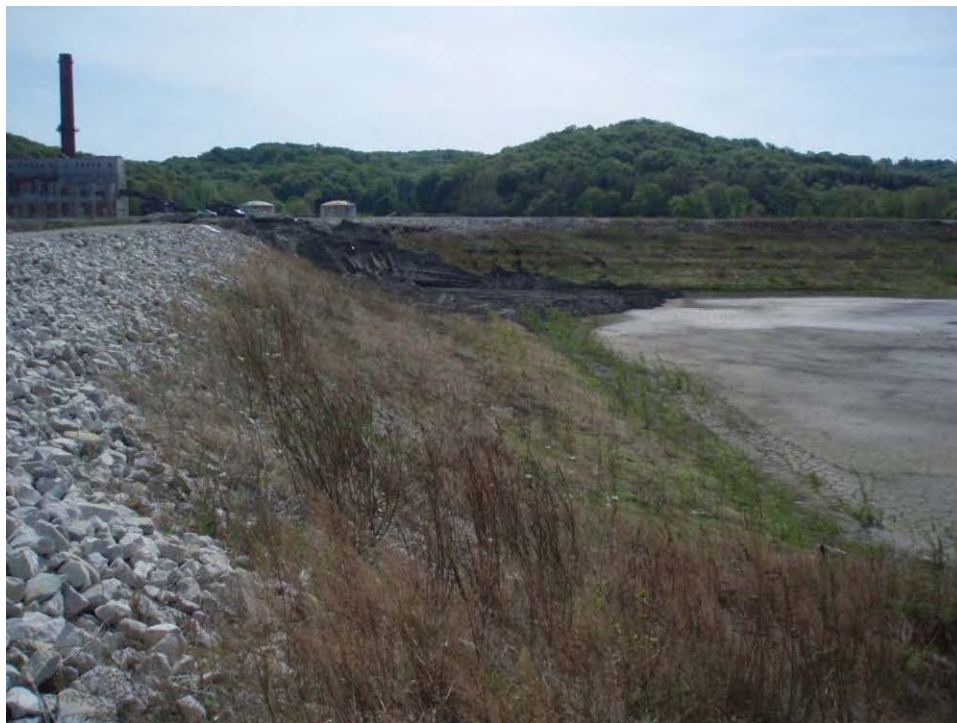
101. South slope of divider embankment D/E, looking east.

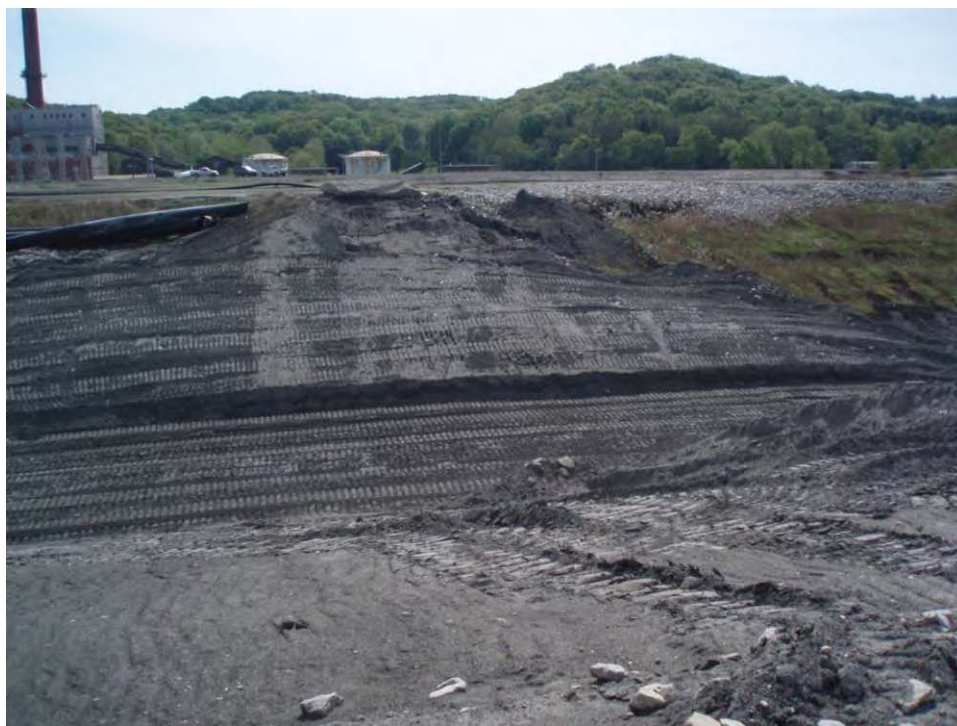
102. Overview of cut in divider embankment D/E for repair work.

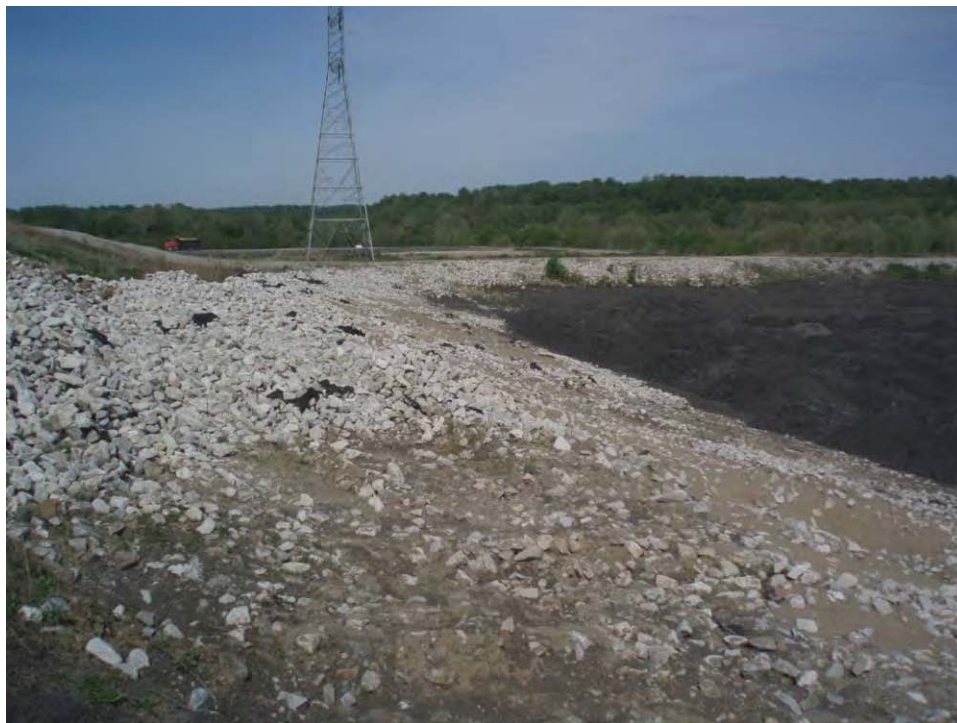
103. North slope of divider embankment D/E, looking west.

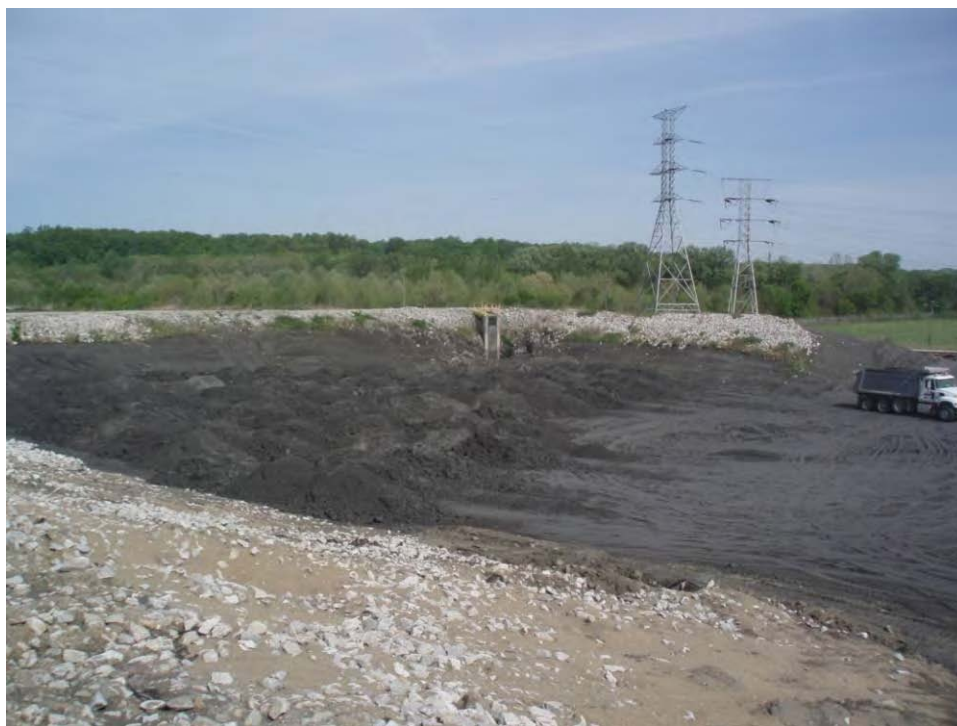
104. Overview of Pond E backfilling operation and Pond E outlet structure, looking northwest.

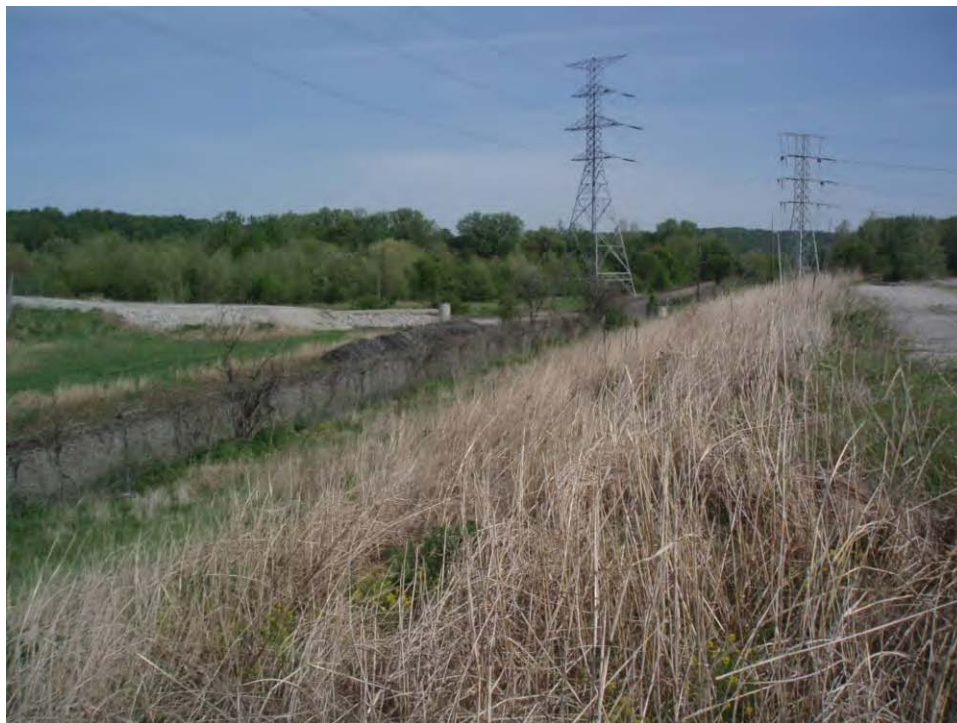
105. Pond E - West embankment exterior slope, looking north.

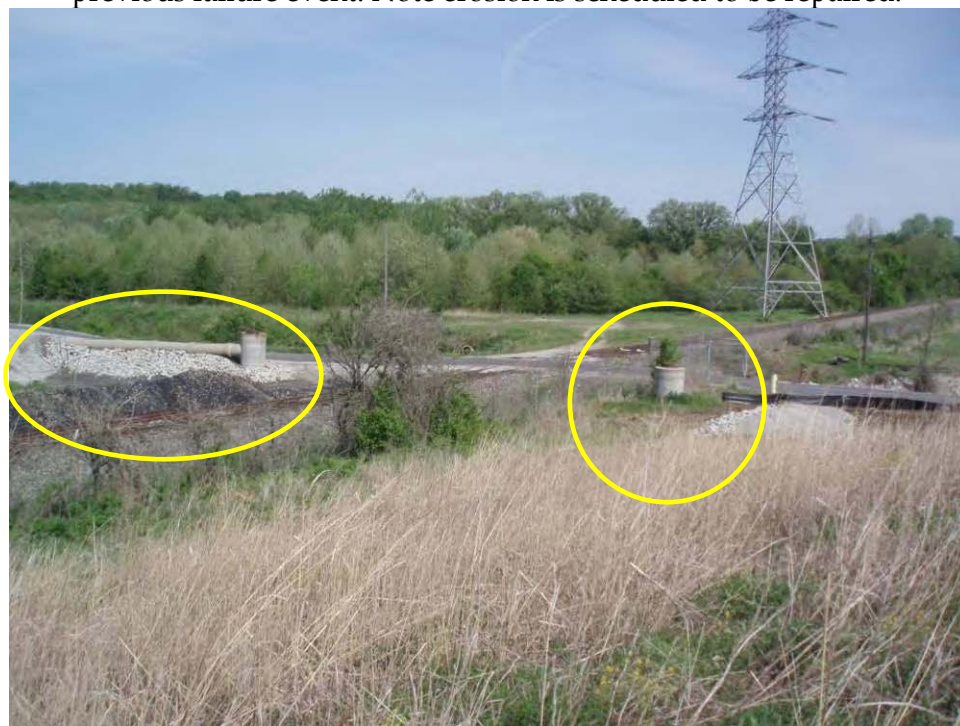
108. Overview of discharge manholes from Pond E into Pond C, looking northwest.

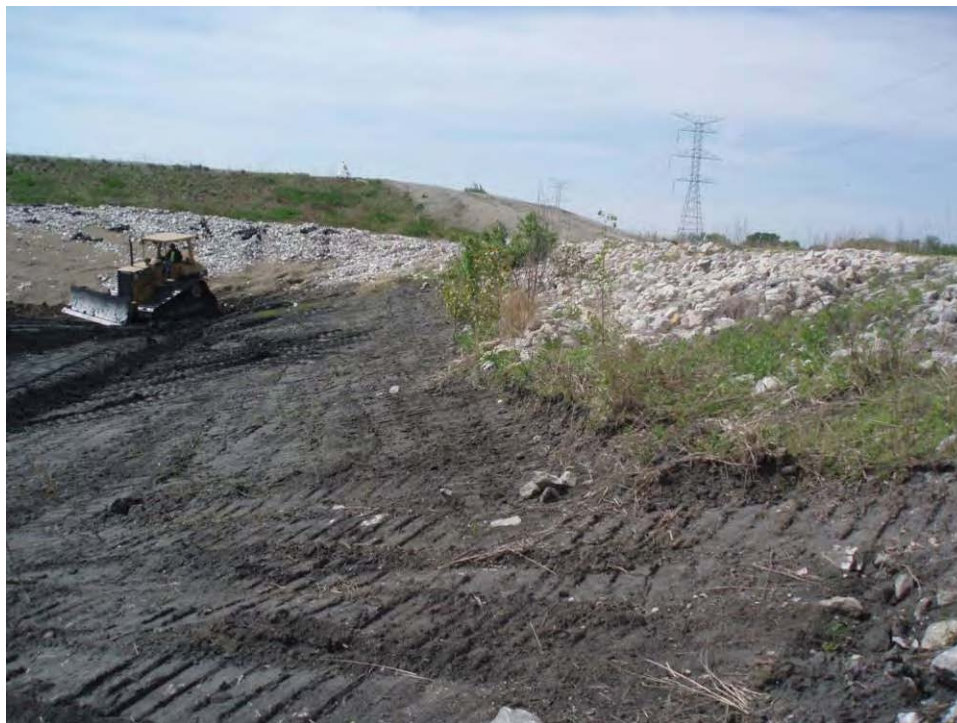
109. Pond E - West embankment interior slope, looking south.

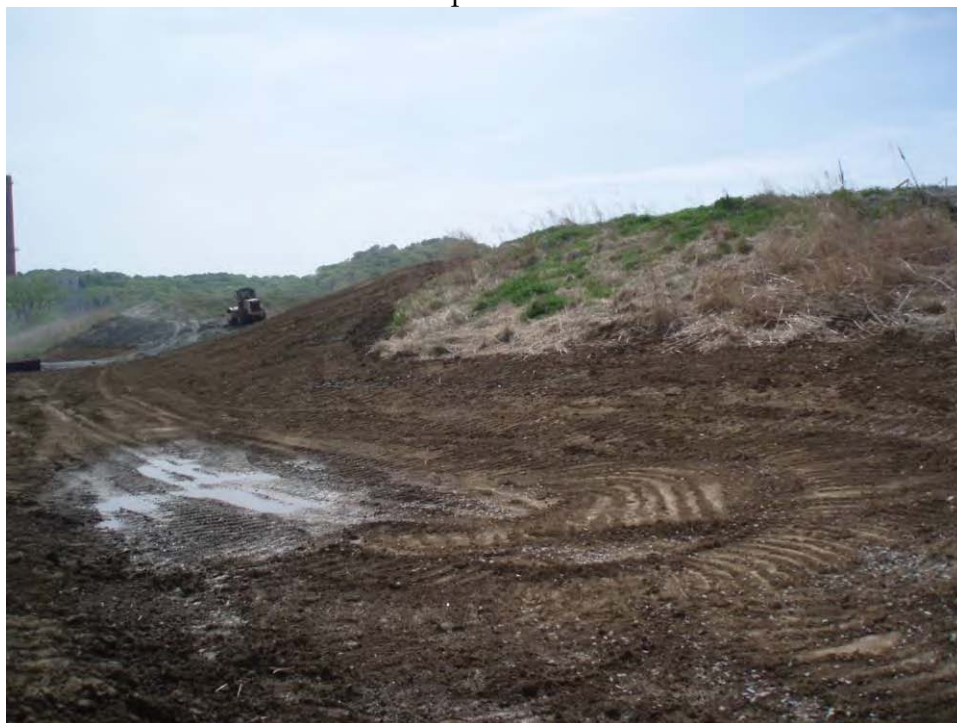
114. Pond E – Downstream area looking south toward failure repair (reconstruction of north embankment).

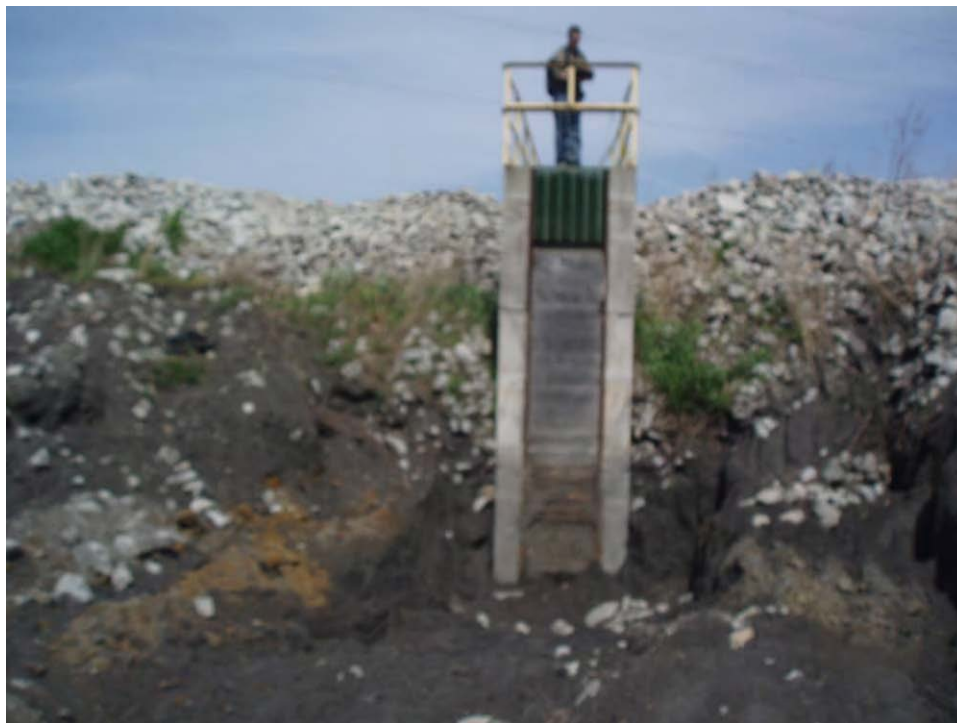
115. Pond E - Overview of outlet control structure with stoplogs and butterfly valve, looking northwest.

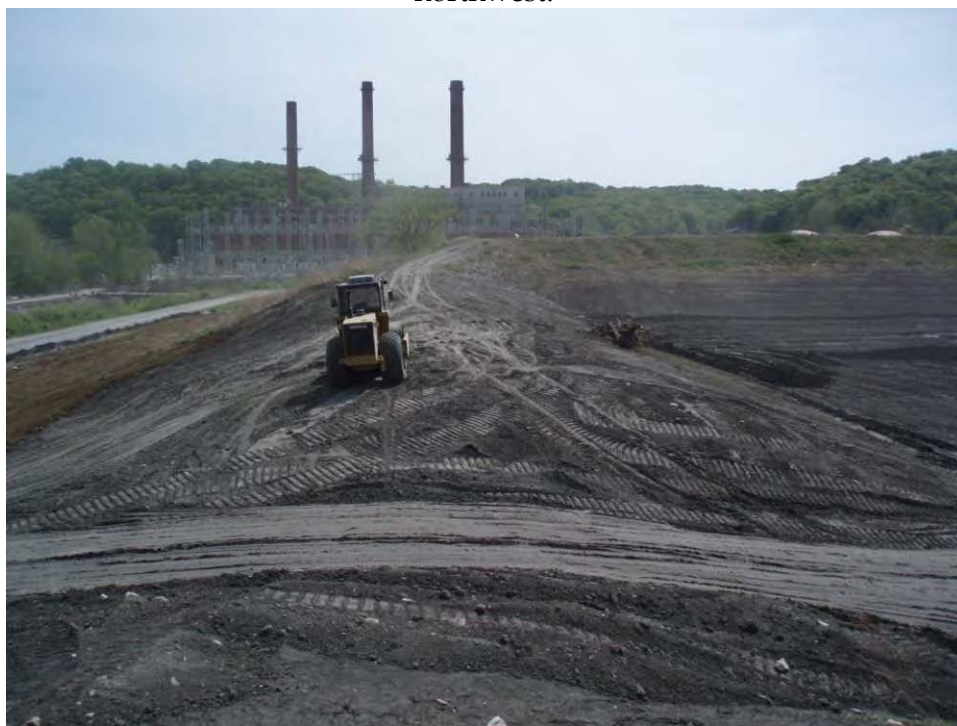
116. Pond E - Overview of north embankment reconstruction, looking east.

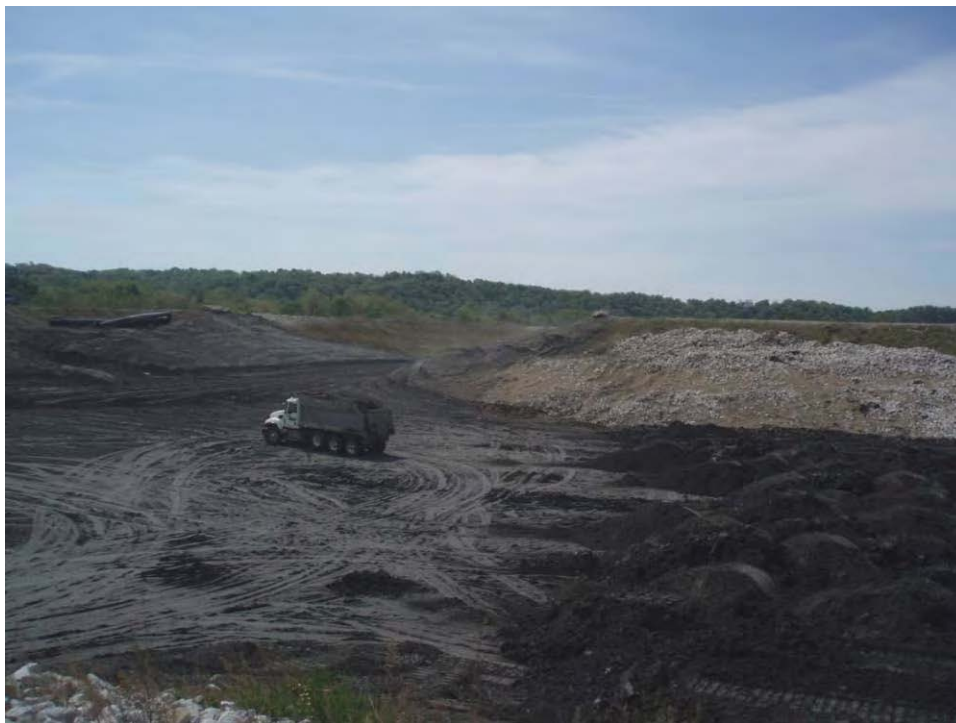
117. Overview of divider embankment D/E reconstruction and Pond E filling operation, looking south.

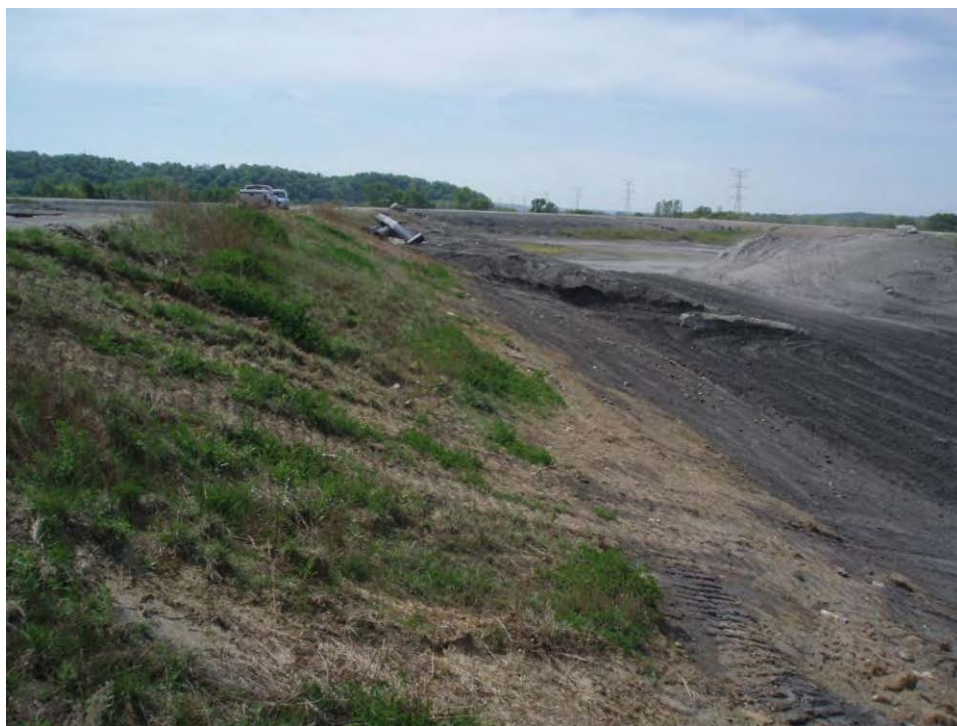
122. West slope of divider embankment D/E, looking south.

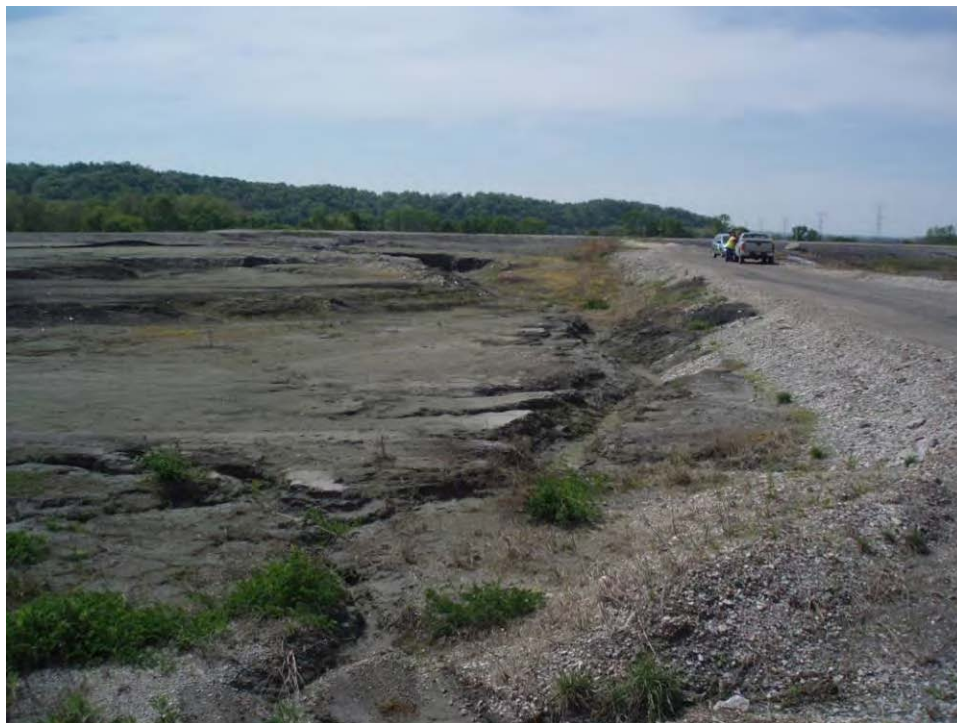
123. East slope of divider embankment D/E, looking south.

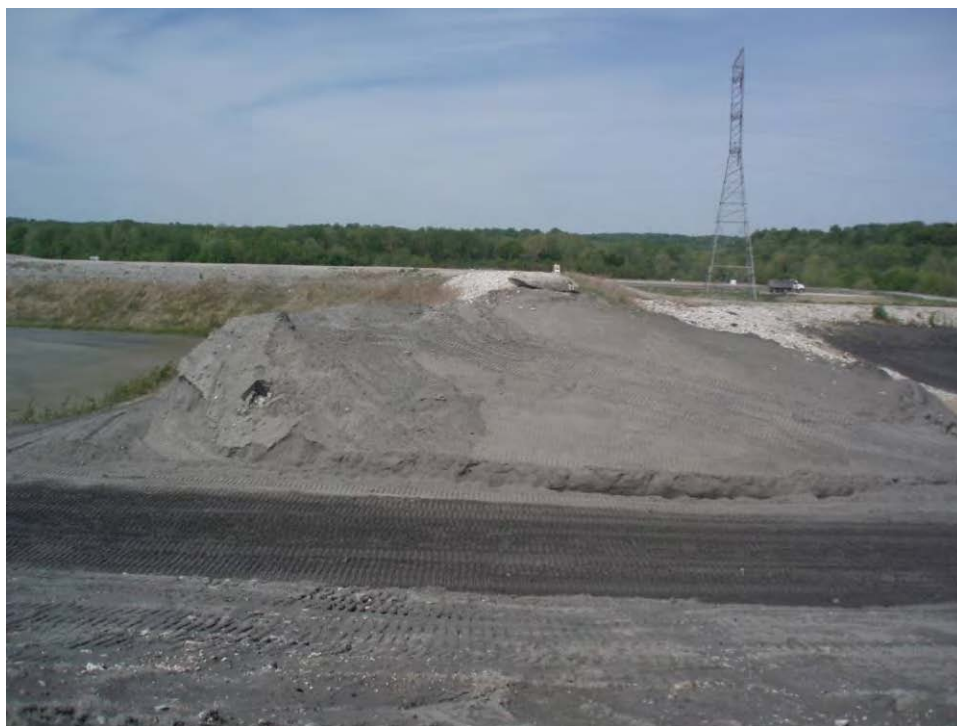
124. Overview of divider embankment D/E reconstruction, looking west.
