# **Assessment of Dam Safety of Coal Combustion Surface Impoundments**

**Indianapolis Power & Light Company**

**Eagle Valley Generating Station**

**November 15, 2010**

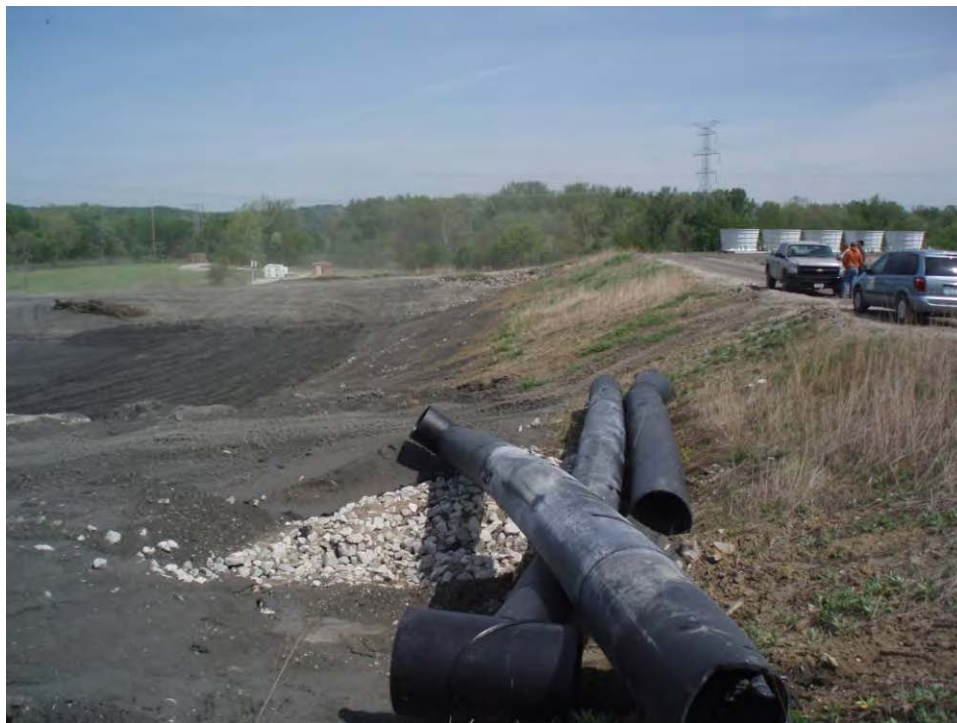
125. West slope of divider embankment D/E, looking north. Note pipes removed from embankment after breach.

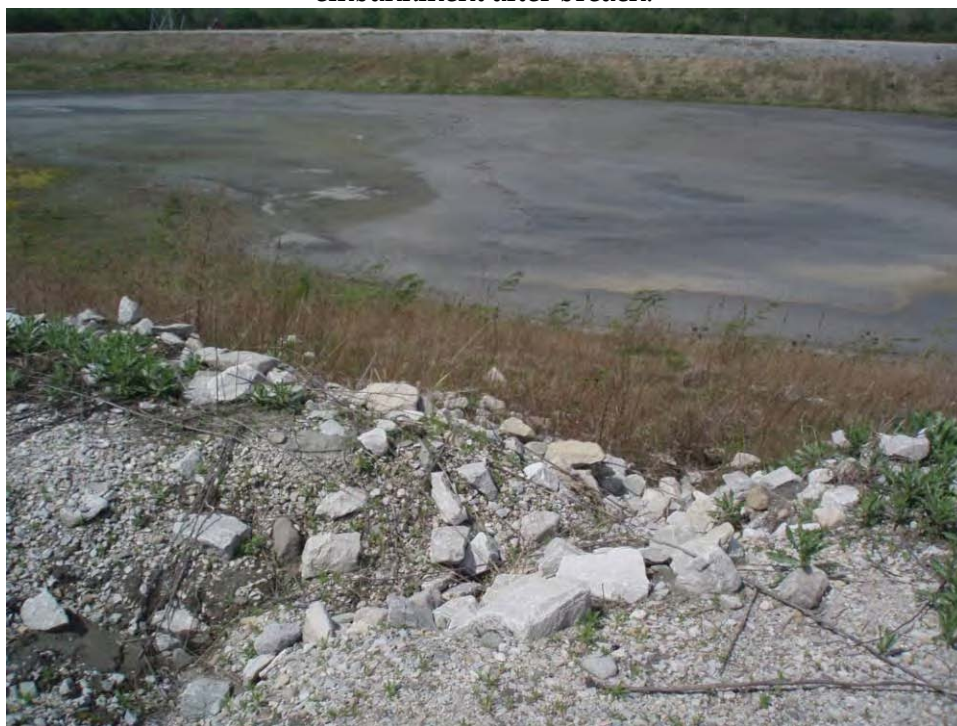
126. Pond D - Erosion rill on west slope of divider embankment, looking southwest.

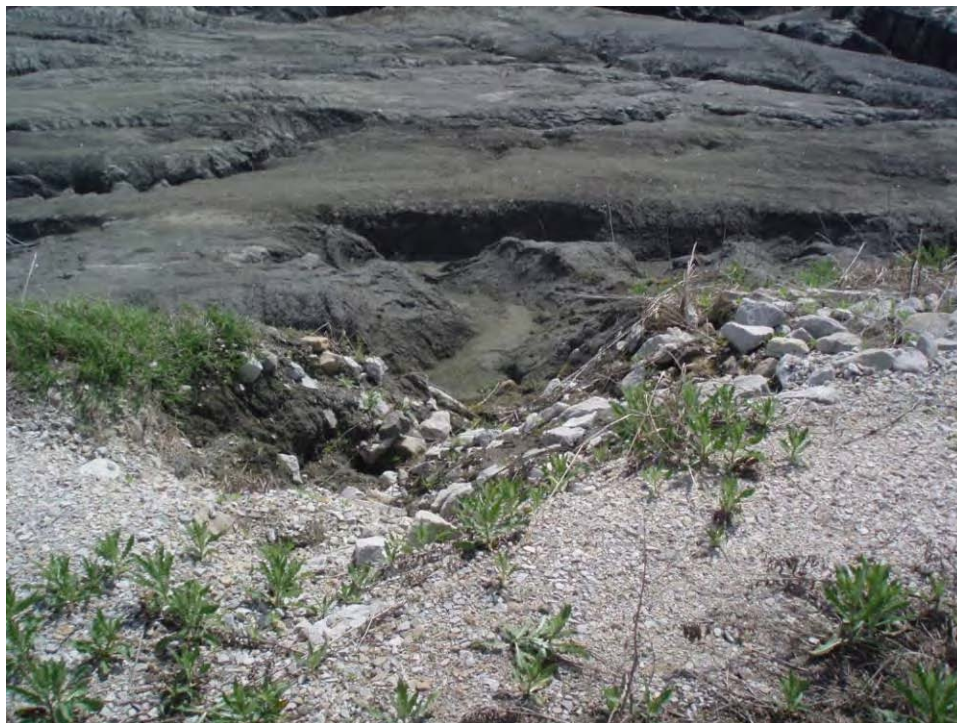
127. Pond D - Erosion feature on east slope of divider embankment, looking east.

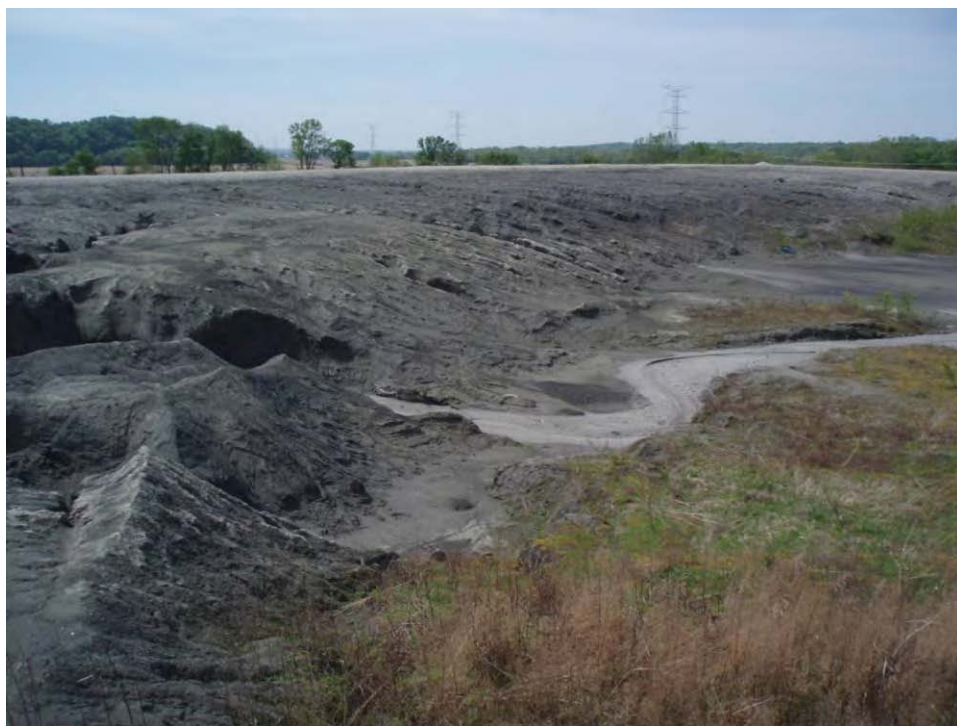
128. Pond D - Limit of ash at end of divider embankment prior to failure, looking southwest.

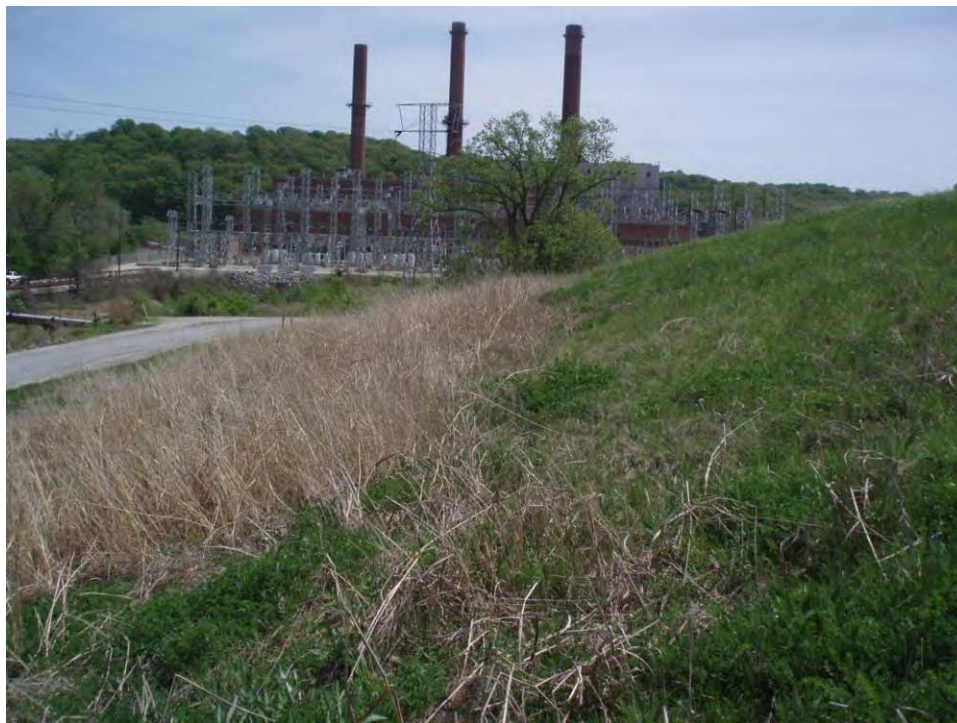
131. Pond D - North embankment exterior slope, looking east.

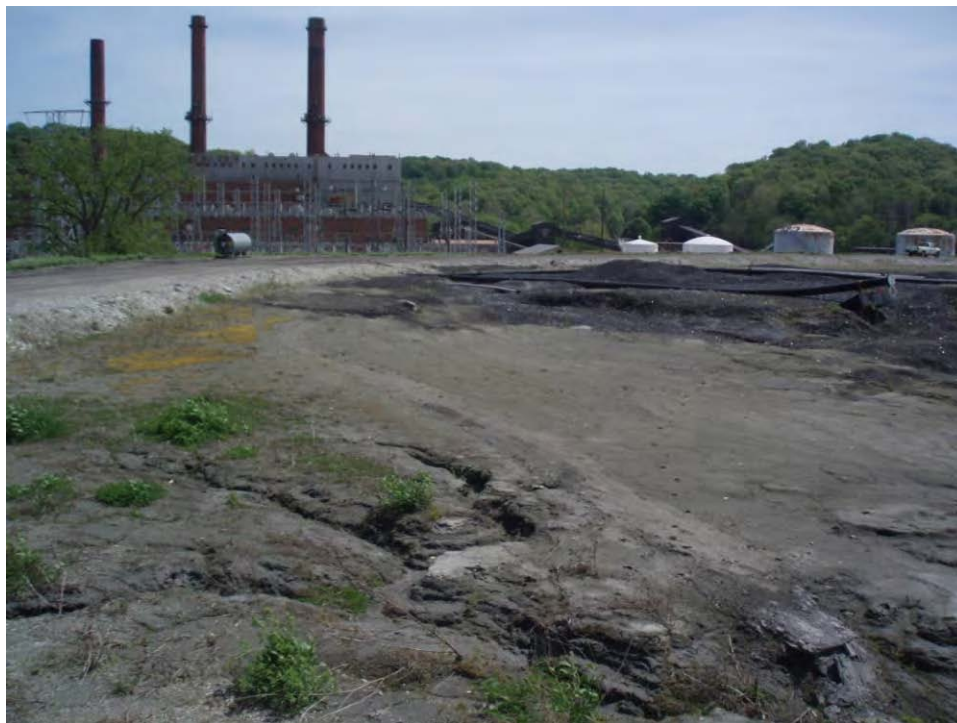
133. Pond D - North embankment interior slope, looking east.

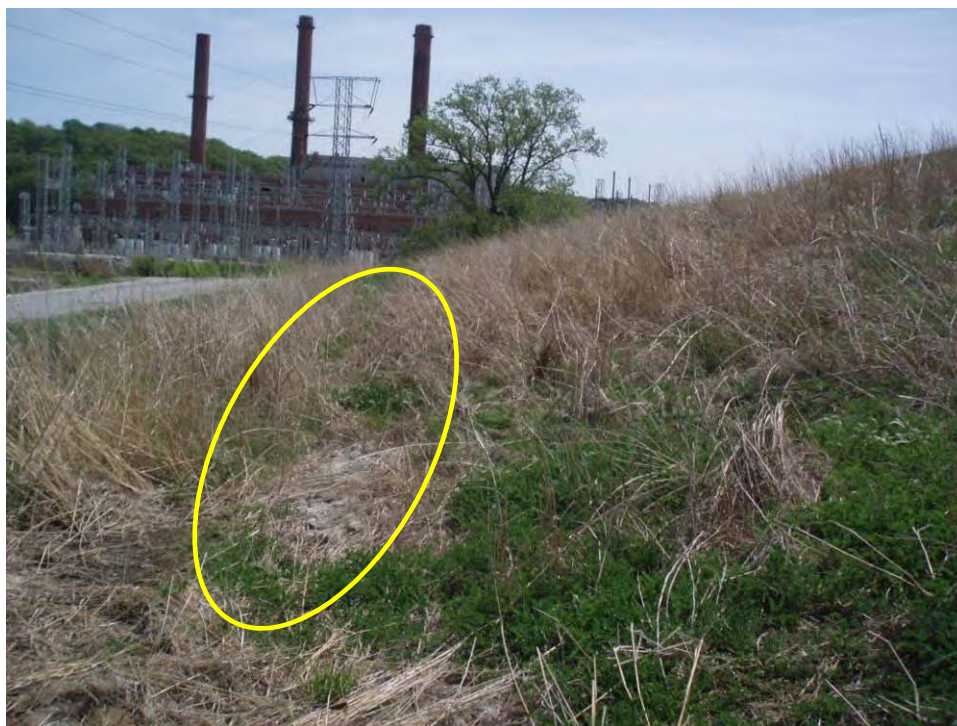
134. Pond D - Toe of north embankment, looking east. Note drainage ditch with seepage collector pipe.

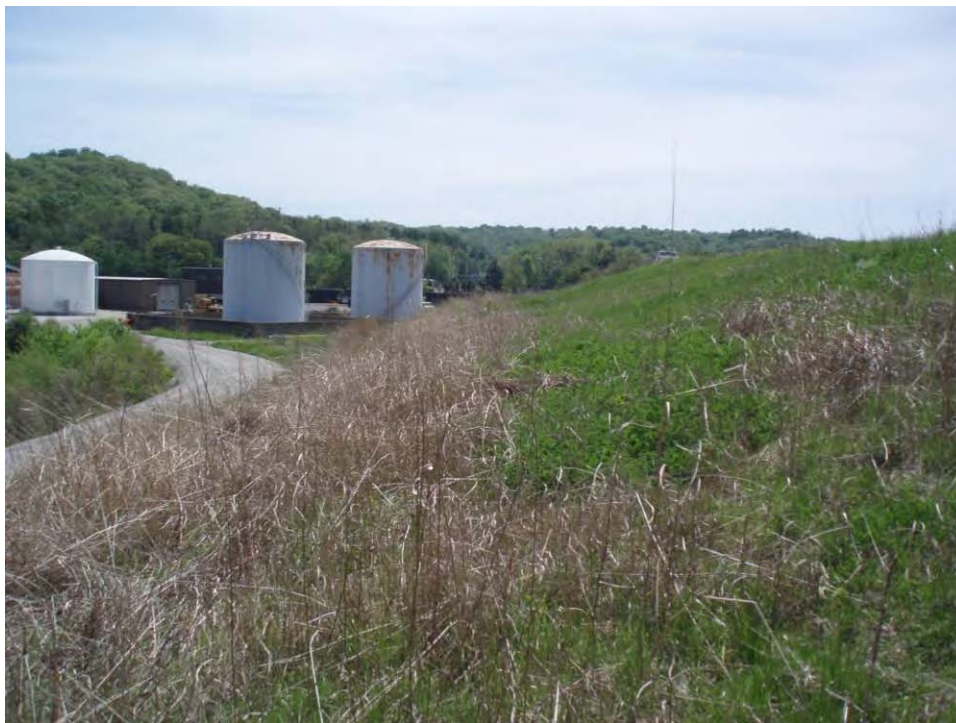
137. Pond D - Northeast embankment exterior slope, looking southeast.

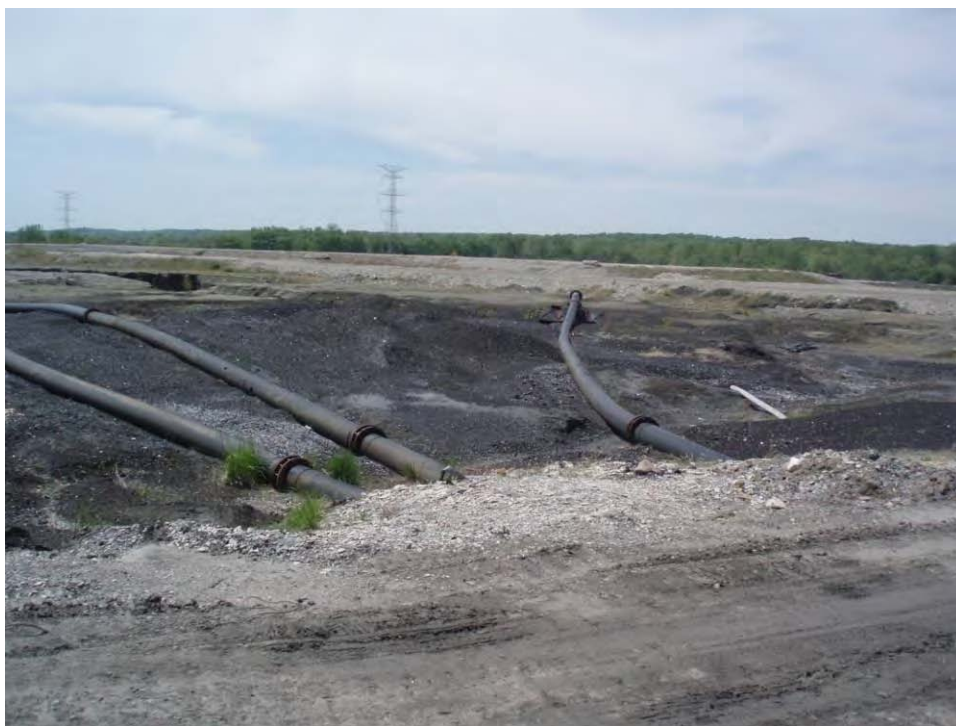
140. Overview of three 10-inch-diameter HDPE discharge pipes into Pond D, looking southwest.

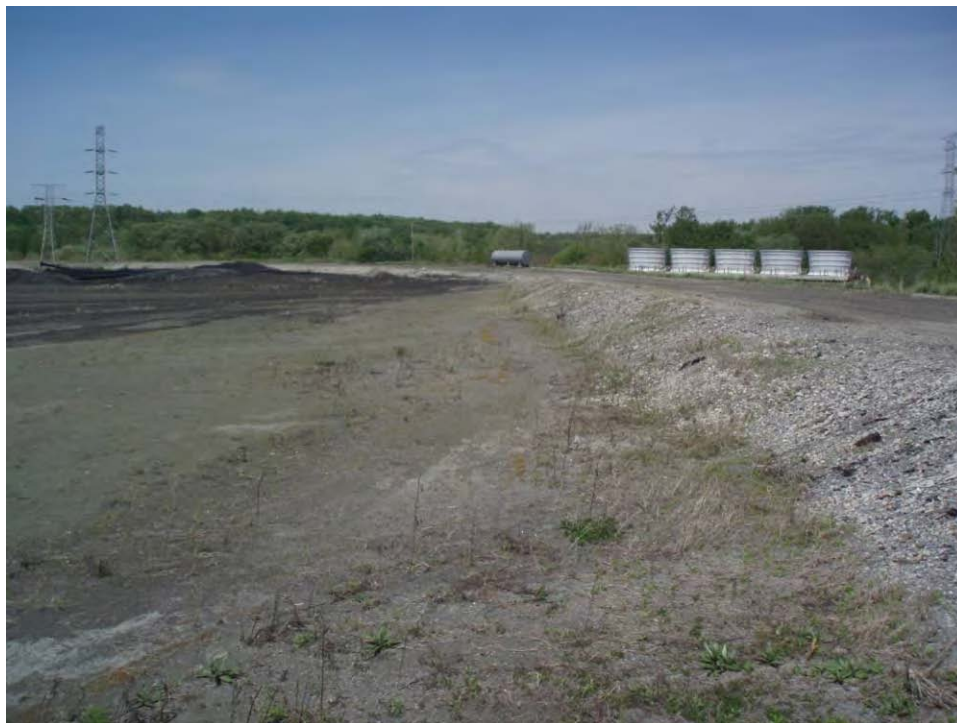
141. Pond D - Northeast embankment interior slope, looking northwest.

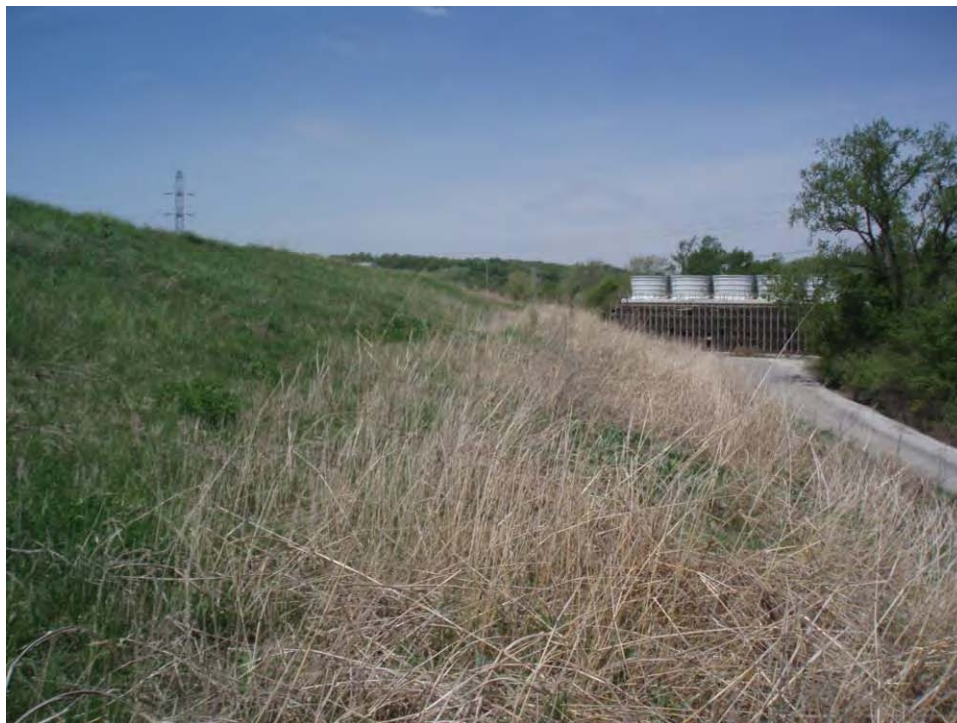
143. Pond D - Northeast embankment exterior slope, looking northwest.

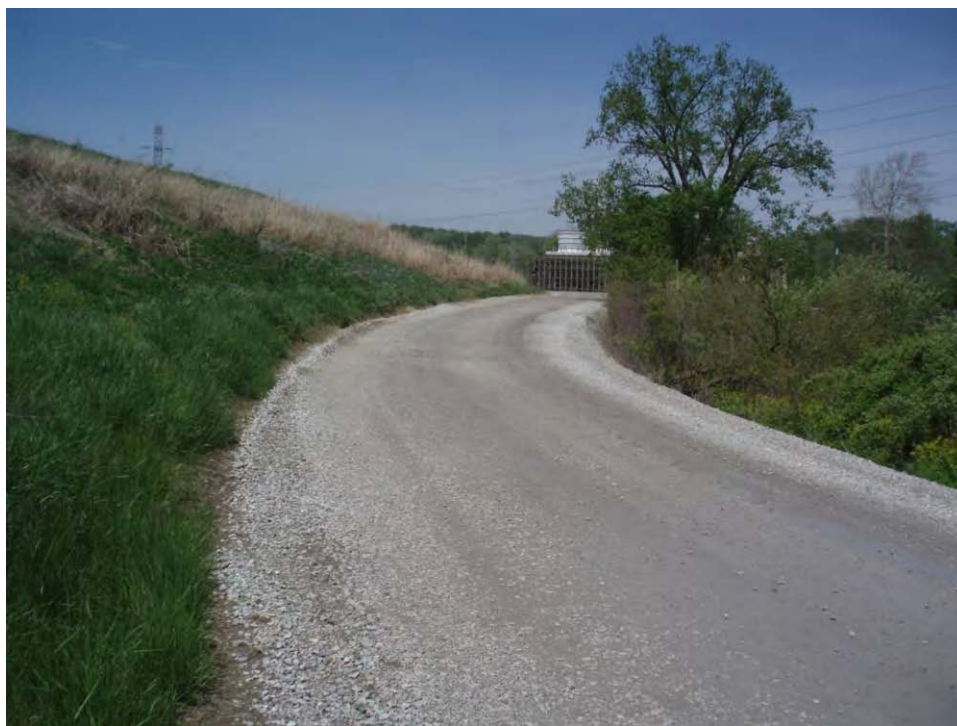
144. Access road and discharge canal adjacent to toe of Pond D, looking northwest.

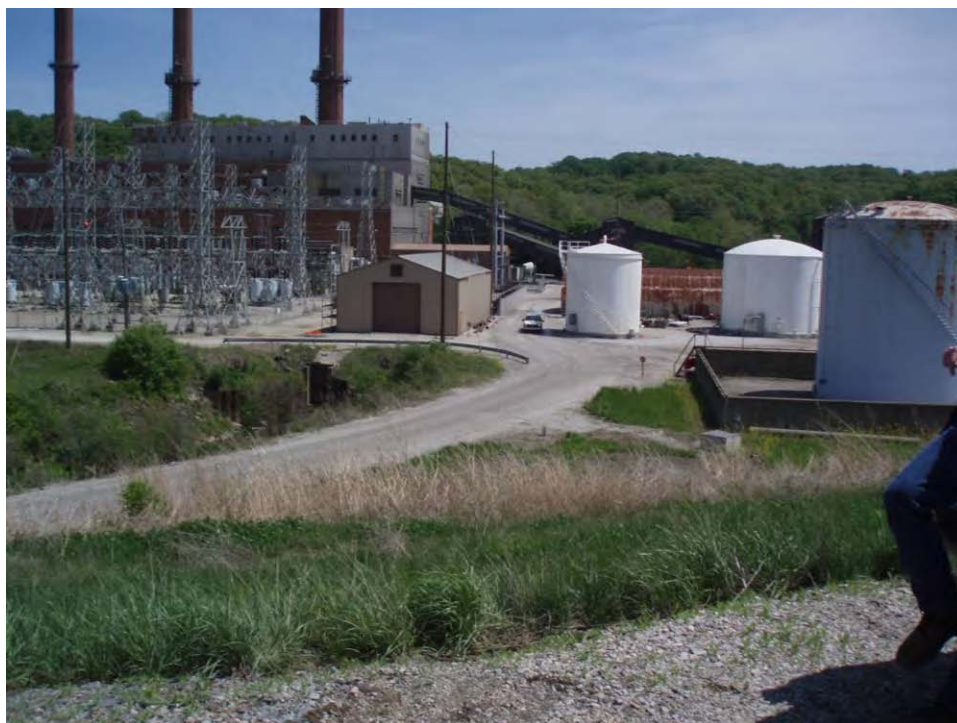
145. Downstream area of Pond D northeast embankment, looking east.

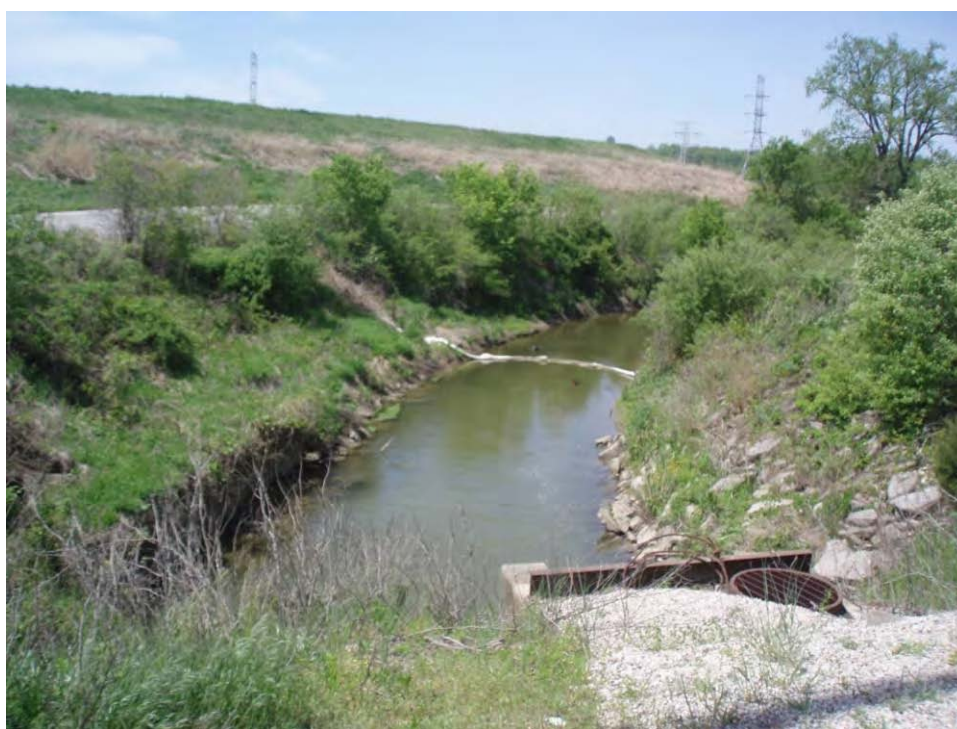
146. Overview of typical discharge canal adjacent the north embankments of Ponds A, C, D, and E.
