# **Assessment of Dam Safety of Coal Combustion Surface Impoundments**

**Indianapolis Power & Light Company**

**Petersburg Generating Station**

**November 15, 2010**

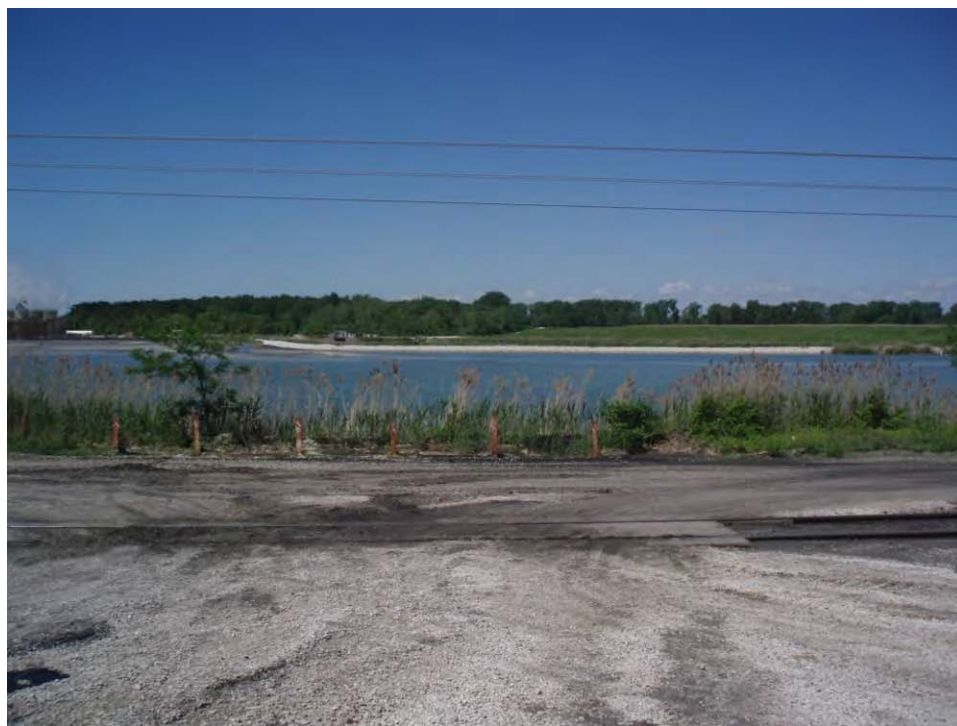
The visible portions of the interior slope generally appeared to be in fair condition (Photos 2, 6, 7, 9, 16, 17, 20, 21, 29, 30, 31, 32, 39, and 48). Tall, thick wetland-type vegetation up to 8 to 10 feet tall obscured the observation of north and east embankment as well as the divider embankment. The north and west interior slope of the divider embankment generally appeared to be armored with a layer of riprap armor.

2. Overview of Pond A and east slope of divider embankment, looking west

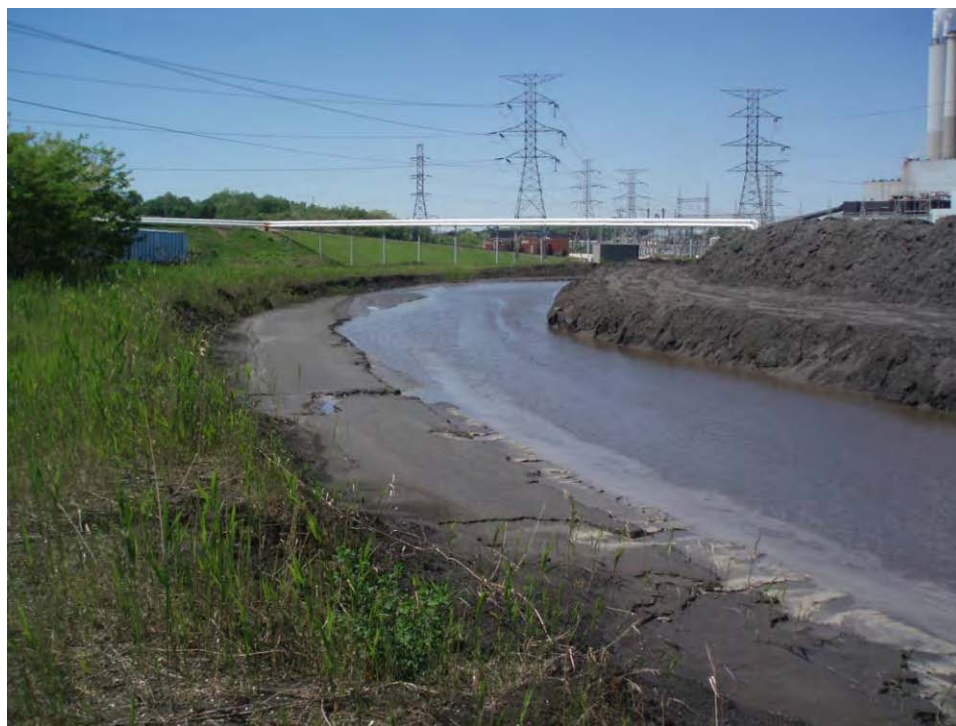
two (2) 36-inch-diameter and five (5) 10-inch-diameter ductile iron (DI) pipes sluice CCW into the impoundment (Photos 7 and 8). A rim ditch (Photos 5, 6, and 7) excavated adjacent to the south and east interior slope diverts flow, increasing the settling time of materials in the impoundment. Along the west embankment one (1) 12-inch-diameter DI and two (2) 8-inch-diameter stainless steel (SS) pipes sluice other liquids into the impoundment (Photo 20). At a headwall located at the western abutment of the divider embankment between Pond A and Pond A – Discharge, two (2) 24-inch-diameter reinforced concrete pipes (RCPs) and one (1) 4-inch-diameter DI pipes sluice other wastes into Pond A (Photo 36). Pond A is connected to Pond A – Discharge through two (2) 36-inch-diameter CMPs (Photo 45). Pond A – Discharge is used as a secondary settling basin prior to water being discharged at the outlet structure or being diverted into the recycling pump station. The outlet structure consists of a box structure with stoplogs and a 24-inch-diameter RCP with an invert elevation of El. 415.9.

6. Pond A rim ditch, looking southeast.

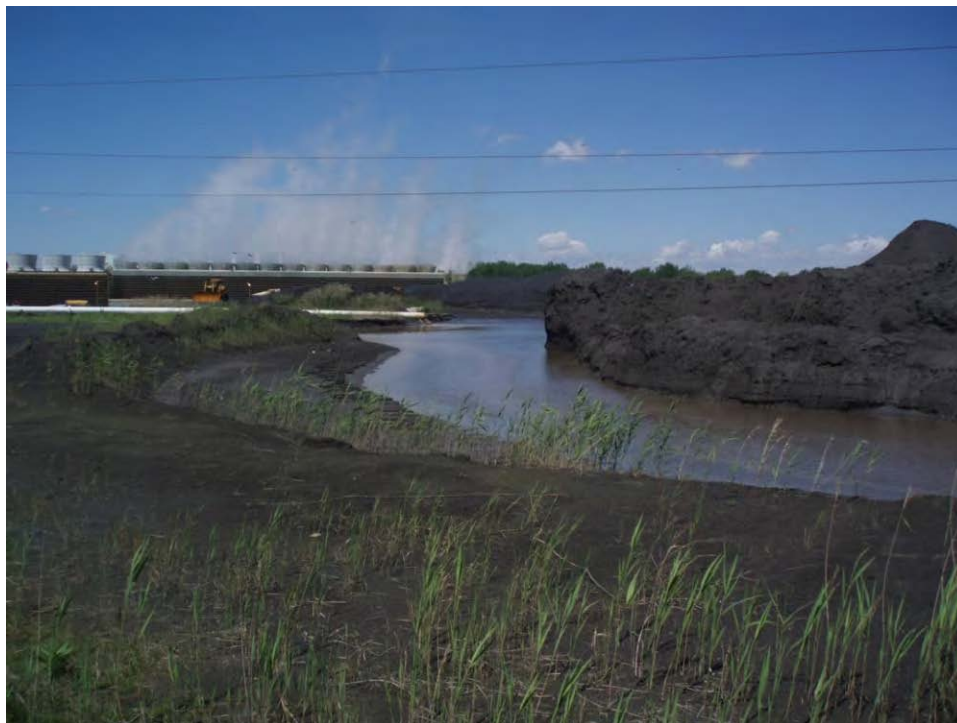
7. Pond A rim ditch looking west at sluice pipes.

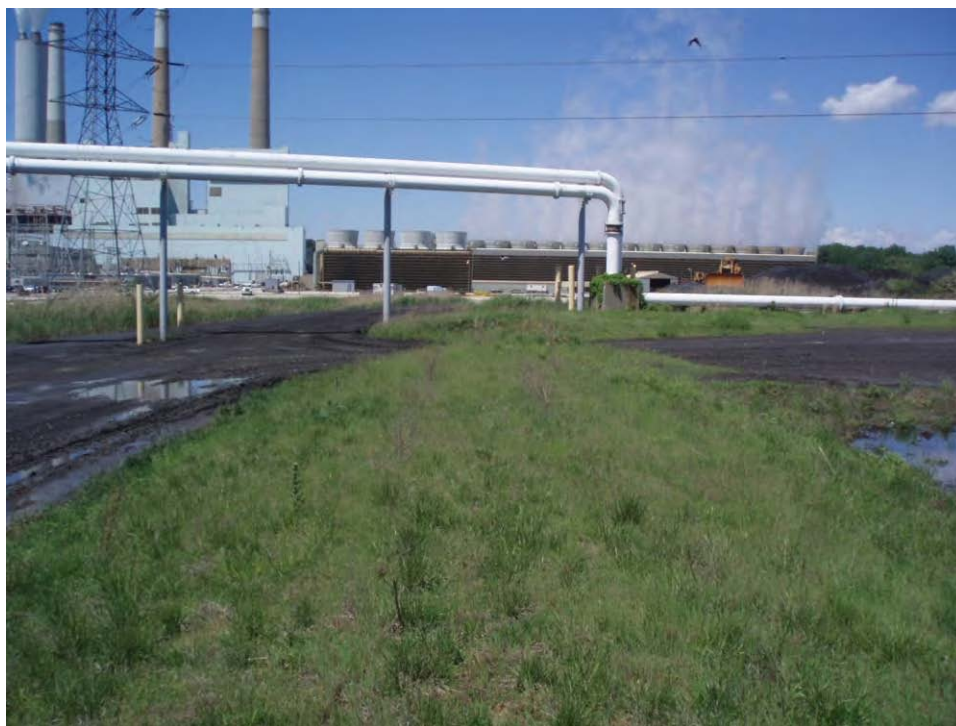
The crest of Pond A generally appeared to be in fair condition (Photos 1, 3, 4, 9, 10, 11, 12, 14, 49, 62, and 64). The crest was approximately 20 feet wide. The crest is surfaced with a compacted gravel access road on the north and east embankments. The crest on the south and west embankments were generally covered with grass approximately 6 to 12 inches tall. The crest around the sluice pipes on the south embankment was covered with ash (Photos 12 and 14). An access ramp excavated into the crest near the sluice pipes on the south embankment was observed (Photo 10 and 12). Track marks from an excavator were observed on the crest of the west embankment (Photos 26, 27, and 29).

10. Pond A - South embankment crest, looking west. Note access ramp excavated in crest to access the sluice pipes.

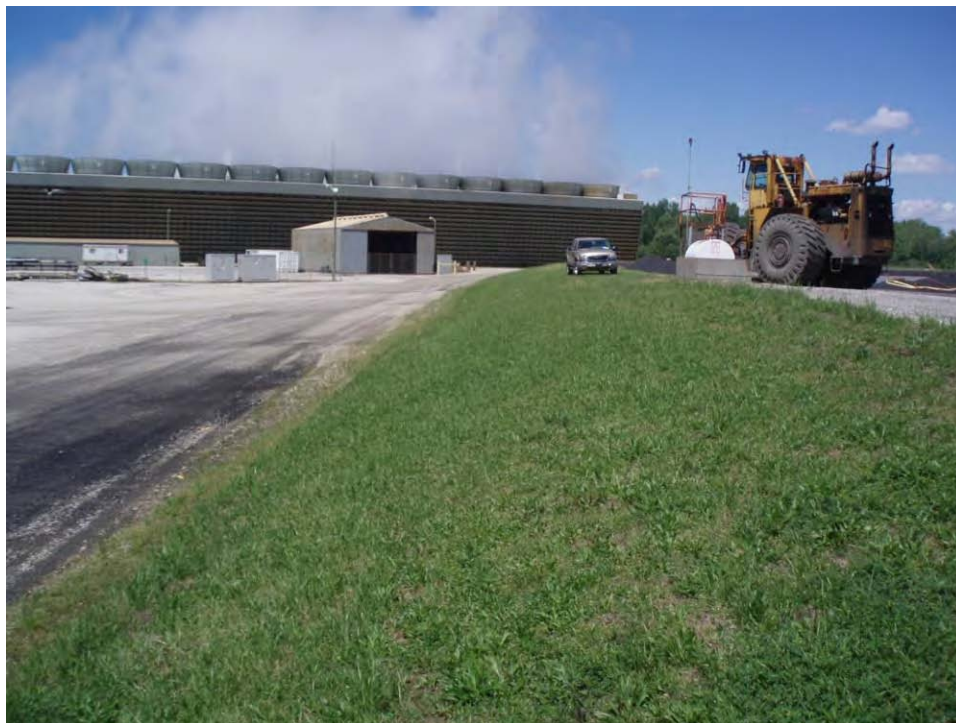
The exterior slopes appear to be in fair condition. The exterior slopes on the south and west embankments were approximately 3H:1V (Photos 13, 19, 22, 23, 24, 26, 27, 28, and 34). The north exterior slope on the divider embankment between Pond A and Pond A – Discharge was approximately 2H:1V (Photos 37 and 47).

13. Pond A - South embankment exterior slope, looking northwest.

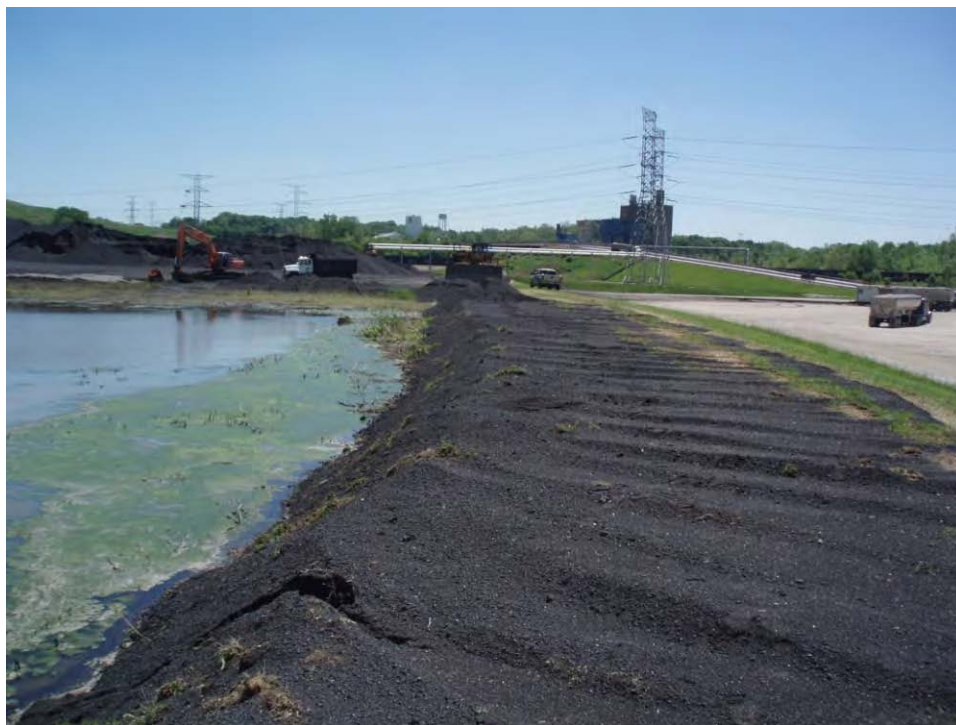
16. Pond A - South embankment crest, looking southeast at recently placed ash material. Note existing embankment was not cleared or grubbed before placing material.

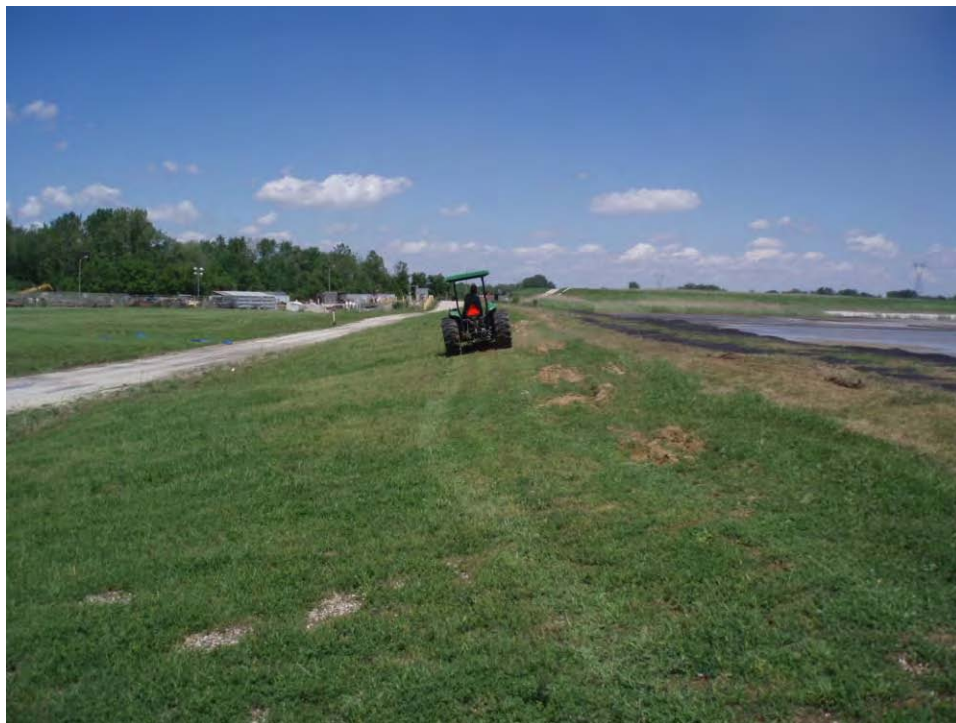
19. Pond A - West embankment exterior slope, looking north at mowing operation.

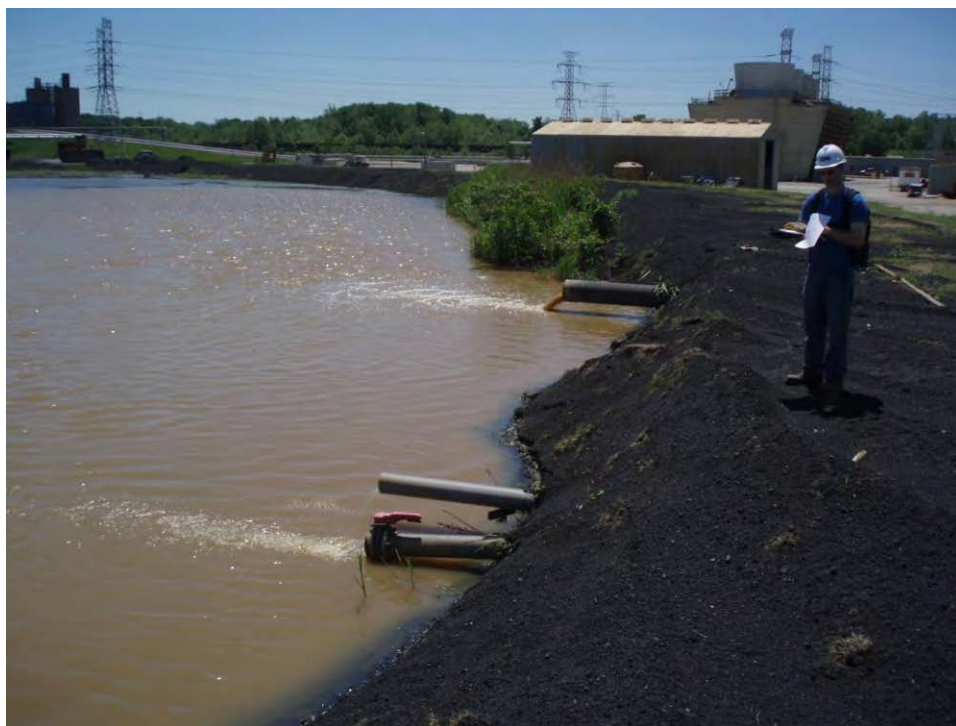
During the site visit, four sets of sluice pipes were observed. The CCW sluice pipes on the south embankment appeared to be in fair condition (Photo 8). The two sets of active sluice pipes on the west embankment (Photo 20) and at the west embankment headwall also appeared to be in fair condition (Photo 36). A fourth set of inactive or abandoned pipes appeared to be in poor condition (Photo 30, 33, and 35). The IPL staff did not know the origin or purpose of these pipes. The excavator operator placed ash over the 24-inch-diameter RCP at the fourth set of pipes.

20. Pond A - West embankment interior slope, looking south at one (1) 12-inch-diameter DI pipe and two (2) 8-inch-diameter steel pipes from plant.

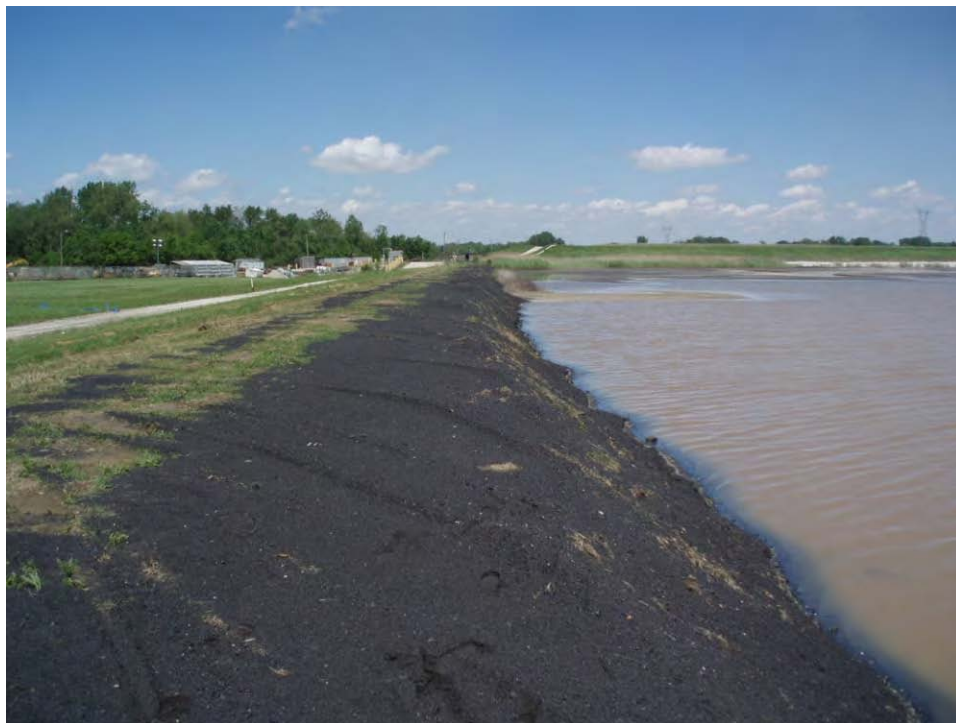
21. Pond A - West embankment interior slope and crest, looking north

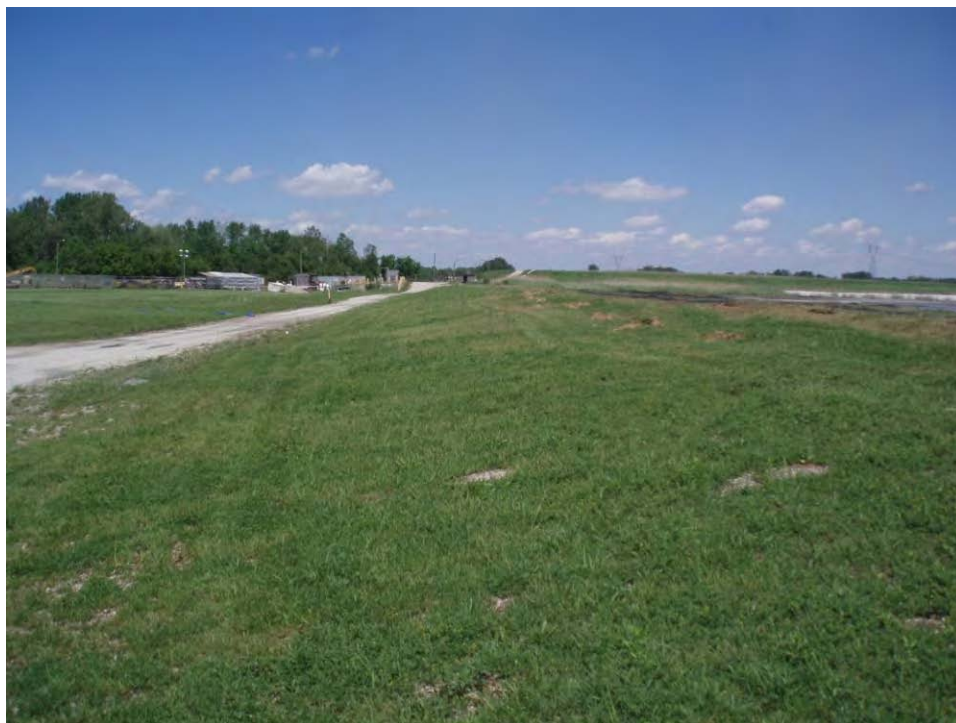
22. Pond A - West embankment exterior slope, looking north.

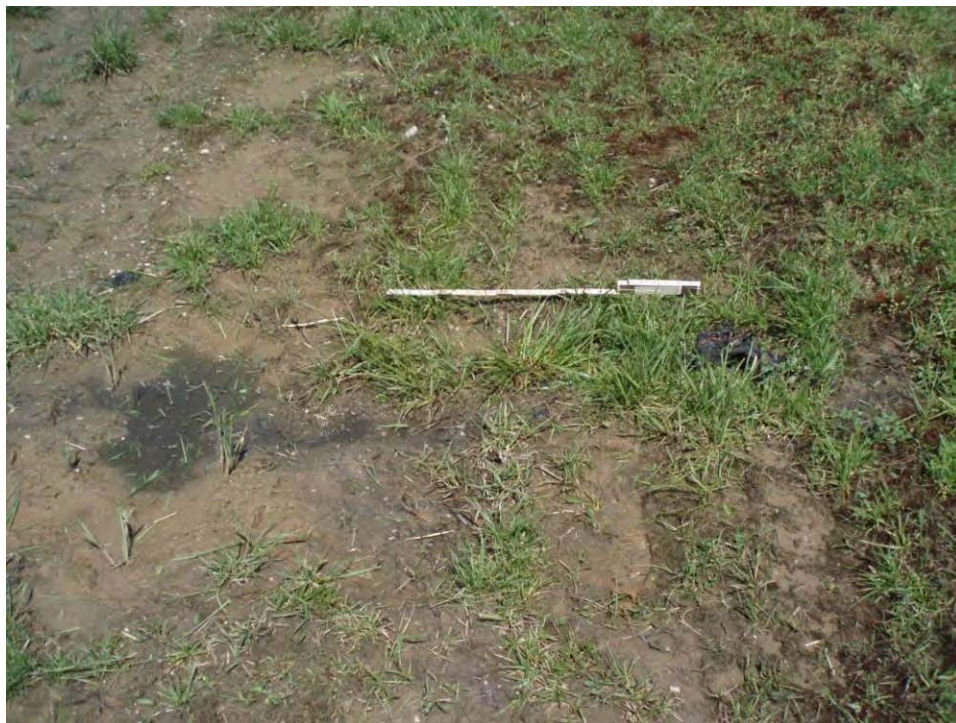
A possible seepage area was observed on the west embankment exterior slope (Photo 25).

25. Pond A - Saturated area on west embankment exterior slope.

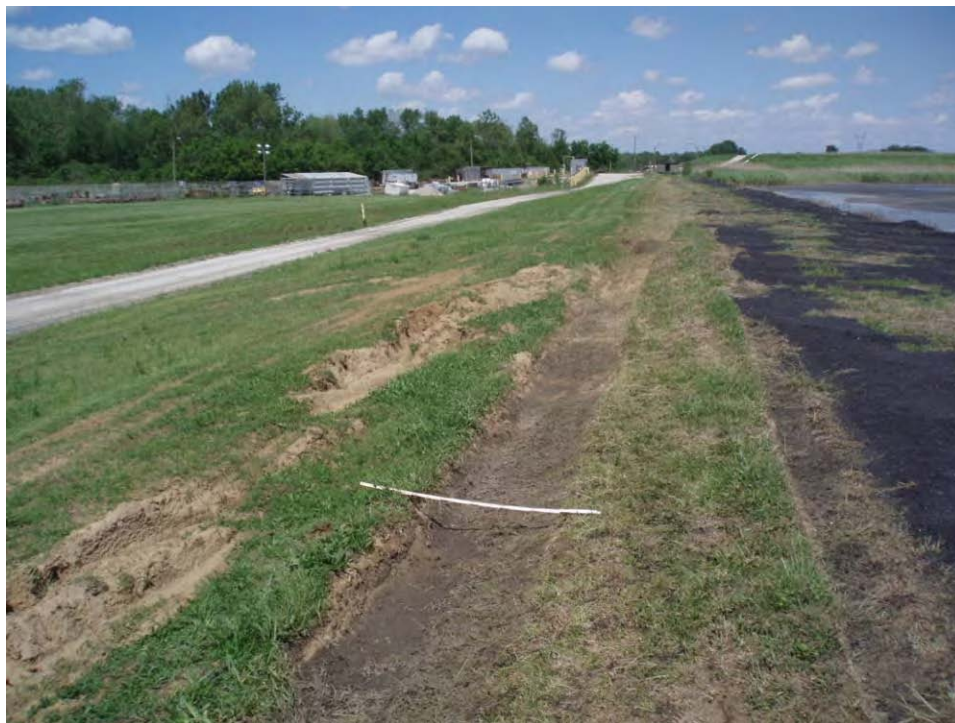
27. Pond A - West embankment exterior slope, looking north at large tractor ruts and excavator tracks.

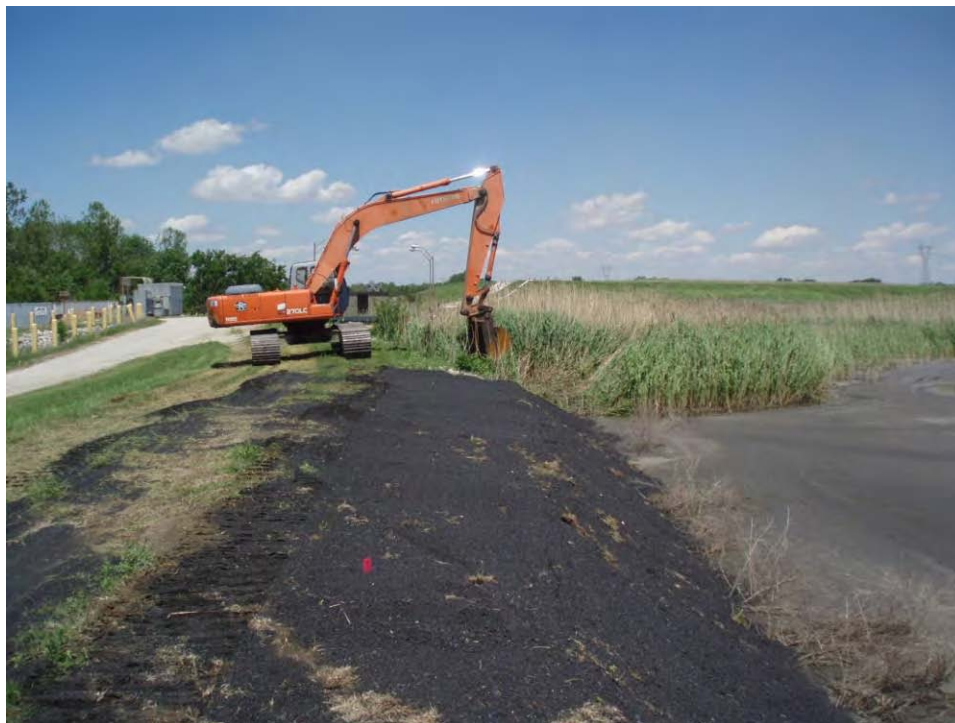
29. Pond A - West embankment interior slope looking north at embankment work.

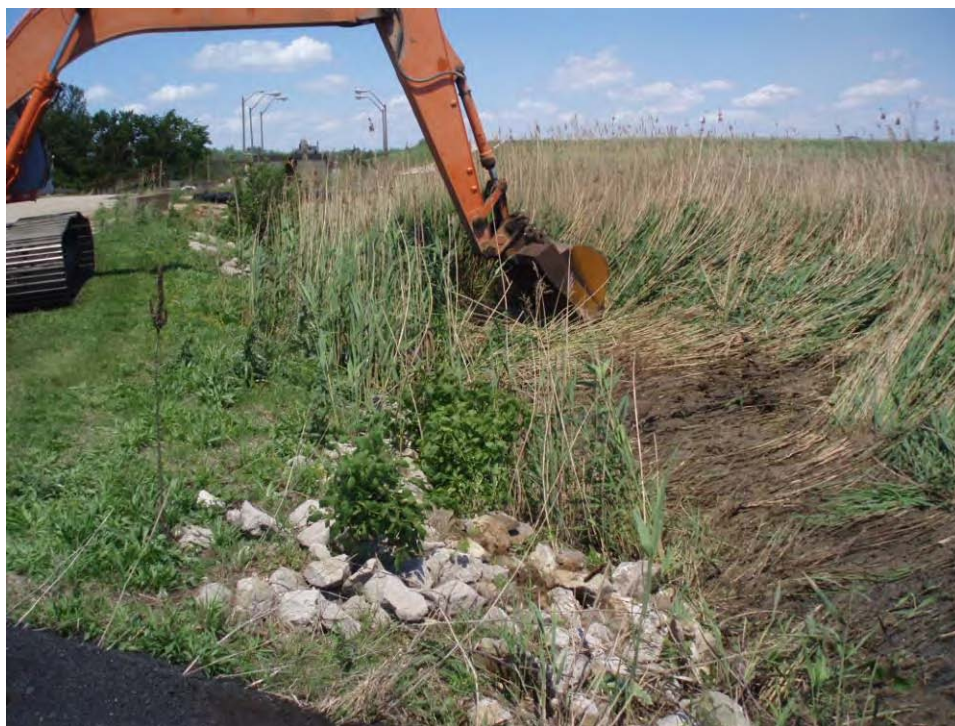
30. Pond A - West embankment interior slope, looking north at excavator flattening vegetation before placing ash material. Note an unknown 24-inch-diameter RC pipe in the embankment was being covered with ash.

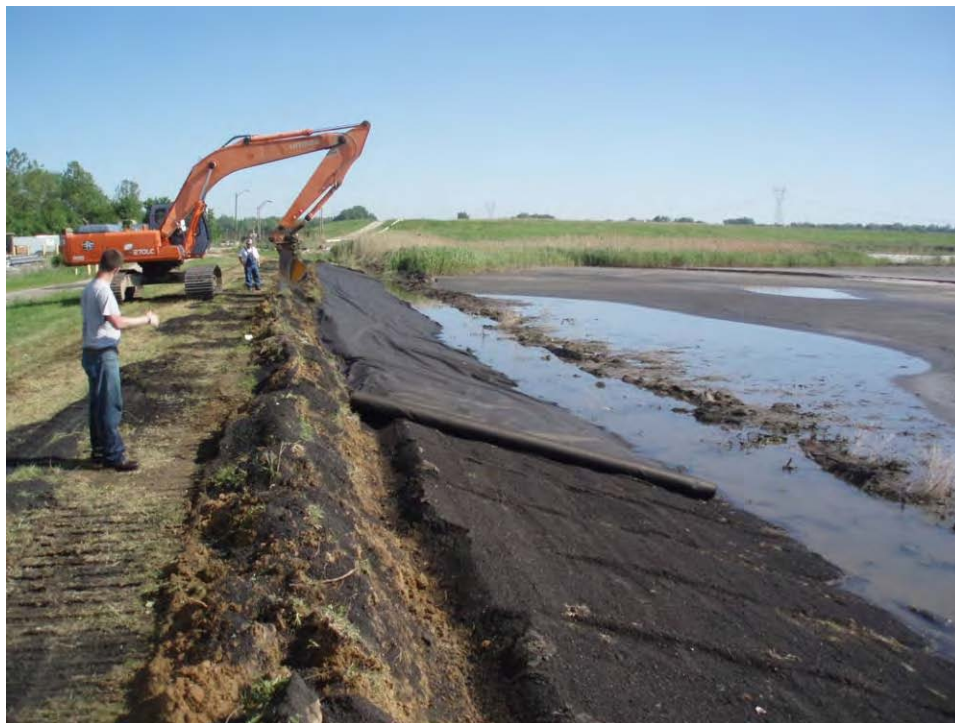
31. Pond A - West embankment interior slope, looking north at rough embankment grading. Note Mirafi geofabric does not extend to the toe of the slope.

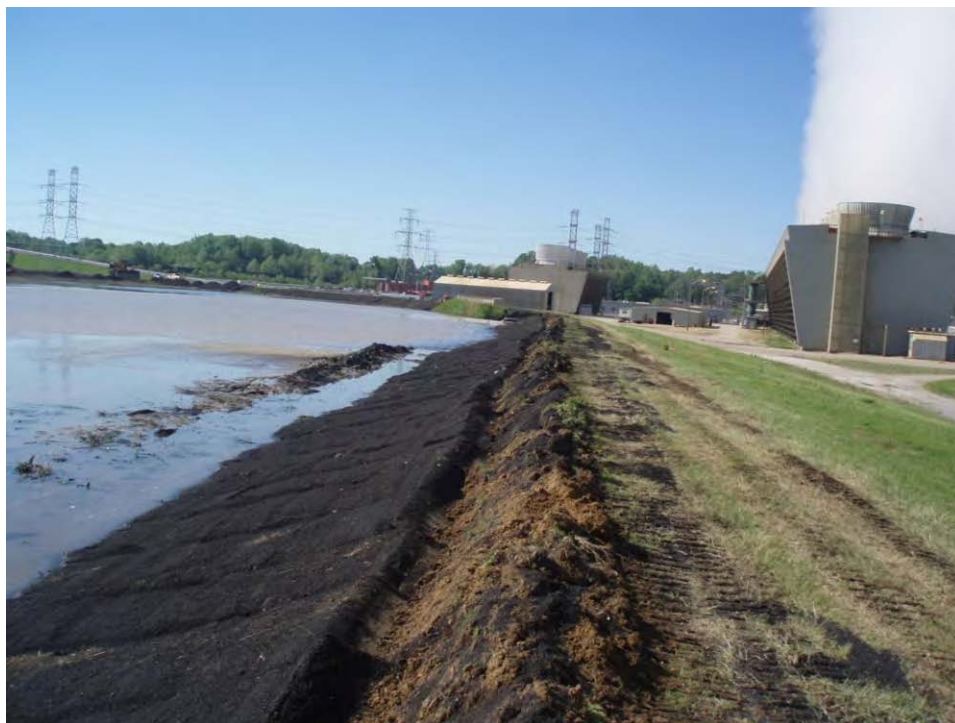
32. Pond A - West embankment interior slope, looking south at rough embankment grading

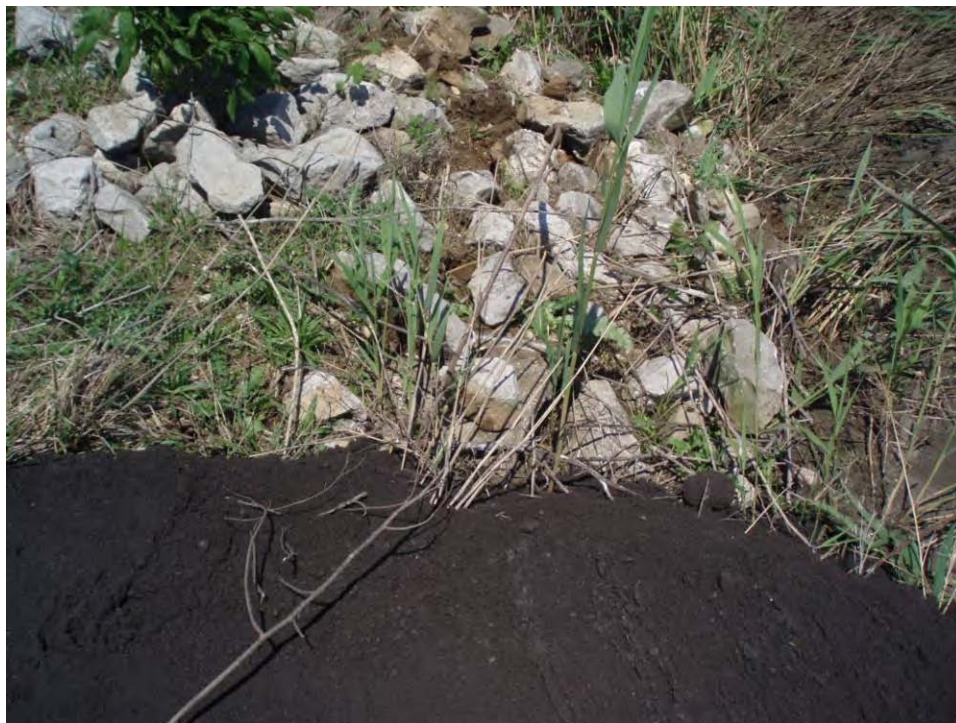
33. Pond A - 24-inch-diameter RC pipe being covered by ash.

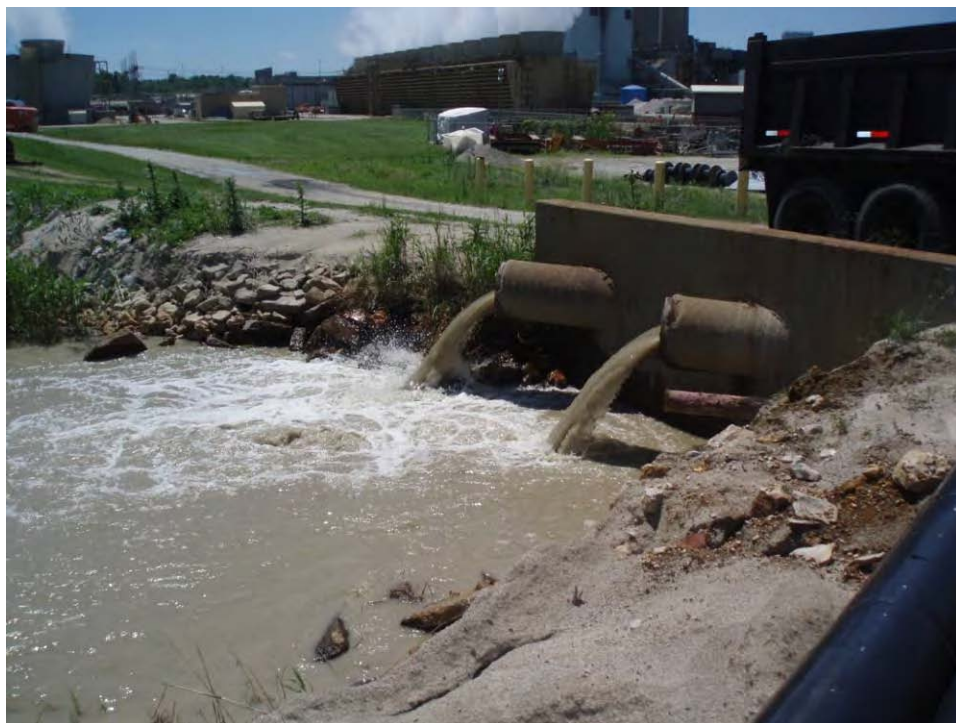
36. Pond A - West embankment interior slope, looking southeast at two (2) 24-inch-diameter RCP from plant super sumps and one (1) 4-inch-diameter DI pipe from unknown origin.

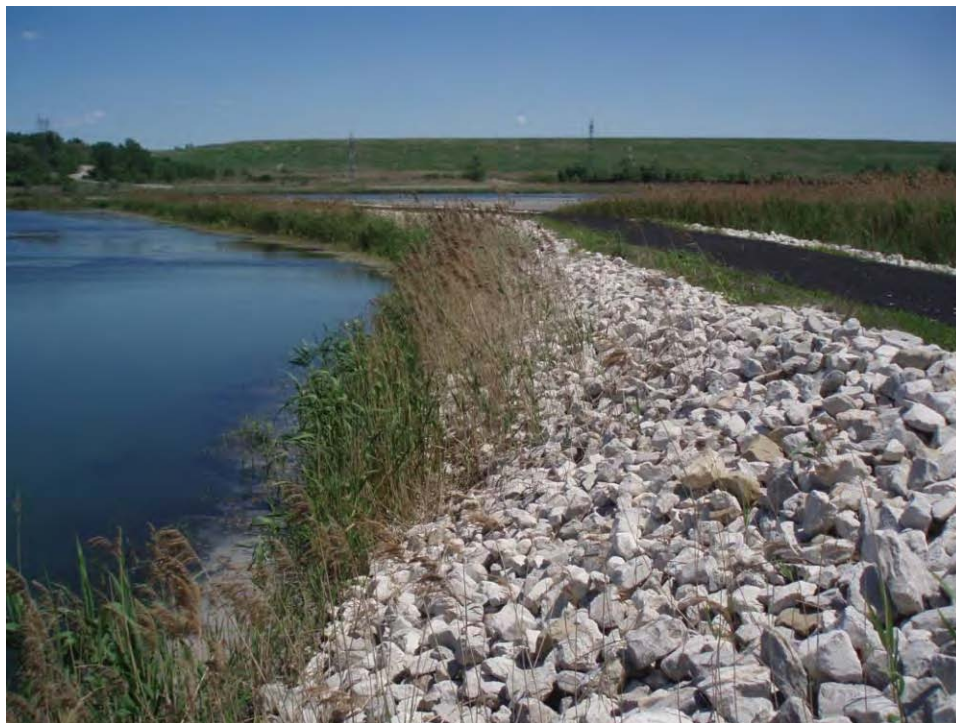
37. North slope of divider embankment between Pond A and Pond A - Discharge, looking east.

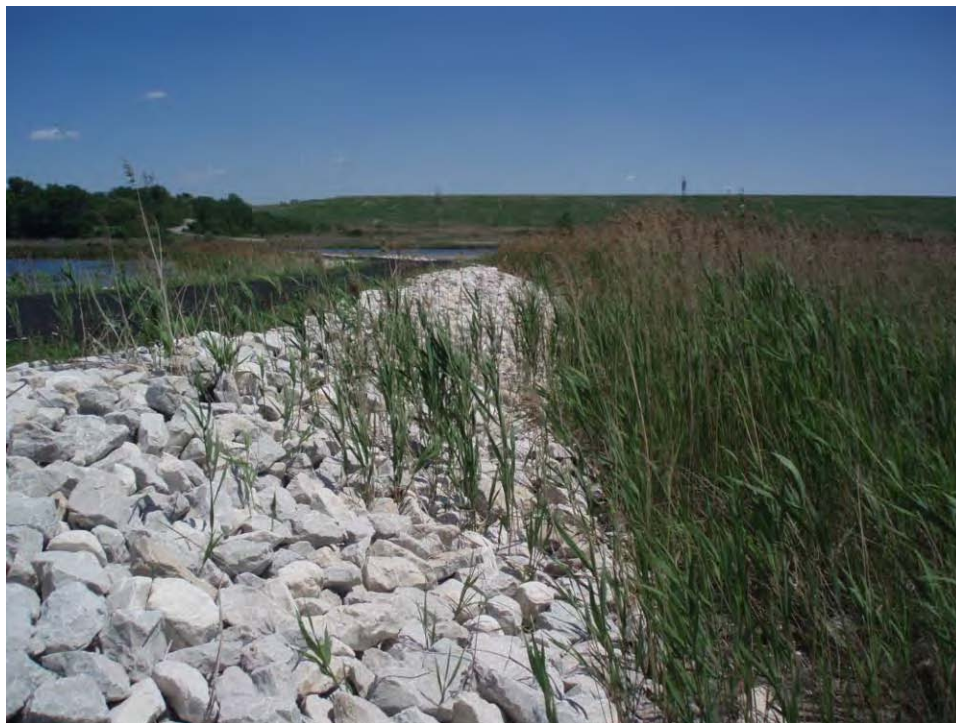
39. South slope of divider embankment between Pond A and Pond A - Discharge, looking east.

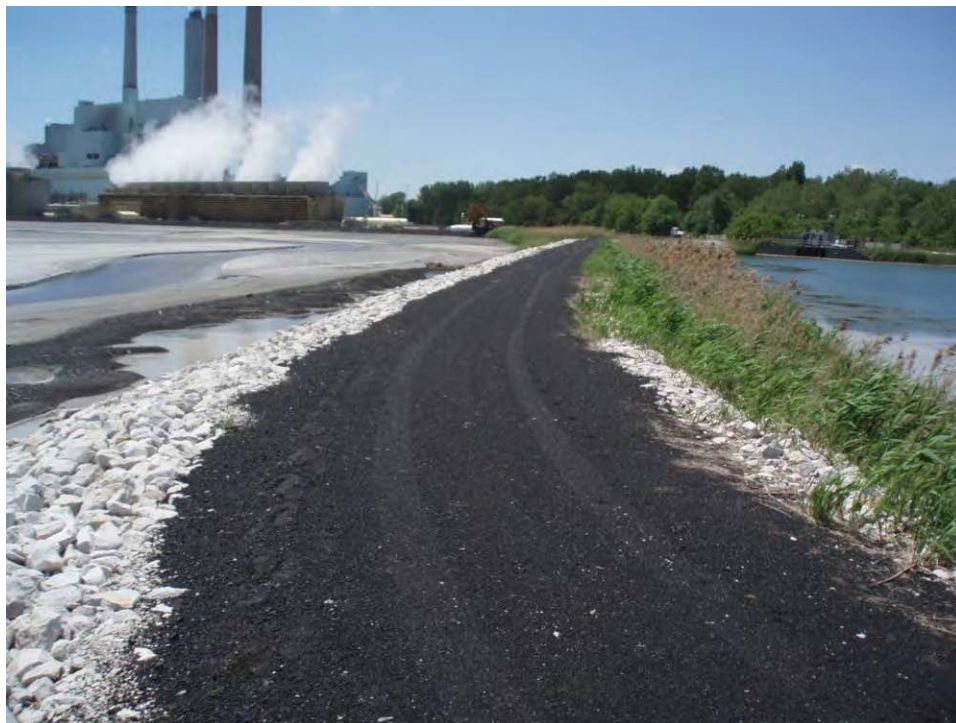
43. Crest of divider embankment between Pond A and Pond A - Discharge, looking southwest.

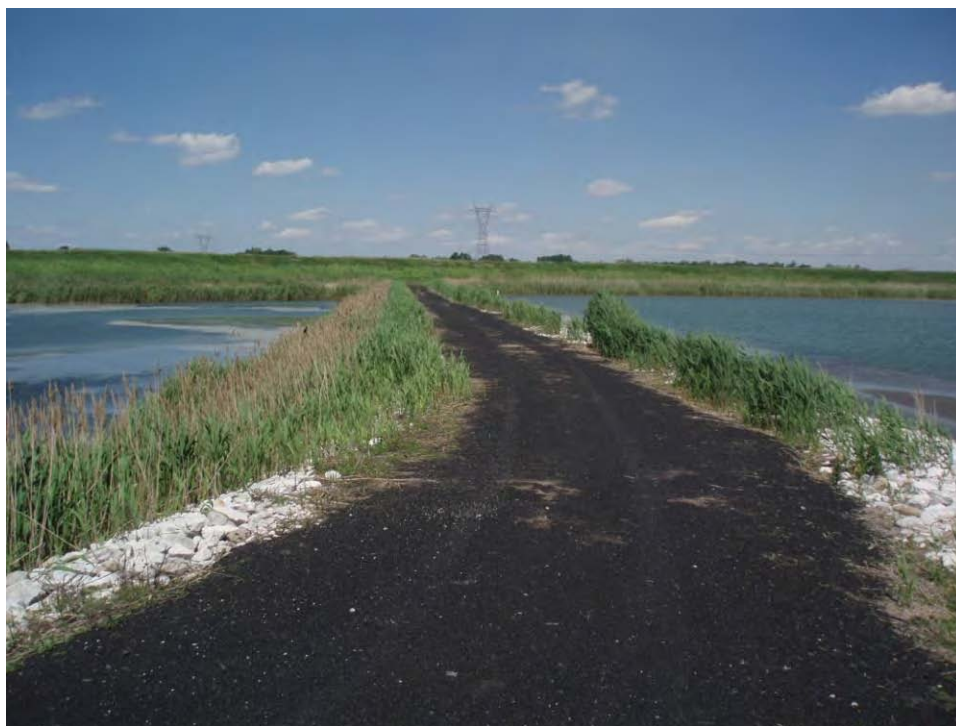
44. Crest of divider embankment between Pond A and Pond A - Discharge, looking northeast.

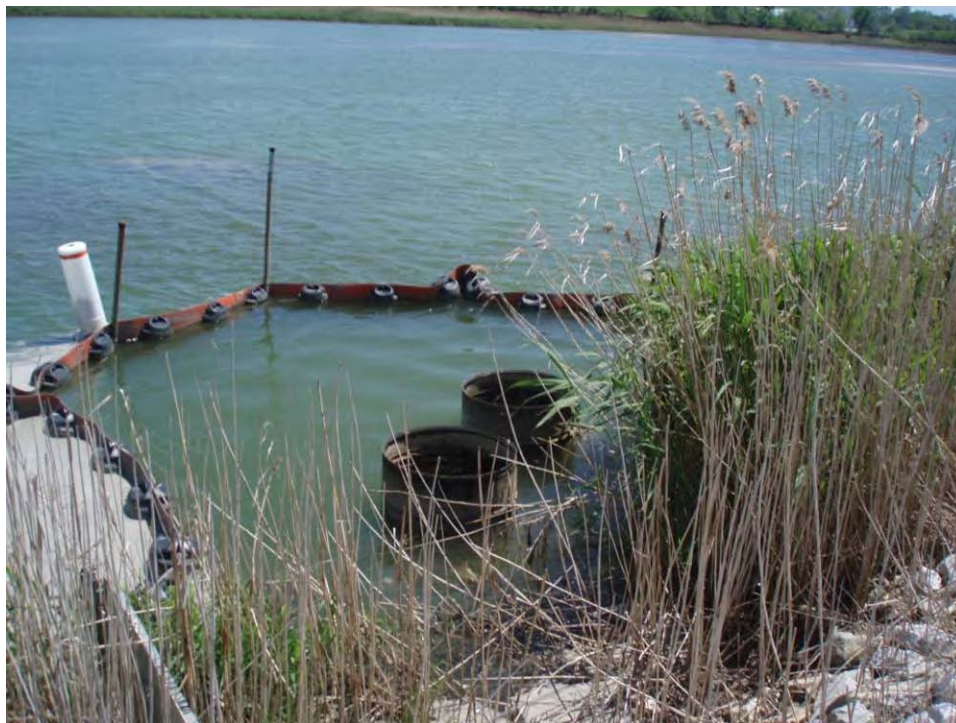
45. Inlet of two (2) 36-inch-diameter CM pipes from Pond A to Pond A - Discharge. Note pipes have T's at inlets and the floating boom to reduce the potential for surface debris from clogging pipes.

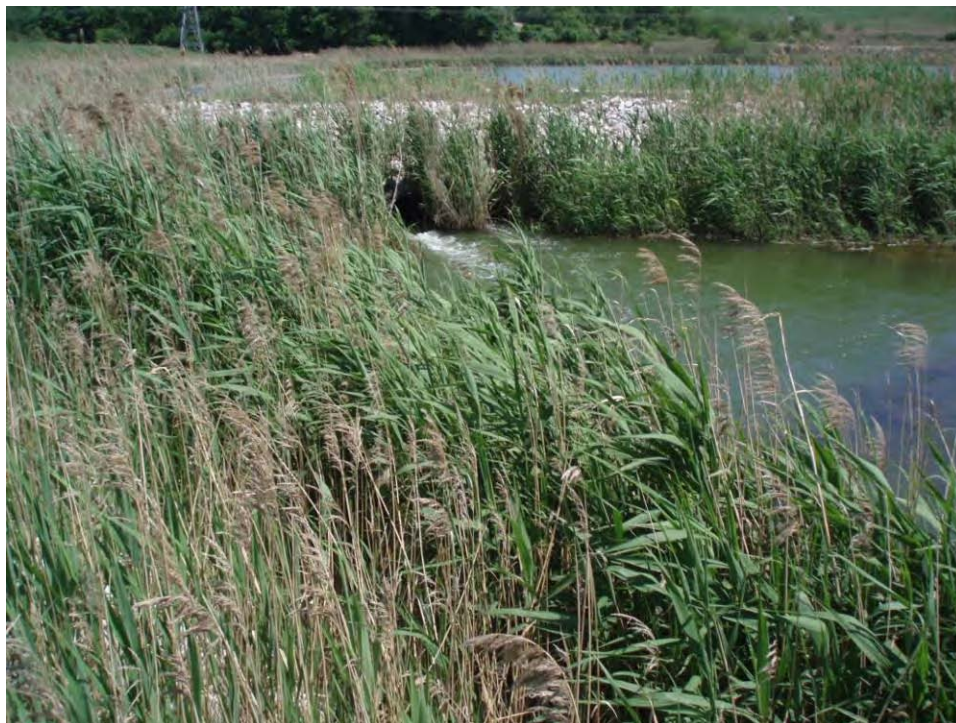
47. Outlet of two (2) 36-inch-diameter CMP outlet pipes from Pond A to Pond A - Discharge.

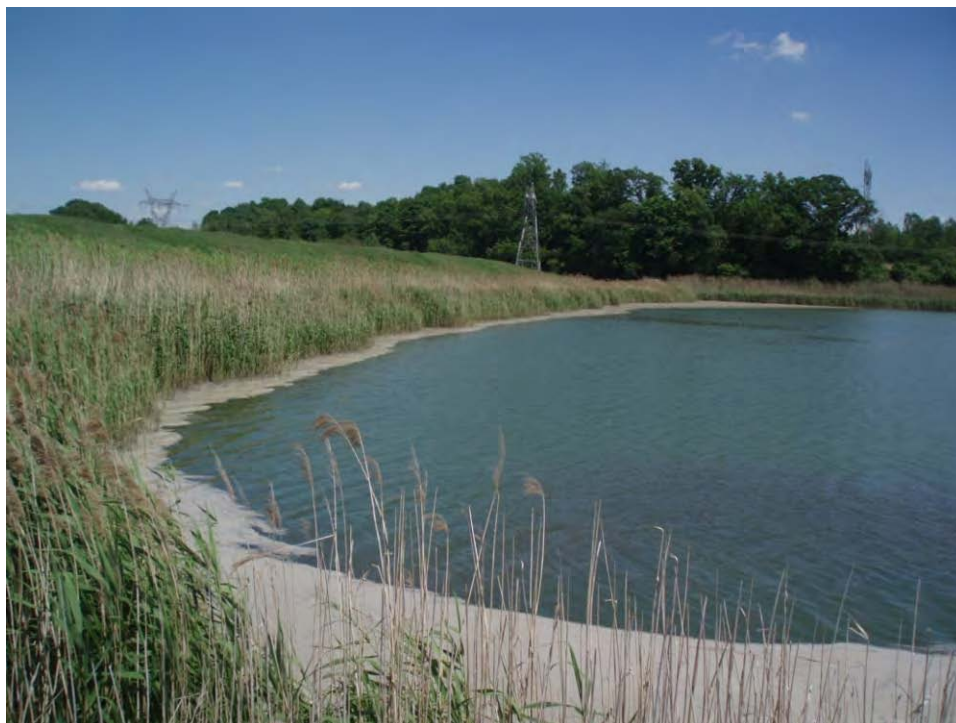
48. Overview of Pond A north interior slope, looking northeast.

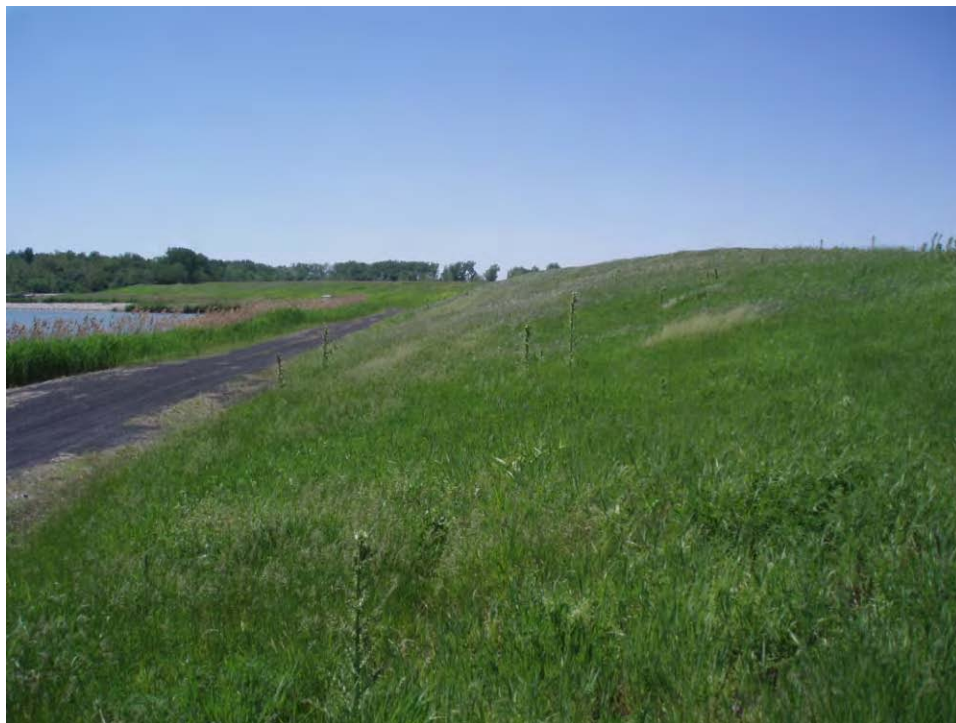
51. Pond B – South embankment exterior slope, looking west.

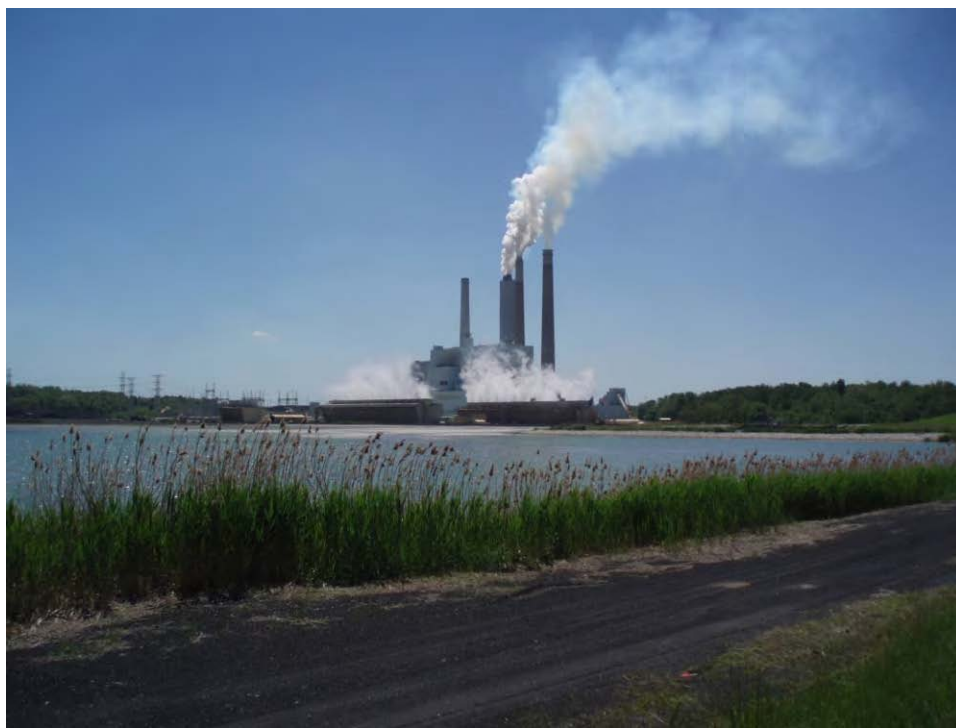
52. Overview of Pond A, looking southwest at Petersburg Generating Station.

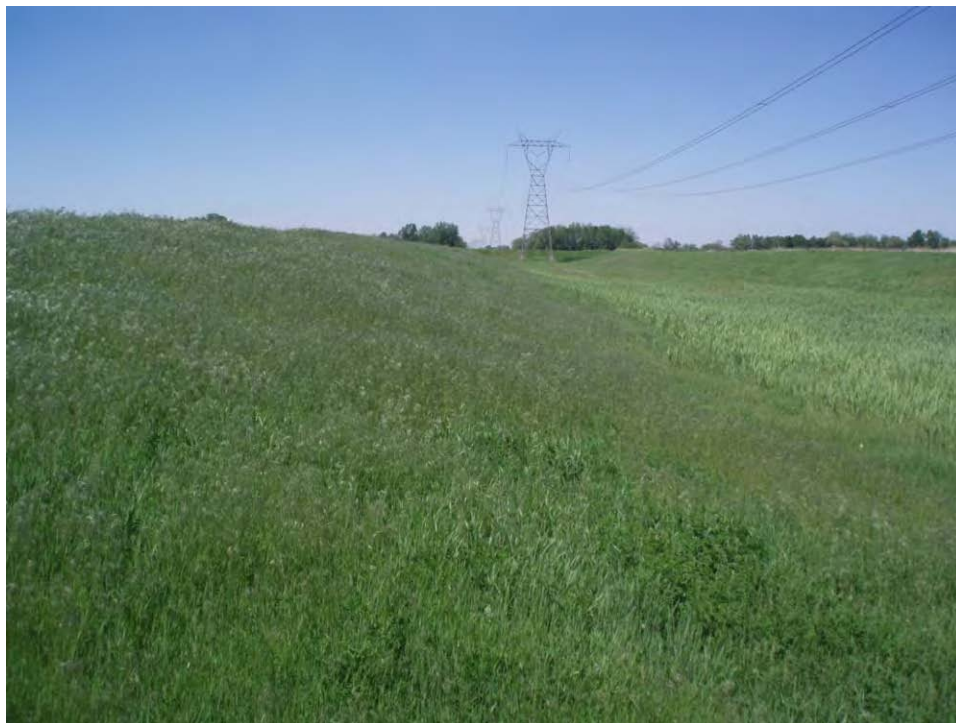
55. Pond B – East embankment exterior slope, looking north.

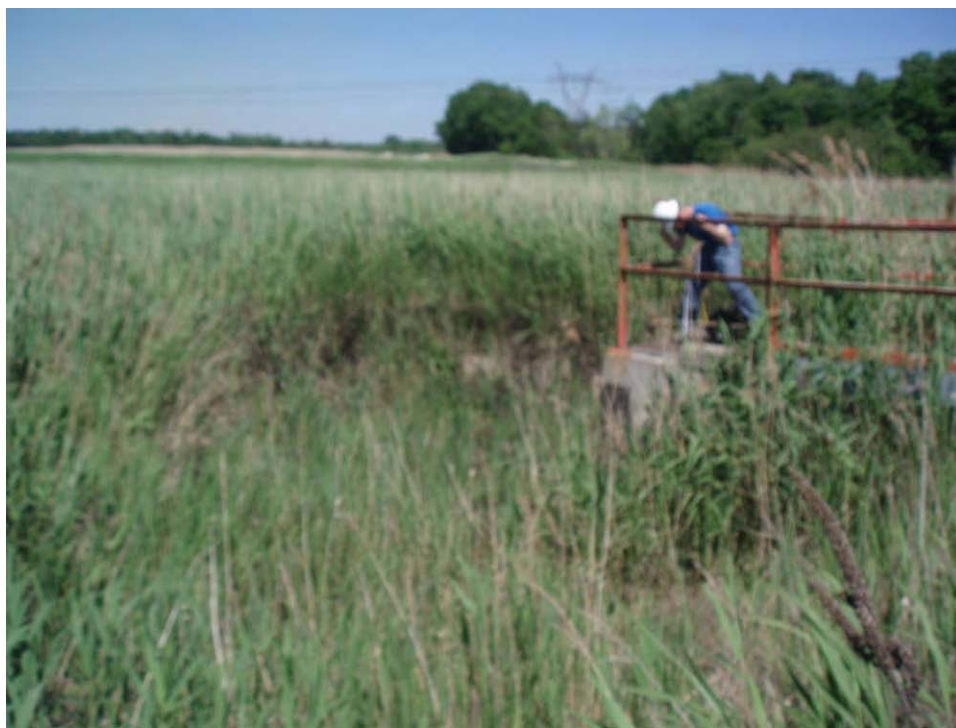
56. Pond B – Overview of outlet control structure with stoplogs, looking east.

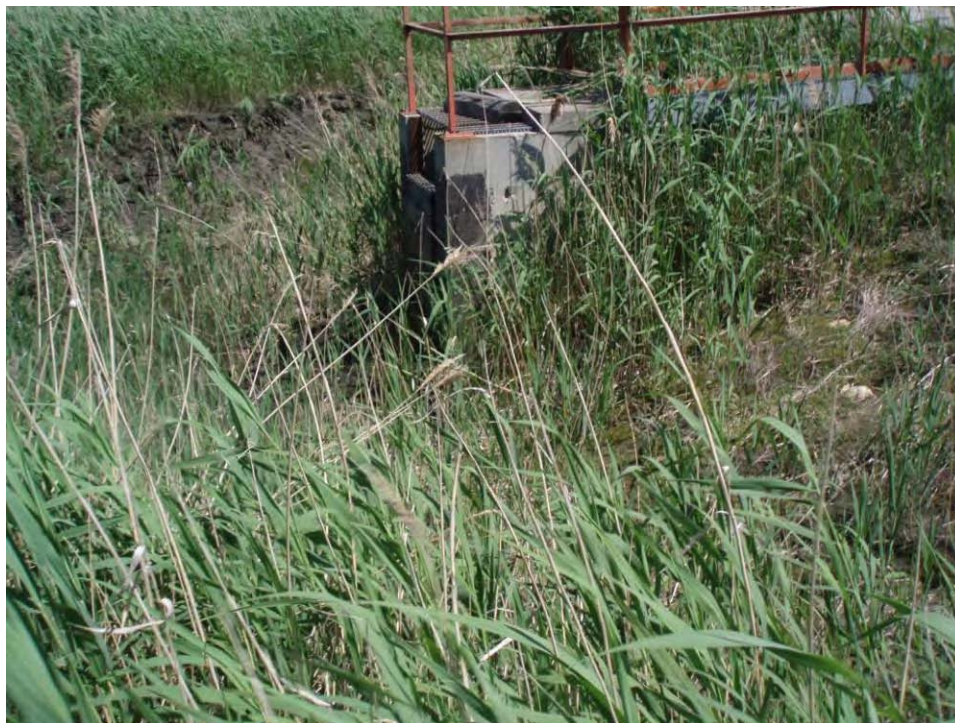
57. Pond B - Overview of outlet control structure with stoplogs, looking east.

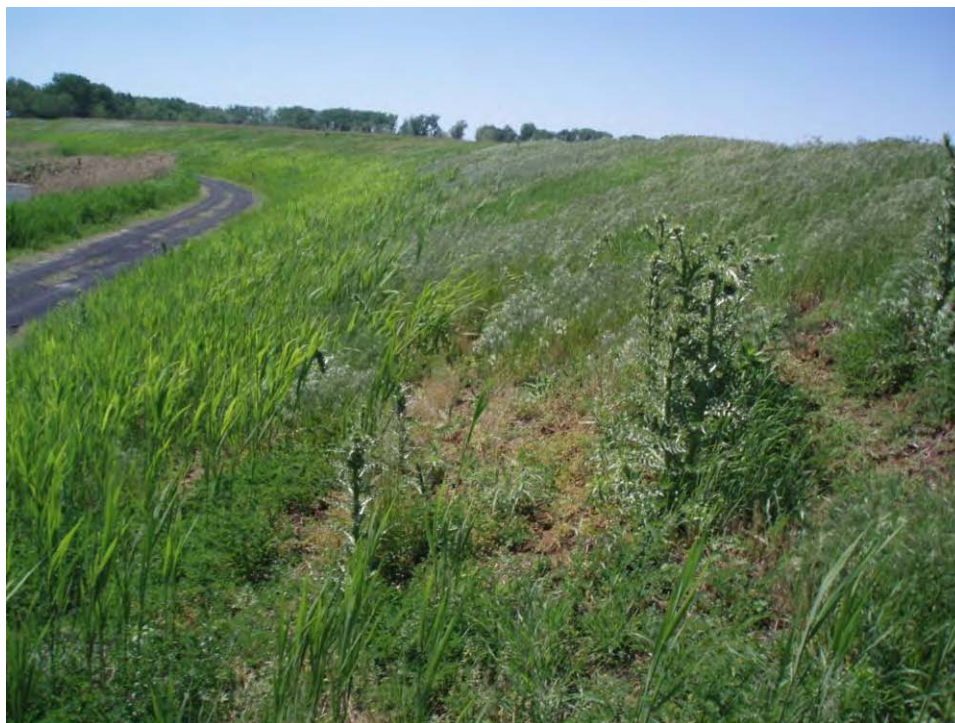
58. Pond B - South embankment exterior slope, looking west at tractor rutting and minor surficial erosion. Note change in vegetation at mid slope and stabilized FGD material very soft.
