# **Assessment of Dam Safety of Coal Combustion Surface Impoundments**

**Indianapolis Power & Light Company**

**Petersburg Generating Station**

**November 15, 2010**

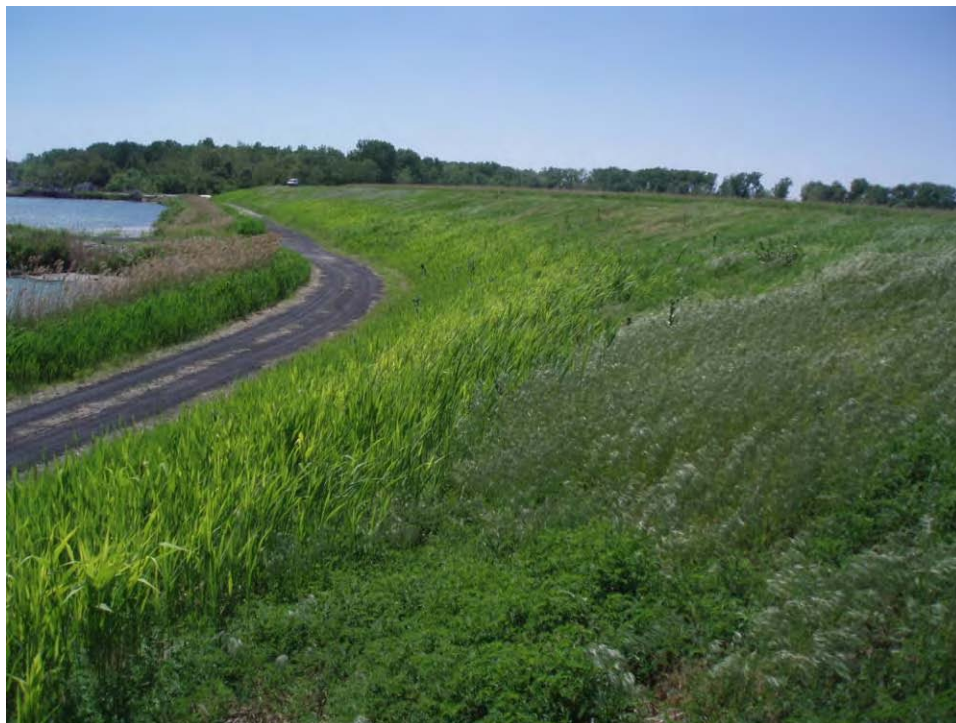
59. Pond B - South embankment exterior slope, looking west. Note change in vegetation at mid slope and stabilized FGD material is very soft.

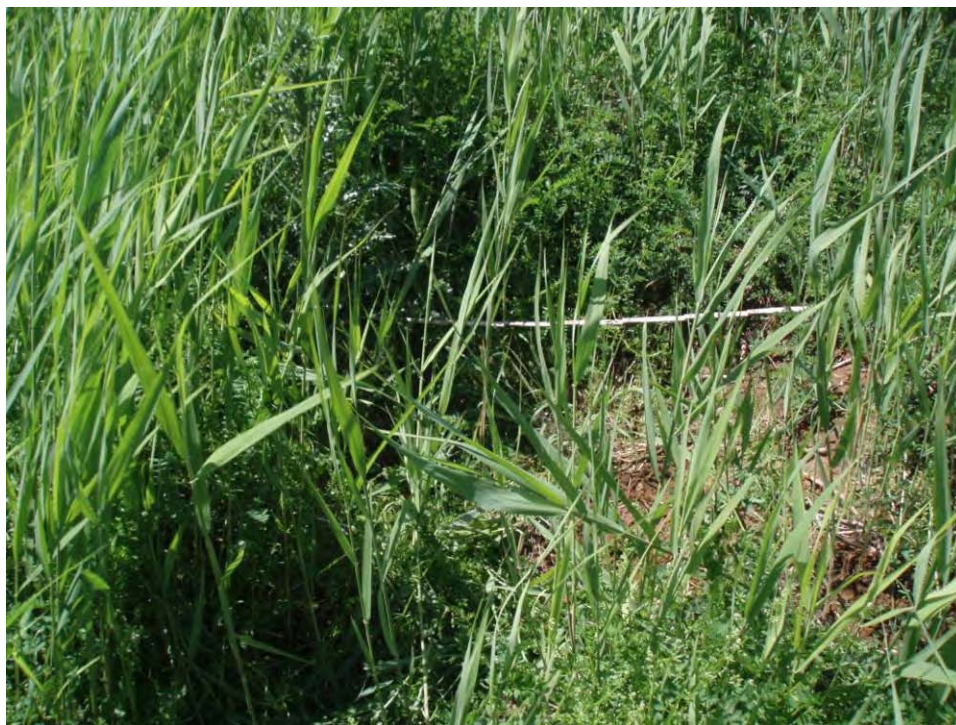
60. Pond B - South embankment exterior slope, looking north at 4'Wx1'D erosion feature.

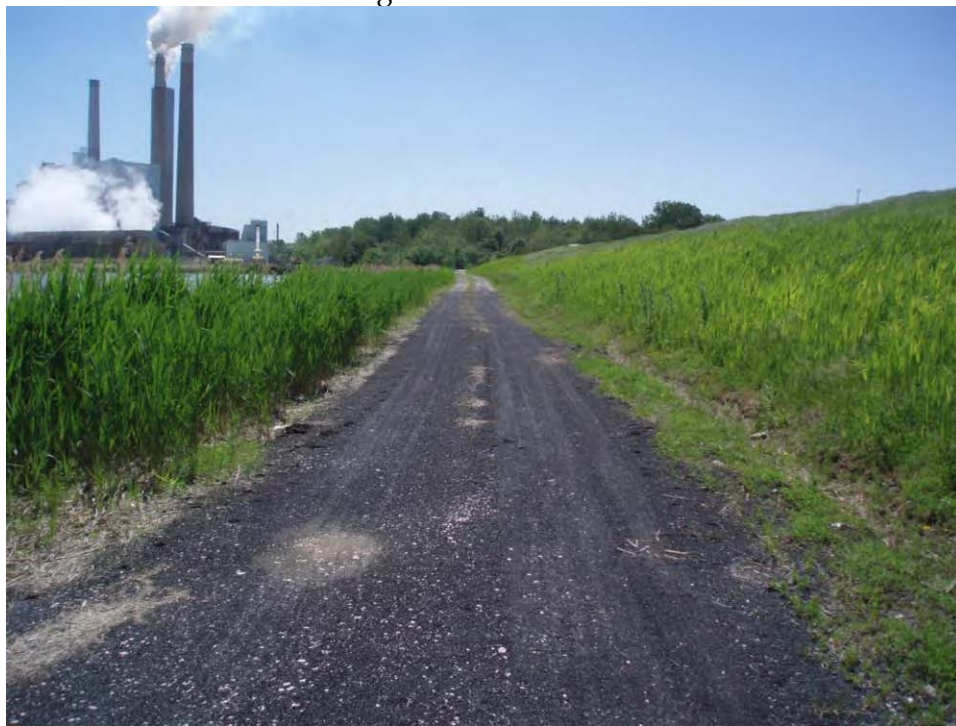
62. Pond A - Discharge north crest and Pond B south embankment toe, looking west.

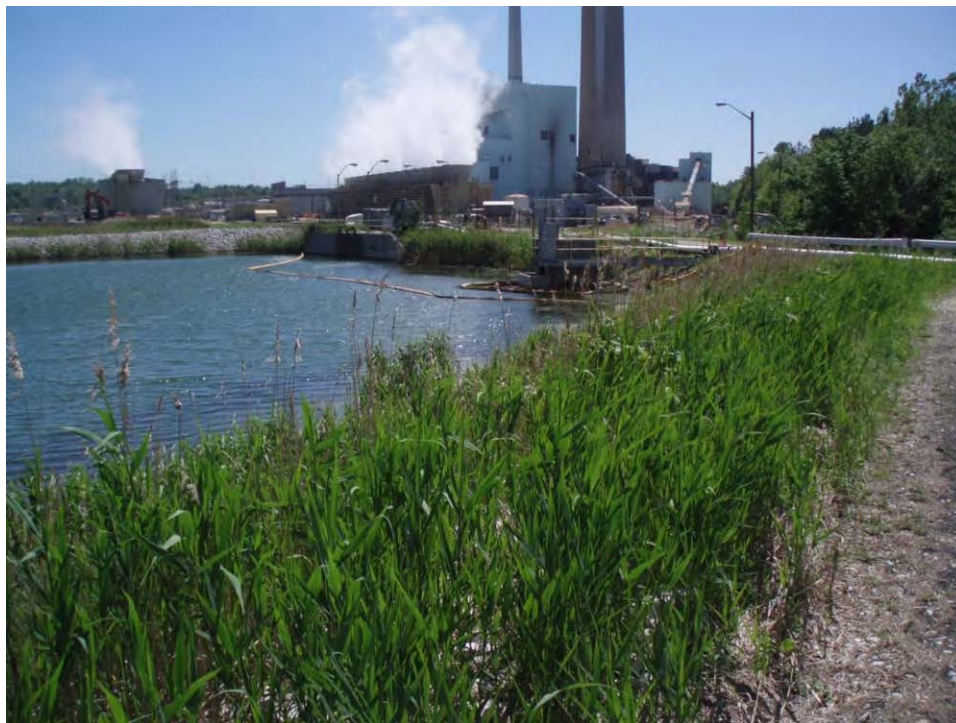
65. Pond A - Discharge, looking southwest at outlet structure and recycle pump station.

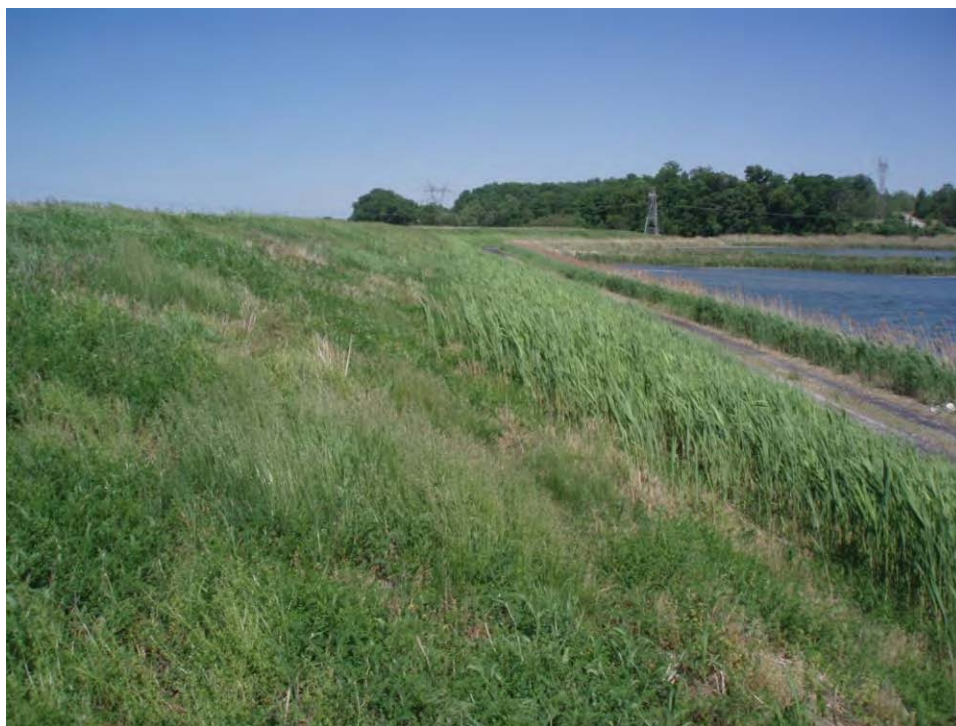
66. Pond B - South embankment exterior slope, looking northeast.

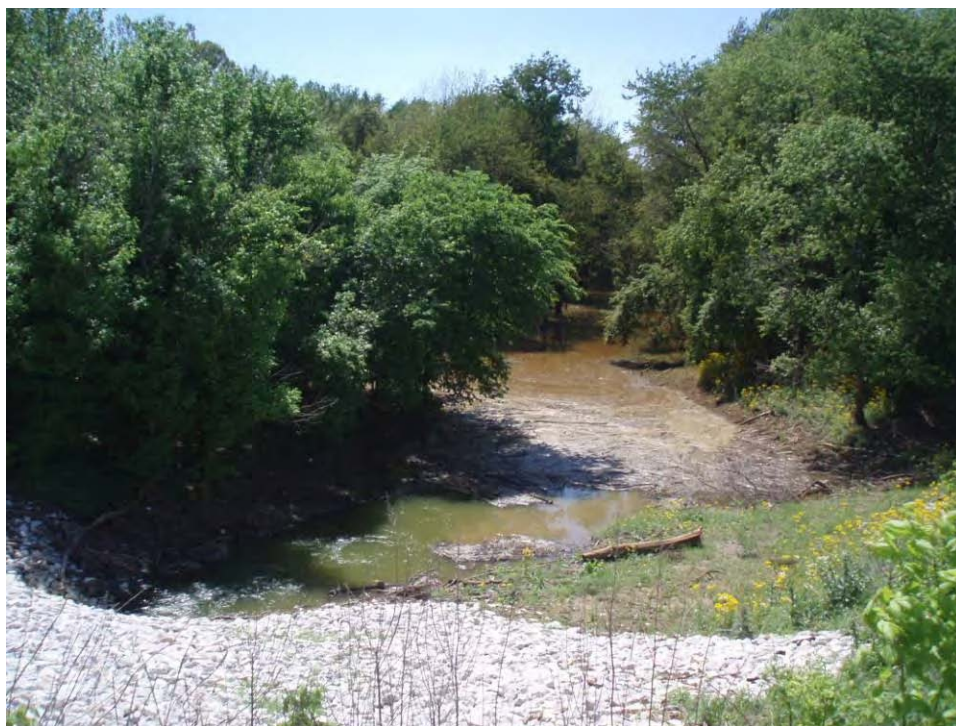
68. Pond A - Discharge, looking west at discharge canal to the White River.

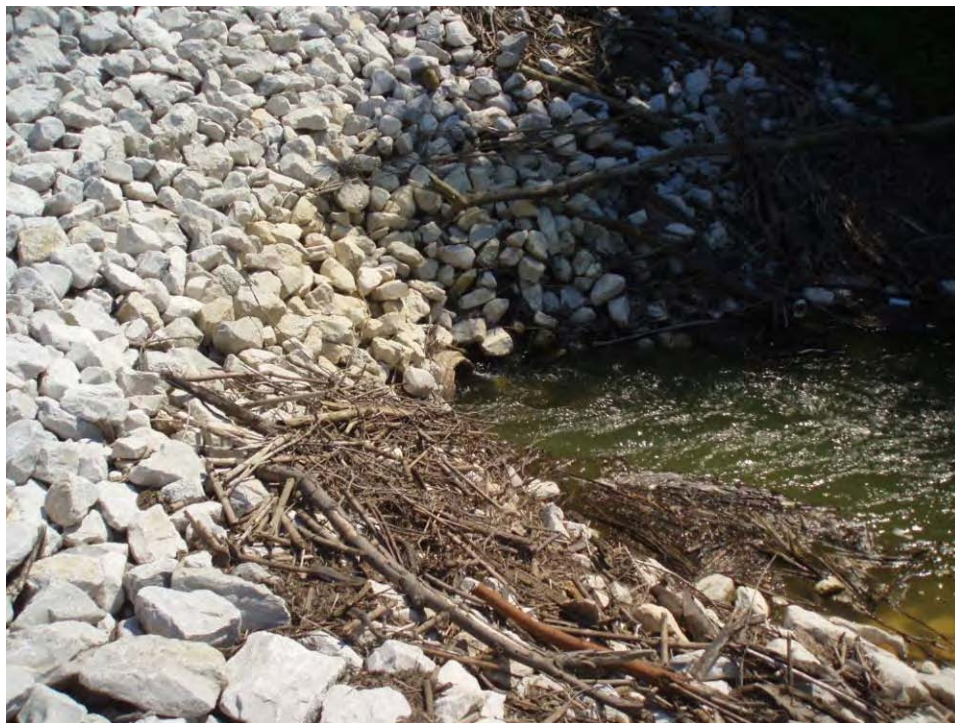
69. Pond A - Discharge, looking south at 24-inch-diameter RCP outlet pipe.

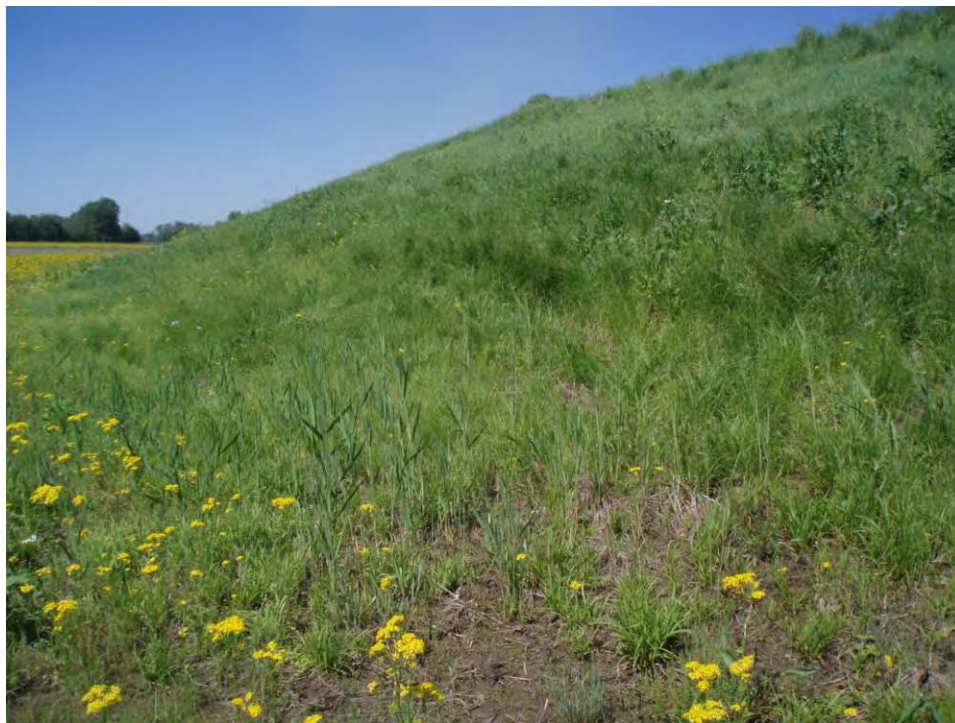
73. Pond B - West embankment lower exterior slope, looking north at saturated area at toe of slope.

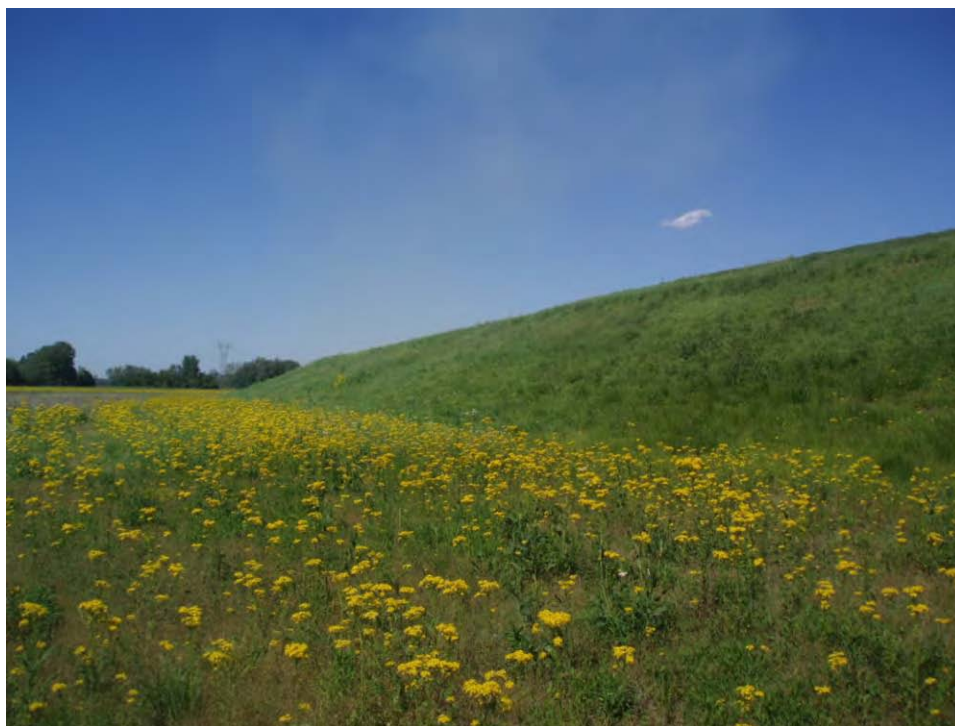
74. Pond B - West embankment, looking north at downstream area in flood plain. Note field area is saturated and wet from recent storm events.

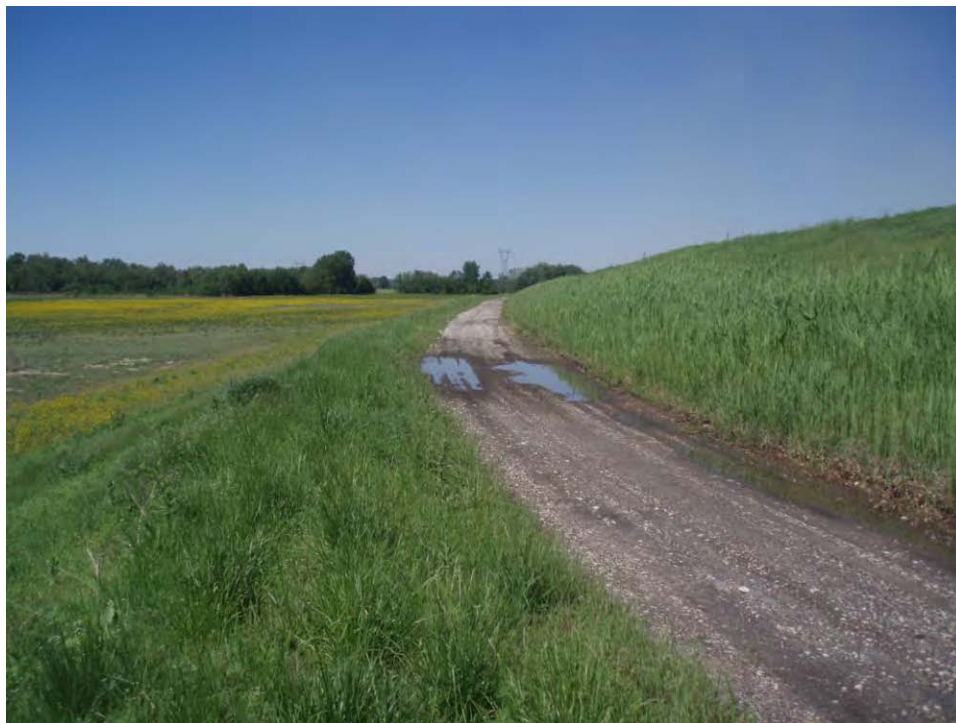
75. Pond B - West embankment bench, looking north. Note inside of bench is wet from recent storm events.

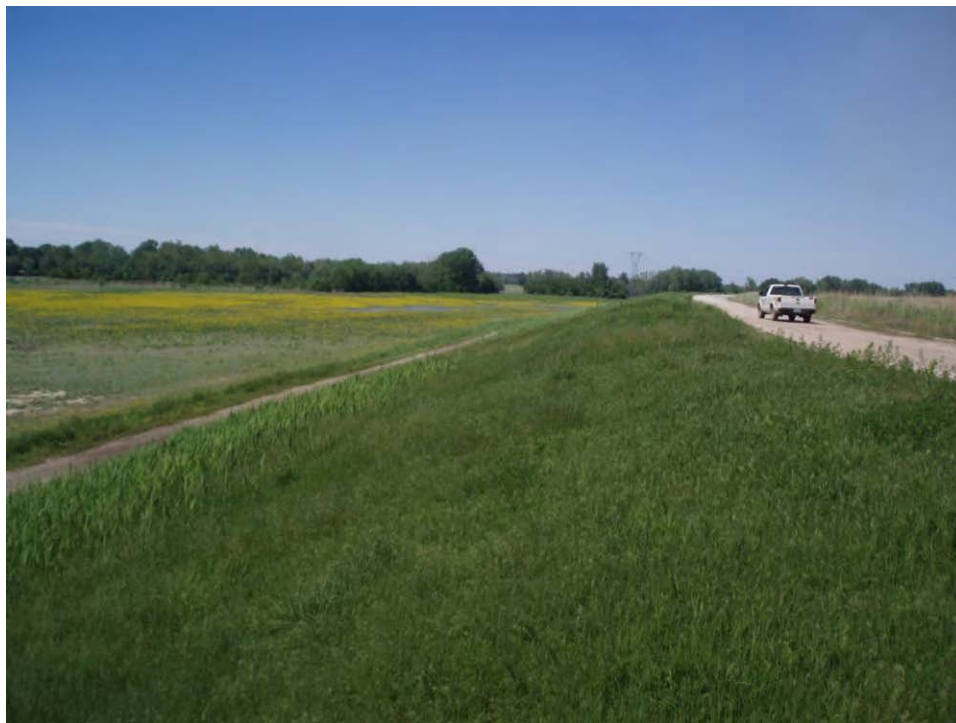
77. Pond B - West embankment upper exterior slope, looking north.

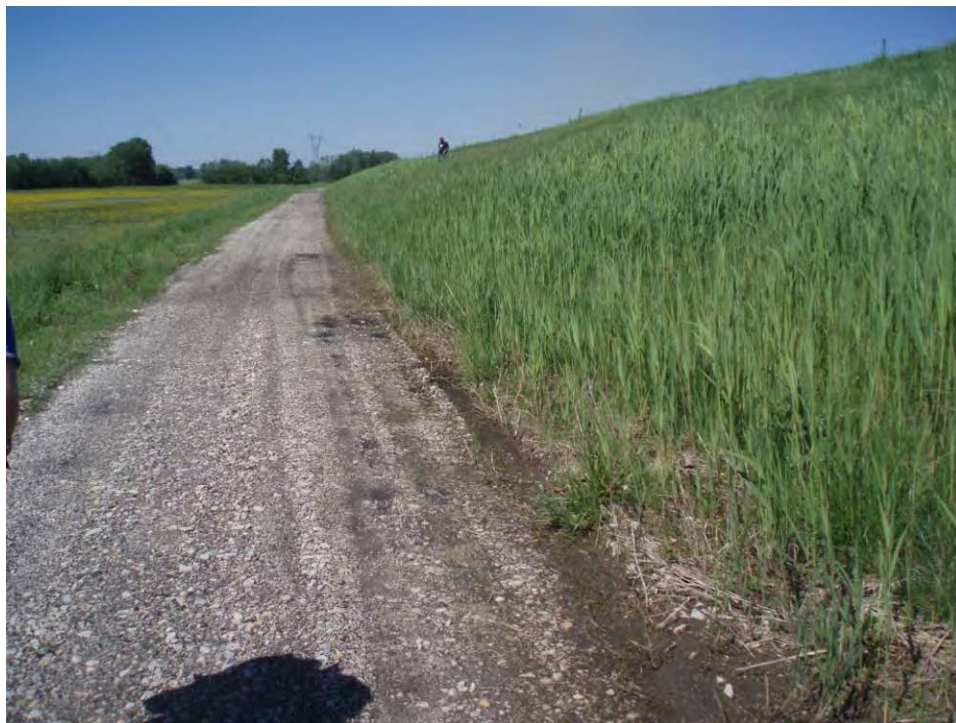
79. Pond B - West embankment bench, looking north at possible seep. Note area is soft and saturated.

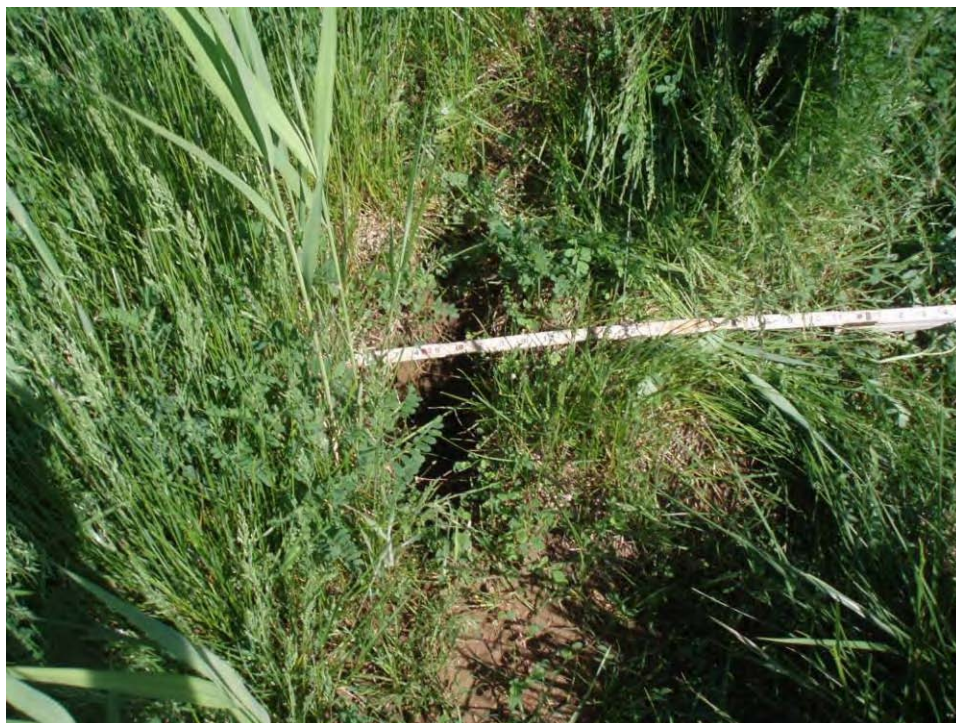
86. Pond B - West embankment upper exterior slope, looking at an 8-inch-diameter rodent hole.

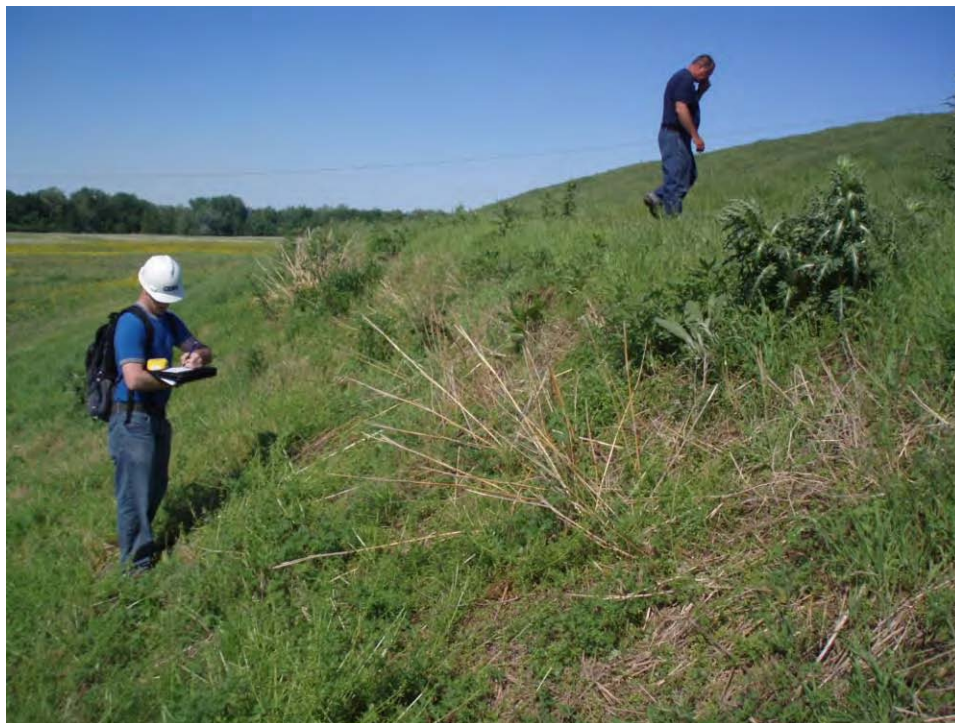
87. Pond B - West embankment lower exterior slope, looking north at over-steep slope and tractor ruts near bench.

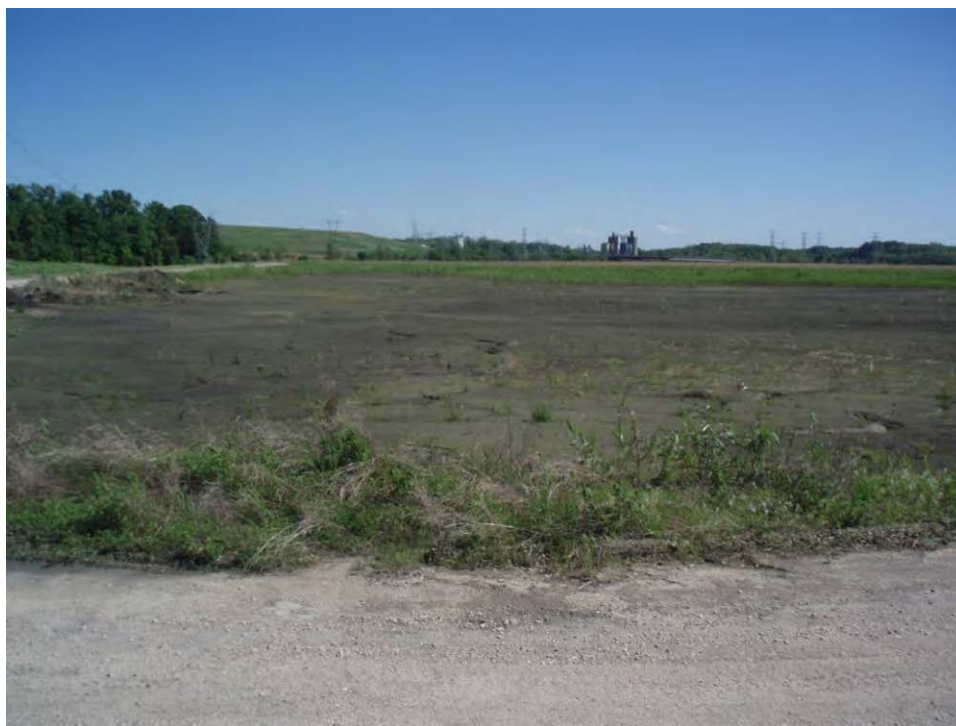
92. Overview of Pond B from northwest corner, looking southeast.

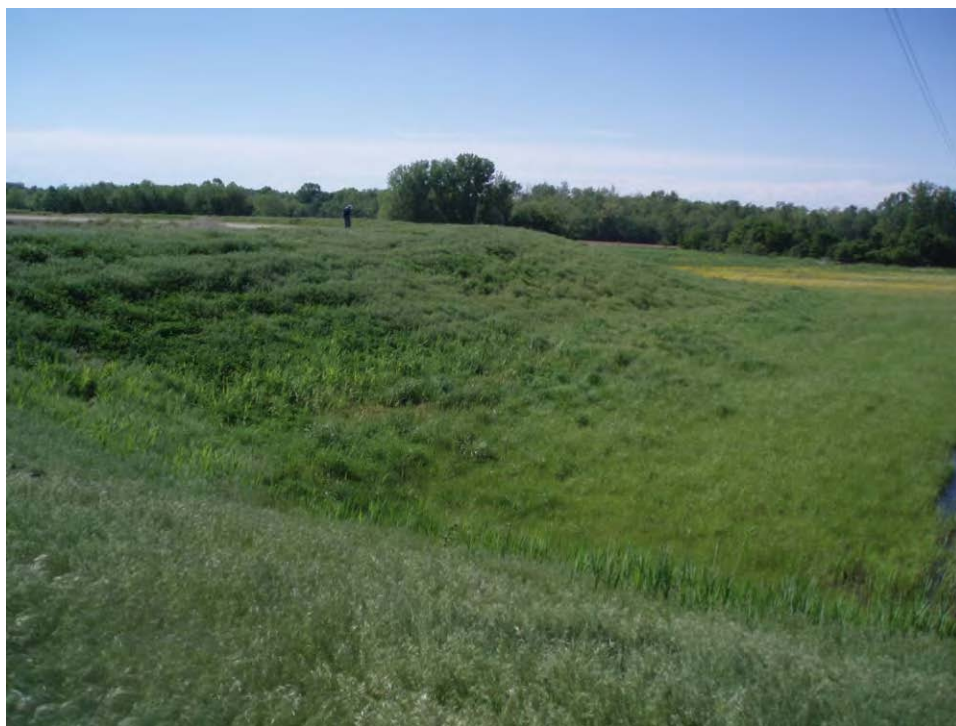
94. Pond B - North embankment exterior slope, looking northwest.

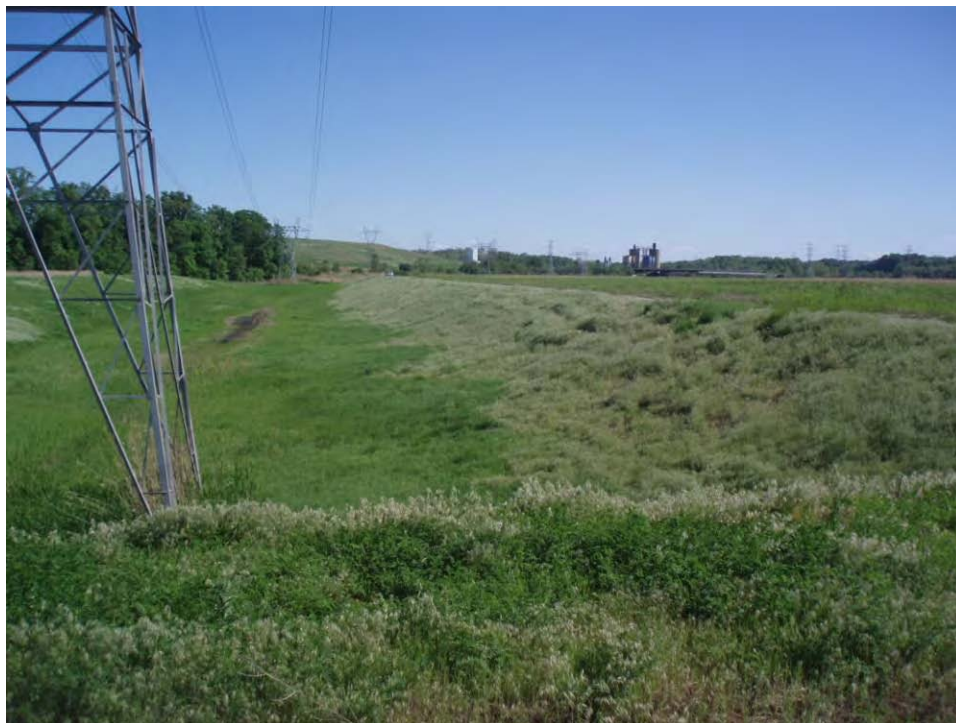
95. Pond B – North embankment exterior slope, looking southeast.

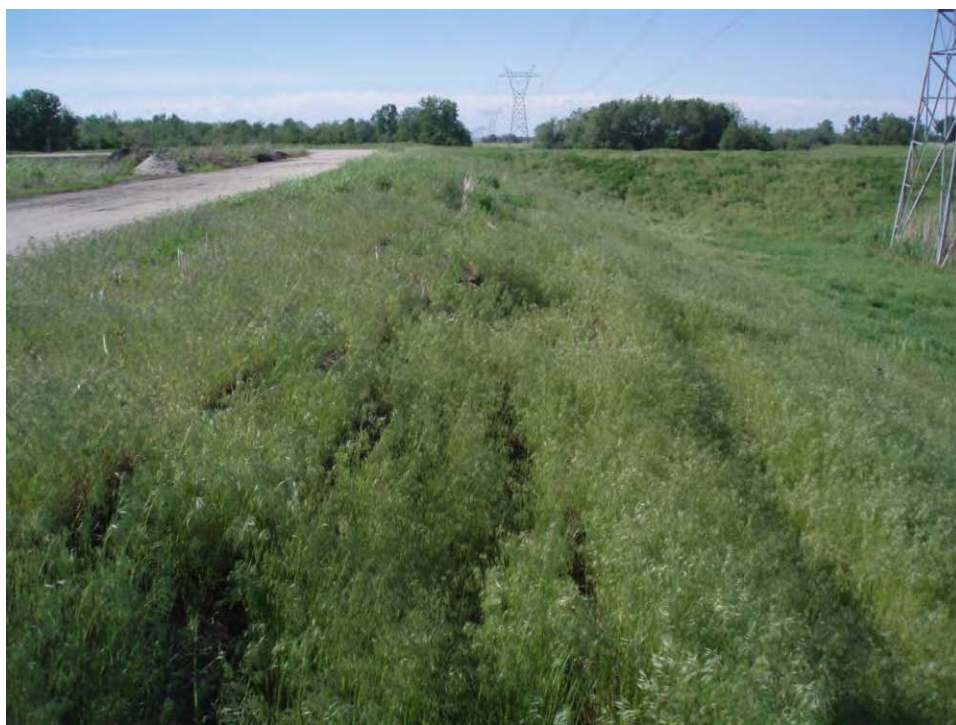
96. Pond B – North embankment exterior slope looking northwest at tractor ruts, bare spots, very soft stabilized FGD.

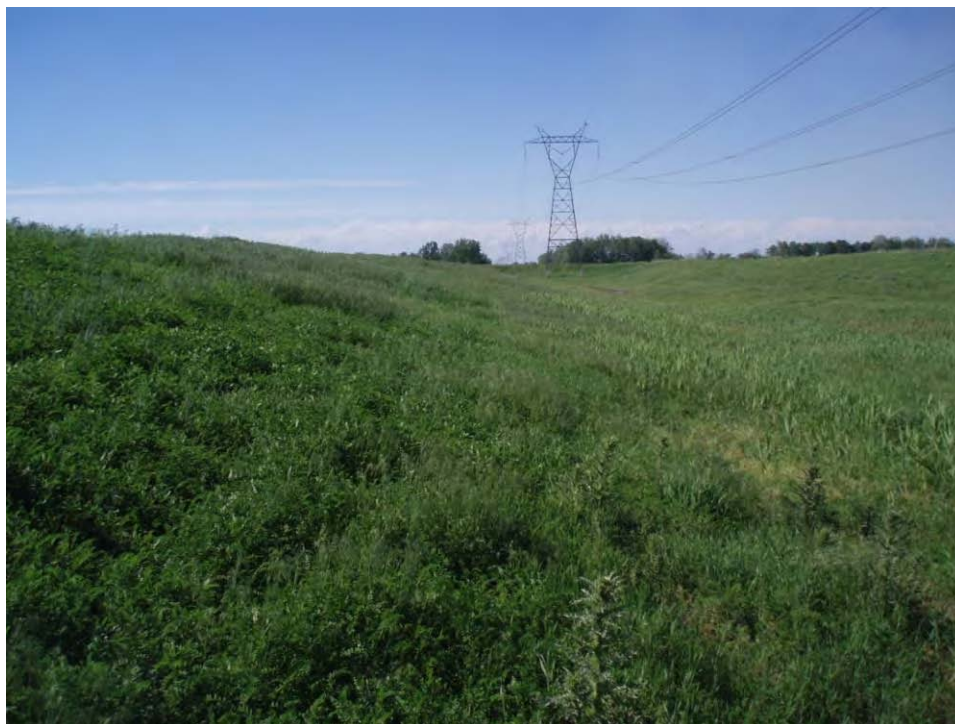
97. Pond B - North embankment exterior slope, looking northwest.

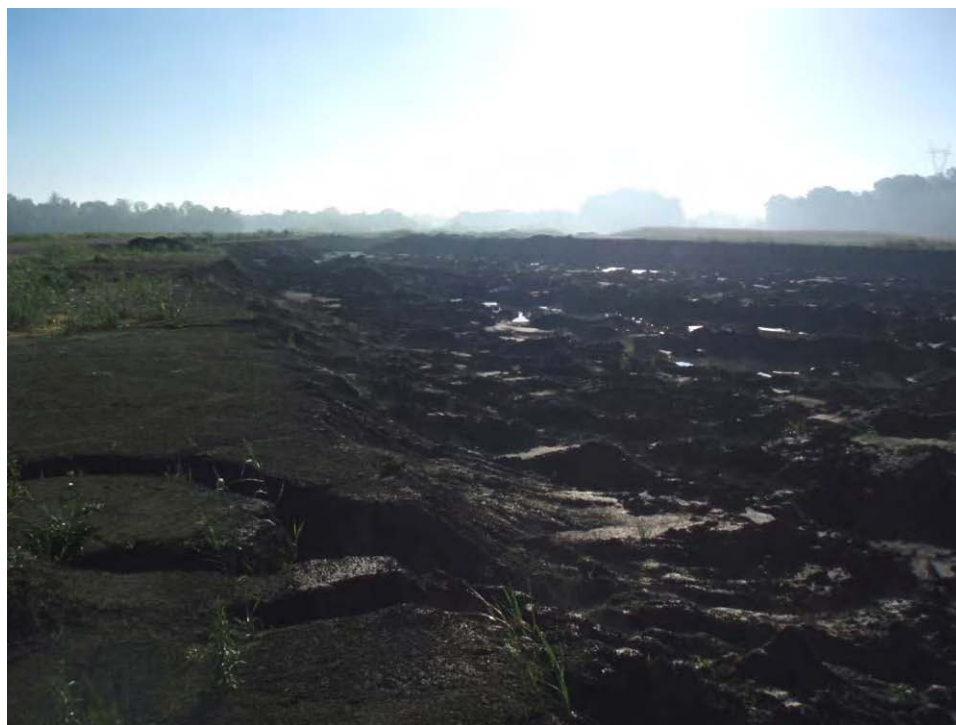
104. Overview of Pond C from northeast corner, looking east.

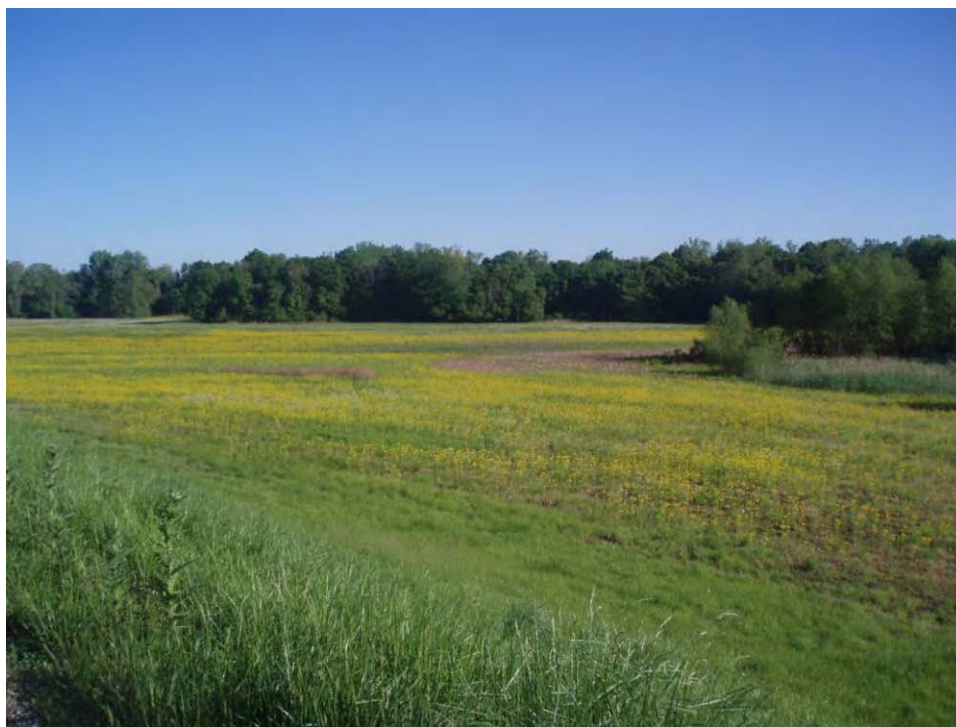
124. Pond C - North embankment, looking north at downstream area.

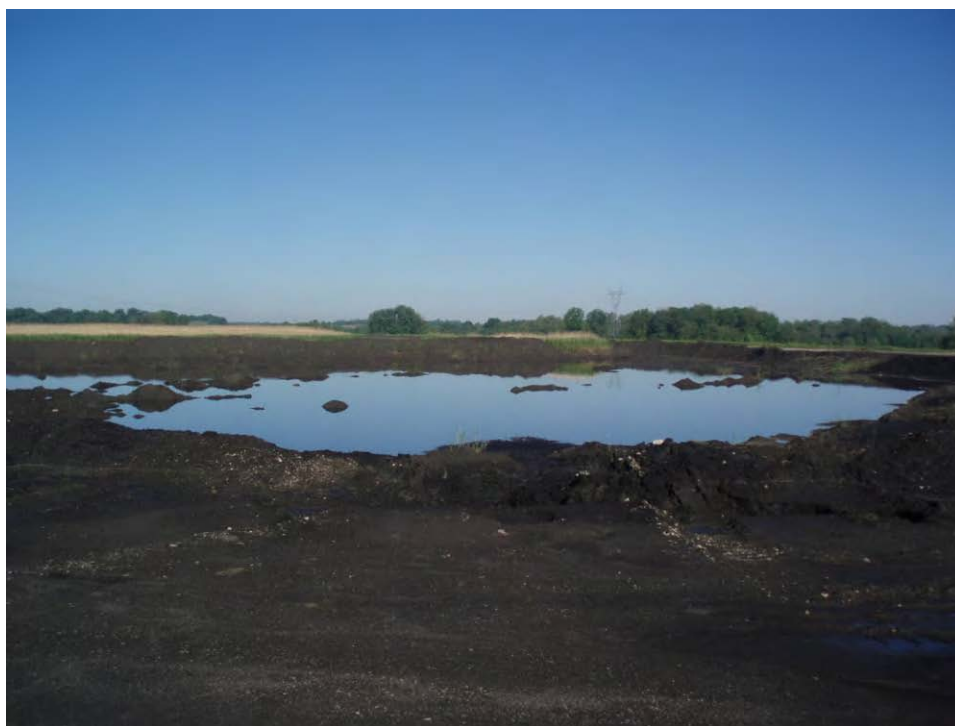
126. Overview of Pond C from northeast corner, looking northwest.

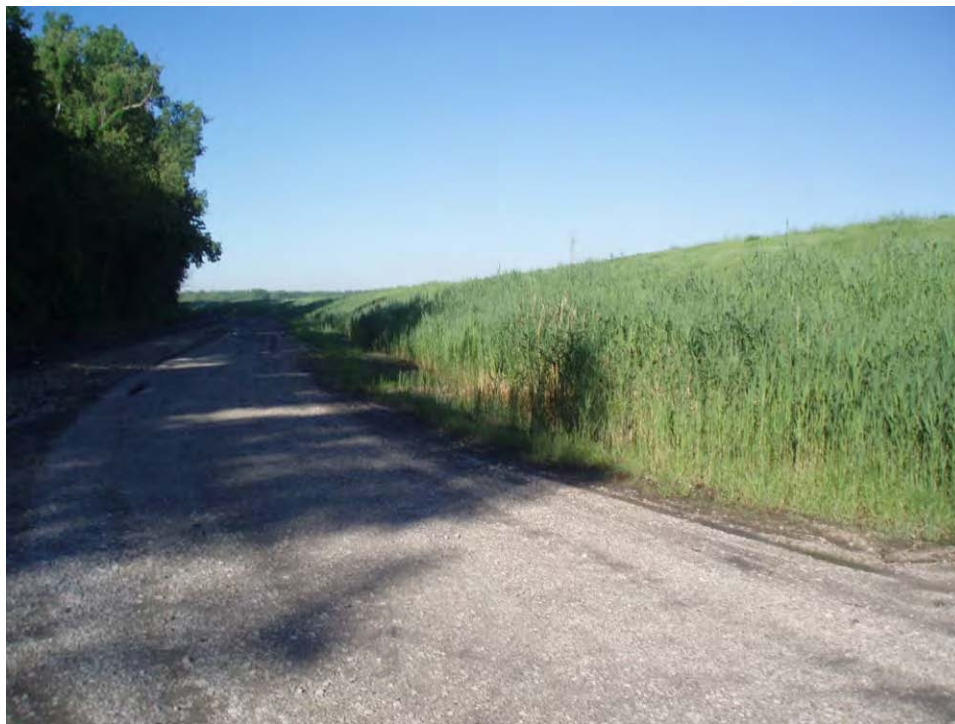
127. Pond C - East embankment exterior slope and drainage ditch, looking southwest. Note water level in drainage ditch approximately 1.5' below roadway and 5'-8' tall vegetation on lower portion of the slope extending from northern corner to access ramp. Slope at drainage ditch is over-steepened.

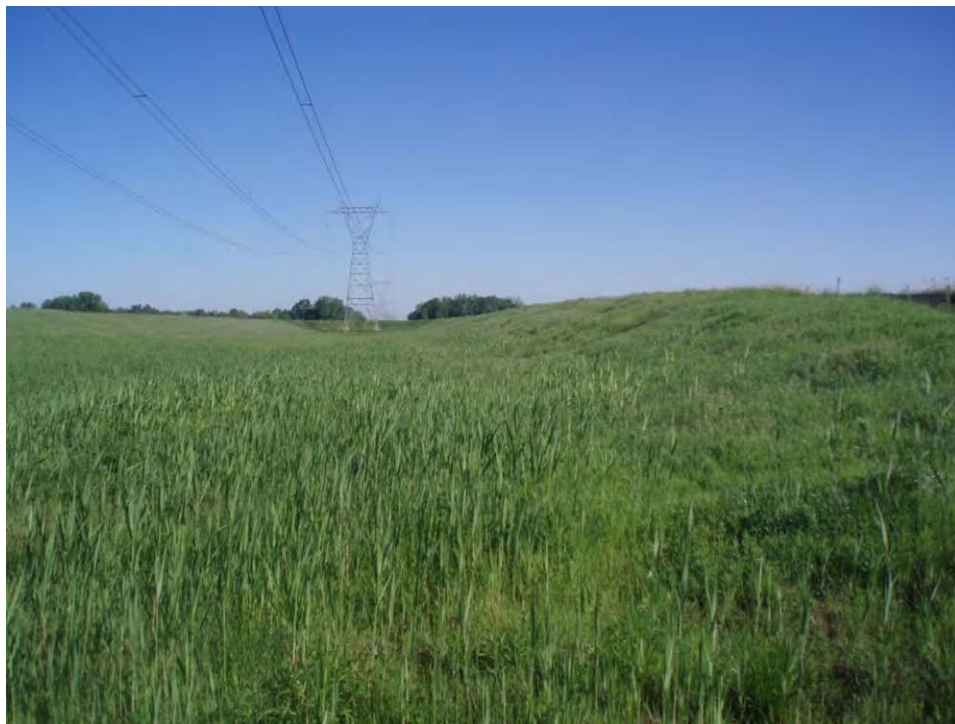
131. Overview of area between Pond B and Pond C, looking northwest. Note area between embankments is the top of the original impoundment.

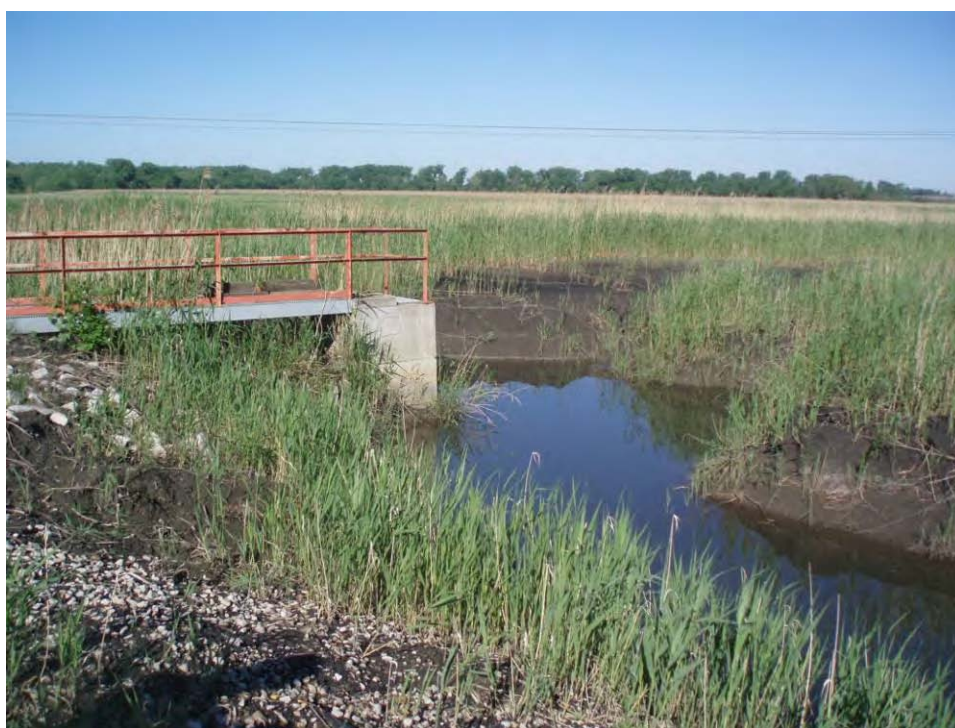
132. Pond C - Outlet structure with stoplogs, looking southwest. Note water level 6.6' below crest at outlet.

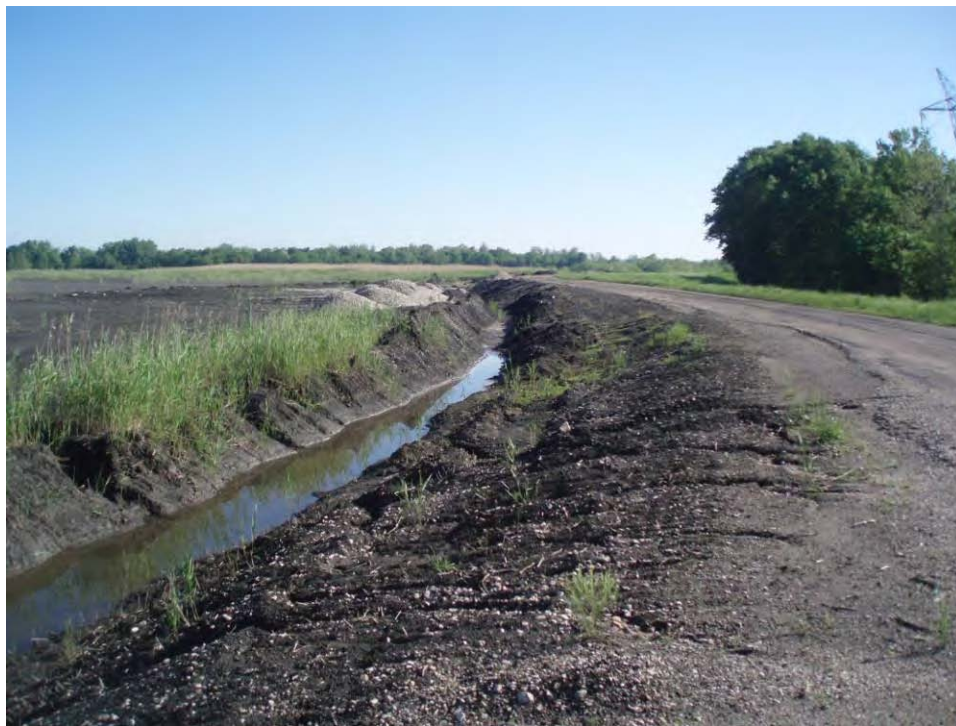
133. Pond C - East embankment interior slope, looking north at rim ditch to outlet structure.

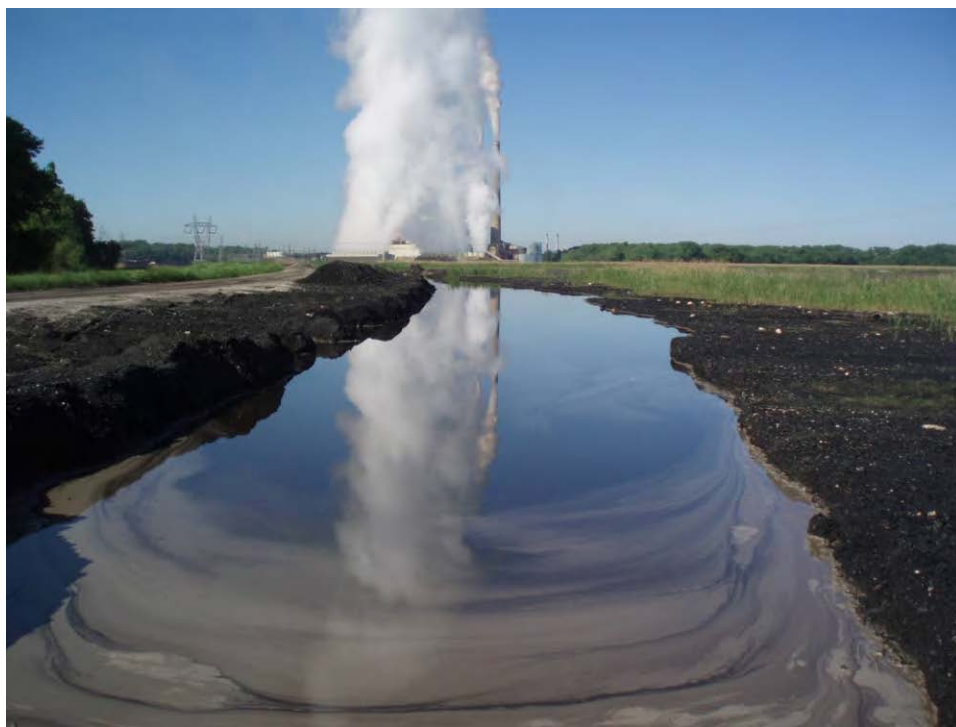
134. Pond C - East embankment interior slope, looking southwest at rim ditch to outlet structure. Note water level 3' below crest.

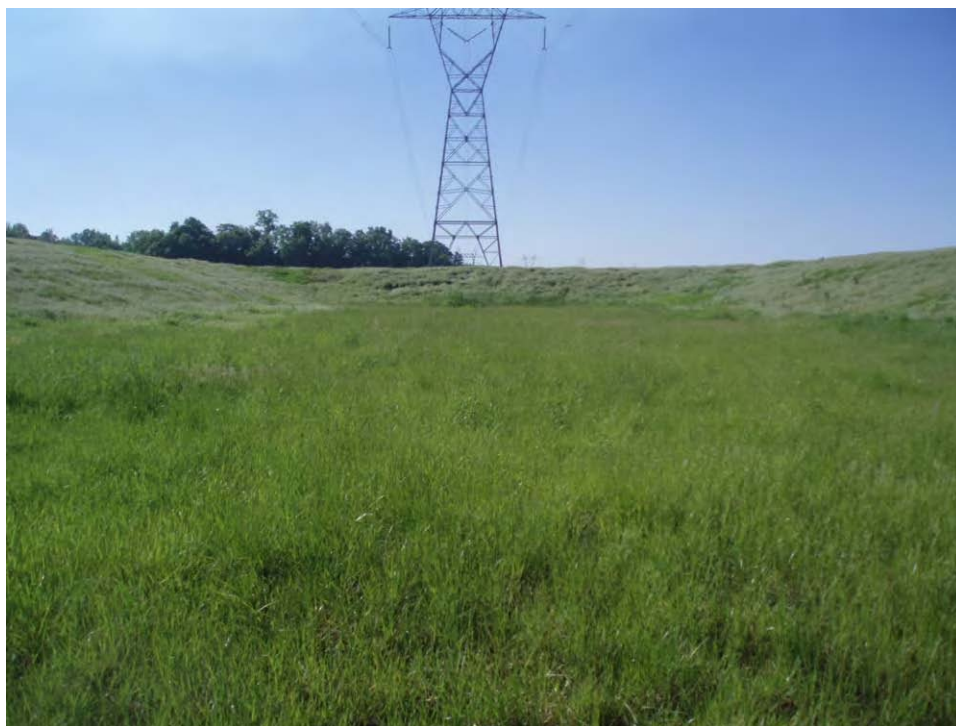
144. Low area between Pond B and Pond C, looking north at embankment between two impoundments. Note the equalizer pipe runs through the embankment.

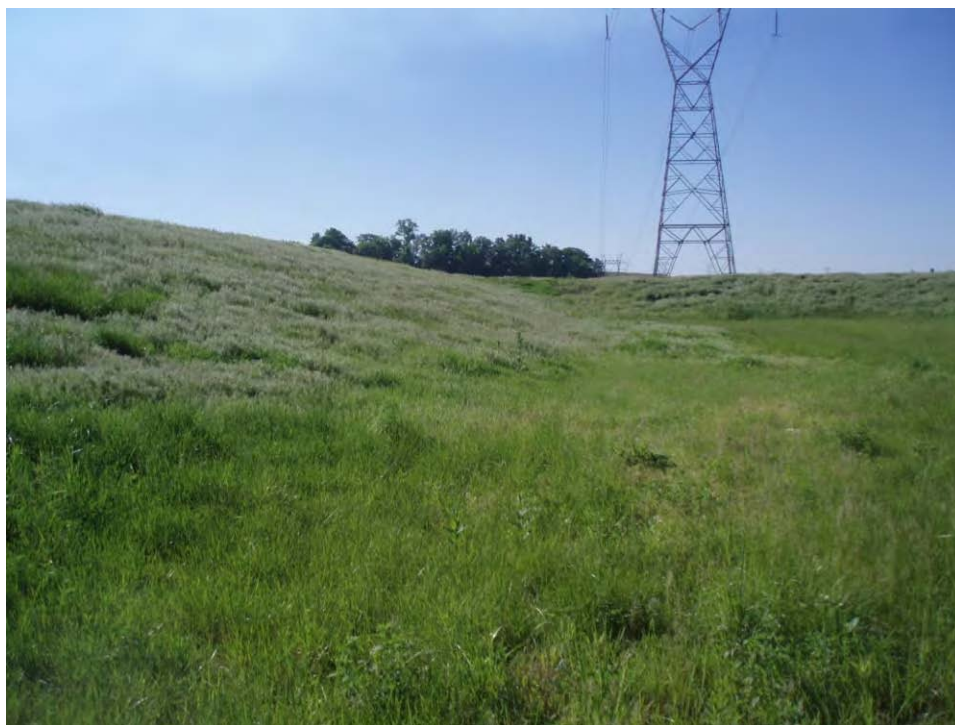
145. Pond C - South embankment exterior slope, looking southeast.

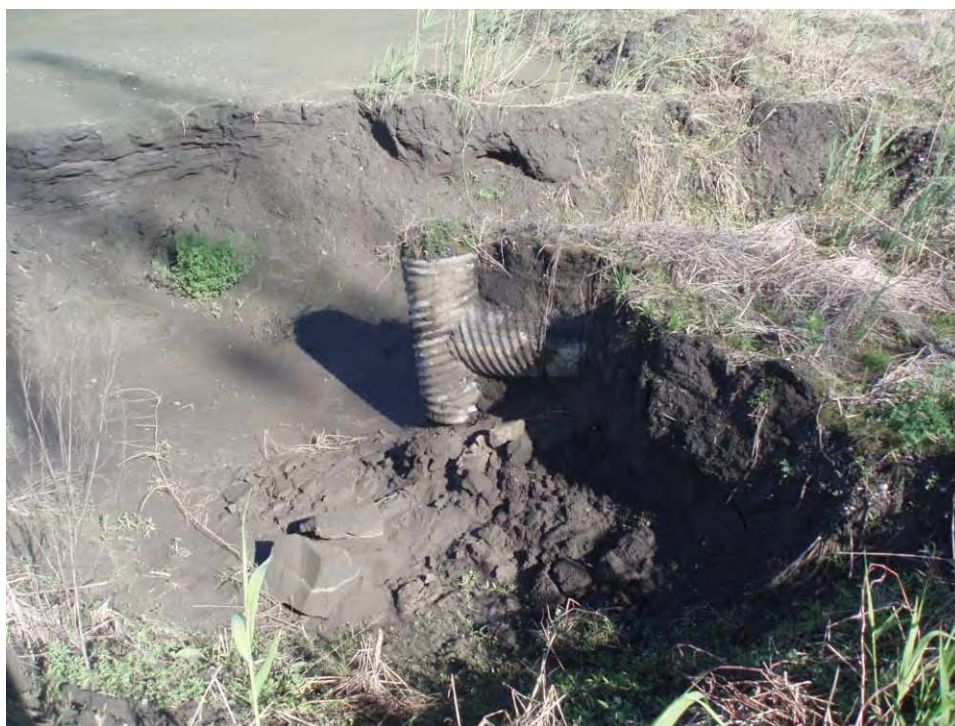
146. 24-inch-diameter CM equalizer pipe from Pond B to Pond C. Note inlet has a T connection on the end of the pipe and is filled with ash.
