Subject: EPA Comments on “Draft Coal Combustion Residue Impoundment: Round 12 – Dam Assessment Report – JB Sims Power Plant”

The design of the J. B. Sims Unit 3 project includes a two-cell bottom ash pond. The pond dikes were originally constructed with a sandy material and the pond bottom and interior slopes of the dikes were covered with 1 foot of compacted clay to seal the pond and control seepage. When the pond was initially filled with water, piping was noted around the ash water reclaim structure. Repair of the piping problem proved to be less than satisfactory. Subsequently, it was noted that the pond was leaking along the perimeter.

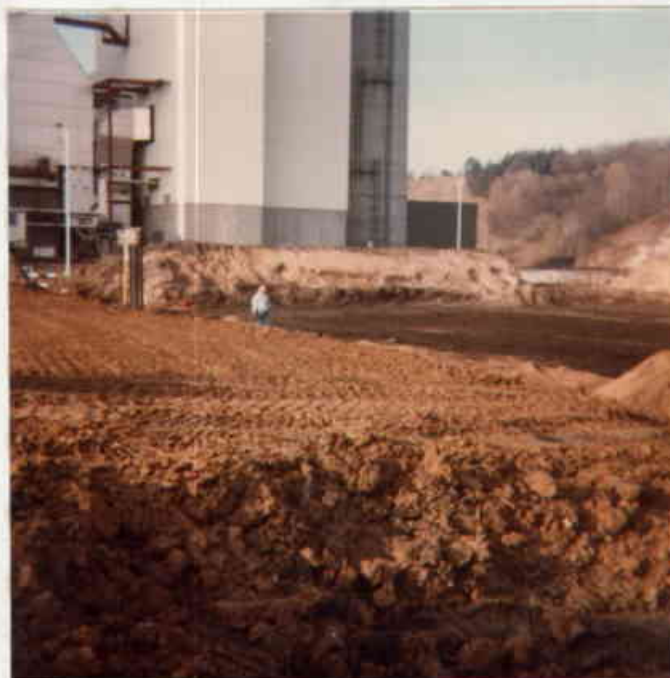
5. Sheet steel cutoff wall
in place at reclaim structure.

Pressure grouting procedures were monitored to assure that the voids under the ash water reclaim structure caused by earlier settlements were filled with grout. To prevent piping under the ash water reclaim structure, a sheet pile cutoff wall was constructed around the base of the reclaim structure.

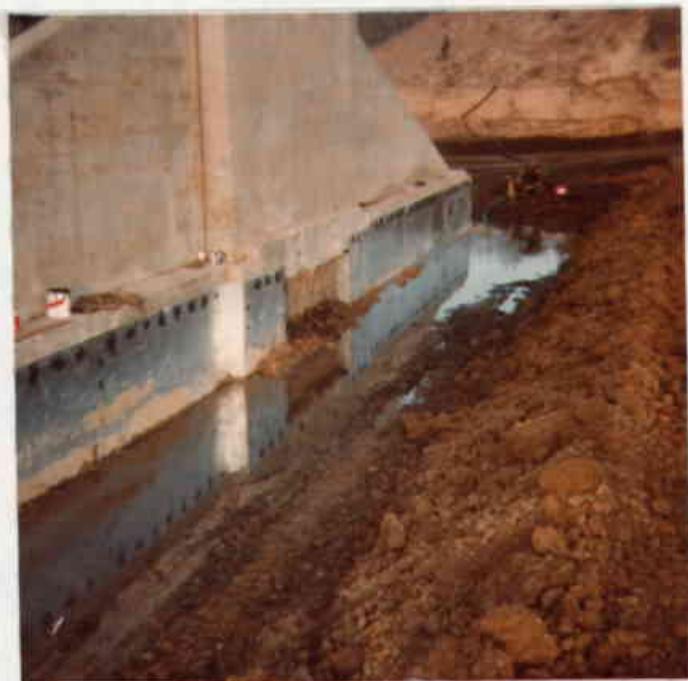
6. North side of the ash water
reclaim structure with cutoff
wall bolted in place.

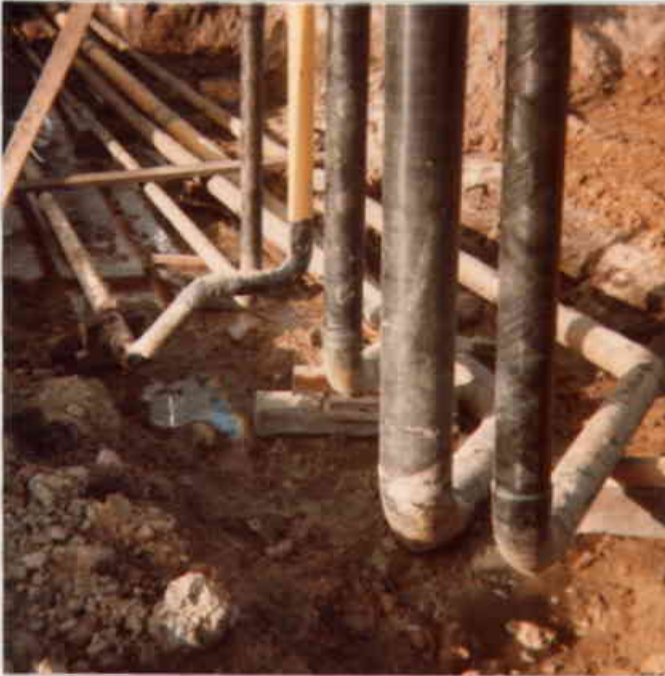
11. Raising the existing piping in the south end of the ash ponds.

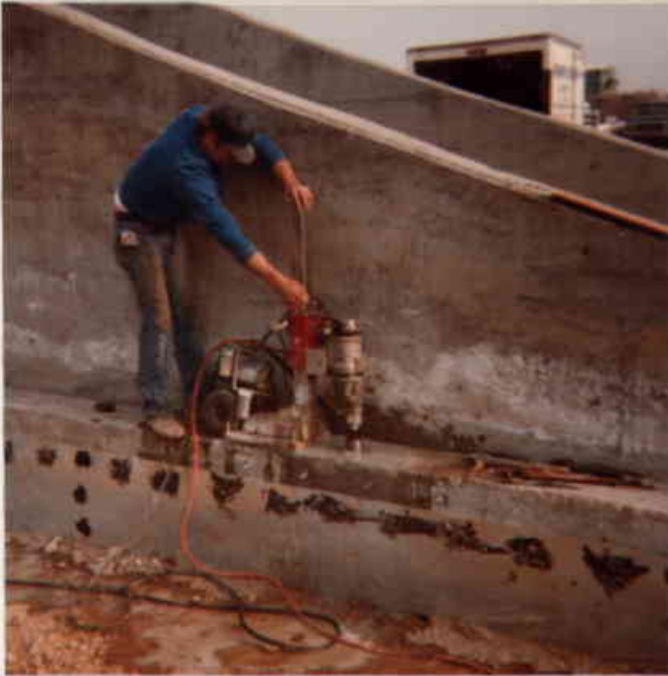
15. Coring through the concrete slab of the ash water reclaim structure for pressure grouting of voids beneath slab.

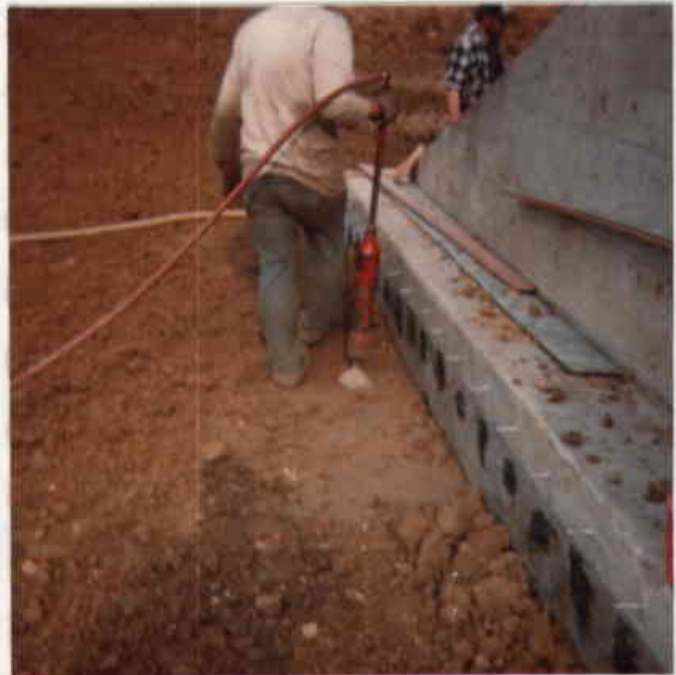
17. Installing additional bolts through the sheet steel cutoff wall.

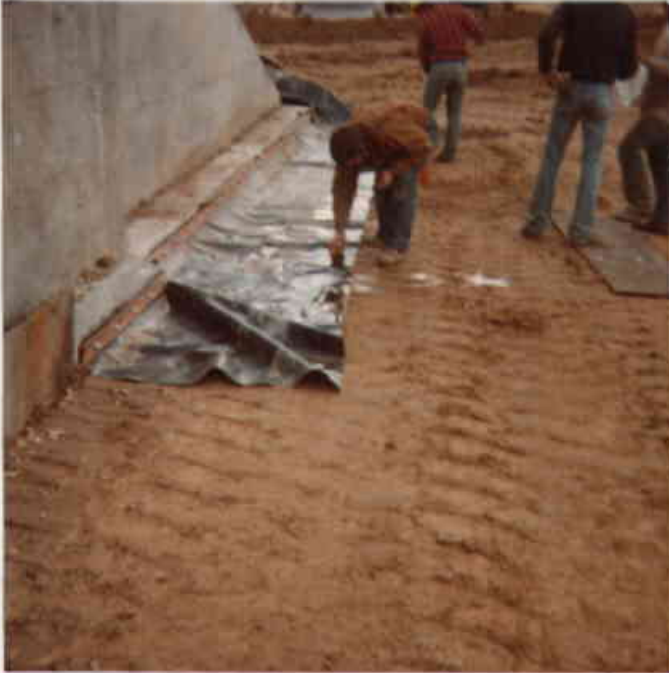
Cool temperatures caused difficulty in seaming the Hypalon. Solved by the application of artificial heat.

23. Cleaning the hypalon prior to seaming.

24. Heat lamps and pads used to supply artificial heat during the hypalon seaming process.

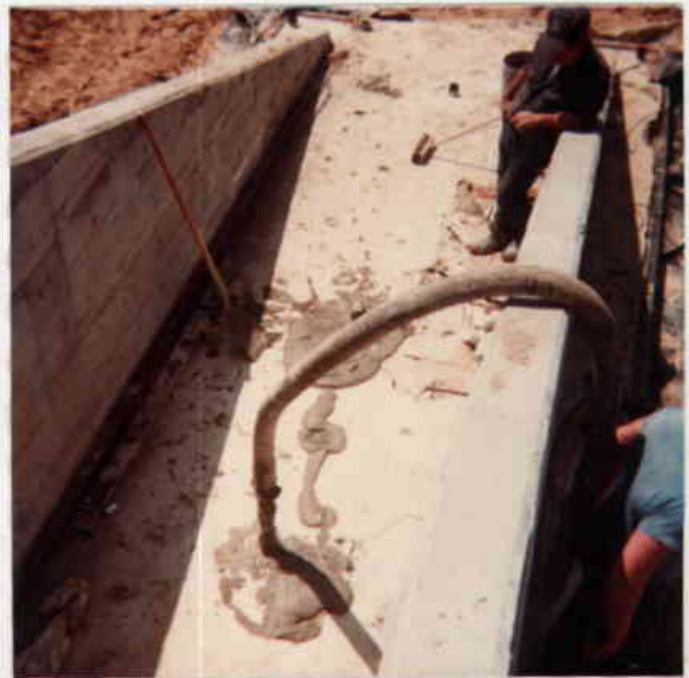
23. Pressure grouting under the ash water reclaim structure.

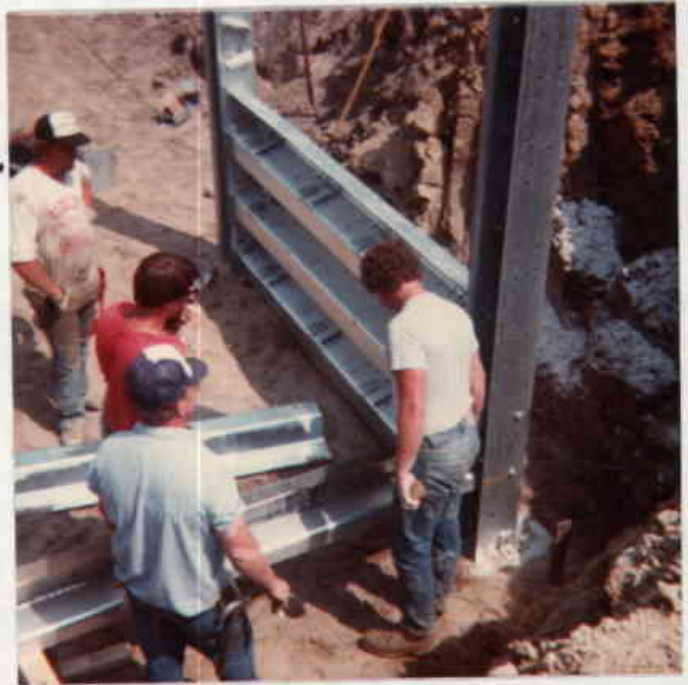
44. Bin-Wall construction, Mid June.

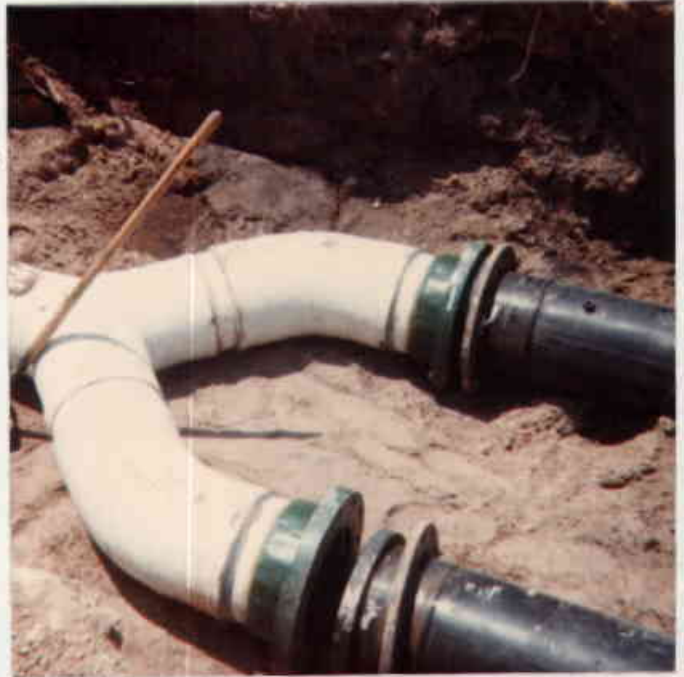
48. Sand backfill being placed around the ABCO piping. Clay backfill was used around the polyethylene piping.

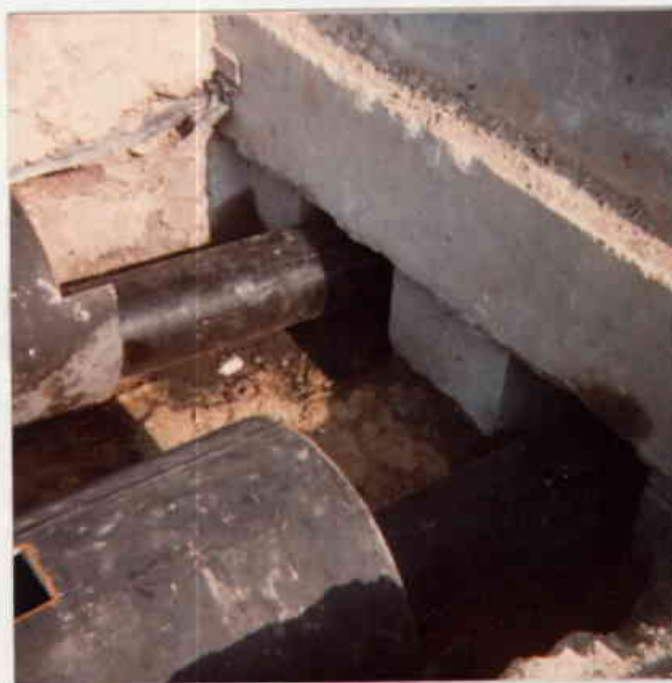
51. 12" \emptyset polyethylene piping grouted in place. The holes in the culverts are to be used to pump in bentonite slurry.

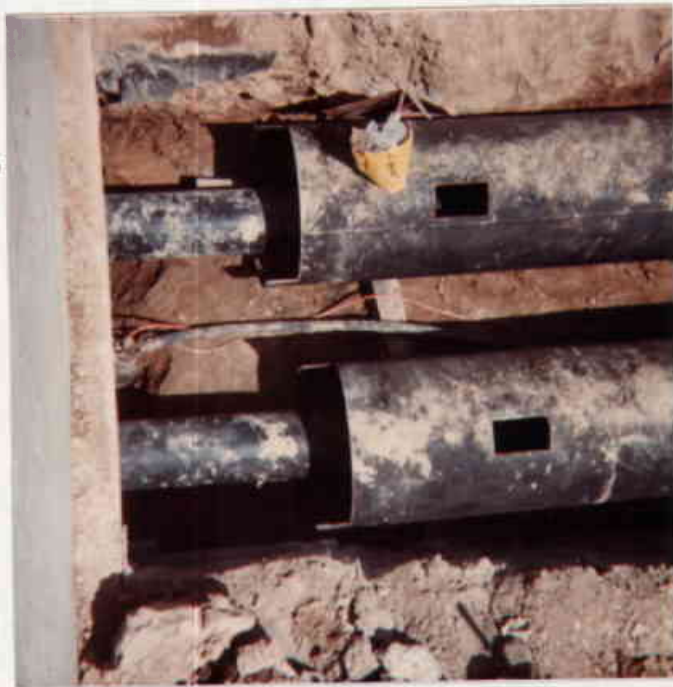
52. Culvert ends capped with celotex and plywood to allow free movement of the culvert around 12" \emptyset polyethylene pipes.

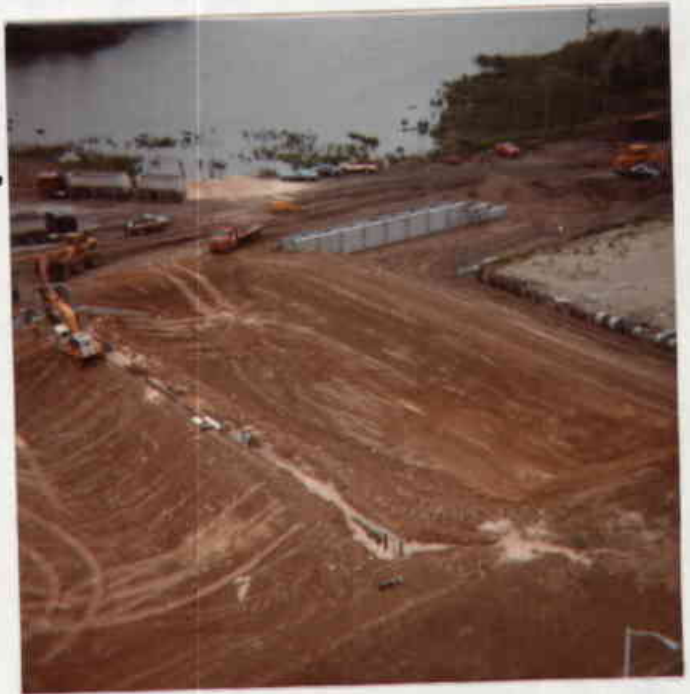
68. West pond construction progress. Late June

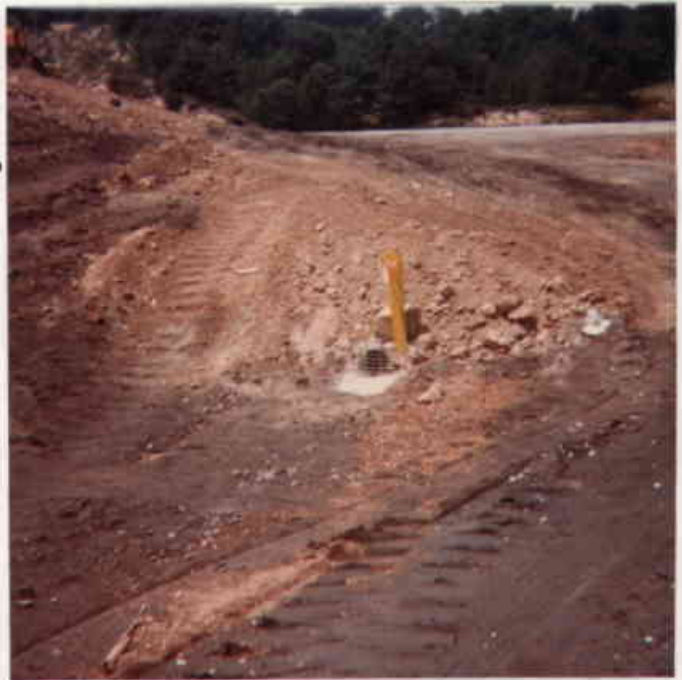
83. 6" ASA-B bond strand
drain line exit point.
Picture is oriented
along the north dike
toe.

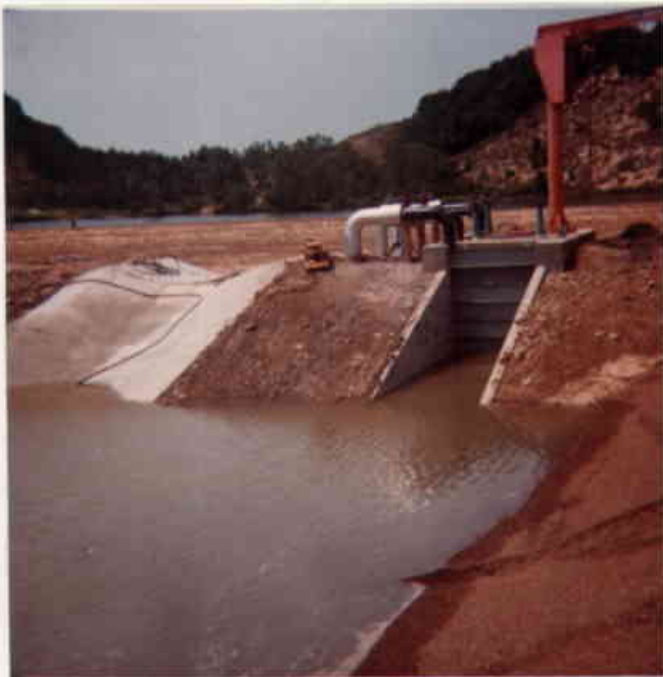
84. East pond partially filled
with water and ready for
use.
